UPDATED SEISMIC FRAGILITY FOR WATER AND SEWER PIPELINES

J. Eidinger¹

¹ G&E Engineering Systems Inc., Olympic Valley, USA, eidinger@earthlink.net

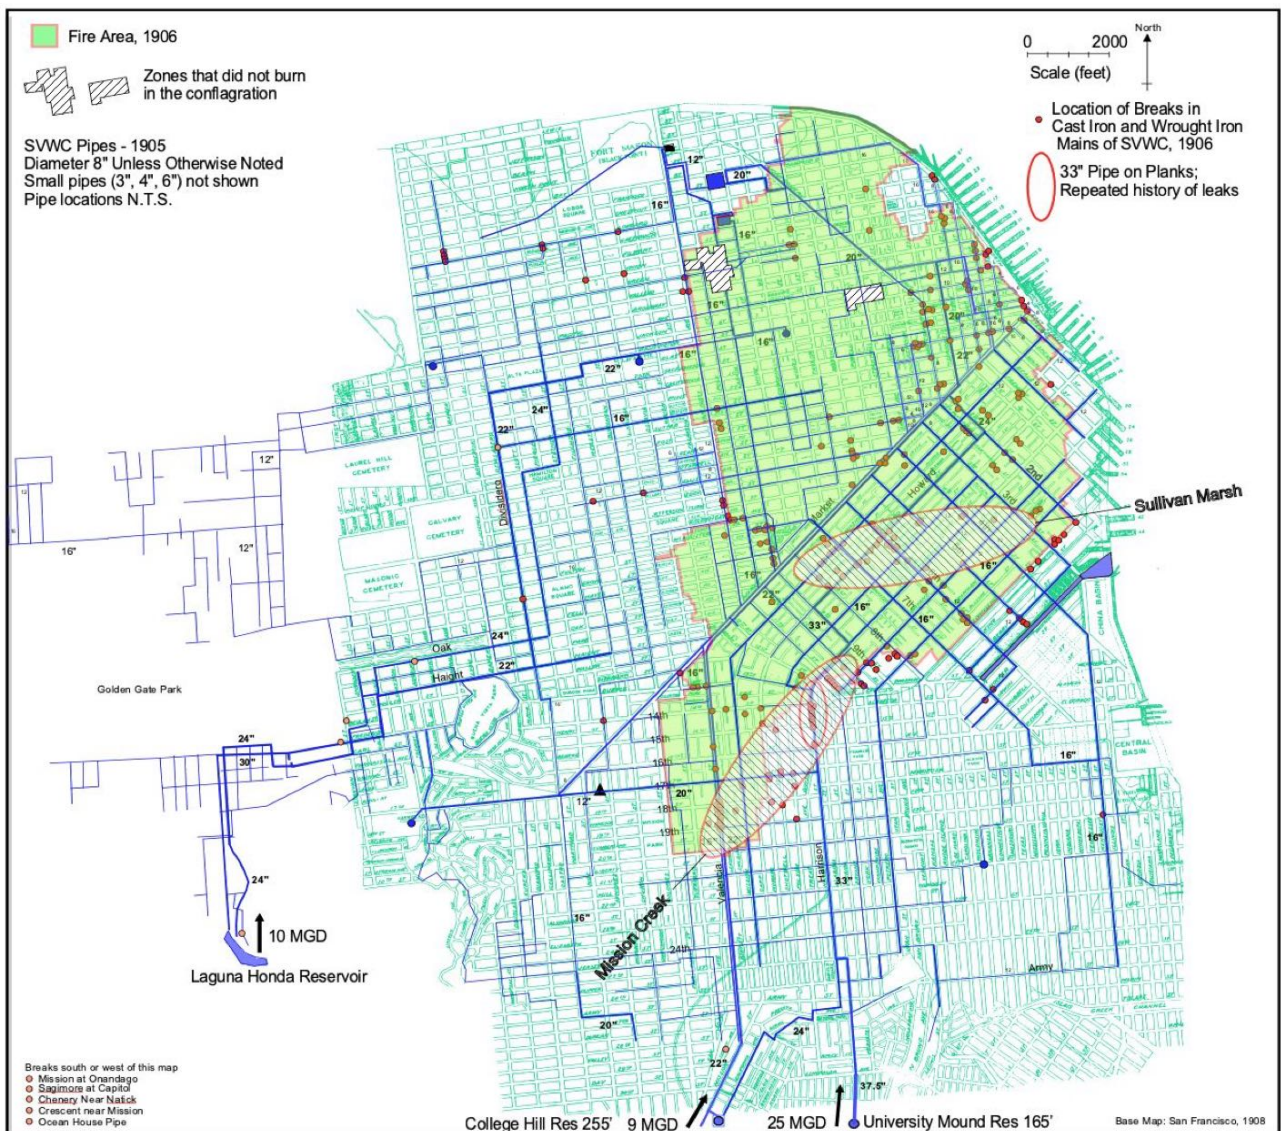
Figure 1. City Distribution System Water Pipes in 1906

Figure 1 (G&E, 2023) is a map that shows the distribution water pipes in San Francisco, and the red dots show locations of known pipe main damage (258 pipe failures). There were 41 additional pipe main failures, of which 5 are known to be outside any PGD zone; the location of the remaining 36 failures is uncertain. The blue lines show 8-inch (200 mm) diameter and larger water mains. Smaller diameter water mains (some 3 and 4, mostly 6-inch) (75, 100, 150 mm) are not drawn. The yellow zone shows the ultimate burned area of the fire conflagration. The hashed ovals show the major liquefaction zones.

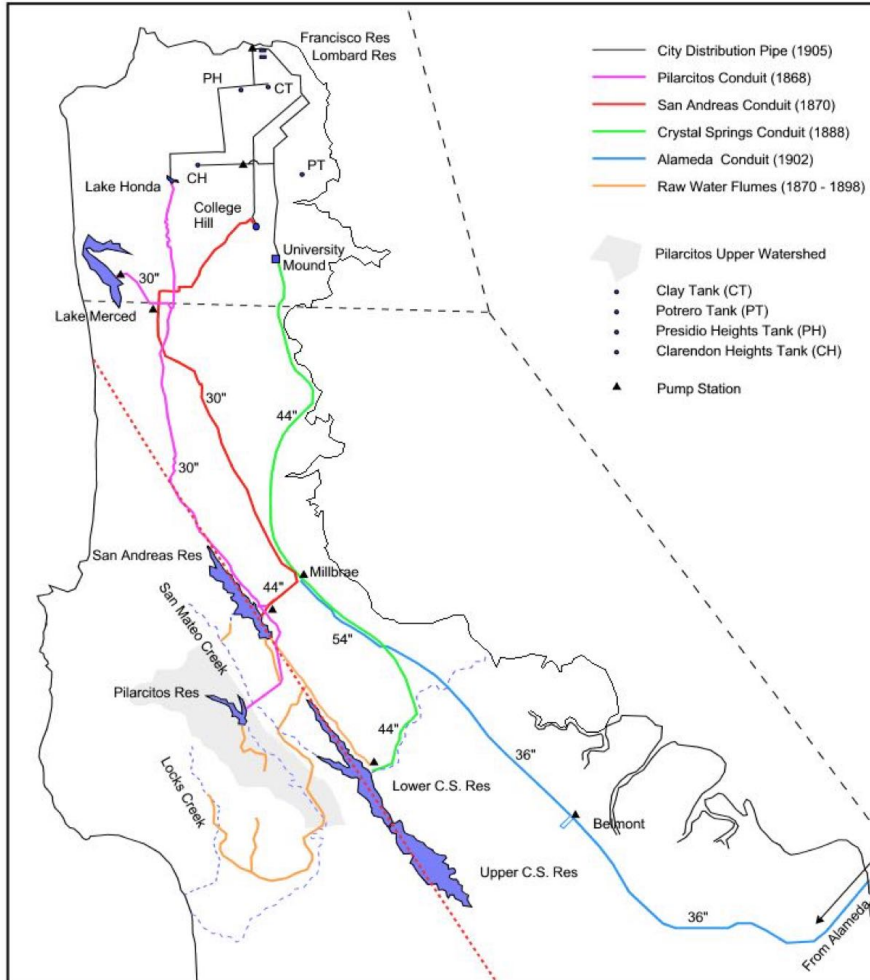
Figure 2. Large Diameter Water Transmission Conduits Serving San Francisco in 1906

Figure 2 (G&E, 2023) is a map showing the 4 transmission water conduits that brought water to San Francisco in 1906. The heavy red dashed line is the location of surface rupture along San Andreas fault in 1906. All 4 conduits sustained damaged (Pilarcitos = purple, San Andreas = red, Crystal Springs = green, and Alameda = blue).

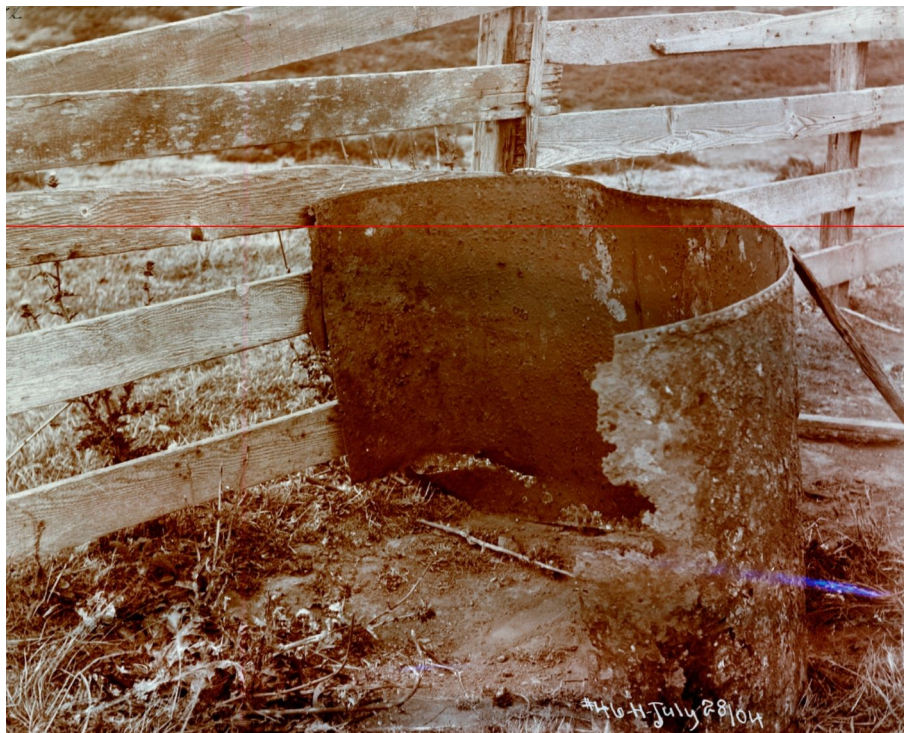
Figure 3. Failure of Pilarcitos 30-inch Low Pressure Pipe (WI-Thin), July 28 1904

Figures 3 and 4 show the 30" riveted steel pipe of the era. Figure 3 shows that the thin-walled riveted pipe was prone to corrosion failure (this failure, in 1904, when the pipe was 36 years old). Figure 4 shows a section of the Pilarcitos pipe that was relocated in 1907 (note the riveter inside the pipe). The riveted girth joints were about 60% to 75% of the strength of the pipe (per equation 2), and wherever the pipe was exposed to PGDs placing the joint in high tension, the rivets popped or the hole edges ripped open.
