PERFORMANCE OF A PIPELINE AT A FAULT CROSSING

John M. Eidinger¹, Michael O'Rourke², Jeff Bachhuber³

Abstract

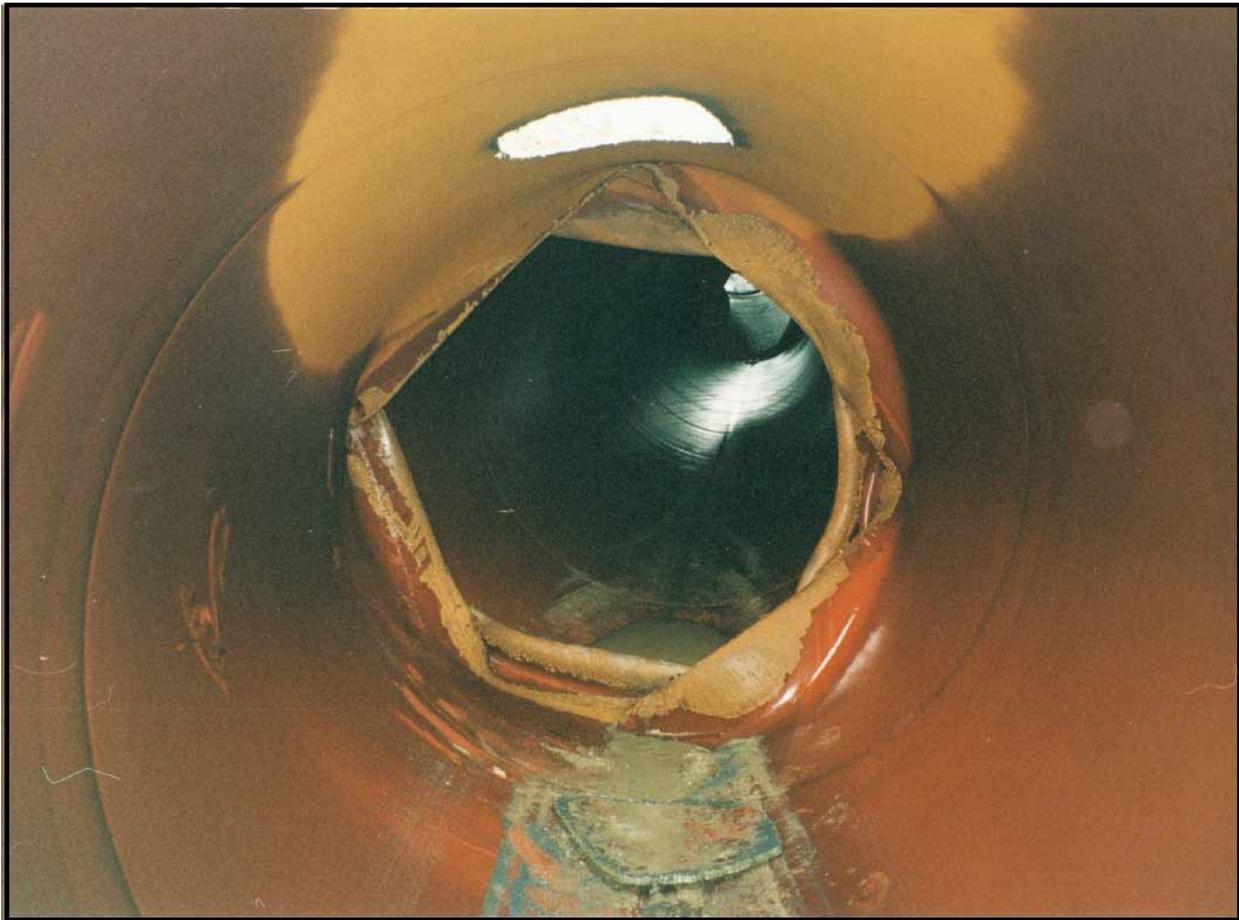
As the extent of the wrinkling in the pipeline was discovered, it became apparent that sleeving the deformed joints and encasing the pipeline in concrete would not be a suitable repair strategy. The extent of the wrinkles suggested that the internal diameter had been "necked" down to about 1400 mm diameter at two of the wrinkles.

Figure 2. Major Wrinkle. Note Steel Plate at Invert from Manhole

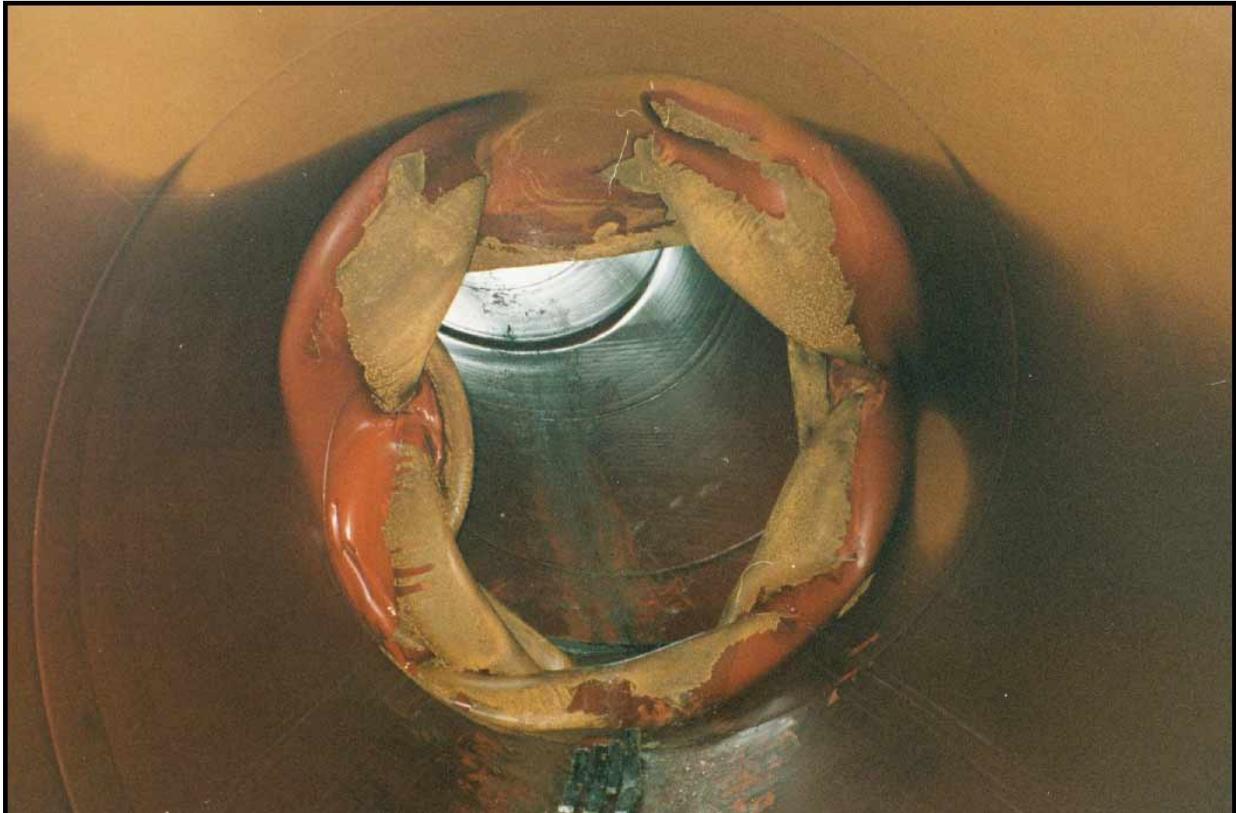
Figure 3. Major Wrinkle. Remaining Flow Diameter is 1400 mm

For this pipeline, with $t = 18$ mm and $R = 1100$ mm, the theoretical strain to reach onset of wrinkling for an imperfect cylinder is 0.00286, or a compressive stress of 85 ksi. The specified material for the pipeline is API Grade B steel or better, with minimum specified yield stress of 241 N/mm^2 (35 ksi). Clearly, this pipe had to wrinkle, and wrinkle it did!

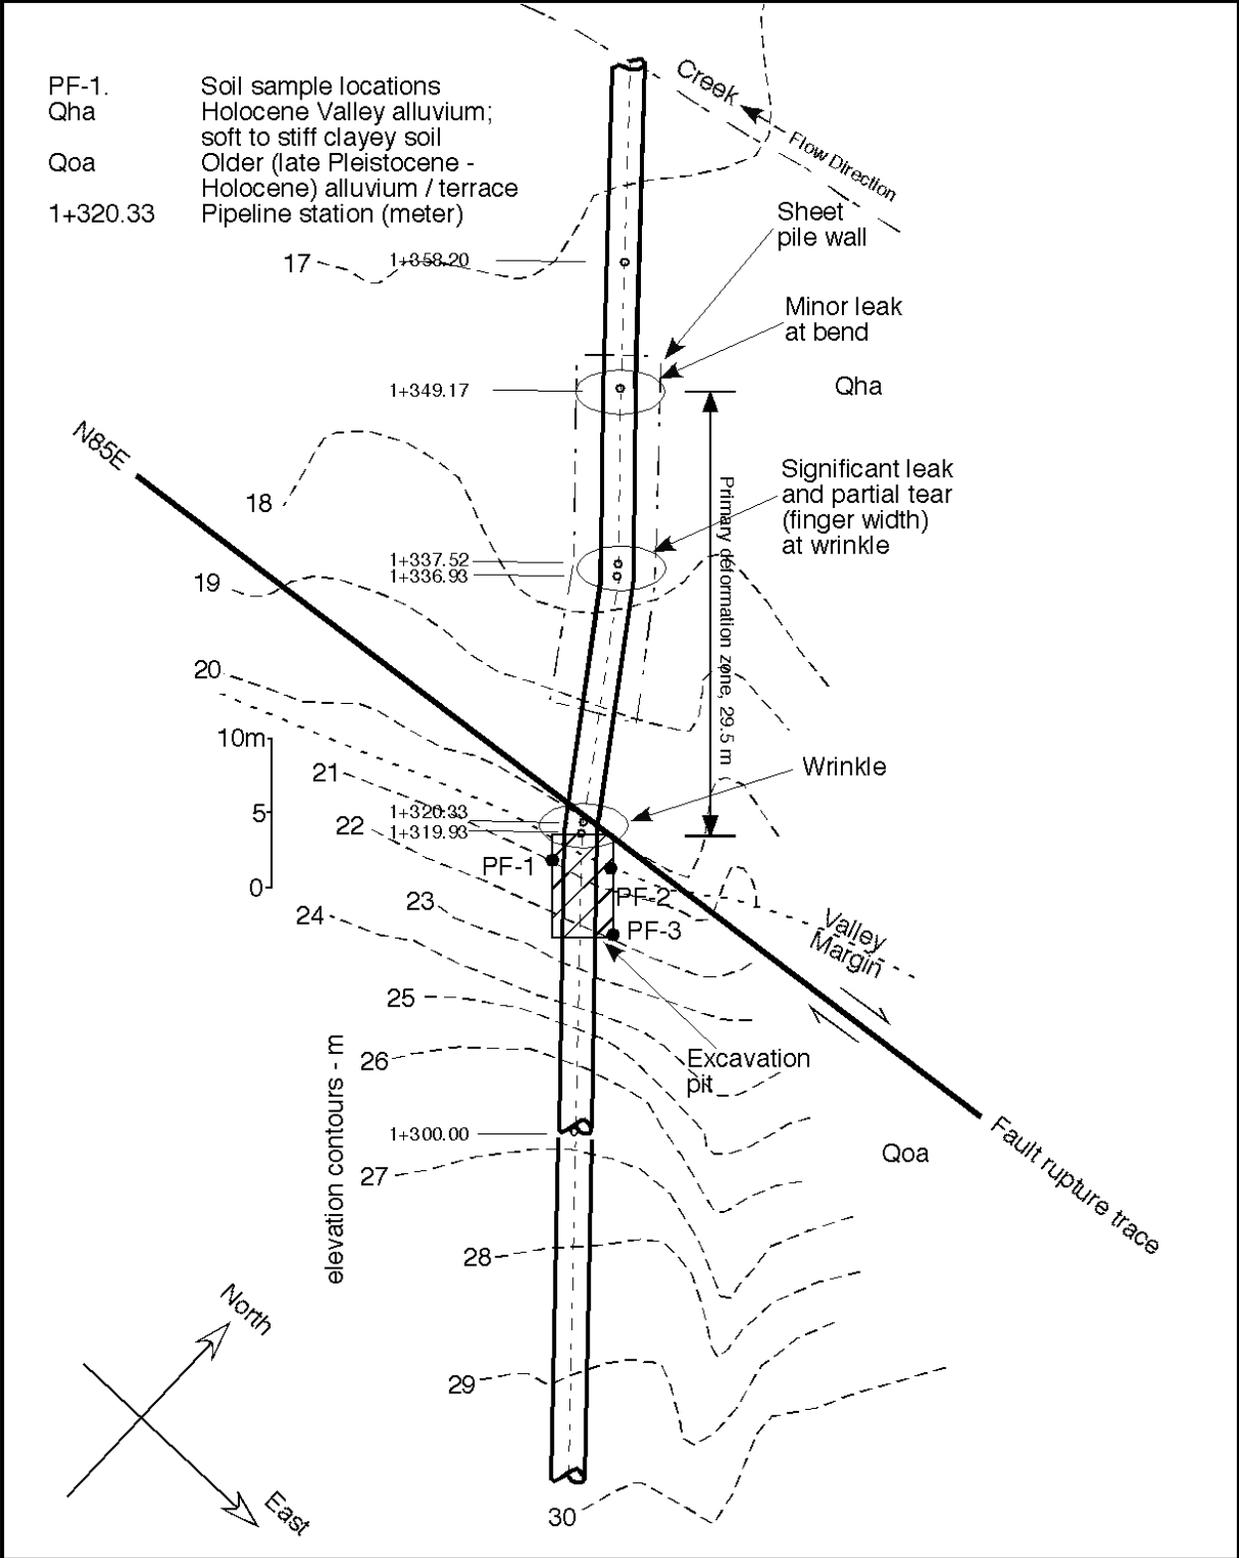
Figure 4. Pipeline and Fault Location After Earthquake.

Figure 4 shows the plan view of the pipeline at the fault crossing location. Key features are as follows: The plan is drawn to scale. The outline of the pipeline is based on a post-earthquake survey of the damaged pipe. Elevation contours are shown using 1 meter contour lines. Seven survey points were made at the top of the pipeline. Station numbers were assigned to the seven survey points, each denoted with a station number. The sheet pile walls and excavation pit were installed as part of the emergency repair process. Each survey point is for the top center of the

pipeline. The survey was to the top of steel (there is an epoxy coating system).

For this pipeline, there were actually two major wrinkled locations and one minor bend location (see Figure 4). The two main wrinkles are those at stations 1+320 and 1+337. The third bend (wrinkle) at station 1+349 is due to sufficiently high bending moments even at that location.

The pipeline crosses the fault at a break-in-slope between an older alluvial terrace or ridge slope and a small active alluvial valley. Surficial geologic units are denoted Q_{oa} and Q_{ha} in Figure 4.

At the fault crossing (i.e., between stations 1+320 and 1+349), the pipe is underlain by Holocene alluvium. Native soils exposed at the excavation pit (Figure 4) consist of medium stiff, dark brown clay and silty clay. When visited, there was some standing water at the bottom of the excavation pit, which may represent either groundwater, pipe leakage or recent rainfall accumulations. In any case, groundwater is likely to occur at shallow depth in the small alluvial valley at the fault crossing. Laboratory testing was performed on three hand collected samples from the excavation pit to document the main soil conditions near the pipeline: Native clay soil (clay to silty clay with sand and fine gravel); Compacted backfill (mixed native clay soil and bedding); Granular bedding (well graded gravel with silt and sand).

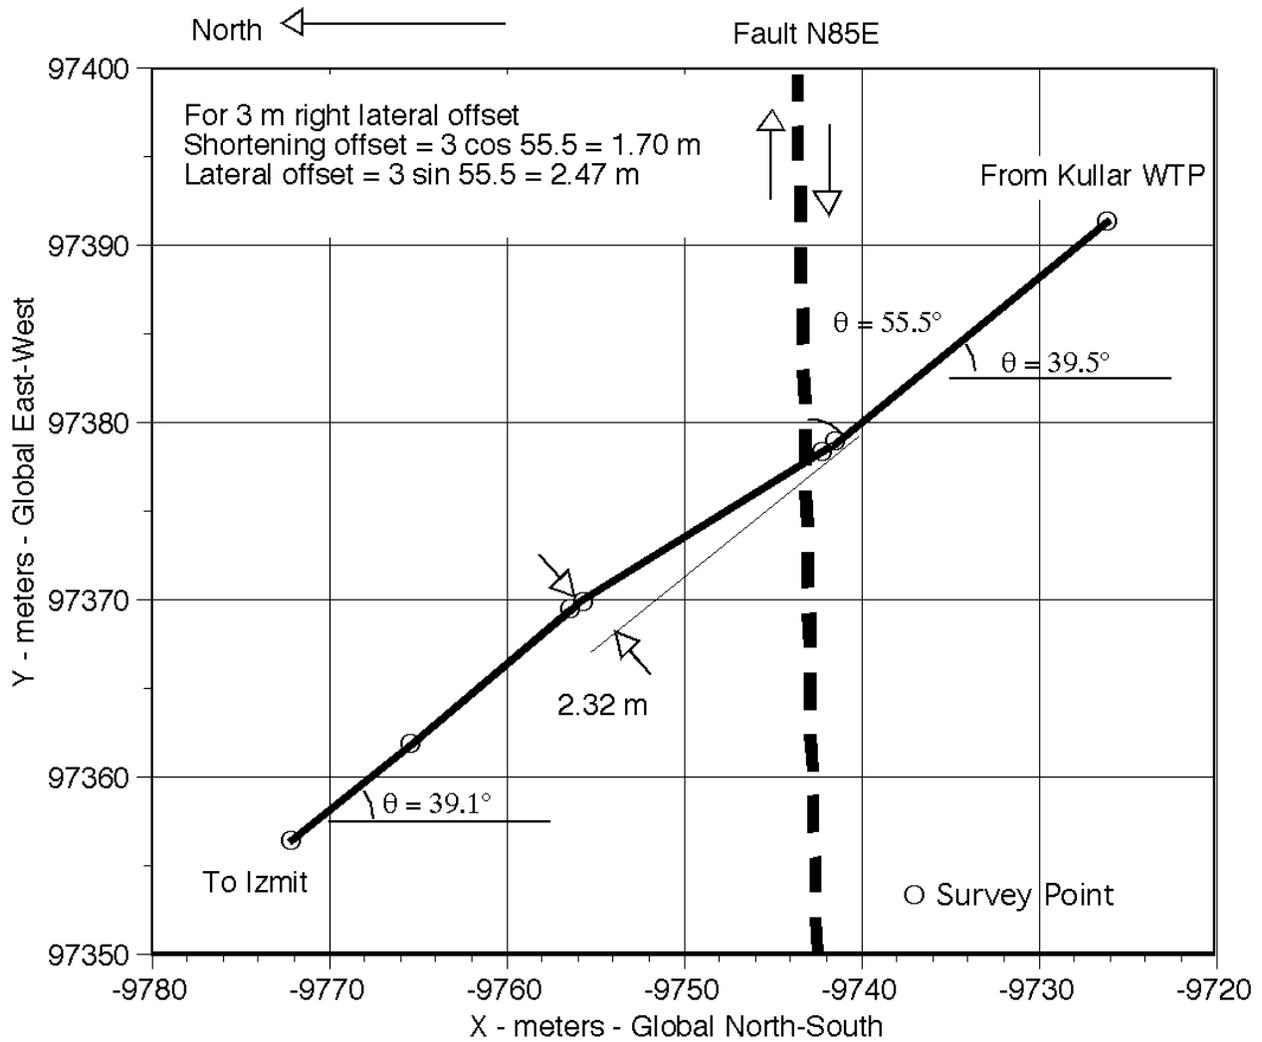
Figure 5. Pipeline and Fault Geometry

Figure 5 also shows the pipeline in its post-earthquake configuration. Angles are shown for various segments of the pipeline. As drawn, each segment is straight, but this is not necessarily true. Assuming that the fault moved in a purely strike-slip fashion, then the pipeline was subjected to 1.70 meters of shortening and 2.47 meters of transverse offset.

The fact that the Thames Water Pipeline was damaged at the North Anatolian fault crossing is not surprising given the nature of the fault offset and the design aspects of the pipeline. The pipeline crossed the fault at a 50° to $55.5^{\circ} \pm$ angle, putting the pipe into compression as the fault moved in right lateral offset.

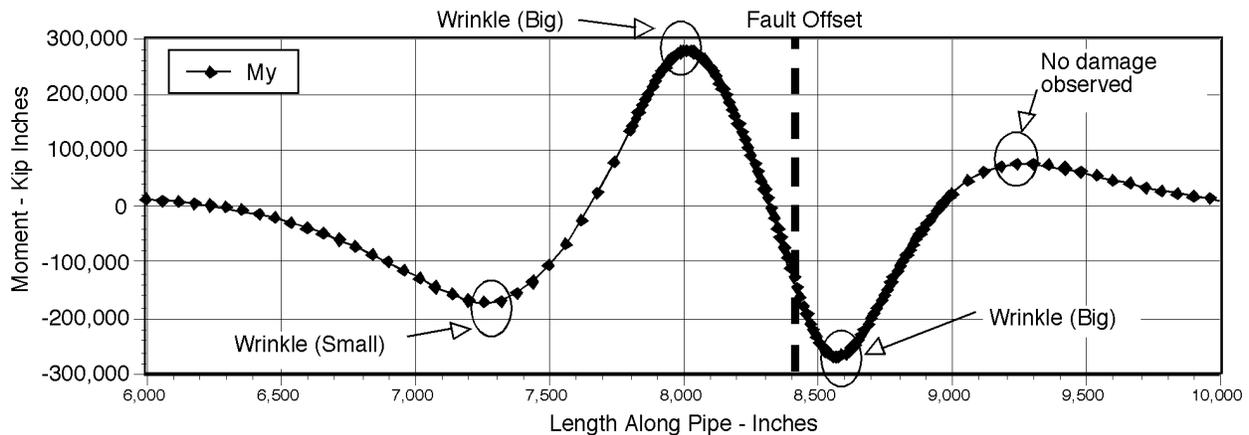
Figure 6. Variation of Bending Moment along the Pipeline Near the Fault, Model 4

Figure 6 shows the variation of bending moment along the length of pipeline nearest the fault, from model 4. The asymmetric location of the points of highest bending moment conform approximately to the observed locations of wrinkles of the actual pipe at stations 1+320 and 1+337. Model 4 predicts a distance between major wrinkles of 45 feet. The actual distance between major wrinkles was 55 feet. Adjustments to the computational model (modifying soil properties downward, adjusting pipeline strength properties upwards) would allow "perfect" agreement of the distance between the wrinkles.

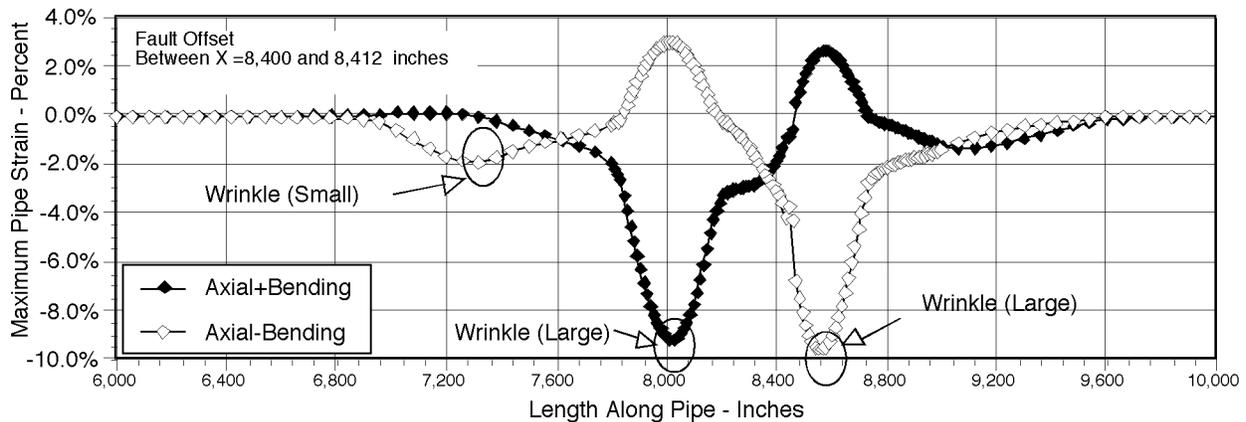
Figure 7. Variation of Strain along the Pipeline Near the Fault, Model 4

Figure 7 shows the variation of tensile and compressive longitudinal strains in the pipeline, as predicted from model 4. Strains above yield are limited to about 130 feet either side of the fault. The model shows that there should be secondary points of high bending moment and strains either side of the fault. In the actual pipe, there was a minor wrinkle at station 1+349, or about 40 feet from the wrinkle at station 1+337. The analytical model would predict a wrinkle forming about 58 feet away from station 1+337.
