Performance of Buried High Voltage Power Cables due to Earthquake Loads

SUMMARY

Buried high voltage power cables failed in many locations in the February 22, 2011 M 6.3 Christchurch earthquake, due to liquefaction. The empirical evidence of these failures is presented. The original design of the cables is considered, and what made the cables so vulnerable. The failure mechanism is described. Recommendations are made for the design of new buried cables in liquefaction zones.

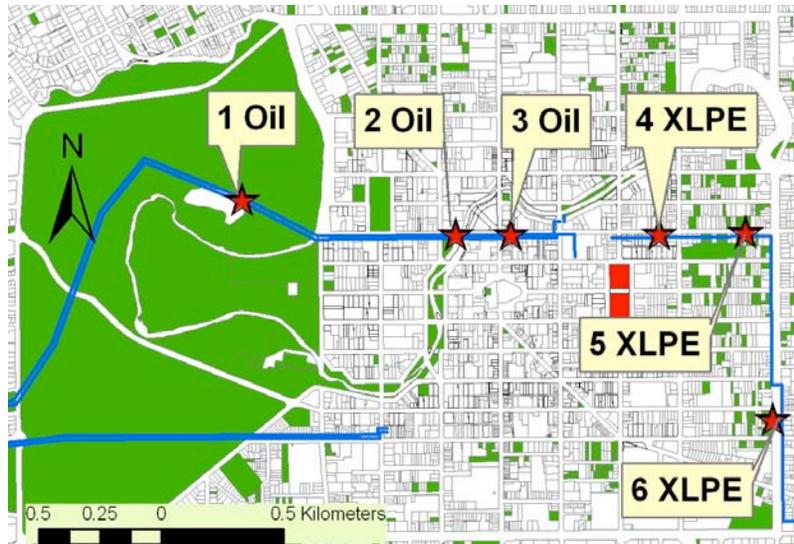
Figure 3 shows the alignment of 66 kV buried circuits in and around the central business district (CBD) of Christchurch, New Zealand. The red stars show the locations where the circuits failed. The blue lines show the circuit alignments. Green areas are parks. The meandering Avon River is highlighted by green parks along either bank. The six circuit failure locations are noted "1, 2, 3, 4, 5, 6". The type of cable at each faulted location is listed as either Oil, or XLPE. Each blue line represents a three-phase circuit. Oil-type cables have all three phases within pipe. XLPE-type cables have three separate cables.

Figure 3. Location of 66 kV Buried Circuit Faults, Central Business District

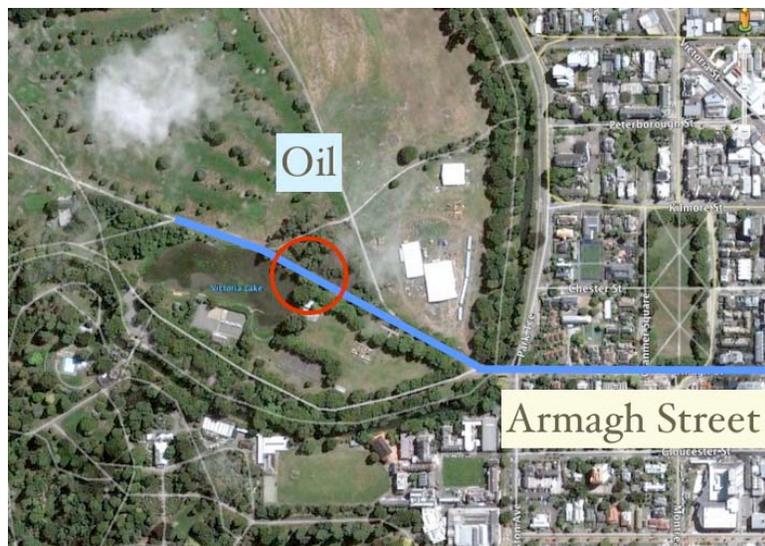
Figure 4 shows failure Location 1. Figure 5 shows the cross section of the trench design used at Location 1, same as used at Locations 2 and 3. In the field, we observed the actual "230 mm cement-bound sand" and "80 mm red concrete cap" to have the consistency of a moderate strength concrete. Native soil in the top 3 meters, surrounding the cables, are typically moderate strength clays / silts, able to withstand a vertical-cut trench wall. Figure 6 shows the buckled cables, as crews dig them up after the earthquake. Figure 7 shows the cable cross section, comprised of three aluminum conductors (300 mm^2), paper wrapped, with three oil-ducts; all housed within a corrugated aluminum pipe and then with protective plastic outer sheath.

Figure 4. Location 1 – 66 kV Oil-filled Cable

Post-earthquake inspection at Location 1 revealed that the cable alignment was parallel and about 6 meters from the edge of Lake Victoria. Liquefaction occurred under the lake, inducing some settlements, and possibly a very slight lateral spread, as indicated by damage to the retaining wall at the edge of the lake¹. One buried storm culverts goes under power cable, another over the power cable. Permanent surface level ground deformations in the zone where the cable failed show sudden "knife edge" settlements on the order of 2 cm, gradual lateral soil movements of perhaps 3 cm.

The actual damage to the cable occurred due to high curvature on the exterior aluminum pipe, leading to local wrinkling of the corrugations, pushing inward on the oil tubes / paper wrap. The aluminum pipe tore, releasing the oil and allowing air into the cable. The actual aluminum cores did not appear worse-for-wear.

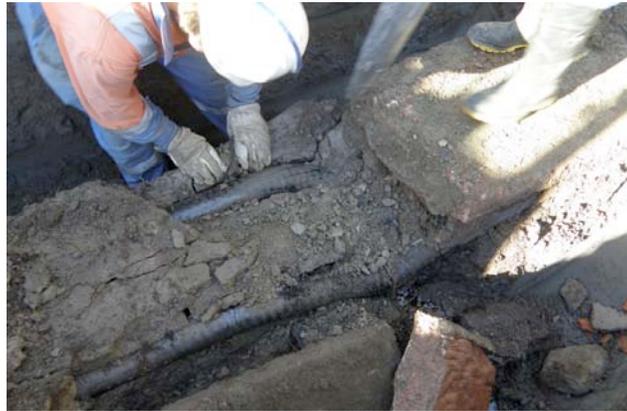
Figure 6. Exposing the Damaged Oil-Type Cables, Location 1

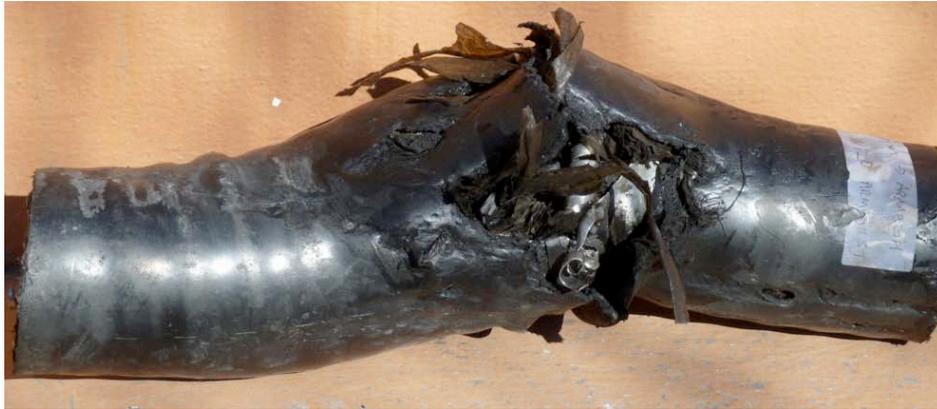
Figure 8 shows the cut-out section of the oil-type cable, from Location 3. The final deformed shape shows that the cable tried to deform in sharp double curvature. The high curvature led to high strain in the aluminum pipe, tearing it.

Figure 8. Oil-Type Cable (Location 3)

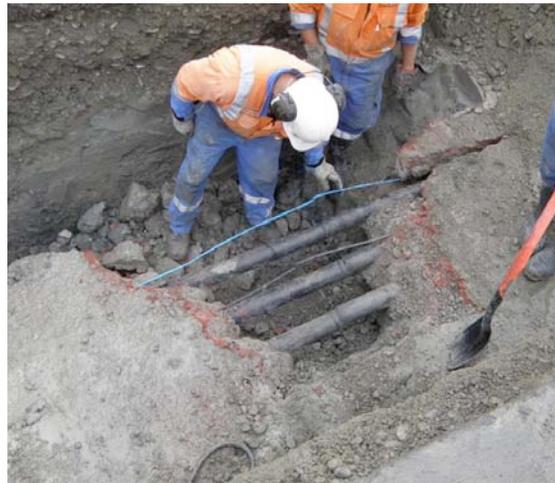
Figure 11. Exposing the Damaged XLPE-Type Cables, Location 6

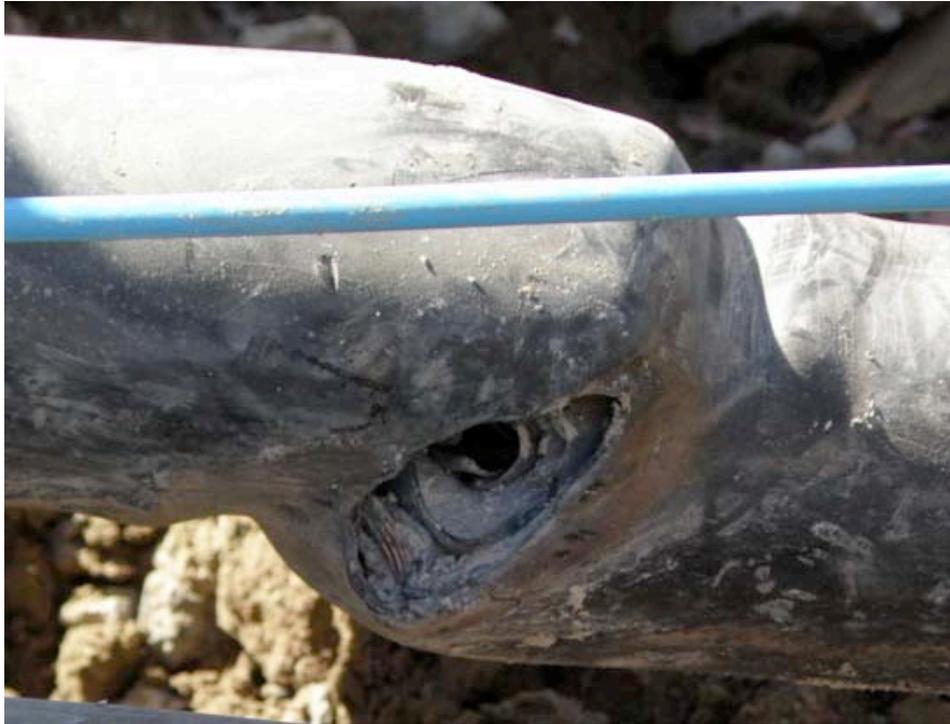
Figure 12 shows the tell-tale reverse-curvature bend in the XLPE cable from Location 4, with a blow-out hole caused when the cable faulted. Each of the three cables had similar reverse curvature at this location. The high reverse curvature has caused the XLPE insulation around the copper core the wrinkle outwards, tearing the outer copper sheath.

Figure 12. Failed XLPE-Type Cable, Location 4
