# Performance of Electric Power Systems in the 2010-2011 Christchurch New Zealand Earthquake Sequence

Alexis Kwasinski,<sup>a</sup> John Eiding,<sup>b</sup> M.EERI, Alex Tang,<sup>c</sup> M.EERI, and Christophe TUDO-Bornarel<sup>d</sup>

From late 2010 to mid 2011, Christchurch suffered a series of earthquakes and aftershocks that affected the city's power supply. The most relevant of these events occurred on September 4, 2010, February 22, 2011, and June 13, 2011. In all these events transmission level power restoration occurred rapidly—within one day. Except for the second event, similar relatively minor damage led to rapid restoration of distribution-level power outages. However, extensive damage to underground cables during the February 2011 earthquake caused some outages that lasted until early March. This damage seems to be amongst the only extensively-documented such failures to date. Despite recorded strong ground shakings, damage to other power infrastructure facilities was moderate to minor. This satisfactory performance of power infrastructure is attributed to a program implemented during the decade prior to this earthquake sequence to seismically upgrade almost all unr

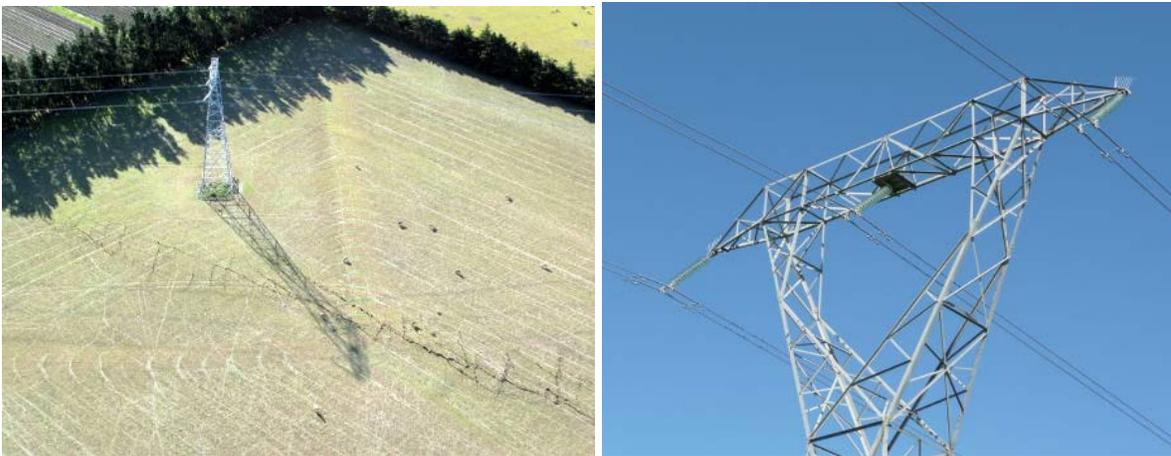
**Figure 2.** a) Left: Surface fault near a steel lattice tower of the ROX-ISL-A line. b) Right: Displaced insulators on a steel lattice tower as a result of the surface fault offset (photos: Transpower).

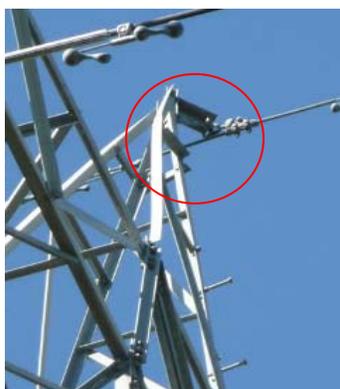
**Figure 3.** Bended steel brace supporting a guard conductor in a lattice tower (photo: Transpower).

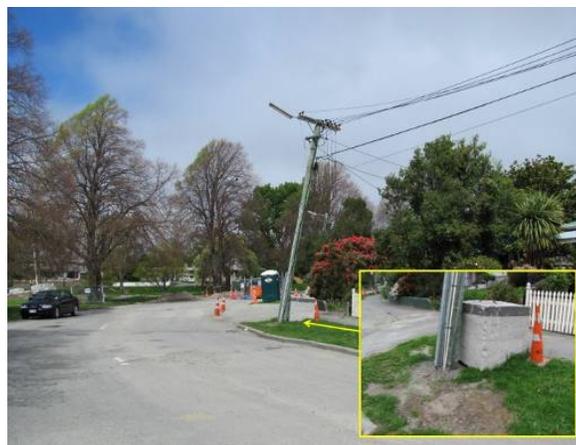
**Figure 5.** Tilted pole for 400 V power distribution being supported by a concrete block. Poles are shared with communications service providers.

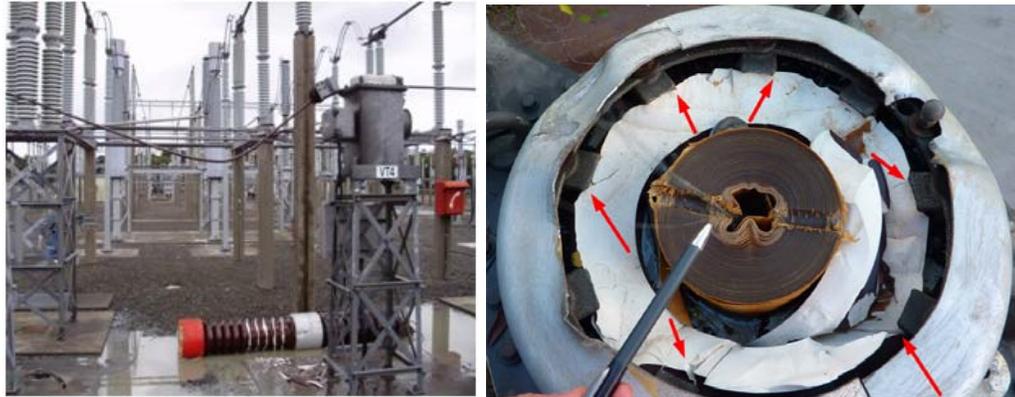
Damage to the 220 kV switchyard included a broken 220 kV capacitor voltage transformer (CVT) (Fig. 7). A very short straight connection between the CVT and rigid bus was identified as a possible cause of the failure. However, it is noted that the CVT insulator is held by finger clamps which create localized stresses on the porcelain material that may increase their failure rate during earthquakes as a result of fatigue induced weakening of the porcelain, as the cracks in the porcelain near the corner of the finger clamps seem to suggest (see Fig. 7). In this event, this failed CVT was one of three in existence. Other (newer) 220 kV equipment including circuit breakers, current transformers and disconnectors were undamaged. The rigid bus was also undamaged despite significant liquefaction in the vicinity of the foundations (Fig. 8 (a)). As Fig. 8 (b) shows, some disconnect switches had some offset in their contacts but their contacts did not disconnect. Damage was observed in a 66 kV transformer bushing that failed probably due to insufficient slack in the connecting conductor. A voltage transformer also failed possibly due to a combination of differential settlement and shaking that affected its vertical tie to a rigid bus. Liquefaction was also observed in nearby steel lattice transmission towers of the 220 kV line to Islington (Fig. 9).

**Figure 7** Broken 220 kV CVT insulator mounting showing finger clamps. The arrows in the photo on the right indicates fatigue induced cracks initiated in the porcelain edges in contact with the corner of the finger clamps. (photos: Transpower)

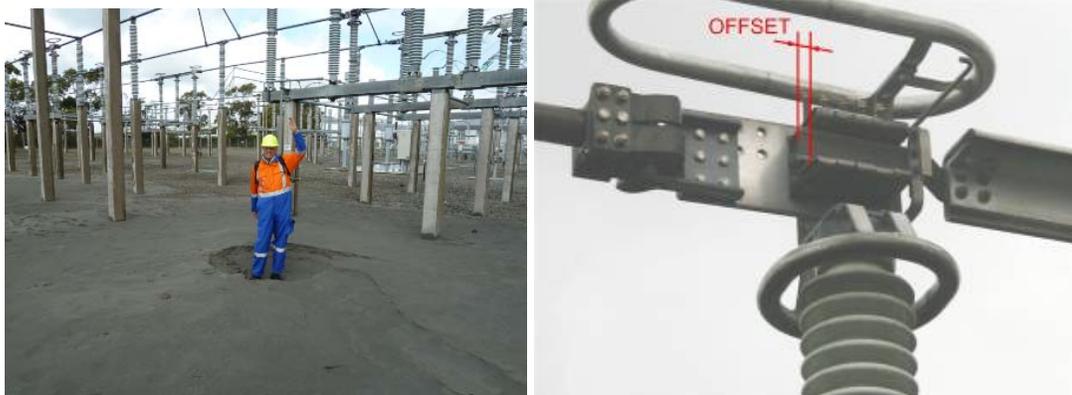
**Figure 8** a) Left: Significant soil liquefaction at Bromley substation. One of the authors is standing inside a sand “volcano.” b) Right: 1 cm offset at a disconnect switch in Bromley substation

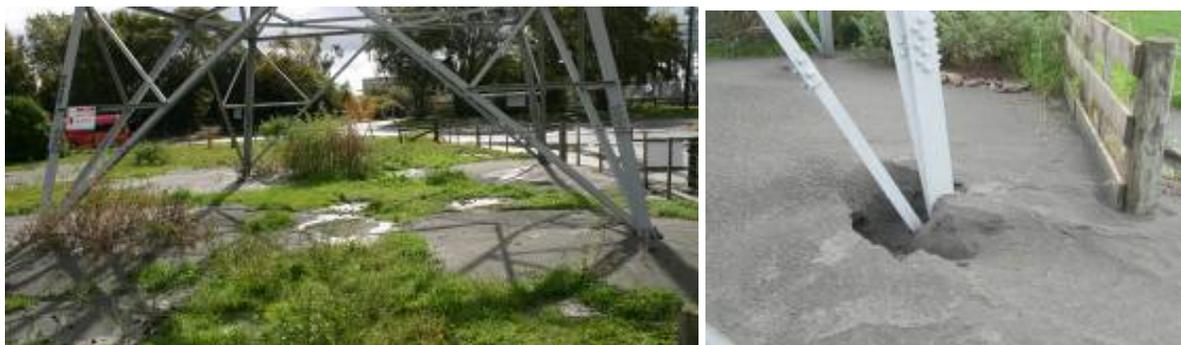
Still, even when a tower had some minor buckling in a few secondary braces, no tower had any significant structural issue that compromised their operation. Other observed damage to steel lattice towers was caused by a rock that fell between the legs of a steel lattice tower in the Port Hills area. However, operation of this line (likely owned by Orion) was not affected because the rock only damaged some auxiliary braces between legs.

**Figure 9.** Examples of soil liquefaction at the base of steel lattice towers.

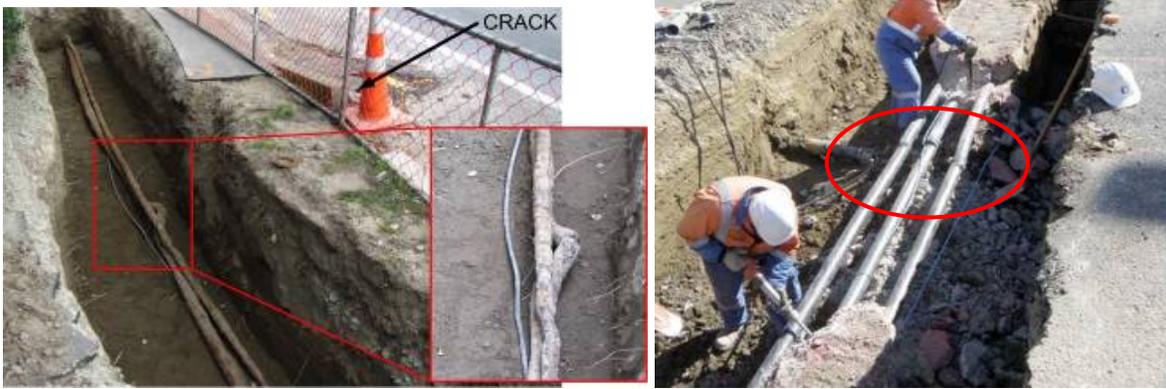
**Figure 13.** a) Left: An apparent crack induced fault in a 11 kV underground cable. b) Right: 66 kV underground line along Armagh street damaged by soil liquefaction (Photo: Orion).

The most serious faults were those occurring in Orion’s 66 kV lines. As explained in (Eidinger, 2012), factoring in the field observations, the causative movements / forces to cause the 66 kV cable failures are thought to be as follows.

At six different locations (three locations using XLPE-type cables, and 3 locations using oil-filled "pipe type" cables, the observed failure mode of the 66 kV cables was as follows. In all locations, the cables were installed using the "direct burial" method, whereby a trench was dug, the cables laid into the trench, and the cable encased in a weak cement "thermal concrete" backfill; finally the trench filled to the surface to make the road surface. At all locations, the damage occurred to all parallel cables, in less than 10 cm of length; in other words, the damage was concentrated at specific locations, and not randomly disbursed along the length of the cables. At all locations, once the cables were dug up for repair, the observed cable condition was high curvatures (as for example, the three buckled cables highlighted in the red circle in Figure 13b). After the earthquake, the authors field inspected the sites of the cable damage, looking for evidence of liquefaction phenomena nearby, that could explain the ground deformation patterns that led to the damage. From these observations, along with numerical modeling of the cables, the authors make the following comments related to the likely conditions that led to the cable damage and their restorations:

Based on the observed physical condition of the cables, and the observed PGDs at the ground level, we posit the failure process occurred from multiple steps. The following describes the expected failure mechanisms. First, the non-reinforced thermal concrete is cracked from ground strains caused by either strong ground shaking, or PGDs induced by liquefaction. Until the thermal concrete cracks, it is impossible for the cables to undergo the observed deformations. Second, and consistent with the PGD environment, it is apparent that the non-liquefied soil cap (within-which are the power cables) begins to "float" (some people say "slosh") sideways. As the soil cap "floats" sideways, the crack in the thermal concrete opens up, and the cables stretch in tension, to the point that the cables yield. The inside core

of the cables, being usually copper or aluminum can readily accommodate modest yielding in tension, although the outer layers (insulation, pressure retaining boundary, etc.) may not. Third, the soil caps continue to "float", and ultimately floats sideways back to more-or-less its original position. As the soil cap returns to its original position, the now-stretched cable cannot recover its original form and length because of the surrounding thermal concrete environment. As a result, the cables go into reverse-curvature, leading to observed high cable curvatures.

through downtown Christchurch, the cables failed at 6 locations (at 5 of the 6 locations, all parallel phases faulted). In downtown Christchurch, with the relatively modest number of 66 kV cable failures, the restoration process was to dig up the damaged cable, cut out the damaged section of cable, and then install a new cable splice, followed by restoration of the thermal backfill and repair of the road.

(3) In eastern Christchurch, where large PGDs were prevalent (5 to 50 cm common), the failures to the 66 kV and 11 kV buried cables were so prevalent as to cause multiple faults on many cables, leading Orion to often abandon-in-place the damaged 11 kV and 66 kV cables in those instances. In eastern Christchurch, with the larger PGDs, the short-term restoration process was to install temporary overhead lines; the moderate term restoration process was to install a new buried transmission cable, routed to avoid the zones thought to have the largest potential for large PGDs in future earthquakes. In some places new cables were laid on a reinforced concrete bed (Orion, October 2012)

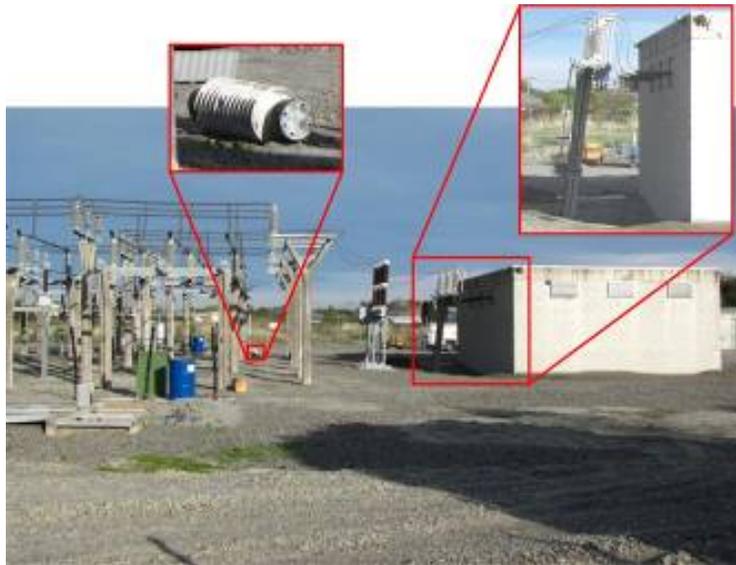
In addition to faults in buried cables, service to the eastern suburbs of Christchurch was affected by liquefaction severely damaging the substations in the area, such as Pages substation (Fig. 16) and Brighton substation. In Brighton intense liquefaction led to loss of bearing capacity, which, in turn, resulted in several feet of settlement and tilting of the transformer building (Fig. 17 (a)). In this site the tilting of the foundation was so severe that the substation experienced complete functional failure. Service in this area was restored by the aforementioned overhead line that was installed running from Bromley substation. In Brighton, this line was terminated in a new circuit breaker and transformer, shown in Fig. 17 (b) that stepped down the voltage from 66 kV to 11 kV. Since the earthquake a new substation combining the functions of Pages and Brighton substations was built nearby in soils with reduced severe liquefaction risk. When this substation is complete, the sites of the Pages and Brighton substations will be abandoned.

**Figure 16.** Damage from soil liquefaction at Pages substation. The details show a damaged bushing (left) and tilted supporting structure at the conductors entrance to the transformer building (right) which had experienced a small settlement.

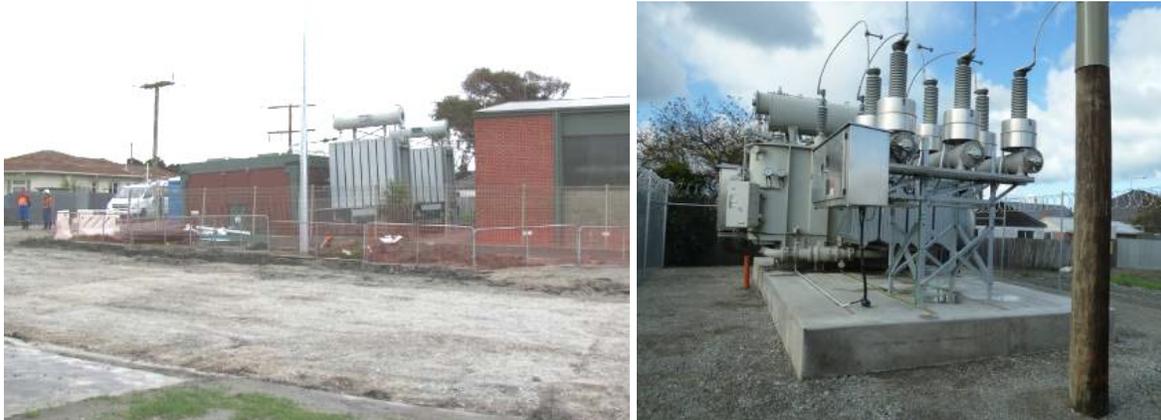
**Figure 17.** Brighton substation. a) Left: Significant settlement and sinking of transformer buildings. b) Right: Circuit breaker and transformer at the end of the temporary line shown in Fig. 10.

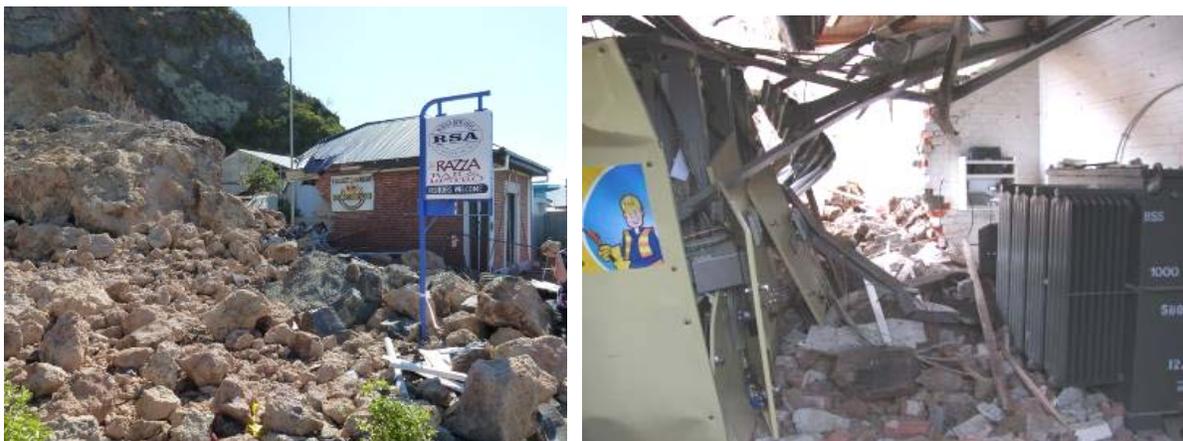
Three other substations were damaged south and south east of Christchurch. One of those that had been seismically reinforced and shown in Fig. 18 was damaged by a falling rock. Service in the area of this substation was restored by bypassing this substation. Another of the upgraded URM substations that failed was the St. Andrews Hill substation. This is the only one of 268 upgraded URM substations that failed during this earthquake from inertial overload due to PGA values that likely exceed well over 0.5g. Eventually, this substation was demolished and was replaced by a slab mounted transformer shown in Fig. 19. Despite this single upgraded URM substation failure, it can be considered that the reinforcement program was highly successful. Examples of undamaged reinforced URM substations are shown in Fig. 20. At least one other of these reinforced URM substations (Fig. 21) experienced considerable settlement due to soil liquefaction but it remained operational.

**Figure 18.** Damaged substation building by rock fall in Sumner. a) Left: Exterior. b) Right: Interior.

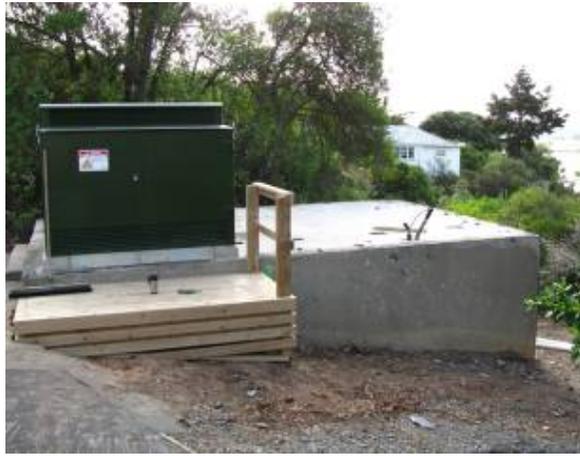
**Figure 19.** Slab mounted transformer installed on the slab where St. Andrews URM substation building used to stand before it was damaged by the February 22, 2011 earthquake.

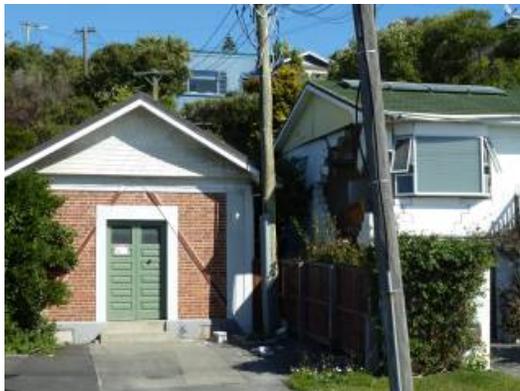
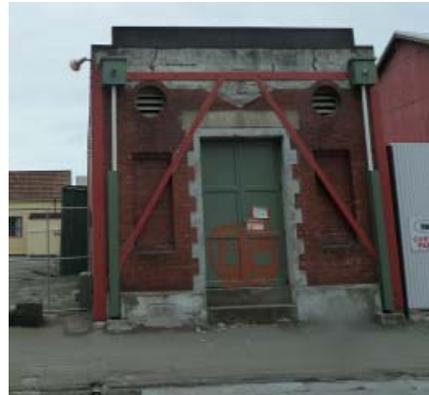
**Figure 20.** Two examples of seismically reinforced URM substations good performance. Notice the damage in the home next to the substation shown in the photo on the left.

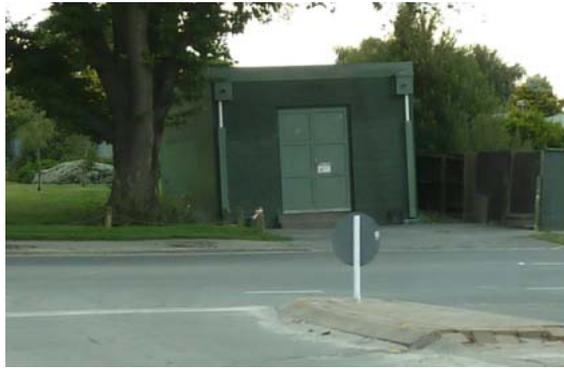
**Figure 21.** Settlement due to liquefaction at a seismically upgraded URM substation.

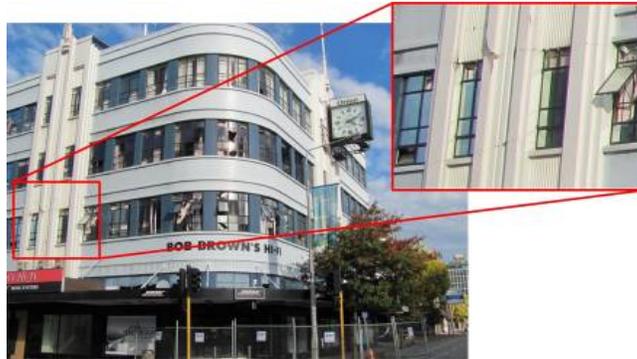
**Figure 22.** Orion's office building next to Orion's main building. Operations in these buildings needed to be relocated.
