Ridgecrest M 7.1 Earthquake of July 5 2019 Performance of Gas Lifeline

March 2 2022
Jeff Bachhuber (PG&E)
John Eidinger (G&E)

Initial Inspections & Observed Damage for Ground Deformation

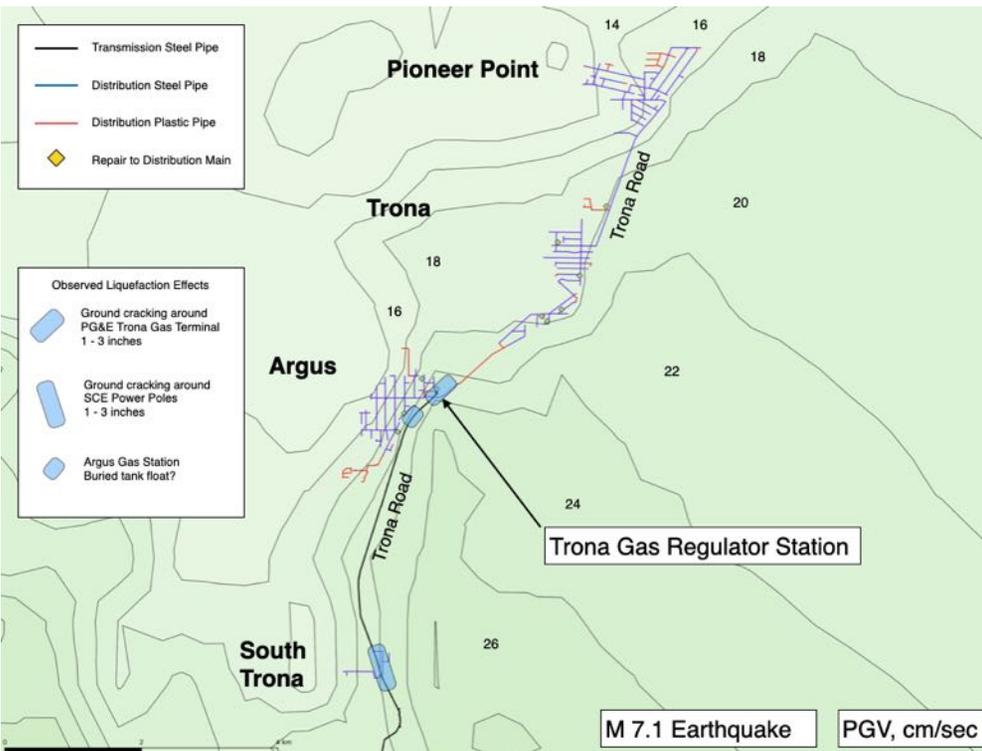
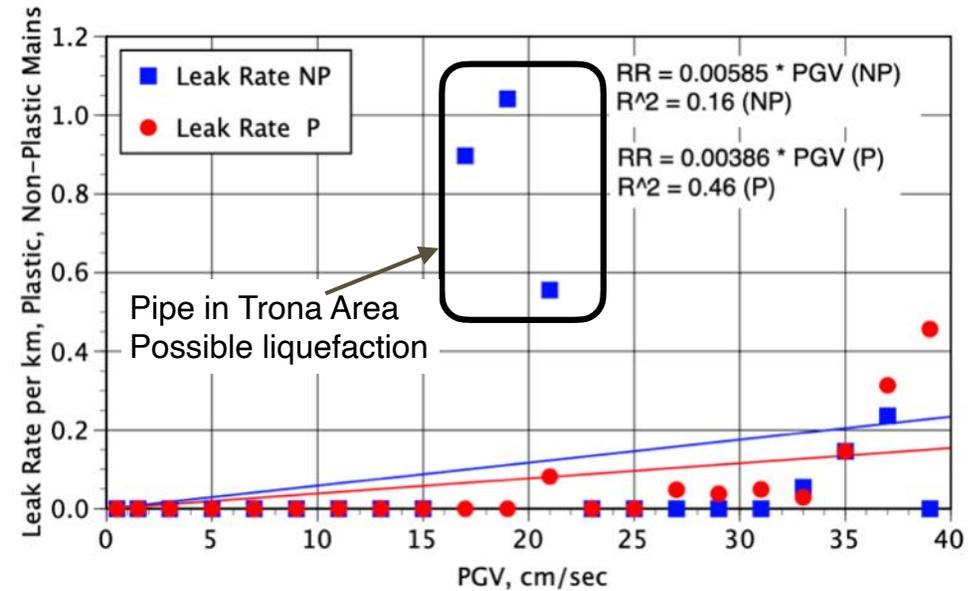
Ridgecrest

Distribution pipe
287 km plastic; 150 km steel

31 Gas Repairs (dots):
Steel: 16 (NP)
Plastic: 15 (P)
Liquefaction zones: blue boxes
324 leaks in services (not mapped)

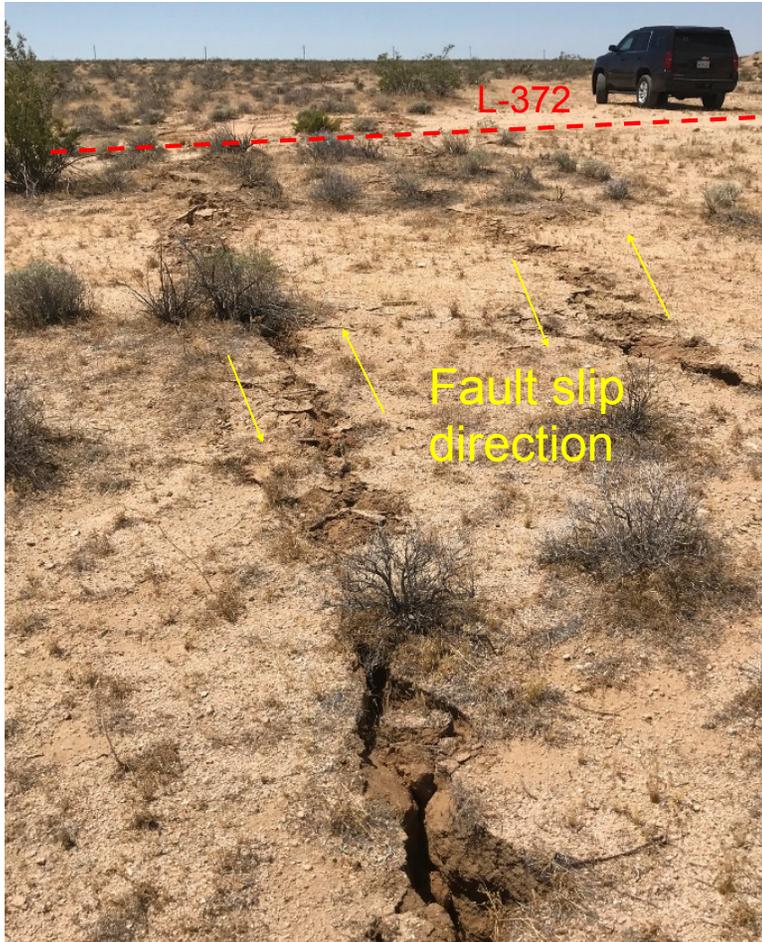
Surface rupture across pipeline alignment (pipeline alignment road at top of photo; southeast view); rupture is at a near-right angle to pipeline

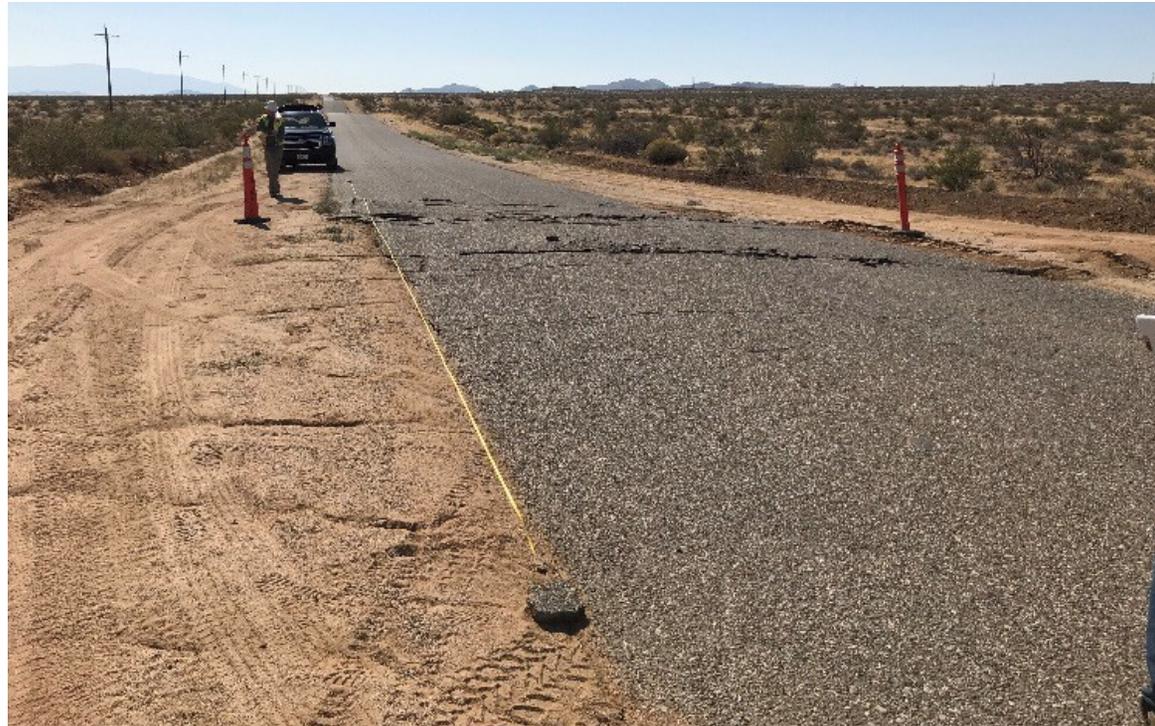
Measurement of left lateral surface fault slip across paved road south of L-372 crossing (east view)

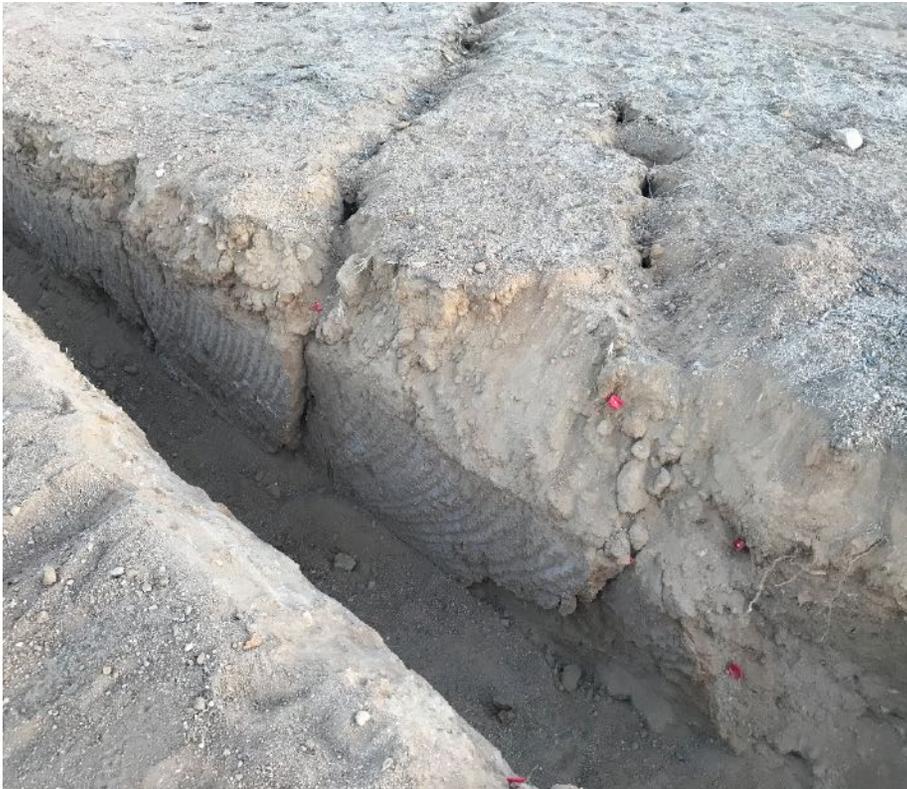
Fault displacement of original pipeline trench excavation wall after pipe backfill was partially removed by vacuum excavation to expose pipe at L-372 M6.4 fault crossing (south view).

- PG&E conveyed initial fault characteristics to evaluate fitness of existing pipeline for planning initial gas response and pipeline mitigation options.
- Estimates for possible future fault displacements were increased to 3-feet to accommodate uncertainties and provide a safety margin for the replacement pipe design.
- Confirmation mapping and documentation were performed in L-372 and L-311 pipeline excavation trenches. This work confirmed the locations and estimates for future fault displacement which were well-defined by offset of the original pipeline trench excavation walls in cemented soils.
- Displacements of the trench wall were measured as 20-inches along the primary fault splay and 7-inches along secondary fault splays for L-372, and 10-inches primary and 3-inches secondary for L-311.
- Both existing stressed pipes were removed and replaced with new unstressed pipes

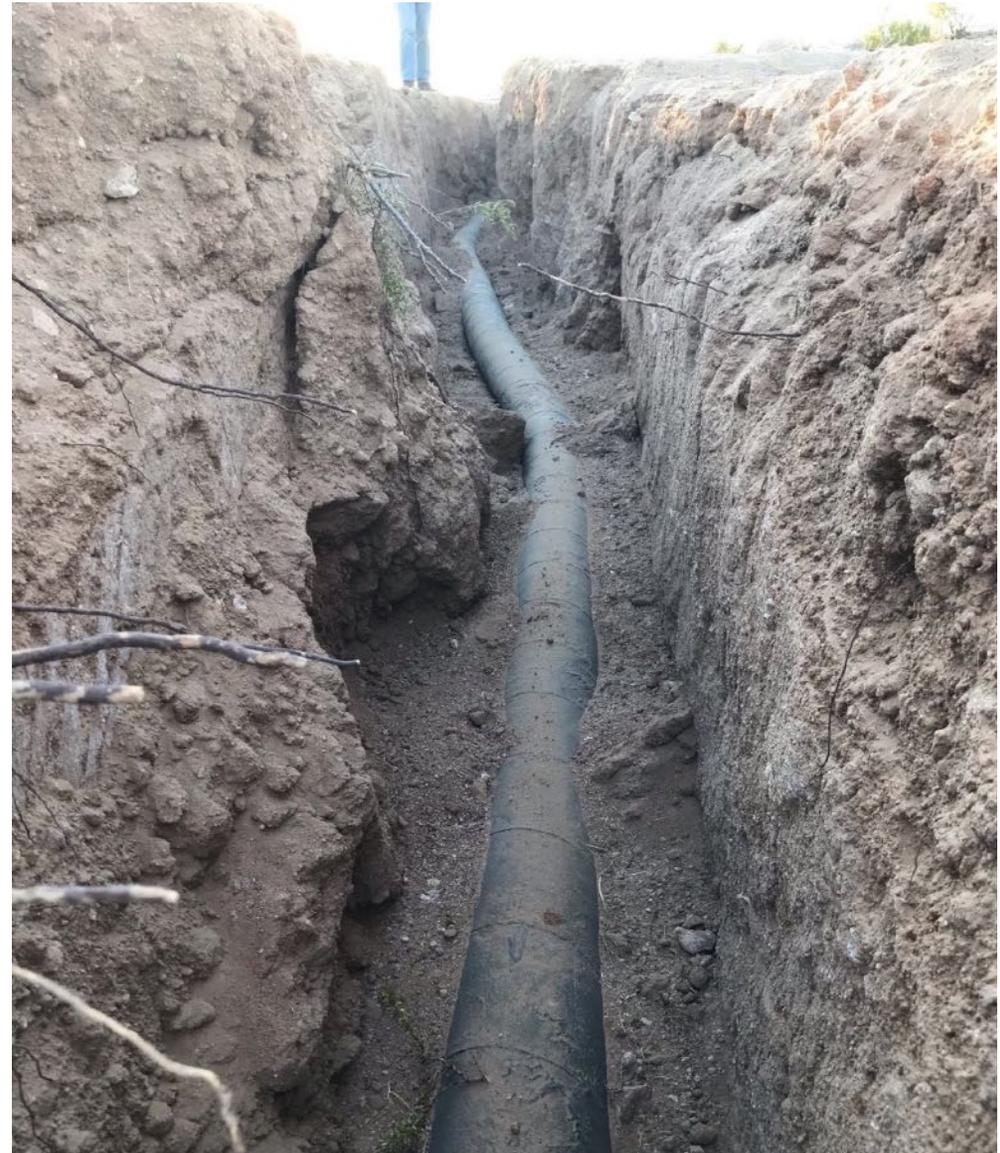
Excavated L372 pipe showing left lateral bending at fault intersection (east view)

- 2 1955-vintage steel pipes underwent ~1 to 2 feet of fault offset. Both deformed. Neither leaked. Both were replaced with new pipes. These lines had common D/t ratios of 57 (10" line) or 35 (6" line) in the fault crossing zones. These D/t ratios are much lower than commonly used for low pressure steel water pipes of similar diameter, which have common D/t ratios of 125 to 150. The low D/t ratios, coupled with lack of appurtenances in the fault crossing zone, coupled with corrosion protection and quality construction, are all factors that led to successful performance (no leak) under fault offset.

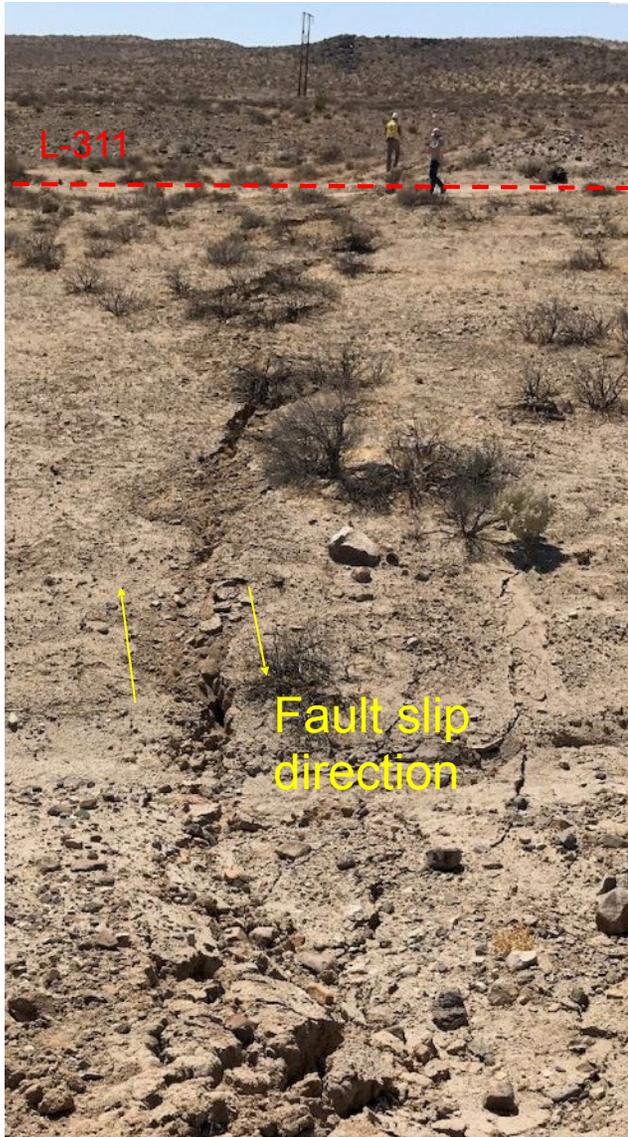
Surface fault rupture crossing L-311 pipeline (trending near-perpendicular to rupture at alignment road/geologists (southeast view)

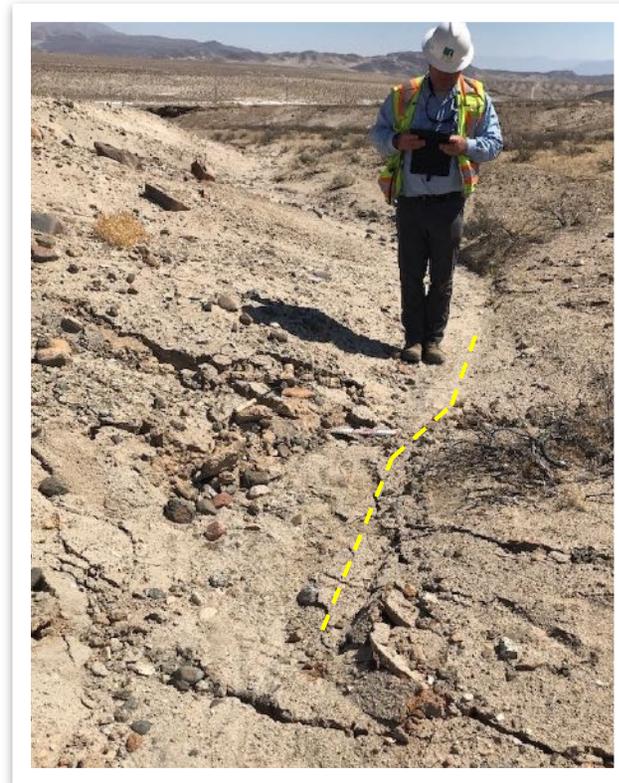
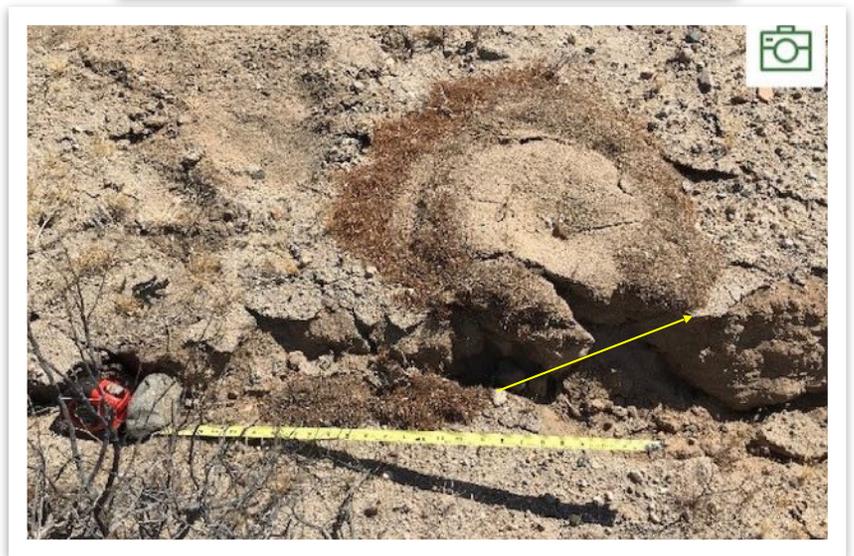
Right lateral displacement of stream channel and ant hill indicating 1-1.5 feet of displacement

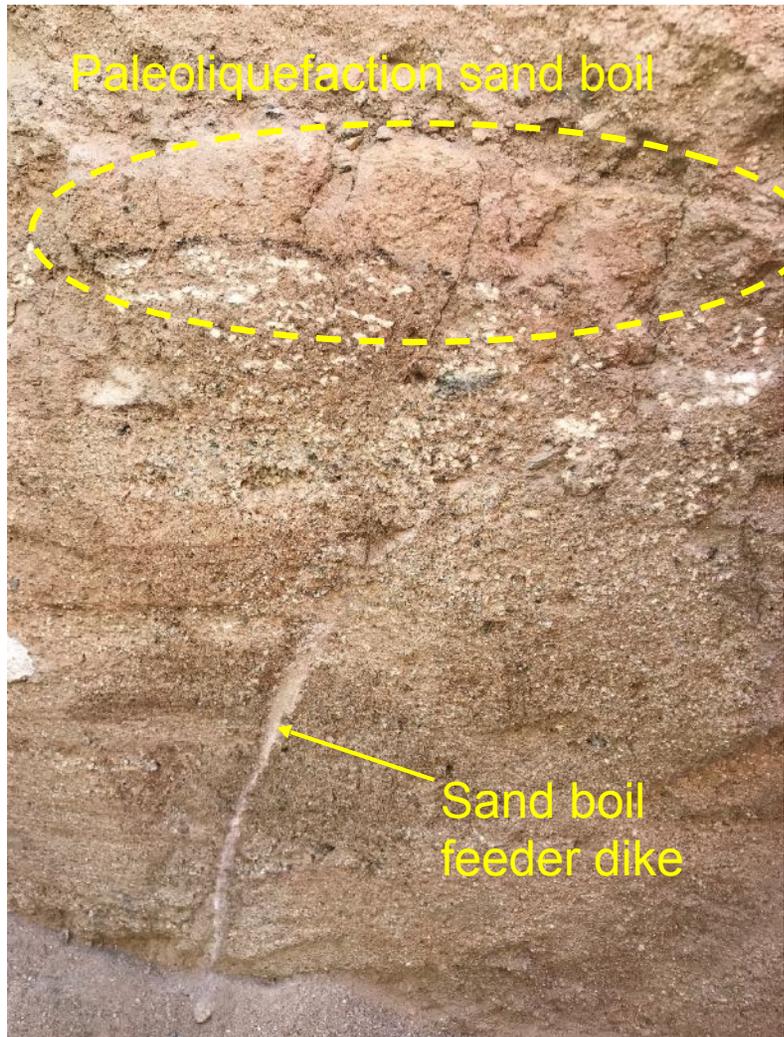
Evidence of past (pre-historic) earthquake indicated by paleoliquefaction sand boil and feeder dike in L-311 original pipeline trench wall

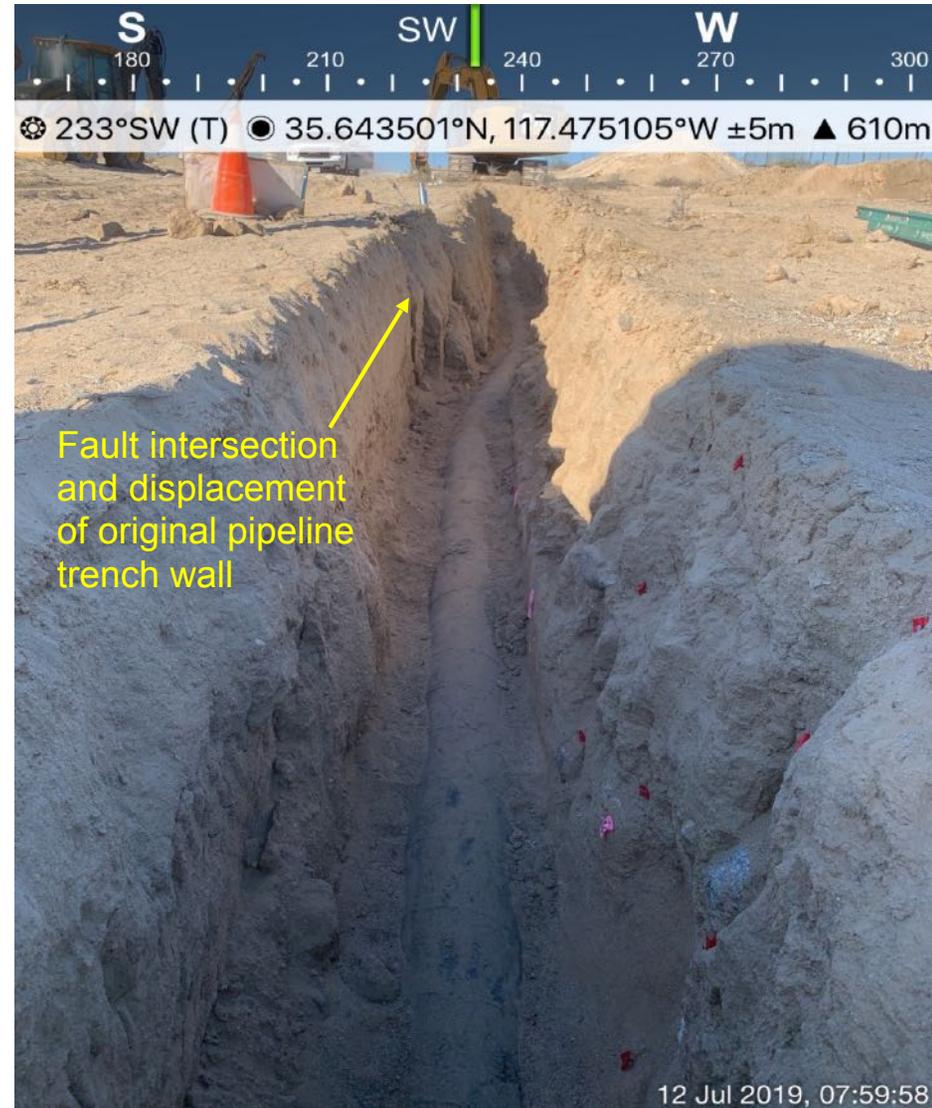
Excavated L-311 pipe showing right lateral bending at fault intersection (southwest view)

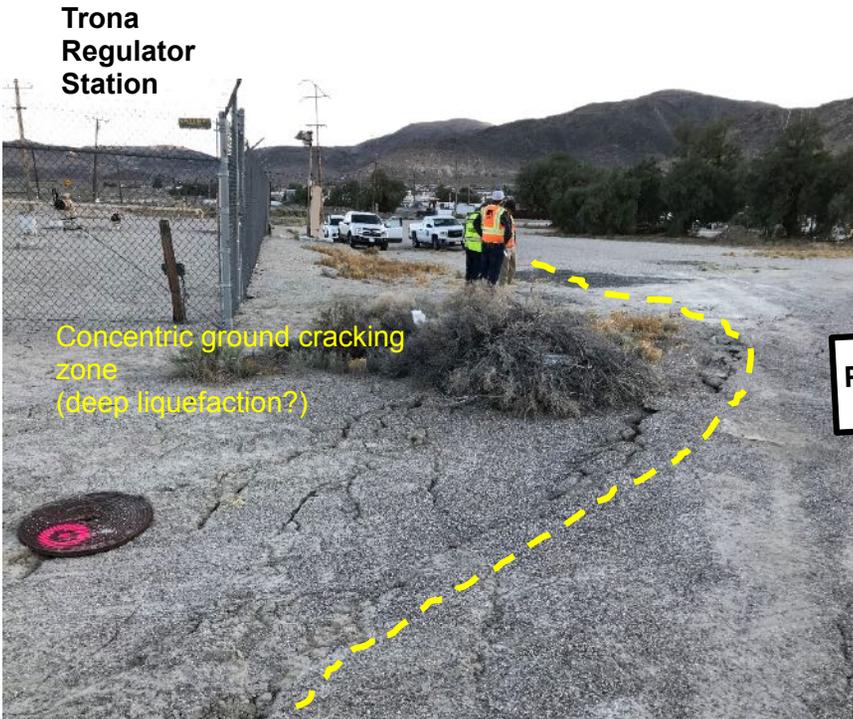
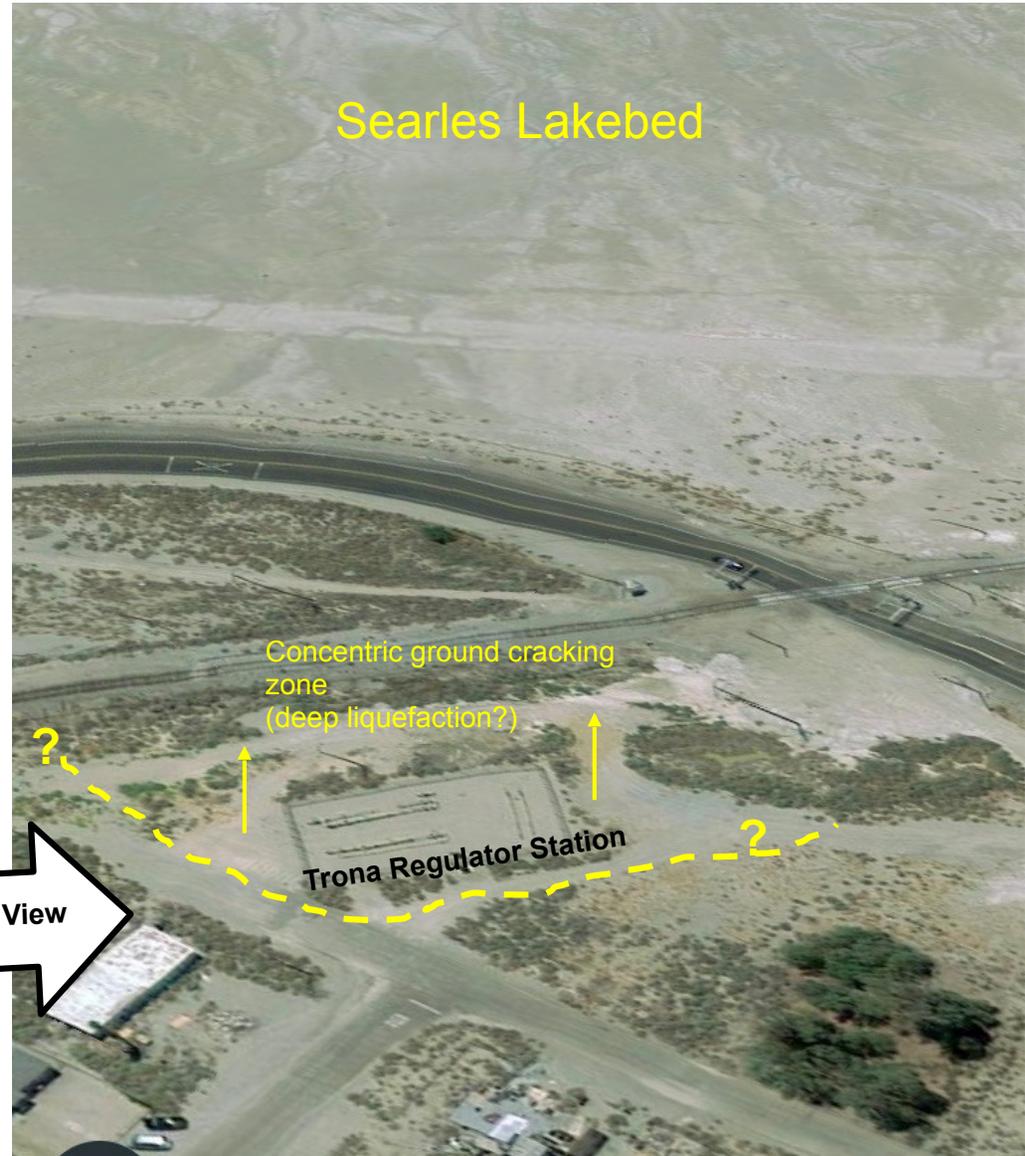
Extensive cracking and settlement zone at Trona Regulator Station (east view; map) and concentric “headscarp” crack (south view; photo)

- Due diligence field reconnaissance was performed along a steel pipe and associated gas regulator/metering stations outside of M6.4 and M7.1 fault rupture areas to check for possible ground failure or triggered rupture. No significant fault rupture was observed at these facilities.
- Extensive cracking, and up to 0.5-1 foot of settlement and lateral movement was observed at the Trona Regulator Station that appears to be caused by fill compaction and possible deep liquefaction/lateral spreading.

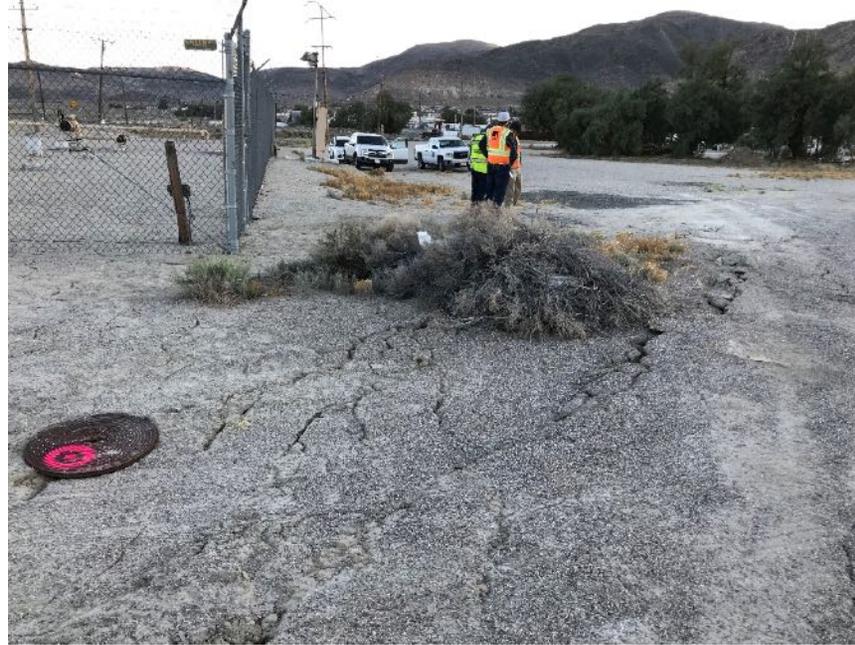
Settlement and lateral movements in station pad fills removed support for piping/valves. Settlement & lateral displacement is up to 0.5-1 foot.

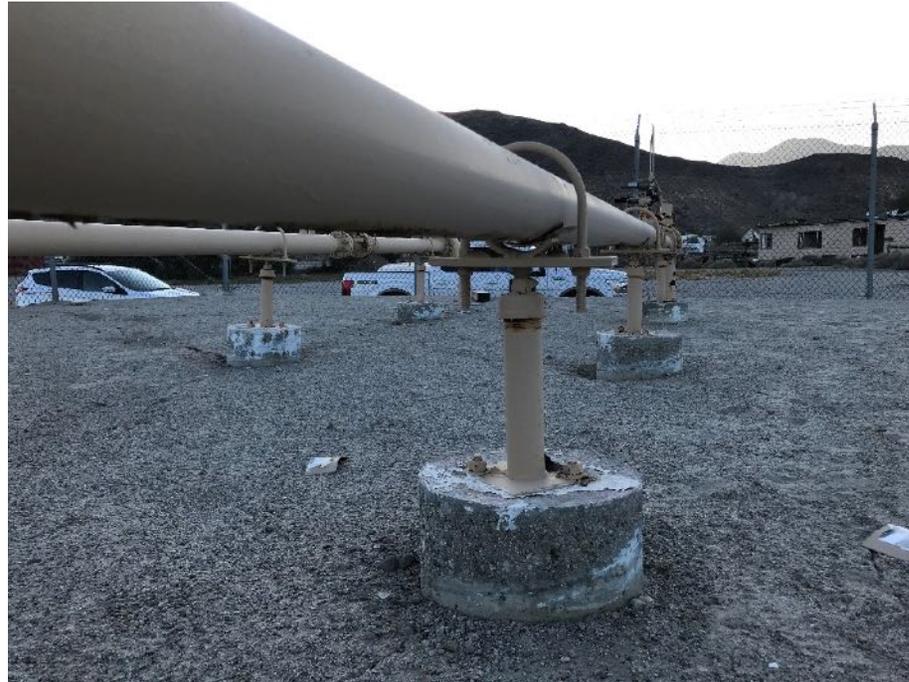
General cracking is pervasive throughout station pad fill.

Differential settlement and lateral displacement across the station pad and foundations
