The 1906 San Francisco Earthquake and its Impact on the Water System

John Eiding
G&E Engineering Systems Inc
October 28, 2004

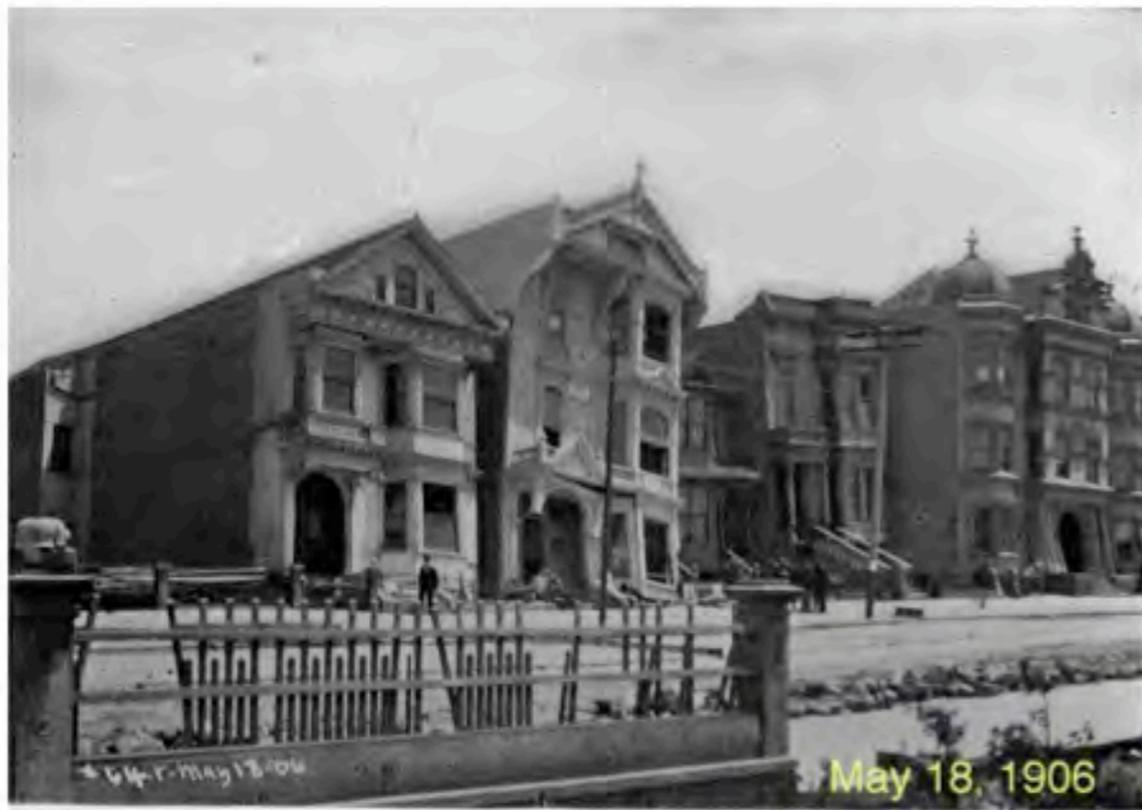
67. East side of Howard Street between 17th and 18th showing effect on buildings

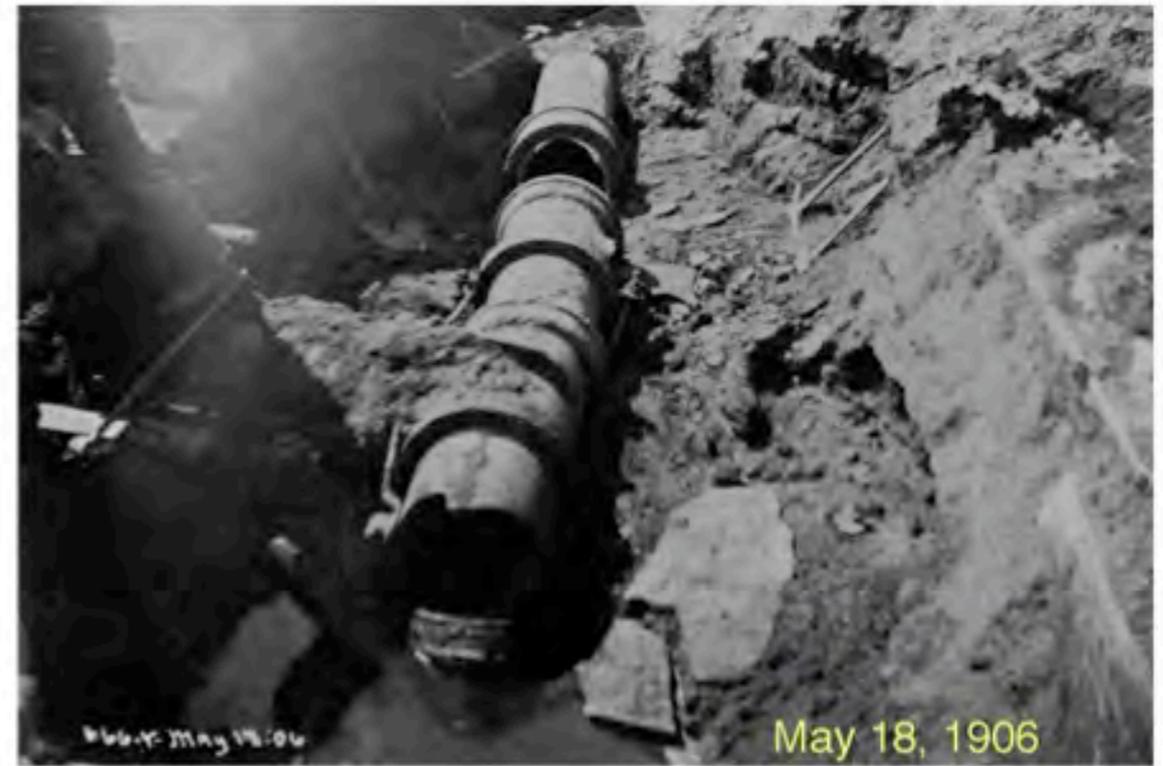
70. Howard Street at 7th. 16" pipe badly fractured

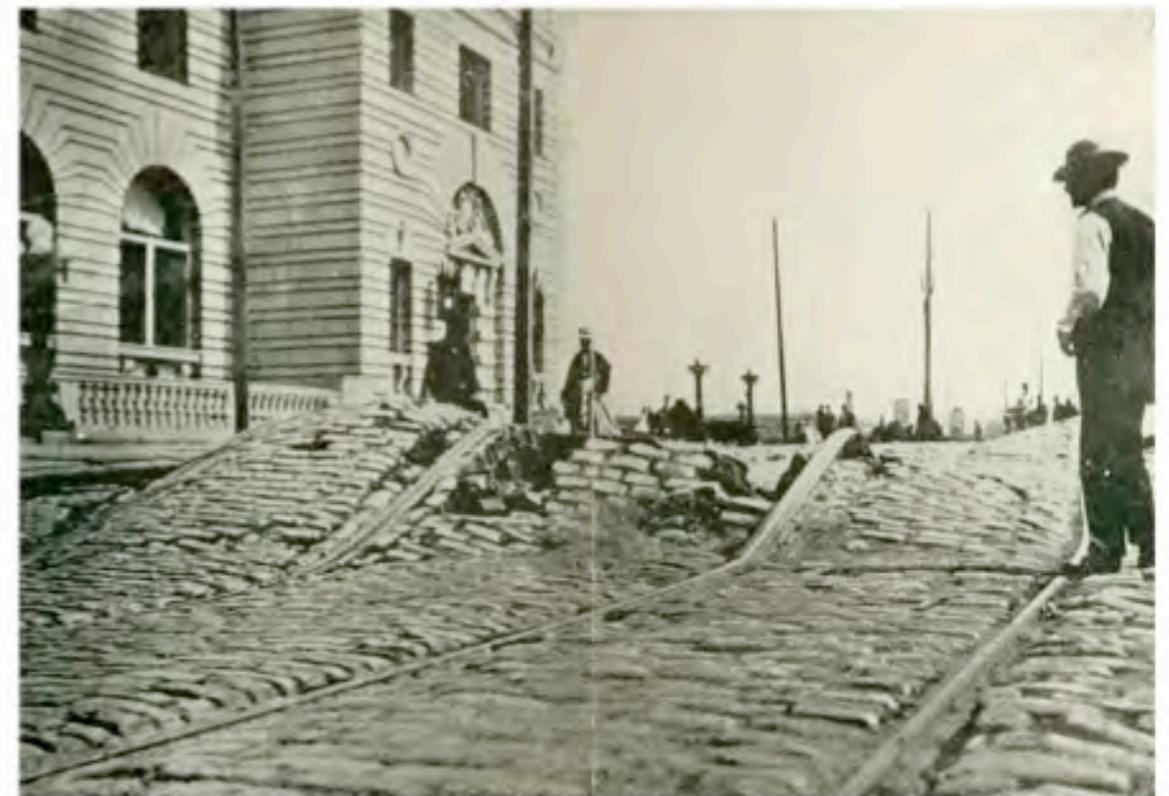
77. Mission Street at 7th St at Post Office. 12" pipe ruptured

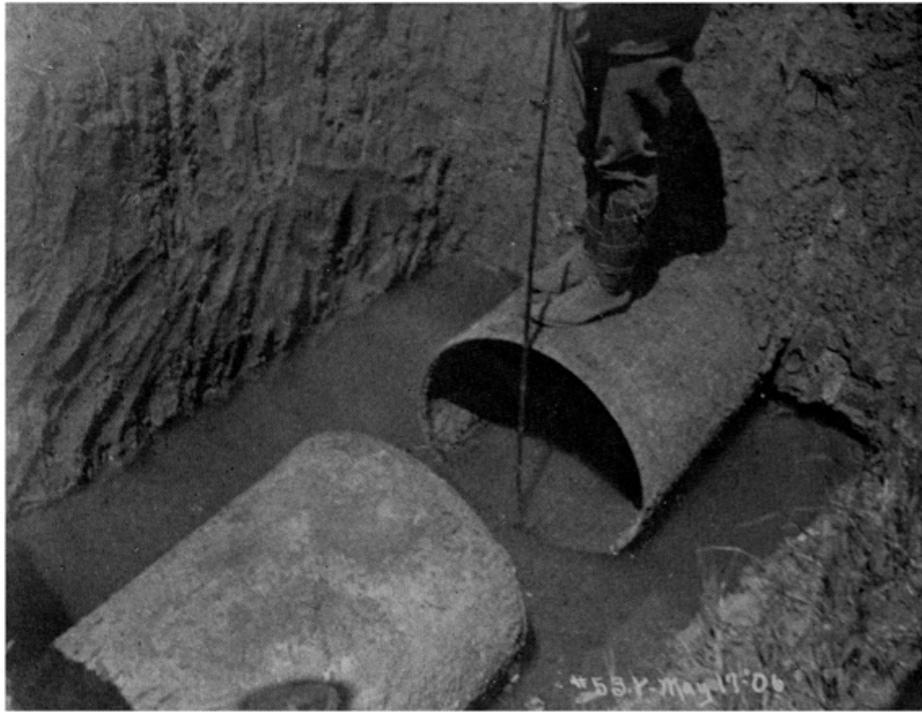
3. 30" Pilarcitos Pipe pulled apart 2 feet

This pipeline criss-crossed the San Andreas fault at many locations. It was also supported on wooden trestles across a few canyons, and suffered complete collapse. There was so much damage, the pipeline was abandoned south of Daly City. Today, Pilarcitos Reservoir dumps its water to San Andreas Reservoir.

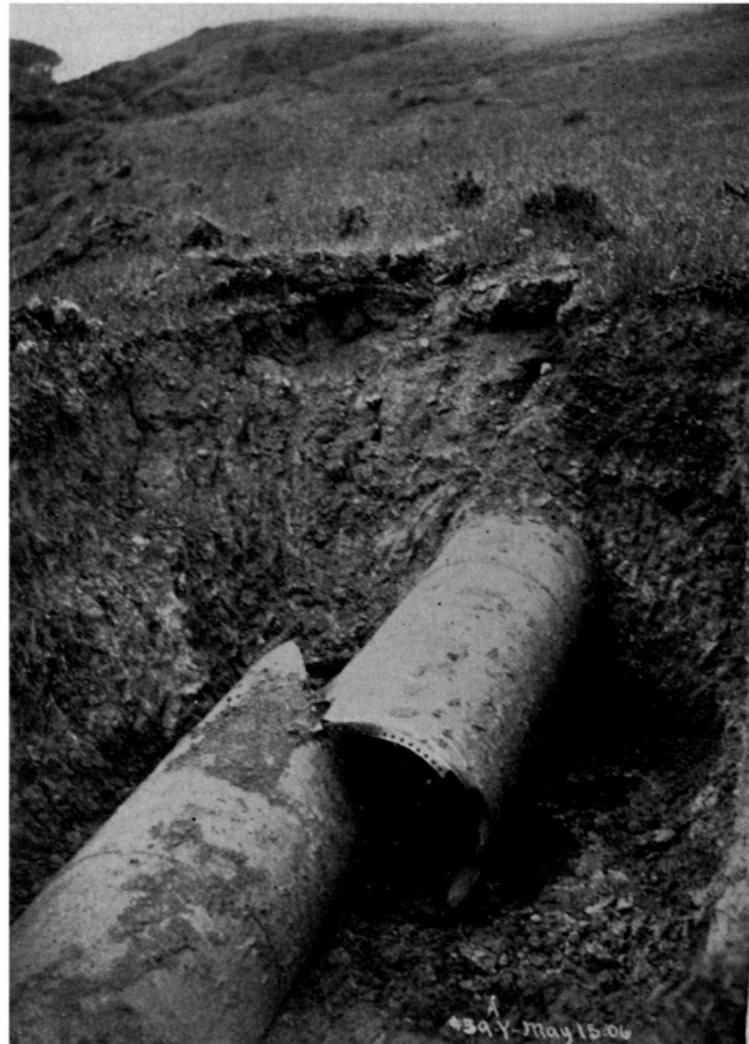
6. 30" Pilarcitos Pipe telescoped

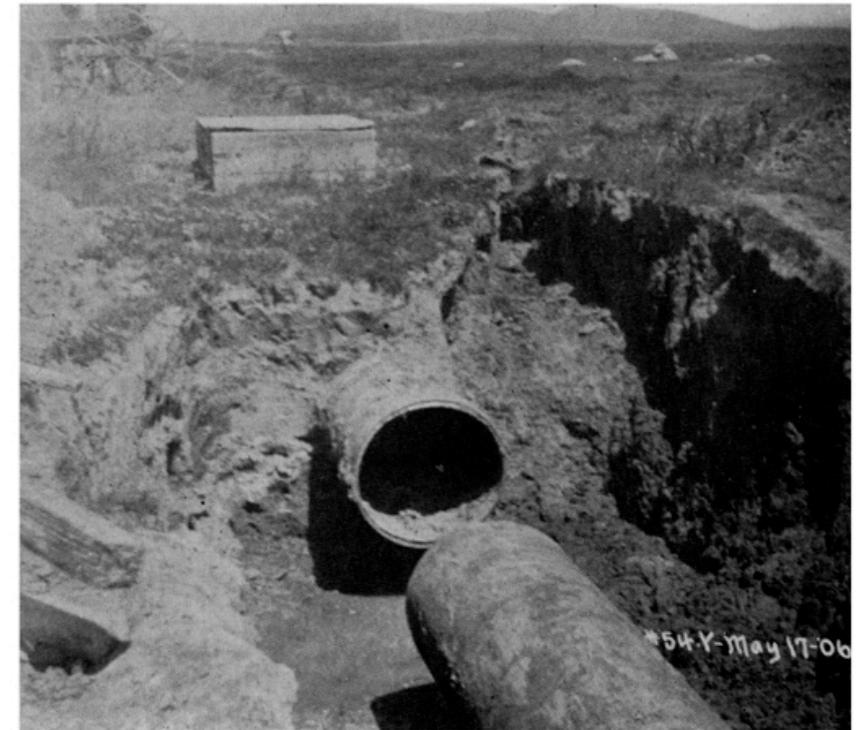
7. 30" Pilarcitos Pipe pulled apart 3 feet

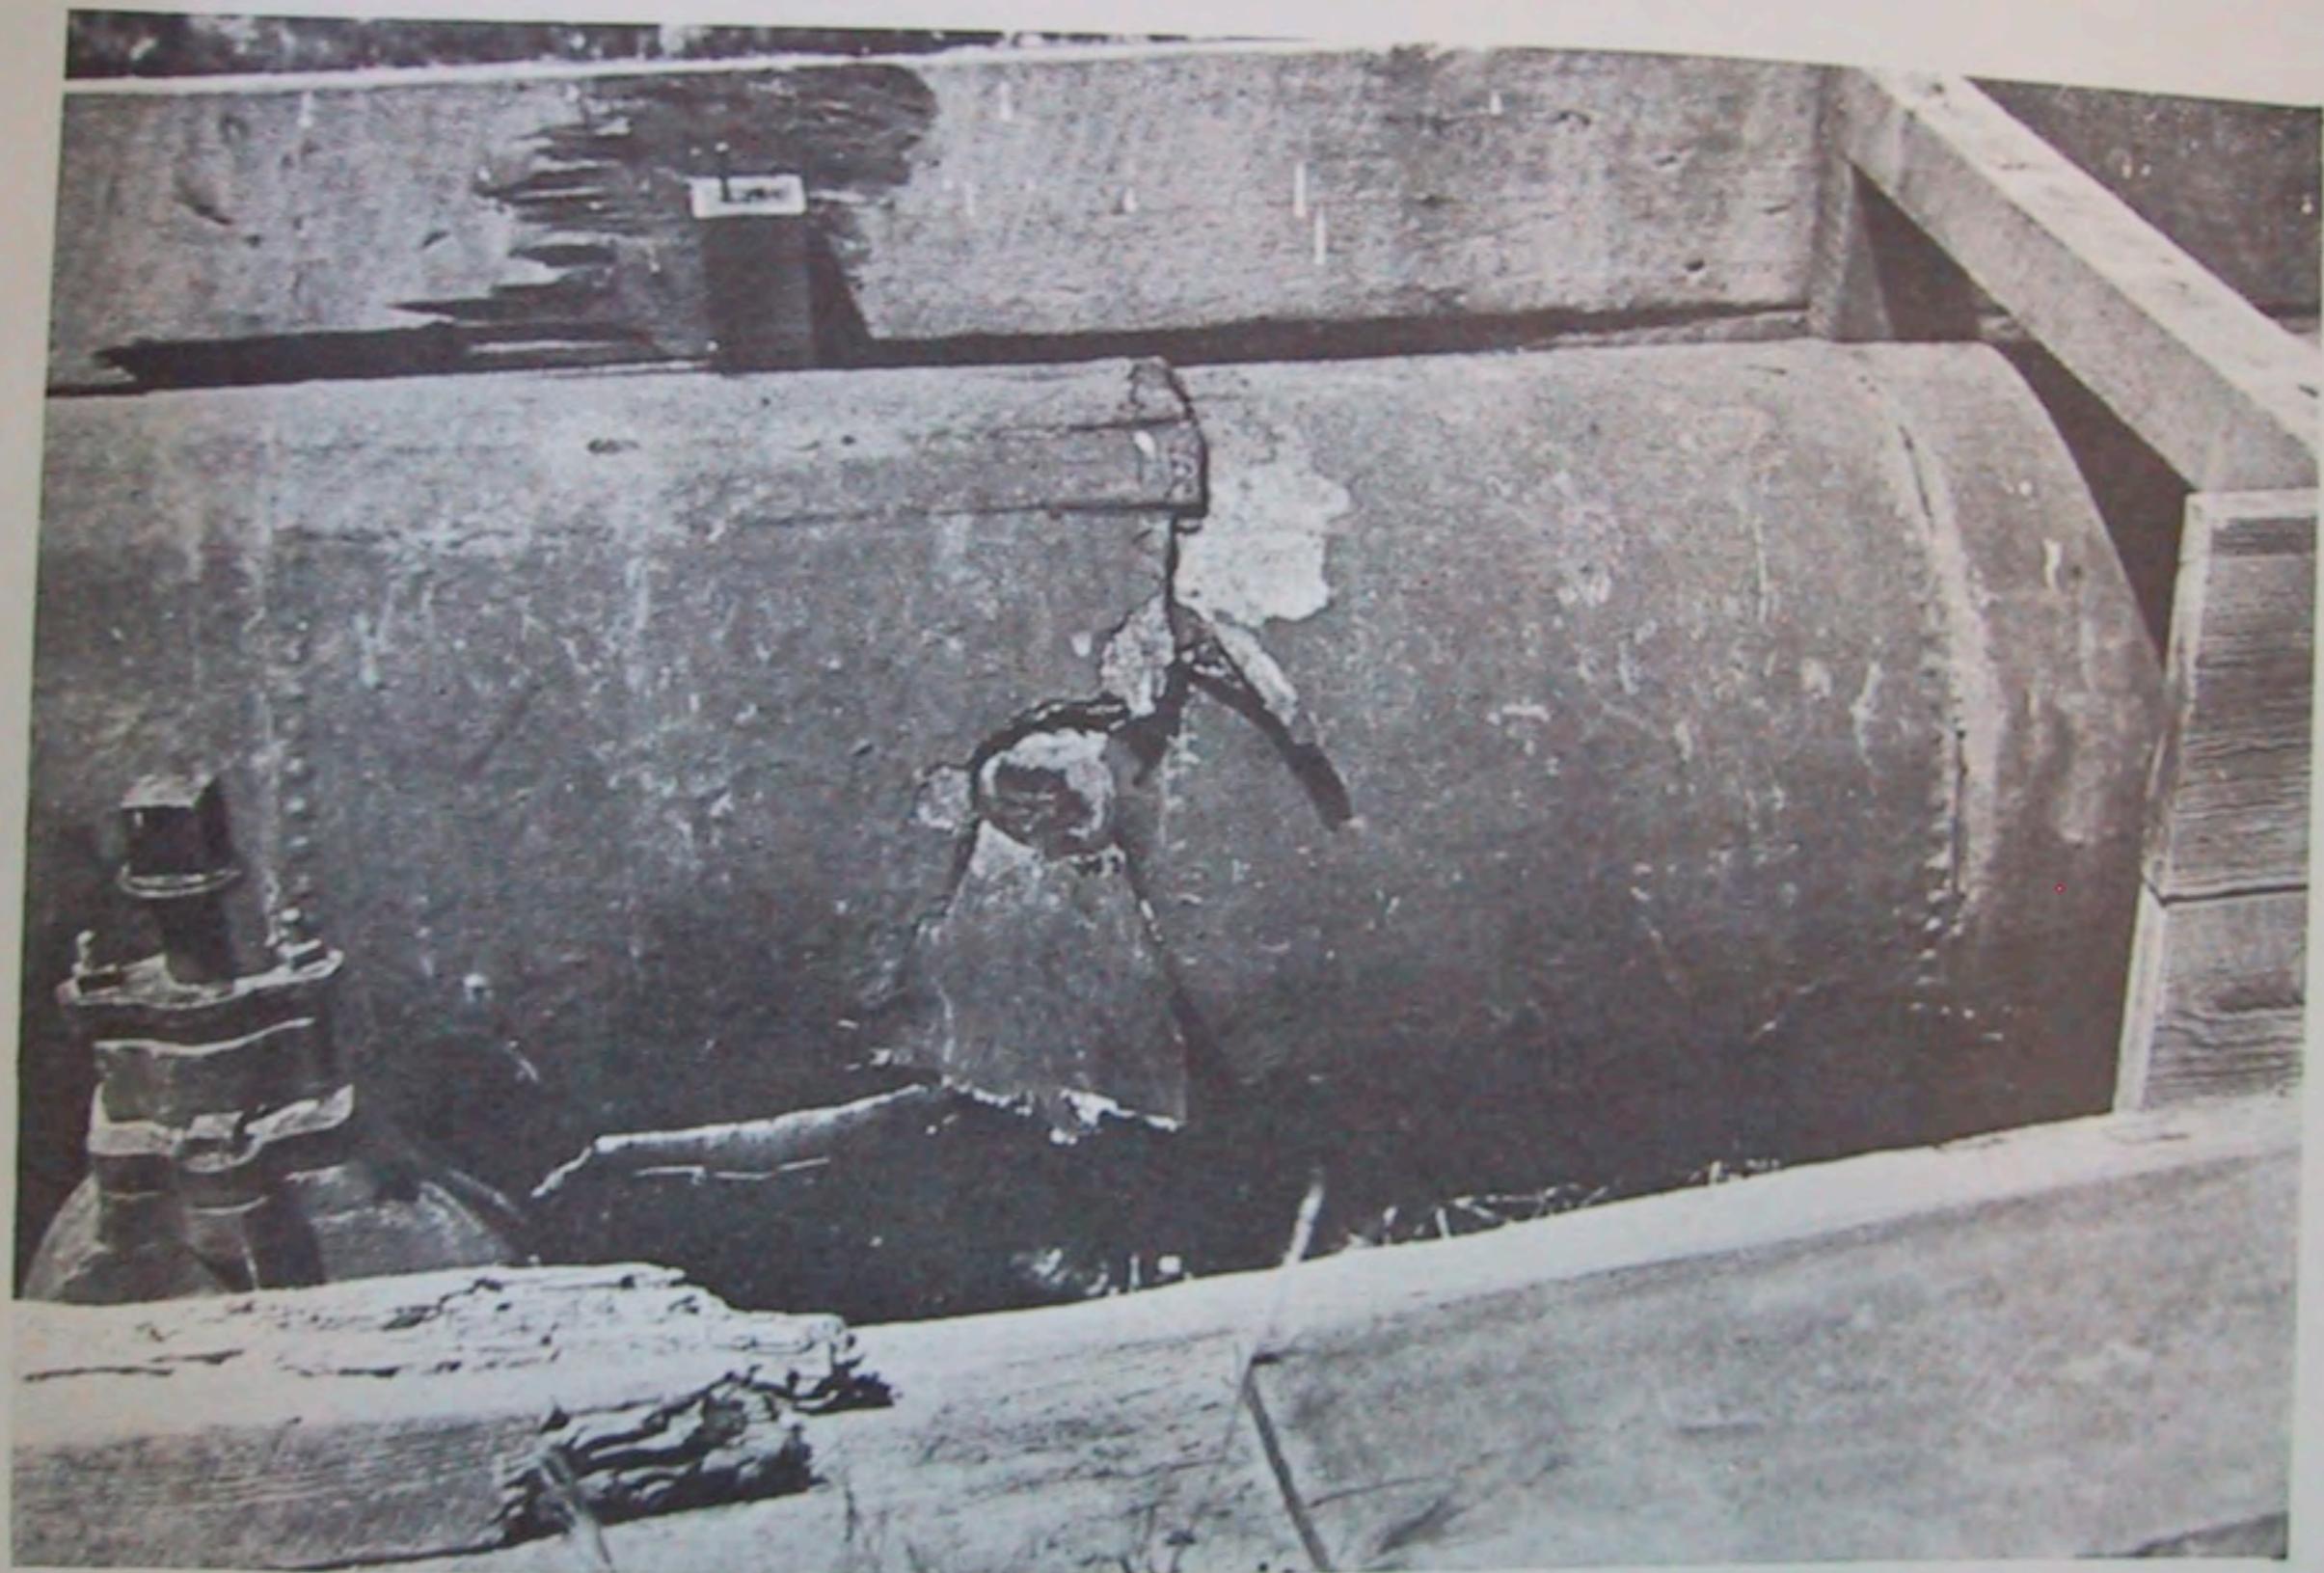
B. Thrust of 30-inch water-pipe by fault, northwest of San Andreas Lake. Amount of telescoping is 58 inches. A. C. L.

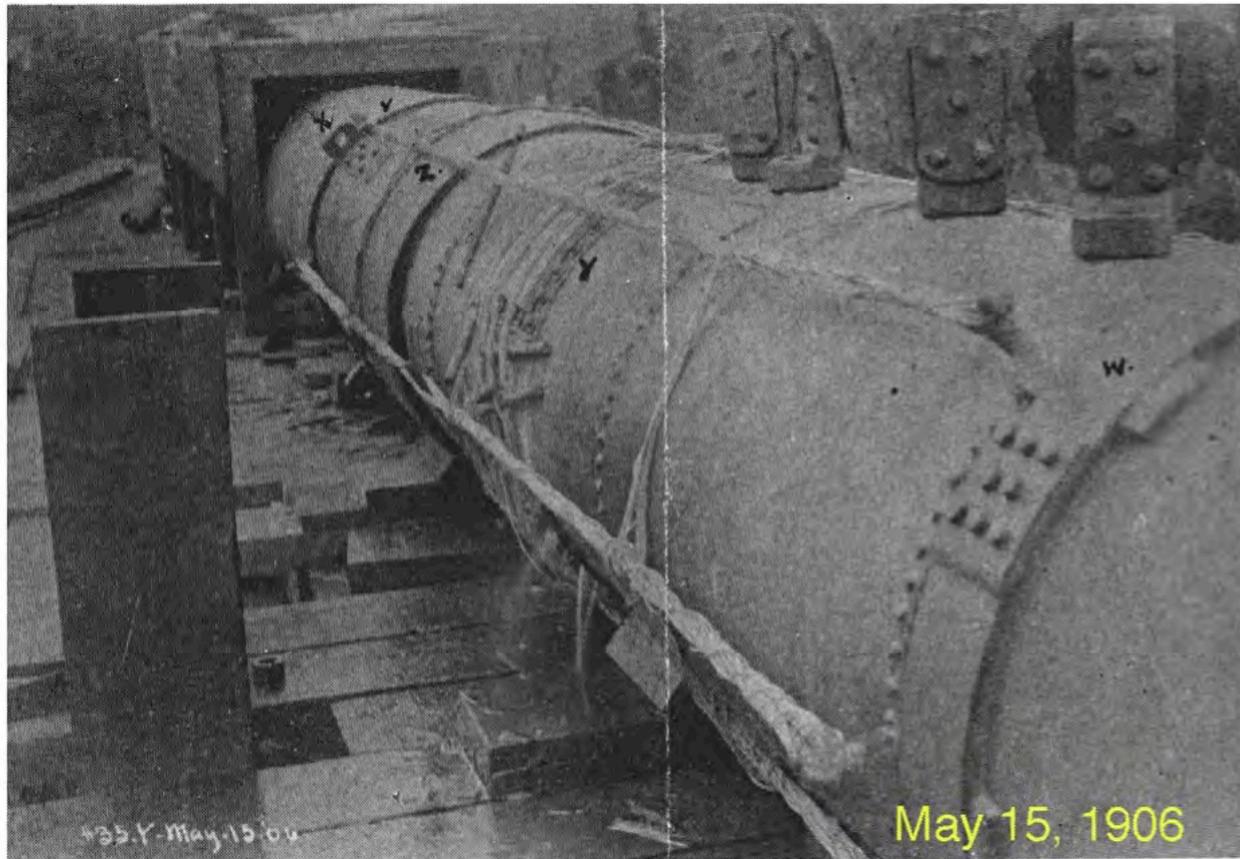
24. 37" San Andreas Pipe Repair at Colma Creek

Badly fractured at 1 location, on a trestle crossing modern Colma Creek. It took 62 hours to fix it

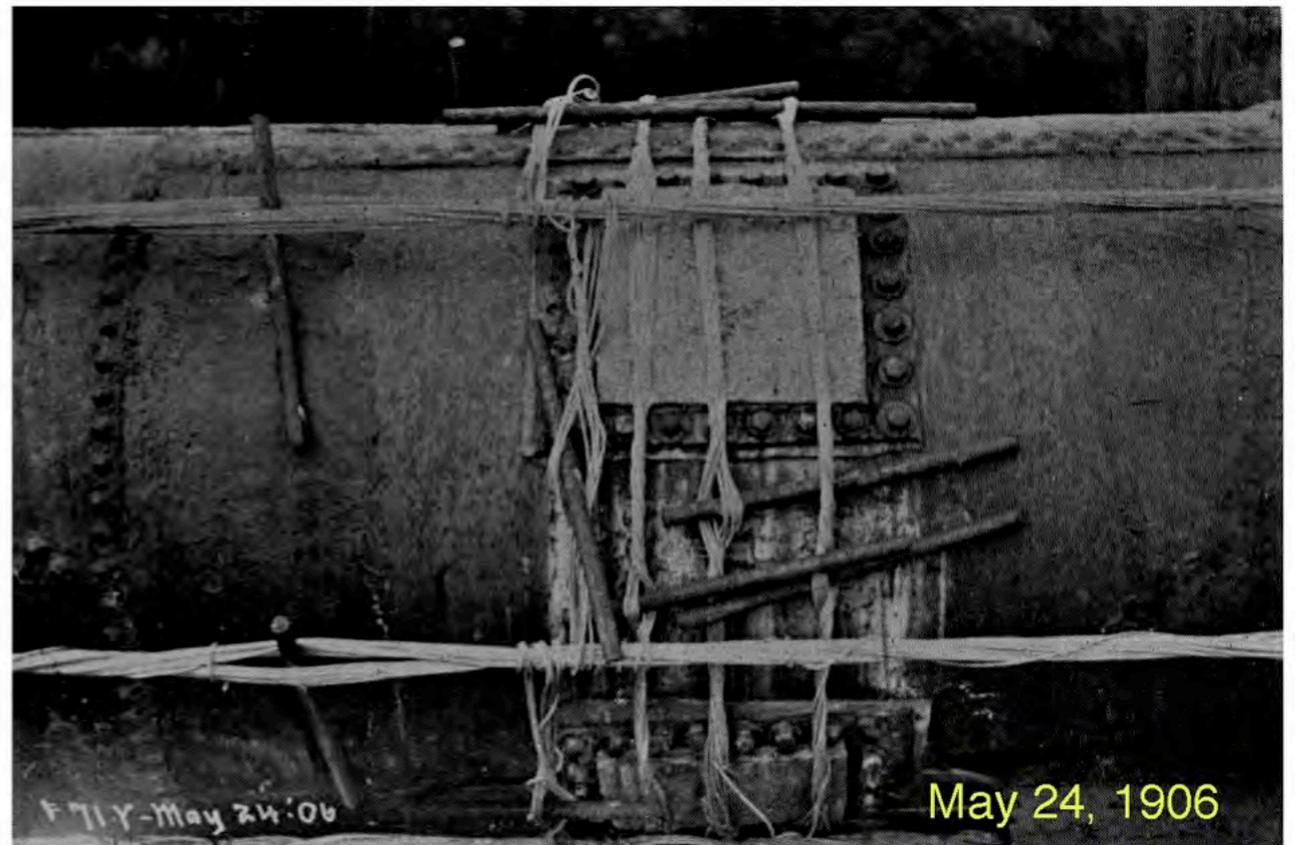
25. 37" San Andreas Pipe Repair

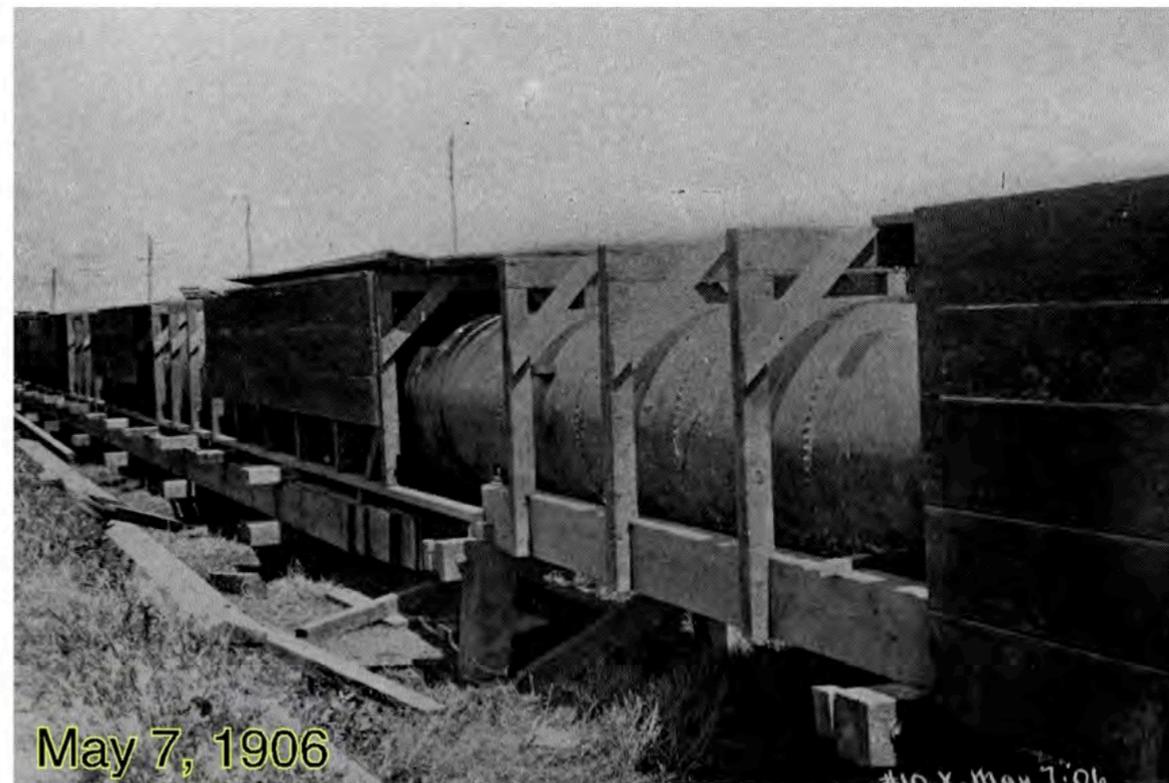
500 feet of 44" pipe
thrown from trestle
onto the mud flats

22. 44" Crystal Springs Pipe at
San Bruno Marsh on reconstructed trestle

It took 30 days to
fix this.

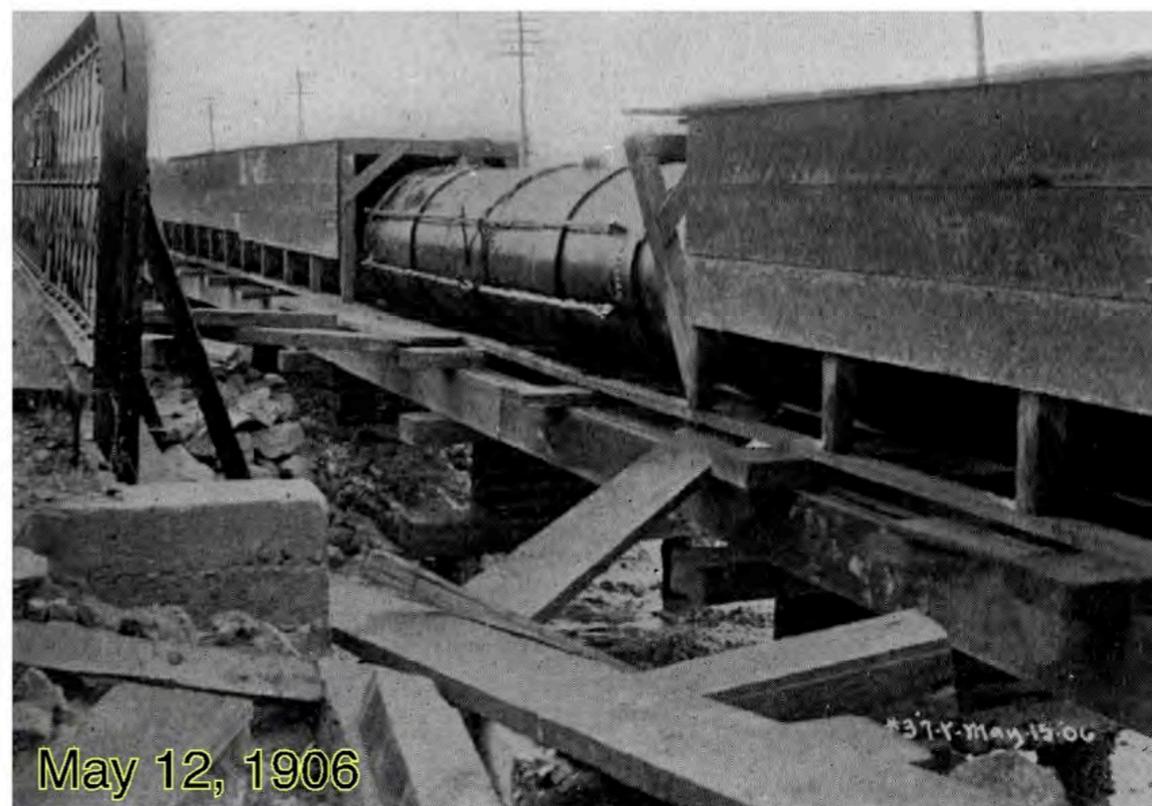
23. 44" Crystal Springs Pipe at
San Bruno Marsh on reconstructed trestle

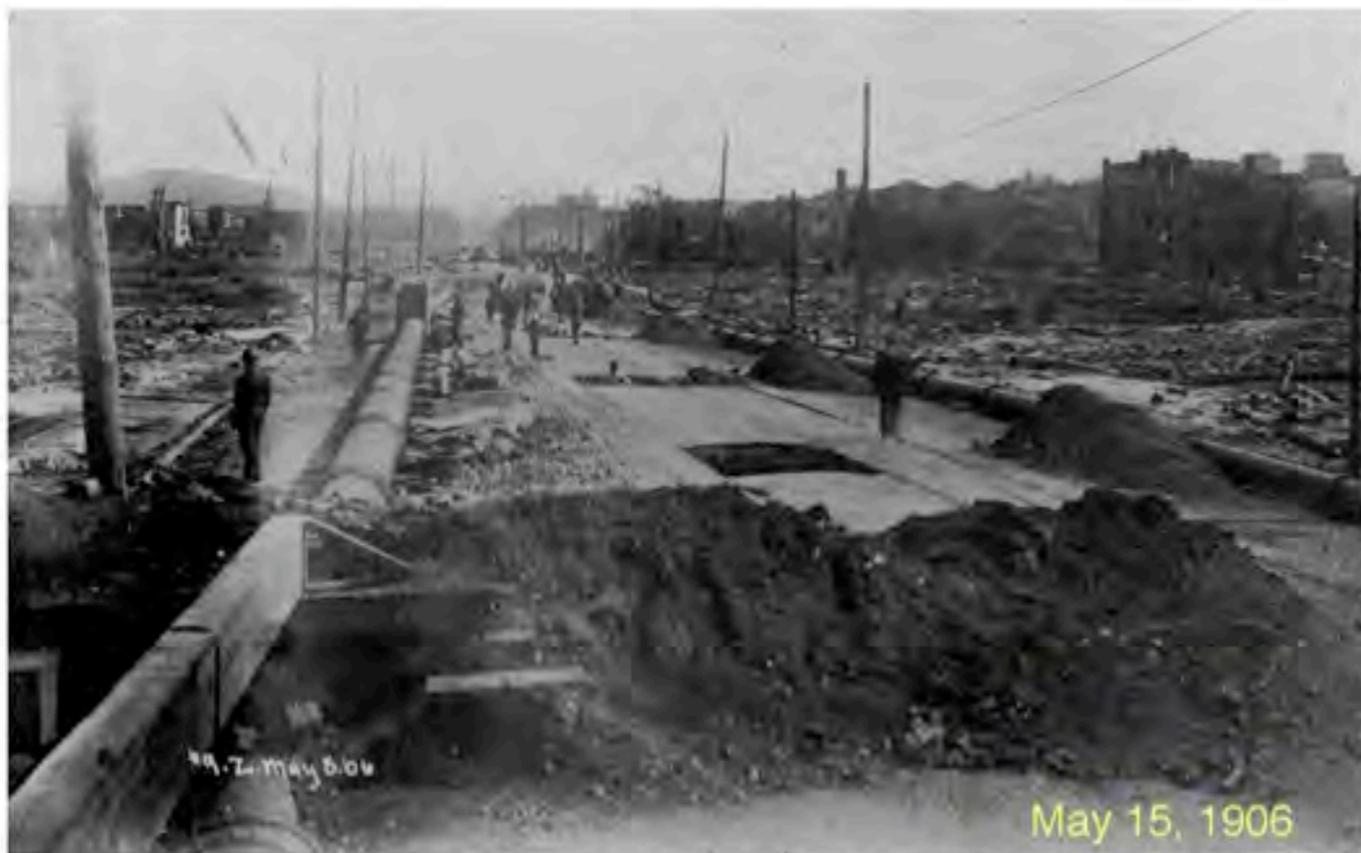
58. View south on Valencia Street showing new 24" and 16" pipes on top of pavement of sunken street

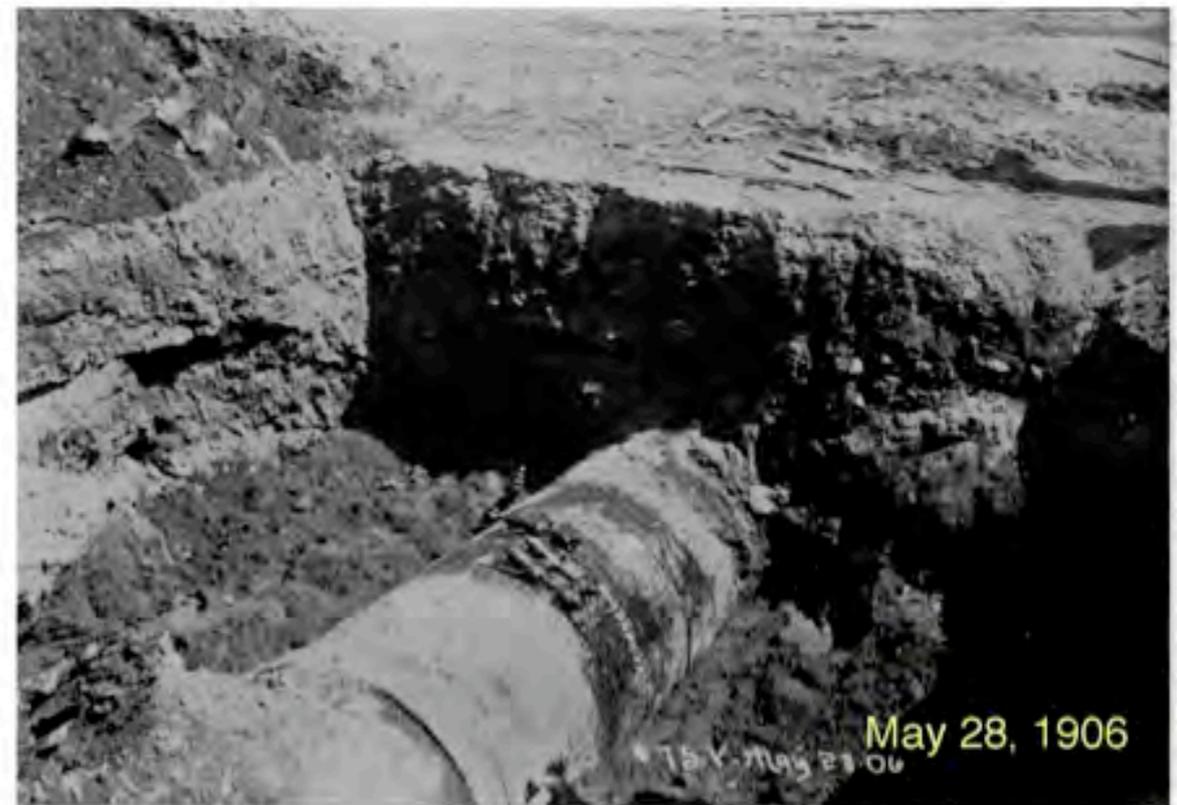
57. Repair of 37" wrought iron pipe on Harrison Street

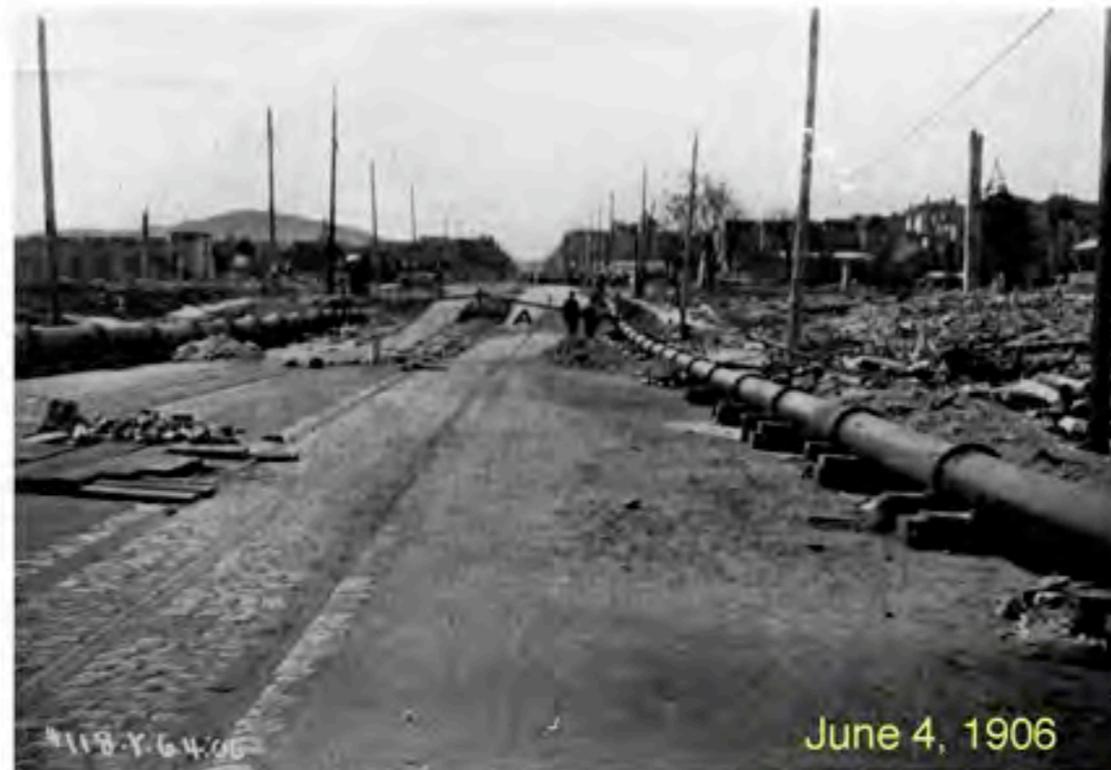
59. Valencia Street showing above ground emergency pipe. The street that settled 5 feet at the point A
