# Lifelines, M 9.0 Tohoku Japan, March 2011

John Eidinger  
August 11, 2011

G&E Engineering Systems Inc.  
[eidinger@geEngineeringSystems.com](mailto:eidinger@geEngineeringSystems.com)

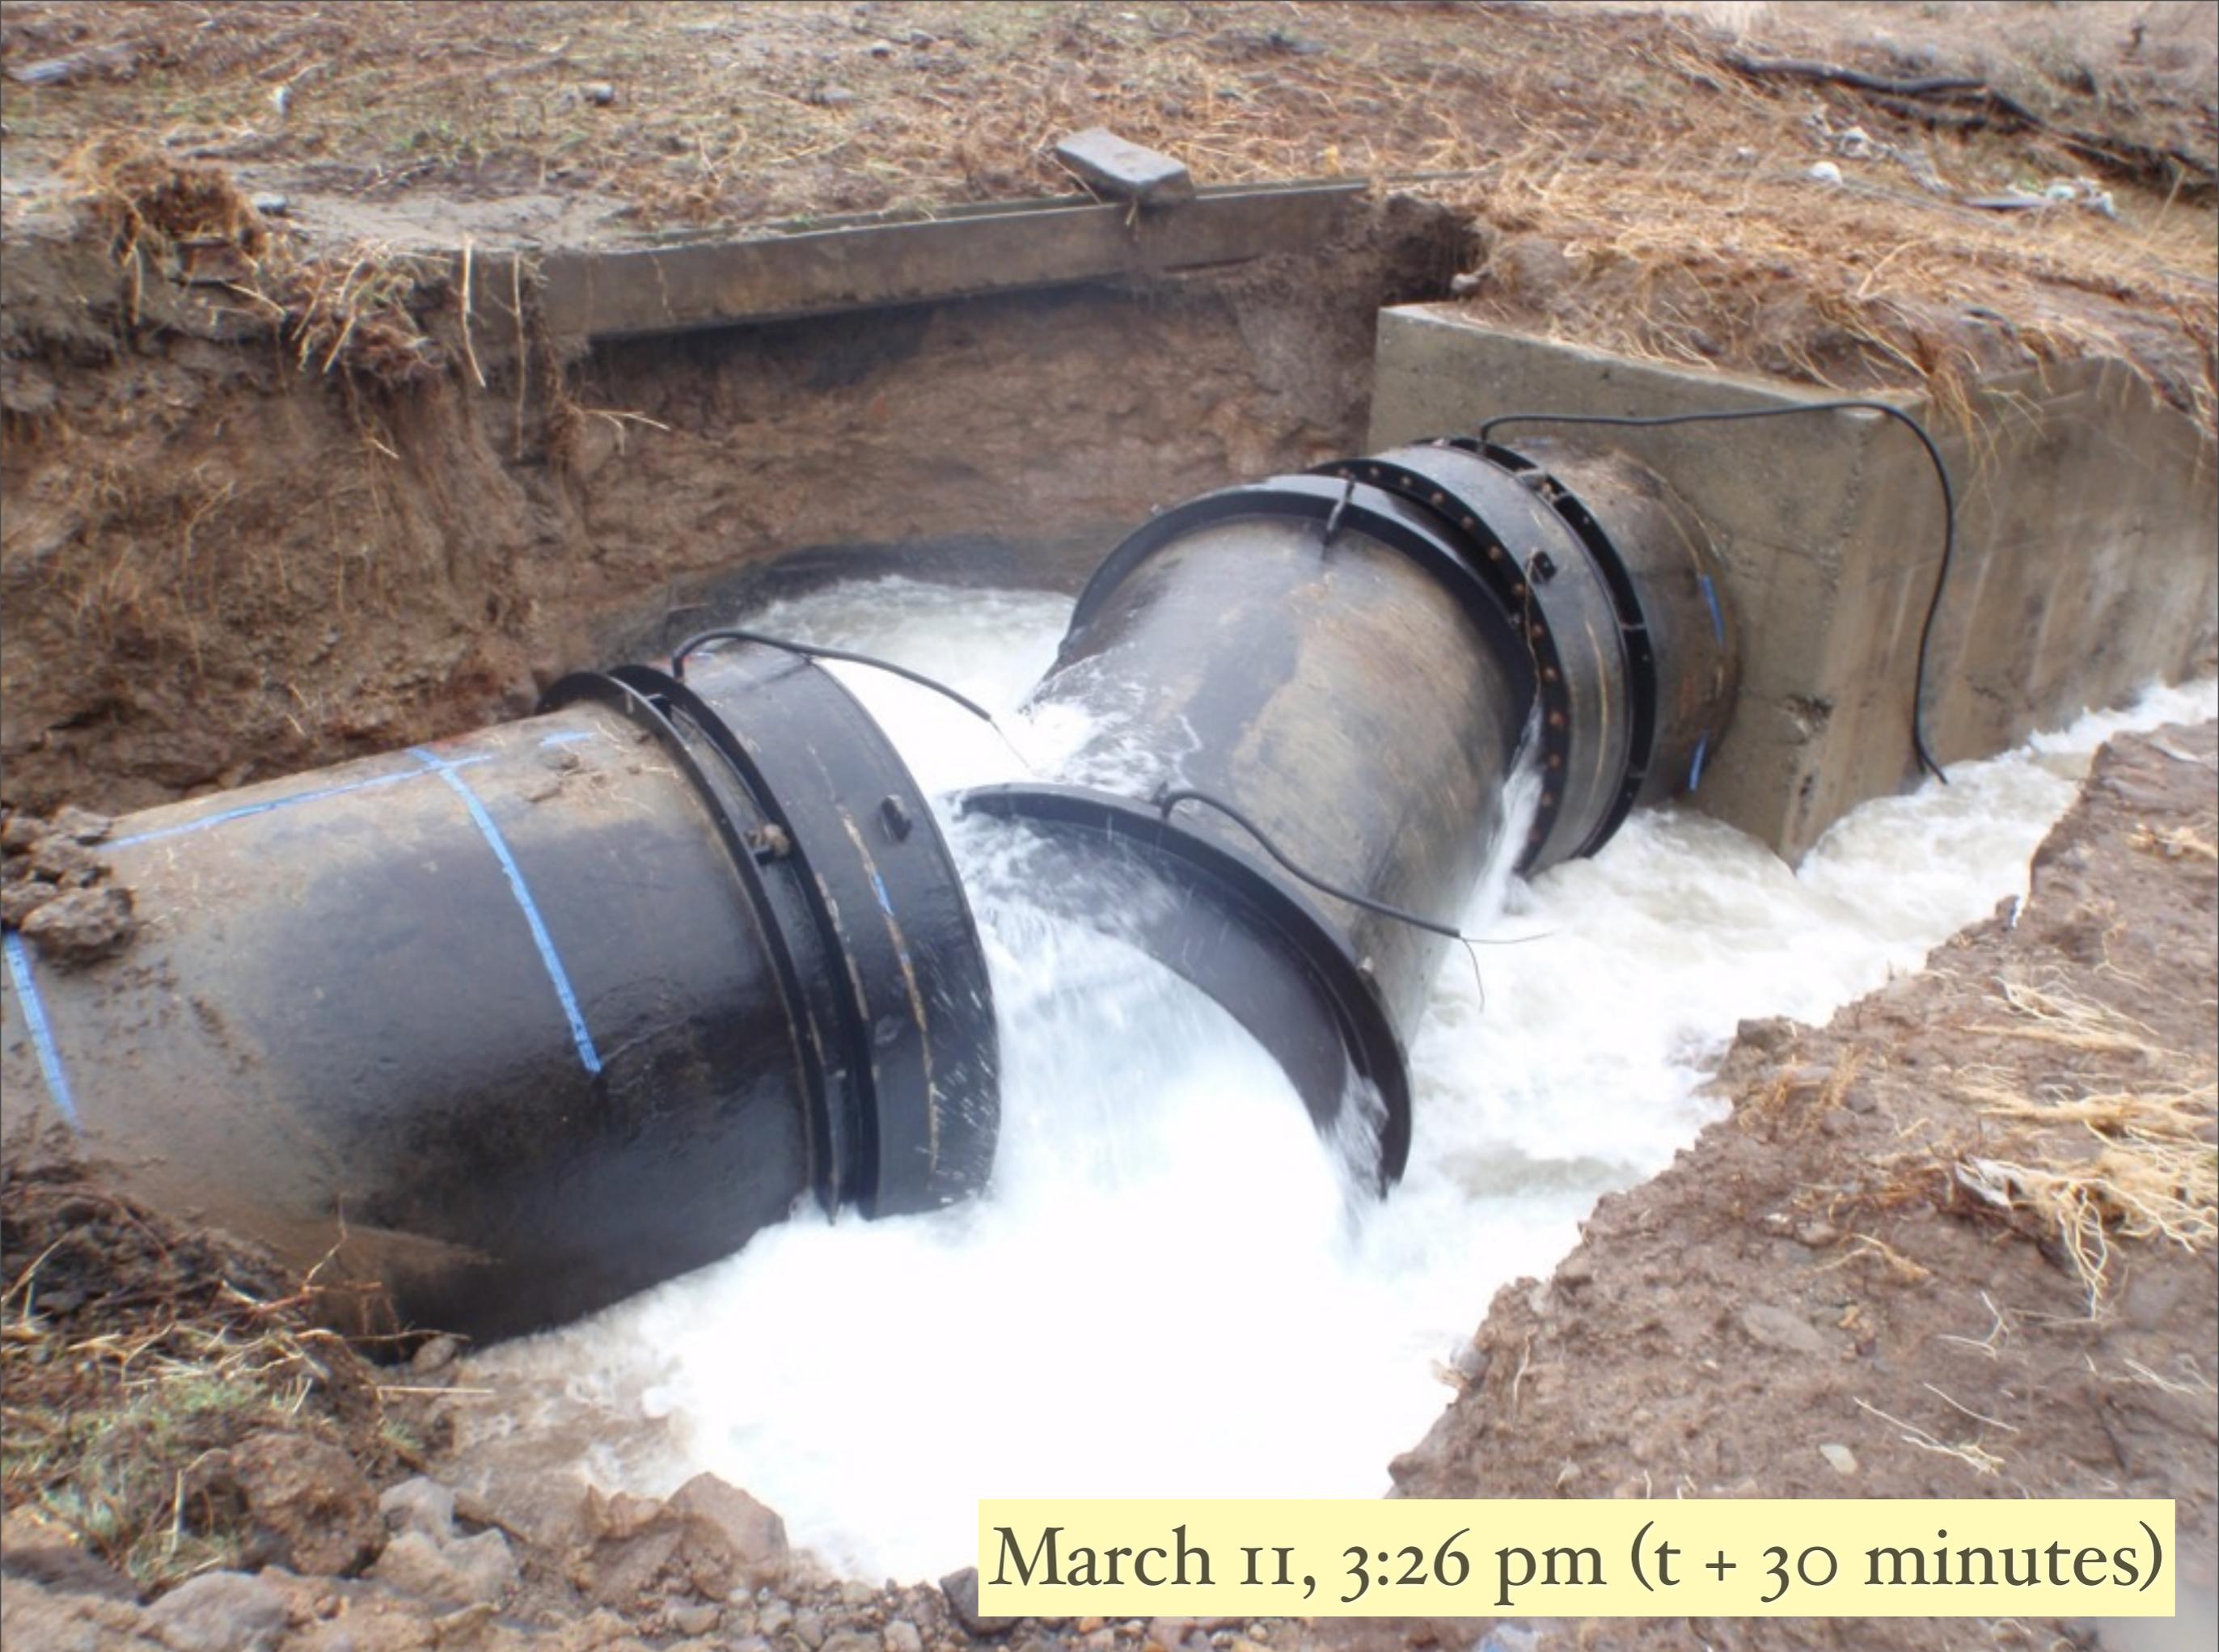
March 11, 3:26 pm (t + 30 minutes)

48" (1.2m) steel pipe with pulled couplings

Concrete encasement

Route 4, near Shiroshi. This pipe is in the low zone, going to Natori

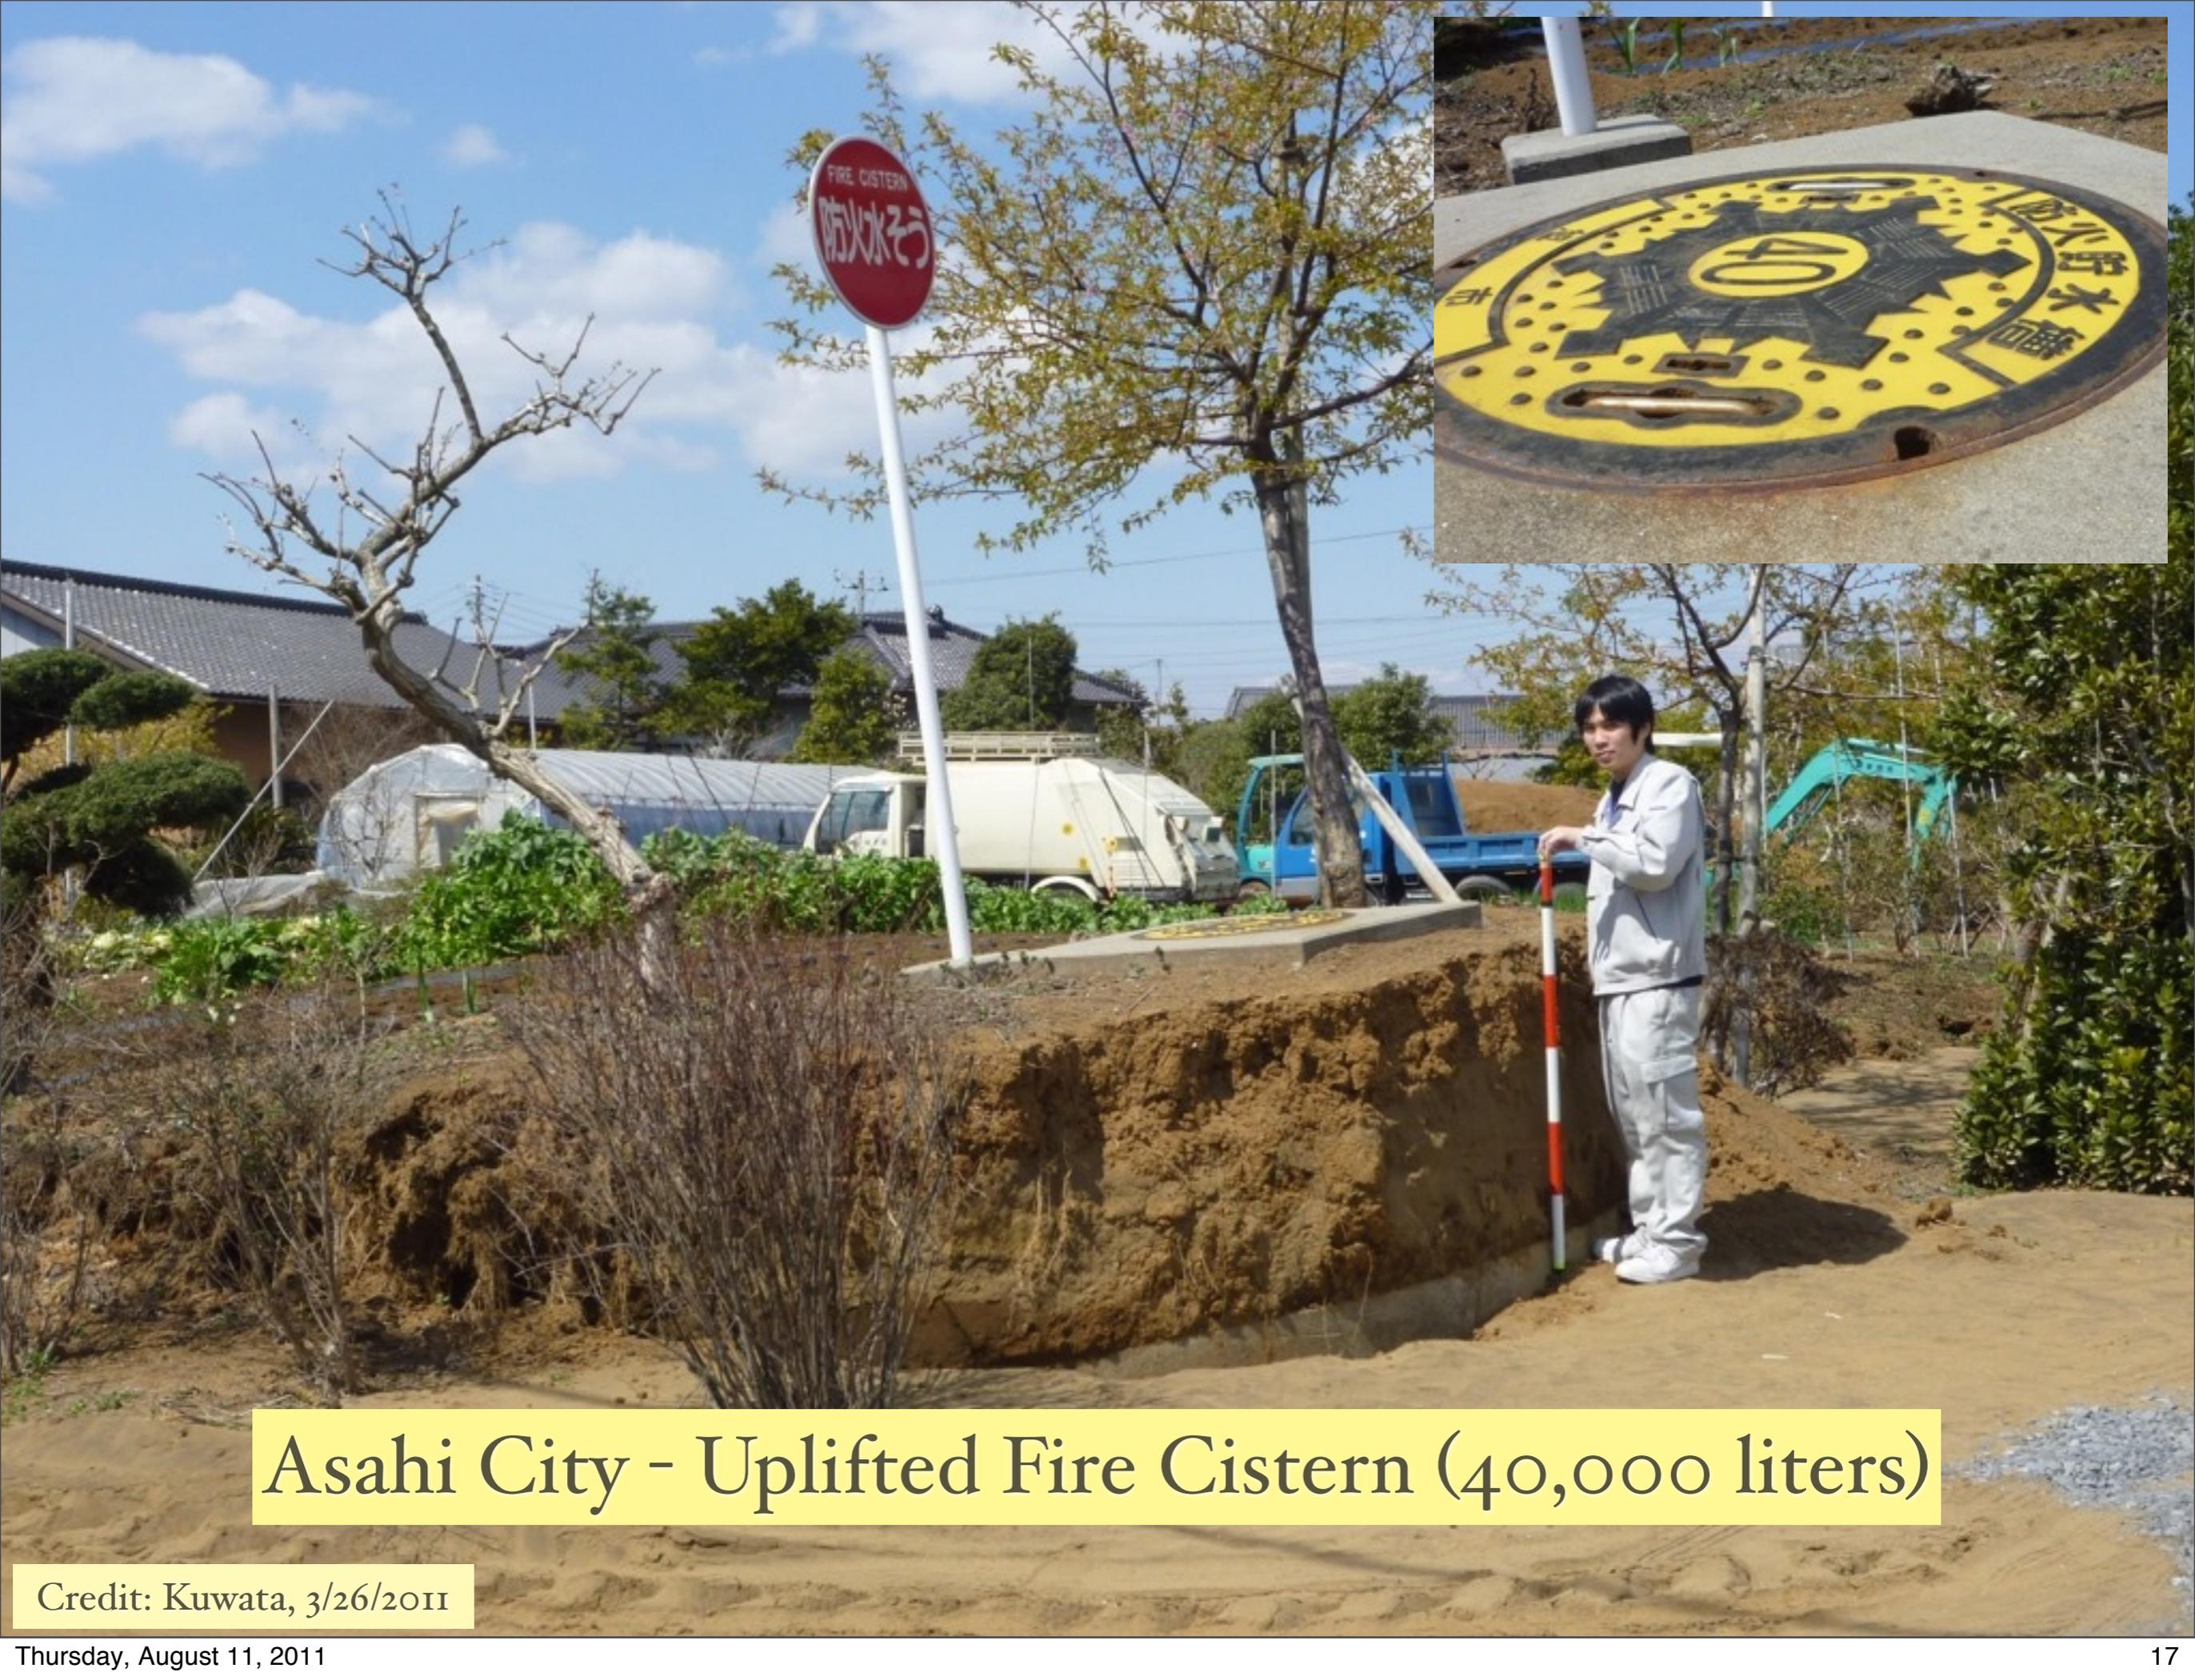
Asahi City - Uplifted Fire Cistern (40,000 liters)

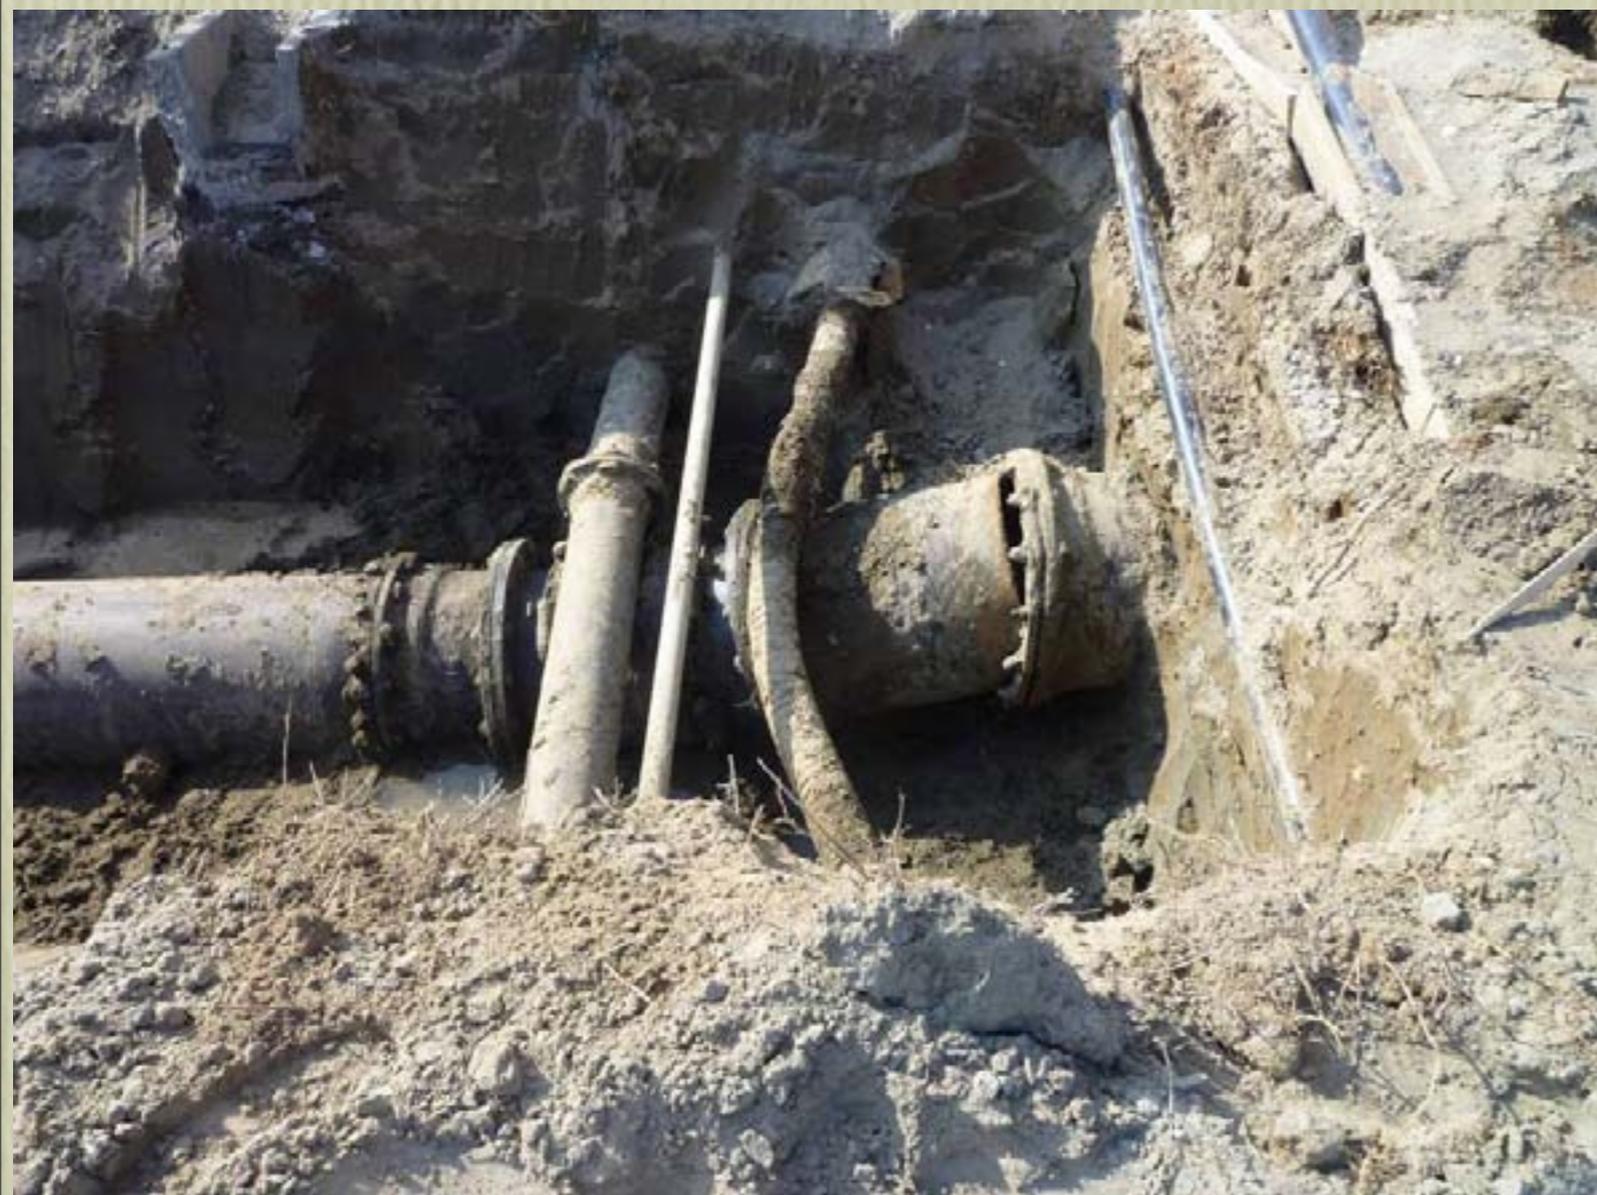
鹿行広域水道用水供給事業の取水棟への取り付け部の伸縮可とう管  
φ600。周辺小口径管路が地盤と共に沈下したため、継手部で漏水

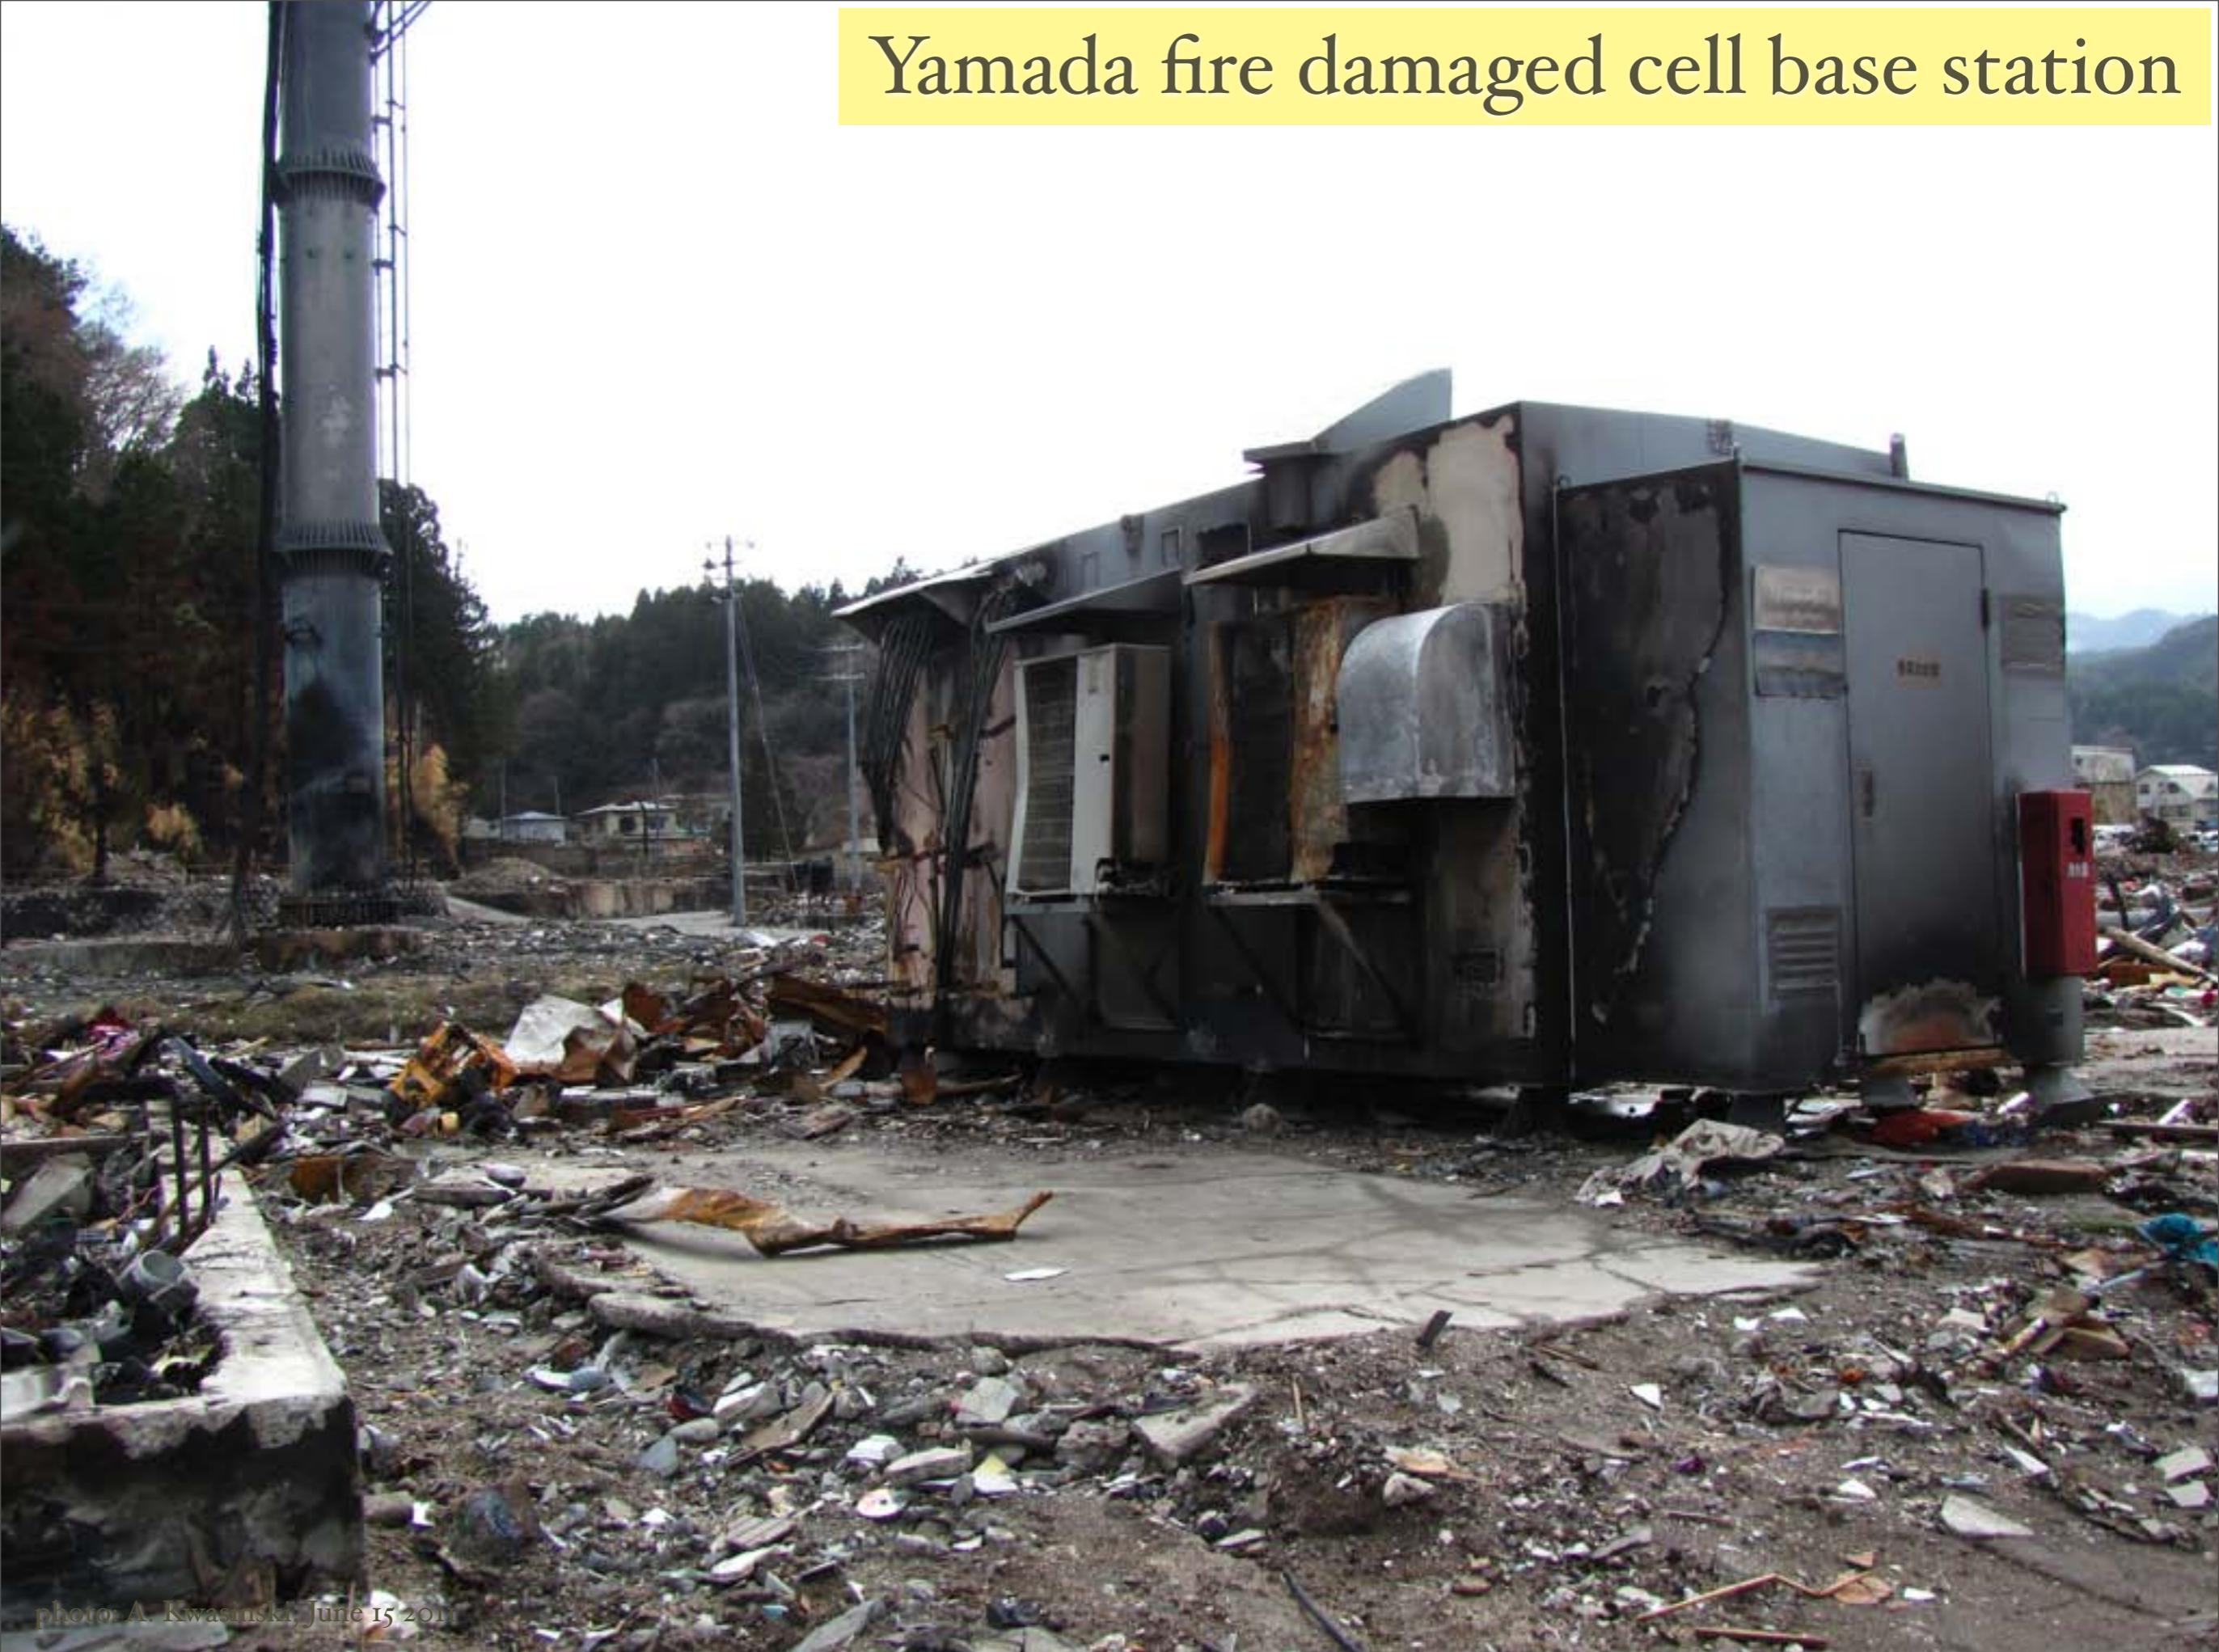
# Yamada fire damaged cell base station

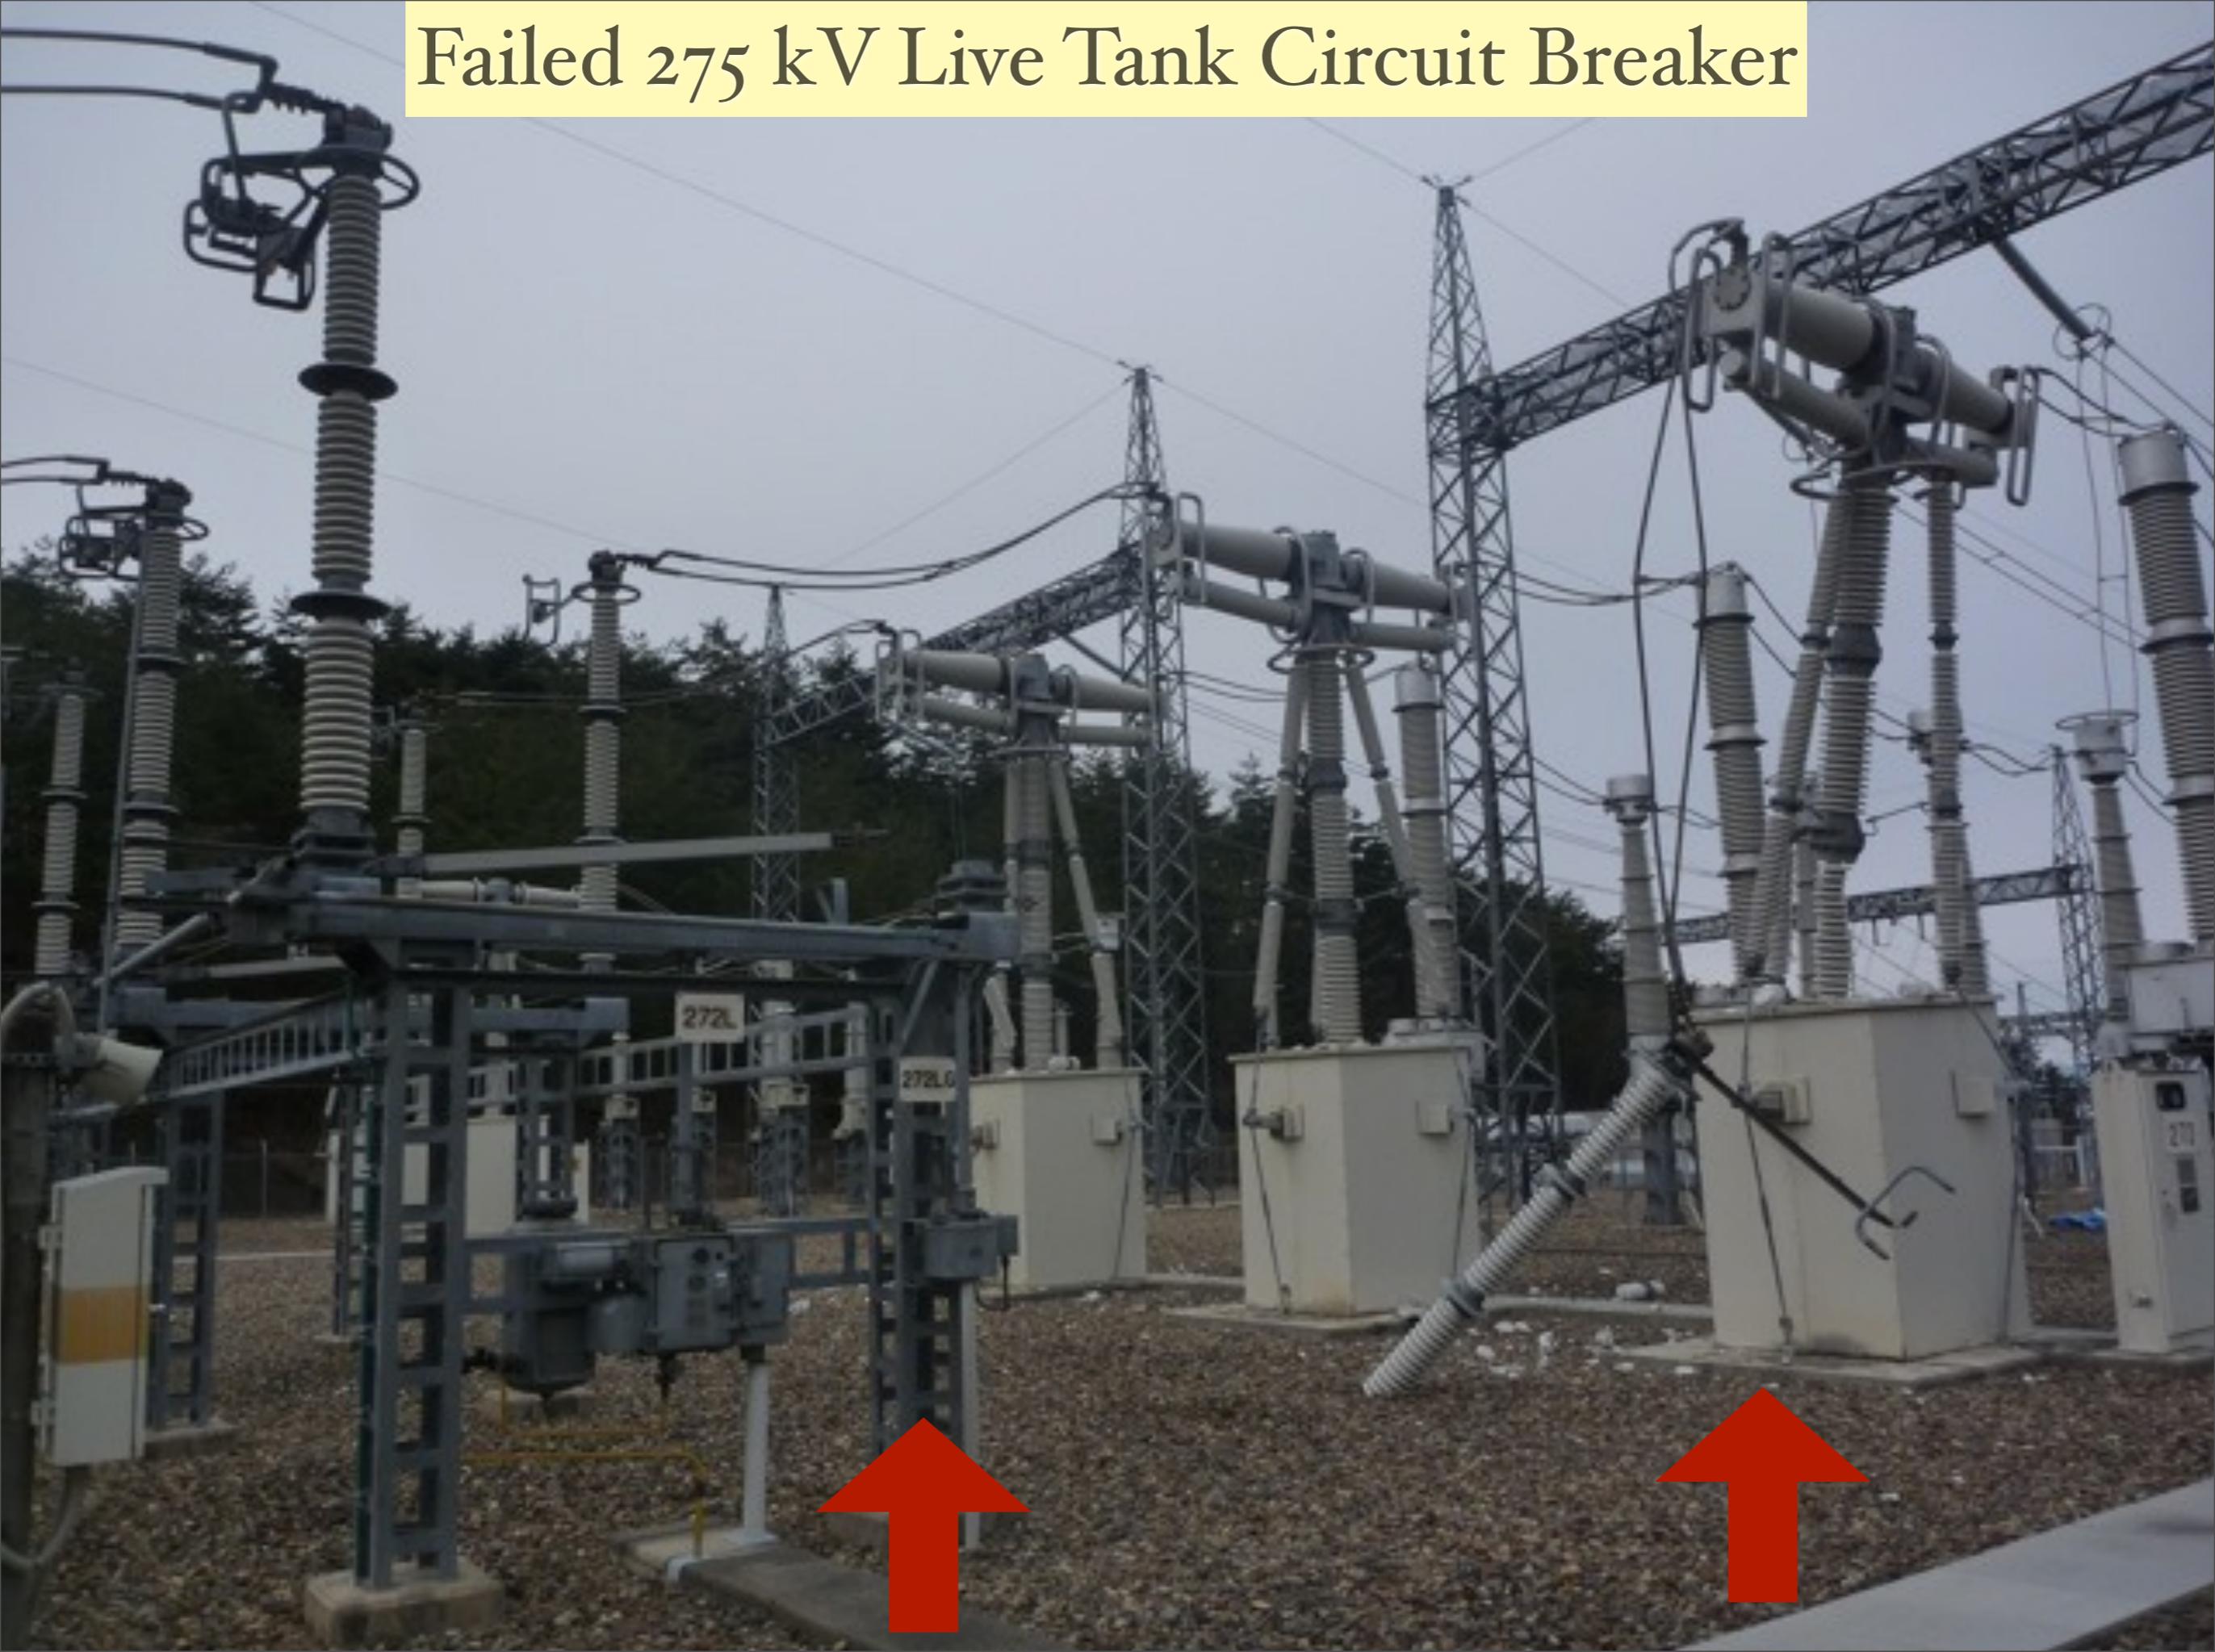
# Failed 275 kV Live Tank Circuit Breaker

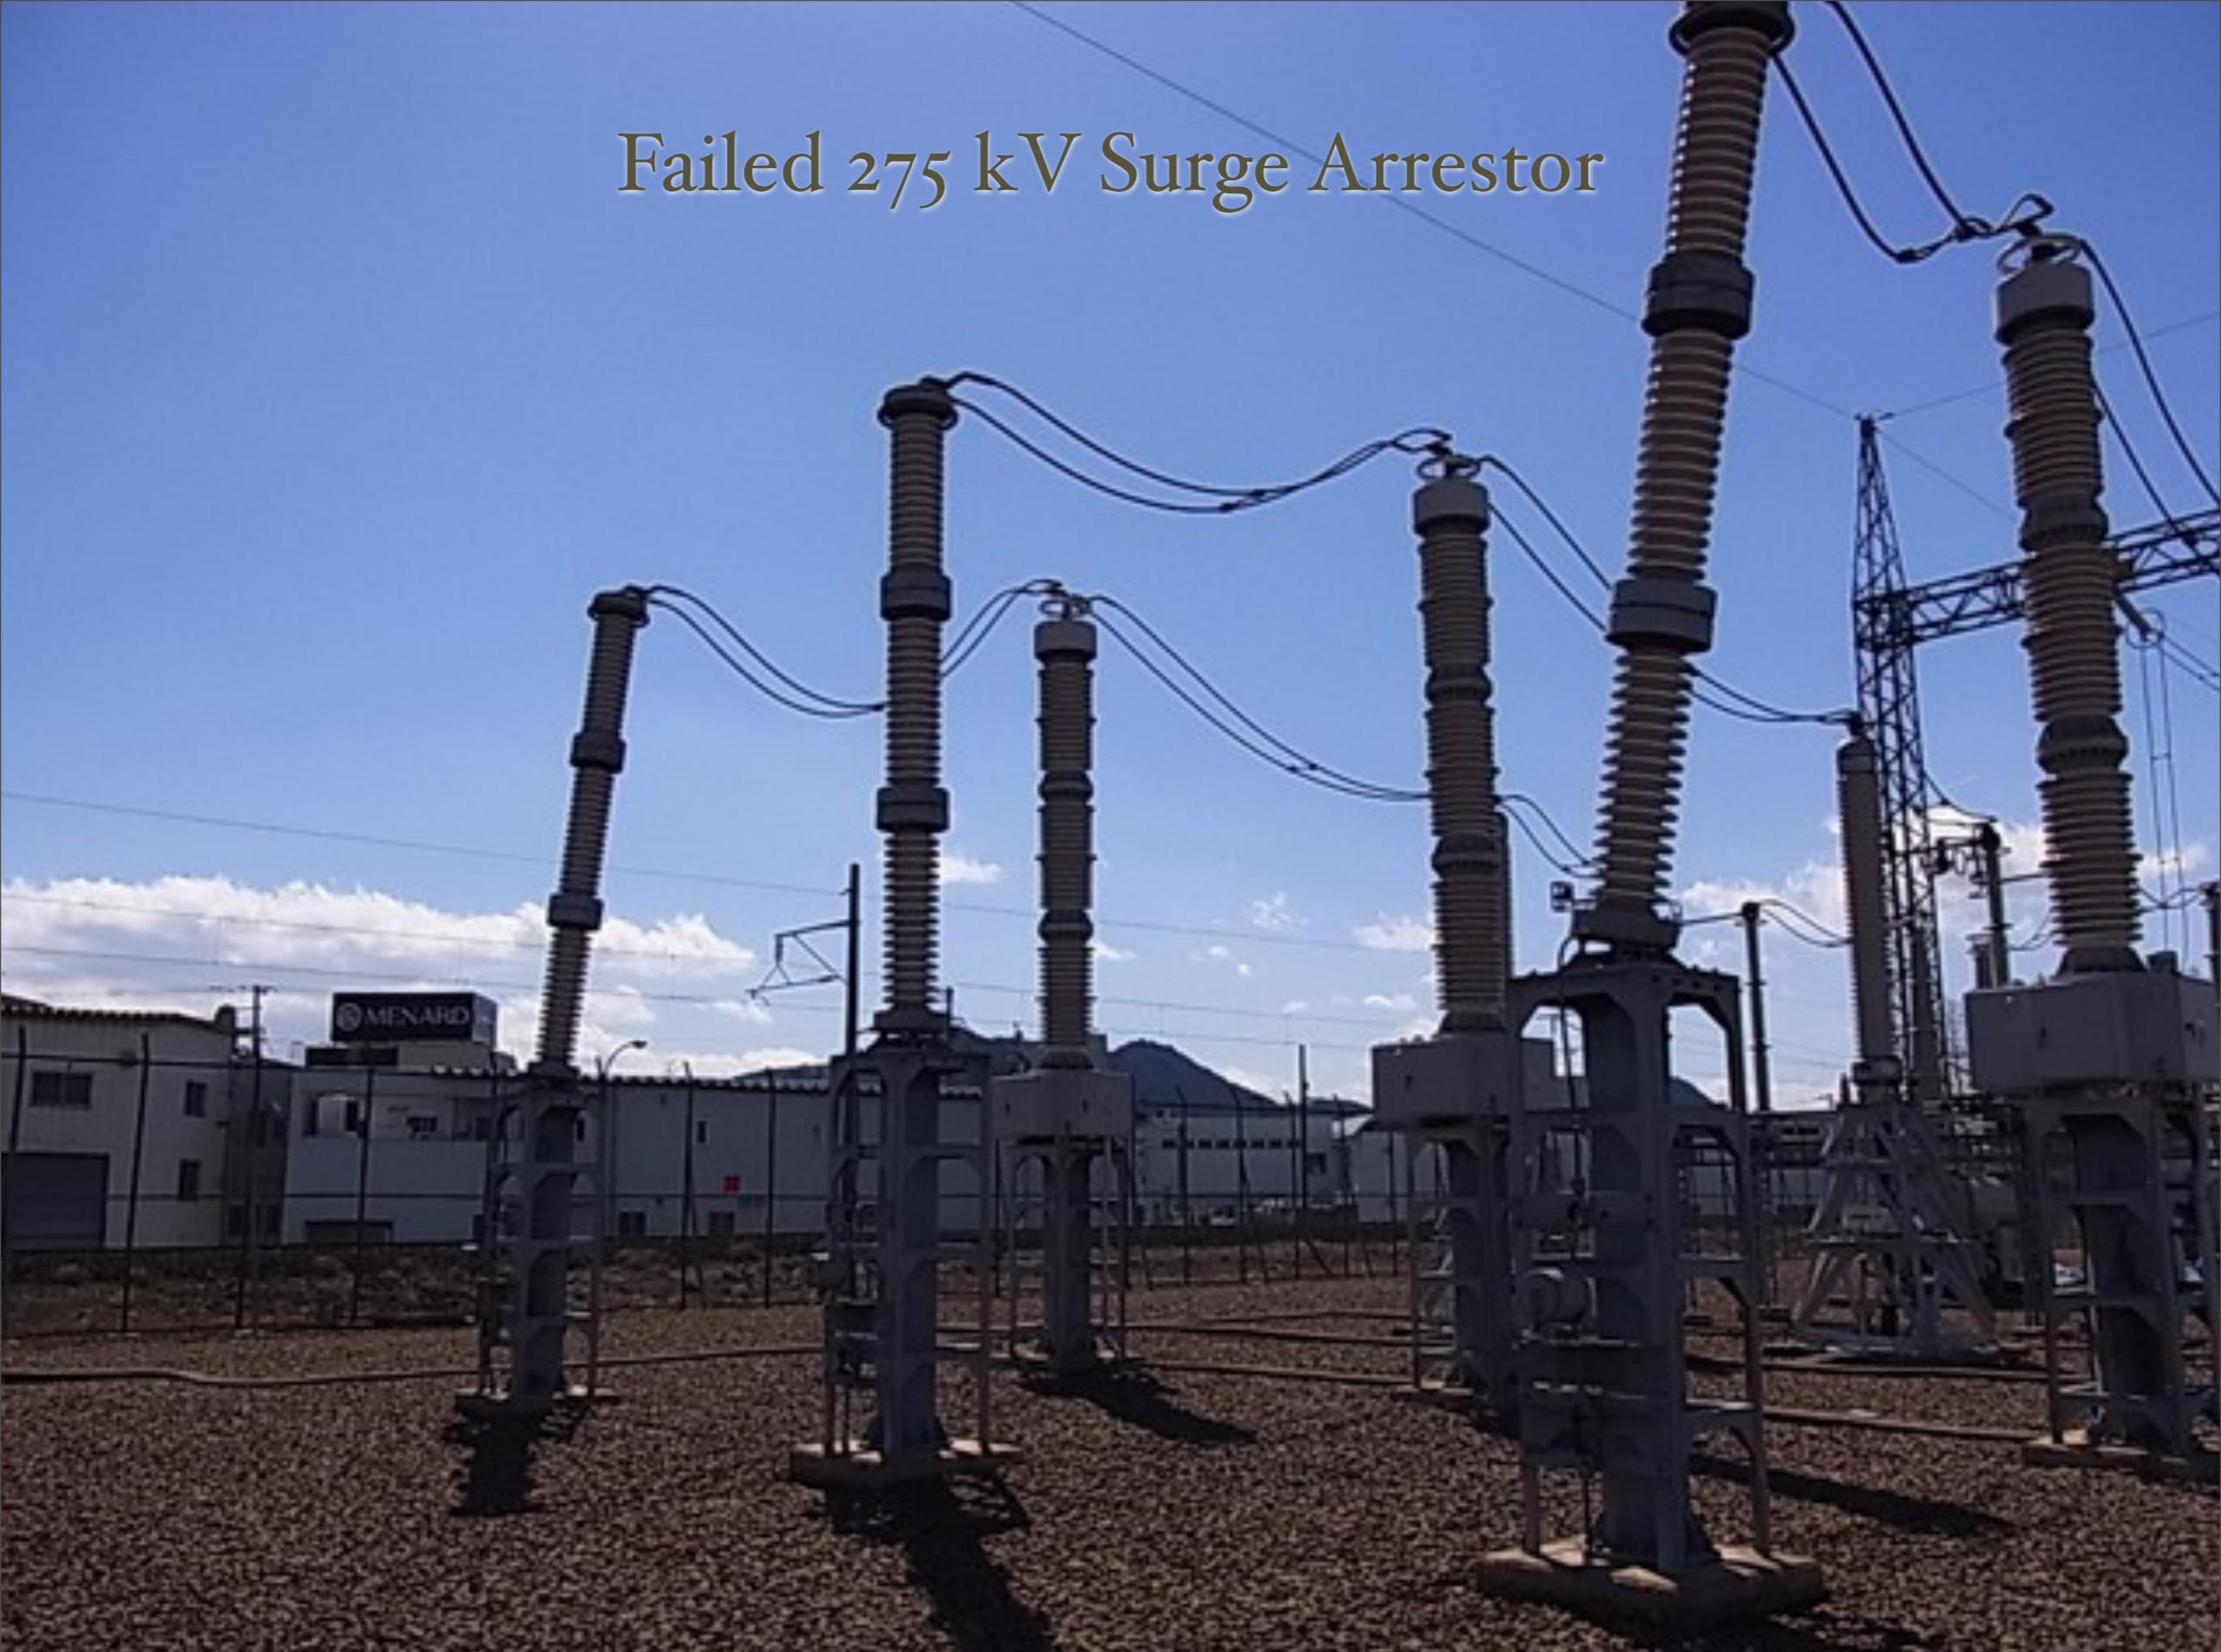
# Failed 275 kV Surge Arrestor
