# Lifelines, M 9.0 Tohoku Japan, March 2011

John Eidinger  
August 11, 2011

G&E Engineering Systems Inc.  
[eidinger@geEngineeringSystems.com](mailto:eidinger@geEngineeringSystems.com)

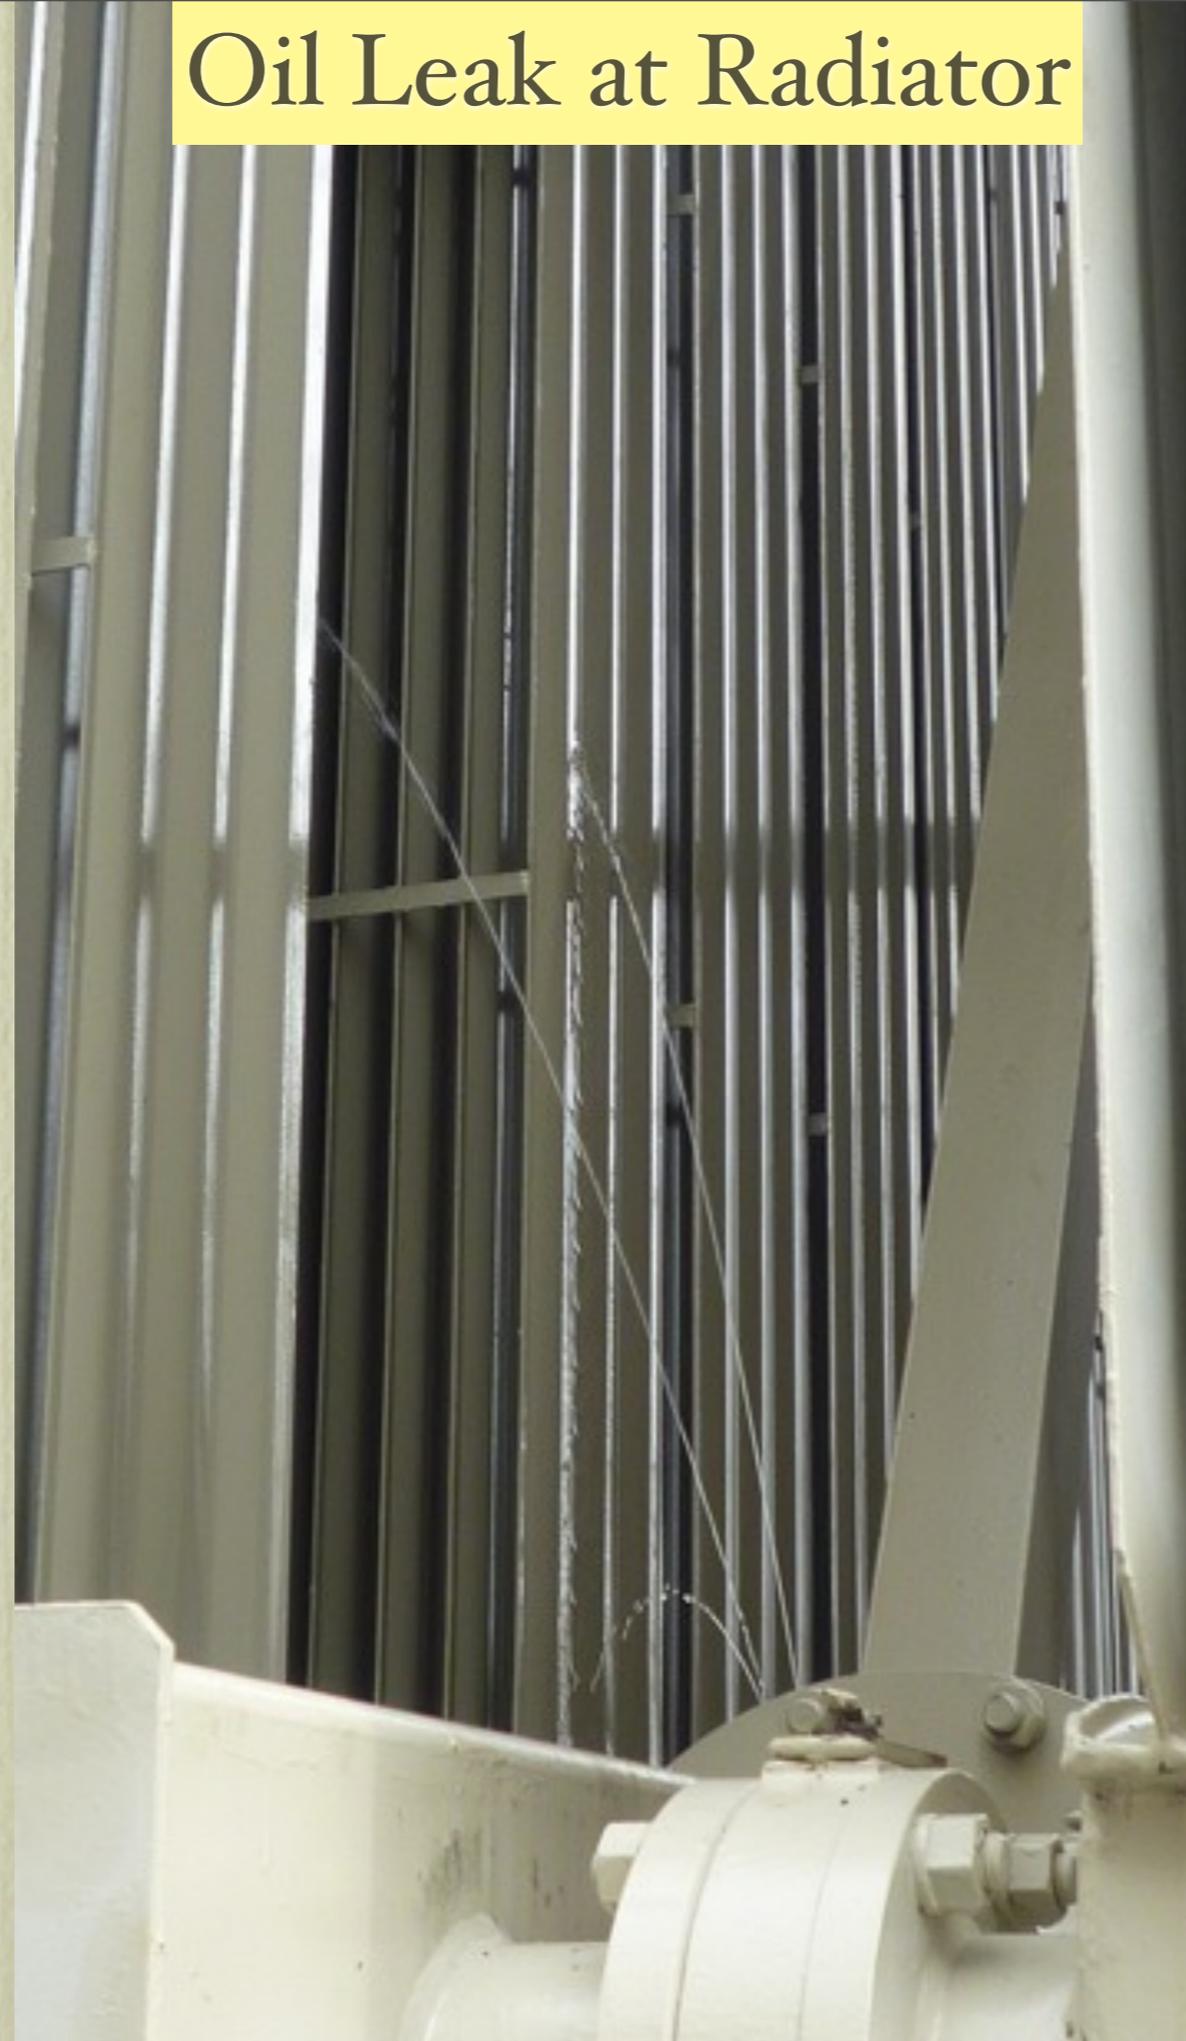
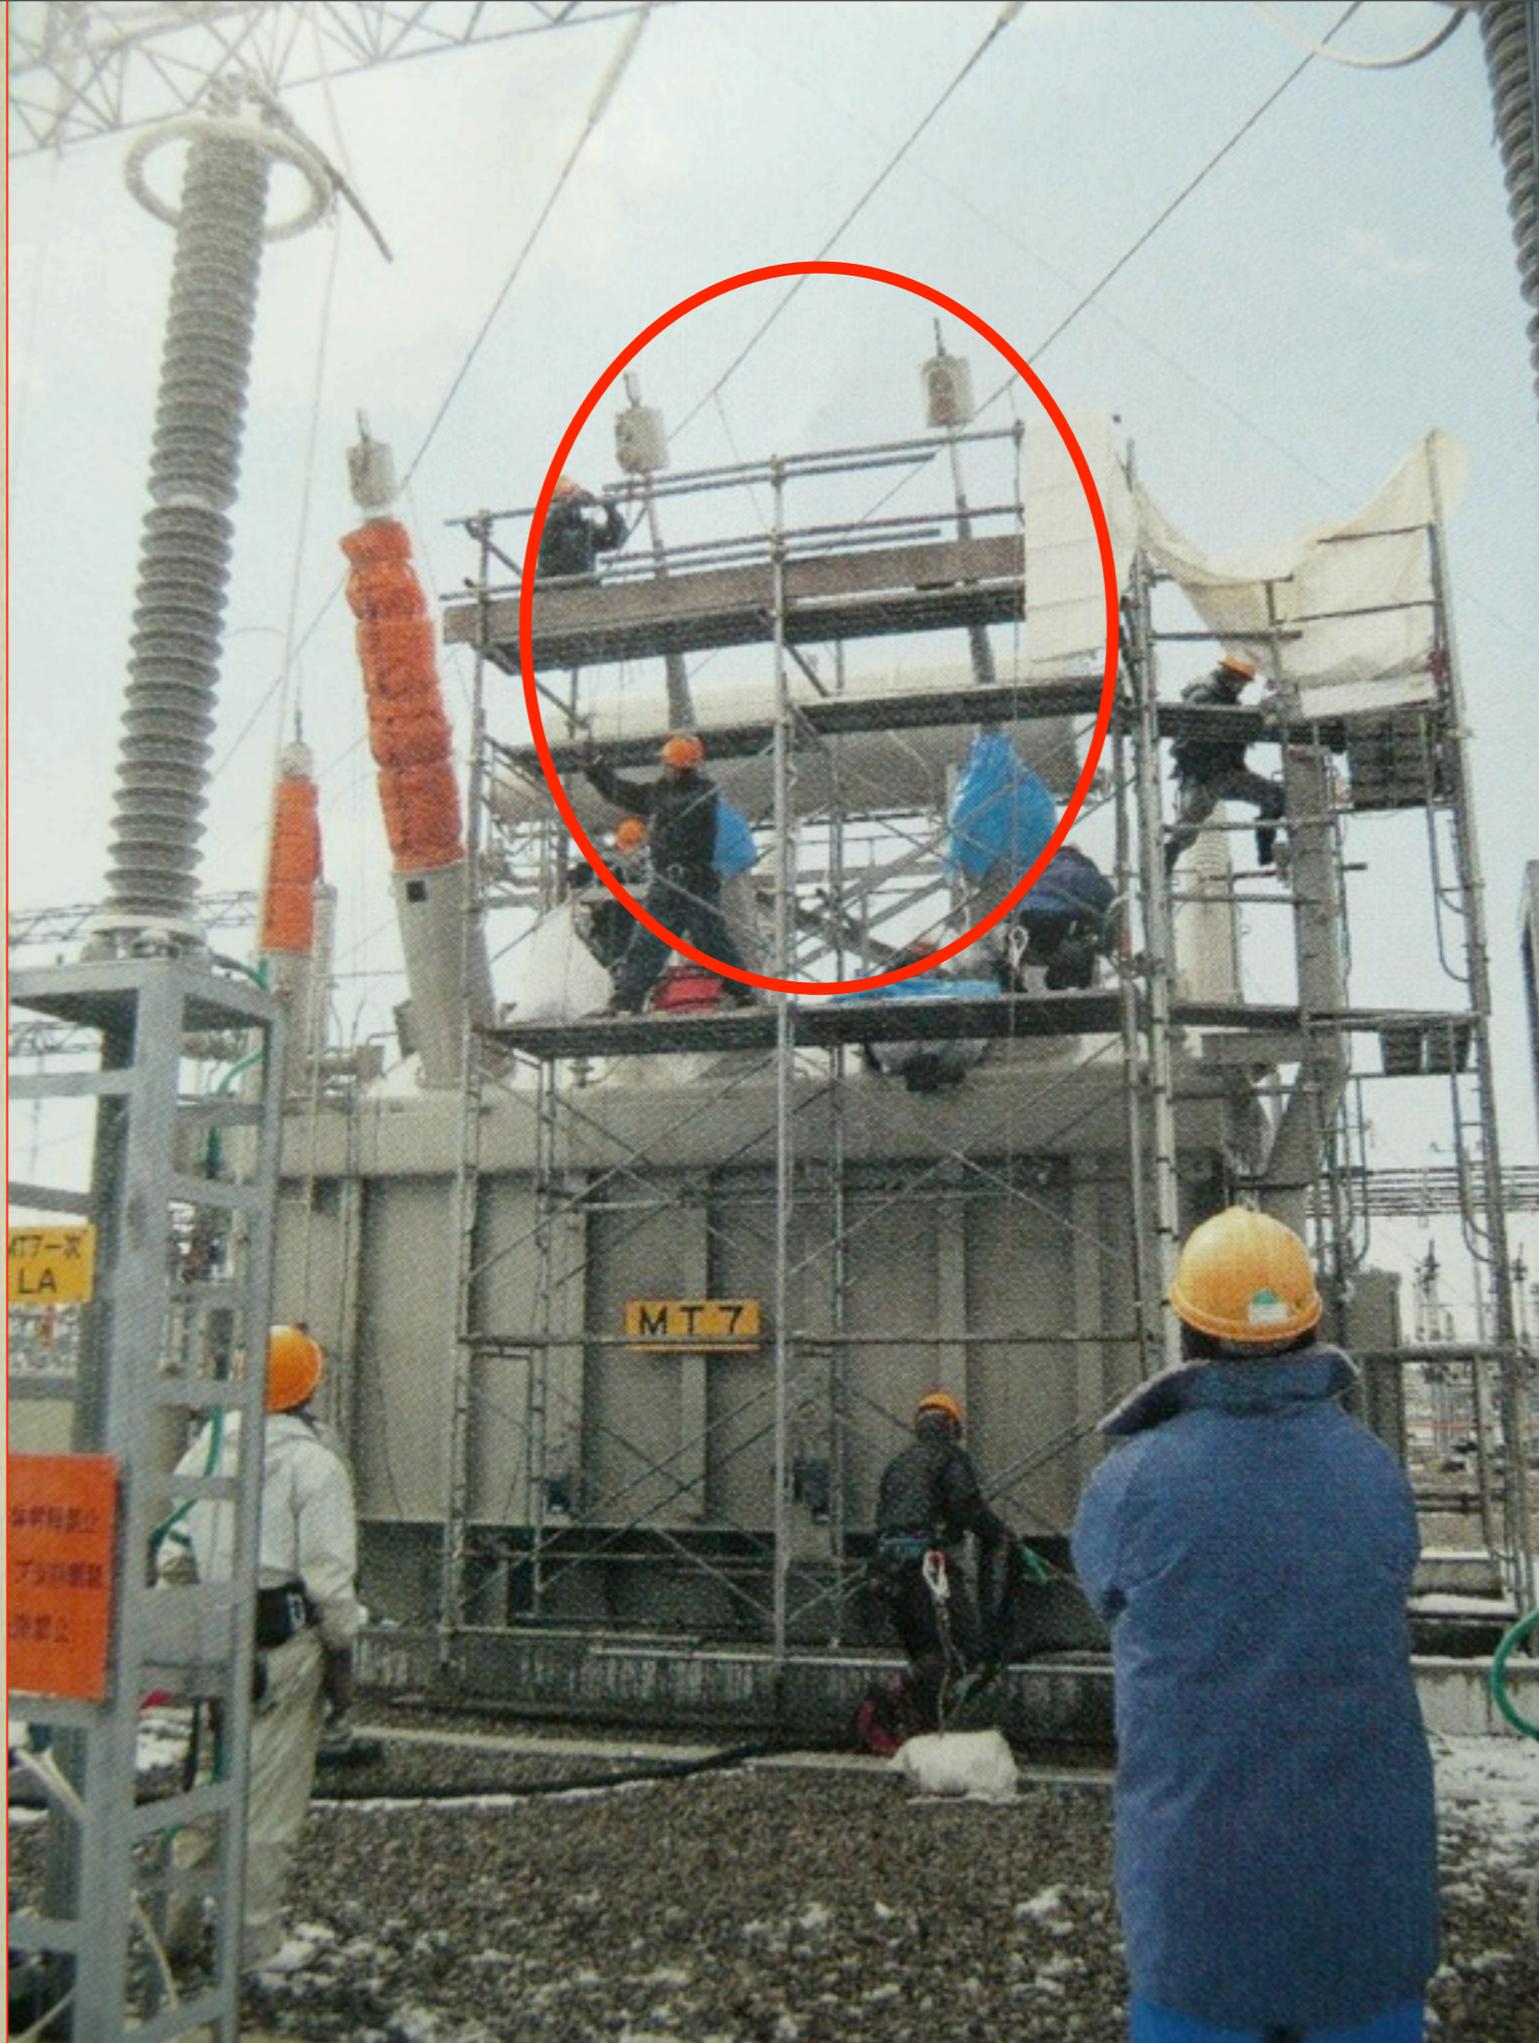
# Oil Leak at Radiator

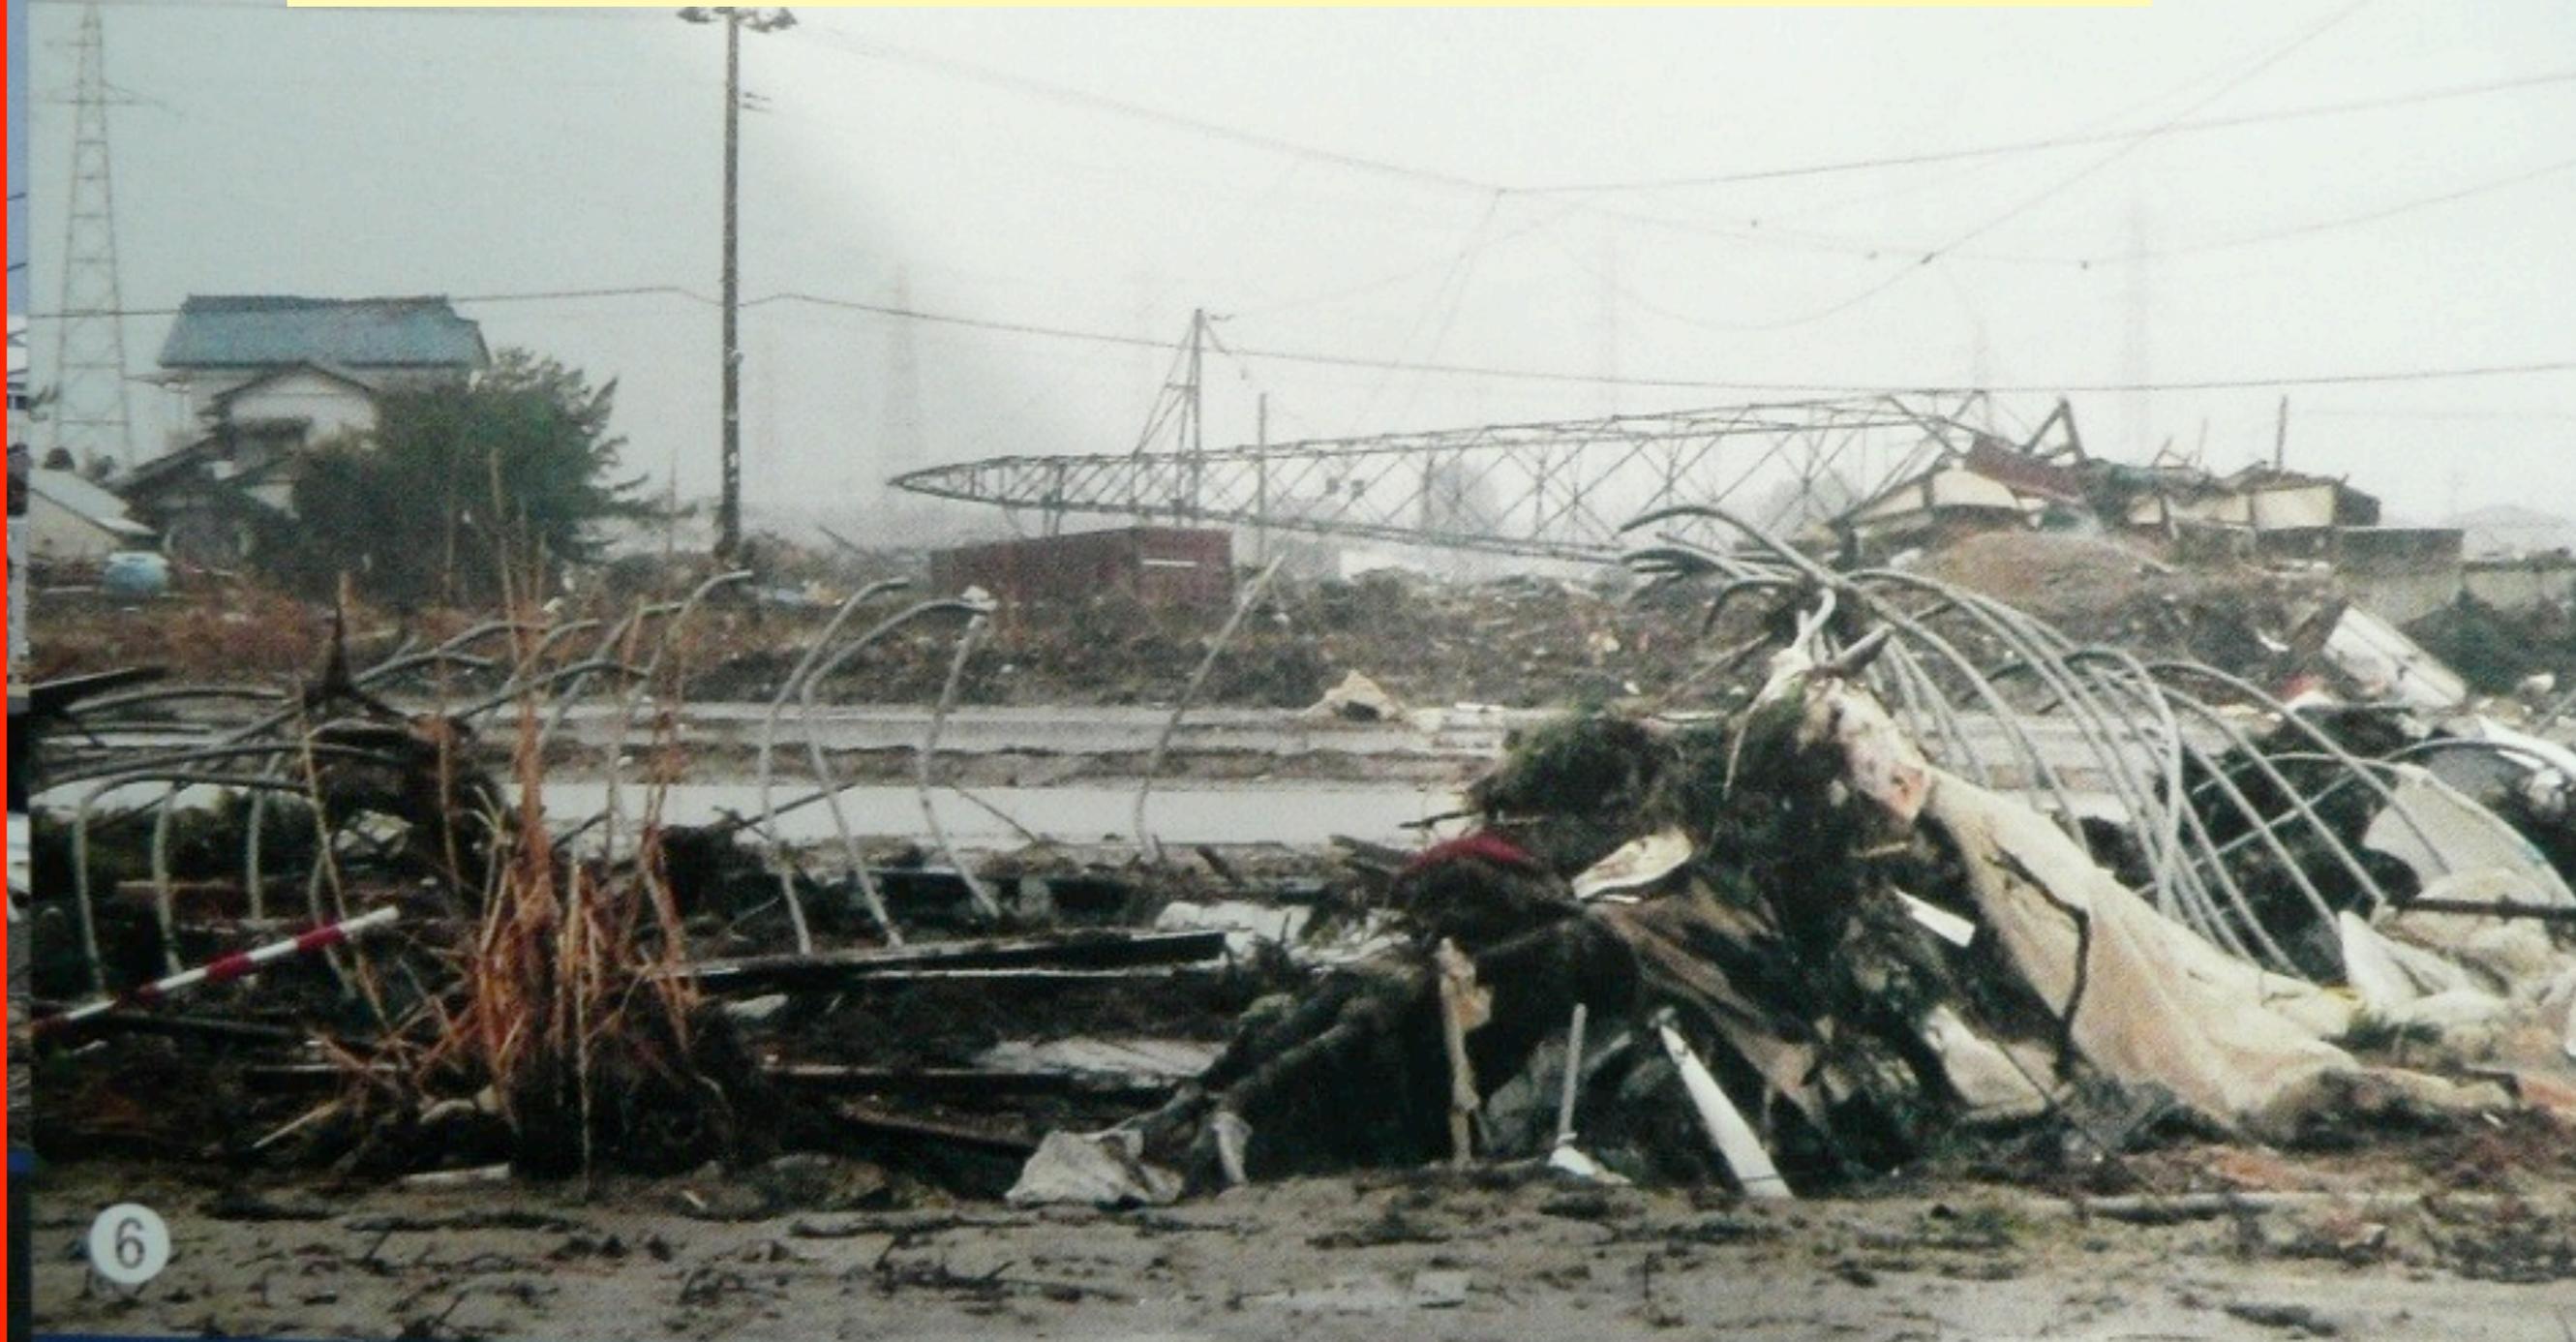
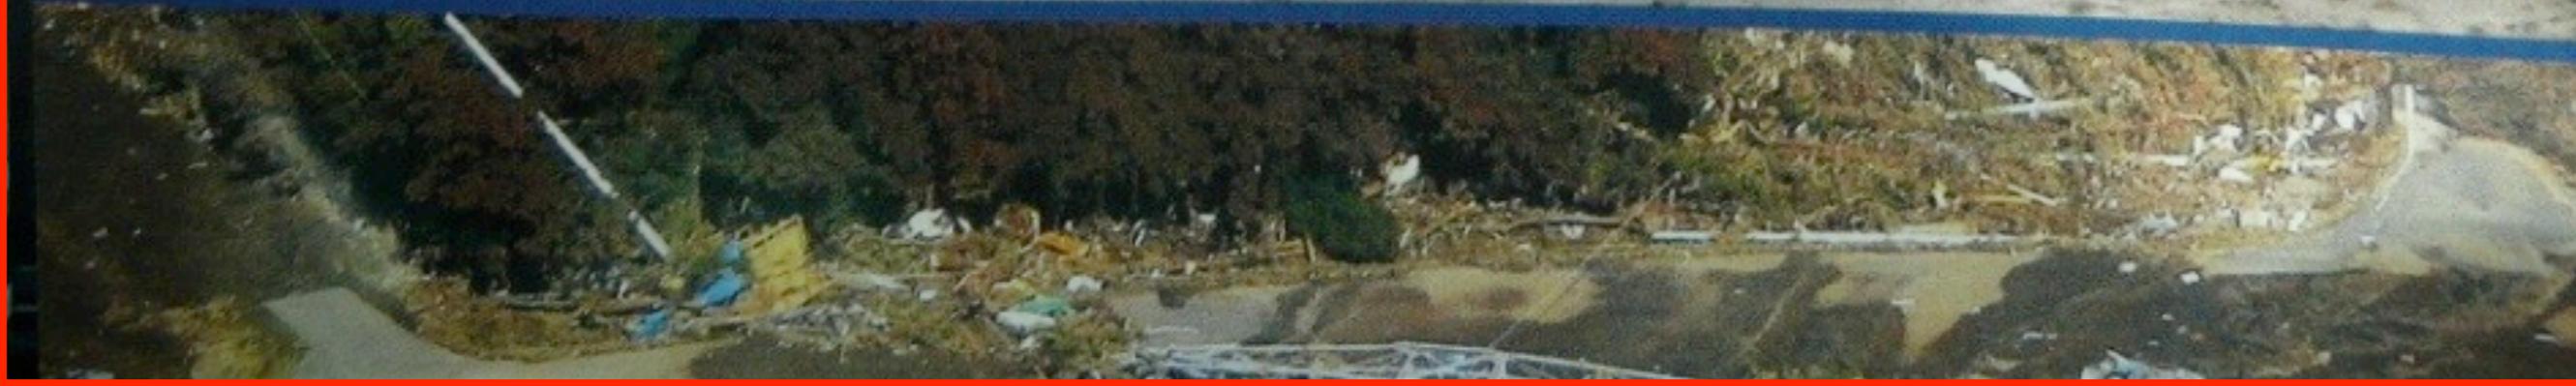
# Debris impact / Tsunami Knocks over tower

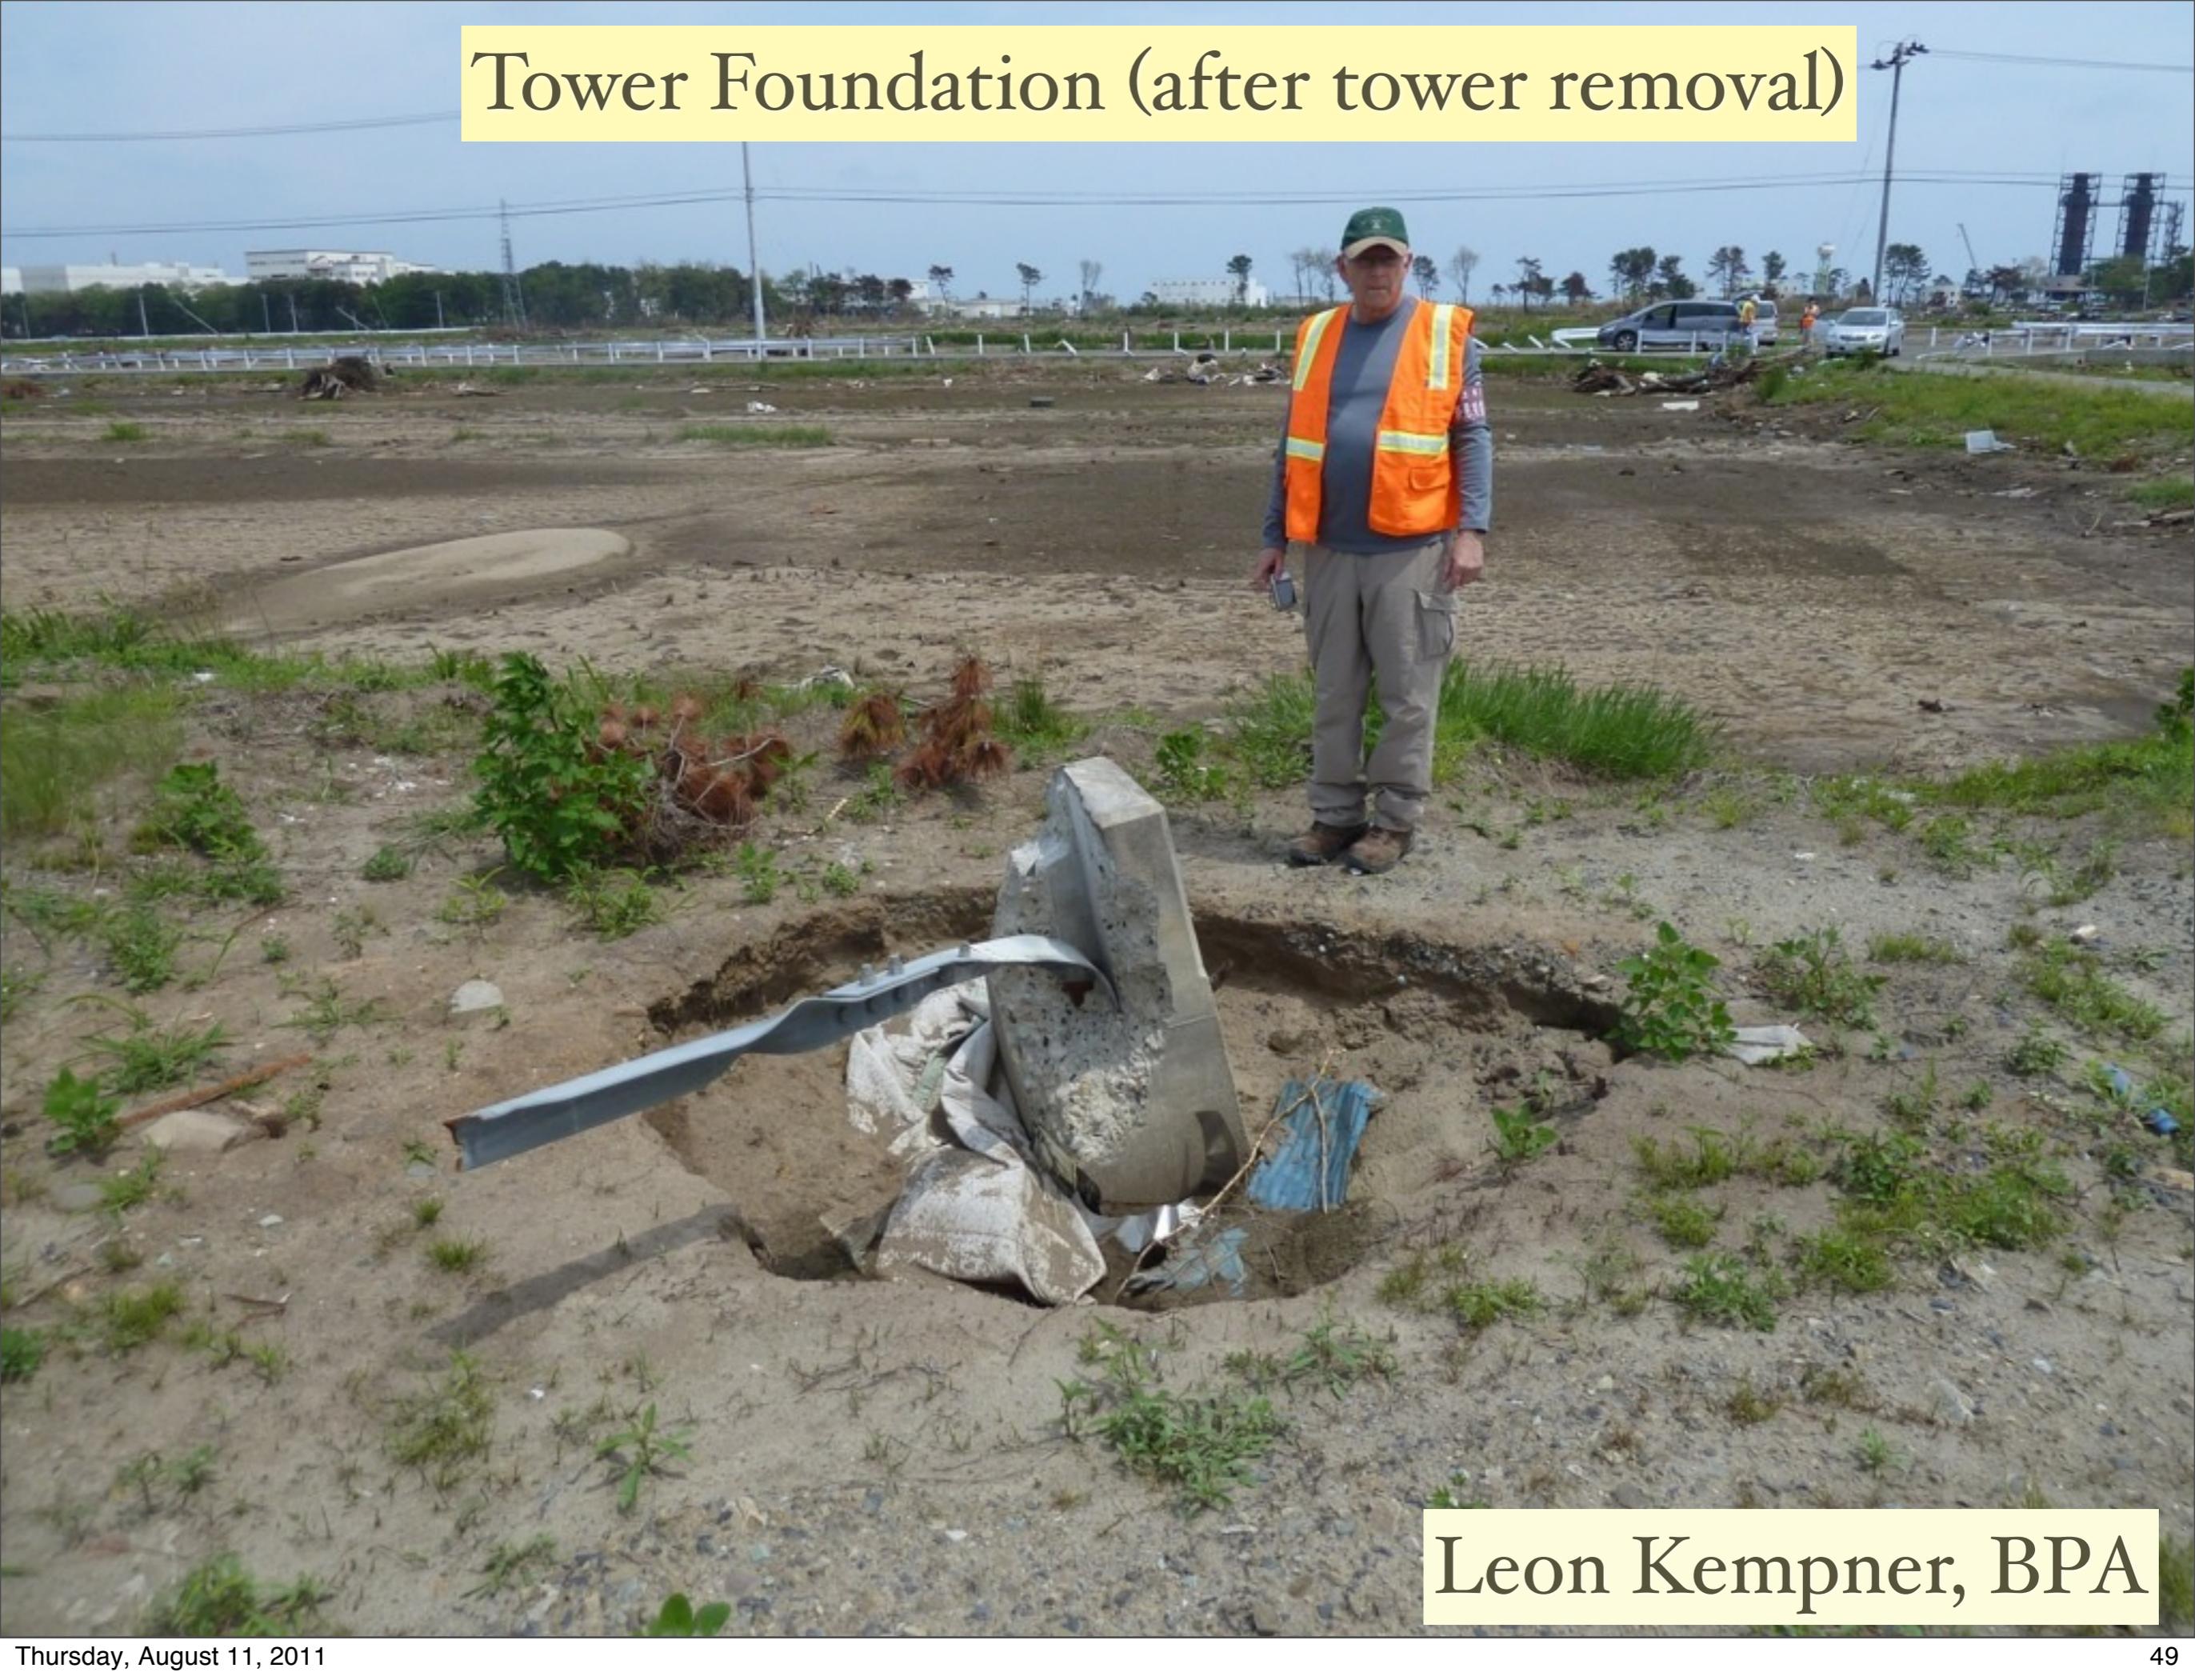
# Tower Foundation (after tower removal)

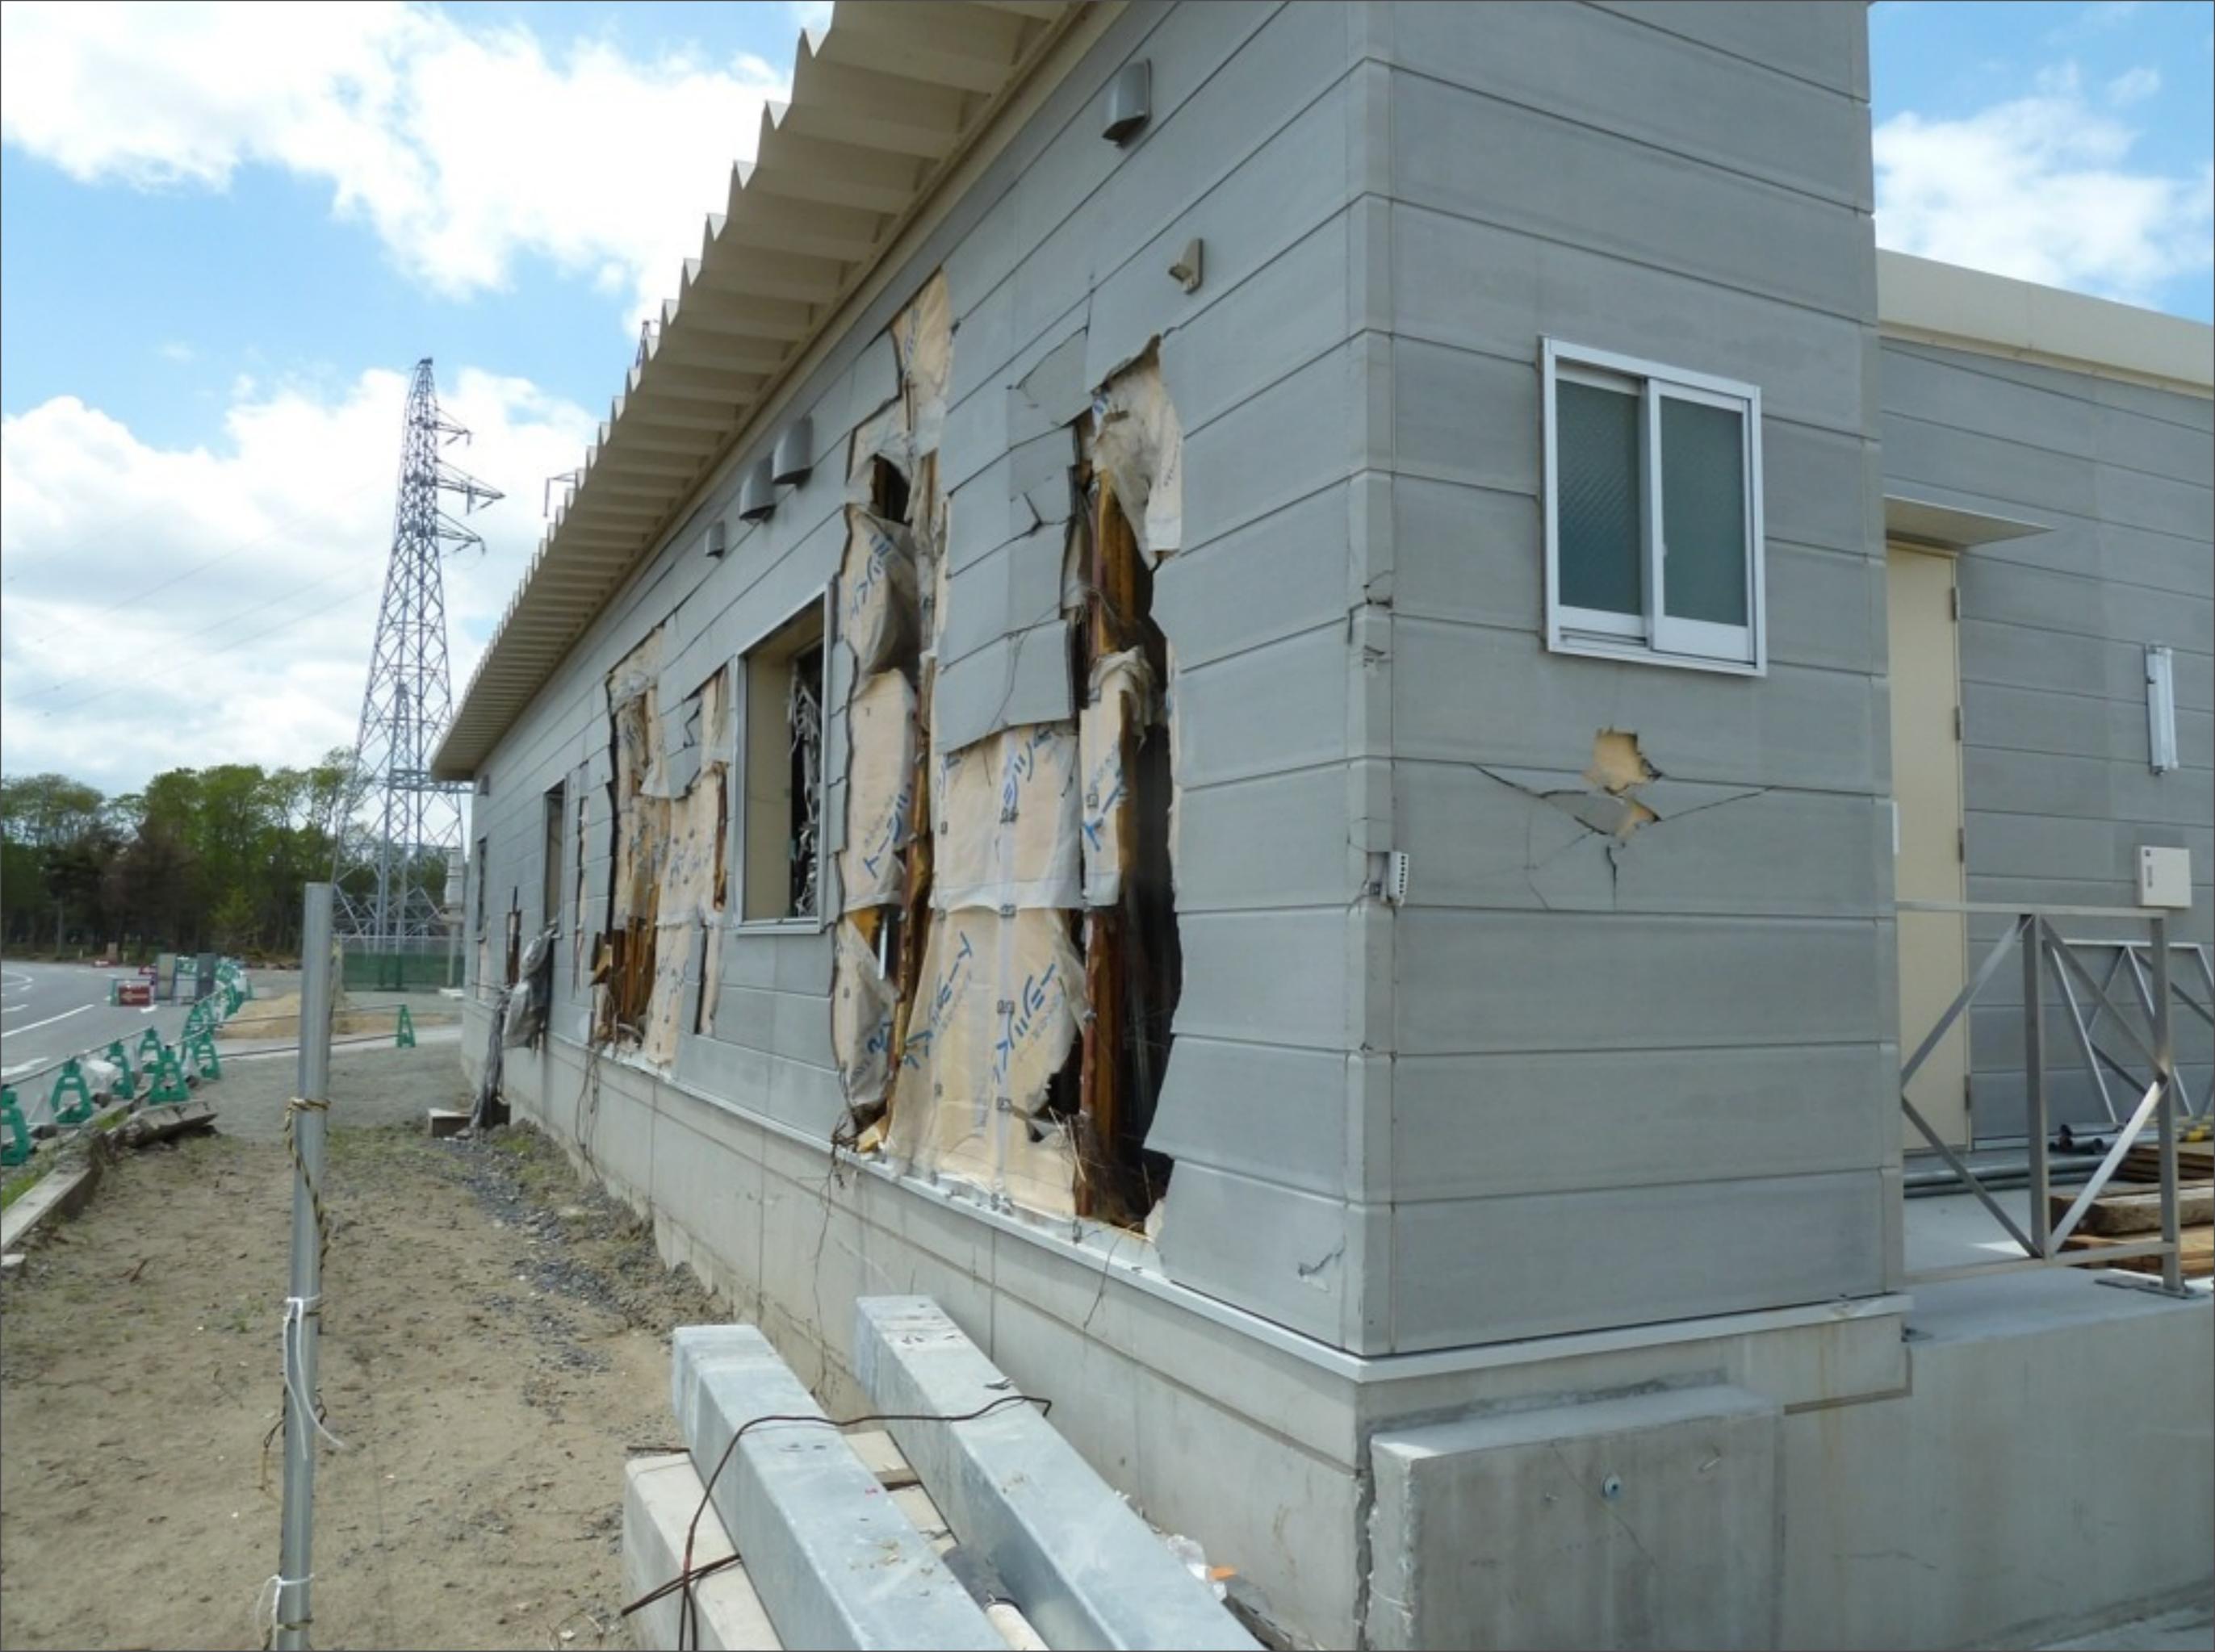
66 kV tsunami  
inundation, with  
scour

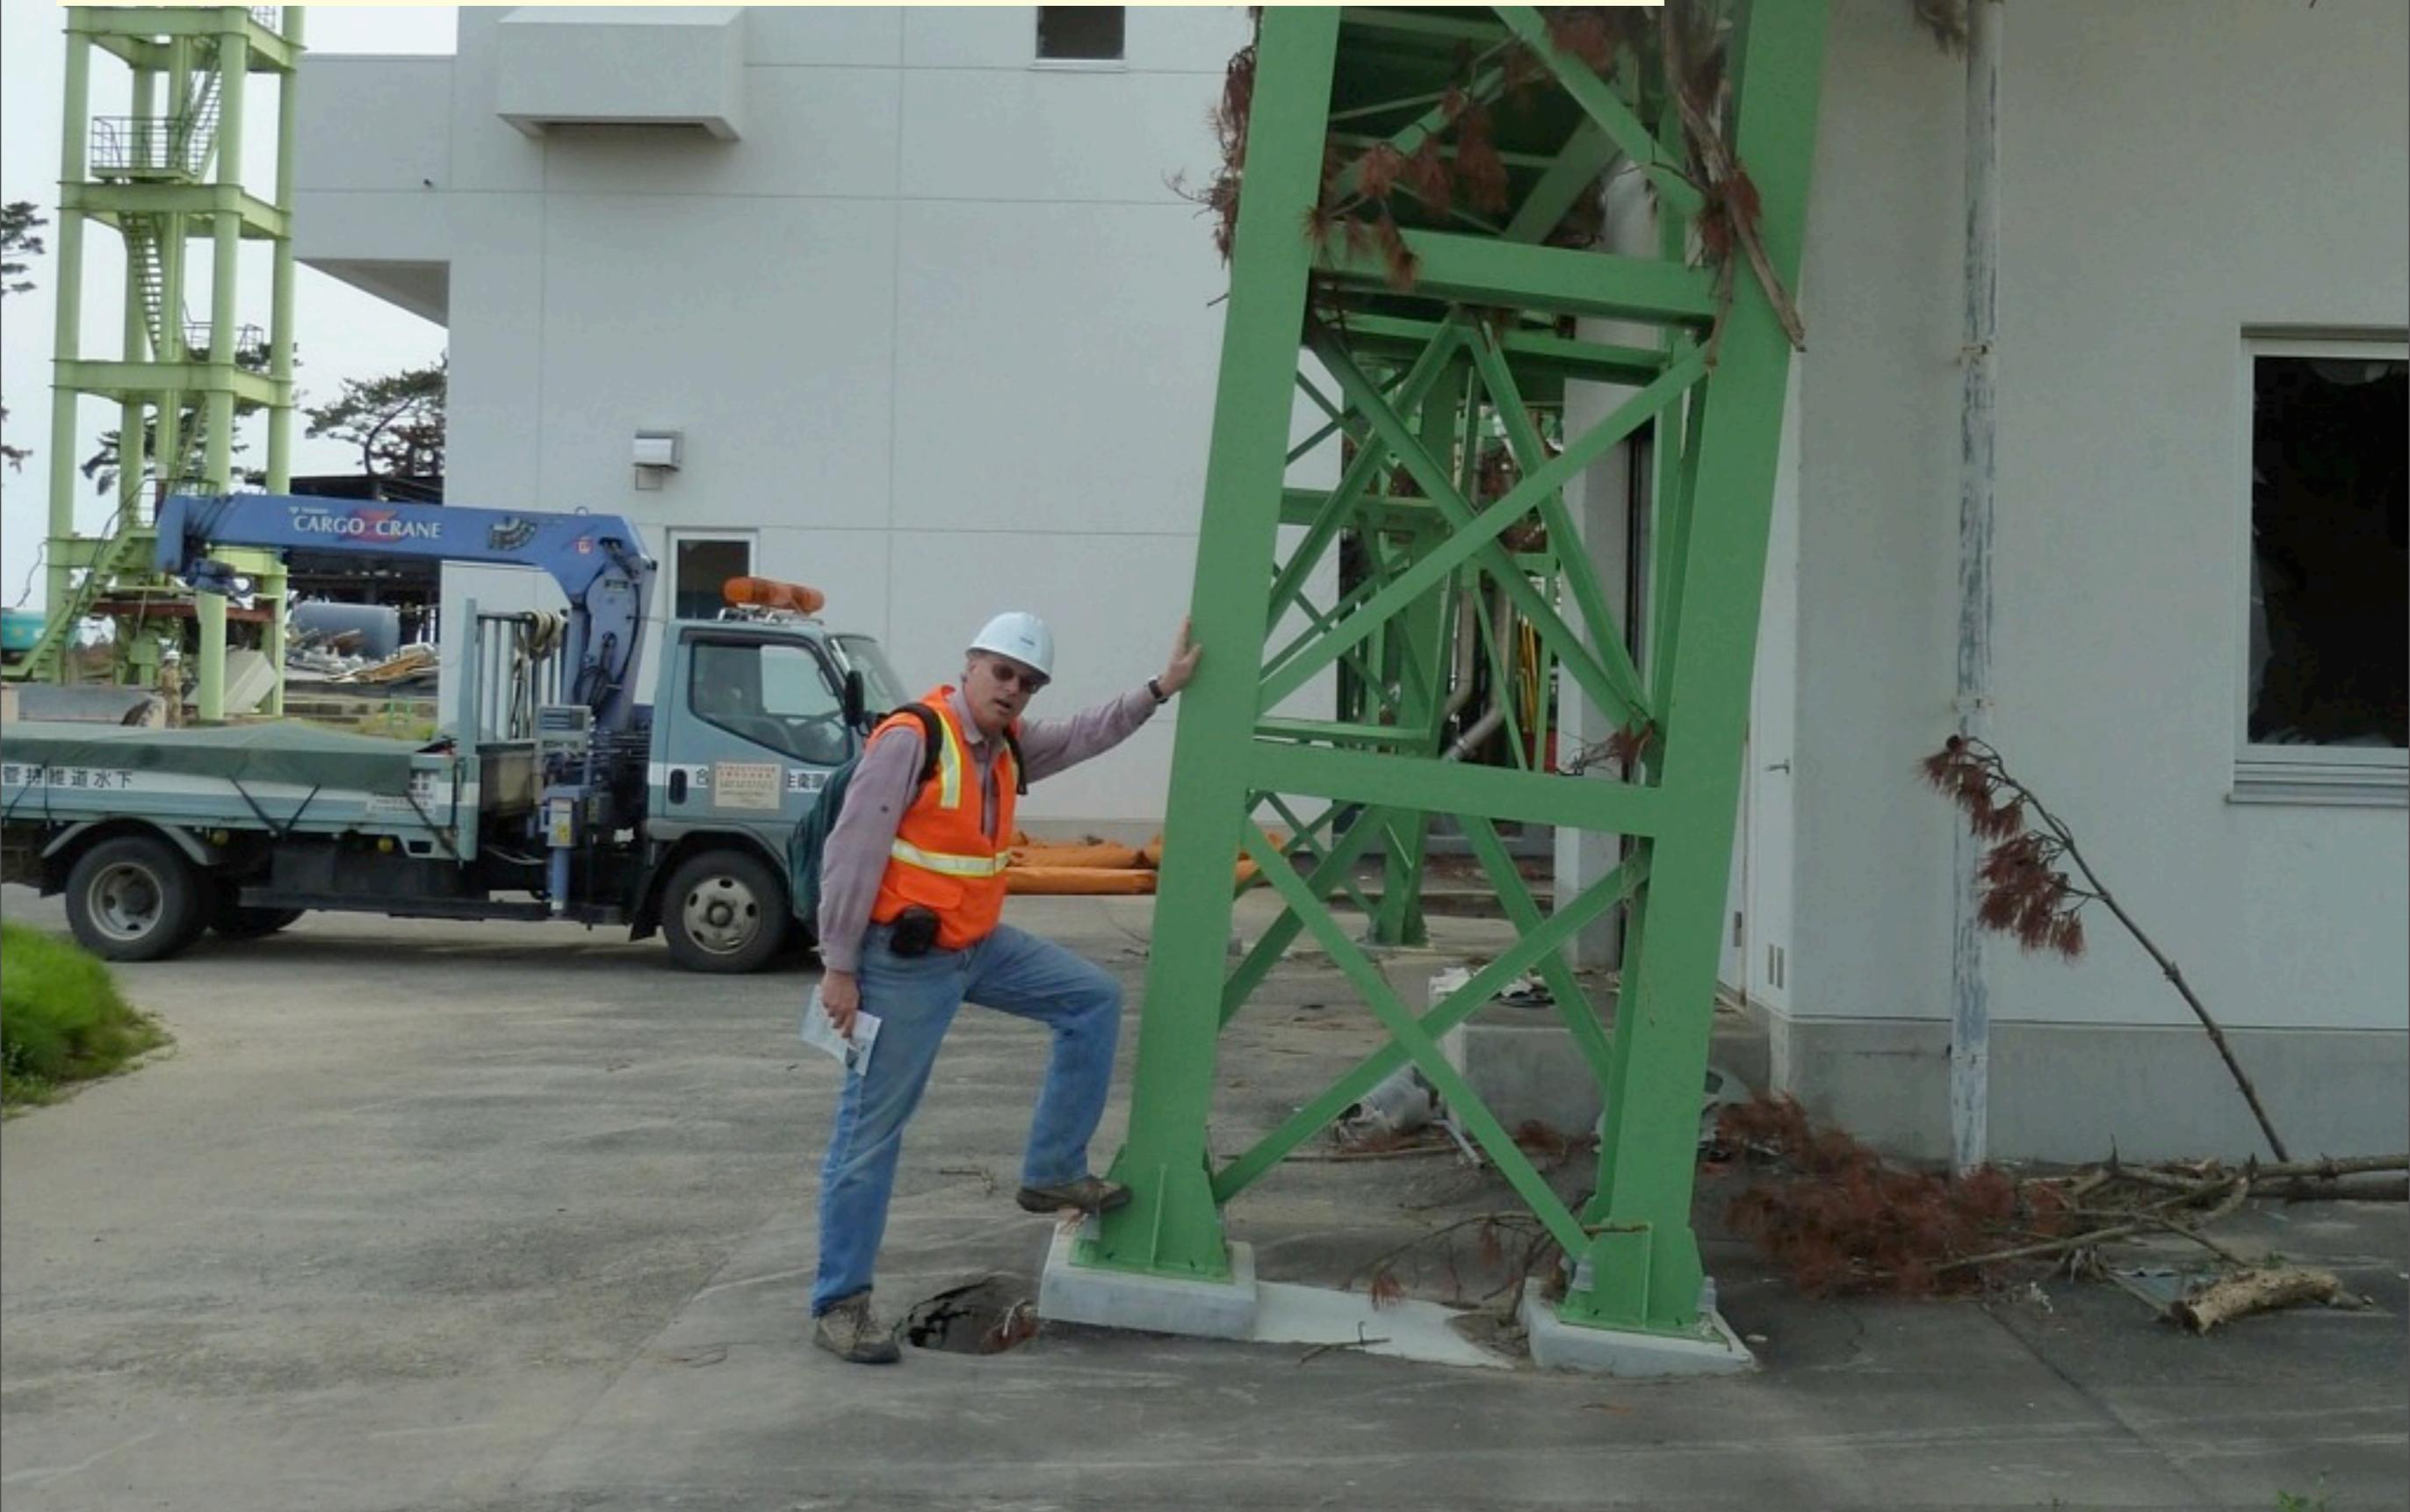
# Foundation bearing failure due to tsunami
