# Lifelines, M 9.0 Tohoku Japan, March 2011

John Eidinger  
August 11, 2011

G&E Engineering Systems Inc.  
[eidinger@geEngineeringSystems.com](mailto:eidinger@geEngineeringSystems.com)

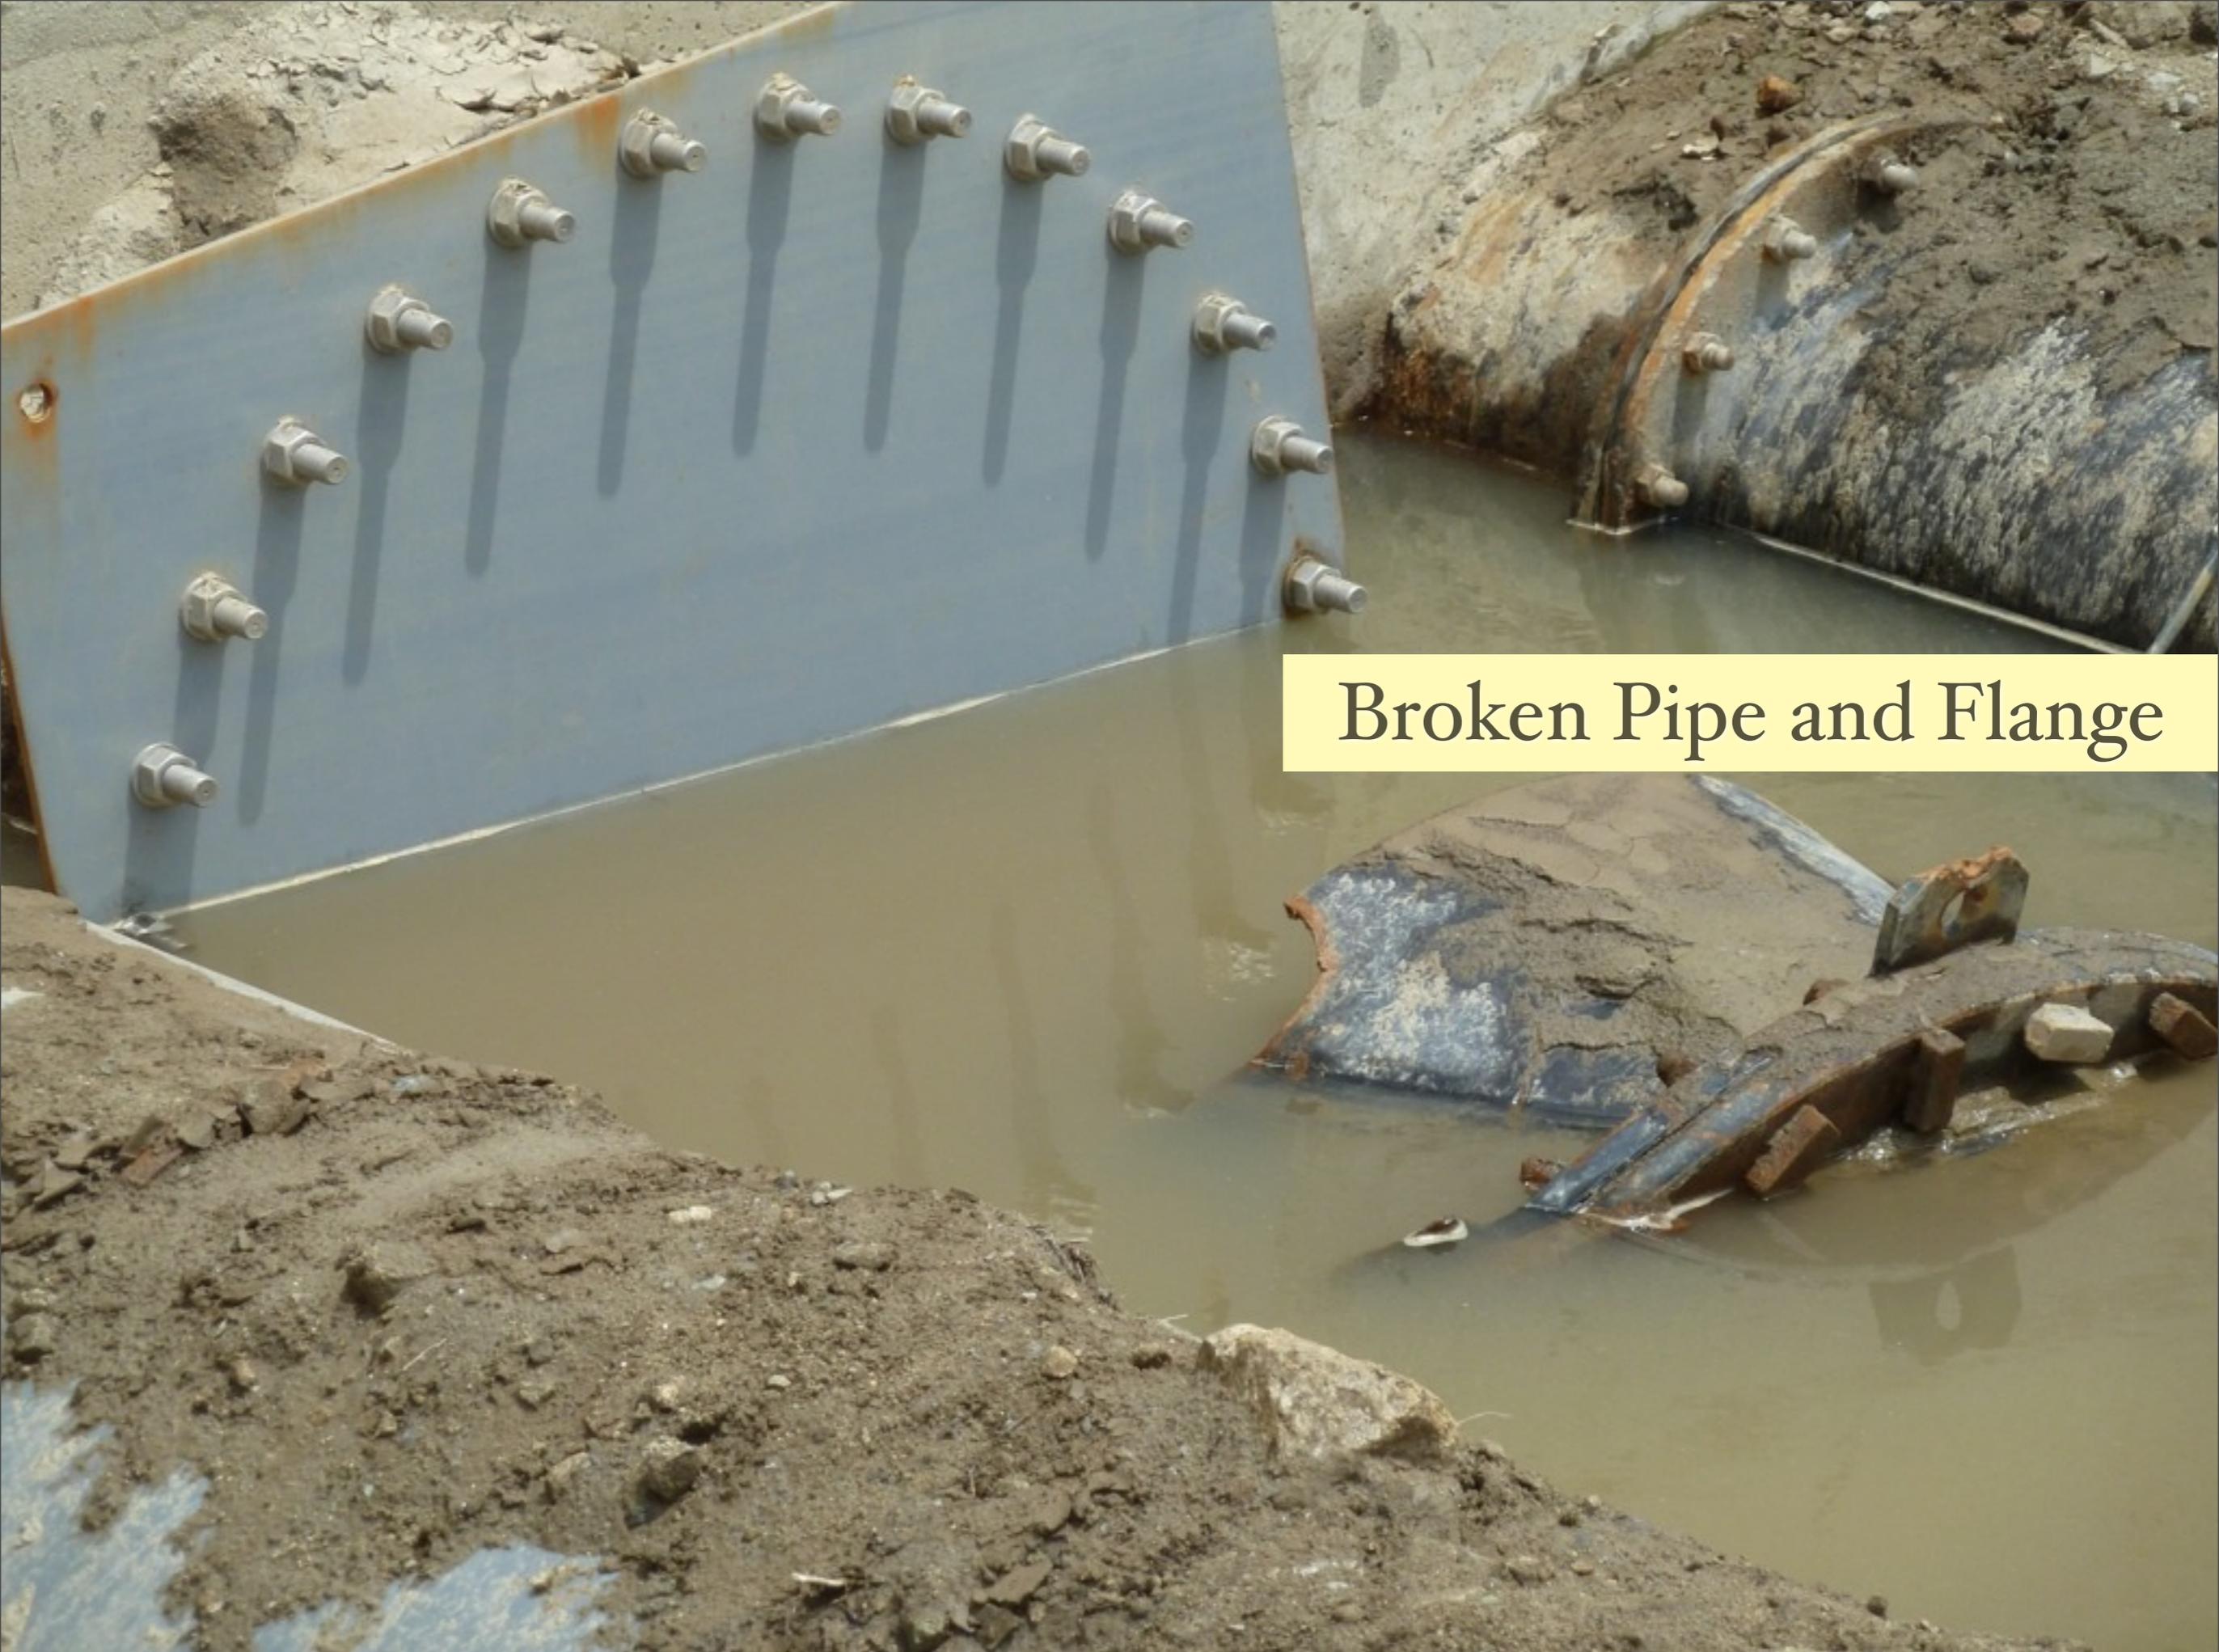
Broken Pipe and Flange

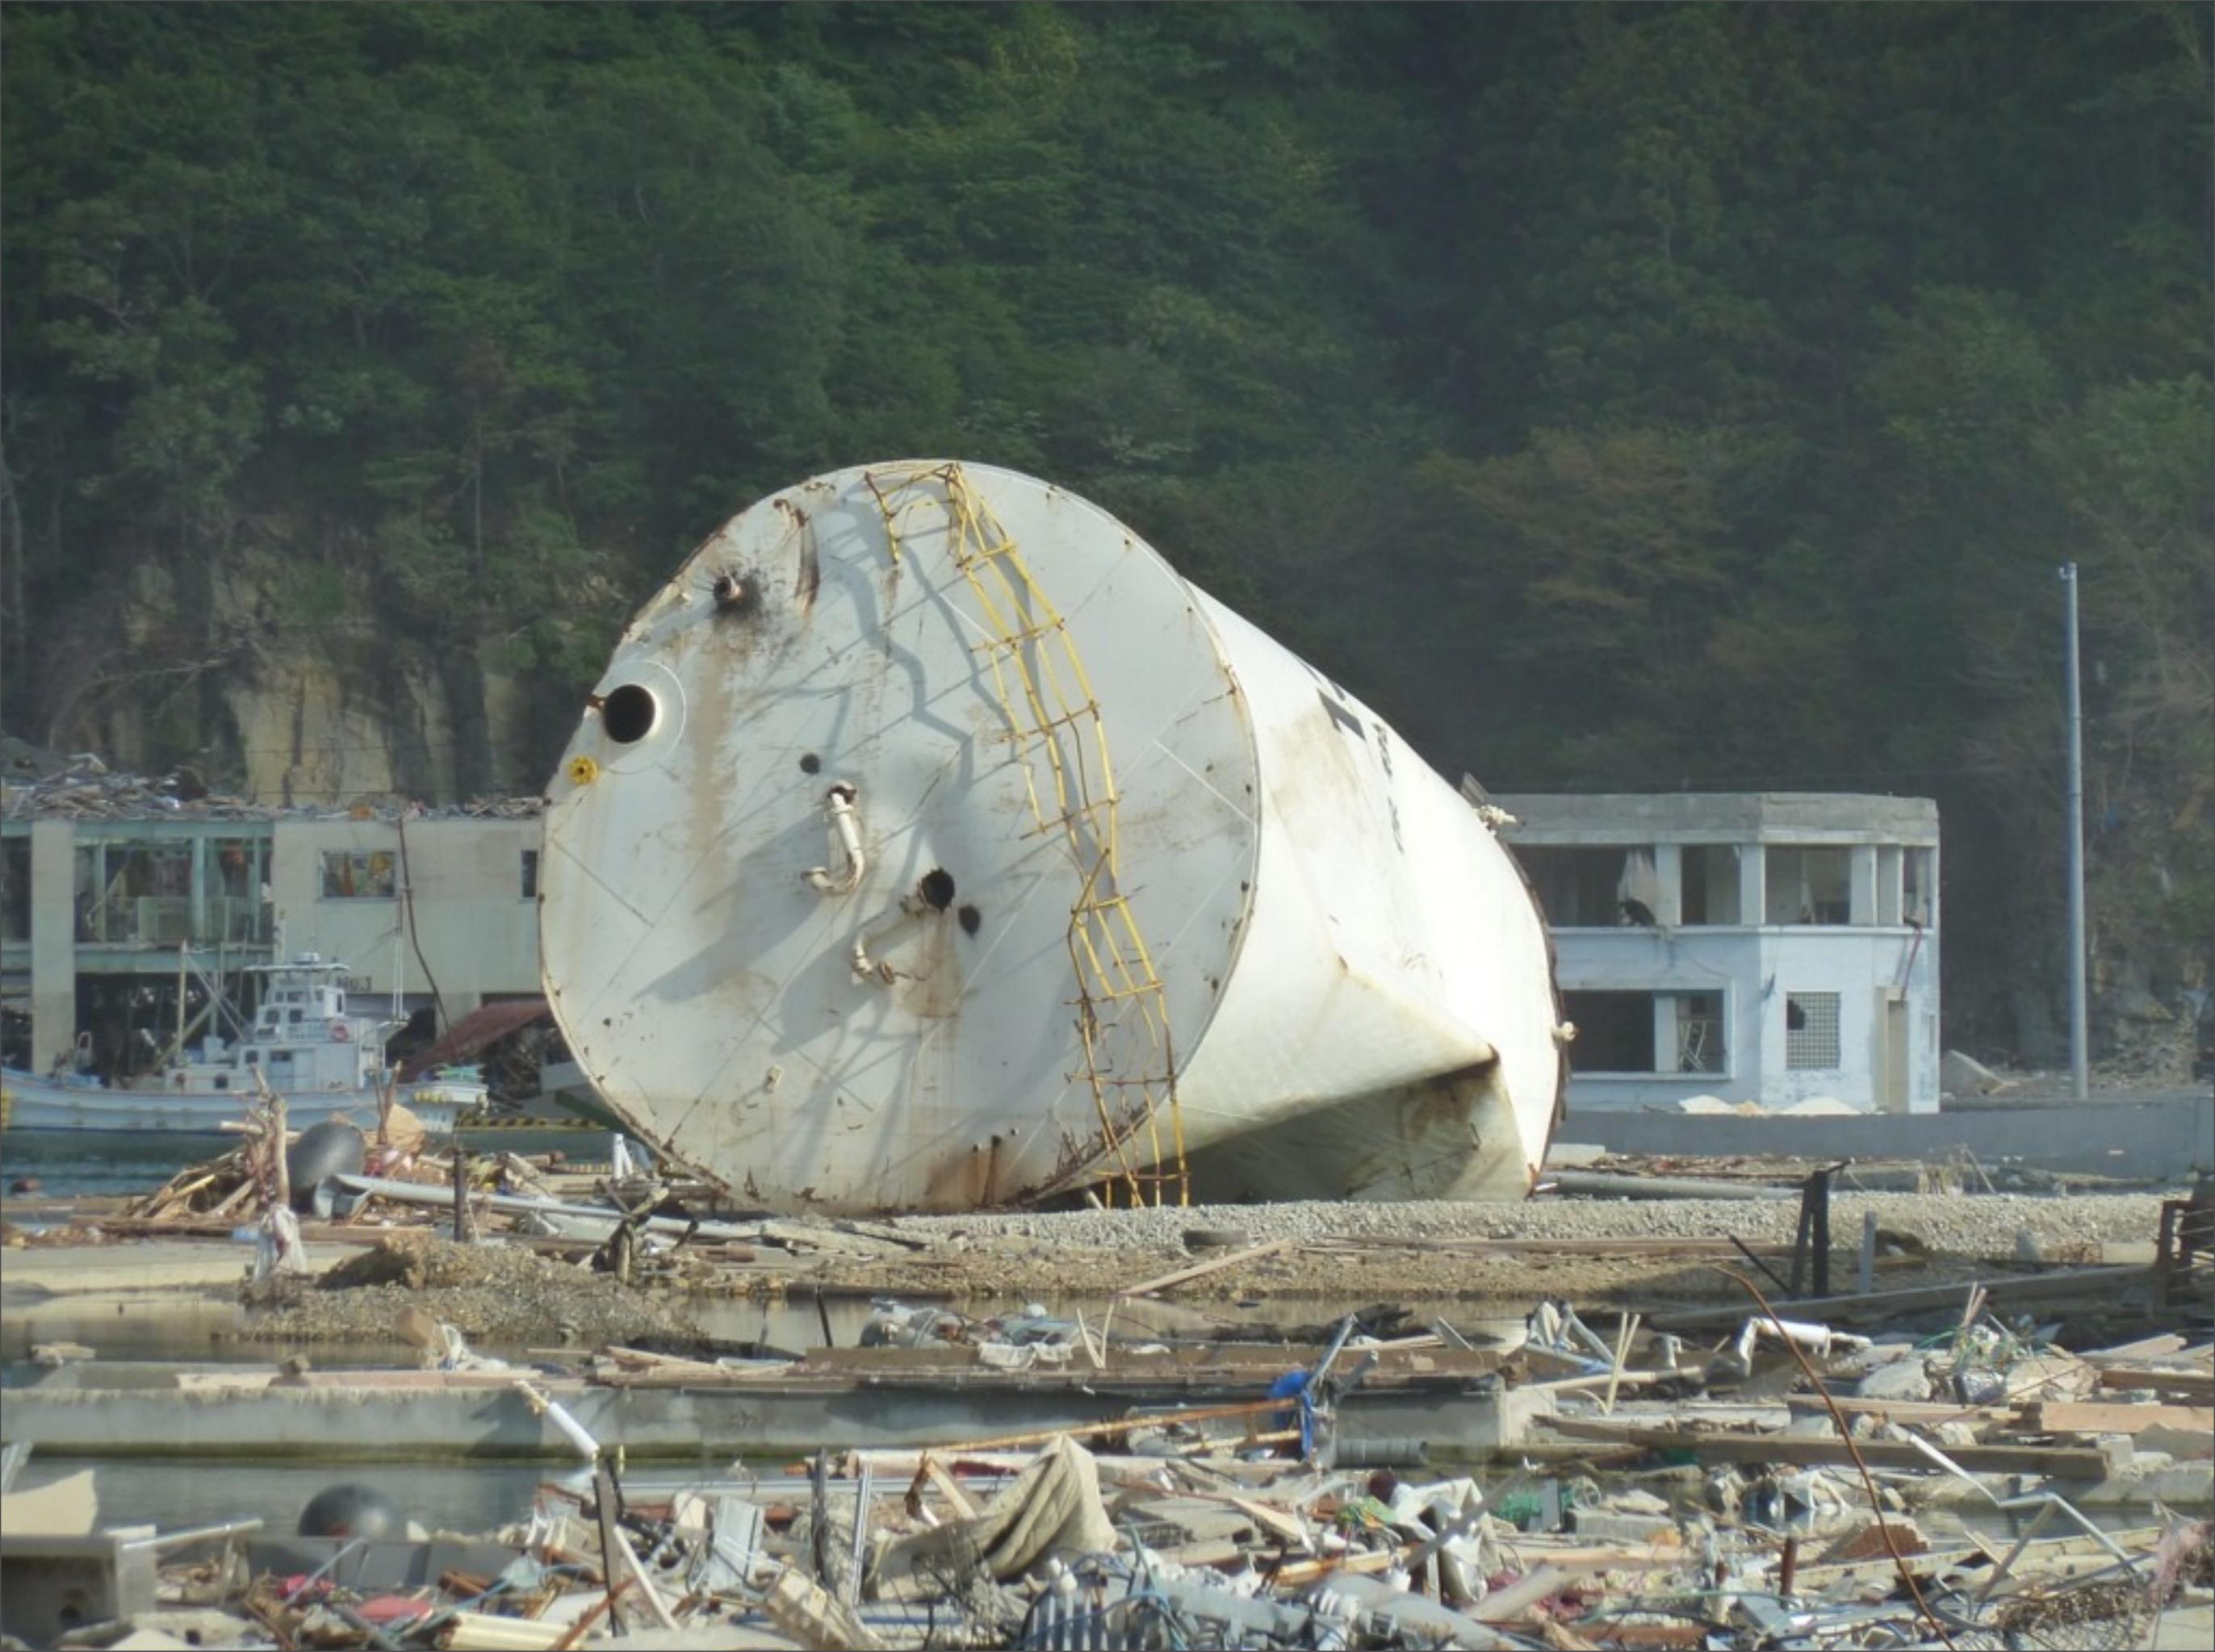
Two failed oil tanks, the higher one was OK
