Water System Performance – Paso Robles M 6.5 Earthquake of December 22, 2003

By John Eiding¹ and Anshel Schiff²

City of Paso Robles

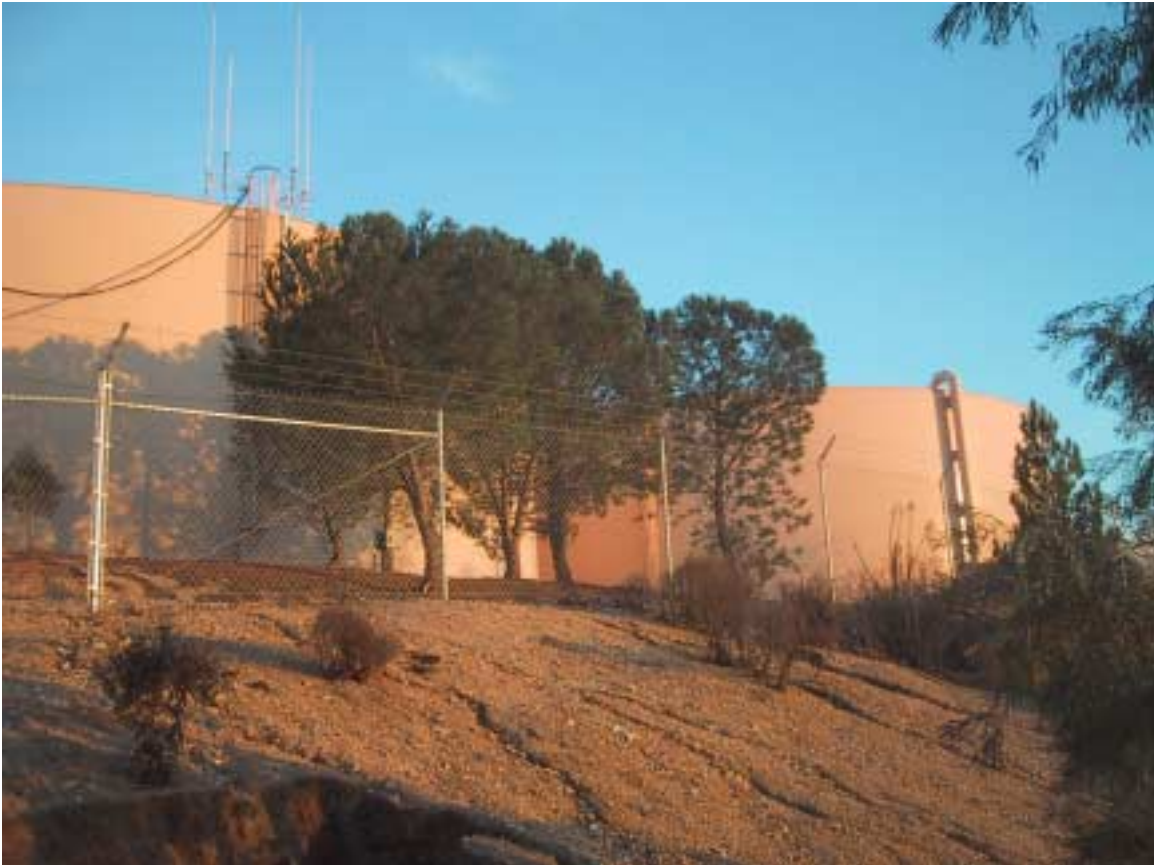
Figure 1. Paso Robles Golden Hill Tanks (North Tank on left)

The earthquake damaged the two steel tanks (Figure 1). Both tanks are at the same site, with the north tank built in 1972, and the south tank built in 2001. The north tank rests on grade; the south tank walls rest on a circumferential reinforced concrete ring beam. Both tanks are unanchored.

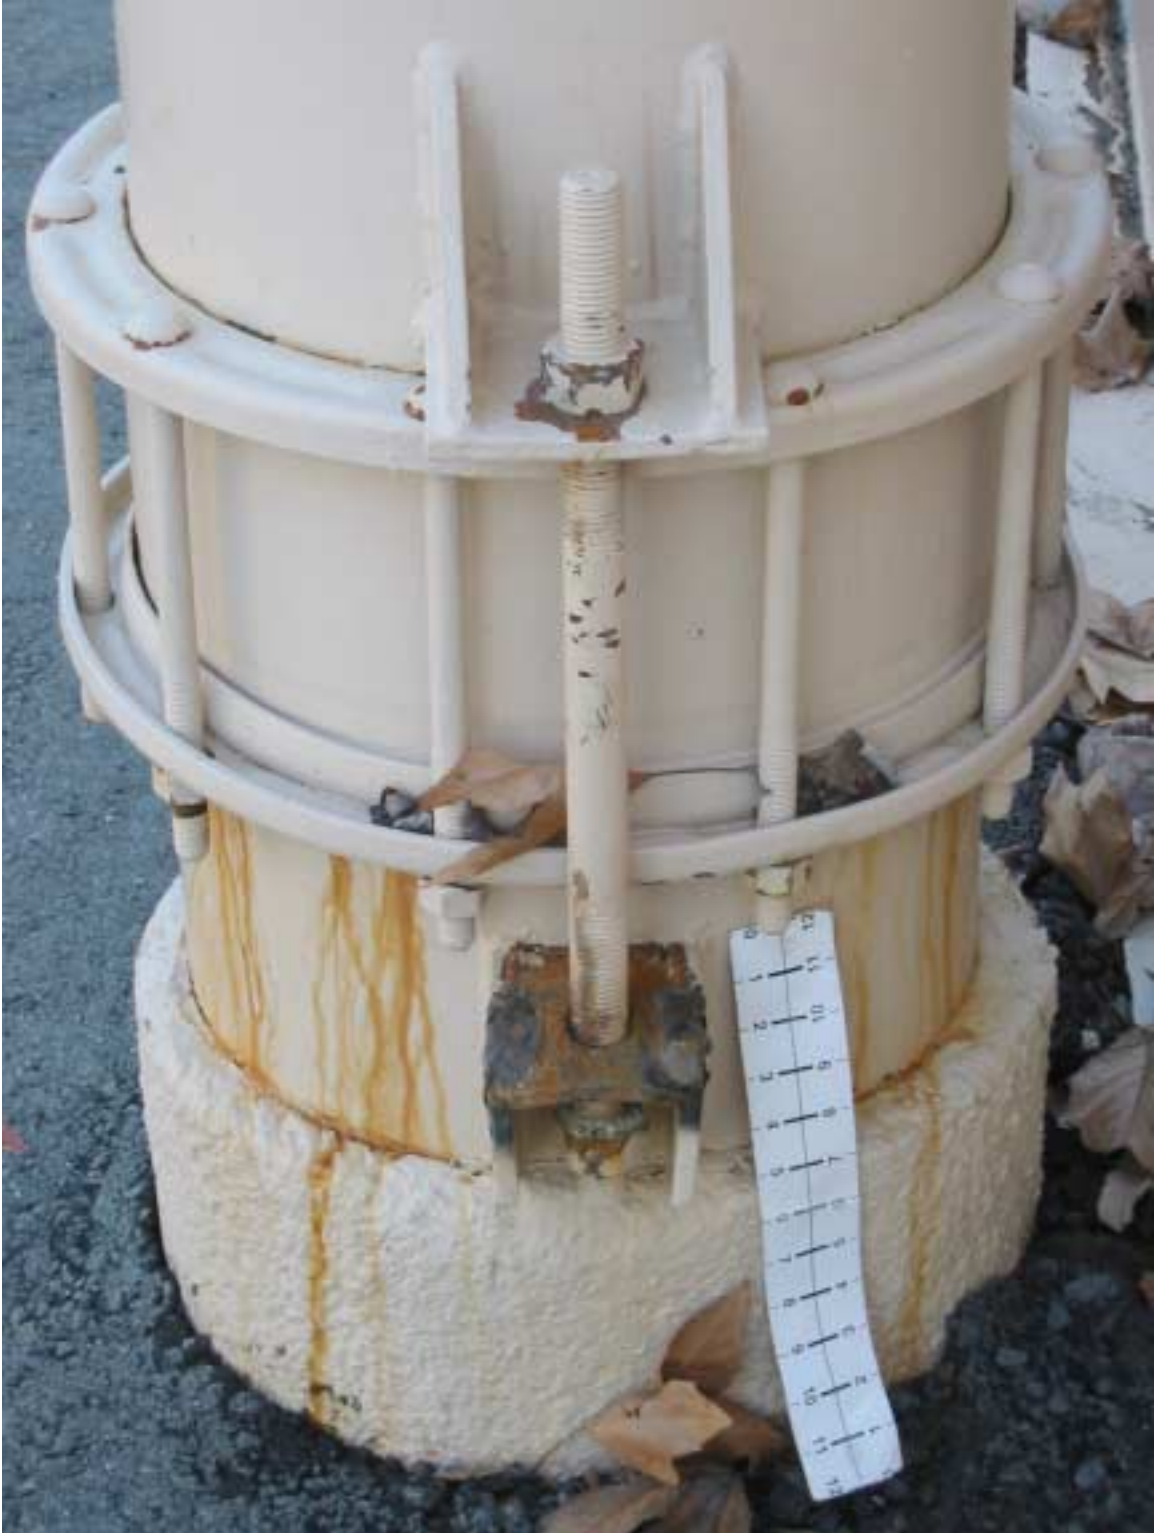
The north tank showed evidence of wall uplift of perhaps 2 to 3 inches. This uplift damaged the inlet pipe (pulled apart coupling, Figure 2). This led to flooding outside the tank. The recently-painted bottom plate showed evidence of substantial yielding (cracked paint, Figure 3). The outlet pipe and the steel floor near the pipe showed evidence of high stress (cracked paint), a permanent displacement downwards, suggesting that subsurface had been washed away by a pipe leak (Figure 4). The cross connection pipe was leaking where it entered the ground. The columns supporting the roof appeared to be slightly out-of-plumb. The roof beams and rafters had substantial movement, with perhaps 50% of the rafters moving 6 to 10 inches permanently away from their original position (Figure 5). The bottom course of the tank showed evidence of bowing outwards at about 3 to 8 feet above the foundation, perhaps by an inch or so. No elephant foot buckling was noted at the base of the tank. The external ladder was slightly buckled, likely caused by the bulging of the tank wall that could not be accommodated by the stiffer ladder rails.

Figure 2. North Tank, Inlet Pipe with Pulled Apart Coupling

Given the damage, the tank was drained immediately after the earthquake, and remained empty at the time of the inspection (January 12, 2004).

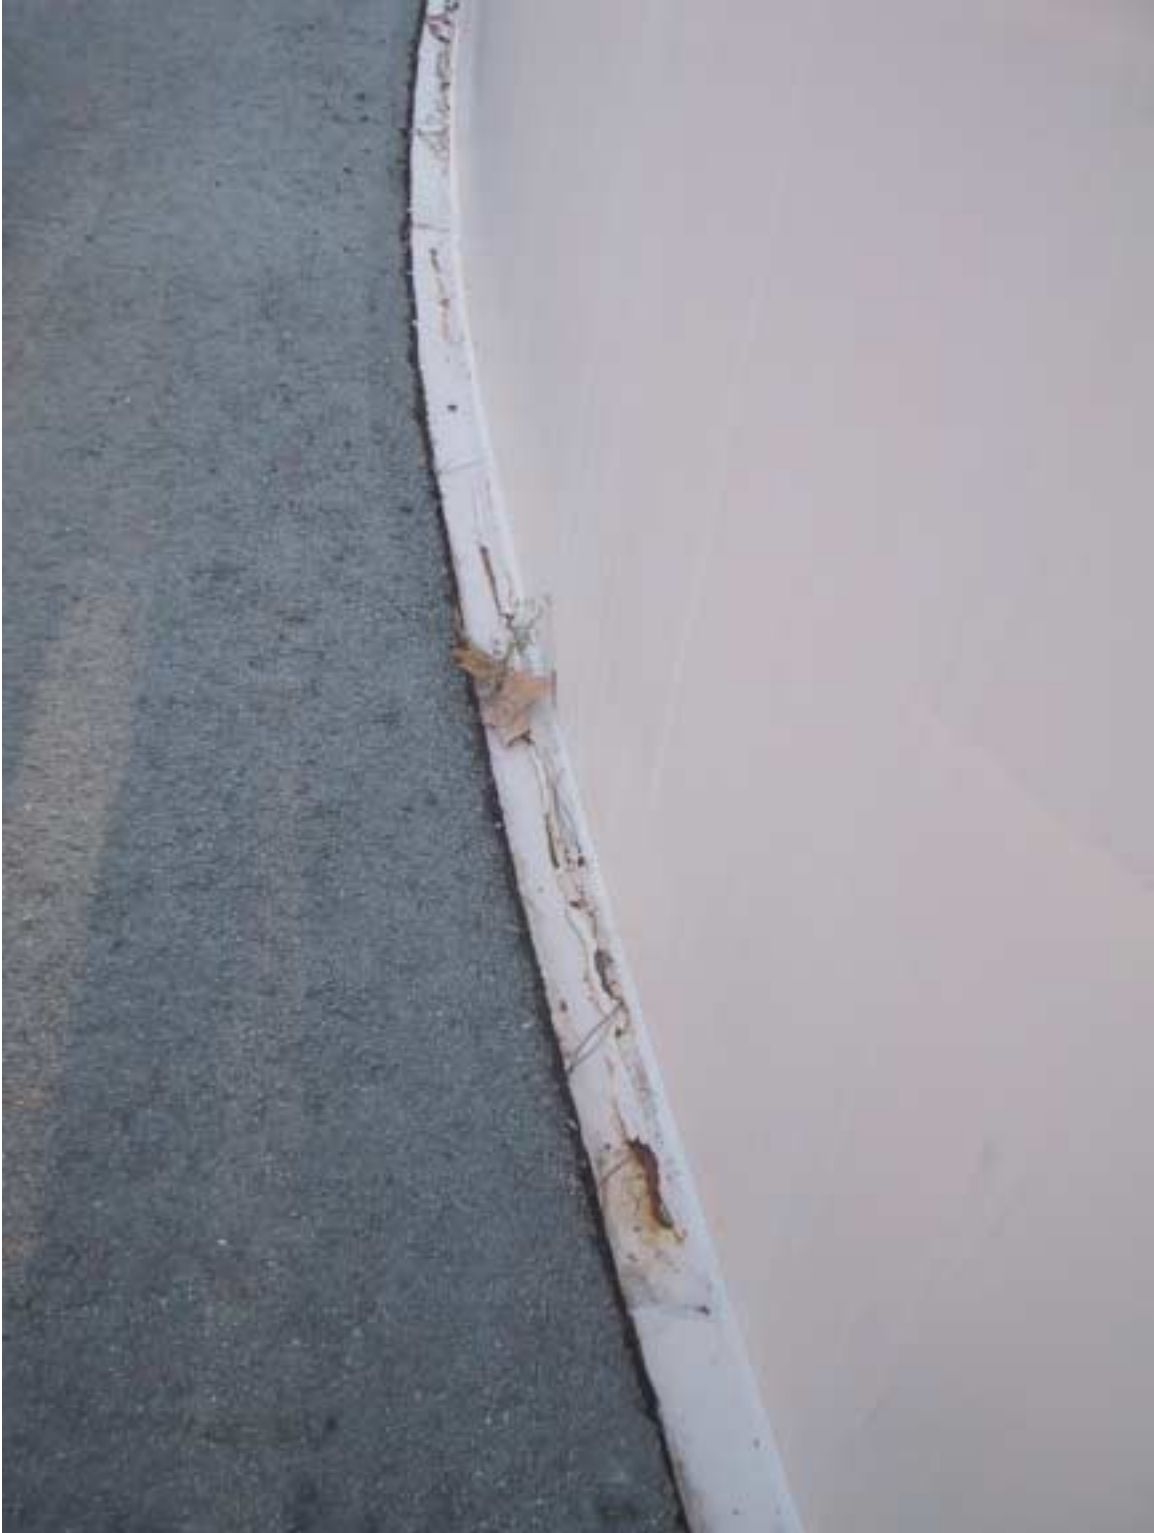
Figure 3. North Tank, Cracking of Paint on Bottom Base Plate

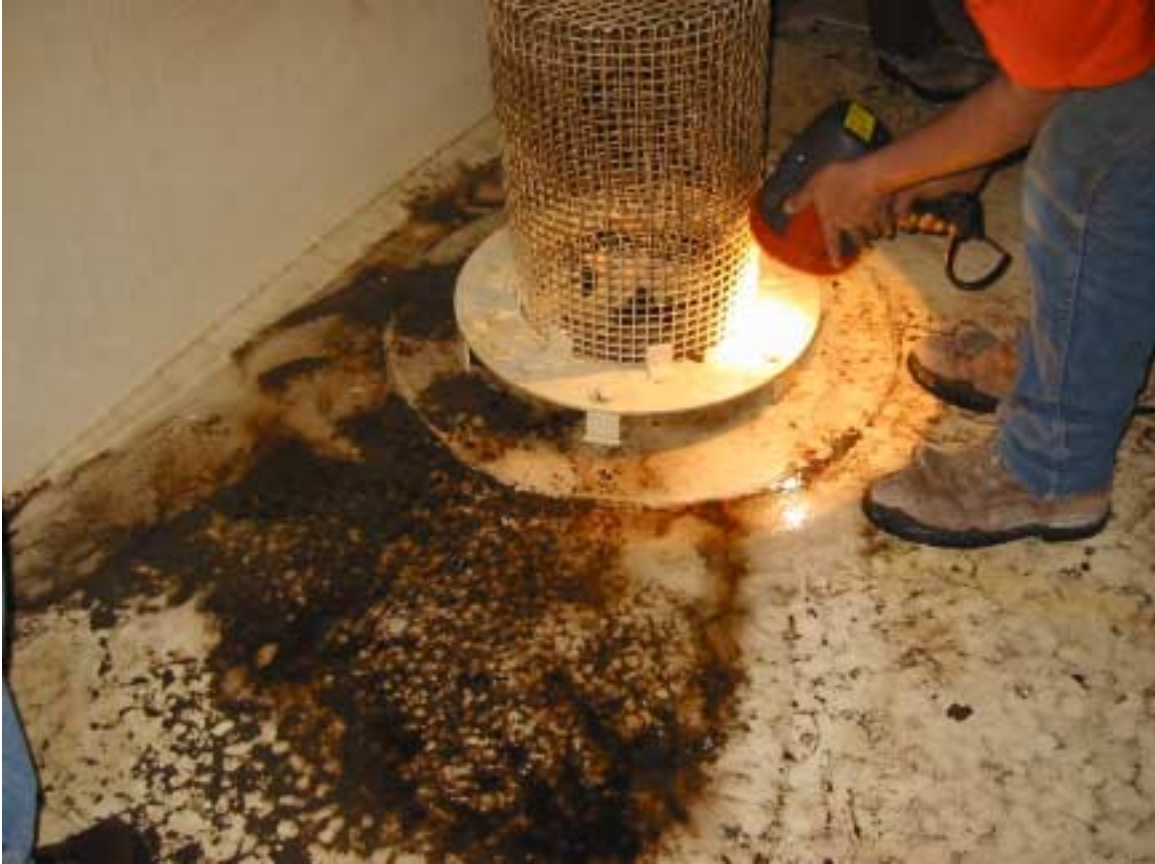
Figure 4. North Tank, Outlet Near Tank Wall

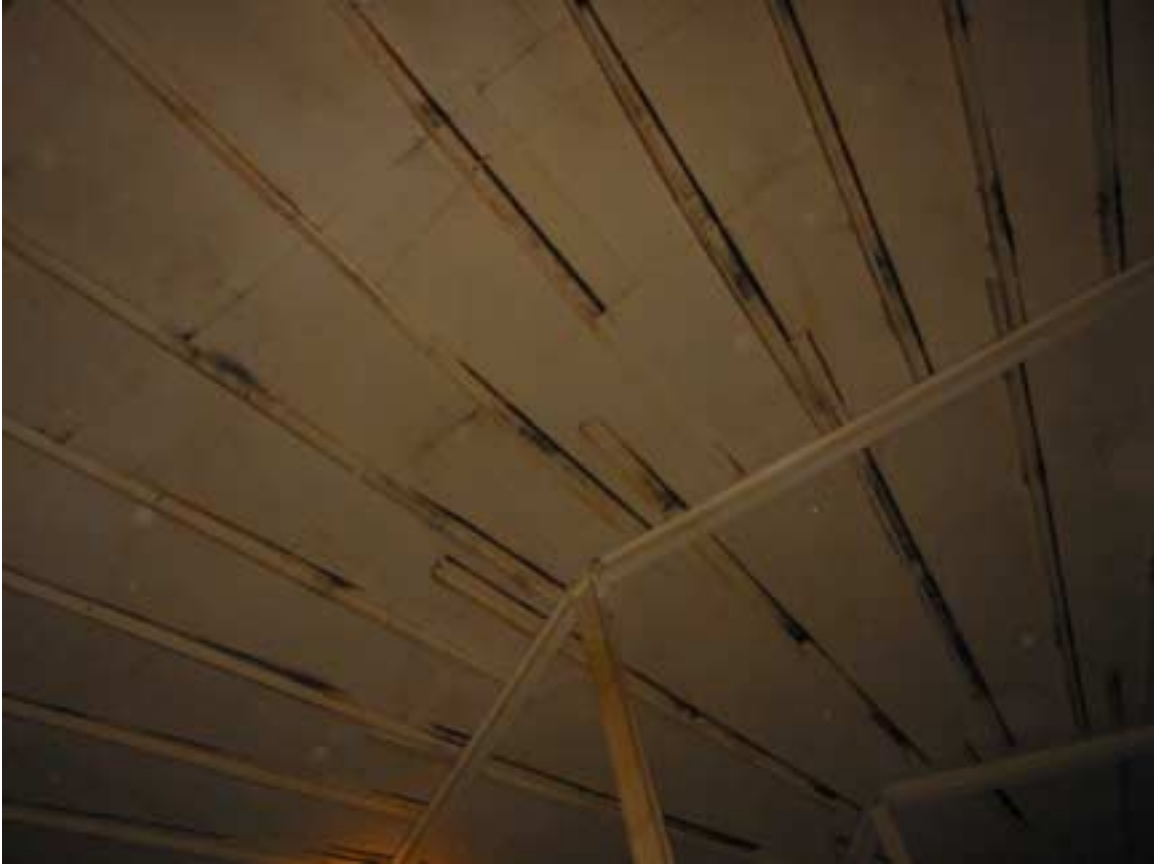
Figure 5. North Tank, Displaced Roof Rafters

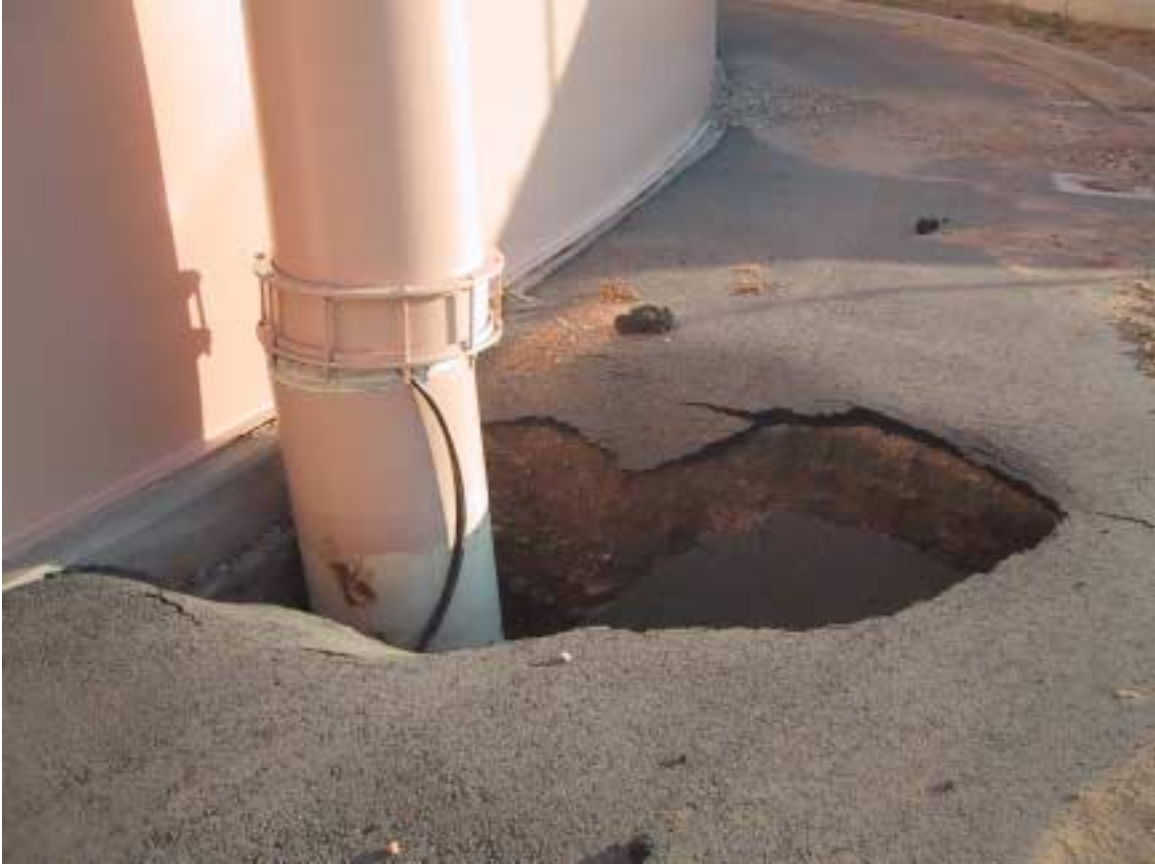
The south tank also showed evidence of wall uplift, although perhaps on the order of an inch. The inlet pipe pulled apart (Figure 6) leading to flooding and erosion near the pipe.

Figure 6. South Tank, Inlet Part Pulled Apart

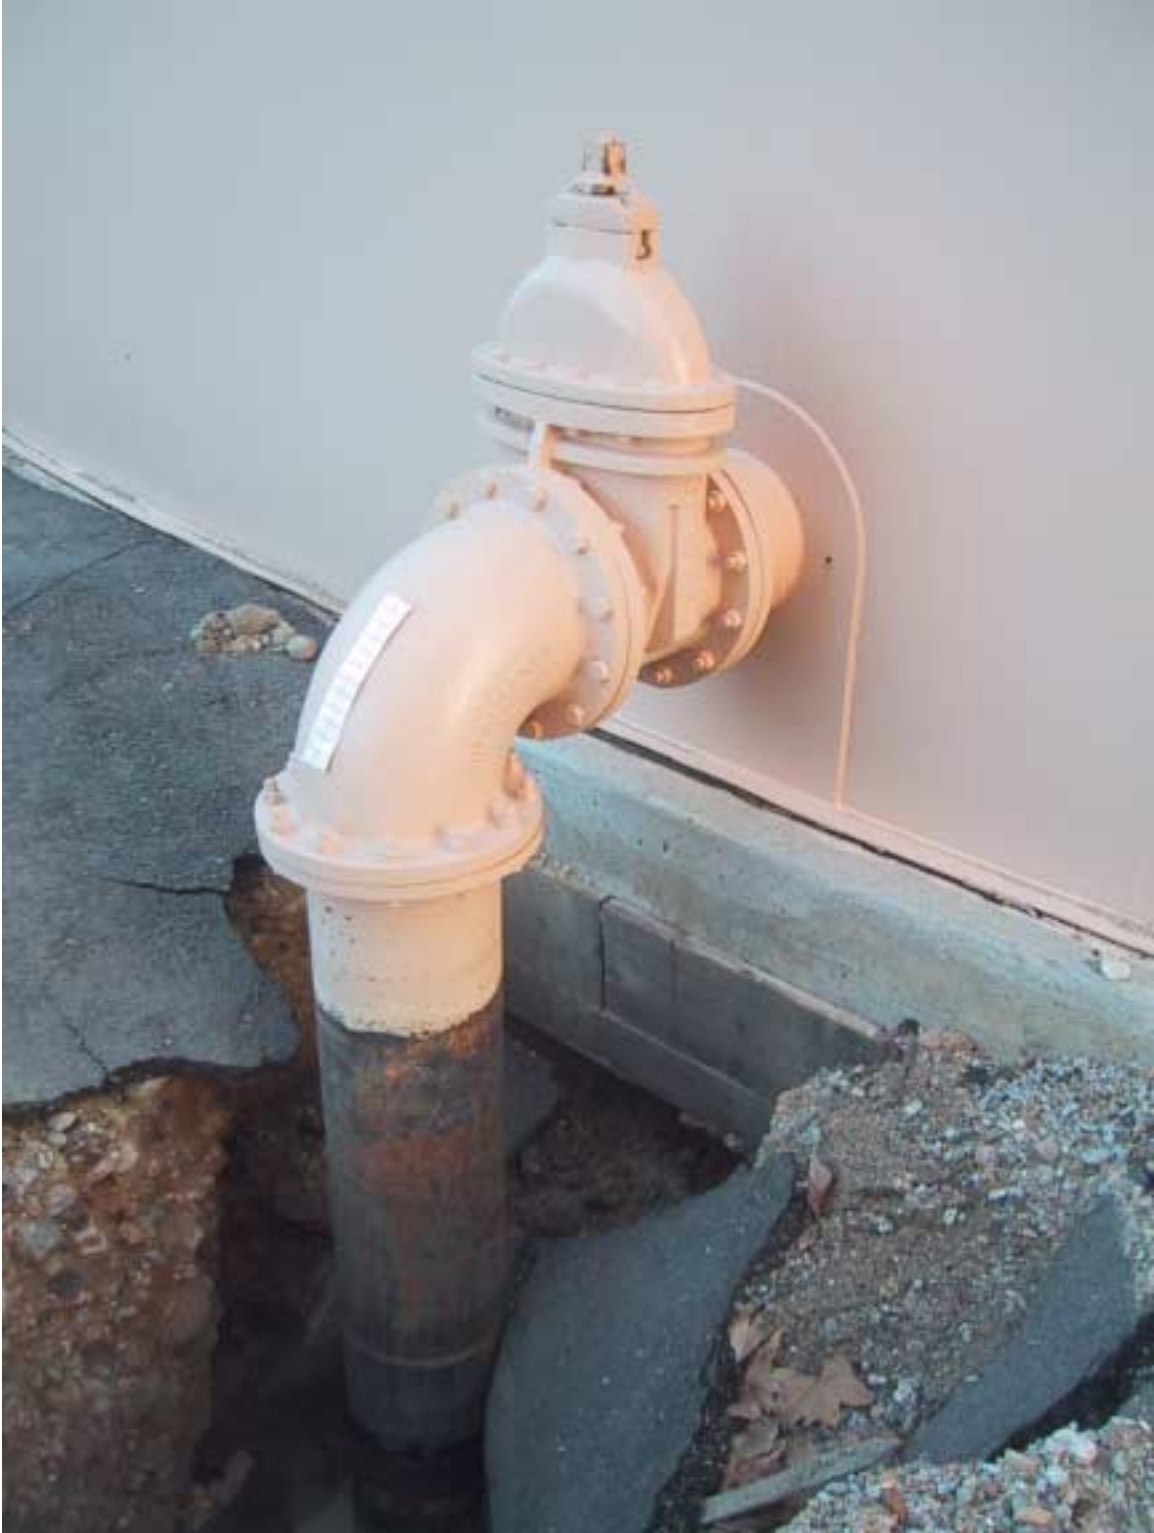
The side-entry pipe leading to the north tank was damaged where it enters the ground (uplift leading to pull apart of a mega-lug joint, Figure 7). The utility staff closed the gate valves on both of these damaged pipes before the entire tank could be drained; and the tank remained in service, using its third outlet pipe. Divers were sent into the tank and reported that there was no observable damage, so the tank has been kept in service.

Figure 7. South Tank, Uplift Failed this Side Entry Pipe (pull apart joint under the ground)

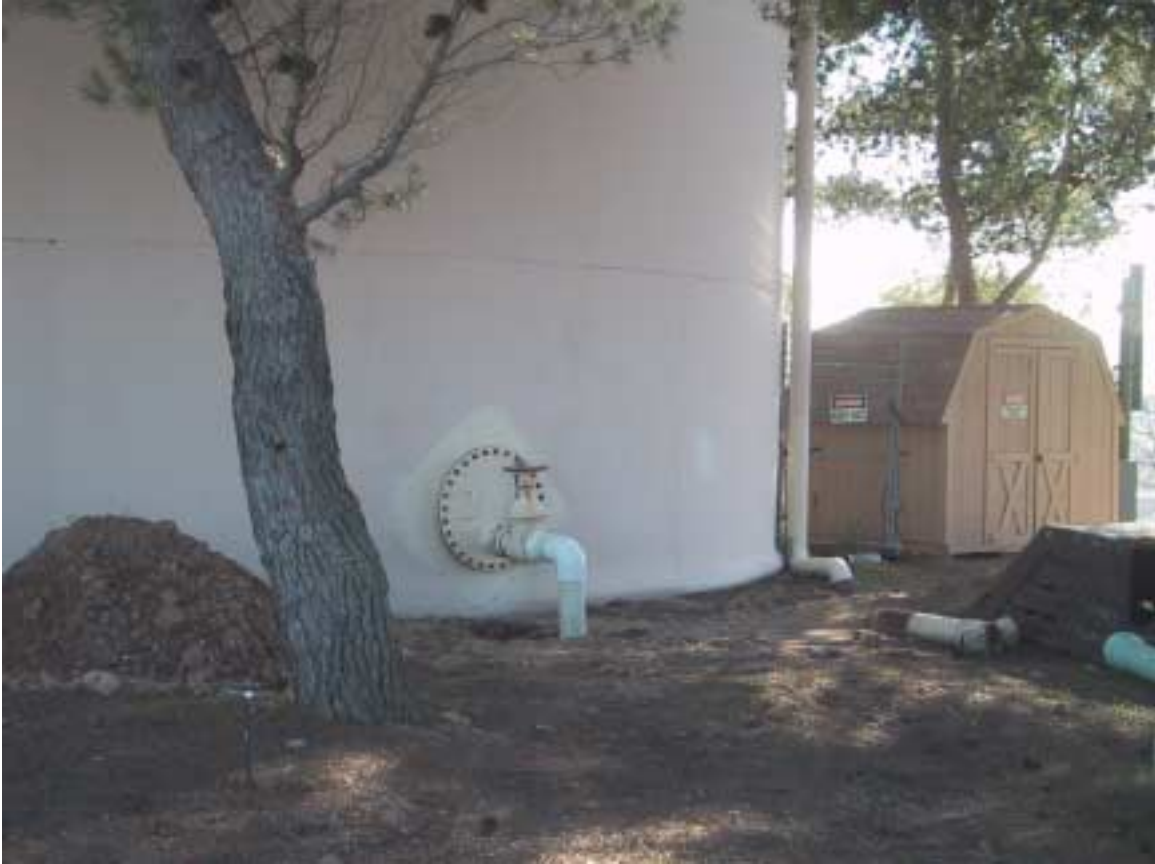
The 0.15 MG welded steel tank was damaged by the earthquake. The tank suffered an elephant foot buckle, Figure 8. The buckle led to damage of several attached inlet-outlet lines and the overflow pipe. The buckle can be seen in Figure 9, and its outwards displacement (about 3 to 4 inches) impacted an adjacent fence; the elastic rebound of the buckle can be seen as the dent in the fence post is lower than the final position of the buckle. The tank also showed evidence of a small top-course buckle. The attached pipes of the tank were repaired and the tank was returned to service on January 12, 2004.

Figure 8. Tank with Elephant Foot Buckle

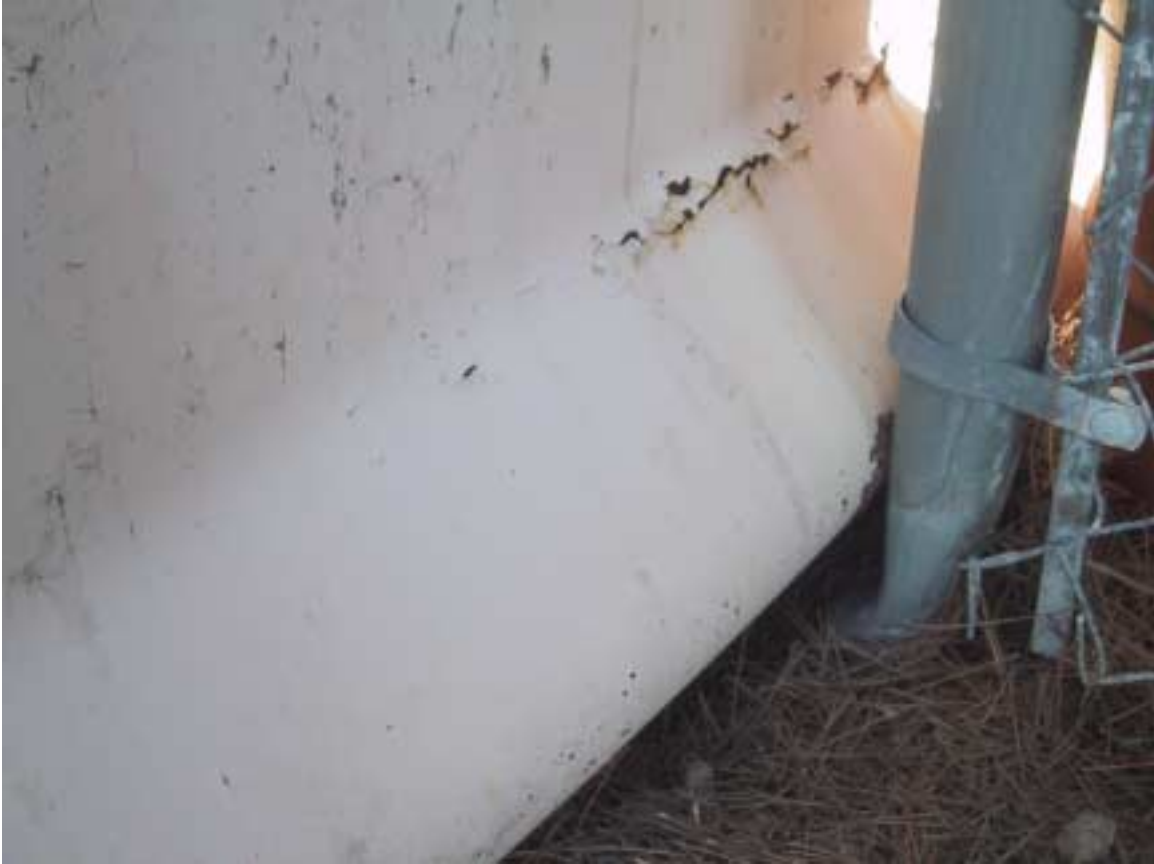
Figure 9. Buckle and Impacted Fence Post
