Tohoku Off Shore Earthquake & Tsunami, Japan
 $M_w=9.0$ 11 March 2011

Lifelines Performance Assessment
Preliminary Summary

(c) 2011, ASCE

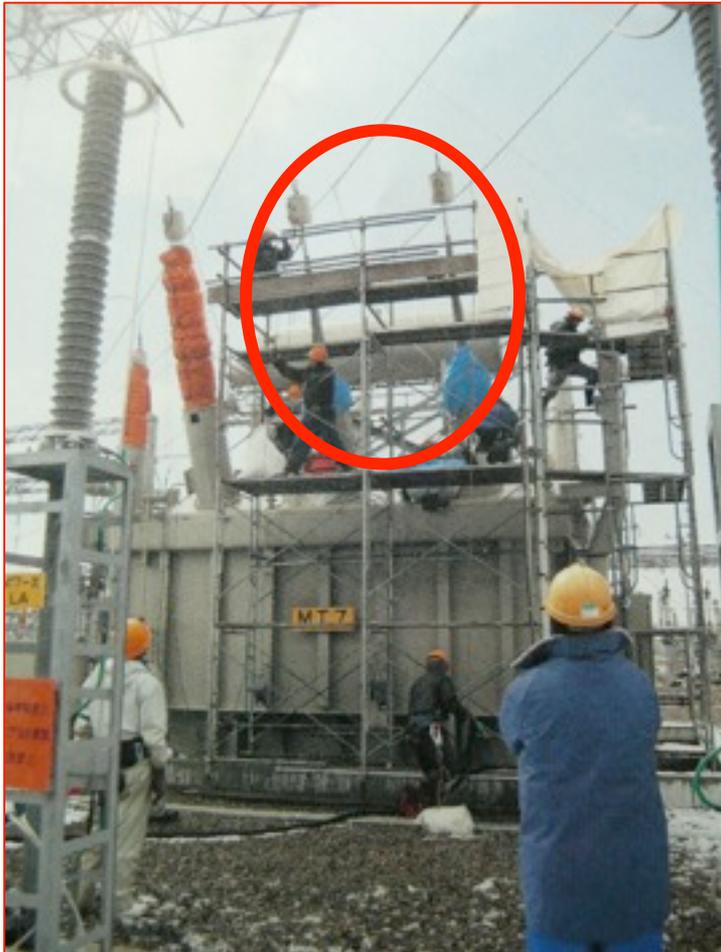
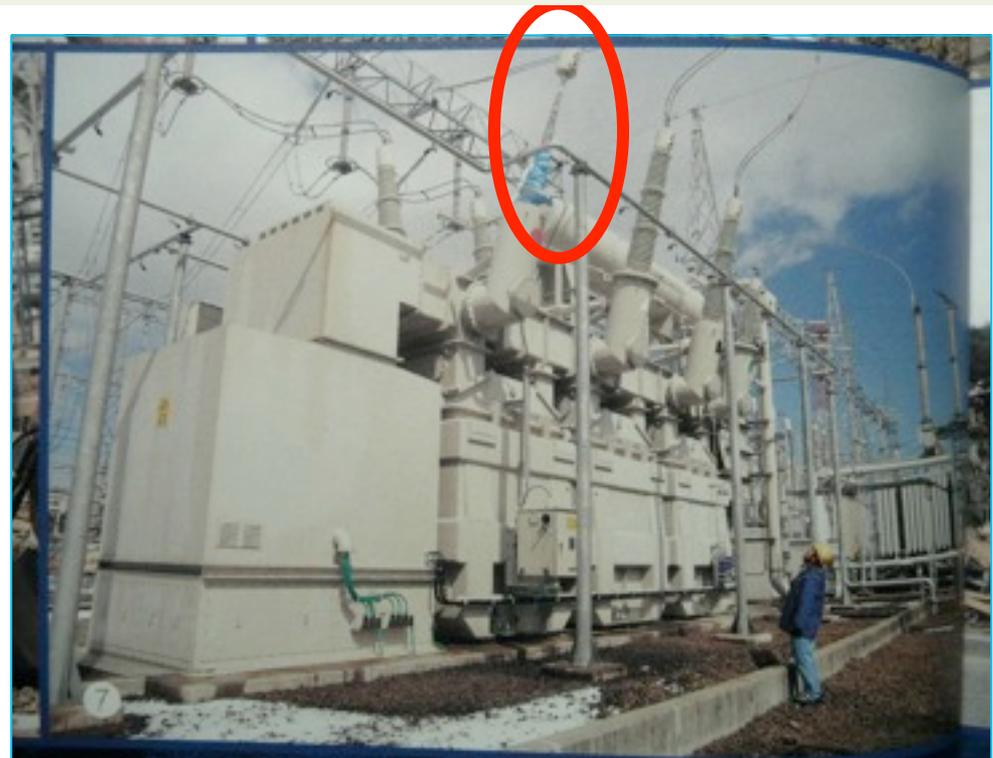
POWER TRANSFORMER FAILURES: Significant issue for transmission line system

M9 (3/11/11)	M7.2 (4/7/11)	M7.1/M6.3 (4/11-12/11)
47 Shaking	15 Shaking	1 Shaking
23 Tsunami

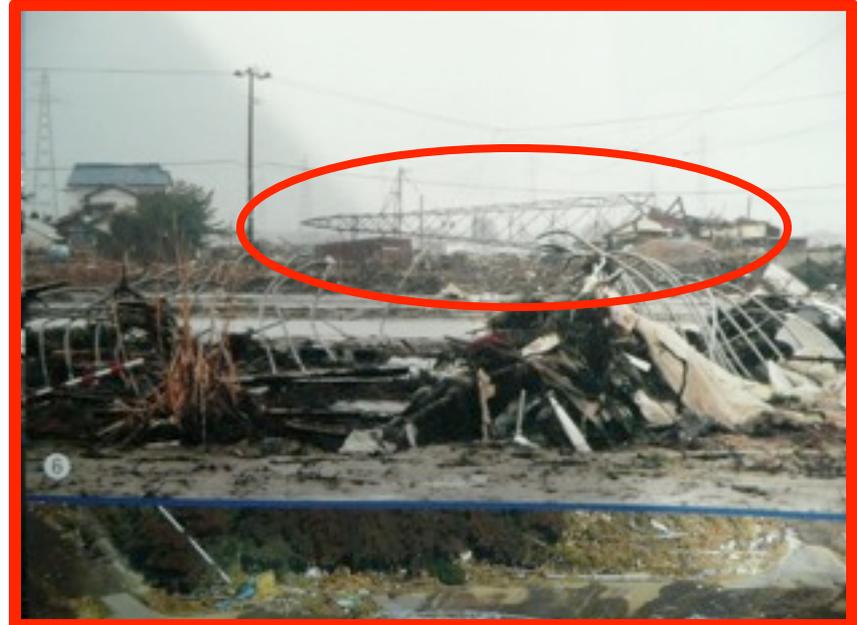
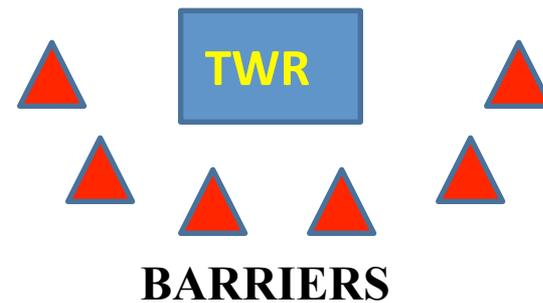
TRANSMISSION LINE TOWER

1. Recovery of the Electric Power grid access was timely (6 days, 90% – 10 days, 95%)
2. Significant percentage of damage was caused by the Tsunami
3. Transmission line tower performance was typical to other earthquakes (Liquefaction and Landslides)
4. Nearly IMPOSSIBLE to protect open air, ground level, substations against a Tsunami (Water & Tsunami impact)
5. High level of shaking damage to High Voltage Electric Power Transformers
6. Distribution System Failures: Tsunami impact, and typical failures from Landslides, Liquefaction, Pole mounted transformers, Unanchored equipment
7. Power Plant Problems (along the coast) Tsunami related, no/to very little information on actual failures of components from ground shaking (e.g. Soil failure of penstock)

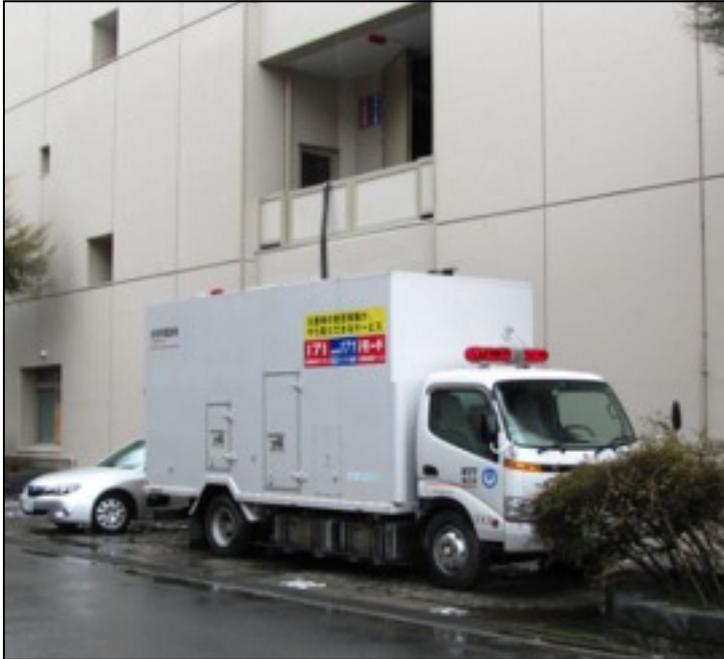
Miyako

- 16 Buildings had minor damage to its building but power facilities were lost due to water damage.
- Restored with mobile power plants.

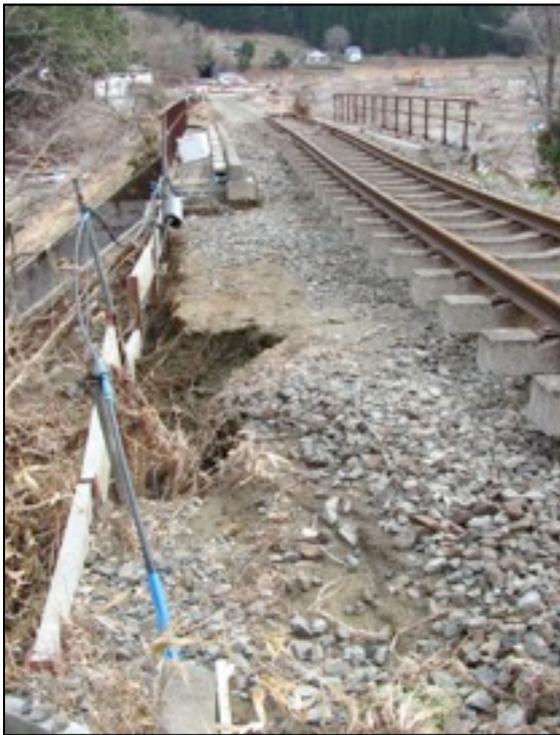
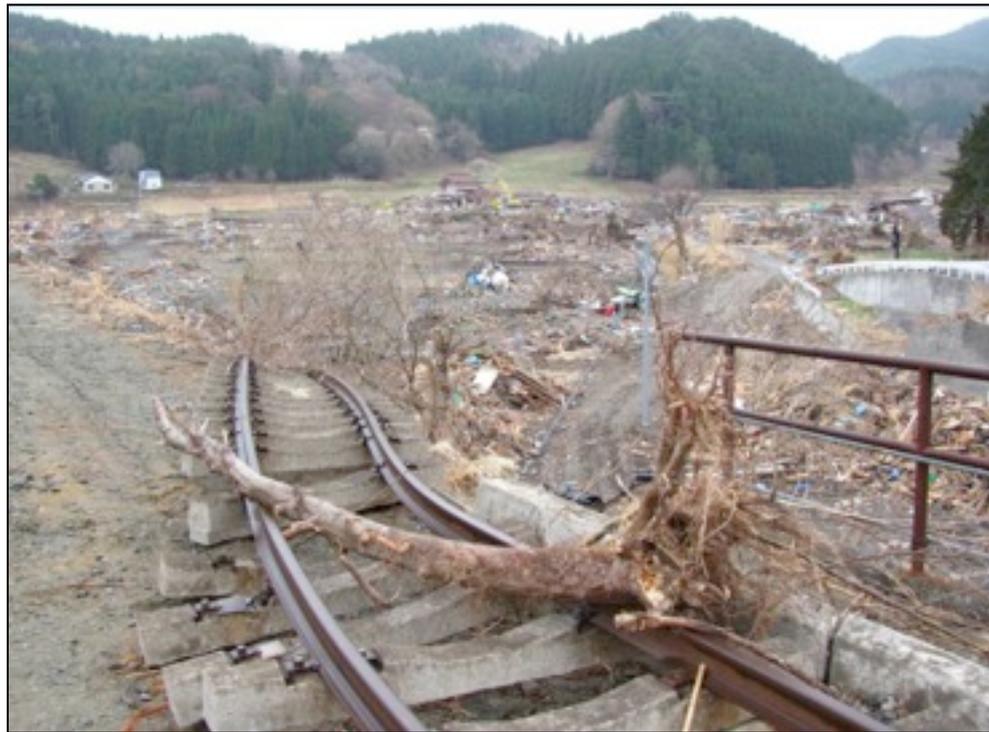
Sanriku

- 4 central offices lost service due to isolation from the rest of the network caused by severed transmission links caused by destroyed bridges.
- Restored with new by-pass transmission routes.

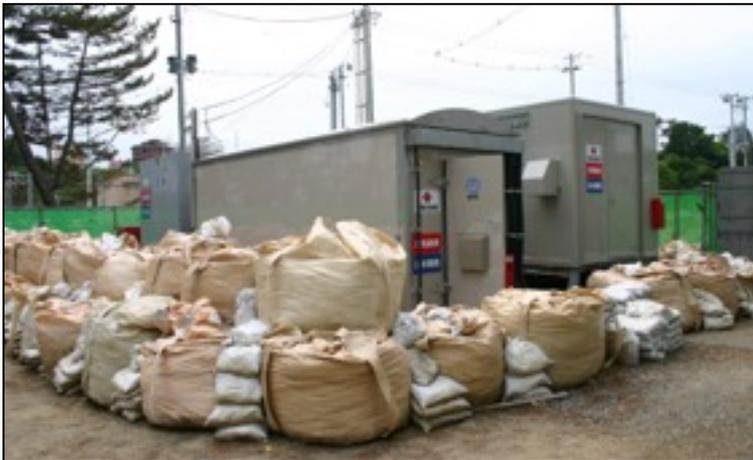
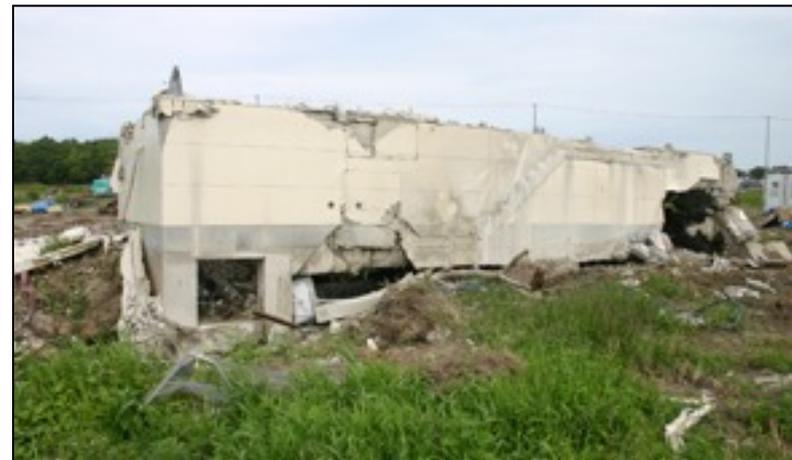
- 26 Buildings were damaged by the tsunami and all of its equipment in its interior was destroyed..
- Restored with switches in shelters located at the location of the destroyed central office building, or remote subscriber line modules (RSBM) small cabinets (also called digital loop carrier or fiber to the curb systems) distributed along the destroyed central office service area.

Shichigahama CO building carried away 500 m by the tsunami

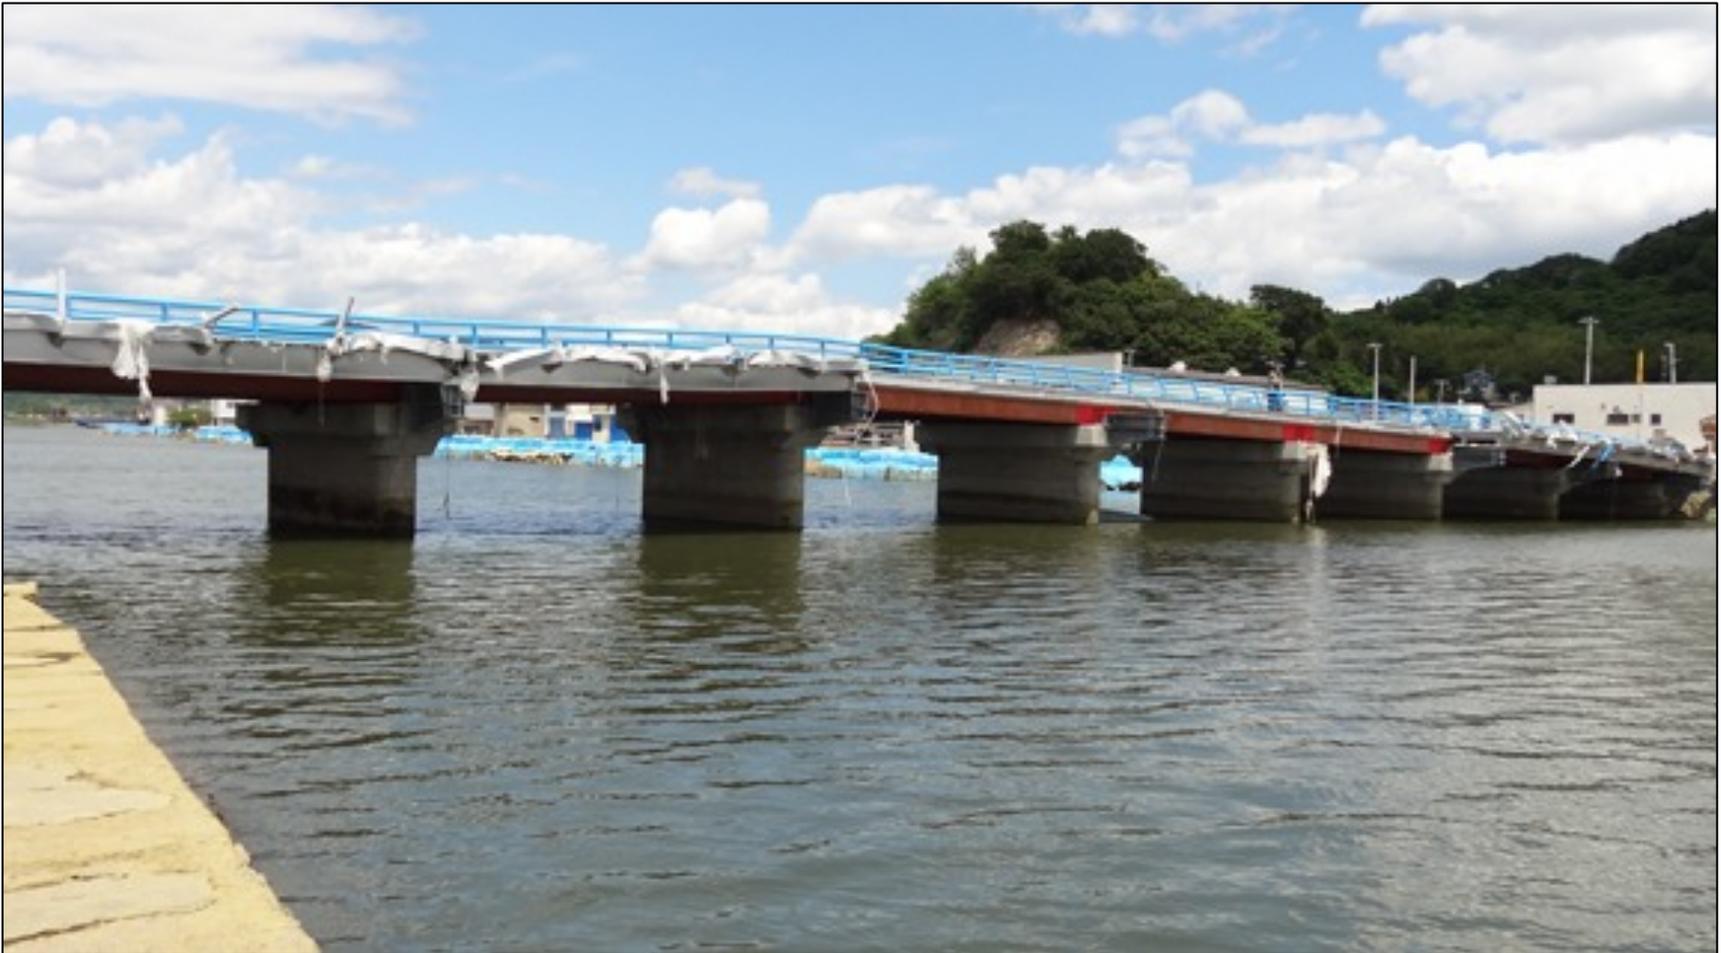
During tsunami why do a few spans get knocked off bridges but most spans stay on bridges?

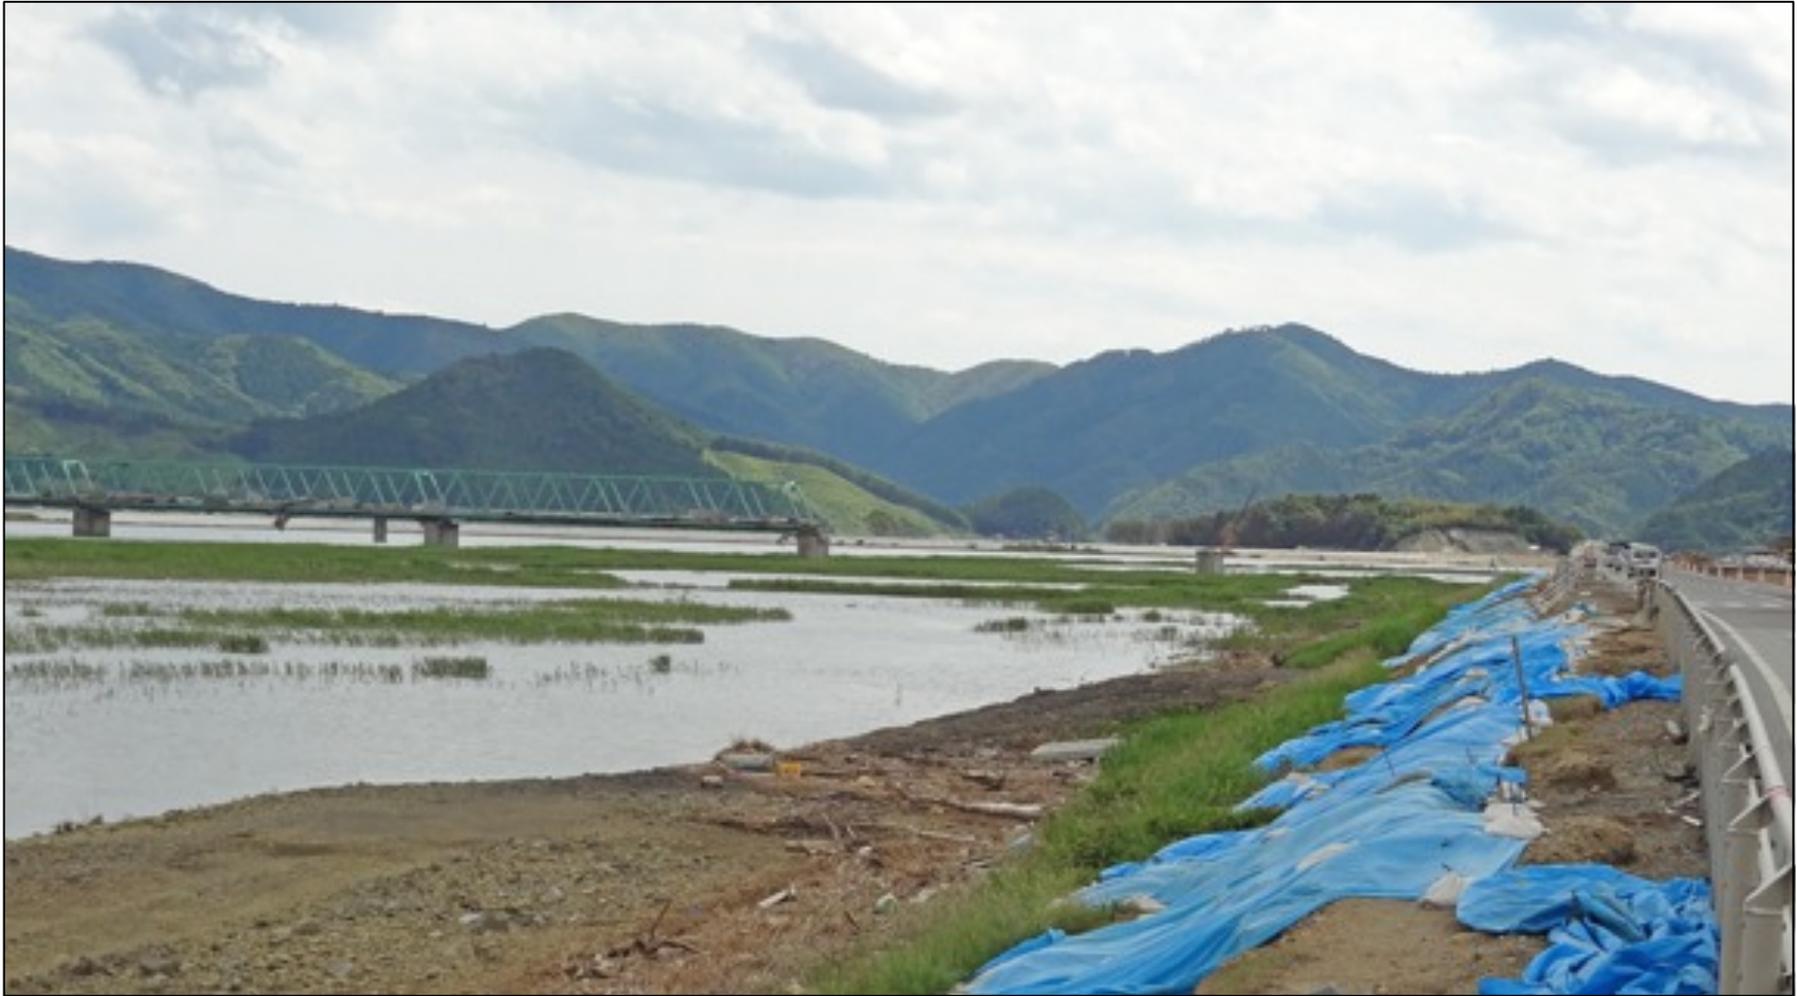
Is it better to tie the girders to the piers or will that just cause the piers to be damaged during tsunami ?

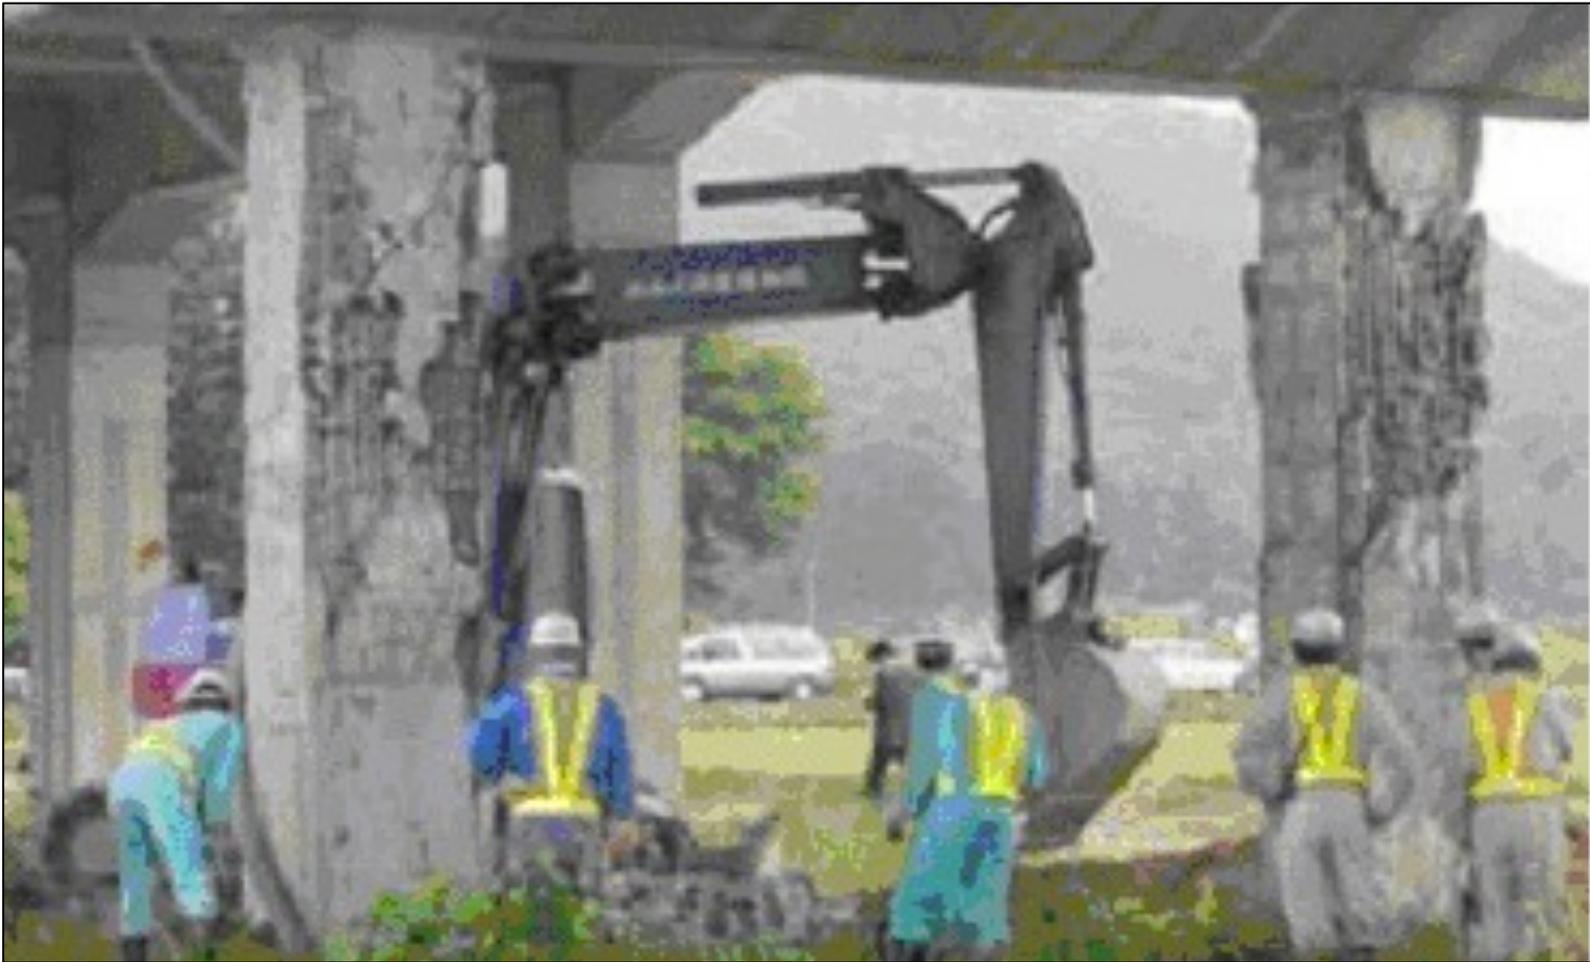
Is it better to retrofit Shinkansen viaducts or just repair them after each earthquake?

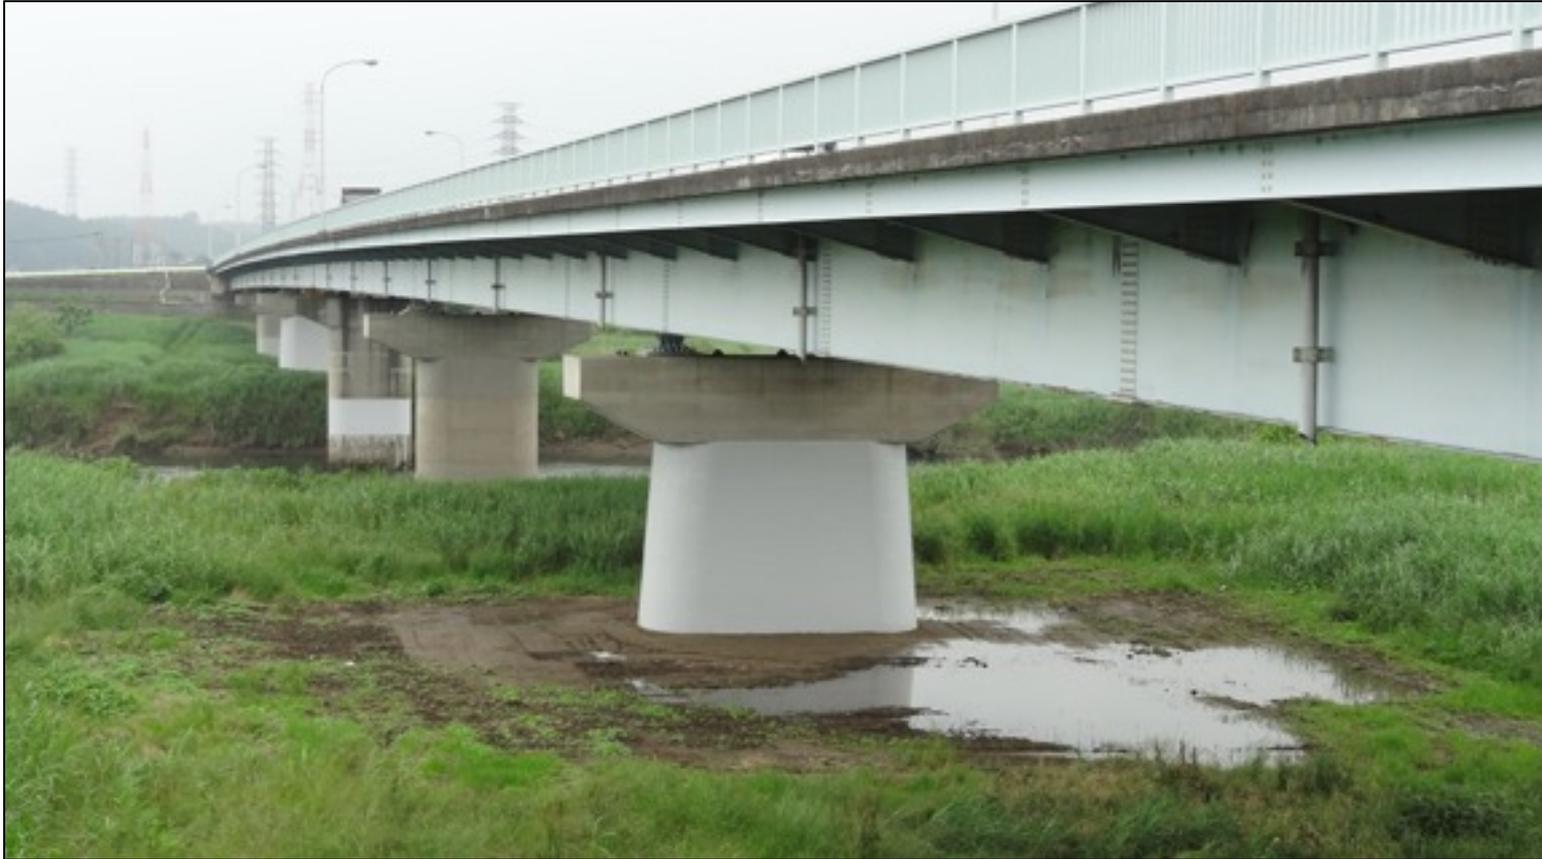
What are the consequences of designing tall columns and short columns on the same bridge?
