CHRISTCHURCH, NEW ZEALAND EARTHQUAKE SEQUENCE OF M_w 7.1 September 04, 2010 M_w 6.3 February 22, 2011 M_w 6.0 June 13, 2011: LIFELINE PERFORMANCE

**Technical Council on Lifeline Earthquake Engineering
Monograph No. 40
February 2012 – Revision 0
ASCE**

ABSTRACT

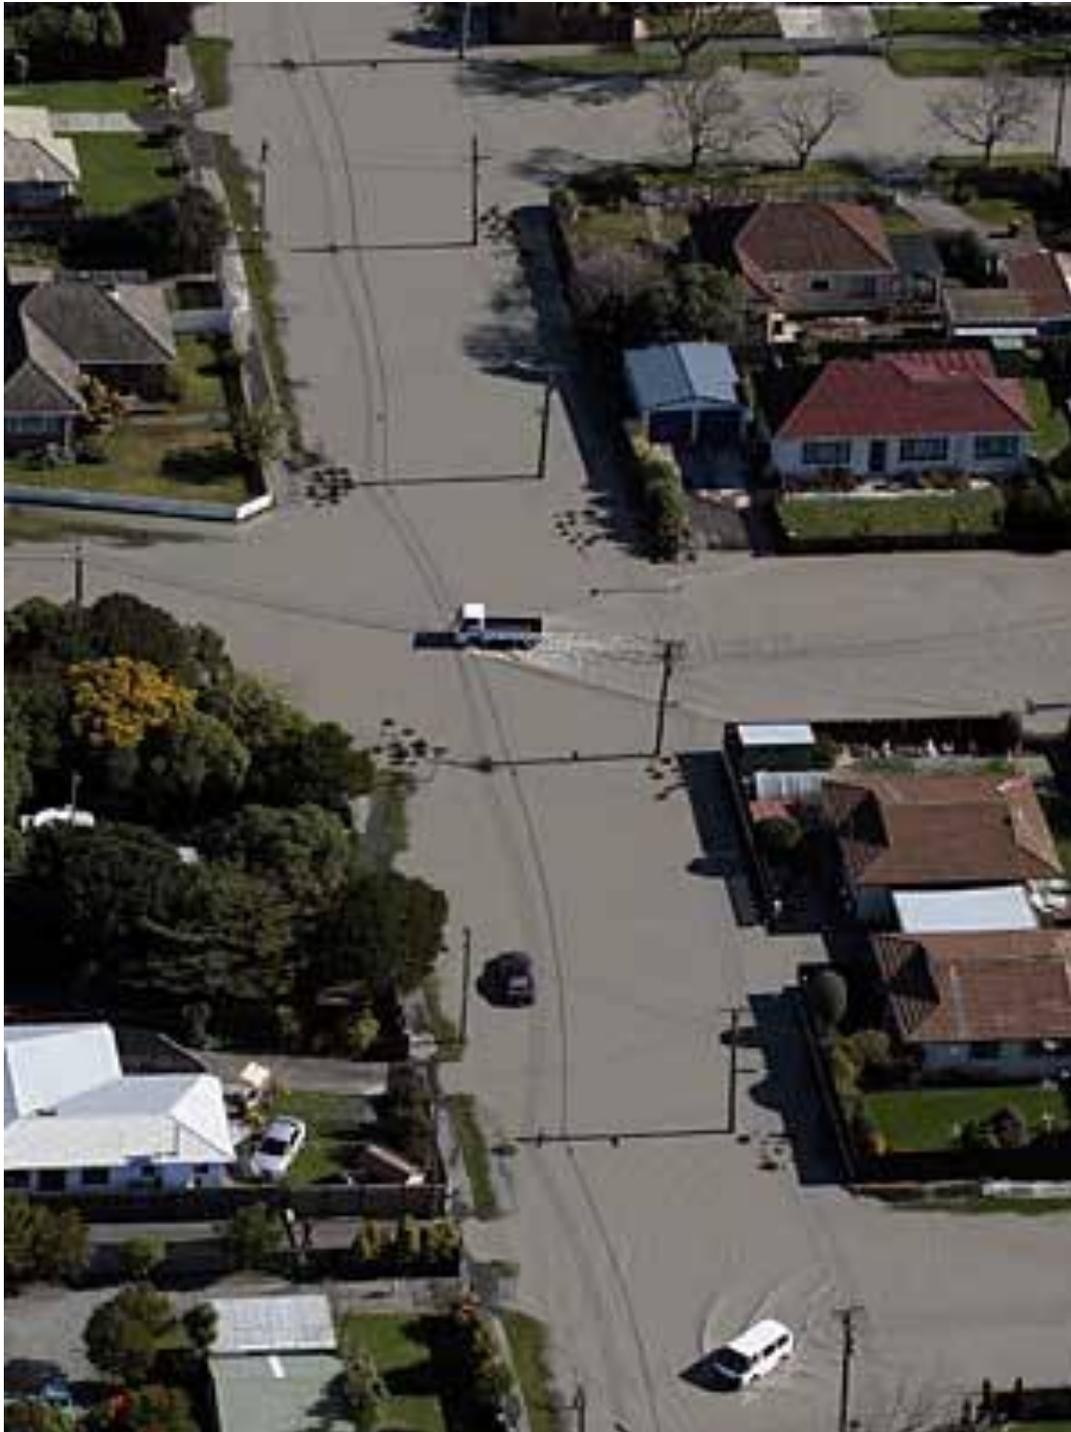
flooding. However, the liquefaction forced great volumes of water from the ground for very long periods of time and ultimately caused the flooding seen in Figure 2-33; this was repeated in the February 2011 earthquake, Figure 2-40.

Figure 2-33. Flooding due to Liquefaction

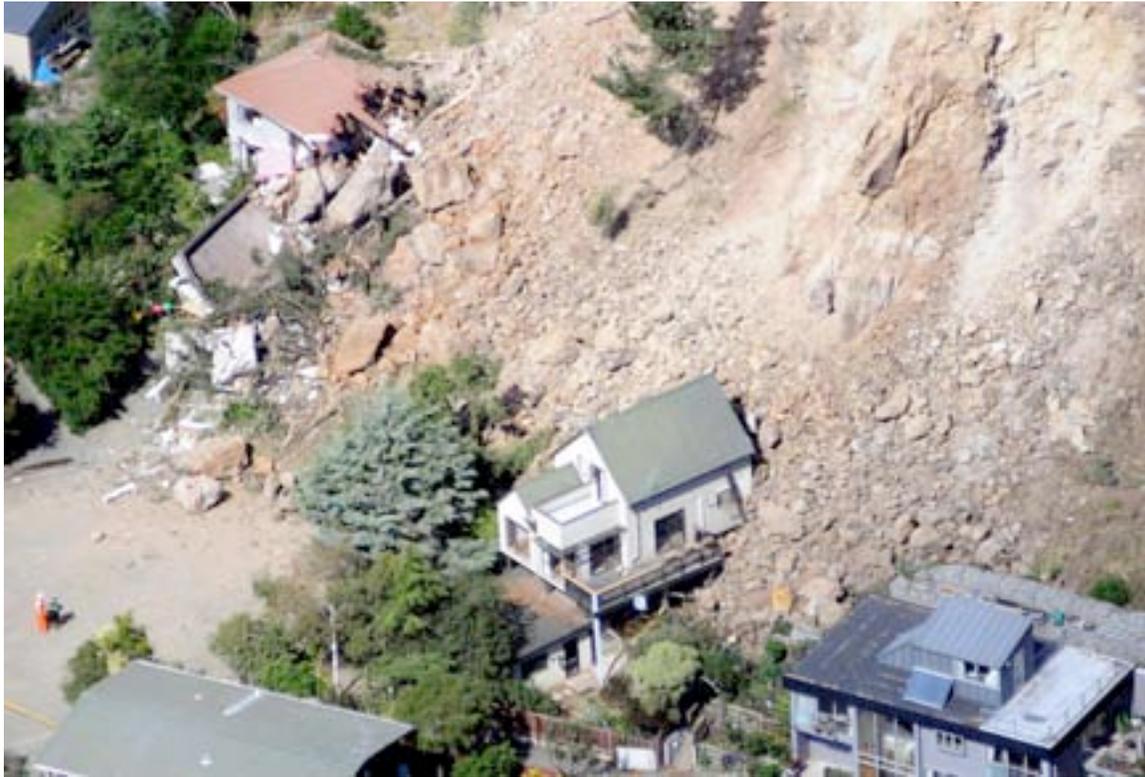
The rock falls in Redcliff, Figure 2-47, were fatal to a building occupant.

Figure 2-47. Rock falls in Redcliffs, February 22 2011

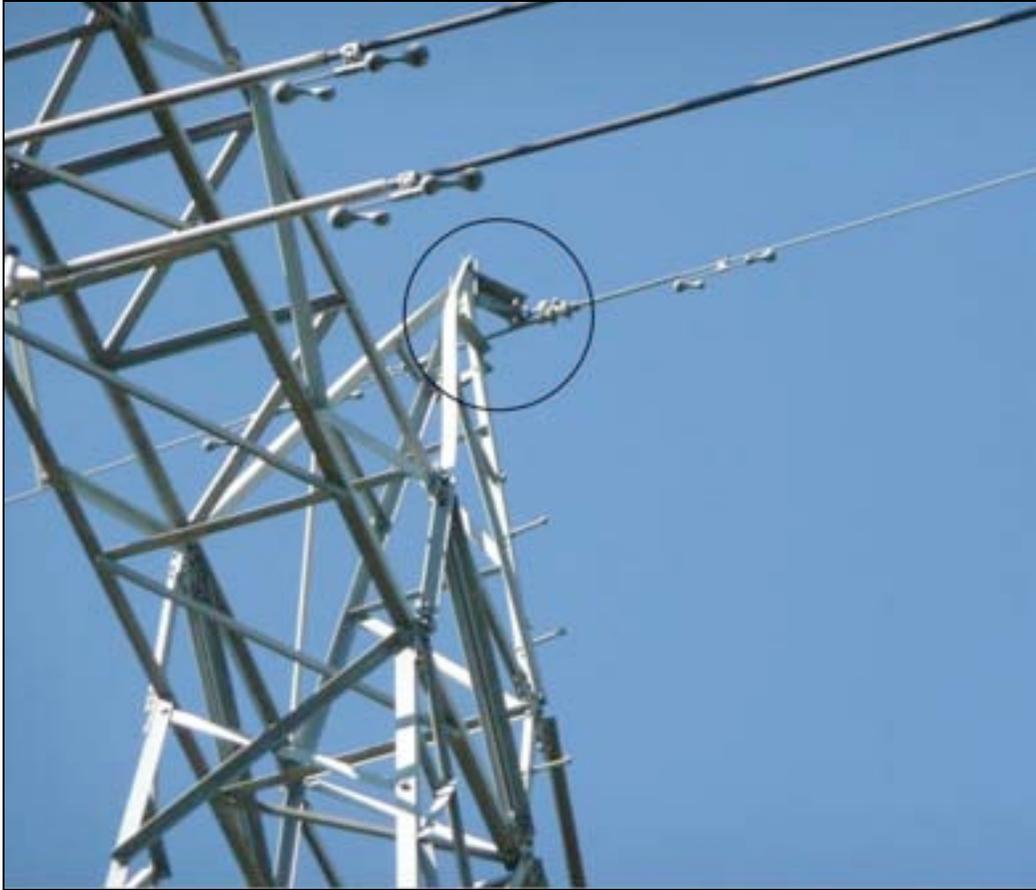
Figure 4-7. Damaged Tower Extension for Ground Wire

On the Benmore-Islington 220 kV line, the Sept 2010 fault offset resulted in excess ground wire tension that resulted in damage to a tower extension that supported the ground wire, Figure 4-7.

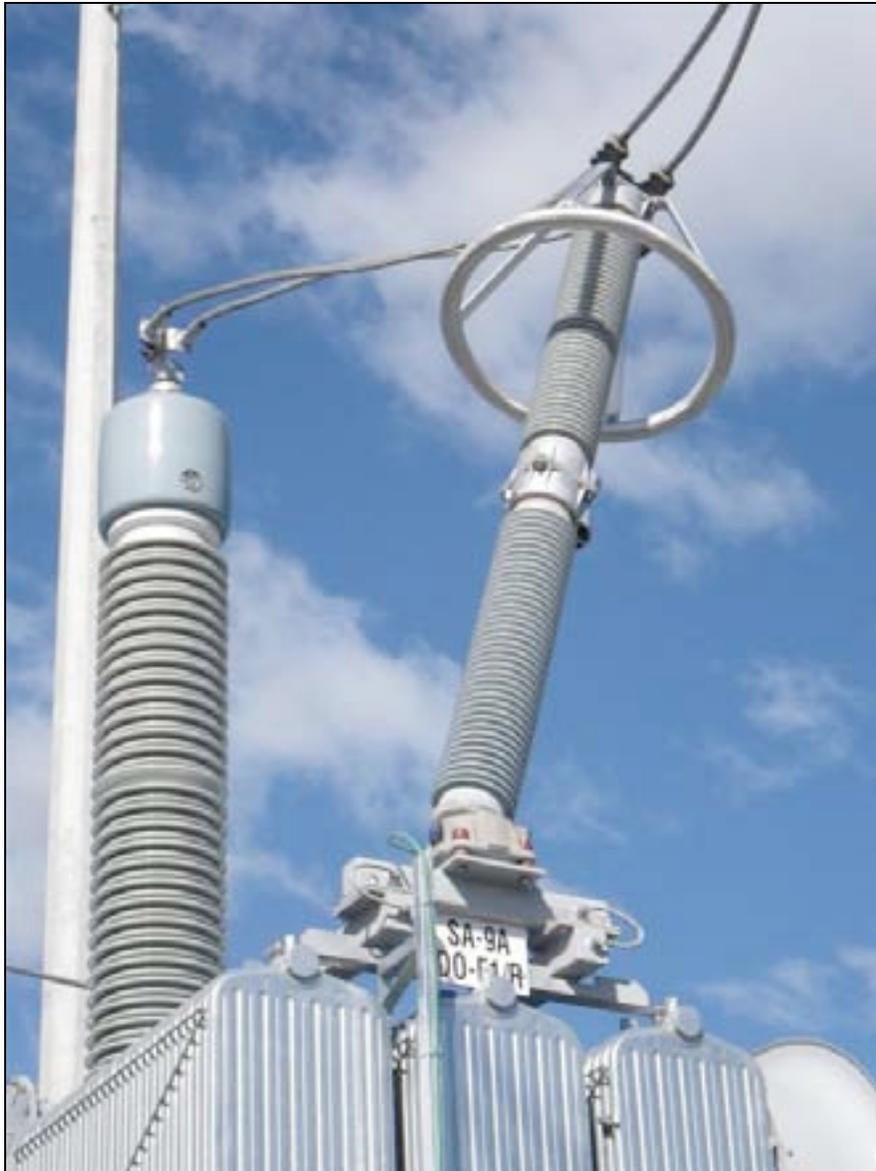
Figure 4-10. Broken Lightning Arrester

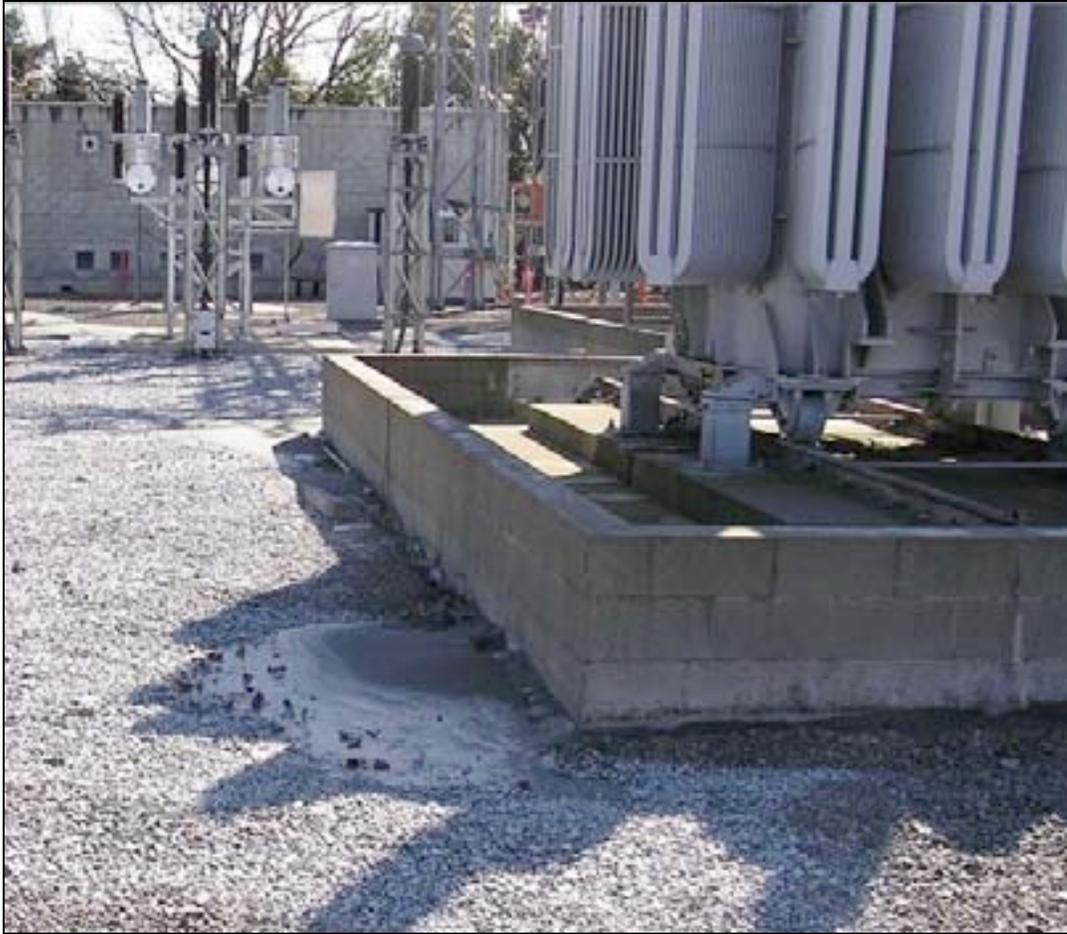
Figure 4-12. Sand Boil, Settlement and Cracking of Oil Containment, Papanui Substation

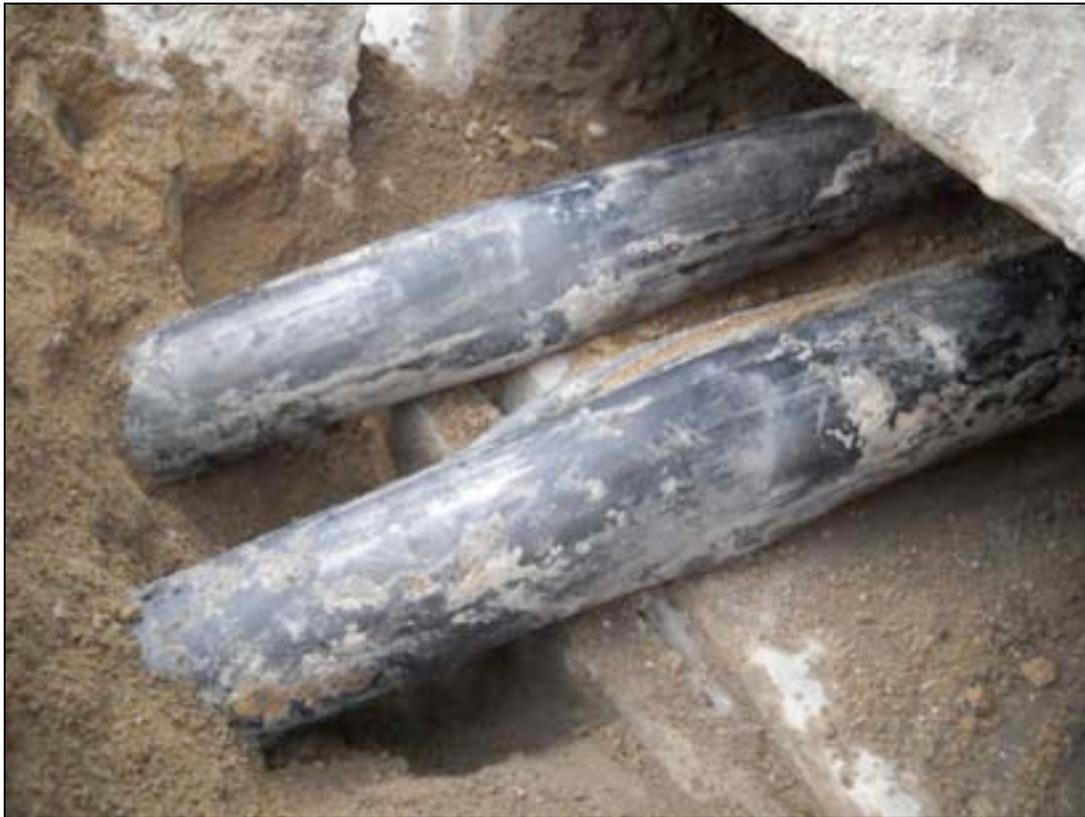
Figure 4-21. 66 kV Cables

Figure 4-21 shows two partially crushed 66 kV oil-filled low pressure cables. This occurred where the buried cables transitioned from a buried condition, and went onto a pile-supported bridge across the Avon river. The cables remained functional after the September 2010 earthquake, but failed in the February 2011 earthquake. As part of a temporary measure after the September 2010 earthquake, Orion braced the bridge on which the cables are located. There were several other 11 kV buried cables that were completely broken in the September 2010; we believe all of the broken cables were in the areas with lateral spreads and/or settlements. In the February 2011 and June 2011 earthquakes, there were many more failures (at least 120) of buried 66 kV and 11 kV cables.

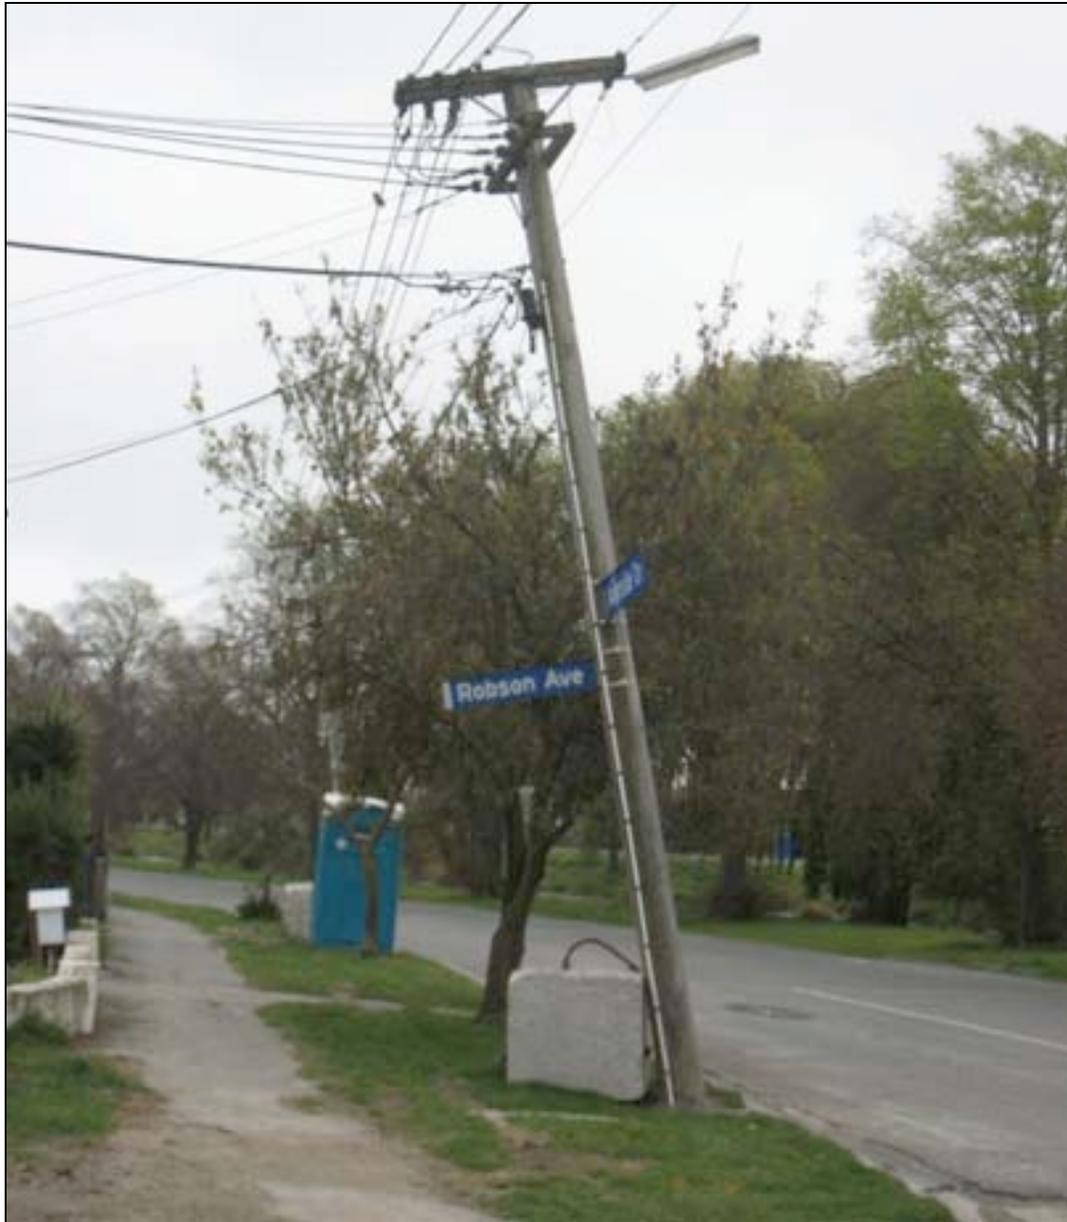
Figure 4-22 shows one of many tilted low voltage power poles, located at Avonside and Robson Ave. These wood poles commonly are buried 6 to 7 feet into the ground (~2 meters). The locations with observed tilted poles correspond essentially one-to-one with the areas with observed liquefaction. According to Orion, none of the poles toppled.

Figure 4-22. Titled Power Pole

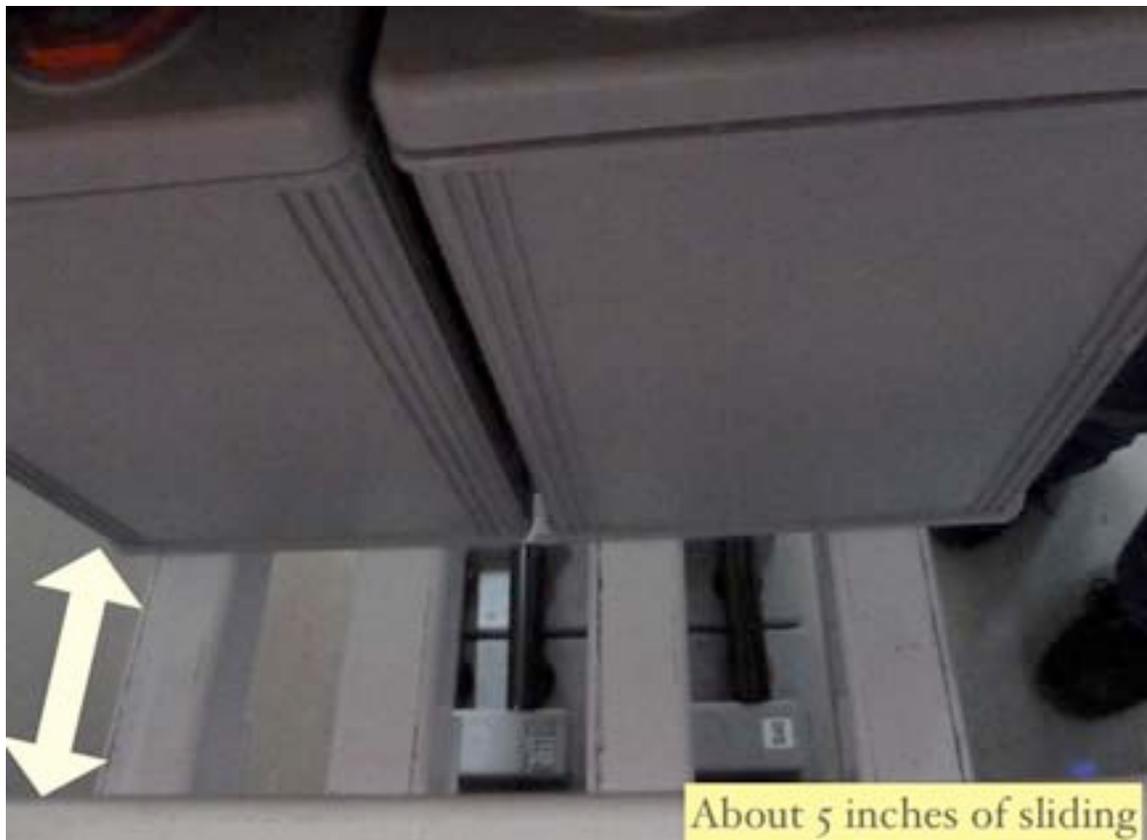
- Some tiles from a suspended ceiling dislodged and fell. These had no adverse impact on equipment.
- Cabinets, table top equipment all performed well. Transpower had previously seismically-restrained all the equipment (including desk-top computer monitors, shelving, etc.) using angles, hold down clips, etc.
- A new battery rack had been installed. The battery rack, on the second floor, was seismically anchored; however, the batteries within the rack did not have spacers, and they slid several inches during the earthquake. Figure 4-24 shows scratch marks caused by the sliding movement of the batteries. Transpower reported that the batteries remained functional, all the same.

Figure 4-24. Sliding of Batteries in Battery Rack at Bromley Substation

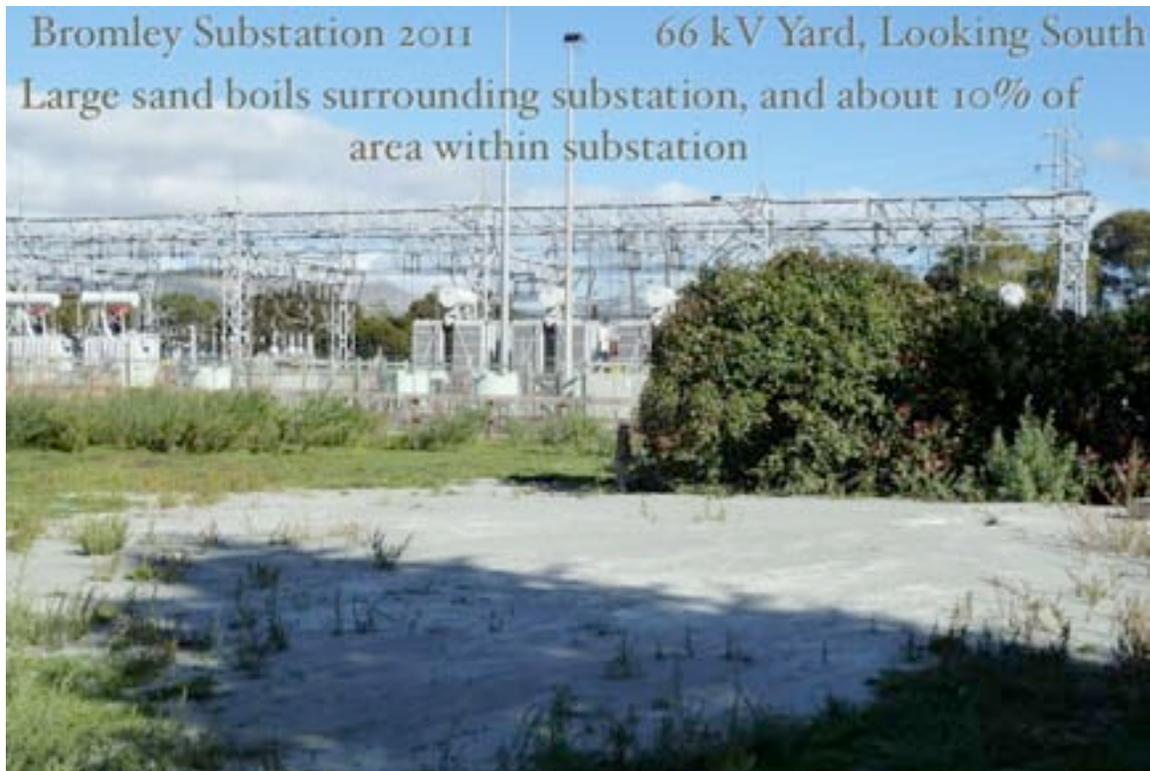
There was a lot of liquefaction around, and some within the 220 kV and 66 kV yards at the Bromley substation, Figures 4-27 and 4-28.

Figure 4-27. Liquefaction Outside the 66 kV Yard, Bromley Substation

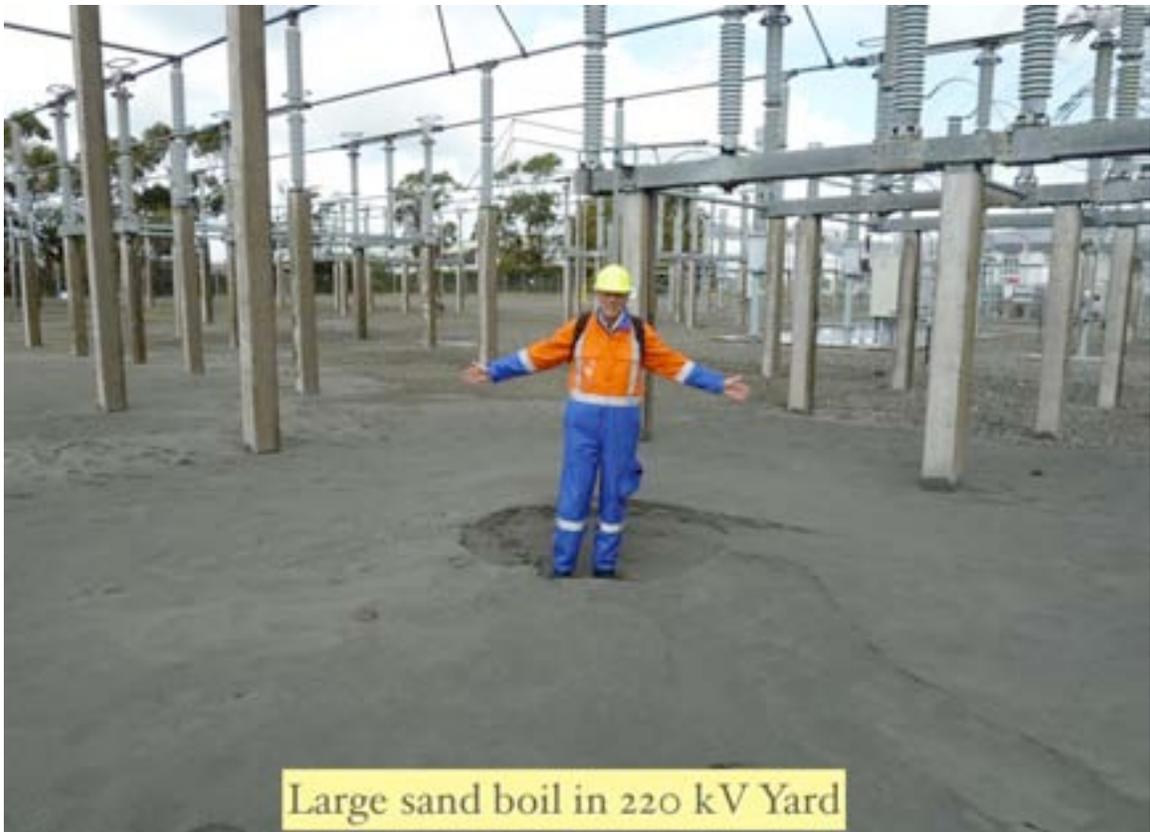
Figure 4-28. Sand Volcano, ~ 1 Foot Deep, inside the 220 kV Yard, Bromley Substation

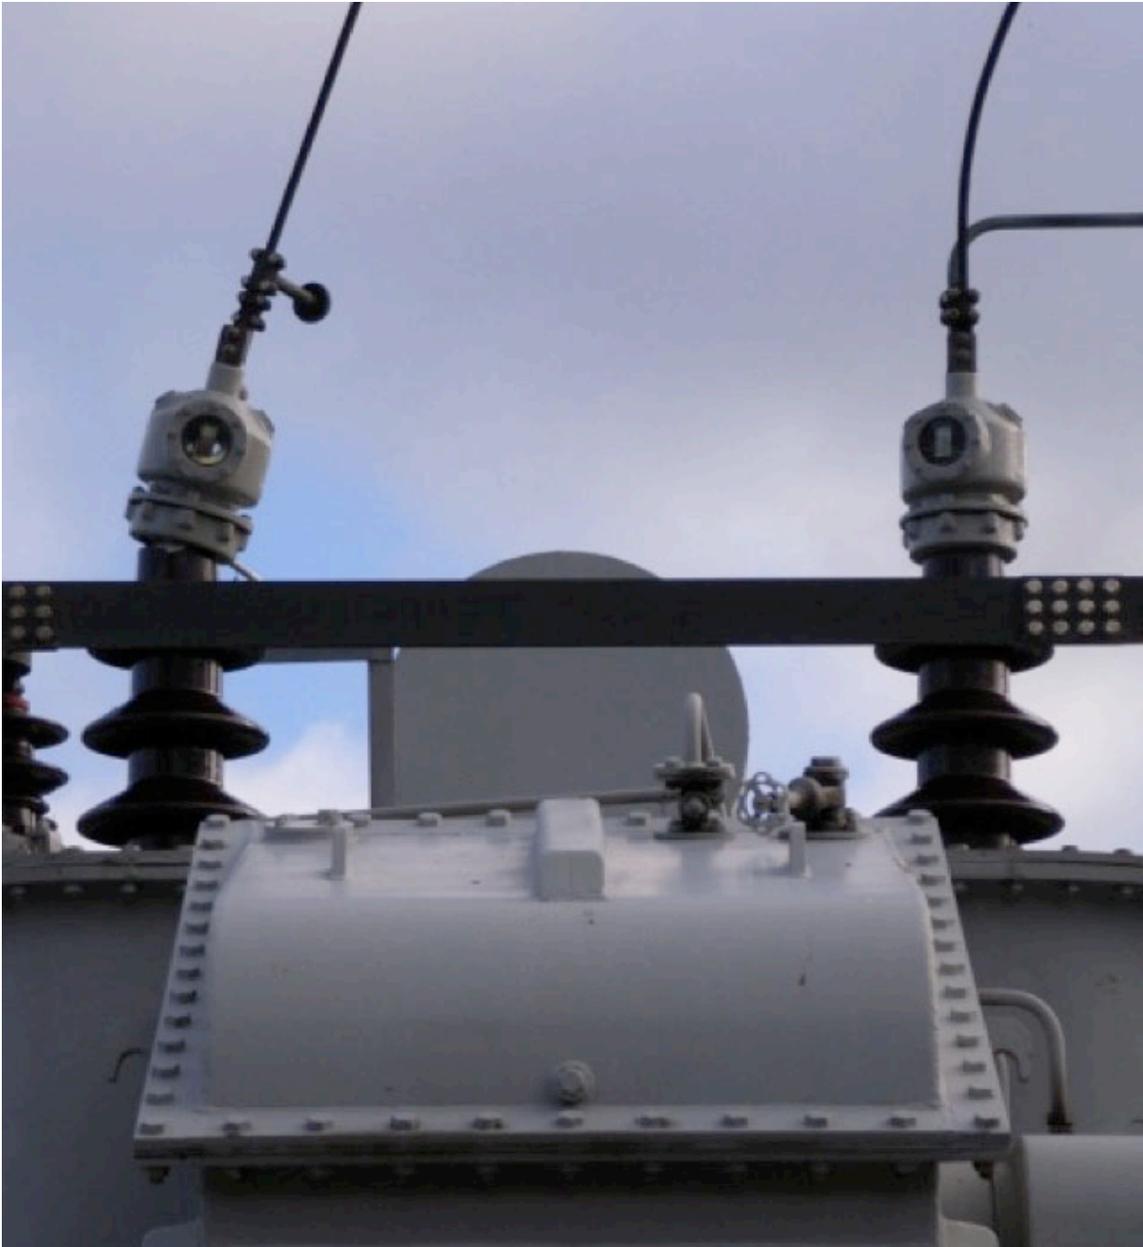
One bushing on a 66 kV transformer failed (Figure 4-29), possibly due to insufficient slack. All transformers at the yard were anchored; a few bolted anchors showed signs of slippage, but less than an inch.

Figure 4-29. Broken Transformer Bushing, 66 kV, Bromley Substation

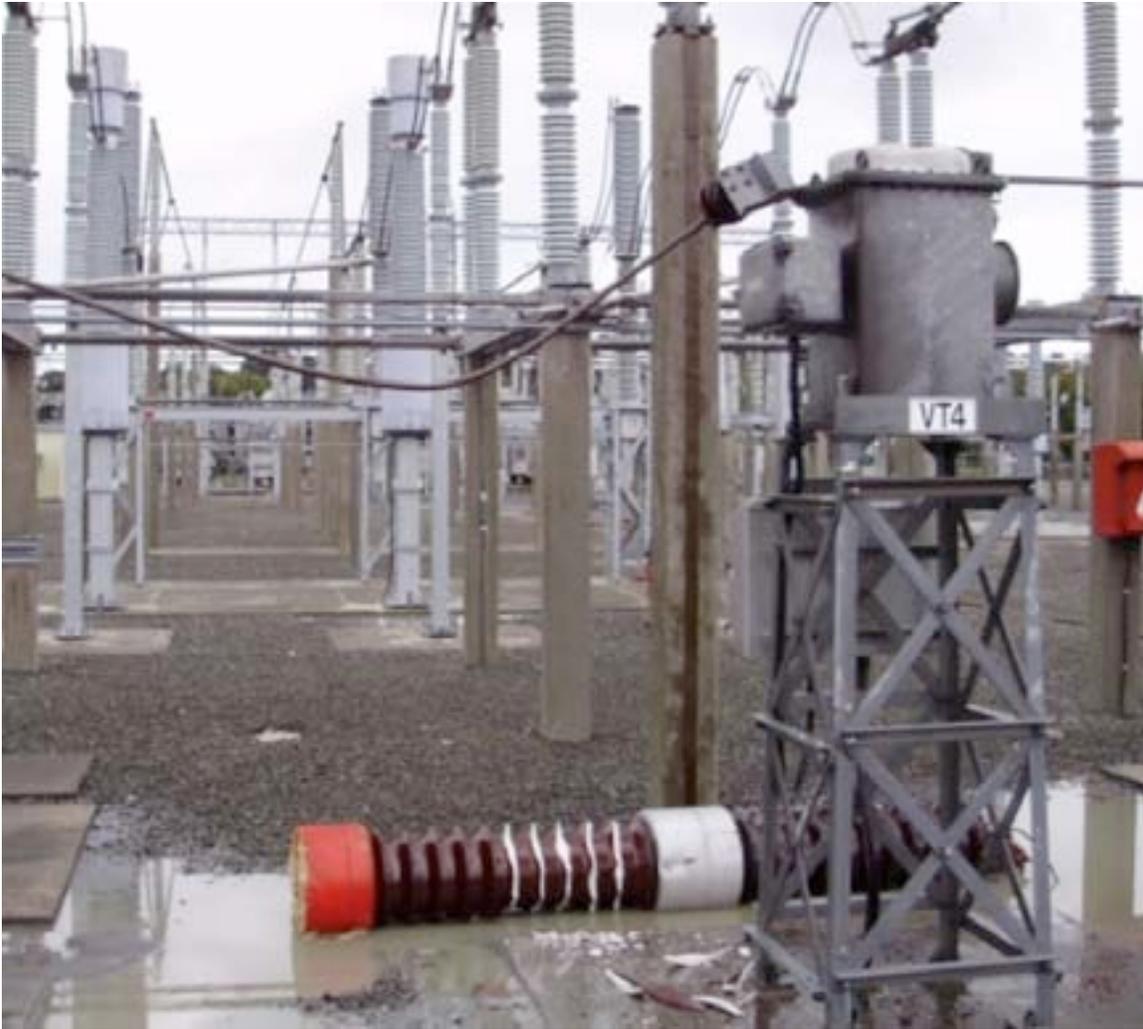
One of six identical voltage transformers broke (Figure 4-30). This component was tied into the rigid bus using a short vertical riser cable; it is possible that relative movement (combination vertical, horizontal shaking and possibly differential settlement) allowed the cable to become tight, putting a high "yanking" load on the component below.

Figure 4-30. Broken Voltage Transformer, 220 kV, Bromley Substation

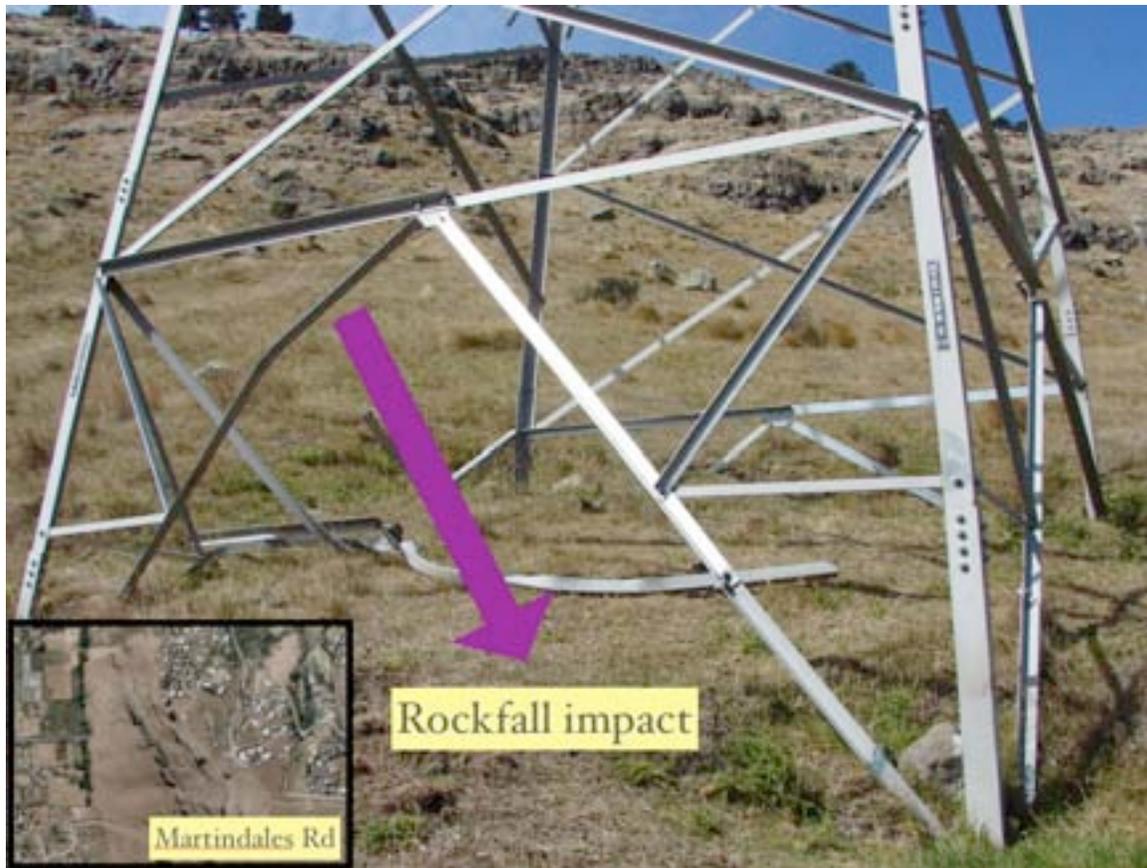
Figure 4-32 shows a 66 kV transmission tower that suffered damage due to a boulder that rolled down the hill (Port Hills area). Fortunately, the boulder decided to "miss" the four main support legs. Similar damage with the boulder going through the tower and hitting only secondary members, with the tower remaining standing, has been observed to transmission towers in the 2008 M 8.0 Wenchuan, China earthquake.

Figure 4-32. Damaged 66 kV Transmission Tower

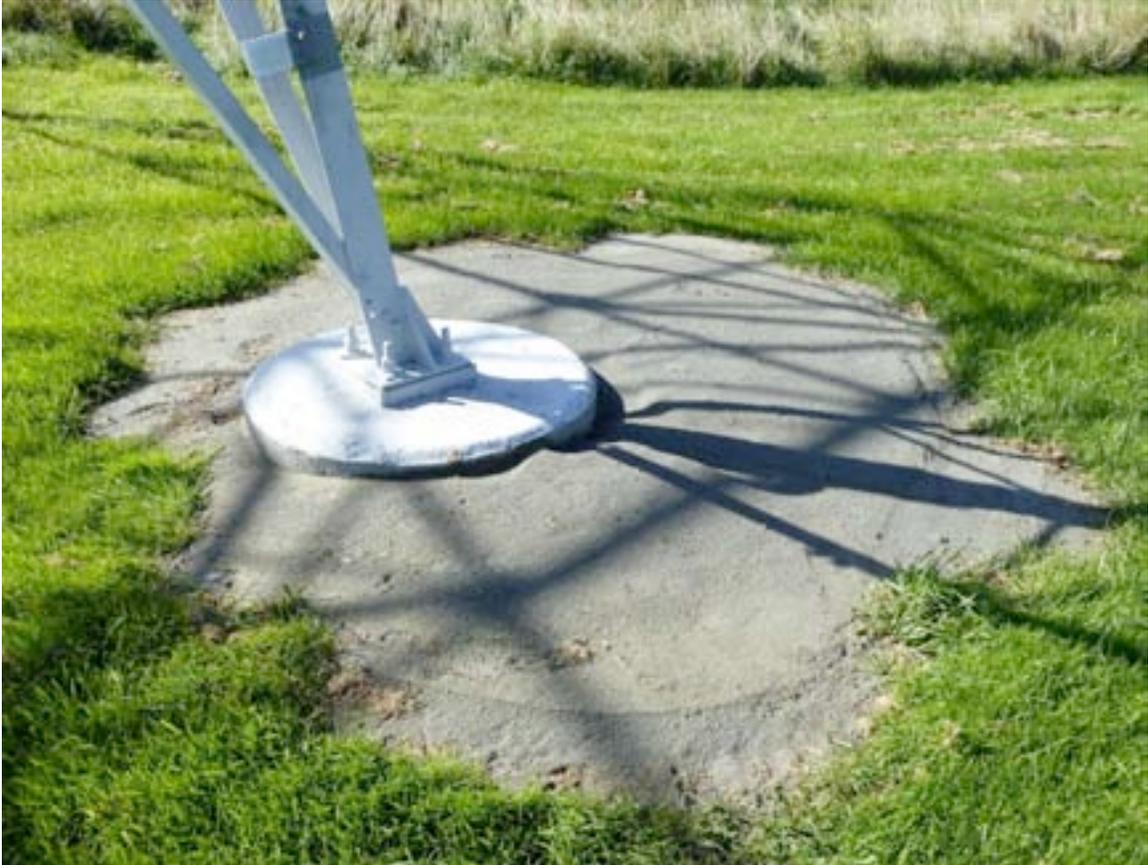
Many 220 kV towers were in zones with liquefaction (Figures 4-33, 4-34). While evidence of sand boils (commonly 4" to 12" deep) were observed on a variety of towers, it was reported that some (all?) of the 220 kV towers had been upgraded by tying-together their four foundations; there was no lateral spreading observed at these locations; the tower members appeared to remain elastic. On an adjacent 66 kV tower that did not have the foundations tied together, the liquefaction allowed relative movement of a leg, with attendant buckling of secondary members; but the tower remained in service.

Figure 4-33. Liquefaction at 220 kV Transmission Tower

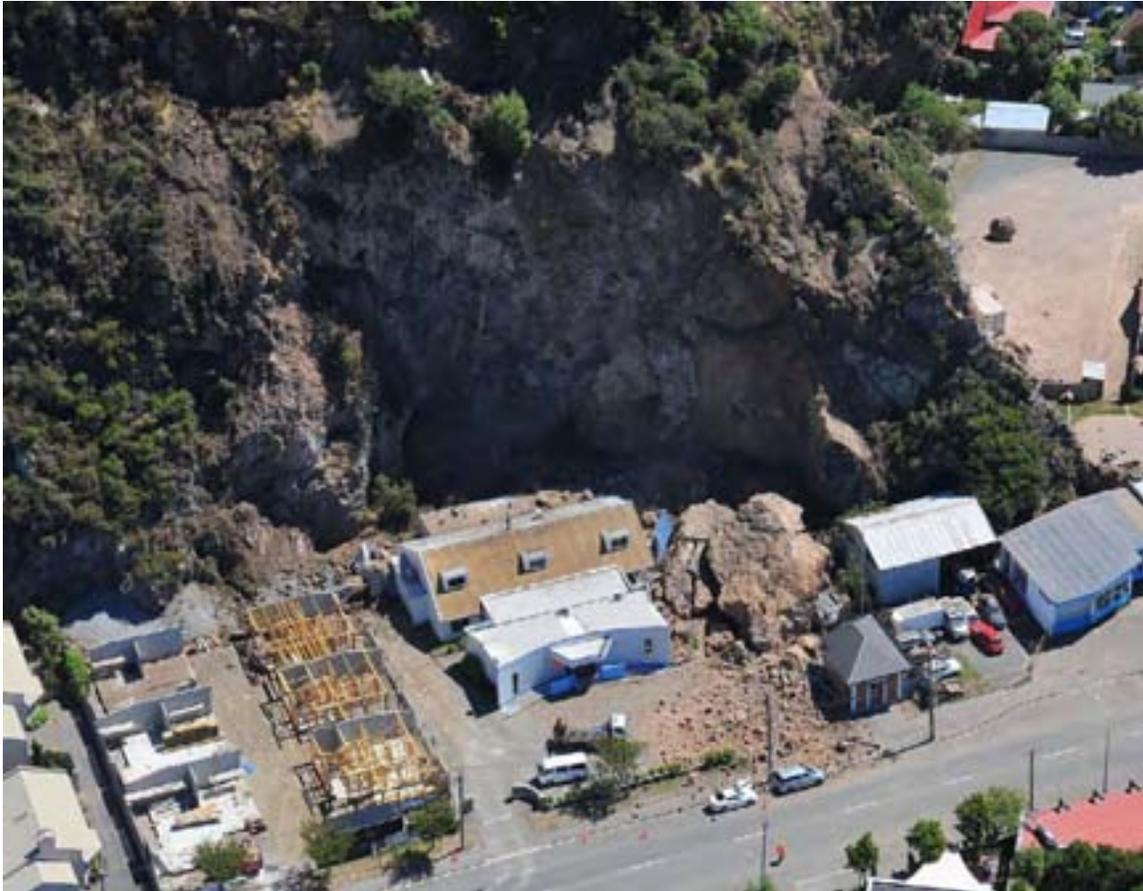
In Sumner (eastern Christchurch at the base of the Port Hills), there was a considerable amount of rock falls. One of the small distribution substation was directly impacted, resulting in the total loss of the substation, see Figures 4-35 and 4-36. This URM facility had been seismically upgraded prior to the earthquake, but evidently earthquake-triggered avalanche landslide was not considered as a hazard. Figure 4-37 shows the damaged switchgear within this substation.

Figure 4-35. Substation in Sumner damaged by a large boulder that fall in its back.

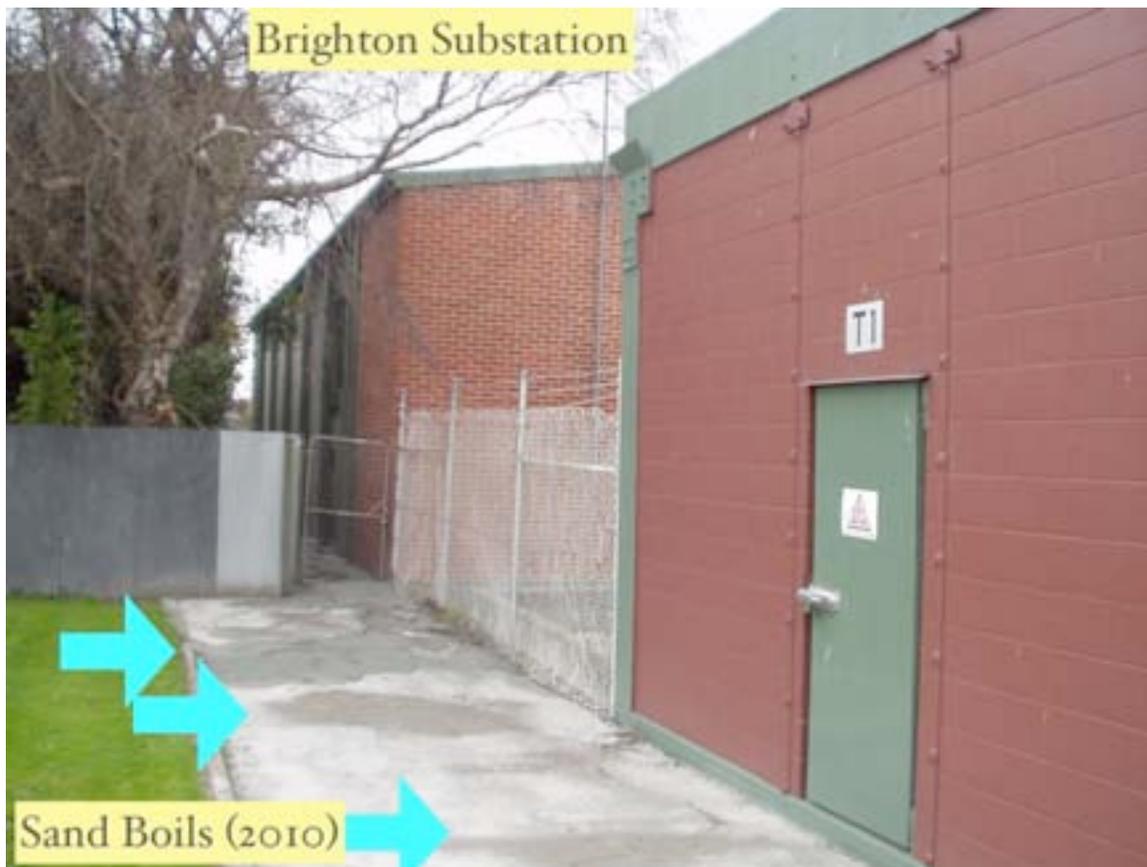
Figures 4-38 (September 2010) and 4-39 to 4-41 (February 2011) show the effects of liquefaction at the Brighton substation. While there are sand boils apparent in the 2010 event, facility remained functional. In the February 2011 event, the liquefaction was more severe, resulting in a loss of bearing capacity and several feet of settlement and tilting of the building. The water seen in Figure 4-39 is just a couple of inches deep; under the water are a few feet of silts and sands. Figures 4-40 and 4-41 show the transformer building and adjacent radiators after the water drained and the soils were dug out. While the door held leak tight, the tilting of the foundation led to complete functional failure, requiring a brand new substation to be built. Similar liquefaction-induced foundation failures and tilting of the building occurred at the New Brighton substation.

Figure 4-38. Liquefaction at Brighton Substation, September 4 2010

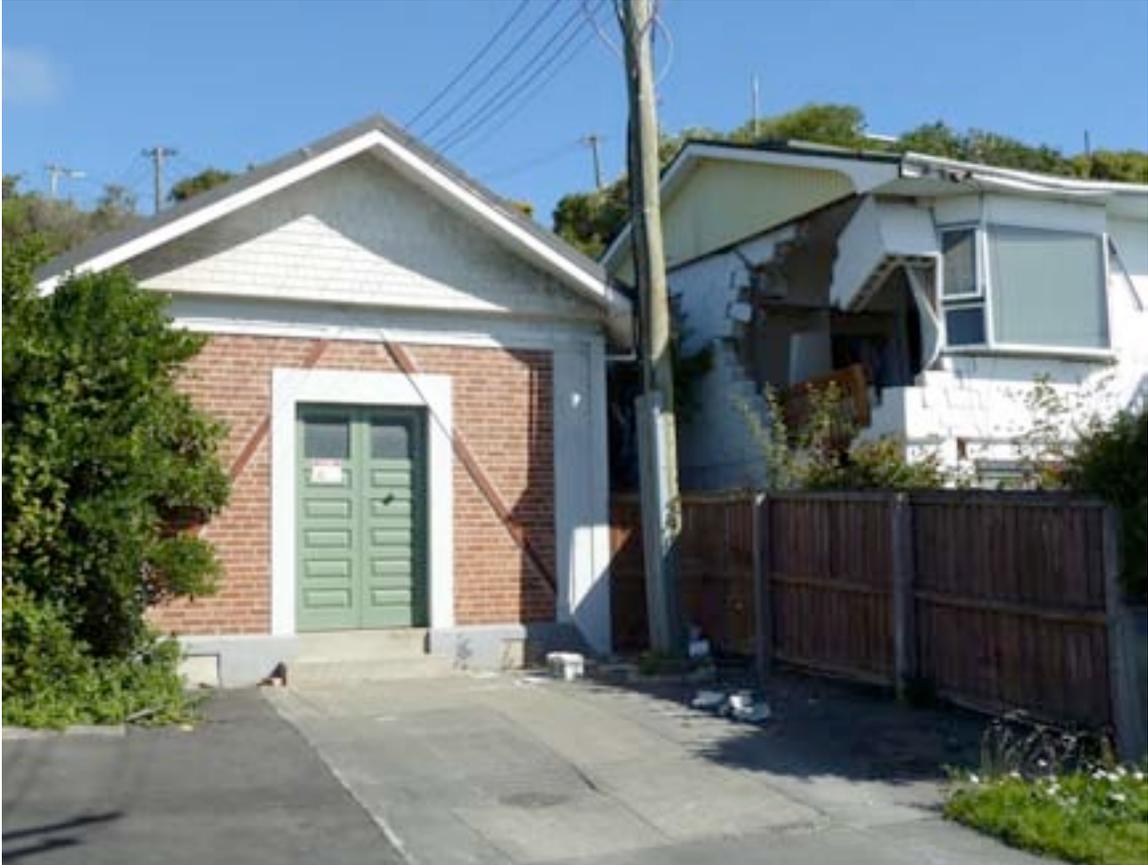
Figure 4-47. Success of Upgraded URM Substation, Feb 22 2011

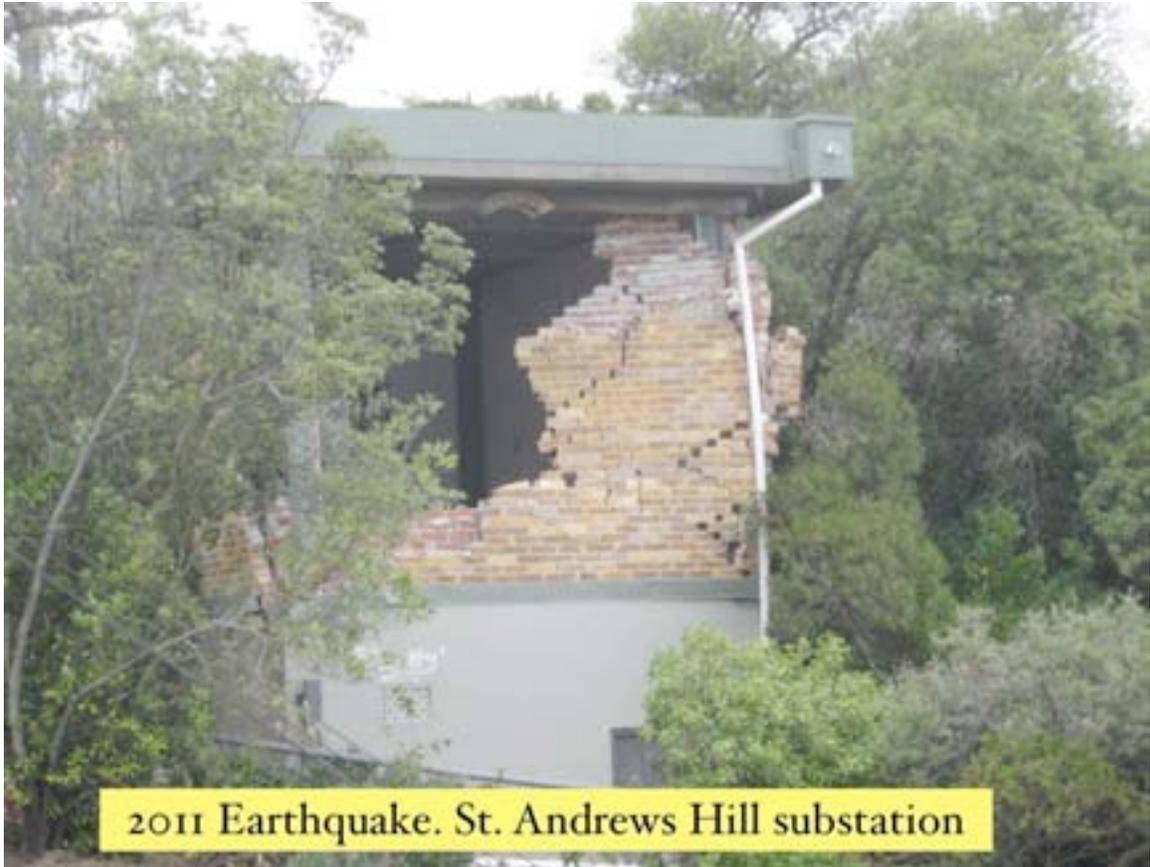
Figure 4-48. Failure of Upgraded URM Substation, Feb 22 2011

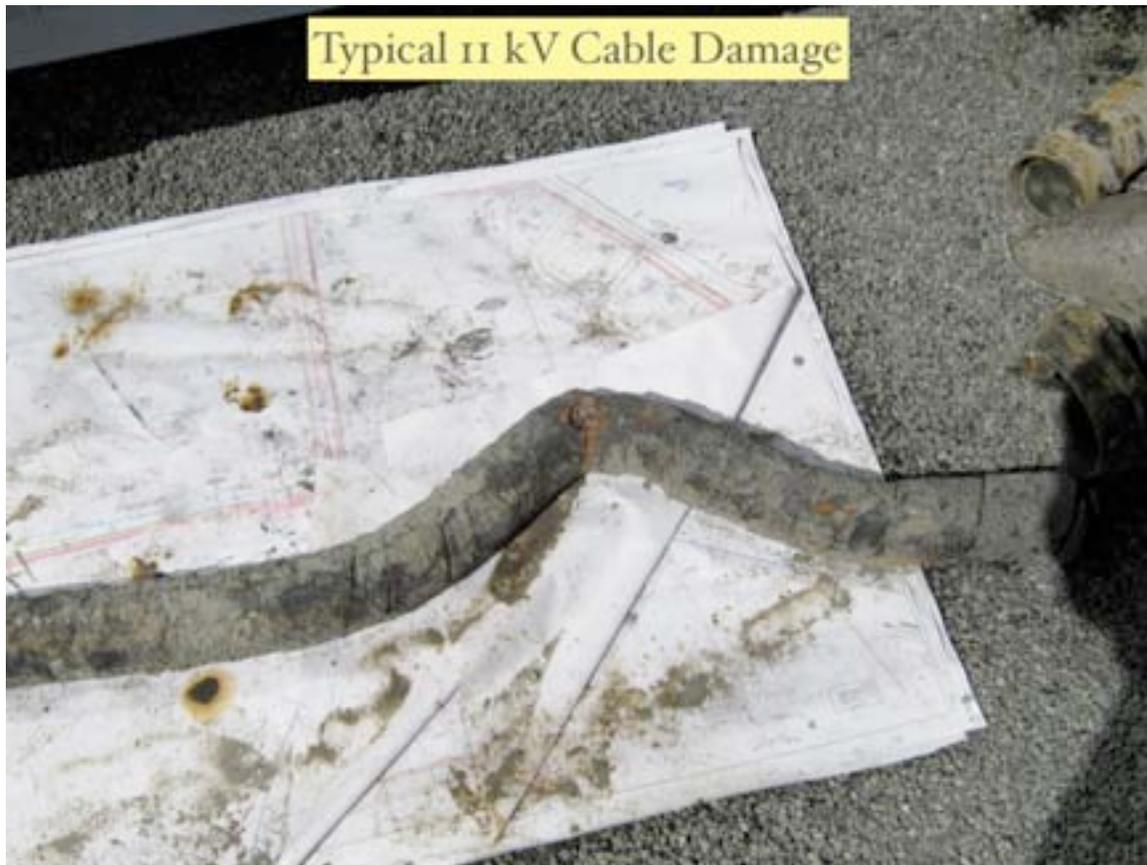
Figure 4-50. Failure of Typical 11 kV Buried Cable, Feb 22 2011

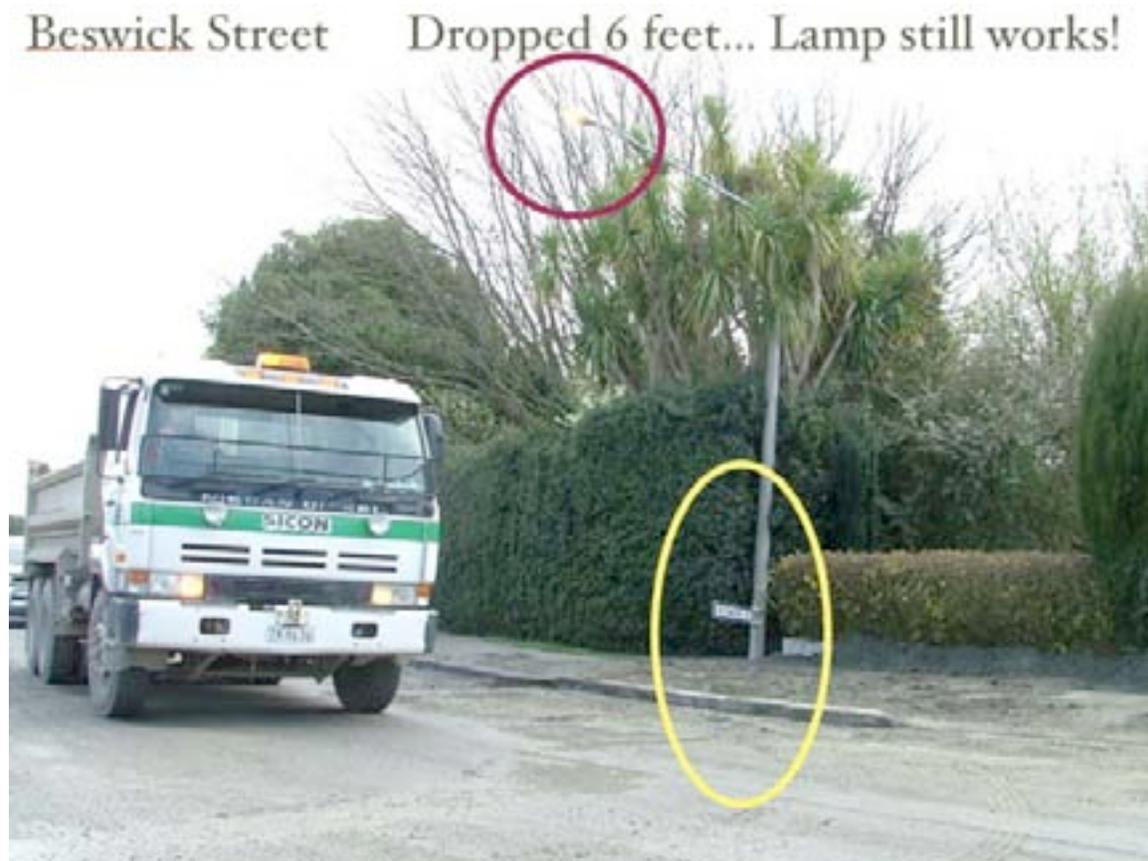
Figure 4-57. Electrified Lamp – September 4 2010 – 1.8 meter movement
