CHRISTCHURCH, NEW ZEALAND EARTHQUAKE SEQUENCE OF M_w 7.1 September 04, 2010 M_w 6.3 February 22, 2011 M_w 6.0 June 13, 2011: LIFELINE PERFORMANCE

**Technical Council on Lifeline Earthquake Engineering
Monograph No. 40
February 2012 – Revision 0
ASCE**

ABSTRACT

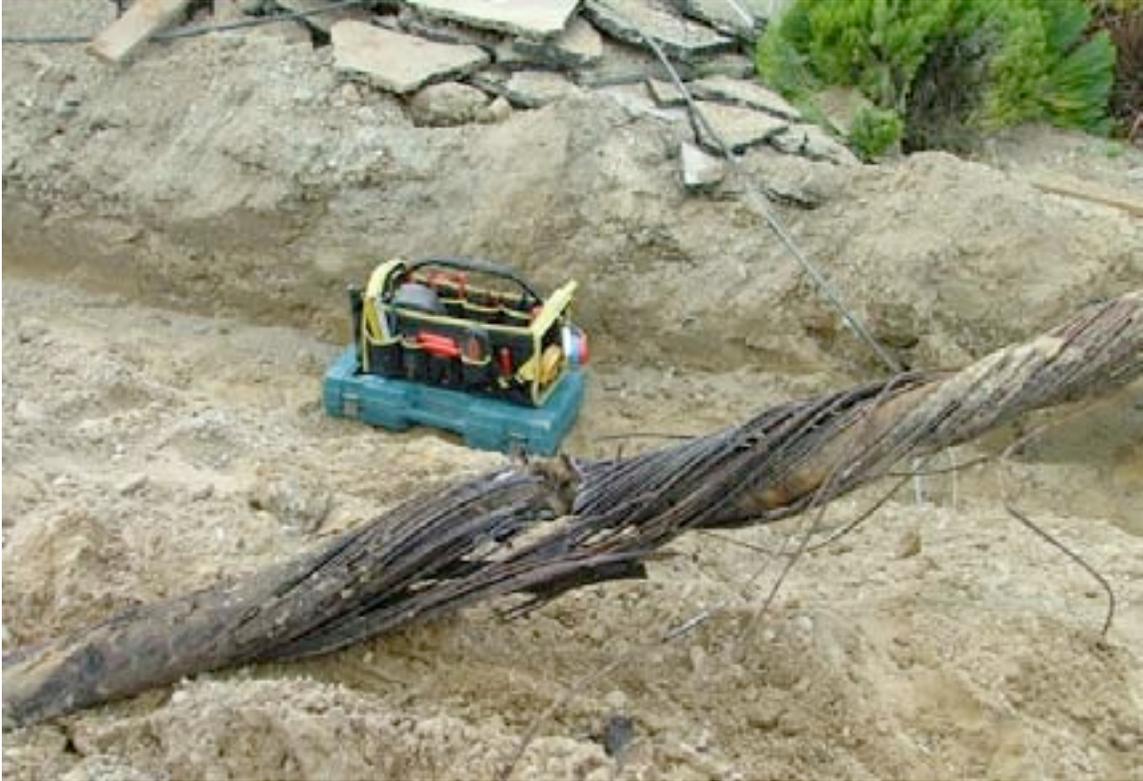
Figure 4-58. Damaged Buried Cable– Sept 4 2010 – Mainpower

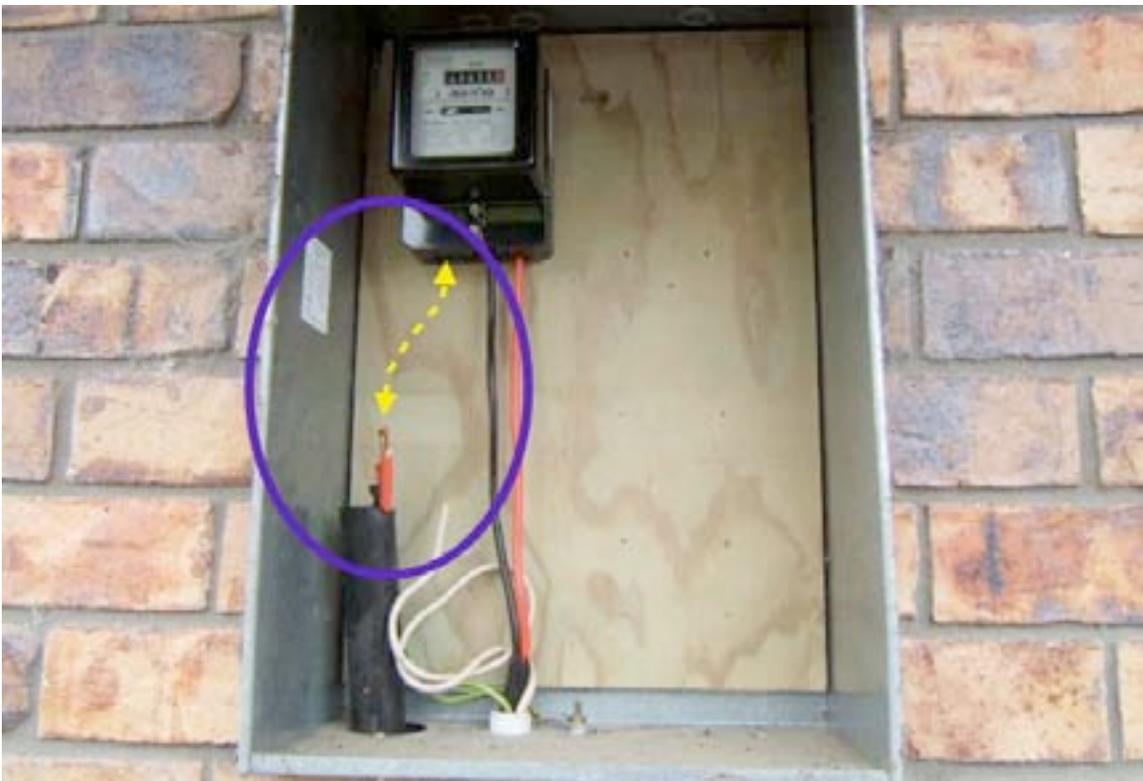
Figure 4-59. Damaged Cable to House Electric Meter – Kaiapoi – Sept 2010

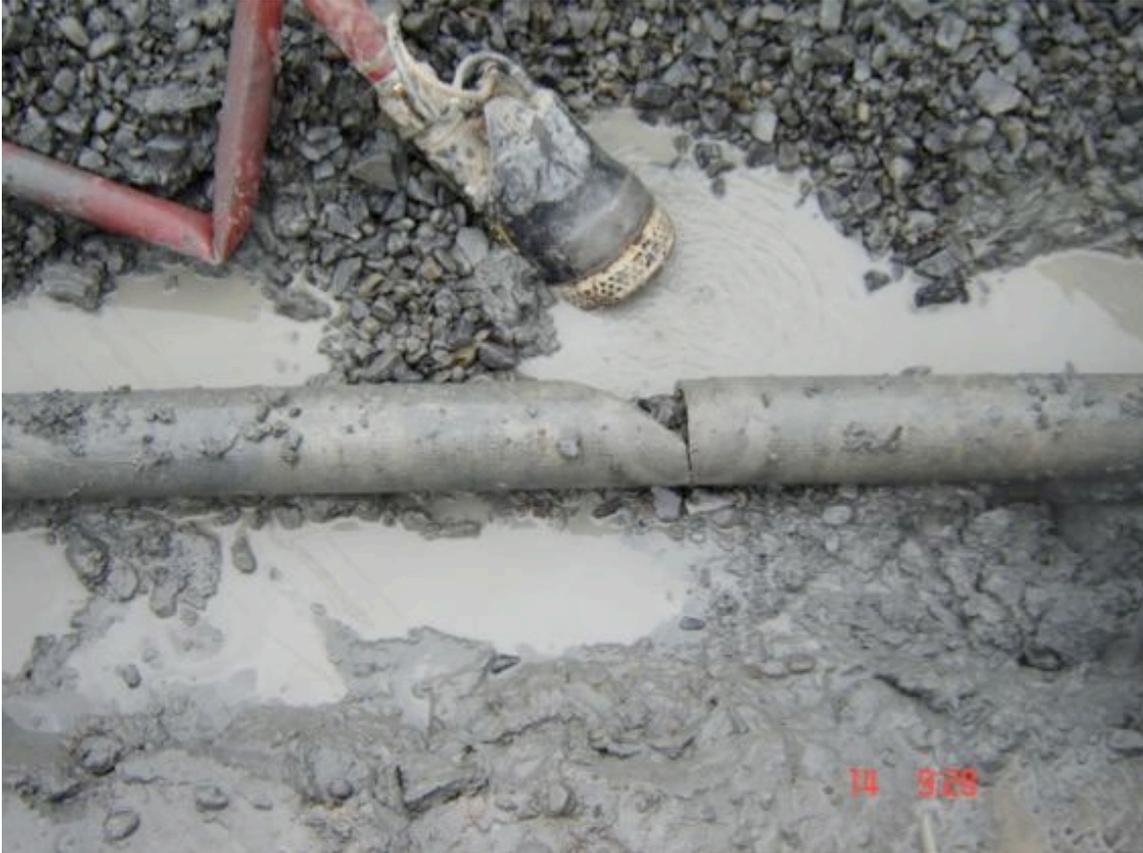
Figure 6-8. Broken Barrel of Water Pipe (September 2010)

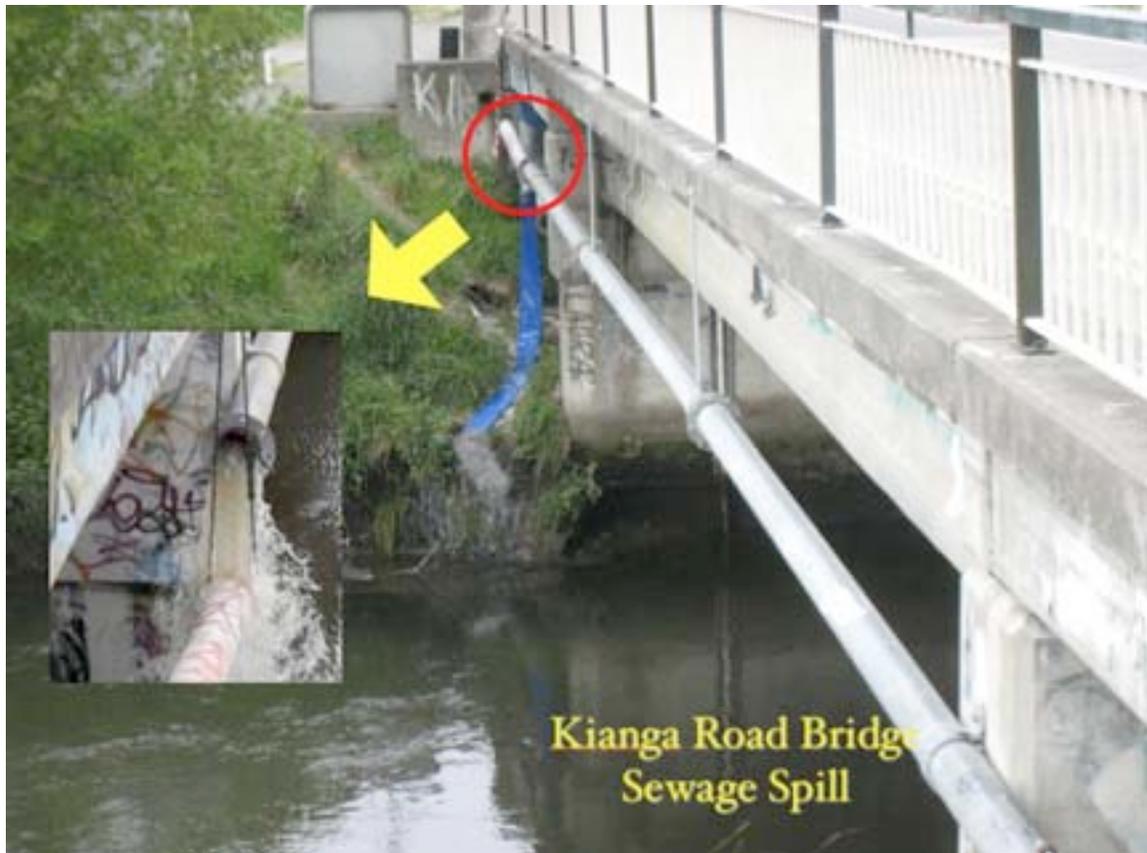
Figure 7-14. Broken Sewer Pipe

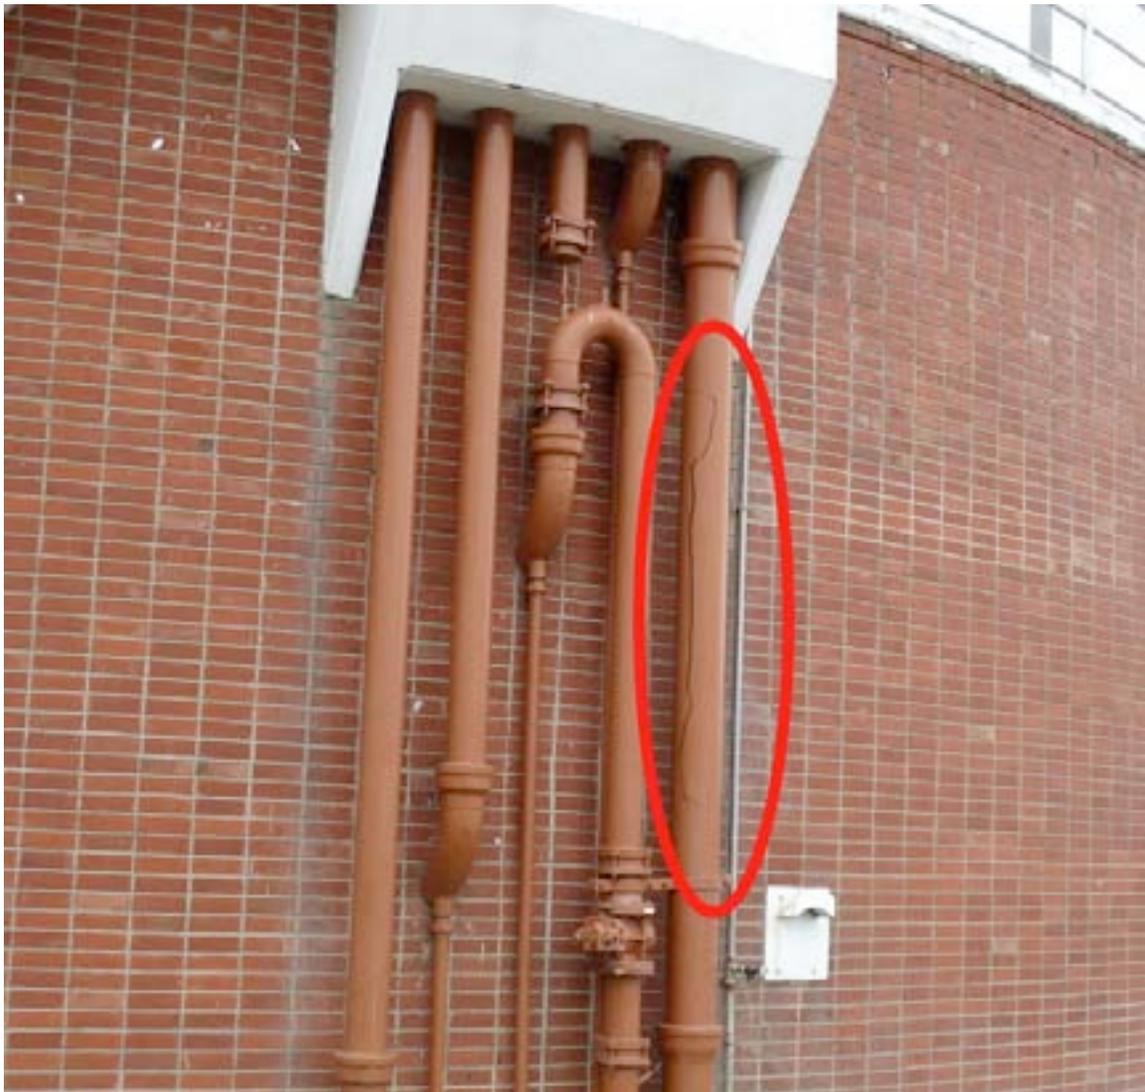
Figure 7-41. Cracked Pipe to Digester, Bromley WWTP

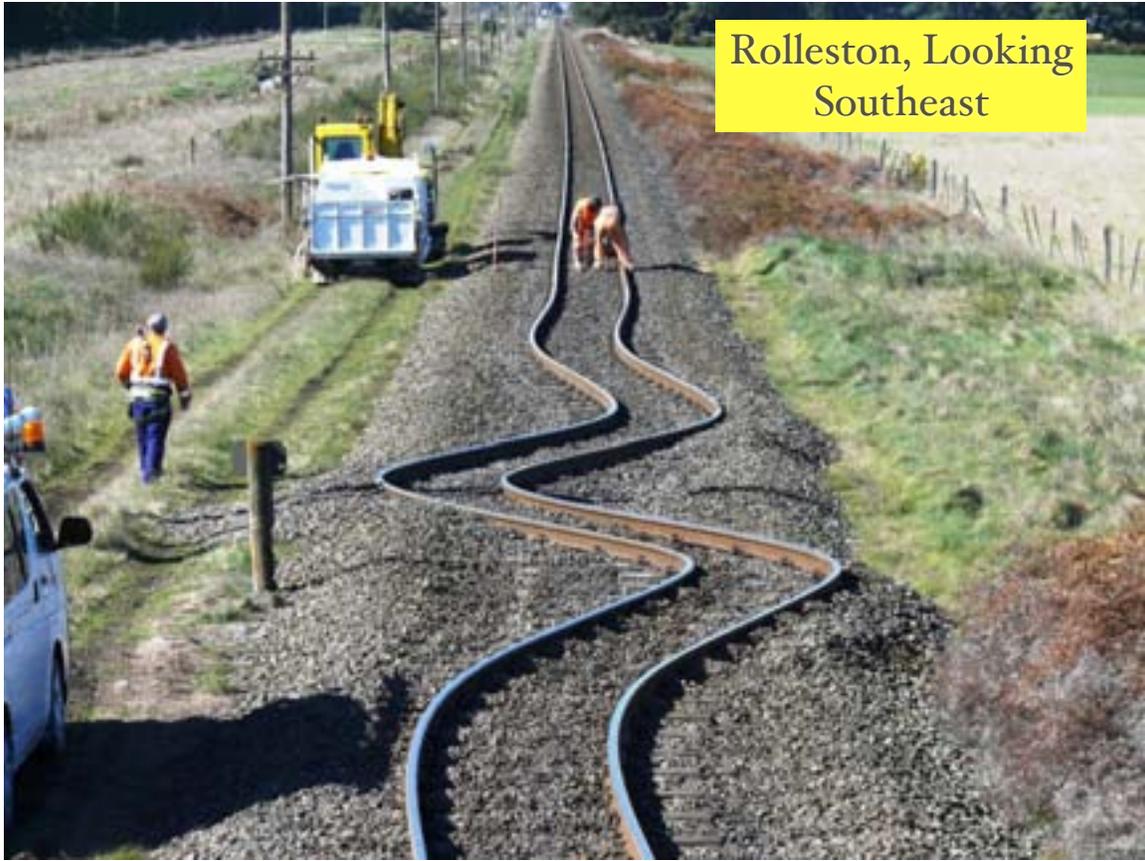
Figure 12-3. Buckling of Rails at Fault Offset Location

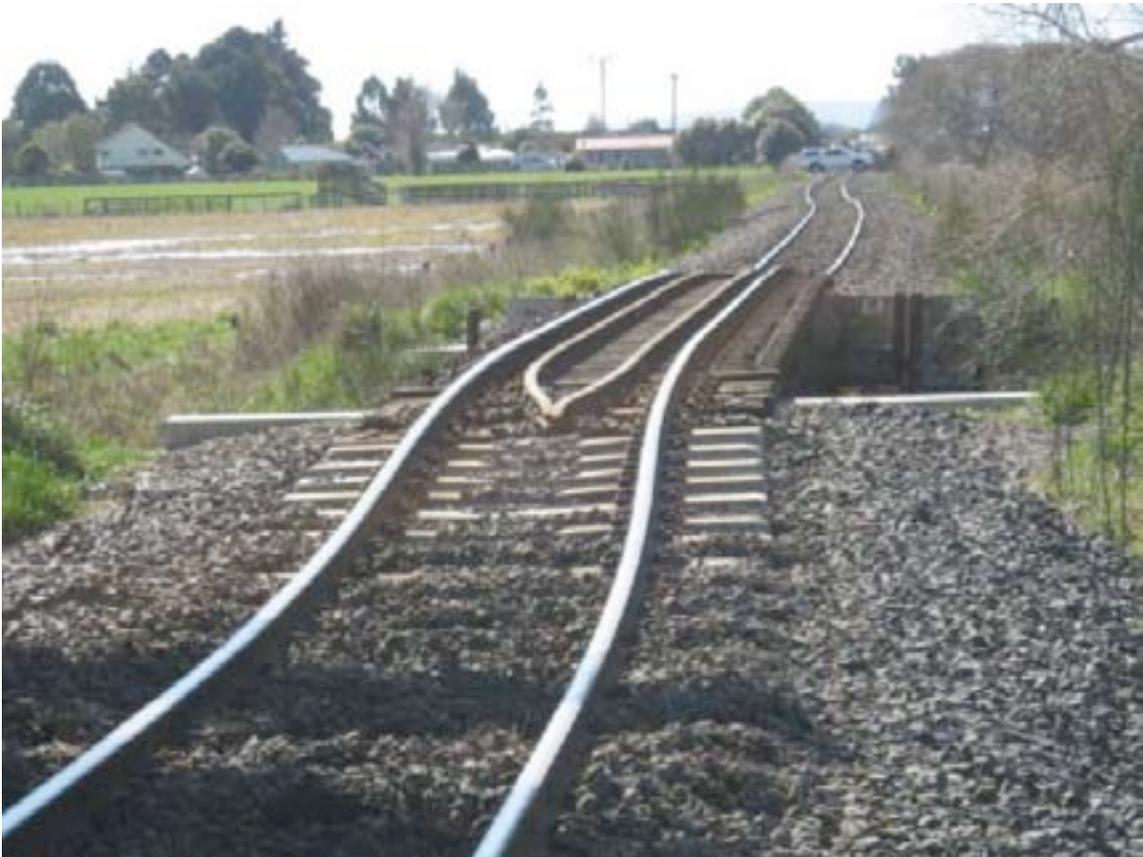
Figure 12-10. Soil Movement Next to Bridge Abutments

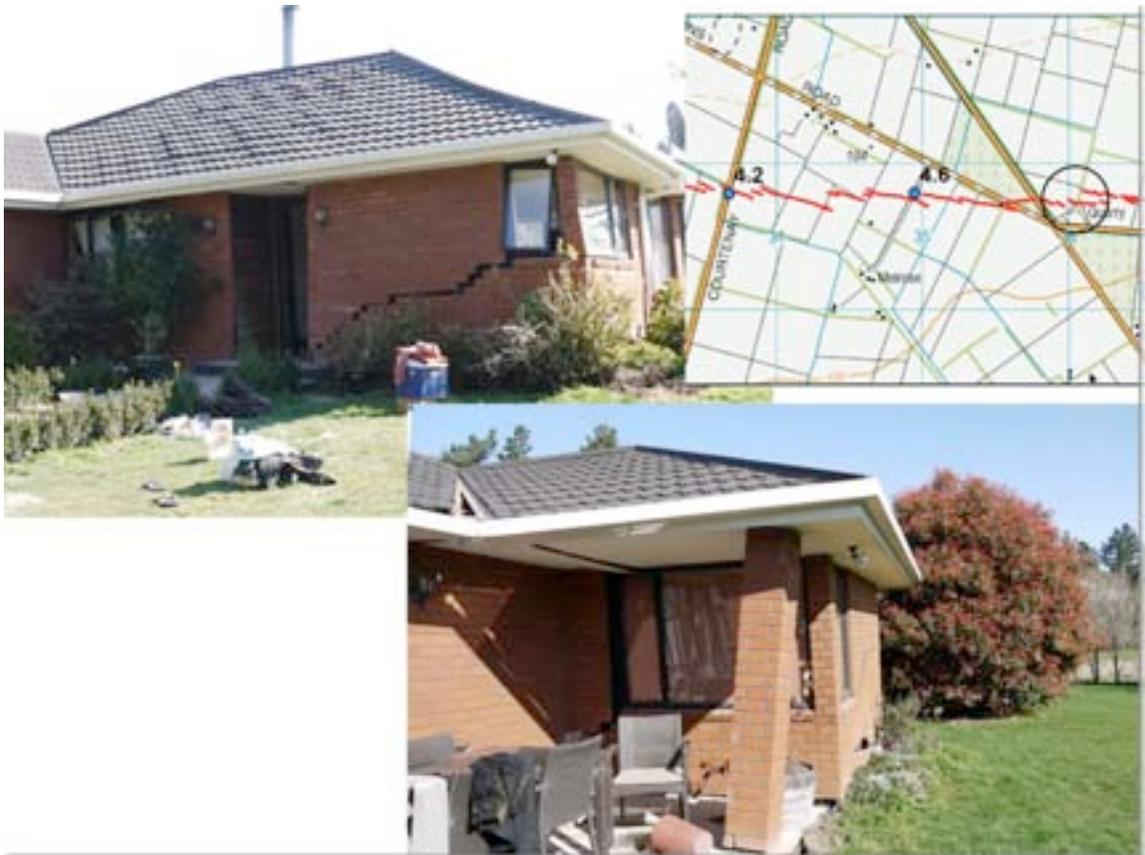
Figure 16-7. Fault Offset Through a House

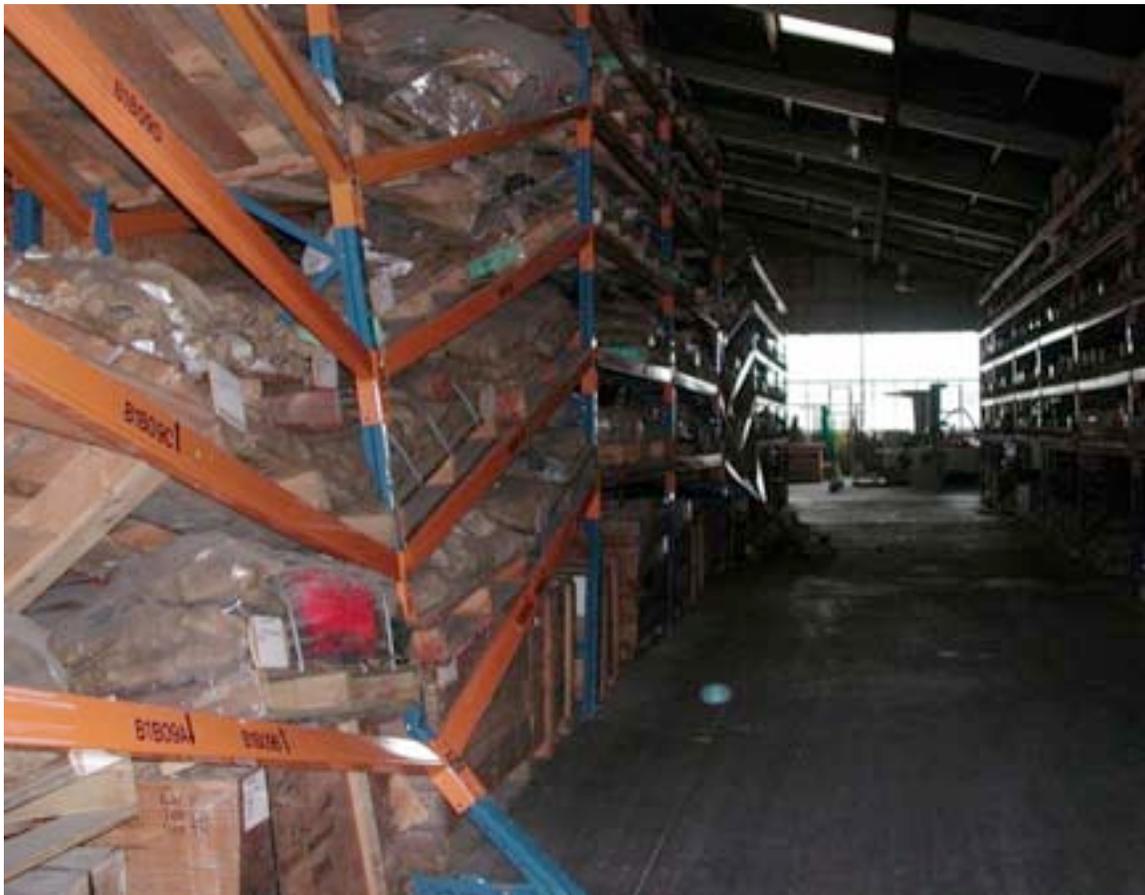
Figure 17-1. Damaged Storage Rack, Addington Warehouse

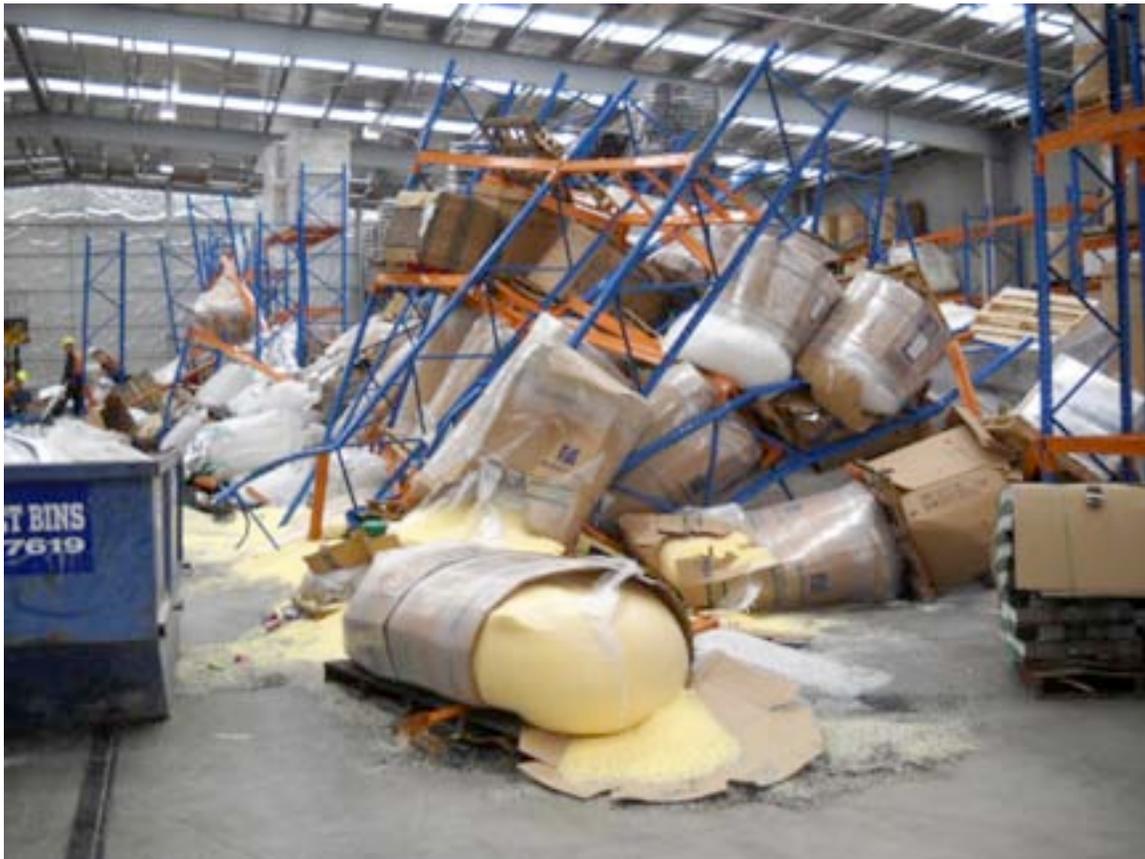
Figure 17-4. Collapsed Storage Racks, September 2010

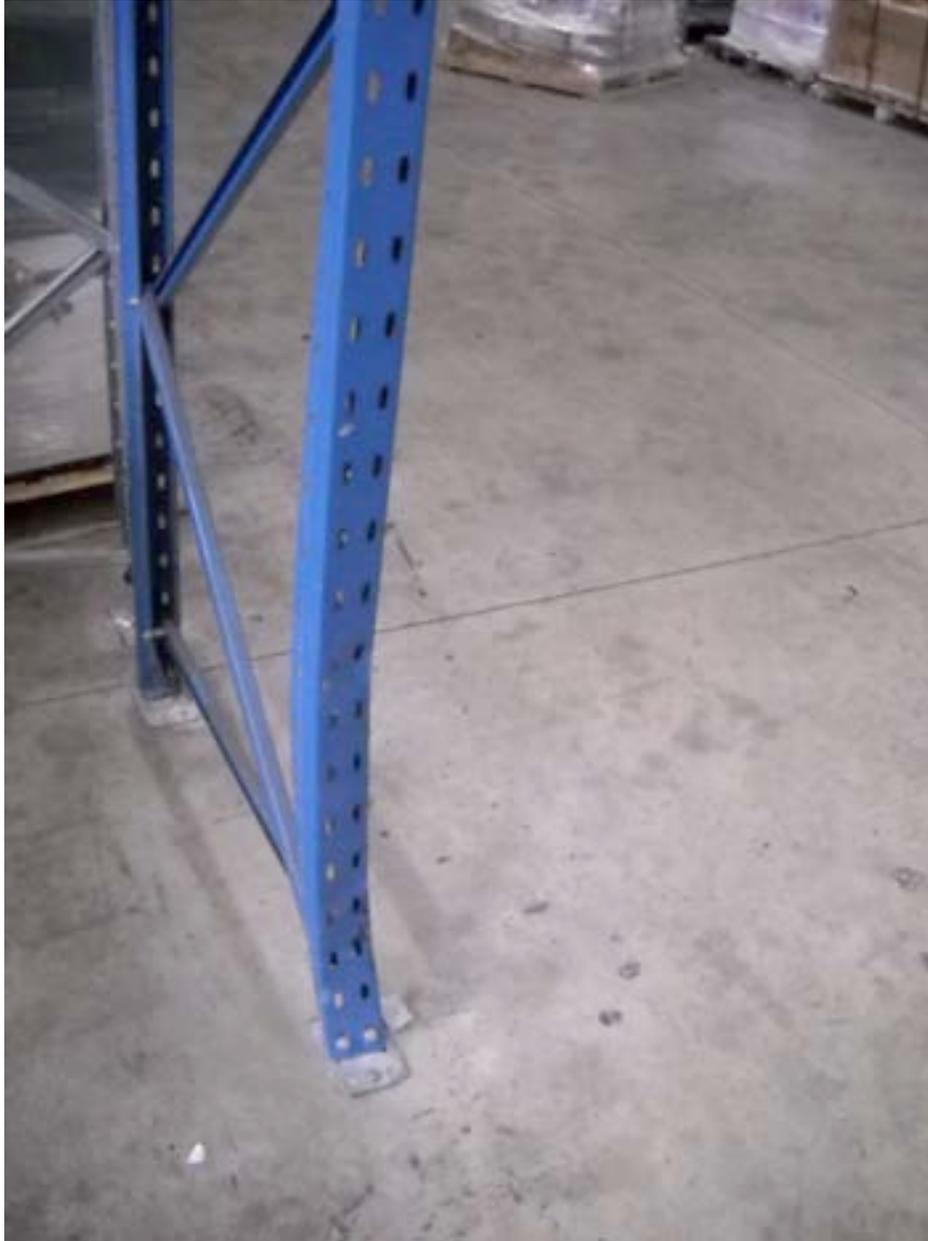
Figure 17-5. Storage Rack Leg, Incipient Failure, September 2010
