Anchorage M 7.1 Earthquake

Nov 30 2018, 8:29 am
(TCLEE 5B)

John Eidinger
G&E Engineering Systems Inc.
With contributions by:
John Dai, Southern California Edison
Bruce Maison, Structural Engineer
Engineers and staff of MEA, ML&P, CEA
October 15 2019

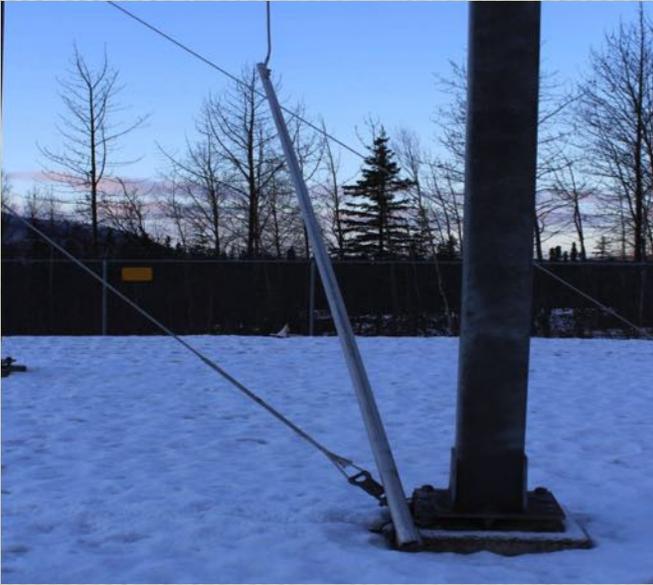
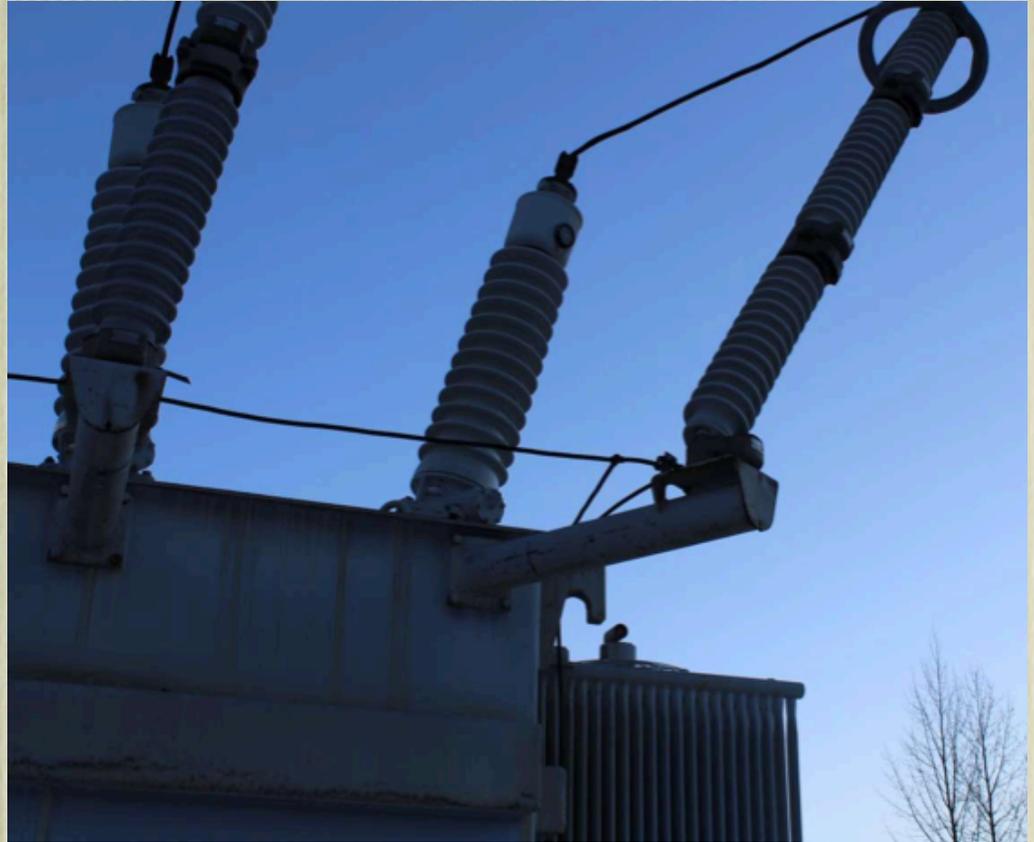
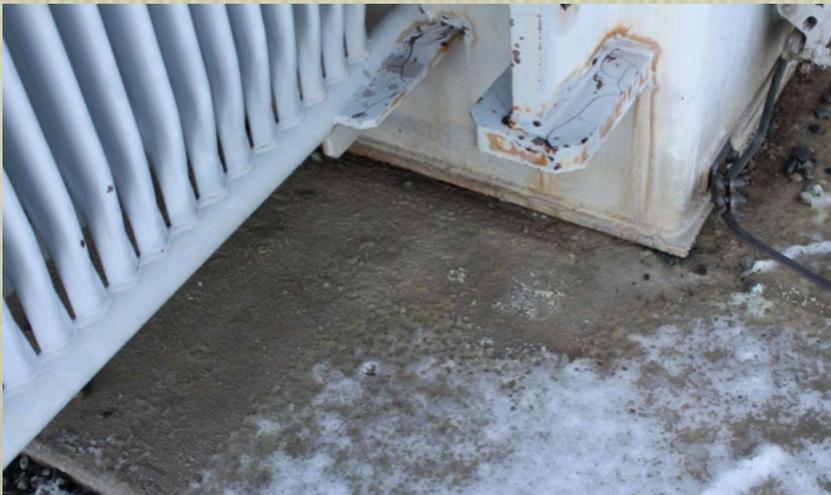
MEA Briggs Substation

Rigid Bus. Surge Arrestors. Transformer slid, breaking 4 bushings.
PGA ~ 0.30g

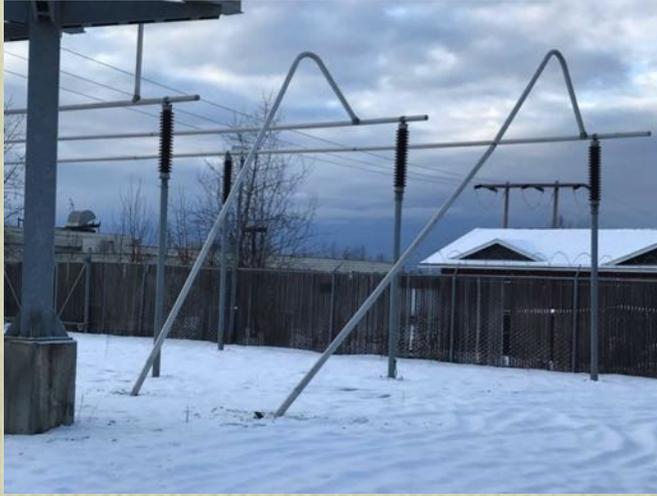
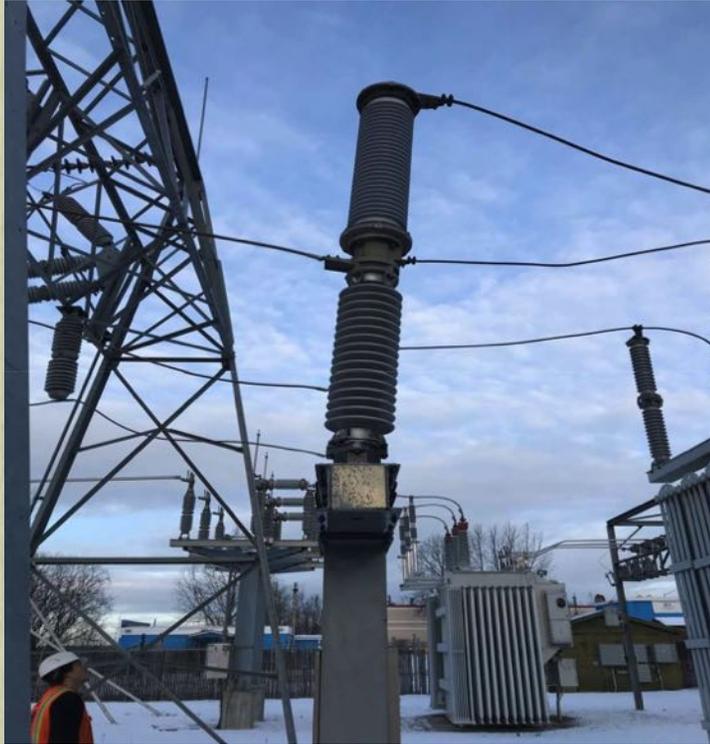
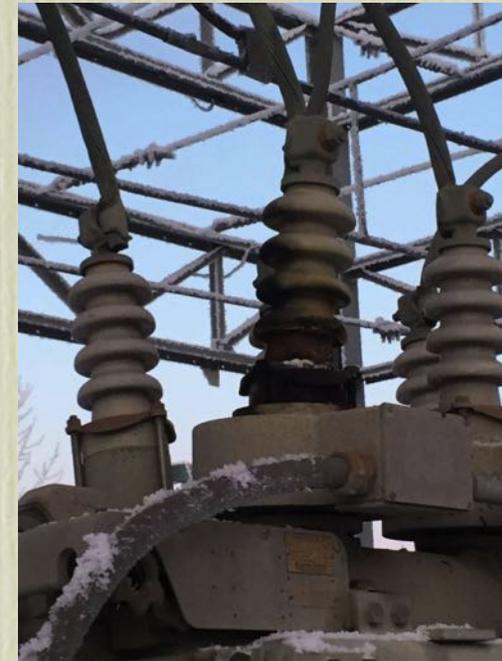
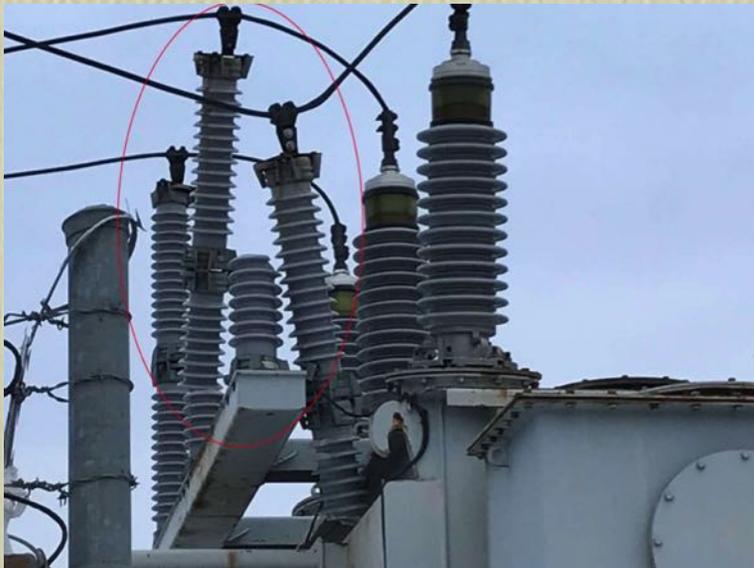
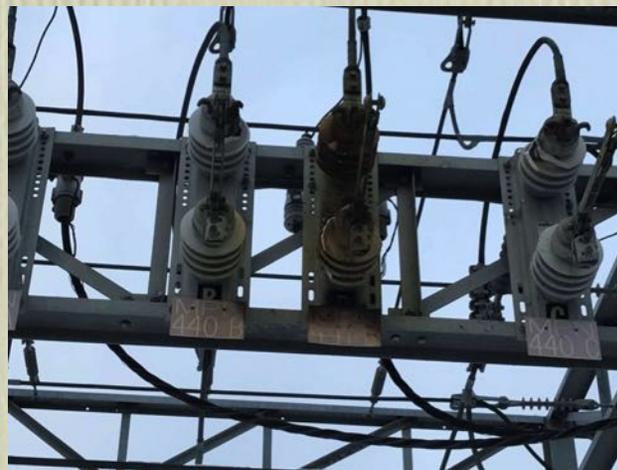
MEA Pippel Substation

Candlestick Breaker. Surge Arrestors. Bus. 15 kV DS + CB. PGA ~ 0.30g

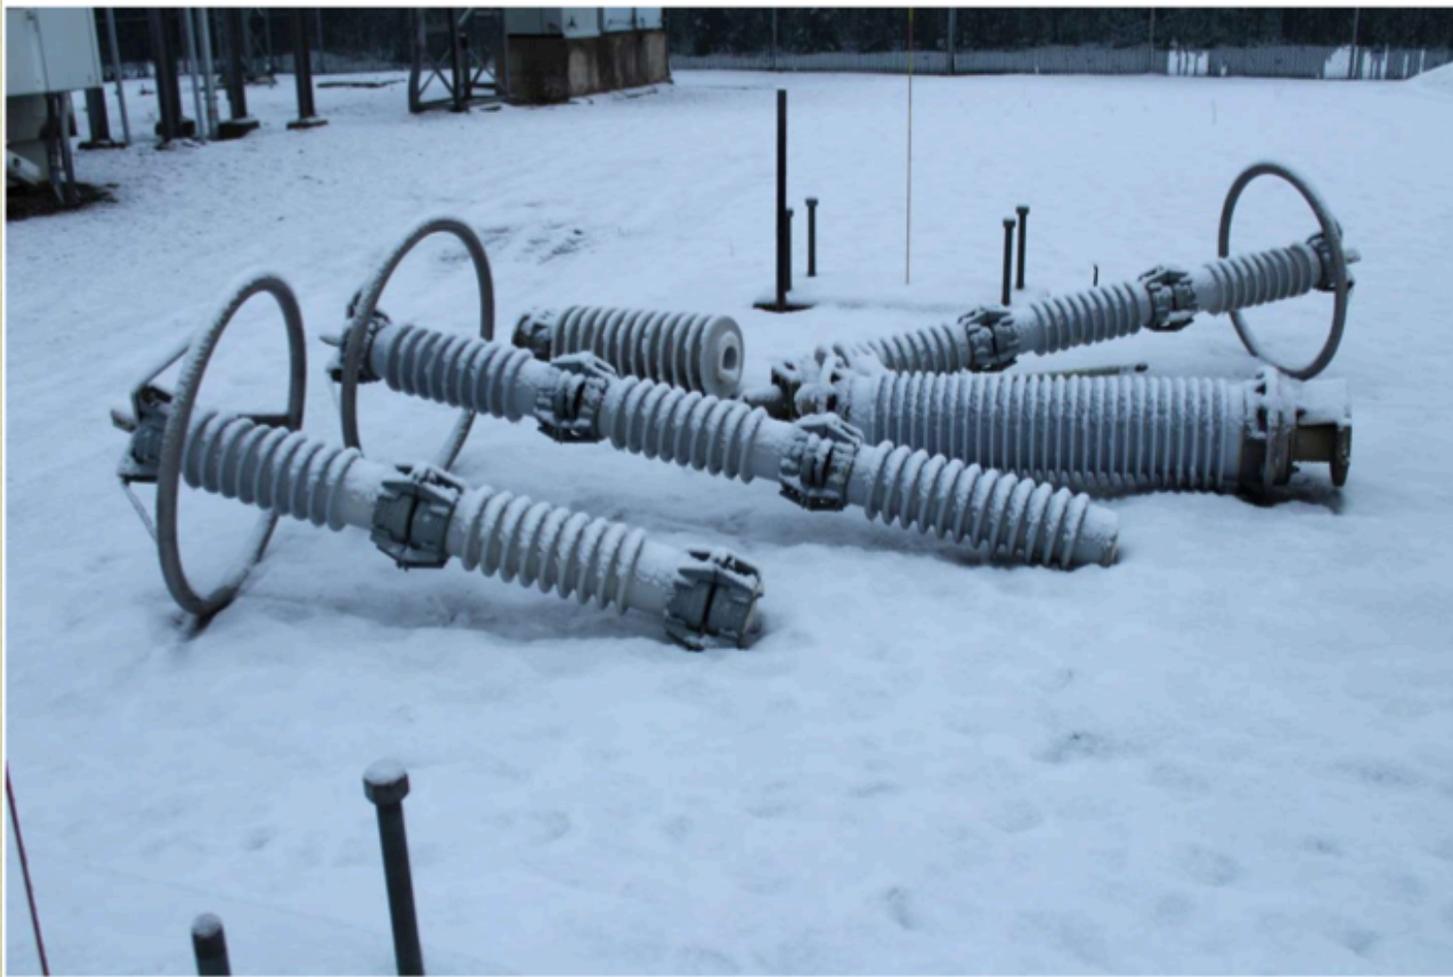
MEA Anderson Substation

Surge Arrestors. Circuit Switchers (candlestick breakers)
PGA ~ 0.30g

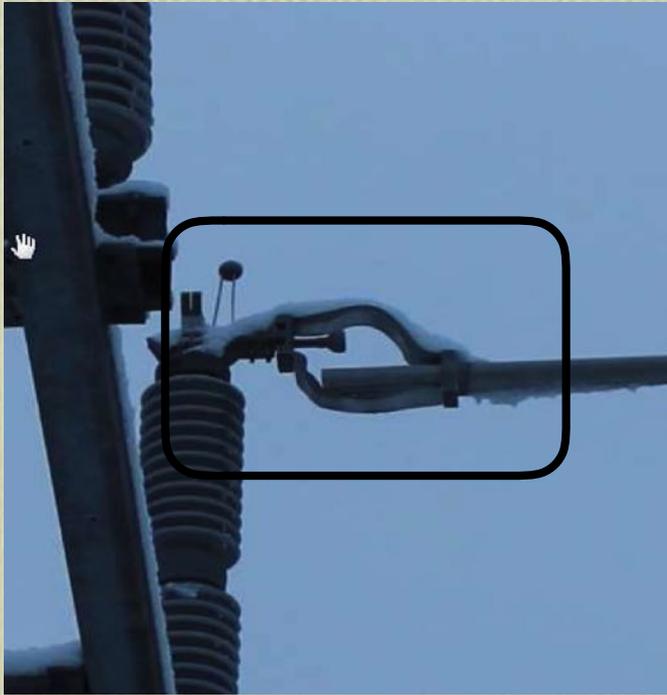
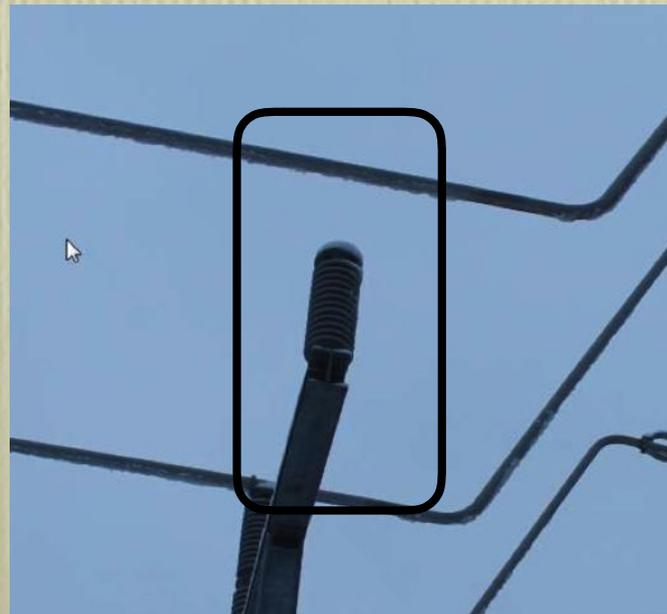
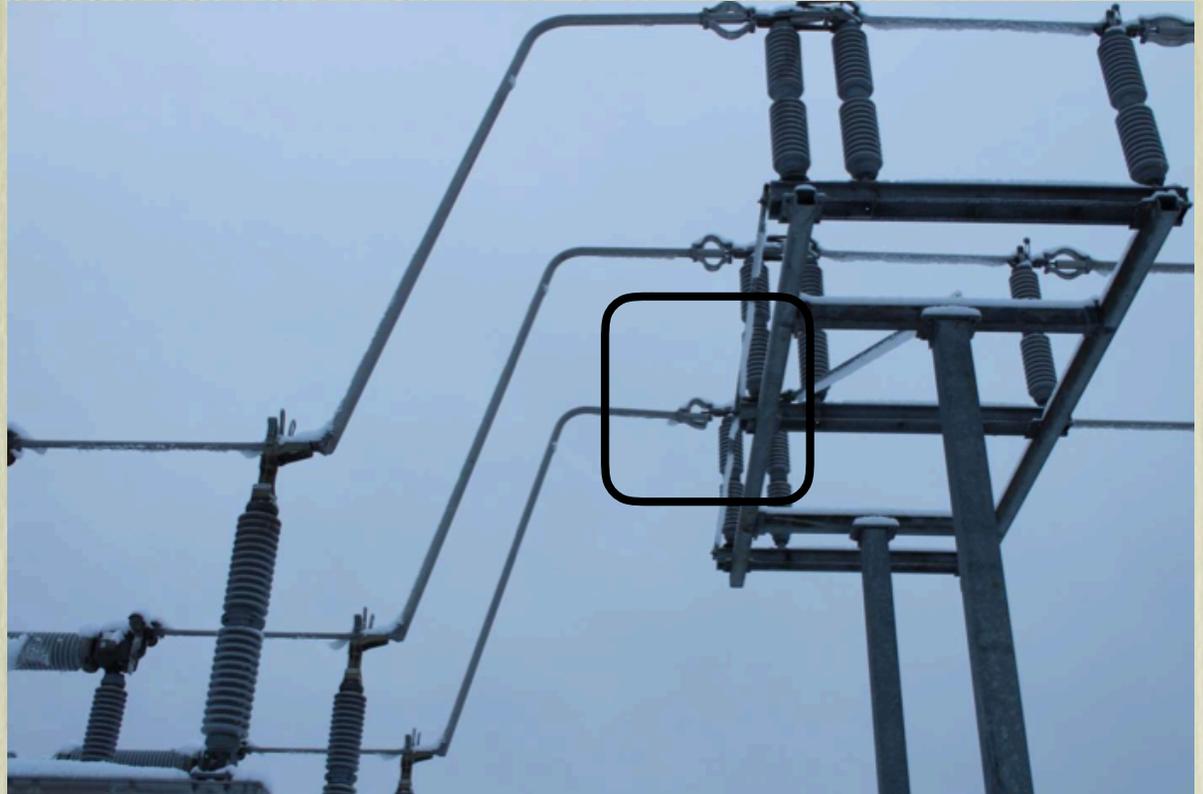
MEA Douglas Substation

Rigid Bus Expansion Joints, Bus Supports. PGA ~ 0.30g

Excessive differential movements leads to failures
Switch steel structures and bus supports
use I-beams, low frequencies,
twisting / torsion. All this is readily computed.
Suitable connectors are available.
Do utilities (and their A/Es) turn a blind eye?
Sunshine will expose the weaknesses.
CEA, ML&P and MEA all have work to do.

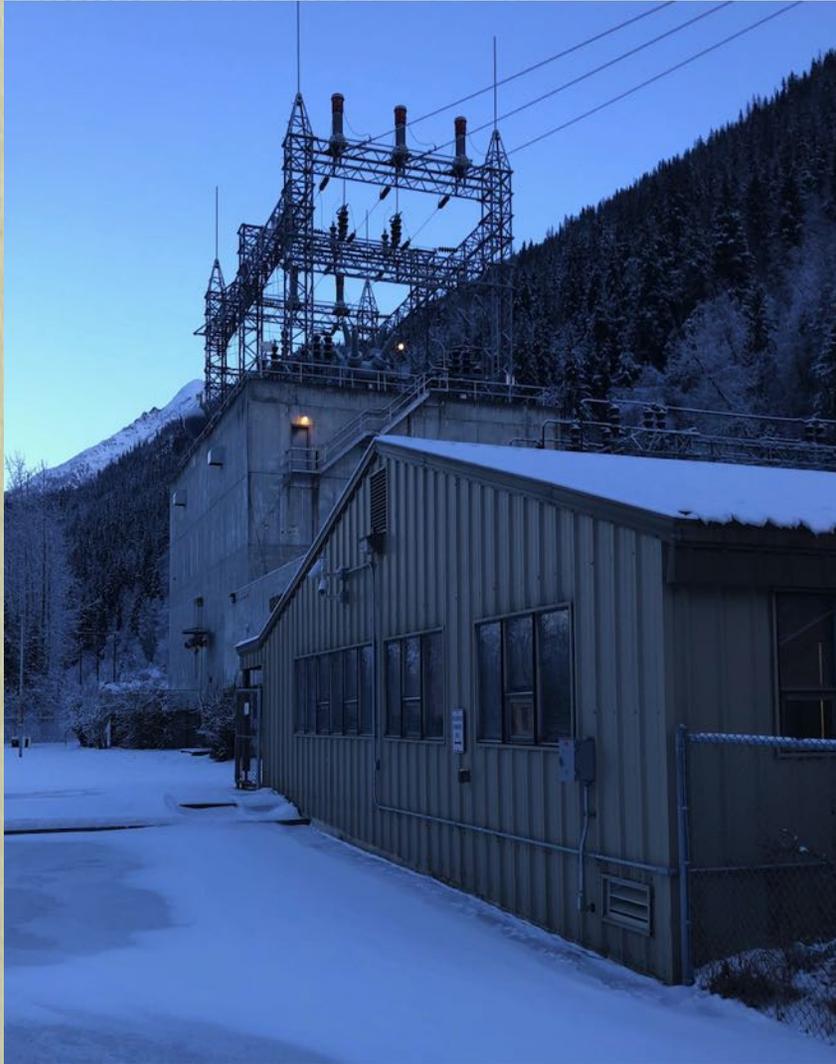
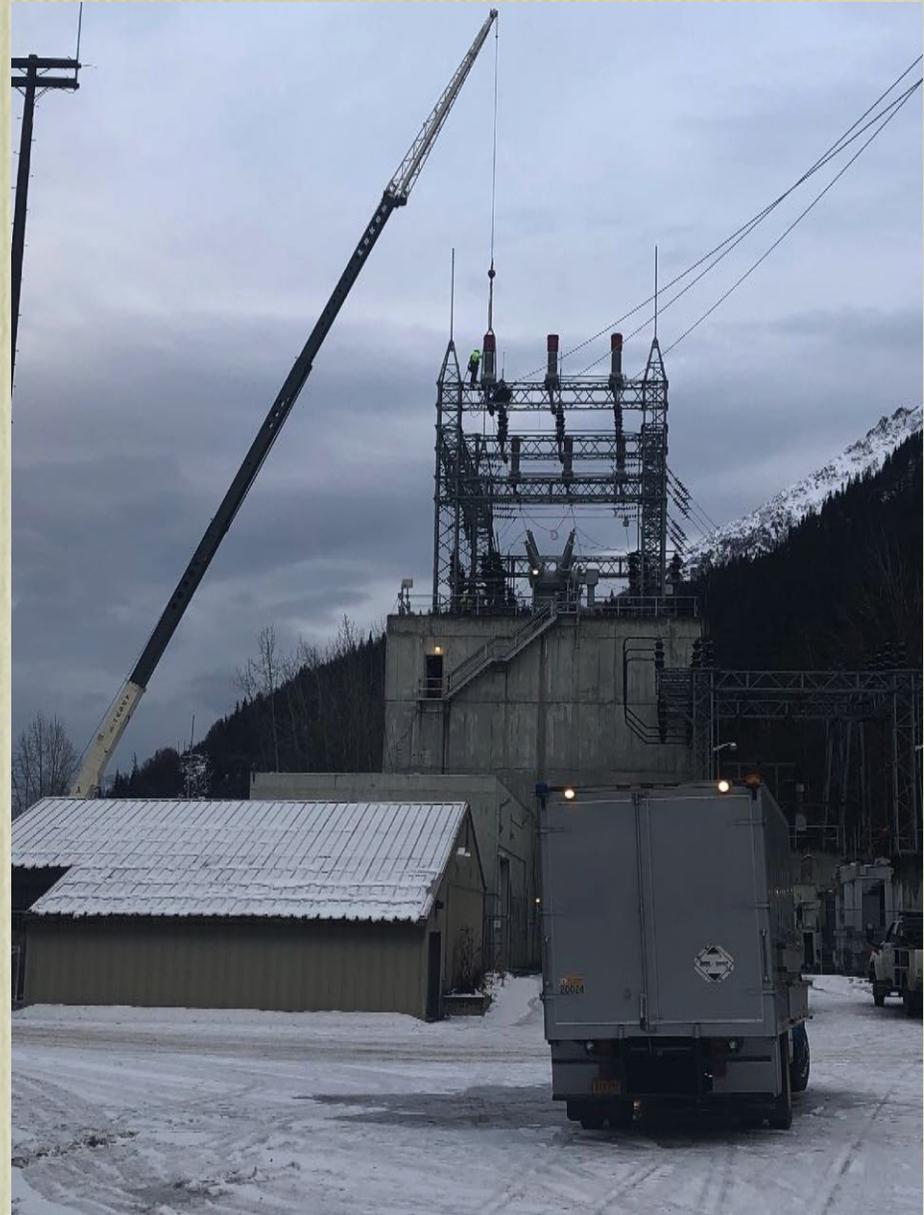
ML&P Eklutna

3 of 6 PT / CT damaged. Transformers slid (a bit). Minor damage to buildings

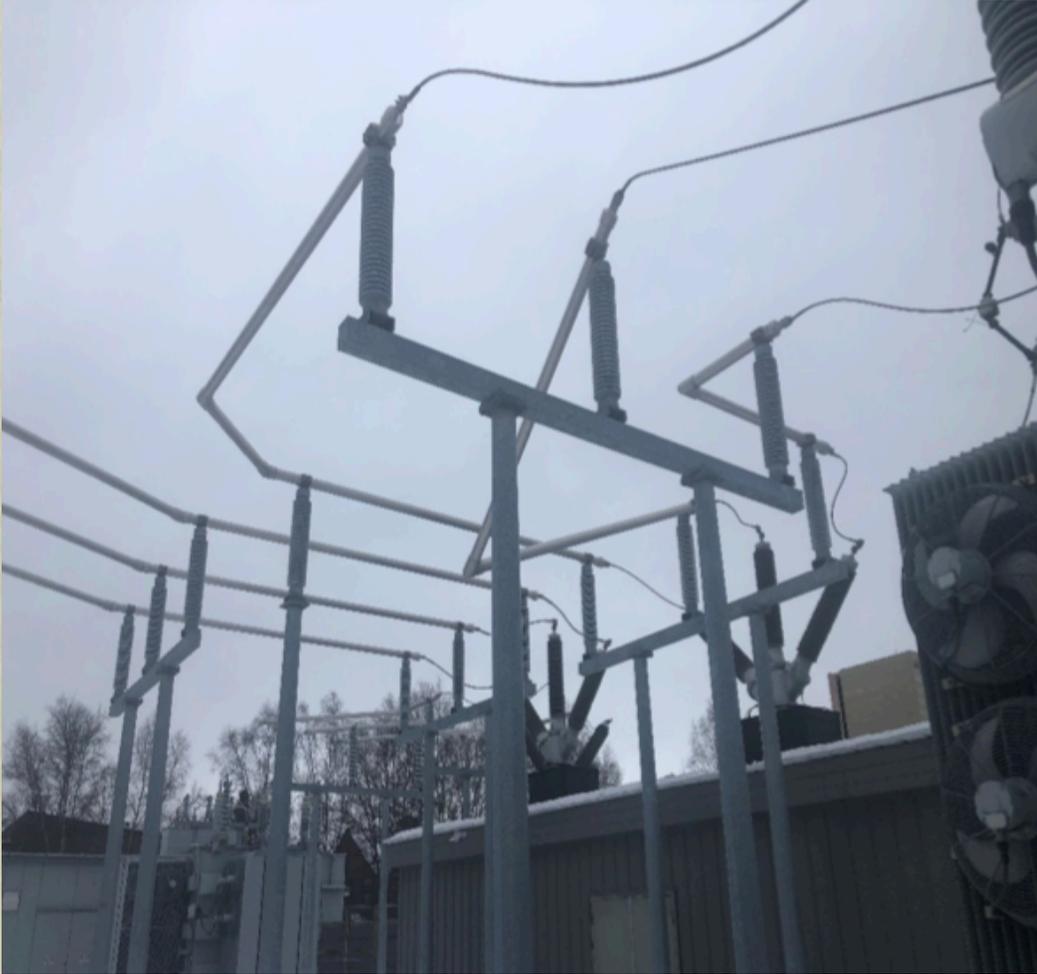
Rigid bus

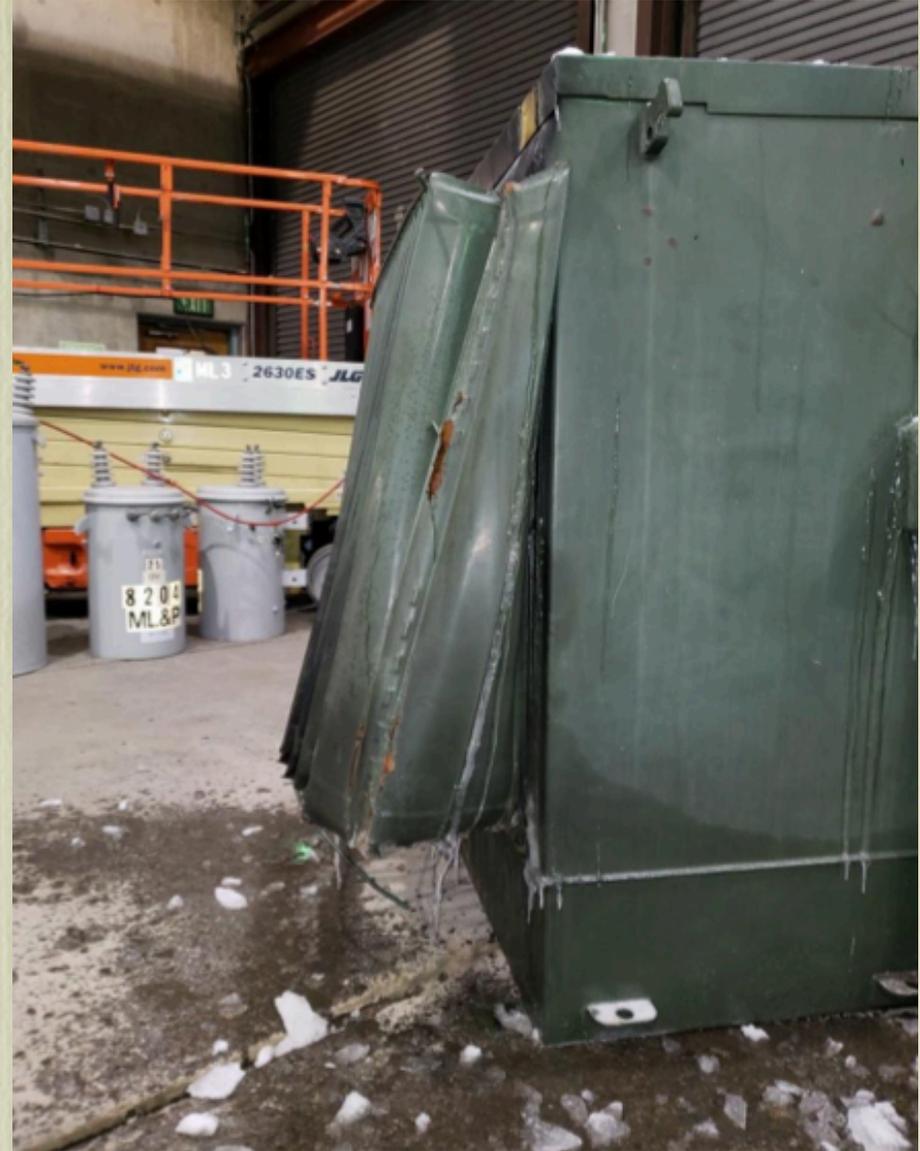
Underground TR

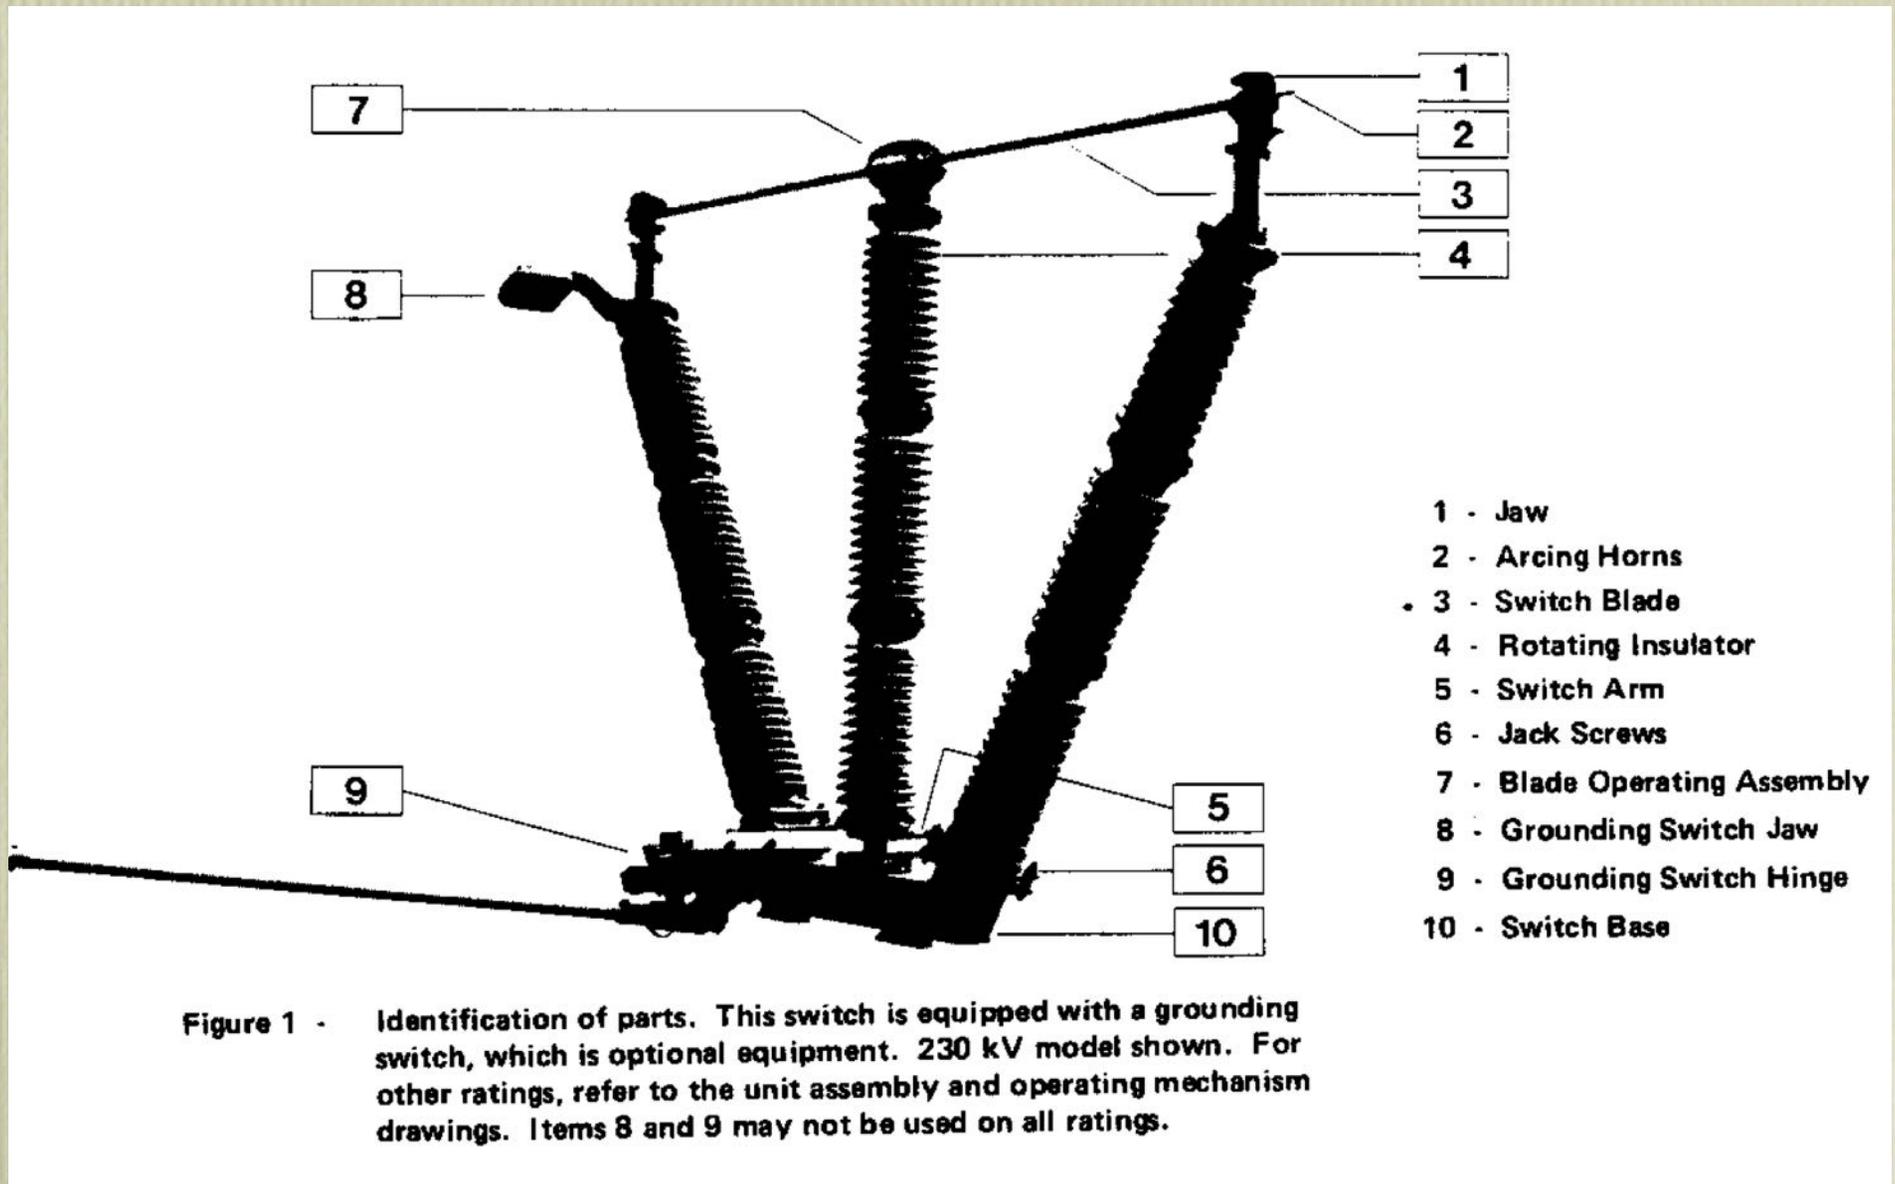
Double End Break 230 kV Switch

The switches are a hybrid between original Siemens Allis, with replaced parts by Southern States

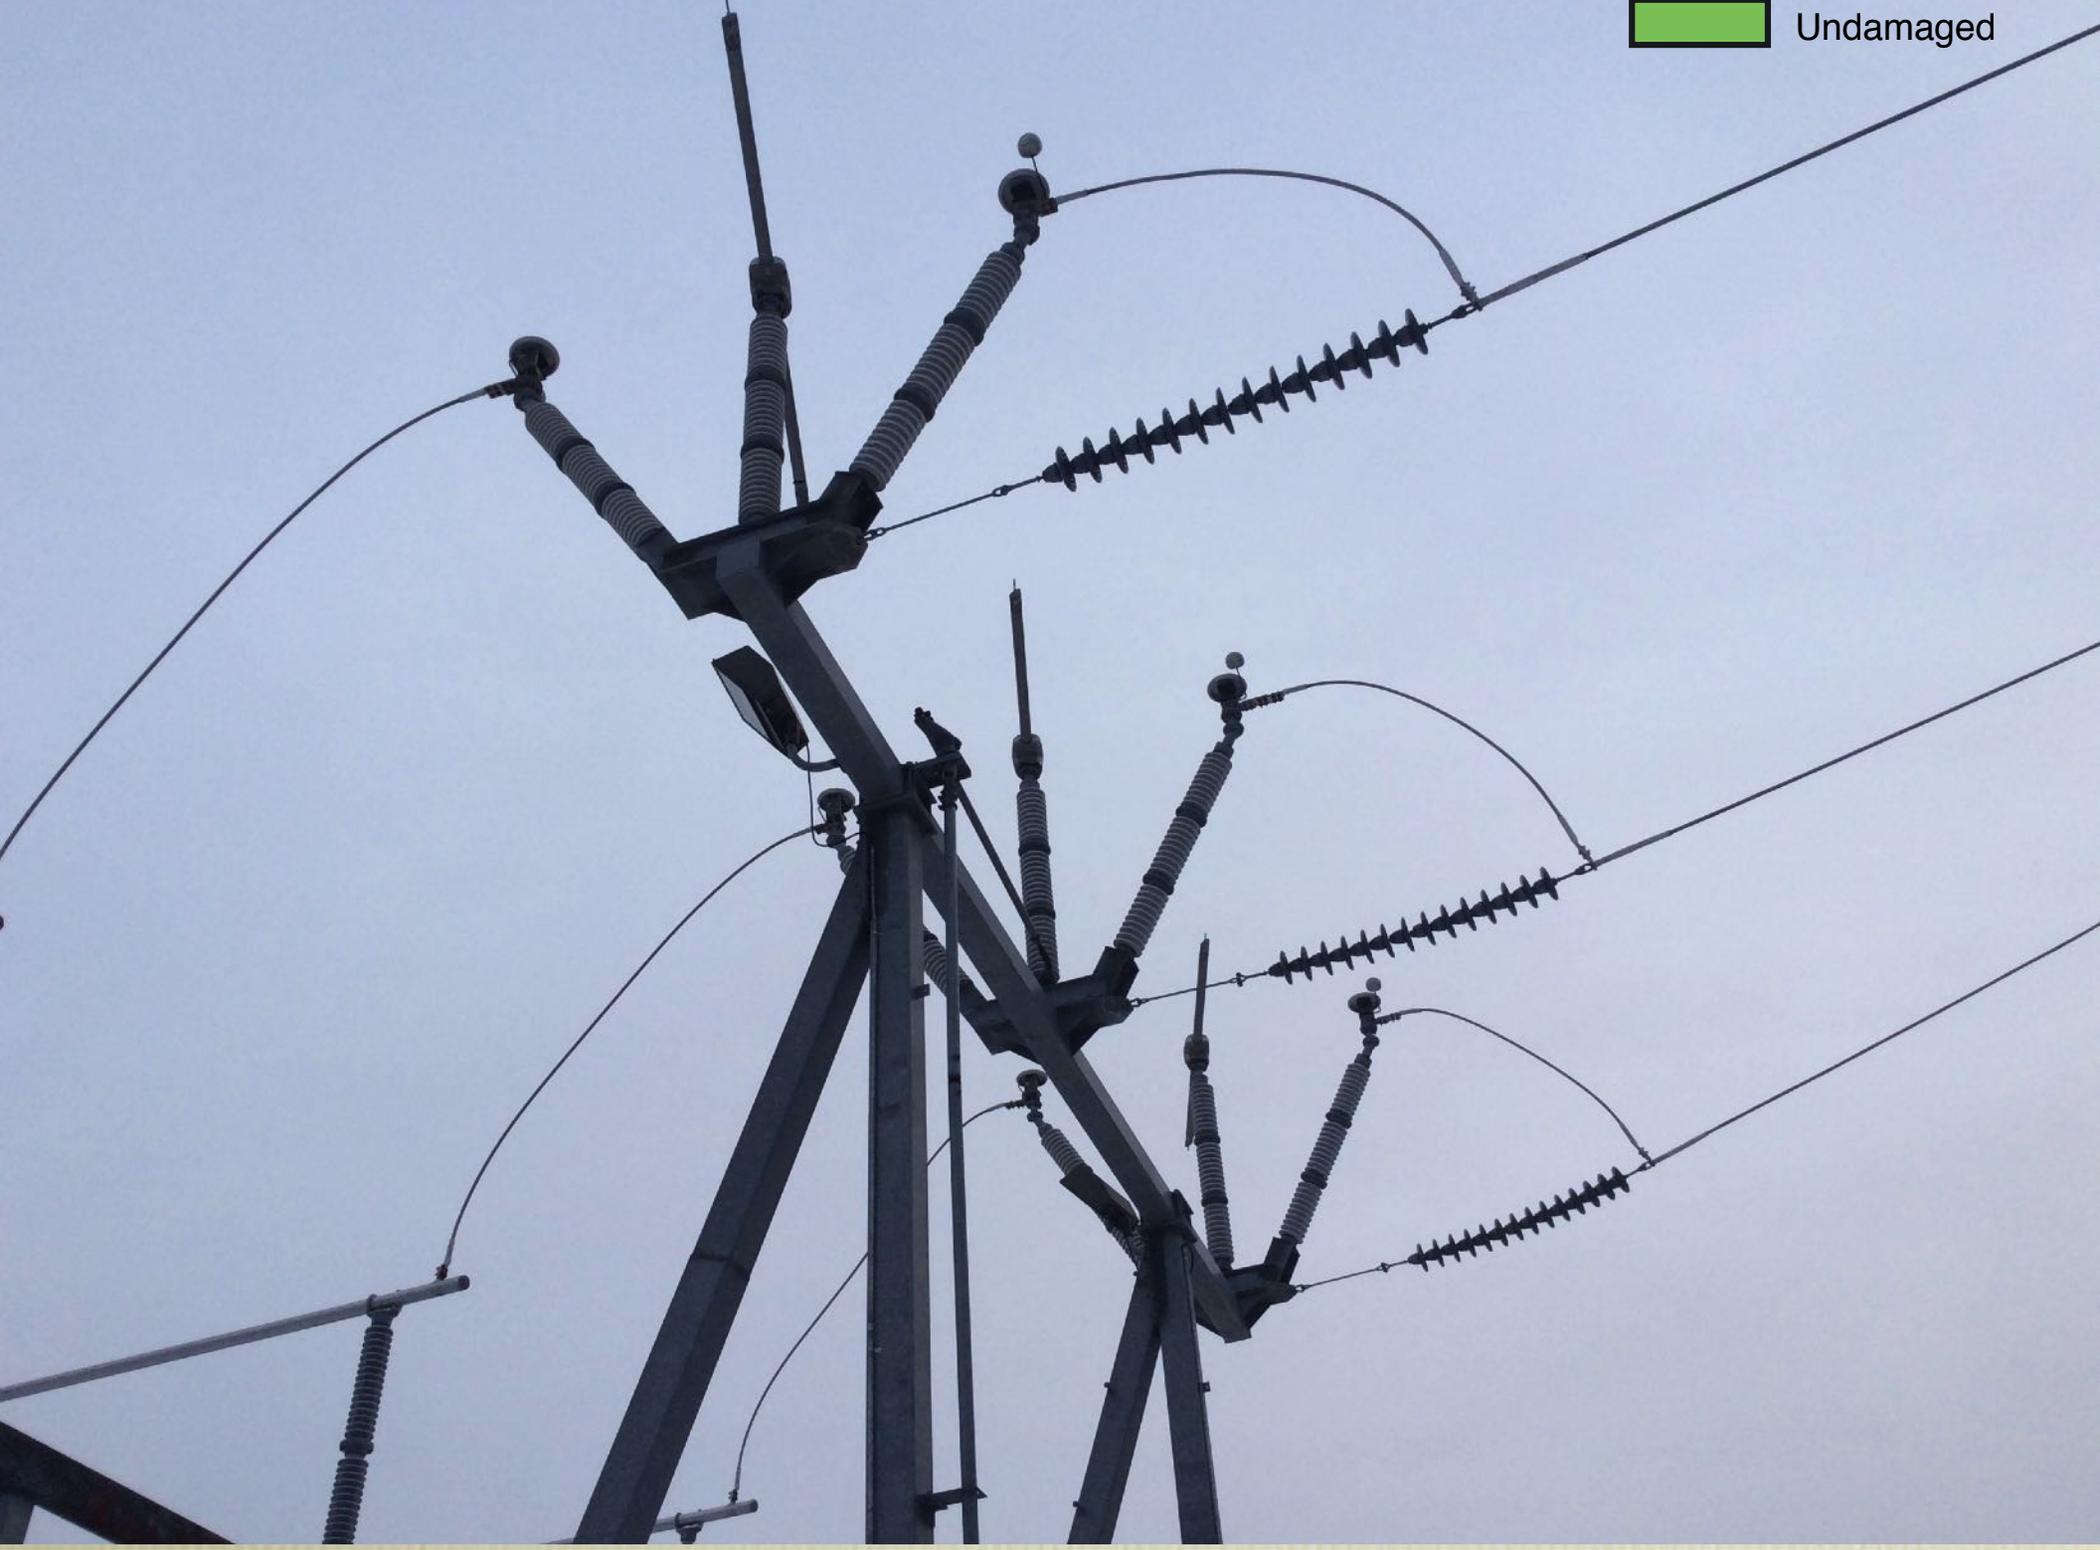
Rocking lack of stiffeners
Low frequency

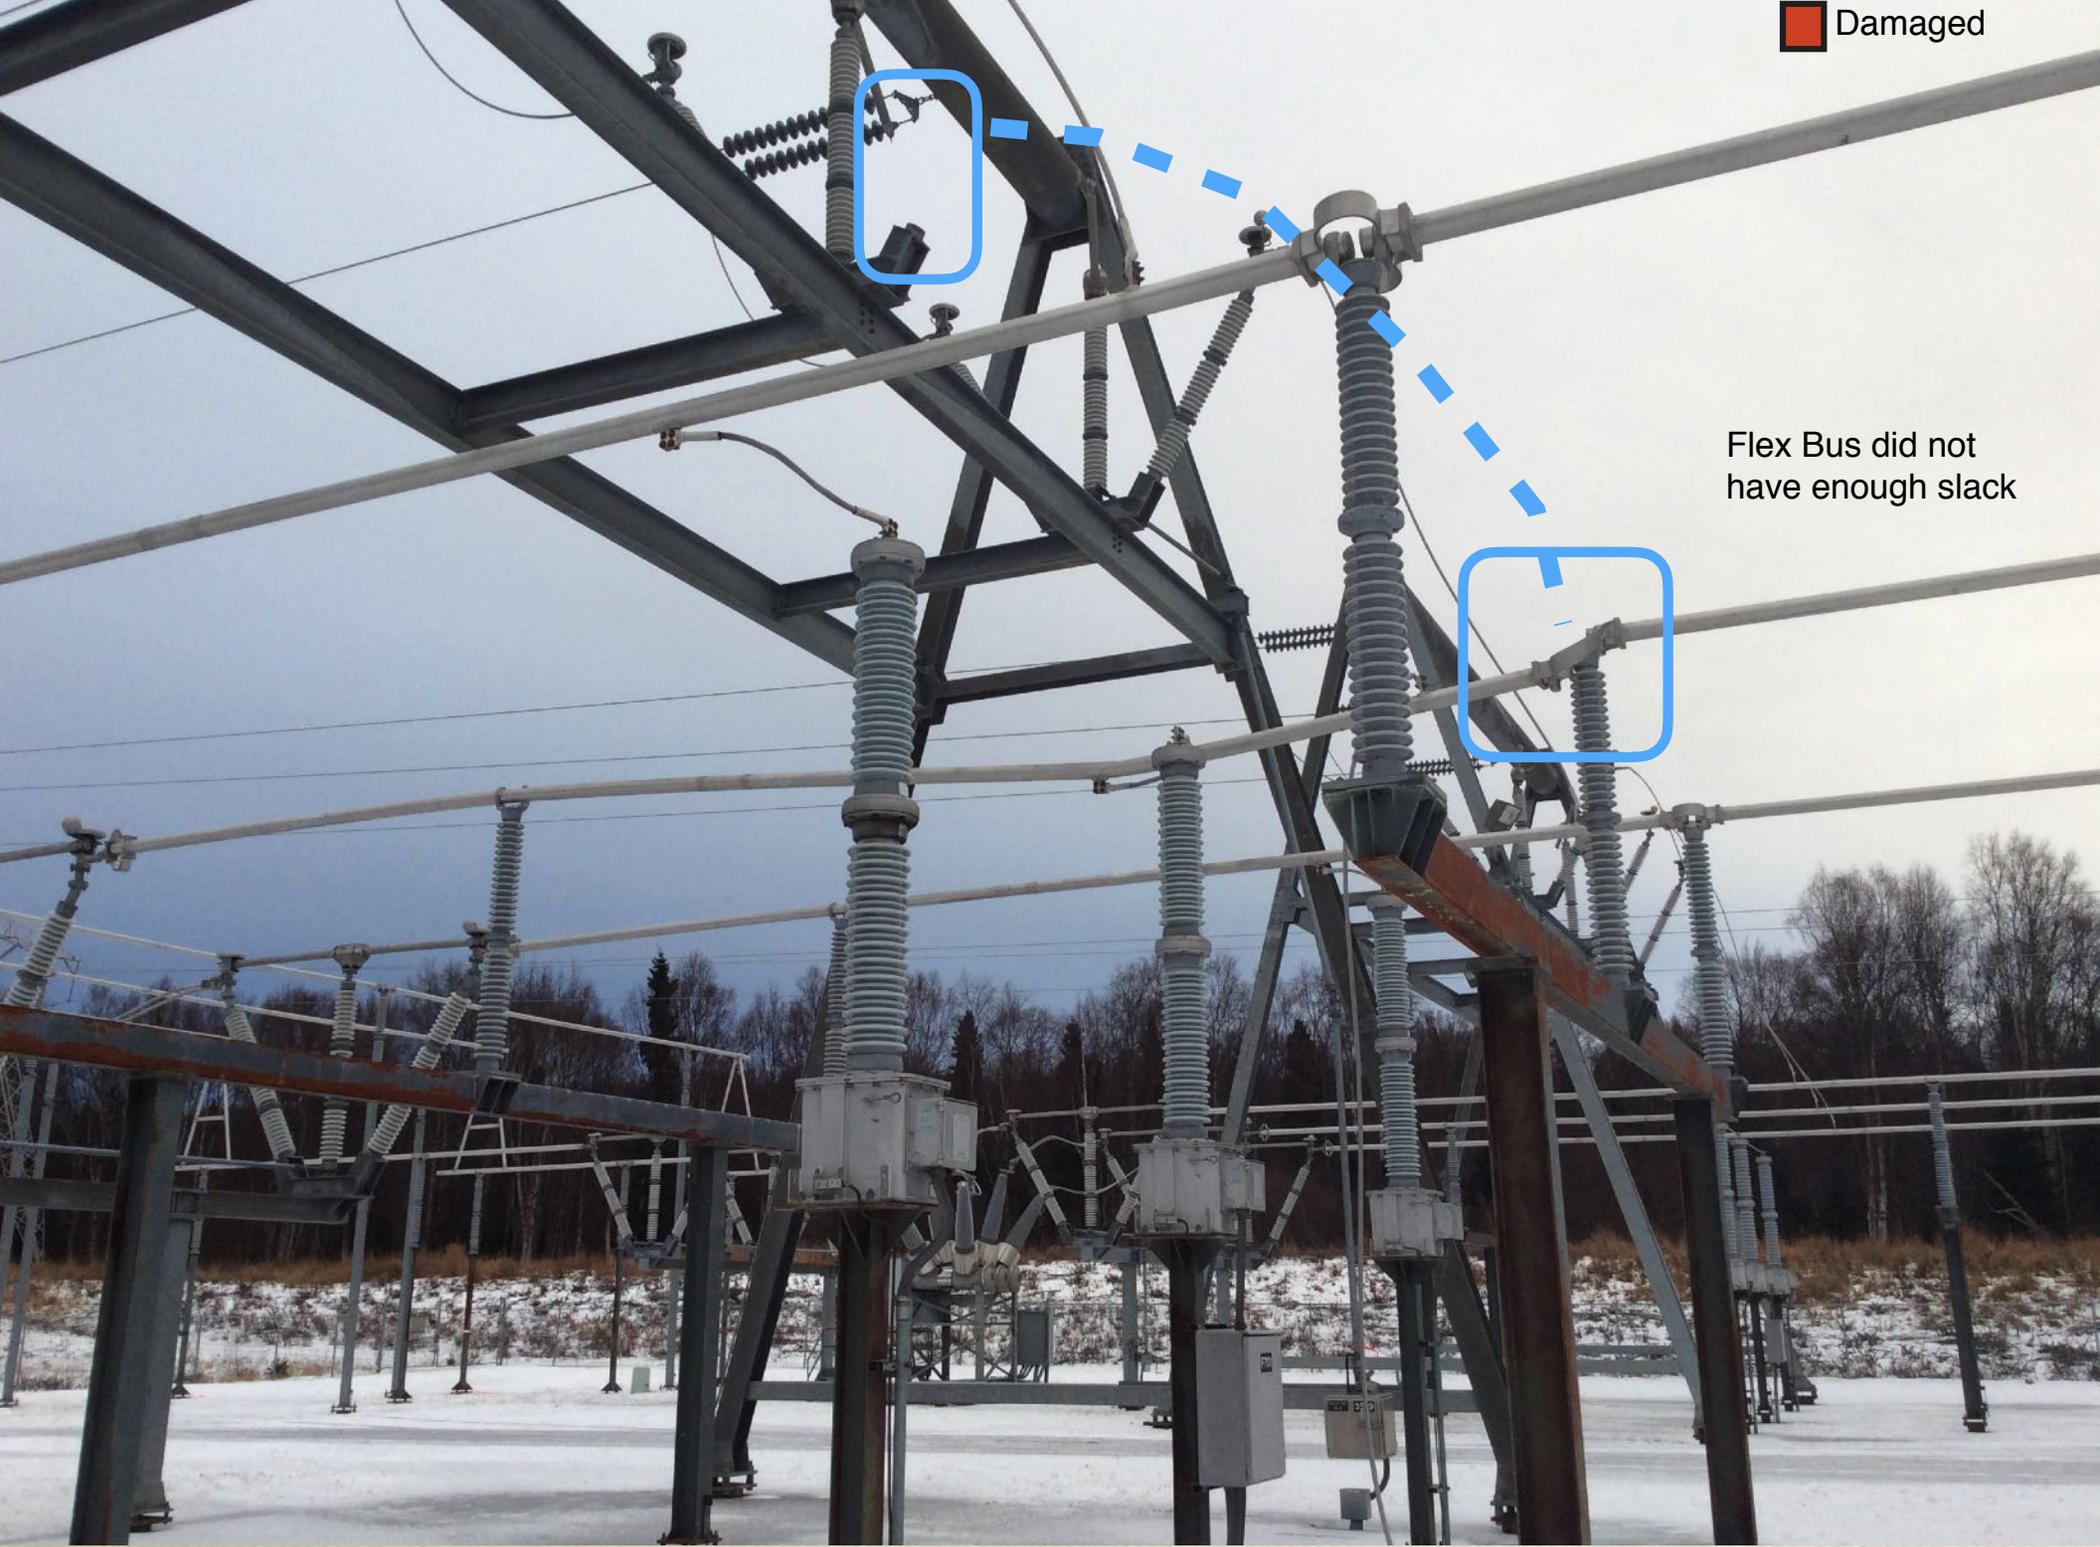
Flex Bus did not have enough slack

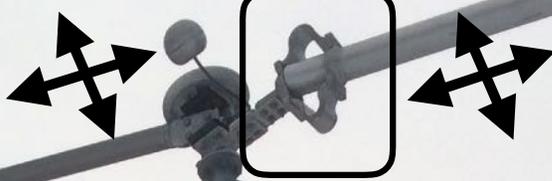
Plunger Device

Bus pushes on the Switch.
Switch pushes on the Bus.
Leads to high M at bottom of switch
($P_x + P_y + P_z$) * L exceeds moment capacity of porcelain.
 P_x (axial) alone is not the sole culprit.
The rigid bus "plunger" hardware, if not designed properly is not acceptable.

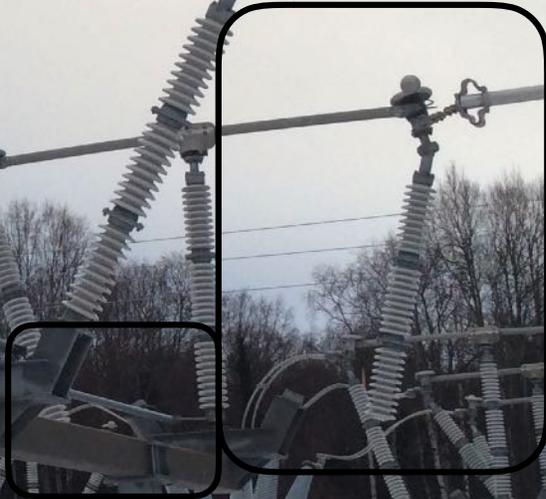
Transverse relative movements
Between the switch and bus
May have been the primary reason
for the porcelain post failures
