Magna M 5.7 2020

John Eiding, G&E

October 23 2020

- Magna M 5.7, March 18 2020
- Gas Pipes in Ridgecrest 2019, Alaska 2018, Napa 2014, Eureka 2010, Northridge 1994, Imperial Valley 1979, San Fernando 1971, Long Beach 1933, and others
- Data analysis (fragility)
- The issue of mobile homes and gas meters

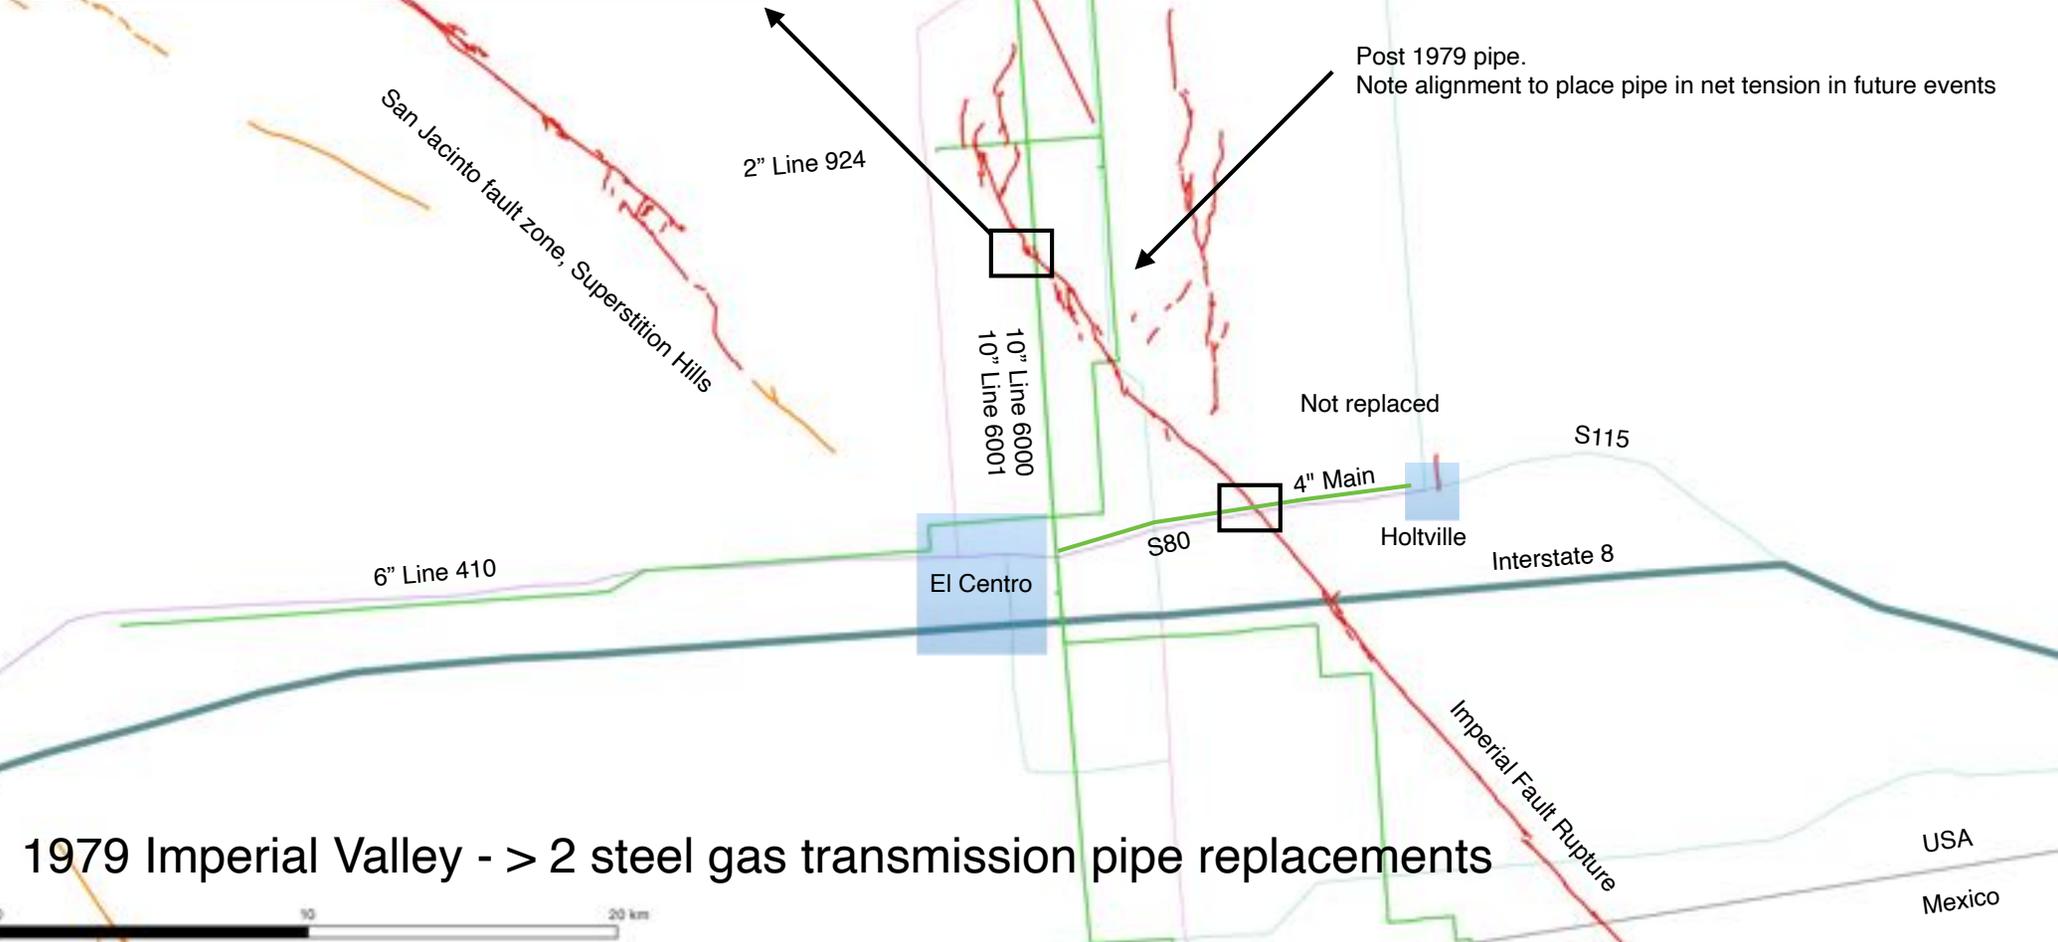
Post 1979 pipe.
Note alignment to place pipe in net tension in future events

Not replaced

1979 Imperial Valley - > 2 steel gas transmission pipe replacements

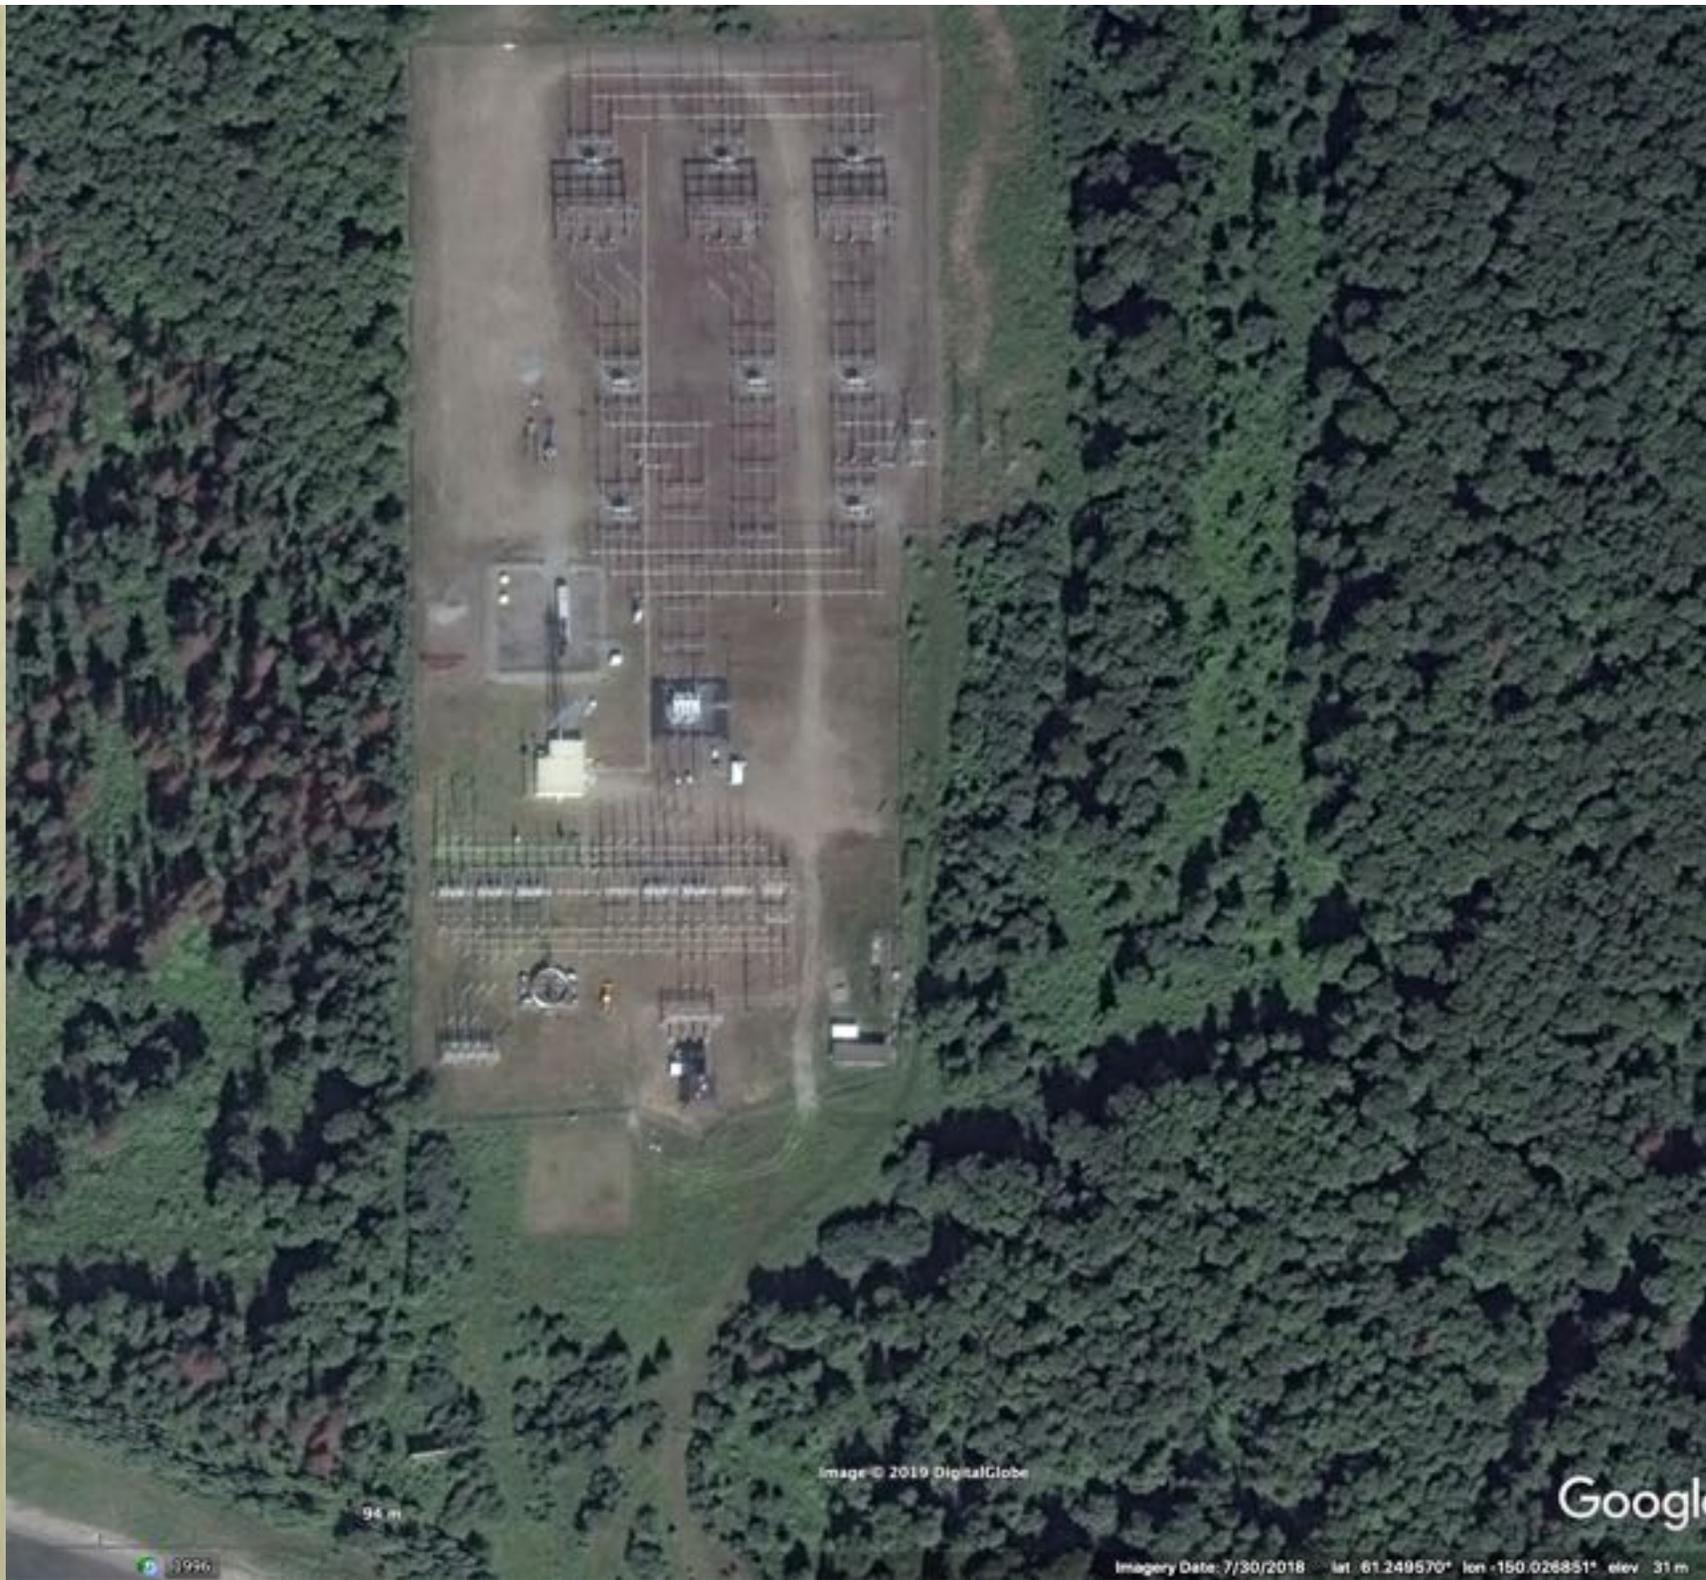
Chugach Electric Association
Point MacKenzie Substation
Photo Pre-EQ, July 2018
230 138 kV
Lat 61.2496
Long -150.0268

230 kV Yard
17/22 switches collapse
Rigid bus with plungers
\$2 M to \$8 million to re-build
1+ Year re-build

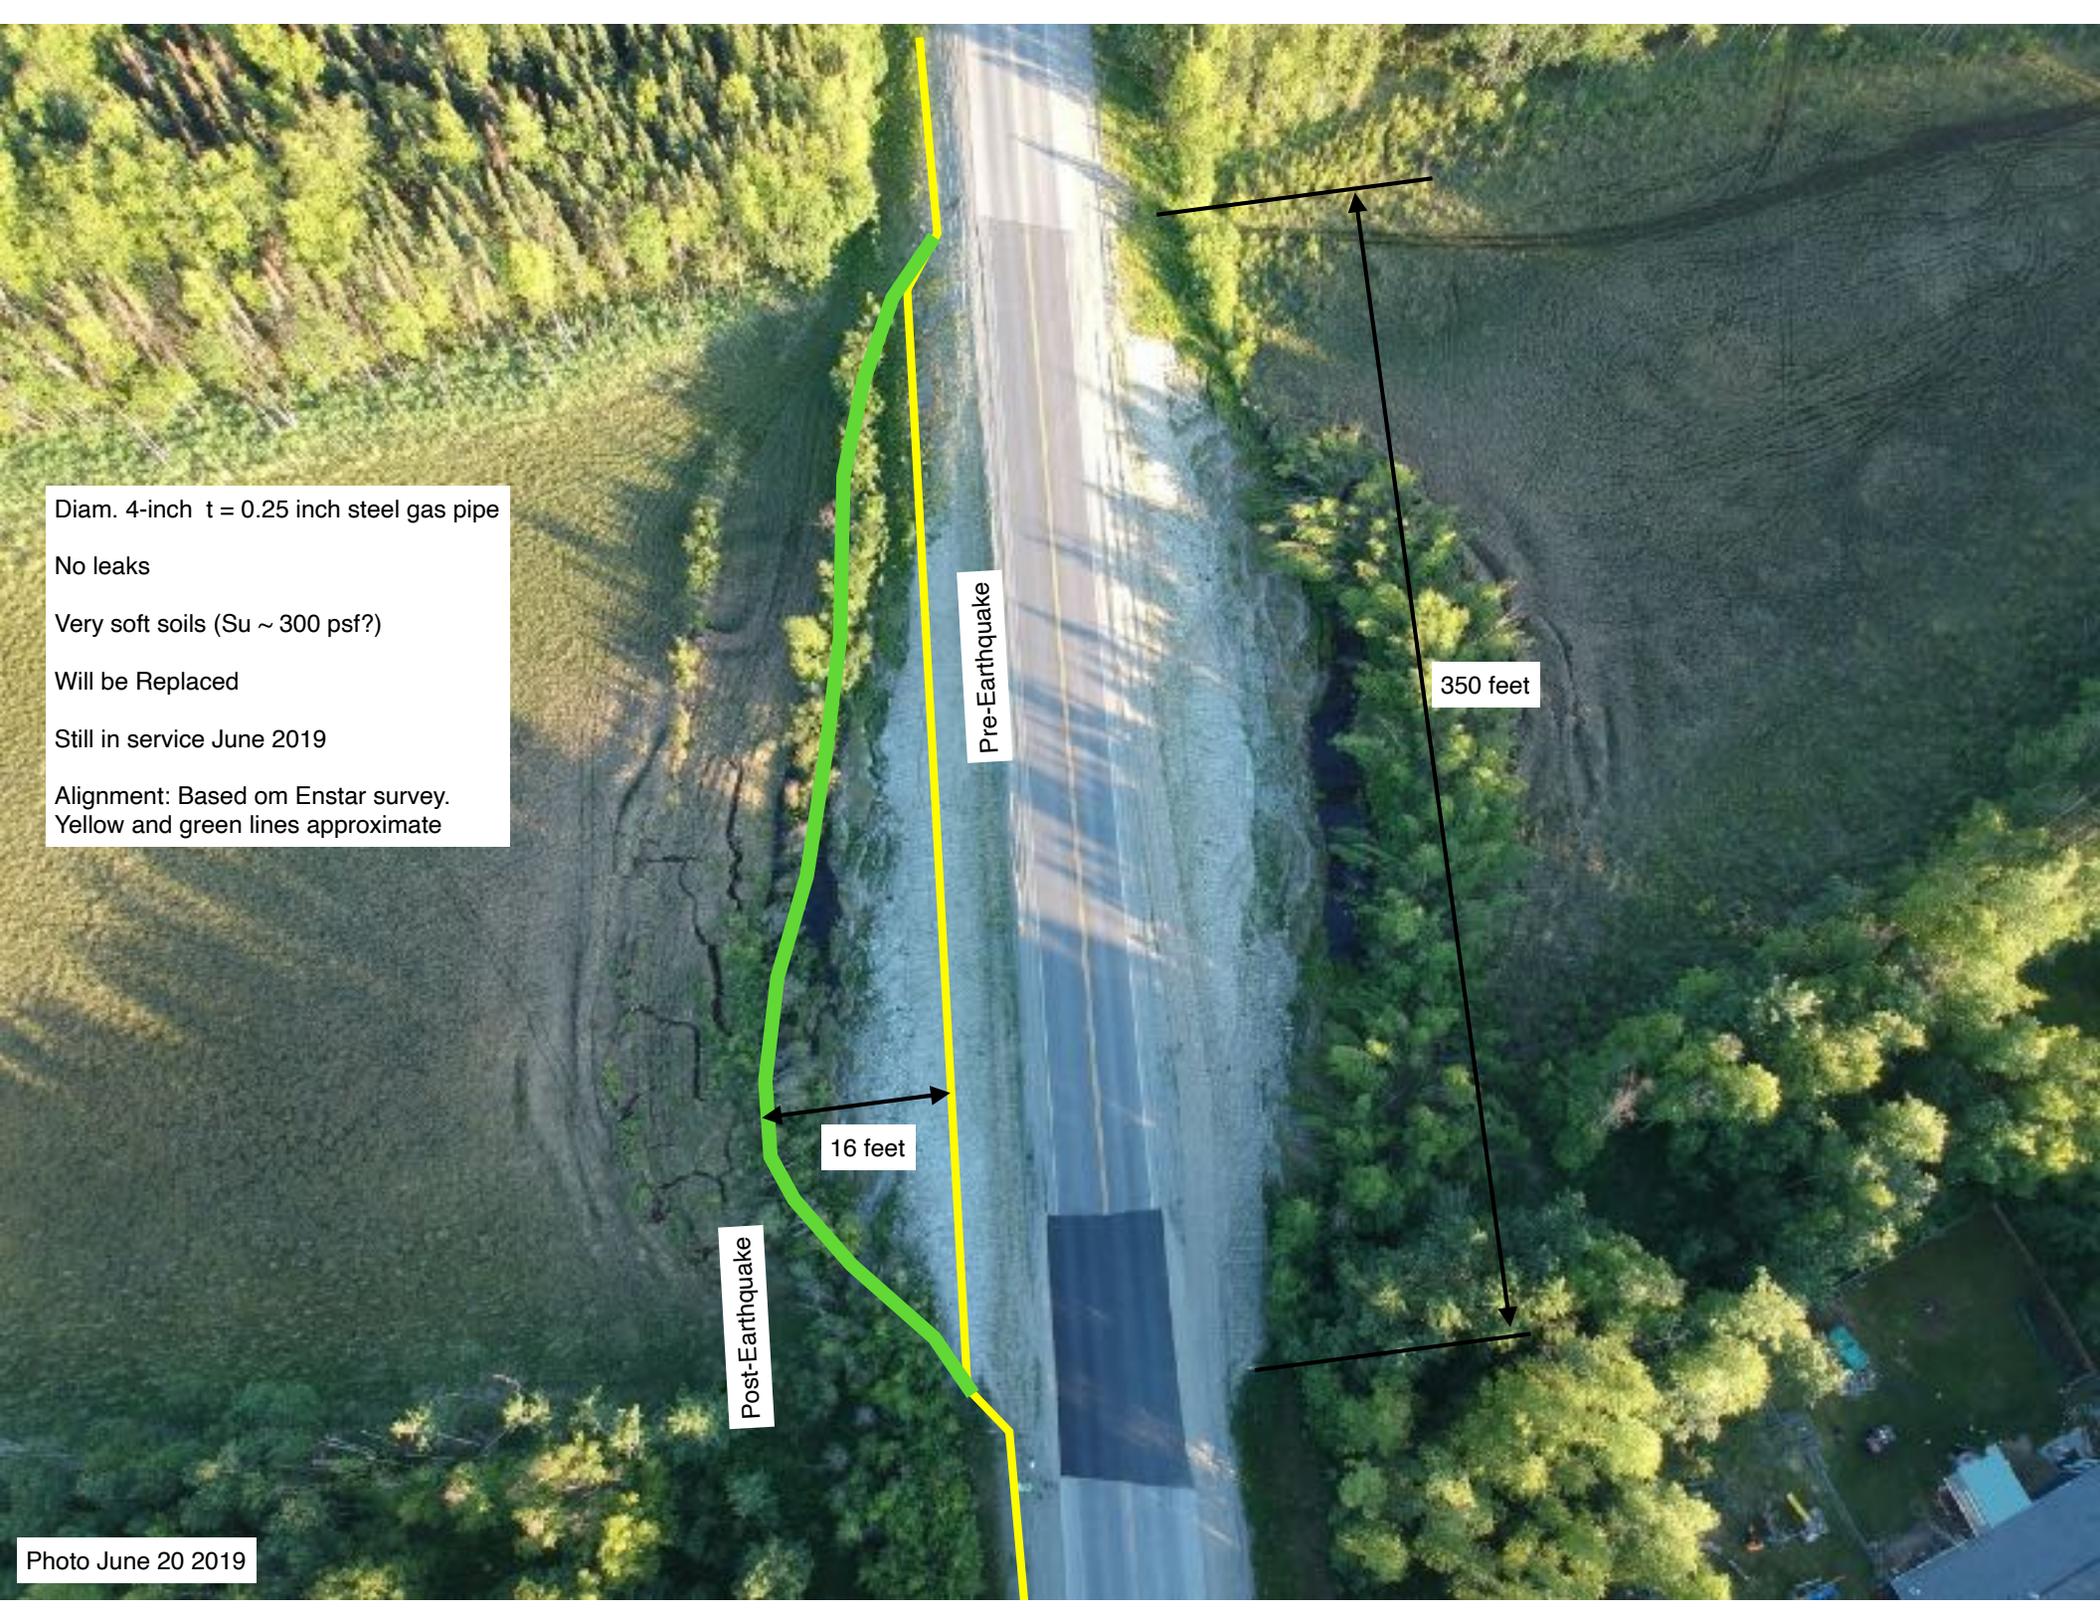
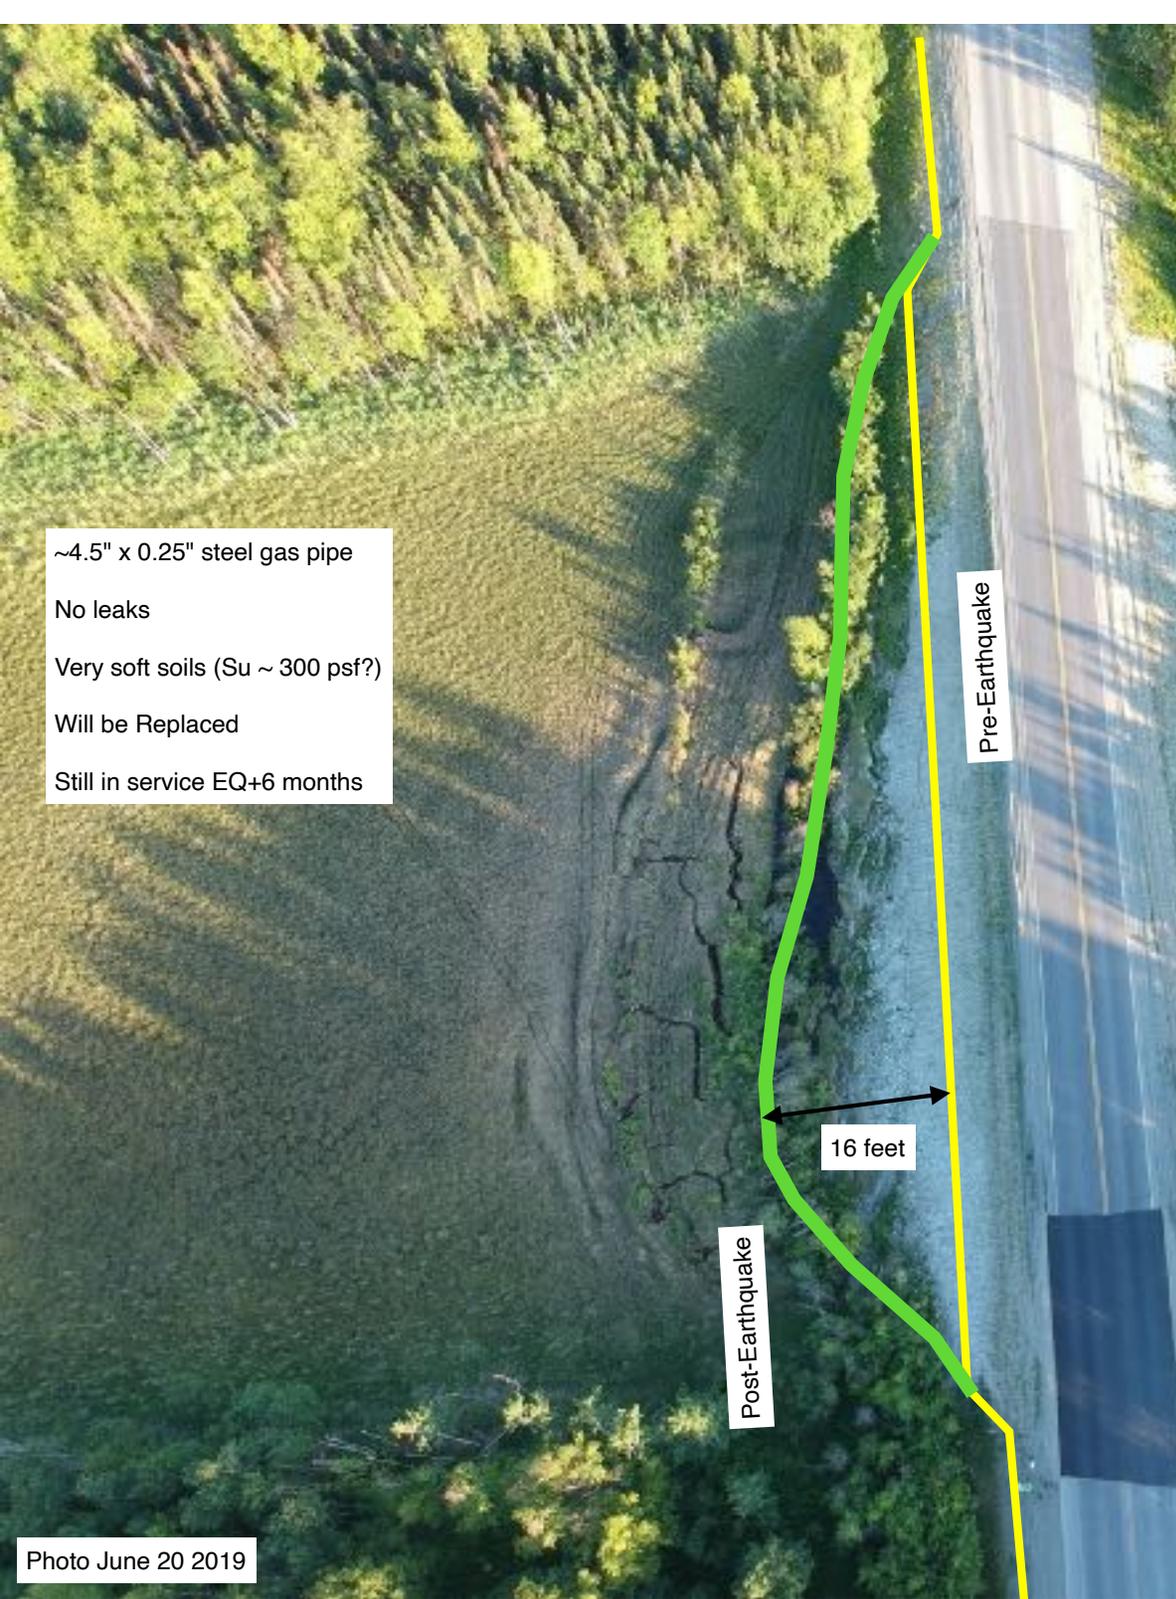
Diam. 4-inch t = 0.25 inch steel gas pipe
No leaks
Very soft soils (Su ~ 300 psf?)
Will be Replaced
Still in service June 2019
Alignment: Based om Enstar survey.
Yellow and green lines approximate

~4.5" x 0.25" steel gas pipe
 No leaks
 Very soft soils ($S_u \sim 300$ psf?)
 Will be Replaced
 Still in service EQ+6 months

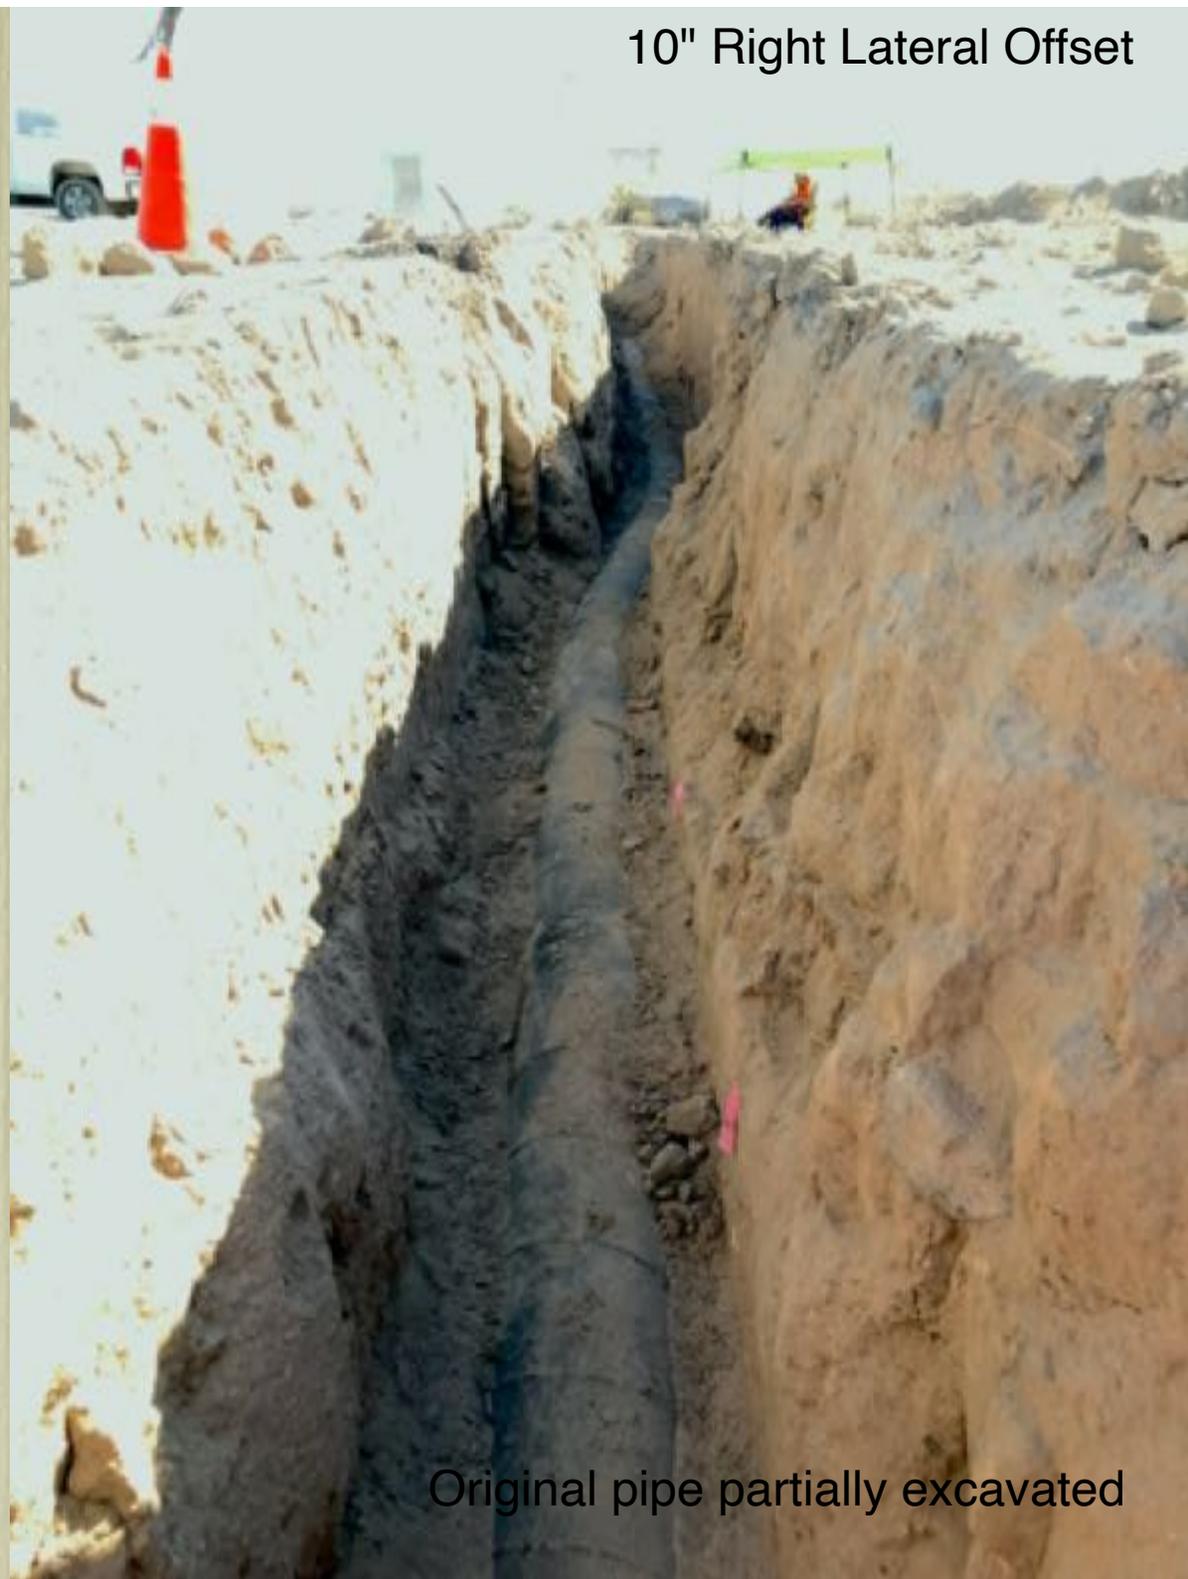
Original pipe partially excavated

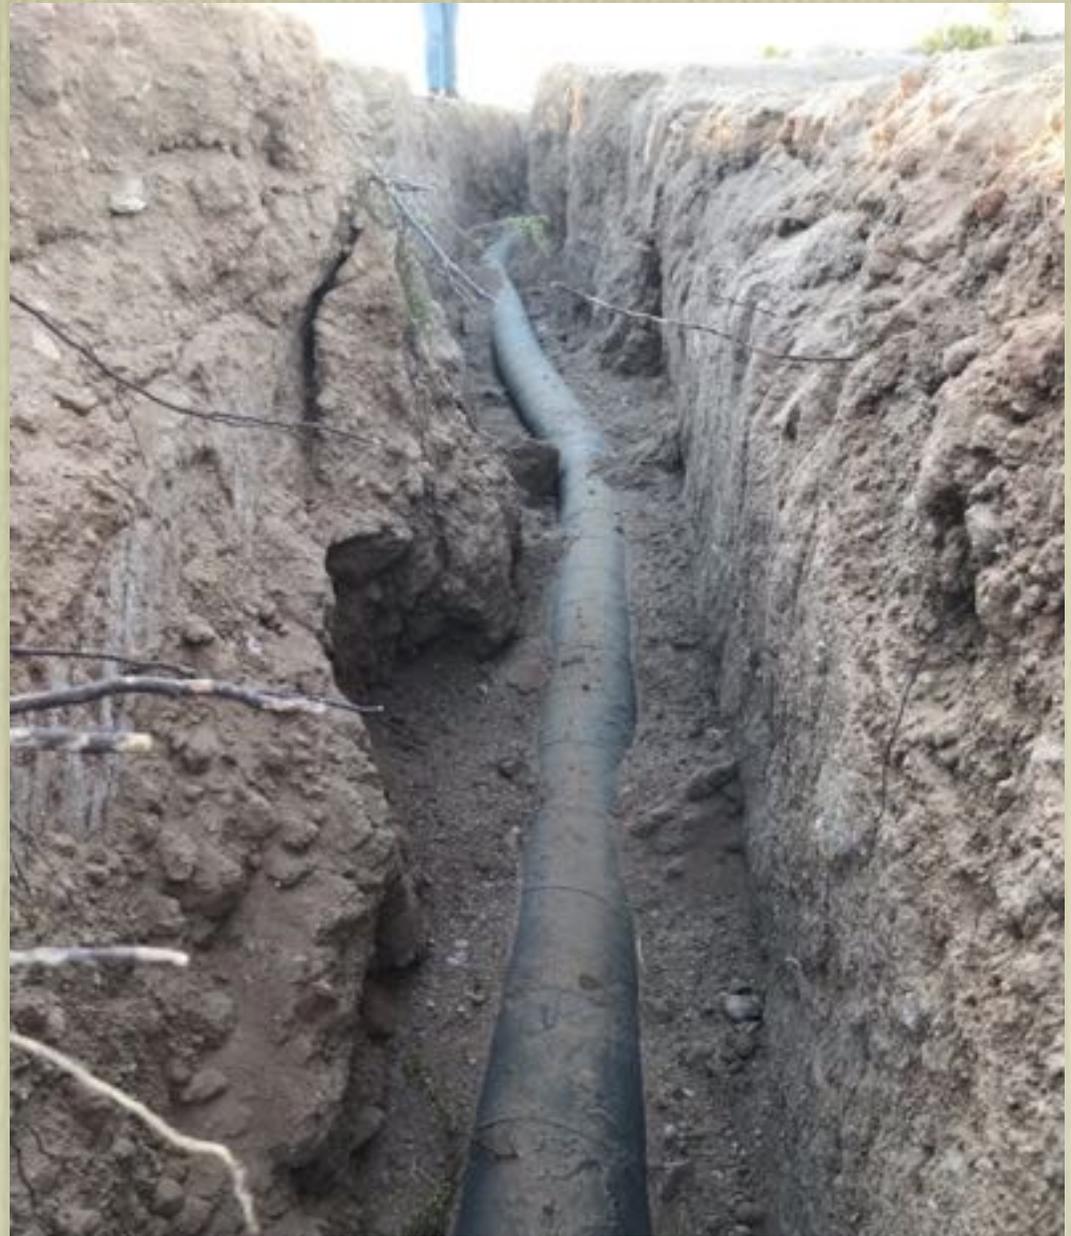
6" Pipe Left Lateral Offset

Original pipe partially excavated

Original pipe after fully excavated

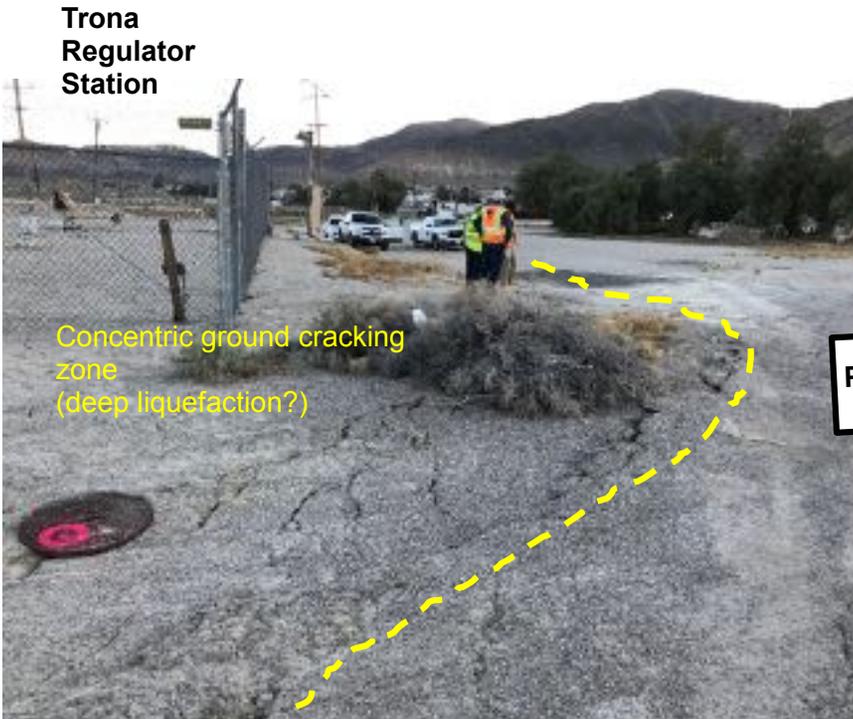
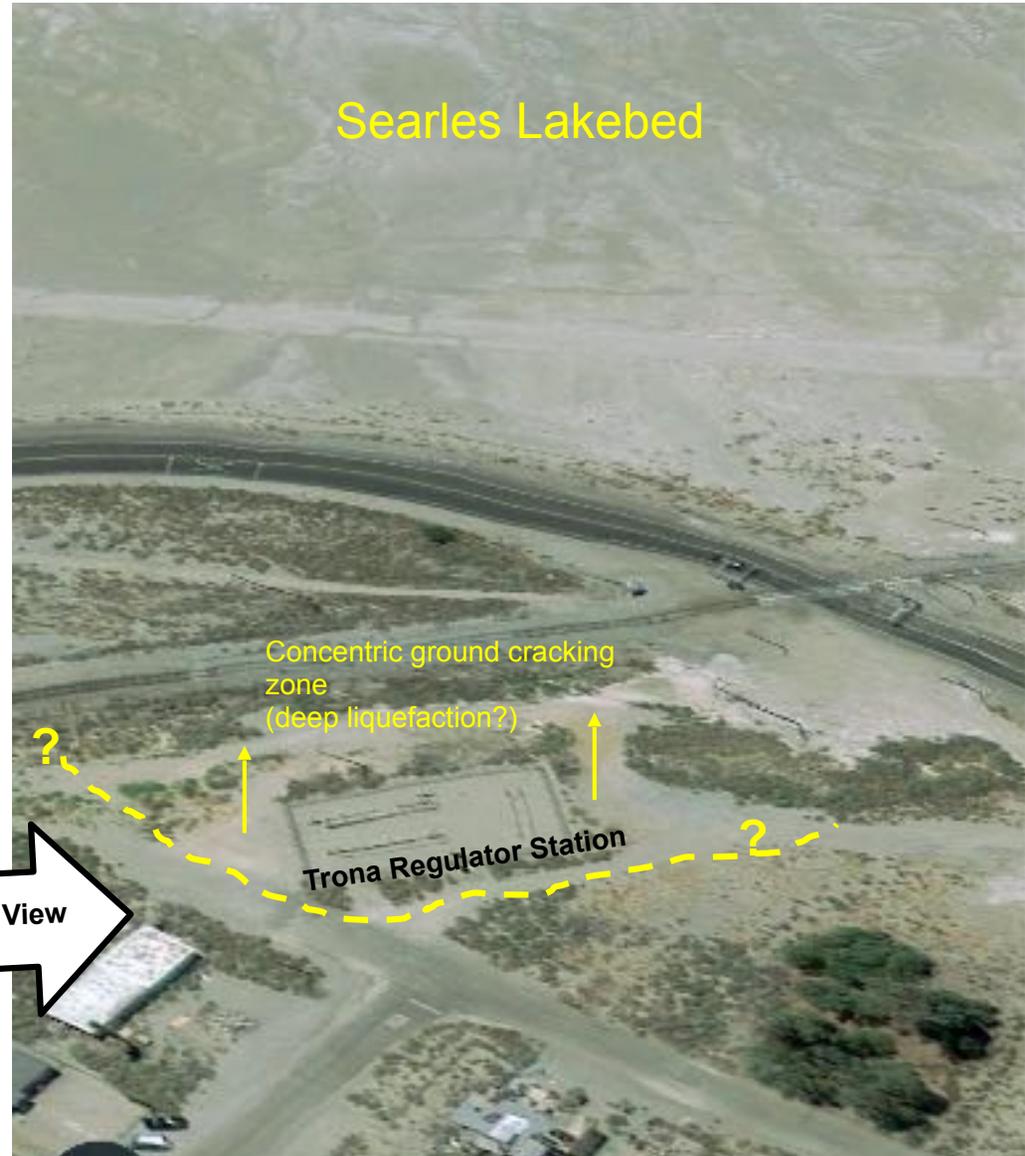
Trona Gas Regulator Station Damage Assessment

Extensive cracking and settlement zone at Trona Regulator Station (east view; map) and concentric “headscarp” crack (south view; photo)

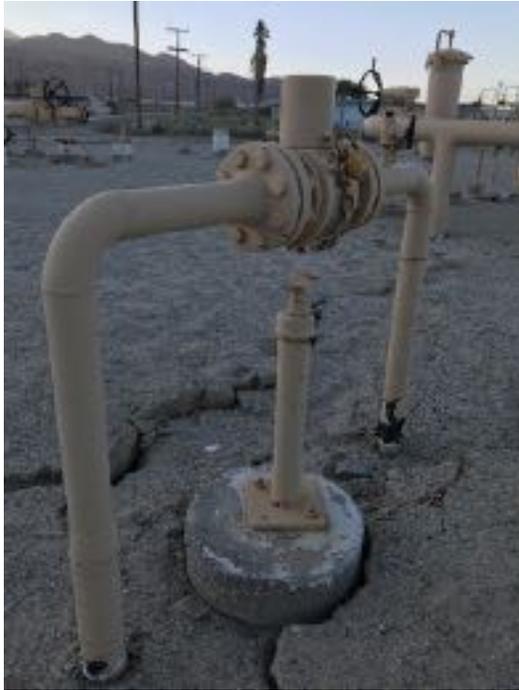
Settlement and lateral movements in station pad fills removed support for piping/valves. Settlement & lateral displacement is up to 0.5-1 foot.

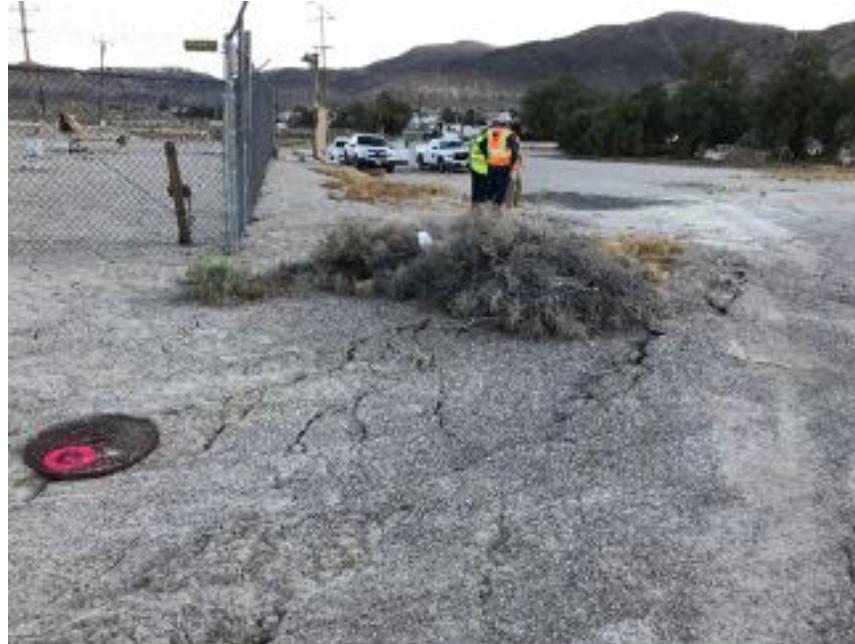
Apparent settlement/lateral spread headscarp at northwest corner of station. Searles Lake is off the photo to the left (east), and crack patterns and direction of extension suggest lateral movements toward the lake.

General cracking is pervasive throughout station pad fill.

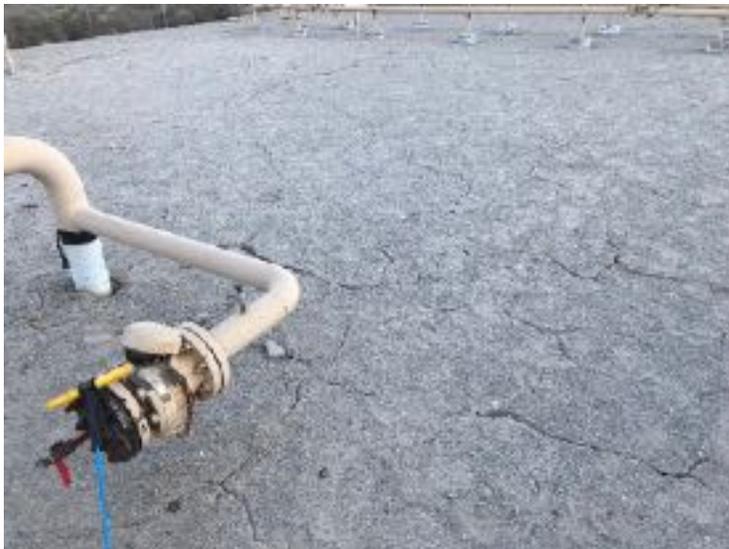
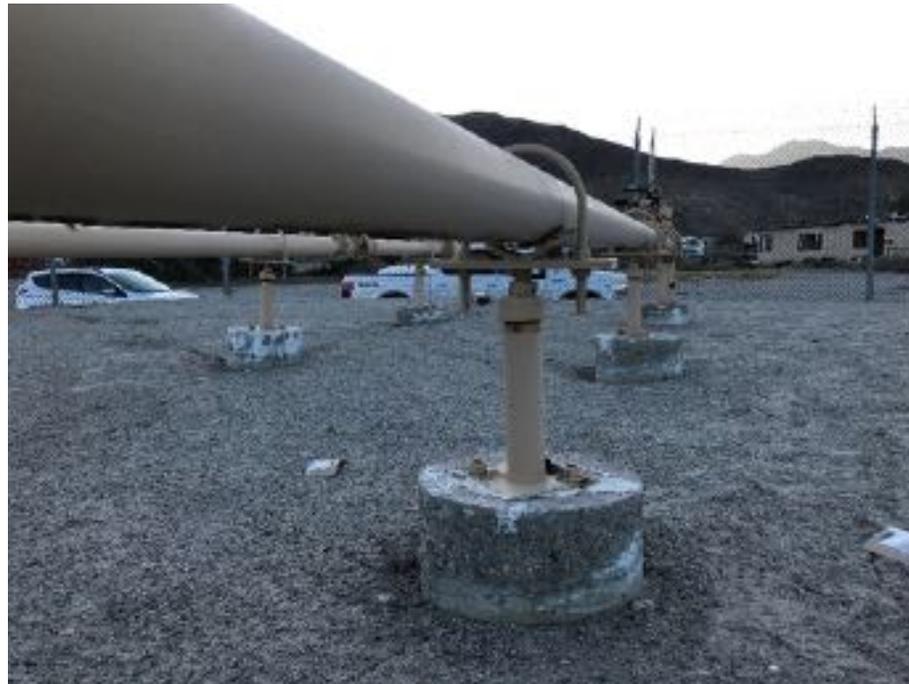
Differential settlement and lateral displacement across the station pad and foundations

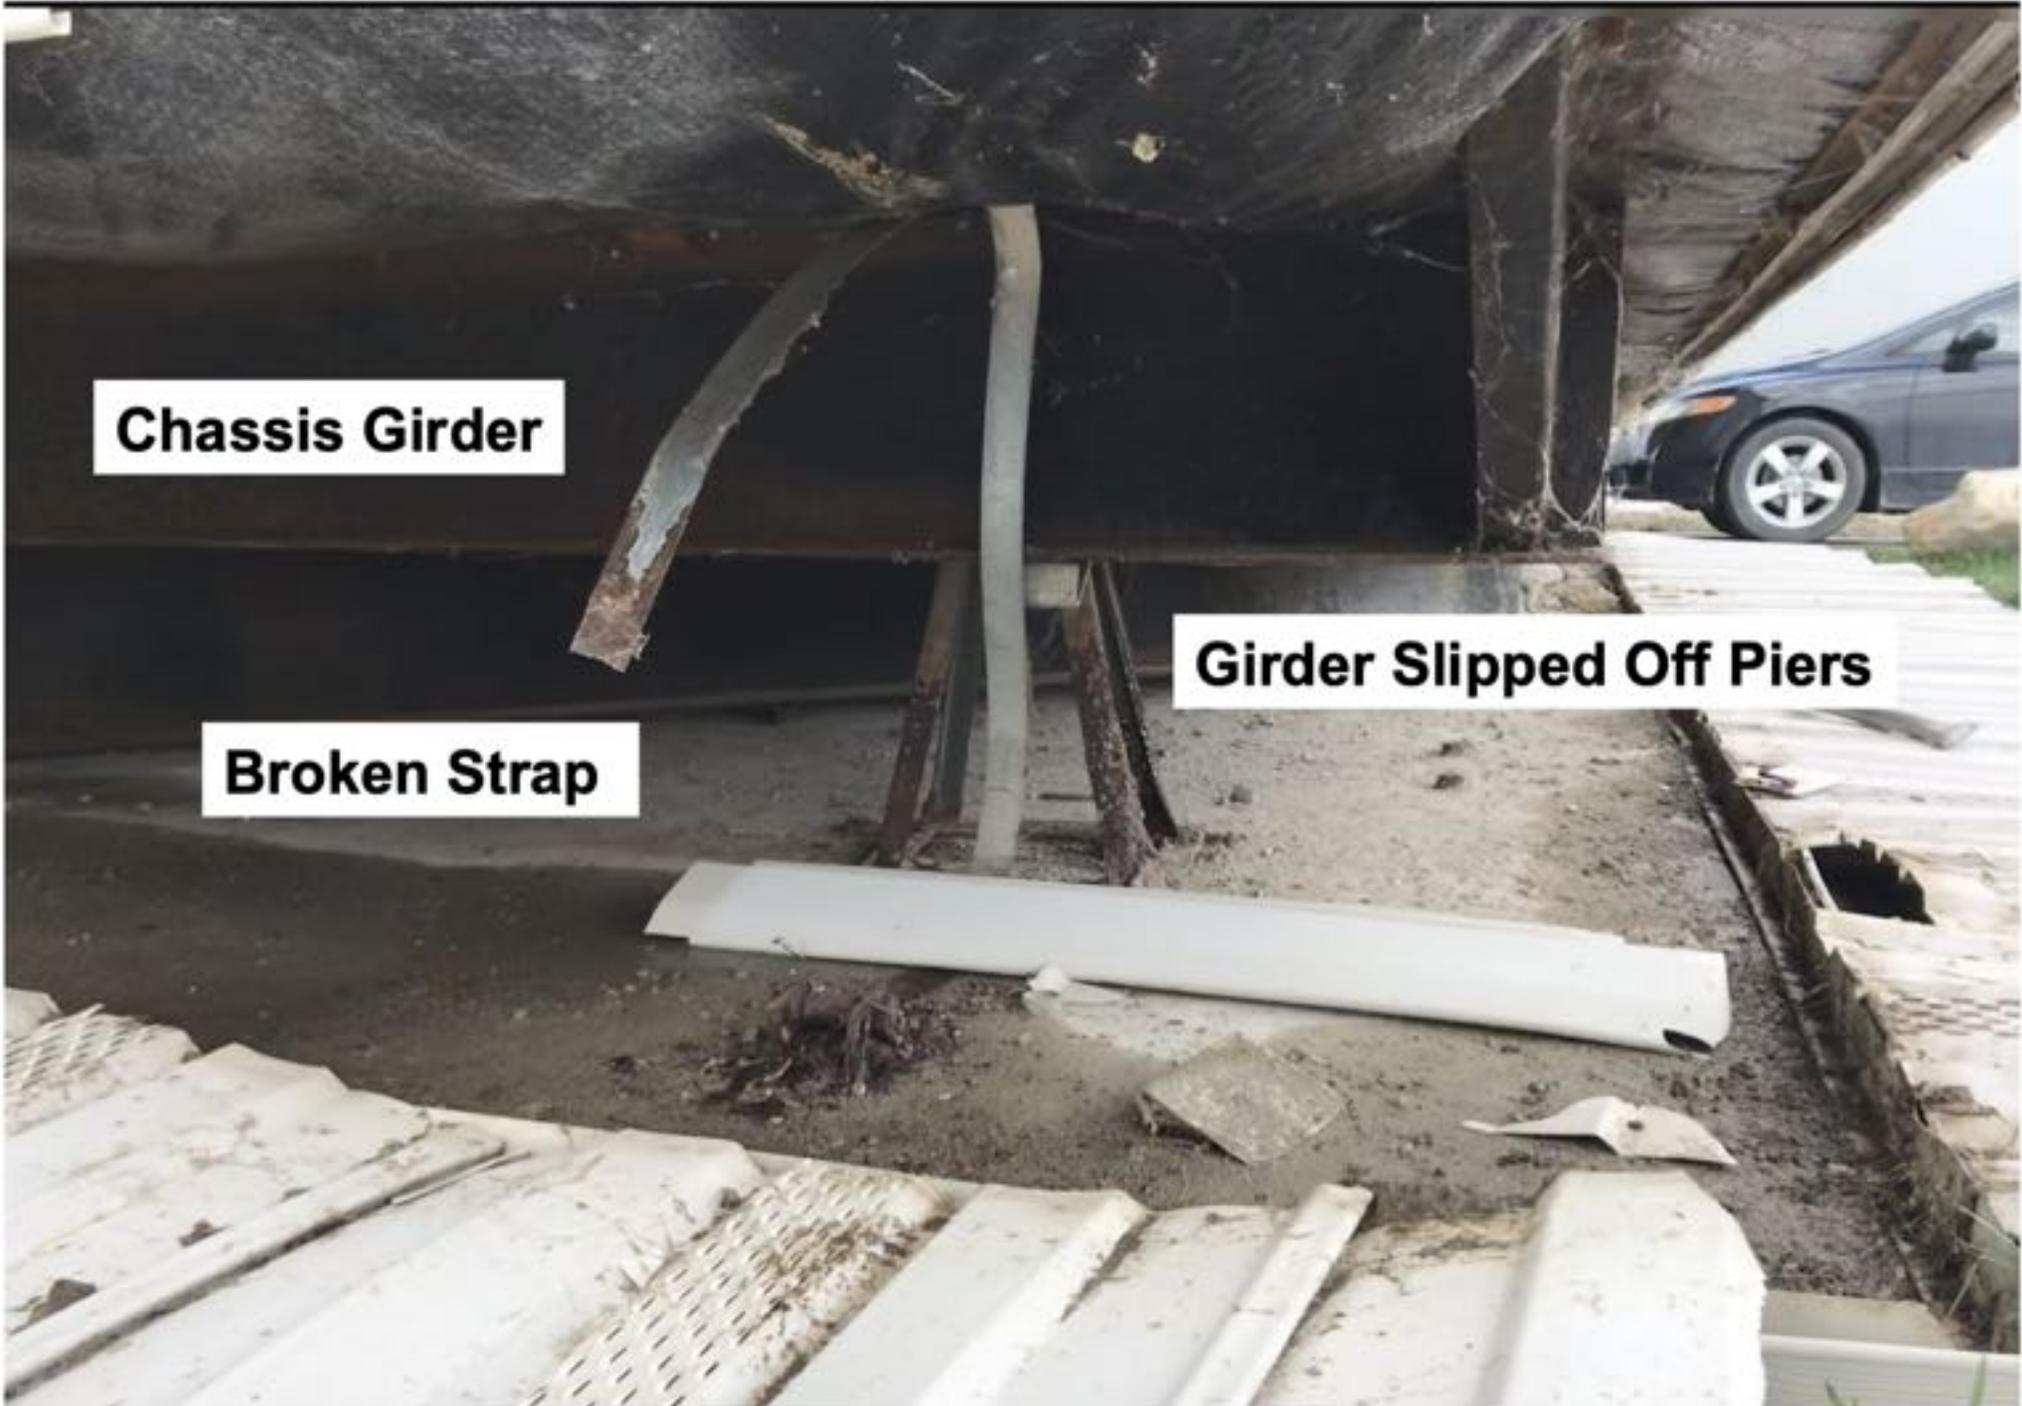
Underneath Home

Broken Strap

Girder Slipped Off Piers

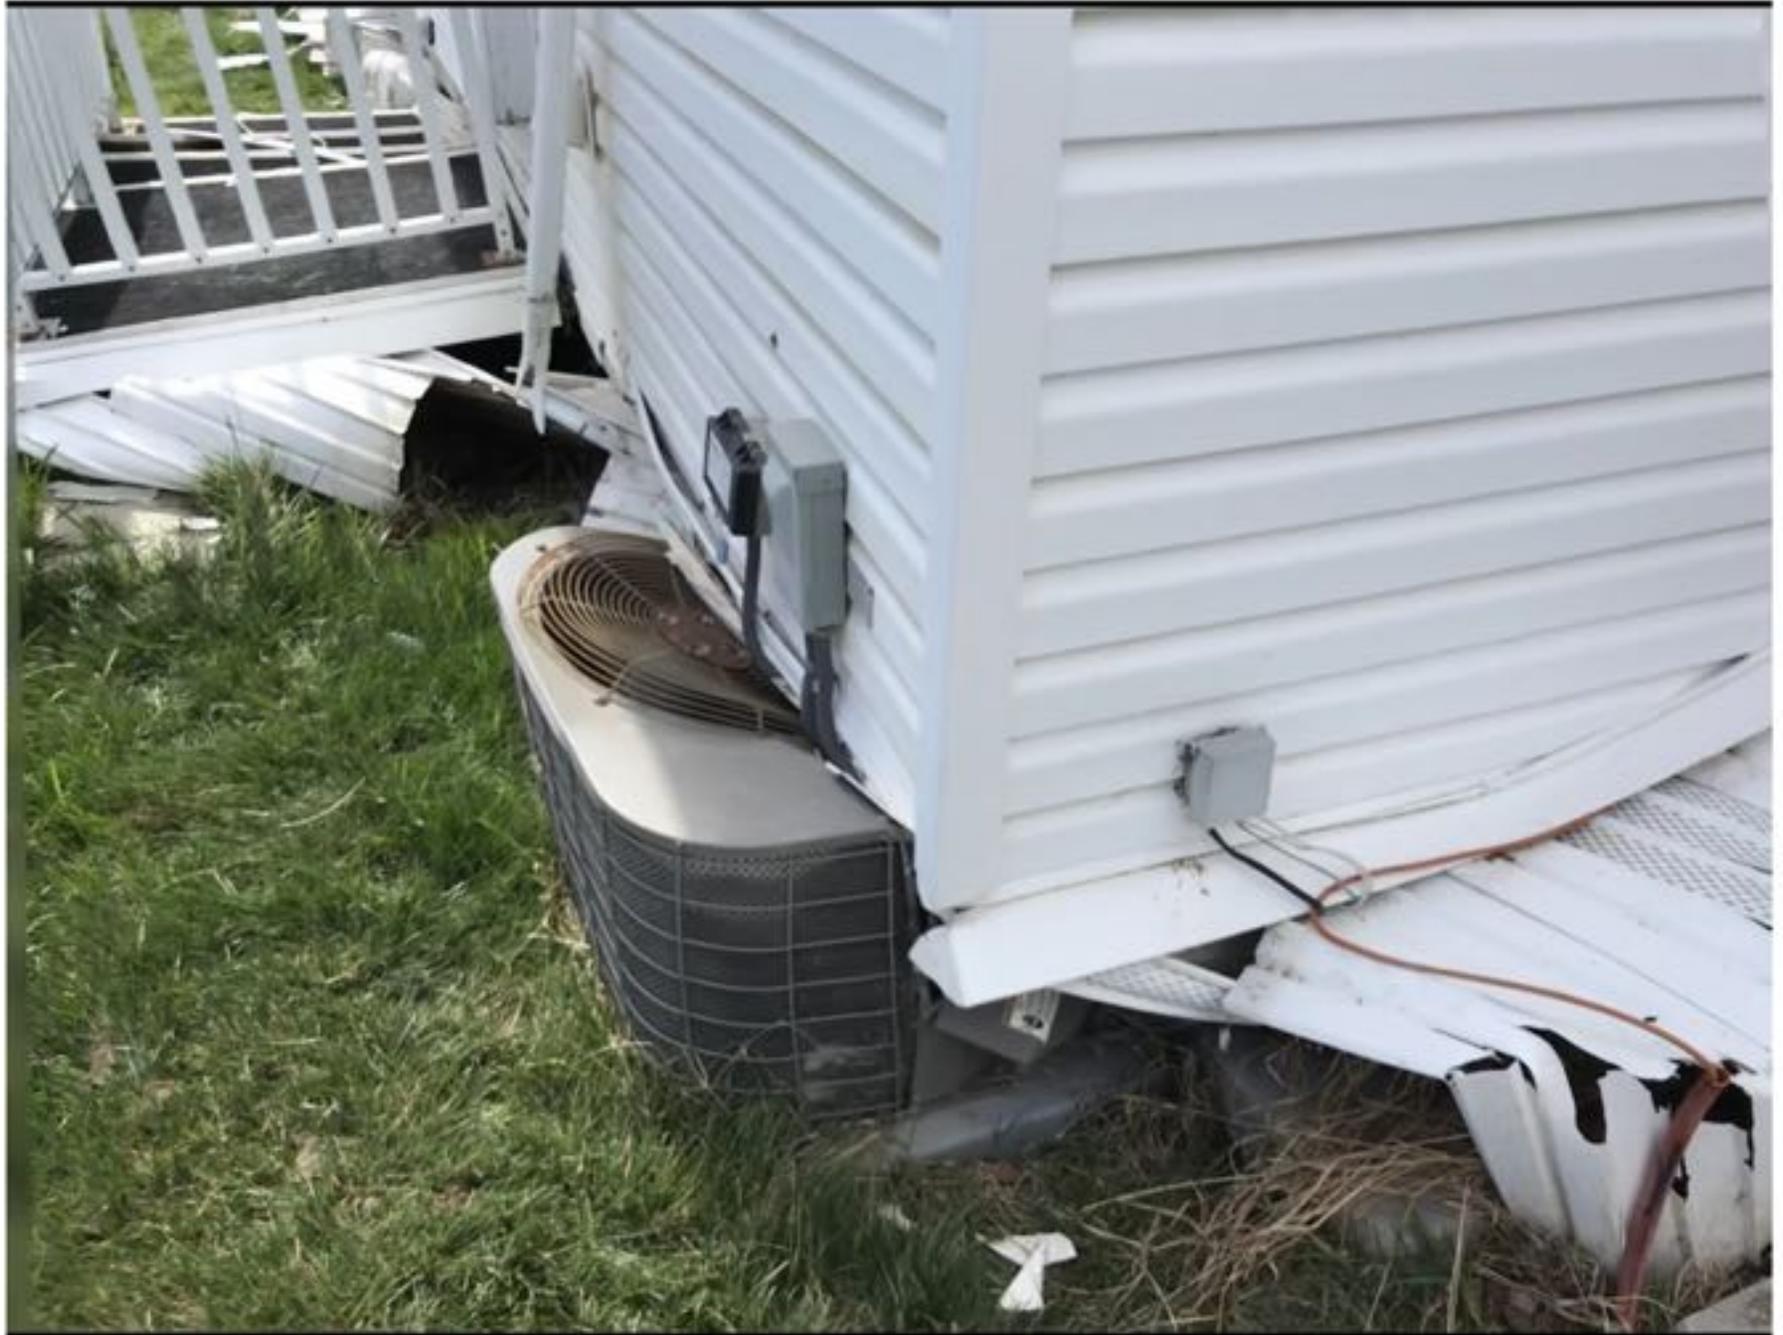
Steel Piers Tipped

Components Nearby Crushed
