Magna M 5.7 2020

John Eiding, G&E

October 23 2020

- Magna M 5.7, March 18 2020
- Gas Pipes in Ridgecrest 2019, Alaska 2018, Napa 2014, Eureka 2010, Northridge 1994, Imperial Valley 1979, San Fernando 1971, Long Beach 1933, and others
- Data analysis (fragility)
- The issue of mobile homes and gas meters

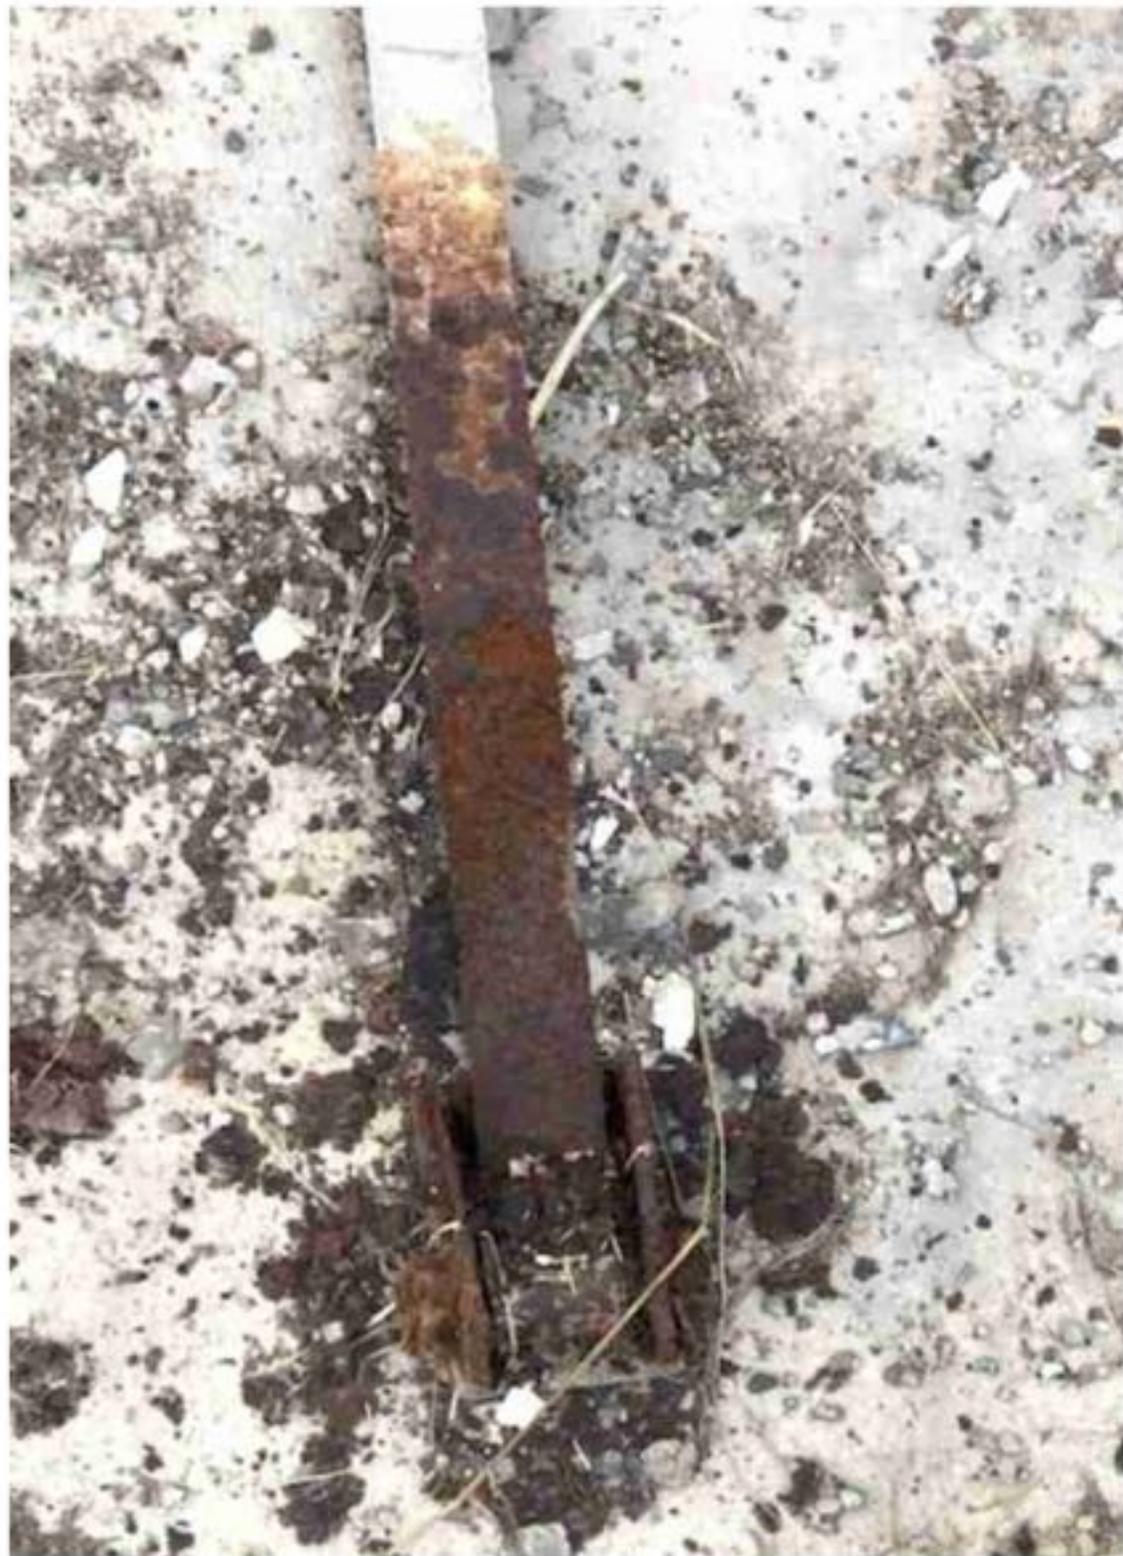
Corrosion Problem

Strap connection to
concrete foundation

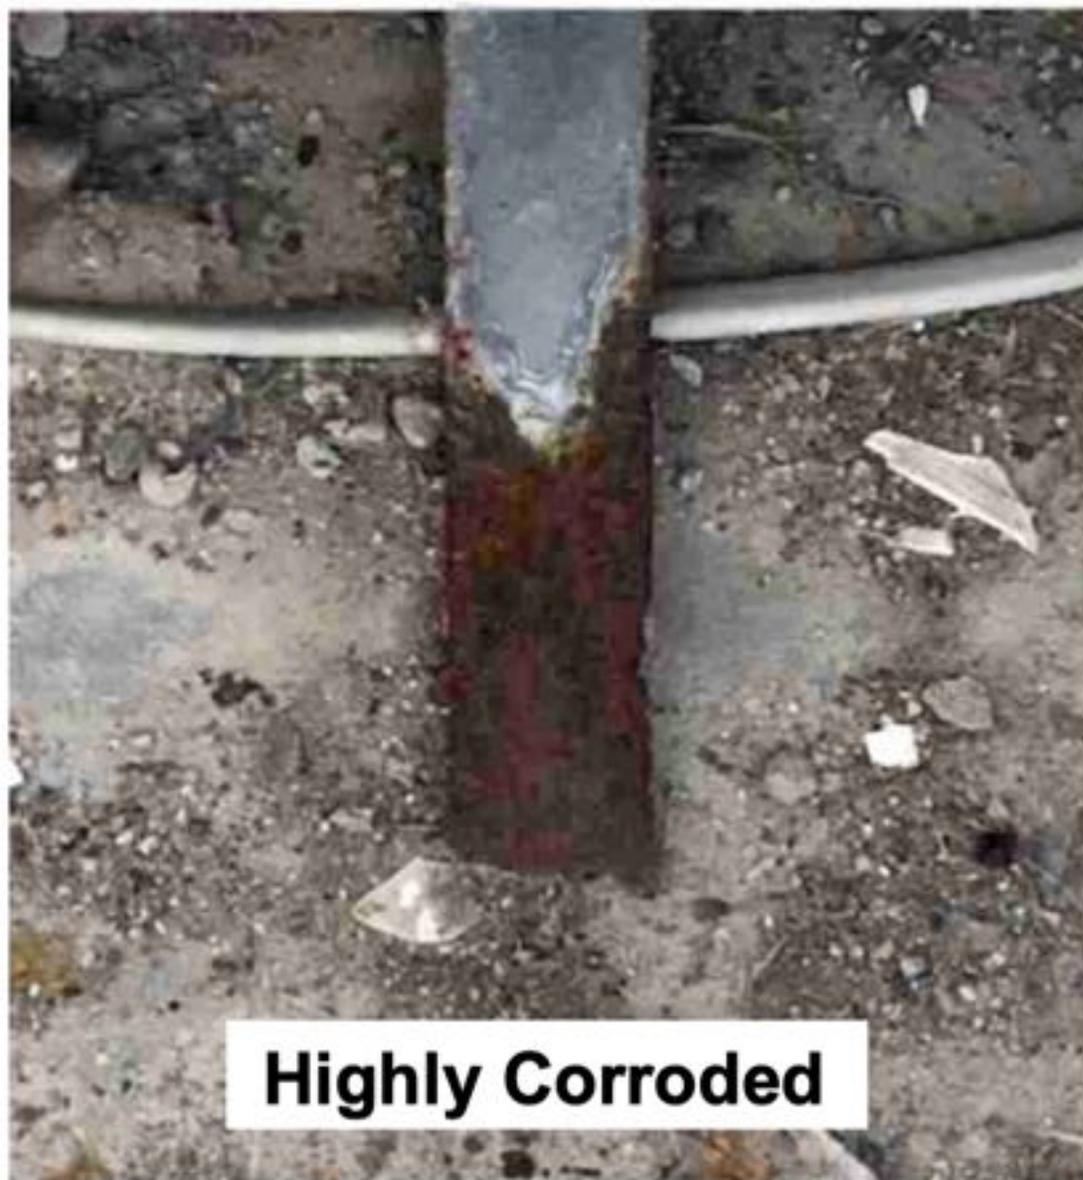
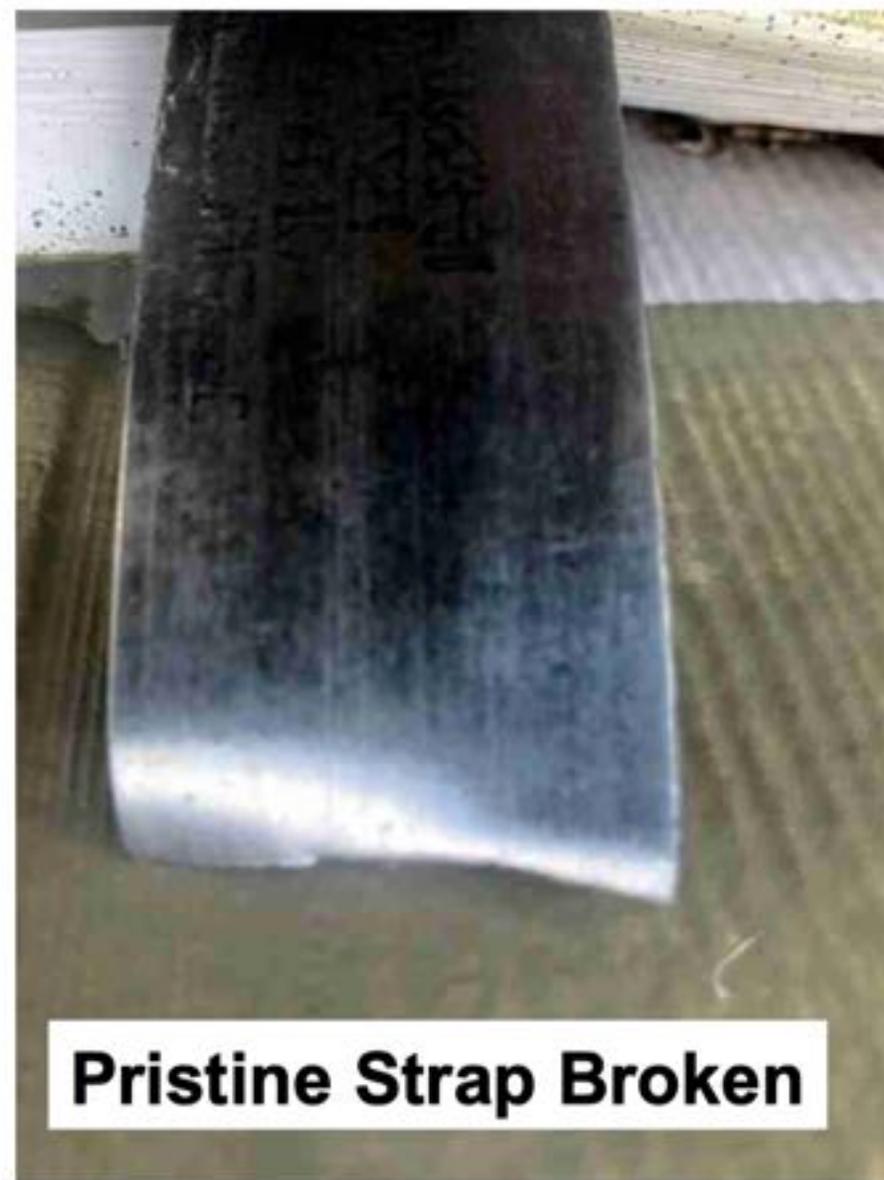
Broken Tie-Down Straps

- Tie-downs for wind forces **NOT** sufficient for EQ
 - Tension straps overloaded in EQ
- Corrosion played role in damage
 - But some collapses even with pristine tie-downs
- Detailed report in-progress
 - Available on EERI ***Learning from Earthquakes*** clearinghouse later this year
