The Great San Francisco 1906 Earthquake: Why Did the Water Transmission Pipes Break at 49 Locations?

John Eiding and N. Timothy Hall

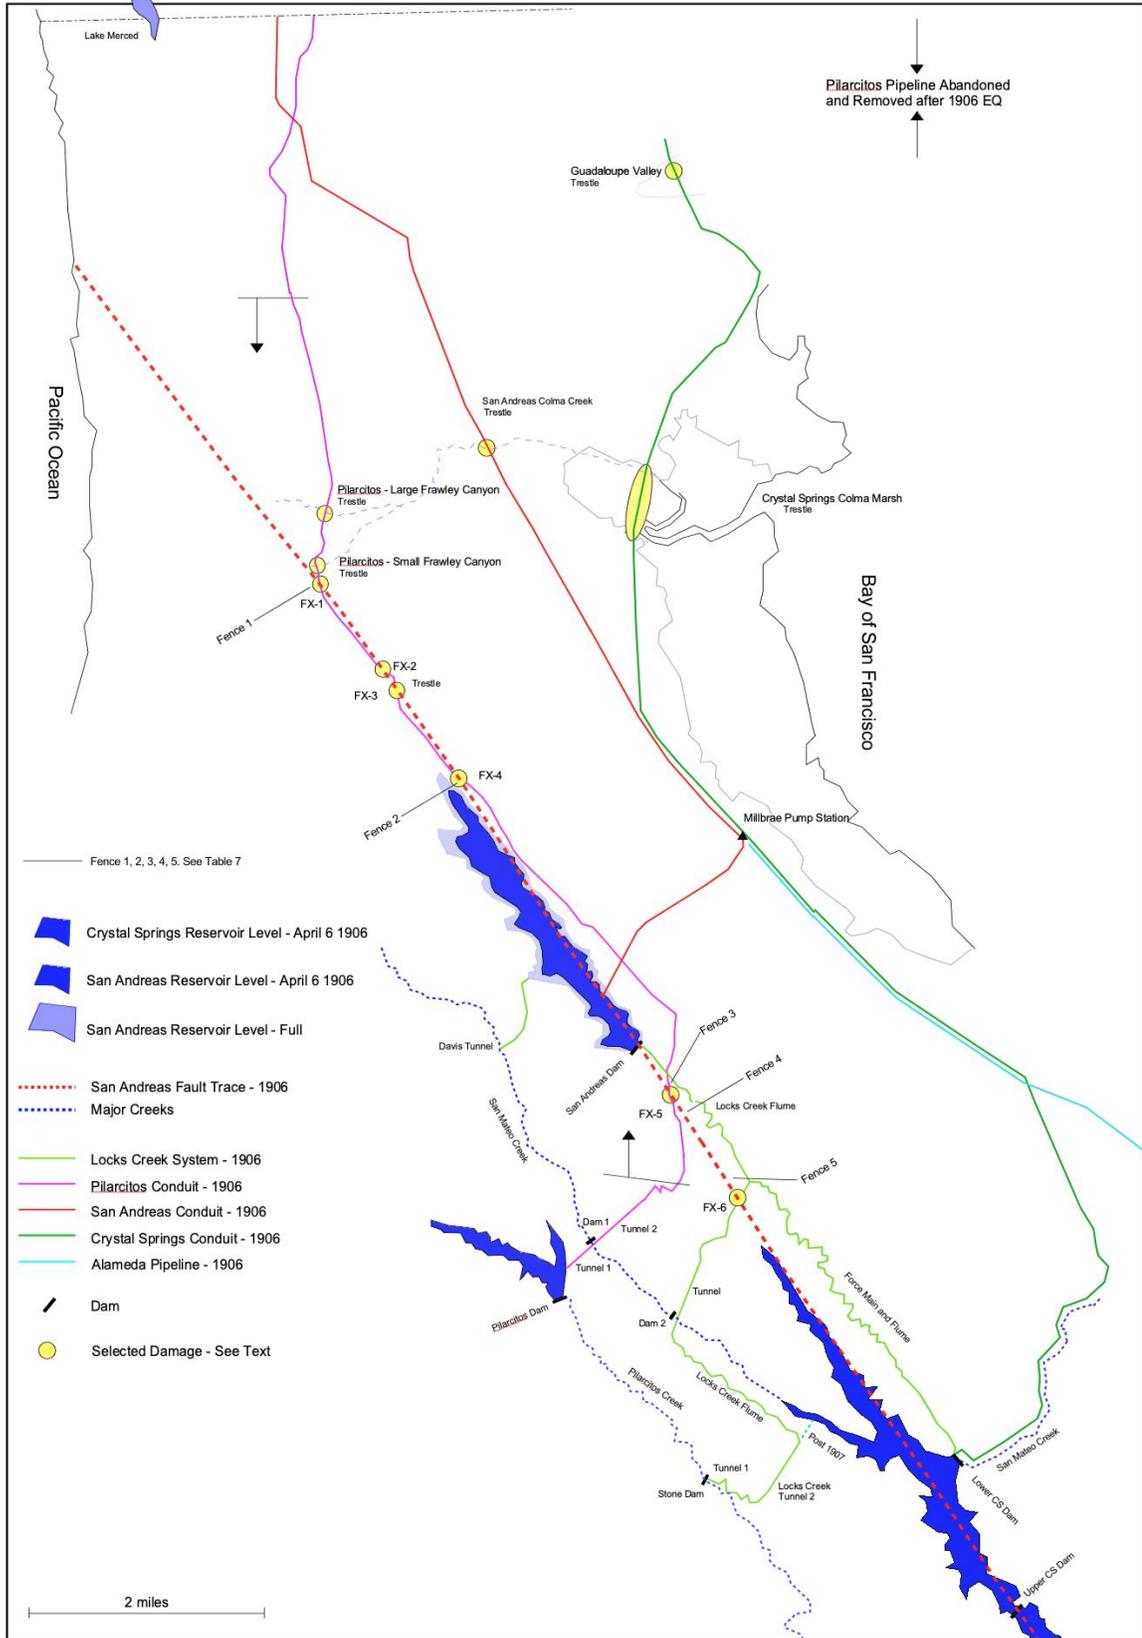
Figure 3. Location of Major Pipeline Damage in the 1906 Earthquake

Pipes at Fault Crossings. There were 6 locations where pipes crossed the primary offset zone of the San Andreas fault: 5 along the Pilarcitos conduit and 1 on the Locks Creek raw water collection system. The 22-inch CI Pilarcitos pipe was exposed to primary fault offset (about 10 feet PGD) (FX-5 in Figure 3), and 4 segments of CI pipe were broken at this location. The buried 30-inch WI-thin Pilarcitos pipe ($t = 0.104\text{-inch}$) was exposed to primary fault offset at 4 different locations (about 7 to 10 feet PGD at each location, FX-1, FX-2, FX-3 and FX-4 in Figure 3), and many pipe segments broke at these locations, no matter if the offset placed the pipe in net tension or compression; always, the weak girth riveted joint broke, and there was no evidence of pipe wrinkling as a failure mode. The 44-inch WI Locks Creek pipe failed with several broken segments where it crossed the San Andreas fault (FX-6 in Figure 3).

The 1906 zone of faulting was narrow and lay along the east boundary of the San Andreas Valley in the areas adjacent to the San Andreas and Upper Crystal Springs reservoirs. It is the only major active trace identified in this segment of the valley. This zone is denoted by the red dashed line in Figure 3.

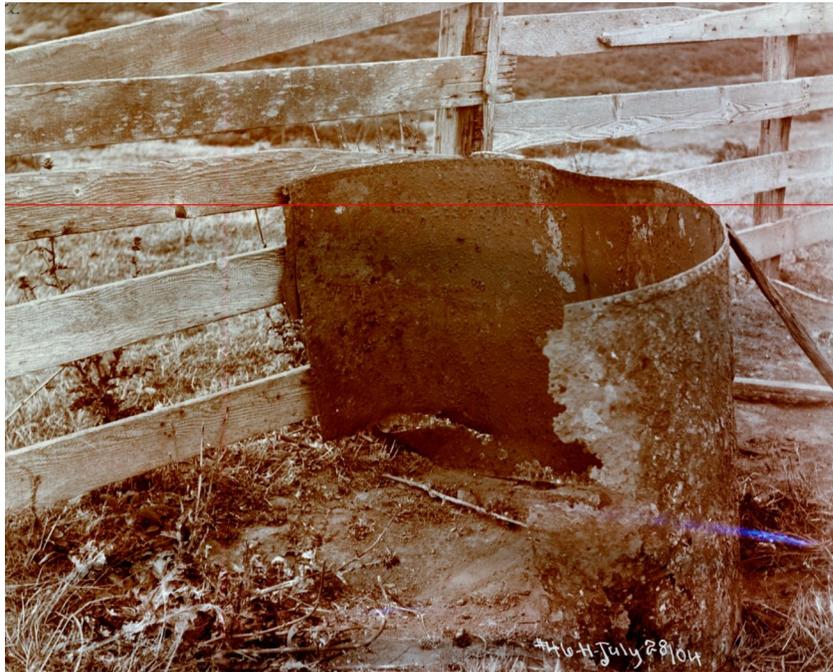
Figure 4. Failure of Pilarcitos 30" Low Pressure Pipe (WI-thin), July 28 1904

- Dip all the WI pipe into asphaltum for corrosion protection. Schussler built a pipe dipping facility in Millbrae for this purpose. There were no sacrificial anodes or impressed current used for corrosion control. There were no interior cement mortar linings used for erosion protection of the inside of the pipe. There was no water chemistry control (such as the addition of alum) to keep the pH of the pipe slightly basic (7.5 or so). In 1904, a 500 foot length of the 30-inch Pilarcitos pipeline (thin walled WI pipe directly east of San Andreas reservoir) failed: Figure 4 indicates the failure was due to corrosion of the thin-walled pipe.

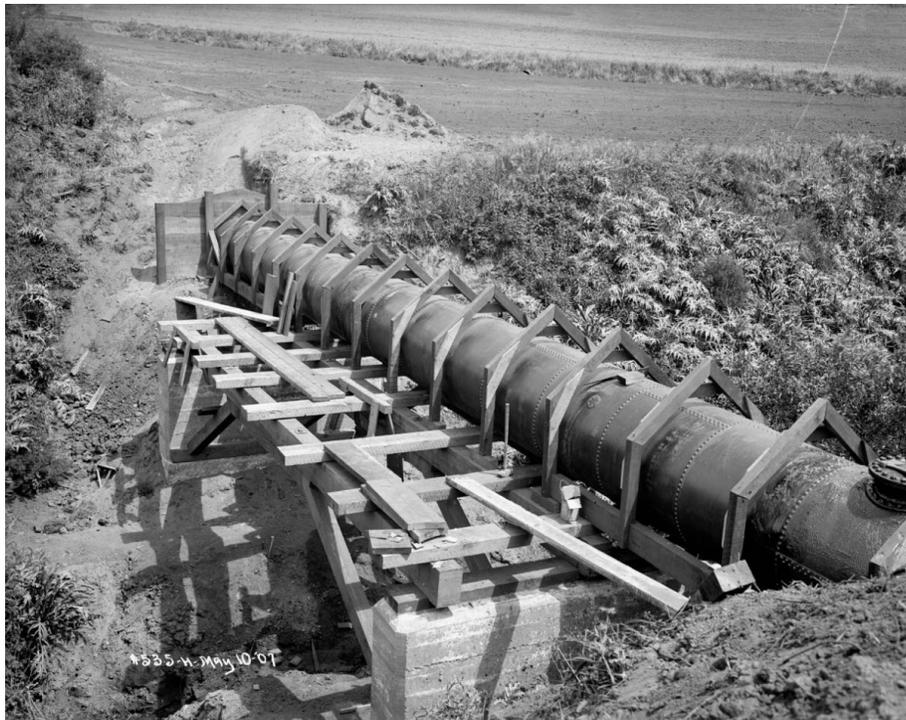
- Where the pipe traversed creeks, support the pipe atop a short wooden trestle over the creek. Figure 5 shows one such installation, constructed in 1907, supporting a 30-inch pipeline (a portion of the same Pilarcitos pipe that was dug up after the 1906 earthquake). Trestle spans were commonly 12 to 16 feet. At each creek crossing, a blow off (commonly an 8-inch pipe with a gate valve) was included to allow draining of the pipe for maintenance purposes. It was not until 1923 that burying large pipe under creeks become a common practice.

Figure 5. 30-inch Pilarcitos Pipe at Creek Crossing (1907)
