Chapter 3. Water and Wastewater System Performance in the August 17, 1999 Izmit (Kocaeli), Turkey Earthquake

Abstract

This chapter describes damage to several water and wastewater systems that were affected by the M_w 7.4 earthquake of August 17, 1999, with epicenter near Izmit, Turkey. Figure 1 shows the main locations covered in this chapter.

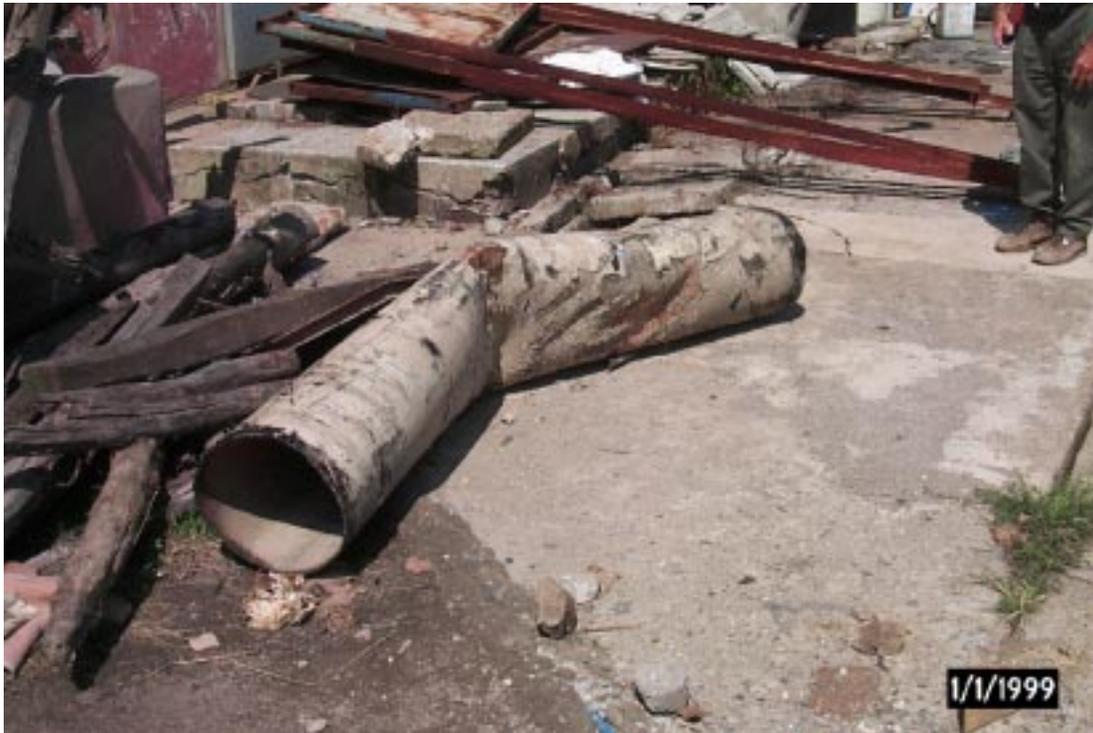
Once water supply was restored from Lake Sapanca, it was discovered that there were many pipeline breaks in the Arifiye area. Of largest concern was the damage to the 350 mm (14 inch) diameter welded steel pipeline (wall thickness 4 mm) where it crossed the fault trace. Once this pipeline was repaired, water supply could be restored to all regions of the lower zone, and the backbone pipes of the upper zone.

Figure 4. Ovalized Steel Pipeline, Removed From Fault Offset Location, Arifiye

The 350 mm steel pipeline (Figure 4) was damaged due to right lateral fault offset of about 3.6 m (12 feet). The pipeline crossed the fault at about a 70 degree orientation, placing the pipeline in tension due to the offset (90 degrees = the pipe is perpendicular to the fault). Contributing factors to the pipeline damage could be the large amount of offset; a possible concrete encasement of the pipeline where it crossed beneath the motorway; and a mitred joint in the pipeline where it changed direction to go under the motorway. Note the significant amount of ovalization in the piece of steel pipeline that

was removed (Figure 4); according to the City Manager in charge of pipeline repairs, the ovalization shown in Figure 4 was exactly how the pipe looked before it was taken out of the ground.

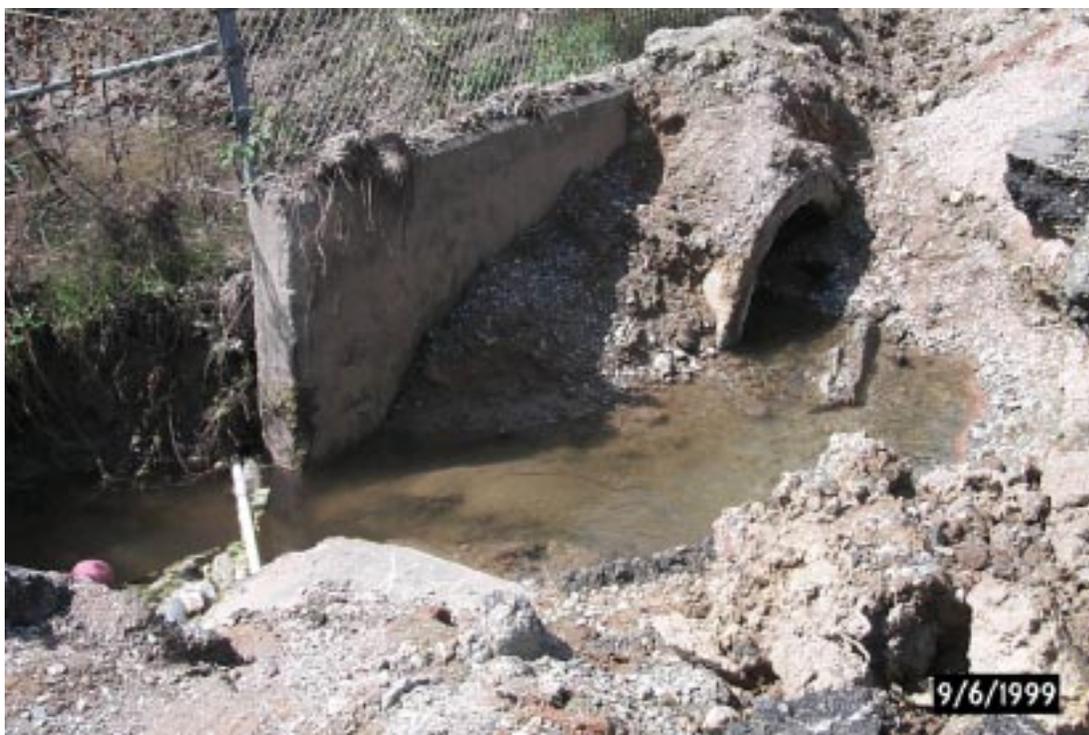
Similar damage was sustained to the sanitary and storm sewer systems in Arifiye. Figure 5 shows about 10 feet of right lateral offset of a storm sewer, where it crossed the trace of the fault.

Figure 5. Fault Offset Through Storm Drain, Arifiye

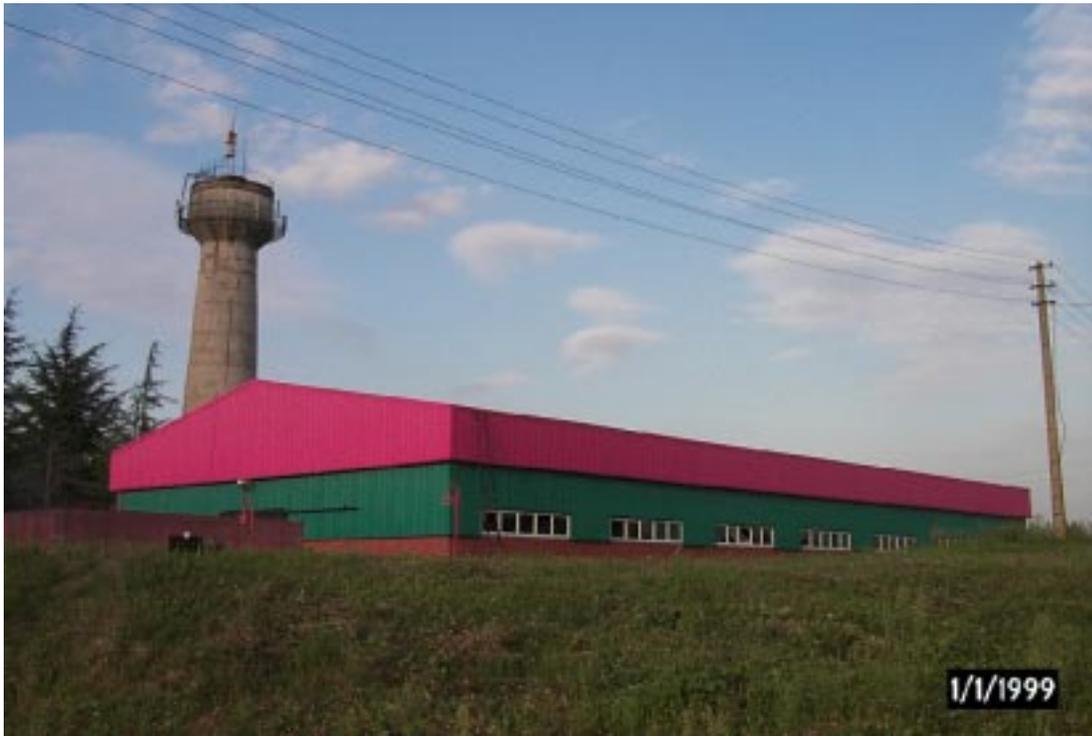
The steel enclosure (Figure 6) building suffered no visible damage.

Figure 6. Maltepe Water Treatment Plant (Steel Building and Elevated Concrete Tank)

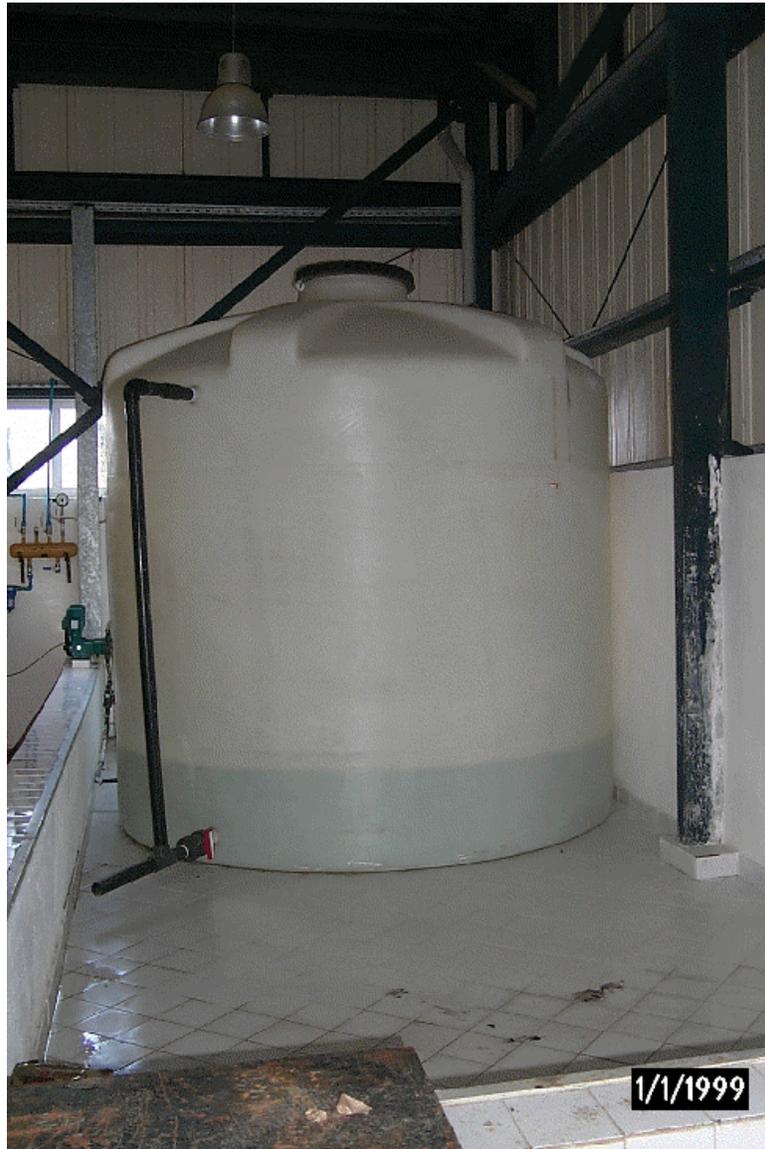
The chemicals used for treatment (chlorine, alum) were housed in plastic tanks. These tanks were not anchored, and likely slid sideways small amounts during the earthquake. However, the attached chemical line pipes (PVC) were apparently sufficiently flexible (few / no anchor points observed) and had no reported damage.

Figure 7, Unanchored Plastic Tanks – Maltepe WTP

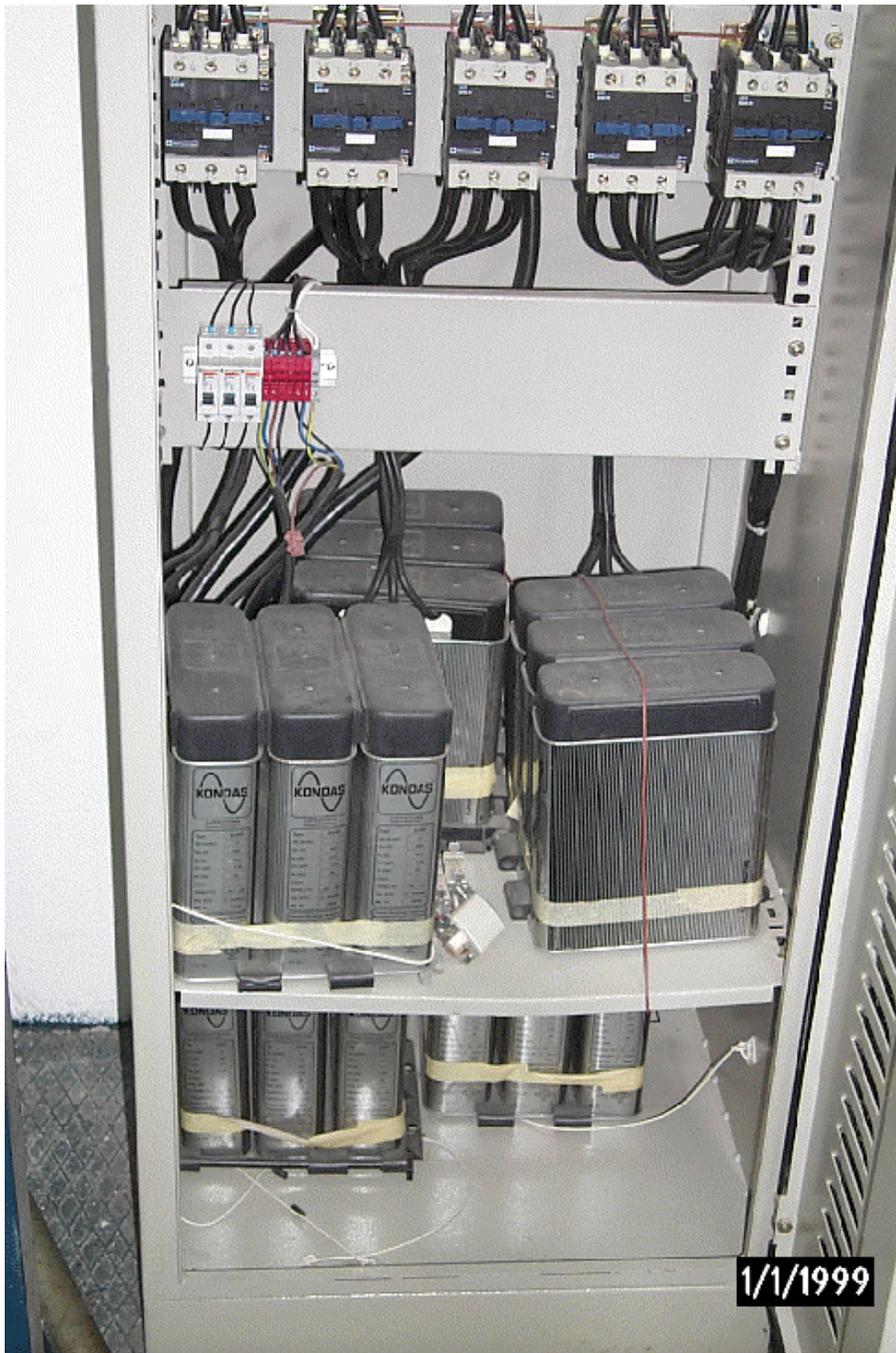
Figure 8. Unanchored Batteries at Maltepe WTP. They Tipped Over in the Earthquake

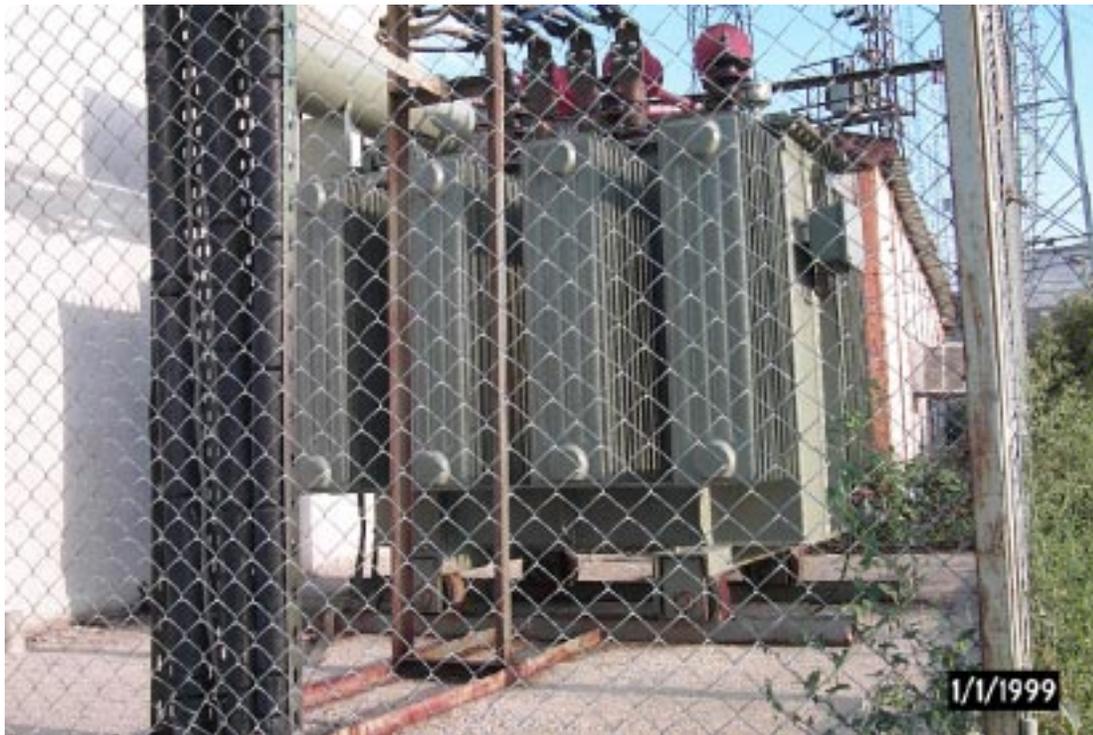
- The power transformer used for the booster pump station and the WTP was installed on roller wheels. One bushing of the transformer had been damaged and replaced (Figure 9).

Figure 9. Unanchored Transformer Serving Maltepe WTP. A Bushing was Damaged.

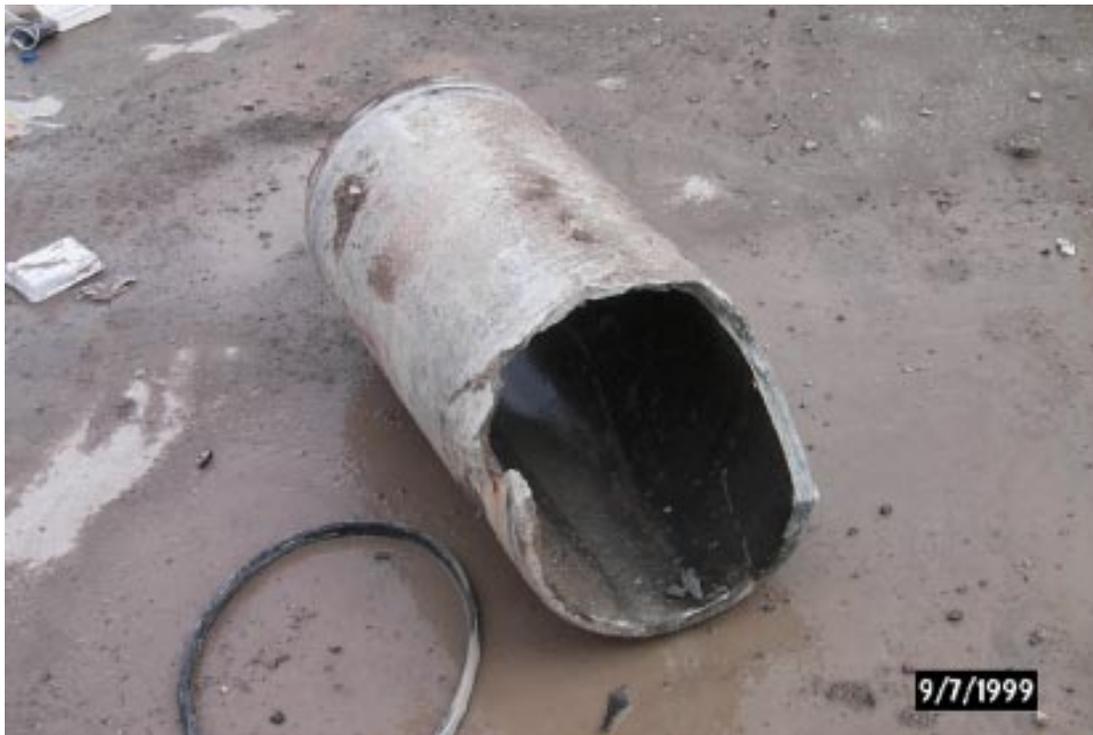
Figure 11. Damage to 14" Diameter AC Pipe – Liquefaction Area

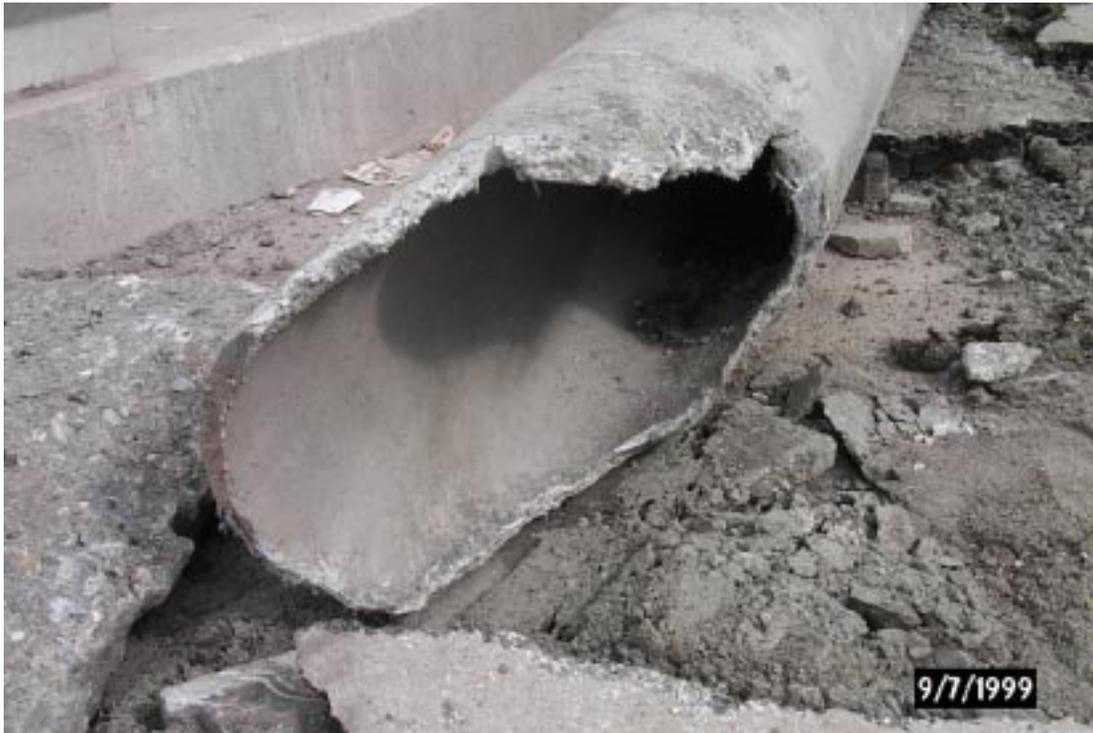
Figure 12. Common Damage Pattern to AC Pipe In Areas with Settlement

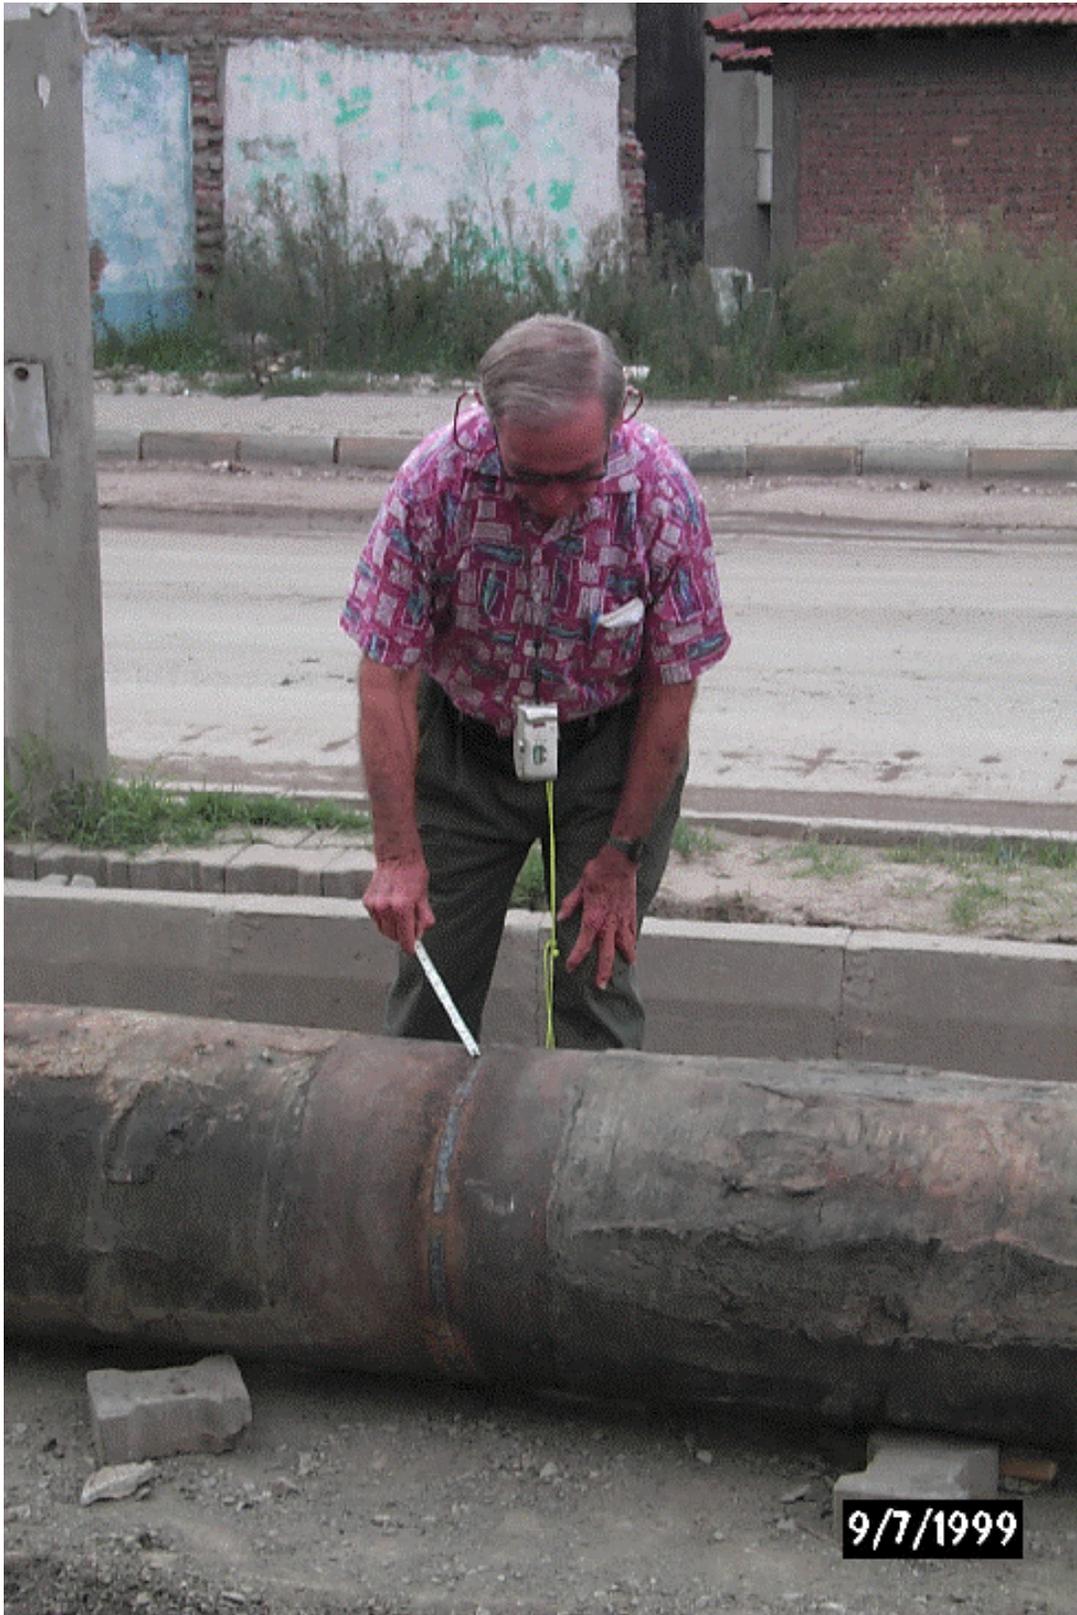
Figure 13. New 16" Diameter Butt Welded Pipe for Replacement of AC Pipe

For the main distribution pipeline serving the downtown area (18" diameter), the entire length of AC pipe was being dug up and replaced with butt welded steel pipe. Our investigation team noted that the effort was going along at about a 200 feet of pipe replacement per day, using a single crew. Figure 13 shows the replacement steel pipe outside the trench, ready for installation. Note the following: the replacement steel pipe uses bevelled joints; there is no interior lining for the steel pipe; the exterior coating appears to be a coal tar finish; there are no special safety precautions used to construct and maintain the trench; there appears to be special soil bedding or compaction being used for the new steel pipe; there is evidence that liquefaction occurred adjacent to the alignment. It appeared from our limited observations that the repairs to the distribution system did not include flushing the pipeline with super-chlorinated water prior to returning the line to service.

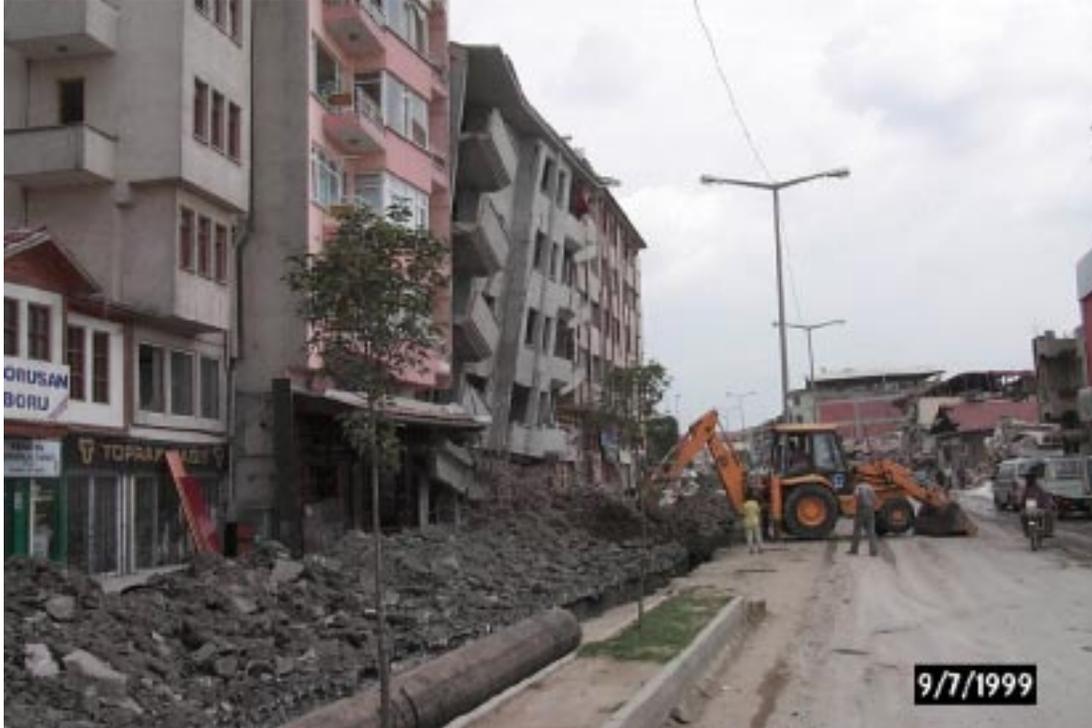
Figure 14. Installation of New Butt Welded Steel Pipe – Adapazari

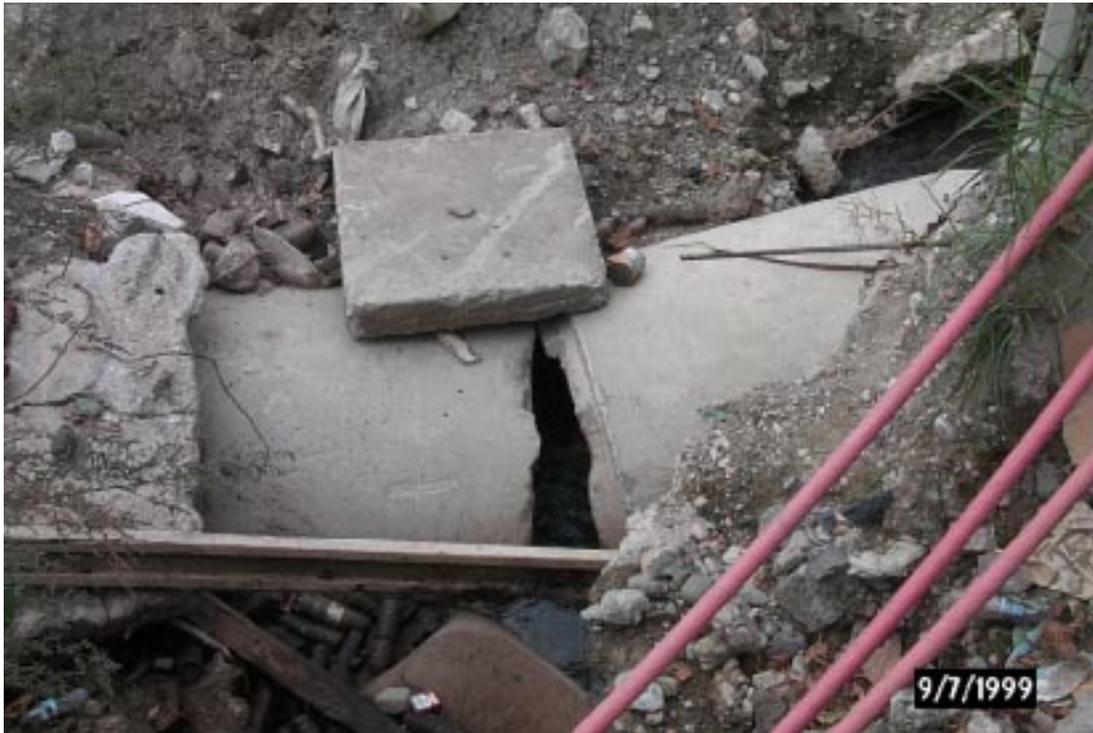
The earthquake caused heavy damage to the collection system. In some areas, temporary bypasses had been made to allow the broken sanitary sewers to discharge into the storm water collection system. Figure xx shows such a location, with solids floating down the storm channel.

Figure 15. Broken Sanitary Sewer in Adapazari.

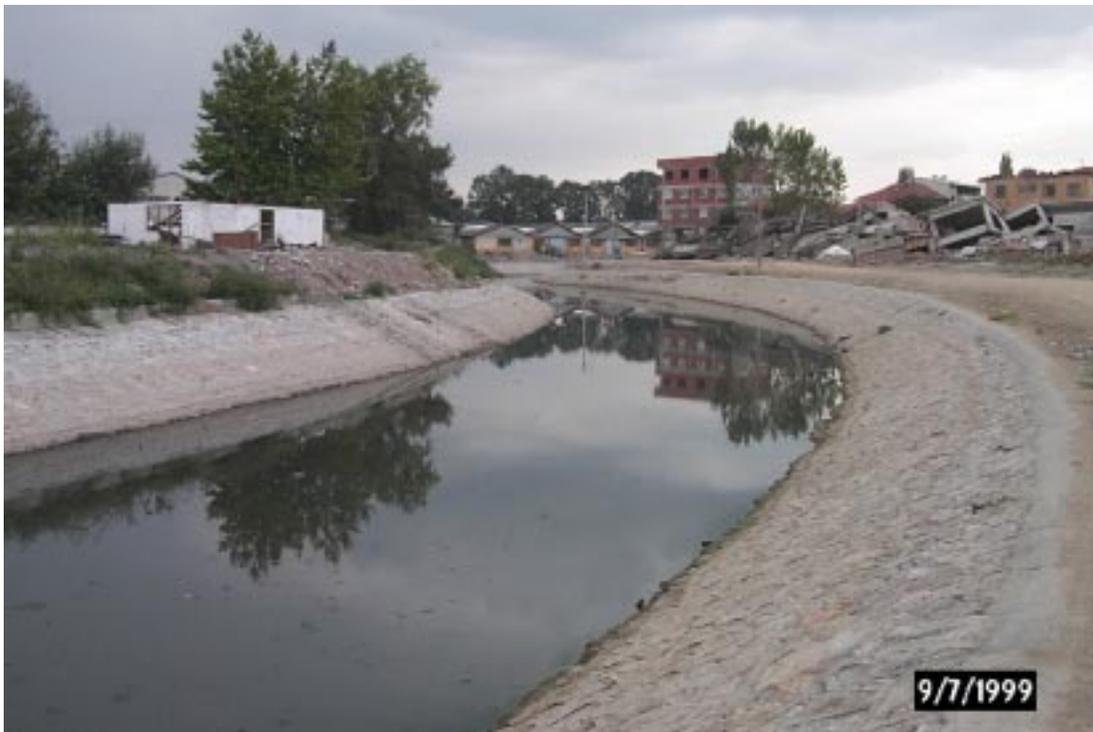
Figure 16. Solids in Storm Canal Due to Combined Flow from Broken Sanitary Sewers

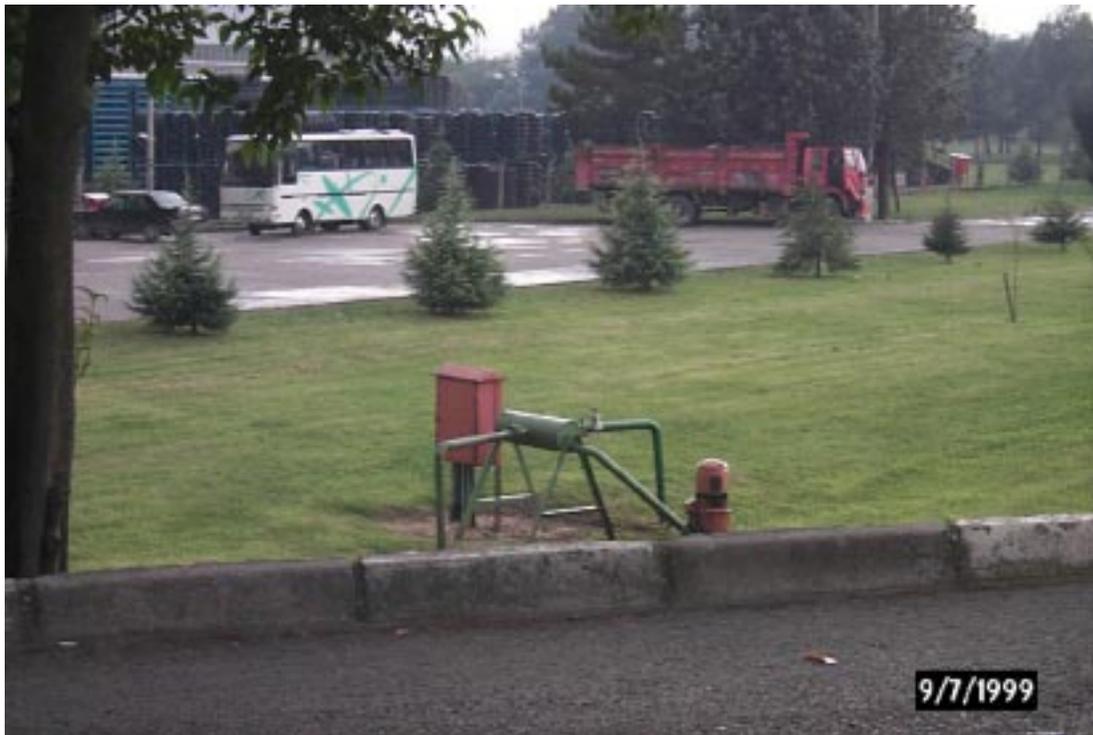
Figure 17. Well at Goodyear Tire Facility – No Damage

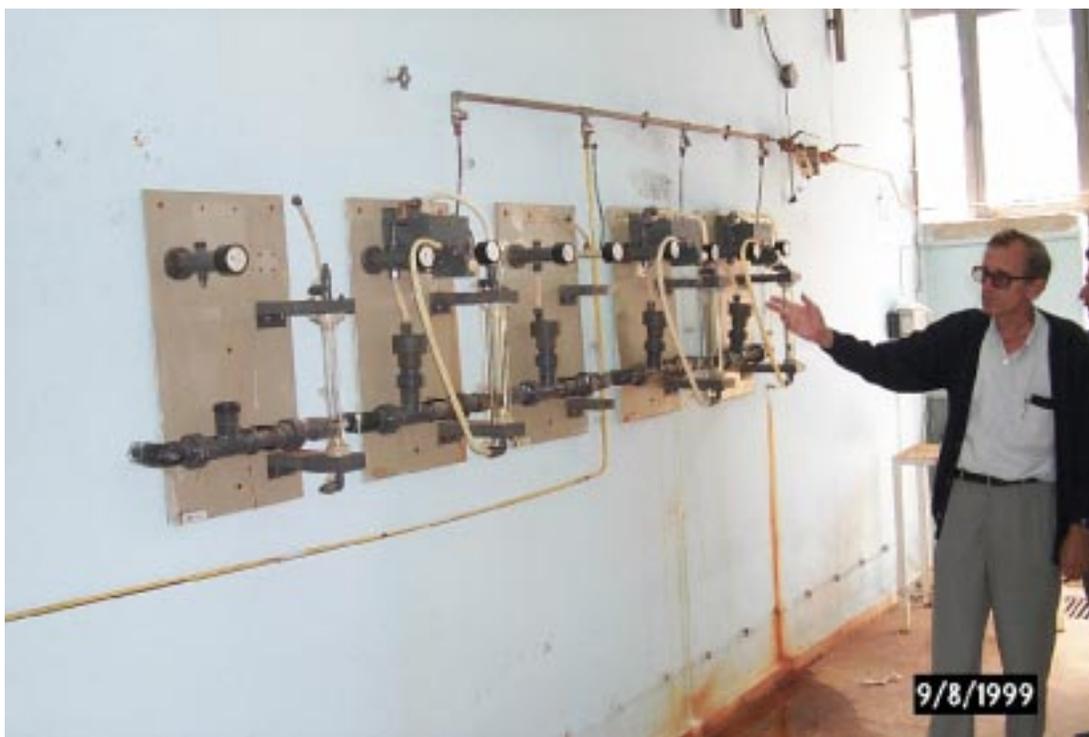
Figure 18. Damage to Five Chlorine Mixing Units – Yalova WTP

Damage to the WTP was limited to the loss of all five chlorine mixing units. Sodium hypochlorite was manually added to the finished water while repairs to the mixing units were made. As of September 8, only 3 of the 5 mixing units had been repaired.

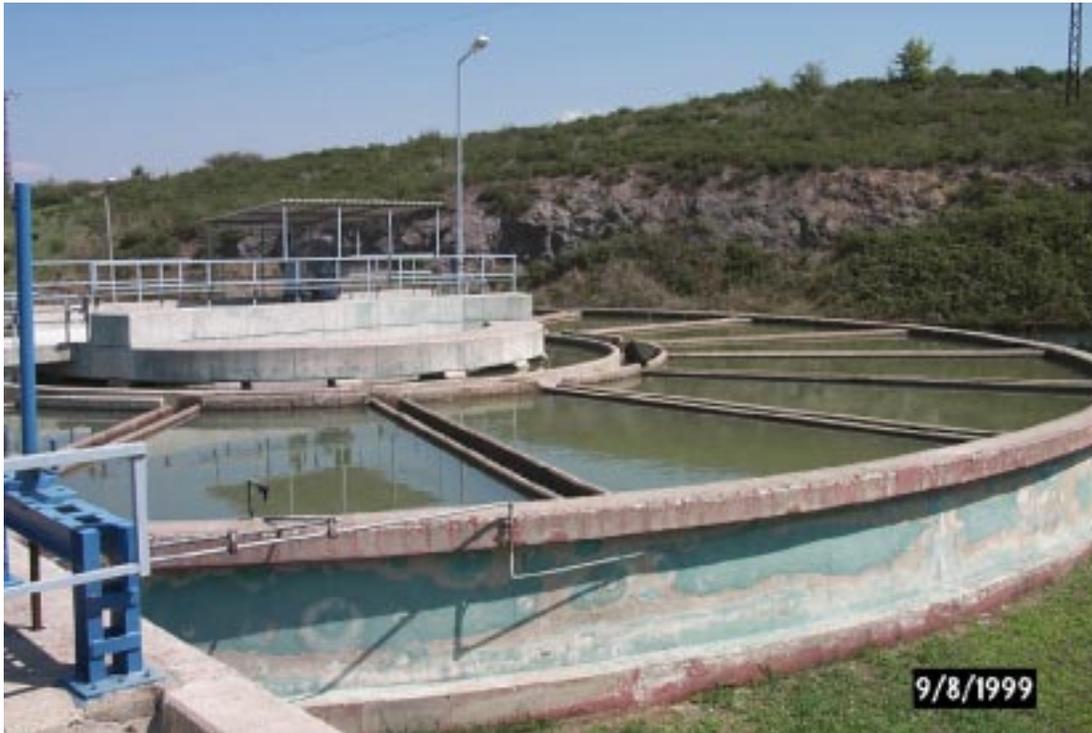
The apparent lack of other types of damage to the facility can be attributed to the following factors. The level of ground shaking at the site was moderate (0.10g to 0.20g range estimated); all clarifiers were reinforced concrete, with all internal baffles and water troughs and intermediate basin walls also made from reinforced concrete. The main filter beds also used reinforced concrete water troughs. The site is on a hillside, characterized as a rock foundation. While the plant did well overall, we noted that the one ton chlorine tanks were unanchored (not strapped); lab equipment (glassware and countertop equipment) had not toppled; nearby housing structures of average structural quality were not damaged.

Figure 19. Clarifiers at Yalova WTP. No Damage to RC Water Troughs or Baffles
