# Puebla M 7.1 Earthquake of Sept 19 2017 Impact to Water and Power

John Eiding, Bruce Maison  
[eiding@geEngineeringSystems.com](mailto:eiding@geEngineeringSystems.com)  
[maison@netscape.com](mailto:maison@netscape.com)

Updated 9.14.2018

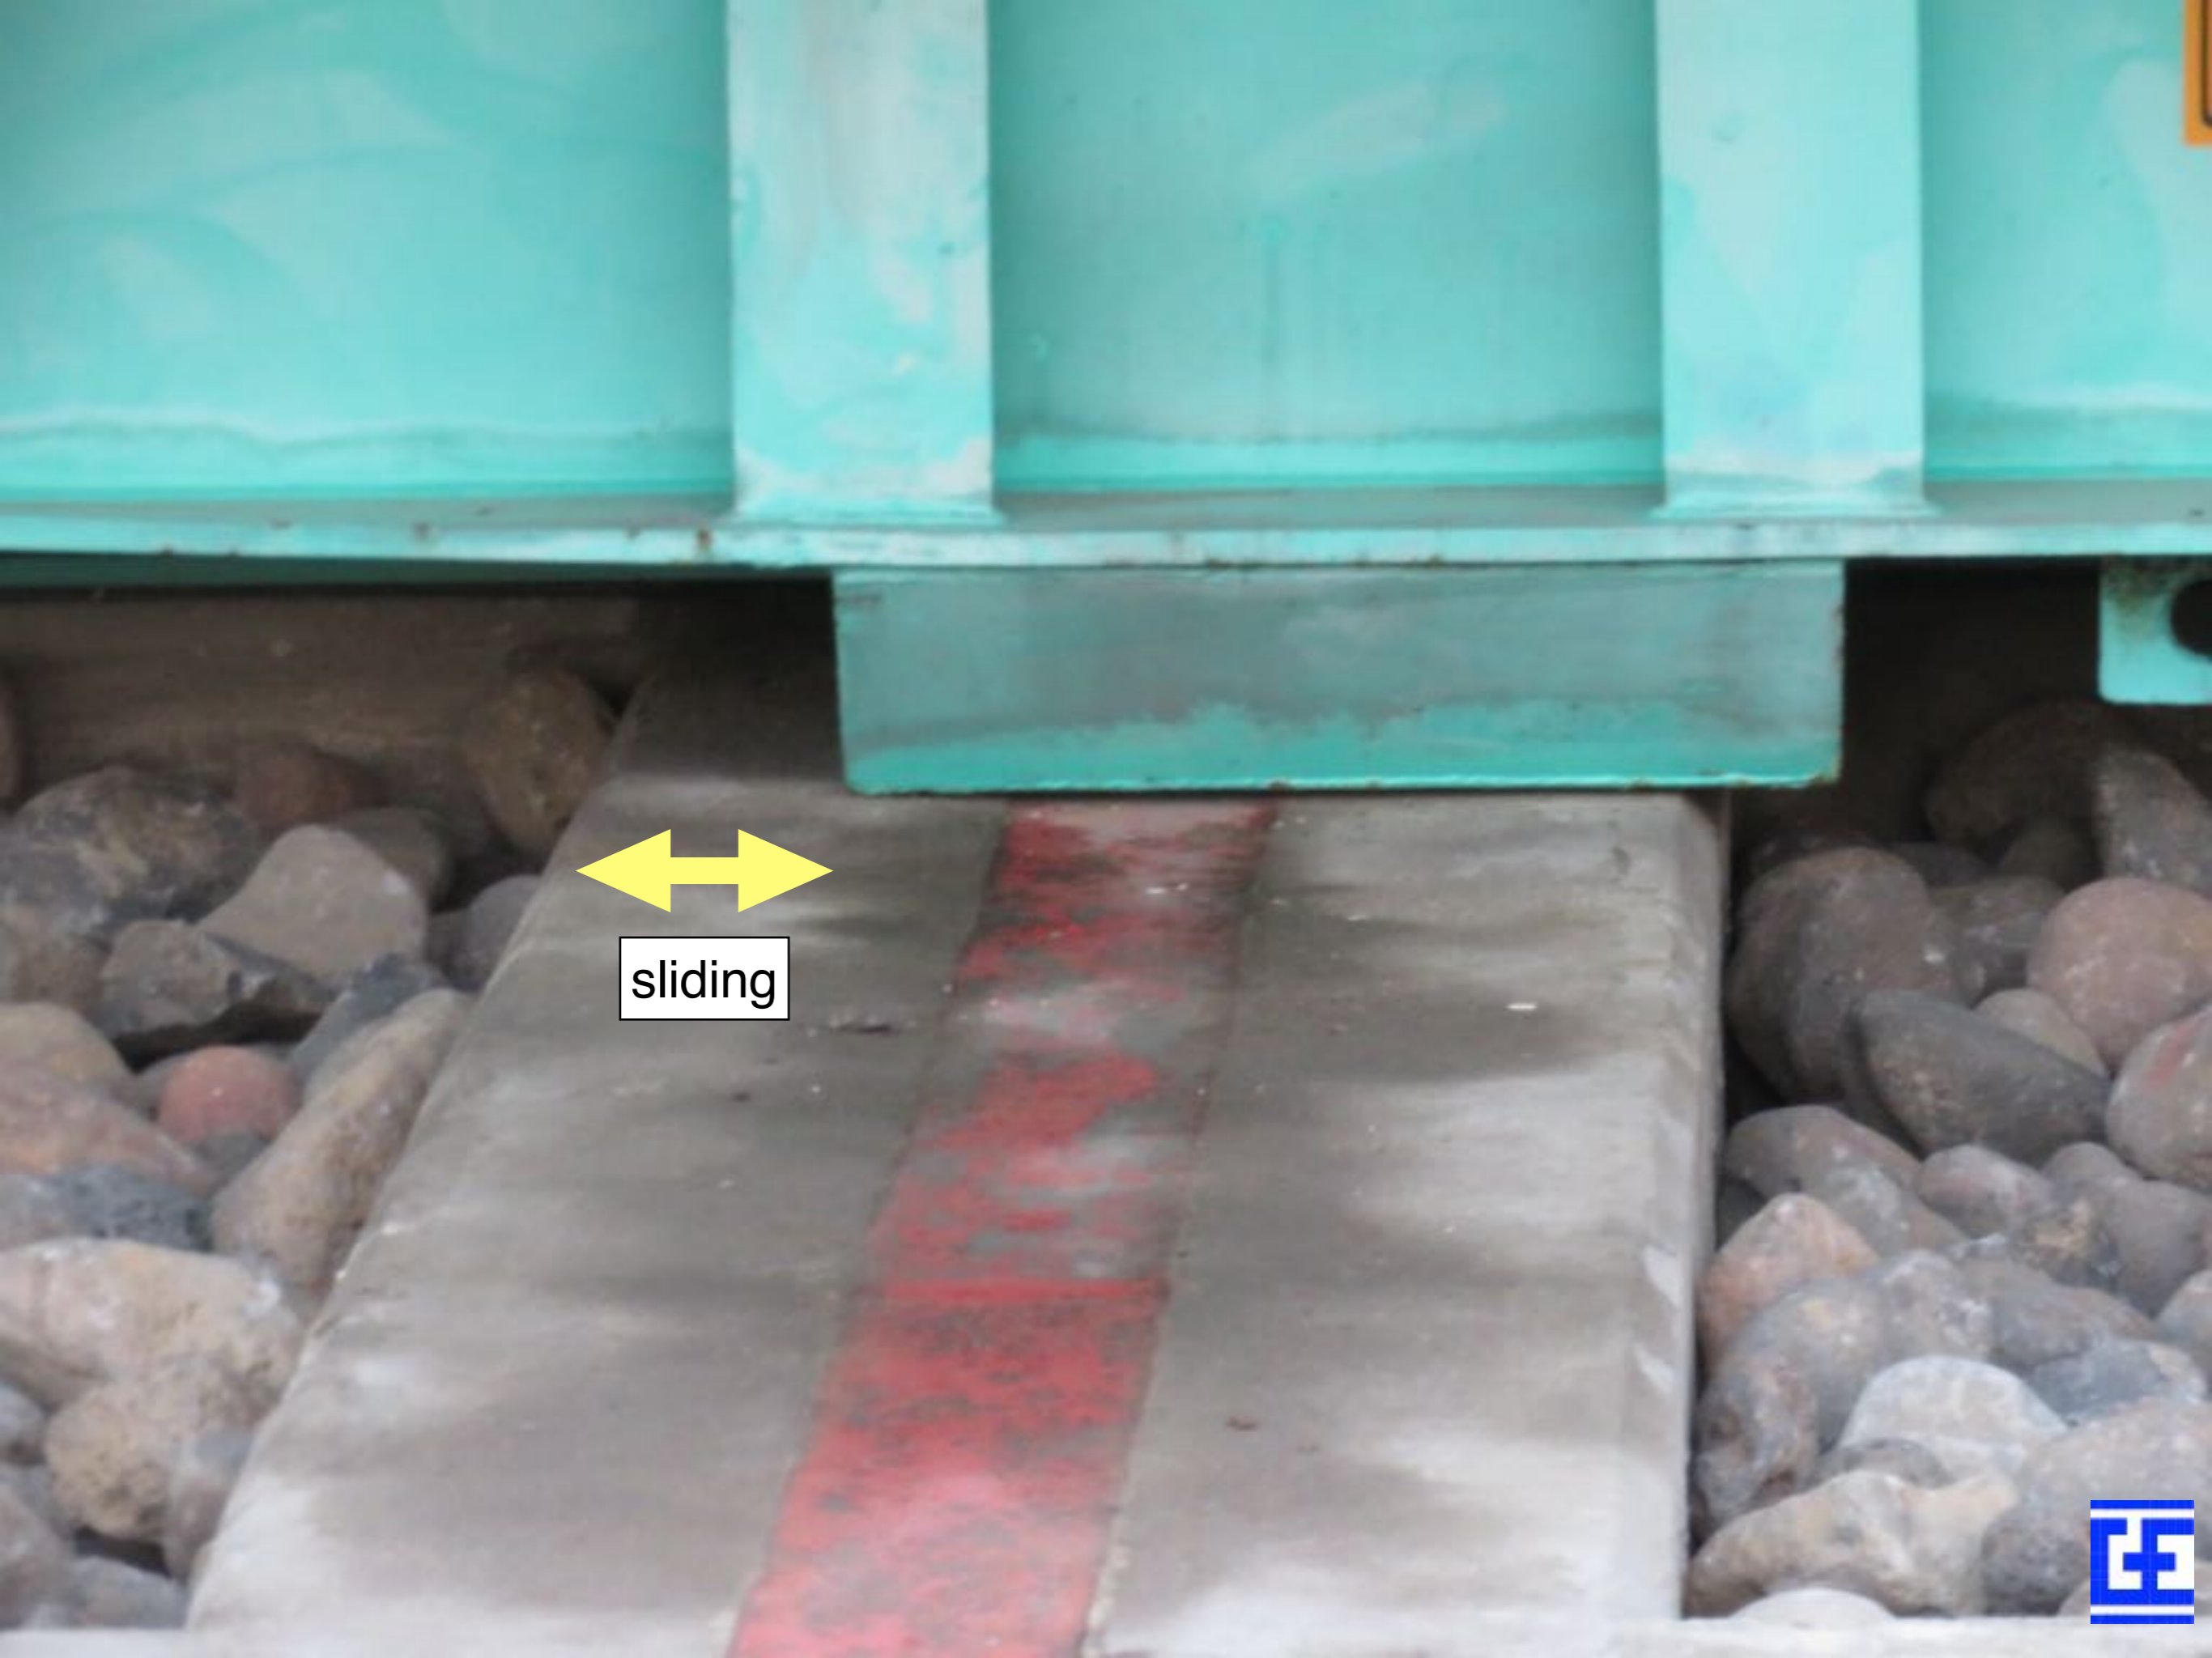
400 kV Transformers (11) (4 x 400-115; 7 x 400-230)

All unanchored

1 slid ~7 inches

1 slid ~2 inches

9 showed ~0 to 1 inch sliding

Many control cables deformed, none reported damaged

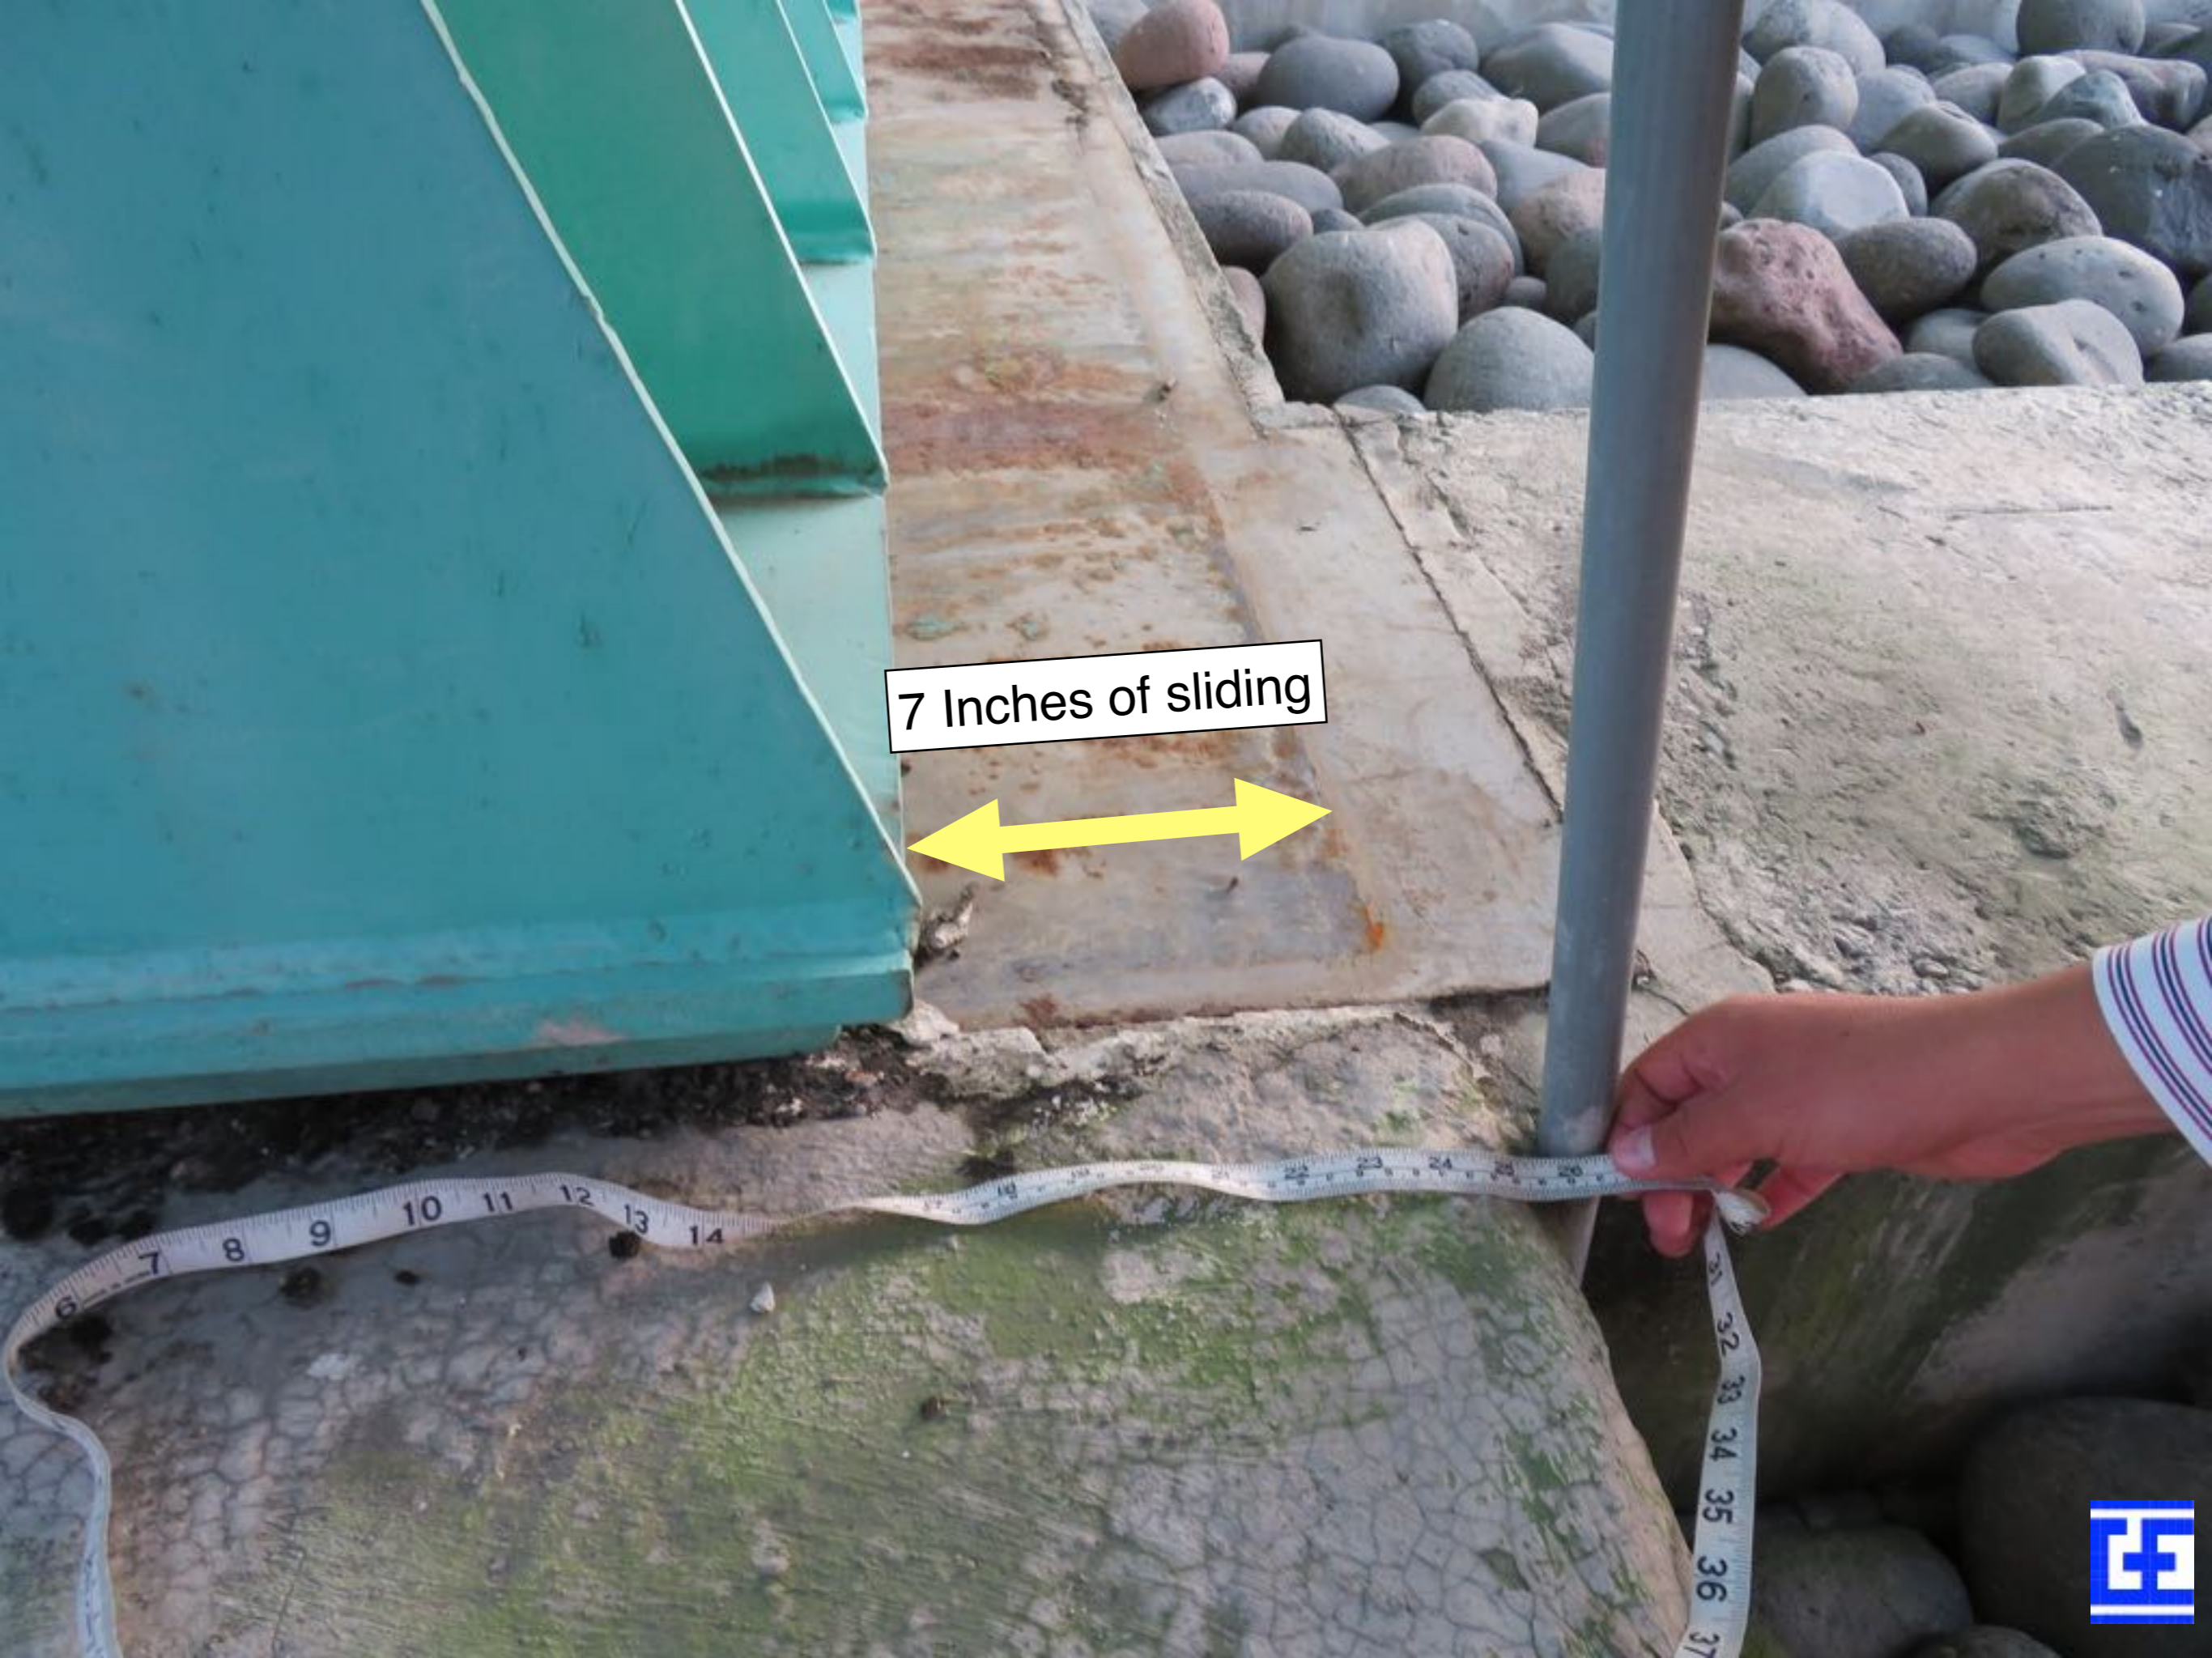
7 Inches of sliding

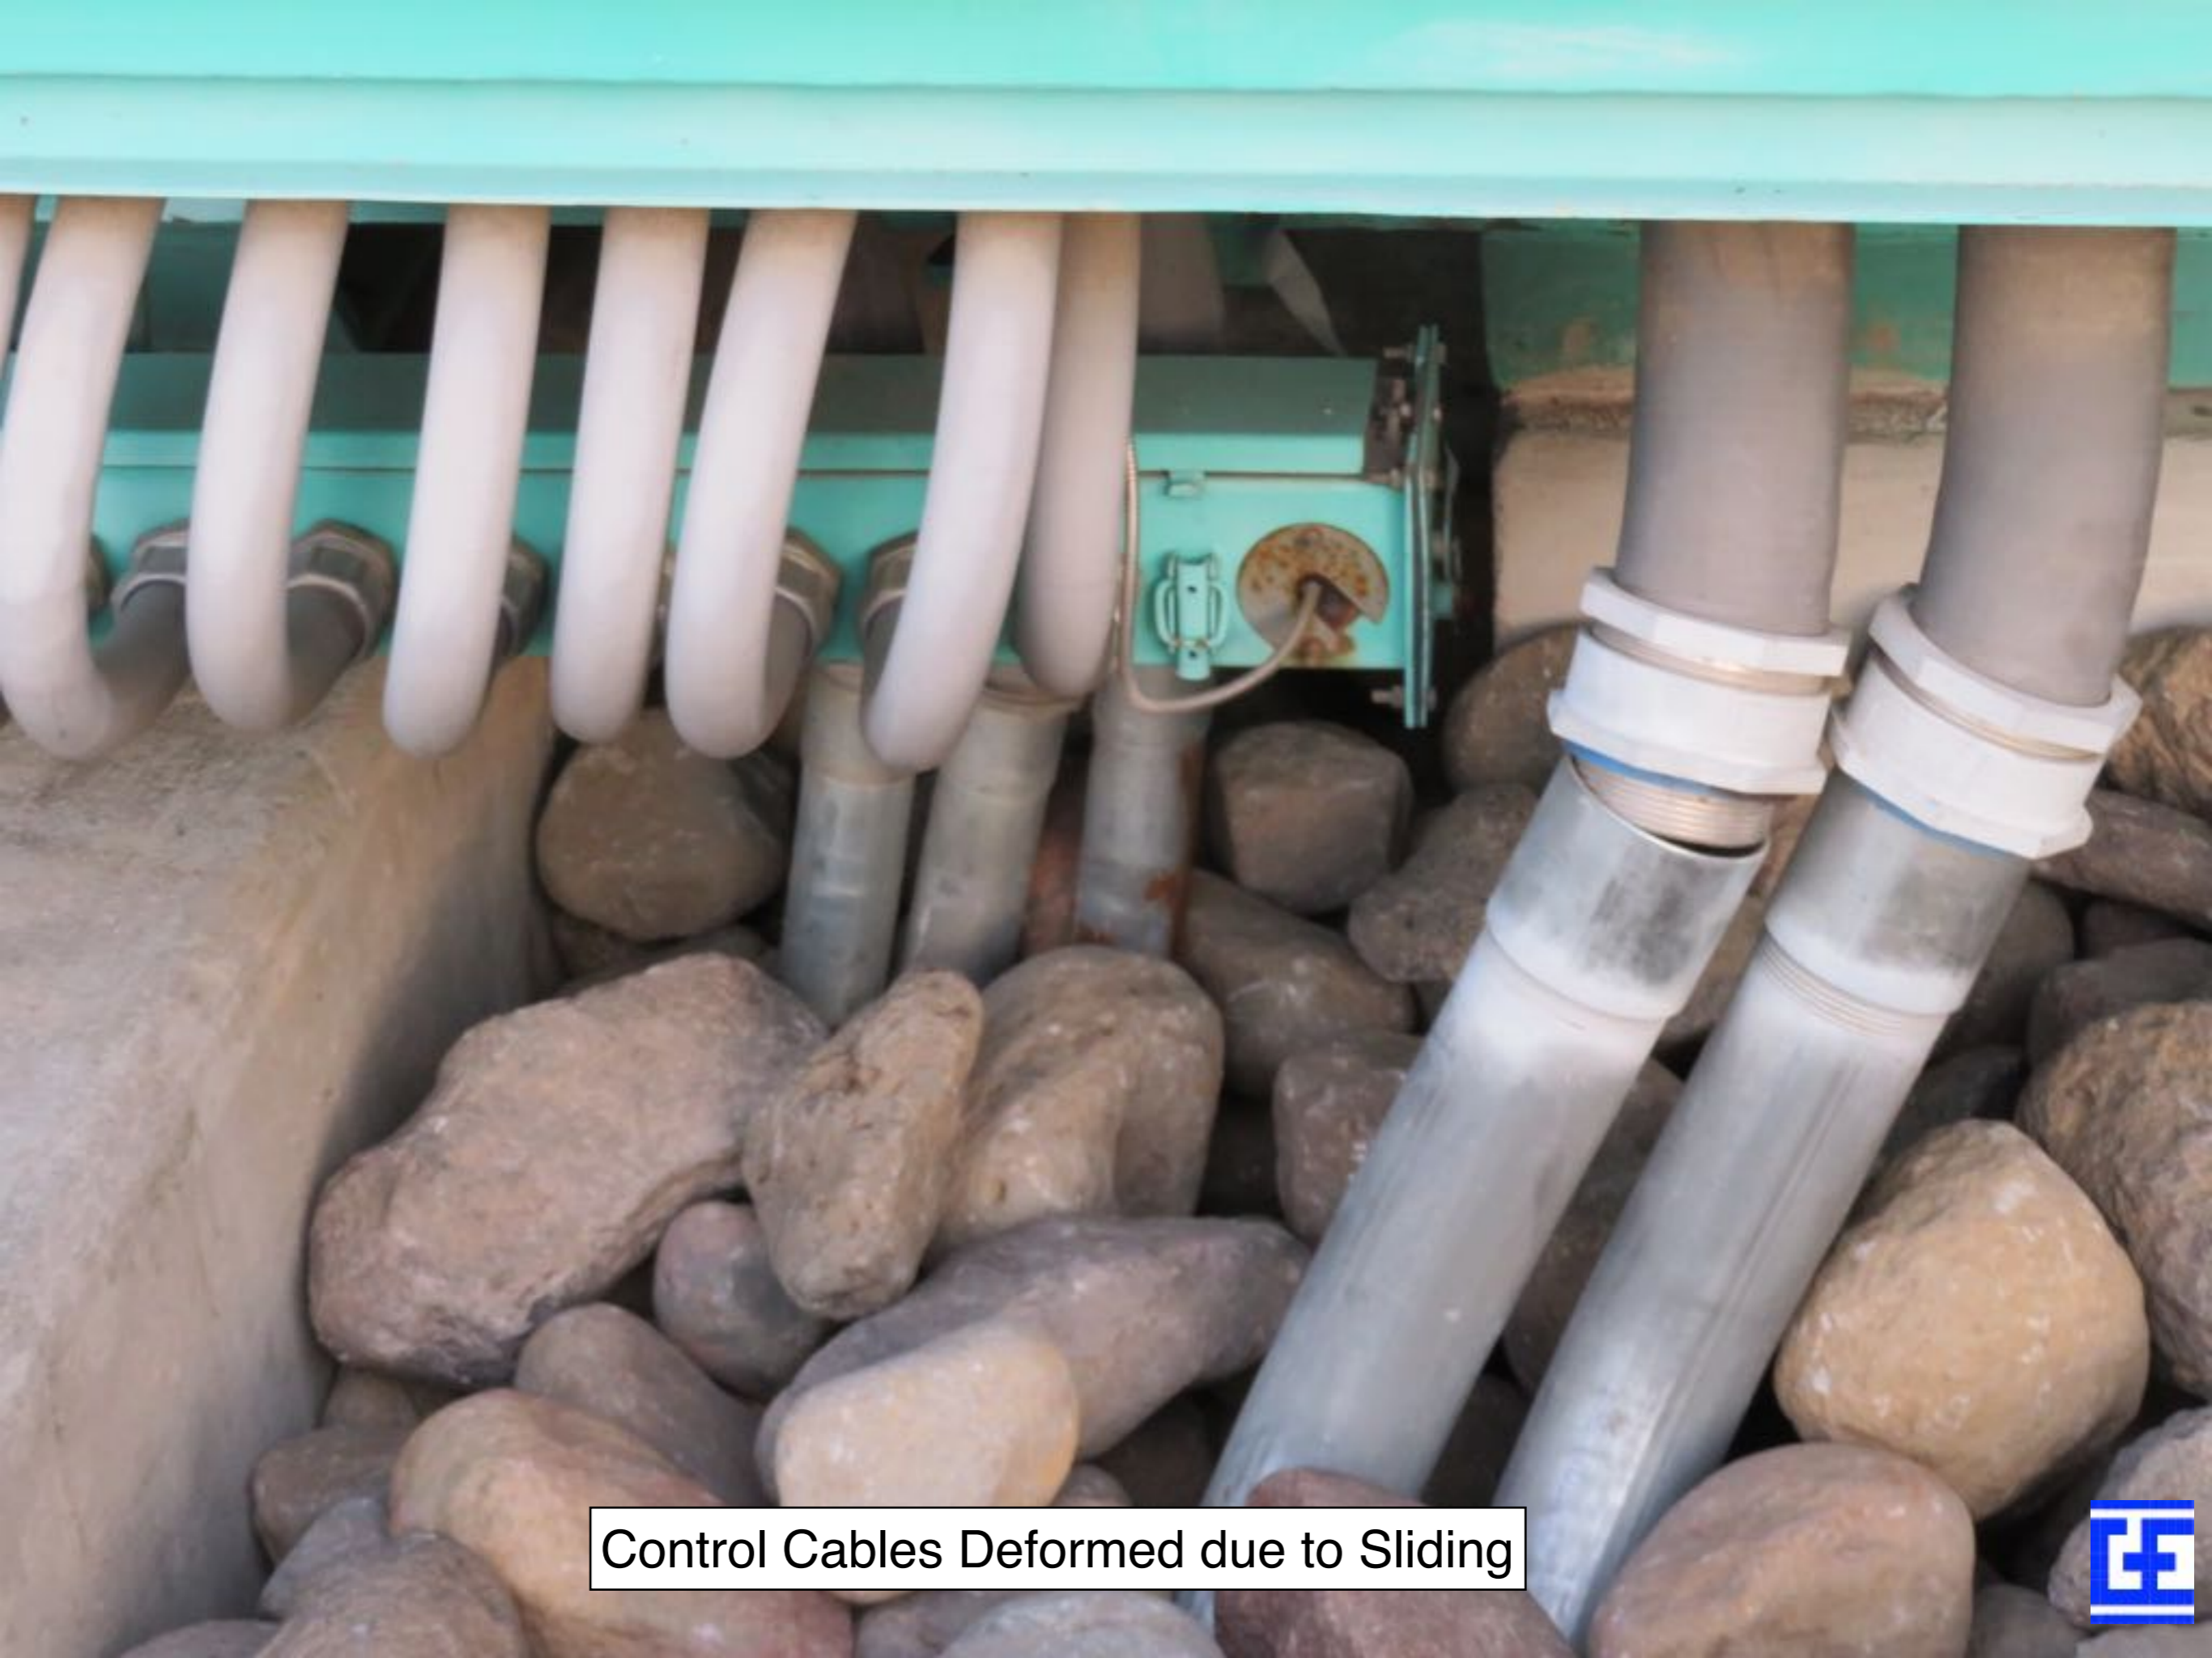
Control Cables Deformed due to Sliding

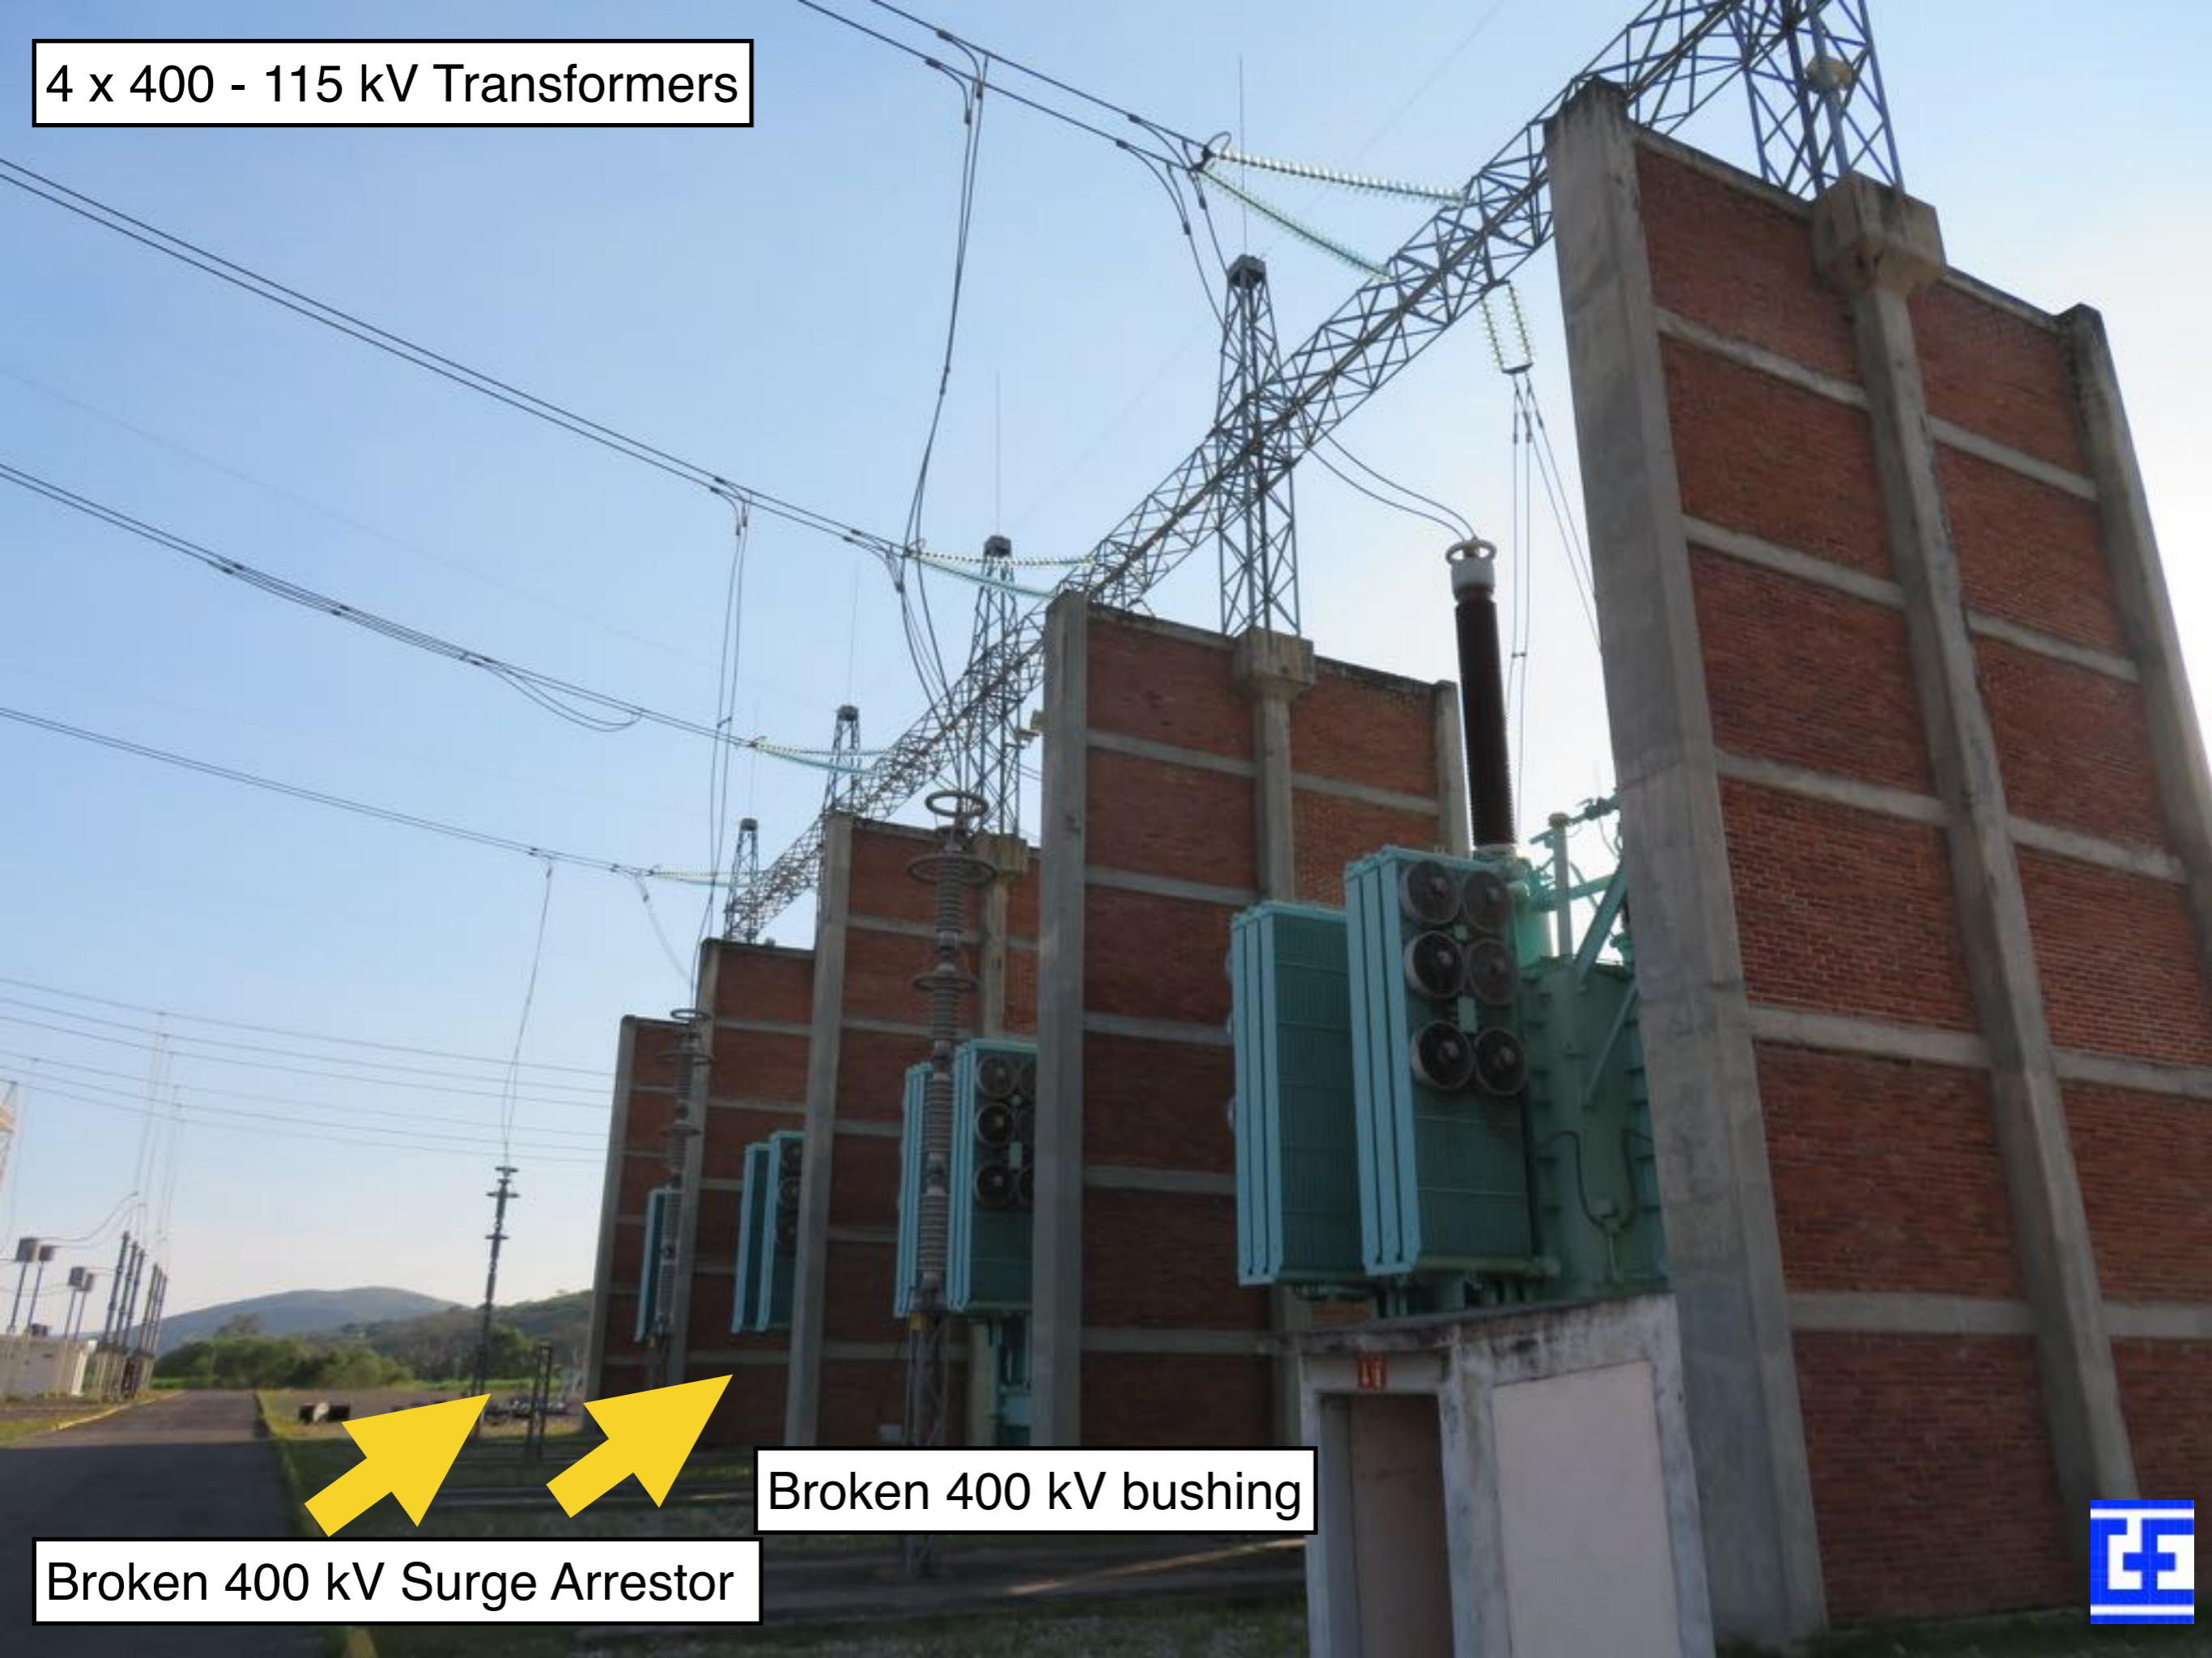
Broken 400 kV Surge Arrestor

Broken 400 kV bushing

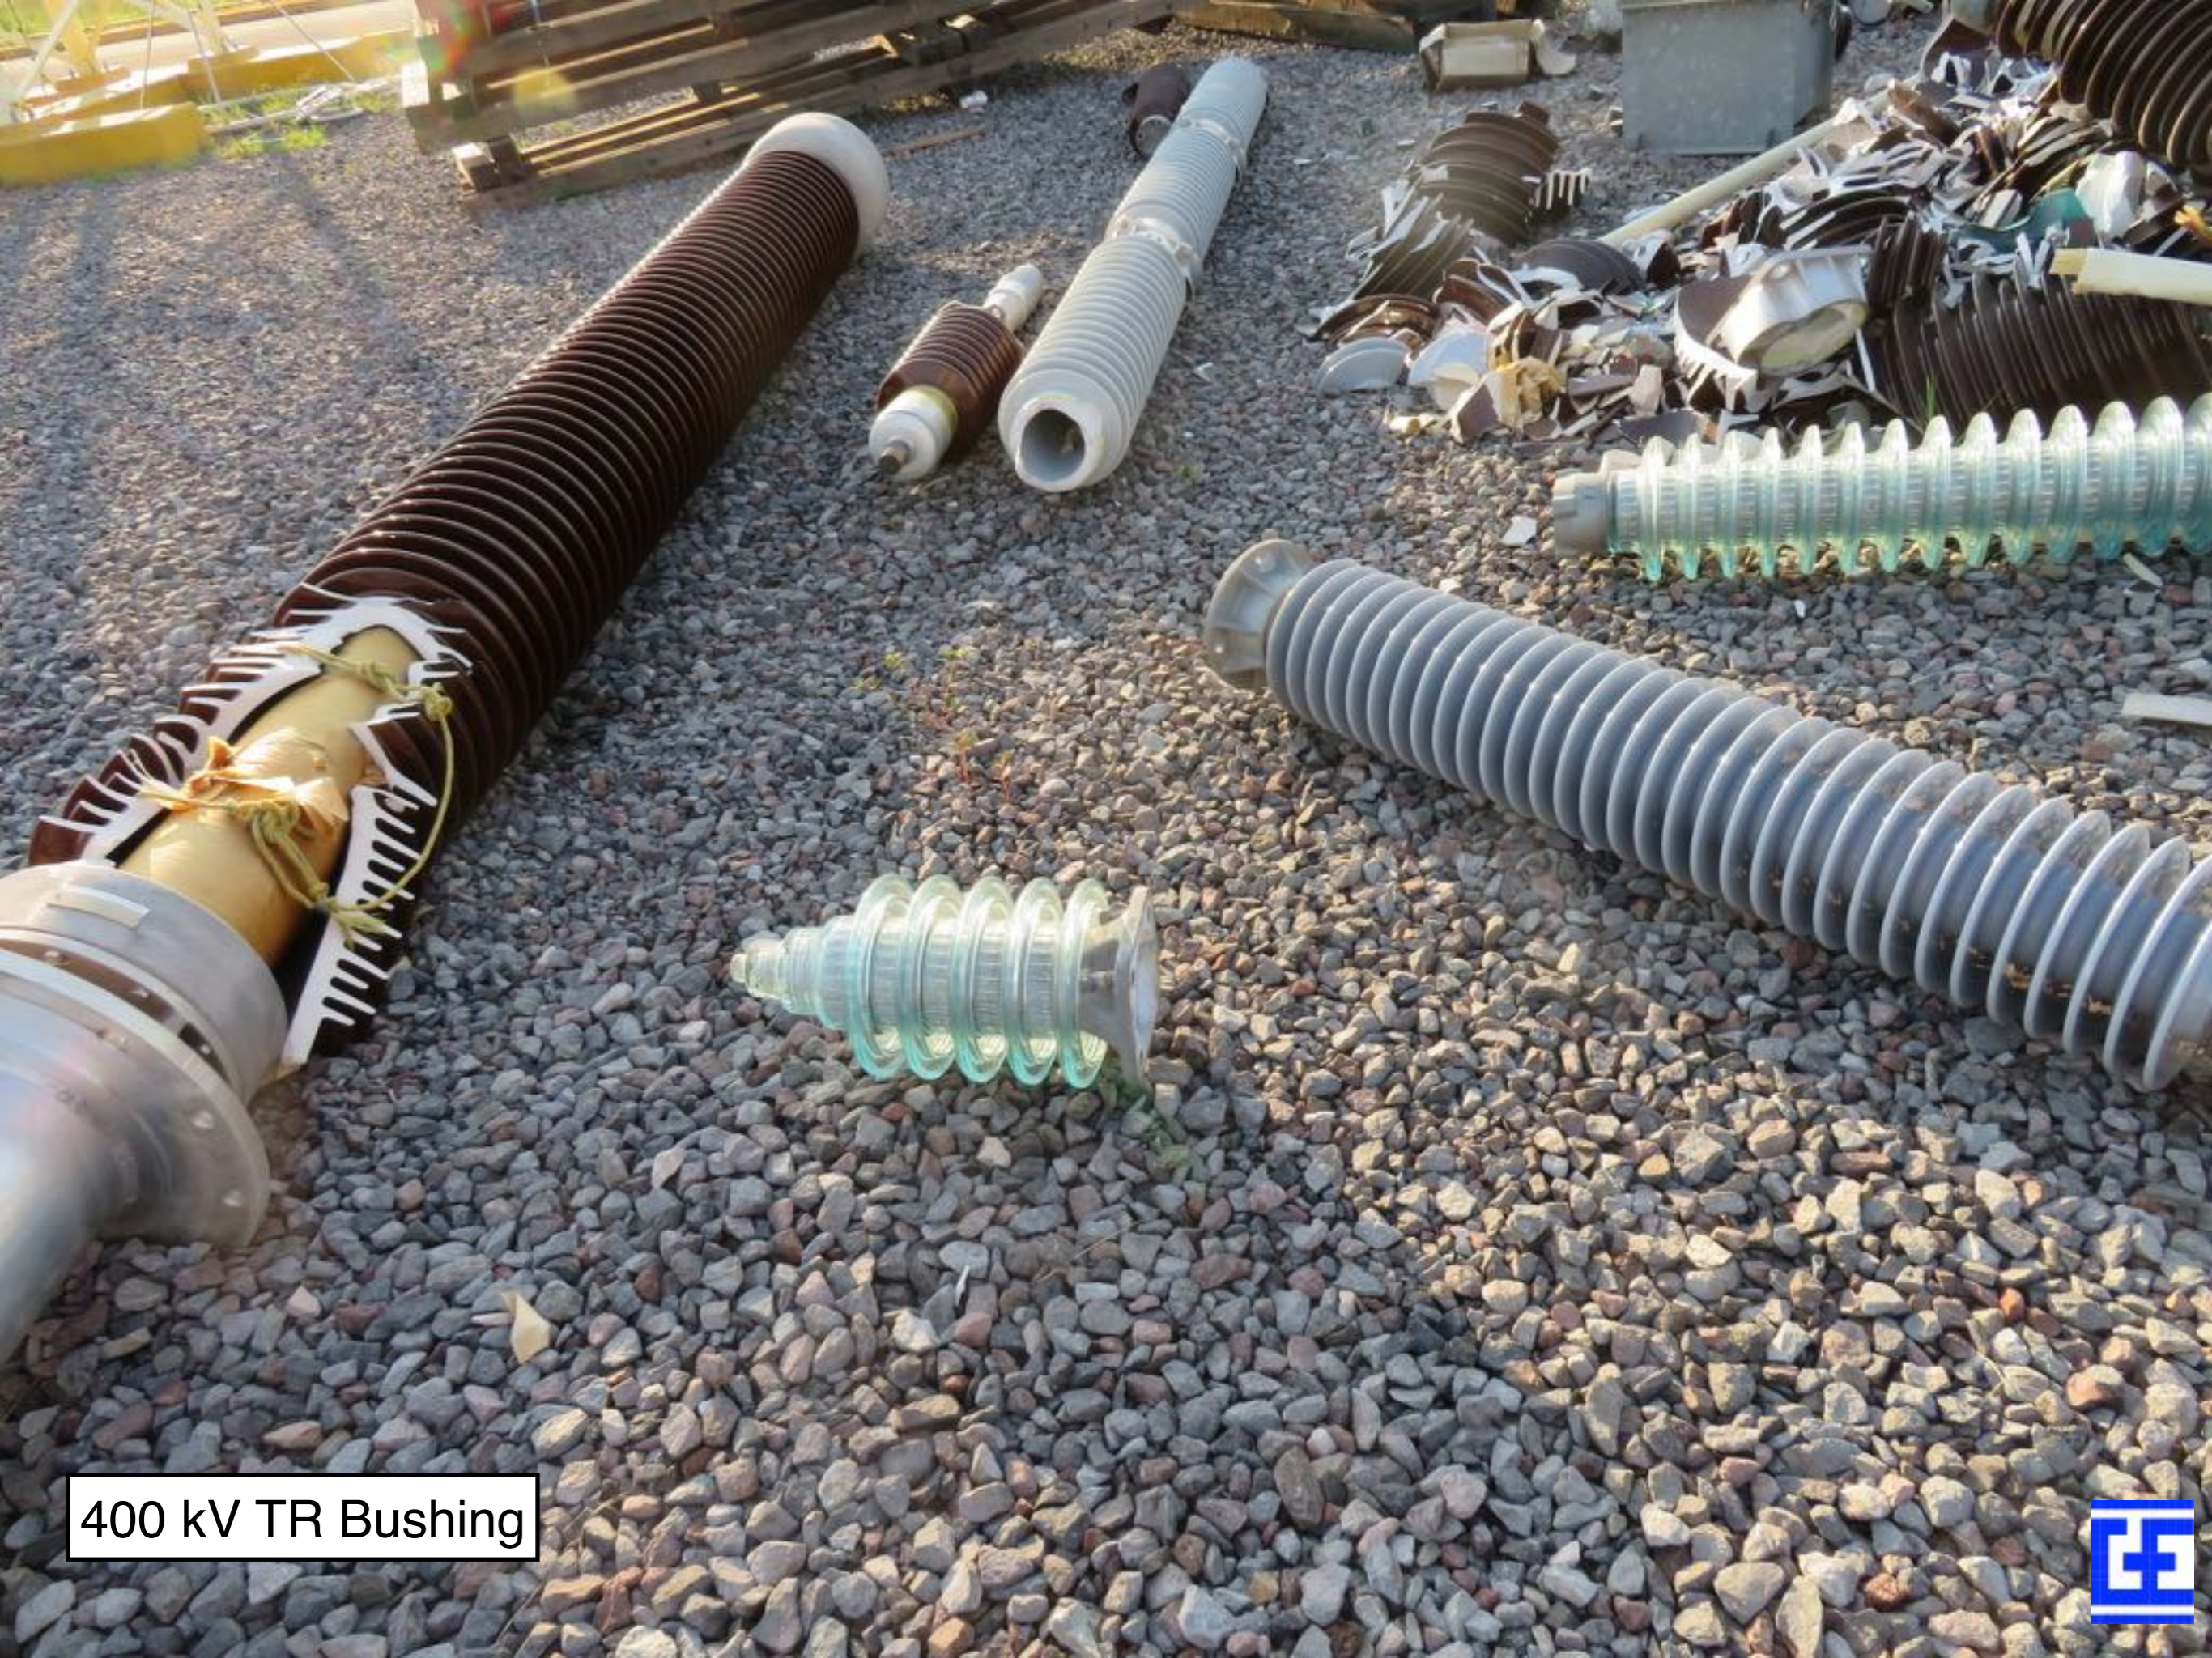
400 kV Bushings (1 / 10 with damage)

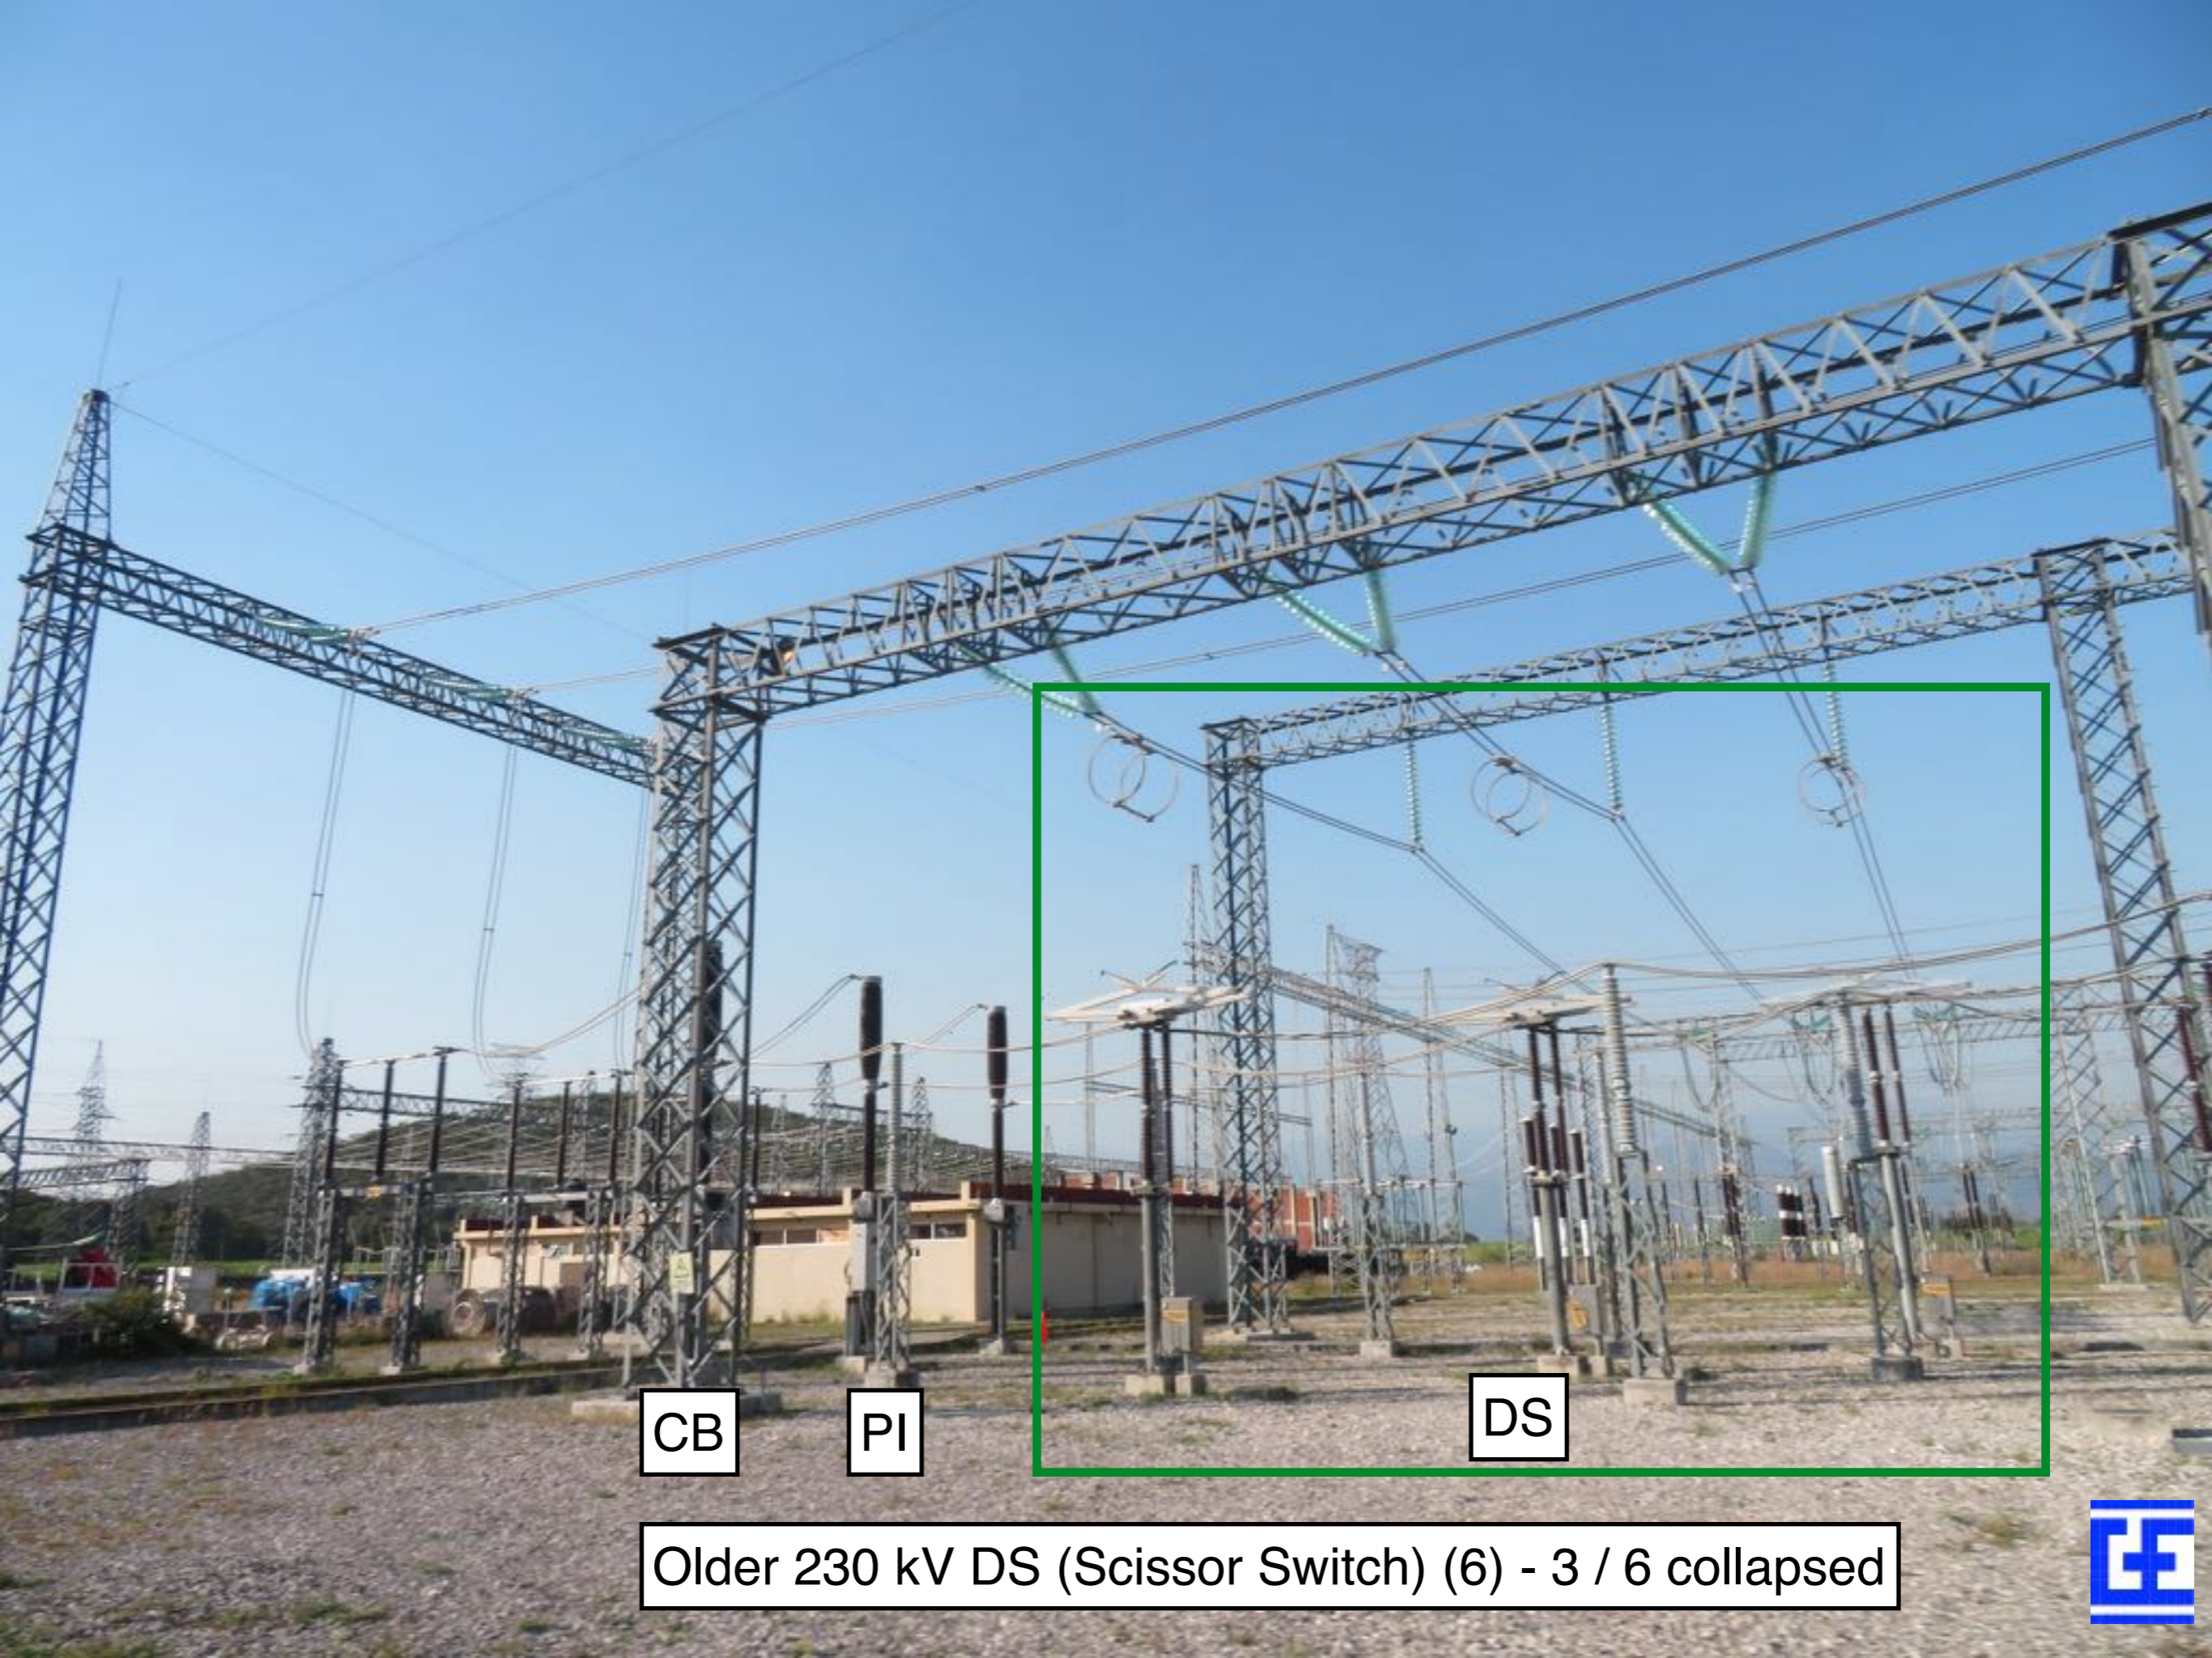
Older 230 kV DS (Scissor Switch) (6) - 3 / 6 collapsed
