# Puebla M 7.1 Earthquake of Sept 19 2017 Impact to Water and Power

John Eiding, Bruce Maison  
[eiding@geEngineeringSystems.com](mailto:eiding@geEngineeringSystems.com)  
[maison@netscape.com](mailto:maison@netscape.com)

Updated 9.14.2018

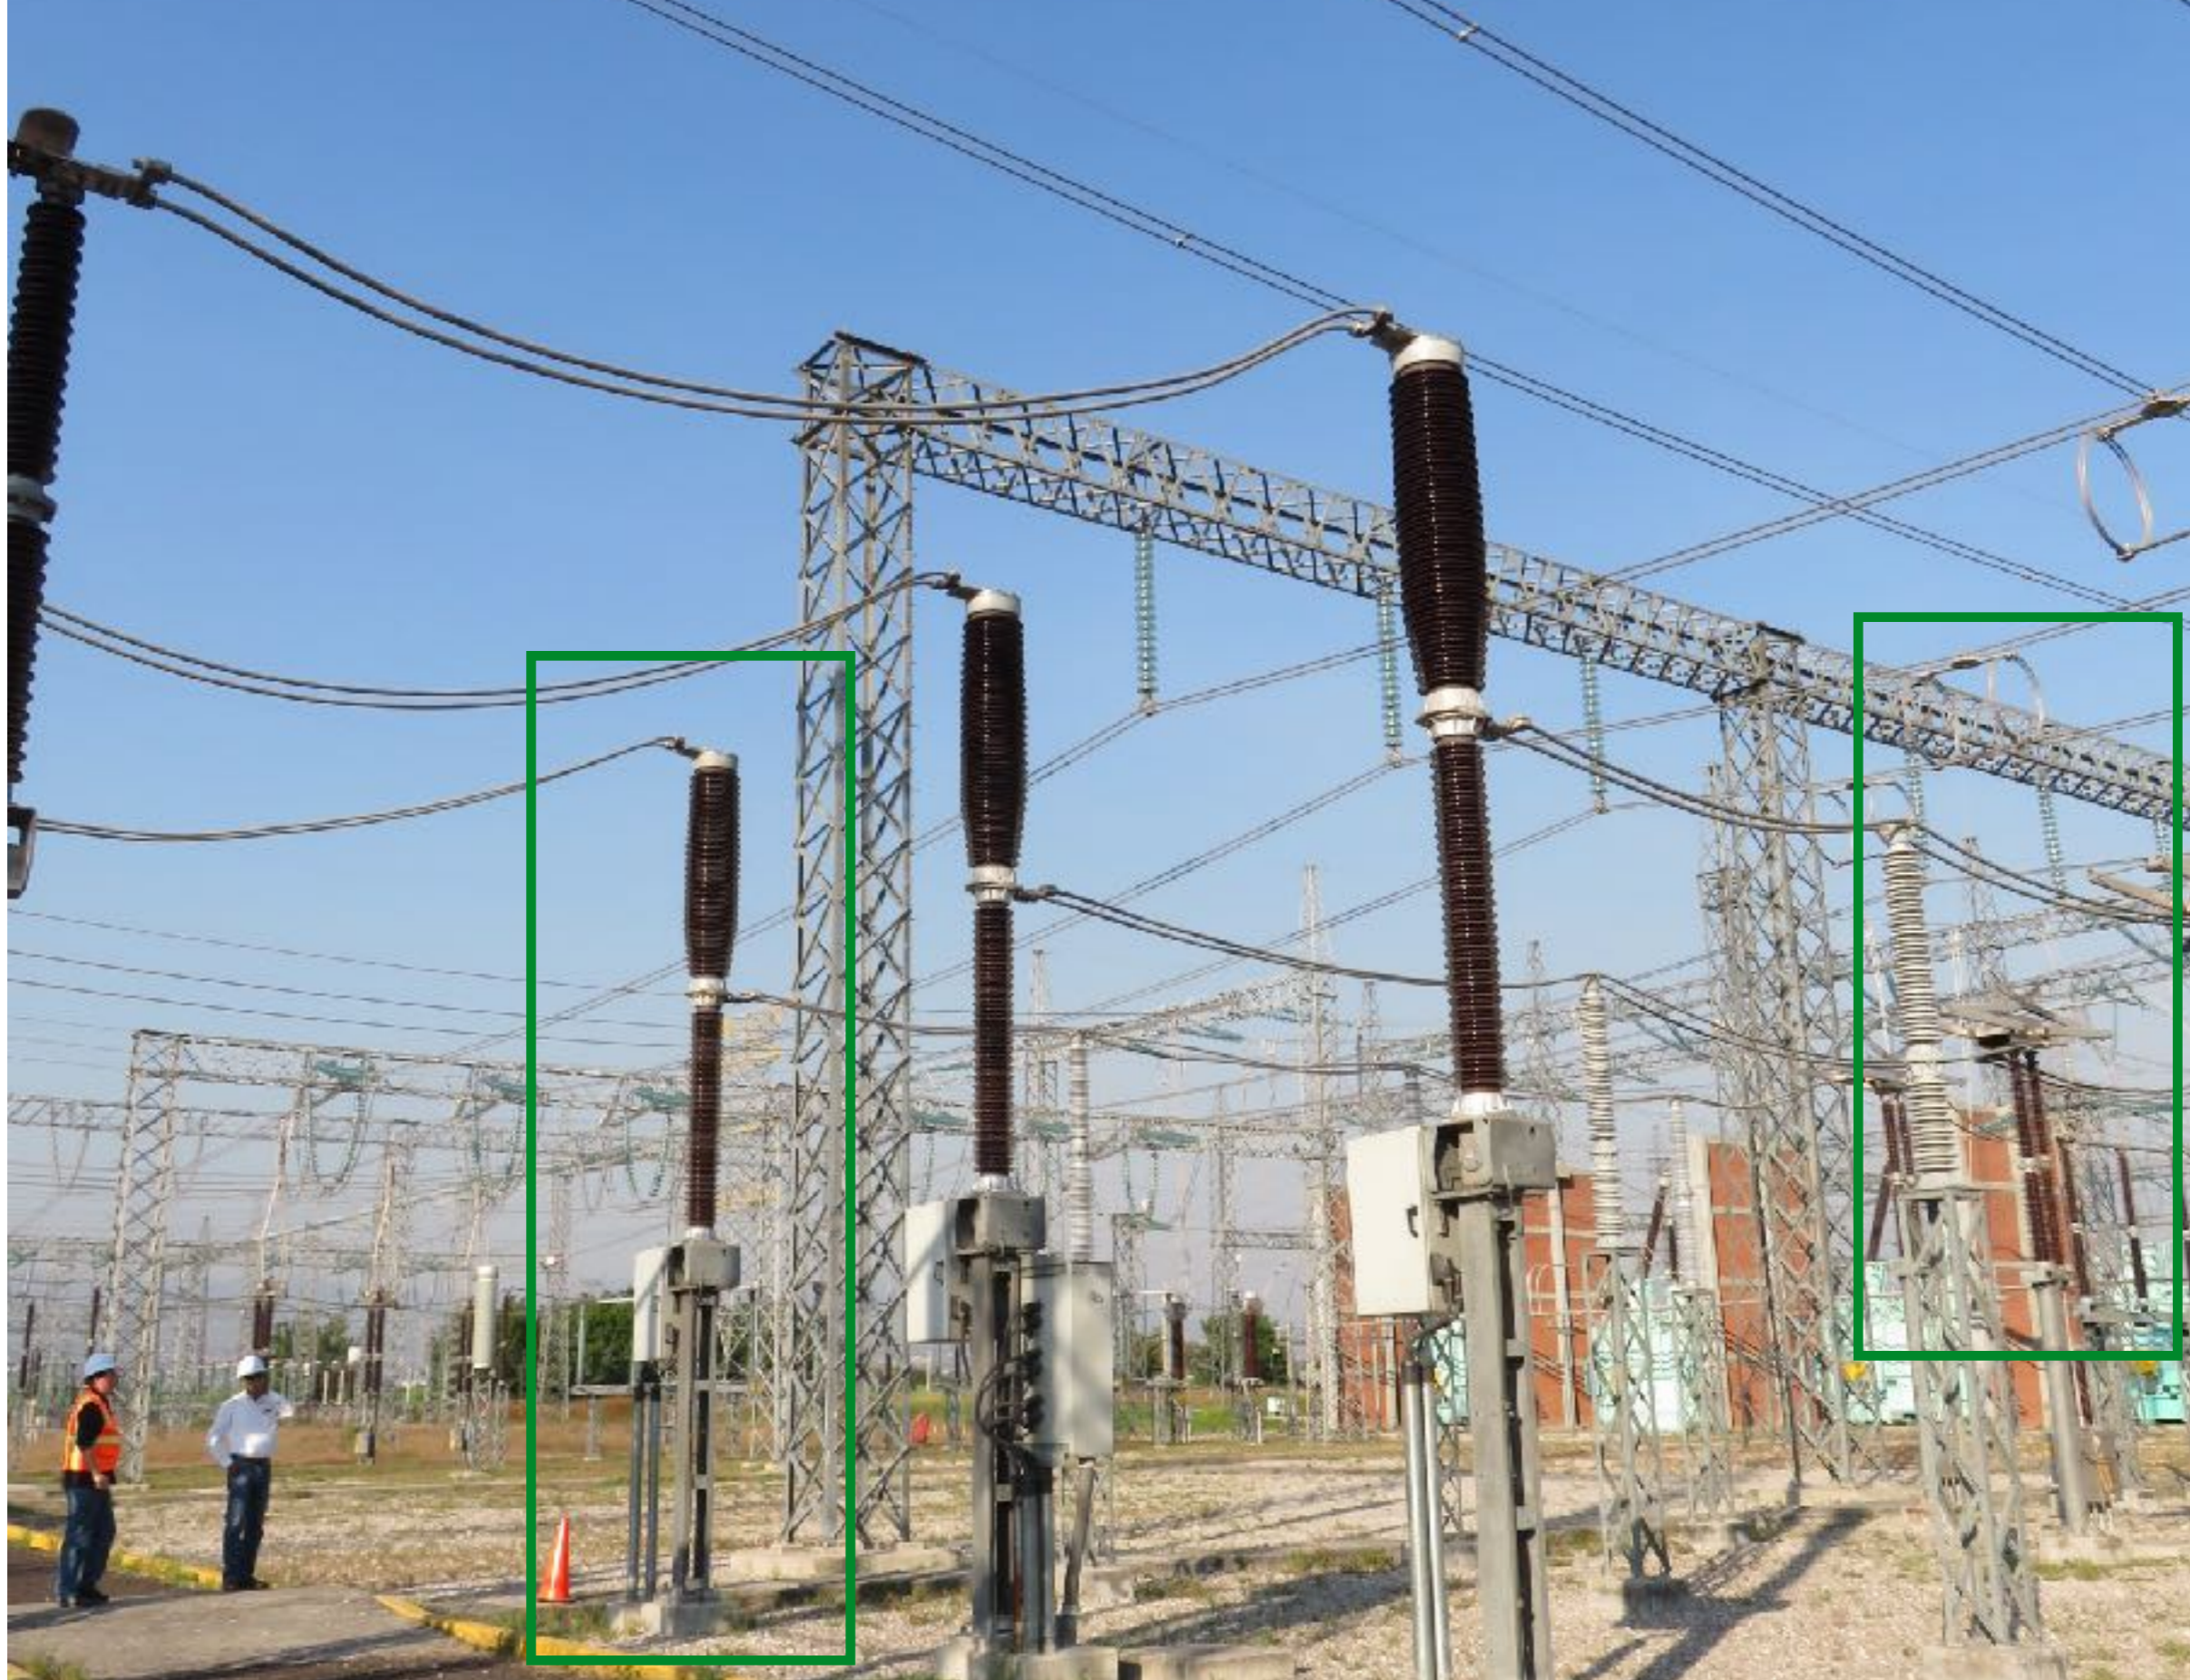
230 kV CBs 3 / 6 collapsed. May have been aggravated by collapse of adjacent Scissor Switches, note the tight slack

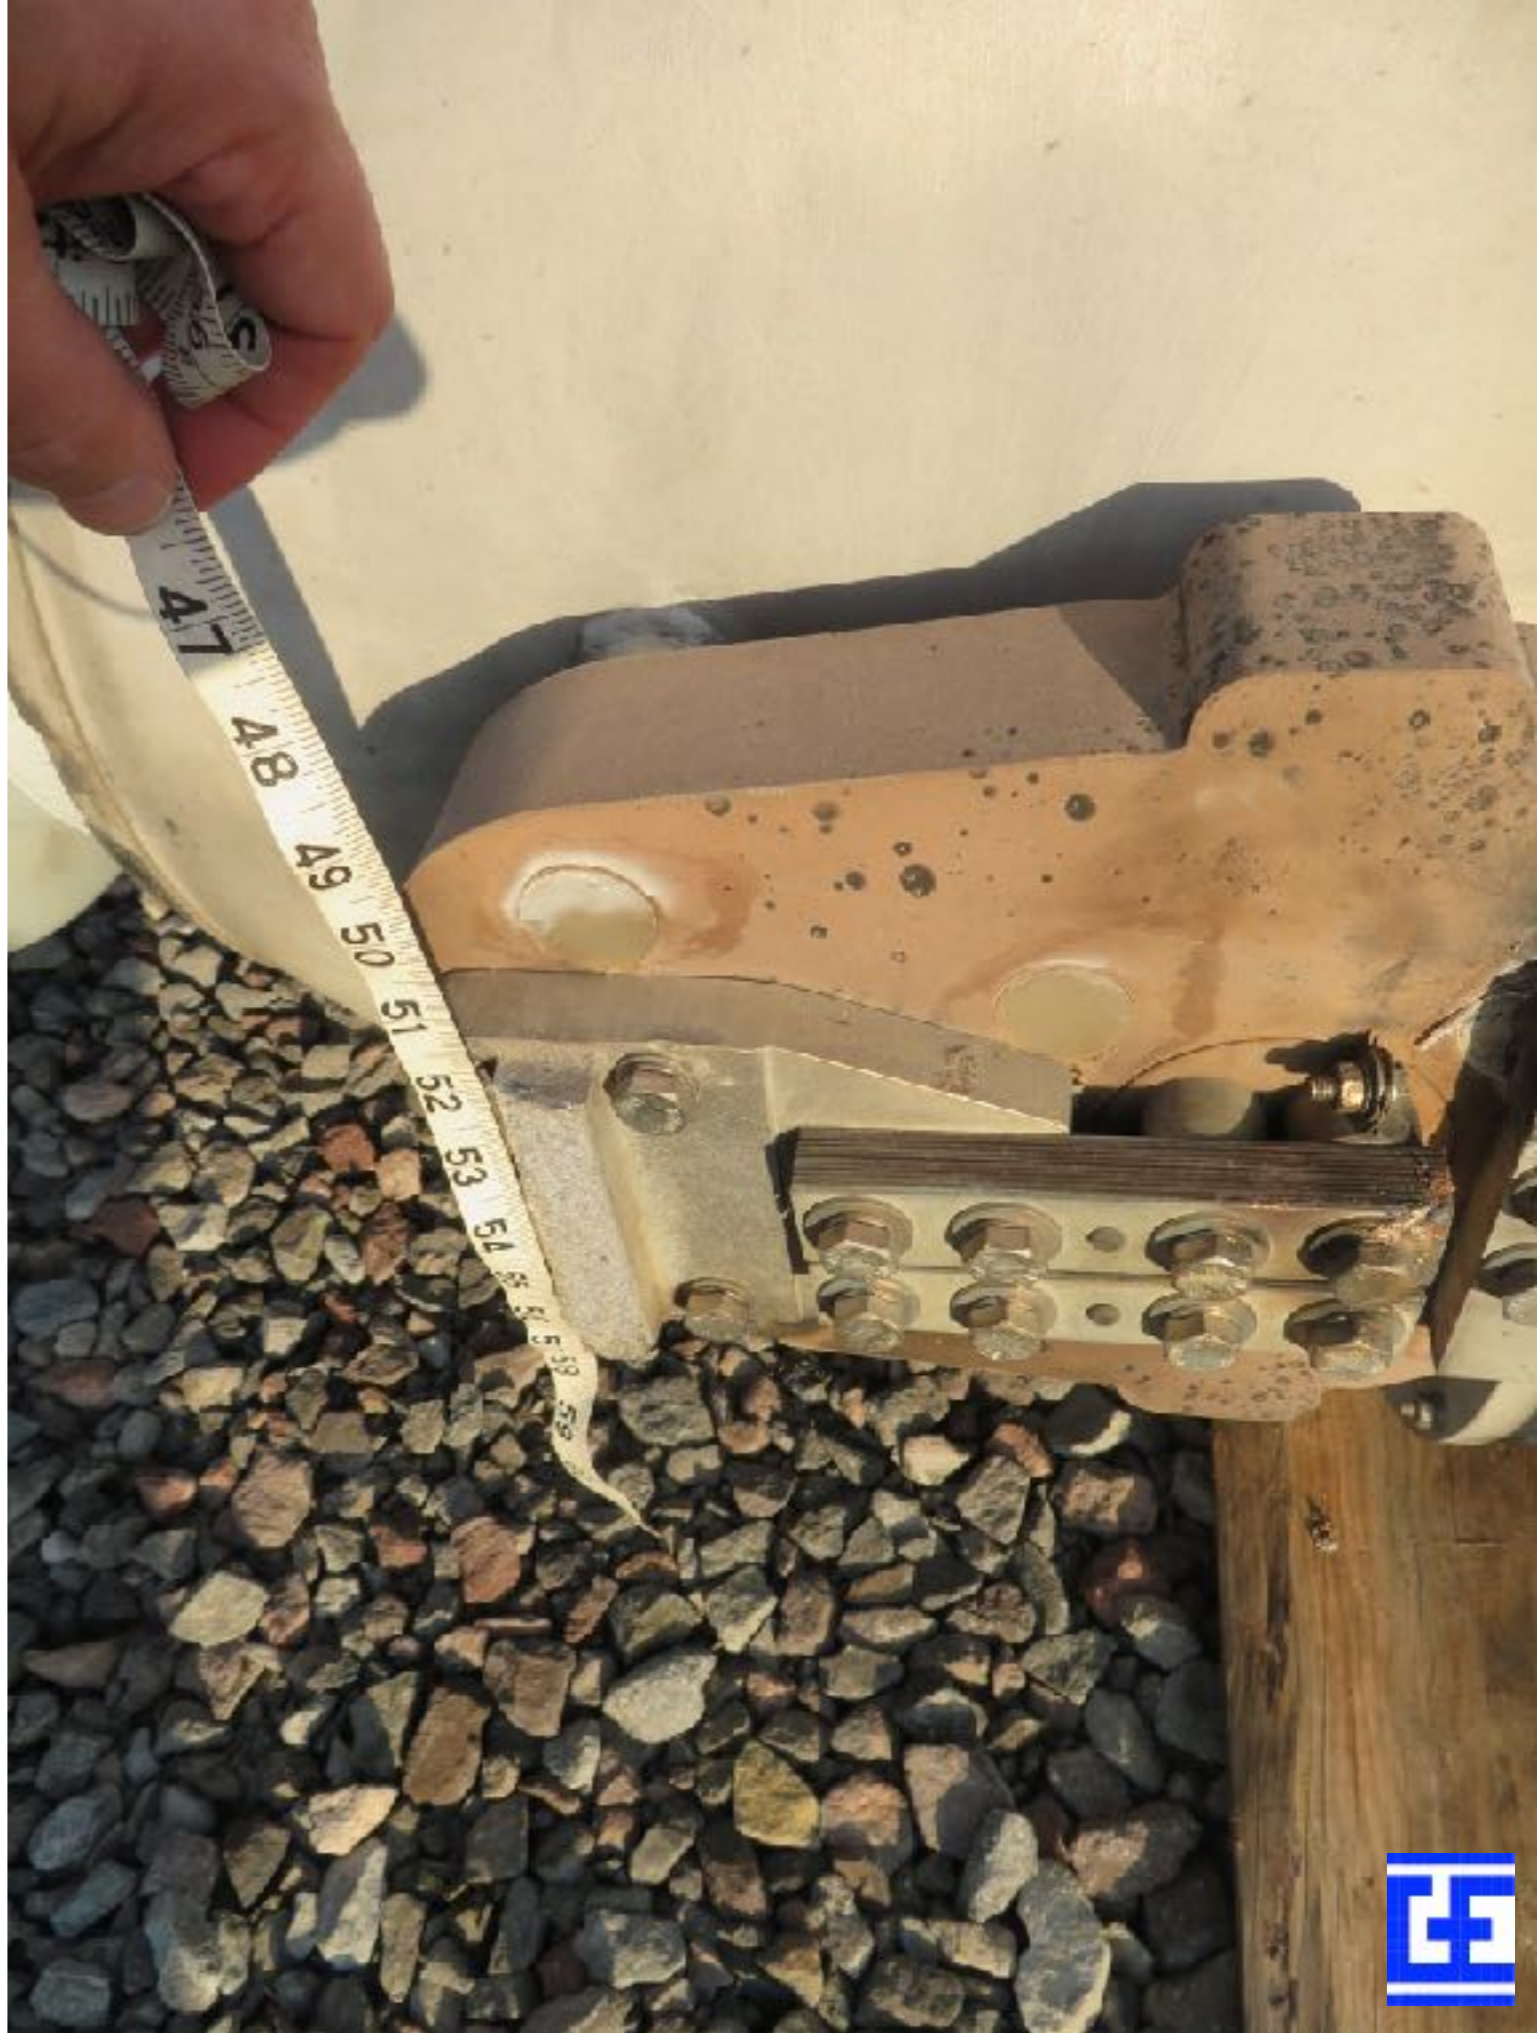
400 kV CT  
Failure is non-ductile failure of  
cast aluminum bracket.  
Likely due to insufficient slack

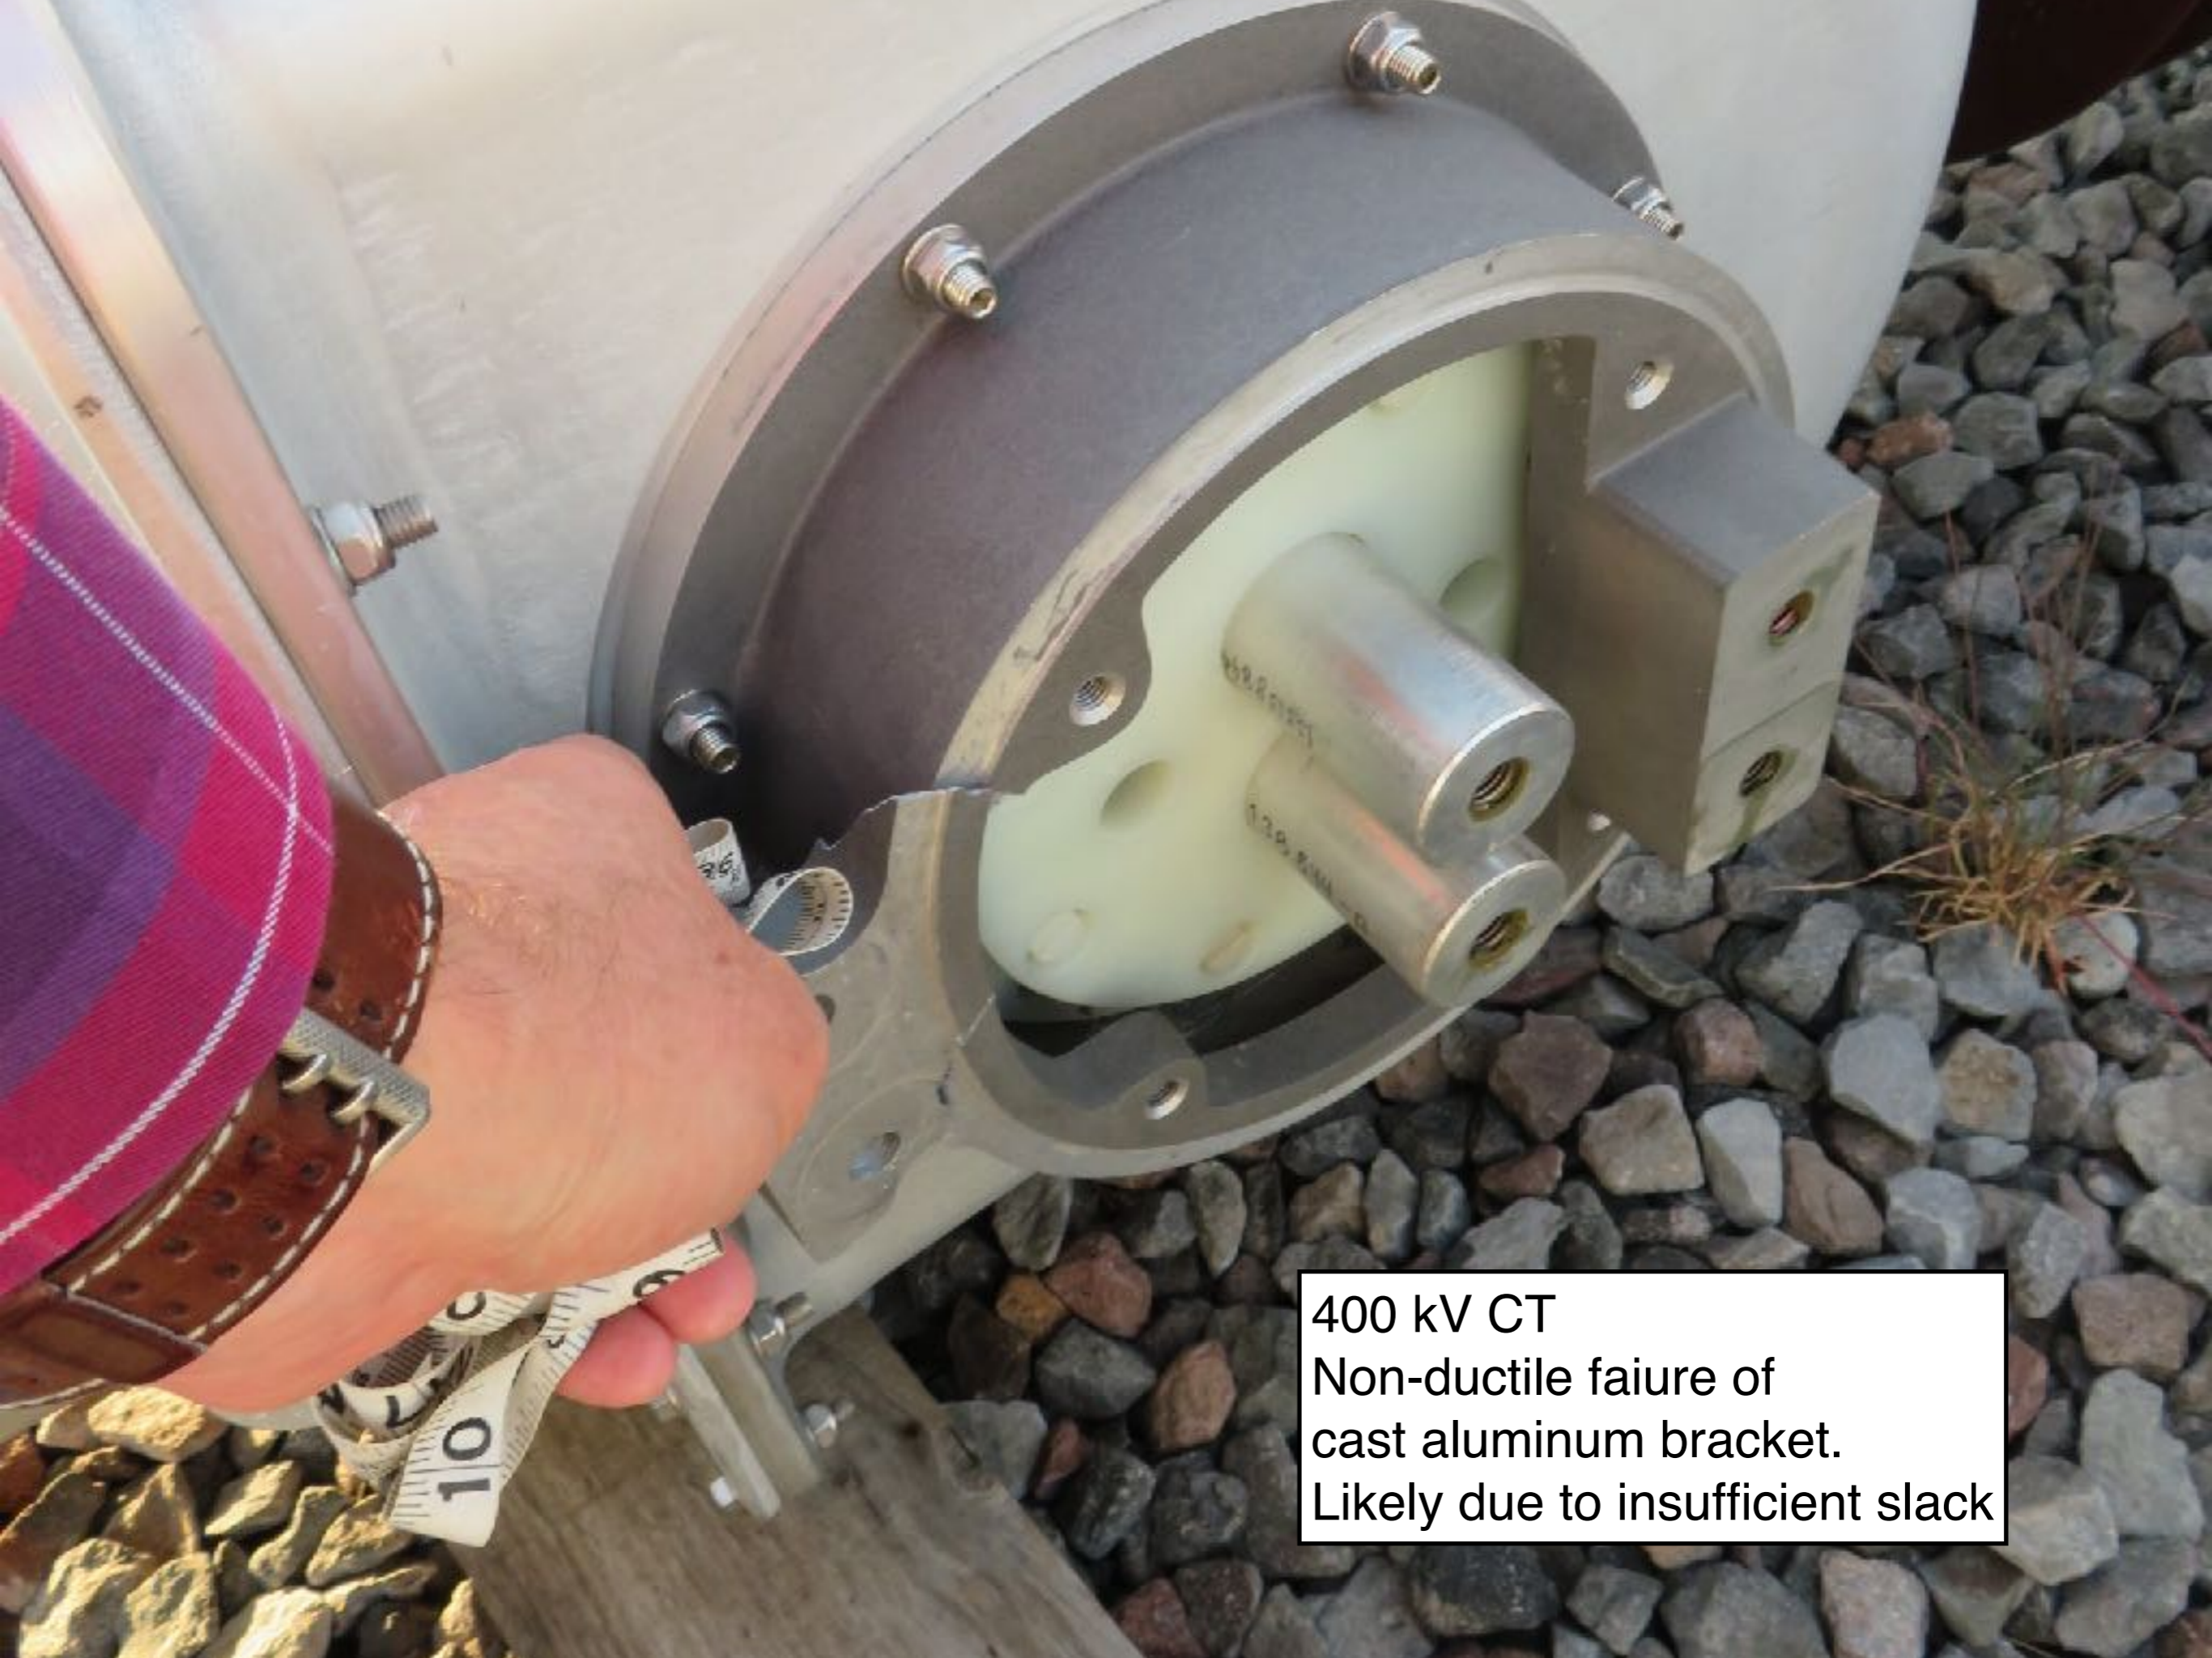
400 kV CT  
Non-ductile failure of  
cast aluminum bracket.  
Likely due to insufficient slack

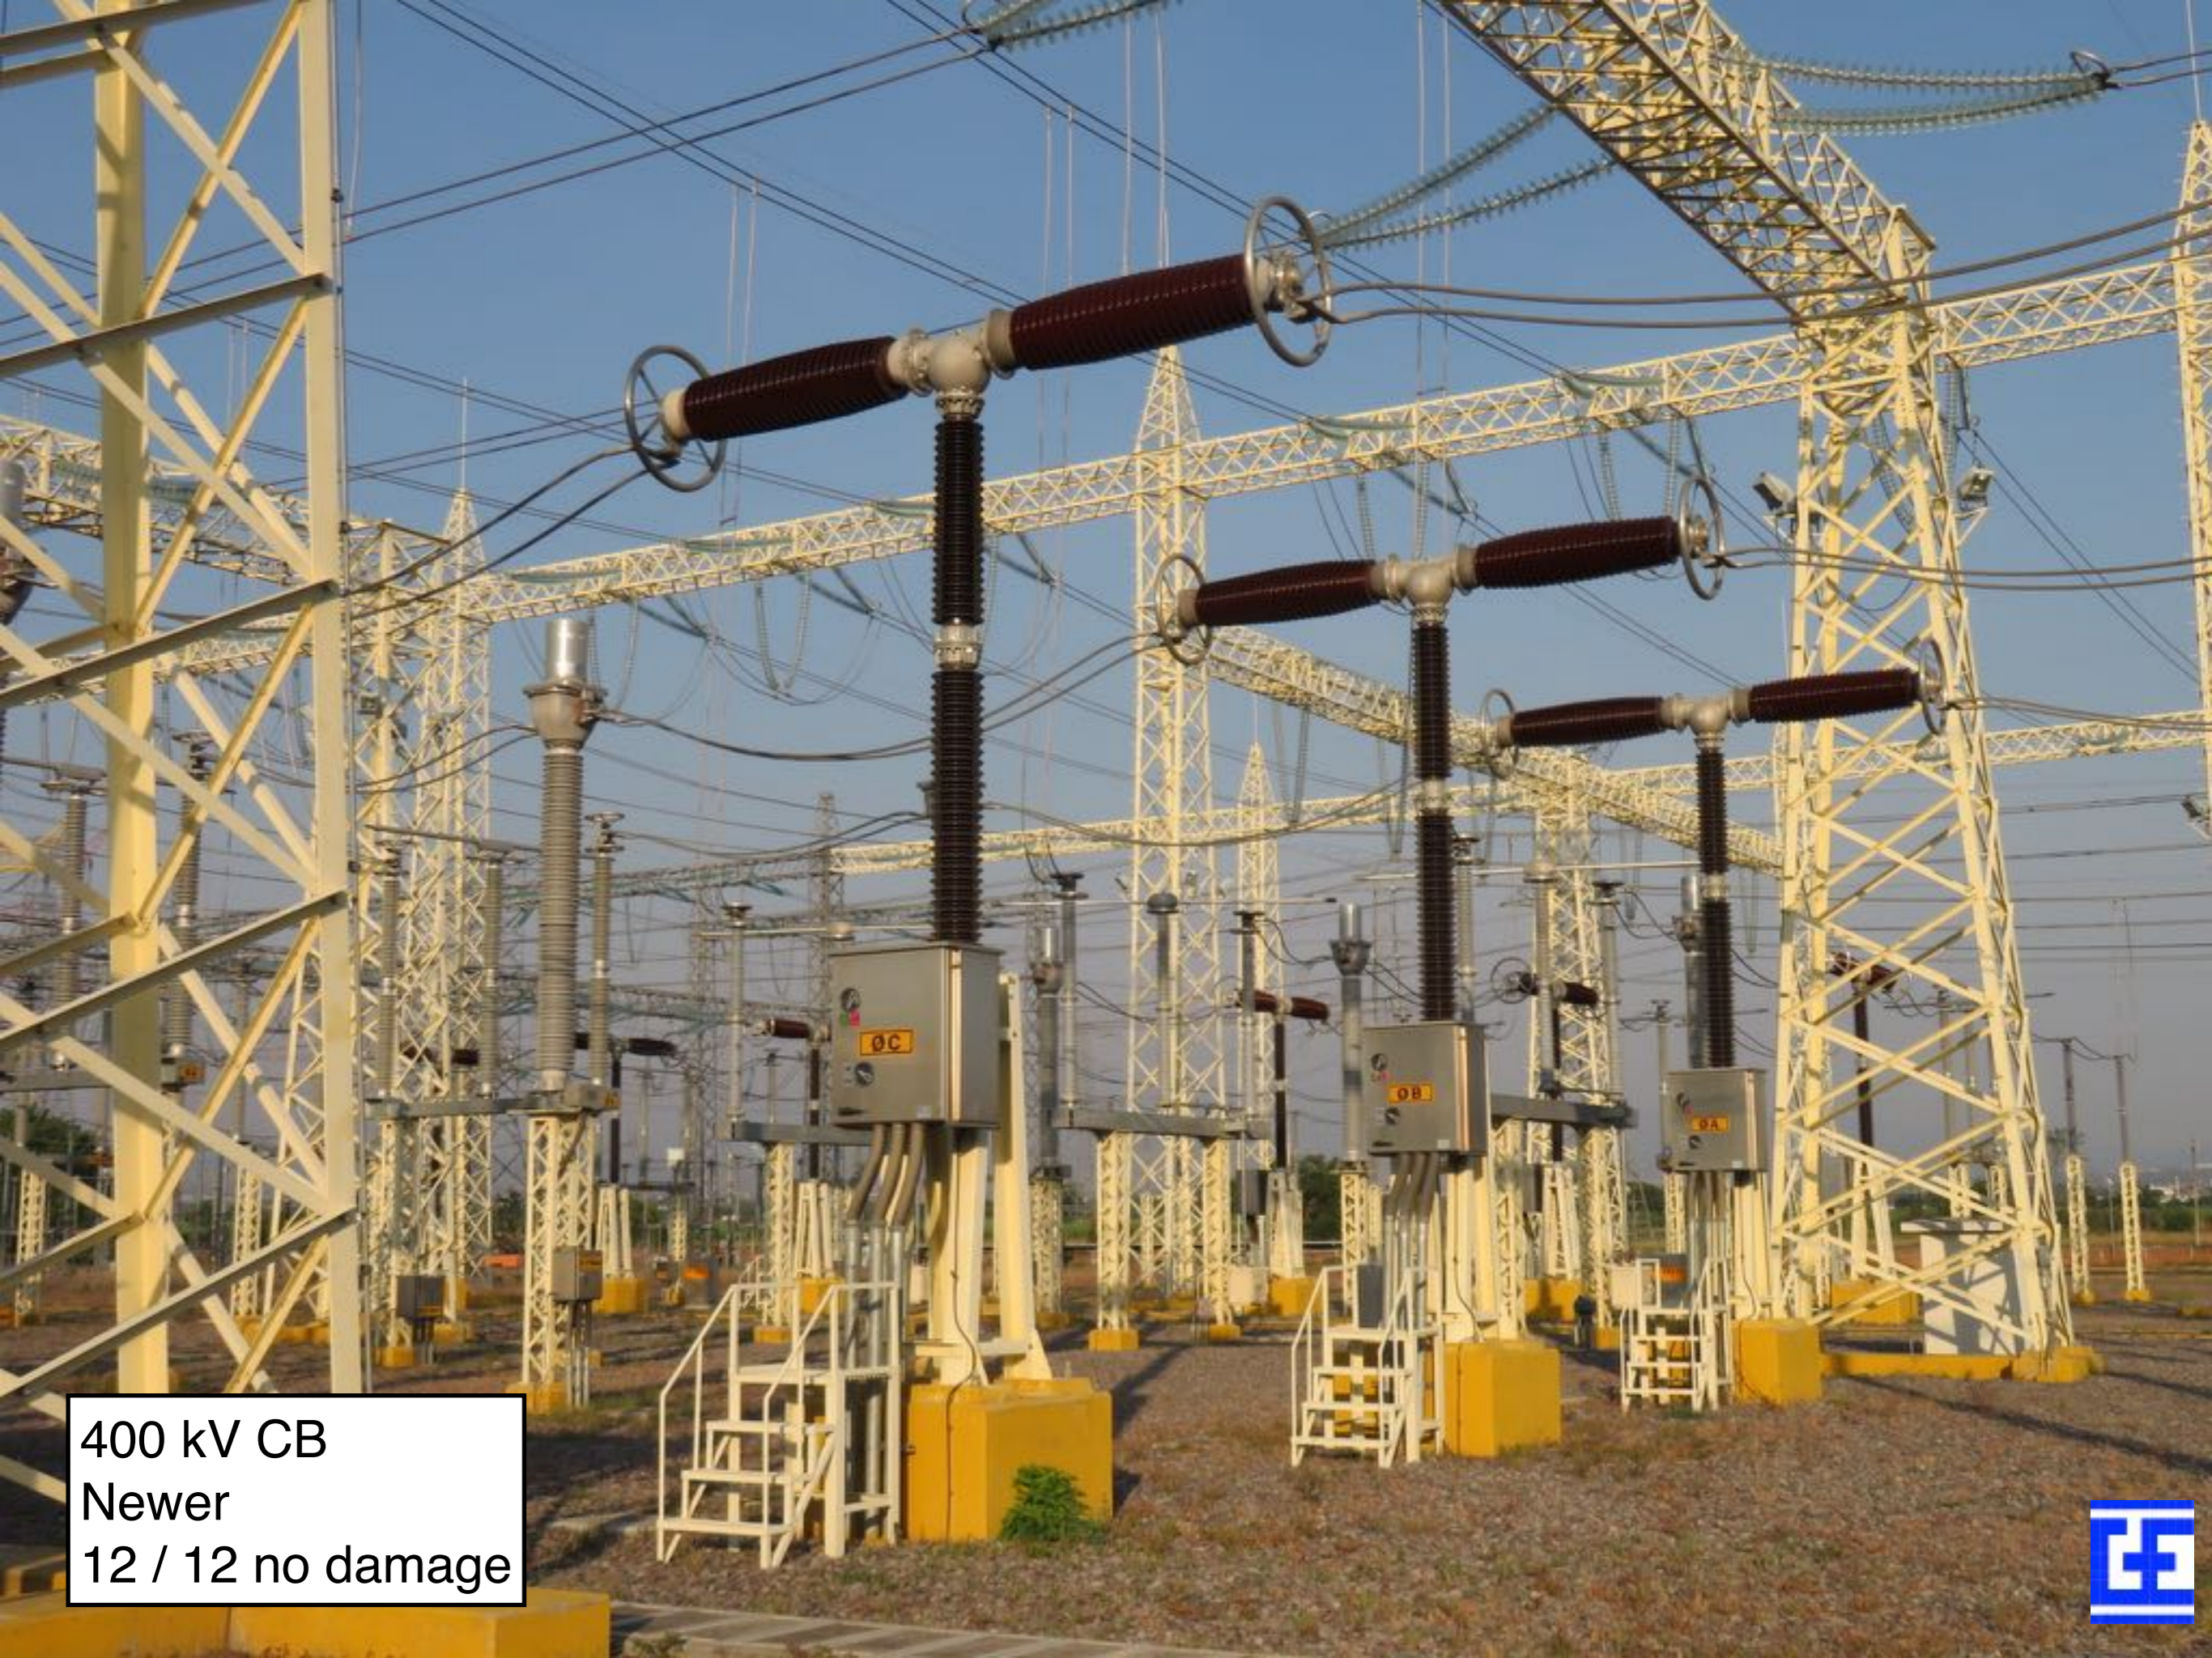
400 kV CT  
Non-ductile failure of  
cast aluminum bracket.  
Likely due to insufficient slack

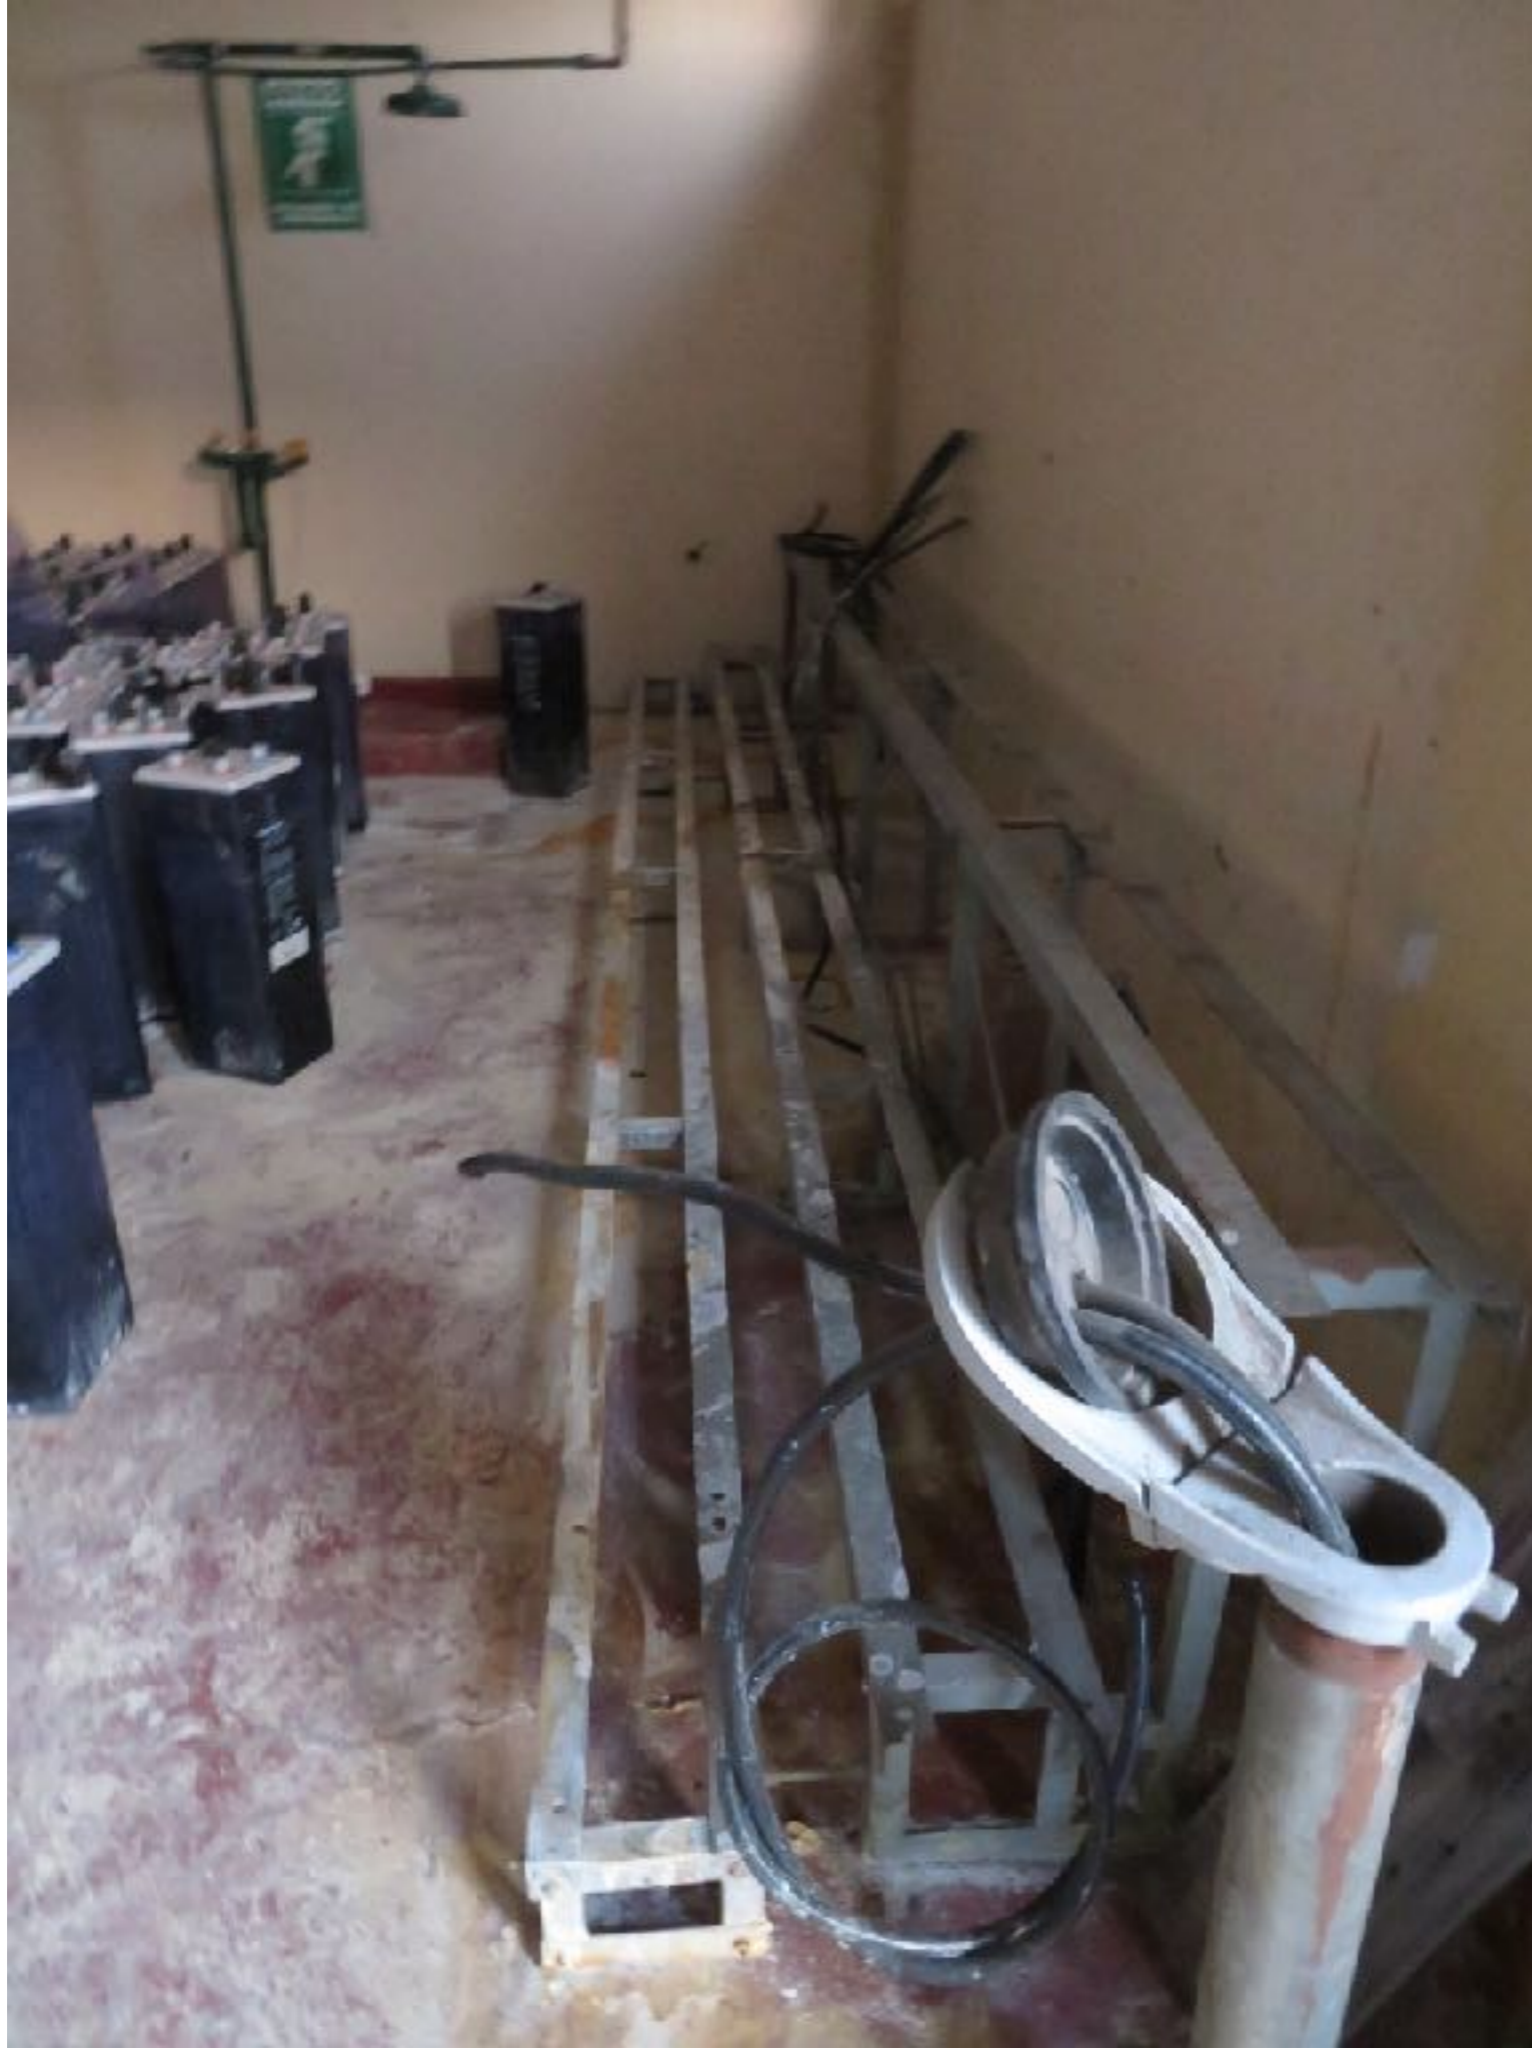
Batteries

No seismic design!  
(how can this be?)

Rocking starts at  $PGA > 0.1g$ .

1 cell toppled.

Remaining cells  
manually moved.

Evidence suggests  
that  $PGA$  was likely  $< 0.3g$ .

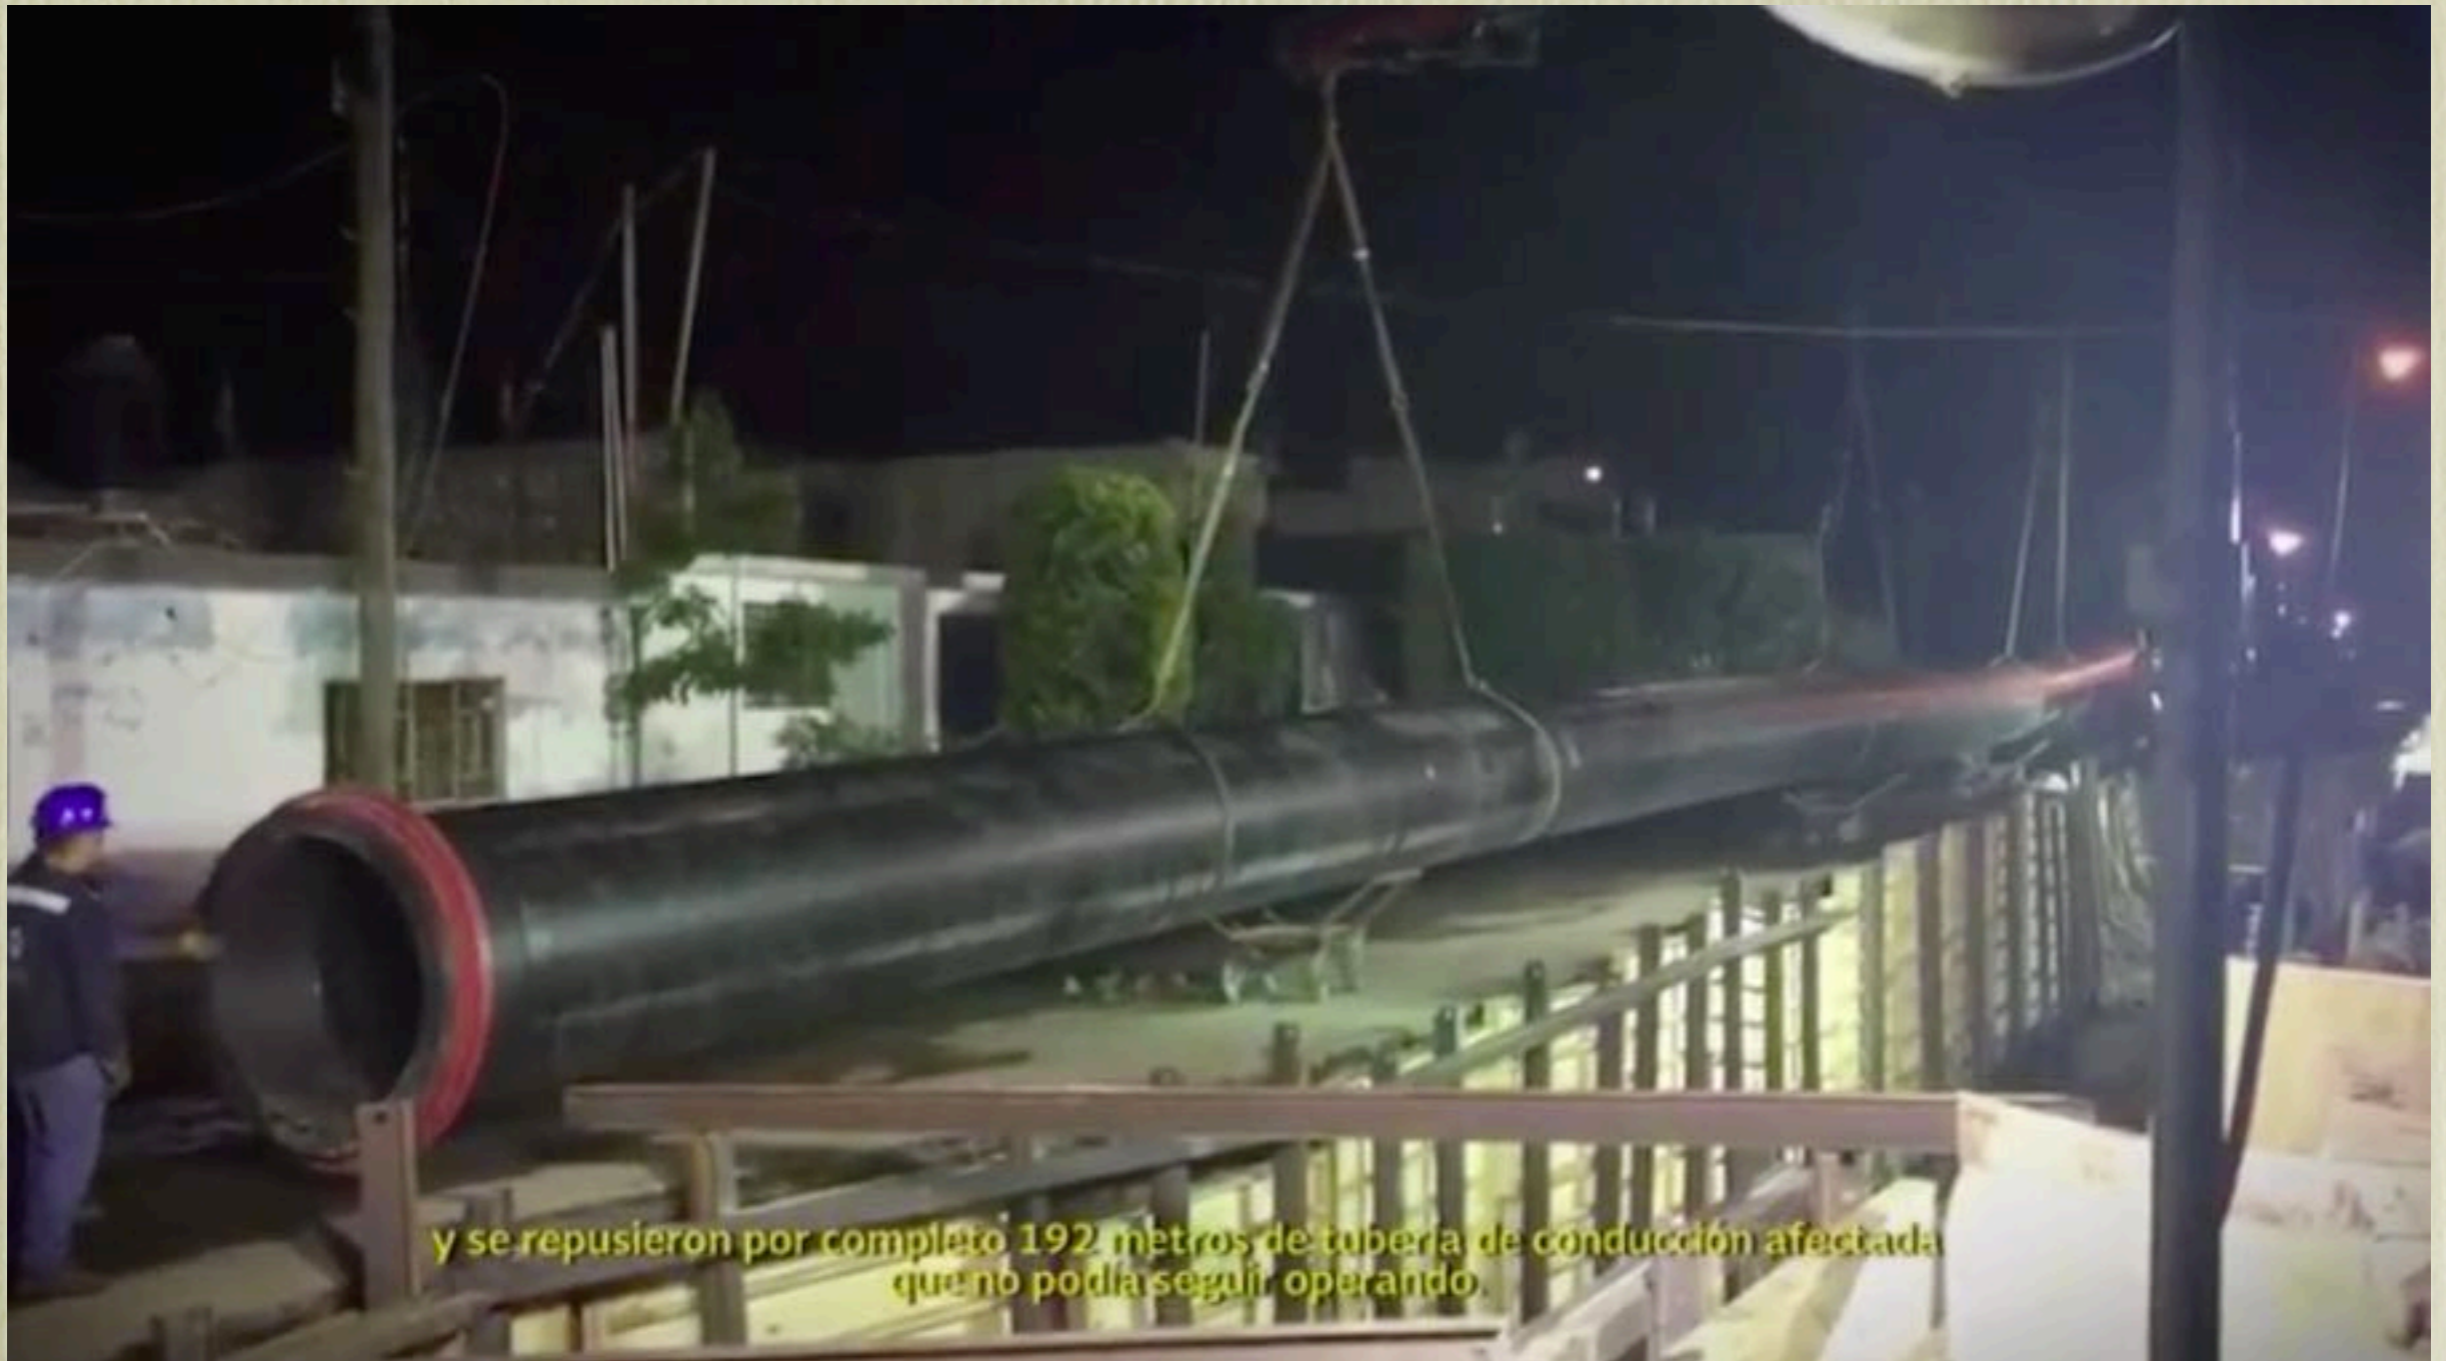
Santa Catarina

48" diameter

26 leaks in 22 km

Replaced 192 meters of pipe that were so badly damaged that they could not be quickly repaired
