**M 9.0 Tohoku Earthquake  
March 11 2011  
Performance of Water and Power  
Systems**

*G&E Engineering Systems Inc.  
6315 Swainland Rd  
Oakland, CA 94611  
(510) 595-9453 (510) 595-9454 (fax)  
eidinger@earthlink.net*

*June 25, 2012*

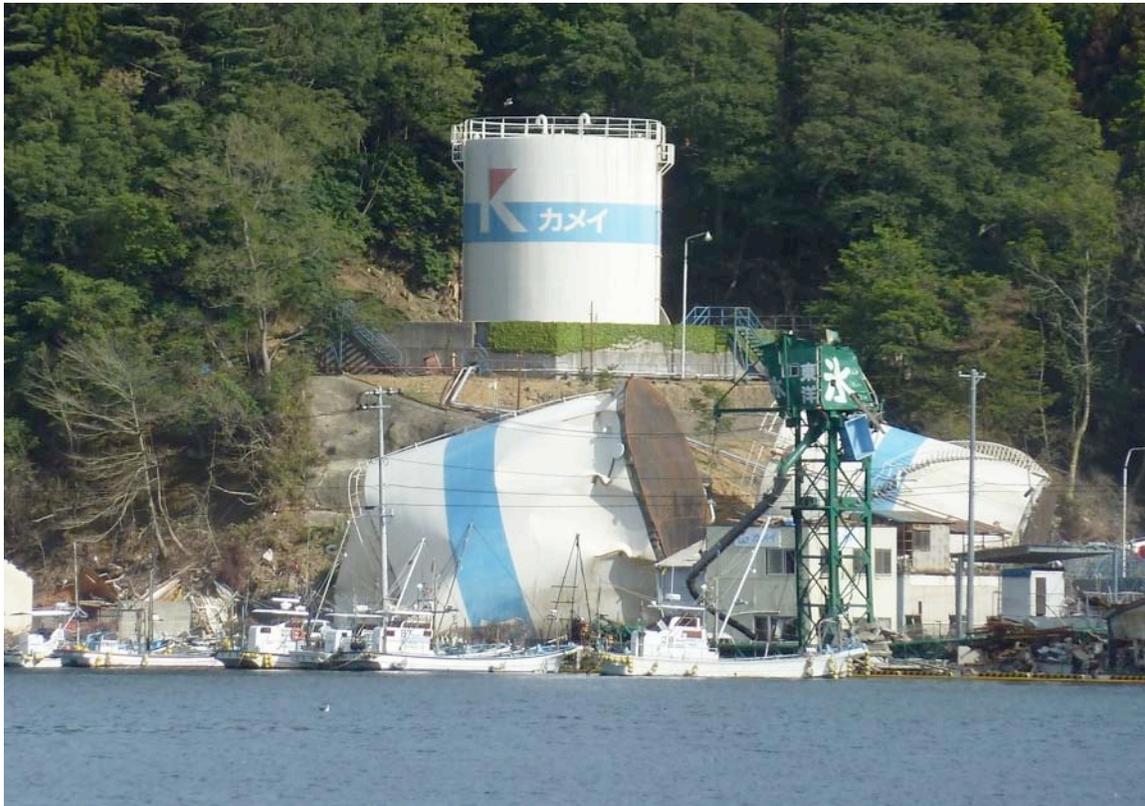
We observed more than 20 floated steel tanks in the tsunami zones. Figure 2-12 shows three oil tanks in Onegawa. The tsunami floated two of the tanks that were at about 20 feet above sea level; but the third tank, at about 50 feet above sea level, was placed high enough on a hill to avoid the tsunami. All three tanks were anchored; the anchors on the two lower tanks broke in the anchor bolts, Figure 2-13. The anchored upper tank appears to have survived the strong ground shaking effects without damage.

*Figure 2-12. Two Floated Tanks, One OK Tank (Onegawa)*

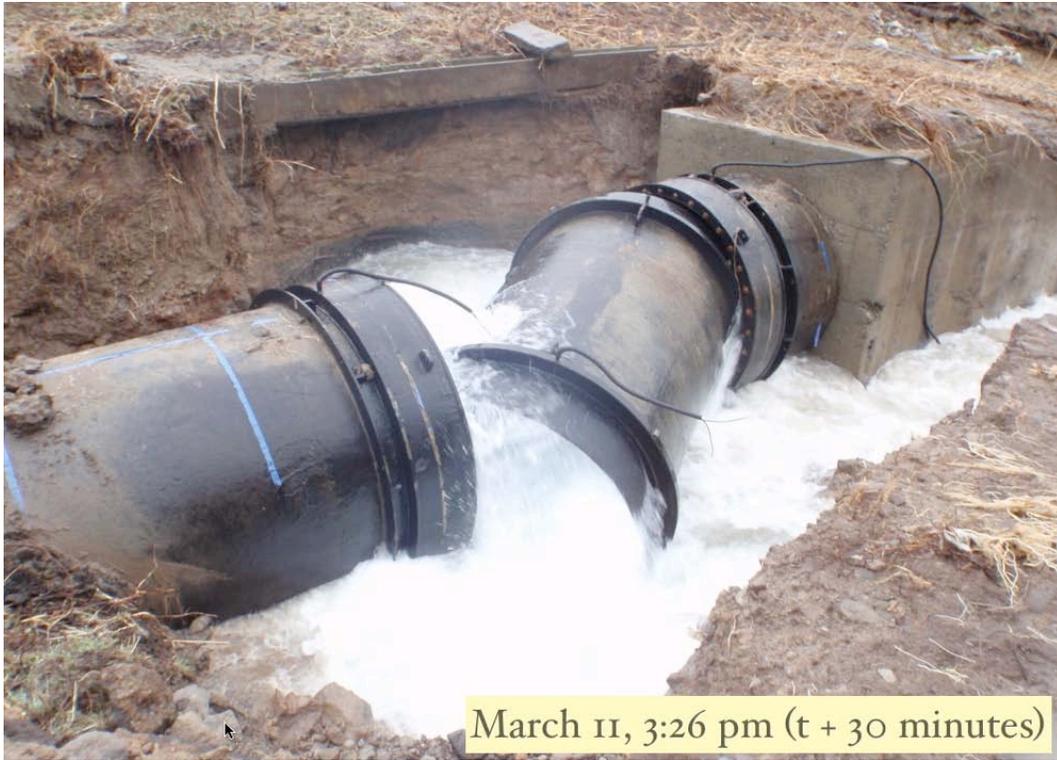
Figure 3-4. Damage Point 1, (96", 2400 mm Diameter Pipe)

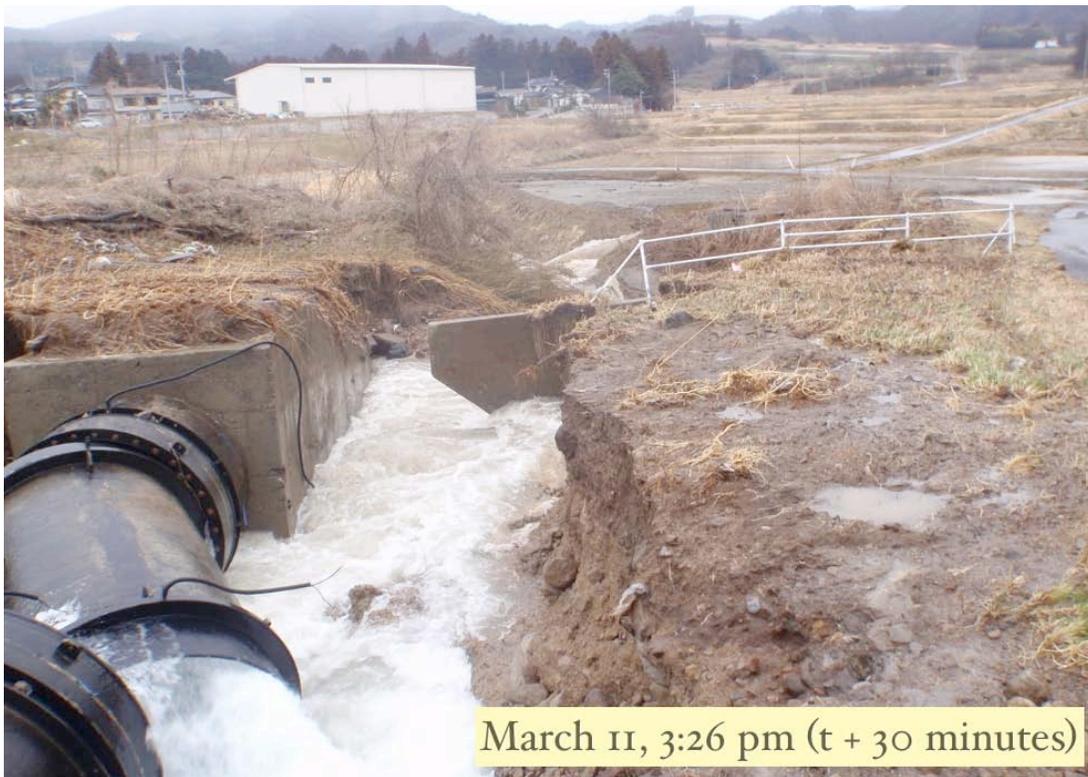
Figure 3-5. Water Being Released, 30 minutes after the earthquake

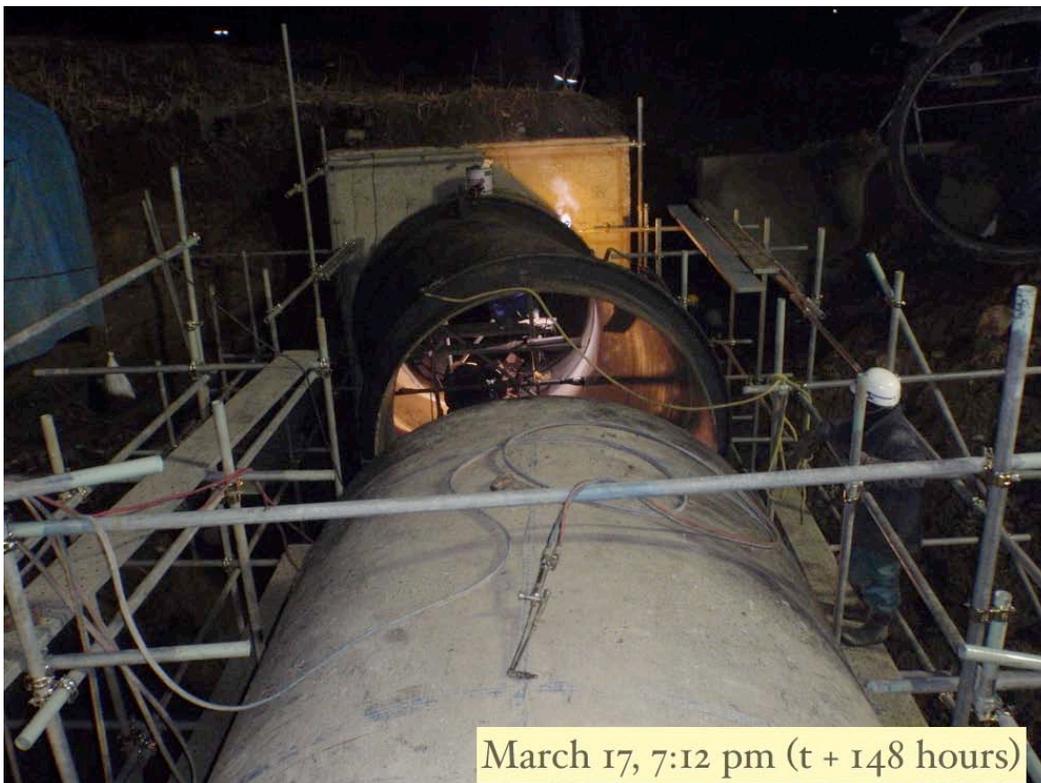
Figure 3-7. Repair Efforts, Night time, (96", 2400 mm Diameter Pipe)

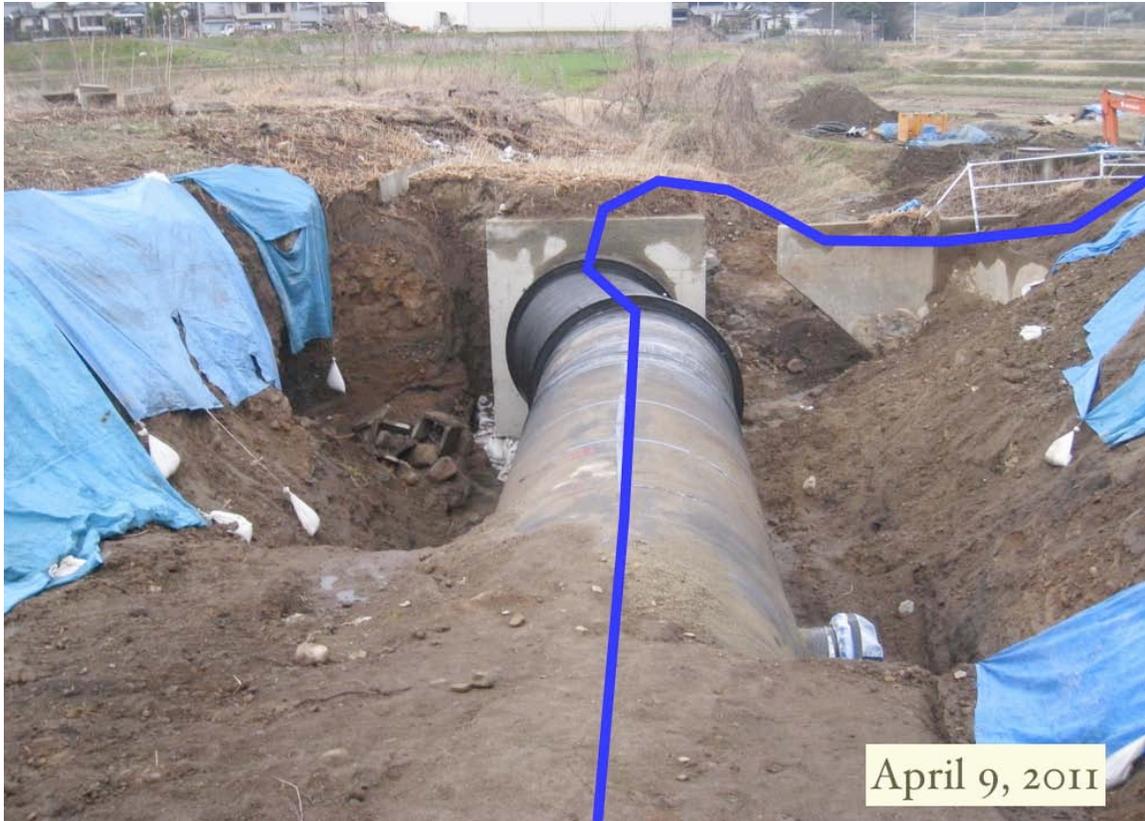
*Figure 3-8. Repaired Pipe, Point 1 (96", 2400 mm Diameter Pipe)*

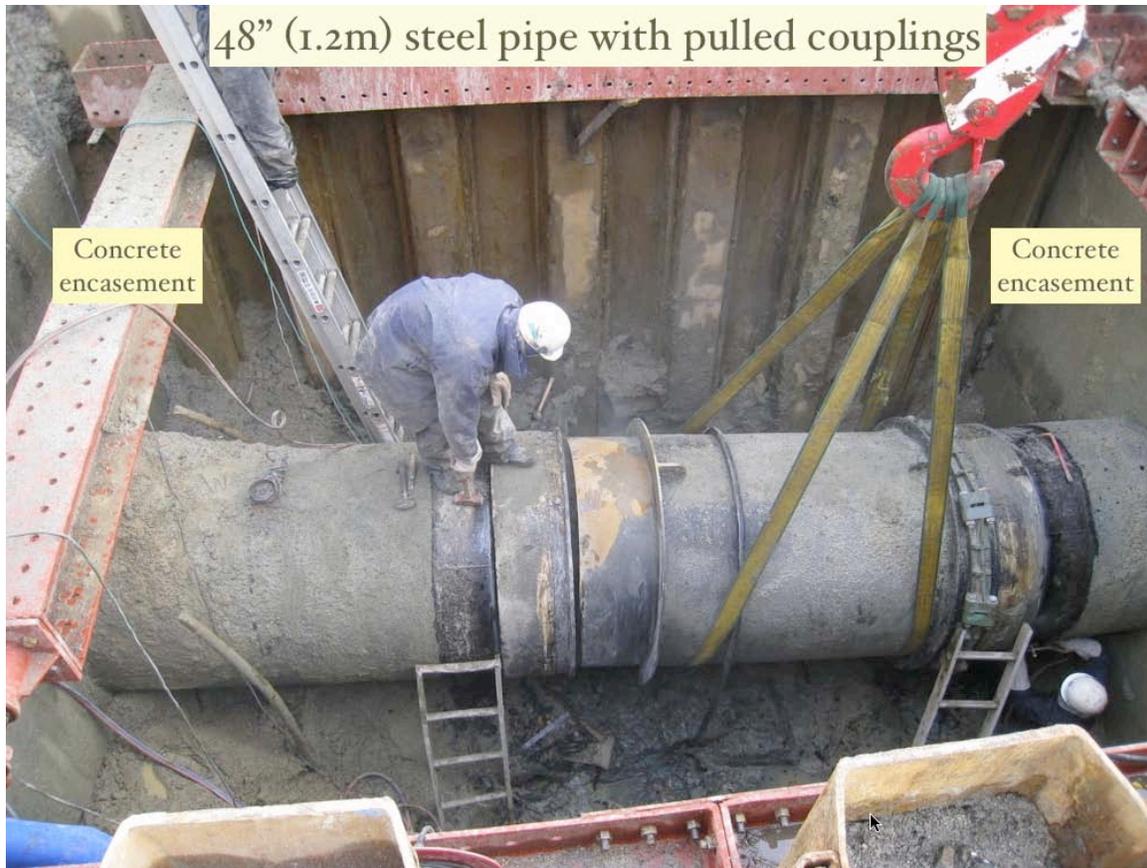
Figure 3-9 shows repairs being made to a 1.2m (48") diameter steel pipe with pulled couplings. This pipe is located along Route 4 near Shiroshi. This pipe is part of the "low" zone that delivers water to Natori.

Figure 3-9. Pipe Under Repair, (48", 1200 mm Diameter Pipe) (Kuwata)

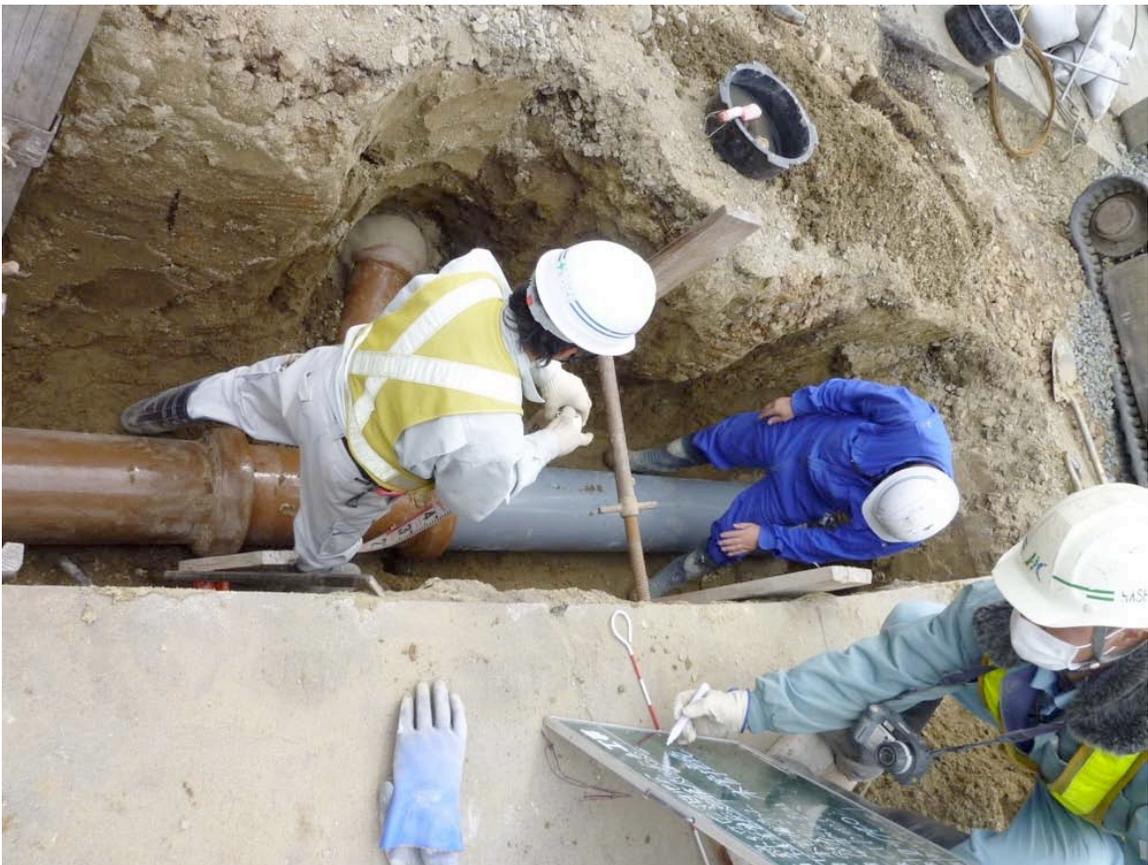
*Figure 3-19. Typical Distribution Pipe Repair being made in Sendai (Kuwata)*

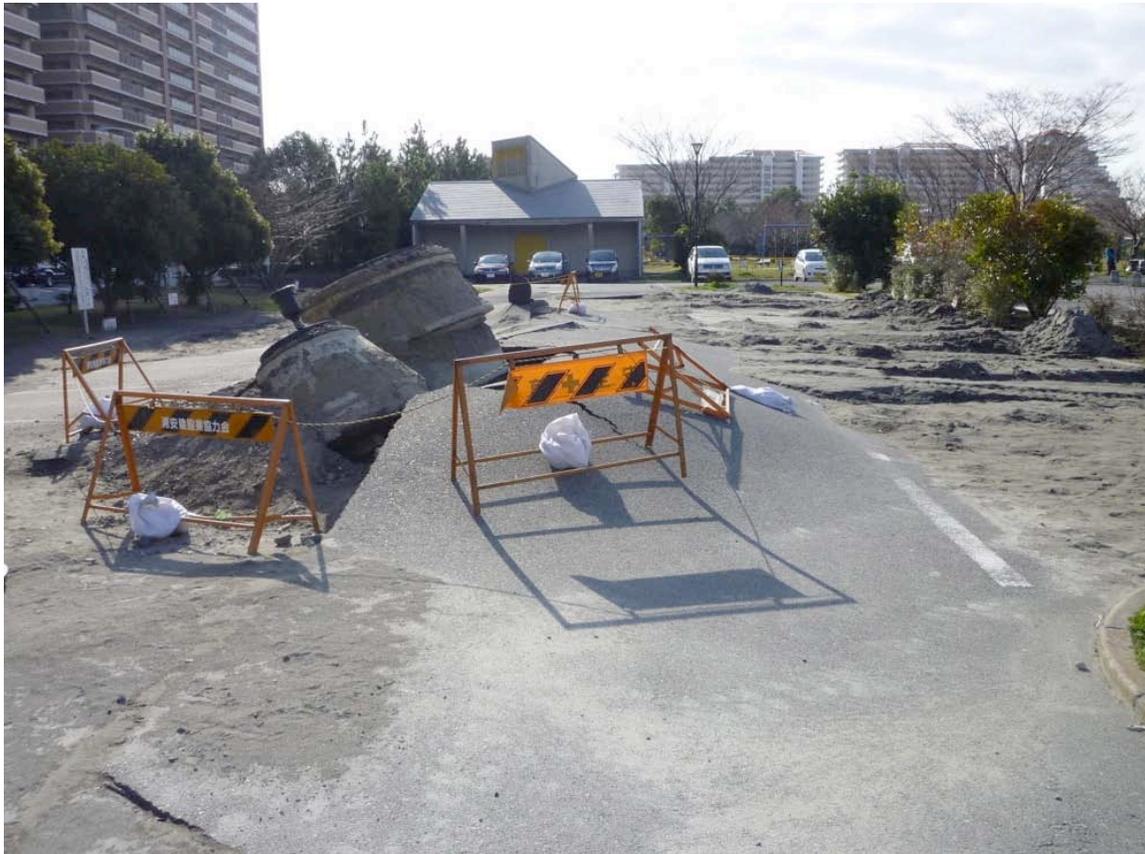
Figure 3-33 shows an uplifted seismic storage tank in Urayusa. This tank had been installed to provide potable water after earthquakes. The area here liquefied, and it is apparent that the high pore pressures uplifted the tank. The tank could not be used for its intended purpose.

*Figure 3-33. Urayusa City Uplifted Water Tank*

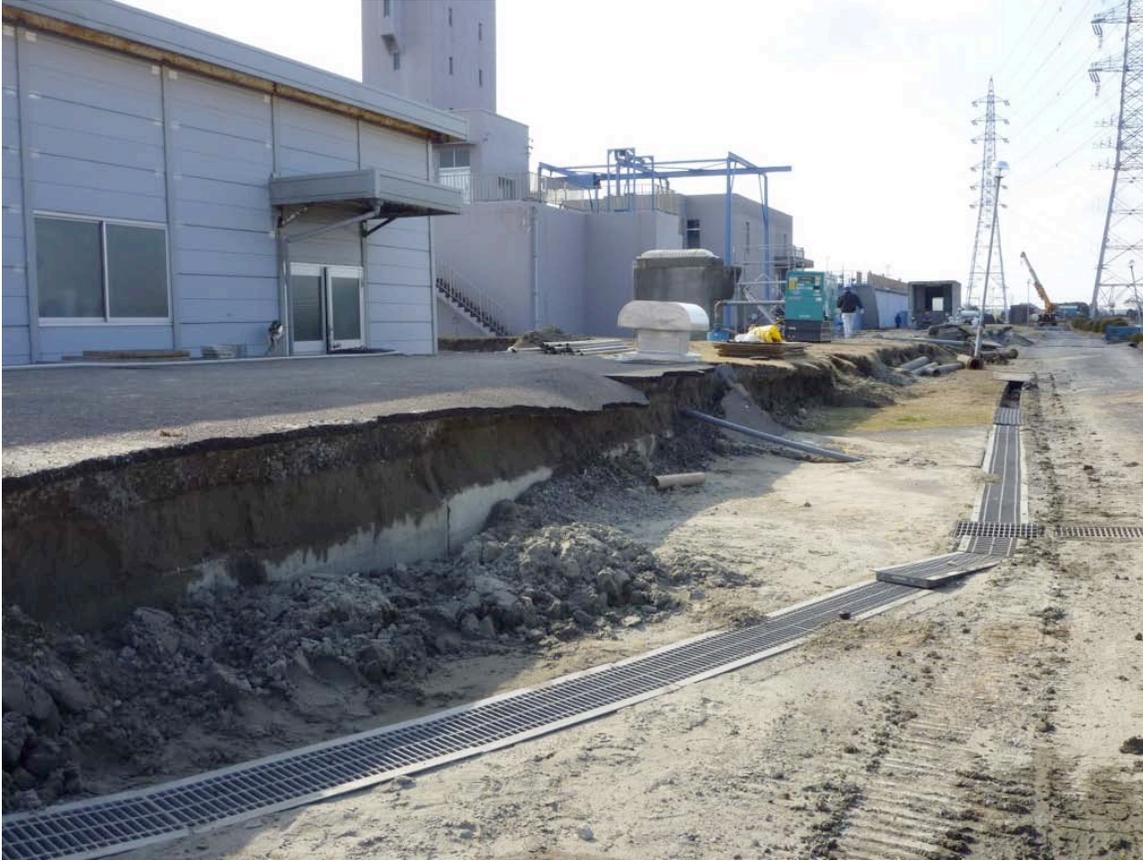
Figure 3-36 shows the domestic water treatment plant, looking to the northwest. The transmission towers are in the central lagoon area. The large scarp is caused by uplift of a buried concrete utility corridor, as well as ground settlements.

*Figure 3-36. Wanagawa Water Treatment Plant, Uplifted Utility Corridor*

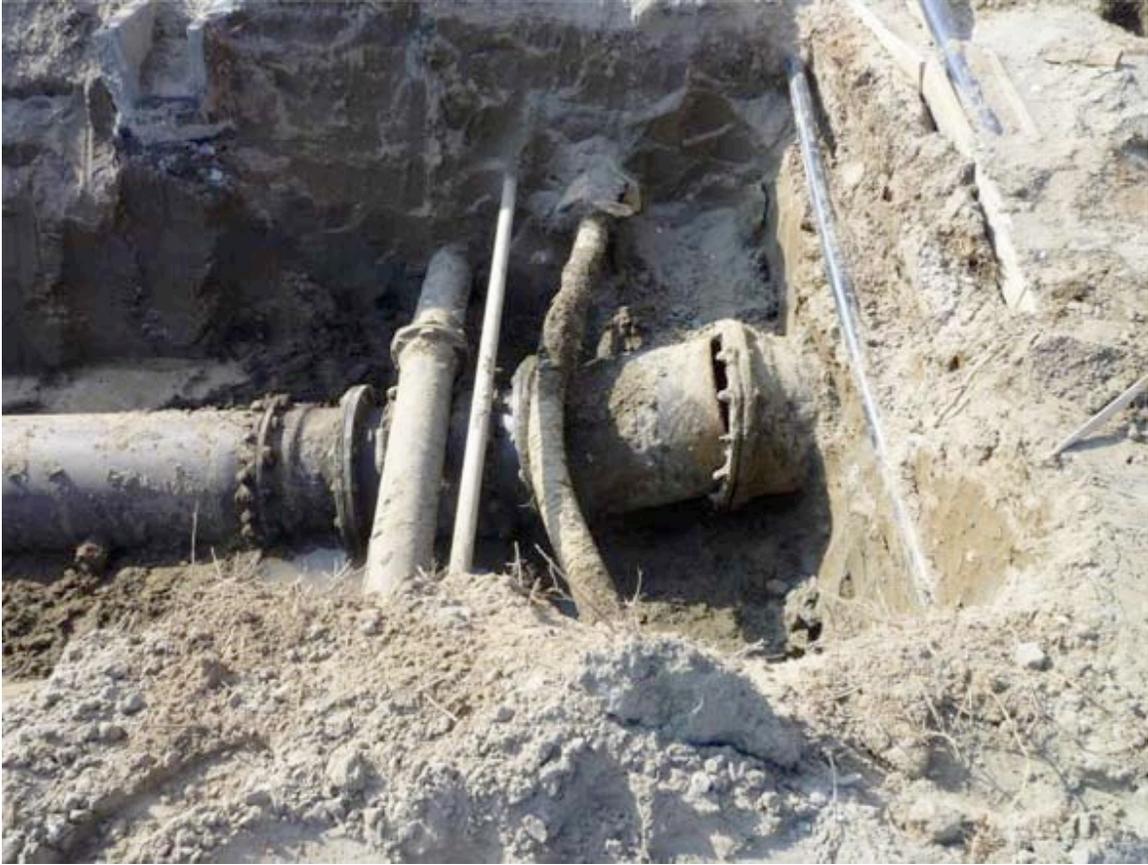
The washwater tank is located at the top of a reinforced concrete building, on piles. The pipes leading into this building, to the tank, failed due to settlement of the ground; the pipe joints failed, Figure 3-37 and 3-38.

*Figure 3-37. Wanagawa Water Treatment Plant, Failed Pipe*

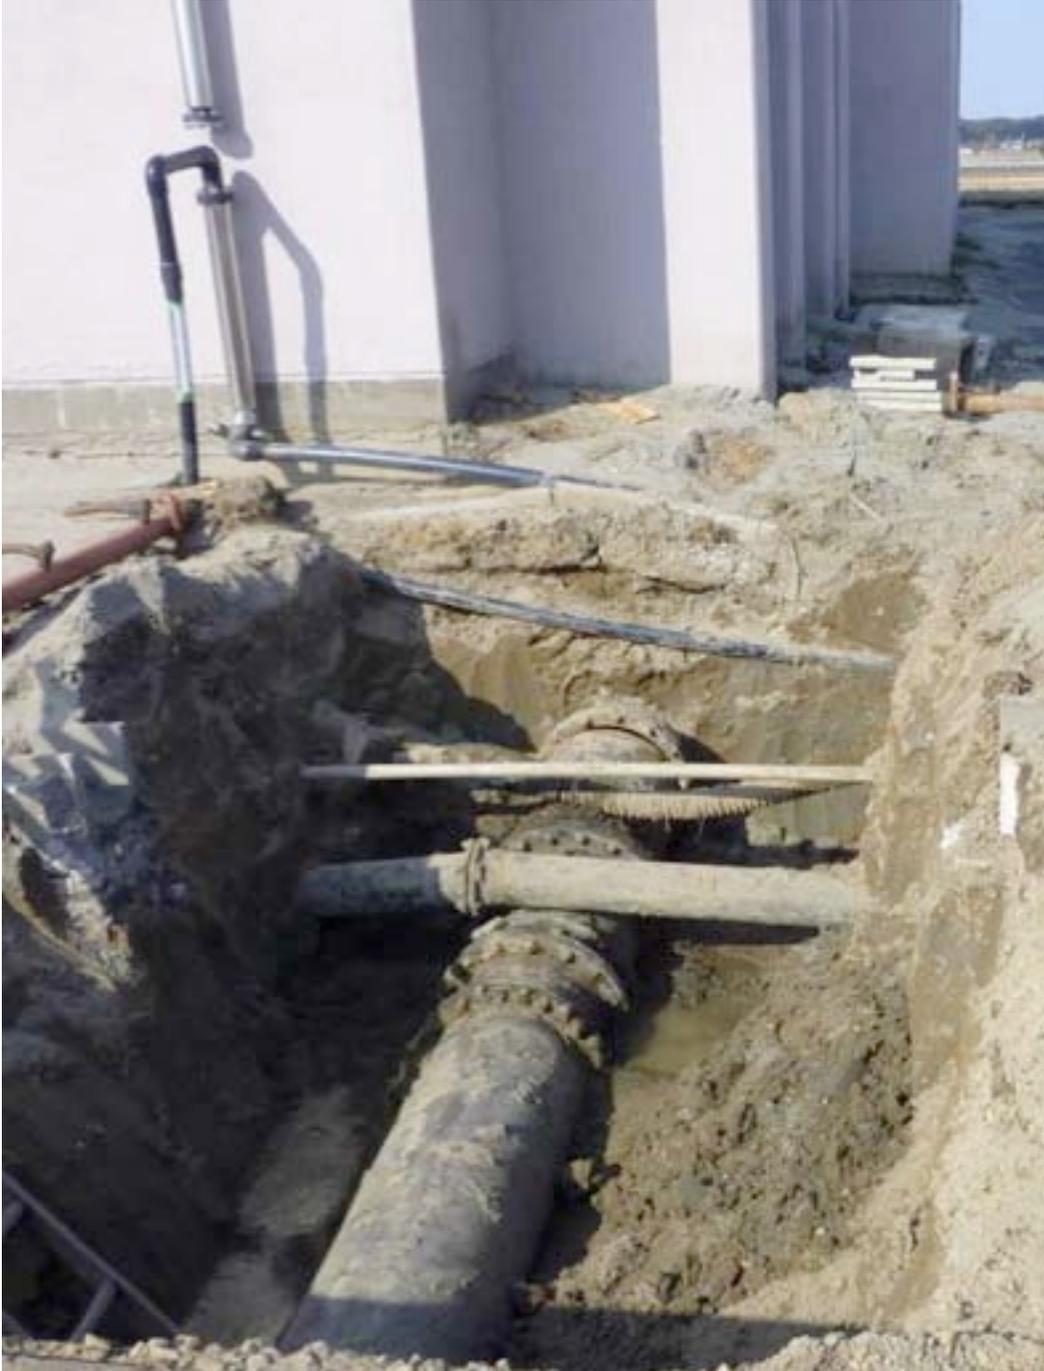
*Figure 3-38. Failed Pipe, Wanagawa WTP*

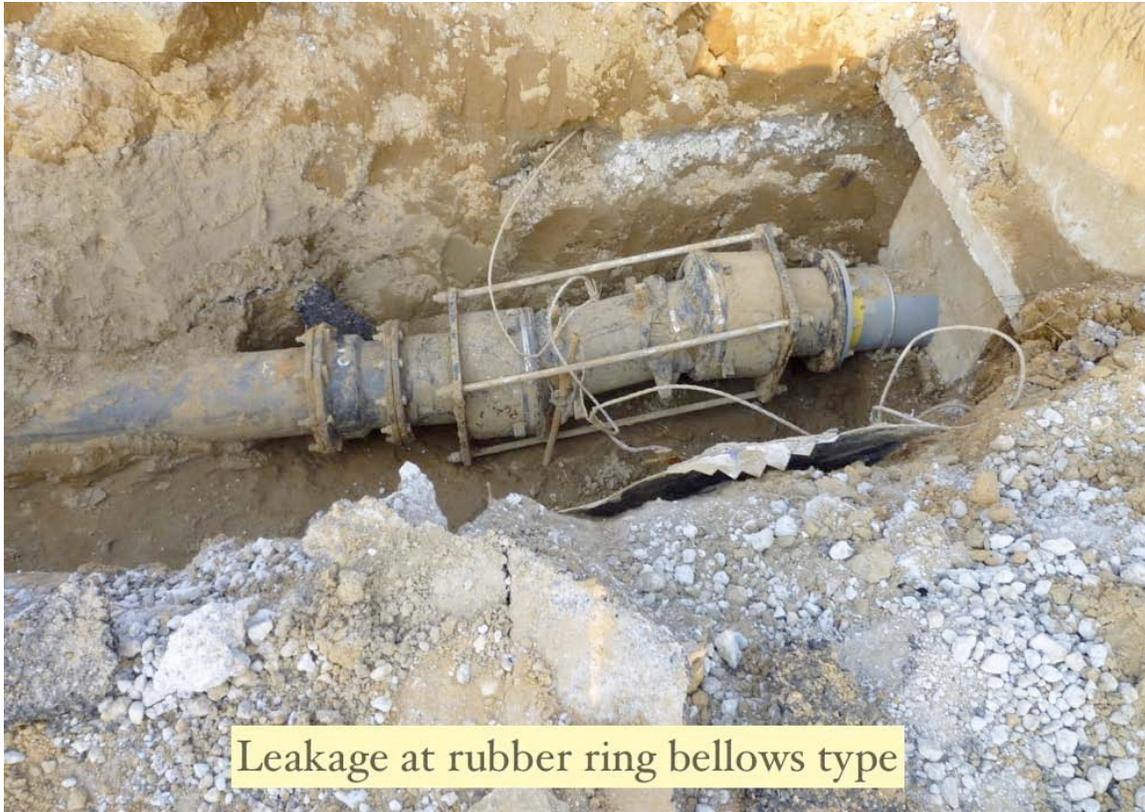
*Figure 3-41. Leakage at the Flexible Joint Next to the Tank (Not Flexible Enough)*

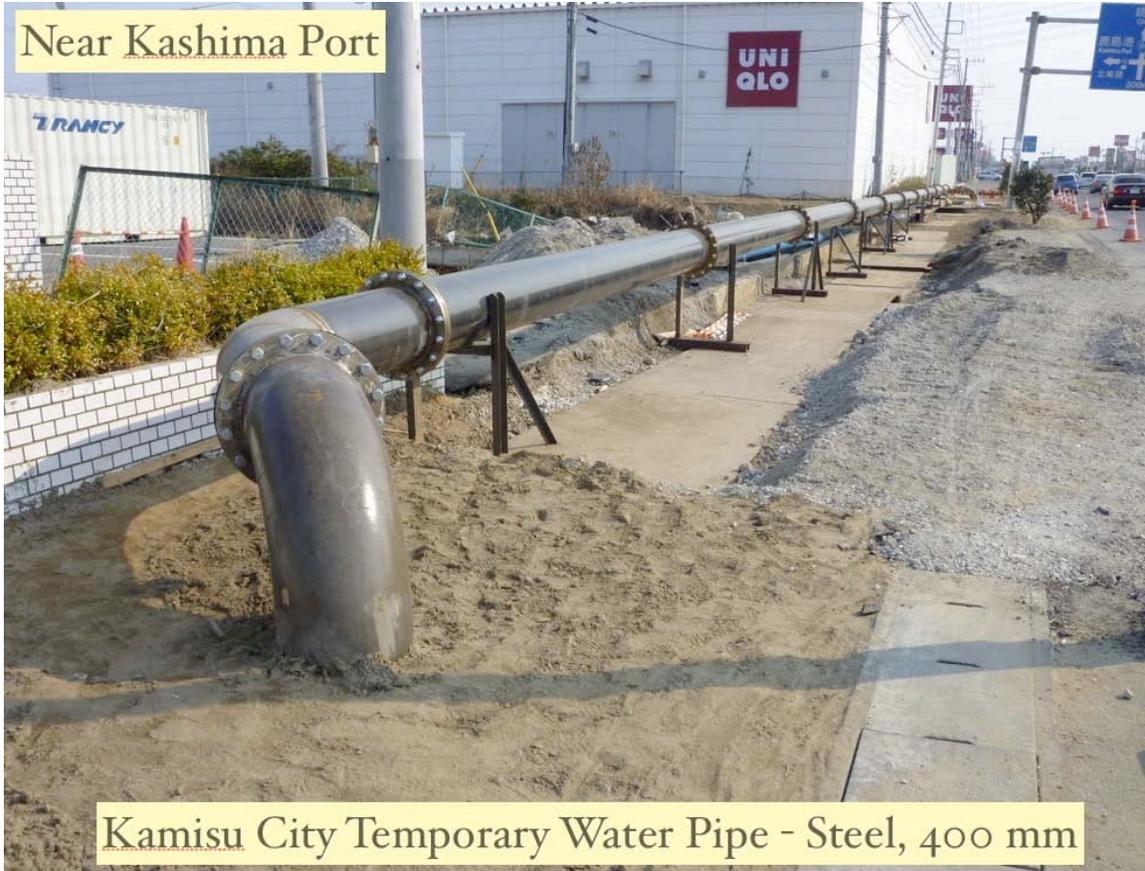
Figure 3-42 shows a temporary pipe installed across a bridge over a creek. A combination of inundation, inundation-caused erosion and/or creek embankment movement laterally, breaking the original water pipe at this location, Figure 3-43.

*Figure 3-42. Temporary Pipe Installed Across a Creek*

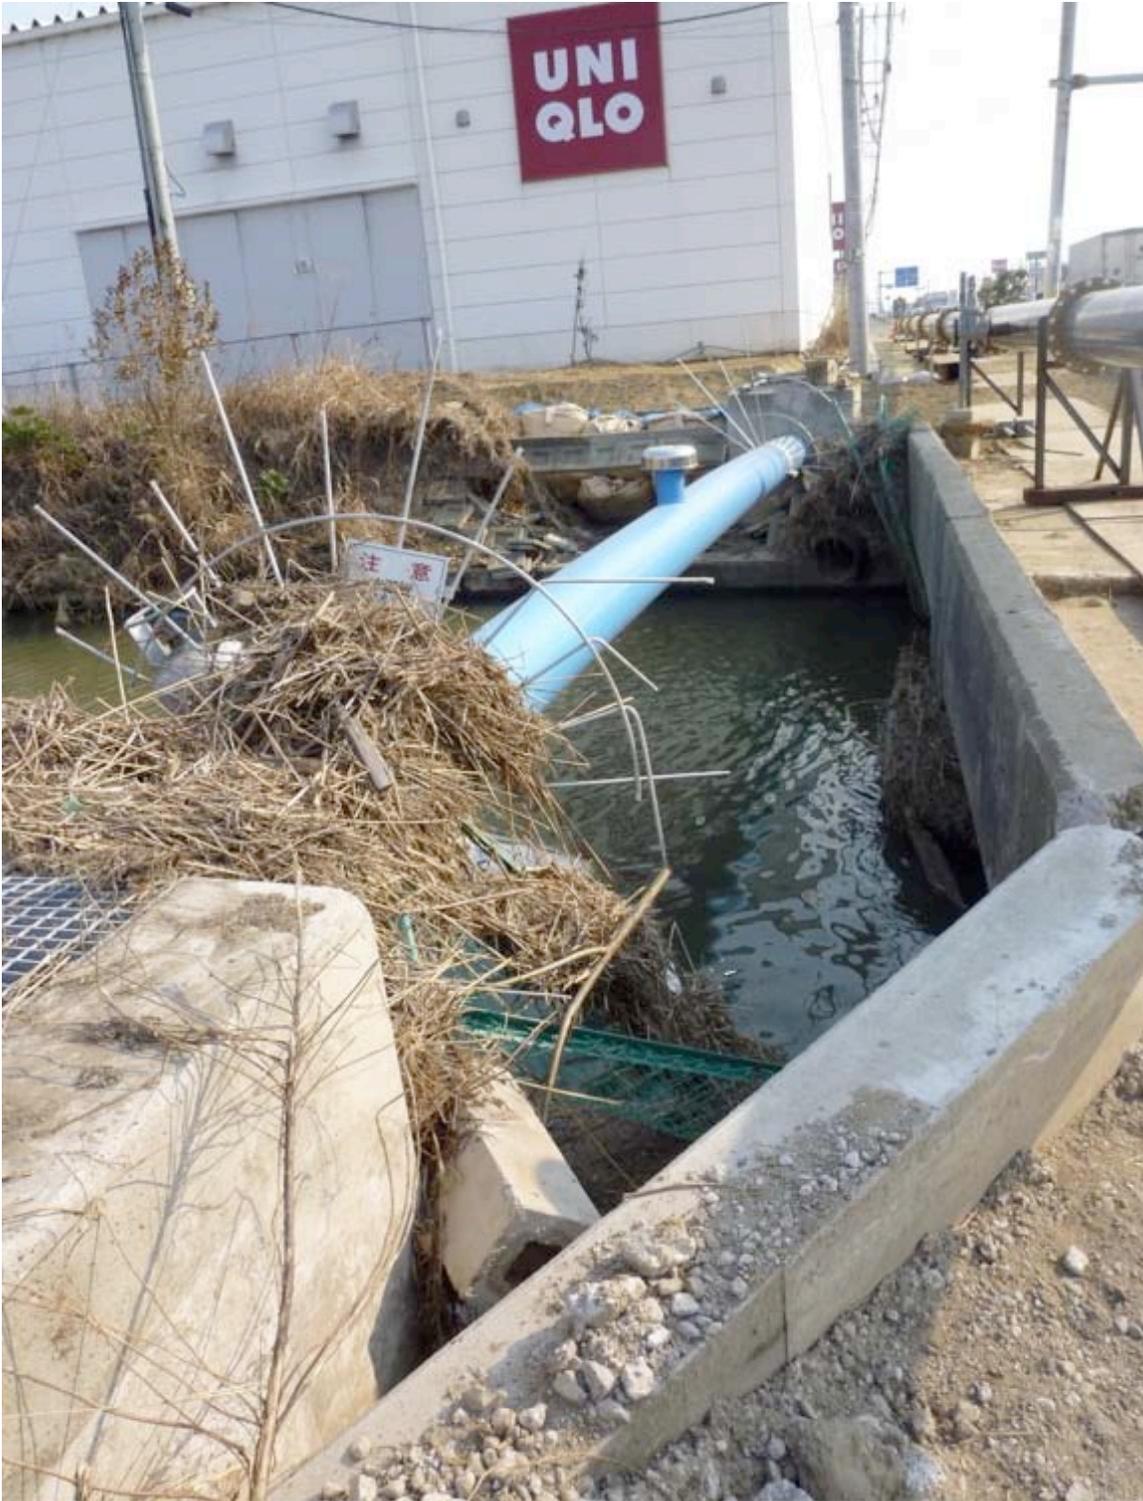
*Figure 3-43. Failed Water Pipe, Kamisu City (Temporary Pipe seen on right)*

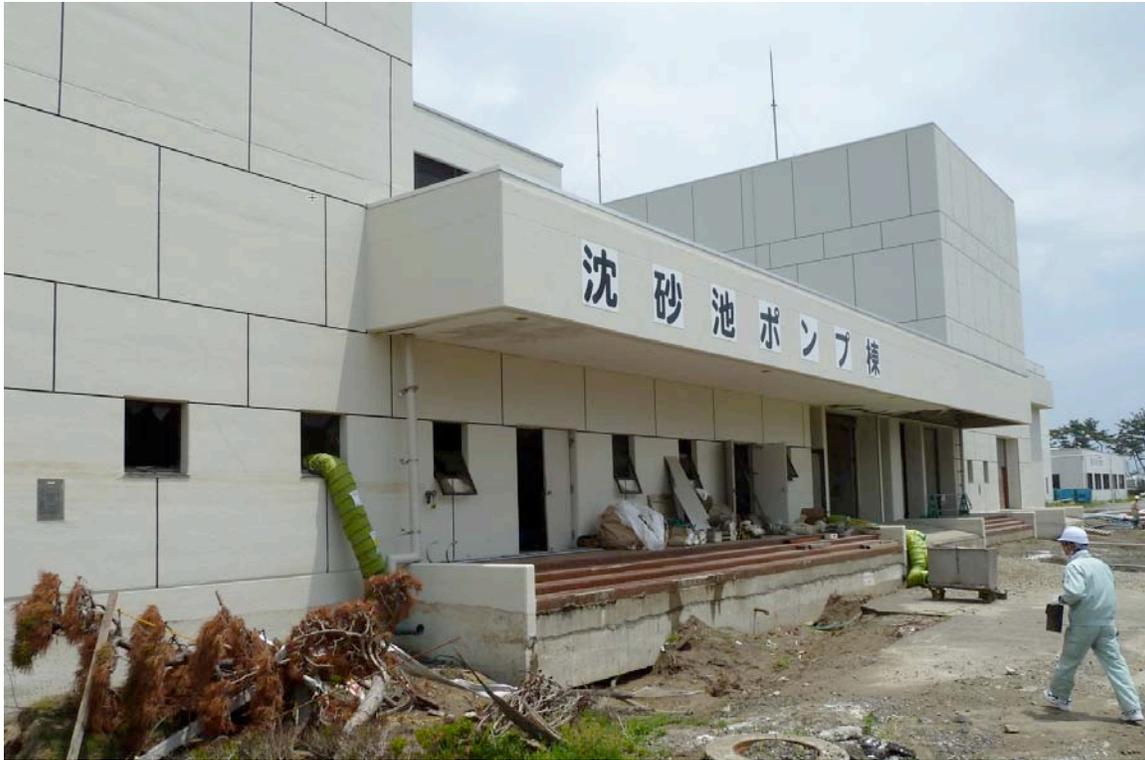
Figure 3-45 shows the intake pump station at the wastewater treatment plant, located about 400 m from the coastline. This reinforced concrete structure was inundated by the tsunami, to a height of about 1.5 meters above grade (see high water marks next to first floor windows). The structure includes basement levels with pumps and motors. It does not appear that there was any settlement of the building. At the ground level, the soil has dropped by about 2 to 3 feet, as evidenced by the soil scar marks and drop at the staircases.

*Figure 3-45. Pump Station – Erosion Impacts due to Tsunami*

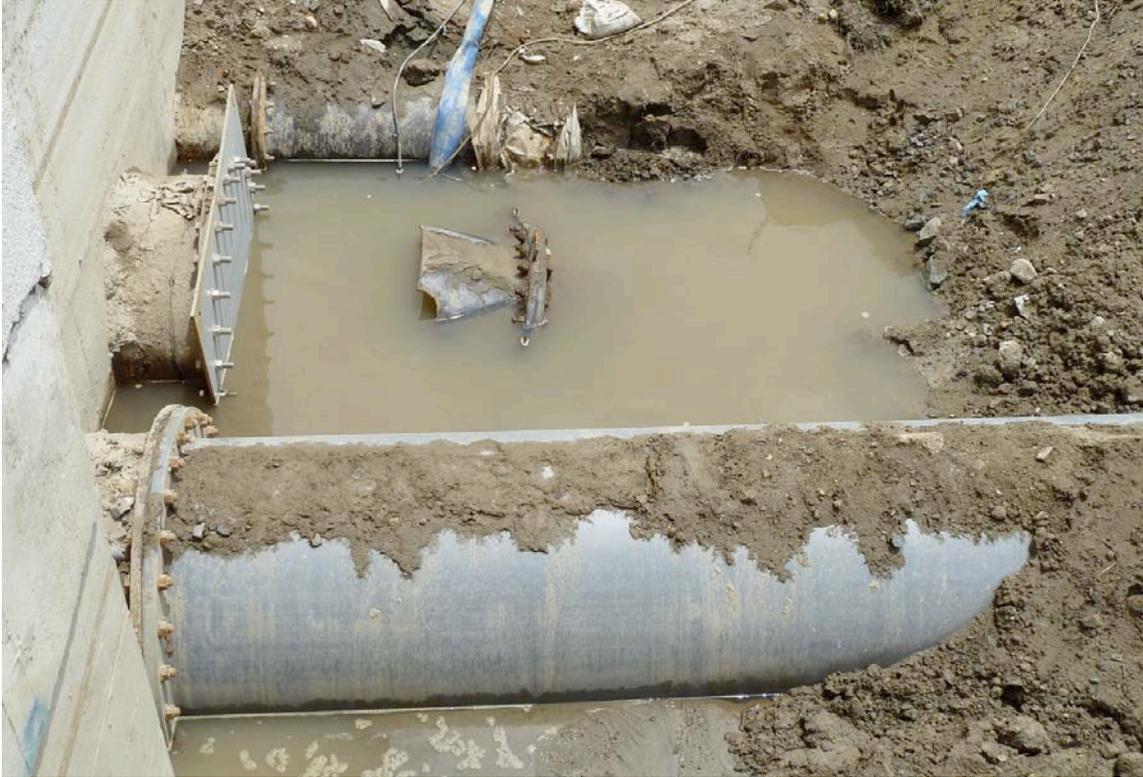
Figure 3-46 shows the three outlet pipes from this pump station to the rest of the plant. The middle pipe has been capped (a piece of the original flange is seen above the water line). The furthest pipe is partially seen; just outside of this photo to the right, workmen are repairing this pipe. Subsequent to the time this photo was taken, the near pipe was also discovered to be leaking. There was some discussion as to whether the damage was due to liquefaction or erosion; whichever the case, it is likely the soil covering these pipes dropped 1 to 2 feet; leading to high loads on the pipes, and thus damage. More likely than not, this was due to erosion, when the tsunami waters receded and scoured the soils around the corners of buildings. We observed many such sites with similar scour effects near the corners of buildings.

*Figure 3-46. Three Large Diameter Pipes Damaged due to Tsunami-Caused Erosion*

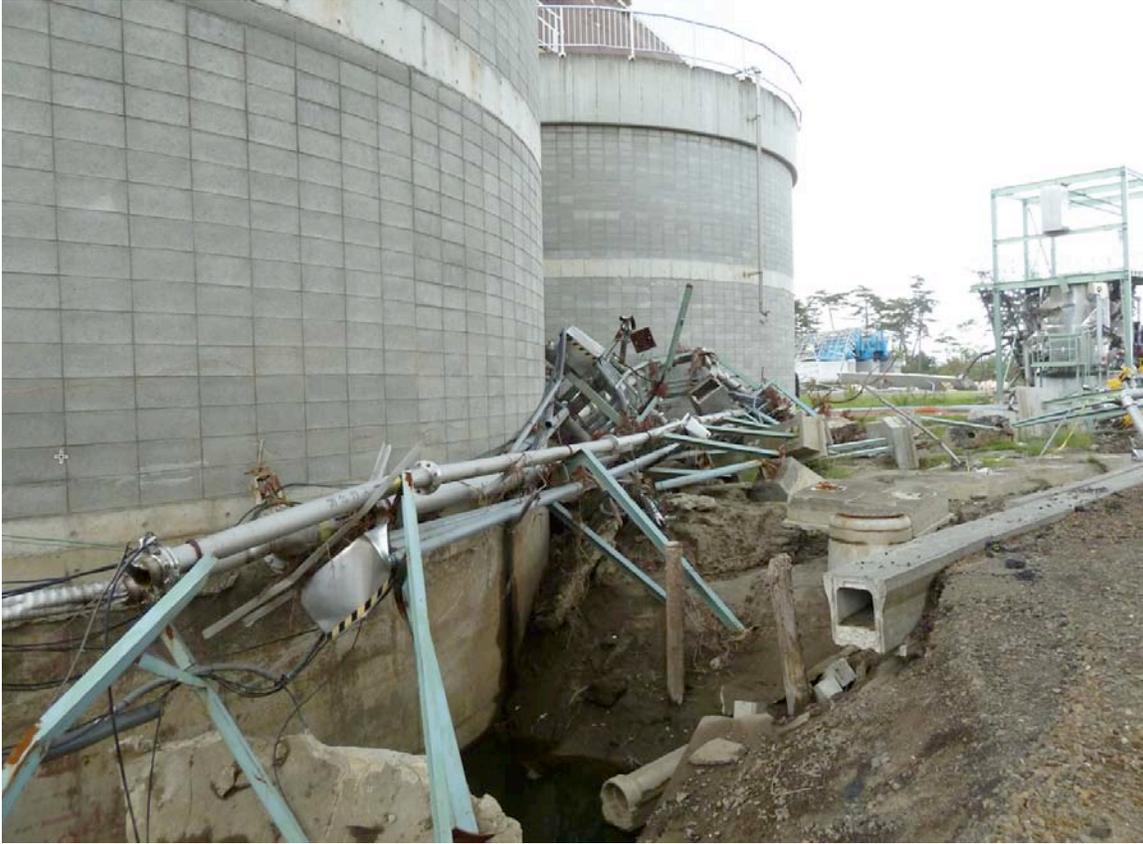
Figure 3-47 shows the effects of tsunami scour on a pipe rack next to digester tanks at the WWTP.

*Figure 3-47. Damage to Pipe Racks Next to Digesters, due to Erosion*

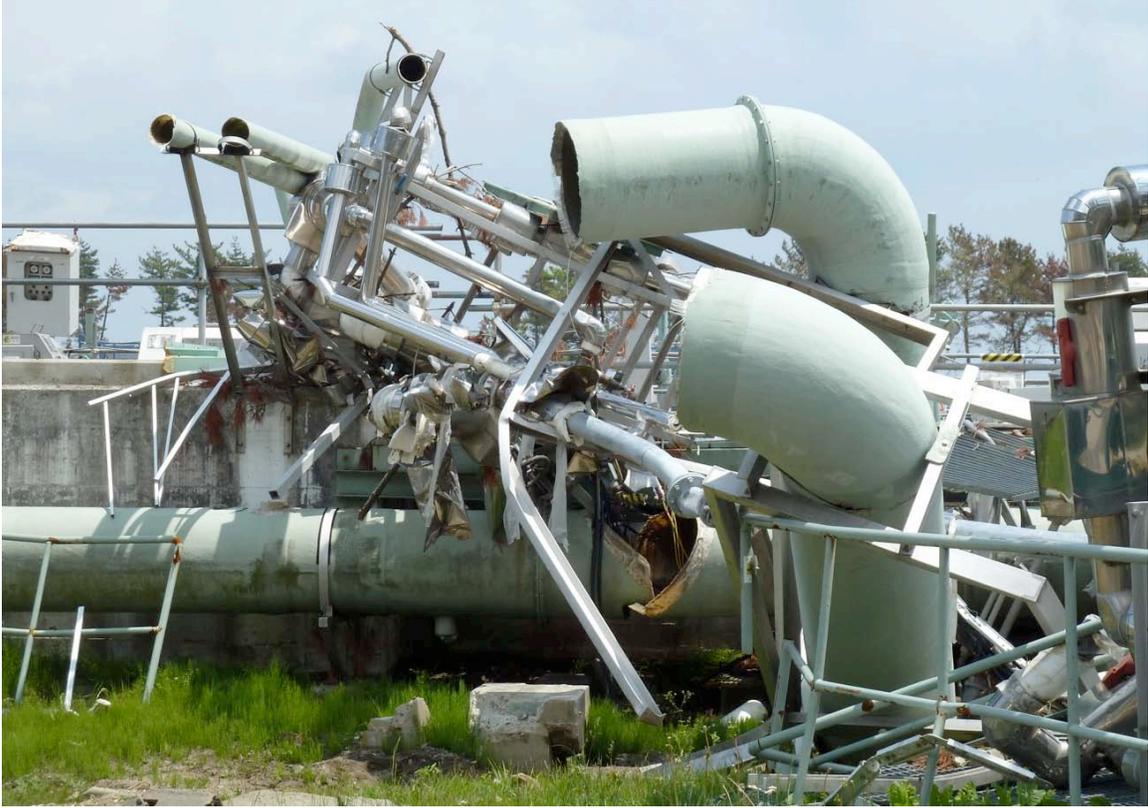
Another form of damage is due to the unbalanced loading due to wave loads. Two processes are involved: the difference in hydrostatic head (generally modest), and the impact forces of the water hitting the structure (pipe) at velocity. The impacted structure must be able to take both these forces, at capacity below yield, else it will be damaged. For design purposes, both the height of the wave and the velocity of the wave need to be known. The velocity of the water imparts a drag force on the structure as it goes around the structure; the shape of the structure will also affect the drag force. The design approach for these types of loads is similar to that used for seismic loading of pipes and internals within water tanks. As can be seen in Figure 3-48, the designers of this WWTP did not consider these loads.

*Figure 3-48. Damage to Air Pipes due to Tsunami Velocity Effects*

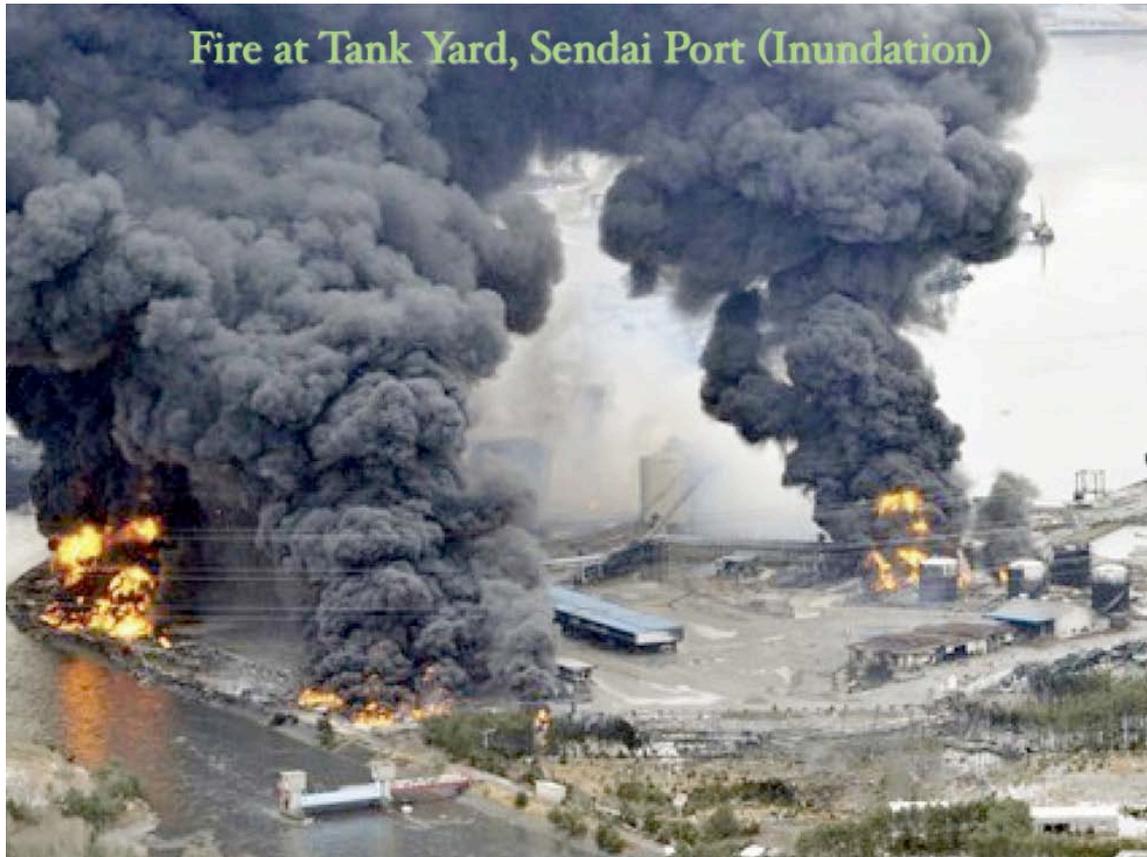
There were two fires of note in refineries. One fire was in the Sendai refinery, Figure 3-54, and the cause was inundation. It appears that the tsunami waves broke an inlet-outlet pipe to a tank holding asphalt; the spilt contents were ignited, leading to the fire. The fire did not spread to the adjacent power plant or gas facilities. It is unknown if there was any fire fighting activities to control the fire.

*Figure 3-54. Fire at Refinery, Port of Sendai*

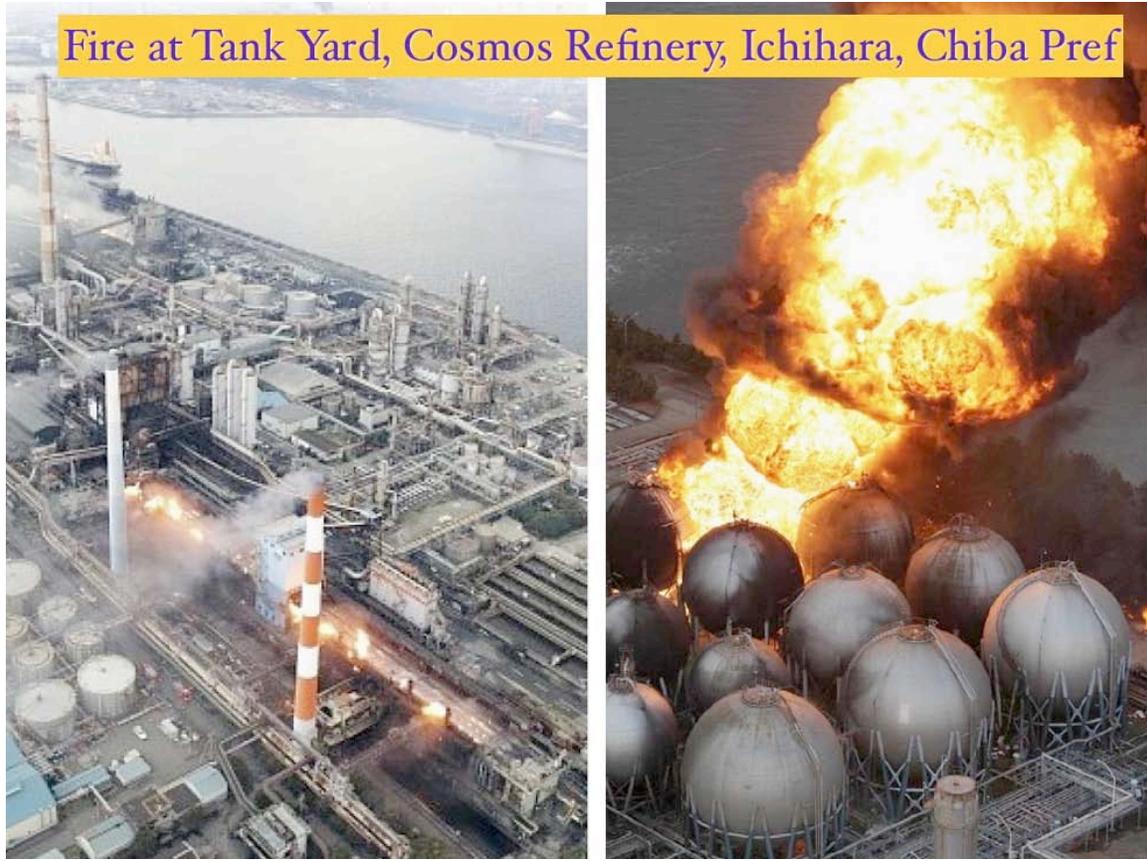
Figure 3-55 shows a fire at the tank yard at the Cosmos Refinery, Chiba Prefecture. The seismic cross bracing for one of the gas holder tanks was damaged by the main shock of the M 9.0 earthquake; 30 minutes later, a M 7.2 aftershock collapsed the tank, leading to the ignition. Figure 3-56 shows the collapsed tank after the fire; power outages after the M 9.0 earthquake had prevented closure of isolation valves.

Fire at Tank Yard, Cosmos Refinery, Ichihara, Chiba Pref

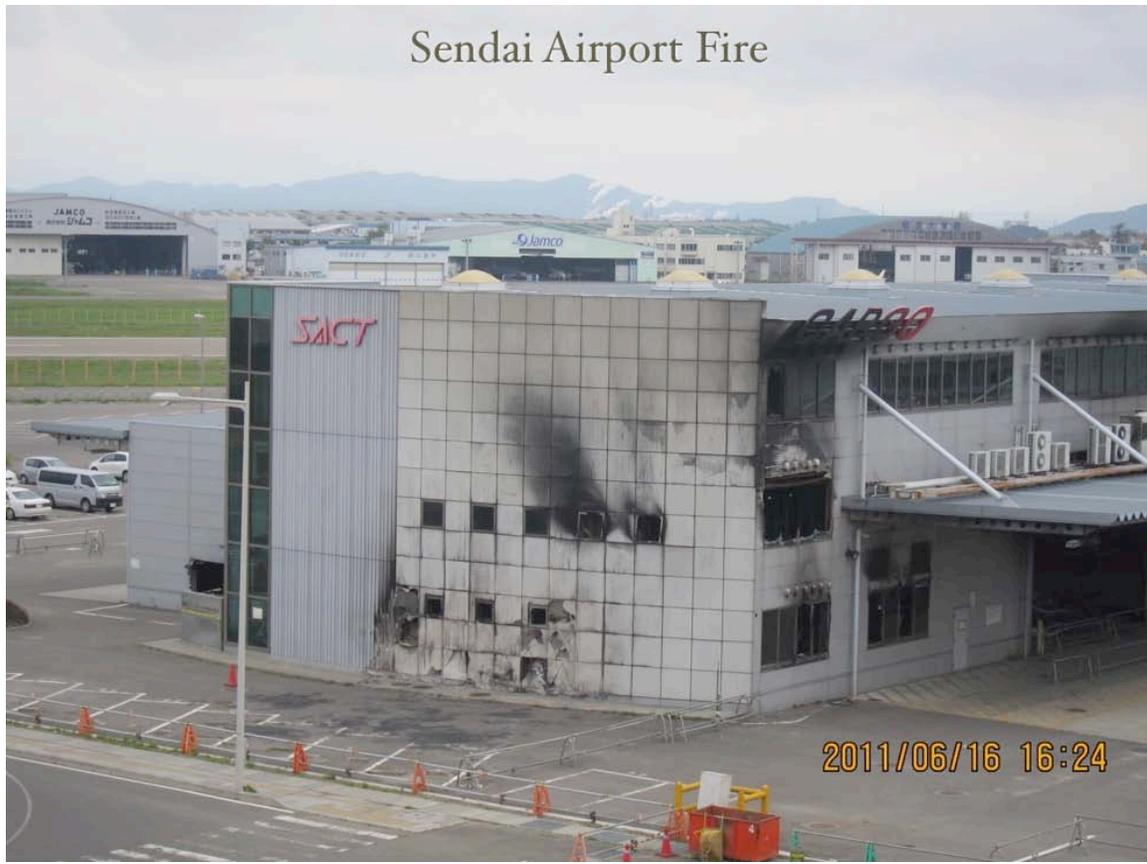
Figure 3-57 shows the fire scars on a cargo building at the Sendai Airport. According to staff at the airport, the tsunami carried a burning car to this building; the fire scars are due to the burning car, and not to an ignition within the building.

*Figure 3-57. Fire at Sendai Airport*
