**M 9.0 Tohoku Earthquake  
March 11 2011  
Performance of Water and Power  
Systems**

*G&E Engineering Systems Inc.  
6315 Swainland Rd  
Oakland, CA 94611  
(510) 595-9453 (510) 595-9454 (fax)  
eidinger@earthlink.net*

*June 25, 2012*

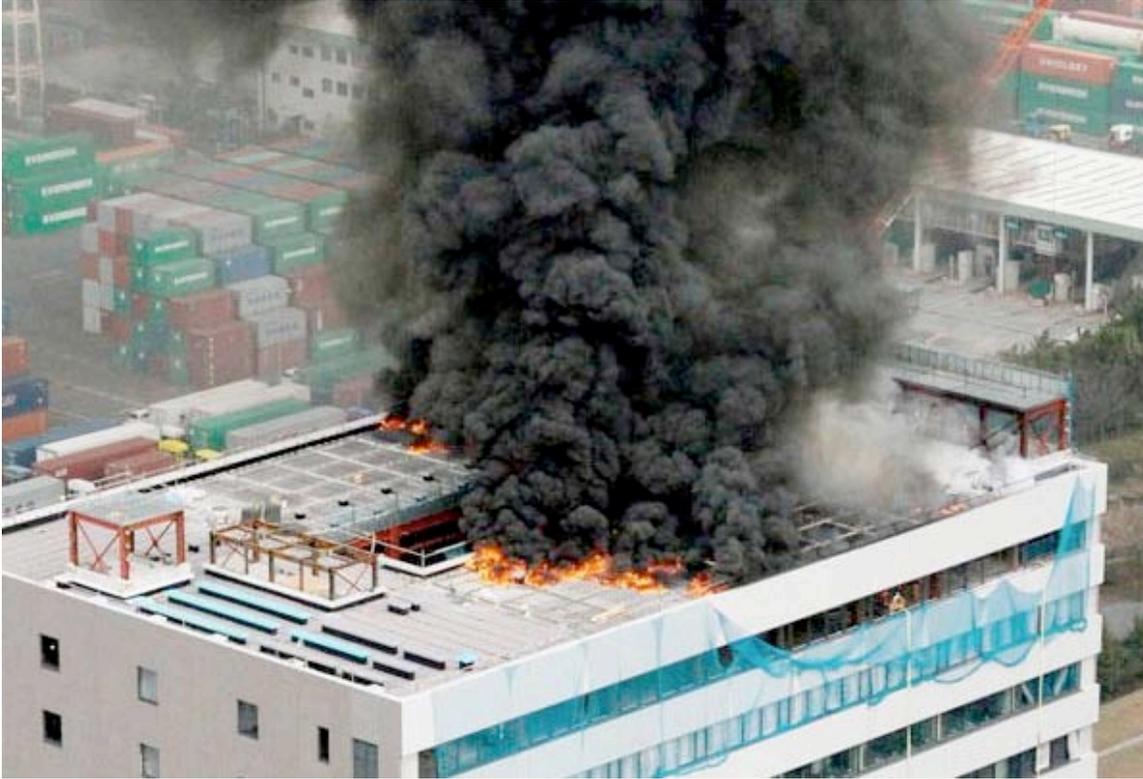
Figure 3-58 shows a fire atop an office building near the port of Tokyo. It was reported that this fire was caused by toppling of welding equipment that was being used to make repairs atop the building.

Figure 3-58. Tokyo Office Building Fire

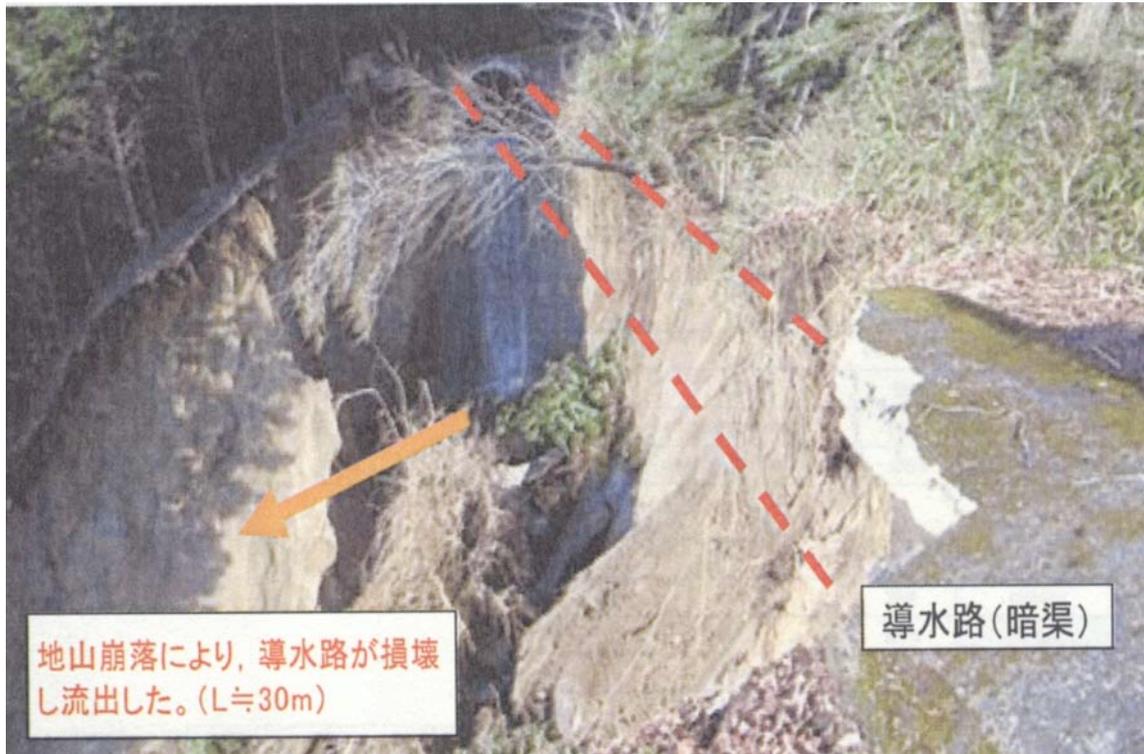
Figure 4-10 shows damage to about 30 meters of a headrace (water channel) at a hydroelectric facility.

Figure 4-10. Damaged Headrace – Tohoku EPCo

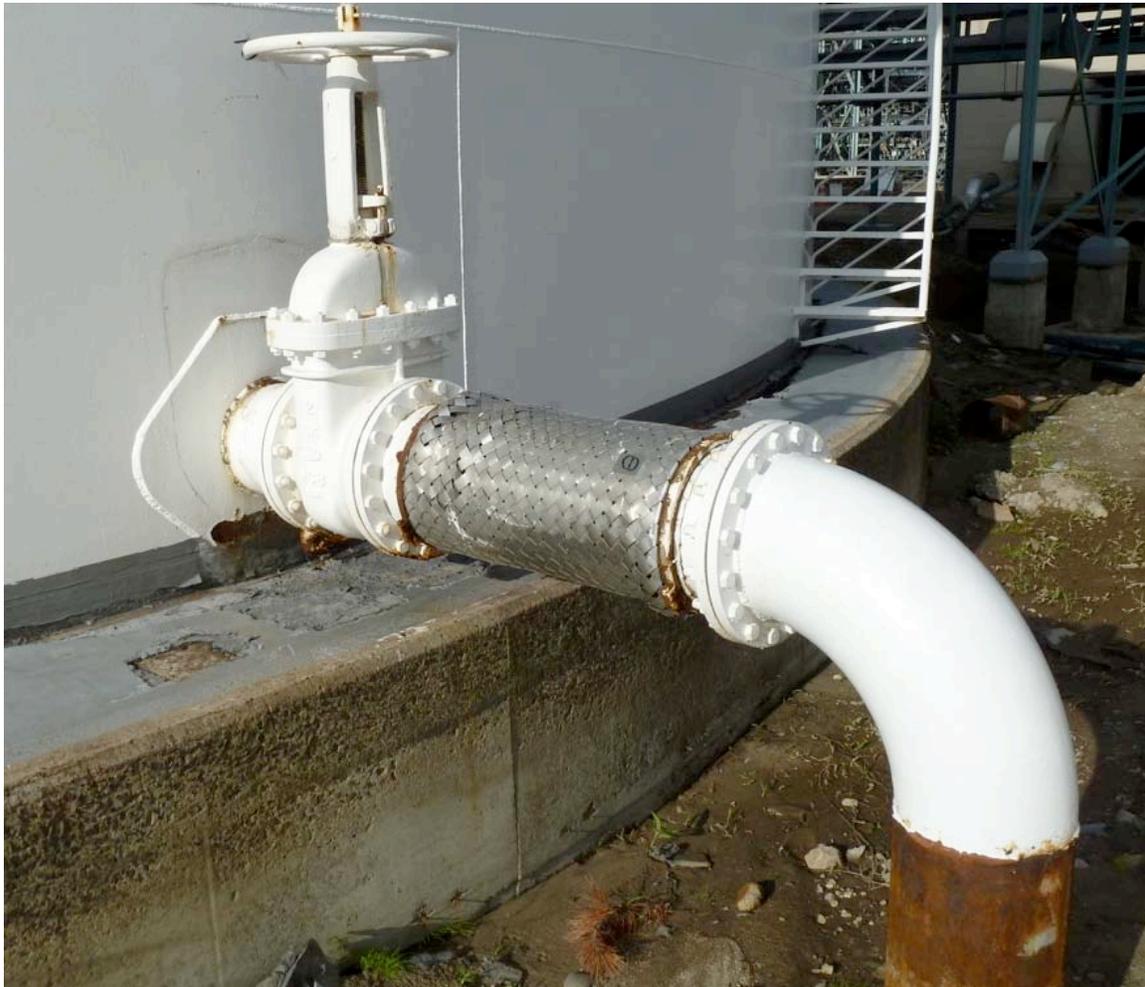
Figure 4-17 shows the south side of Tank 1, with part of the concrete ring wall exposed due to scour from the water inundation. One of the flexible connections is seen on an inlet pipe. The scour depth here is about 2.5 feet deep.

*Figure 4-17. Shin Sendai Power Station – Water Tank 1, Scour*

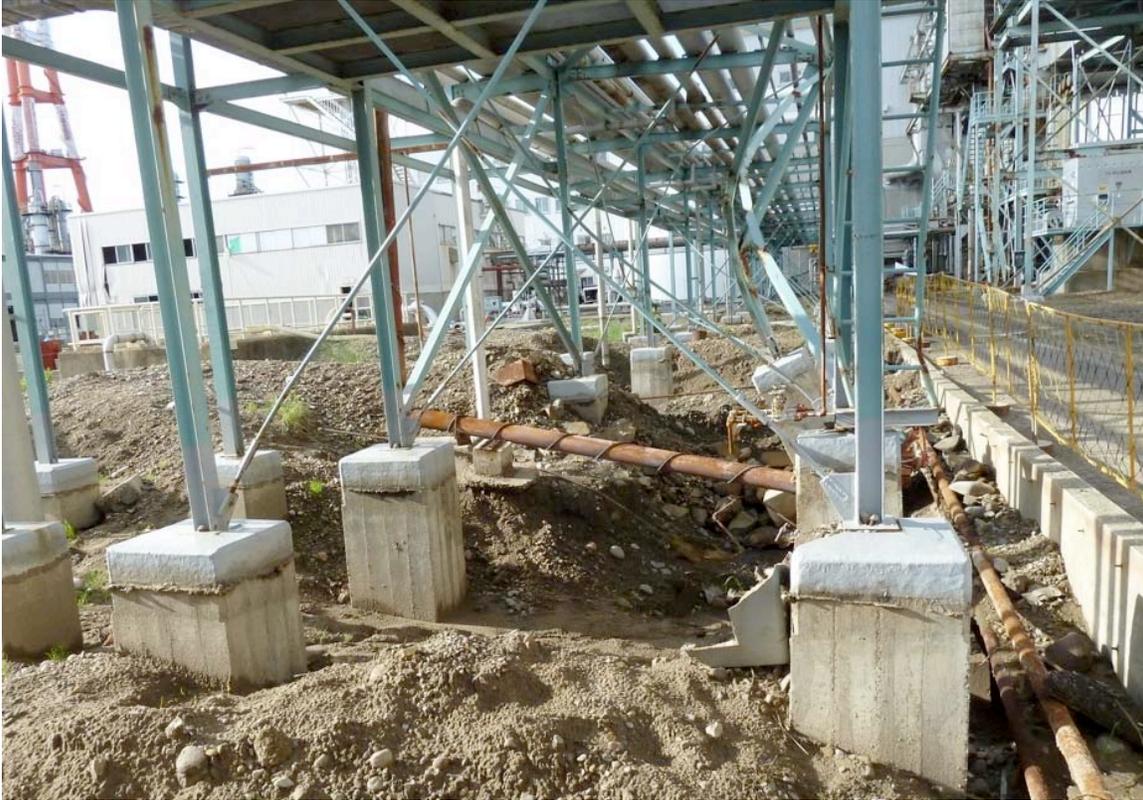
Figure 4-18 (looking north) shows the extensive scour of the pedestal supports around the pipe chase; the damage to one of the cross braces is thought to have been from vehicle impact. The scrapes at the "X" locations on the rod cross bracing suggest that the top level of pipe chase moved back and forth at least several inches; several cross brace rods are buckled, and some rod-frame connections are broken.

*Figure 4-18. Shin Sendai Power Station – Pipe Chase, Scour, Bracing Damage*

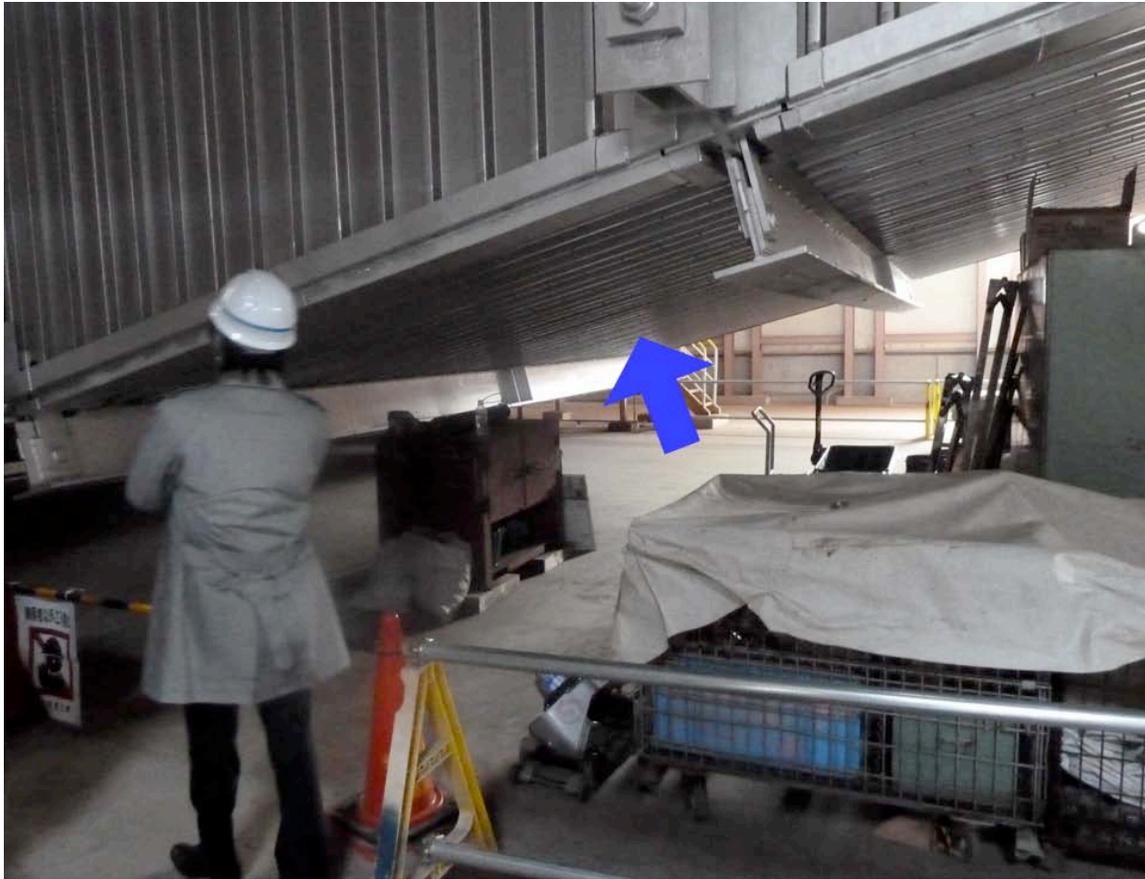
*Figure 4-31. Damage Location to Steam Generator Exhaust Manifold*

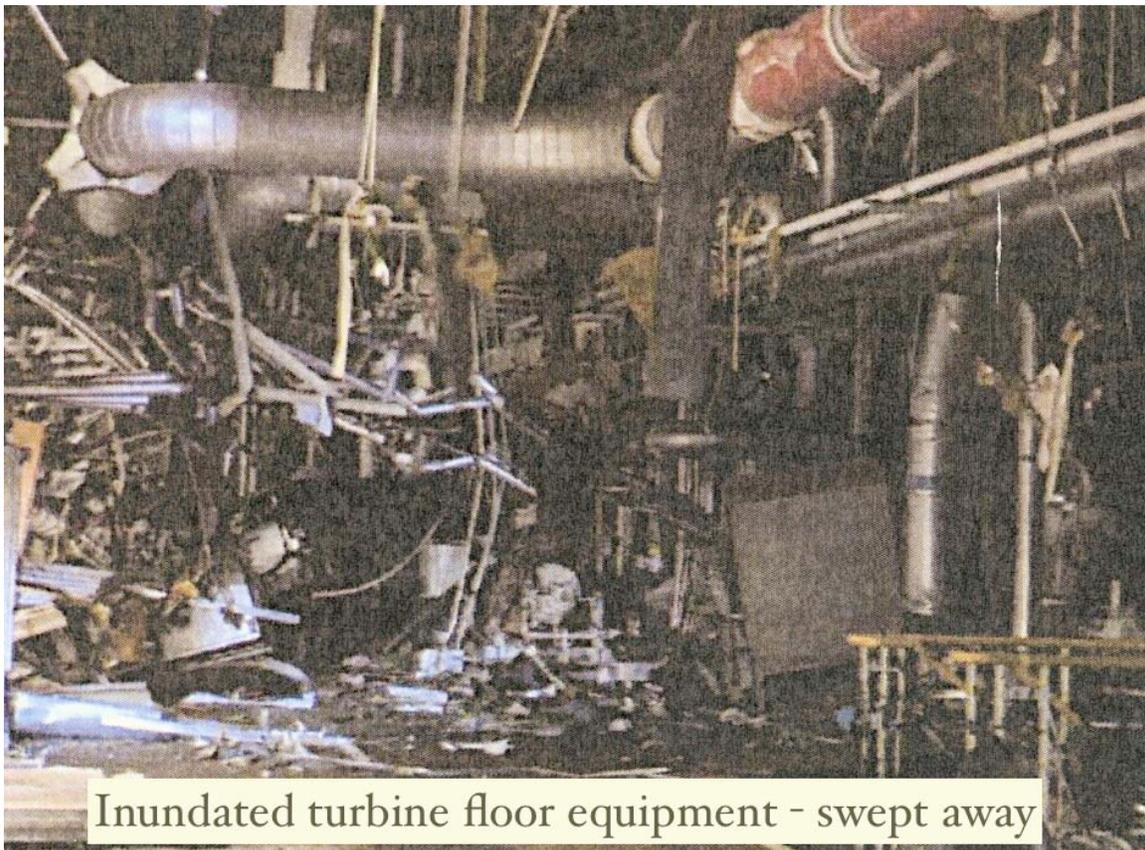
*Figure 4-33. Haramachi Power Station – Damage due to Tsunami Inundation*

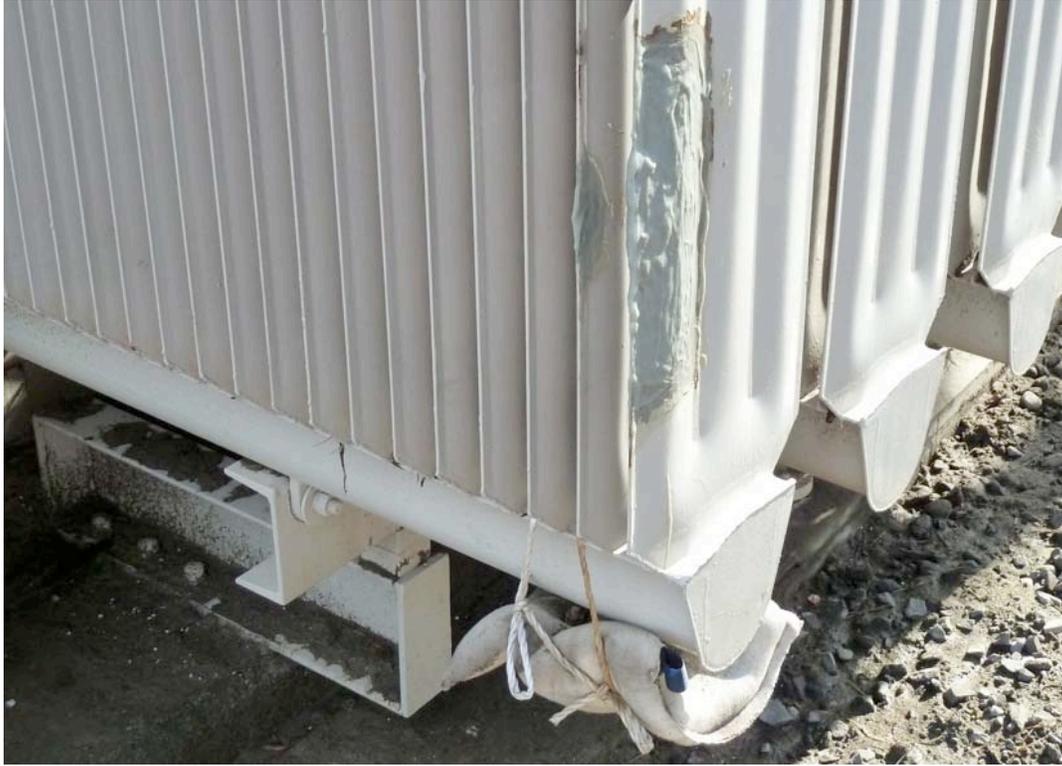
*Figure 4-40. Transformer Radiator Damage at Tagajyo Substation*

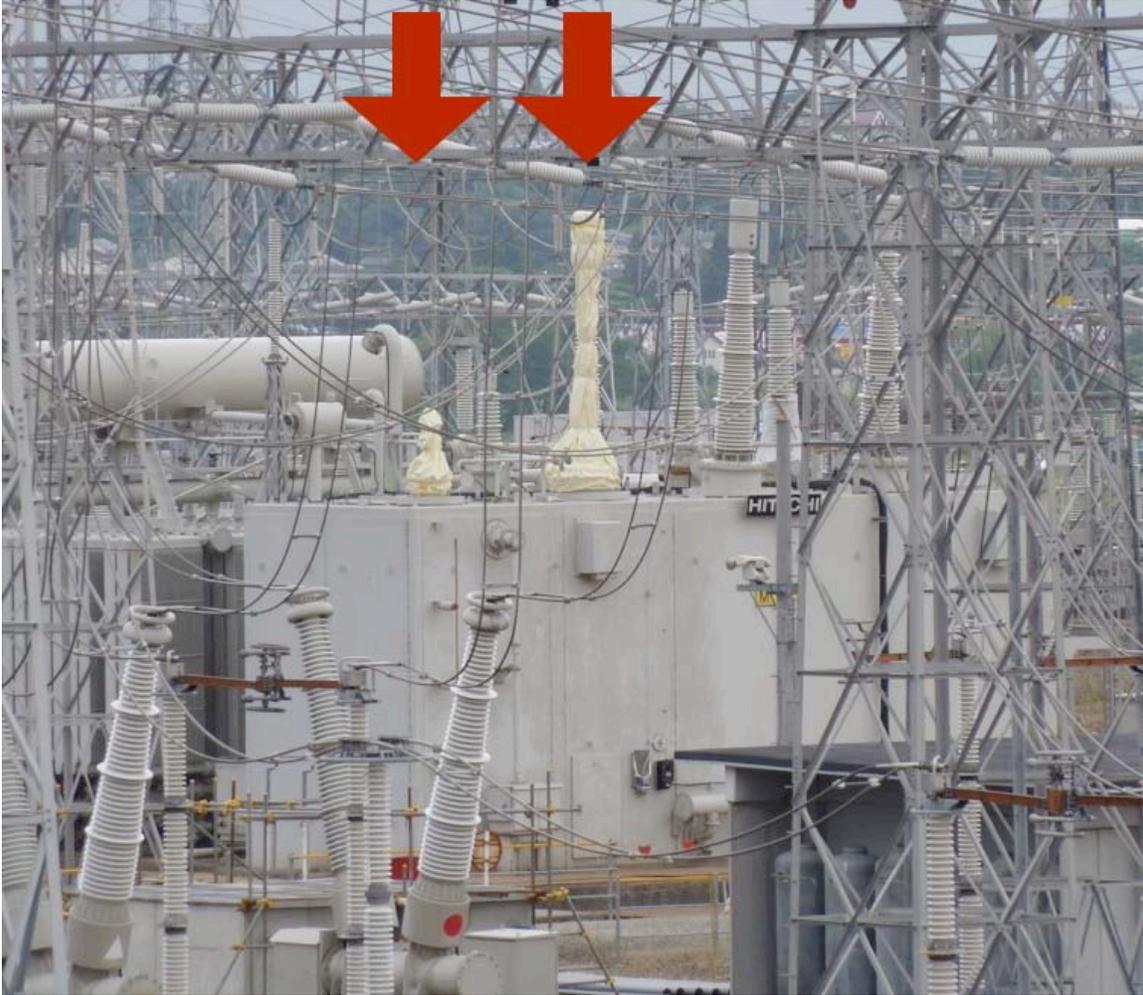
*Figure 4-45. 275 kV Bushing Damage, Sendai Substation*

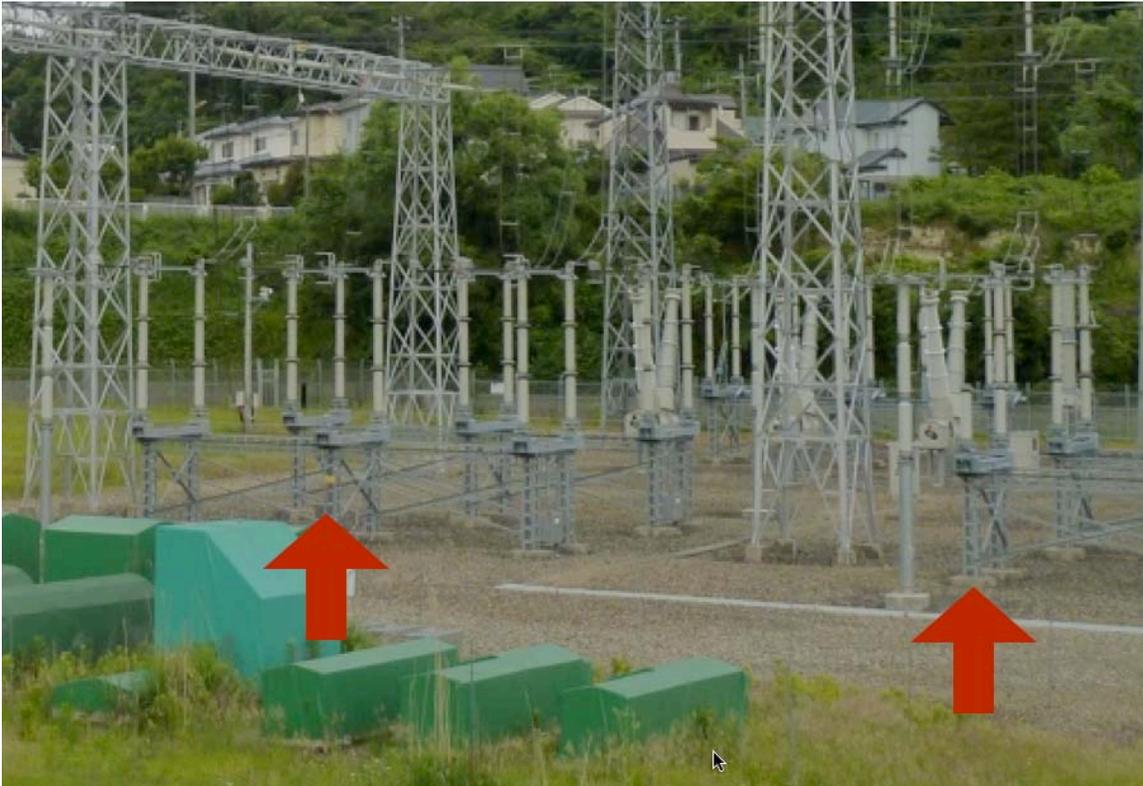
*Figure 4-48. 275 kV Disconnect Switch Damage, Sendai Substation*

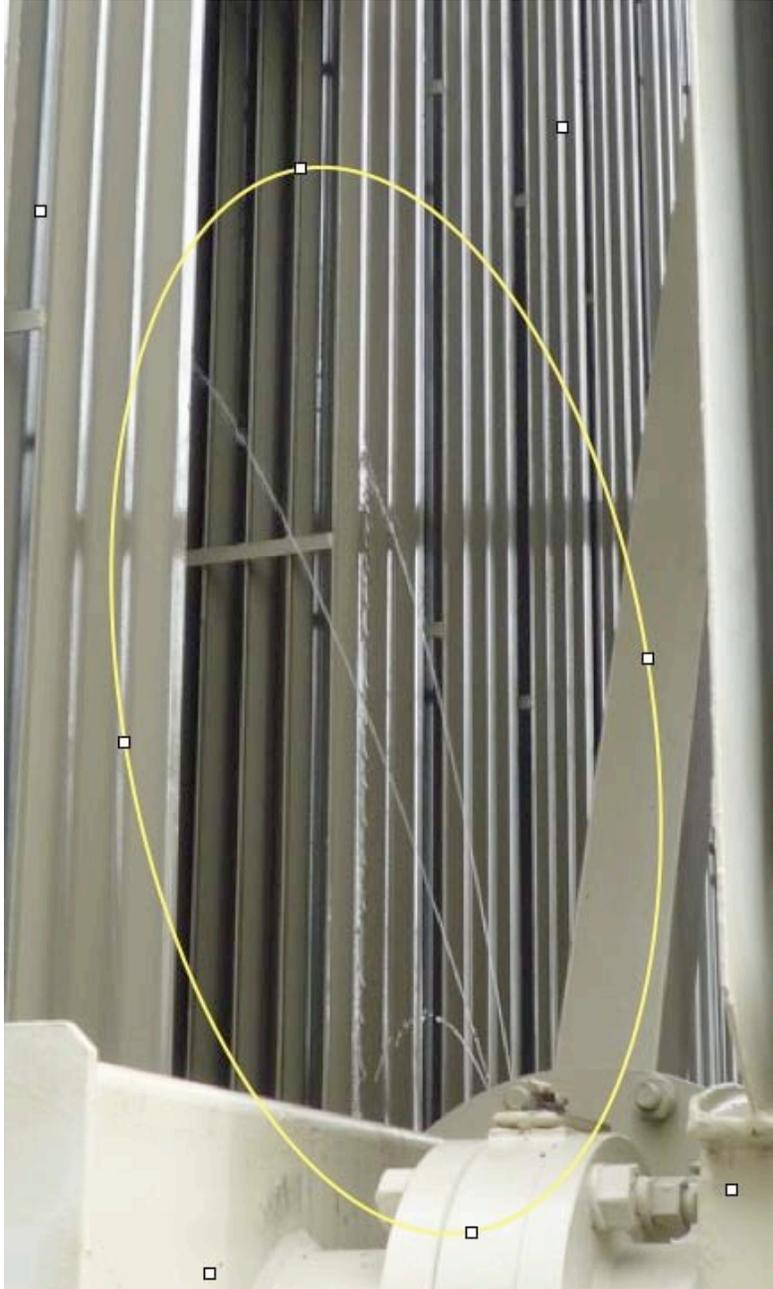
*Figure 4-52. Oil Leak at Radiator Pipe Fitting*

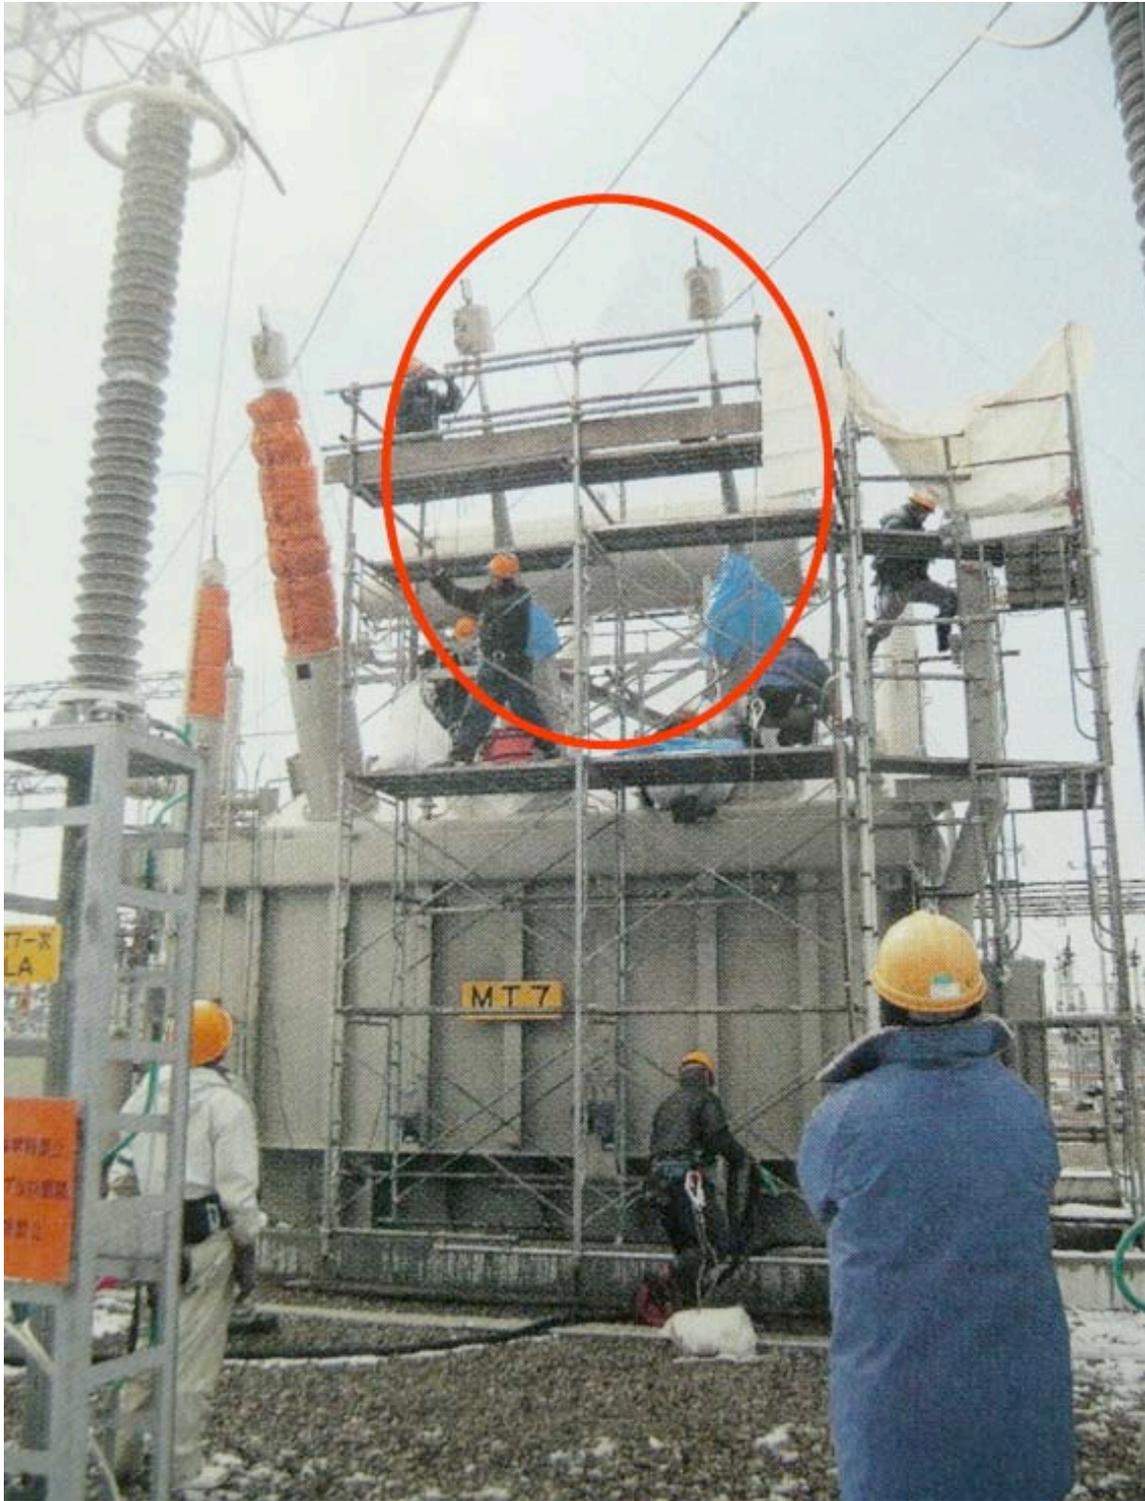
*Figure 4-53. Bushing Replacements on Transformer*

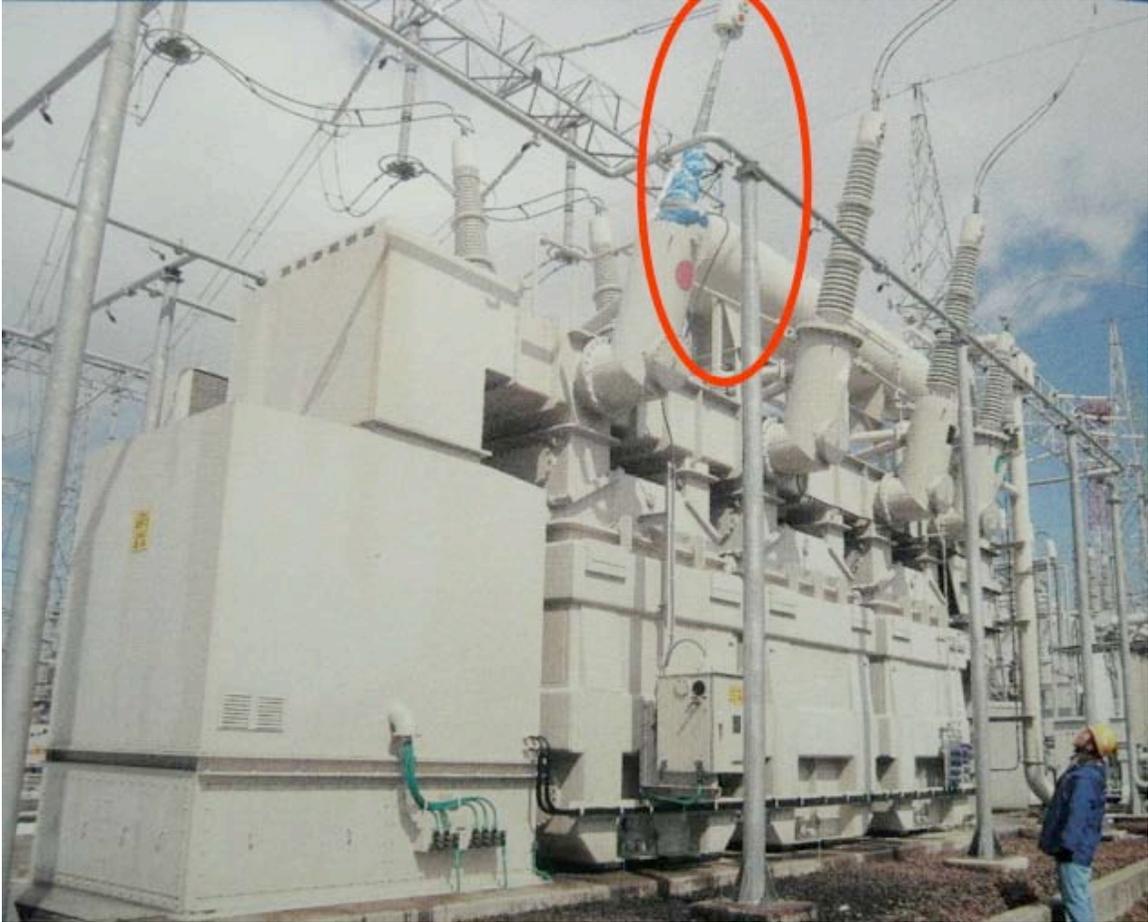
*Figure 4-54. Bushing Failure on Transformer*

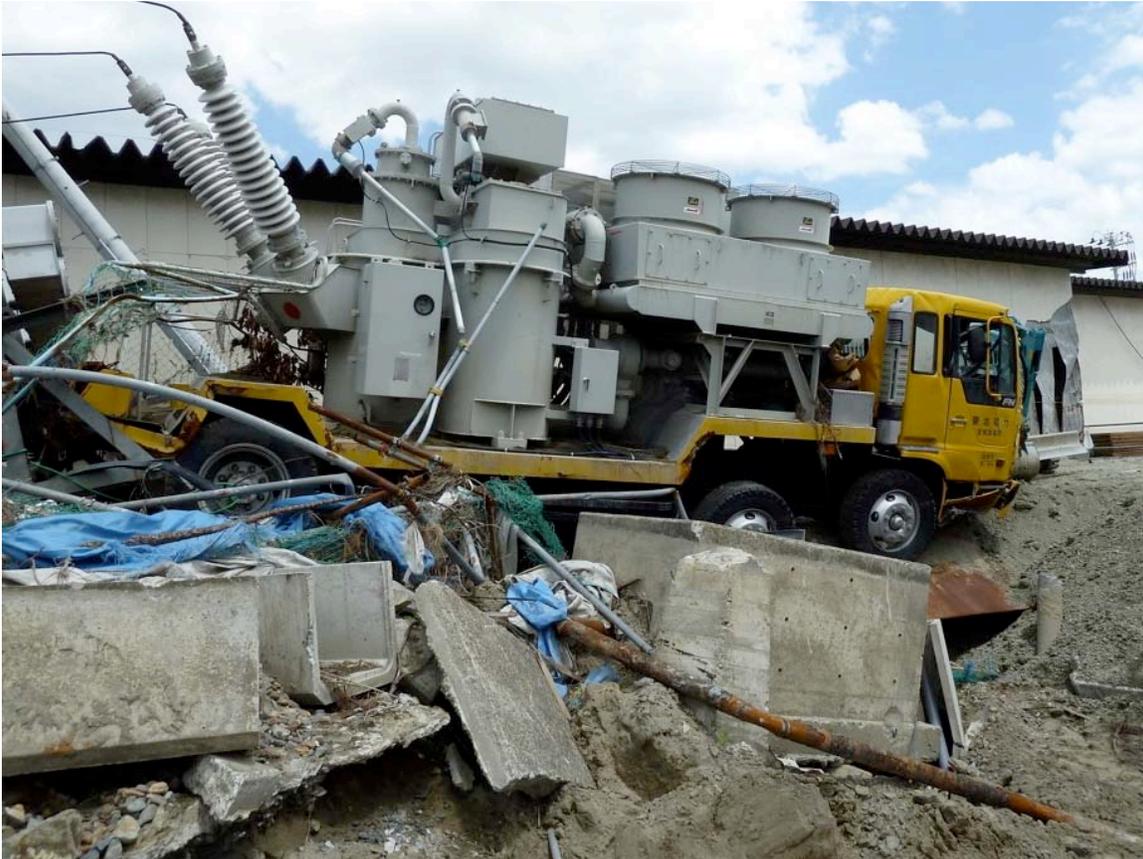
*Figure 4-57. Portable 66 kV Transformer Damaged by Inundation, Ishinomaki*

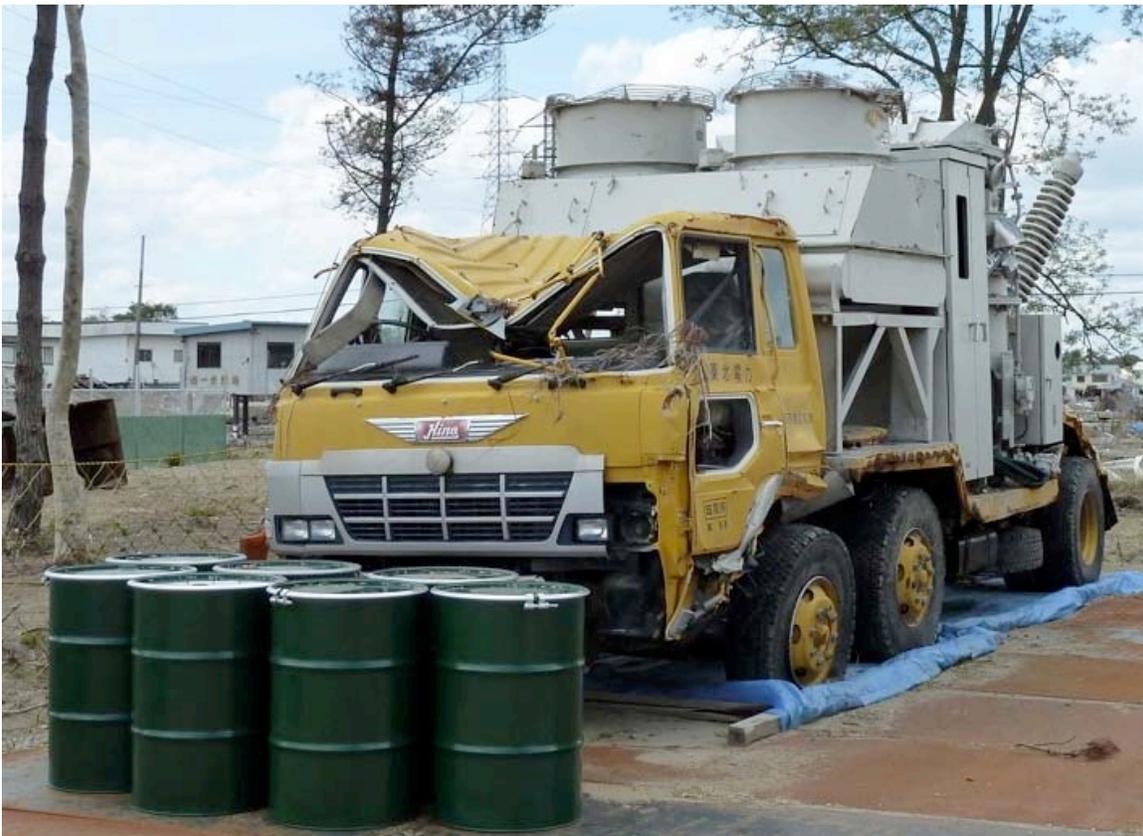
*Figure 4-59. Portable 66 kV Transformer Damaged by Inundation, Ishinomaki*

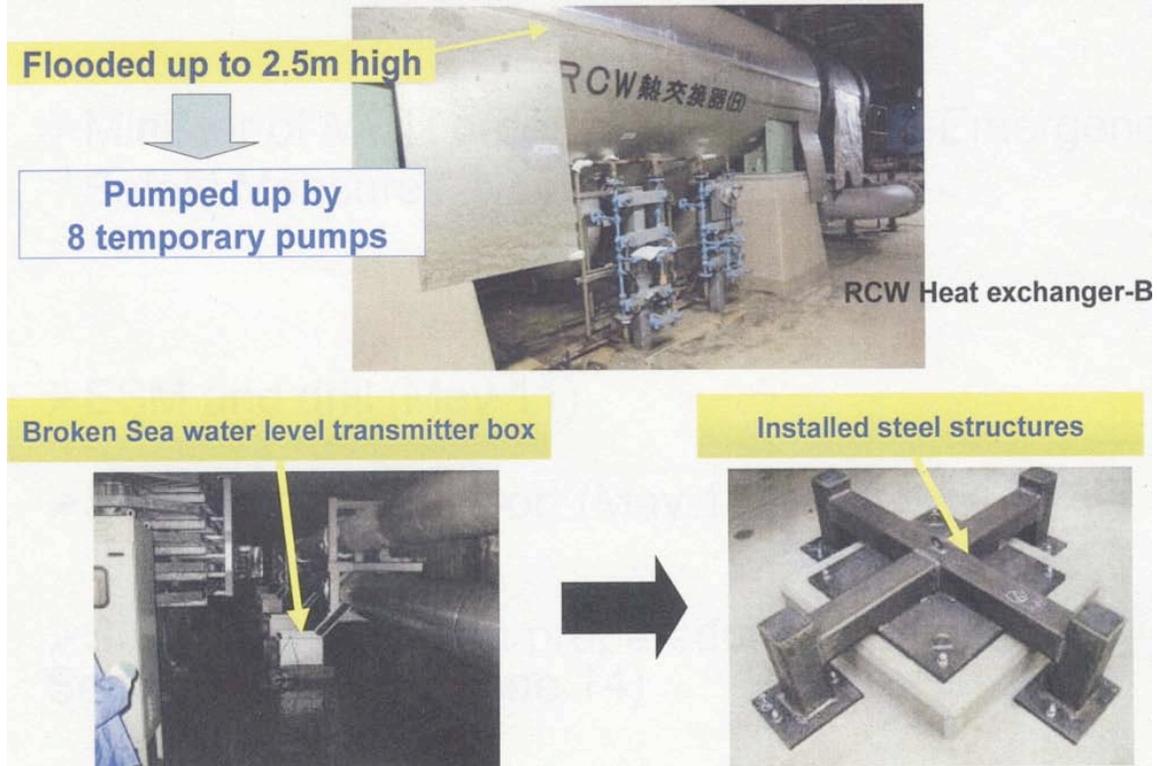
Figure 4-71. Flooded RCW-B Heat Exchanger and Pressure Transmitter Box – Onegawa Unit 2

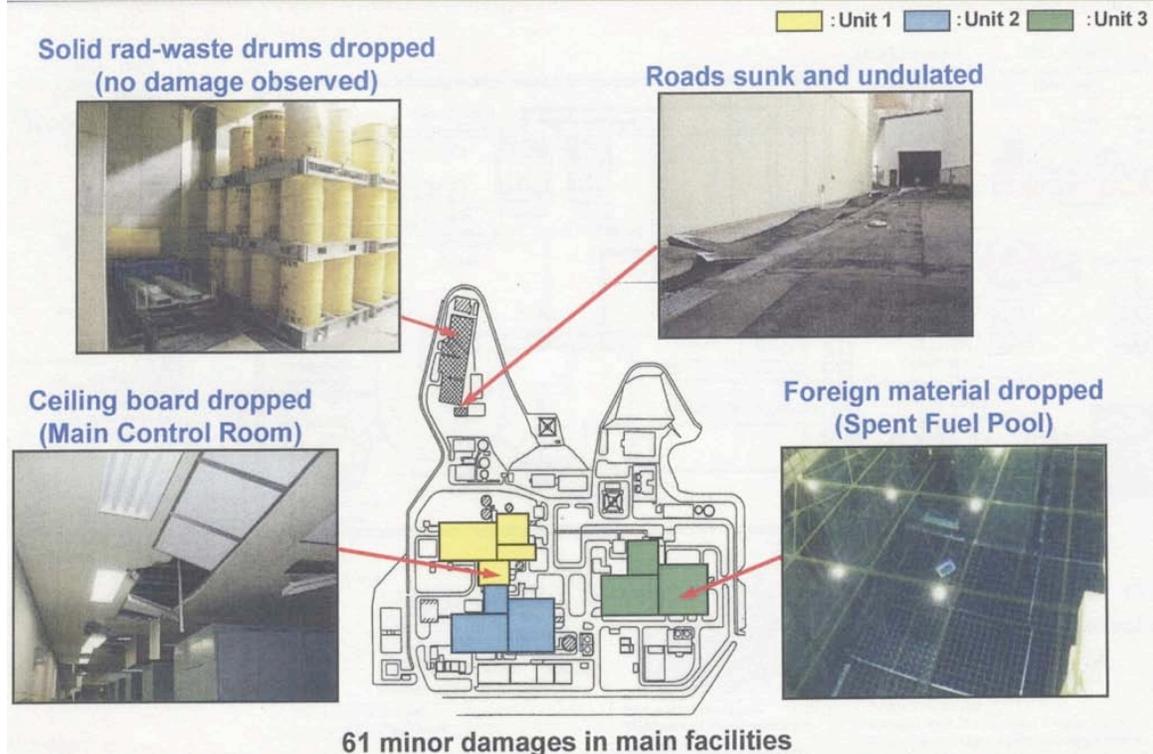
Figure 4-72. Examples of Minor Damage – Onegawa Units 1, 2, 3

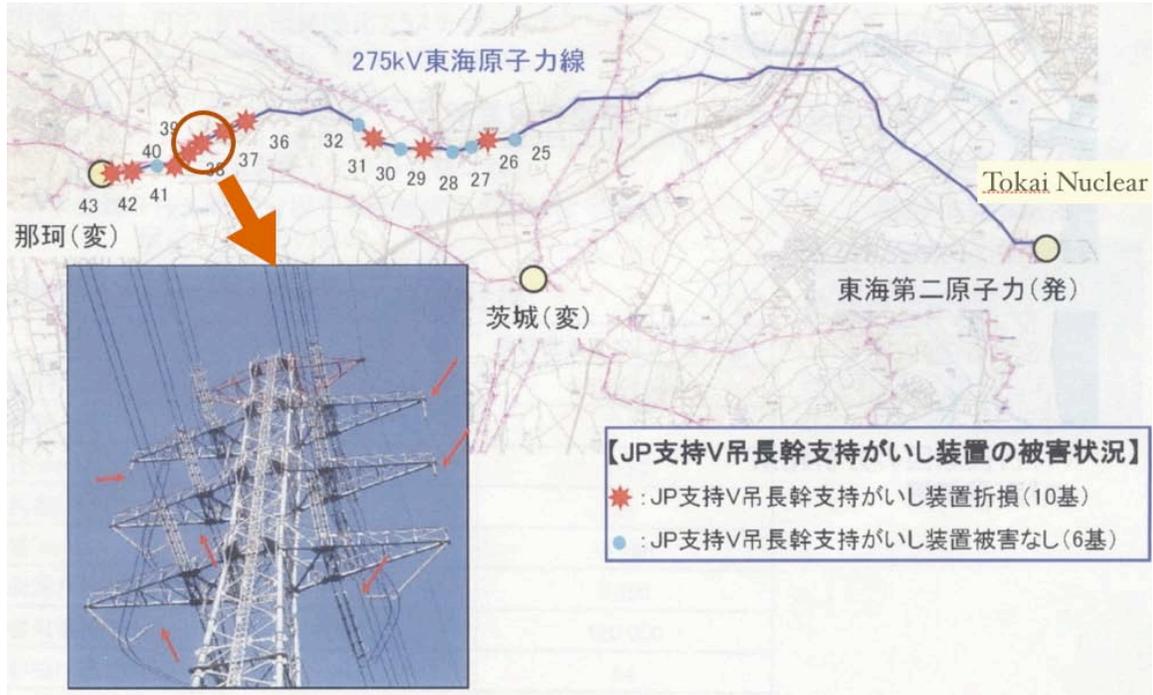
Figure 4-91. Damage to 275 kV Transmission Line
