Wenchuan Earthquake Impact to Power Systems

John Eidinger¹

ABSTRACT

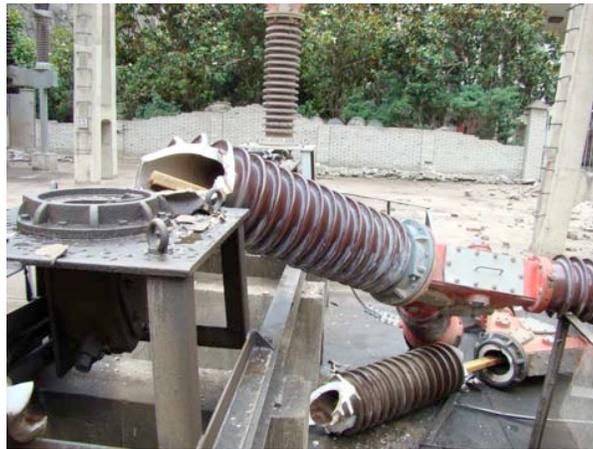
Figure 2 shows typical damage to a live tank circuit breaker. In this case, the initial damage is concentrated at the base of the porcelain, where it is connected to a flange with only a shallow embedment. The primary weaknesses of this type of equipment is either excessive bending moments on the porcelain, or weak porcelain-to-flange fittings.

Figure 2. Damaged Live Tank Circuit Breaker (110 kV)

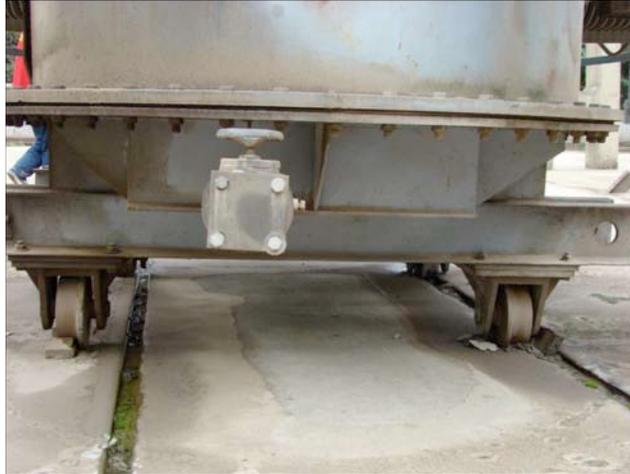
Figure 3 shows a transformer on wheels that jumped its tracks. This type of damage has been observed in almost every corner of the world when ground motions much exceed $PGA = 0.25g$ or so.

Figure 3. Wheel-Mounted Transformer

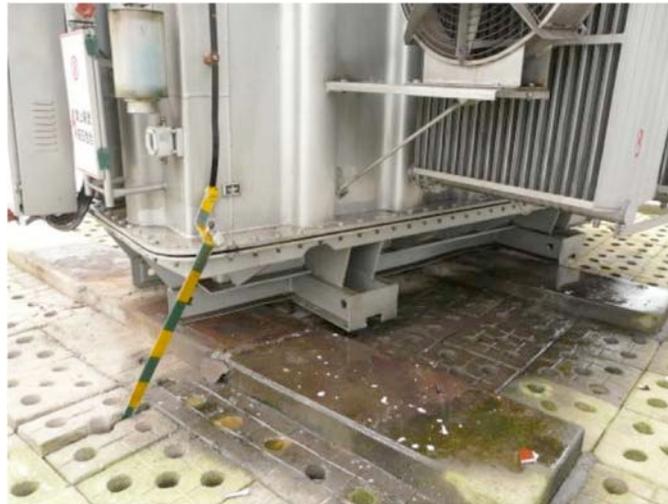
Figure 4 shows a slid 110 kV transformer. The sliding amounts to well over 1-foot, for a steel-on-concrete installation. The staining of the concrete reflects that there was a large oil leak here.

Figure 4. Skid-Mounted Transformer

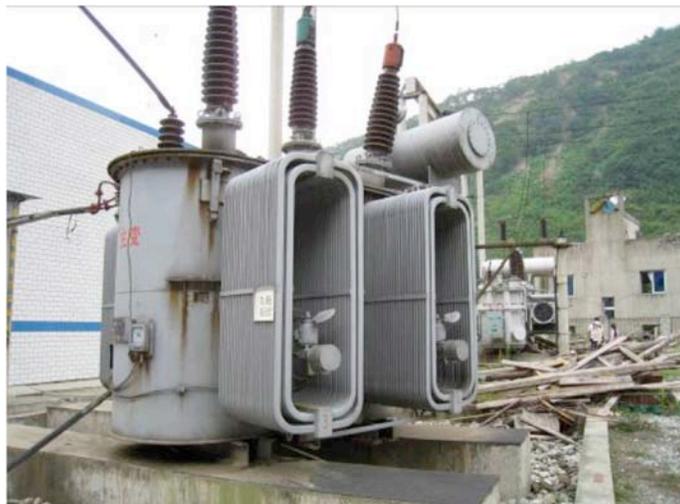
Figure 5 shows the sliding of a 110 kV transformer at Beichuan substation (PGA > 0.3g). It leaked oil. While the two radiators are braced to each other, there appears to be no lateral support for the radiator other than the pipe connections; the State Grid reported many oil leaks due to pipe failures of radiators.

Figure 5. Skid-Mounted Transformer

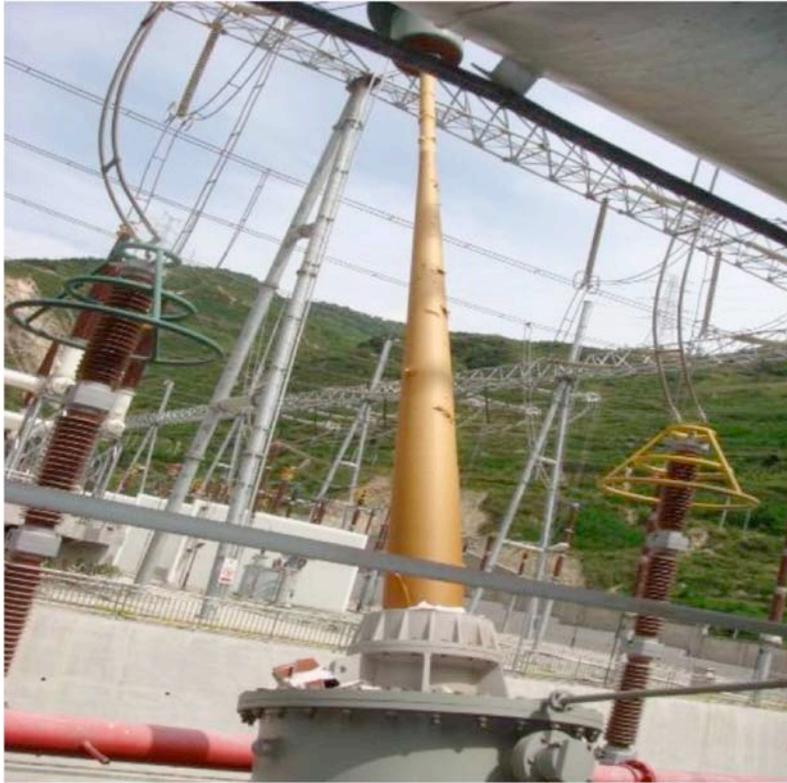
Figure 6 show the damage to a bushing on a 500 kV transformer. The bushing had total failure of its porcelain. This appears to be a grouted bushing. The adjacent surge arrestors, provided with good slack, appear unharmed.

Figure 6. Bushing, 500 kV Transformer

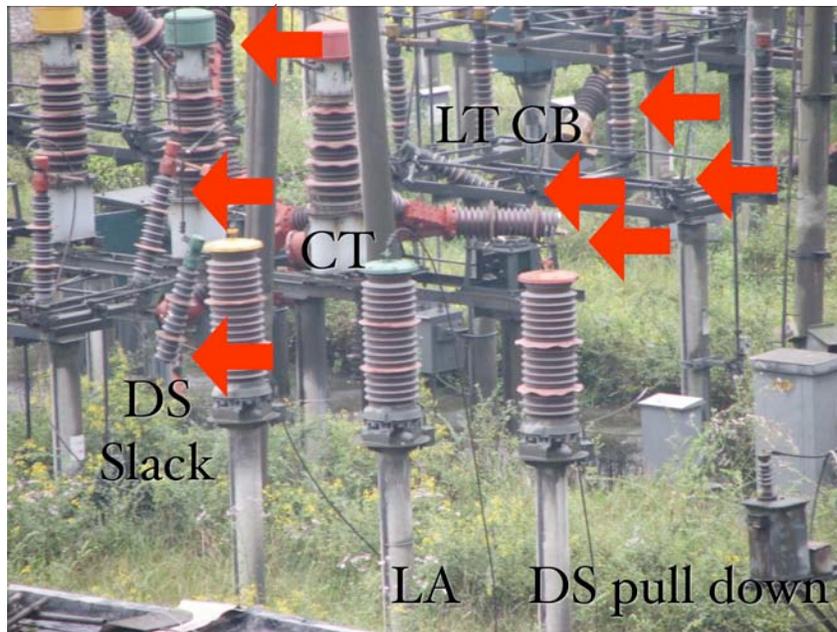
Figure 7 shows a 110 kV substation located near Yingzhou. Damage to nearby structures would suggest PGA ~ 0.5g at the substation. Repair work had not begun as of 160 days after the earthquake, and there were weeds growing in many areas reflecting the lack of maintenance at the yard over 5+ months. It is speculated that the reason for non repair is that the local industrial factories within a mile or so of the yard were heavily damaged, with no repair efforts ongoing, resulting in loss of load.

At this substation, there was gross failure of at least 13 of 21 live tank circuit breakers (it is possible that all were damaged, but access into the yard was limited to verify each individual breaker).

Figure 7. Examples of damage to Yard Equipment, Yingzhou 110 kV Substation

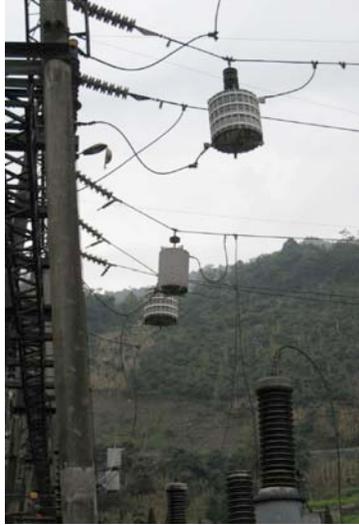
In Figure 8, all three bus drop from hanging wave traps to the potential transformers below are broken, surmised due to large movements of the hanging wave traps that impacted the drop; or (less likely) due to cable dynamics.

Figure 8. Hanging Wave Traps and Damage to Bus Connections to PTs

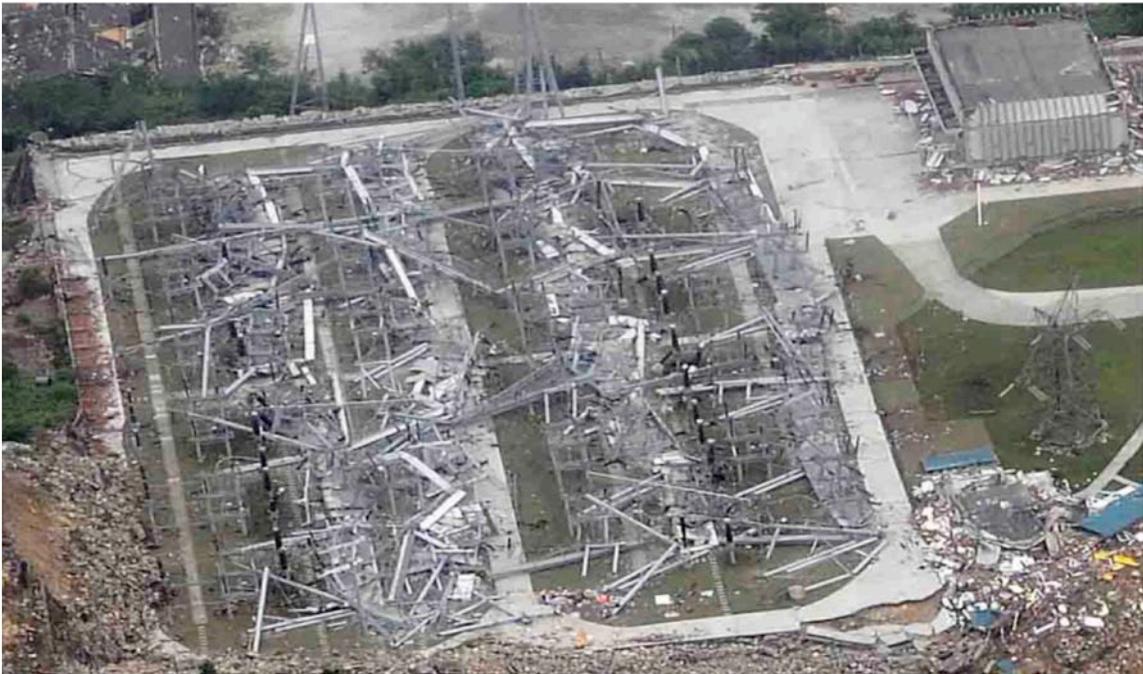
Figure 9 shows an aerial view of the destruction of 220 kV Ertaihan substation (PGA about 0.5g). The primary cause of the damage is inertially-induced destruction of concrete line-drop / dead end structures, likely coupled with inertially-caused damage to some otherwise undamaged substation equipment.

Figure 9. Destruction to Ertai Shan Substation, 220 kV, Yingzhou

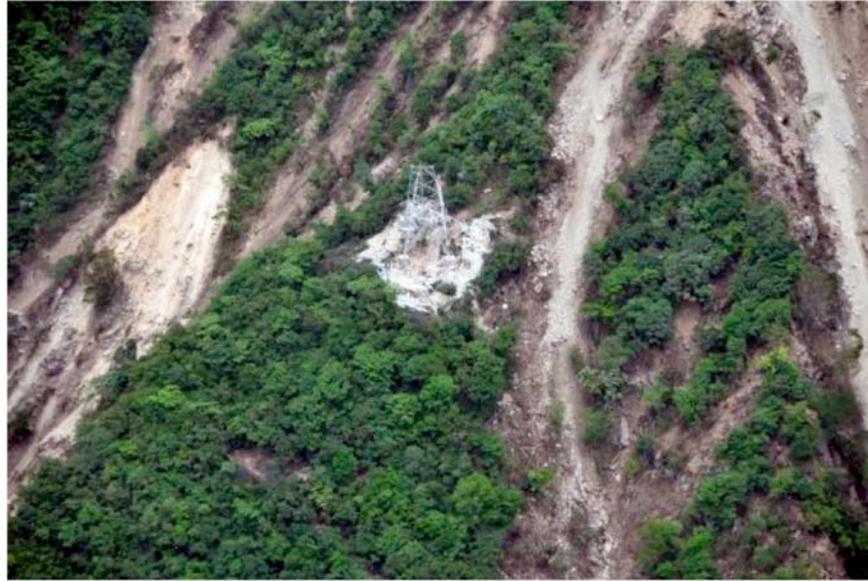
There were many partially or completely damaged high voltage (110 kV and higher) transmission towers in this earthquake. The predominant causes for tower failure were landslides that moved the tower foundations many 10s of feet (in some cases 100s of feet); or localized damage due to rock fall impacts. In one case, a tower collapsed apparently due to inertial loading, which is considered very uncommon. Where there were tower collapses, there was the potential of pull down of adjacent towers. The author did not observe tower failures due to large debris flows, but that is not to say that they did not occur.

Figure 10. Collapsed Tower

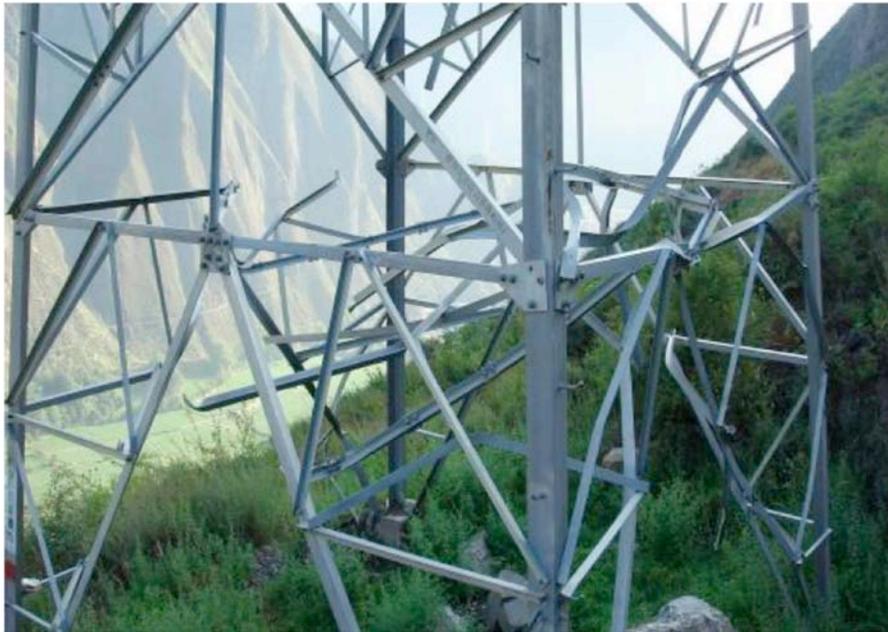
Figure 11. Rockfall-Impacted Tower, #123, Hongxue Line of Yingxiu Town

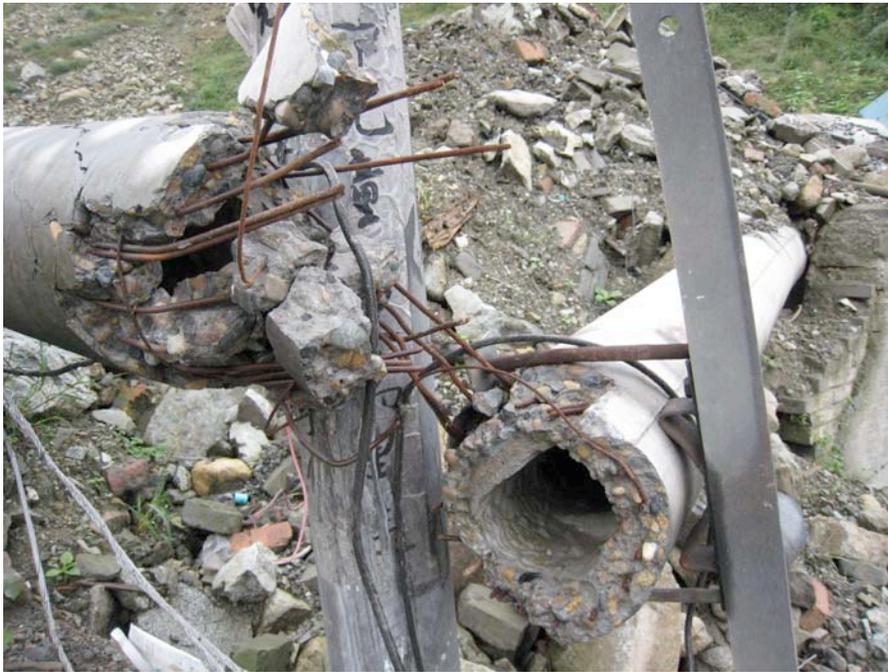
Overhead distribution (4 kV – 34.5 kV) is common in cities and towns. The most common style of pole is a concrete tube. These concrete tubes appeared to have no shear steel, (Figure 12) and high bending / shear induced failures occurred where there were pull down forces. Many dead-end frames at substations also use this kind of construction, albeit oriented into a A-frame assembly; at 220 kV substations with $PGA > 0.4g$, perhaps 25% to 50% of these collapsed due to a combination of inertial loading coupled with cable line dynamic loading (not landslide), leading to gross damage to yard equipment below.

Figure 12. Collapsed 10 kV Distribution Pole (10 inch diameter, 2.5-inch wall thickness)

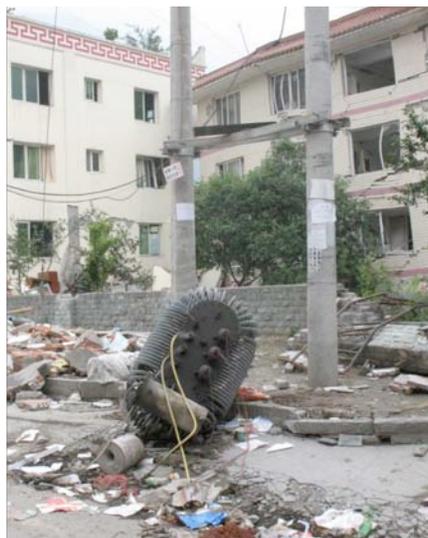
Figure 13. Fallen Distribution Transformer

Platform-mounted transformers were observed, Figure 13. This type of damage was observed in a California earthquake in 1952, and since then, power distribution companies in California have all but eliminated the placement of unanchored transformers on elevated platforms for new installations. We recommend that in China that similar retrofits be adopted as a high priority in all high-seismic regions of the country.
