# **Fragility Models that Reflect Pipe Damage in the 2014 Napa M 6.0 Earthquake**

John M. Eidinger\*

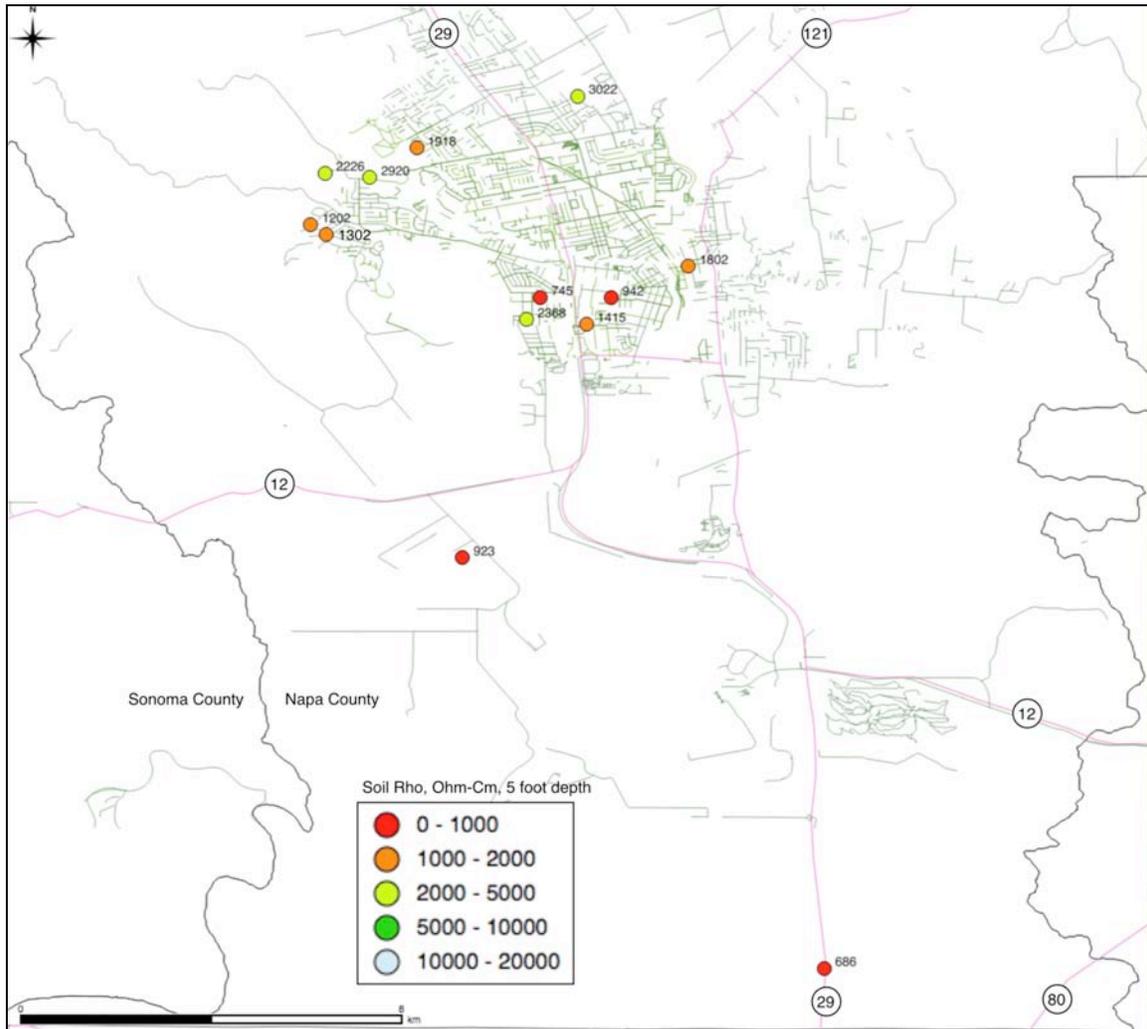
Figure 3. Soil Resistivity and Location of Pipe Repairs for Napa Water Pipe

Figure 3 shows the results from soil resistivity ( $\rho$ ) tests performed in Napa after the earthquake. The locations of the  $\rho$  tests are indicated by small colored dots, and the actual test value at the

depth of the water pipes (1.5 meters below grade is most common) is shown next to the symbol. The numbers in round circles are the highway numbers of major roads in and near Napa.

Figure 3 shows that the soils in Napa are extremely aggressive. This may be in part due to the volcanic origins of the soils; many are clayey-in nature. At three test locations, Rho was under 1,000 ohm-cm (extremely corrosive); four more tests showed Rho from 1,000 to 2,000 ohm-cm (very aggressive); and four more tests showed Rho from 2,000 to 3,022 ohm-cm.

The Napa water department reports that their ductile iron pipe has had a fairly high leak rate, even without the earthquake, and this reflects that Napa apparently did not install polyethylene "baggies" over the ductile iron pipe. The very aggressive nature of the soils; coupled with the relatively thinner wall thickness of ductile iron pipe, under 0.5 cm (0.2 inches), relative older but thicker cast iron pipe that are commonly 1.27 cm (0.5 inches) or thicker.

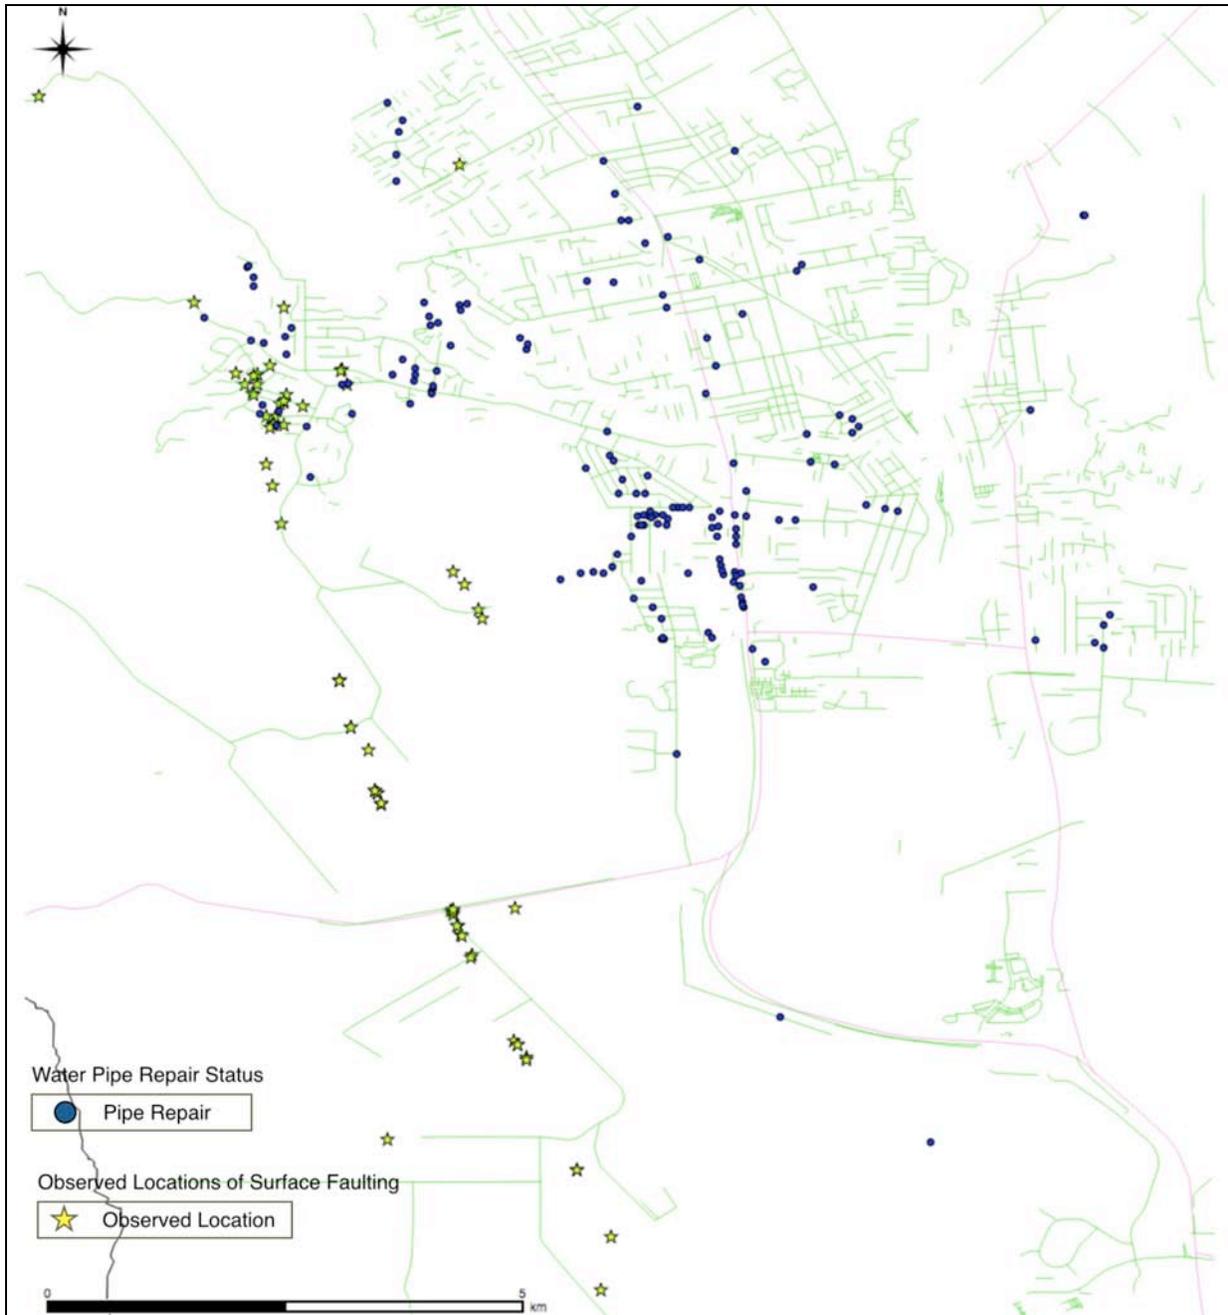
Figure 4. Location of Surface Faulting and Water Pipe Repairs

In the northwest part of the water system, there was surface faulting. Figure 4 (left) shows a map of the 71 locations with observed surface faulting (yellow stars), along with the pipe repair locations. The light green lines indicate streets; light blue lines indicate major roads / highways.

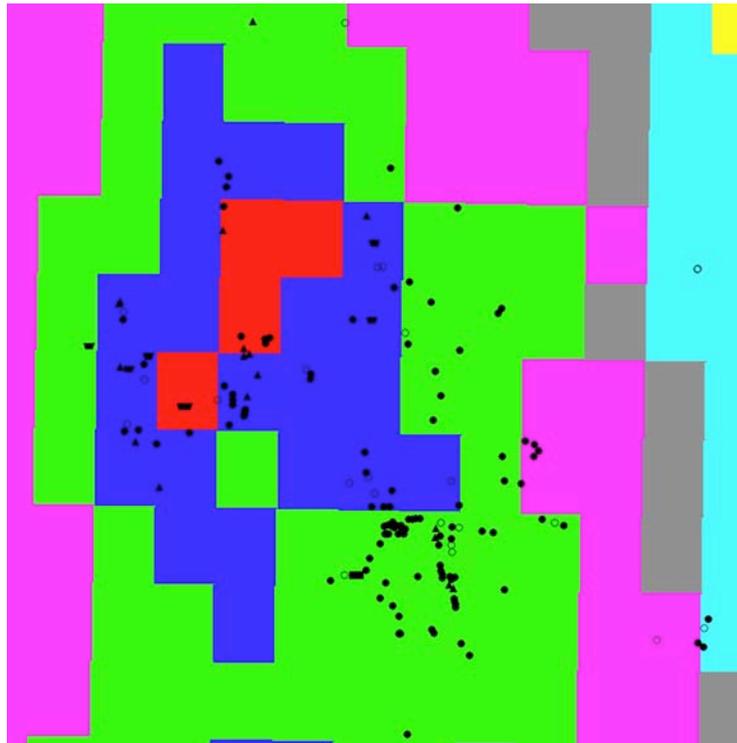
*Figure 5. ShakeMap PGVs (Maximum of NS, EW)*

Figure 5 shows the Peak Ground Velocity (PGV) map for the Napa area due to the August 2014 earthquake. This map shows the maximum of north-south or east-west direction PGV. Each "box"

represents an area of about 0.8 km (east-west) by 1 km (north-south). The symbols are at the locations of the pipe repairs as shown in Figure 4: solid dot: CI; triangle: DI; open dot = unknown; polygon: AC; square: PVC. The colors of the PGV shaking in Figure 5 correspond to: Red: PGV  $\geq$  85 cm/sec. Blue: PGV = 70 cm/sec to 85 cm/sec. Green: PGV = 55 cm/sec to 70 cm/sec. Magenta: PGV = 40 cm/sec to 55 cm/sec. Dark Grey: PGV = 30 cm/sec to 40 cm/sec. Cyan: PGV = 20 cm/sec to 30 cm/sec. Yellow: PGV = 10 cm/sec to 20 cm/sec

Using the corresponding PGV ShakeMap levels of shaking from Figure 5, Table 3 shows the number of pipe repairs that were subjected to various levels of PGV (totals add to 164; 163 elsewhere in this report; the 1 pipe repair location had uncertain attribute as to whether there was 1 or 2 repairs at that location).

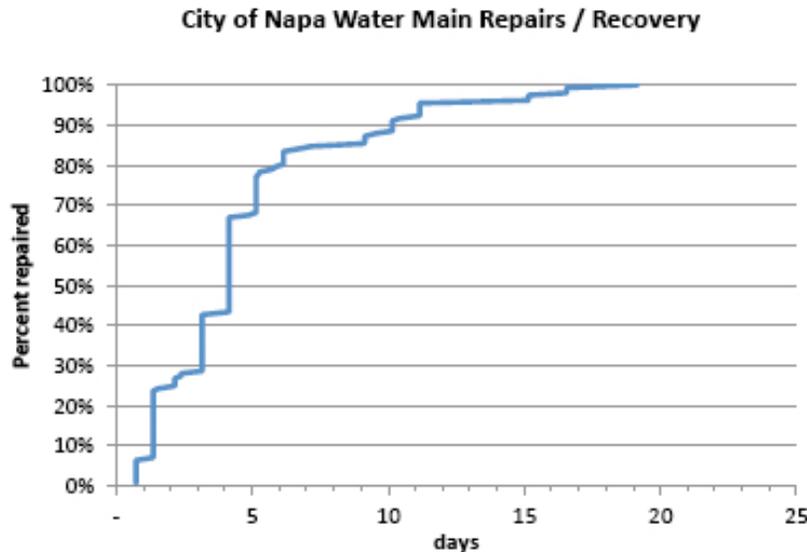
*Figure 6. Napa Water Recovery*

Figure 6 shows the restoration of water service after the earthquake.

All crews arrived with spare parts, trucks and equipment, typically 5 people per crew. All mutual aid crews were released by August 29 2014 (note the slow down in the rate of pipe repairs after Day 5, Figure 6). It was initially thought that the mutual aid crews were sufficient to effect nearly all the pipe repairs by August 29; however, over time, as the last pipe repairs were made, additional pipe leaks were identified as repaired pipes were re-pressurized.
