Oil and Water System Performance – Denali M 7.9 Earthquake of November 3, 2002

By John Eidinger¹ and Mark Yashinsky²

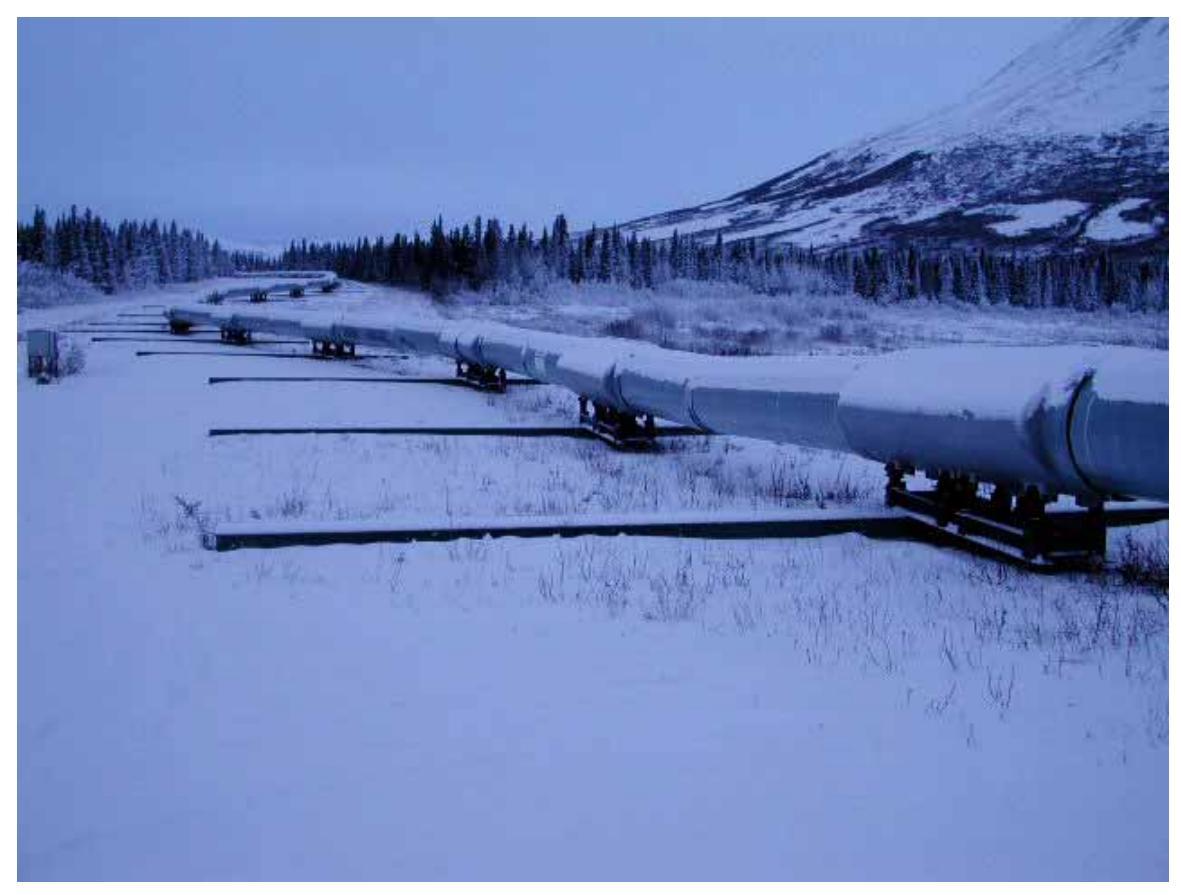
Figure 3.8. Concrete 'sleepers' supporting pipeline in fault crossing zone (post-earthquake)

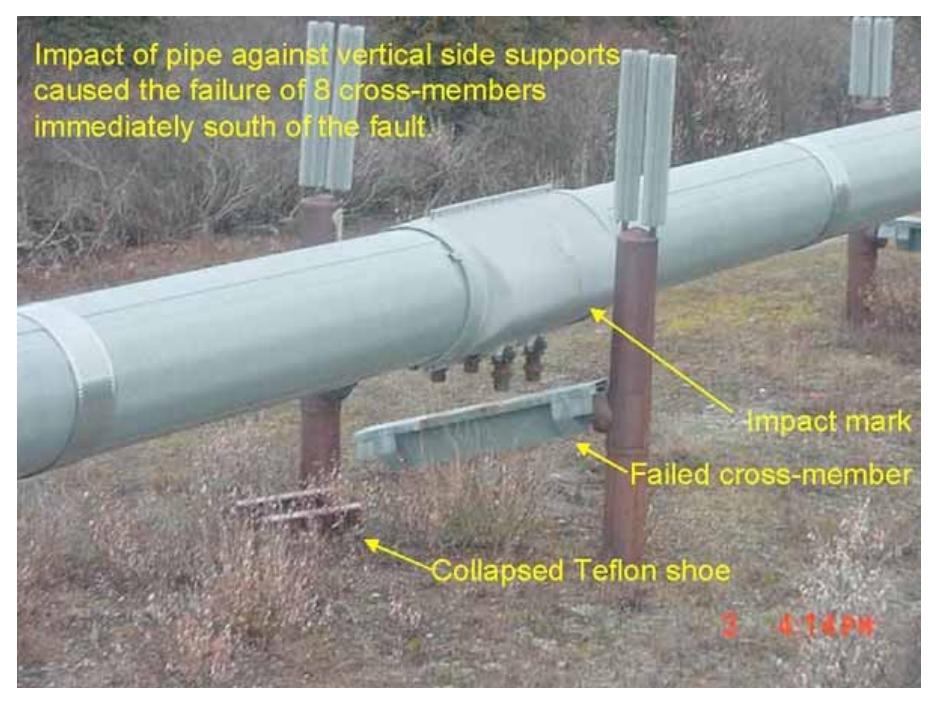
Five vertical support members (VSMs) were damaged, although none fell or were so severely damaged that they had to be replaced. In 8 locations, the "shoes" that connect the pipeline to the horizontal cross members were on the ground, leaving the pipeline unsupported for one or two spans. During the 66 hours that the pipeline was shut down, repairs were made to the few VSMs that were damaged as the pipe moved laterally, axially and vertically during the earthquake. At one support, wooden sleepers were temporarily installed to provide additional support under the pipeline to prevent a drop if there was a substantial aftershock. Figure 3.12 to 3.16 shows the typical damage.

Figure 3.12. Damage to vertical and horizontal members and to teflon shoe supports (Alyeska)

After these repairs were completed, the pipeline was unfastened at the anchorage on each side of the fault and moved about a foot to relieve the stress. A pig was then run through the pipeline to check for curvature and the pipeline was found to be okay. It was determined that the pipeline in its present configuration can handle another few feet of fault movement. Studies are currently being done to determine what future repairs and mitigation efforts need to be done. For instance, it may be decided to lift up the pipeline and to move the supports so they are re-centered under the pipeline in its current configuration to handle the next earthquake.

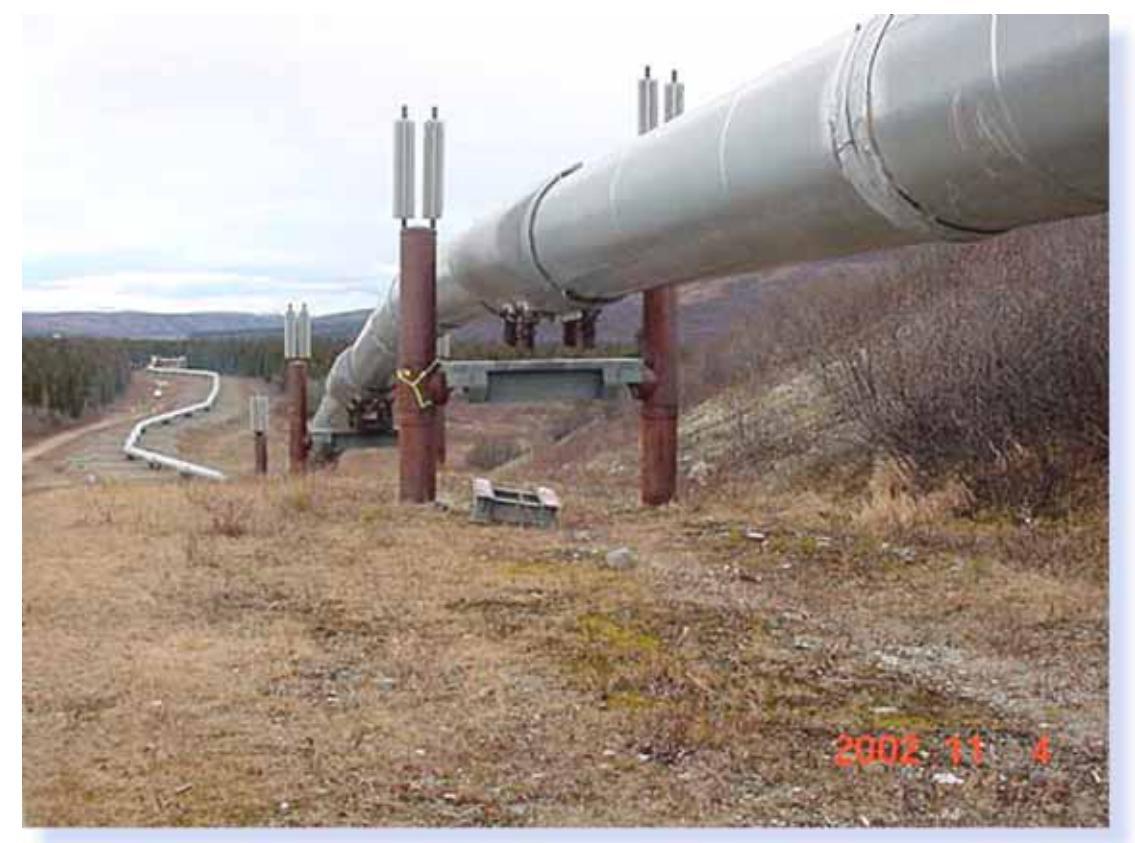
Figure 3.13. Dropped Shoe on elevated portion at north end of Fault Crossing Zone (Alyeska)

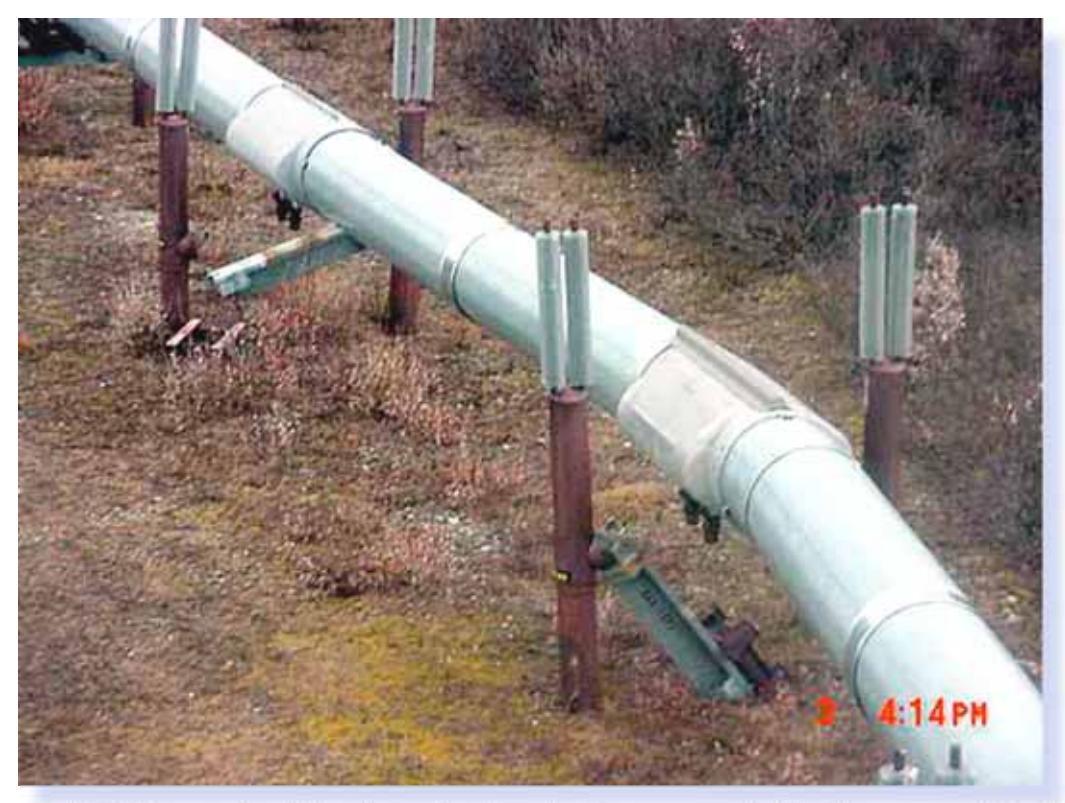
Figure 3.14. Consecutive fallen beams leaving pipeline unsupported for three spans (Alyeska)

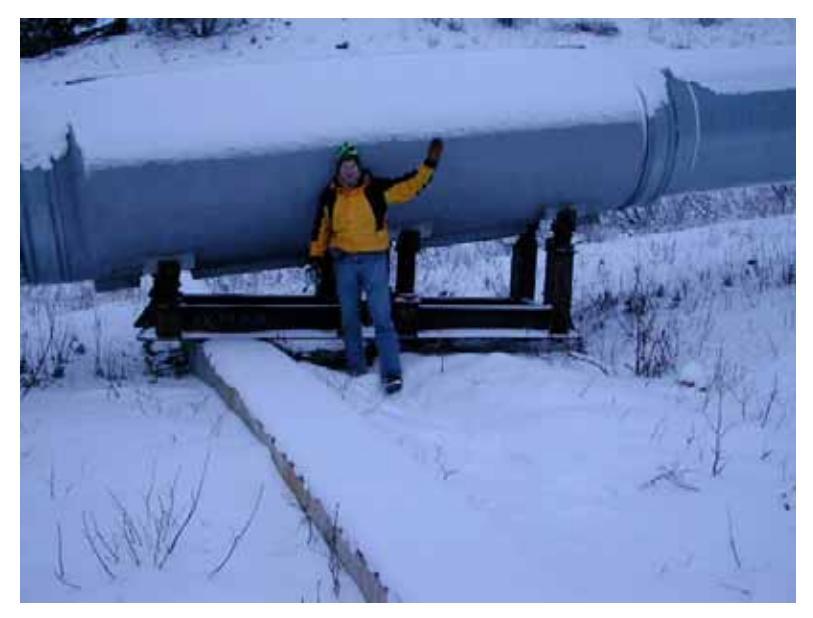
Figure 3.15. Perched Shoe at end of 'sleeper.'

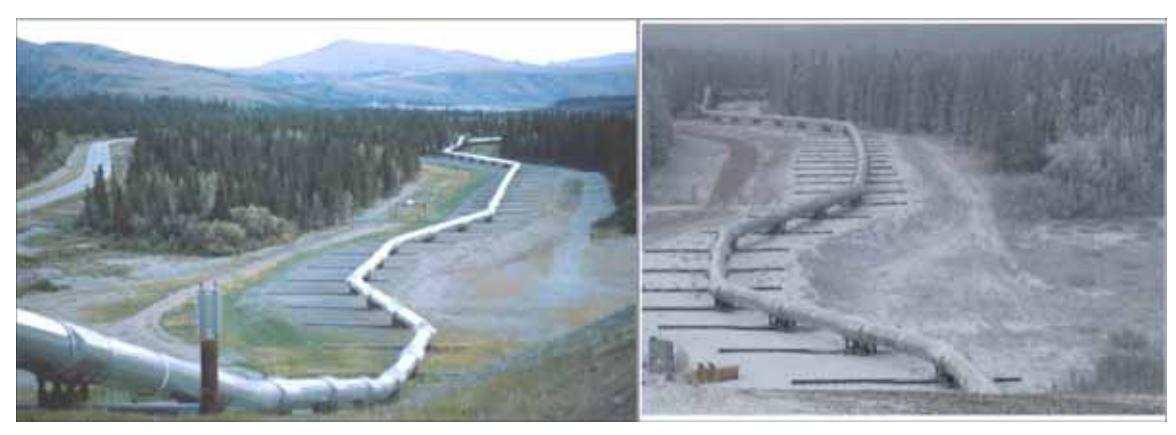
Figure 3.16 (left side) shows the pipeline at the Denali fault crossing in its pre-earthquake configuration. Figure 3.16 (right side) shows the same pipeline in its immediate post-earthquake distorted configuration. Note that the straight legs of the pipeline (pre-earthquake) have a modest bow outwards in the post-earthquake condition, demonstrating that the pipeline has moved outwards from its original centerline position, in order to accommodate the (about) net-axial shortening between the two anchors either side of the

Figure 3.16. TAPS pipeline, before (left image) and after (right image) earthquake

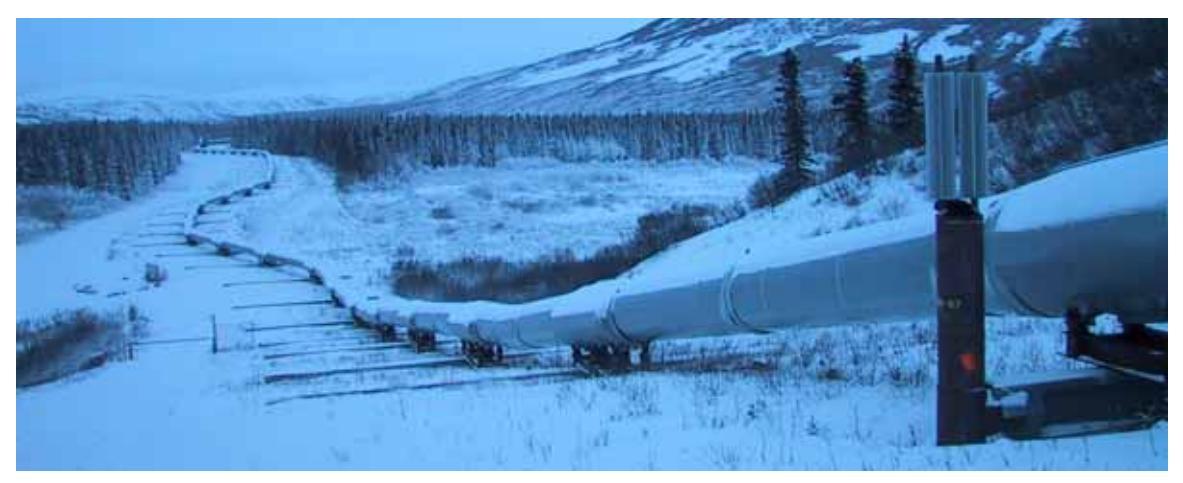
fault, as well as the net lateral offset caused by the fault offset. Figure 3.17 shows the snow-covered in-service pipeline about six weeks after the earthquake – the residual displacement of the pipe is still apparent; 9 months after the earthquake some more of the residual displacement had "dissipated".

Figure 3.17. TAPS pipeline, six weeks after the earthquake

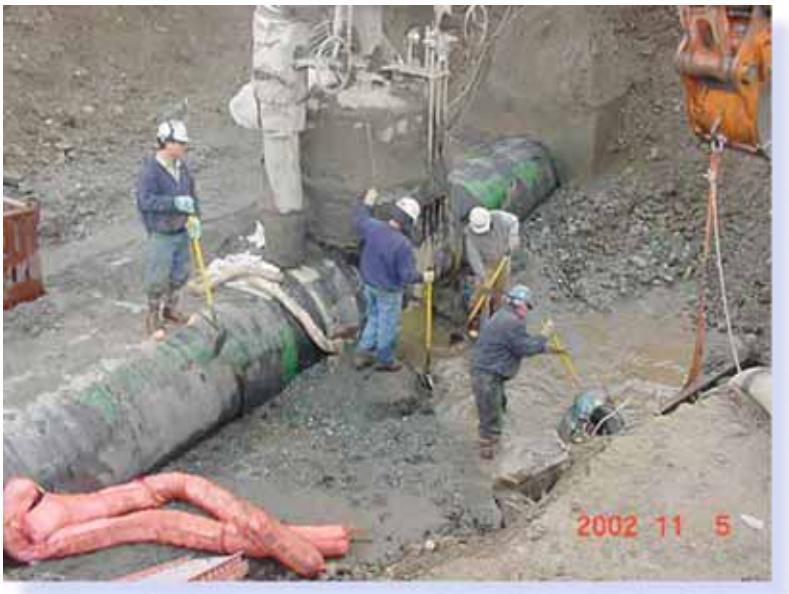
Portions of the pipeline near the fault-crossing zone that are not underlain by frost-heave susceptible soils are buried. Liquefaction of sandy soils occurred at and near some of these sections of buried pipeline (about 2 kilometers of pipe alignment liquefied, cumulatively at 4 locations). Lateral spreads dragged one section of buried pipeline laterally a number of feet, causing visible distortion and torsional tilting (3 degrees) of a gate valve, but the pipe did not leak. Inspection after the earthquake showed that the stress was within acceptable tolerances (Figure 3.18).

Figure 3.18. Inspection at site of liquefied soil (Alyeska)

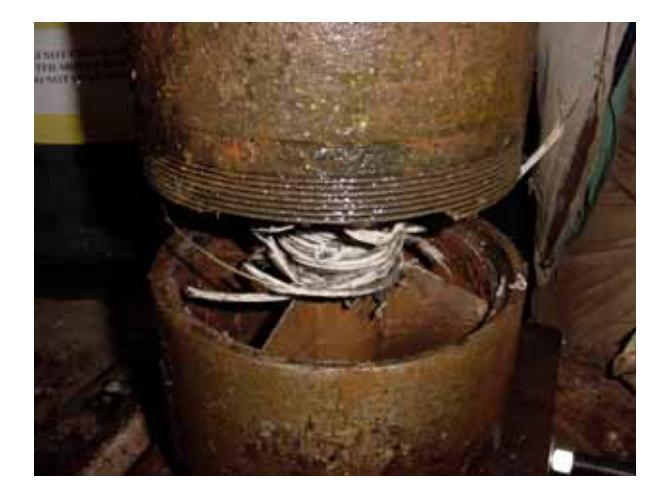
Figure 4.1. Damaged well casing at Fort Richardson in Anchorage

On the military bases there are drilled wells, water treatment facilities, but no sewage treatment plants. The only reported damage was to a water well casing at Fort Richardson many miles away. Figure 4.1 shows the spider bushing inside the broken 8-inch pump casing. The damage occurred 80 feet below the ground surface. The many reports of increased turbidity of well water, changes in the level of water tables, and damaged well casings suggests that aquifers are particularly sensitive to even weak ground motion.
