Observations of the February 27, 2010 M8.8 Chile Earthquake

John Eidinger, G&E Engineering Systems Inc.

Keith I. Kelson, Fugro-WLA (primary author)

Updated March 31, 2010

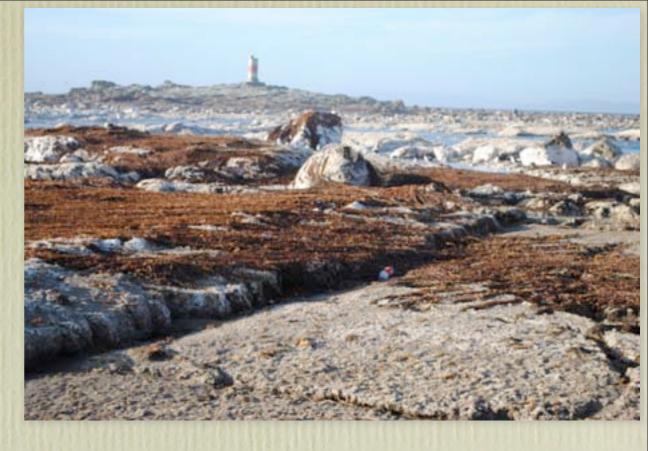
+2.5 m

Lebu

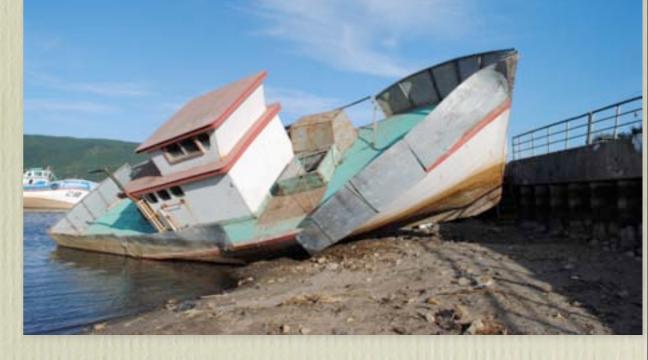
Uplift Influenced Areas of Inundation

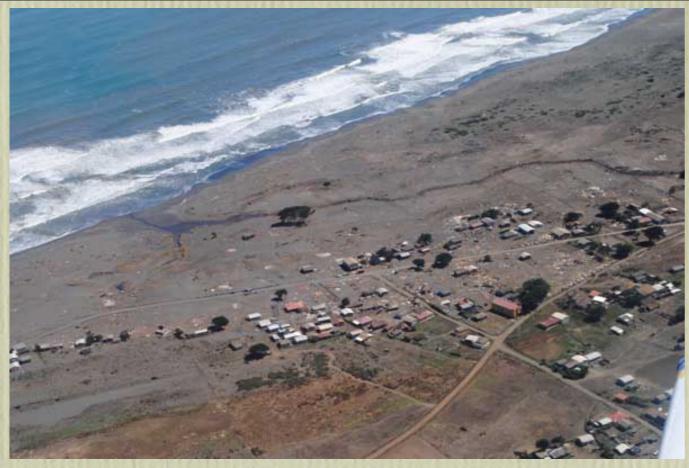
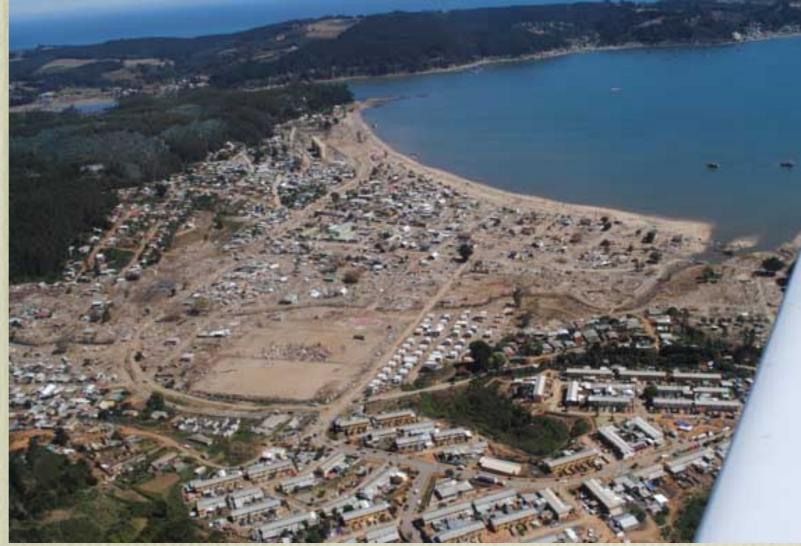
Village of Curalnipe

Town of Dichato

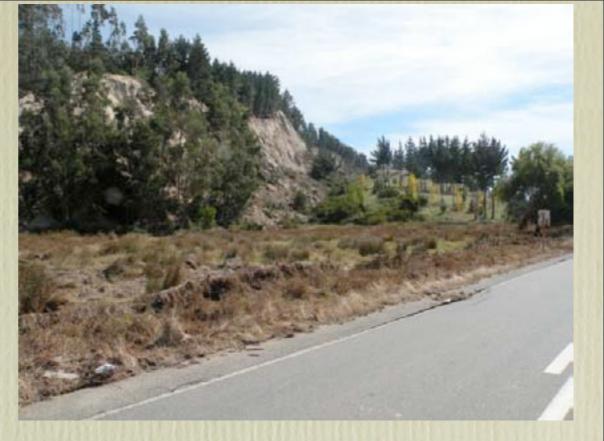
Landslides and Slope Failures

Dry late summer = Low soil moistures

Highest concentrations: Coastal bluffs on Arauco Peninsula
Logging roads in coastal mountains

Landslides and natural slope failures: surprisingly few given earthquake magnitude; dry season likely contributed to greater stability.

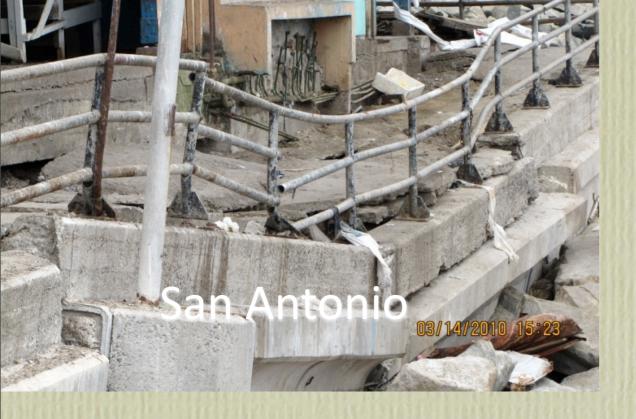
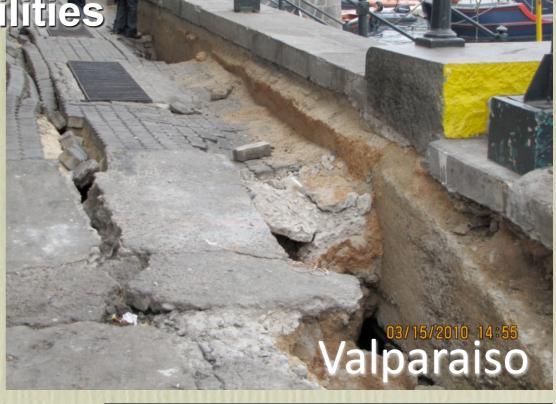
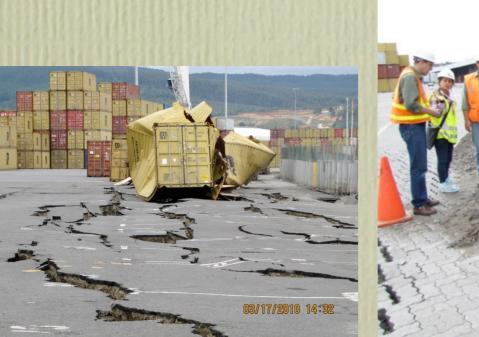
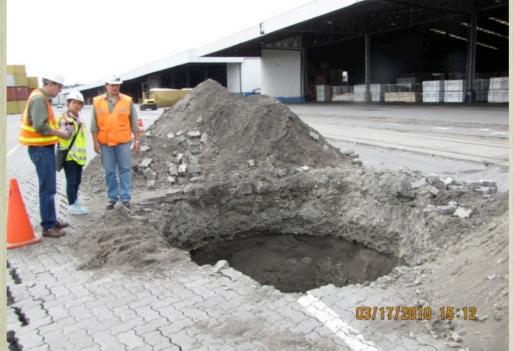
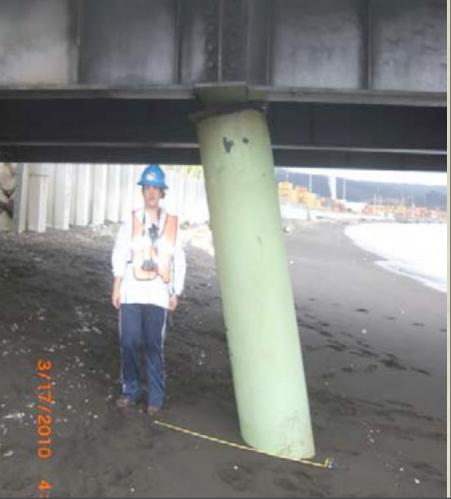
Effects of Ground Failure on Port Facilities

Coronel : a) Lateral Spreading/Settlement, & Sediment Ejecta/Sinkholes, & c) Pile Damag

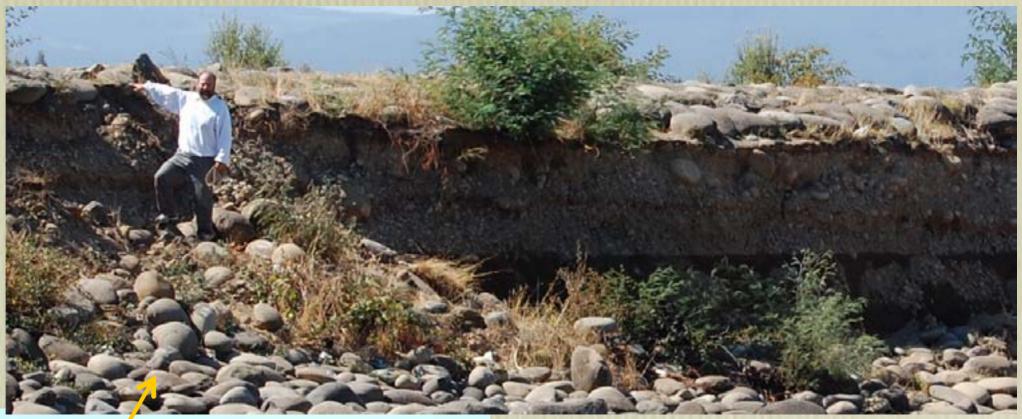
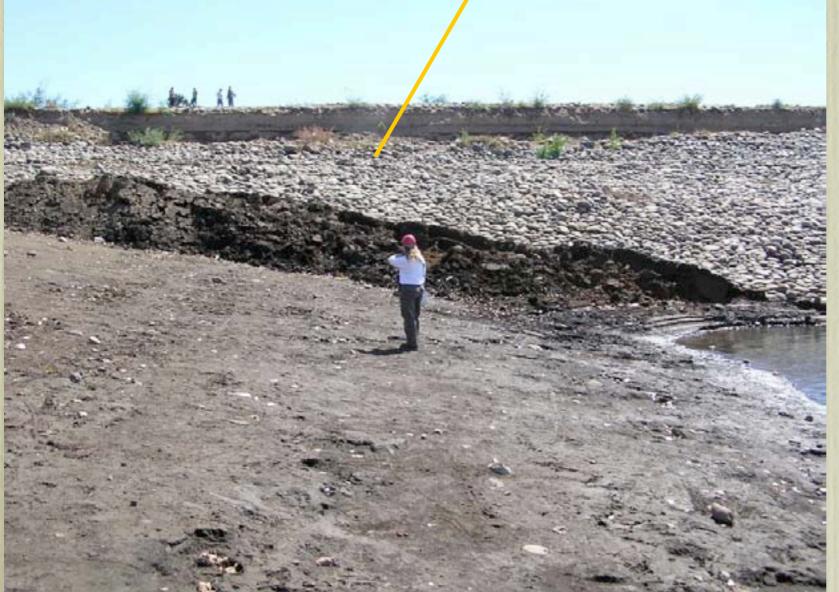
Seismic Performance of Dams

Coihueco Zoned Earth Dam Upstream Slope Failure

Rapel Concrete Dam

(most dams performed well)

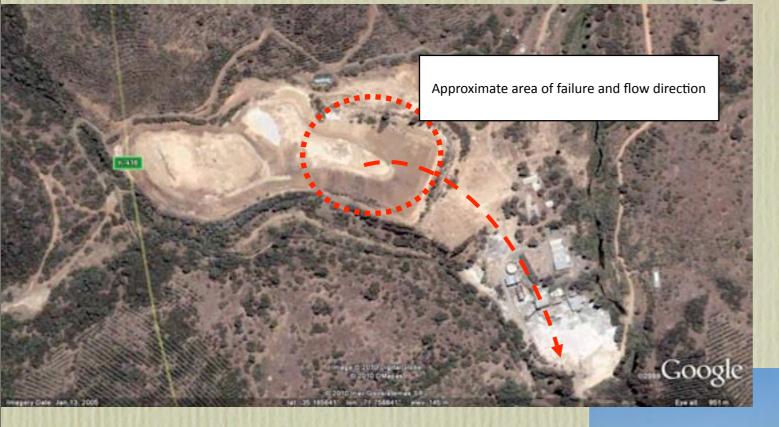
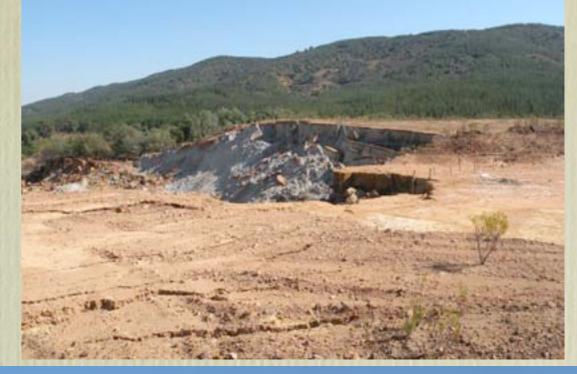
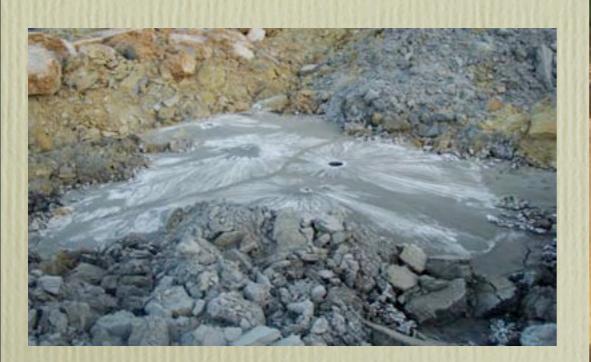
Seismic Performance of Tailings Dams

Las Palmas Tailings Dam Failure
