Southern Loop Pipeline – Seismic Installation in Today's Urban Environment

Tom Shastid, Javier Prospero¹
John Eidinger²

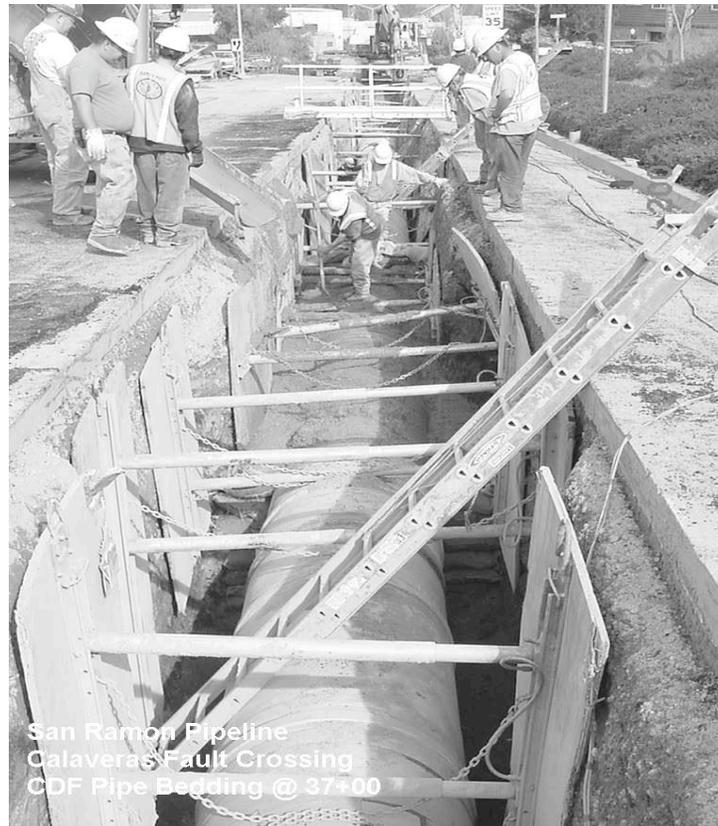
quality control program should be included in the specifications. Photo 1 shows the installation of the CDF around the pipeline. Several of the exterior steel rings that provide the “teeth” for the CDF to grab onto can also be seen in the foreground.

Photo 1. Placement of CDF Around the Pipeline

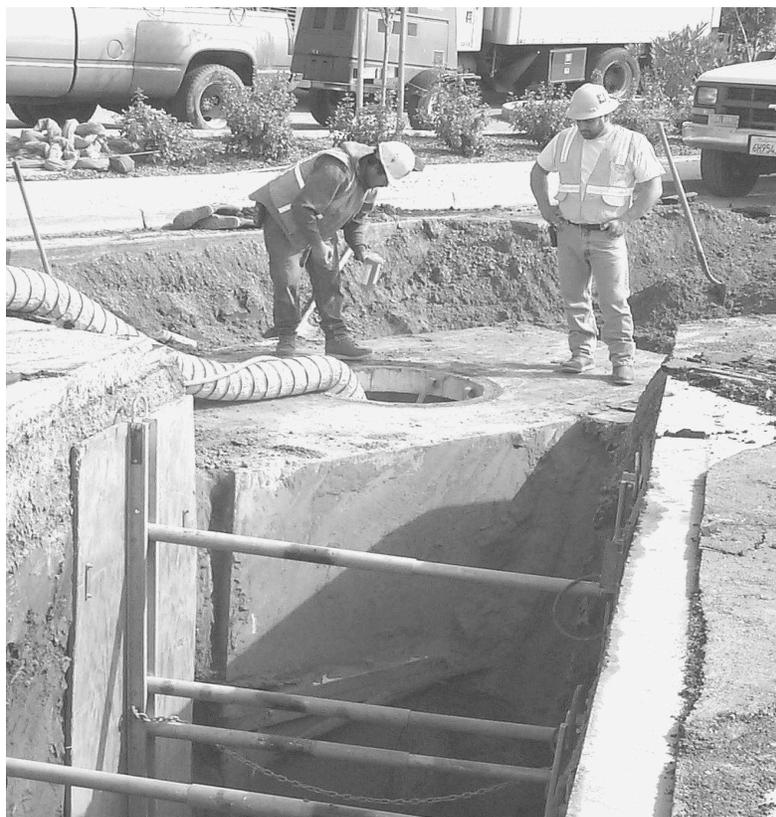
Towards the end of the pipeline installation within the fault zone a buried concrete vault was discovered directly in the pipeline alignment, see Photo 2. As discussed in the previous paragraph, modifying the pipeline alignment to the degree necessary to avoid the vault would have a major impact on pipeline performance. Relocating the vault, if at all possible, would have had major cost and schedule impacts. Surprisingly, the owners of the vault quickly determined that its removal would have minimal impacts on their operation and the vault was demolished within one day. Future designs with similar tight dimensional constraints within an urbanized area should anticipate the potential for similar conflicts.

Photo 2. Large Concrete Vault Discovered in Pipeline Alignment
