Christchurch, Feb 22 2011 and Sept 4 2010

John Eiding  
G&E Engineering Systems Inc.  
[eidinger@geEngineeringSystems.com](mailto:eidinger@geEngineeringSystems.com)

## Impact to Electric Power Systems

ASCE - Structural Congress

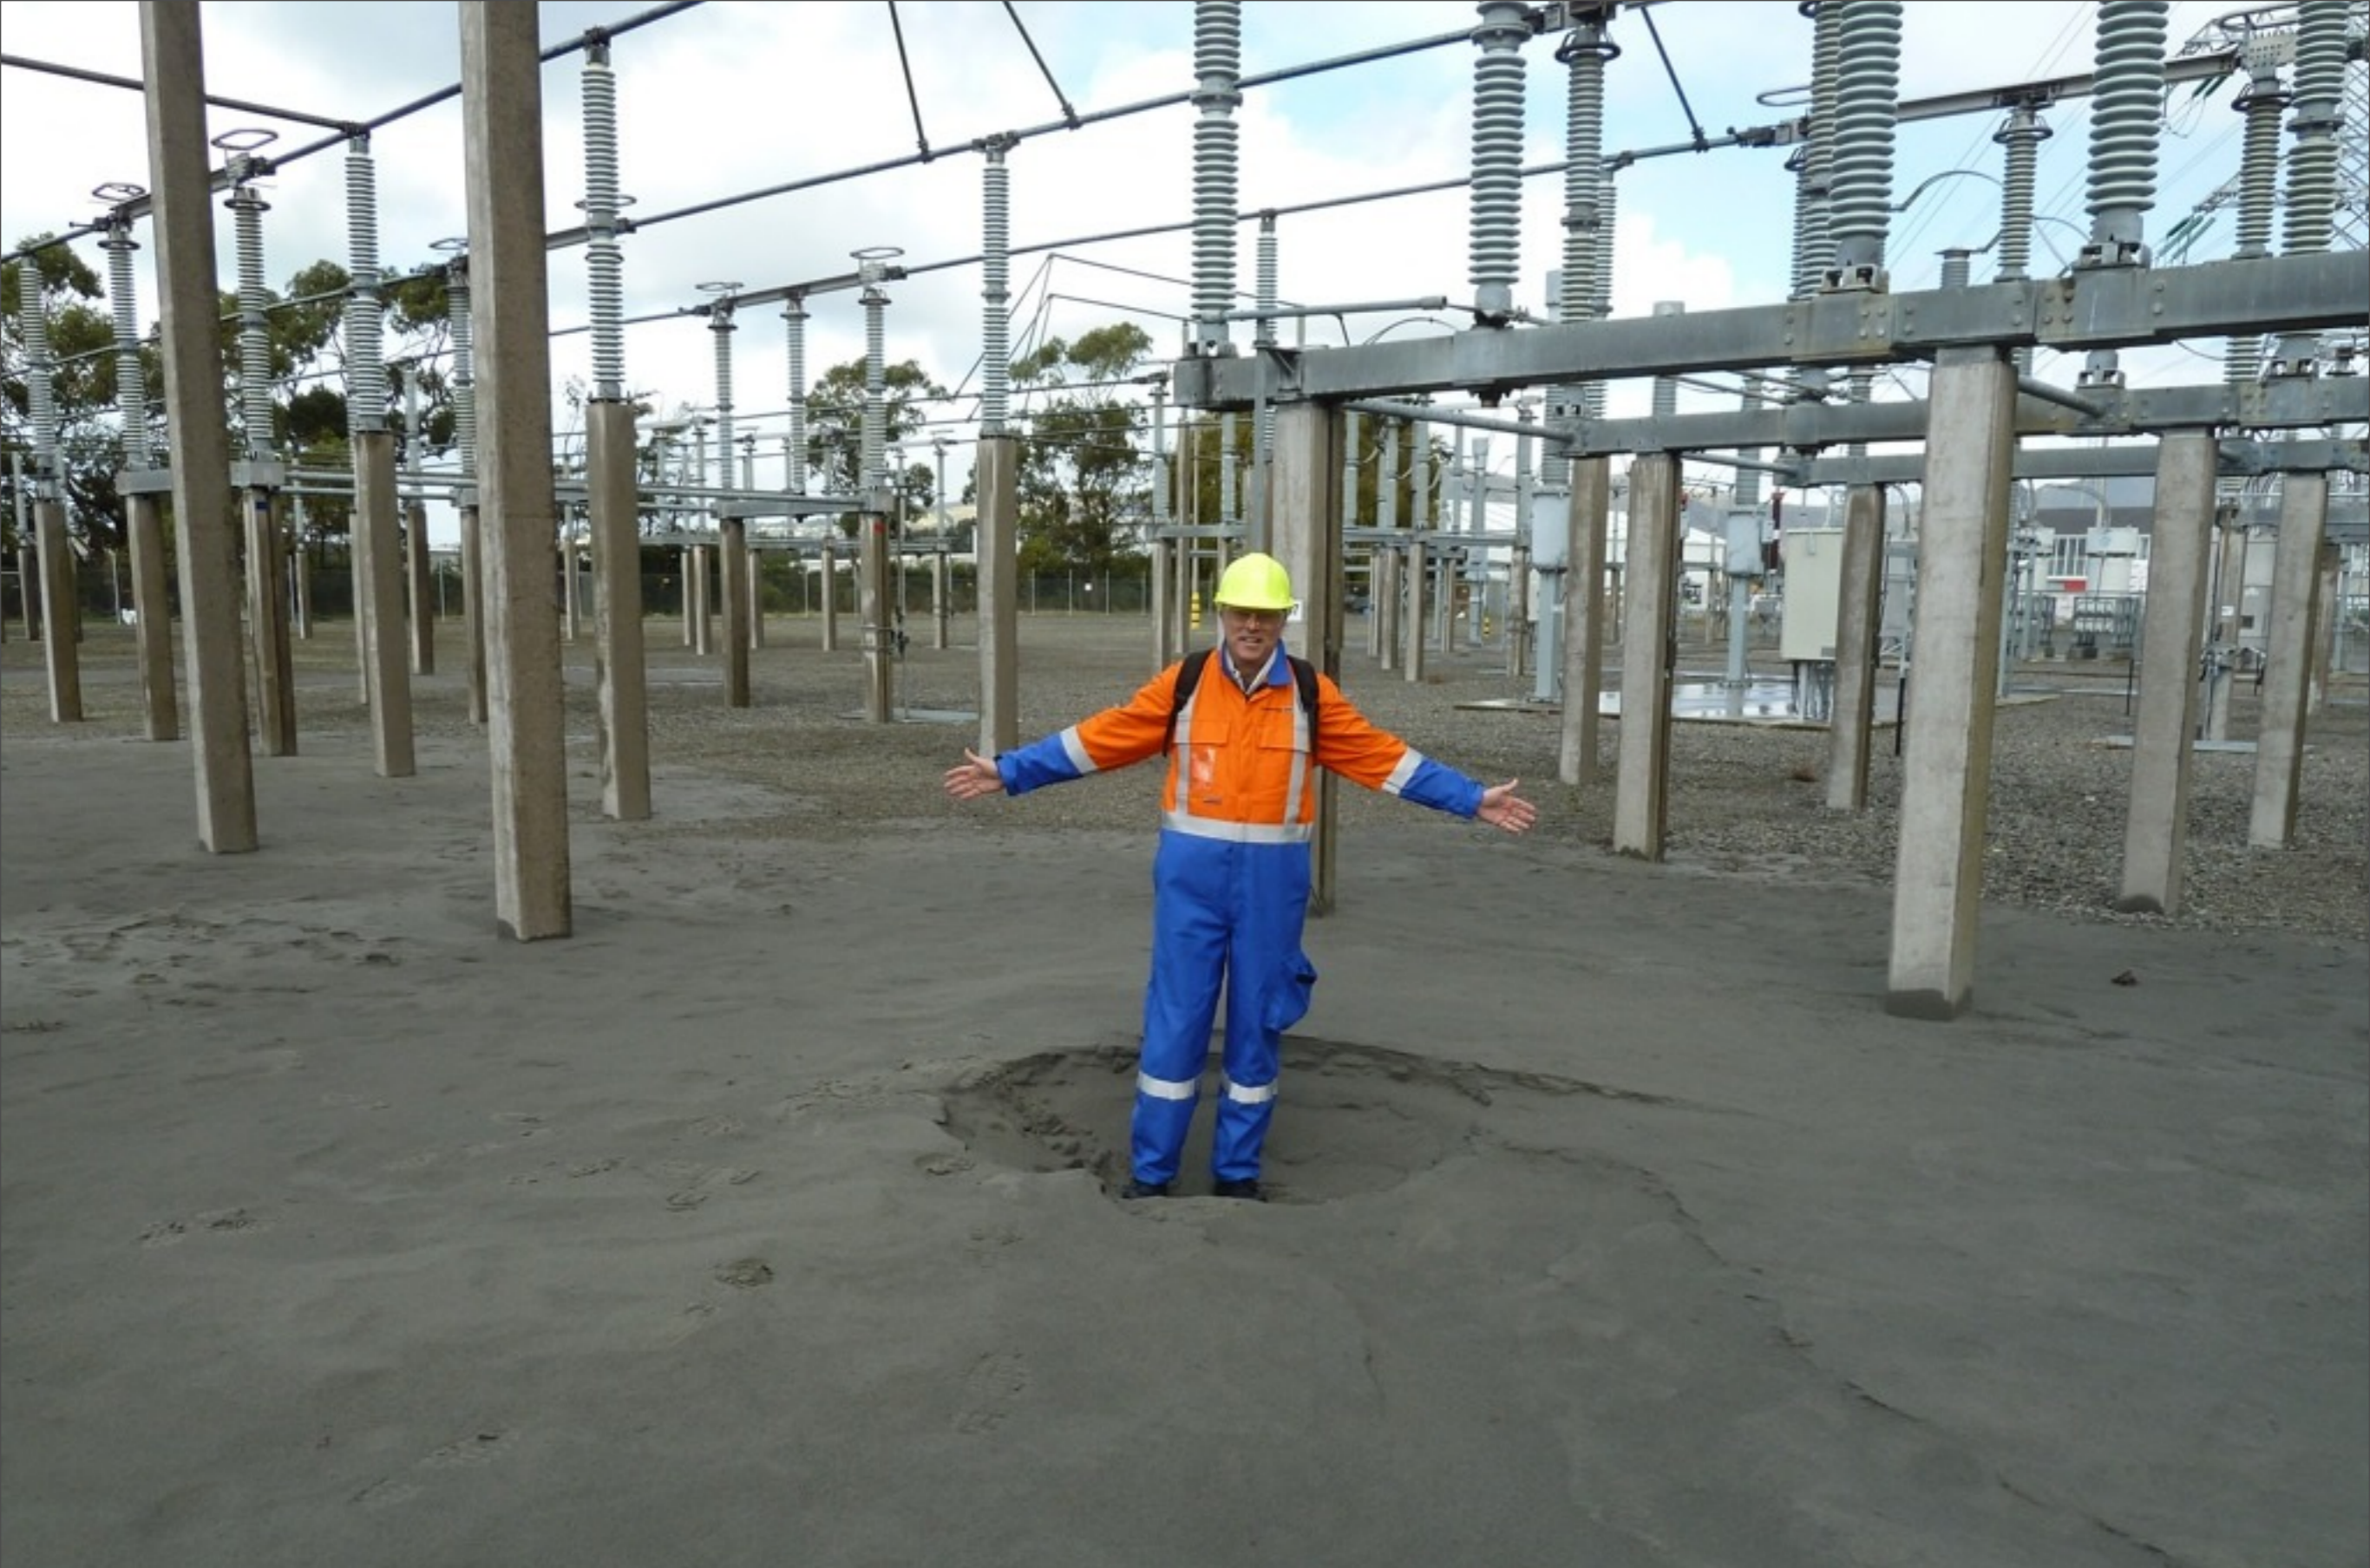
Large sand boil in 220 kV Yard

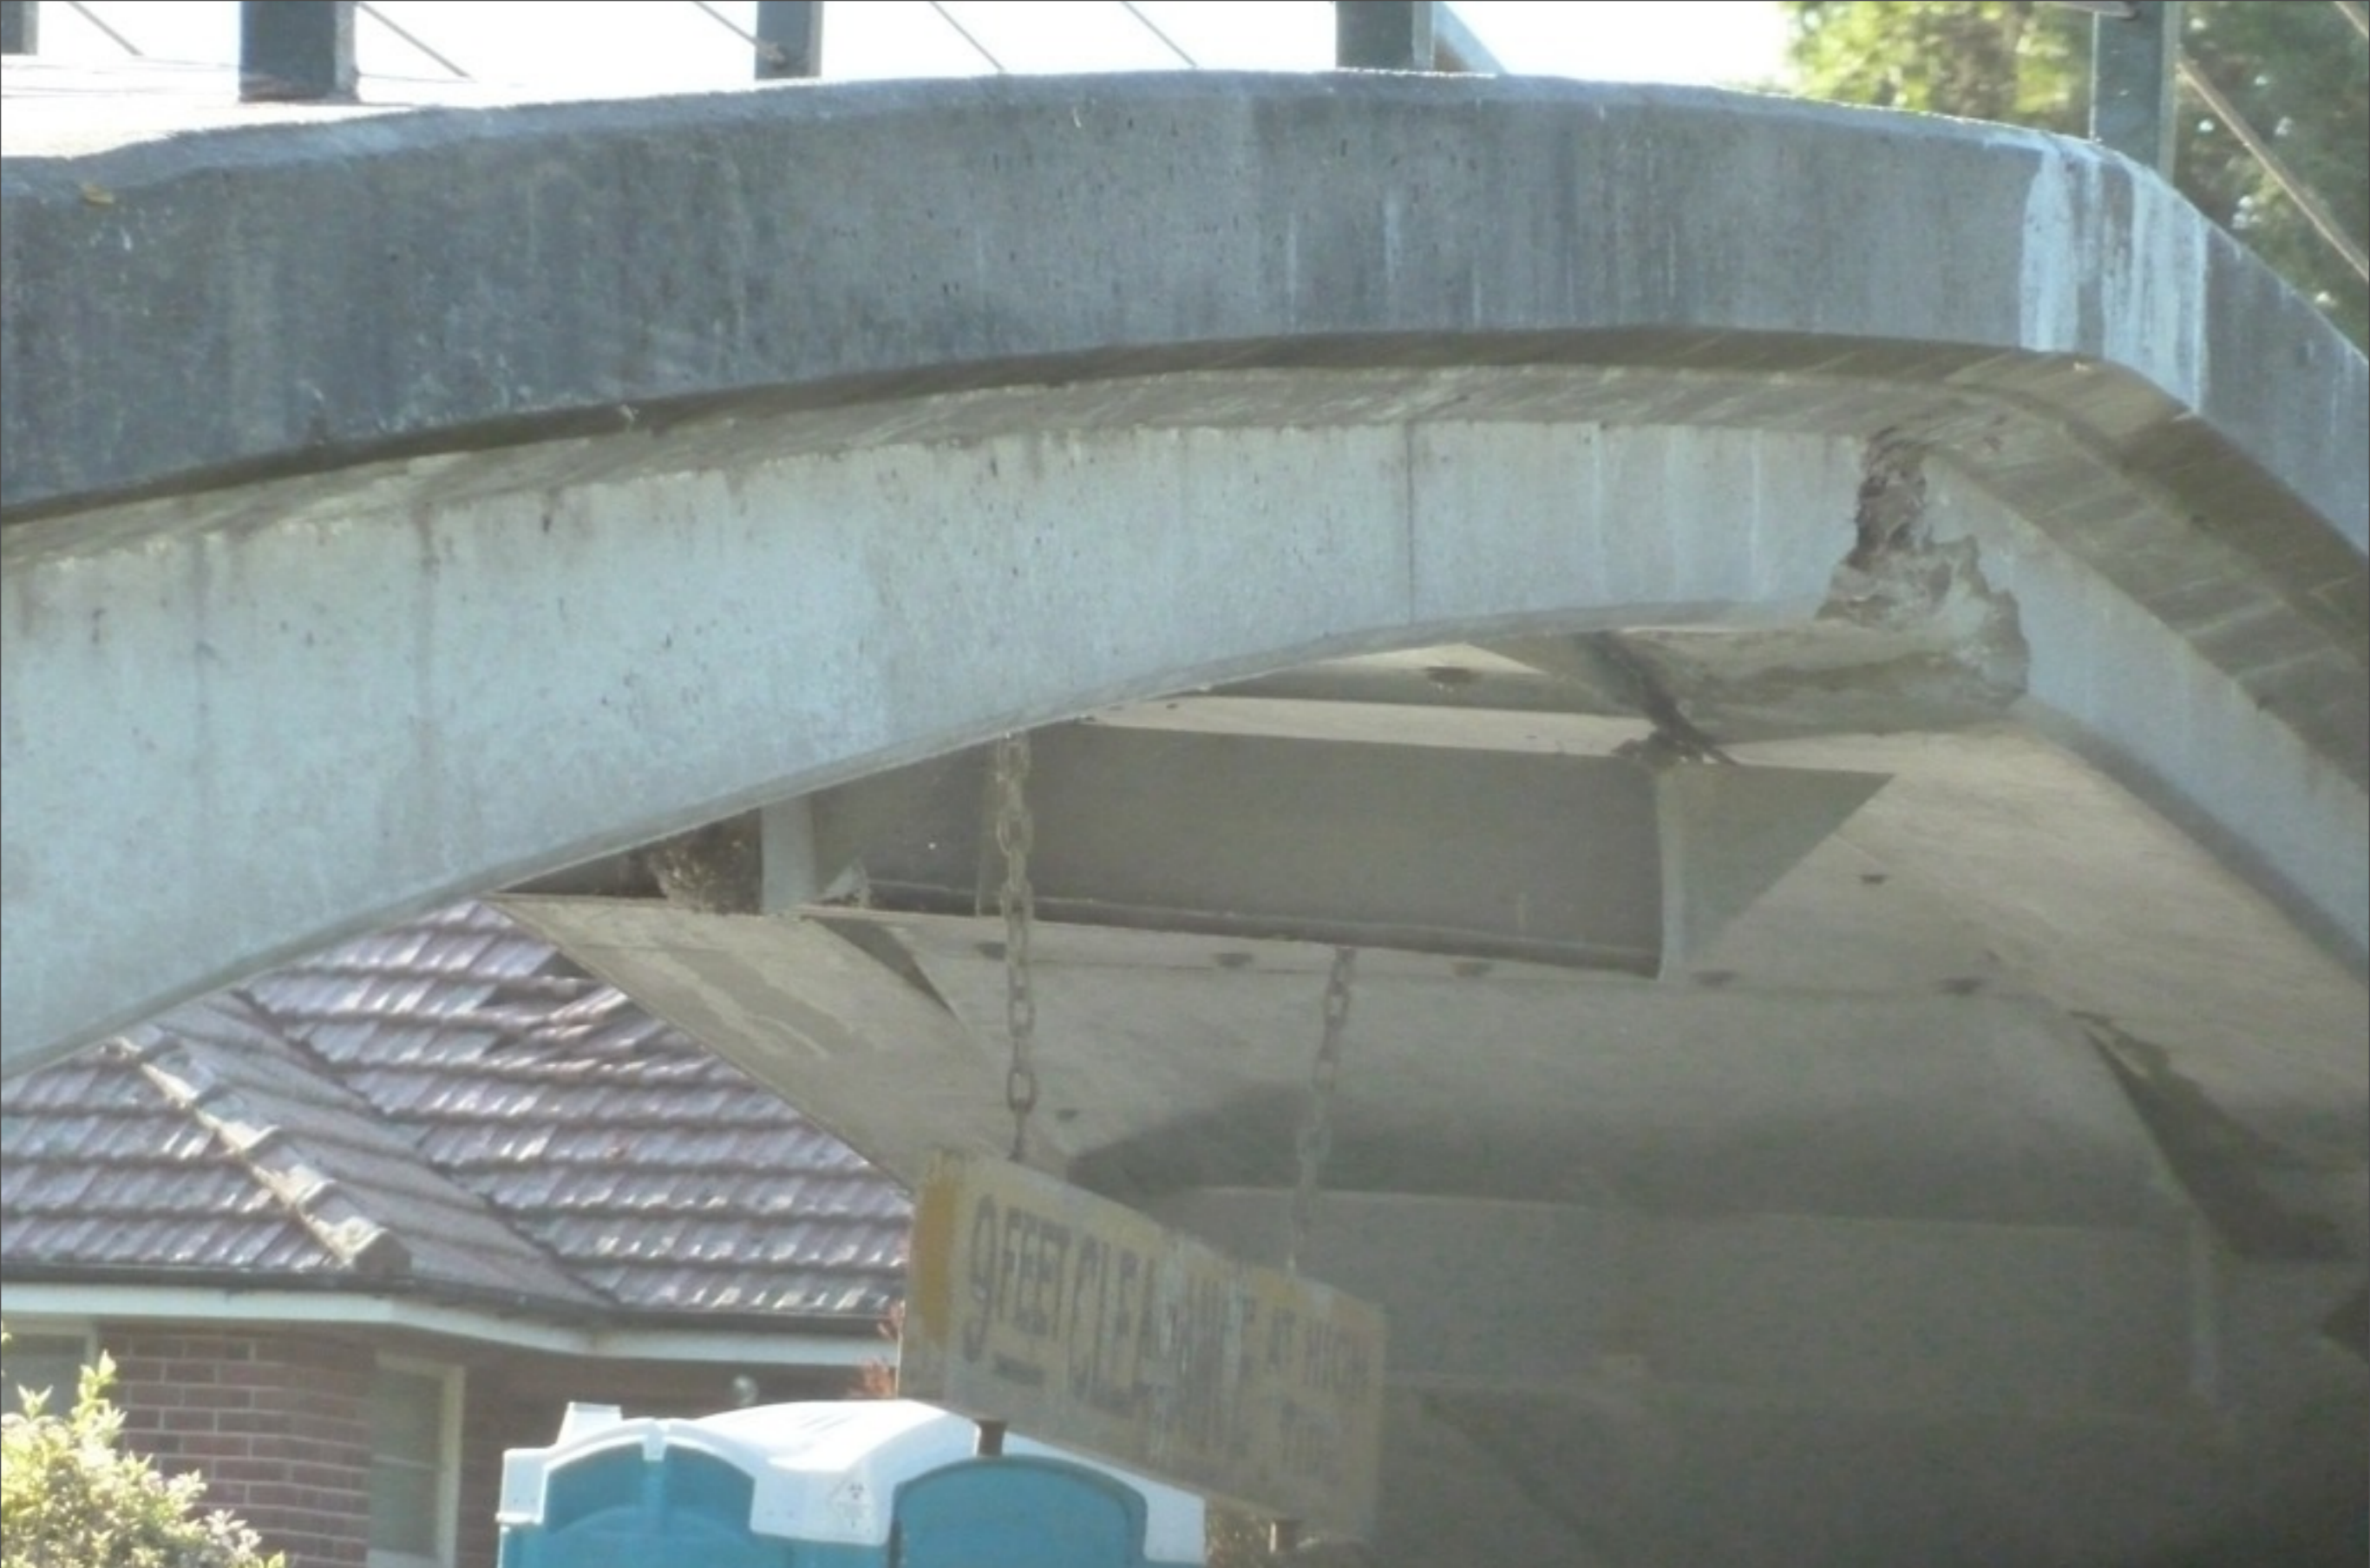
2011: More lateral Spreading, now forming a 3-pin arch

(2010) Two 66 kV cables, Buckled, pinched, not faulted (2010)

(2011) Same cables faulted, not yet dug up or repaired (as of April 5 2011)
