Oil and Water System Performance – Denali M 7.9 Earthquake of November 3, 2002

By John Eidinger¹ and Mark Yashinsky²

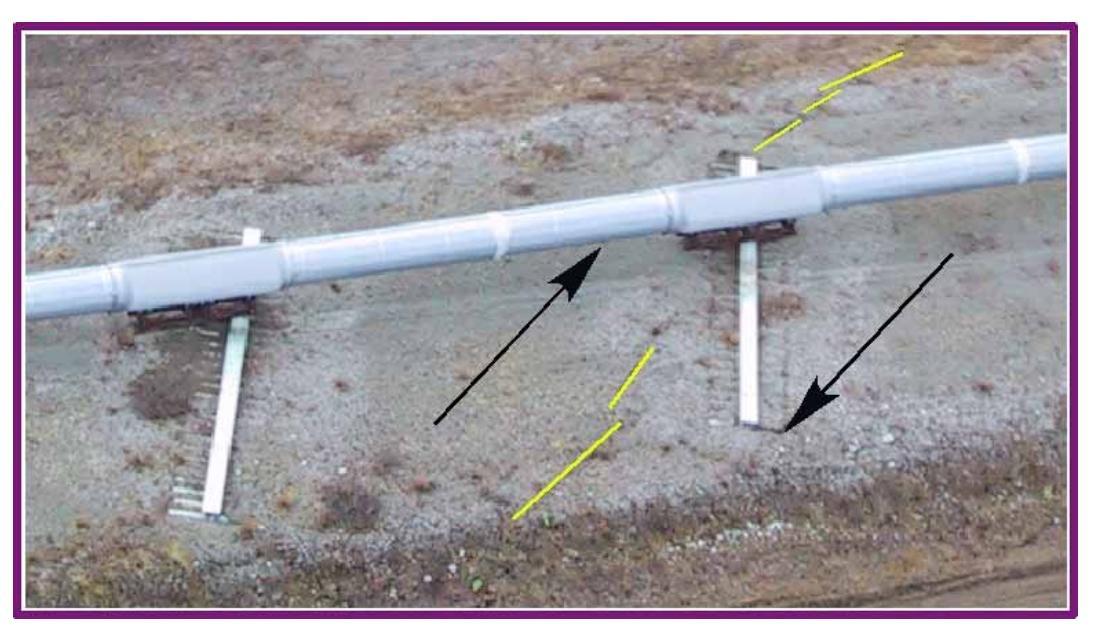
The earthquake occurred at 1:13 PM Alaska Standard Time on 11/3/2002. During the earthquake, the fault caused a surface offset (near the south end of the fault rupture zone) of about 18 feet (5.5 meter) horizontal and 2 feet (0.8 meter) vertical, distributed over a zone of about 600 feet (Figure 3.11). There was an automatic shutdown switch (with an acceleration trigger) that closes the pipeline valves 10 minutes after an earthquake. However, this type of shutdown is extremely undesirable since it can cause hydraulic surges and it disables the leak detection system. After it was determined that there was no leakage, the switch was manually over-ridden to have a more controlled (and safer) shutdown. One it became known that there had been some damage to some pipe supports, at 2:00 PM the pipeline was restored to service. By "shutdown", it is meant that a series of valves were consecutively closed along the length of the pipeline. Once shut down, the oil remained in the pipeline, without moving. During the shutdown, oil production on the North Slope continued, with excess oil being stored locally.

Figure 3.11. Location of Surface Fault Rupture (Alyeska)
