Water and Sewer Systems

John M. Eiding, M. ASCE¹

1.0 Introduction

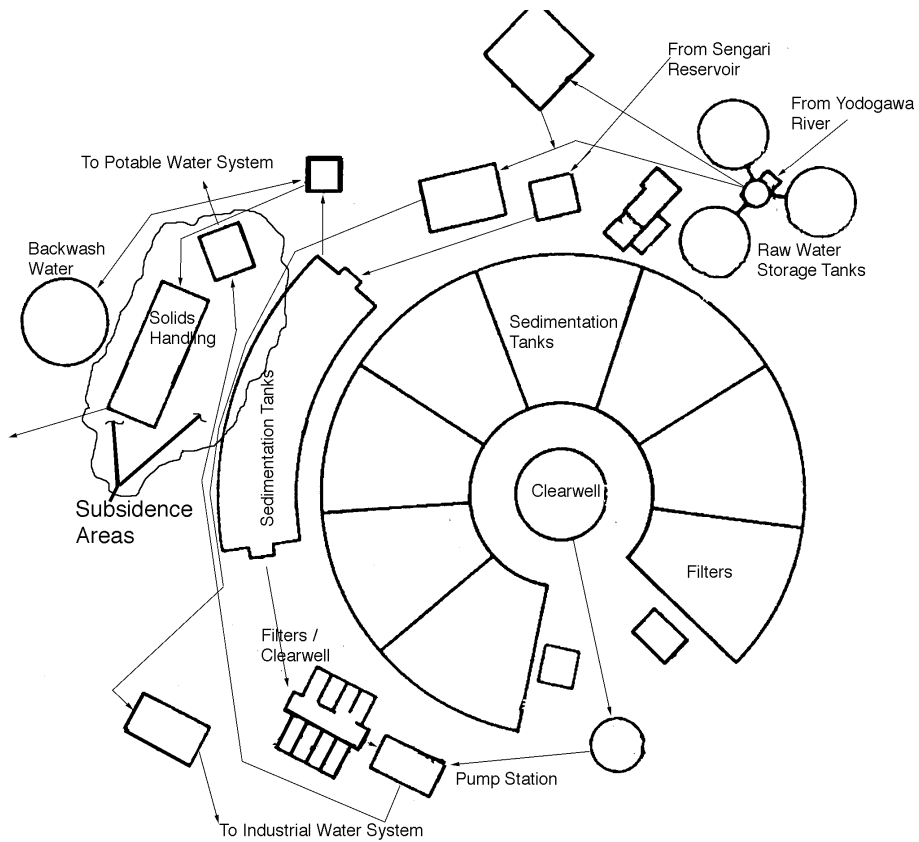
Figure 5. Uegahara Water Treatment Plant

On the west side of the plant (see Figure 5 and Photo 9), fill behind a retaining wall subsided when the retaining wall moved outward resulting in separating pipeline joints on three treated water lines each 1.2 m diameter reinforced concrete. The lines were 1) Uegahara potable water, 2) Uegahara industrial water, and 3) Hanshin potable pipelines. The Hanshin line was operating as of 2/11/95.

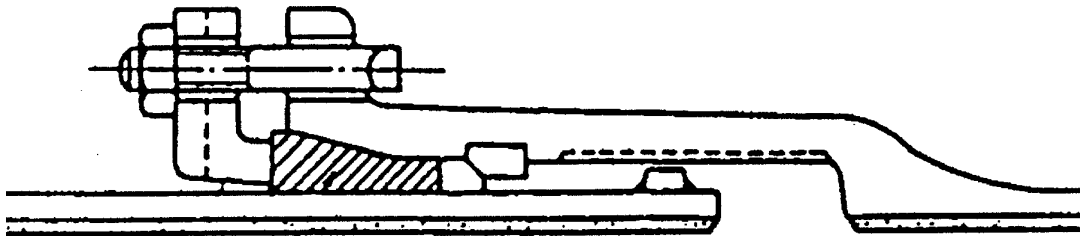
Figure 6. Special "S" and "S-II" Joints Used on Key Pipelines. Type "S" have 2-4 cm of flexibility (500 - 2600 mm diameter); type "S-II" have 5-7 cm of flexibility (100 - 450 mm diameter). Type "S" were used until 1980, type "S-II" since 1980.

Type "S" Joint - Allows 2 - 4 cm of slip. Faired Okay.

Type "SII" Joint - Allows 5 - 7 cm of slip. Faired Very Well.

It has also been reported but not confirmed that the “S” and “S-II” connection used in Nishinomiya suffered significant amounts of damage; the “S” joints had damage in Ashiya; the “S-II” joints had no reported damage in Ashiya or Kobe. Photo 16 shows a pulled apart mechanical joint connection on a 300 mm ductile iron pipeline. Photo 17 shows a pulled apart joint on a 600 mm steel pipeline. Photo 18 shows a body failure on a 800 mm cast iron pipe. Photo 19 shows a damaged 200 mm “T” joint on ductile iron pipe. Photo 20 shows a failure of a “K” mechanical joint on a 800 mm ductile iron pipe.

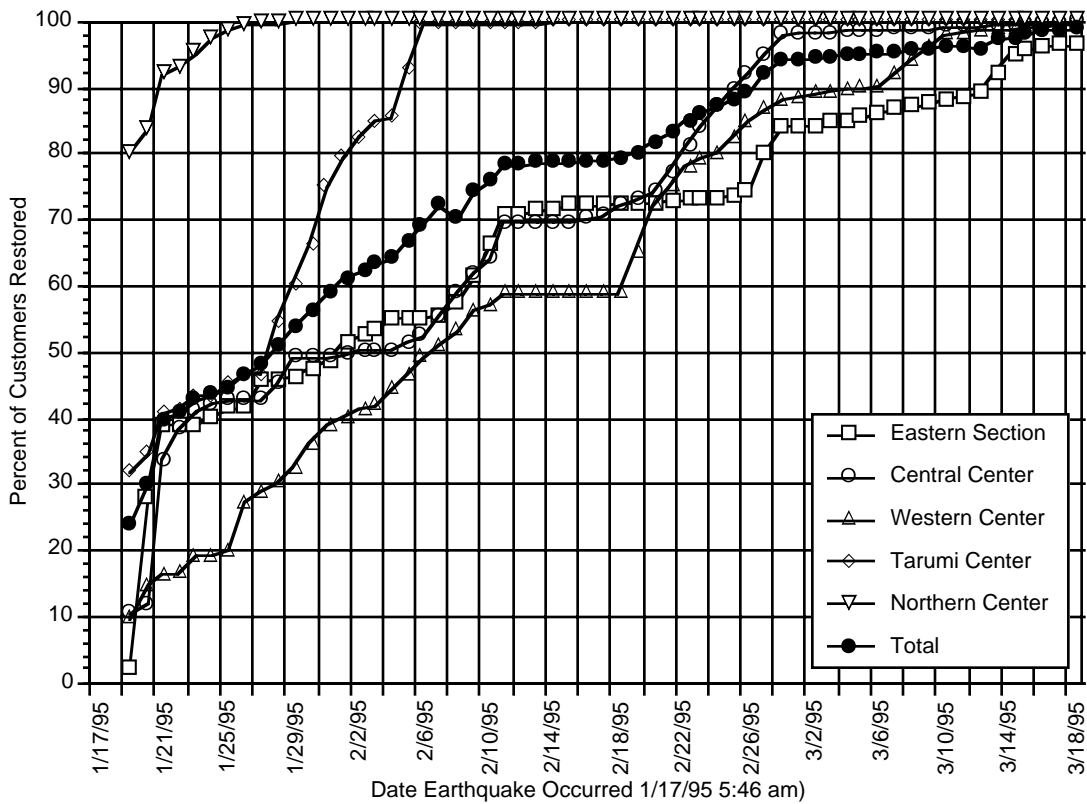
Figure 17. City of Kobe Water Restoration

Figure 17 shows the status of system restoration by area, through March 18. Based on the information in this table, approximately three-quarters of this system was initially without service. The western area of the system was the most severely impacted, while the northern part of the system had the least damage. Other parts of the system appear to be equally hard hit.

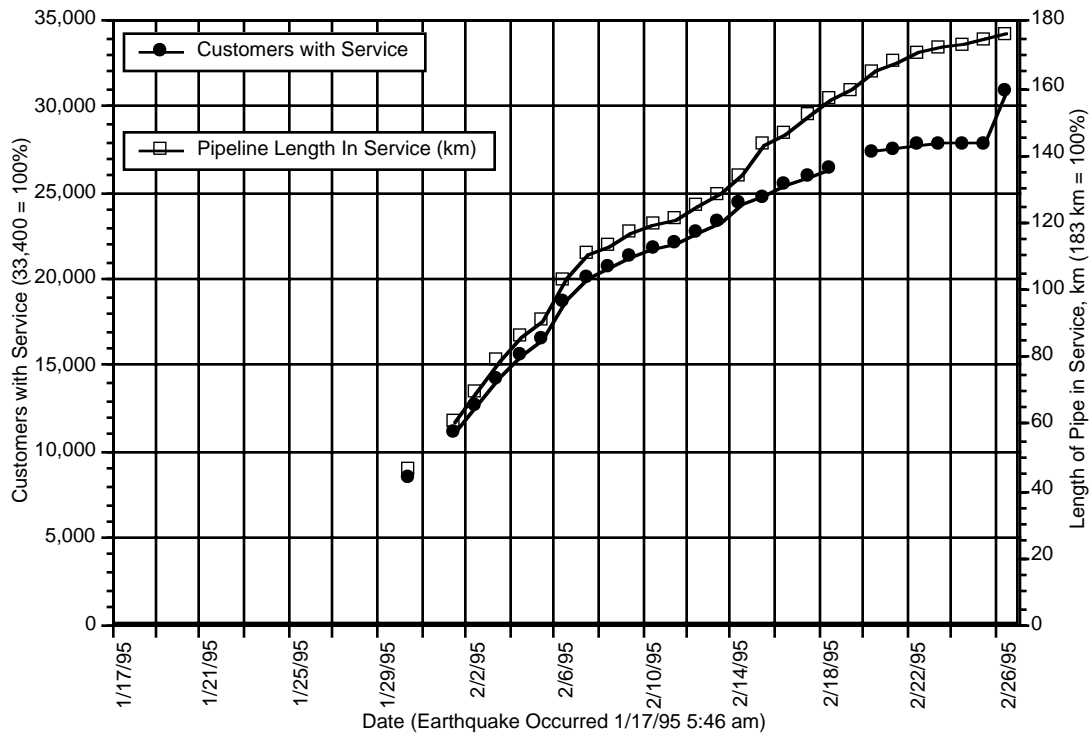
Figure 18. City of Ashiya Water System Restoration

Figure 18 shows the water service restoration effort for the City of Ashiya. For the first 8 days after the earthquake, there was zero water available to Ashiya, as the transmission system failed. For this reason, no pipe repairs could be made during this time, as there was no water to find the leaks.

Once the transmission system pipes were repaired, the repair of all distribution pipe breaks proceeded using a staff of 50 Ashiya Public Works Department staff, augmented by an additional 30 staff from other water agencies. The repair process took 32 days once begun. At no time did the water department issue a “boil water” alert, as they considered all water that they introduced into the distribution system to be treated.
