Seismic Performance of Water System – M 6.6 Lushan, China Earthquake of April 20 2013

John Eiding, President, G&E Engineering Systems Inc., Olympic Valley, CA 96146
eidinger@geEngineeringSystems.com

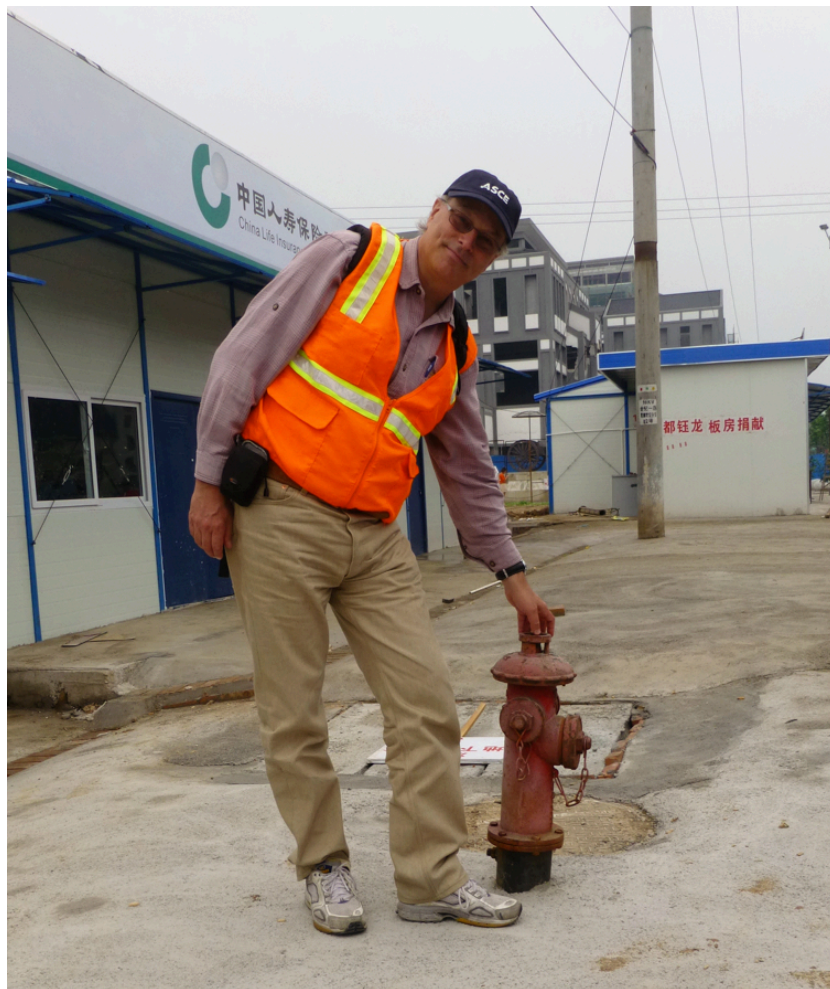
Figure 12. Author and a Fire Hydrant in Lushan

Lushan city has about 300 km of water distribution pipes. Most are cast iron (dating back 50+ years) and newer pipes are PVC. Most distribution pipes are 100 mm diameter; 500 mm diameter is the largest pipe in the system. Figure 12 shows the author with a fire hydrant. Note the temporary office buildings in the background: dozens of such buildings were placed on main city streets in Lushan, providing needed services: life insurance, telecom, banking, etc.
