History of the Water Works of San Francisco, Its Performance in the 1906 Earthquake and Aftermath

John M. Eiding and N. Timothy Hall

December 19, 2023

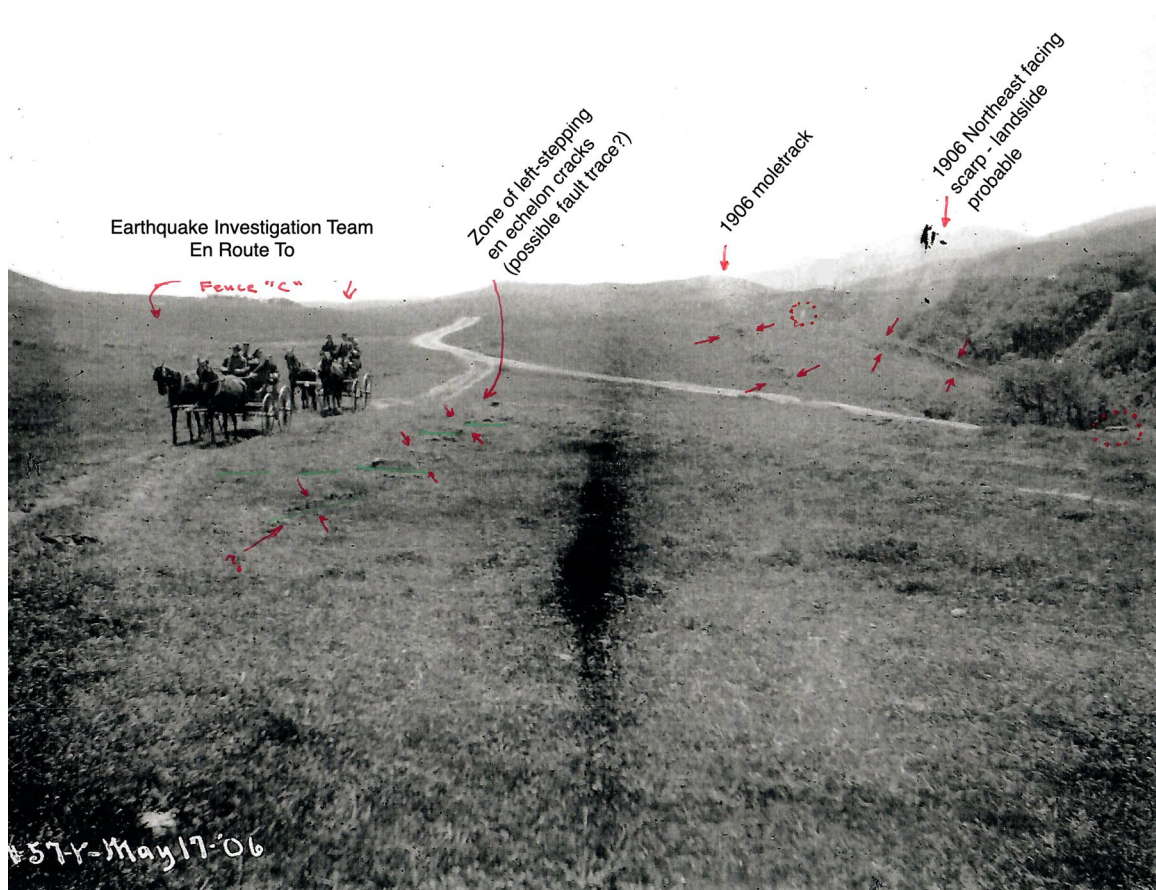
Figure 0-1 shows a photo of the Earthquake Investigation Team en-route to examine the San Andreas fault and the damaged Pilarcitos water pipeline at "Site 9" (see Section 4.1.9 for details of what happened at that site). The black splotch in the center of the photo and a few other dark splotches in the top right are artificial as the old photo was creased; hand-drawn arrows have been added to highlight certain features; "Fence C" is discussed in Section 4.1.8.

Figure 0-1. Earthquake Investigation Team (photo: Schussler 1906)

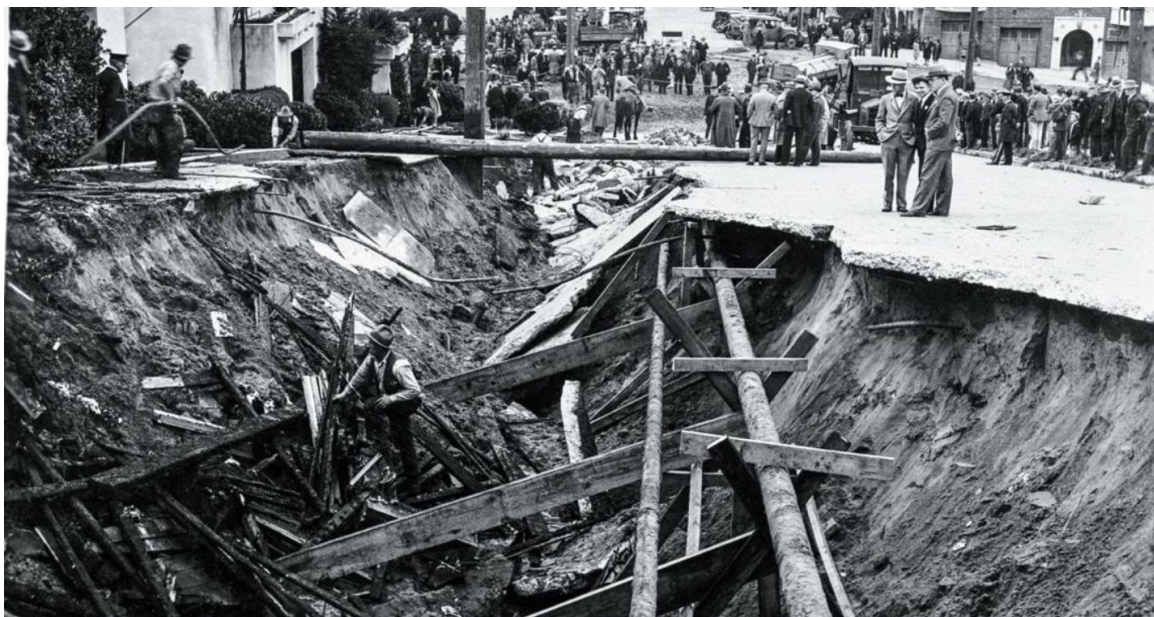
Figure 2-17. Collapsed street on 4th Avenue between Anza and Balboa on March 18, 1930. (Horace Chaffee, SF Department of Public Works book A2488). Salt Water pipe runs perpendicular to the trench caused by erosion from the broken 12" pipe. It took 2 hours to isolate the leaking pipe.

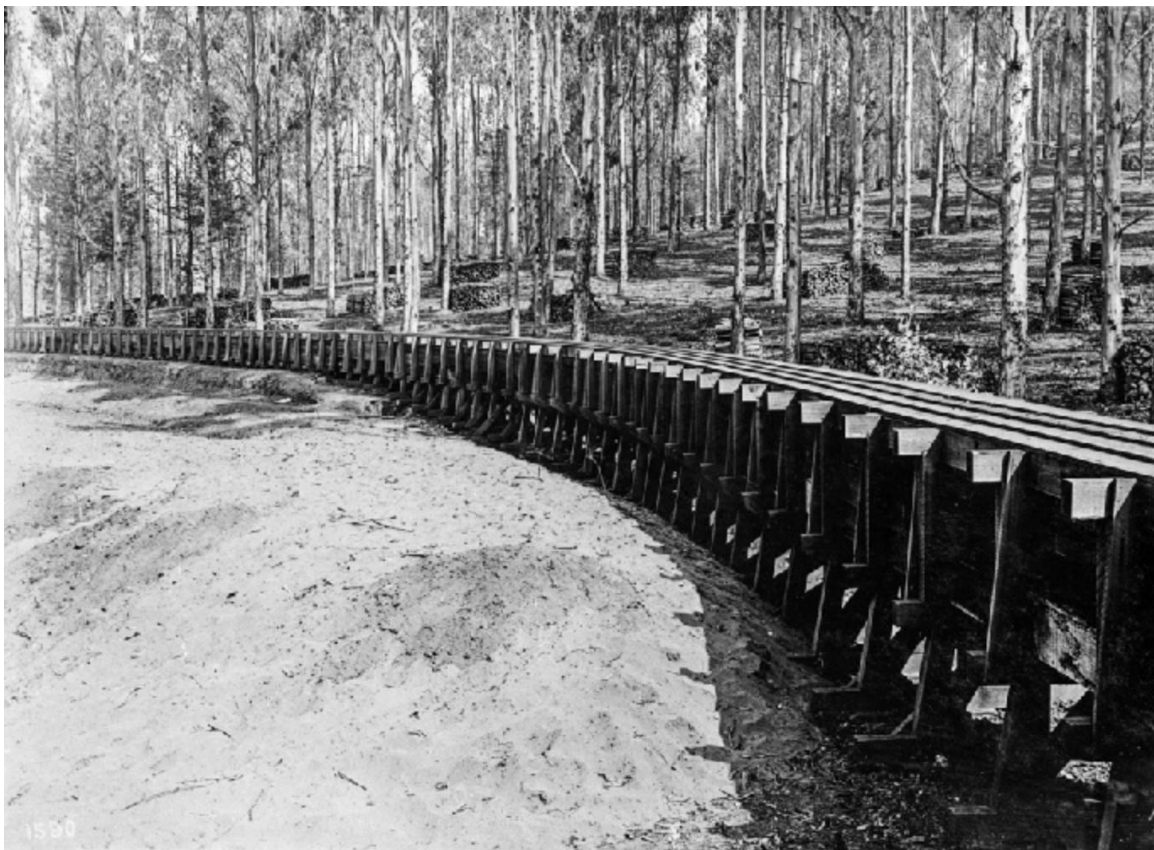
Figure 2-18. Pilarcitos Flume 1913. Looking north, near Ocean Avenue (Credit SF Library, dpwbook6 dpw 1590)

- Flume south of Lake Honda. See Figure 4-7 for location, Figure 2-18 for photo. This flume suffered some damage, which was repaired on the same day of the earthquake, April 18, 1906.

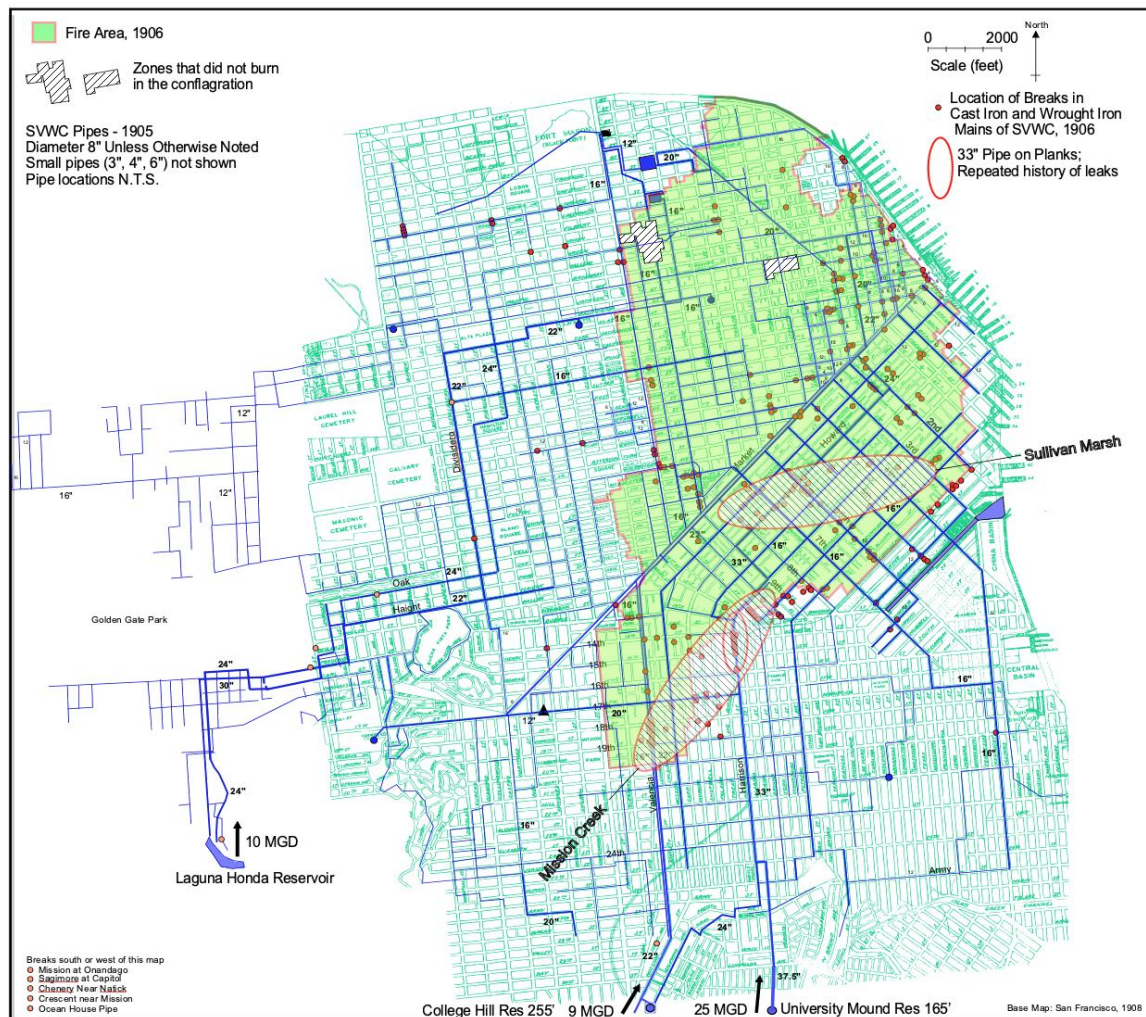
Figure 2-28. 1906 Water Pipe Breaks (Dots) in City Mains (Blue Lines) and Ultimate Fire Area

Figure 2-28 shows the water distribution system serving San Francisco, as it existed just prior to the 1906 earthquake. At the south side of the City were three terminal reservoirs: Laguna Honda, College Hill and University Mound. Water from reservoirs along the Peninsula and Alameda County was delivered to these three terminal reservoirs by the four transmission conduits. In 1906, Average Day Demand (ADD) was about 29 MGD. Prior to the 1906 earthquake, water supply capability was 10 MGD via Laguna Honda, 9 MGD via College Hill Reservoir, and 25 MGD via University Mound reservoir. The red dots show the location of where 299 distribution system water pipes broke in the 1906 earthquake. The major liquefaction areas in the 1906 earthquake were in the Sullivan Marsh and Mission Creek zones, schematically highlighted in Figure 2-27 by the two ovals; these same areas are shown in Figure 2-28 by the diagonal hatched areas.

Table 4-2 shows the number of repairs made to distribution pipes within the City distribution system, as a function of pipe diameter and the amount of PGD at each repair location. Schussler (1906, 1909) reported that there were a total of 299 repairs made to the distribution system, and provided mapped locations for 258 of these repairs. The mapped total of 258 repairs is 41 fewer than the actual total 299 repairs; the location of 5 of these 41 repairs is known to be in locations with no PGD (locations listed in lower left of Figure 2-28); the location for the remaining repairs is uncertain.

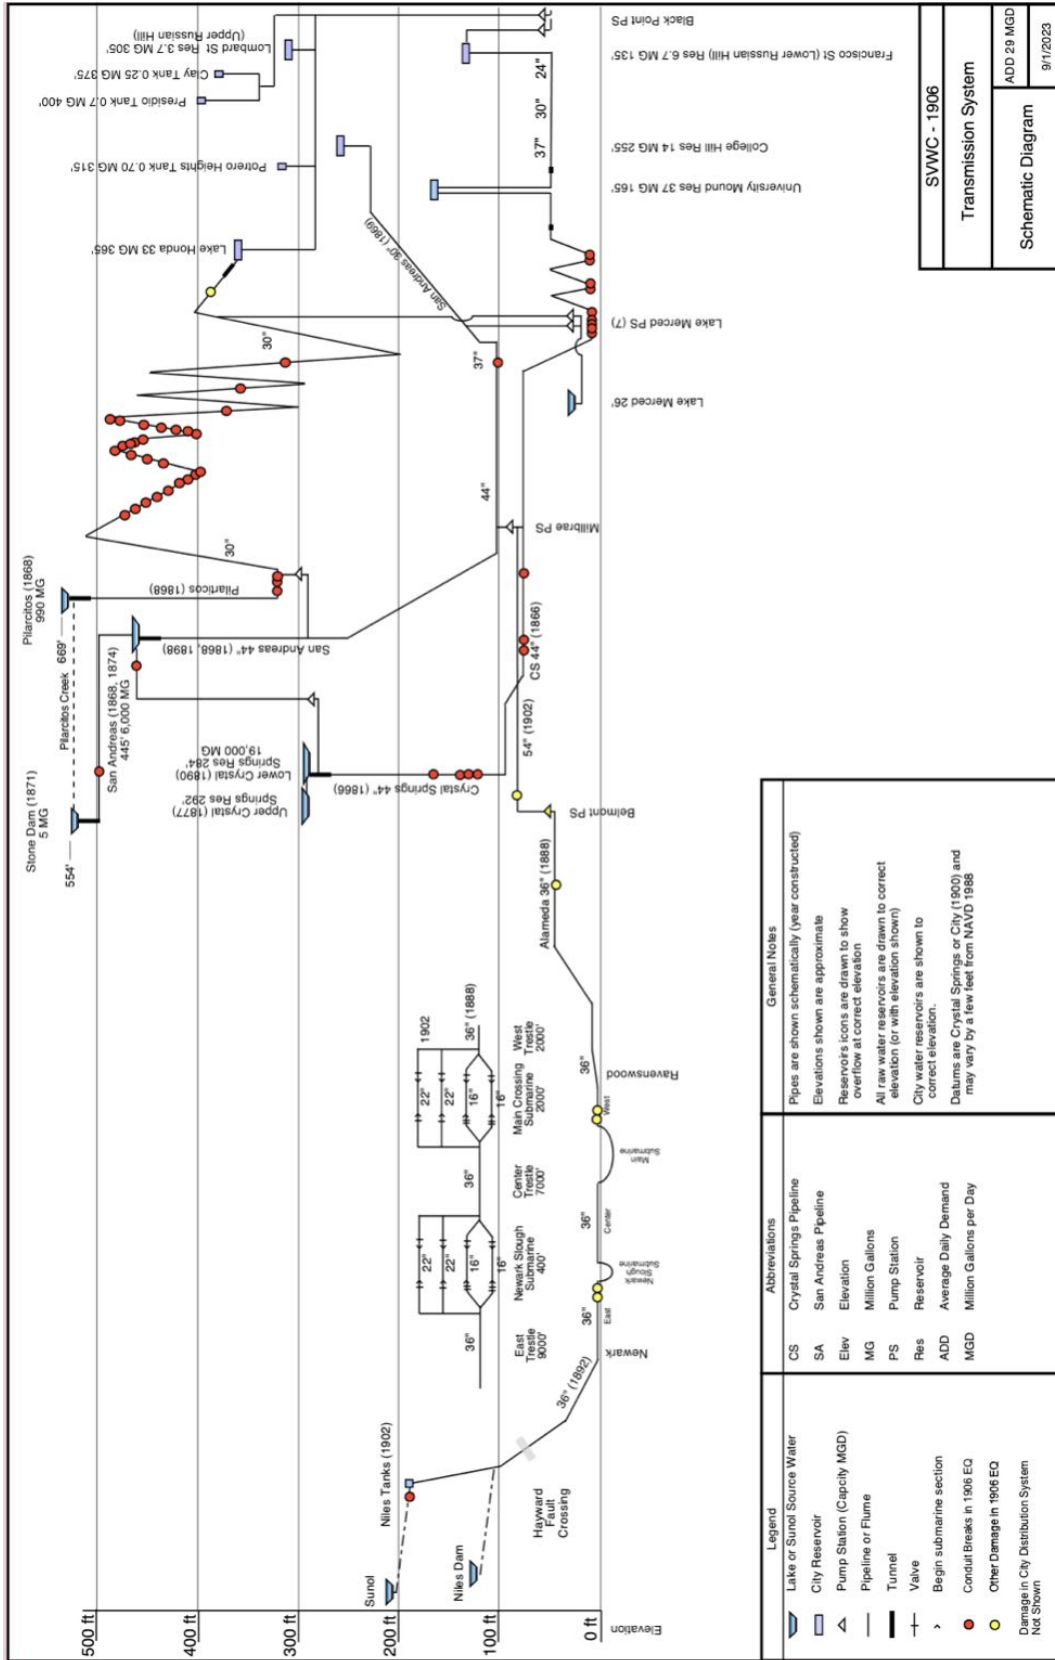
Figure 2-30. Hydraulic Profile, Regional System, With Transmission System Damage (1906)

Figures 2-29 and 2-30 show hydraulic profiles of the 1906-vintage regional water transmission system. The overflow for the San Andras reservoir is shown as 445 feet; the dam was later raised in 1928 and today (2023) the overflow is 449 feet.

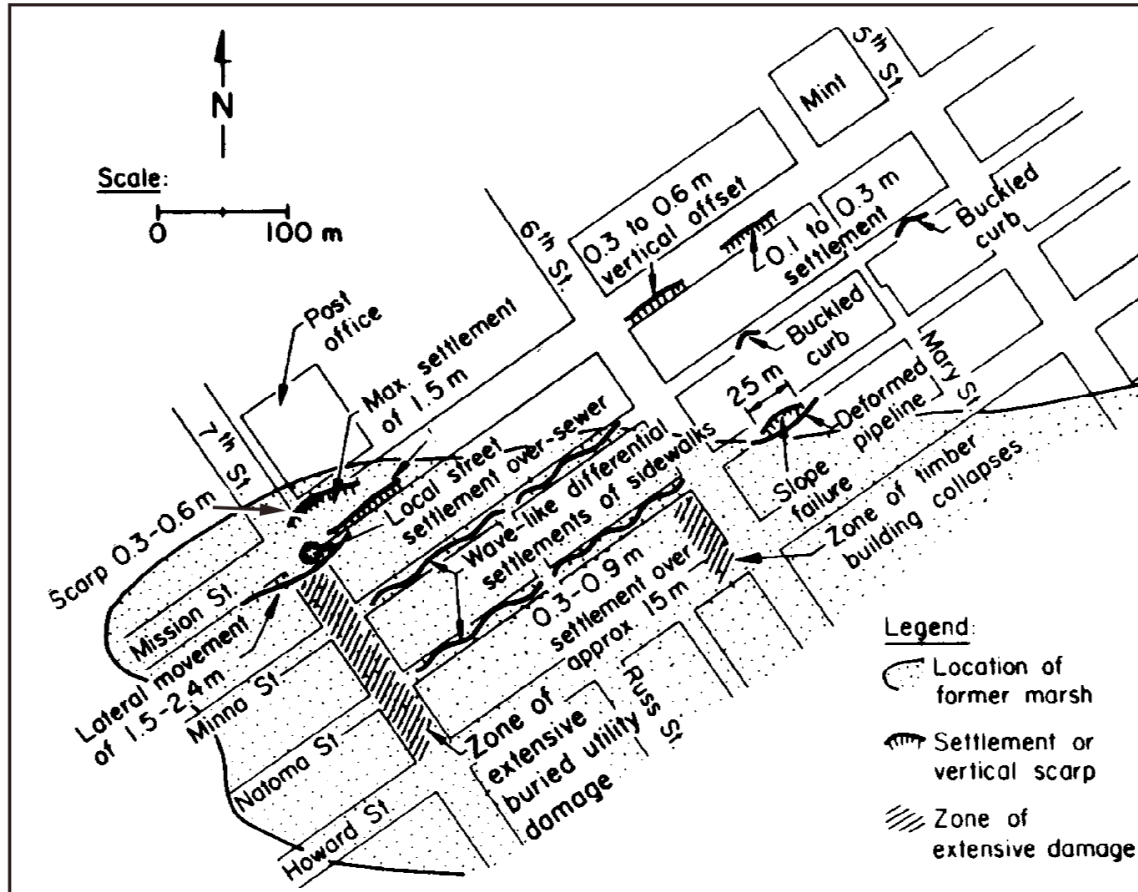
Figure 3-4a. Detailed map of 1906 Earthquake-Induced PGDs (Sullivan Marsh Area)

A record of the estimated PGDs that occurred in the 1906 earthquake has been compiled by O'Rourke et al (1992), see Figures 3-4a, b. These PGDs were estimated based on available photographic evidence from the 1906 earthquake. The following are the main observations:

Lateral spreads of up to 8 feet were recorded along the length of 7th Street, with ground moving from northwest to southeast. 1 to 2 foot settlements occurred sporadically over the entire lengths of Minna and Natoma streets. Probable lateral spreads on 6th Street between Natoma and Howard led to collapse of timber structures.

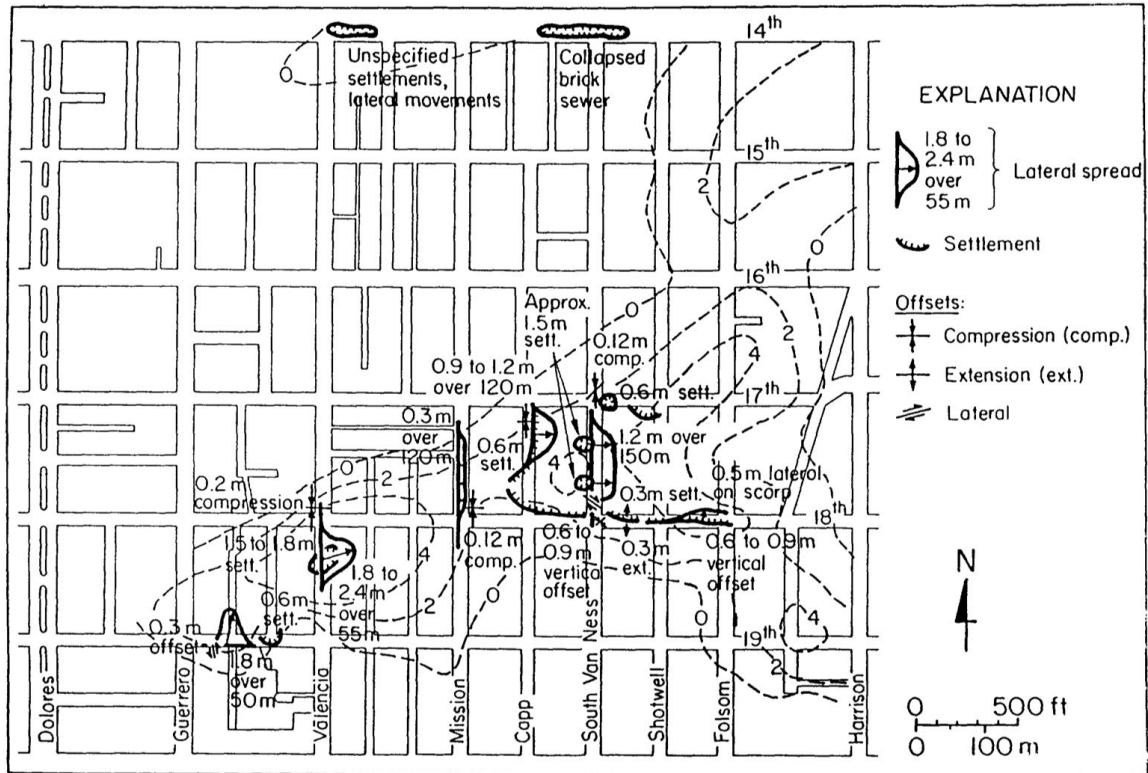
Figure 3-4b. Detailed map of 1906 Earthquake-Induced PGDs (Mission Creek Area). Dashed lines show depth of fill in 2 meter contours.

In the 1906 earthquake, there was major damage to water pipelines where they traversed the filled areas of the former Mission Creek (Valencia Street) and its lagoonal waters (see Section 7.7).

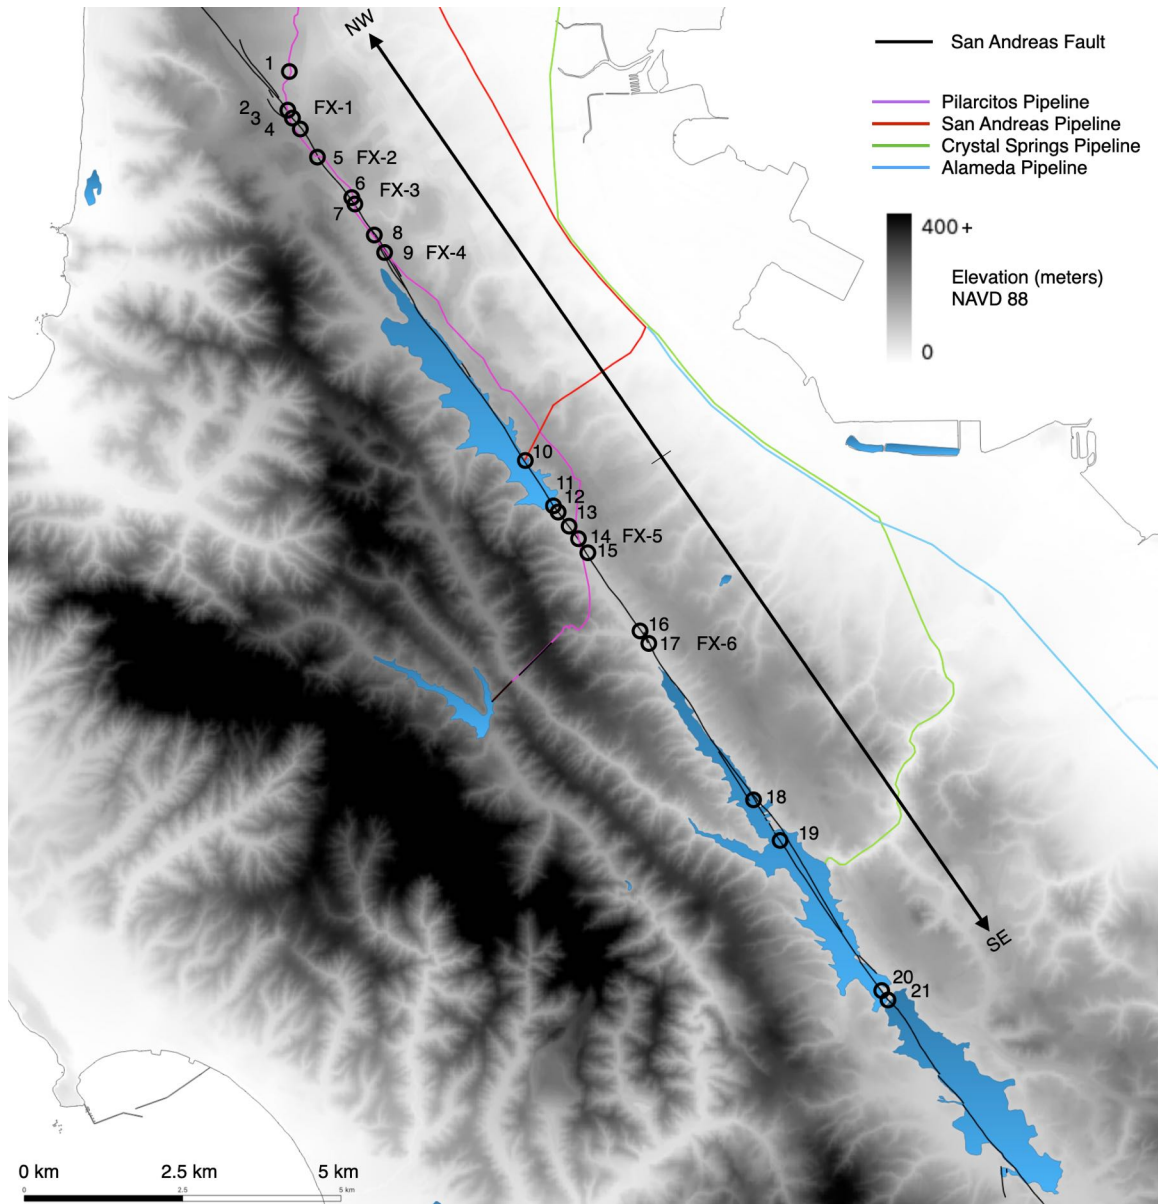
Figure 3-12. Location of Fault Offset / Other Pipe Damage Descriptions in the San Andreas Valley

Table 3-2 lists a summary of fault crossings (FX), Fences (F) and Water Supply Facilities, including the Pilarcitos Pipeline (PP) wrought iron and cast iron and Locks Creek wrought iron pipes near San Andreas dam, as affected by the 1906 earthquake. Sections 4.1.1 through 4.1.21 provide further details and photos at each of the 21 locations.

The Pilarcitos 30-inch WI pipe (thin wall) pipe collapsed at two trestle locations with the pipe broken and laying at the bottom of the canyons and the two wooden trestles collapsed or with major damage (Locations 1 and 2 in Figure 3-12). The San Andreas 37-inch WI pipe broke atop one trestle, where an expansion joint pulled open, requiring repair to 2 pipe segments. The Crystal Springs 44-inch WI pipe broke at three trestles across San Bruno (Colma), Guadalupe and Visitacion Valley Marshes: at these locations, the 44-inch WI pipe was thrown sideways up to 5 feet, and broken open at multiple expansion joint locations. The abandoned 37-inch Stone Dam (Locks Creek) pipe on an old trestle that traversed under the flooded Crystal Springs reservoir (Site 18) failed.

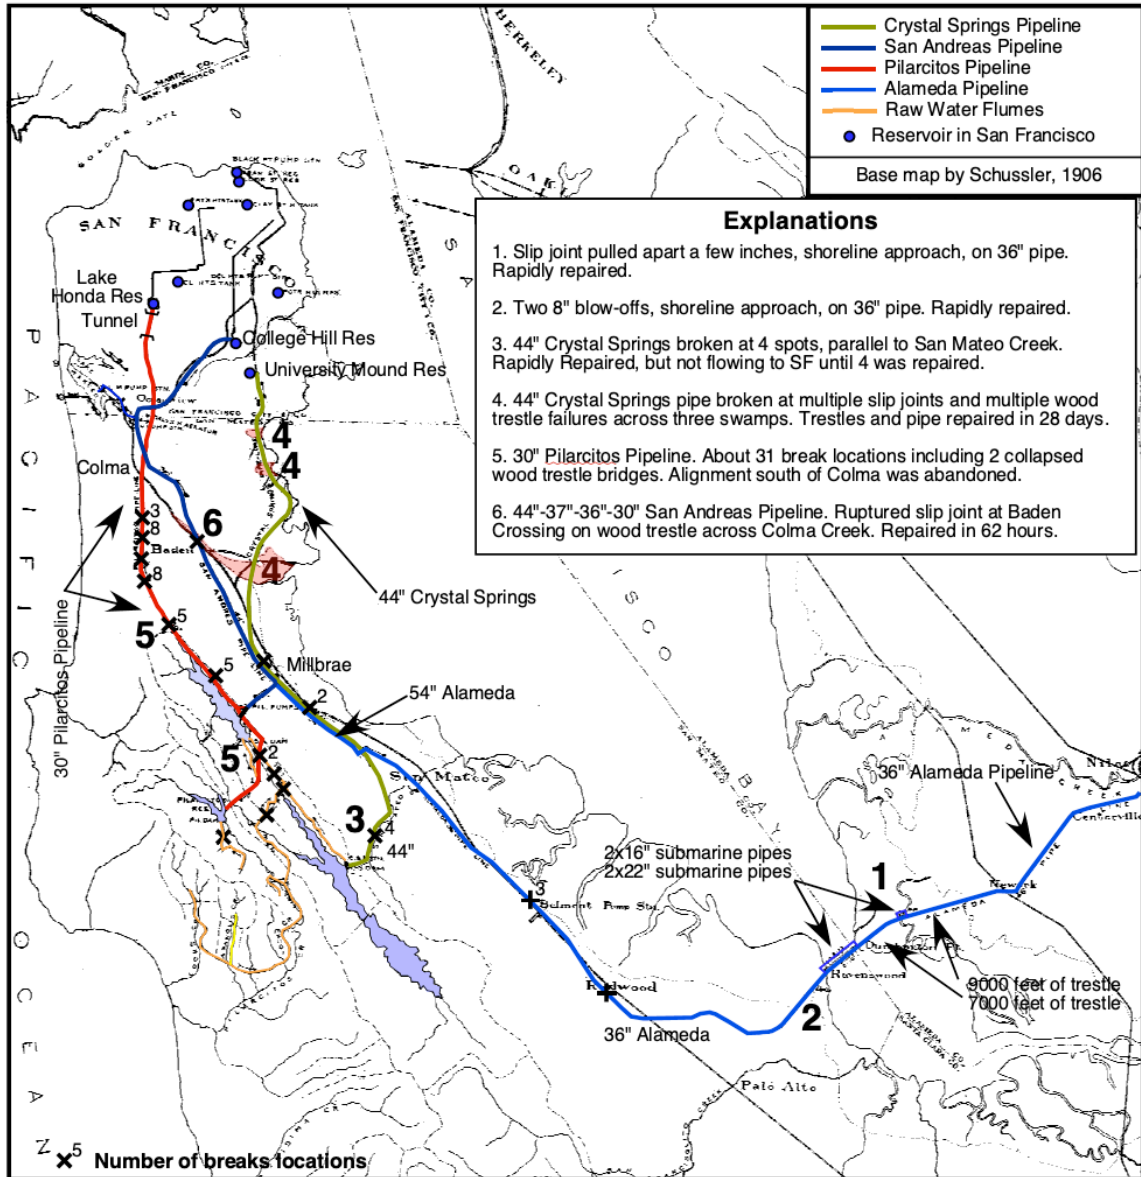
Figure 4-1. Damage to the Transmission Pipelines Serving San Francisco, 1906

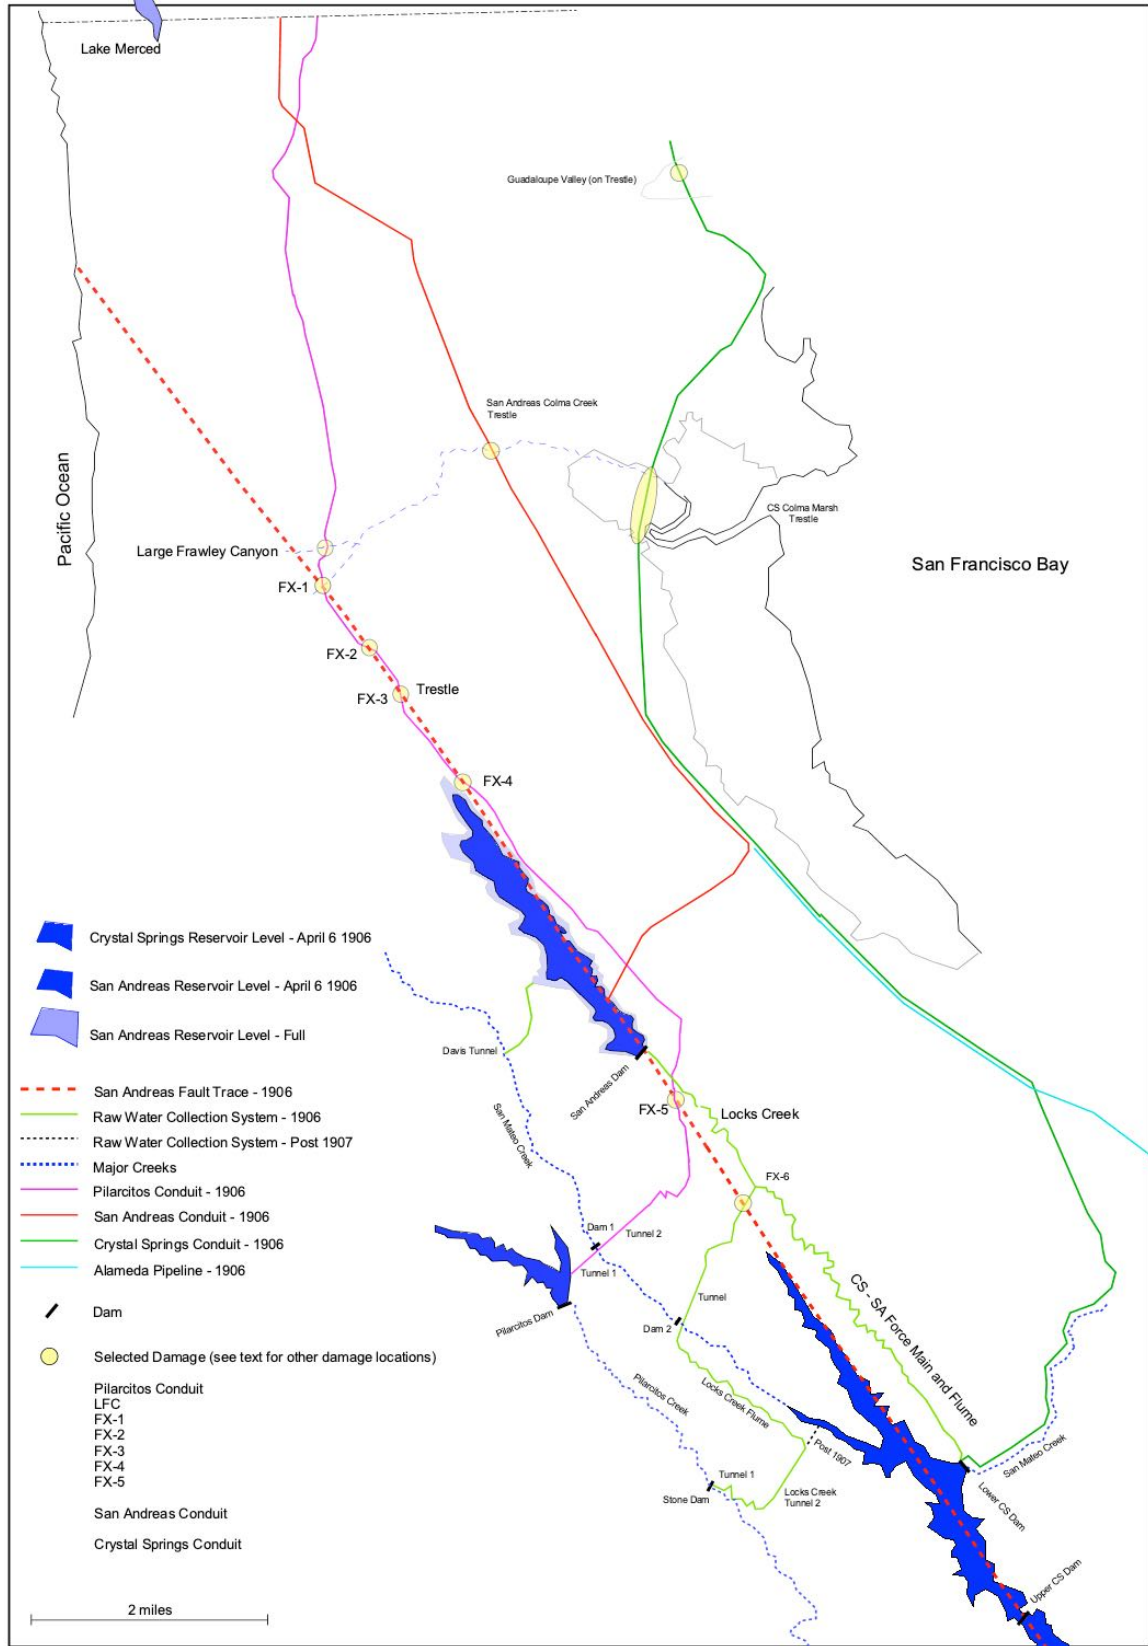
Figure 4-2. Location of Selected Pipeline Damage in the 1906 Earthquake

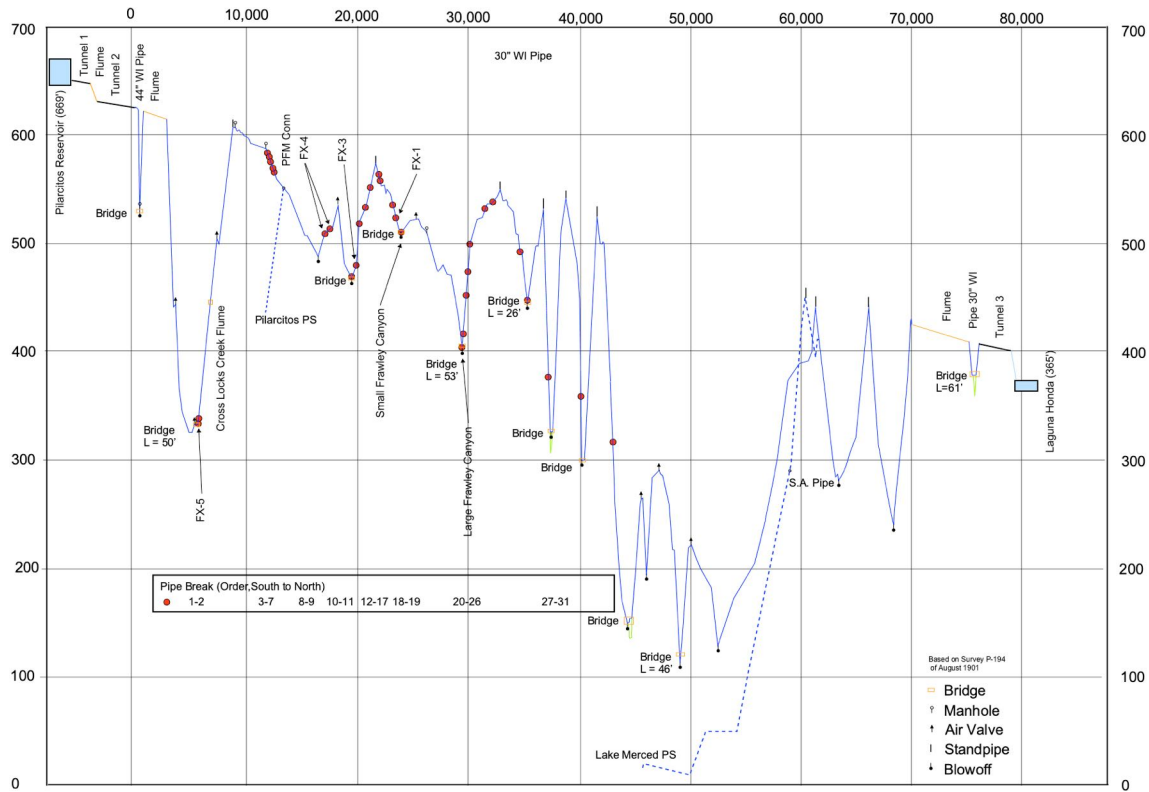
Figure 4-9 shows the approximate locations of the pipe breaks. There are 31 reported pipe breaks, as reported by Schussler (1906). Schussler also reported "between these breaks, there are no doubt many more". To aide in interpretation, each red dot is assigned a number (1 through 31). Some dots represent 1 break; some dots represent multiple breaks (the red dot numbering in Figure 4-9 differs from the site numbering in Figure 3-7). The locations of FX-1 through FX-4 and small and large Frawley Canyons are highlighted by arrows (actual geographic locations should not be scaled from this drawing).

Figure 4-9. Pilarcitos Conduit Profile and Earthquake Breaks (Location of Breaks after Schussler 1906)

Today, we have no photographic evidence of the damage at most of the locations: dots 3-7, 12-17, 21-31. The rate of damage (breaks / km) tapers off as the pipe heads further away from the San Andreas fault (somewhat lower shaking) and at lower elevations (thicker wall and stronger girth joints).

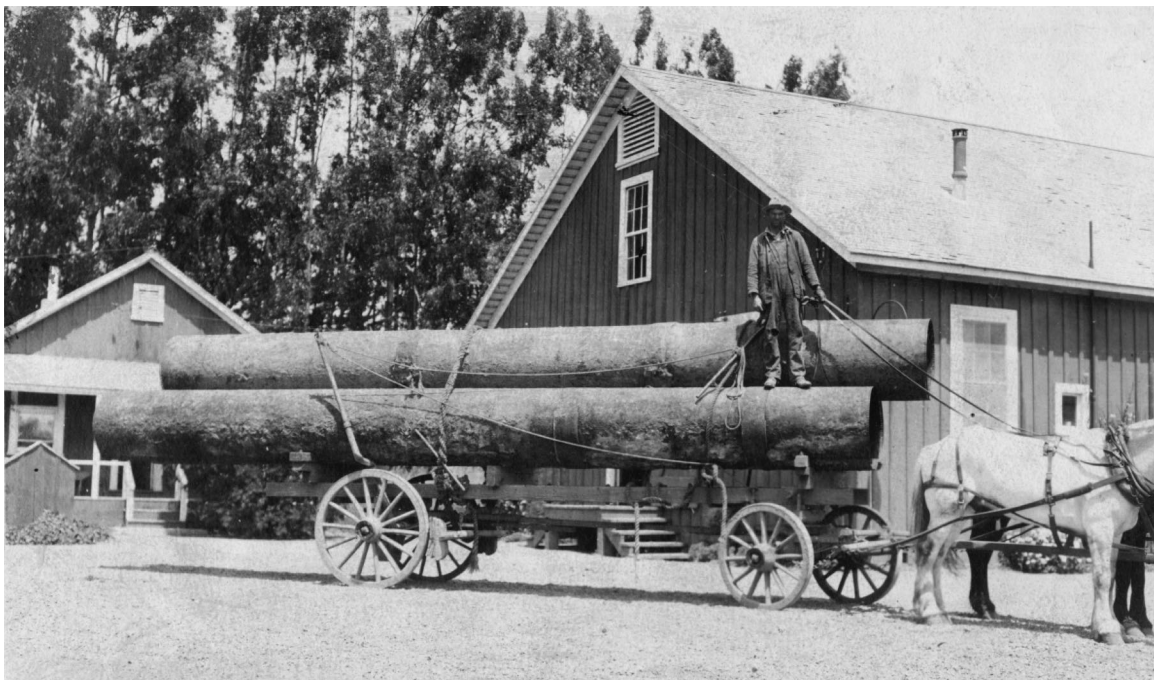
Figure 4-10. Portion of Pilarcitos Pipeline taken up. (Photo: SVWC, May 1913, near Marceau's)

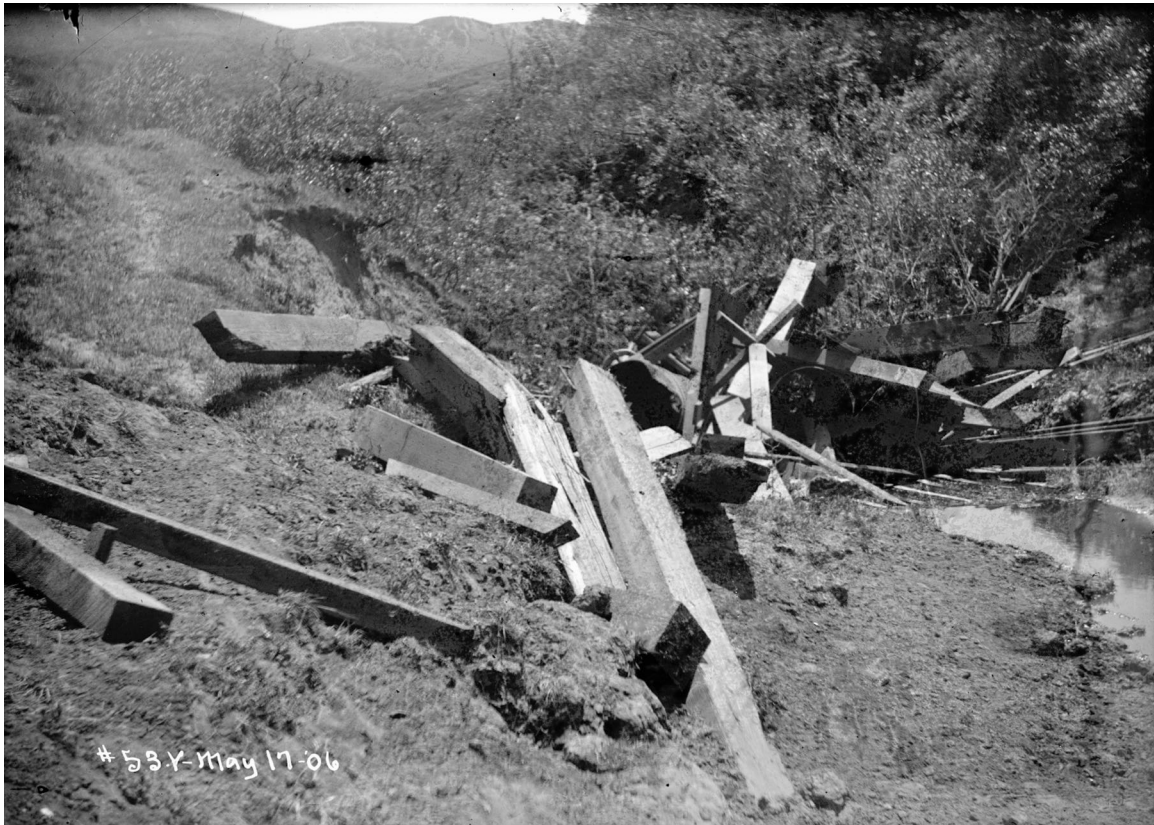
Figure 4.1.1-3 shows the debris from the failed trestle.

Figure 4.1.1-3. Large Frawley Canyon. View downstream, looking easterly Shows debris of the bridge that has been thrown 40' to 50' to the east. (Photo: Schussler 1906, HS10)

In the gully can be observed two sections of pipe. Several 12x12 pieces of lumber show steel "dogs": a $\frac{3}{4}$ " diameter steel bar, L-shaped, about 12" long and 3" wide; these steel bars were used to form connections between heavy lumber.

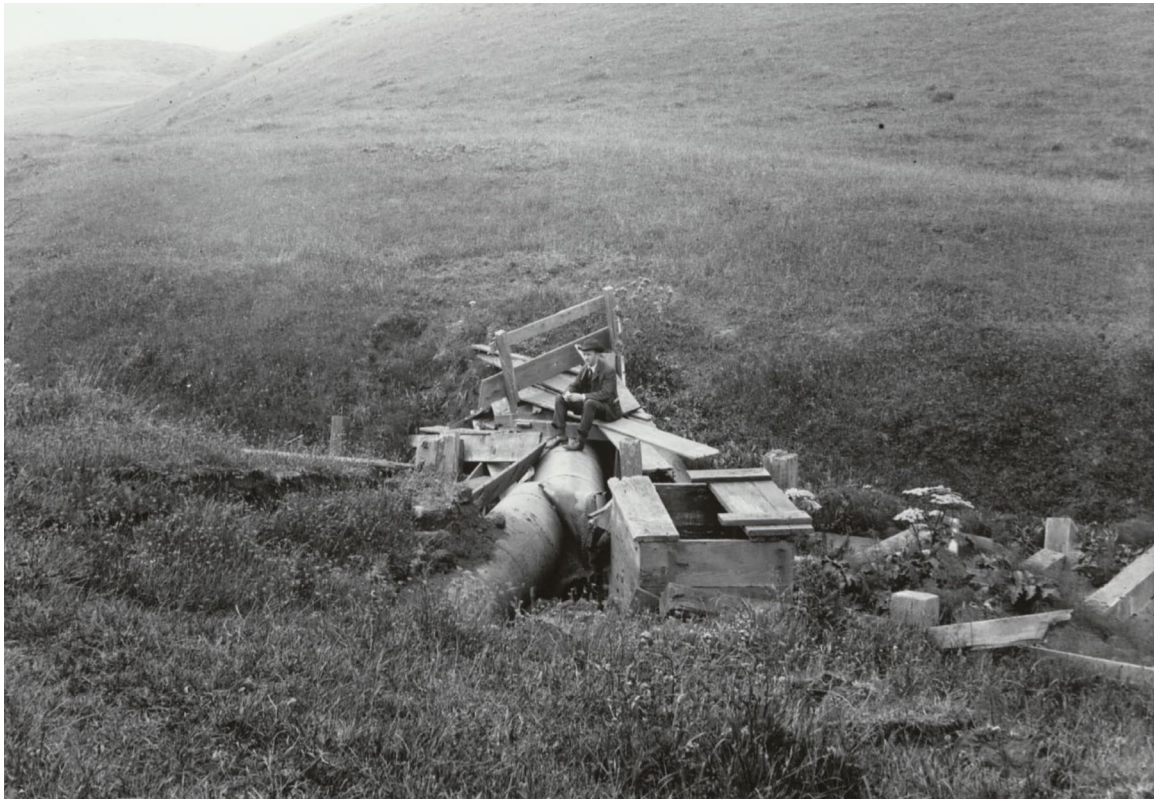
Figure 4.1.2-2. Failure of Pilarcitos 30 inch pipeline. Pipe telescoped and was thrown sideways off the wooden bridge crossing Small Frawley Canyon. View looking northeasterly. (Photo: Harry O. Wood, 1906)

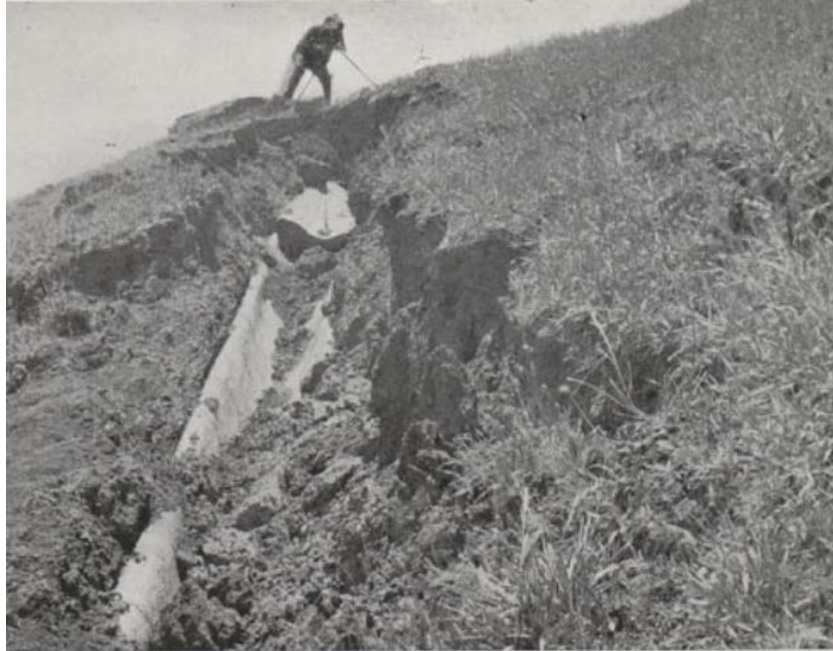
Figure 4.1.3-3. Vacuum Failure of Pilarcitos 30 inch pipeline; same location as 4.1.3-1. South of the failure at FX-1, Small Frawley Canyon (Photo RLH)

Site 3 is about 660 feet south of the FX-1 / Small Frawley Canyon. Figures 4.1.3-1, -2, -3 show the pipe, looking southward. At this location the pipe is $D = 30"$, $t = 0.104"$.

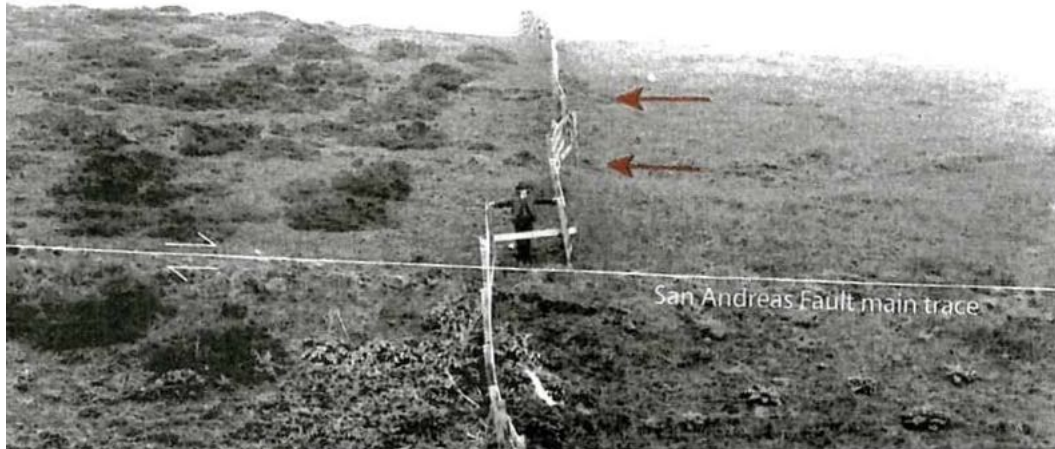
Figure 4.1.4-1. Offset of Fence, looking east, (Photo: Lawson 1908)

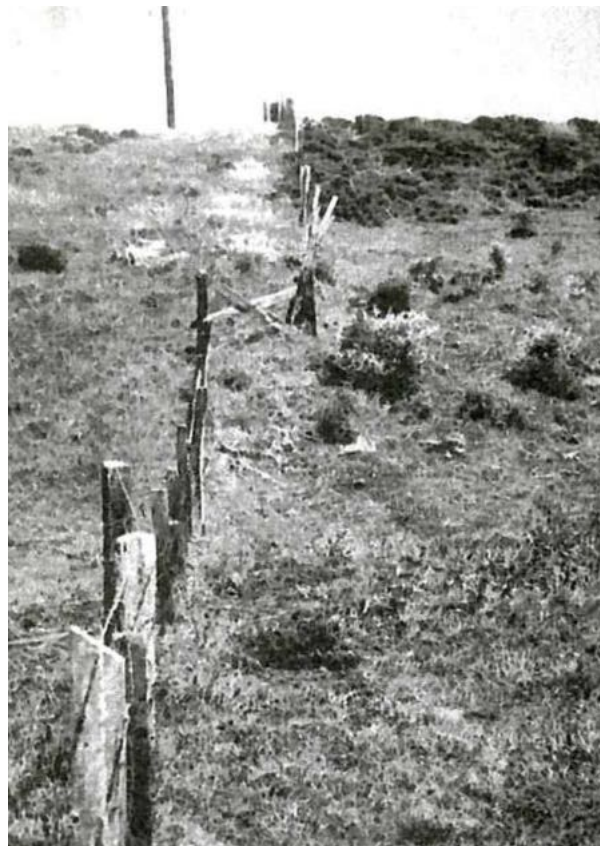
in relation to where the Pilarcitos pipeline is known to have failed in 1906. We suspect that the Pilarcitos pipeline lies buried within the linear swale that lies just west of the offset fence shown in Figure 4.1.4-2. The Pilarcitos pipeline did fail at over 20 locations where the pipe was parallel (but not crossing) the fault, likely reflecting ongoing corrosion, hydrodynamic water pressure pulses as well as ground strain related to high ground velocities.

Figure 4.1.4-2. Offset of Fence. The change of vegetation from 1906 to 1956 reflects changes in land use / grazing conditions over time. (Photo: Bonilla 1956)

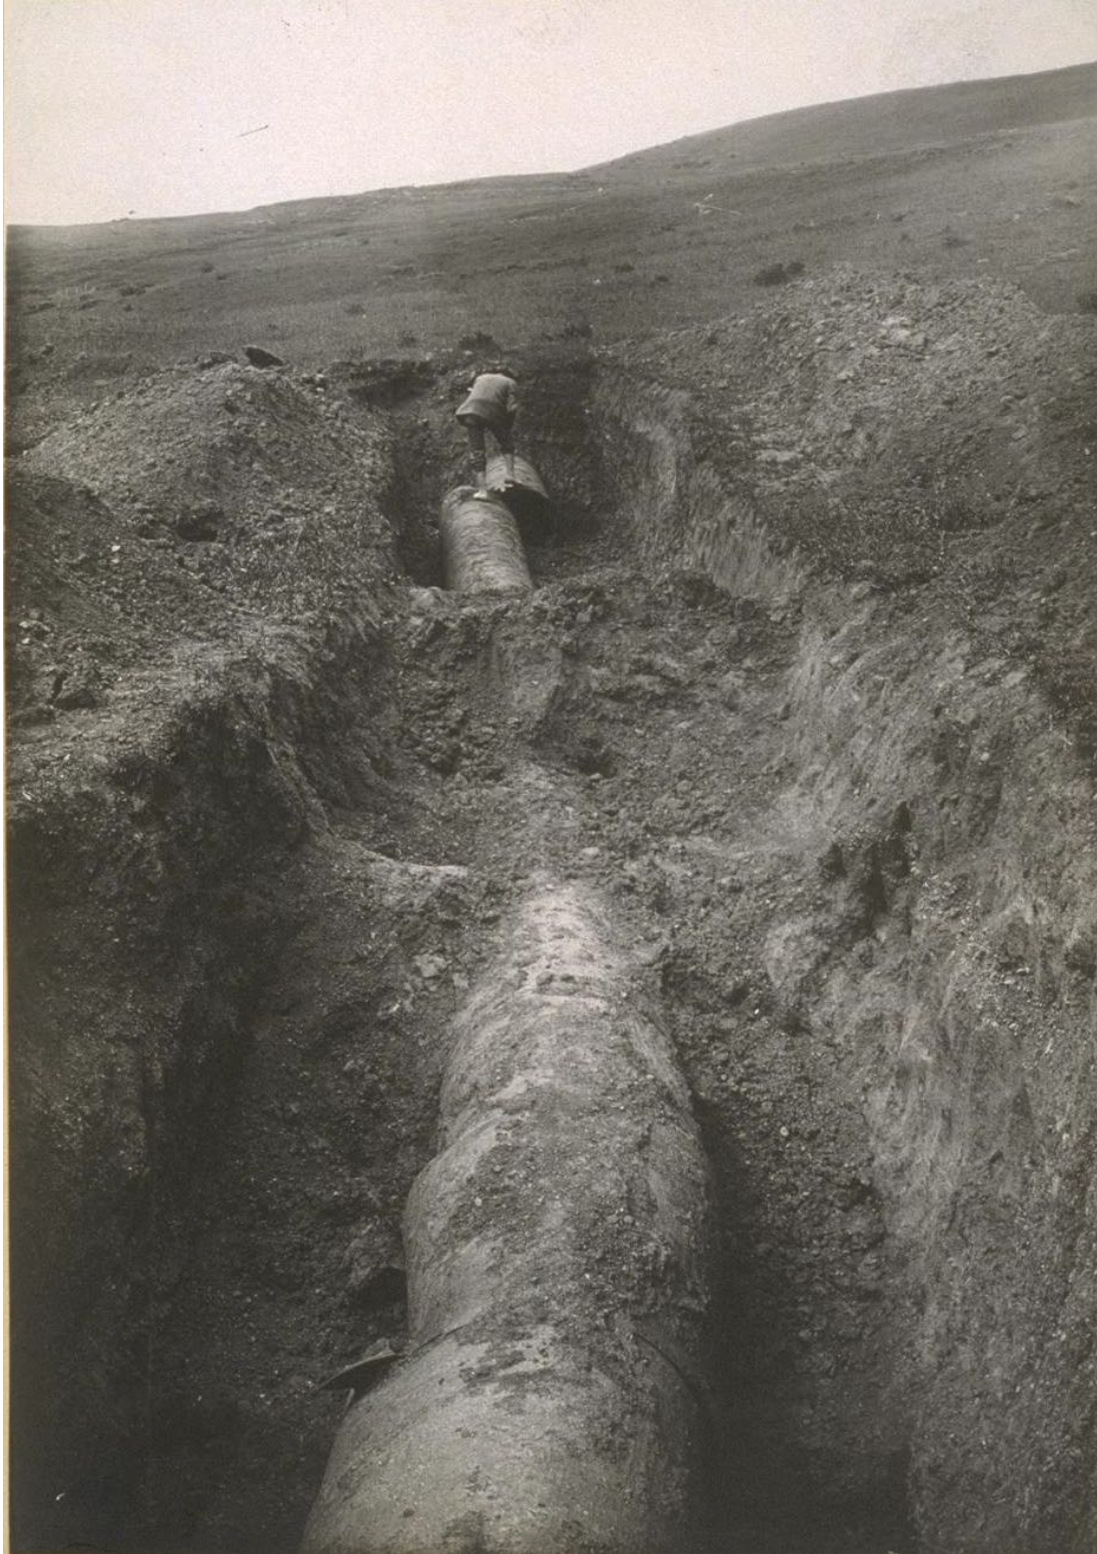
At FX-3, the fault offset furrow covered a considerable width. The pipe was broken at 3 locations over a length of 100 feet (just one red dot is placed at FX-3 in Figure 4-9).

At one place, the pipe was telescoped by 17 inches, at another place and the farthest north, by 41 inches. Combined with Site 7 (also affected by the FX-3 fault offset), the pipe telescoped 58 inches. The minimum amount of right lateral offset along the strike of the fault at FX-3 was about 9.5 feet

Figure 4.1.6-1. FX-3. View North. South end telescoped 21". The north end moved 17" west and telescoped 41". (Photo: Derleth 1907. See Also Schussler 1906 HS2 for similar photo)
