History of the Water Works of San Francisco, Its Performance in the 1906 Earthquake and Aftermath

John M. Eiding and N. Timothy Hall

December 19, 2023

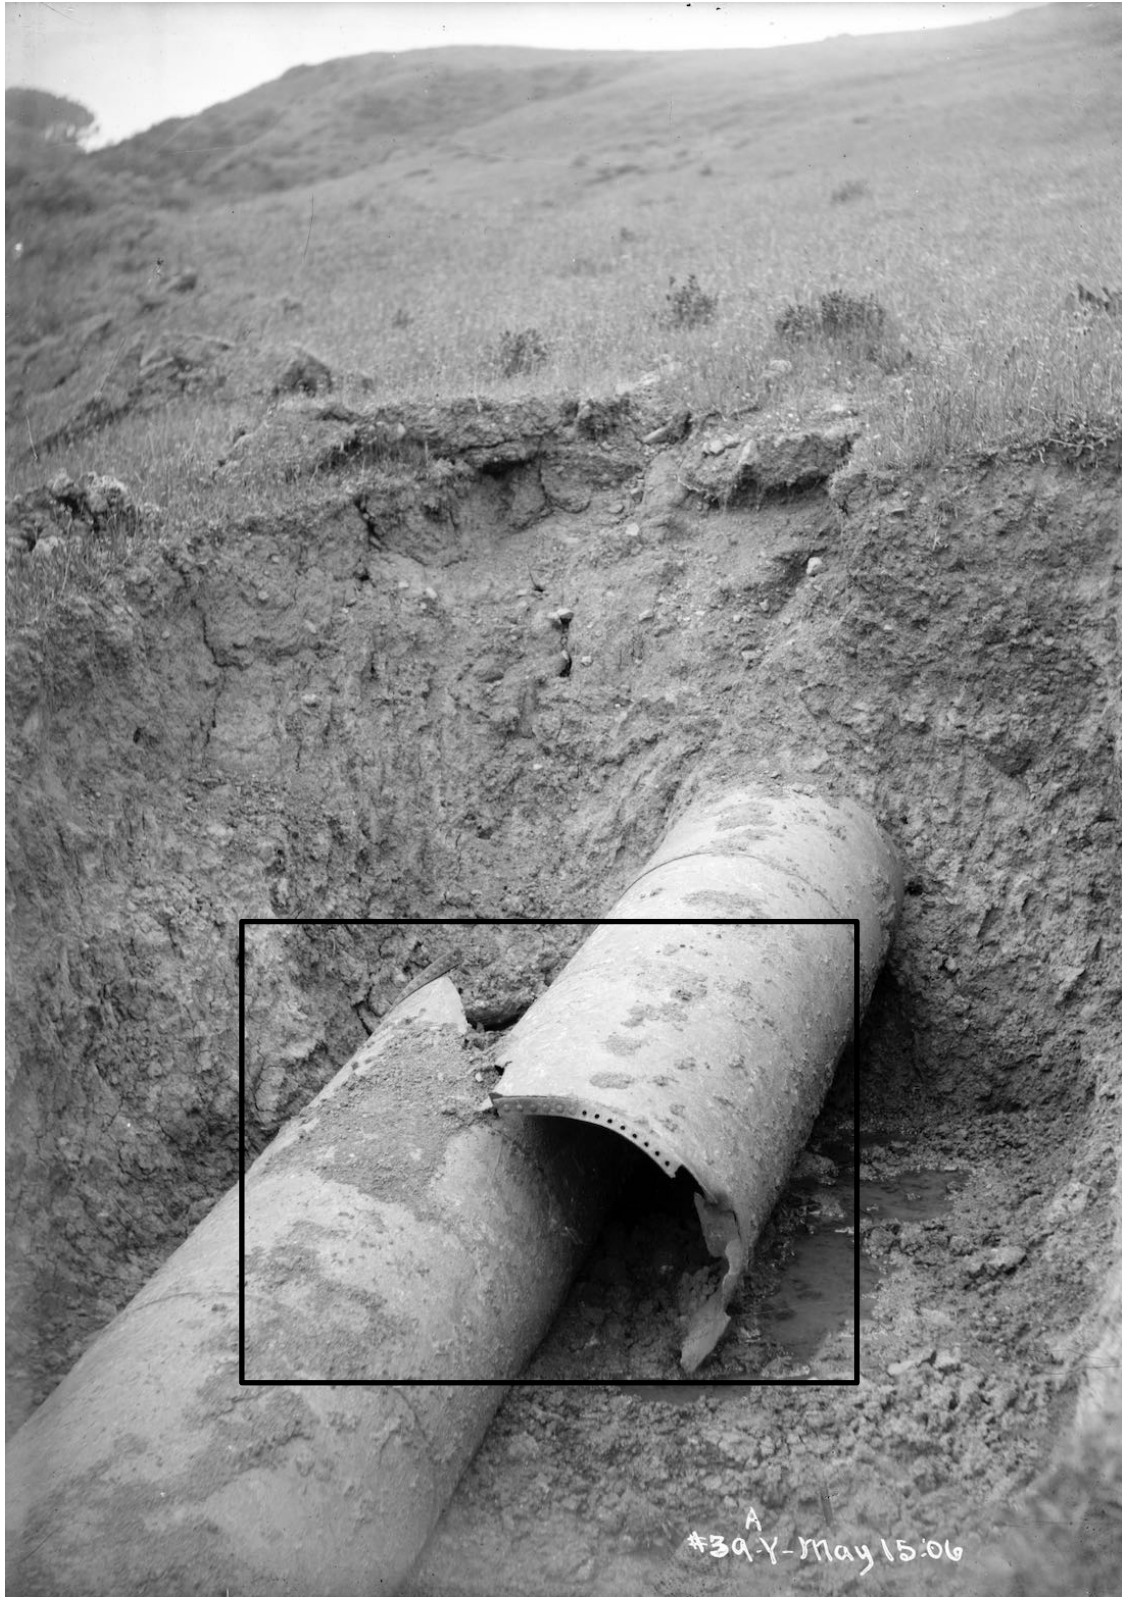
*Figure 4.1.6-2. Detail of north end of fault crossing 3. (Photo: Schussler HS6).
See Figure 4.1.6-3 for closeup of rivets.*

The girth riveted joint is clearly seen in Figure 4.1.6-2, 4.1.6-3. In the foreground of the closeup (Figure 4.1.6-3), 8 rivets are missing, 6 rivet heads remain. In the background is the continuation of the riveted joint. The neat fold in the steel adjacent to the rivets suggests that the inch (or so) at the end of the pipe has been specially prepared to accept rivets, in a manner that might (?) allow overlap of the pipe in the riveted girth connection zone. The visual evidence suggests that the riveted girth joint is much weaker than the main barrel of the pipe. The hole spacing suggest about 80 rivets around the girth joint; circumference about 95 inches. This suggest center-to-center rivet spacing about 1.19 inches, and rivet hole about 0.5 inches. This suggests a rivet cross sectional area of about 0.2 square inches. Allowing $F_u = 50$ ksi, and 80 rivets, the single shear ultimate strength of the joint is $80 \text{ rivets} * 0.2 \text{ sq in} * 50 \text{ ksi} * 1/1.73 = 462 \text{ kips}$. Allowing $D = 30$ " and $t = 0.1875$ ", Area (pipe) = 17.78 sq inches. Allowing $F_u = 50$ ksi, the nominal tensile or compressive strength of the pipe = 889 kips. Nowhere along the length of pipe is there any evidence of pipe wrinkling, which should initiate at about compressive strain $0.175t/R$ (or so), considering the eccentricity of the lap girth joint (about compressive strain $0.6t/R$ if the adjacent pipes are perfectly concentric, which they are not).

The "fold" at the base of the girth rivet line (sharp fold seen in the figure above) gives a clue as to the failure mode. At this offset location, the rivets are being loaded in single shear by net compression in the pipe. The overall eccentricity of the ends of adjacent pipe segments introduces some bending into the pipe. For a rivet to reach yield in single shear, a bending moment of 0.36 kip-inch is applied to the base width ($2\pi R/80$) of the steel fold. Assuming $F_y = 30$ ksi, under pure local bending, the steel fold yields at about 0.06 kip-inches. In other words, the girth joint folds (as observed) at about $1/6^{\text{th}}$ the yield level of the rivet. At other locations, the rivet joint fails in tension, and we do not see the fold. Once folding is initiated, the rivet is loaded in high shear and bending, and many of the rivets break off.

Thus, it is clear that high compression in the pipe induces bending at the girth joint due to eccentricities, and this bending fails the girth joint fold well before the rivets break in direct shear and well before main pipe has initiated wrinkling. In other words, this is not a ductile seismic design.

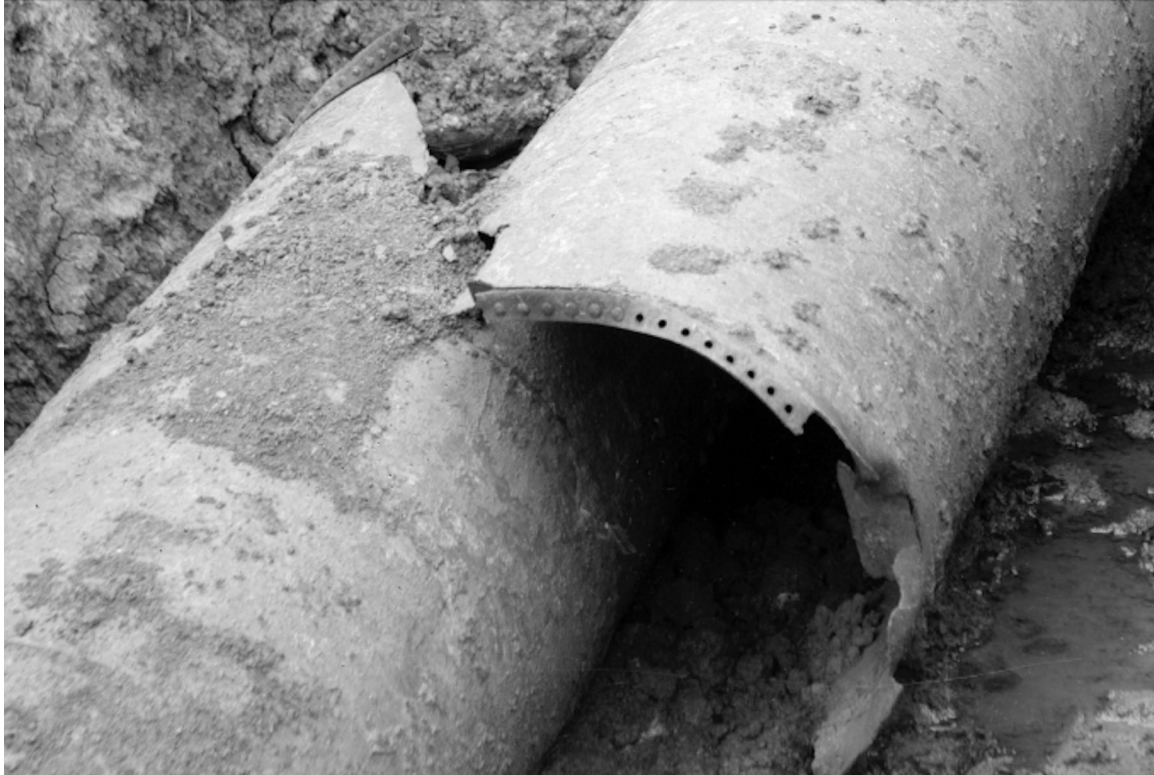
Figure 4.1.6-3. Closeup of Figure 4.1.6-2 showing rivets.

Assuming $t = 0.104$ ", $R = 15$ ", then idealized local wrinkling should occur at elastically computed compressive stress = $29,000 \text{ ksi} * .6 (.104)/15 = -120 \text{ ksi}$, and initiating near a girth joint at elastically computed compressive stress = $29,000 \text{ ksi} * 0.175 * 0.104 / 15 = -35 \text{ ksi}$. As the girth joint will rupture at about half the stress of the main pipe, or perhaps no more than about -15 ksi to -20 ksi in the main barrel of the pipe, one might expect the

compressive failure mode to sometimes be exhibited as local wrinkling. But, local wrinkling was not exhibited at this or any other site.

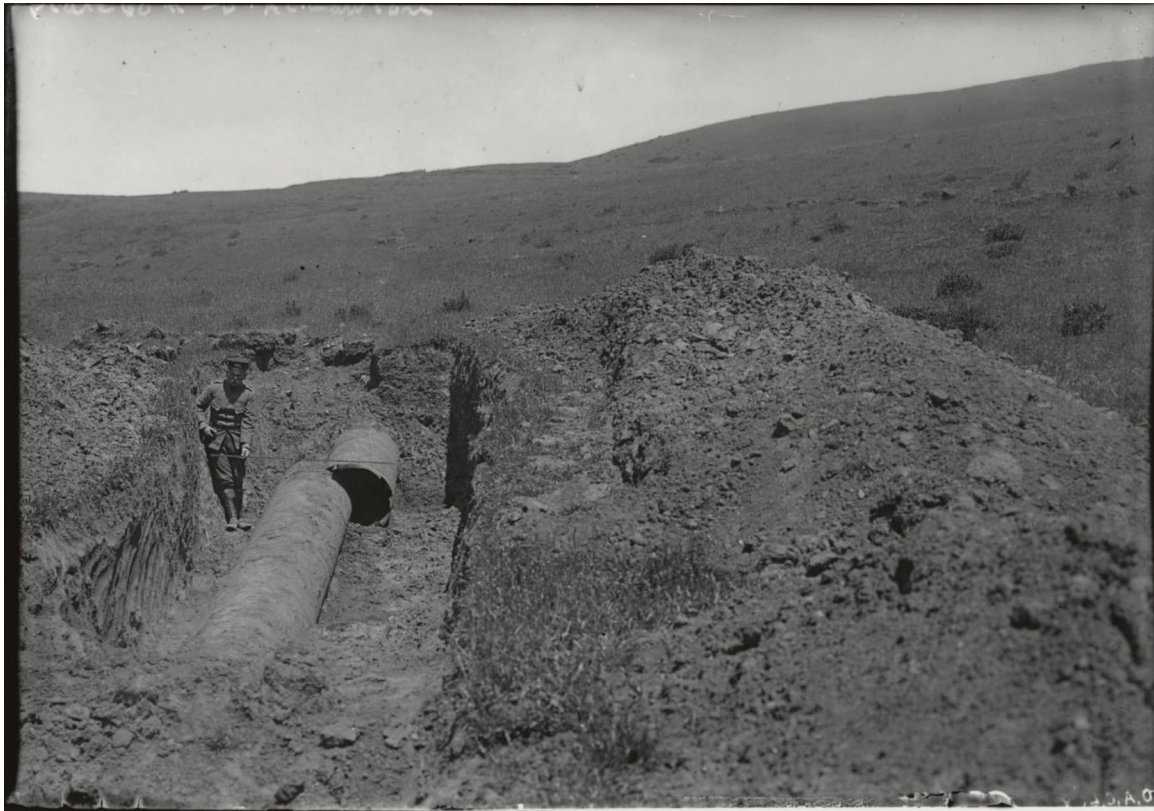
*Figure 4.1.6-4. Crossing FX-3. Failure of Pilarcitos 30 inch pipe.
(Photo: Lawson 1908)*

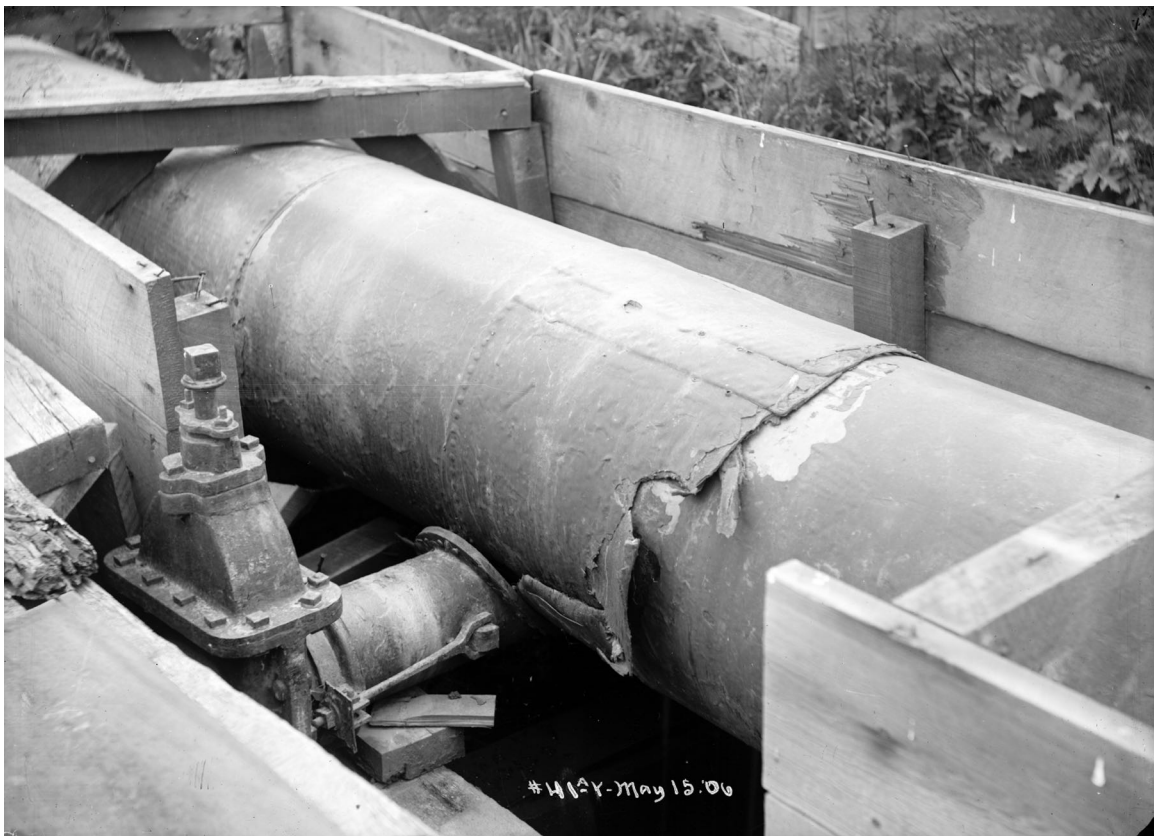
Figure 4.1.7-1 shows a gate valve for a blow off that could be used to drain the pipe into the small creek below. The high compression has sheared the girth riveted joints, and the pipe had telescoped neatly on itself about 58". The two sides of the wood box have twisted, indicated by top level twisted 4x4s that would have been perpendicular to the pipe before the earthquake. The far side (east side) of the wood box has been displaced southerly compared to the west side, suggesting the fault offset may have bisected the wooden box too.

Figure 4.1.7-1. South of FX-3. Pipe has telescoped 58" on the trestle. Just south of Sneath Rancho. Looking northerly. (Photo: Schussler 1906 HS1)

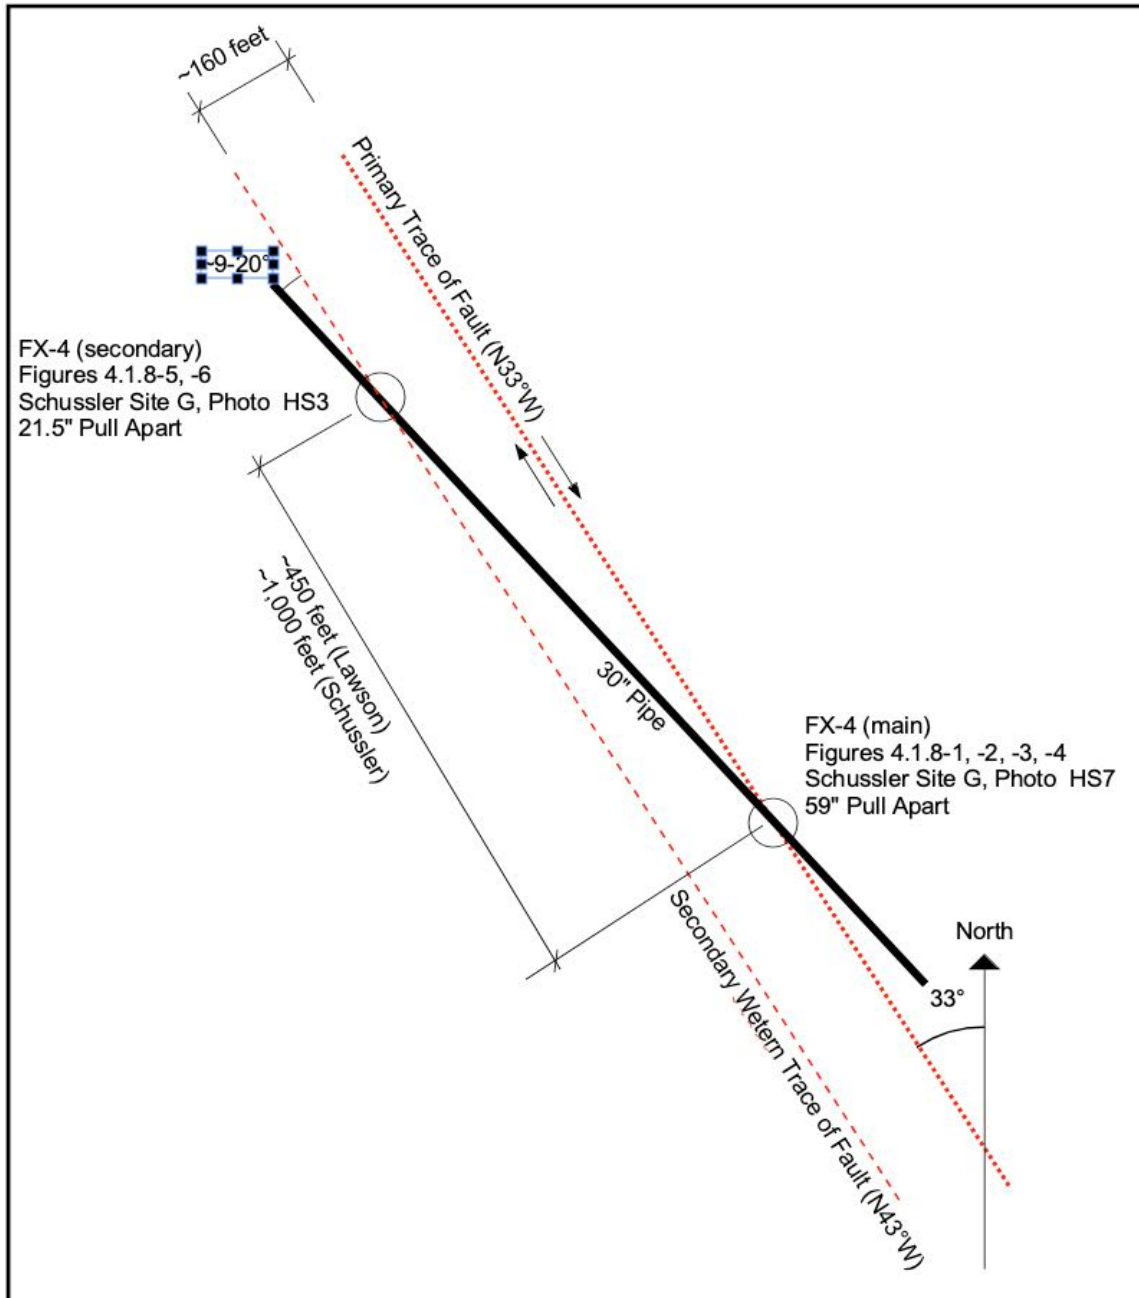
Figure 4.1.8-0. FX-4. Orientation of the Pipe, Fault and Pipe failures at FX-4

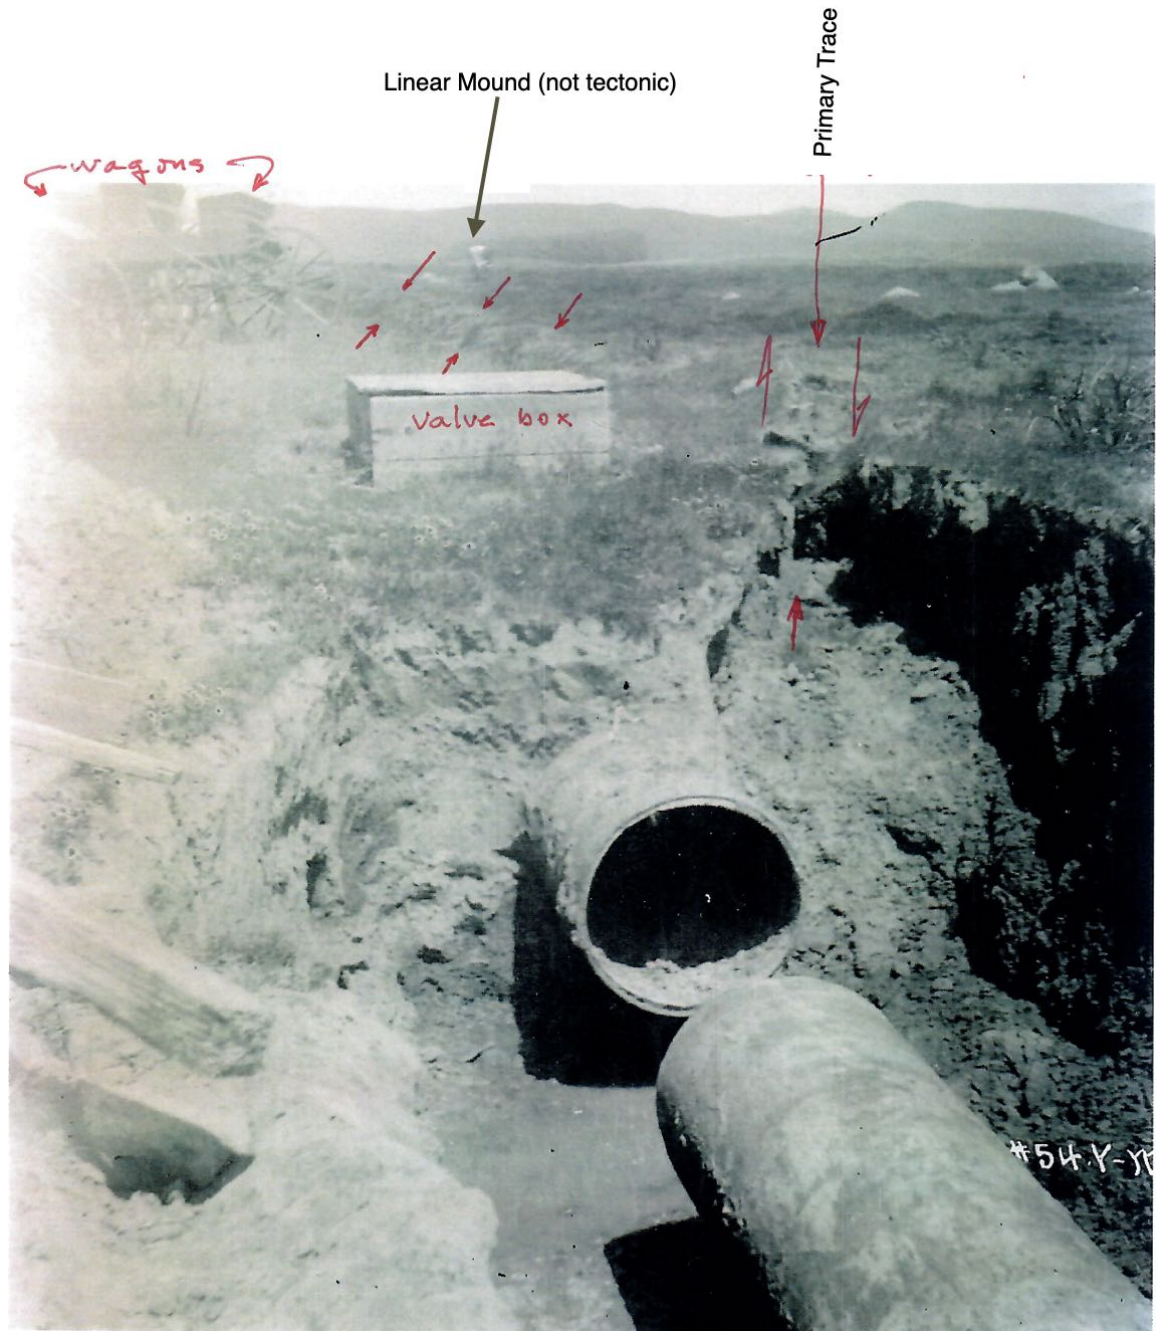
This pipe failure at the primary offset zone reflects that the right lateral offset of the fault put high tension along the longitudinal axis of the pipe, easily overcoming the capacity of the riveted girth joint.

Figure 4.1.8-2. FX-4. Same as 4.1.8-1, with author's notes

Figure 4.1.8-2 suggests that the azimuth of the primary offset is about 10° clockwise from the azimuth of the pipe. If we take $\tan(\text{angle}) = 4''/59''$, then the angle = 4° ; but visually the angle between the pipe and fault (see Figure 4.1.8-2) is more than 4° . If one combines the nearby fence offset (Site 9), we see that at this site, there was a main trace (offset about 7 feet) and a secondary west trace (offset about 3 feet), measured about 160 feet to the west. Assuming the original pipe is set straight through this zone, then the azimuth of the pipe to the fault was about $9^\circ = \tan^{-1}(160/1000)$. with 90° being perpendicular, and 1° nearly parallel). The lumber on the left is remnants of the damaged

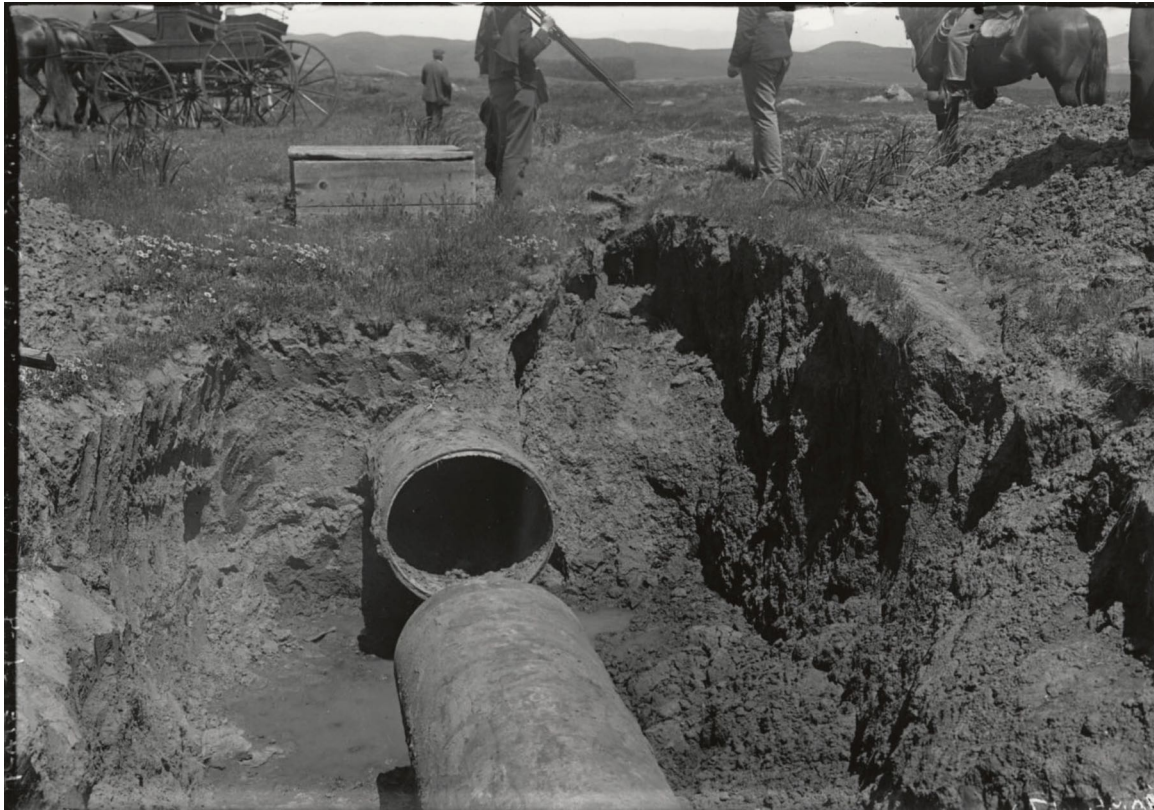
Figure 4.1.8-3. FX-4. Failure of Pilarcitos 30 inch pipeline. At north end of San Andreas Reservoir (Photo: Lawson 1908)

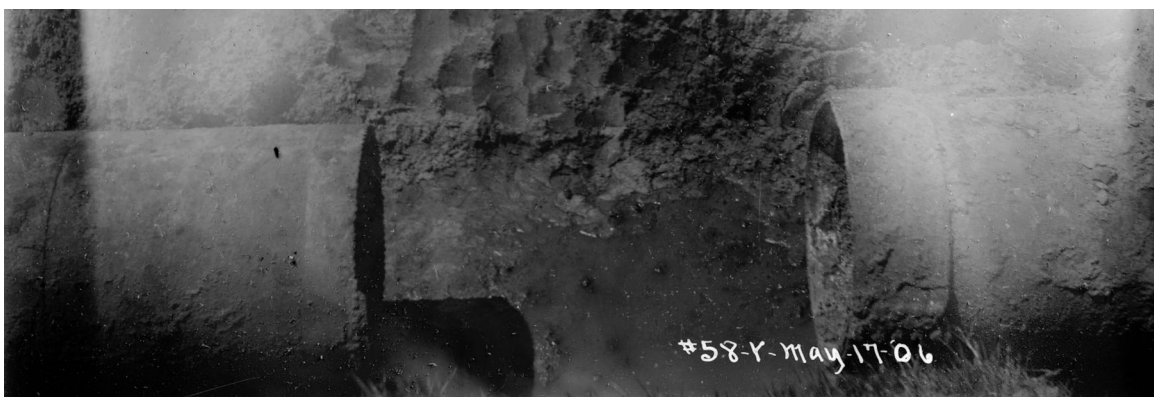
Figure 4.18-4 shows the torn joint at the primary offset location. The serrated edges of an edge-distance failure is seen on the left joint.

Figure 4.1.8-4. Crossing 4. Failure of Pilarcitos 30 inch pipeline. Looking Westerly (Photo: SVWC 1906)

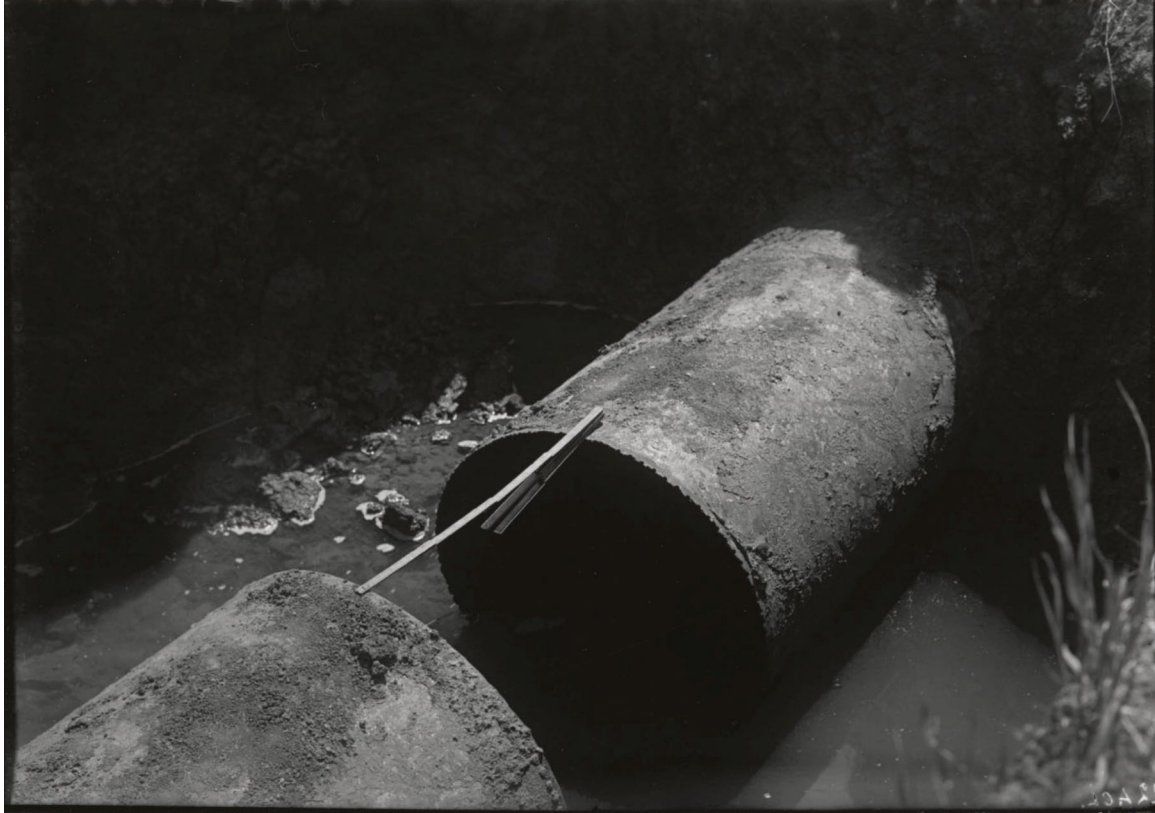
Figure 4.1.8-6. Failure of Pilarcitos 30 inch pipe at FX-4. Pull Apart ~ 21.5 inches. Note edge distance tears at rivets. (Photo credit: Lawson, 1908)

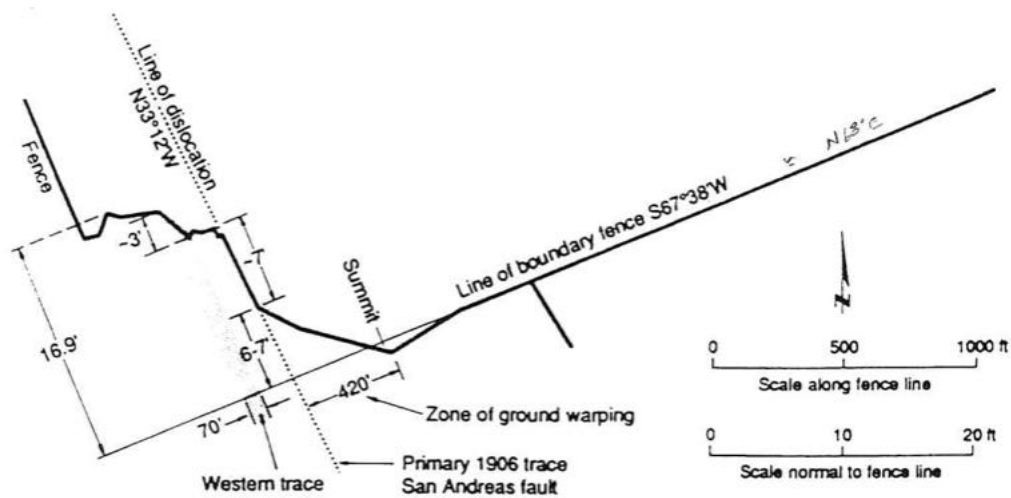
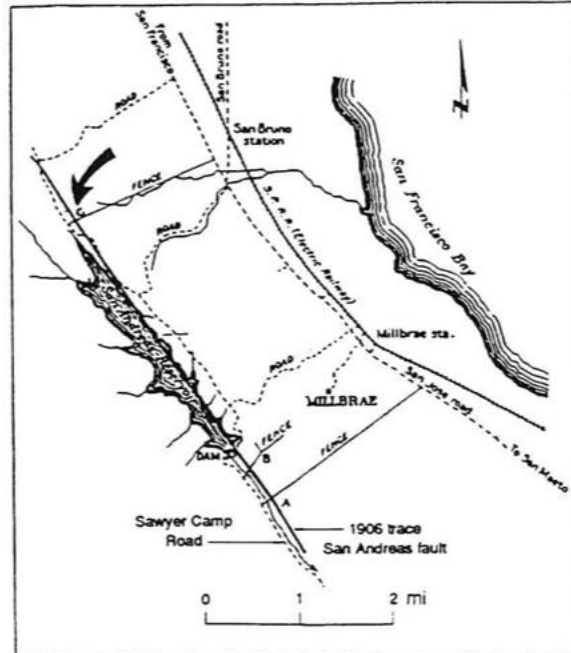
The total surveyed offset of the fence is 16'-9", composed of 7' of slip at the primary trace, 3' of slip corresponding to the western secondary trace, and 6'-7" of offset over an eastern zone (extending about 725' east of the primary slip) that we call the zone of warping.

Figure 4.1.9-3. Details of Fence C

Figures 4.1.9-2, -3 (Site 9) show the location of Fence C (modified from Lawson 1908 Figure 30). The configuration of Fence C following the 1906 earthquake shows a western trace, the primary trace, and an eastern zone of ground warping.

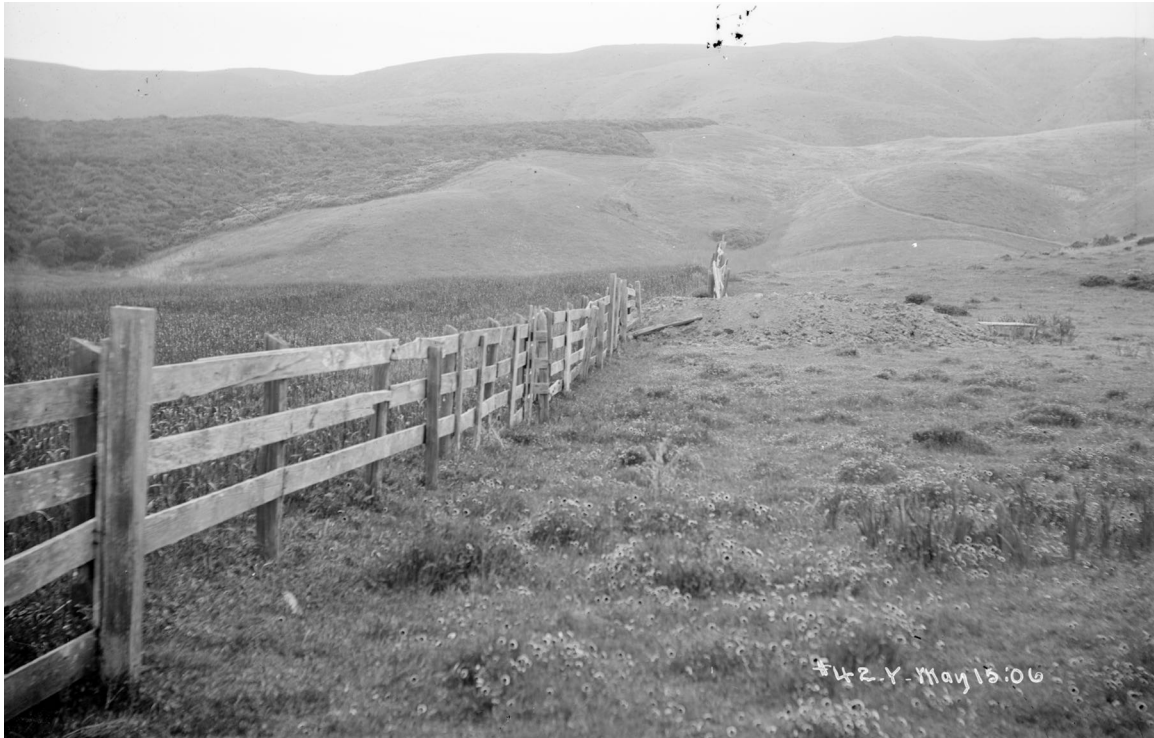
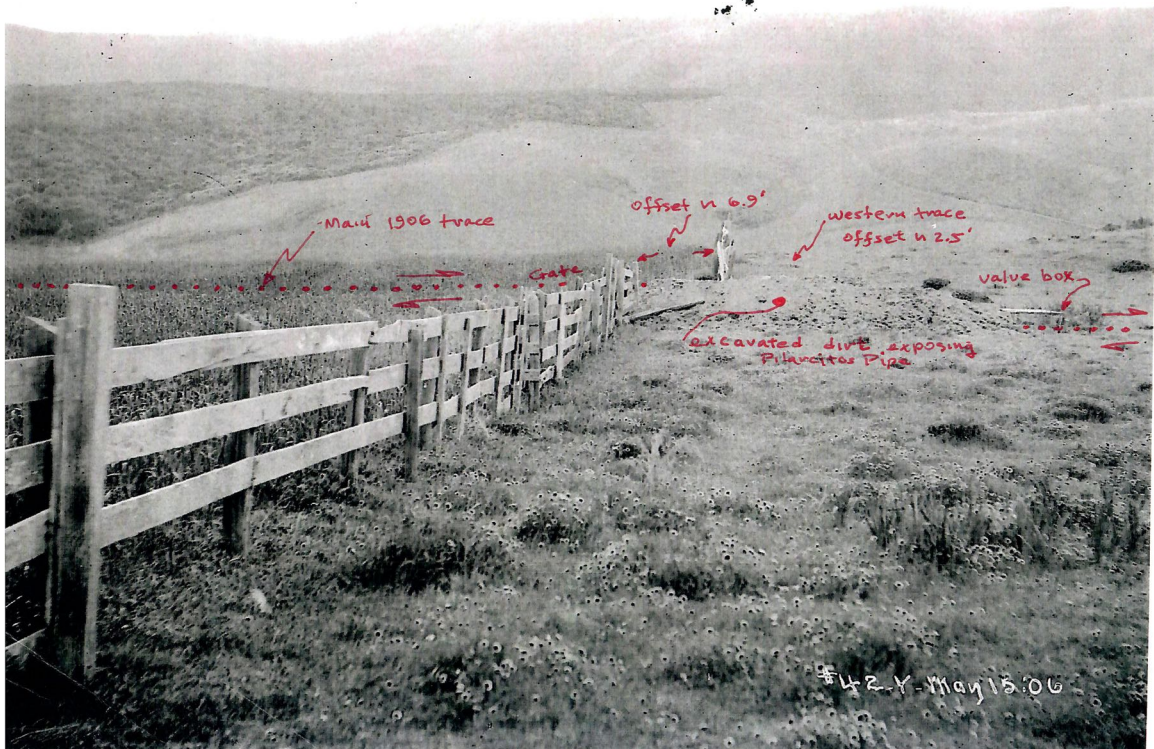
Figures 4.1.9-4 and 4.1.9-5 show Fence C, looking towards the southwest (same photo, without and with author's notes). Figure 4.1.9-6 shows a close up of the fence offset, including 5 members of the May 17 1906 investigation team seen in Figure 0-1. At the center of the photos can be seen the primary fault offset of 6.9 feet in the fence (corresponds to the ~7' offset in Figure 4.1.9-3). In the distance, marked "western trace, offset ~2.5' " (corresponds to the ~3' offset in Figure 4.1.9-3). At the right side of the photo is marked "valve box", which corresponds to the wooden box seen in Figures 4.1.8-1, -2, -3. Just to the left of "valve box" is marked "excavated dirt exposing Pilarcitos Pipe" (corresponds to the direct piled up on the right side of Figures 4.1.8-1, -2, -3).

Figure 4.1.9-4. Fence C, View to Southwest (Photo: SVWC 1906)

Figure 4.1.9-5. Fence C, View to Southwest (Photo: Schussler 1906) with Author's notes

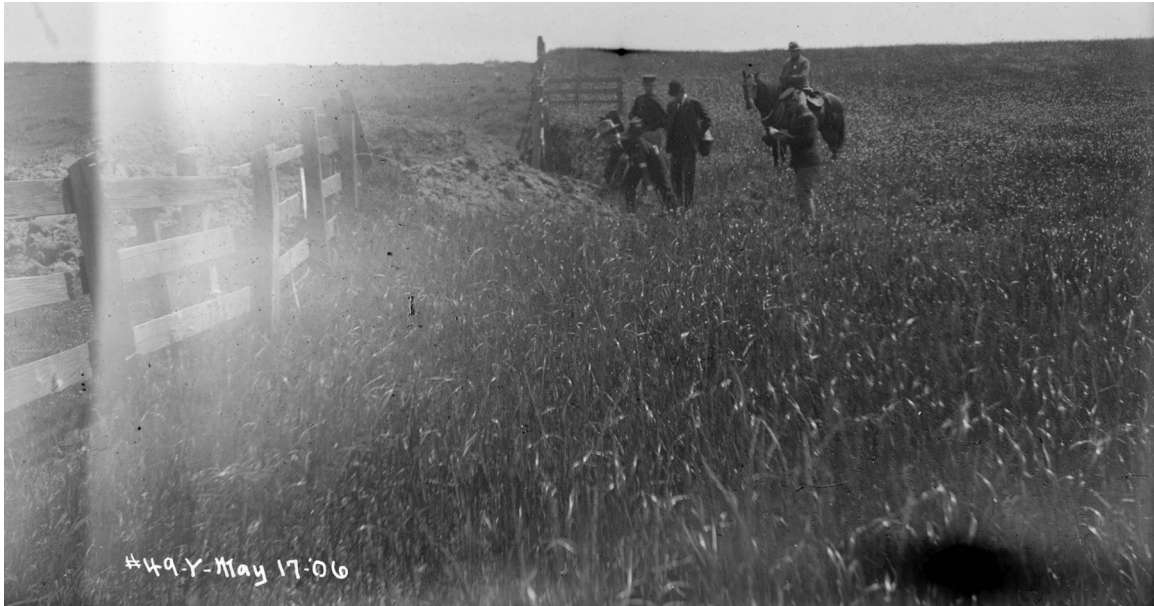
Figure 4.1.9-6 Fence C, View to Southwest (Photo: SVWC 1906)

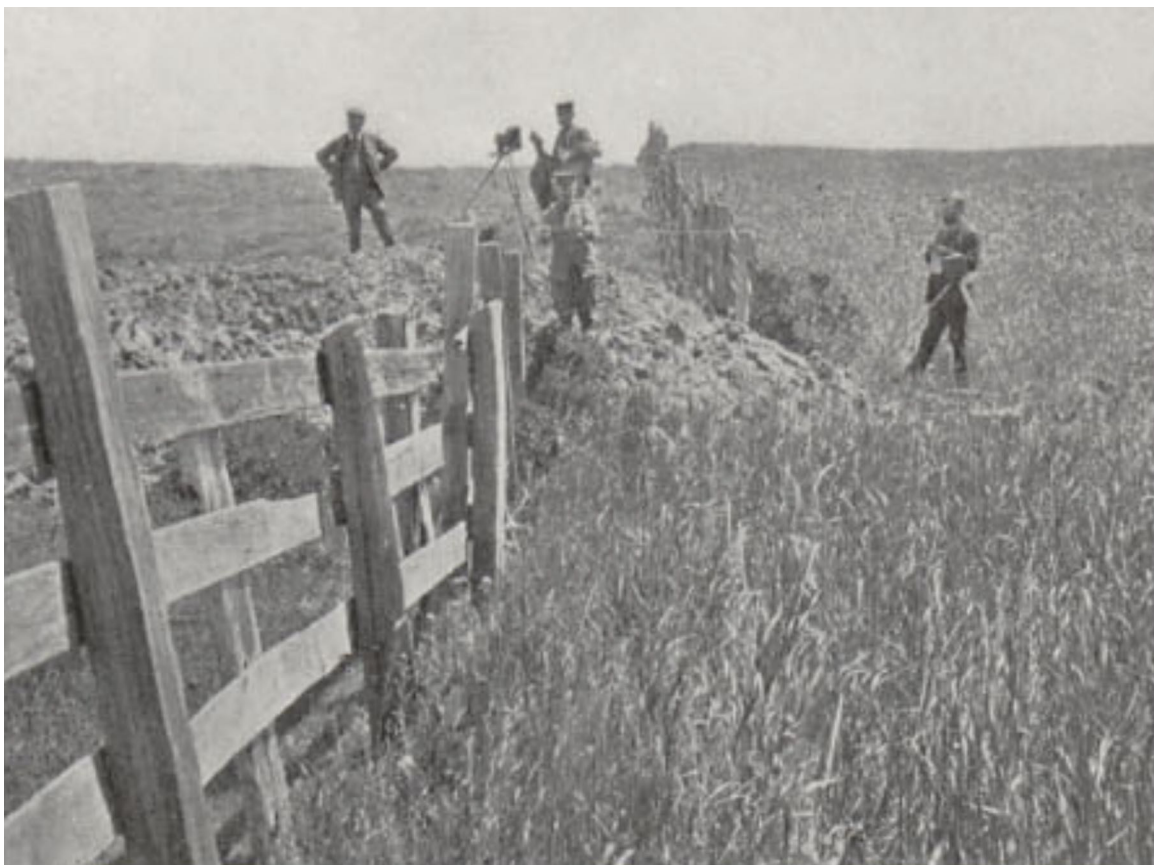
Figure 4.1.9-7 Fence C, View to Southwest (Photo: Lawson 1908 Plate 60C)

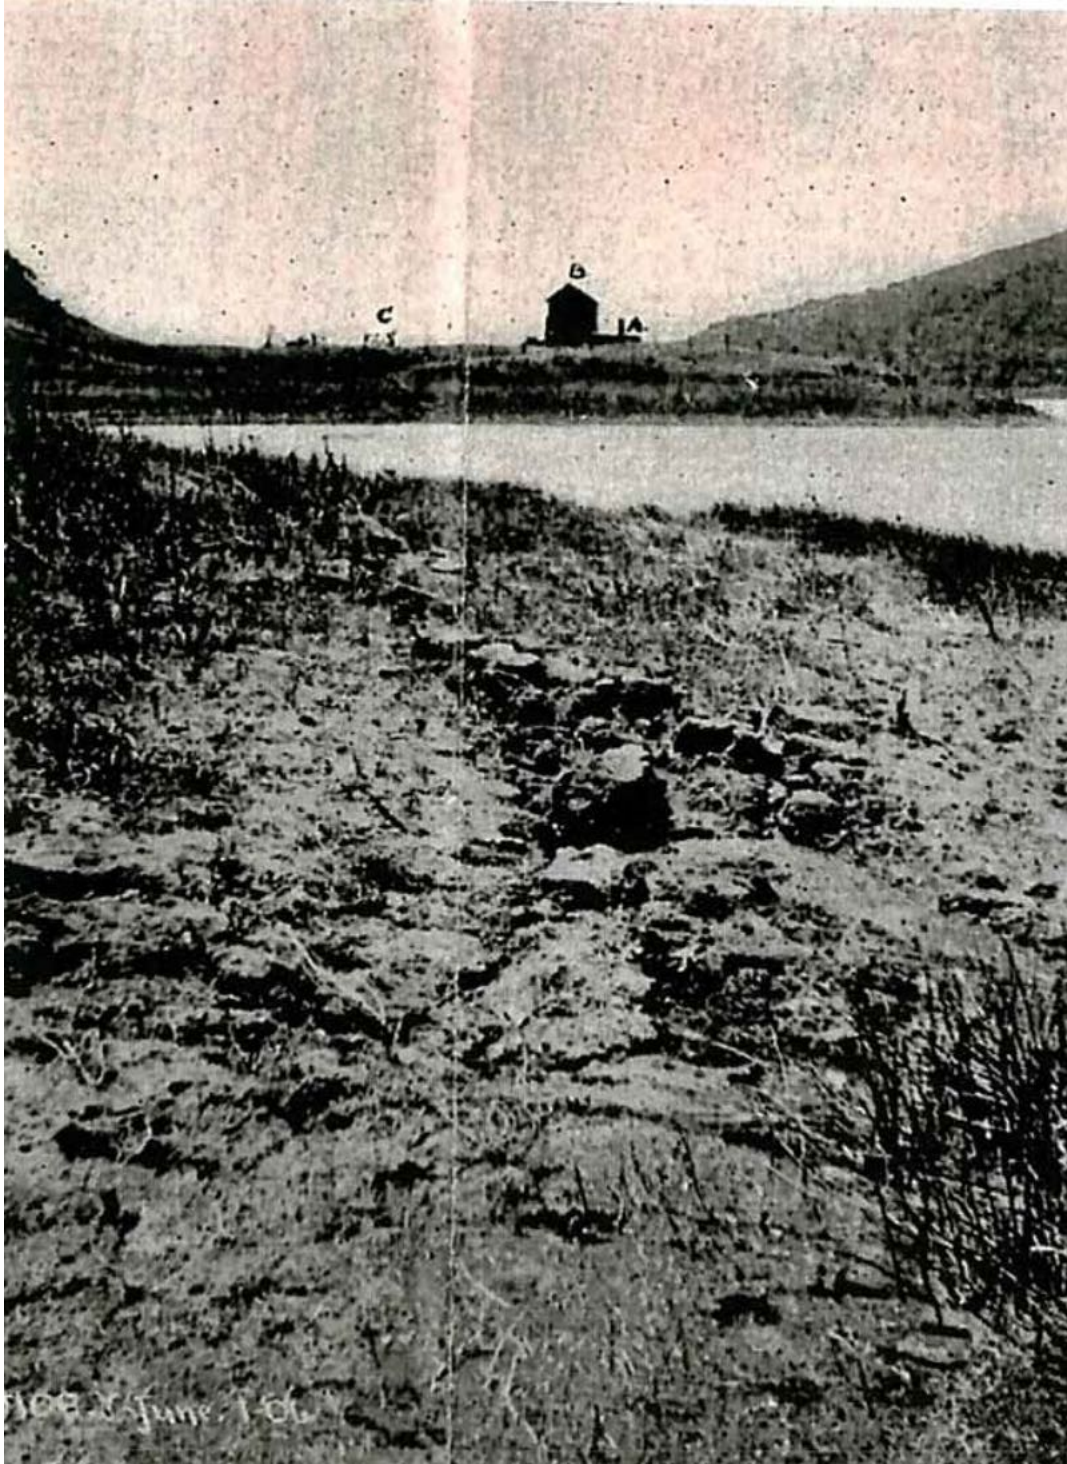
Figure 4.1.10-2 shows the ground surface rupture of the San Andras fault, as of June 1906. The photo direction is south-southwesterly, and the three structures A, B, C in Figure 4.1.10-1 can be seen in the background. The primary ground rupture extends along the uphill eastern side of structure A.

Figure 4.1.10-2. San Andreas Fault Rupture (Credit Schussler)

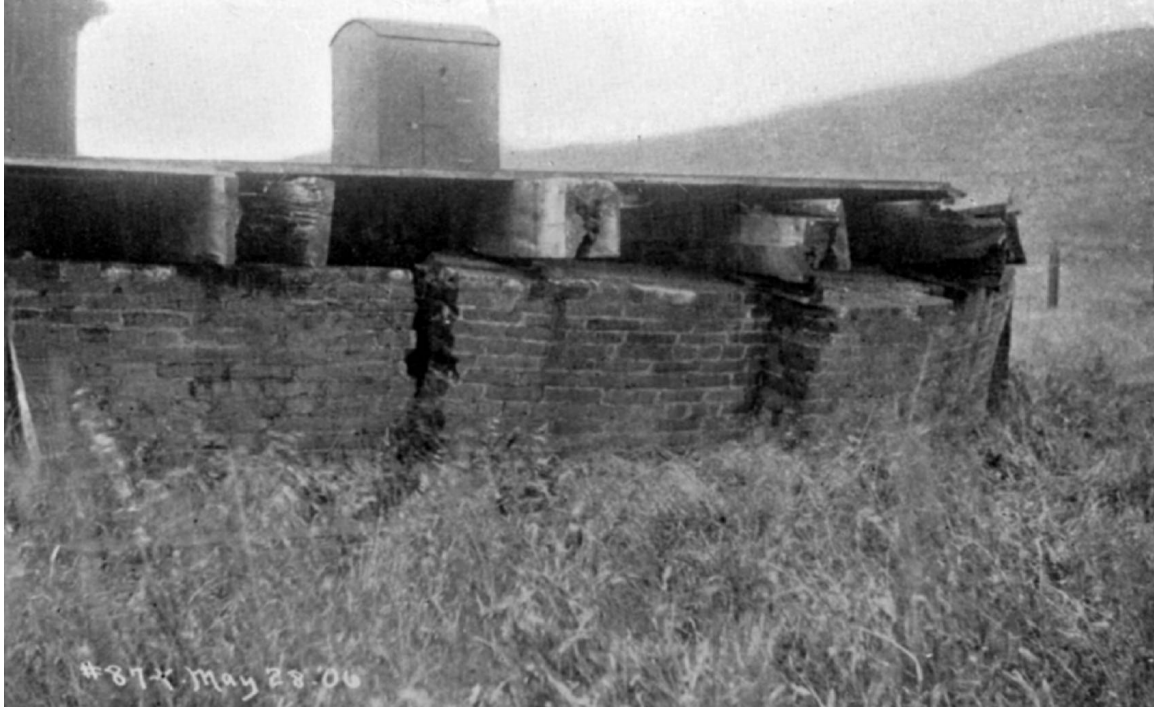
Immediately after the 1906 earthquake, water from the lake went undisturbed into the Bald Hill outlet tunnel, even though there was major damage to the brick forebay. Figure 4.1.10-6 shows the damage to the brick forebay at the ground level. The cracks in the brick walls correspond to the breaks in the brickwork seen in Figure 4.1.10-5.

Figure 4.1.10-6. Brick forebay damage (view looking northerly)

- Schussler (1906) noted that "The brick tunnel, connecting the concrete gate-well and the main San Andreas Bald Hill tunnel, was somewhat damaged by the earthquake, but not so as to interfere with the flow of water through the same... the fissure will be easily closed by cement grouting".

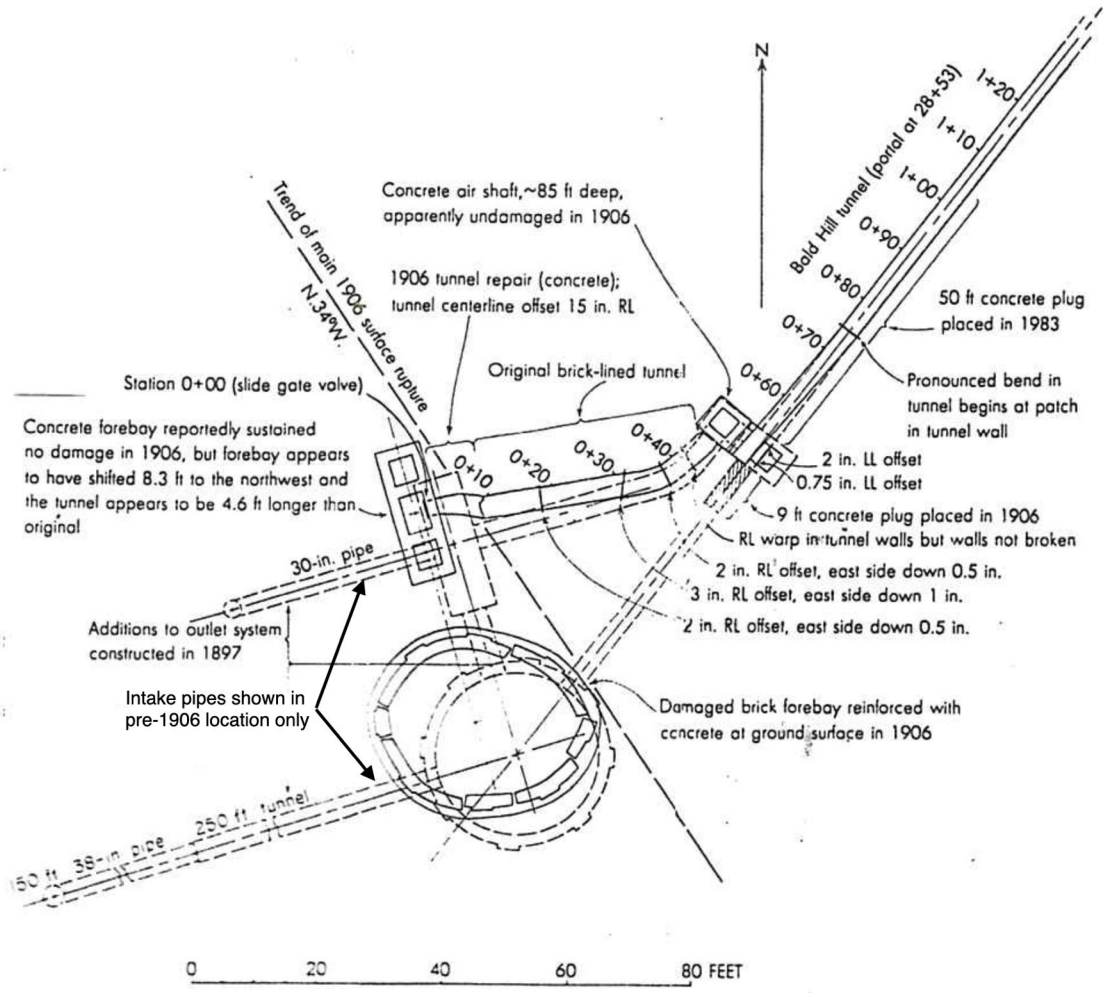
- Figure 4.1.10-7 documents the findings in 1983. At about station 0+75 along the Bald Hill tunnel, there was a repair made; and a concrete ring was placed around the damaged brick shaft.

- About half way through the Bald Hill tunnel, the tunnel was damaged and squeezed. Hall hypothesized that the tunnel traversed a zone of squeezing clayey soils within the Franciscan bedrock. At this location, there is no mapped surface trace of the Serra fault; but that fault is inclined, and thus this zone may (?) correspond to a shear zone associated with the Serra fault (this is speculative).

Figure 4.1.10-7. Survey of Outlet Works, 1983 (adapted from Pampeyan 1983)

Soon thereafter the second 1983 inspection, the SFPUC pumped concrete into the shaft and west end of the Bald Hill tunnel. As of 2023, the tunnel is now plugged, and further investigation of the 1906 damage from the interior of the Bald Tunnel is no longer feasible.

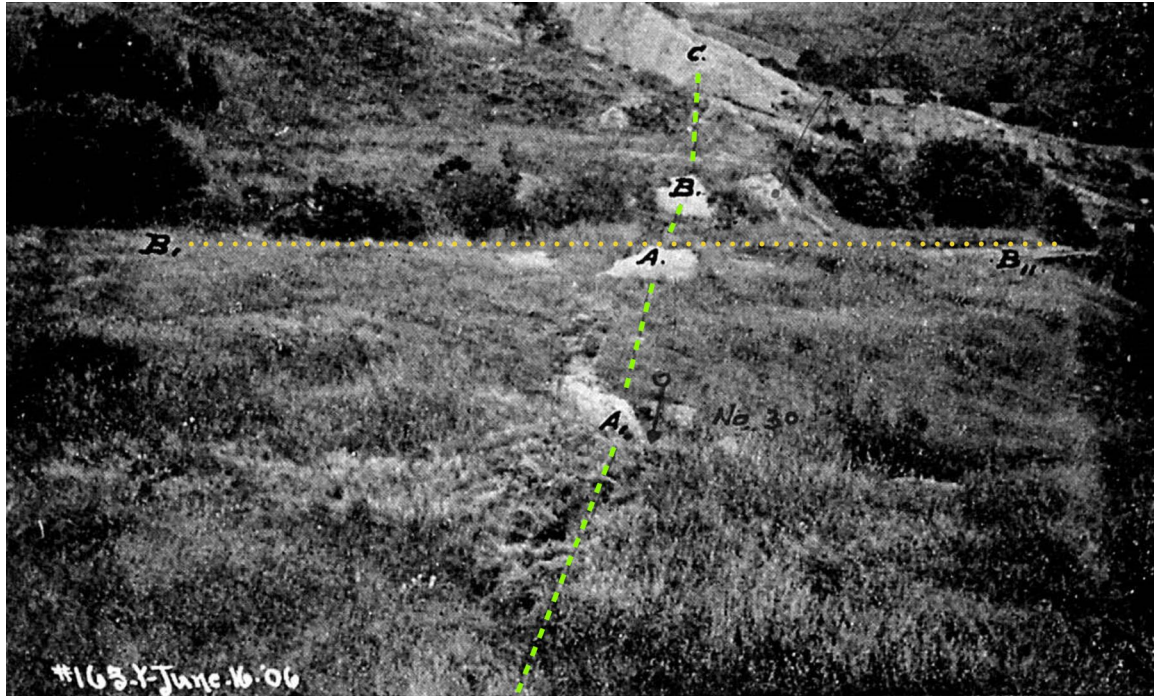
In Figure 4.1.11-6, the fault trace follows points A₁-A-B-C, and the brick wastewater tunnel and wood flume (see Site 12) traverse the fault, roughly from points B₁ (left side of photo) to B₁₁ (right side of photo) (dotted line). The photo is taken from near the top the dam, just west of the Locks Creek (Stone Dam) flume, and looking southeasterly.

Figure 4.1.11-6. San Andreas Fault Track (Yellow dashed line through $A_1 - A - B - C$). Dotted line $B_1 - B_{11}$ is the alignment of the buried wastewater tunnel outlet. Looking Southeasterly
(Credit: Schussler 1906)

Schussler not only sketched the area of intersection between the main zone of faulting and the dam's crest, but also photographed it as well (Figures 4.1.11-6, -7). These photos show the fault's typical expression as a series of north-trending, left-stepping en echelon ground cracks, which here have well developed north-facing scarps. In Figure 4.1.11-6, between Points A and B is the brick wastewater tunnel, which was dislocated by right lateral (see Site 12 for details).
