History of the Water Works of San Francisco, Its Performance in the 1906 Earthquake and Aftermath

John M. Eiding and N. Timothy Hall

December 19, 2023

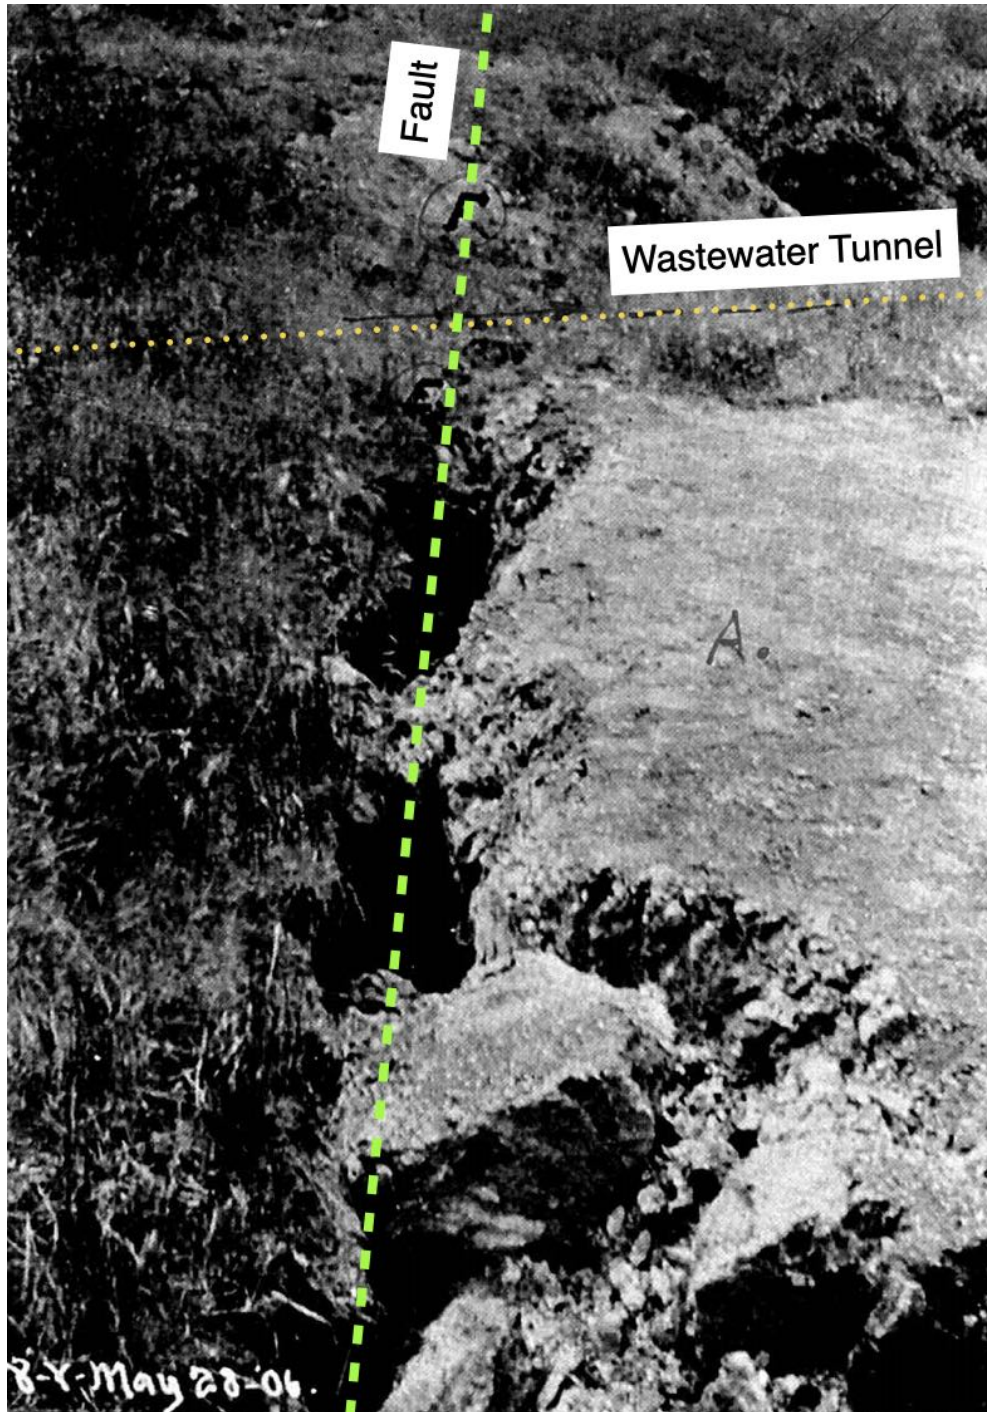
In Figure 4.1.11-7, the Brick Wastewater Tunnel and Wood Flume (Site 12) traverse the fault (green dotted line). Point "A" in Figure 4.1.11-7 corresponds to point "A" in Figure 4.1.11-6. The fault rupture path is indicated by the yellow dashed line, The photo is taken from the downstream face of the dam, west of the Locks Creek flume, and looking southeasterly.

*Figure 4.1.11-7. Closeup of San Andreas Fault Trace Looking Southeasterly
(Credit: Schussler 1906)*

Schussler not only sketched the area of intersection between the main zone of faulting and the dam's crest, but also photographed it as well (Figures 4.1.11-6, -7). These photos show the fault's typical expression as a series of north-trending, left-stepping en echelon ground cracks, which here have well developed north-facing scarps. In Figure 4.1.11-6, between Points A and B is the brick wastewater tunnel, which was dislocated by right lateral (see Site 12 for details).

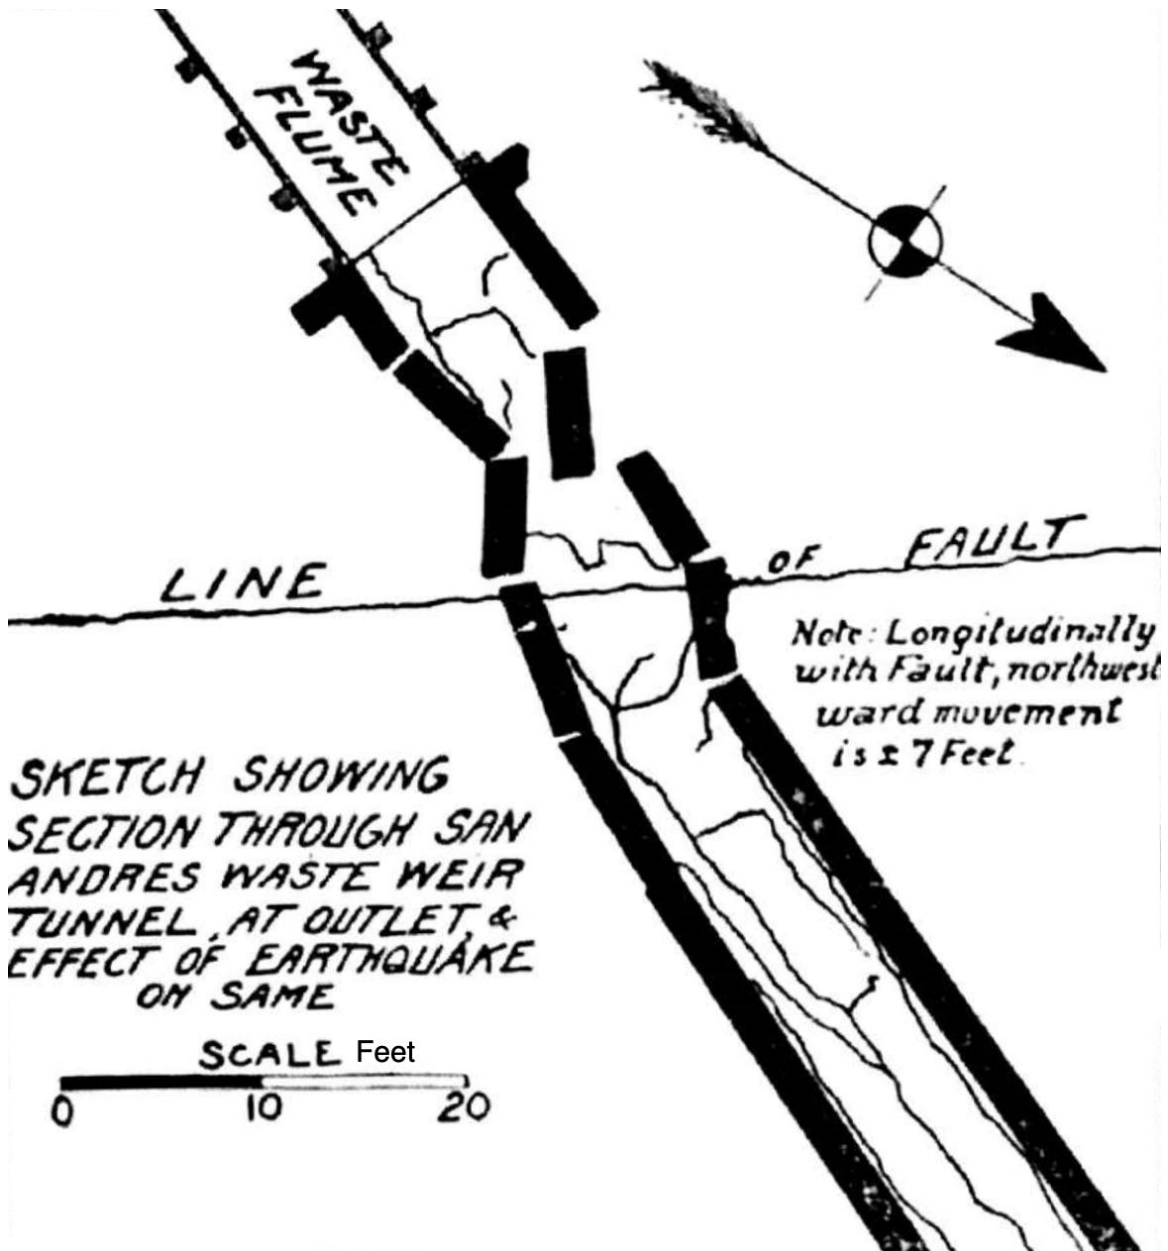
Figure 4.1.12-1. Line of Fault Through Wastewater Tunnel

The main tunnel was several feet wide, and built with four layers of cement and brick both of good quality. When the fault slipped, cracking occurred equally across both brick and mortar, i.e., the bricks did not pull away from the mortar, see Figure 4.1.12-2. Lawson (1908, p. 100) reported that the tunnel was "stove in and smashed in pieces for a distance of about 28 feet" and was offset about 5 feet. Schussler also made a map of the tunnel cracks and estimated that right slip across the fault here was ~ 7 feet (see Figure 4.1.12-1). Schussler also photographed the brick tunnel and the wooded flume:

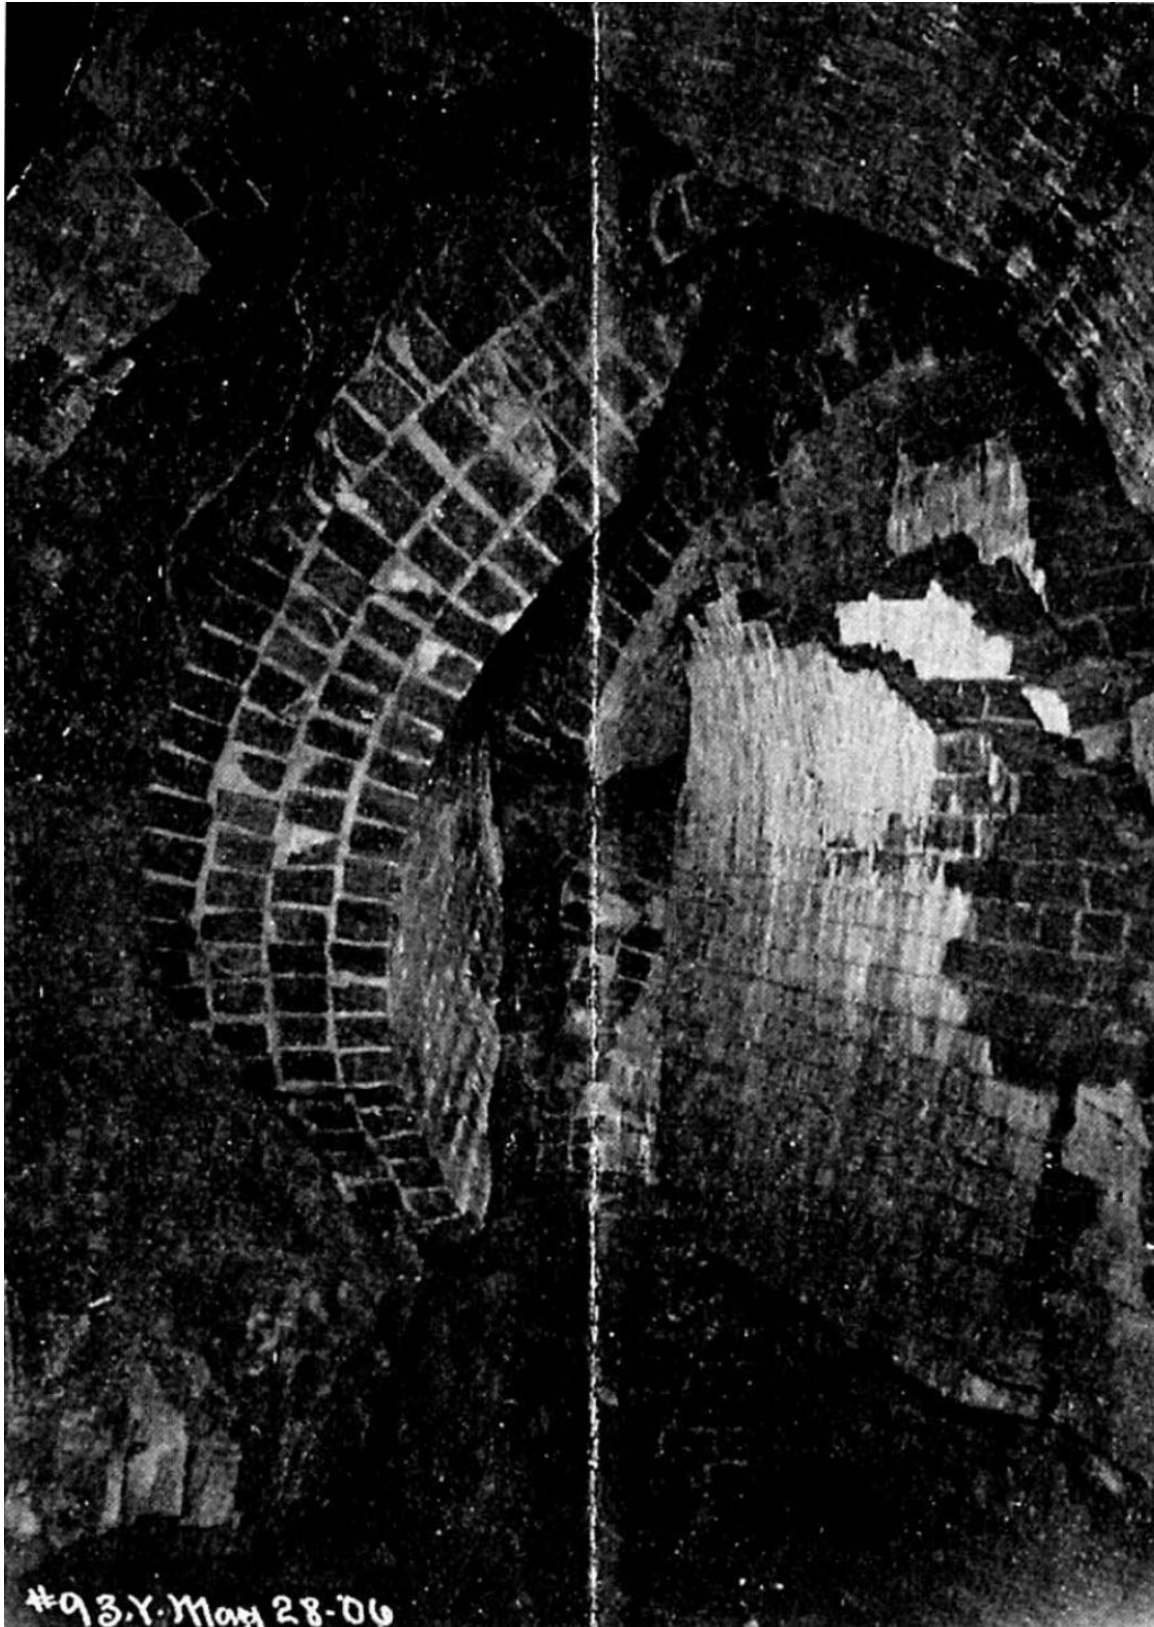
- Figure 4.1.12-2. Shows damaged wastewater brick tunnel.
- Figure 4.1.12-3. Shows damaged wastewater brick tunnel.
- Figure 4.1.12-4. Shows the interior of the damaged wastewater wood flume, looking southwesterly.

Figure 4.1.12-2. Wastewater Tunnel looking northerly (photo: Schussler 1906)

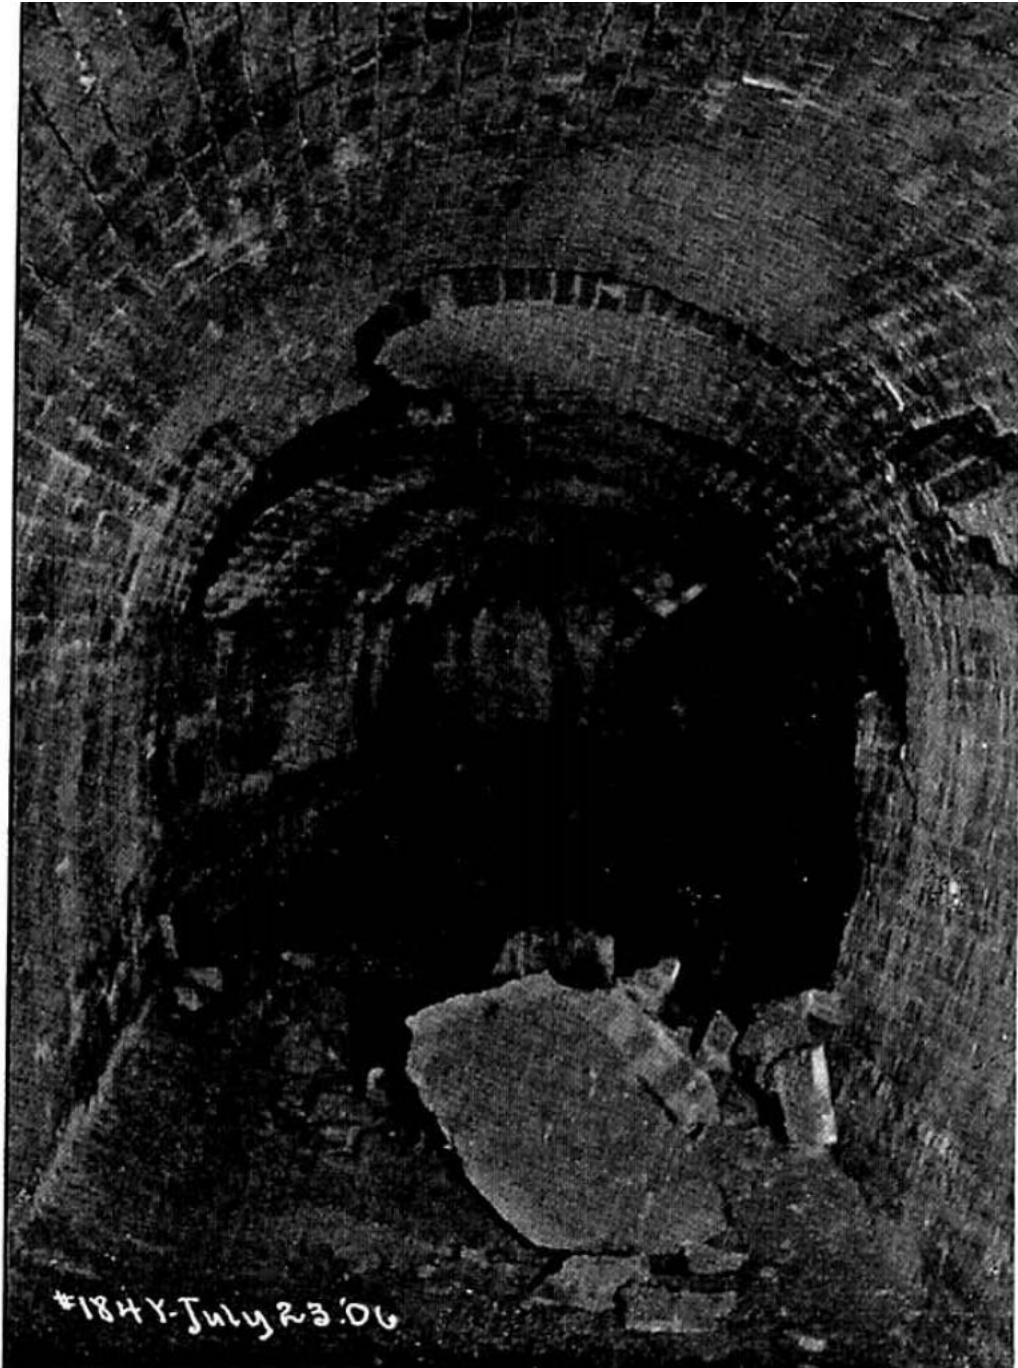
Figure 4.1.12-3. Wastewater Tunnel looking southerly (photo: Schussler 1906)

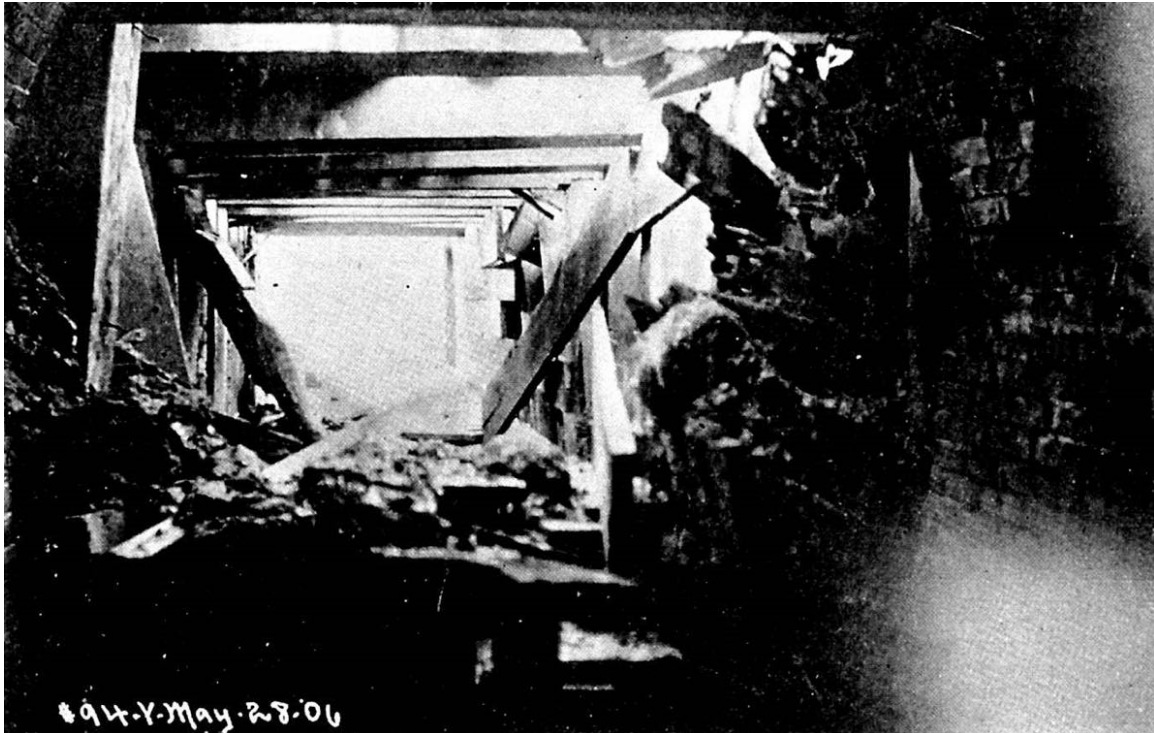
Figures 4.1.12-4, -5 show many $\sim 1 \times 8$ (possibly $\sim 2 \times 10$) lumber planks resting on the floor of the tunnel. The evidence suggests that these planks were lightly nailed to the interior of the 12x12s to form a fairly smooth interior surface for when the tunnel was flooded. More than 90 percent of these nailed connections failed, allowing this lumber to fall to the floor (a few connections staying intact, with a couple of planks now diagonally resting in the damaged flume).

- Hypothesis 1. Primary offset traversed nearby through the brick tunnel. The distortion of the brick tunnel may have imposed high forces onto the wood structure, leading to its demise. This is suggested by the rupture of the first horizontal 12x12 beam nearest the brick tunnel.
- Hypothesis 2. There was high active soil loading onto the exterior lumber walls. These high lateral loads could not be balanced by passive resistance on the other side of the lumber structure, owing to the very weak bending moment capacity through the 12x12 columns to 12x12 beam "dog" / "doweled" connections.

We think the Hypothesis 1 is the primary failure mode. This reflects that the vertical 12x12s on the south side of the wood flume are tilted about 20° to the south, being there pushed by the façade of the damaged heavy thick-walled brick tunnel. However, Hypothesis 2, being the lack of good connections in the lumber, would also have allowed racking of the structure due to the inability of the structure to transfer the active loading to be resisted by the passive soil resistance on the other side of the lumber structure. Overall, whichever hypothesis has the more weight, the bottom line is that both the brick-lined tunnel and the wood flume failed grossly; had there been necessity of draining the reservoir quickly, this outlet system, having been seriously compromised, would have allowed considerably lower flow rates than originally intended.

Figure 4.1.12-4. Interior of Wastewater Flume, Looking Southwesterly (photo: Schussler 1906)

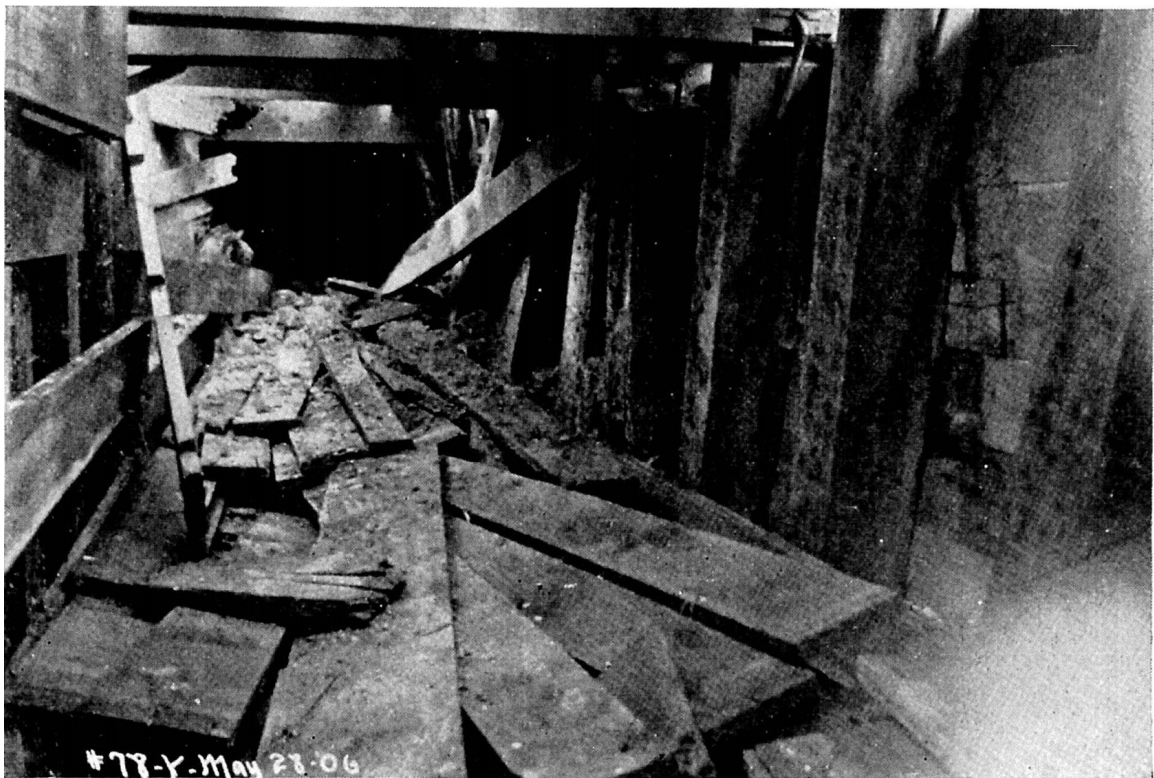
- Figure 4.1.12-5. Shows the interior of the damaged wastewater wood flume, looking northeasterly. Note the separation of the horizontal wood 12x12s from the vertical 12x12s, which had been connected with ~ 0.5 " diameter steel dowels ("dogs" using Schussler's description).

Figure 4.1.12-5. Interior of Wastewater Flume, Looking Northeasterly (photo: Schussler 1906)

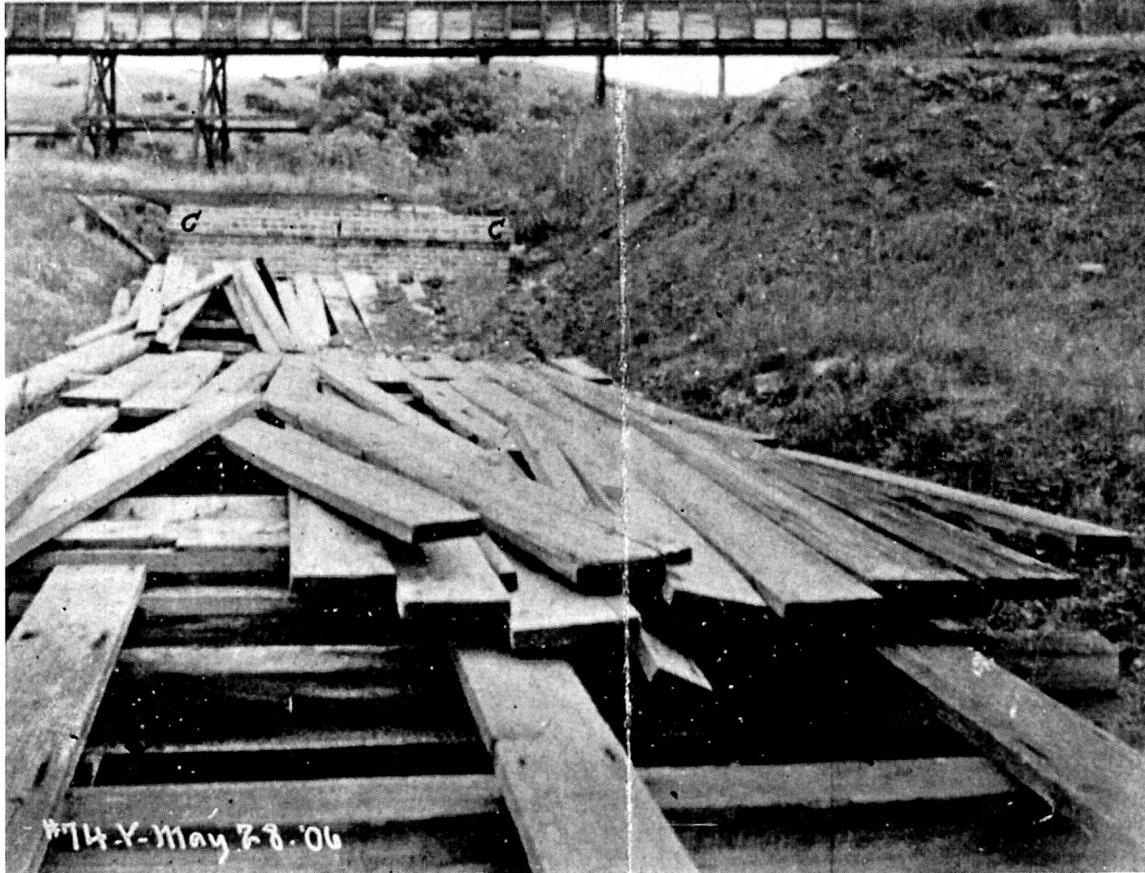
- Figure 4.1.12-6. Shows the exterior of the damaged wastewater wood flume, looking northeasterly. In the distance is the elevated Stone Dam Flume, which, when delivering water to San Andreas Reservoir, would have flowed right to left (northerly) in this photo. Just to the left of Figure 4.1.12-6, the flume collapsed (dashed lines in Figure 4.1.11-1). Letters "C-C" indicate the transition from wood flume to brick tunnel. The hill to the right of right-side "C" in this photo is the striped bedrock knob seen to the right of point "B" in Figure 4.1.11-6.

Figure 4.1.12-6. Exterior of Wastewater Flume, Looking Northeasterly. Elevated Stone Dam Flume in Distance (photo: Schussler 1906)

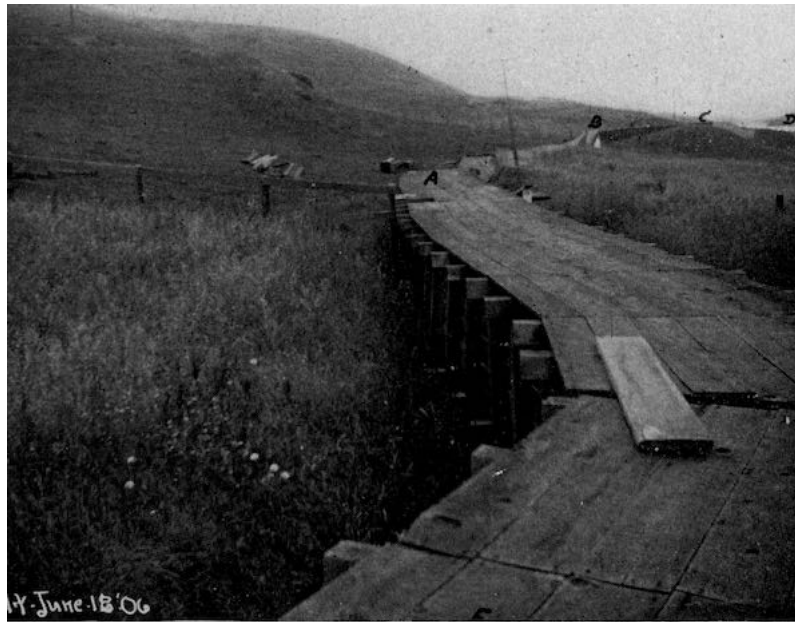
Figures 4.1.12-9, -10, -11 show about 100 feet of the Stone Dam (Locks Creek) flume that was wrecked. The location of the failure is between points A and B (the location of the collapse is also indicated by the dashed line in Figures 4.1.11-2 and 4.1.11-3). The cross section of the flume at this location was 6 feet wide by 4 feet high. The elevated flume was sound between points B and C. In the distance in Figures 4.1.12-9 and -10 at point D is the northern end of Lower Crystal Springs Reservoir.

Figure 4.1.12-9. Failure of Stone Dam Flume, Looking Southerly (Photo: Schussler 1906 HS50)

- The flumes in these locations did not cross the fault. Therefore, fault offset PGD is not the root cause.
- There is no clearly observed landslides in these locations (Figures 4.1.12-9, -10, -11, also Figures 4.6-3, -4).
- The flume failures did not extend indefinitely: the bulk of the length of the flumes remained standing. The style of construction was similar along the entire length, and the height of water would have been the similar along the length.

- This leaves high inertial loading as the most likely cause of the failure. The photos suggest that the 4x6 vertical bents rotated and that led to the collapses. This failure mode is consistent with a large sideways inertial loading (weight of water plus lumber, acting sideways). The toe nailing and small dado joints would have been sufficient to resist opposing hydrostatic water forces, but under seismic loading, all forces are to one side, and these joints were not strong enough to resist the applied moments.

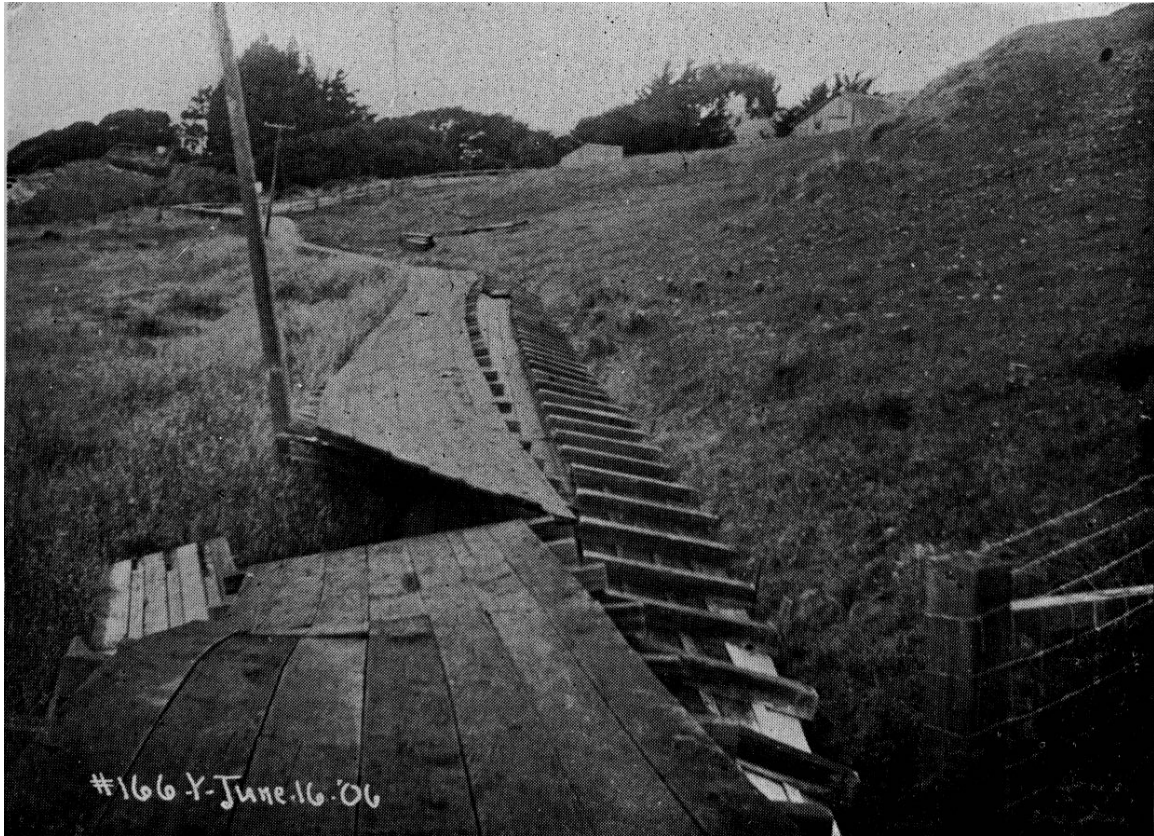
Figures 4.1.12-10, -11 show that this section of the flume has collapsed to the west. The fault does not go through the wood flume but is parallel to it (see Figures 4.1.11-2, -3).

Figure 4.1.12-11. Failure of Stone Dam Flume, Looking Northerly (Photo: Schussler 1906 HS51)

The failures seen in Figures 4.1.12-10, -11, as well as Figures 4.6-3, -4, coupled with the side view in Figure 4.1.12-6, suggest that at least some (or most) of elevated trestle piers (Figure 4.1.12-8) remained standing. The possible underlying loading that leads to this type of failure mode is described below:

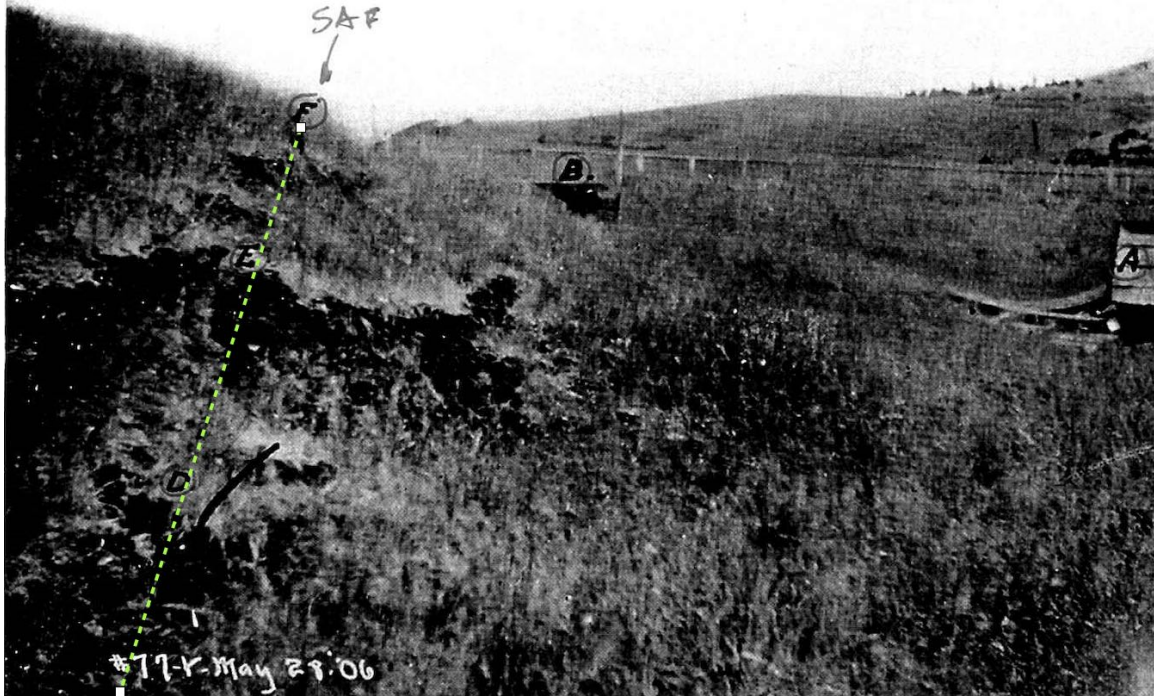
Figure 4.1.12-12 shows the traces of the main fault offset (line C – D – E – F) and the collapsed flume (between points A and B) seen in Figure 4.1.12-10. The linear feature near the top of the photo is a fence that runs across the crest of the San Andreas dam. The fault offset is marked by typical north-trending left stepping en echelon shears.

Figure 4.1.12-12. Fault Offset Near Flume, Looking northwesterly (Photo: Schussler 1906 HS50)

Schussler (1906) reported that the distance between points A and B (Figure 4.1.12-12) was 4 feet longer than before the earthquake. But presently, we cannot verify this claim: there is no evidence of fault offset through this segment.

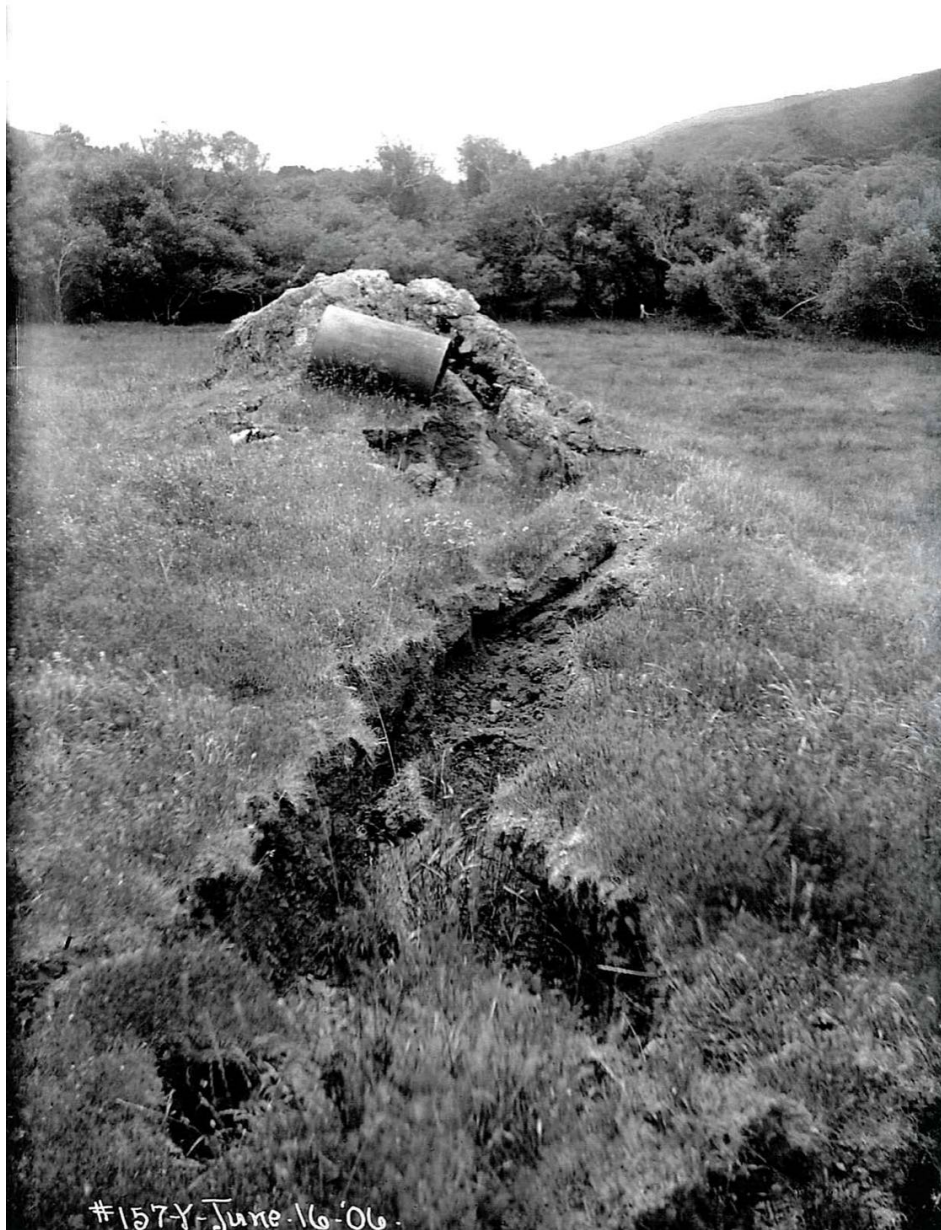
Perhaps ~1,600 feet southeast of Site 13 is a photo of the fault offset trace, Figure 4.1.13-2. This photo is believed to have been taken looking southeasterly. Schussler's 1906 report places this photo someplace between Sites 13 and 14; but Hall suggests that this photo is in fact about 600 feet north of Site 14. FX-5 is not seen in this photo. At this location, Schussler describes the offset as about 7 feet. In the middle of the photo is a short segment of riveted wrought iron pipe, resting on what appears to be a tectonic "knocker" or rock outcrop of Franciscan chert. It is uncertain if this is a 30" or 44" diameter WI pipe from the Pilarcitos pipe, or a 44" pipe from the Locks Creek pipe.

Figure 4.1.13-2. About ¼ miles southeast of Site 13, looking southeasterly (Credit: Schussler 1906). Believed to be within 100 feet± of Site 14, FX-5

The "tectonic knocker" seen Figure 4.1.13-2, is one of the common very hard rock type of marine origin found in Franciscan mélangé; it demonstrates clearly that the fault, seeking to navigate the path of least resistance through the earth to reach the surface, will not necessarily be able to choose a straight path. Schussler's caption on this photo says the fault here slipped 7 feet, but does not tell us what sort of feature he found to measure this displacement. Another 0.1 mile southeast along the fault from this chert boulder is our well-located site 15, which where the San Andreas fault crossed Lawson's Fence "A". In any case, we believe that seven feet of right slip for Site 13 is likely a minimum value and indicates there might have been an unrecognized fault strand near the chert knocker or at least two or more feet of ground warping in this neighborhood that was not recorded.

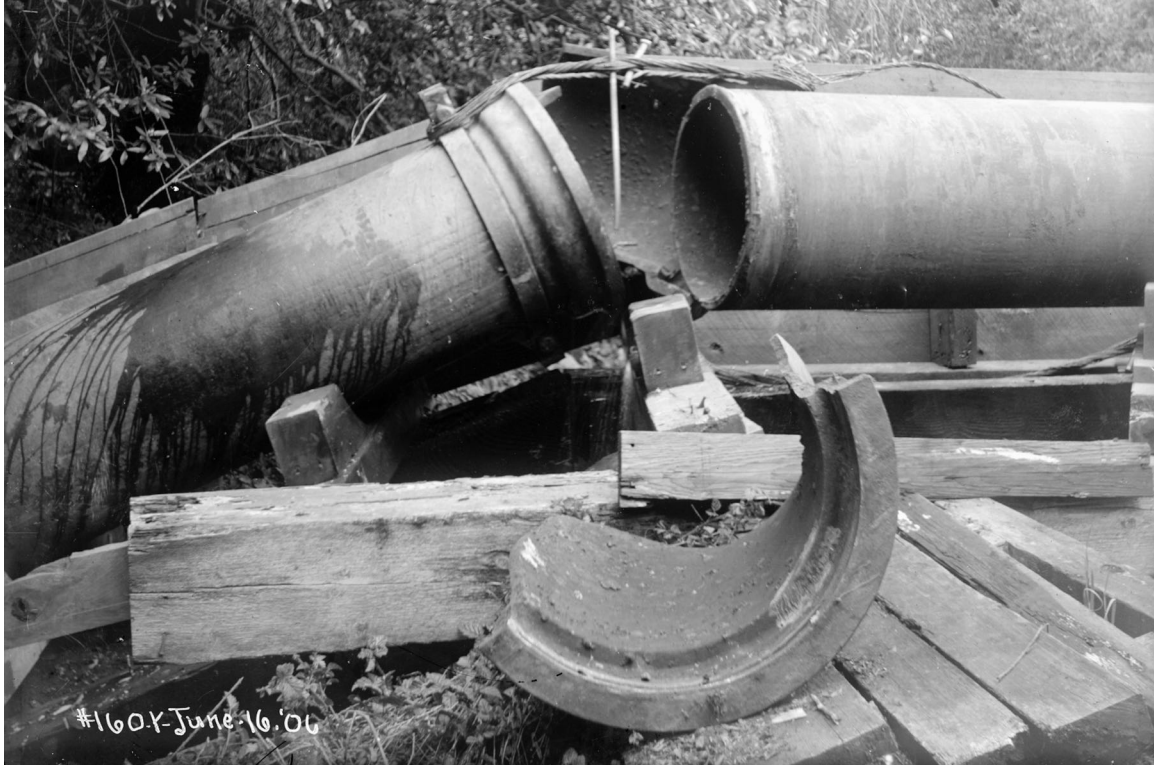
On the bridge, the pipe was a 24" cast iron pipe with bell and spigot joints, and 1" thick wall. Figures 4.1.14-3, -4 show the damage of the pipe at FX-5. Note the clamp on the left pipe segment (Figure 4.1.14-3) (foreground in Figure 4.1.14-4) and a cable; presumably these were restrained joints for the bridge crossing; but these restrained joints were insufficient to accommodate anything resembling ductile response of the complete cast iron pipe when subjected to the right lateral offset. The collapse of the bridge in Figure 4.1.14-4 indicates that the cast iron pipe segment in the foreground must be similarly disconnected to the continuing cast iron pipe behind the photographer's location. Further, we have assumed that these photos were taken looking northerly or easterly (Figures 4.1.14-3, -4 respectively); but given the shadows, a case could be made that the photos were taken looking in the opposite directions.

Figure 4.1.14-3. Crossing 5. 24" Pilarcitos Cast Iron Pipe. Elbow crushed. View looking north.
(Photo: Schussler 1906 HS11)

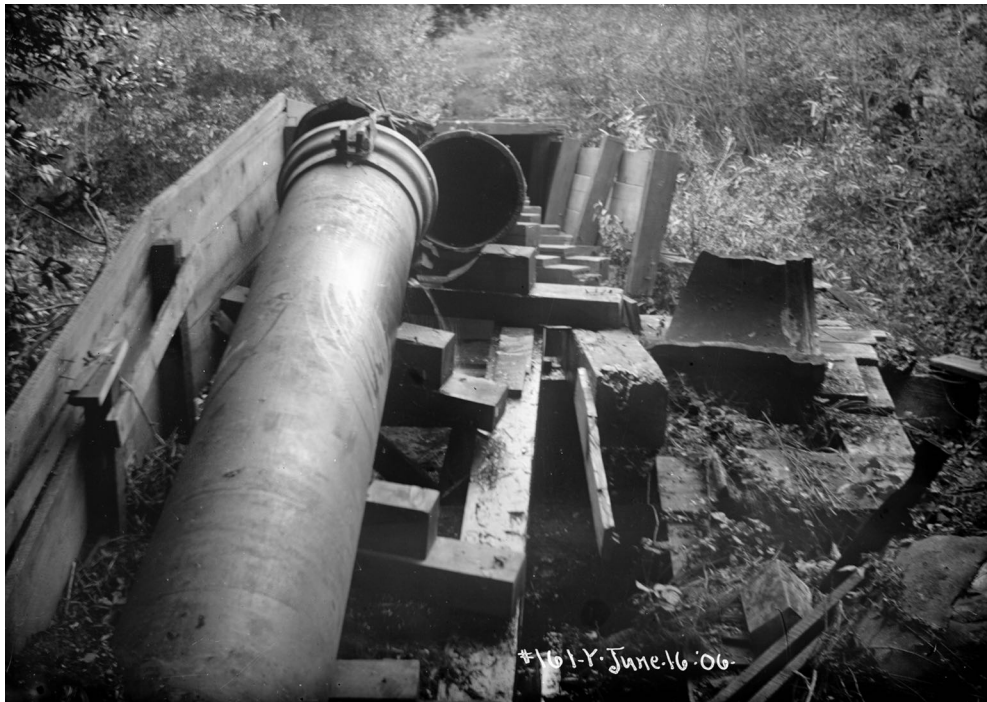
Figure 4.1.14-4. FX-5. 24" Pilarcitos Cast Iron Pipe, Looking east. East end of fault crossing zone. The pipe in the distance has moved to the right (southerly) relative to the pipe in the crossing zone. This is the same location as 4.1.14-3, but looking easterly along the pipe alignment. (Photo: Schussler 1906 HS12)

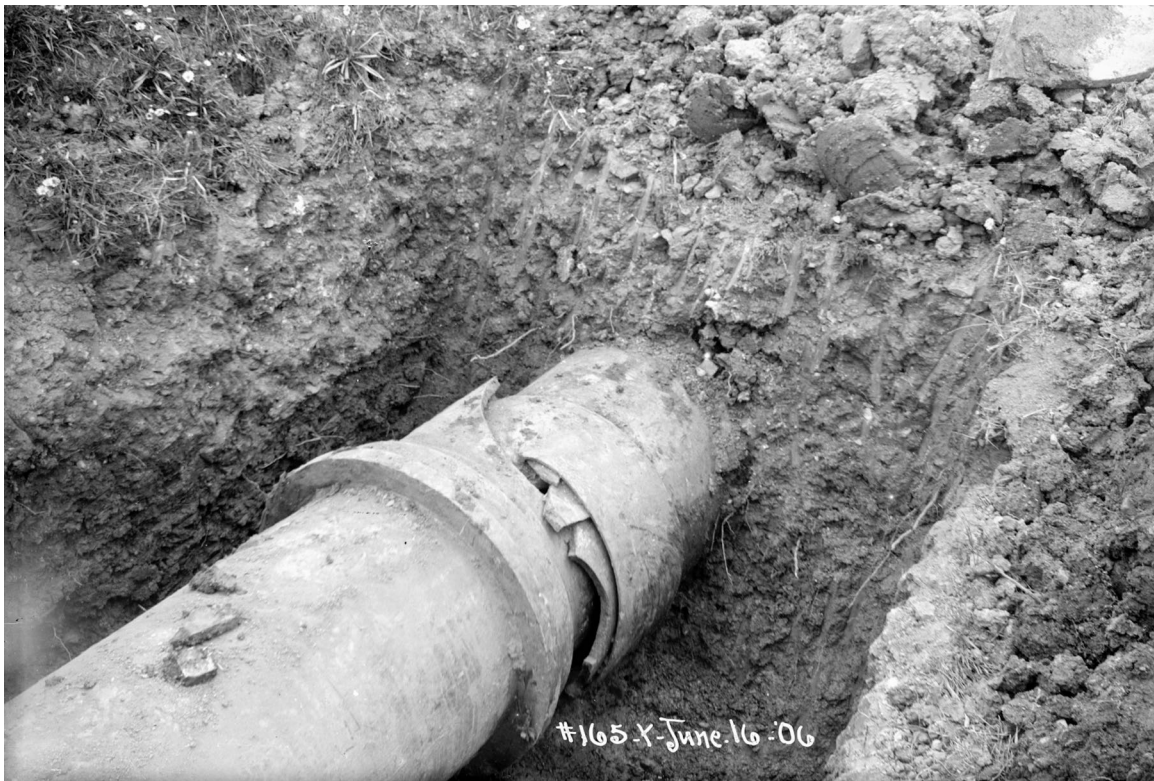
Just east of the fault, the pipe takes an upward bend, as the pipe rises to the 600-foot high hills to the east of the San Andreas reservoir. The pipe broke at an upward bend, Figure 4.1.14-5. Here, the pipe is 24" cast iron. The pipe has cracked in the main body a few inches away from the bell. An elbow at the bend was crushed by the compression and thrown down, while the two remaining ends were brought about 22 inches nearer together. At the same time they were faulted past each other a distance of 20 inches (Lawson 1908).

*Figure 4.1.14-5. FX-5. 24" Pipe has telescoped $\pm 1'$. About 100' north of FX-5.
(Credit: Schussler 1906 HS13)*

Hall suggests that there might have been about 28" of right lateral slip at the location where the cast iron pipe telescoped (Figure 4.1.14-5). The question is open as to whether the damage at Figure 4.1.14-5 is due to some type of local fault offset, or from forces transmitted through the pipe at the main FX-5 crossing to this location. Eidinginger thinks the damage shown in Figure 4.1.14-5 is due to the high compressive forces imposed on the pipe, coupled with some local bending, which then cracked the cast iron body; this factors in that the observed pipe offsets at the wood trestle are insufficient to take up the full 7 feet of offset; but Hall's explanation could also be correct.

In Table 3-2, the amount of fault offset for Site 14 is listed as 7.0 feet. This reflects the measurements / observations by Schussler (1906) and Reid (1910). If one attributes the damage in Figure 4.1.14-5 as due to a secondary trace of the fault that is not documented by Lawson (1908) or Reid (1910), then the total right lateral slip across the fault at FX-5 would be about 8.3 feet.

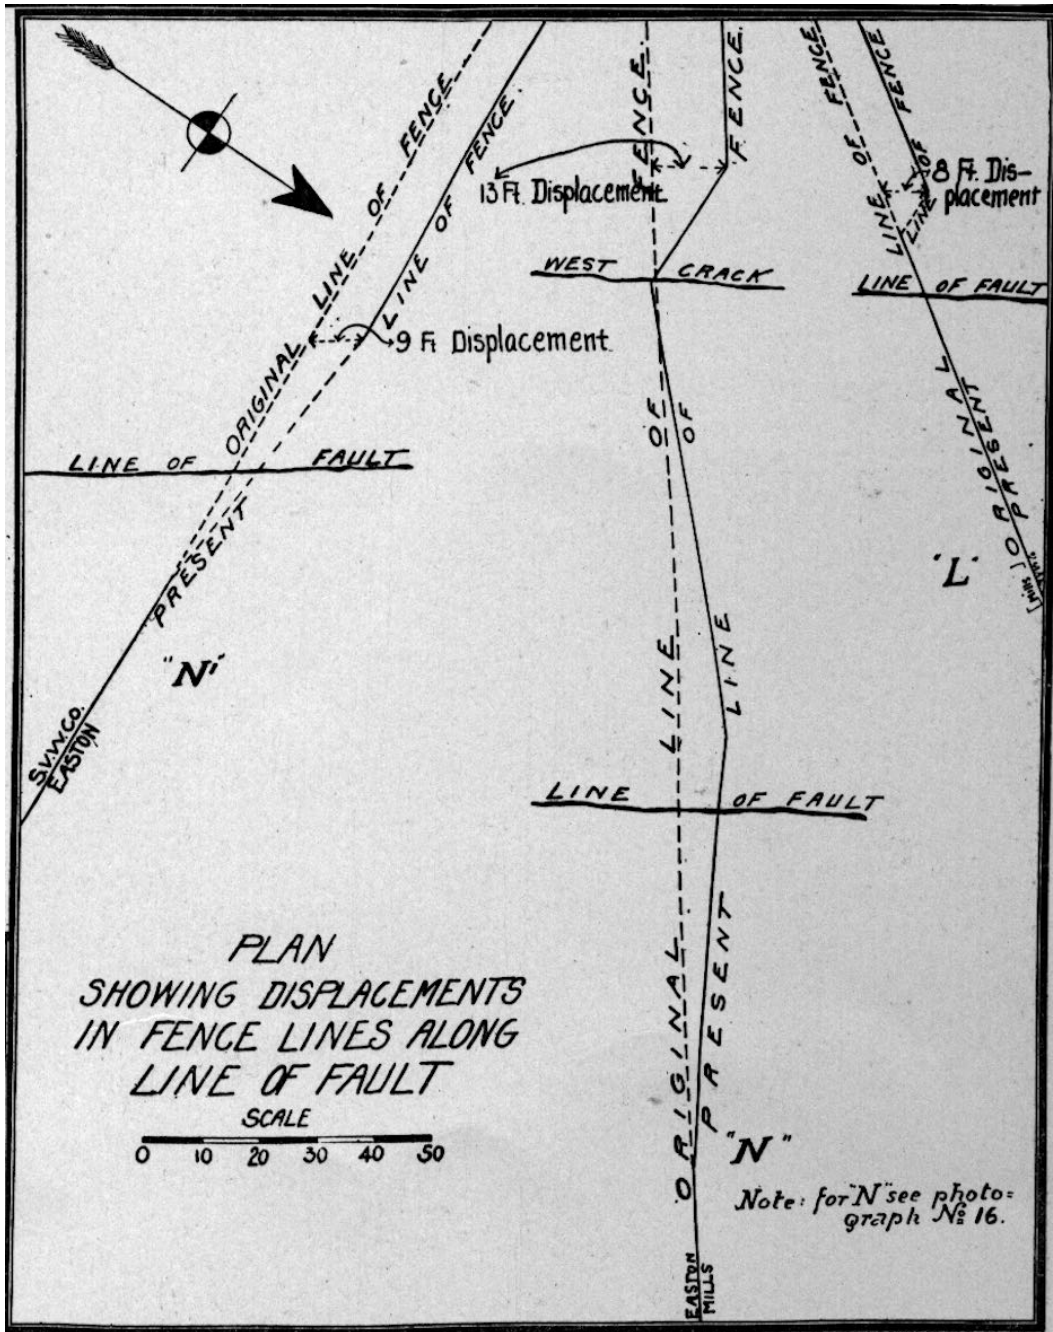
This property boundary wire fence trends N52°E and crosses the 1906 San Andreas faulting at almost a right angle making it a potentially high-quality strain gauge for measuring fault slip. Schussler's sketch map of this area (Figure 4.1.15-1) identified two parallel cracks about 90 feet apart with a combined right lateral slip of 13 feet as measured by the fence offset (center fence in map below). Using Schussler's terms, the "west crack line of fault" break manifested the larger amount of slip.

Figure 4.1.15-1. Map of Faults and Fences (Credit: Schussler 1906)

between DE and C-D₁ as an expression of the vanishing point perspective. In other words, the "triangular" shapes drawn by Schussler as "present line of" and "original line of" in Figure 4.1.15-1 at "line of fault" is incorrect; and the "line of fault" at the bottom of the sketch in Figure 4.1.15-1 is also incorrect and did not exist.

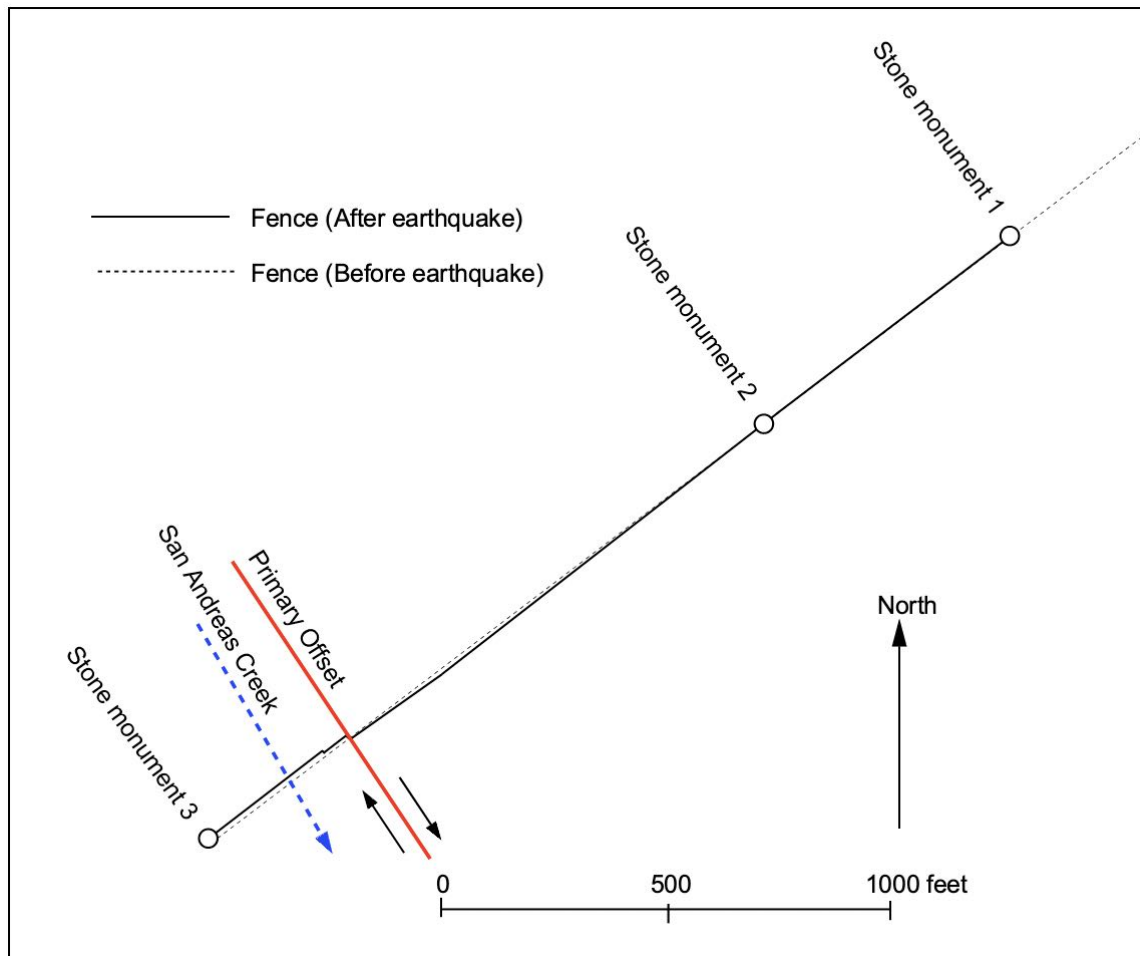
Lawson (1908, Fig. 38, p. 101) presented another map of this area based on professionally surveyed data prepared by R.B. Symington, C.E. that showed this fence and the geometry of how it was deformed through the fault offset zone. Figure 4.1.15-2 redrafts that c. 1908 survey using a 1:1 scale; Figure 5.1.15-3 redrafts using a 50:1 scale. The original fence is denoted by the dashed line, and the post-earthquake fence by the solid line. To the east of the primary offset zone, the fence has dislocated about 3.4 feet to the left; to the west of the primary offset zone, the fence has been dislocated 9.3 feet to the right (left and right as oriented looking southwesterly along the fence). If one measures the "total" fence dislocation, one gets $3.4 + 9.3 = 12.7$ feet, or nearly the same amount as indicated by Schussler in 1906 in Figure 4.1.15-1; but Schussler's stated amount of 13 feet clearly is not the correct amount of the actual primary fault offset, which is better measured using the difference between the stone monuments 1 and 3. In Figure 4.1.15-2, the fence azimuth between Stone monument 1 and 2 is 52.27° ; and between monument 2 and the primary offset zone is 52.17° .

Figure 4.1.15-2. Map of Fault and Fence "N" (After Symington 1908, in Lawson 1908)

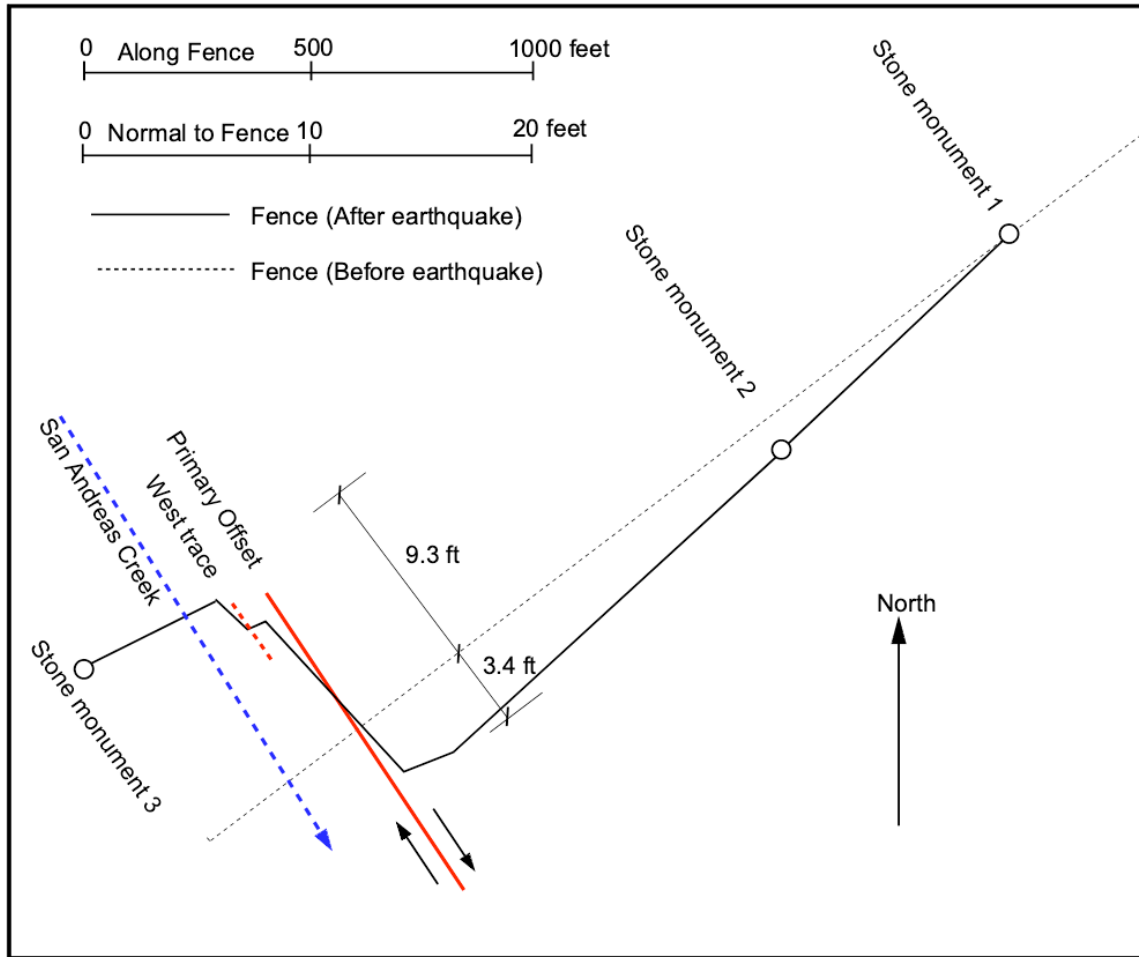
Figure 4.1.15-3. Map of Fault and Fence "N" (Exaggerated Scale, After Symington 1908, in Lawson 1908)
