History of the Water Works of San Francisco, Its Performance in the 1906 Earthquake and Aftermath

John M. Eiding and N. Timothy Hall

December 19, 2023

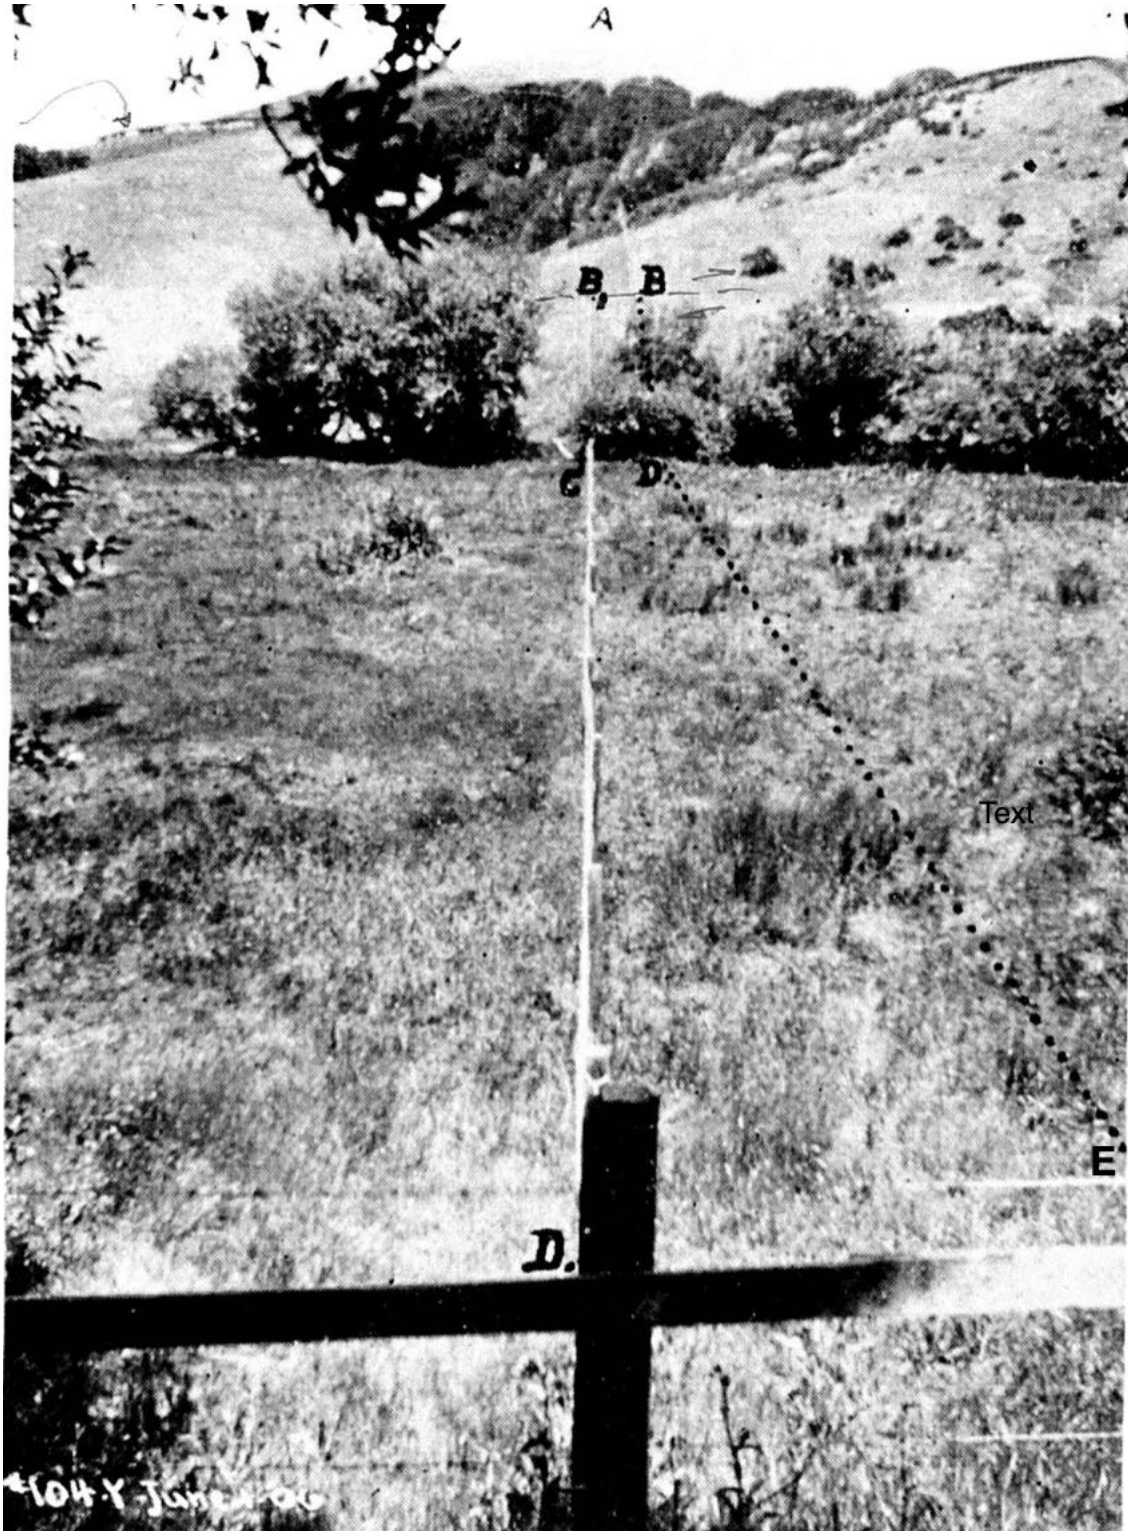
Figure 4.1.15-4. Offset of Fence N, looking westerly? (Credit: Schussler, 1906)

4.1.15-4 is a photo by Schussler (1906). The post-earthquake location of the fence is A-B-B₁-C-D₁. Schussler hand-drew in the dotted line (Point D to E) as to original location of the fence. We interpret the seemingly "left lateral" offset suggested by the angle

between DE and C-D₁ as an expression of the vanishing point perspective. In other words, the "triangular" shapes drawn by Schussler as "present line of" and "original line of" in Figure 4.1.15-1 at "line of fault" is incorrect; and the "line of fault" at the bottom of the sketch in Figure 4.1.15-1 is also incorrect and did not exist.

Schussler noted that the primary offset is nearly normal to the fence line, just beyond B₁-B.

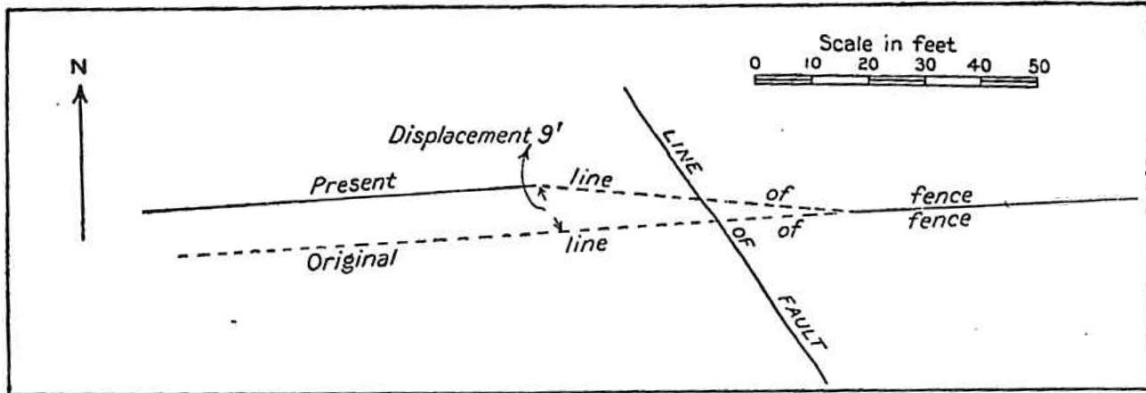
Fence line N¹ is denoted by the fence line sketched by Schussler in Figure 4.1.16-1. Figure 4.1.16-2 shows the same area mapped by Hall in 1984. Here, a property is marked by a fence and a row of Cypress trees that were offset 9 feet right laterally. Figure 4.1.16-3 clearly shows the young trees, the bent fence and a geologist standing bravely on the 1906 mole track.

Figure 4.1.16-1. Map of Faults and Fences (Credit: Schussler 1906)

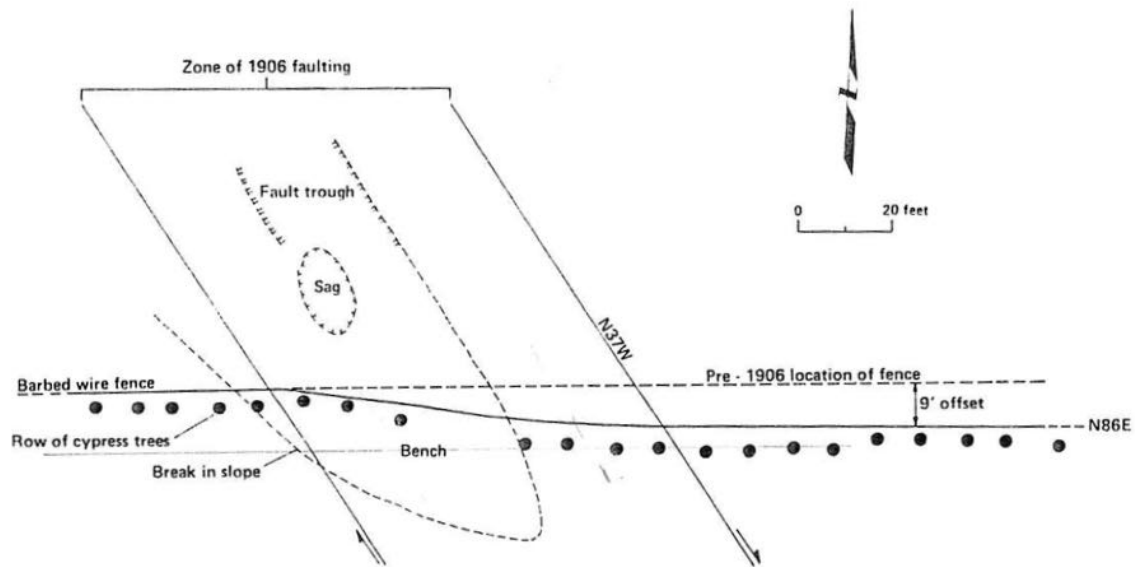
Figure 4.1.16-2. Map showing fence and row of cypress trees offset by 1906 faulting (Credit: Hall 1984)

Schussler (1906) and Lawson (1908) both sketched the site and both agreed on 9 feet or right lateral offset. Hall (1984, p. 286) also surveyed this site in 1980 and measured the same displacement even though the fence had obviously been repaired. Because the watershed lands are protected, the fence may yet exist today (2023). At the time of the 1980 survey, the tree trunks were several feet in diameter, making it difficult to measure their exact position when planted at least 80 years earlier. What the 1980 survey did show is that here the zone of maximum slip was at least 30 feet wide and showed evidence in the form of a hillside bench with a central trough and sag that indicated the ground surface along the fault here experienced some extension during fault slip. It is also interesting to speculate that the absence of two trees within the zone of concentrated slip probably had their roots sheared in 1906, which might have weakened them and led to their premature demise.

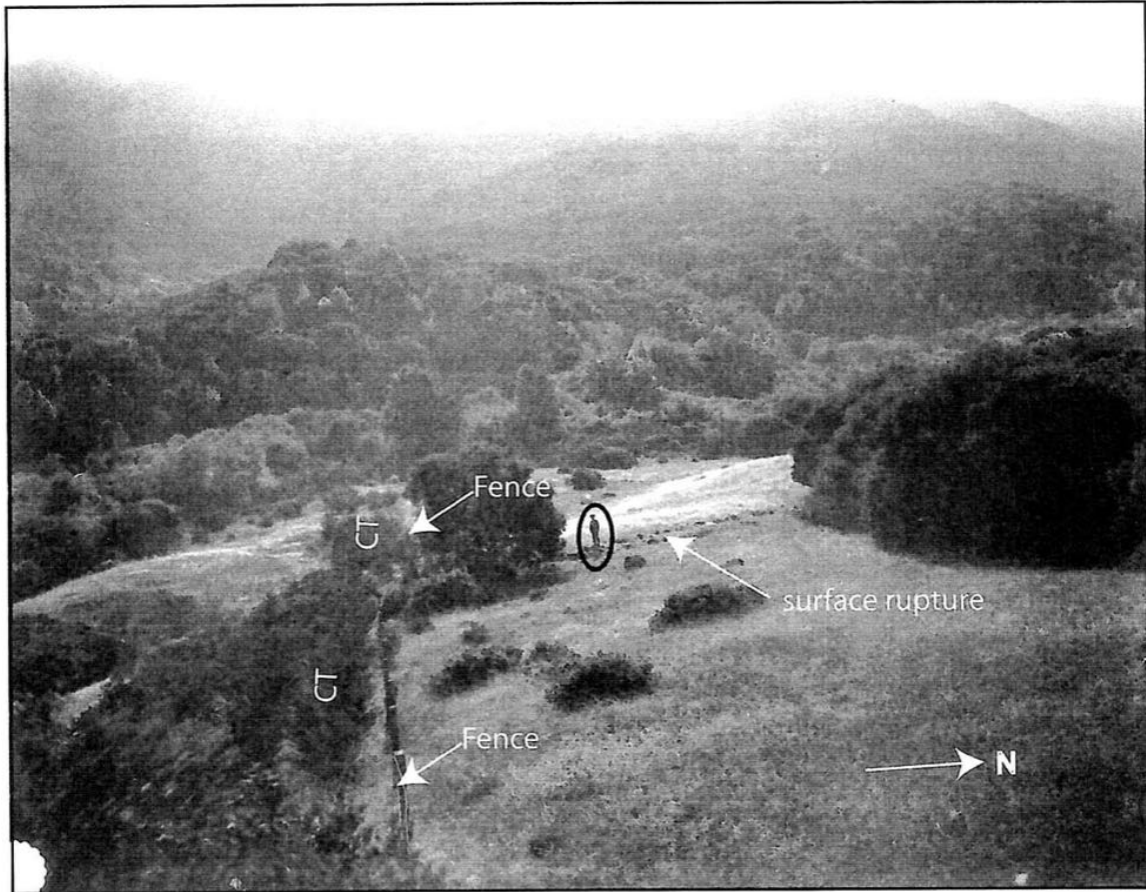
Figure 4.1.16-3. Photo showing surface rupture, fence and trees (Photo: Lawson 1908)

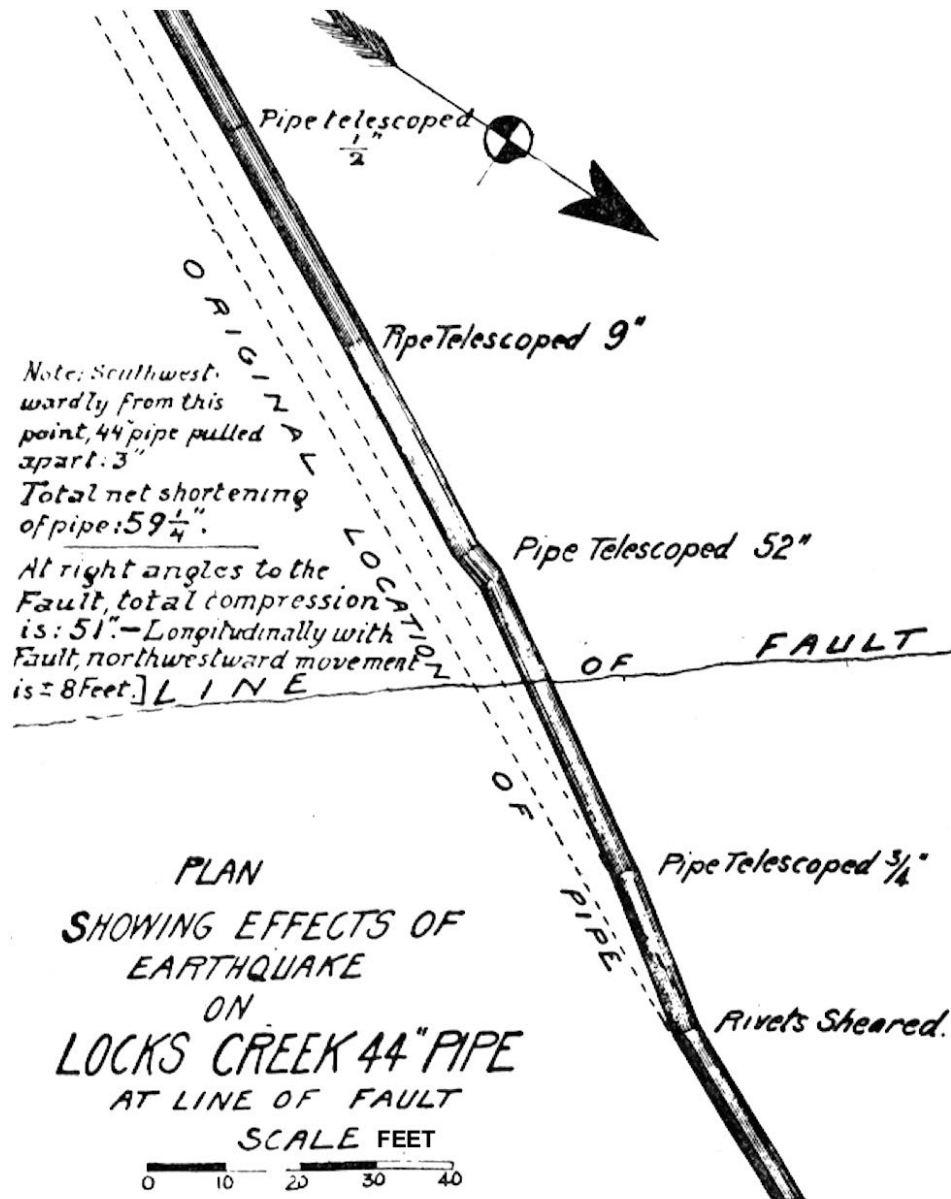
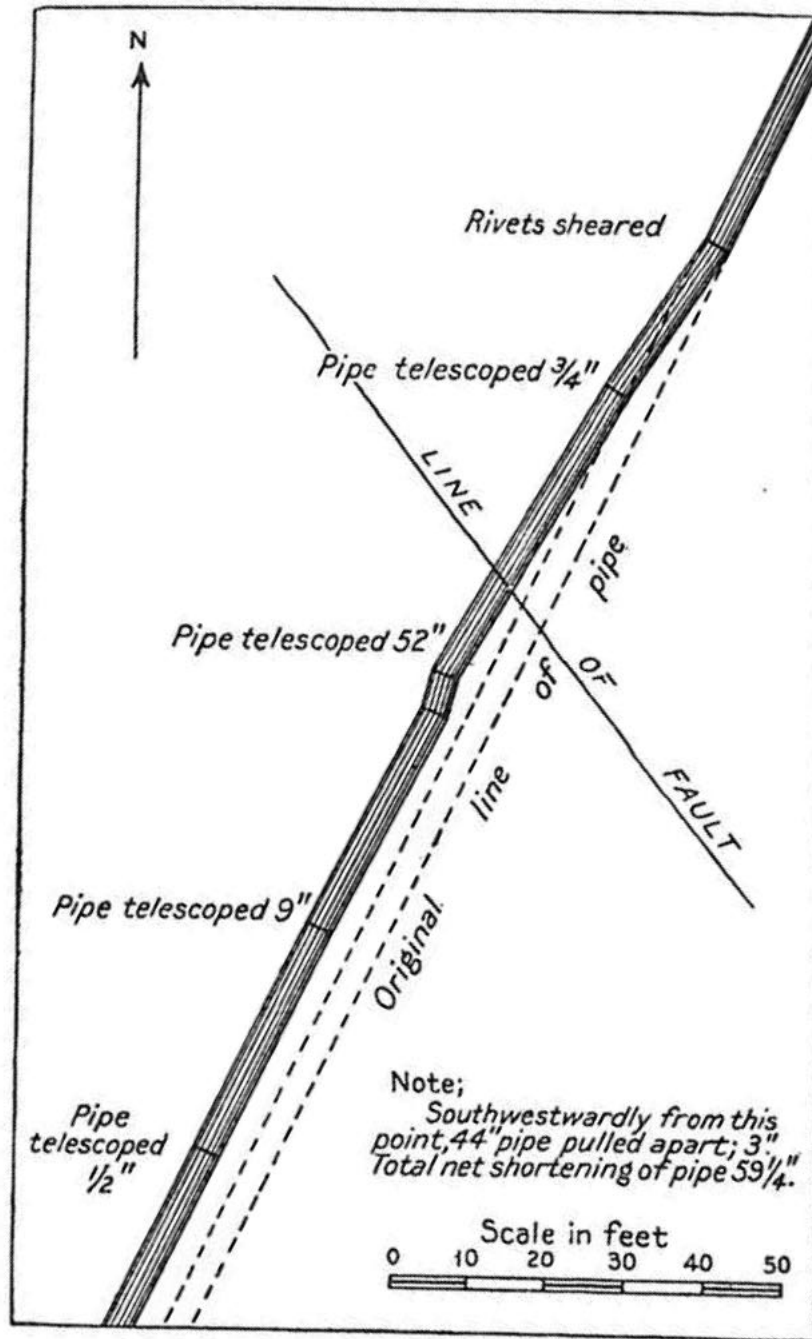
Figure 4.1.17-1 shows Schussler's sketch of the 44" riveted wrought iron pipe at Site 17. Figure 4.1.17-2 shows the re-drafted sketch by Lawson. Here, the pipe crosses the fault at an angle of about 70°, and right lateral offset would place the pipe into net compression, and well as much bending. On the east side of the fault, the pipe shows concentrated damage at two locations, about 30 feet and 50 feet away from the primary fault offset location. On the west side of the fault, the pipe shows concentrated damage at four locations, with compressive/bending failures at about 20 feet and 50 feet away from the primary fault offset location, and another tensile failure at about 400 feet distance from the fault or ±600 feet east of a county road.

The multiple damage locations either side of the fault is the natural condition of a beam (pipe) on nonlinear springs, when subjected to knife edge fault offset. The high bending moment ruptures the pipe in two locations either side of the fault, and this damage pattern was similarly duplicated by the Thames River 2.2 m diameter steel pipeline where it was exposed to similar right lateral fault offset in the 1999 Izmit earthquake (Eidinger, O'Rourke, Bachhuber, 1999b). The Thames River pipeline was butt-welded steel; so the failure mode was gross wrinkling of the pipe, rather than shearing the riveted joints as was the case for the 44" Locks Creek pipeline.

The distance (in feet) between the first two failure locations either side of the primary fault offset (about 50 feet in this case) is a function of the relative stiffness and strength of the pipe versus the stiffness of the backfill soils around the pipe: the stiffer / stronger the pipe and the softer the soil, the wider the distance between the two failure locations.

The four locations where the pipe was reported as "telescoped" are places where the net shortening of the pipe had to occur. If we allow that at a 55° angle and 8 feet of right lateral offset, then the net shortening should be about $96" \sin 25^\circ = 41$ inches. Schussler computes 59.25 inches. We suspect the discrepancy is in the measurement of 52" at the telescoped failure just west of the fault; perhaps this was the maximum measured around the circumference, rather than the average. It is unclear as to the mechanism that led to the tensile failure and pull apart of ~3" at a distance of about 400 feet to the west of the fault.

Figure 4.1.17-1. FX-6. Locks Creek 44" Wrought Iron Pipe (Schussler 1906)

Figure 4.1.17-2. FX-6. Locks Creek 44" Wrought Iron Pipe (Lawson 1908)

The hand-drawn before-and-after pipe locations in Figures 4.1.17-1, -2 suggest the pipe was offset laterally by about 1.5 pipe diameters (66"), but Schussler documents 14" of transverse pipe offset. The difference in these two figures (66", 14") cannot be readily reconciled as a sudden "knife edge" offset of the pipe; but could reflect the transverse offset over several tens of feet.

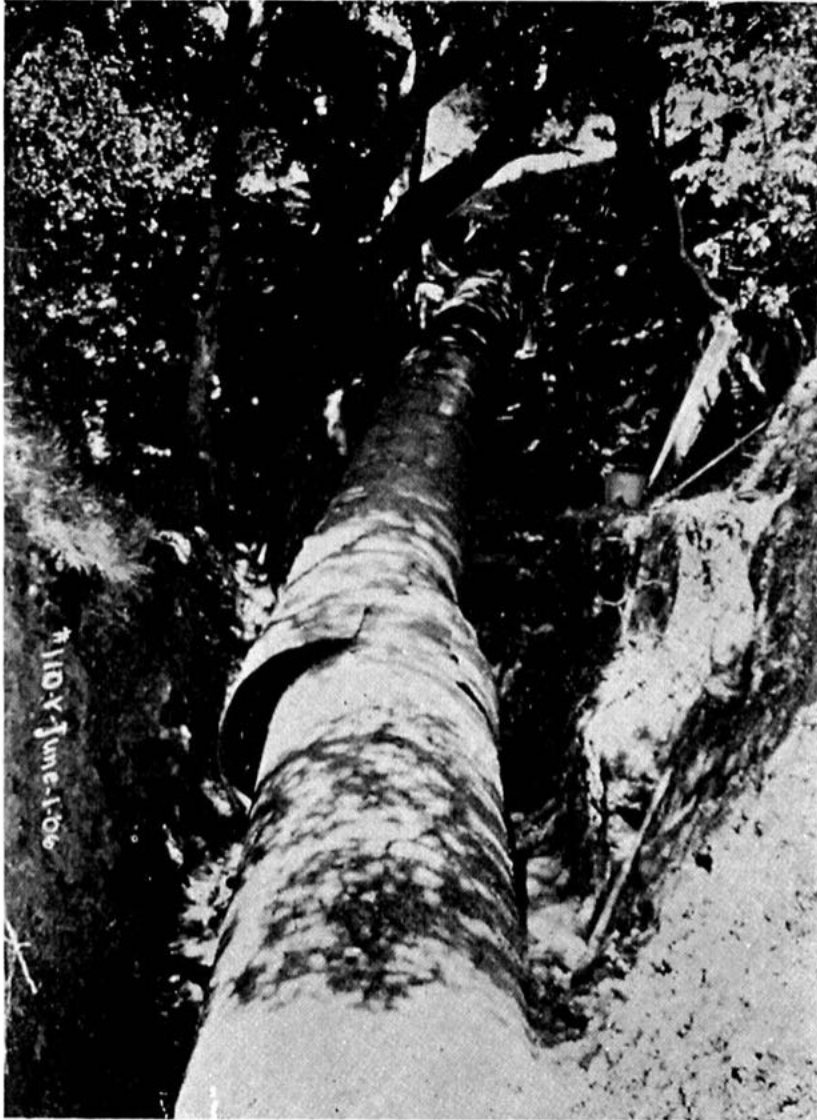
At this location, the 44" riveted wrought iron pipe was buried with 3-4 feet of cover and had wall $t = 0.125$ inches. This pipe runs up the hill from the San Andreas creek valley in a direction of about $N 28^\circ E$. The fault offset bisected this pipe at the base of the hill, with the fault azimuth being $N 37^\circ W$. Thus, the intersection angle between the fault and the pipe is about 65° . At the intersection of the fault, the rivets were torn out all the way around at a girth joint and two pipe segments were telescoped into one another a distance of 52 inches. One observer suggested there was no lateral displacement, the whole

movement being taken up by telescoping of the pipe, but there was bending of the pipes at the point of the break.

Figure 4.1.17-3. FX-6. Locks Creek 44" Wrought Iron Pipe is offset to the north about 14" and telescoped about 51". Looking easterly. Location is about 50 feet east of the County road between the San Andreas and Crystal Springs reservoirs. (Photo: Schussler 1906 HS14)

- In zones with high ground shaking ($PGV > 30$ cm/sec), for pipes that are important and should not break in the earthquake, for low pressure pipes (maximum hydrostatic internal pressures under 100 psi) girth joints should be

- Often time (but not always), for strike slip faults like the San Andreas, there will be secondary fault offsets and ground warping that occur one hundred to a few hundred feet away from the primary fault trace. This has been amply demonstrated for the San Andreas fault in the 1906 event. The same might be true for Hayward fault events. In zones with reverse faulting coming to the surface, there will often be a variety of back traces away from the main scarp. If sufficient study of the geologic record is done as part of the design (trenches for several hundred feet wither side of the primary trace), quite possibly the evidence for these secondary offsets will be observed. But, for many reasons, not all faults can be trenched entirely, so the pipeline designer is left with the decision as to how far back from the presumed primary fault offset location the fault-tolerant pipe design should be carried.

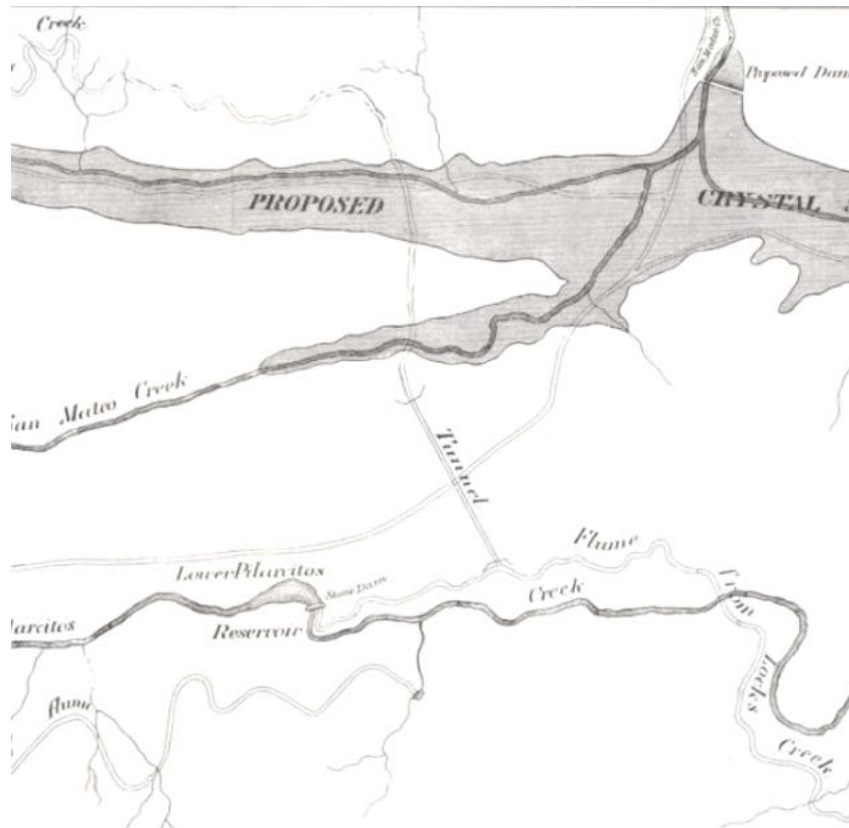
Consider the map prepared by Scowden in 1875, prior to construction of the Lower Crystal Springs reservoir, Figure 4.1.18-1. This shows Stone Dam on Pilarcitos Creek, followed by a flume, followed by a Tunnel (under Sawyer Ridge), followed by flume and pipe sections through San Andreas Valley (including proposed Lower Crystal Springs Reservoir), and then turning north towards San Andreas reservoir. The Tunnel in this map could be filled either with water from Stone Dam or from the Locks Creek collection flume with water coming from to the bottom right of this map.

Figure 4.1.18-1. Old Stone Dam Conduit (credit: Scowden, 1875). North to the left.

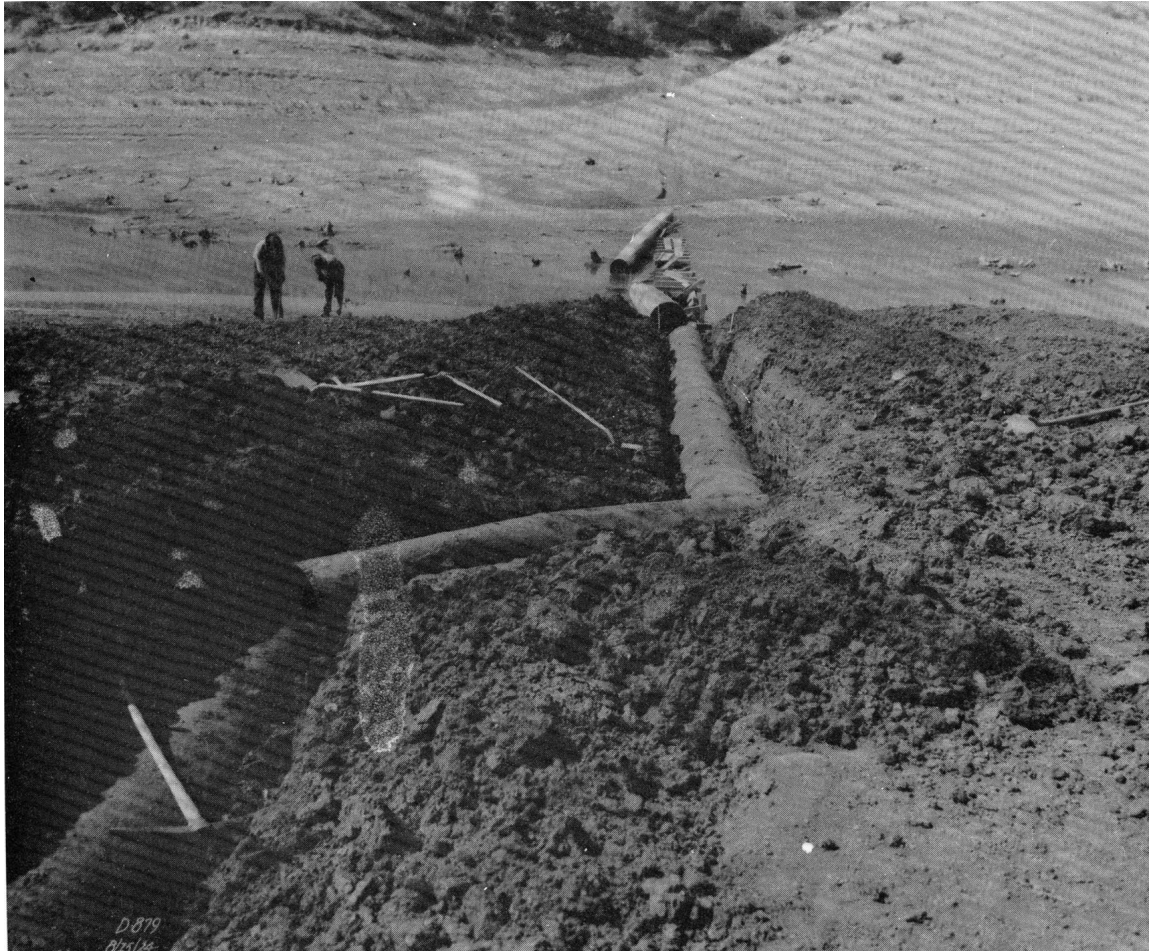
In 1924, the lake level was lowered, and the 37" pipe was taken up. At the San Andreas fault crossing, it crossed at about 78° to the fault (90° being perpendicular), and the pipe was exposed to nearly pure bending offset, coupled with a small compressive component. Figure 4.1.18-2 shows the pipe being removed. This photo is taken looking westerly, and the lowered Crystal Springs reservoir is seen in the background. The ~9-foot right lateral offset of the pipe at the primary offset zone is seen in the foreground.

Figure 4.1.18-2. 37" Abandoned Pipe, 8-25-1924, D-879 (Credit: SVWC 1924). Looking West

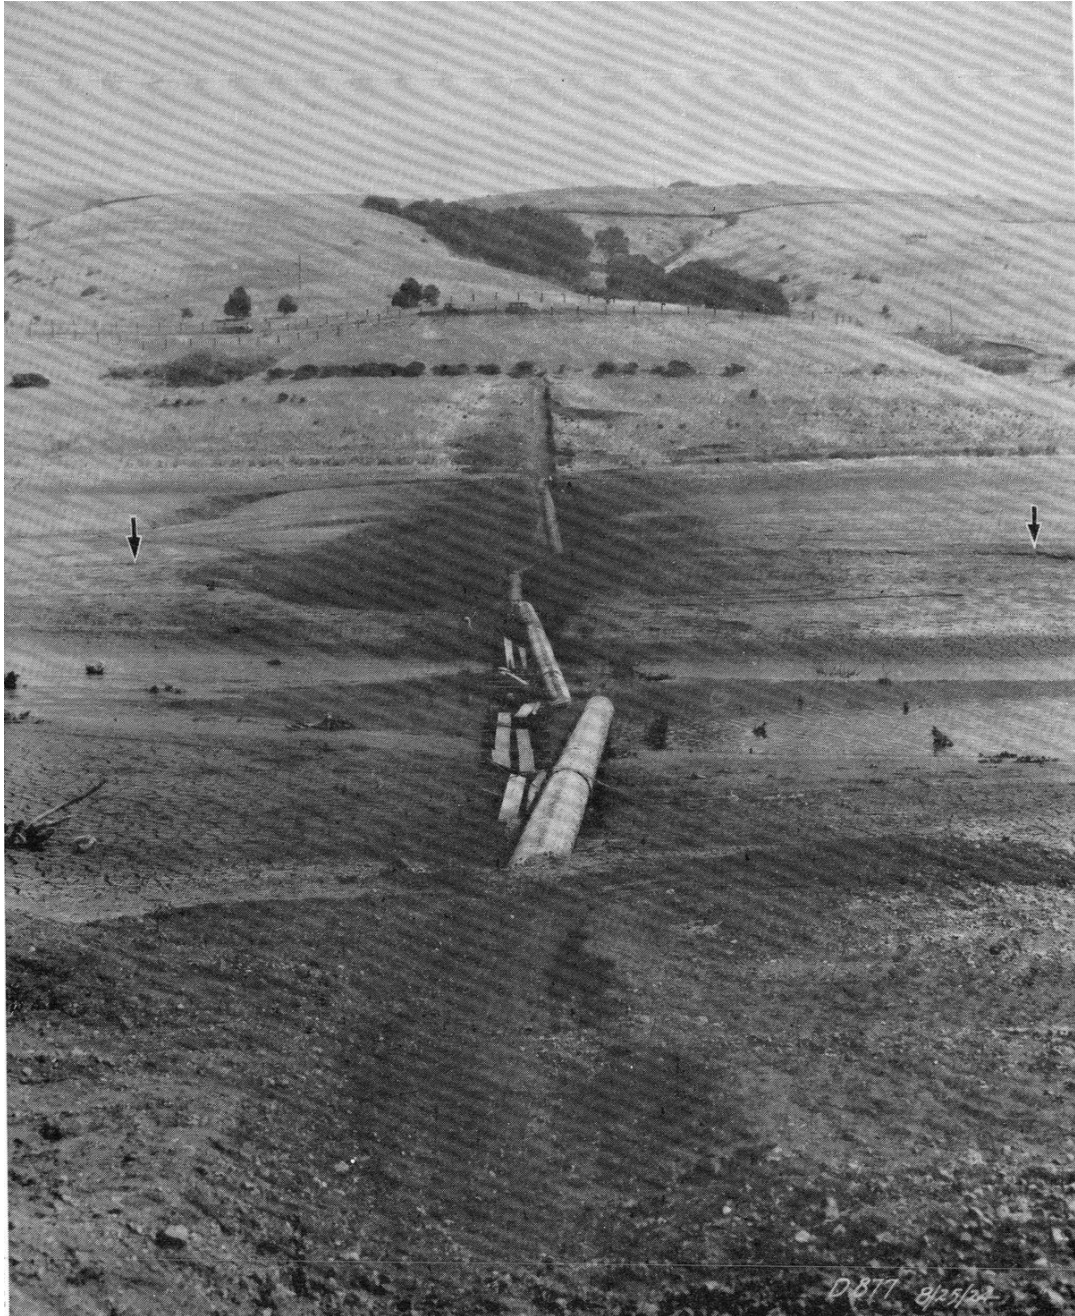
Figure 4.1.18-3 shows the 37" pipe being removed. This photo is taken looking easterly, and the lowered Crystal Springs reservoir is seen in the foreground. The mole track of the fault is denoted by the two arrows.

In the foreground of Figure 4.1.18-3, the pipe is seen fallen off a wood trestle, where it was originally built to go over San Andreas Creek. Whether that damage was due to fluid-structure loading in the 1906 earthquake, or reflects part of the disassembly process, is uncertain.

Figure 4.1.18-3. 37" Abandoned Pipe, 8-25-1924, D-877 (Credit: SVWC 1924). Looking East

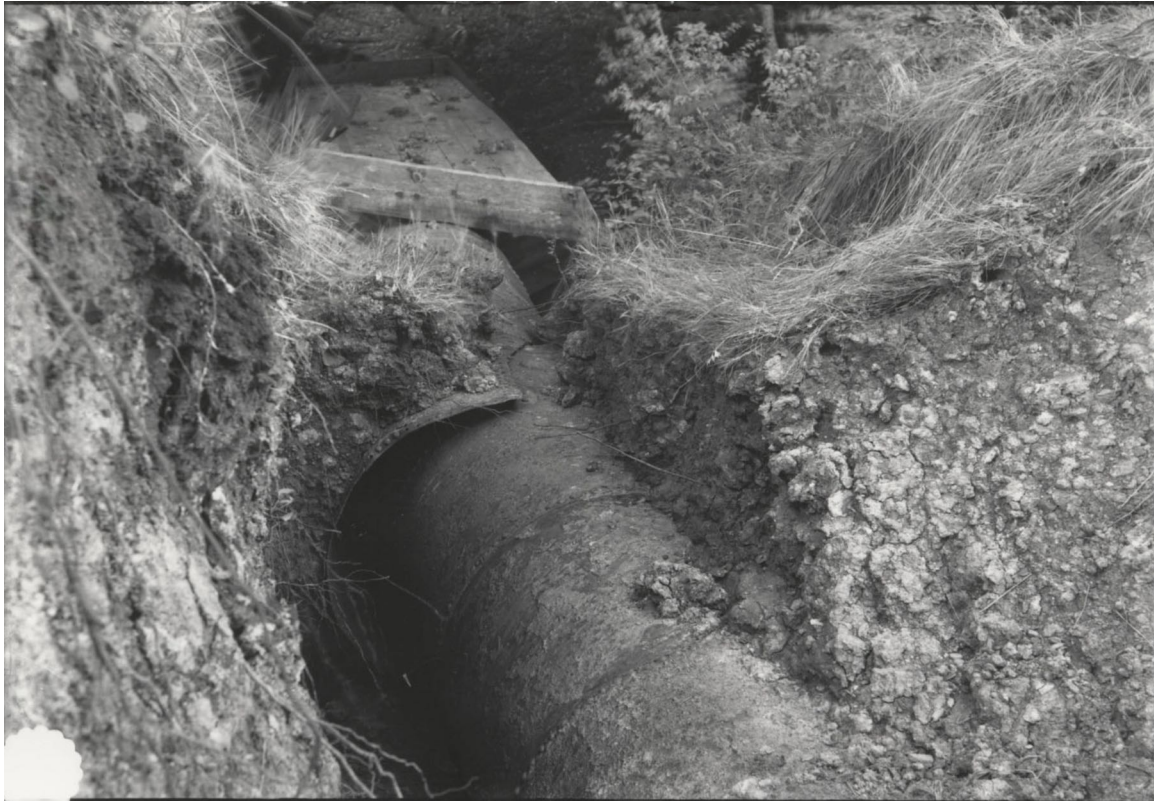
Figure 4.1.18-4 was uncovered as part of a review of historical documents of the 1906 earthquake. However, the provenance of the photo, is undocumented. The photo shows a riveted wrought iron pipe that has failed its girth joint location and suffered several inches of telescoping. The pipe appears to enter a wooden-boxed location. The soils appear to be conglomerate that might be seen in the Franciscan Formation. It is possible that this damage was at a transition to a flume or boxed-enclosed trestle segment. It is also possible that this damage was on the 44" Crystal Springs pipeline at some location downstream of the Crystal Springs dam and west of the Millbrae pump station.

Figure 4.1.18-4. Wrought Iron Pipe Failure. Site 18 (Photo: SVWC, 1906?)

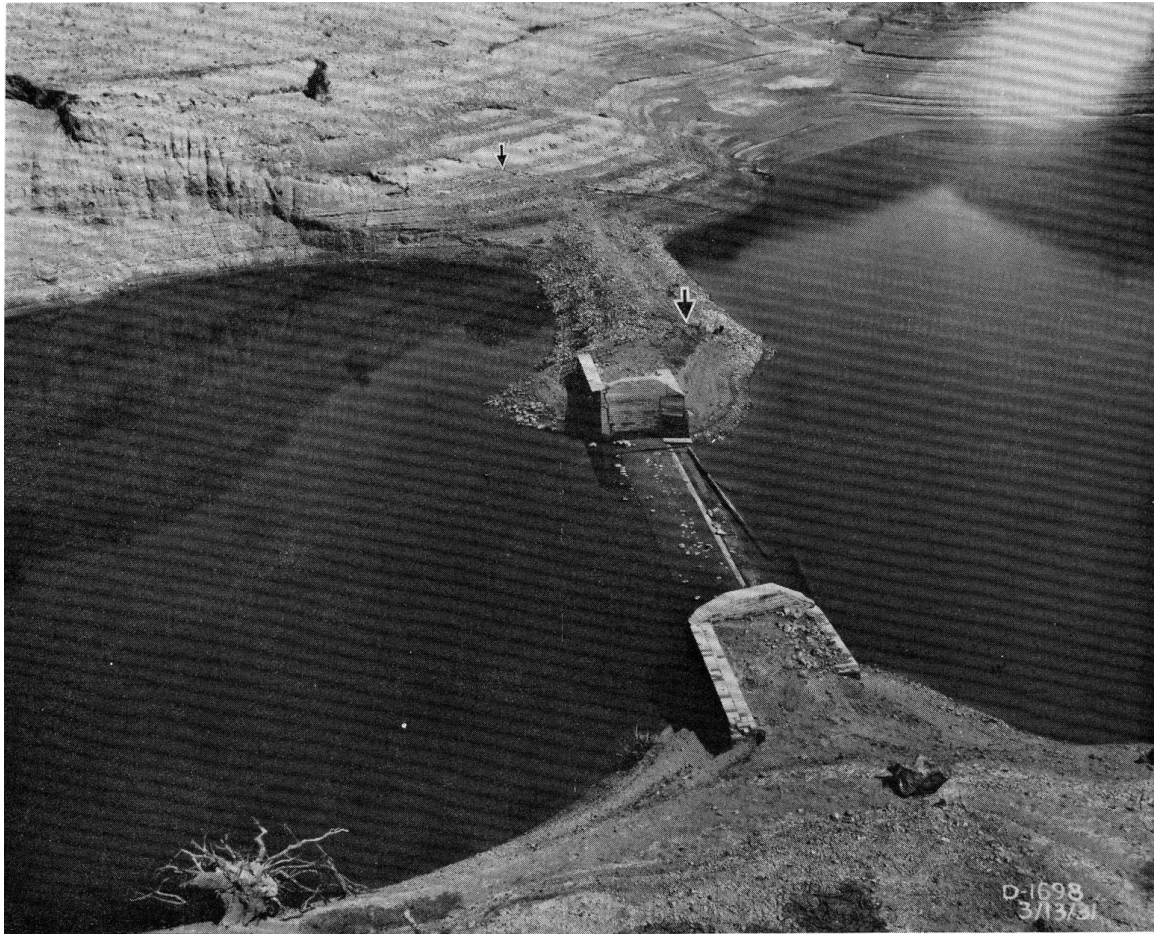
Figure 4.1.10-19. Hayward Dam, looking northeasterly (Photo: SFPUC)

Figure 4.1.10-19 shows remnants of the original Hayward dam. This dam was originally built as an earthen embankment, and was used before 1887. This photo was taken in 1931 during low water. The large opening reflects that the dam was bulldozed to form a single basin as part of the construction of the Lower Crystal Springs reservoir in 1888.

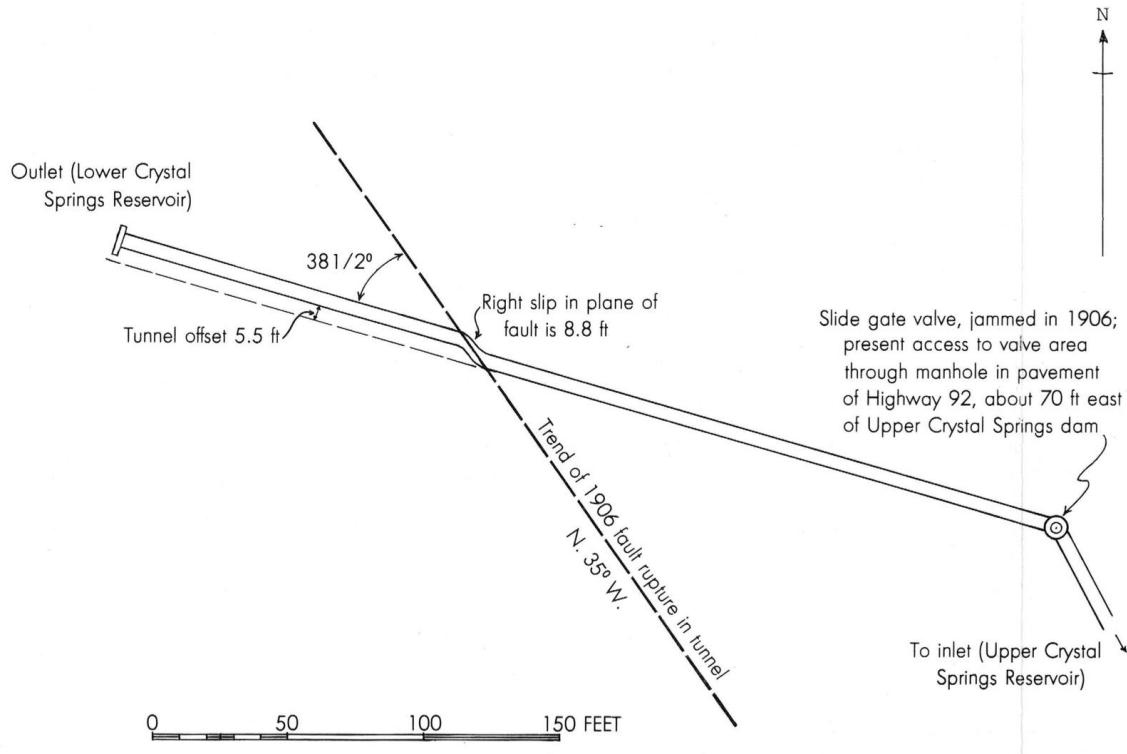
Figure 4.1.20-2. Tunnel Connecting Upper (southerly) and Lower (northerly) Crystal Spring Reservoirs (Credit: Pampeyan 1983)

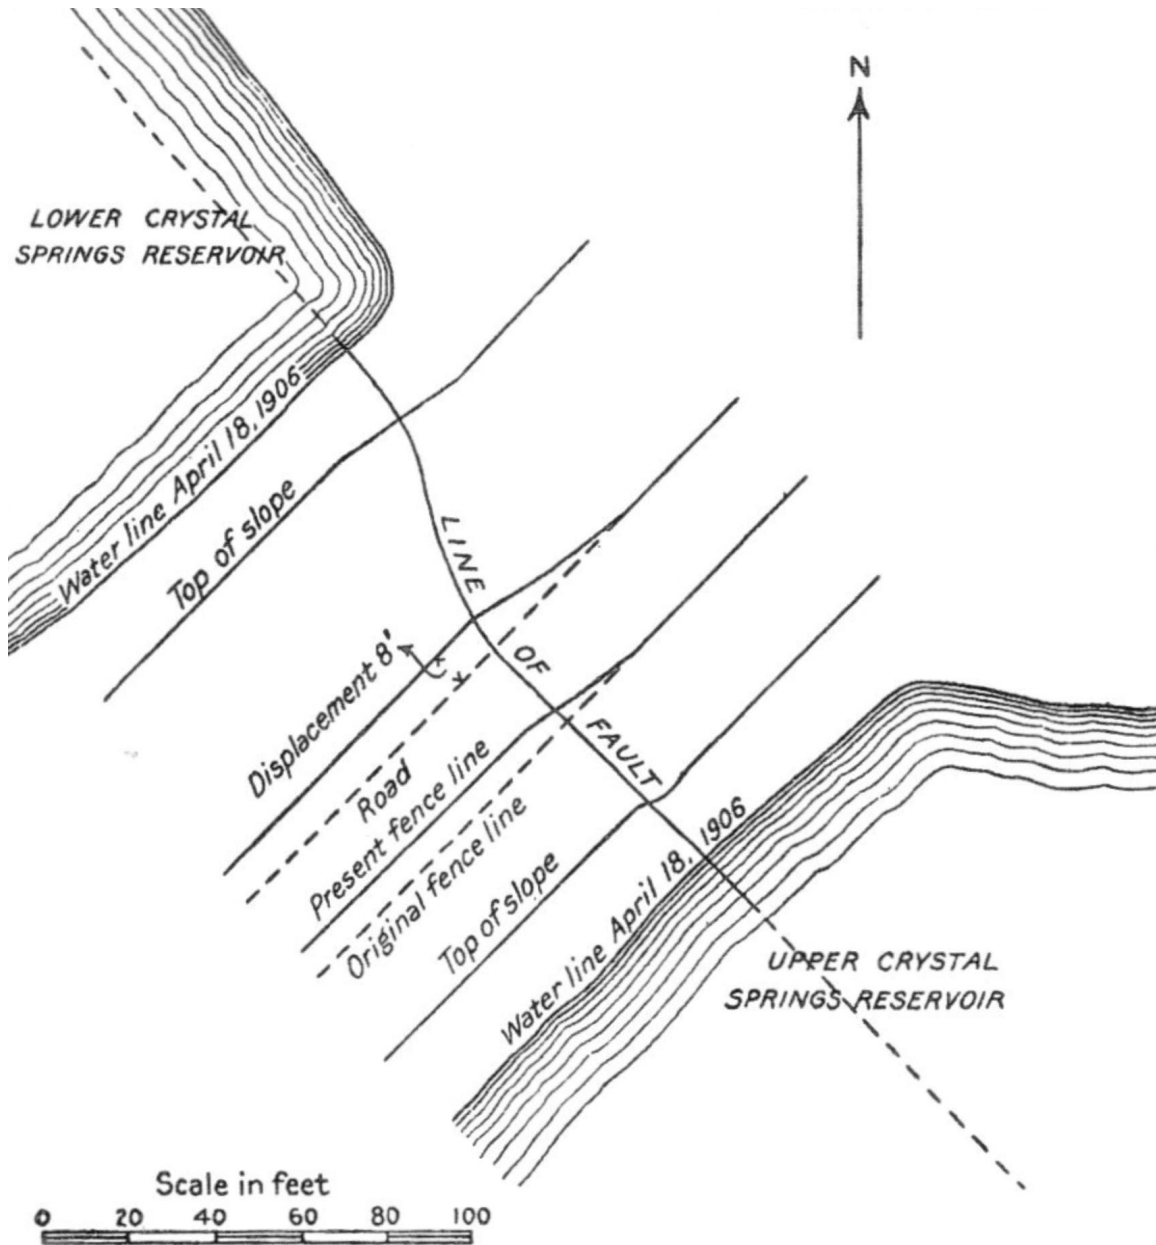
Figure 4.1.21-2. Upper Crystal Springs Dam, looking westerly (Credit: Schussler 1906)

Trending more easterly than the fault, the dam experienced compression during the slip event, causing the fence boards to bend and shorten and the telephone wires to sag. However locally, the right step or bend in the fault is a local releasing environment that probably contributed to the complexity of cracking in the eastern abutment area.

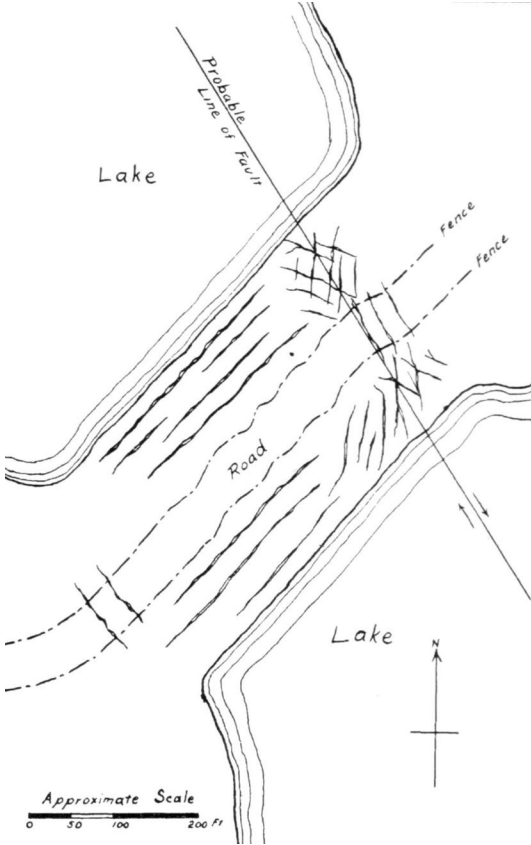
Figure 4.1.21-3. Upper Crystal Springs Dam, (Credit: Taber 1906)

Stephen Taber of Stanford University made his own measurements of the dam and published his findings in 1906, Figure 4.1.21-3. In this figure, Taber documents both the fault rupture location as well as the pattern of cracks that developed in the road surface and embankments. Cracks parallel to the long axis of the dam up to 6-inches wide developed in the embankments on both sides of the road; these cracks could be attributed to lurching or settlements of the embankment; but a pre- and post-earthquake survey of the elevation of the dam crest is not available, so the settlement of the dam is speculative. Taber also shows two sets of transverse cracks at both abutments. As the Lower reservoir (north of the dam) had the same water level at the Upper reservoir (south of the dam), the damage to the dam did not present any immediate life safety issue. Taber also reported that the road, where it crossed the fault at the northeast abutment area, was offset by about 6 feet of right slip. This translates to about 7 feet (after correcting for azimuth); this contrasts with Schussler's report of 8 to 9 feet; the discrepancy of Schussler's and Taber's offset amounts may reflect that Schussler measured the offset based on offset of the fences. Taber also reports: "the fences on both side of the road were broken in a number of places, and the unbroken boards were bent and arched so as to give a serpentine appearance to the fences. The wires of a telephone pole line crossing the dam sag in great loops". This is not at all surprising; given that the mapping (Pampeyan 1983) suggests about a 77° orientation of the fault strike versus the road alignment, which would impart some compression into the road assuming a perfect right lateral offset pattern. From a pipeline designer's point of view, should a new water (or other type) of pipe be installed across this dam (now called Highway 92), it should be evaluated for a primary offset of 7 feet over a width of perhaps a few feet (but knife edge offset is preferred for design), plus another 1 or 2 feet of distributed right lateral offset over a width of perhaps 25 feet either side of the primary offset, plus a shortening along the alignment of the pipe of 1 foot.

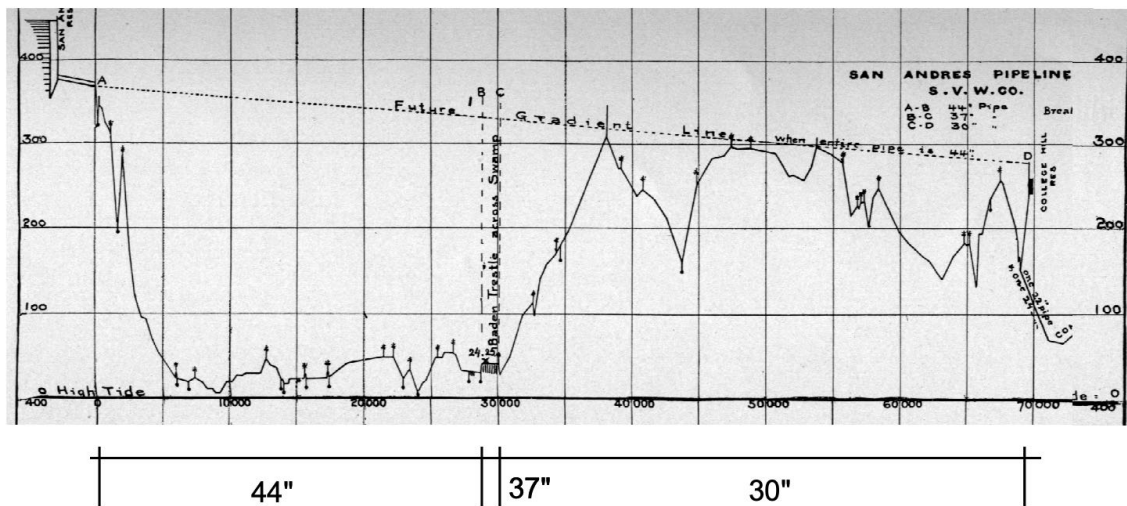
Figure 4.2-1. San Andreas Conduit Profile (Pipe diameter)

Figure 4.2-1 shows the profile of the San Andreas pipeline at the time of the 1906 earthquake. The numbers "24, 25" at the left side of the "Baden Trestle" over Colma Creek was the location of the broken pipe. This is near the south end of the Holy Cross Cemetery.

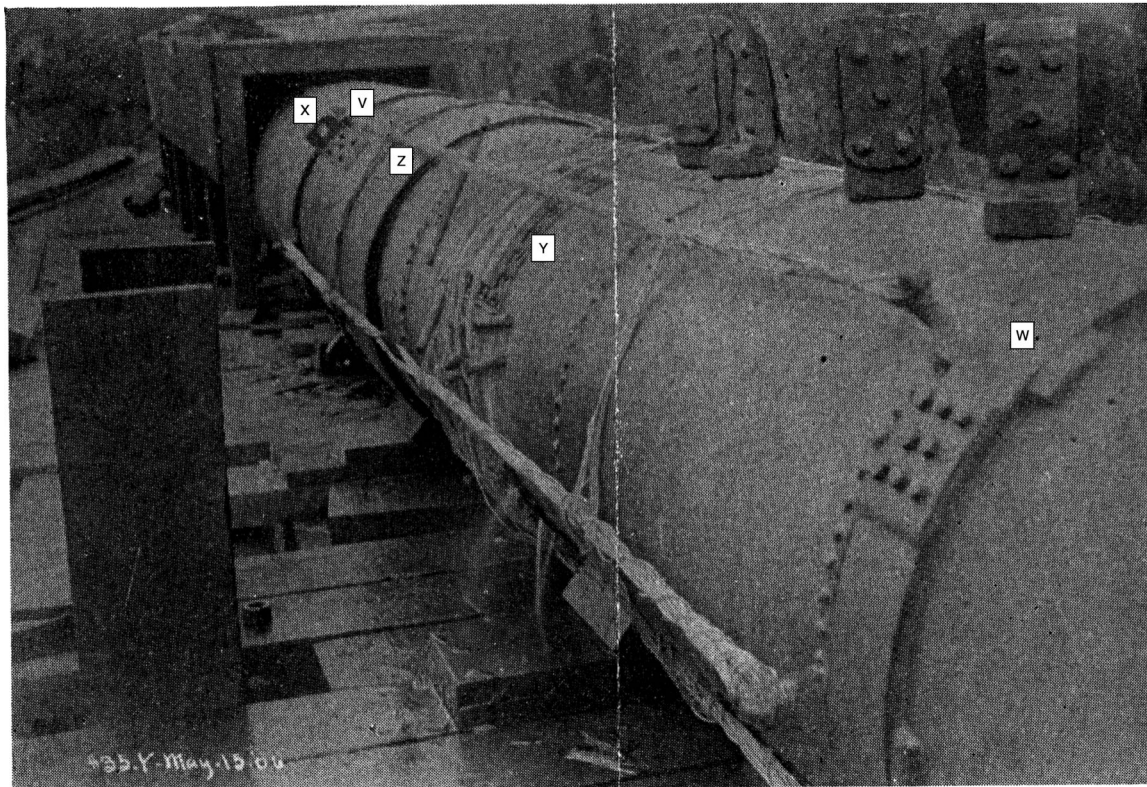
Figure 4.2-4. San Andreas Pipe Repair at Colma Creek Crossing (Credit Schussler 1906 HS24)

Figure 4.2-4 shows the repair of the 37" San Andreas pipeline atop a wood trestle at Colma Creek, near Baden. At this location, the pipe had a slip joint of the type seen on the Crystal Springs pipeline in the foreground in Figure 4.3-1. The slip joint was formed by inserting two ends of pipe into a larger-diameter steel ring, filled with lead. In this manner, the pipe could contract or expand perhaps a couple of inches or so. These slip joints were used by Schussler adjacent to valves (for purpose of assisting replacement / maintenance of the valve), or along long reaches of above ground pipe (for thermal expansion growth / contraction purposes). Exterior wire ropes were attached to the pipe either side of the slip joint to provide some axial restraint.

At the Baden crossing, the damage consisted of 4 iron lugs that had been torn off by the earthquake, for example see the lug at point "X" in Figure 4.2-4. When the lugs were torn off, they left behind 4 ragged holes in the pipe, each about 8"x 10". The holes were closed by installing patch plates at "Y"; the plates were from an old pipe, put on with tap bolts and rubber gaskets. The assembly was then strapped with wires, thereafter the slip joint at "Z" was straddled by 6 wire ropes between bands "V" to "W".

From Schussler's description of the damage and repair at Baden, it can be interpreted that the 37" pipe originally had a slip joint at "Z" that was reinforced longitudinally by tie

rods that were attached to the pipe "ears". During the earthquake, the pipe either moved to open at the slip joint (due to long reach of continuous pipe with a single slip joint due to travelling wave phenomena), or bent sideways due to inertial loading of the pipe on the trestle. The travelling wave phenomena is the preferred explanation as to why the joint tried to open during the shaking. As the joint opened, the tie rods underwent tension to try to limit the opening; clearly, the "ears" were put into high tension, and the rivets that held the ears and underlying plate to the main pipe were grossly overloaded and sheared off at the 4 locations.

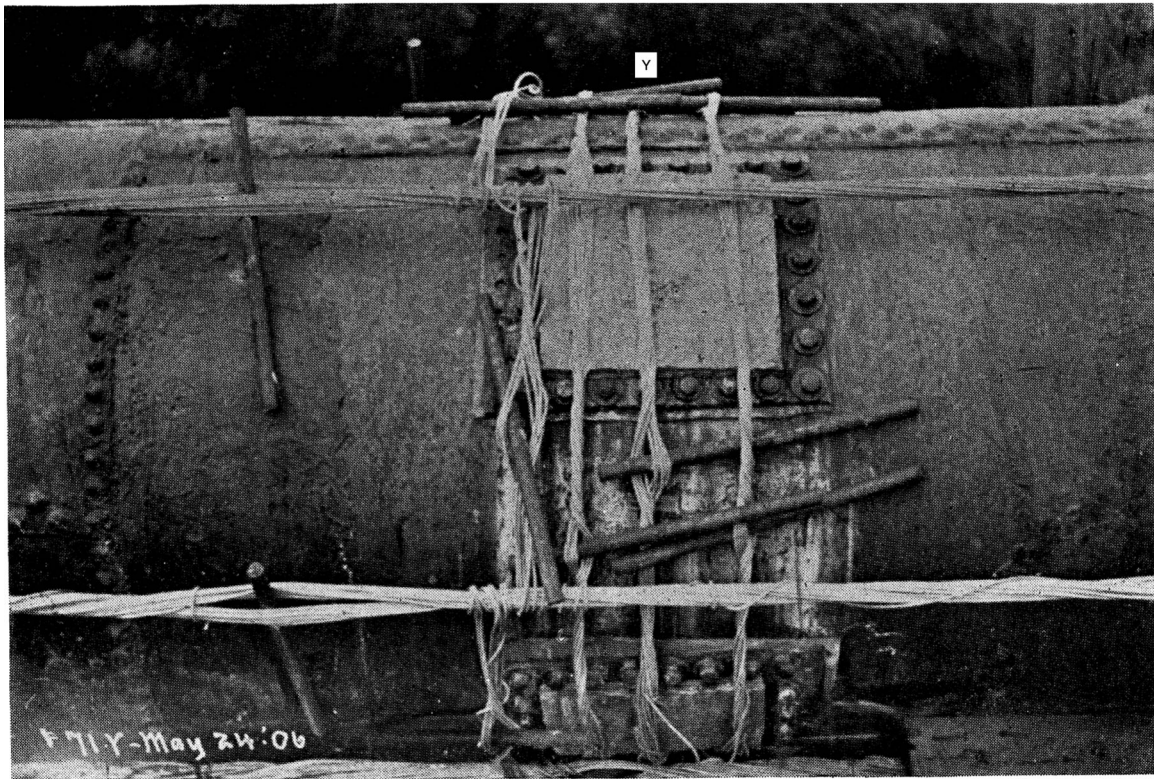
Figures 4.2-5 and 4.2-6 show the repaired 37" wrought iron San Andreas pipeline at point "Y".

Figure 4.2-5. San Andreas Pipe Repair at Colma Creek Crossing (Credit: Schussler 1906 HS25)

Figure 4.2-6. San Andreas Pipe Repair at Colma Creek Crossing (Credit: ASCE 1907)

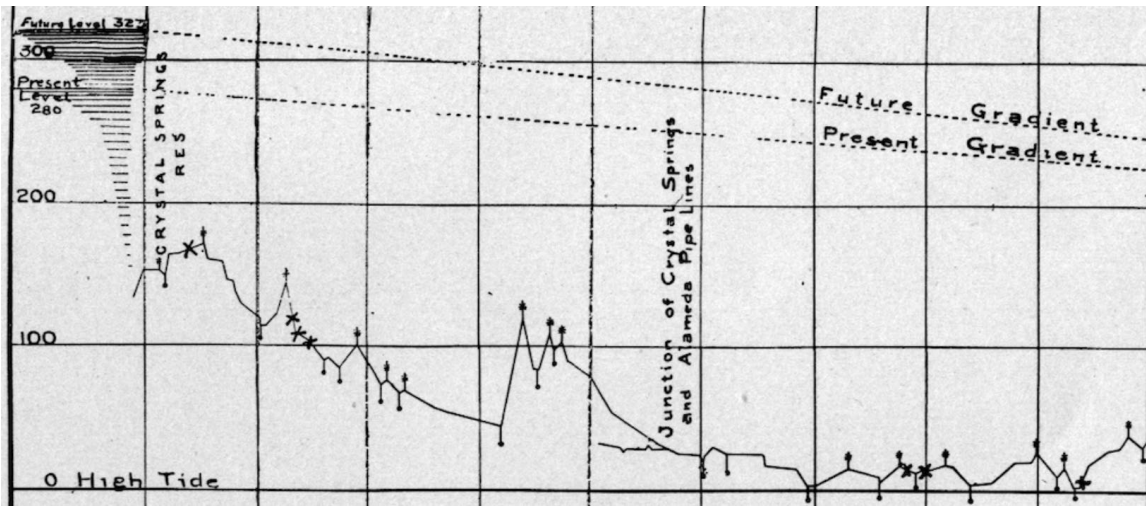
Figure 4.3-4. Location of Upper Crystal Springs 44" Pipeline Damage ("X"s) (Schussler 1906)

Figure 4.3-4 shows locations of 7 spots ("X"s) of damage on the 44" pipeline between the dam outlet and south of the Millbrae pump station.
