History of the Water Works of San Francisco, Its Performance in the 1906 Earthquake and Aftermath

John M. Eiding and N. Timothy Hall

December 19, 2023

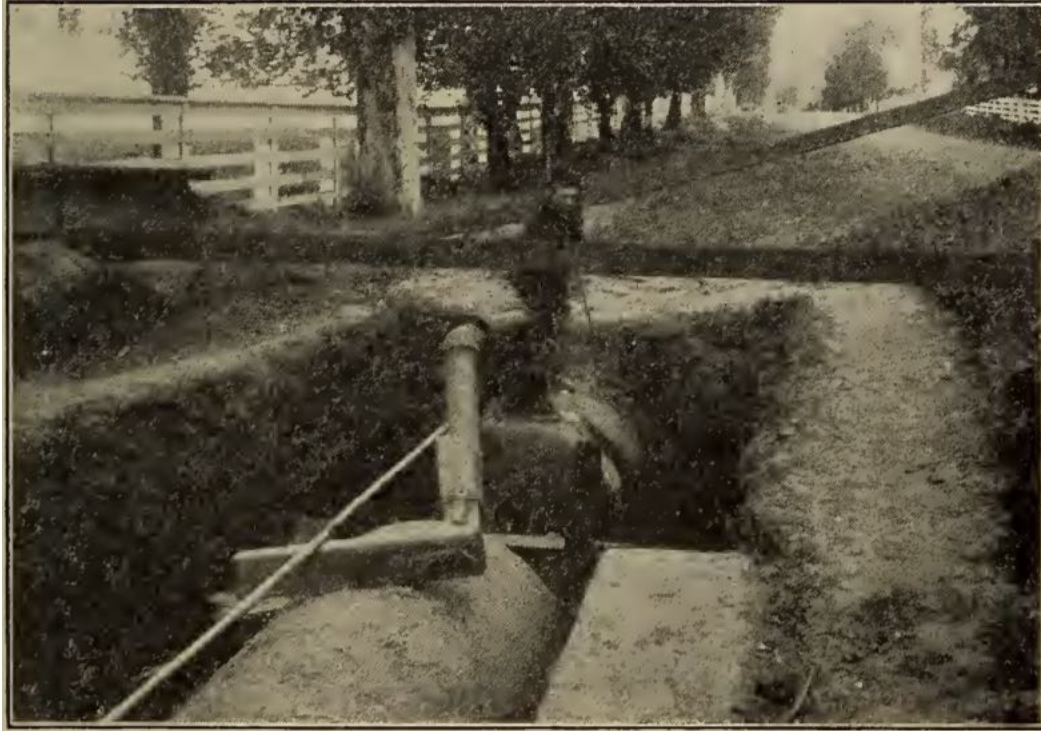
Figure 4.3-5. Crystal Springs Pipeline between San Mateo and Millbrae (Photo: Derleth, 1907)

Figure 4.3-5 shows an exposed segment between San Mateo and Millbrae, soon after the earthquake. Here, the buried pipe has been exposed and isolated to stop the flow northwards towards San Francisco, and thus maintain pressure and supply for the City of San Mateo.

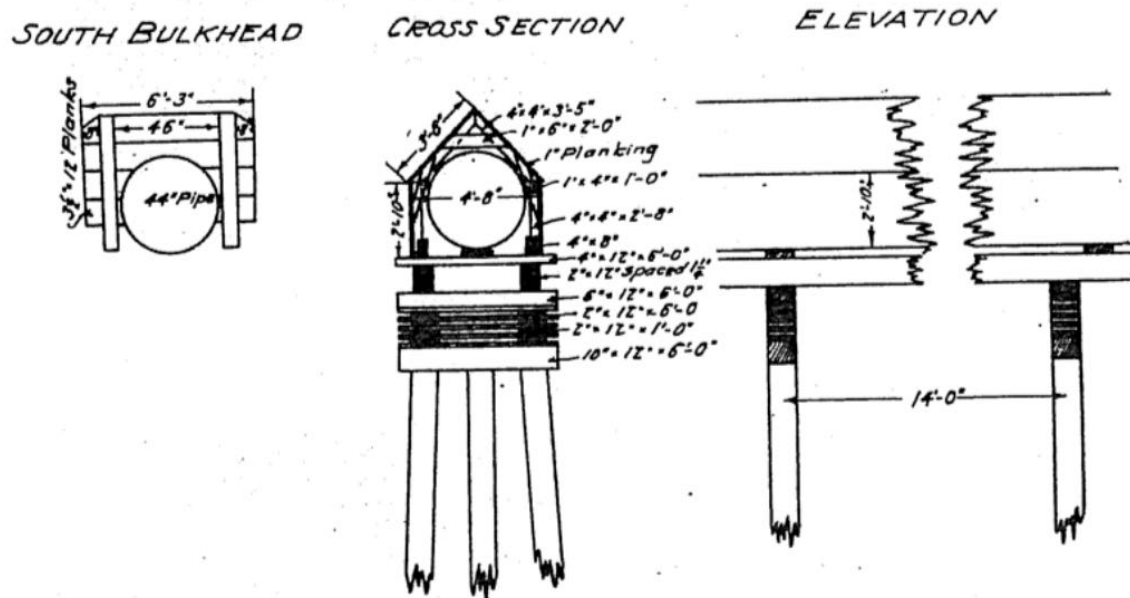
Figure 4.3-7. Crystal Springs Trestle 12 (3,039 feet long)

Trestle 12 is 3,038.9 feet long, see Figure 4.3-7. It consists of wood pile supports spaced at 14 feet.

- Buried section, parallel to and just north of San Mateo Creek, to the east of the Lower Crystal Springs Dam. Damaged at 7 locations.
- Trestle 12, across San Bruno Marsh (Colma Creek). Worst damage, over a length of about 1,600 feet (variously reported as 1,300 feet). Here, the pipe rested on a wooden floor, supported by pile bents. The pipe penetration was commonly 40

feet. After the earthquake, the pipe was replaced atop a re-built trestle, taking 28 days. The trestle had to be rebuilt, as many of the timbers had rotted. Few (if any) of the piles had to be rebuilt. Humphrey (in Lawson 1908) reported that the where the Crystal Springs 44" pipeline failed atop a trestle crossing Colma Creek, the pipe had telescoped 42 inches, shearing off a 8" gate valve. Along the long trestle through the San Bruno marsh, the 44" pipe was thrown off the trestle by 4 to 5 feet, either in a easterly or westerly direction.

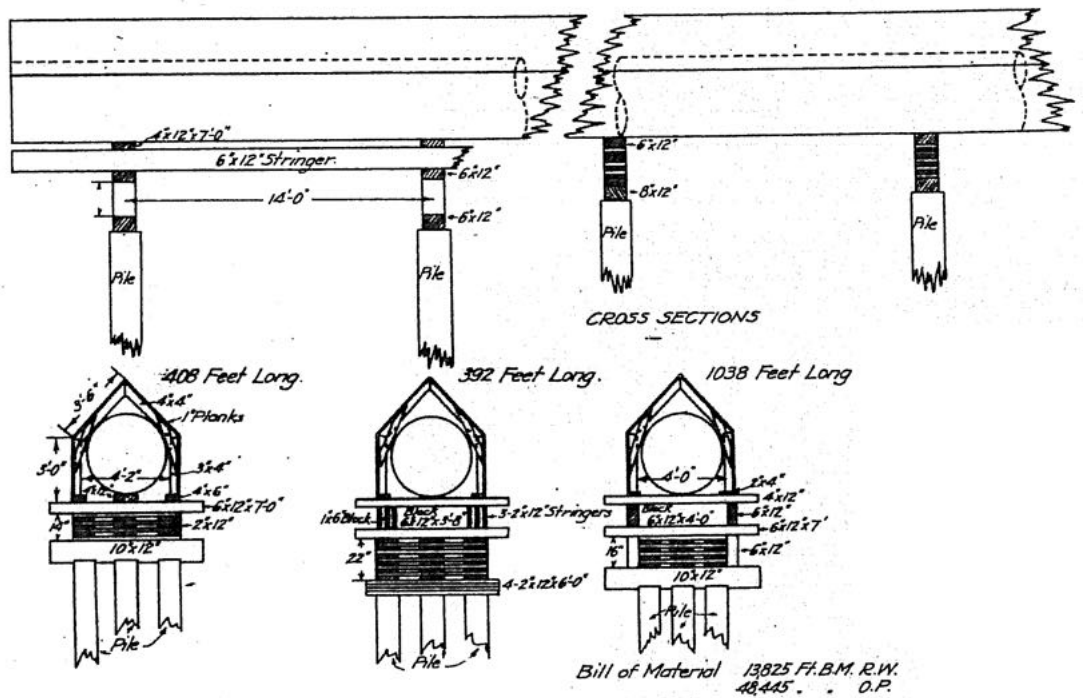
Figure 4.3-8. Crystal Springs Trestle 17 (1,961 feet long) Guadalupe Valley

Figures 4.3-8 and 4.3-9 show the details of the wood trestle that supported the pipe through Guadalupe and Visitacion Valleys, respectively. The pipe failed at multiple locations atop both these trestles. The trestle details are very similar to those at Trestle 12, where the pipe also failed at multiple locations. There are 140 support bents (Guadalupe), or 54 support bents (Visitacion Valley) at 14-foot spacing. The available historical evidence suggests that the pipe had restrained slip joints at about 500-foot spacing, or likely at about 4 locations along these two trestles. Under high lateral inertial loading, the pipes would impart high lateral loads on the longitudinal stringers, which would have a tendency to roll over.

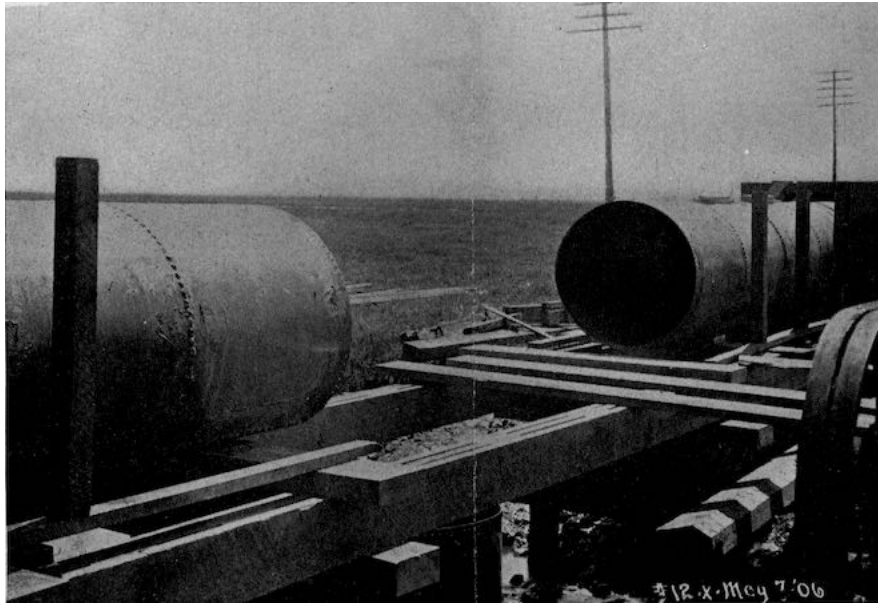
Figure 4.3-11. Crystal Springs 44" at San Bruno Marsh, showing repair process. Photo viewing southeasterly. (Photo: Schussler HS21)

Figure 4.3-11 shows the 44" Crystal Springs pipe atop the trestle at San Bruno Marsh. The blocking and stringers are made of 2-inch thick wood planks. The riveted girth joint indicates 80 rivets for about the circumference. The handrail in the foreground is for a steel bridge. This photo was taken May 7, 1906, 20 days after the earthquake: the repair of the pipe is then about two-thirds complete.

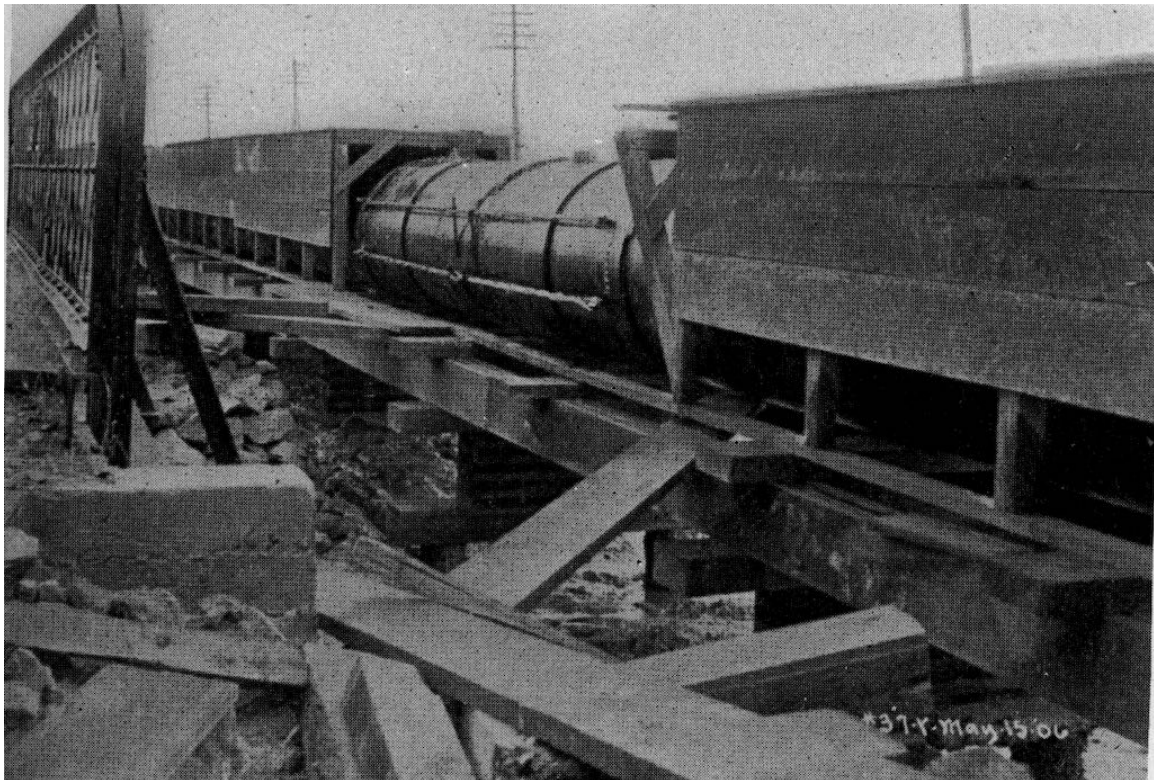
Figure 4.3-13 shows a flexible joint installed along the pipe, with the photo taken a few days later, at the same location as Figure 4.3-10. This joint is similar to that used for the 37" San Andreas pipe across Colma Creek. The ropes used to restrain the expansion joint are made of four 1"Ø galvanized wires. The slip joint is packed with lead.

Figure 4.3-13. Crystal Springs 44" at San Bruno Marsh, showing original pile foundation and caps. The plank stringers and blocking are made of 2x12 redwood, spiked cross and lengthwise and 6x12 pine caps. (Trestle 12) (Photo: Schussler 1906 HS23)

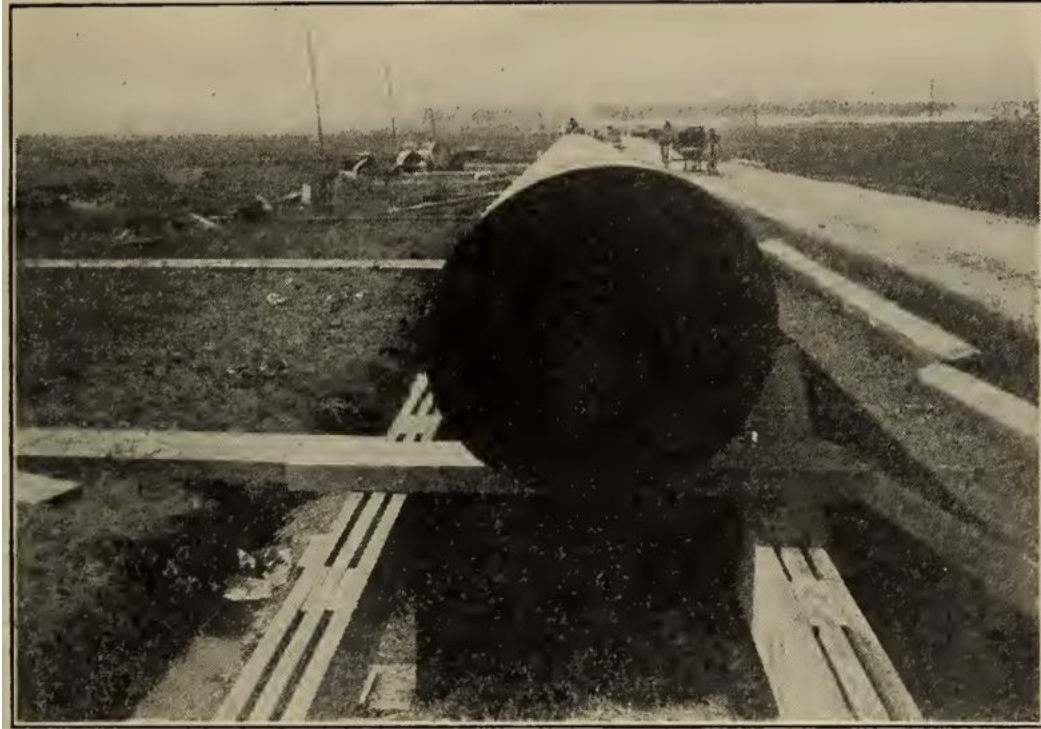
Figure 4.3-14. Crystal Springs 44" at San Bruno Marsh, during the repair process (Photo: Derleth 1907)

Figure 4.3-14 shows the damaged Crystal Springs pipeline during the restoration process (about May 2, 1906) where it has already been placed back atop the trestle in the San Bruno Marsh area. The open pipe is awaiting connection, likely with a slip joint. The wood “box housing” has not yet been installed.

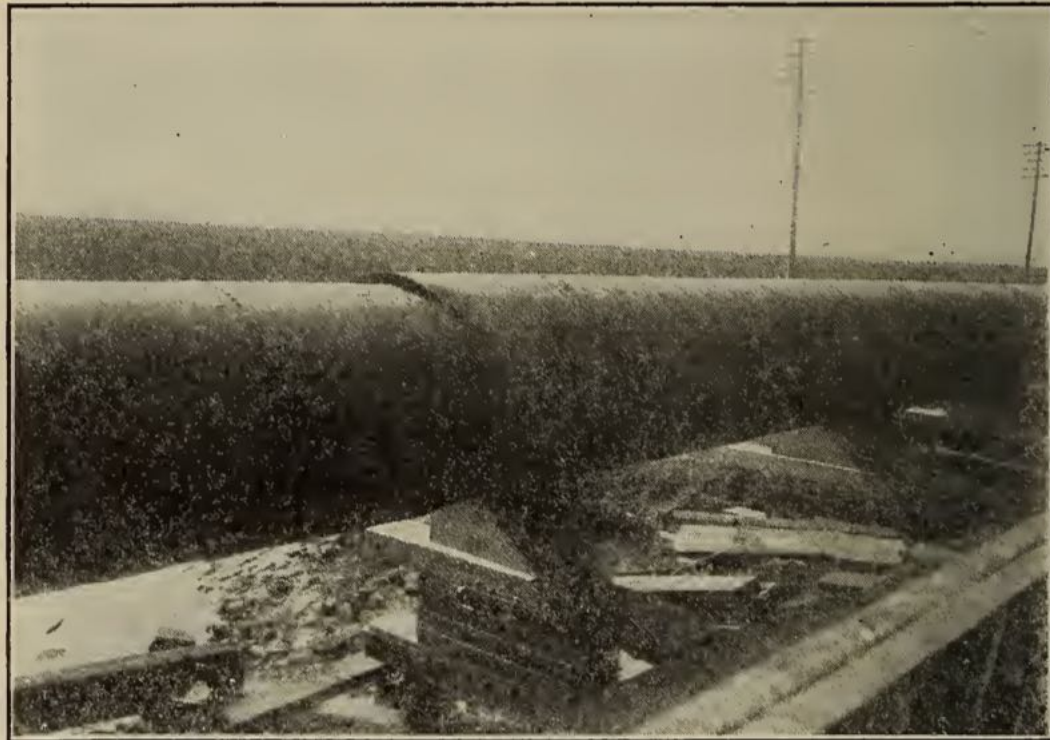
Figure 4.3-15 shows the Crystal Springs Pipeline repair process as of May 2 1906. Here, the riveted pipe segments that had fallen off the damaged trestle, have been restored atop temporary stacked wood supports akin to the detail in Figure 4.3-7; and two segments of the pipe have been positioned awaiting connecting the girth joints by rivets. Redwood planks were sometimes used for the temporary sills and stringers in part because larger timber was not quickly available.

Figure 4.3-15. Crystal Springs 44" at San Bruno Marsh, during the repair process (Photo: May 2, 1907 Derleth)

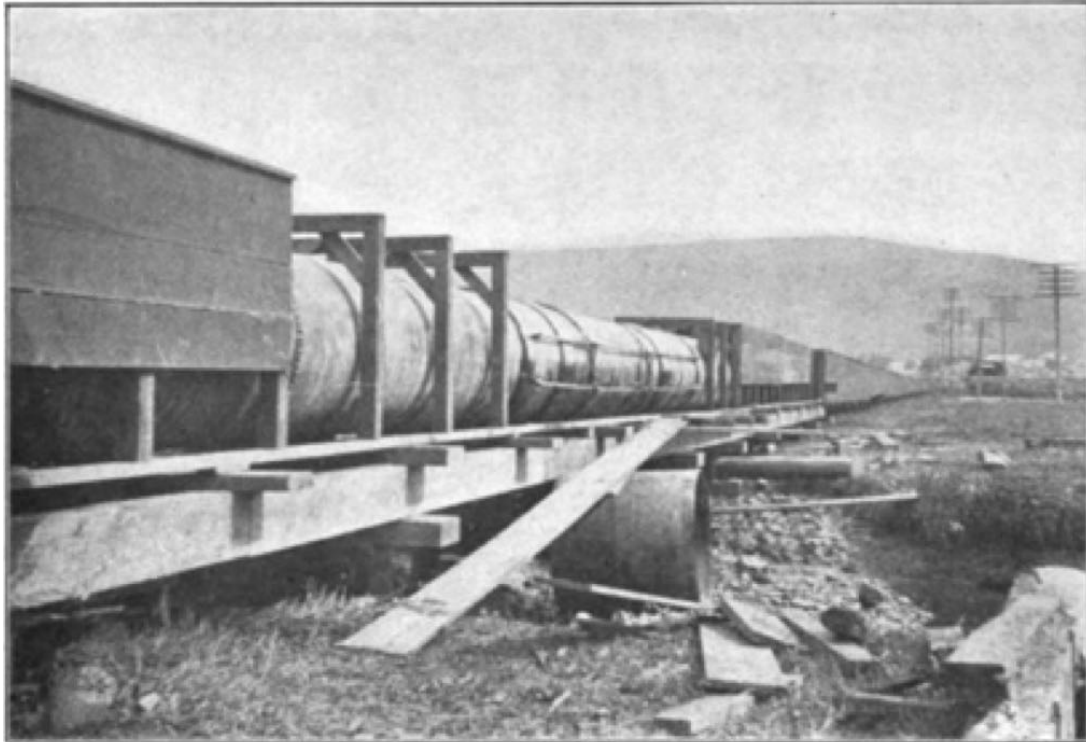
Figure 4.3-16. Crystal Springs 44" at San Bruno Marsh, during the repair process (Photo: ASCE 1907)

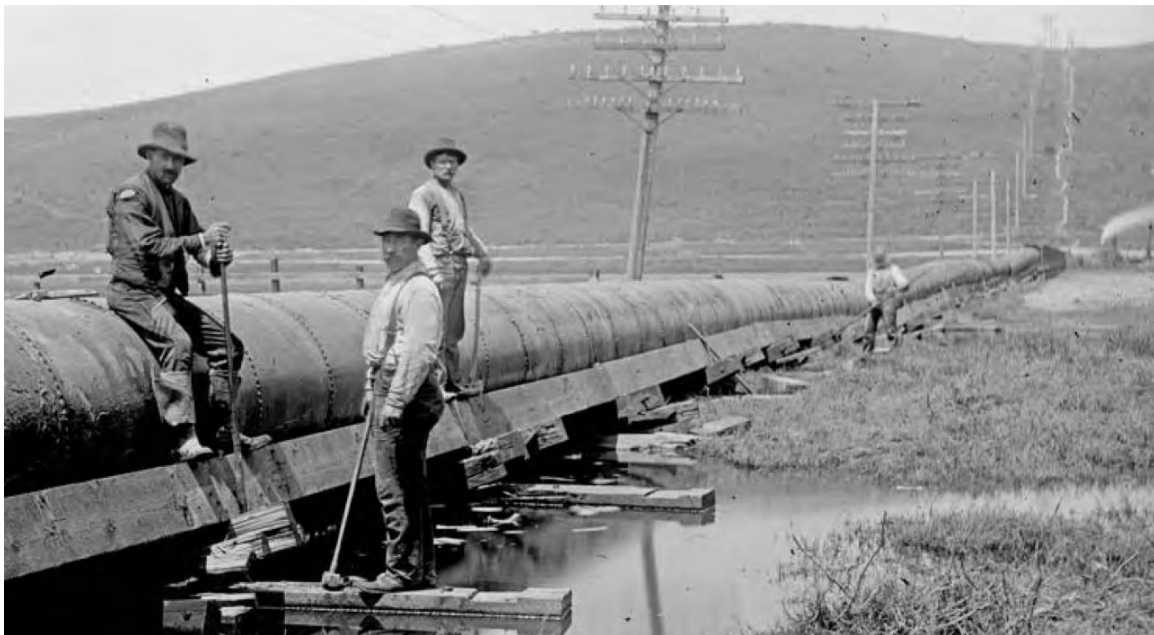
Figure 4.3-17 shows the 44" pipeline after the 1906 earthquake. The photo is taken looking north, with San Bruno Mountain in the background.

Figure 4.3-17. Crystal Springs Pipeline after the 1906 Earthquake, through San Bruno Marsh (Photo: SFPUC)

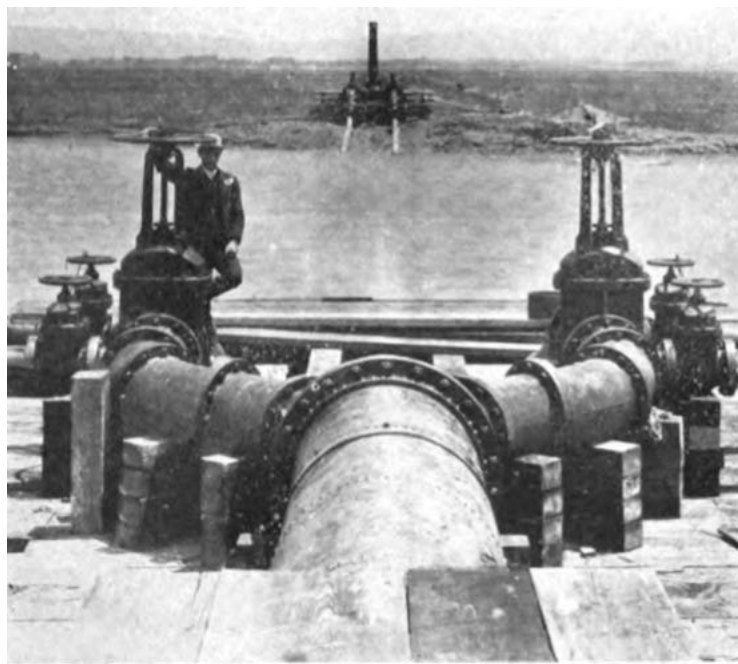
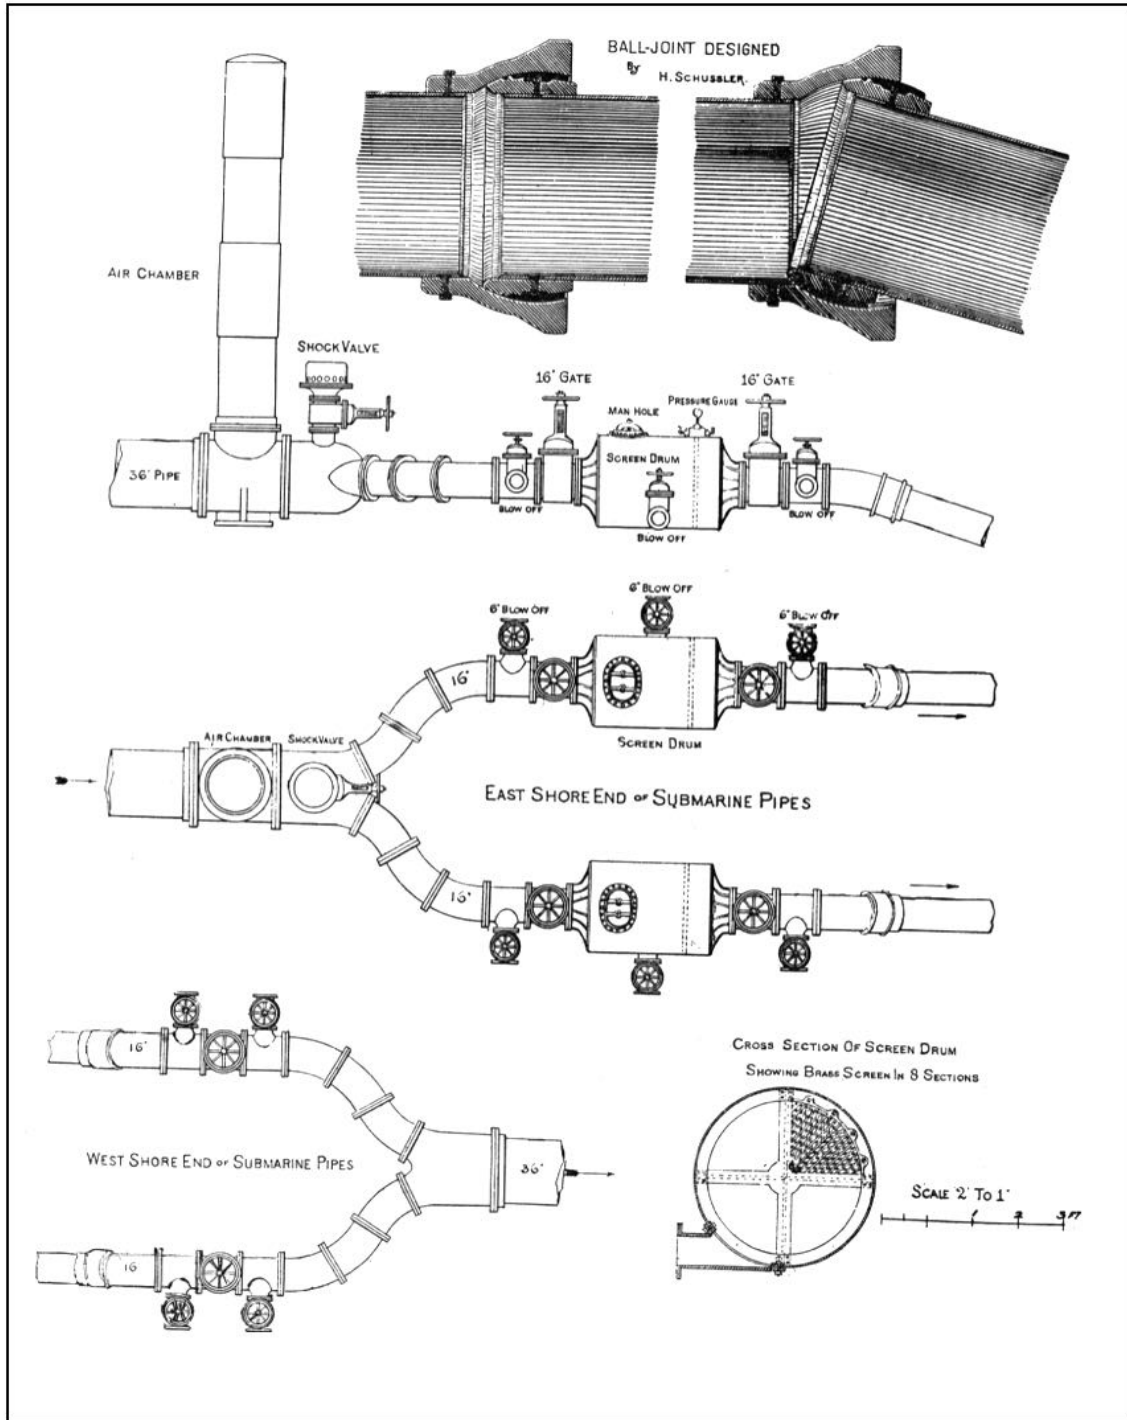
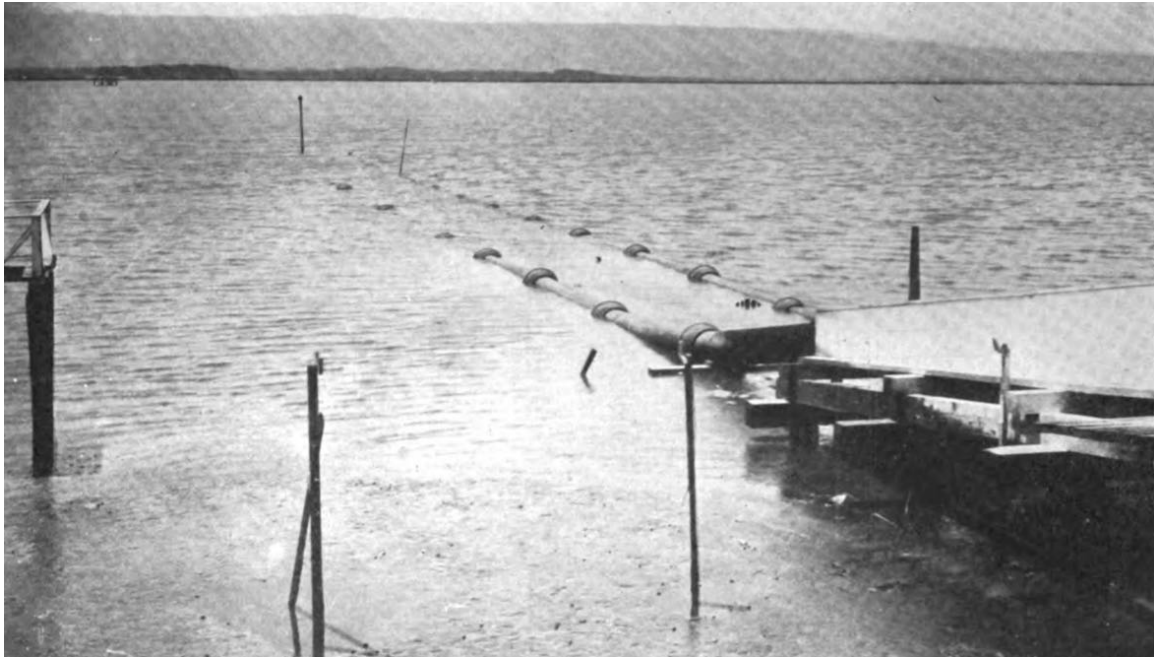
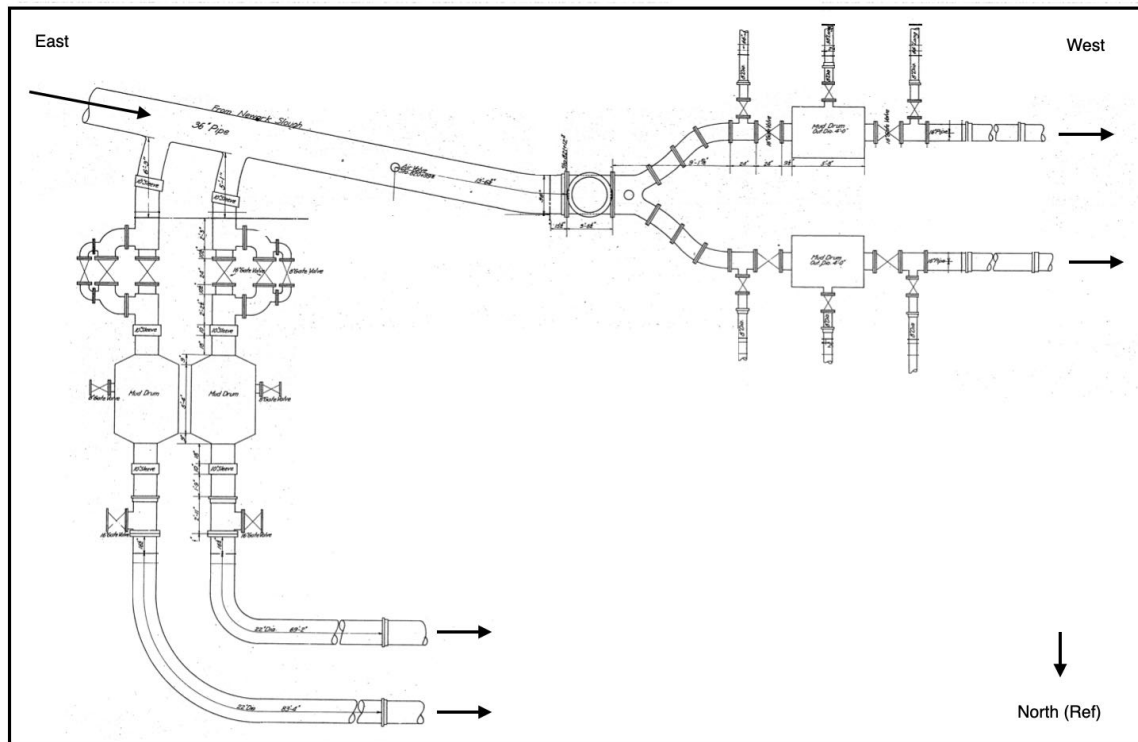
While none of the submarine pipes broke in the 1906 earthquake, subsequent surveys showed that the underwater pipe alignments (by 1950) were anything but straight: some ball joints were rotated to their 15° limits. Whether such movement was due to the earthquake (like a lateral spread) or due to the ongoing movements of the Bay sediments slowly over time, is unknown.

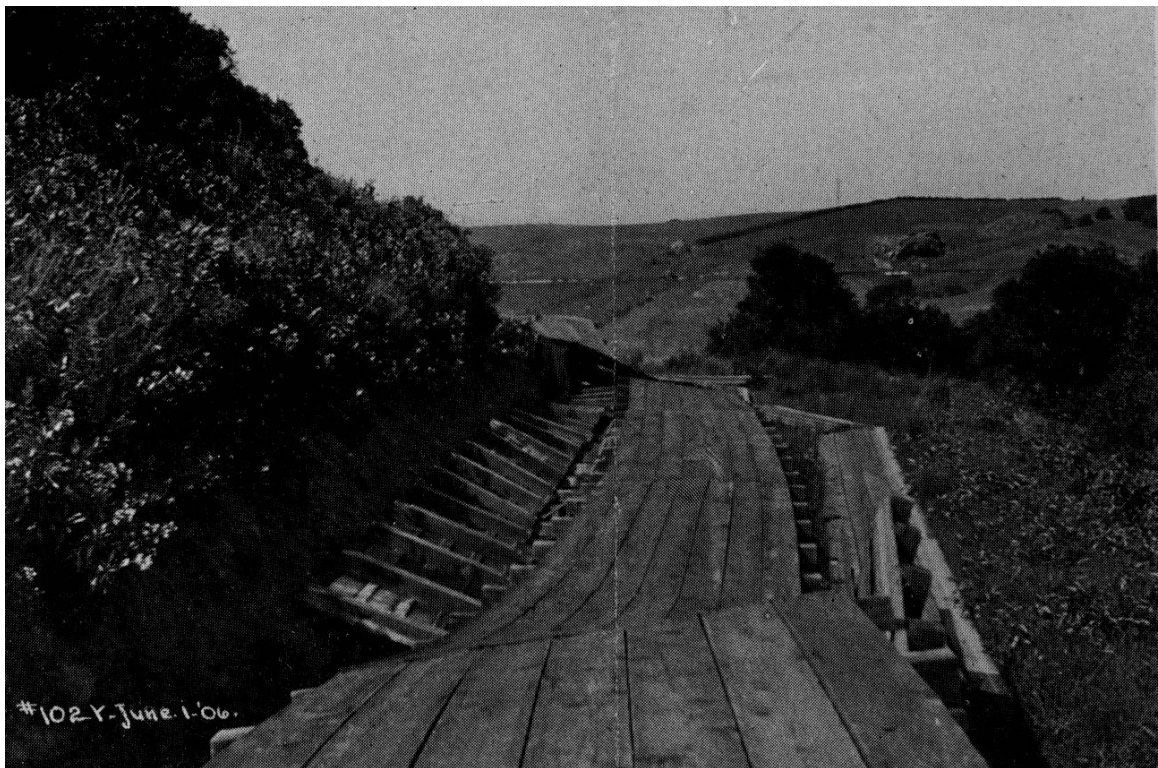
Figures 4.6-3, -4 show another wooden flume that collapsed due to inertial forces. Schussler inconsistently notes that this flume (about 6' wide and 4' high) is on the opposite side of the San Andreas Valley as the fault rupture, and also on the east side of the San Andreas Valley (both cannot be true). In the distance the linear feature is believed to be the Crystal Springs to San Andreas flume (Number 7 in Figure 4.6-1).

We interpret the correct location as being along the flume section denoted "6" in Figure 4.6-1. The manner of failure appears similar to that in Figure 4.1.12-10, with the flume collapsing sideways to the east, probably due to inertial forces. This appears to be an inertial failure; although it is possible it was initiated or aggravated by a landslide under this section.

Figure 4.6-3. Failure of Pilarcitos Waste Water Flume to San Andreas Reservoir, Looking Northerly (Photo: Schussler 1906 HS47)

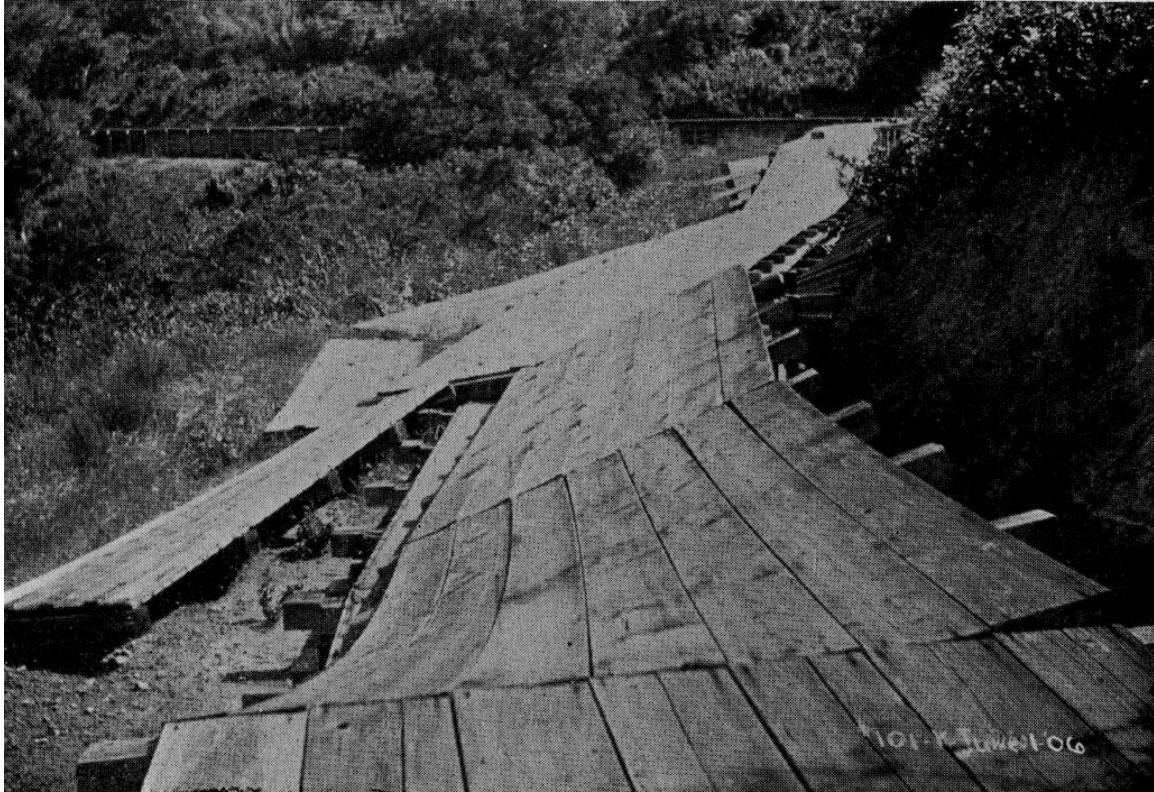
Figure 4.6-4. Failure of Pilarcitos Waste Water (Side) Flume to San Andreas Reservoir, Looking Southerly (Photo: Schussler 1906 HS48)

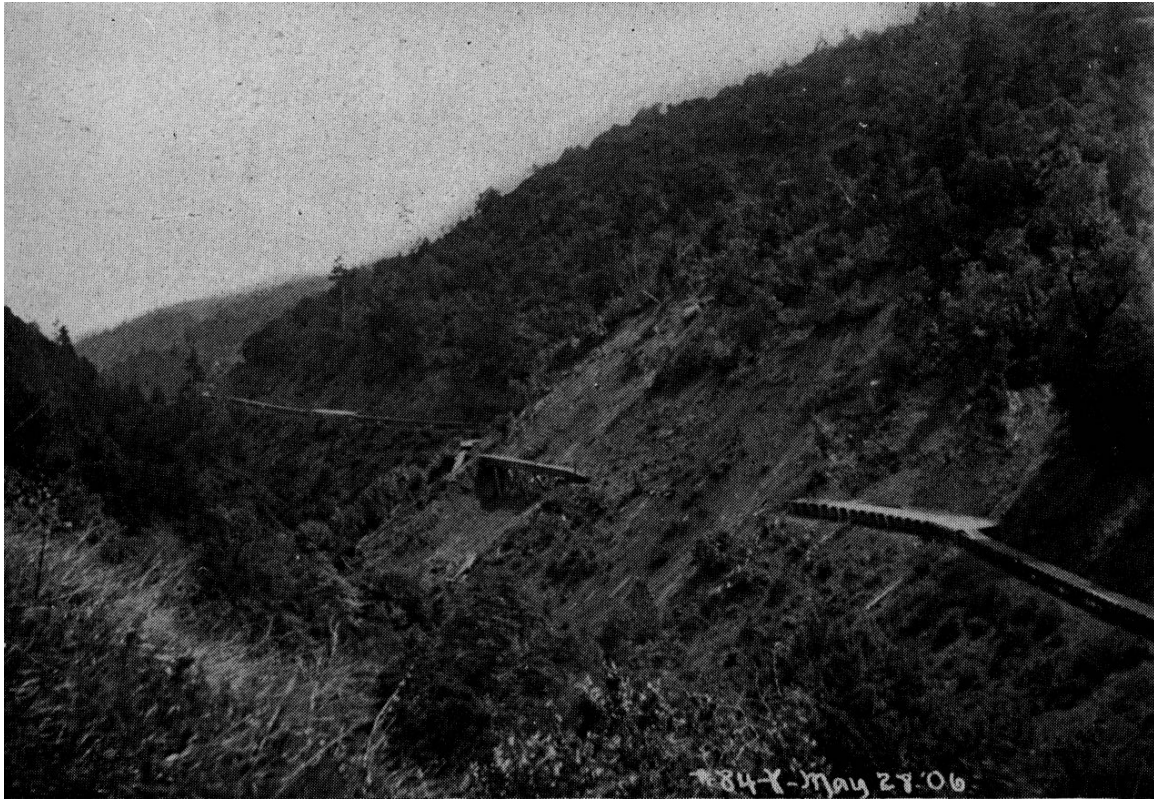
Figure 4.6-5 shows the collapse of a flume section that Schussler described as being in Upper San Mateo Creek canyon. Based on the V-shaped valley we believe this to have occurred along flume section Number 5 in Figure 4.6-1.

Figure 4.6-5. Collapse of Pilarcitos Side Flume between (here 5' x 3') in Upper San Mateo Canyon. Photo dated May 27 1906. (Photo: SVWC).

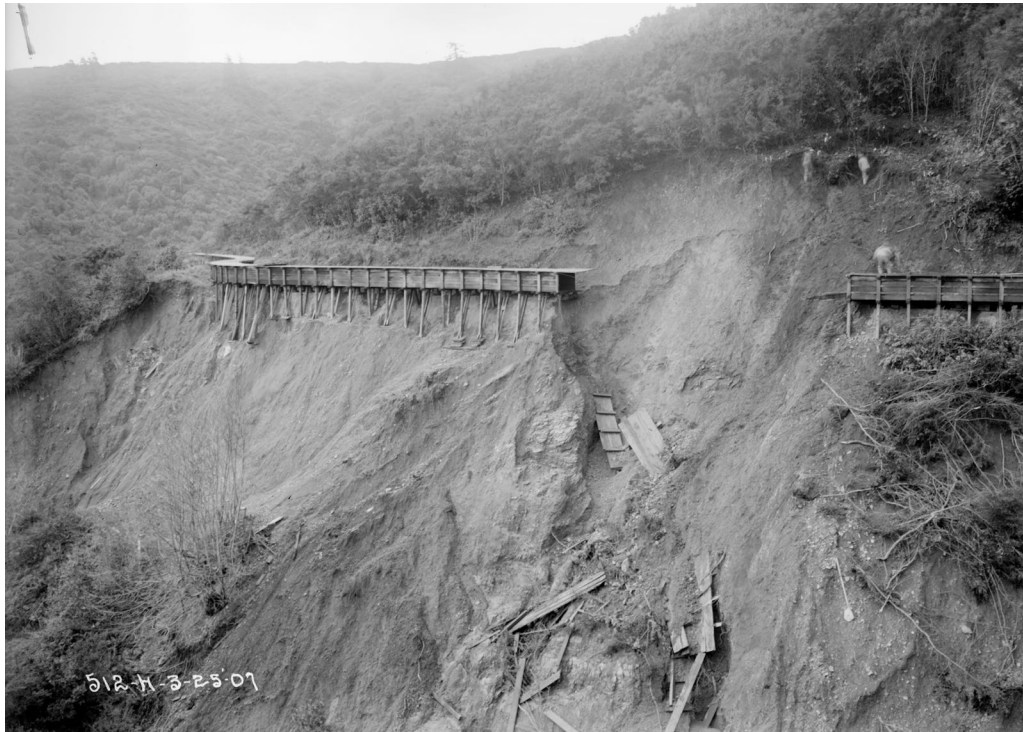
Landslides along the Locks Creek flumes were not uncommon. Figure 4.6-6 shows another landslide failure from March 1907. It is uncertain if this landslide was initiated by the 1906 earthquake, or sometime in the following year's rainy season. It is believed this failure occurred in the Upper San Mateo Creek Canyon (No 5 in Figure 4.6-1) or possibly the Pilarcitos Side Flume (No. 8 in Figure 4.6-1). Figure 4.6-7 shows the repaired flume.

Figure 4.6-6. Collapse of Flume due to Landslide. (Photo: SVWC, 1907).

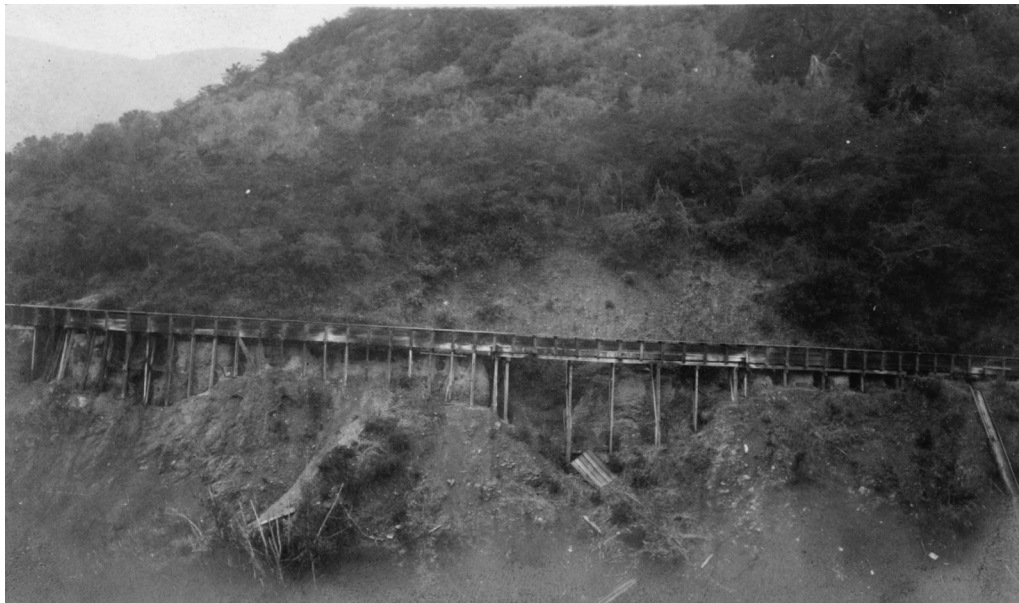
Figure 4.6-7. Repair of Flume. (Photo: SVWC).

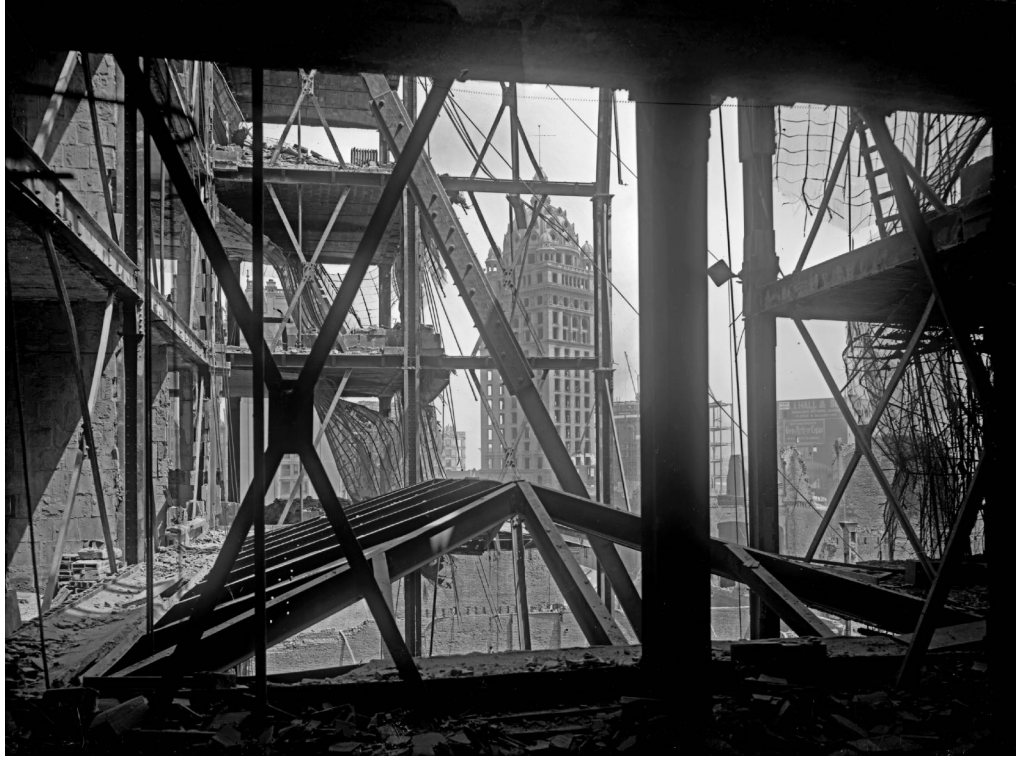
The building had a steel skeleton (Figure 4.7-2). Partitions, column protection and floor arches were made of hollow clay tile. Many floor arches failed. Many clay tile walls failed. The 2-inch thick tile on columns generally failed (see Figure 4.7-3). The columns in the southeast corner of the building buckled, and the upper floors collapsed.

Figure 4.7-2. Interior of SVWC Office Building after 1906 earthquake. Call building in the background. (photo: Courtesy Mike Housh, SF Historian)

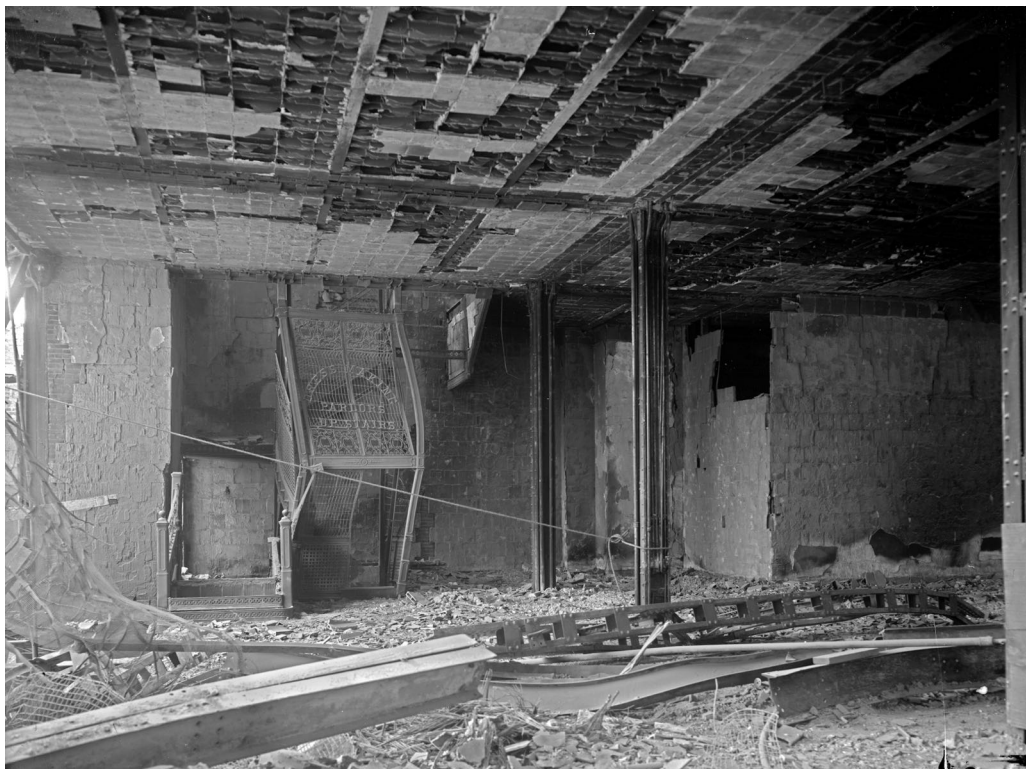
Figure 4.7-3. Interior of SVWC Office Building after 1906 earthquake (photo: Courtesy Mike Housh, SF Historian)

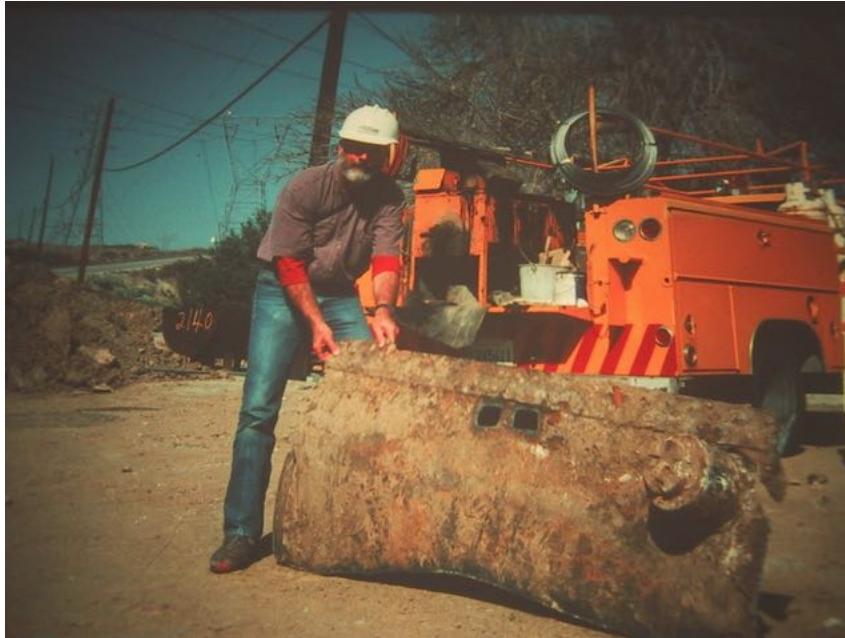
LADWP. The Los Angeles Aqueduct Number 1 (233 miles long) was built between 1908 and 1913; Number 2 was built 1970 (177 miles long). Both Aqueducts were damaged in the 1994 Northridge earthquake (Eidinger and Avila, 1999a). The type of damage included failed riveted pipe, as well as failed canal segments, failed concrete pipe segments, failed single lap welded steel segments. Figures 6-1 and 6-2 shows the Author, Tim Hall, holding a damaged large diameter LADWP riveted steel pipe; this segment of pipe was in the San Fernando Valley, and was exposed to very strong shaking in the 1994 Northridge earthquake.

Figure 6-1. Tim Hall with Segment of Damaged LADWP Riveted Pipe, 1994

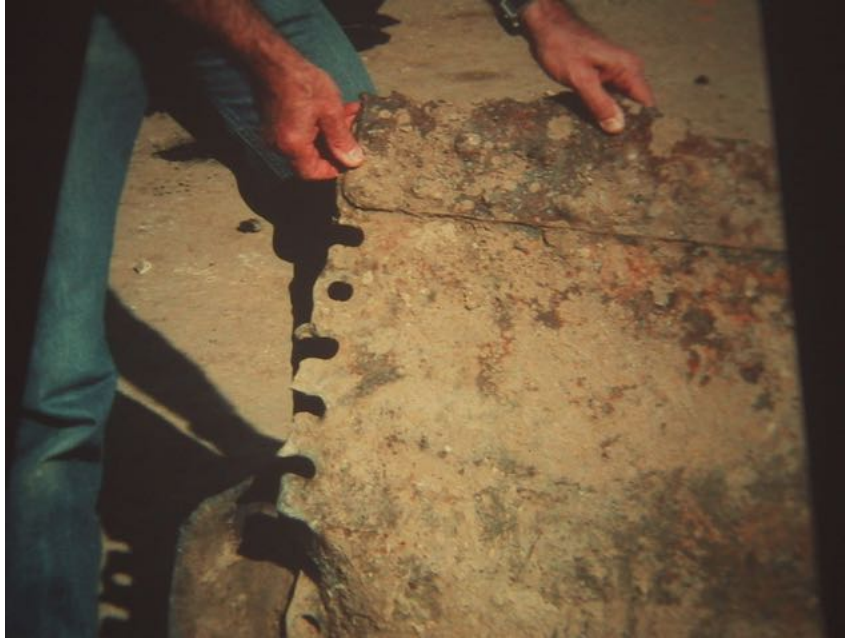
Figure 6-2. Close Up View of Damaged LADWP Riveted Pipe, 1994

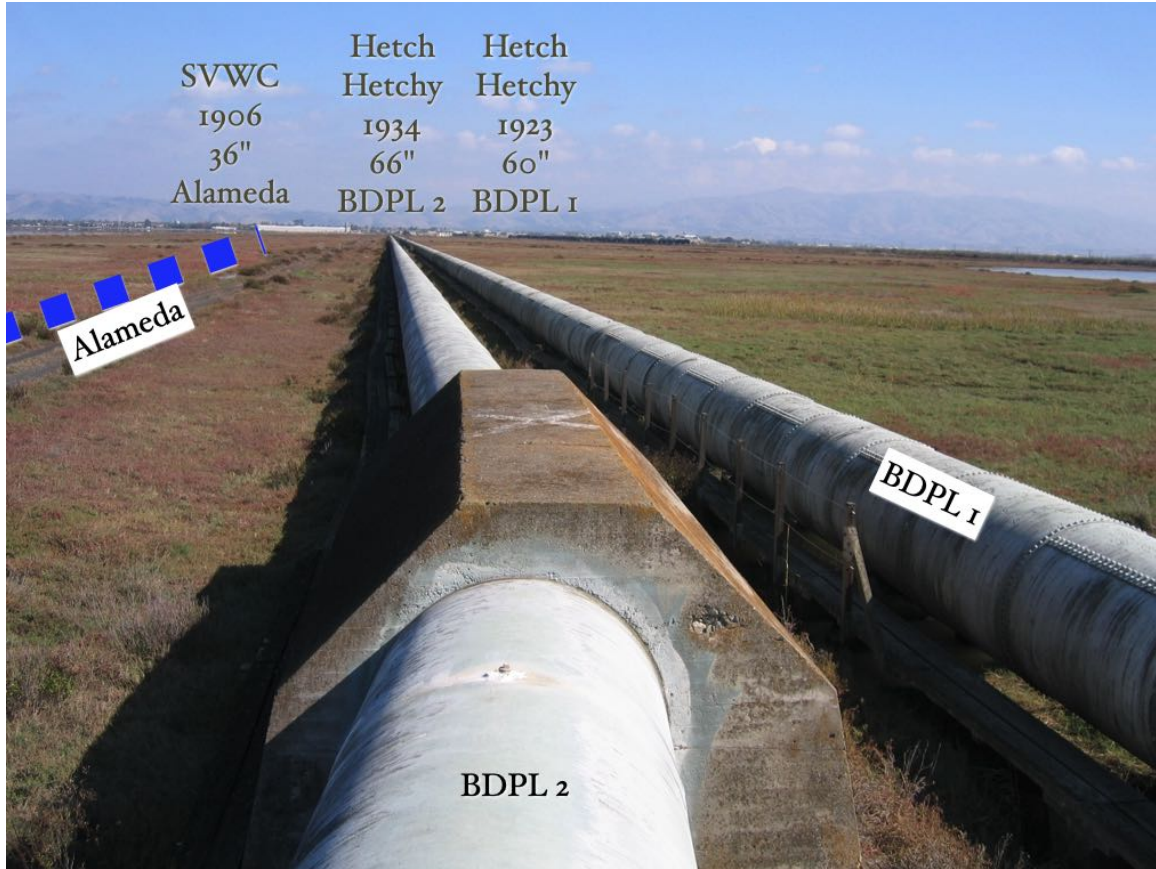
Figure 6-3 (2008) shows a photo of the Bay Division Pipelines 1 and 2 where they cross the San Francisco Bay near Dumbarton Strait. The first pipe, called BDPL 1, is a riveted steel pipe (single line of girth rivets). This same style of construction was used where BDPL 1 crossed the active Hayward fault. The SFPUC removed the riveted section of the BDPL 1 pipe and the single lap-welded BDPL 2 pipe at the Hayward fault crossing in 2003, replacing both of them with heavy-wall butt welded steel pipes. The SFPUC bypassed this section of the BDPL 1 and 2 pipelines with a new tunnel (called BDPL 5) in 2015. Chapter 9 of this report describes design of the Hetch Hetchy system in some detail.

Figure 6-3. SFPUC's Hetch Hetchy Aqueduct BDPL 1 and 2 Pipelines (2008)

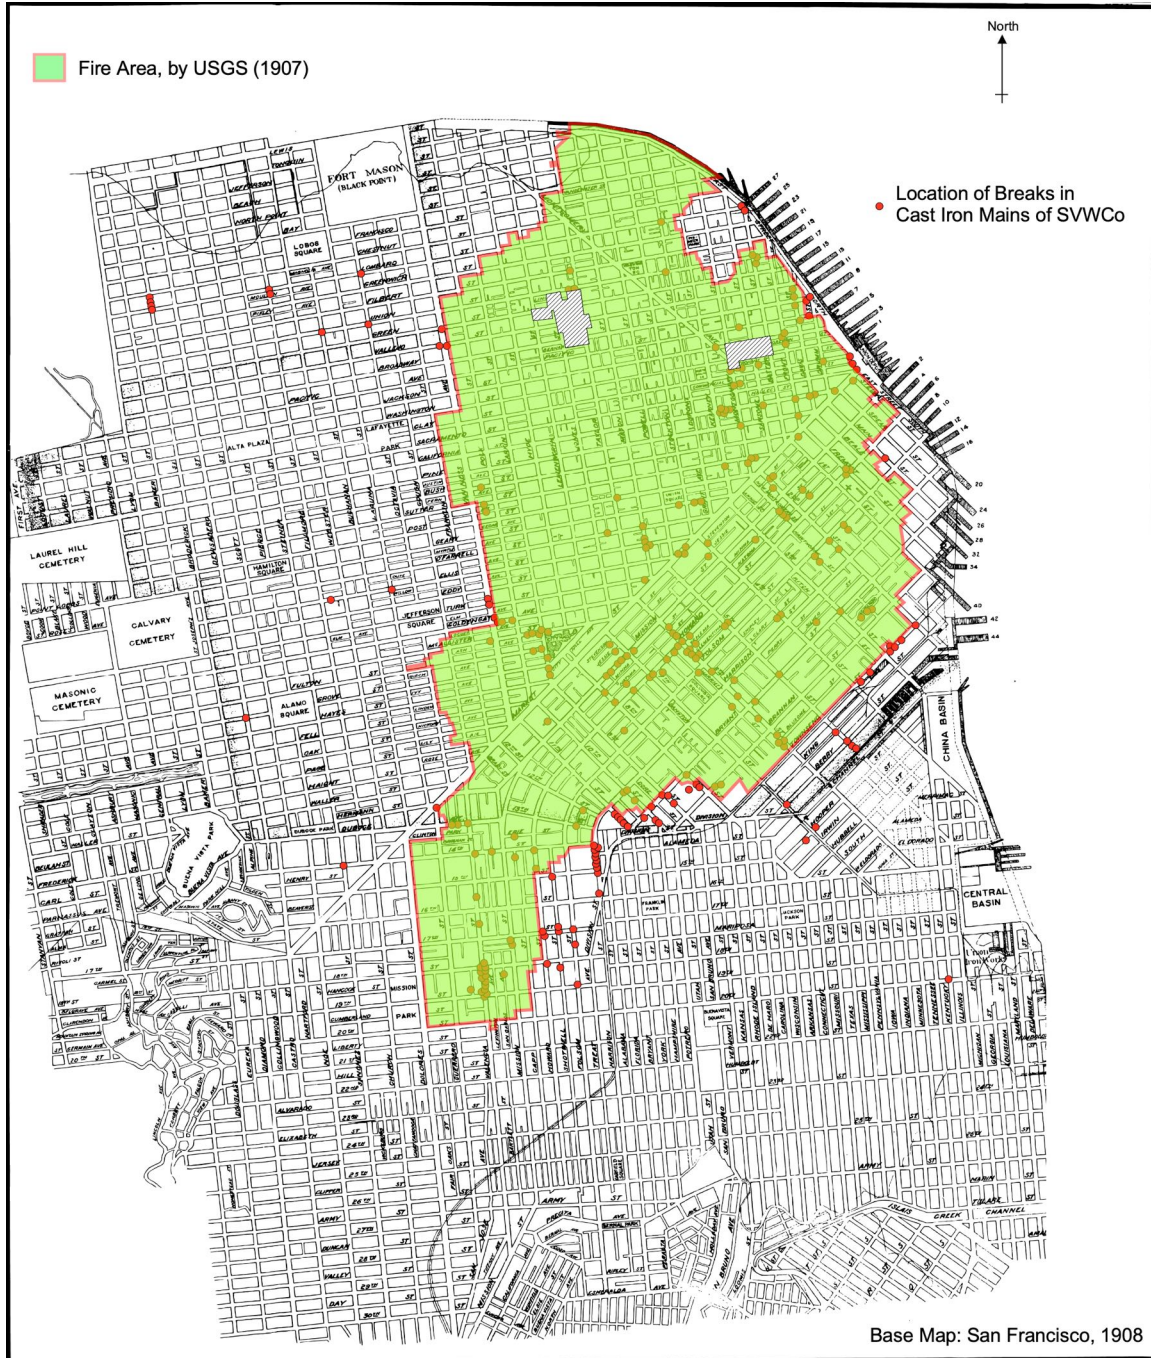
- Figure 7-1. The USGS (1907) produced a map showing the ultimate extent of the fire. This map shows the largest fire area of the three source maps discussed here. This map correctly shows the ultimate fire bounds and corresponds well with the historic photos of the burnt area that are shown later in Chapter 7.

Figure 7-1. San Francisco 1906 Fire – heavy red line and light green color shows final limits as mapped by USGS (1907)
