History of the Water Works of San Francisco, Its Performance in the 1906 Earthquake and Aftermath

John M. Eiding and N. Timothy Hall

December 19, 2023

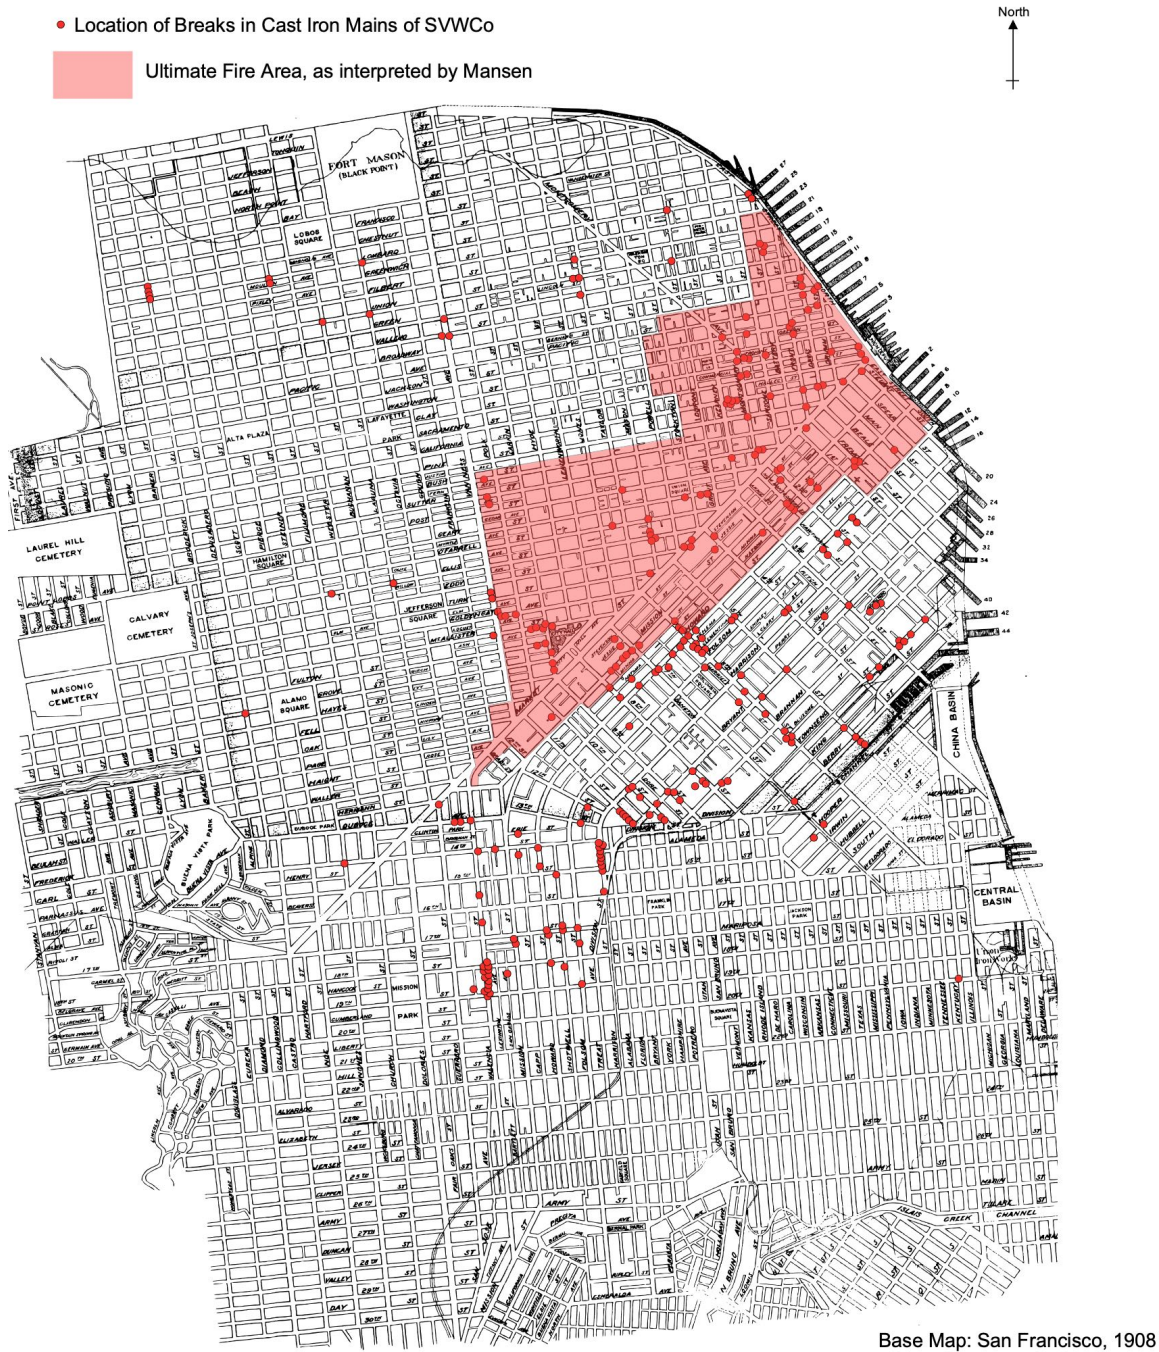
- Figure 7-2. Under the direction of Marsden, Connick and Ransom (1907-1908) produced a map showing the ultimate extent of the fire. This map shows a smaller burnt area as compared to the 1907 USGS map. This map omits the fire in the residential areas of the Mission District; the industrial / commercial areas south of Howard Street; and the Chinatown / North Beach areas.

Figure 7-2. San Francisco 1906 Fire – final extents in shaded area as interpreted by M. Manson, H. D. Connick and T.W. Ransom during the years 1907-1908; breaks to cast iron mains in the water distribution system shown as red dots, as interpreted by H. Schussler, 1906; base map by Manson et al, 1908.

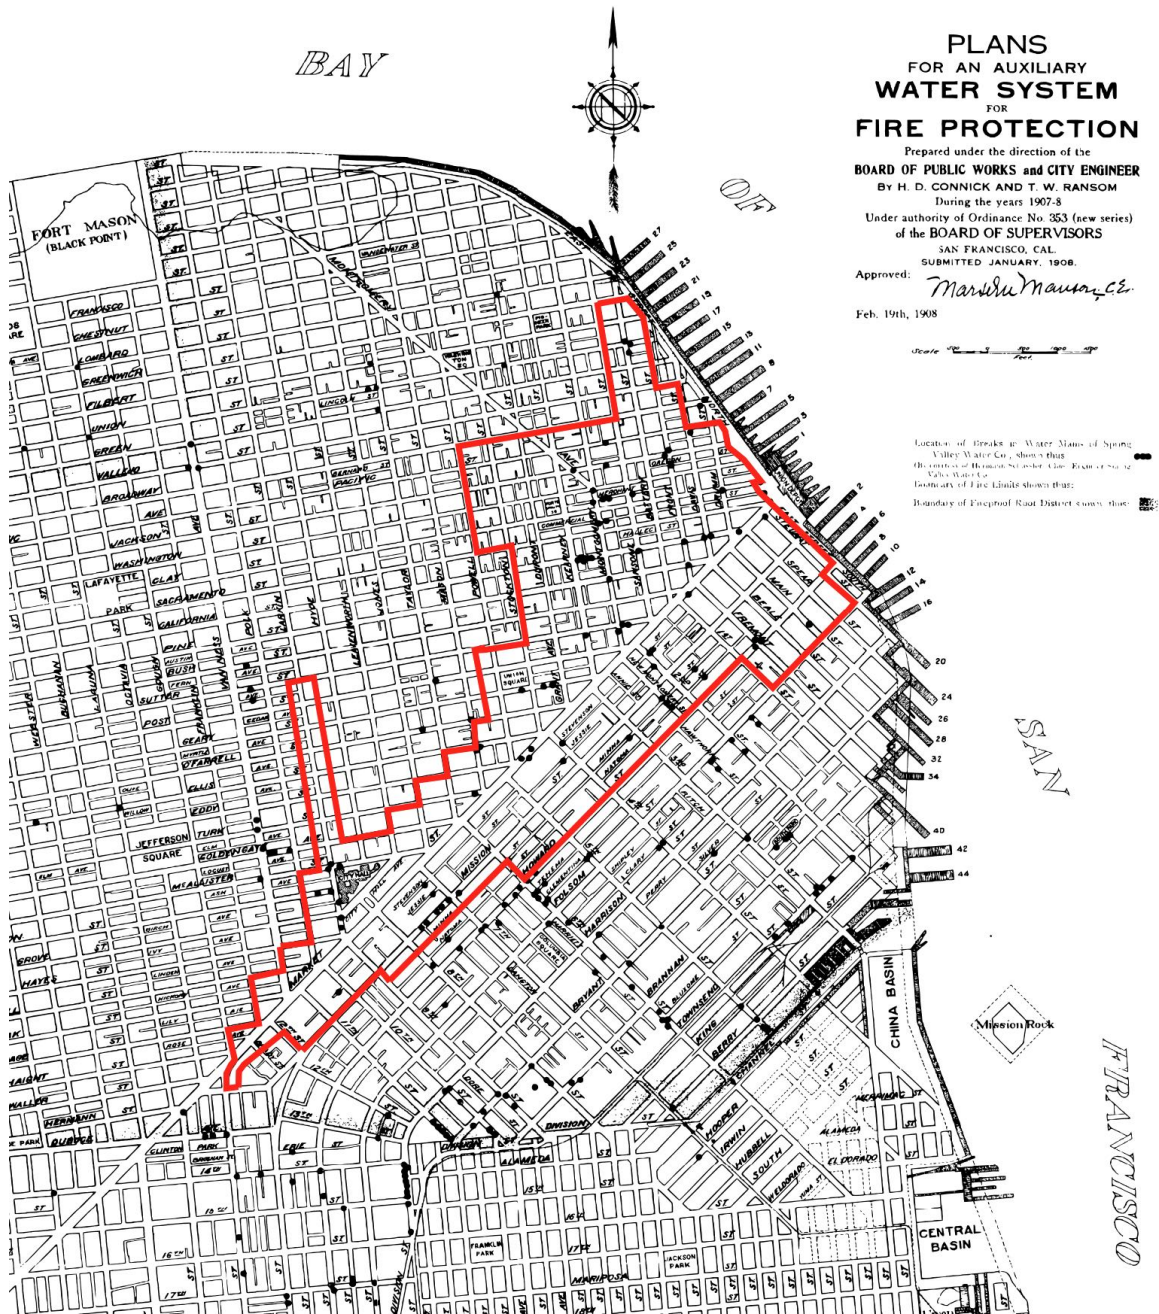
- Figure 7-3. Sanborn (1911) produced a map showing the ultimate extent of the fire. This map shows an even smaller burnt area as compared to the 1907 map. This area represents burnt zones with large commercial buildings.

Figure 7-3. San Francisco 1906 Fire – heavy red line shows final limits as mapped by Sanborn (1911). Breaks to cast iron mains in the water distribution system shown as black dots, as interpreted by H. Schussler, 1906; base map by Manson et al, 1908.

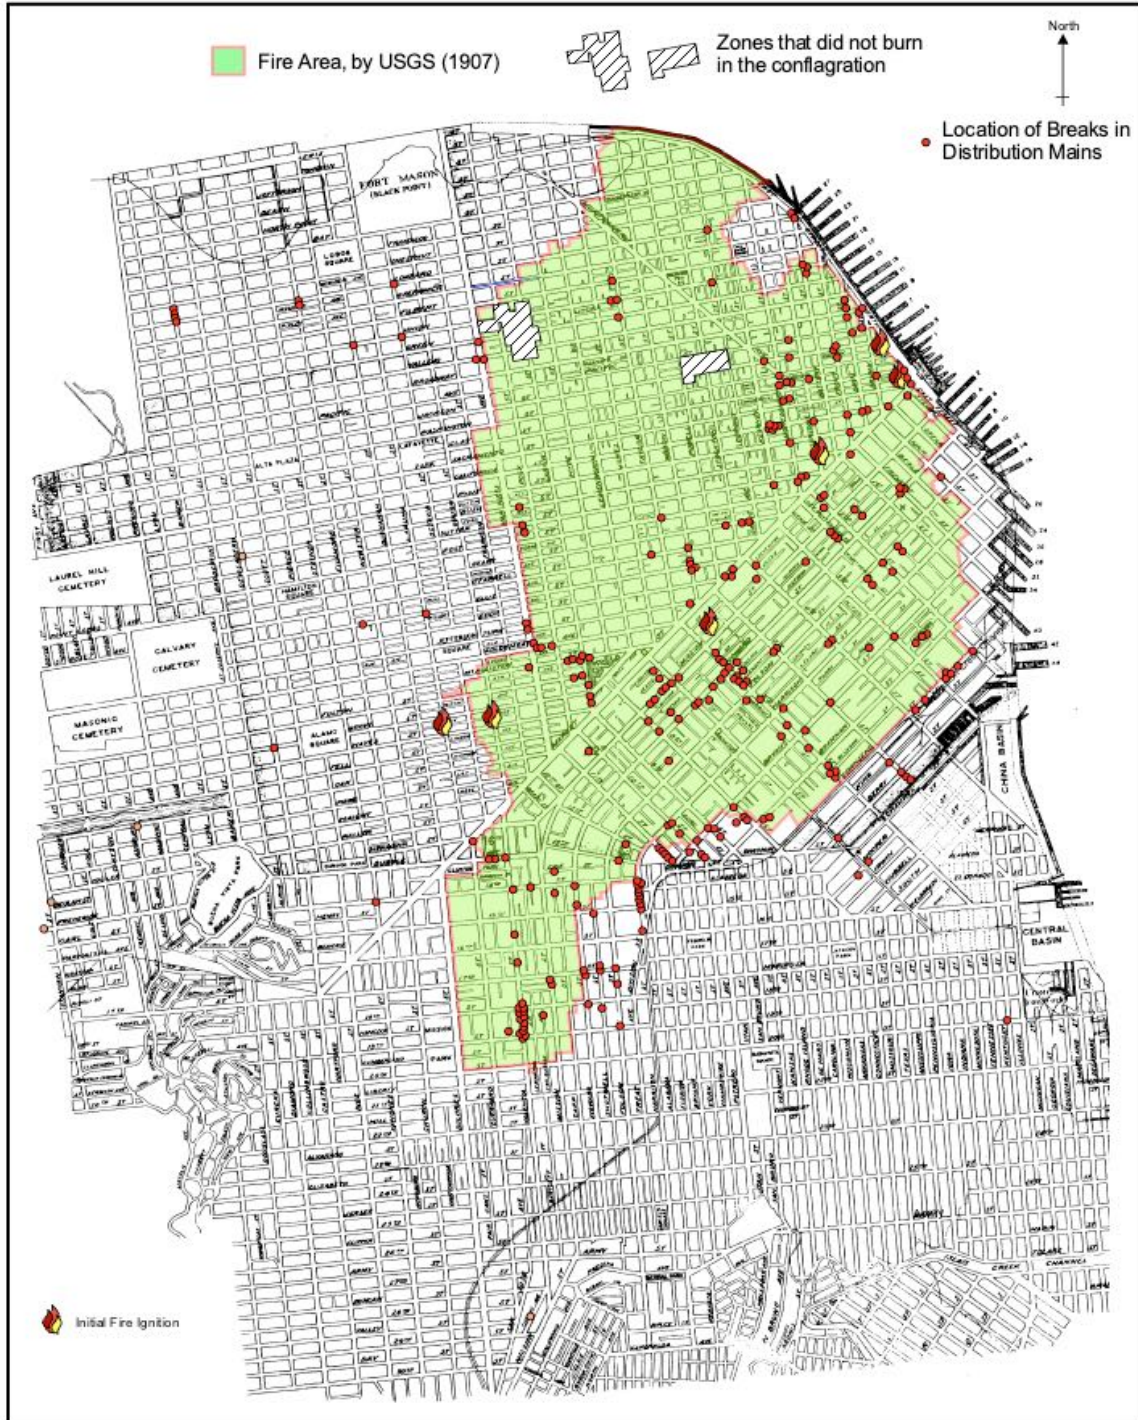
Reed (1906) reports that it was difficult to determine the number and location of the original fire ignitions. The earthquake occurred around 5:13 am April 18, at which time there was daylight in the streets. Figure 7-4 shows 6 initial fires, as derived from the report of Reed (1906); coupled with the ultimate fire spread boundary.

Figure 7-4. Fire Ignitions based on Reed (1906)

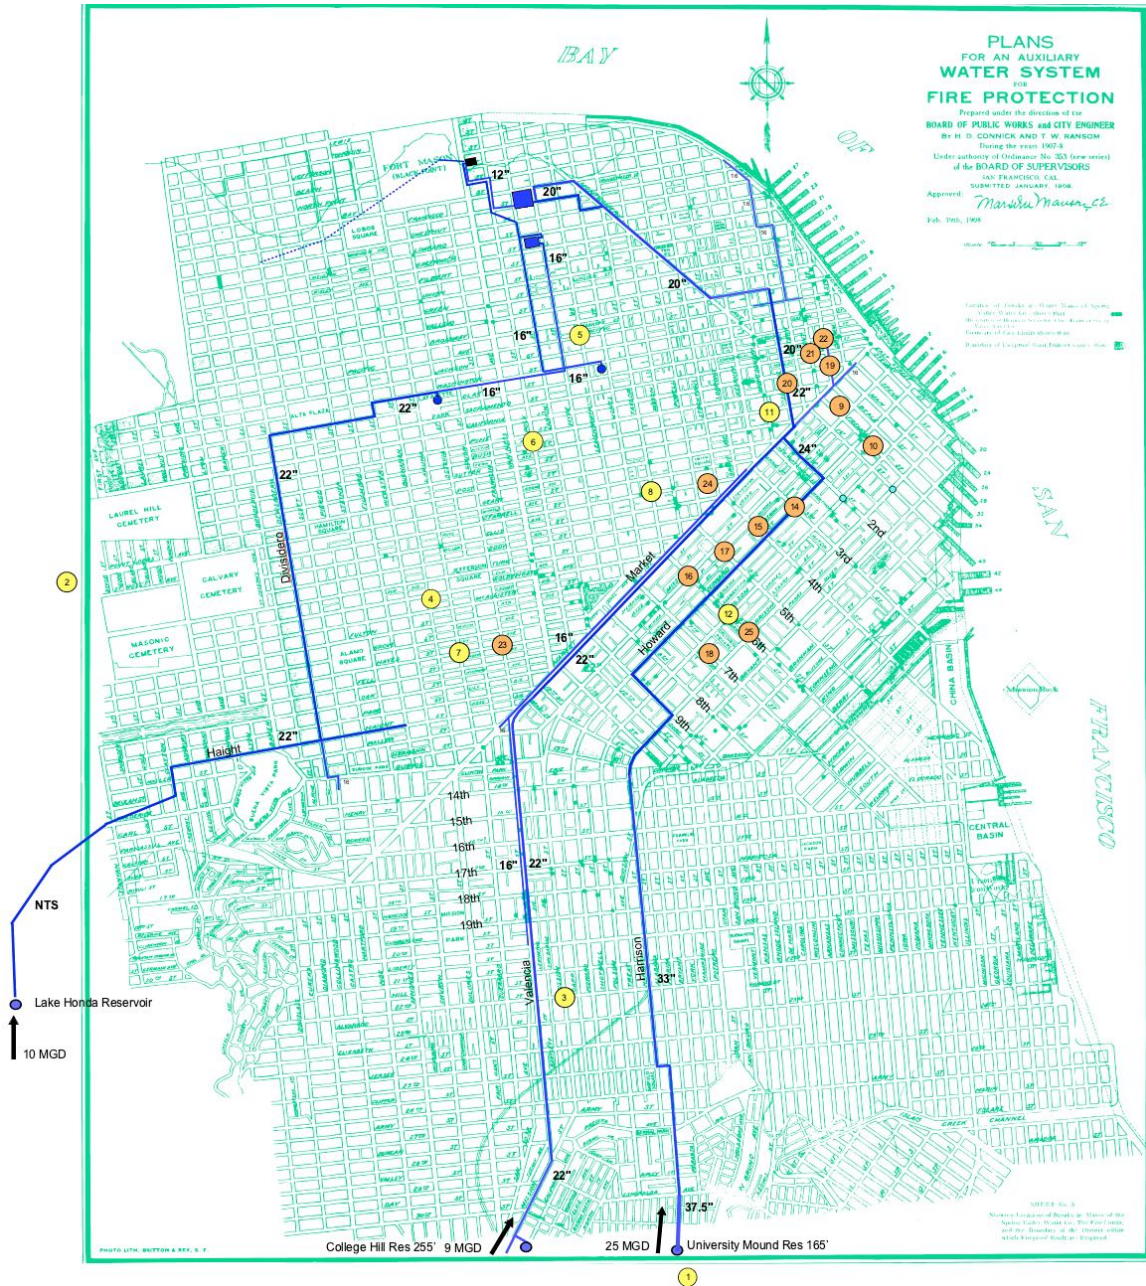
Figure 7-5. Fire Ignitions (April 18, 5:13 am to 10 am). Yellow dots are ignitions that were quickly extinguished. Red dots are ignitions that spread. Blue dots are cisterns where water was accessed at some point during the April 18-20 time frame..

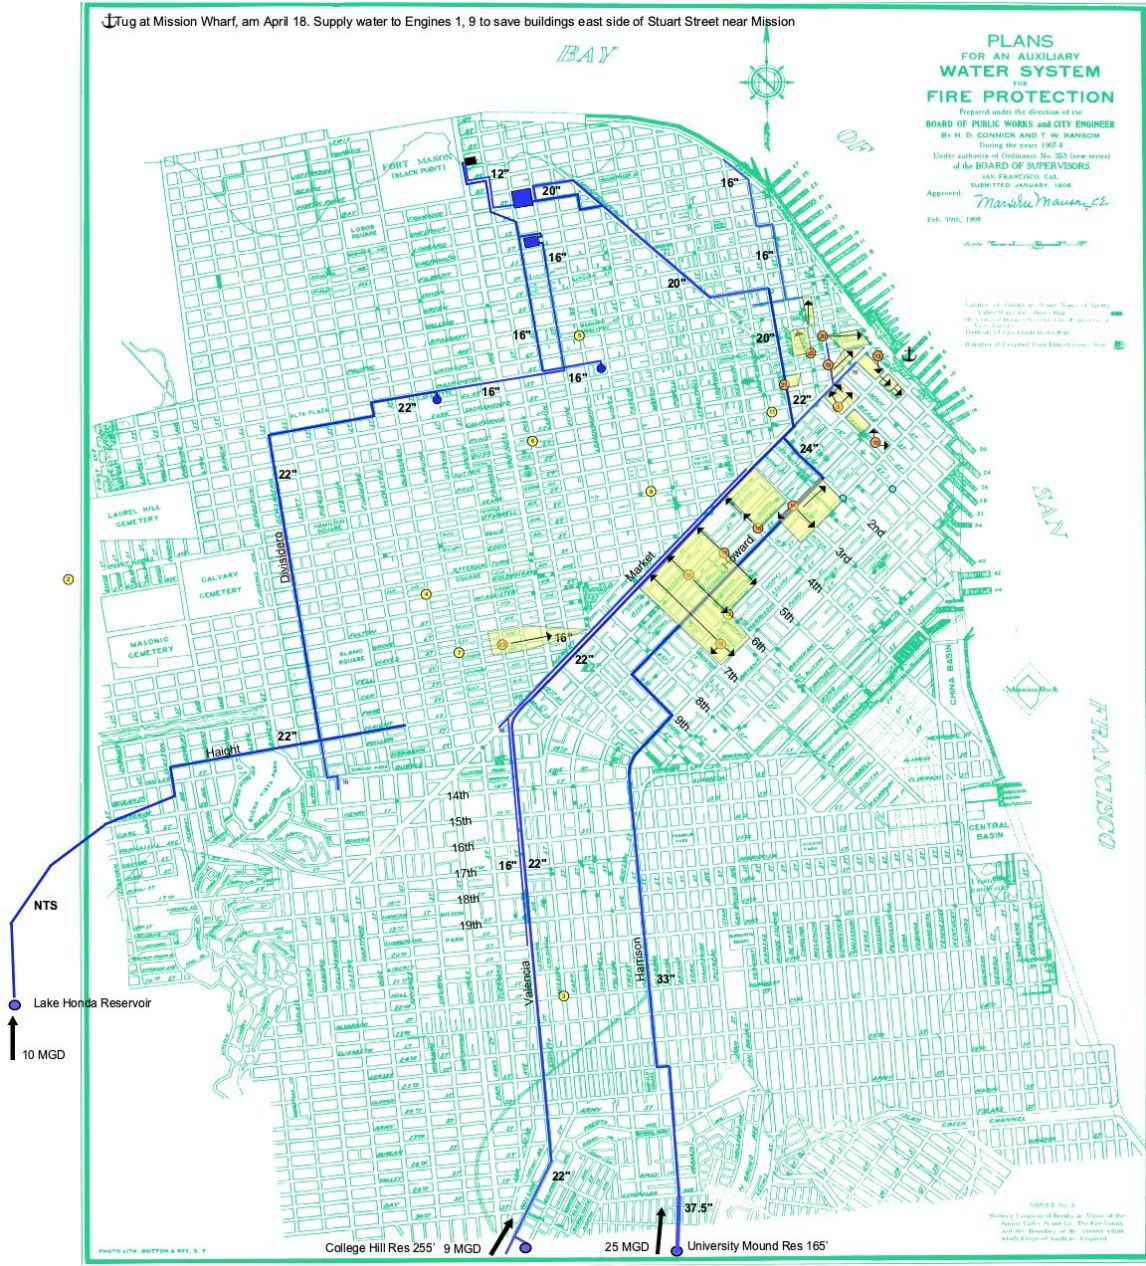
Figure 7-6 shows the initial fire spread from the ignitions (orange dots in Figure 7-5) that could not be initially controlled. The arrows show the general direction of spread at each fire location. By 12 noon April 18, the initial fires had spread in three areas:

Figure 7-6. Fire Spread based on Kennedy (1908). (April 18 5:13 am to noon). Blocks colored yellow had spreading fires as of April 18 noon). Arrows indicate initial direction of spread.

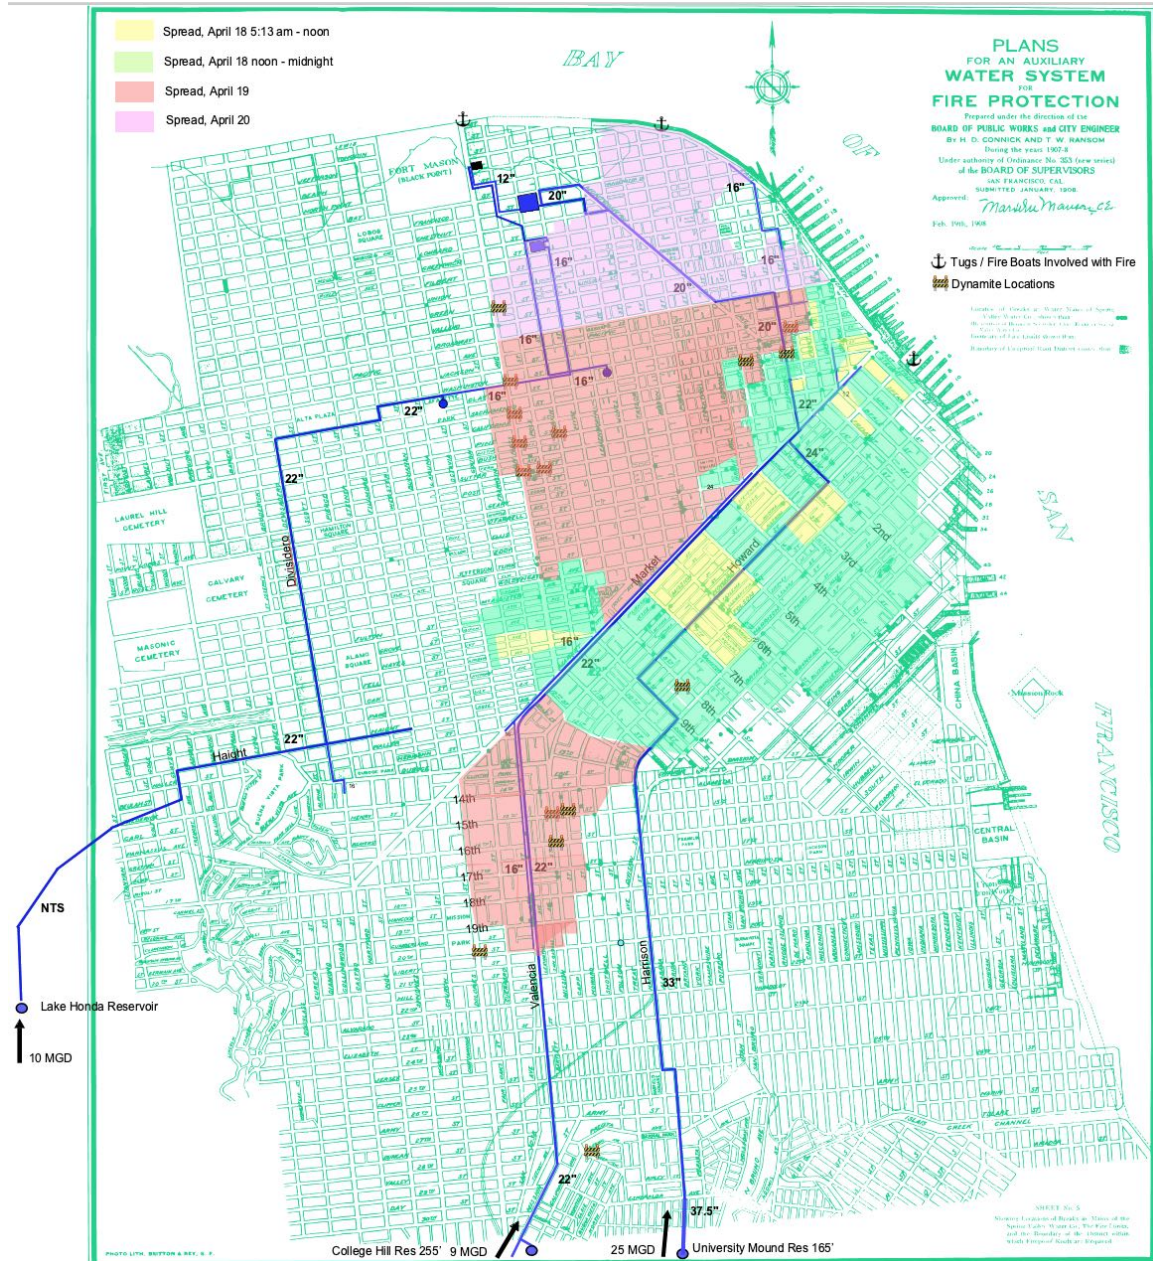
Figure 7-7. Fire Spread based on Kennedy (1908) (April 18 to April 20). Anchors show locations where fire boats supplied water. Barriers show where dynamite was used to create fire breaks.

Figure 7-7 shows the approximate bounds of the fire at the end of each of the four periods (based on Kennedy). The reader should understand that the bounds shown in Figure 7-7 are an interpretation of areas that the fire had burned at various times; precise records of the burn area at various intermediate times are not available.

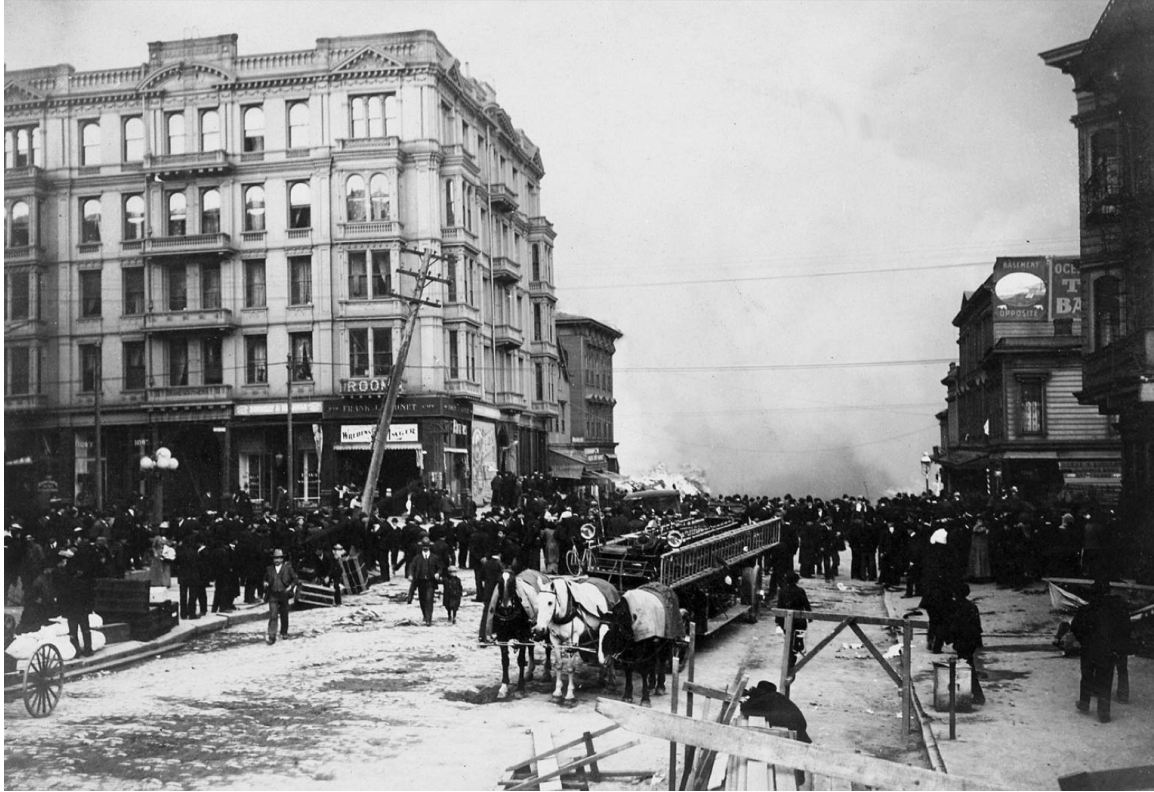
Figure 7-16. April 18. Looking southerly along 7th Street. Mission Street is the cross street the foreground. The tilted wood pole reflects the major liquefaction movements at this corner. There is no water available at any hydrant near here. The fire is burning near 7th and Howard.

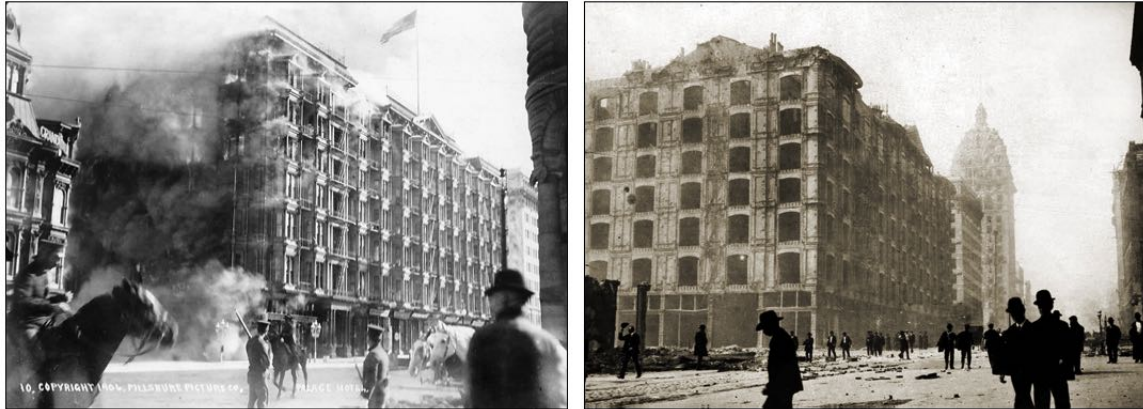
April 18, 2:30 pm. Figure 7-24. Left: The flames had invaded the “fireproof” Palace Hotel (New Montgomery and Market. There was an extensive standpipe system in the Palace hotel, fed by water kept on site in a massive cistern located in the building's basement; by nightfall April 18, the cistern had run dry. Right: By 6 pm April 18, the Palace is an empty, burned out shell. Looking westerly on Market Street; Call building in background on right image.

*Figure 7-24. Left. April 18 By 2:30 pm. Left photo identified as copyright 1906. Right: after fire.
Source: <http://thepalacehotel.org>*

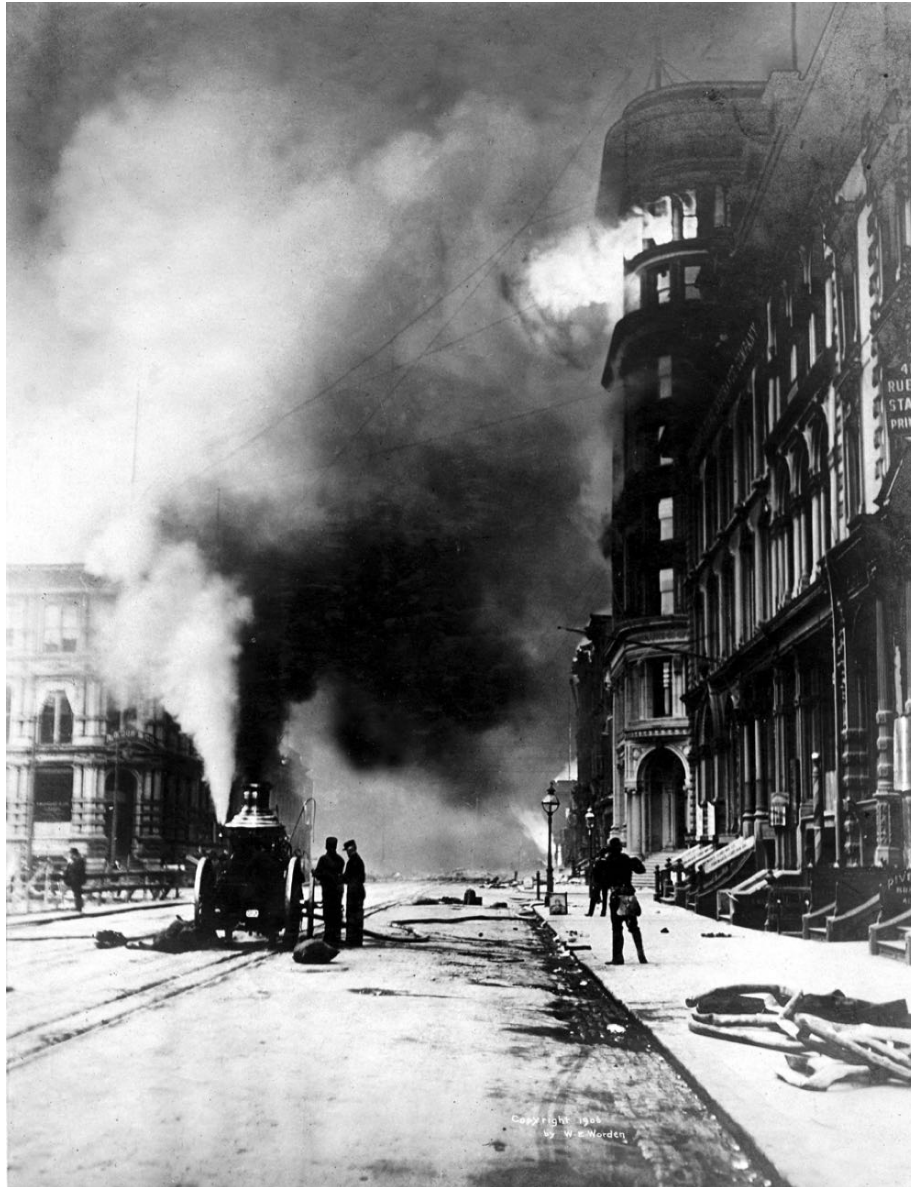
Figure 7-26. A fire department steam engine is in the center. Fires are actively burning in the 8 story building to the right, and in the background. At this time, there is no water via the piped water system here, so it is surmised that this engine is pumping out water from a local cistern, but to little effect. It is possible this photo was taken the morning of April 19.

Figure 7-26. April 18 pm. California Street, between Sansome and Market. (Photo: W. E. Warden, 1906)

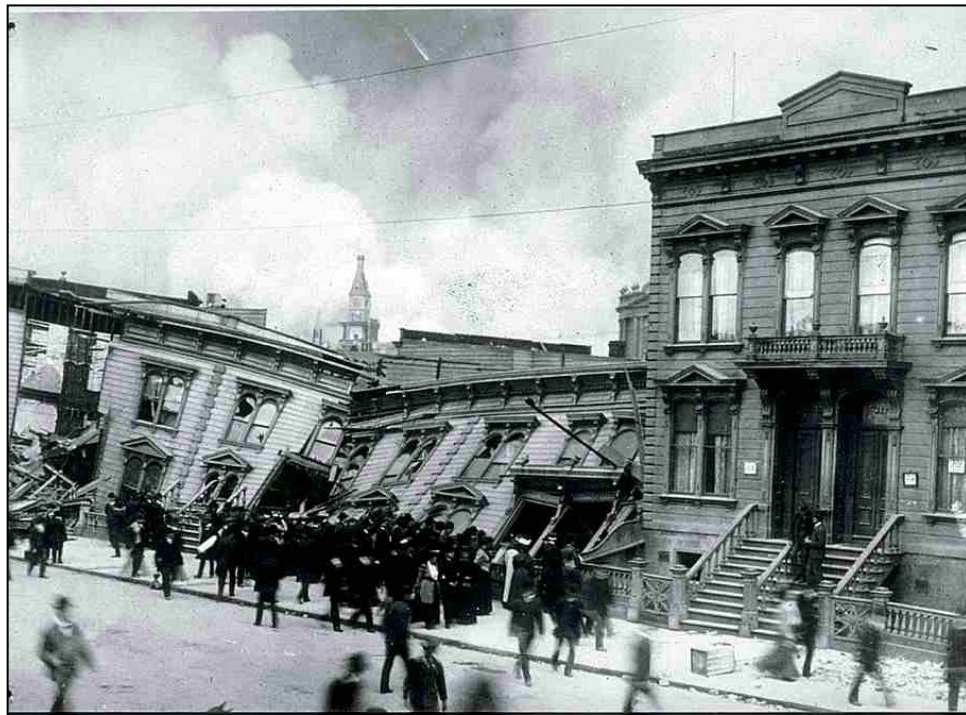
Figure 7-29. April 19. Mission District. Collapsed building, fire in background

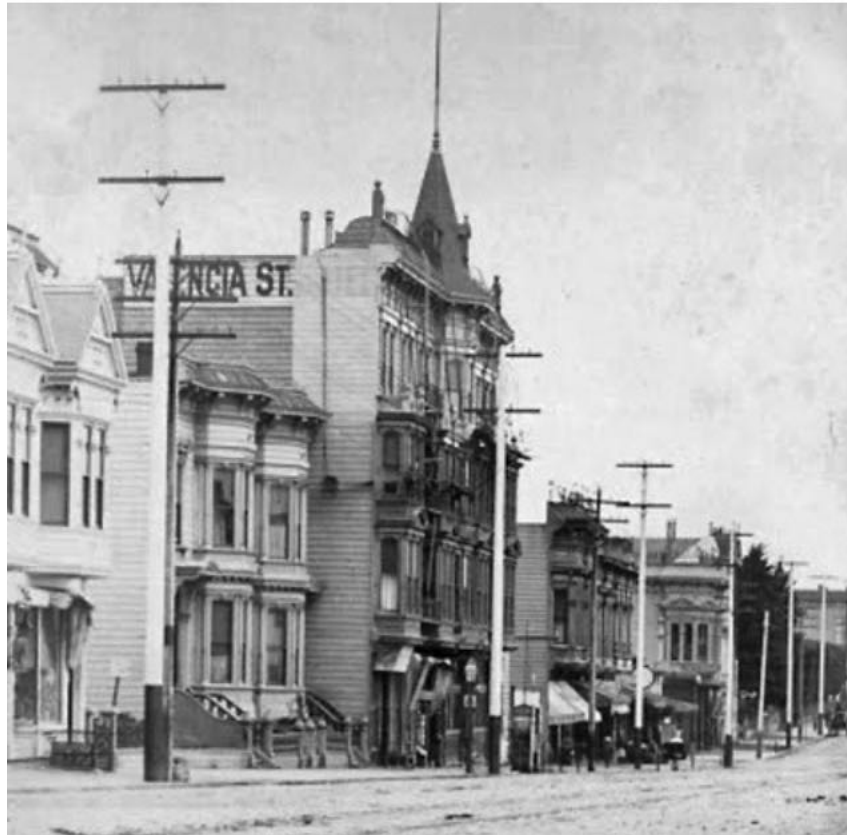
Perhaps the largest loss of life in the earthquake occurred at the Valencia Street Hotel in the upper Mission District along Valencia Street between 18th and 19th Streets. This L-shaped four story wood frame structure on a 75' x 100' lot was built in a filled area atop Mission Creek. The depth of fill here was on the order of 30 feet. The earthquake triggered liquefaction, and the building dropped down about three full stories. Along Valencia Street immediately in front of the hotel, the 16" and 22" water pipes coming from College Hill reservoir broke.

Figure 7-40 shows the Valencia Street Hotel, circa 1898. This photo is taken looking northwesterly, between 18th and 19th streets.

Figure 7-40. c. 1898. Valencia Street Hotel (Photo possibly by Marcel Tanron, Online Archive of California, The 1906 San Francisco Earthquake and Fire Digital Collection, U. C. Berkeley, Bancroft Library)

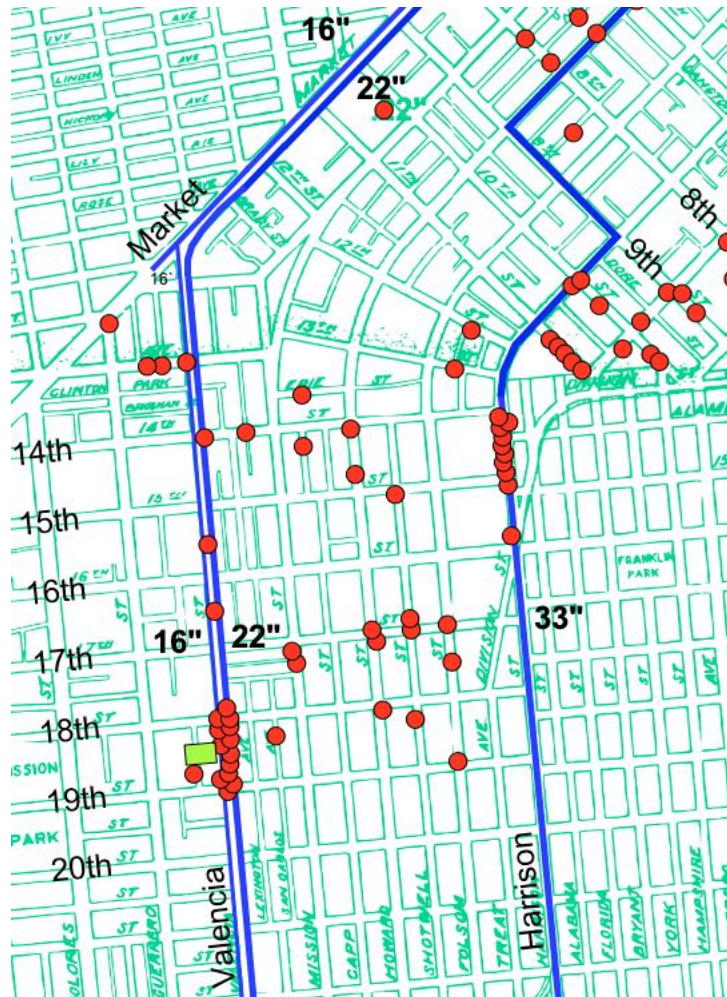
Figure 7-41. Water Mains (16" - 33") in Vicinity of Valencia Street Hotel

Figure 7-41 shows the main water pipe lines in the vicinity of the Valencia Street Hotel. The green box outline shows approximate location of the hotel. The red dots show locations of water main pipe damage (all diameters). Smaller diameter pipe (3" to 12") are not shown. Compare this with Figure 2-28, showing all water pipes 8" and larger. The normal direction of water flow in the 16" and 22" pipes along Valencia Street and the 33" pipe along Harrison Street would be northbound, coming from the College Hill and University Mound reservoirs, respectively. See Figures 3-3 and 3-5 for maps of the original shorelines and drainages in this area. The location and density of pipe breaks (red dots) closely follows the location of Laguna Dolores / Mission Creek.

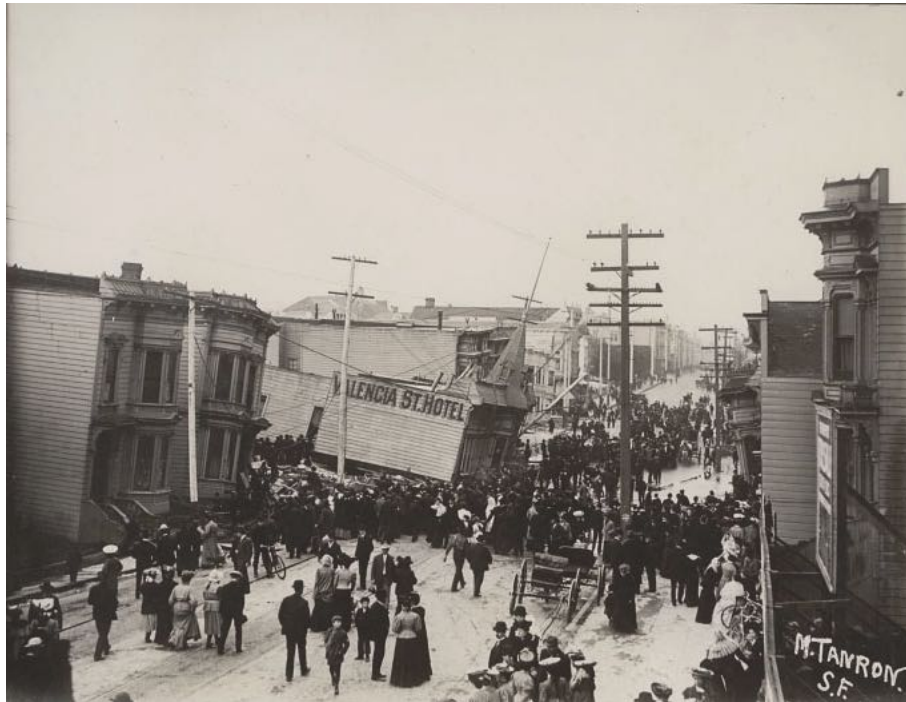
Figure 7-42 shows the collapse of the Valencia Street Hotel. This photo was taken the morning of April 18. The large crowd is possibly more than 200 people. The front of the building has sunk and collapsed some 30 feet or so, with just the fourth floor remaining above ground and displaced sideways into Valencia Street. People are attempting to rescue occupants via a 4th floor window. This building, along with most of the other smaller buildings on the block, were constructed atop a filled-in area of the former Dolores Laguna, a tidal area connected to the Bay via Mission Creek. The area liquefied during the earthquake.

Note that the lightweight telegraph poles remain standing; some are tilted, possibly reflecting the temporary loss of bearing resistance during the time the soil was liquefied; or possibly aggravated by wire pull down forces from the nearby collapsed or partially collapsed buildings.

Figure 7-42. April 18 am. Collapse of Valencia Street Hotel (Photo credit Marcel Tanron, Camera Craft, Vol, 27 1921, Online Archive of California, The 1906 San Francisco Earthquake and Fire Digital Collection, U. C. Berkeley, Bancroft Library)

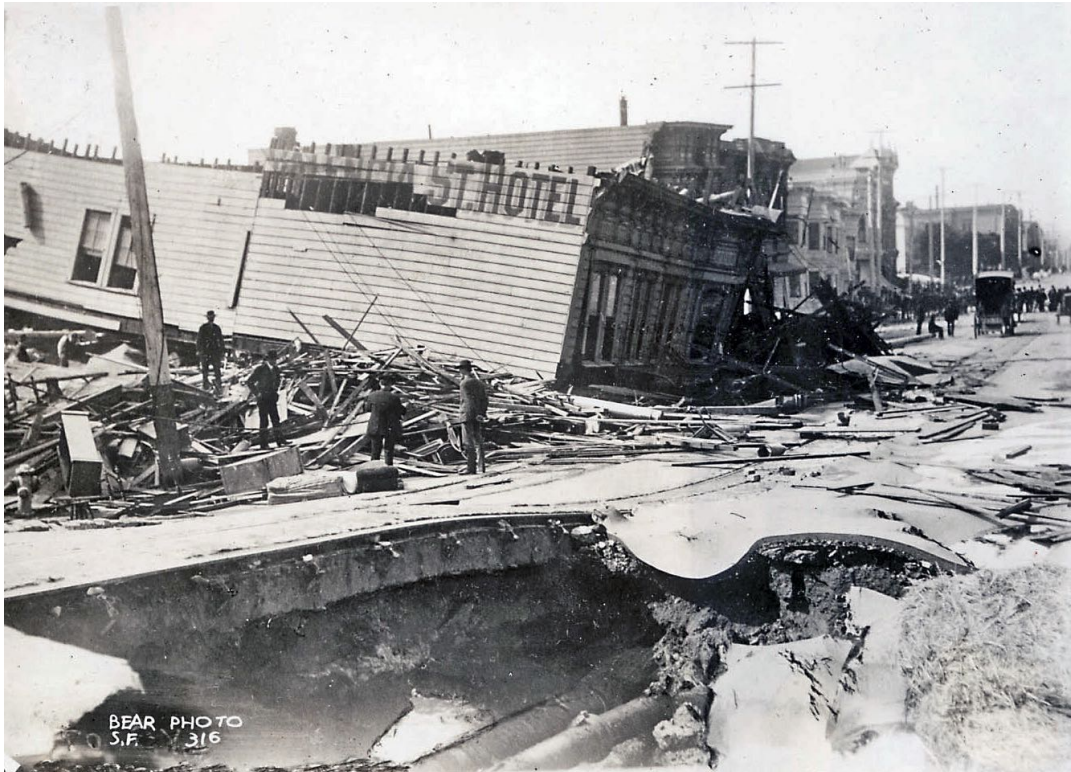
Figure 7-43 shows the Valencia Street Hotel during the early evening of April 18. By this time, the street in front of the hotel has been cordoned off, with bystanders still seen in the background at 18th Street. A sink hole has opened up in the foreground, reflecting the release of water from the damaged 22" main on the east side of the street. The decorative steeple of the hotel has been removed.

Figure 7-43. April 18 pm. Sink hole opened exposing broken SVWC 22" water main. It is unclear if the 4 people in the foreground are onlookers. (Photo credit: Bear Photo Co. 1906, Online Archive of California, The 1906 San Francisco Earthquake and Fire Digital Collection, U. C. Berkeley, Bancroft Library)

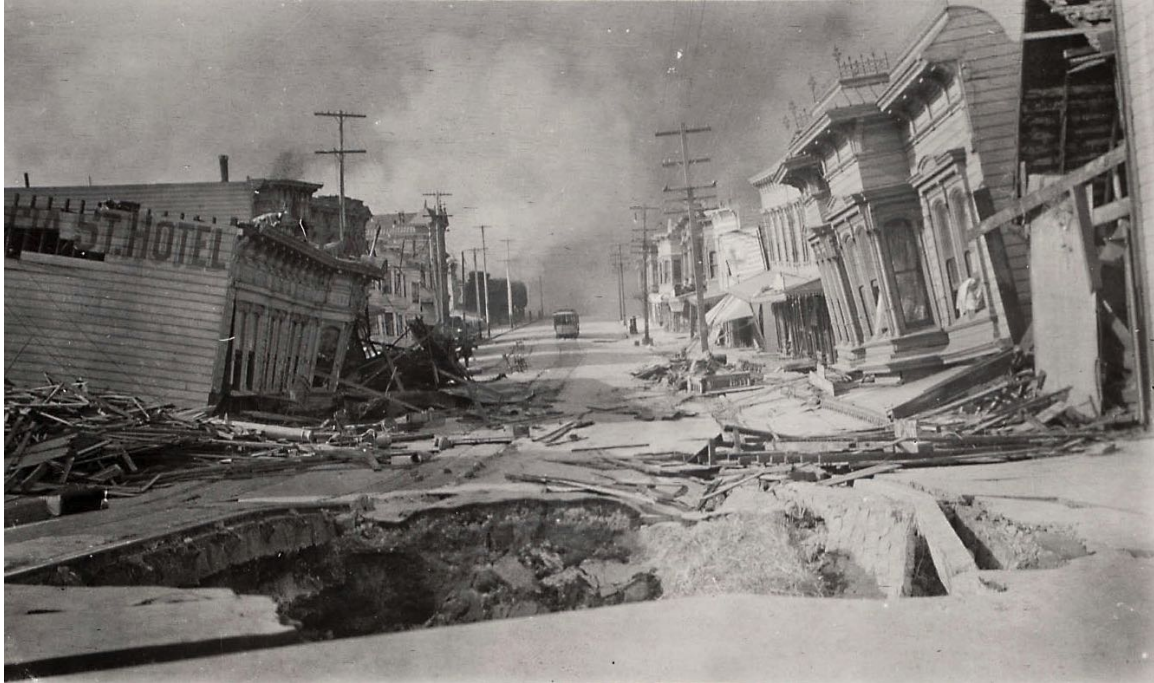
Figure 7-44 shows a wider view of Valencia Street, showing the damage to wood buildings on the east side of the street. This photo is believed to have been taken the morning of April 19, and the fire, then about 16th street, is in the background. The streetcar was stopped at the south side of 18th street. At this time, the street is evacuated.

Figure 7-44. April 19. Looking North. The fire that was burning near Market Street on April 18 has advanced and is making its way southwards along Valencia Street. Liquefaction had wrecked other wood buildings on the east side of Valencia Street. (Photo credit: Online Archive of California, The 1906 San Francisco Earthquake and Fire Digital Collection, U. C. Berkeley, Bancroft Library)

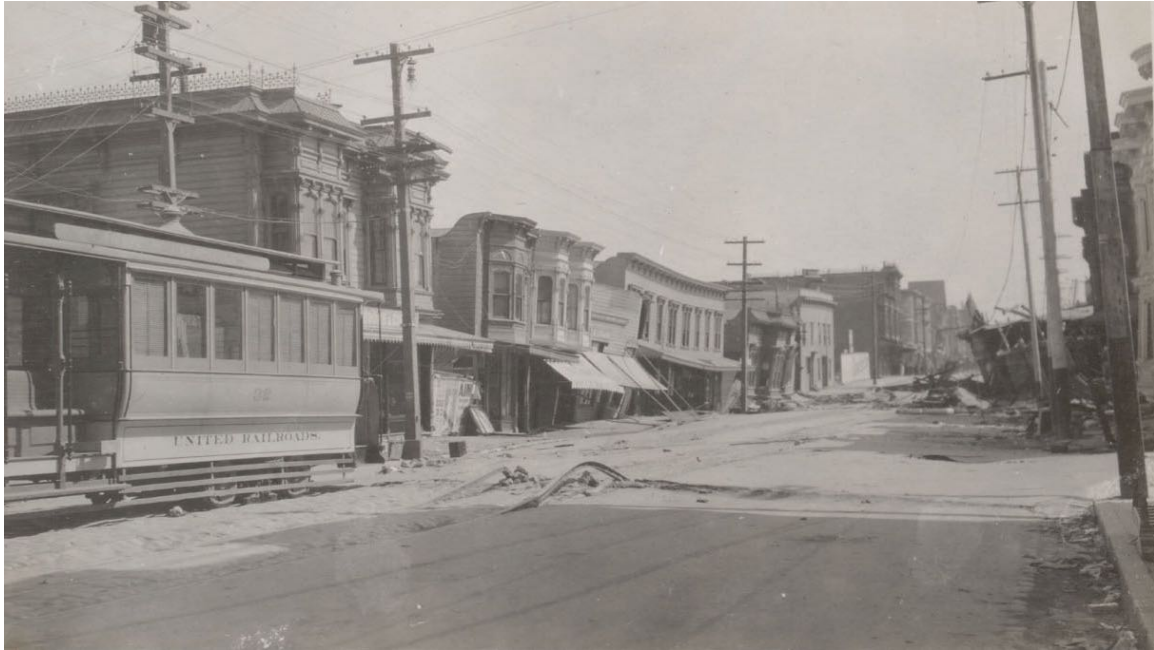
Figure 7-45. April 19. Looking South. (Photo credit: Online Archive of California, The 1906 San Francisco Earthquake and Fire Digital Collection, U. C. Berkeley, Bancroft Library)

Figure 7-45 shows Valencia Street looking south. The streetcar in the foreground is "nearly" level, and the rail tracks have buckled upwards. The "buckling" of the rails suggest that there was a lateral spread that pushed the rails northwards, and they would easily buckle upwards under the compressive action. The collapsed Valencia Street Hotel is on the right. The fire has not yet reached this area. On the east (far) side of the street, the overhead wires appear intact. On the west (near) side of the street, the overhead wires are partially pulled down. On the east side of the street, the power / telegraph poles are square. On the west side of the street, the power / telegraph poles are round.

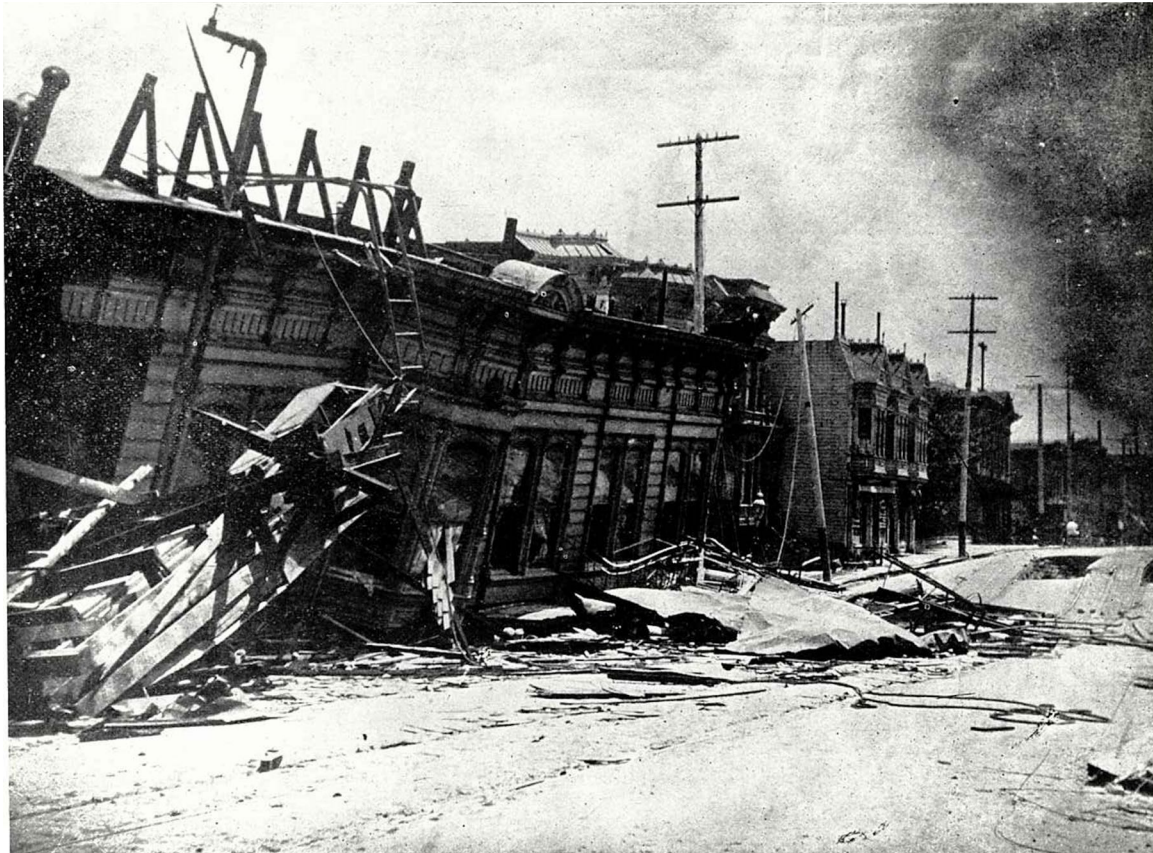
Figure 7-46 shows a close up of the damaged Valencia Street Hotel. The photo is believed to have been taken in the afternoon of April 19. The dark smoke of the fire indicated active burning around 17th Street. The twin trolley car tracks are sunken suggesting a continuing settlement in the liquefied zone over a 24± hour period.

The fire will soon reach the area and all the buildings will be consumed by the fire.

Figure 7-46. April 19. Valencia Hotel Collapse (left foreground); fire approaching from the north. (Photo: provided courtesy USGS). The fire will eventually consume all the buildings seen in this photo. (Photo credit: courtesy of USGS)

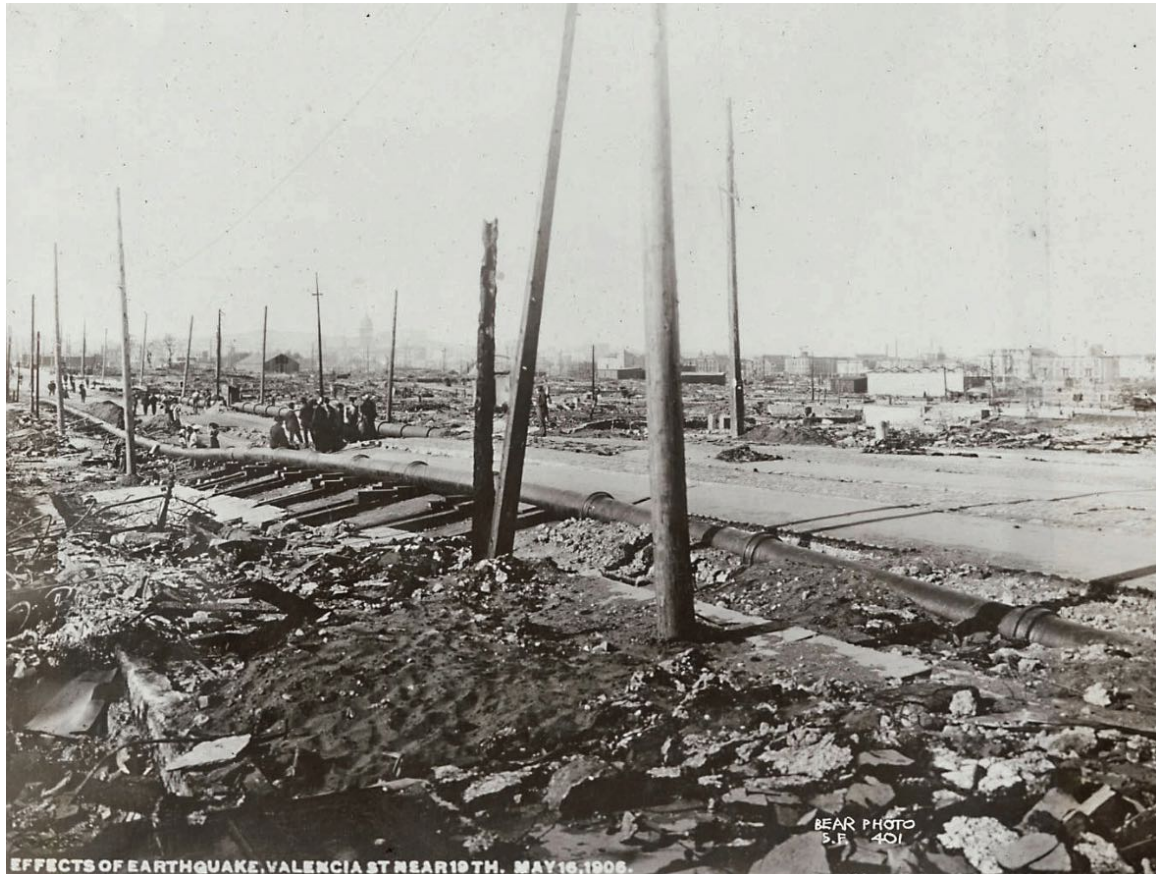
Figure 7-47 shows the area as of May 16, 1906 (28 days after the earthquake). SVWC was able to restore water to College Hill Reservoir from San Andreas Reservoir about 62 hours after the earthquake (April 20). The maps in Figures 2-28, 7-5, 7-41 show that restoring flow to the downtown area (Market Street) would need repair of the 16" and 22" pipes on Valencia Street (at least one of them). The great amount of settlement precluded simple patches on the buried pipe; SVWC elected to construct two new (temporary) above ground pipes instead. The historic photos suggest the temporary 16" pipe (west side of street) was installed first.

Figure 7-47. May 16, 1906. View of Valencia Street between 18th and 19th street, looking northeast. In the foreground is an above-ground 16" pipe laid by SVWC as a temporary bypass. In the background is the above-ground 22" pipe laid by SVWC as a temporary bypass on the east side of the street. City Hall dome is dimly seen in the distance just above the group of people in the center of the photo. The cross-arms on the power / telegraph poles have been lost to the fire, but most poles remain standing. (Photo credit: Bear Photo S.F. 401; Online Archive of California, The 1906 San Francisco Earthquake and Fire Digital Collection, U. C. Berkeley, Bancroft Library)

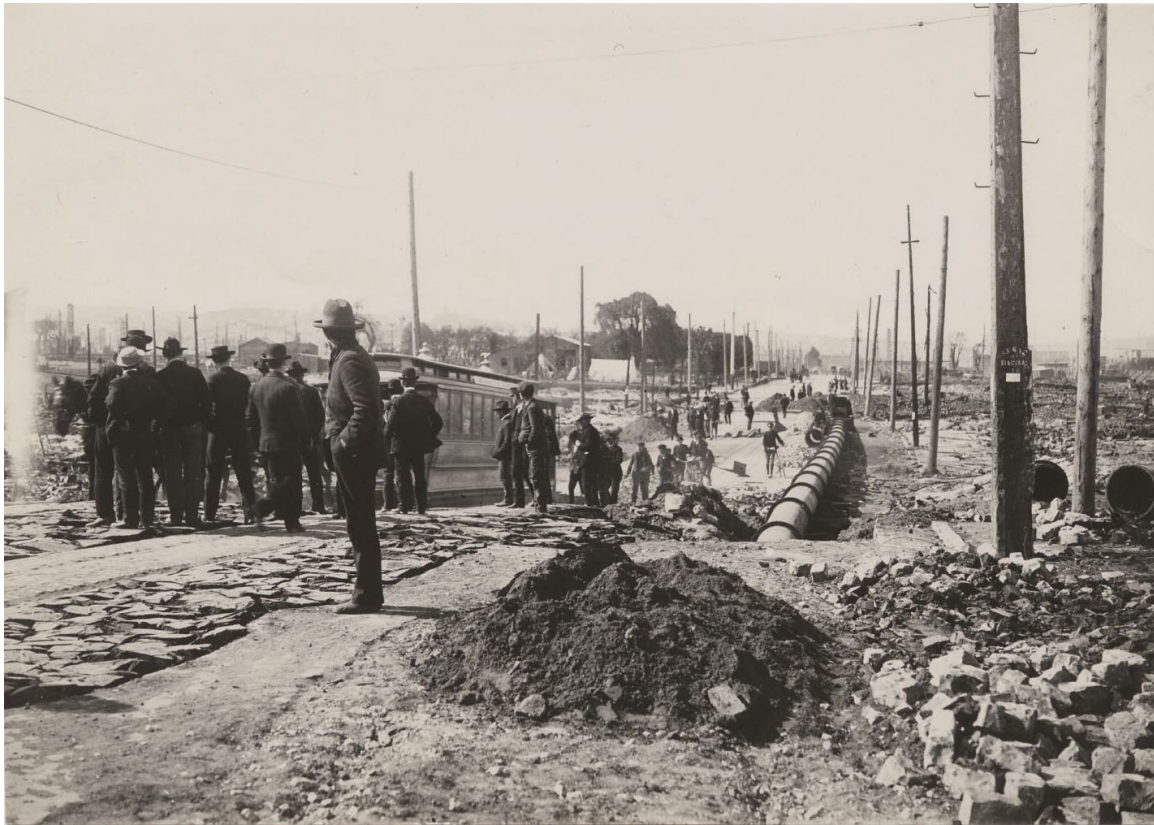
Figure 7-48 shows the temporary pipe on the west side of the street.

Figure 7-48. c. May 16 1906. View of Valencia Street between 18th and 19th street, looking south. In the center is an above-ground pipe laid by SVWC as a temporary bypass of the broken buried pipes. Several extra segments of temporary pipe are seen; pipe joints are apparently unrestrained, not an ideal situation for an above ground pipe, but theoretically feasible over a short straight run. (Photo credit: Online Archive of California, The 1906 San Francisco Earthquake and Fire Digital Collection, U. C. Berkeley, Bancroft Library)
