History of the Water Works of San Francisco, Its Performance in the 1906 Earthquake and Aftermath

John M. Eiding and N. Timothy Hall

December 19, 2023

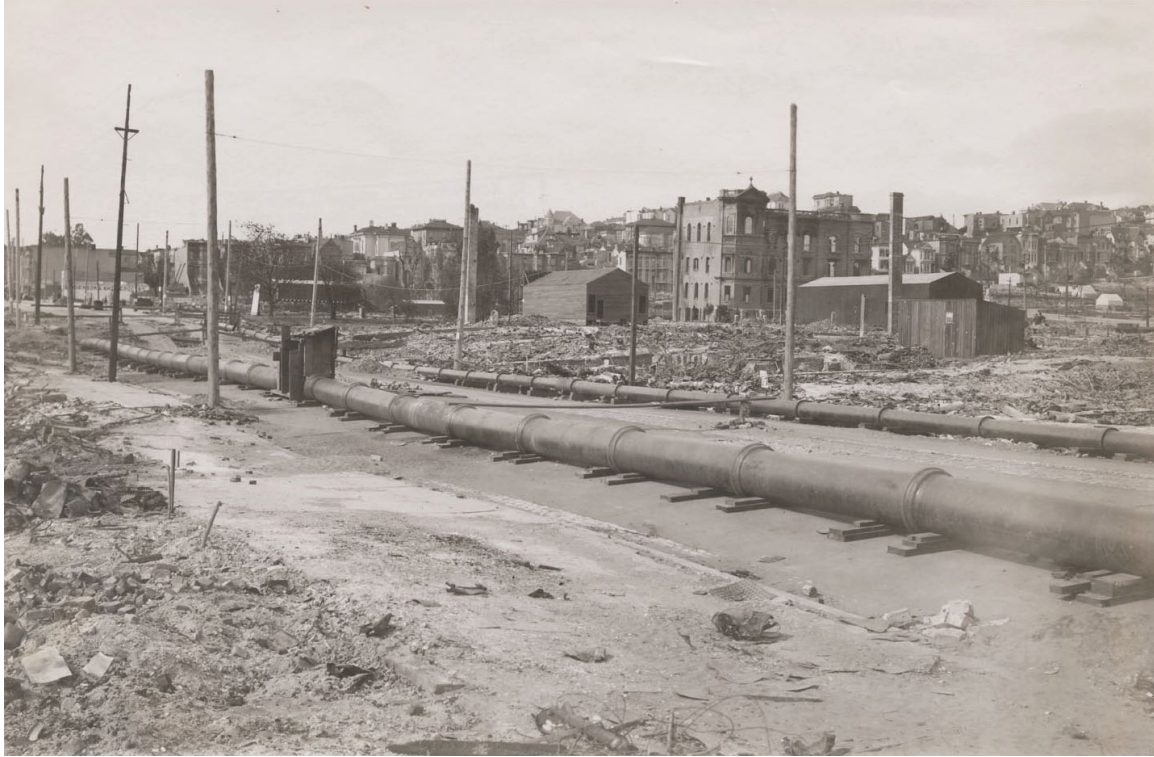
Figure 7-49. c. May 16 1906. View of Valencia Street between 18th and 19th street, looking southwesterly. The two temporary pipes are cast iron with belled joints; no restraints are seen placed across the segmented joints. Each segment is typically supported by two sets of wooden planks. (Photo credit: Online Archive of California, The 1906 San Francisco Earthquake and Fire Digital Collection, U. C. Berkeley, Bancroft Library)

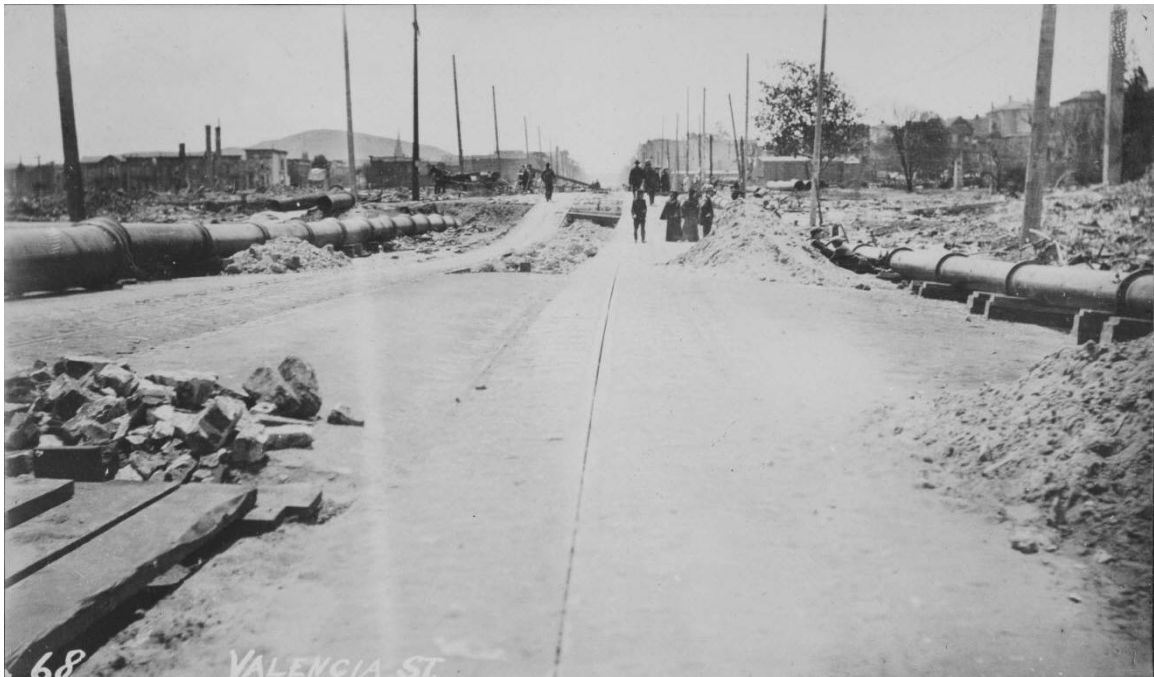
Figure 7-50. c. May 16 1906. View of Valencia Street between 18th and 19th street, looking south. (Photo credit: Online Archive of California, The 1906 San Francisco Earthquake and Fire Digital Collection, U. C. Berkeley, Bancroft Library)

Figure 7-50 shows another view of the temporary pipes. The smaller 16" pipe is on the west (right) side of the street, and the larger 22" pipe is on the east (left) side of the street.

The historic photographic record is not clear as to which pipe SVWC laid first: the smaller (16") or the larger (22"). Practically, this would depend on which diameter pipe SVWC had most available in its yard, and which was easiest / quickest to install. To make the connections to the College Hill Reservoir, the old damaged pipes buried in the street would have had to have been excavated and exposed, and then suitable joinery made; this appears to have been done as straight connections to the undamaged buried pipes either side of the liquefaction zone.

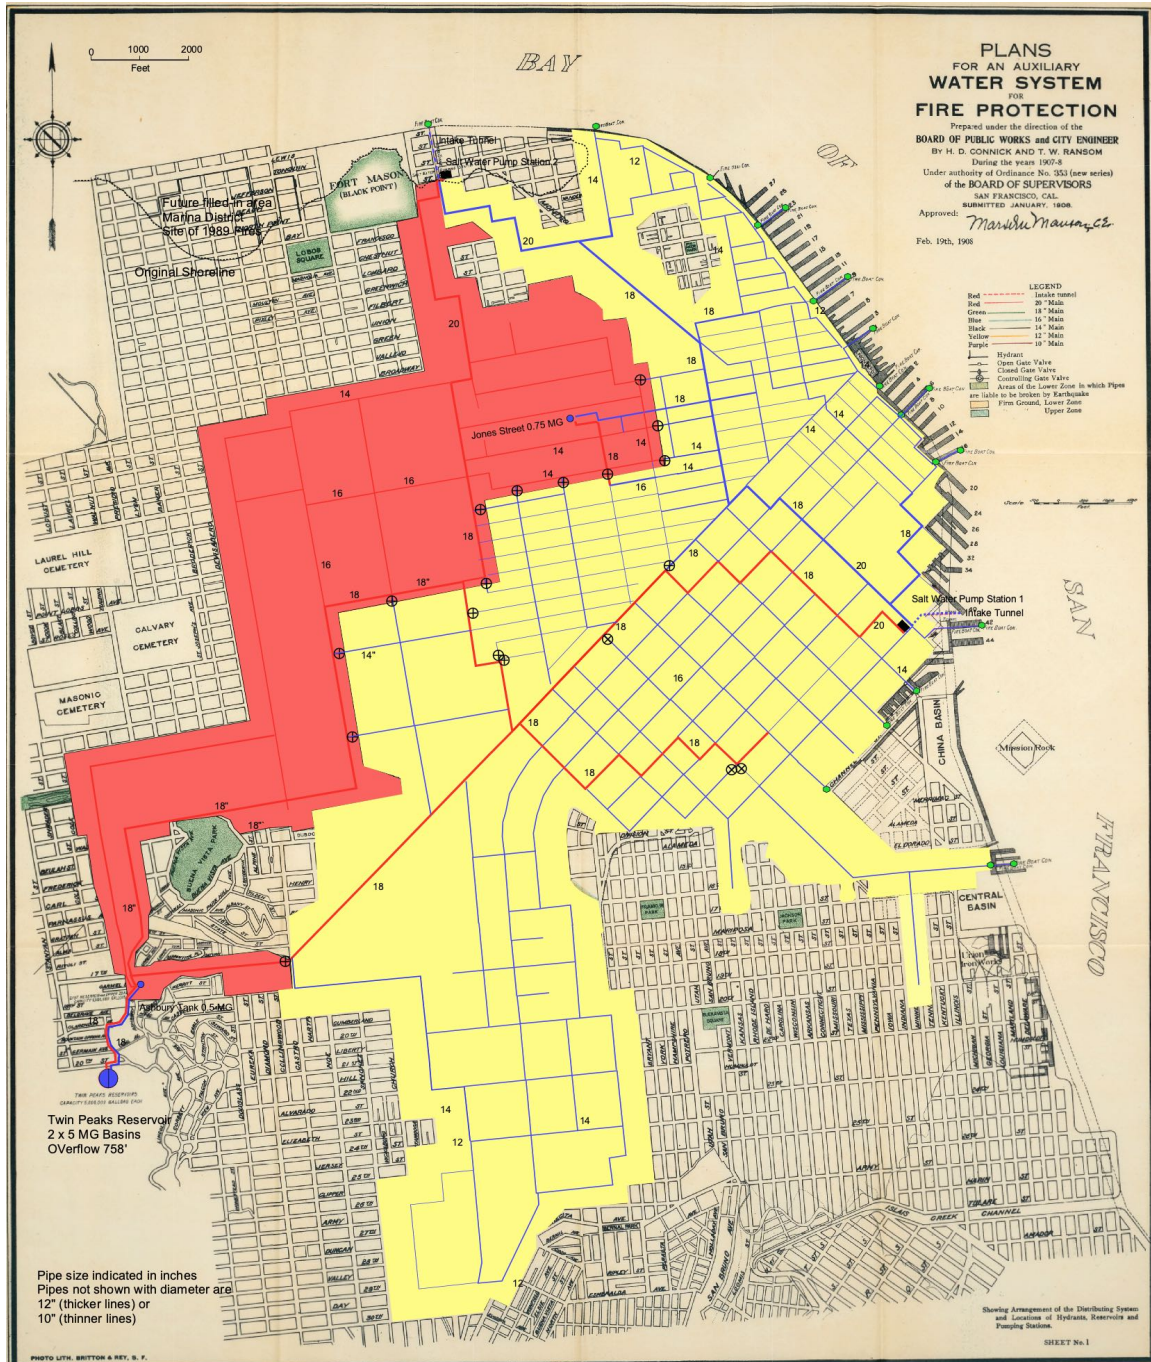
Figure 8-1. The AWSS Water System, 1908 (Base map by Manson, 1908). Blue lines: water pipes (12-inch diameter unless noted). Yellow: lower pressure zone. Red: upper pressure zone. A tiny area is in the uppermost pressure zone directly beneath the Twin Peaks reservoir.

- Lower Zone (mapped in yellow in Figure 8-1). This zone covers the area of the City under 150 foot elevation. The Lower zone is normally controlled hydraulically by the Clay Tank. Comparing the Lower Zone area (Figure 8-1) with the 1906 fire bound area (Figures 8-4), we see an almost exact duplication of the area. Why? This reflects that the thinking was that a future fire conflagration would be in the same area as the 1906 conflagration. This is a dubious assumption, and in the 1989 Loma Prieta earthquake, the major fire was in the Marina district, outside of the Lower (or Upper) AWSS zones as constructed by 1912.

- Upper Zone (mapped in red in Figure 8-1). This area covers the area above 150 feet elevation, covering much of the residential area west of Chinatown and the that burned in the 1906 earthquake. The Upper zone is normally controlled hydraulically by the Ashbury Tank.

The design in Figure 8-1 is often attributed to Manson, who at the time was a City of San Francisco Employee and sometimes called the City Engineer of San Francisco. The historical records suggests that the AWSS design was heavily influenced by Hermann Schussler of SVWC. Between the two of them, the following attributes of the original AWSS were set:

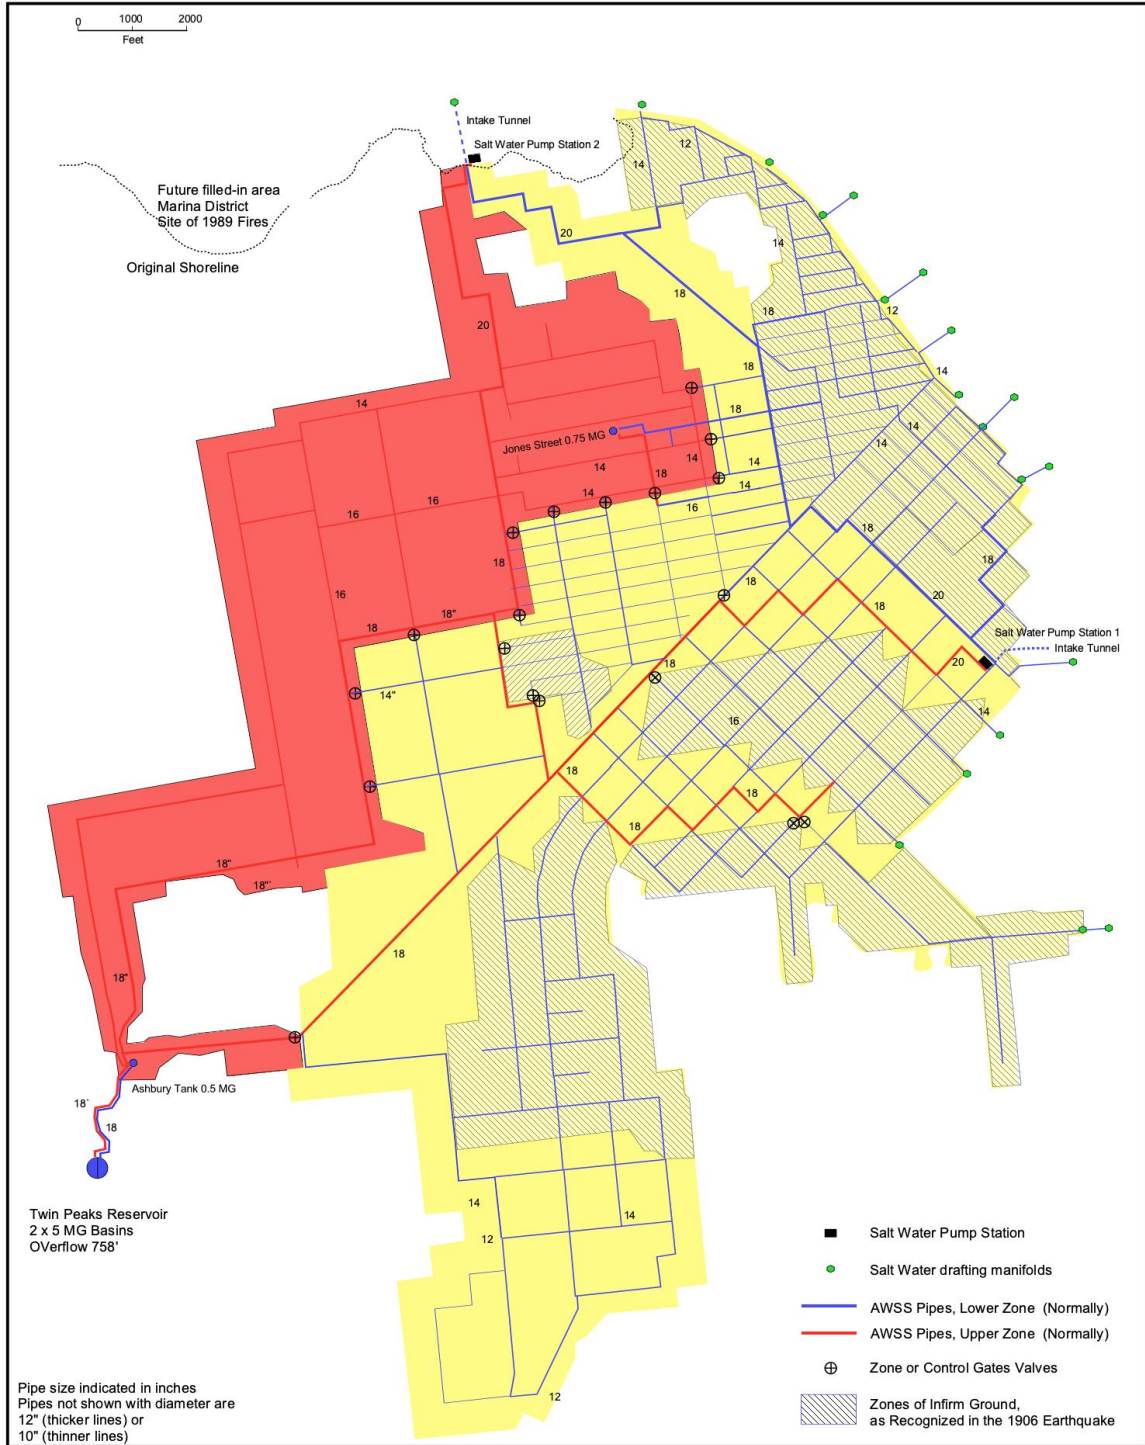
The map in Figure 8-2 highlights that the larger diameter pipes (generally 18-inch) that provide the backbone to move water from the Salt Water pump stations (or the reservoirs) to the grid, were purposely installed outside the infirm ground areas. While this was sound design, the fundamental error in the AWSS design still remains: the cast iron pipes in the infirm ground area are going to break in earthquakes that trigger PGDs; and the time needed to manually identify, send crews, and turn valves will always be more than 1 hour (and could easily be several hours). Any initial fire ignitions, if not controlled within 10 minutes or so, can readily spread to adjacent buildings, especially if it is windy.

Figure 8-2. The AWSS Pipe System, 1908. Zones of Infirm Ground Highlighted by hatched areas. Red and yellow-colored areas are the pressure zones, same as in Figure 8-1

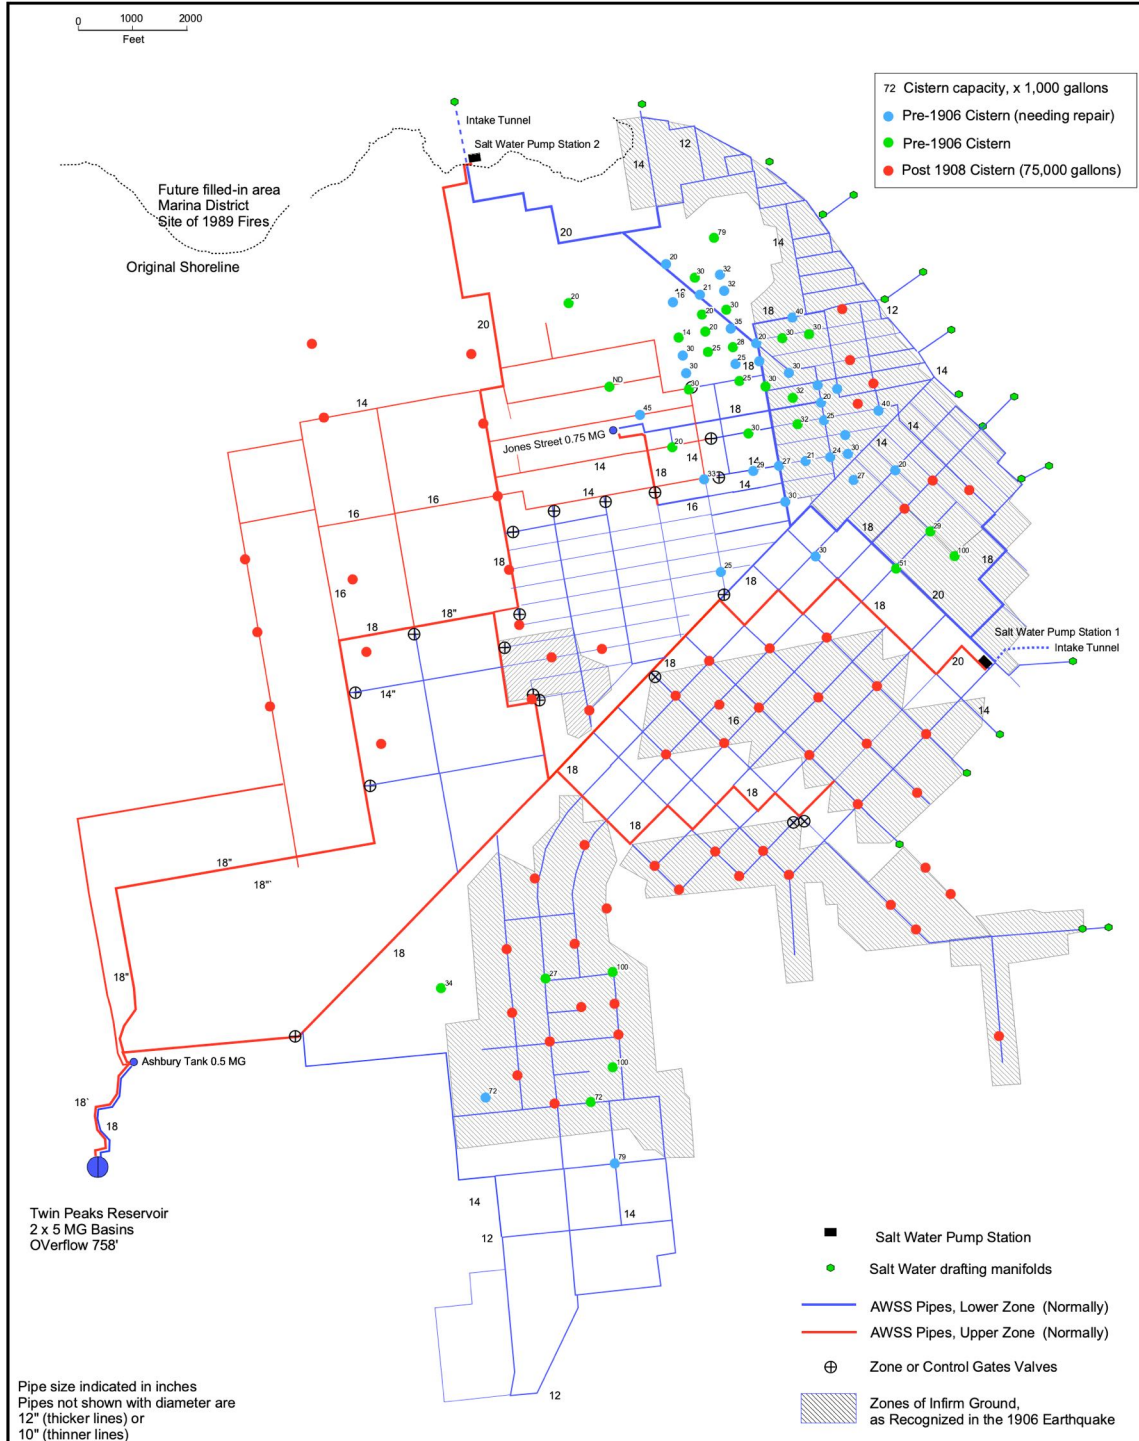
Figure 8-3. The AWSS Cistern and Pipe System, 1908, With Zones of Infirm Ground Highlighted

Figure 8-3 shows the planned AWSS system, this time highlighting the location of cisterns. The green and blue cisterns were in place (and filled) at the time of the 1906 earthquake. The red cisterns were those proposed to be built as part of the 1908 bond issue.

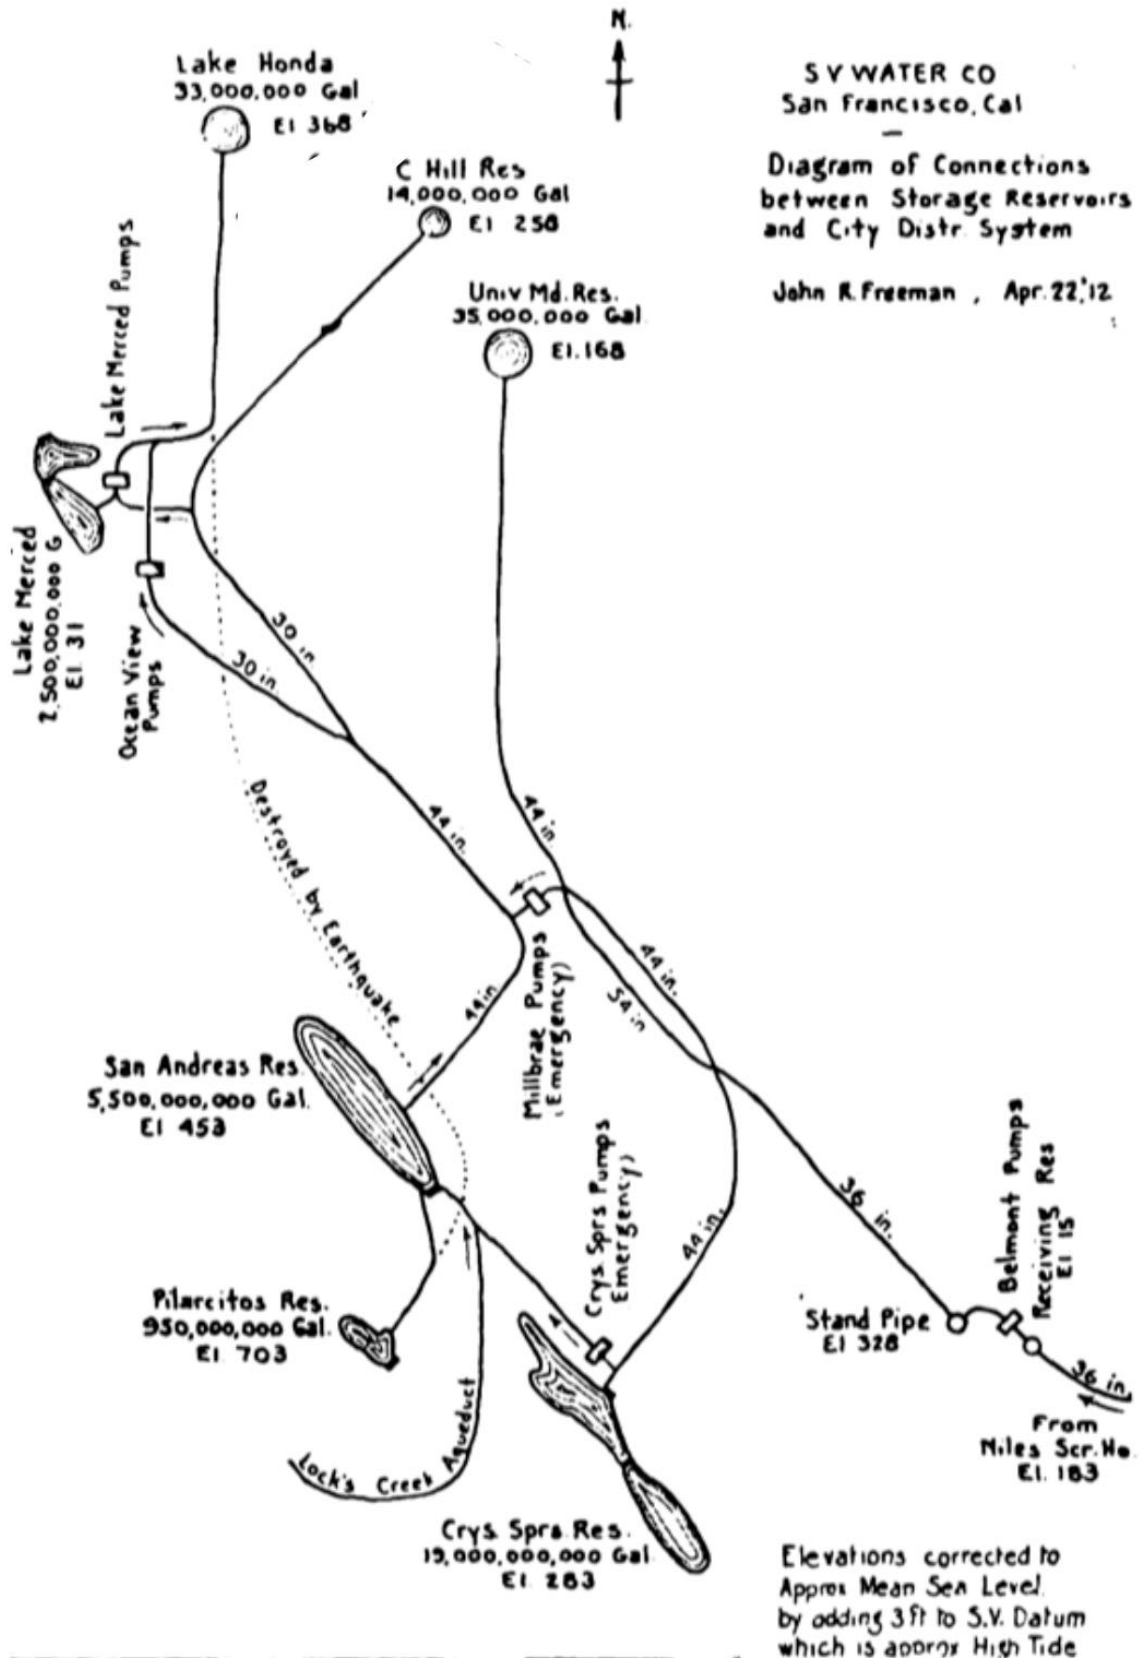
Figure 9-11. Peninsula Transmission System, After the 1906 Earthquake, Freeman (1912)

Freeman also considered the SVWC system in laying out the Hetch Hetchy system. In 1912, he sketched the SVWC system as shown in Figure 9-11. Figure 9-11 shows the same SVWC system as before the 1906 earthquake, except that the Pilarcitos pipeline is gone (damaged by the 1906 earthquake and removed); the new Baden-Merced 30-inch pipeline (conceived in 1907 using remnants of the old Pilarcitos pipe as well as new pipe), and the new Central pump station (needed to boost water from the San Andreas pipeline up to Lake Honda).

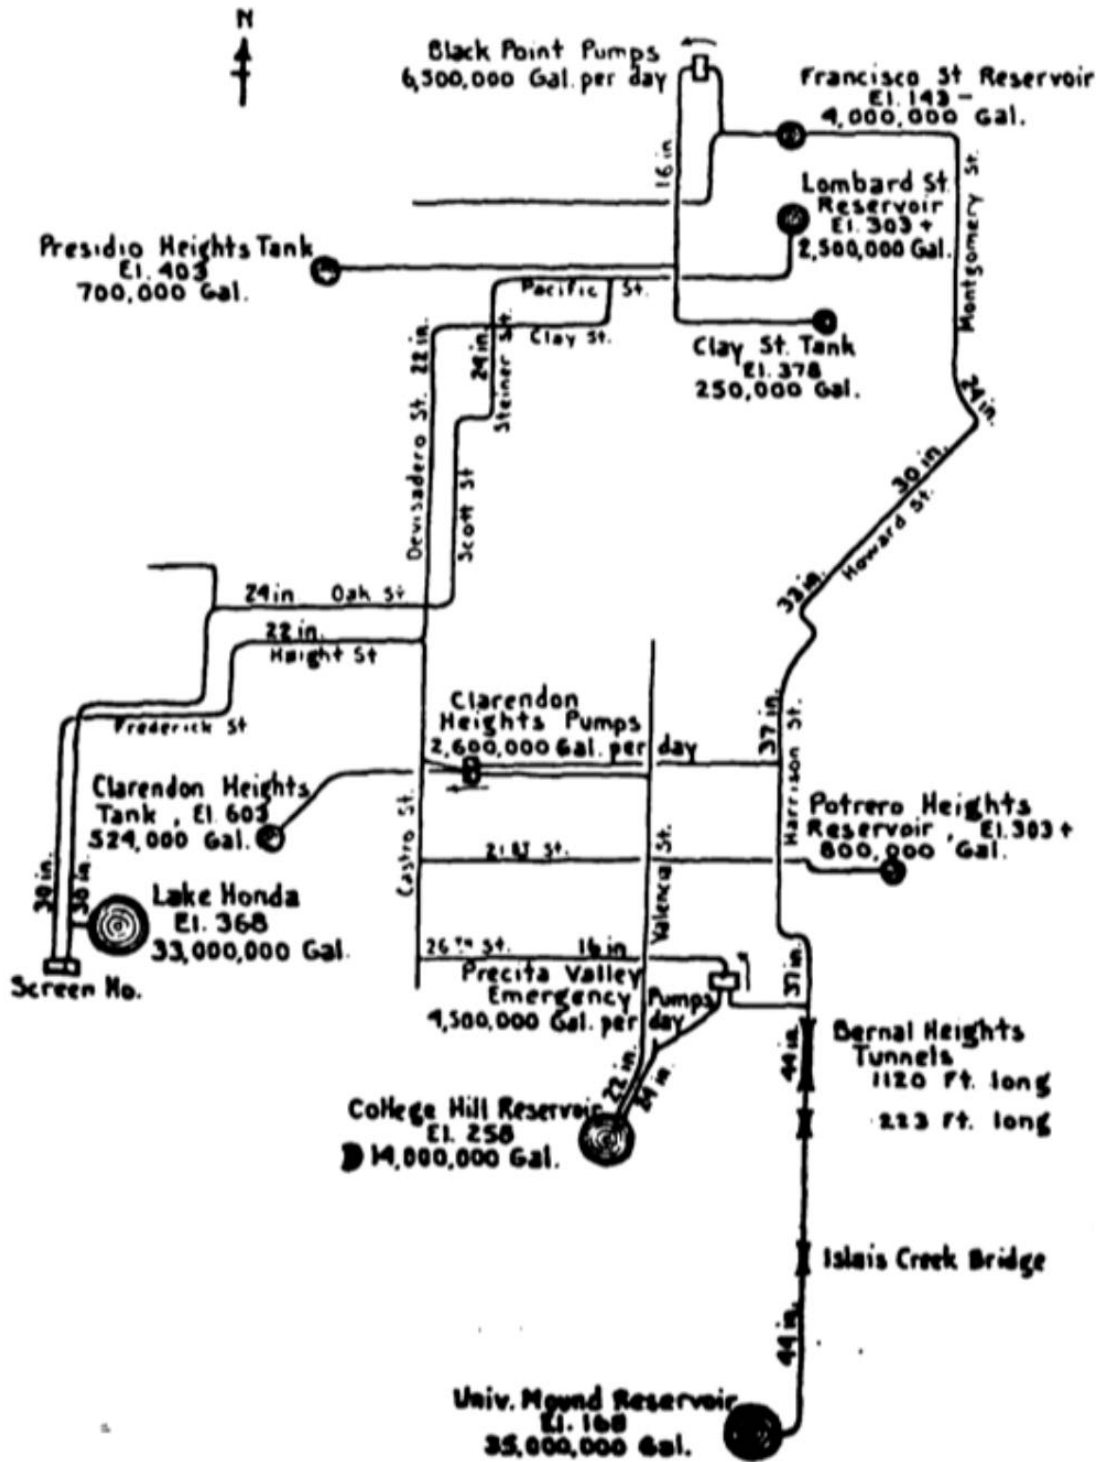
Figure 9-12. City Trunk Line System, After the 1906 Earthquake, Freeman (1912)

The City trunk line system sketch prepared by Freeman in 1912. Figure 9-12 highlights the main changes since 1906.

- The Precita Valley pumps were installed (relocated from the abandoned Pilarcitos pump station) to move water from the Crystal Springs zone up to the Lake Honda zone; this was needed to reinforce the reliability of supply to the upper zone, given that its original supply pipeline (Pilarcitos) was no longer available.

- The 37-inch pipe down Harrison Street (through Mission Creek Marsh) and the 22-inch line down Valencia Street (through Mission Creek) are still shown. This suggests that the rebuild of the water system post-1906 was done as rapidly as possible, to get the city back in business. Conceivably, the Precita Valley pumps could bypass these liquefaction zones; but this is limited in flow, requires pumping, and a fair amount of manual turning of zone gates to achieve. Perhaps SVWC just abandoned fire flows as a core mission, as the City was building its parallel AWSS. Whichever the case, both the SVWC system (later to be bought and operated by SFD) and the AWSS system (operated by SFD) remained seismically vulnerable in 1912, and remain svulnerable in 2023.

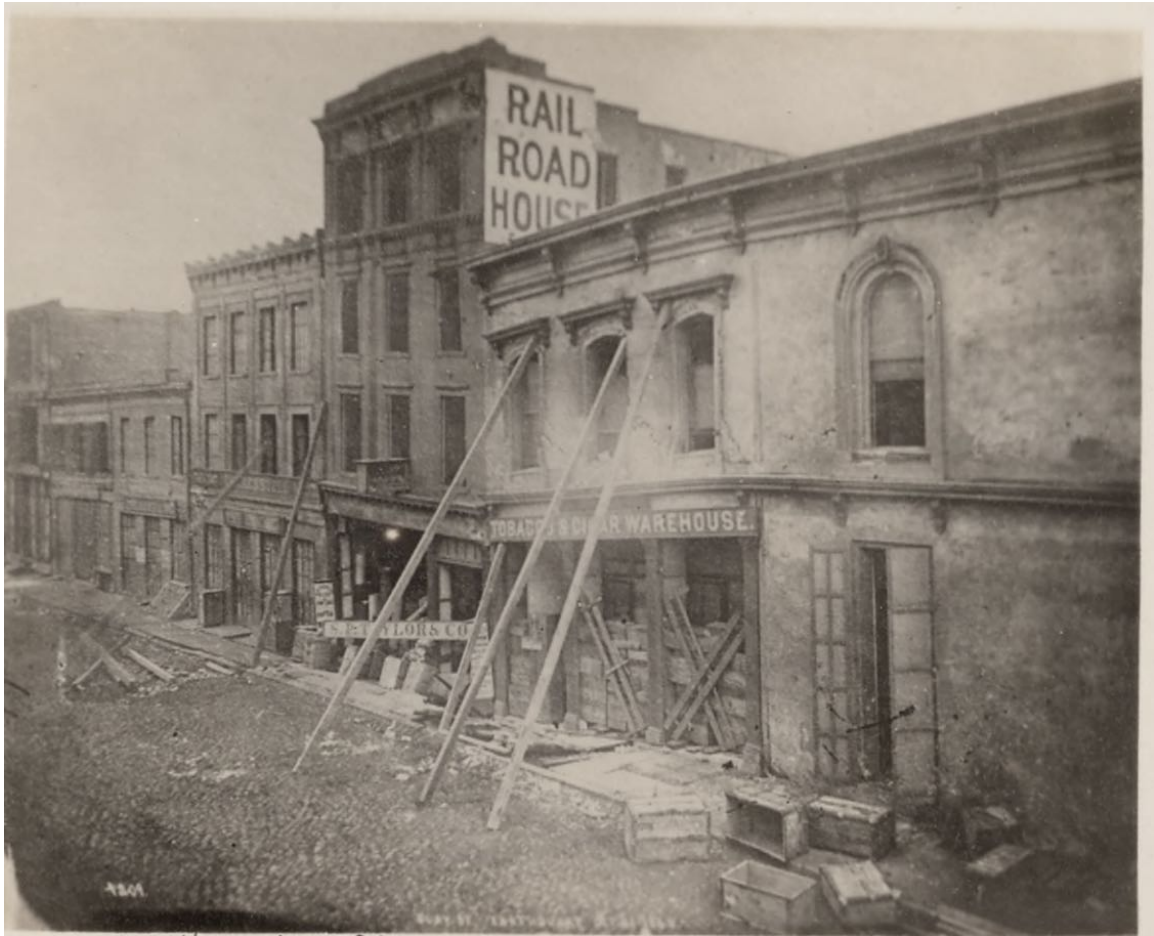
Figure A-1. Clay Street East of Sansome (Photo: Thomas Woodward, 1868)

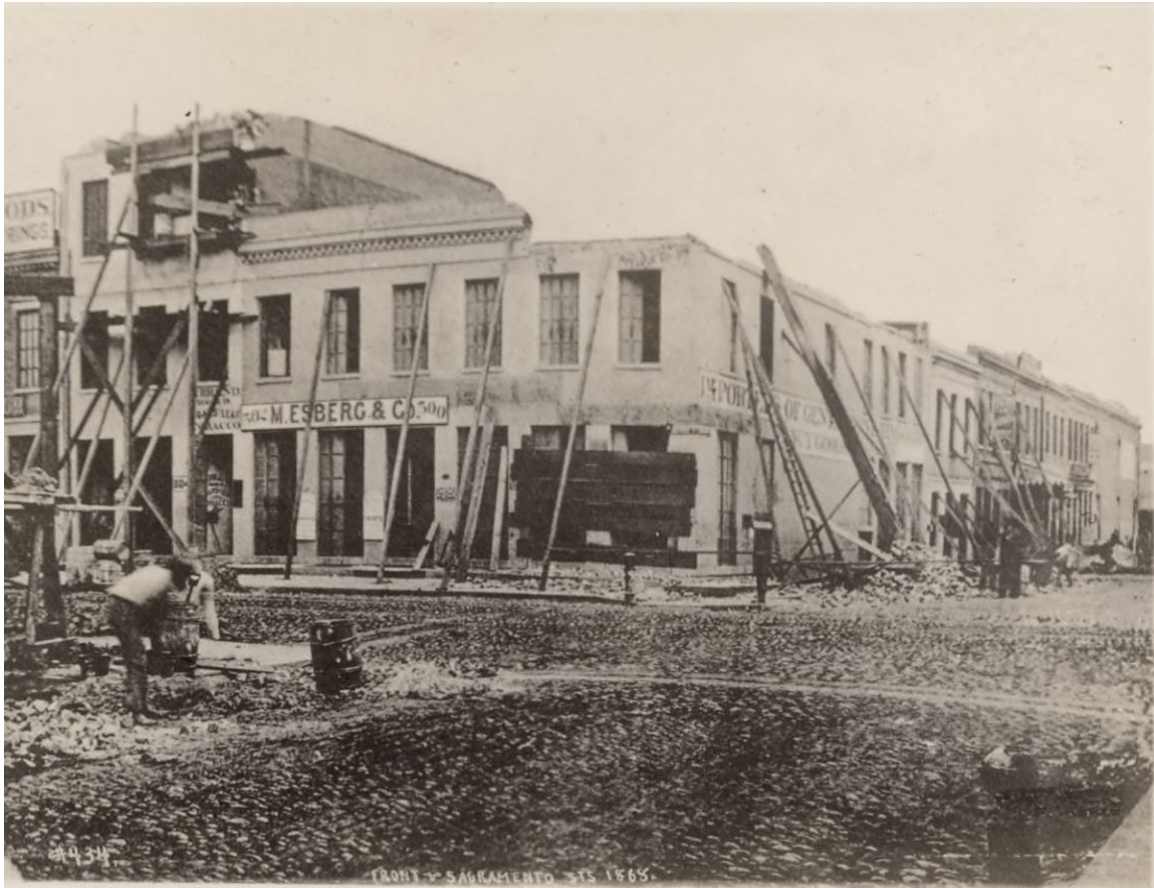
Figure A-2. Front and Sacramento (Photo: Thomas Woodward, 1868)

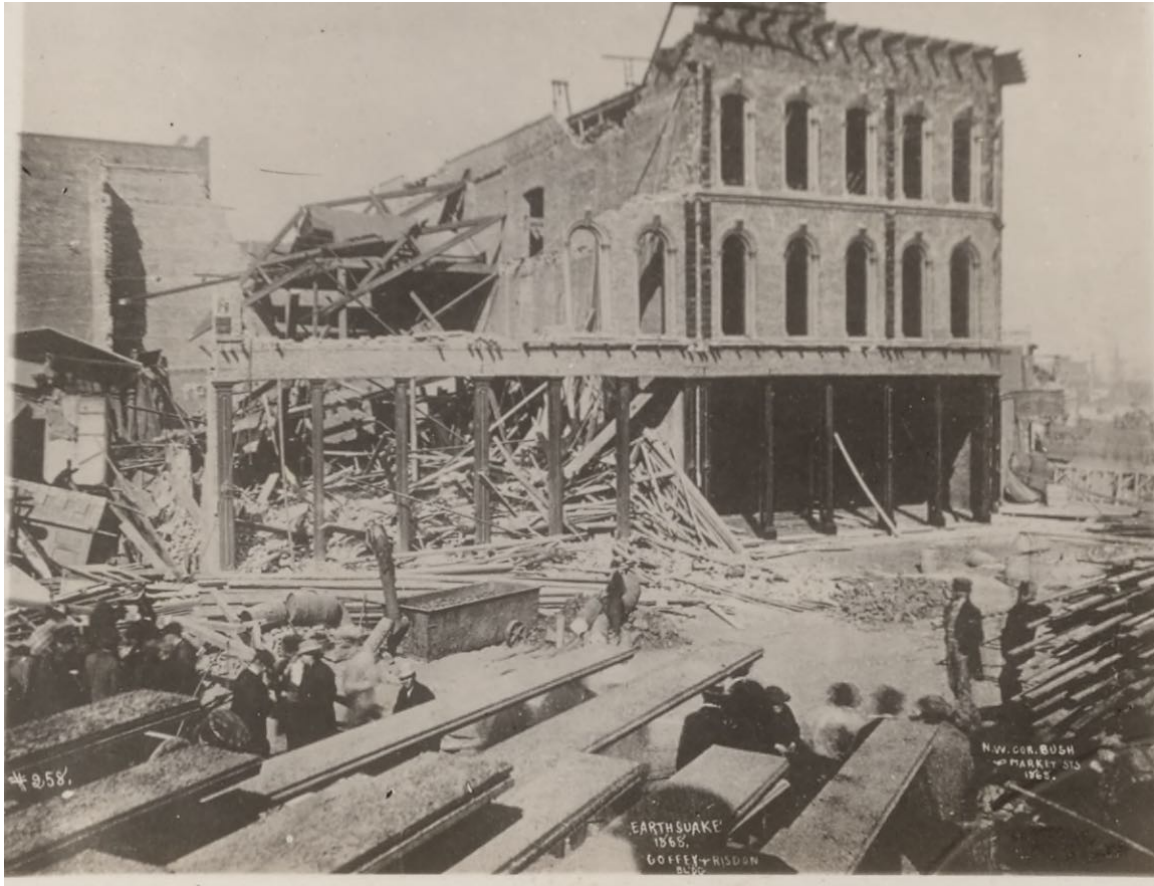
Figure A-3. Northwest Bush and Market Streets (Photo: Thomas Woodward, 1868)

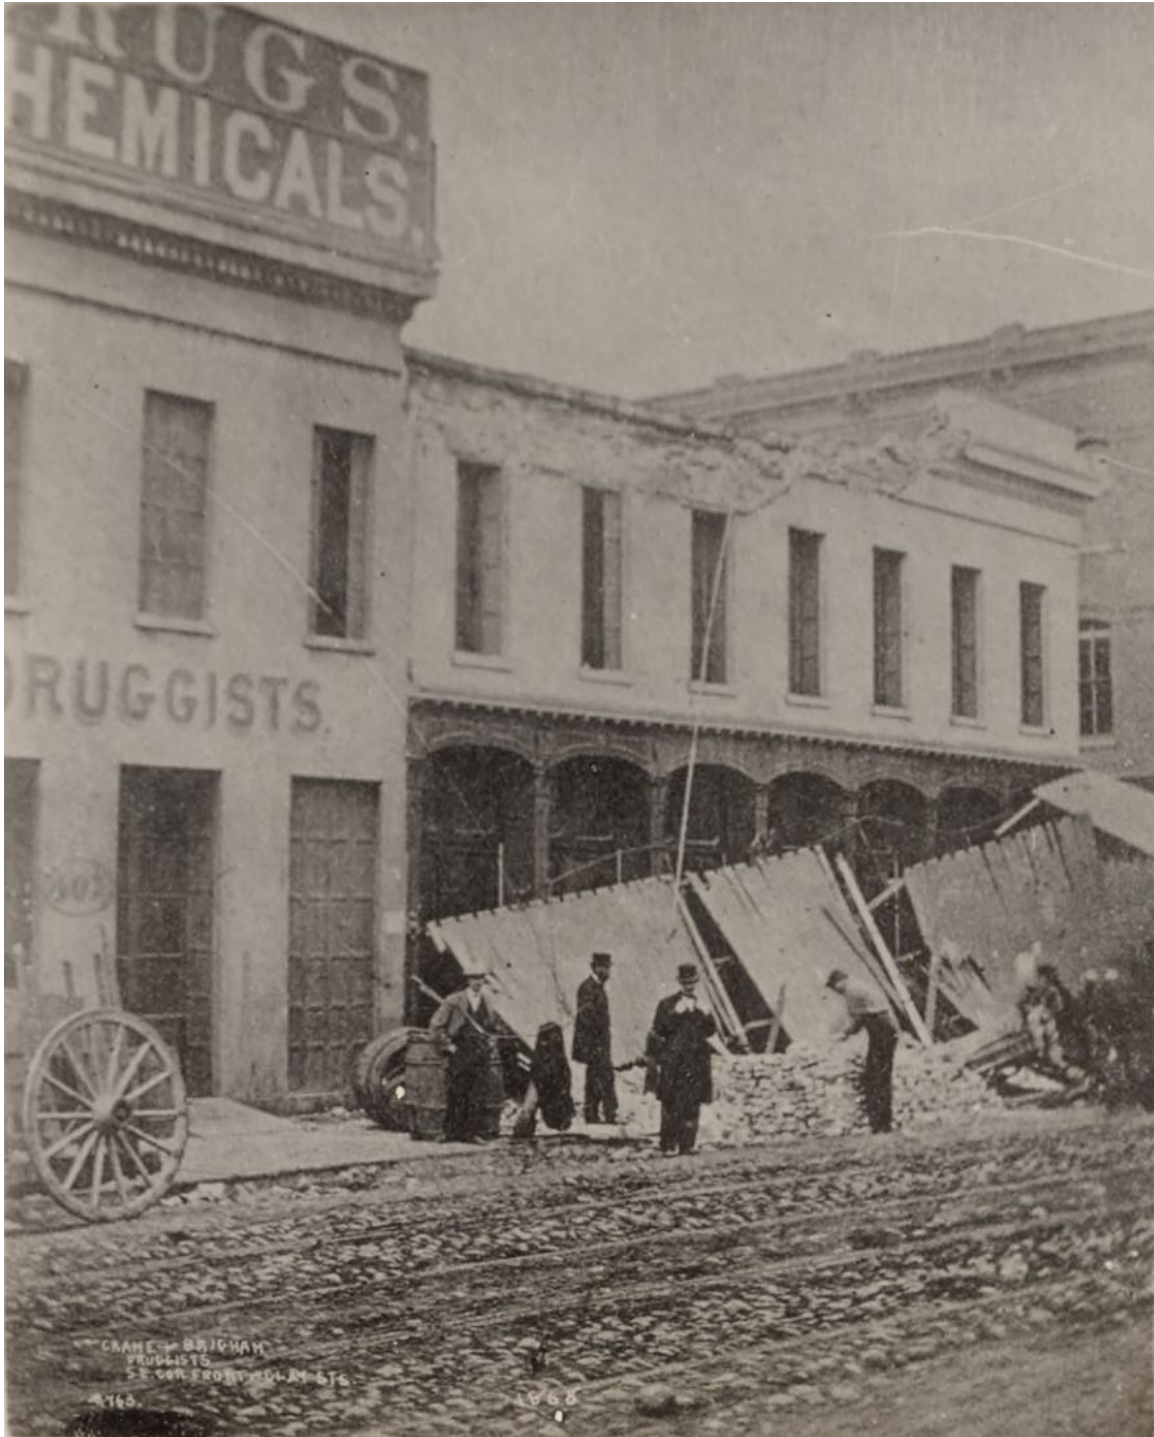
Figure A-4. Southeast Front and Clay (Photo: Thomas Woodward, 1868)
