History of the Water Works of San Francisco: Its Performance in the 1906 Earthquake and Aftermath

John M. Eidinger and N. Timothy Hall

Revision 2

August 2024

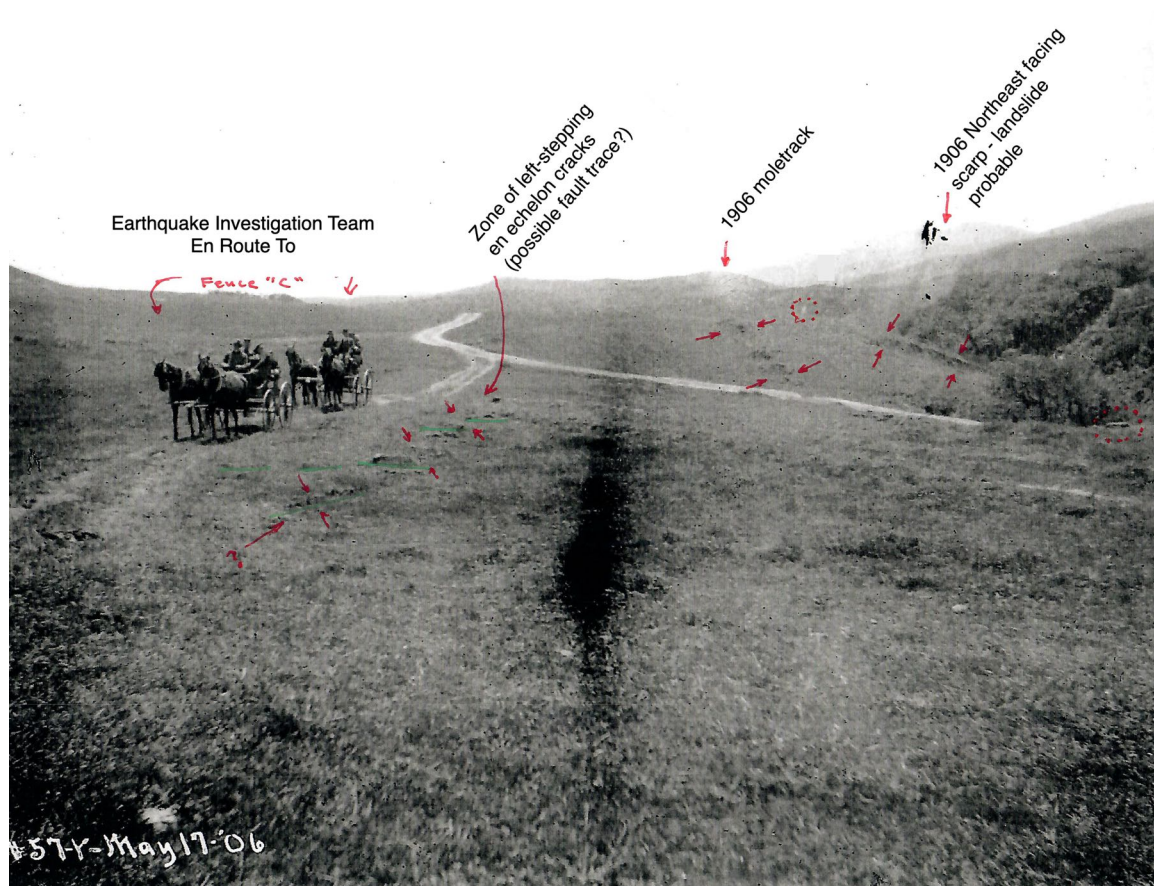
Figure 0-1. Earthquake Investigation Team (photo: Schussler 1906)

Figure 0-1 shows a photo of the Earthquake Investigation Team en-route to examine the San Andreas fault and the damaged Pilarcitos water pipeline at "Site 9" (see Section 4.1.9 for details of what happened at that site). The black splotch in the center of the photo and a few other dark splotches in the top right are artificial as the old photo was creased; hand-drawn arrows have been added to highlight certain features; "Fence C" is discussed in Section 4.1.8.

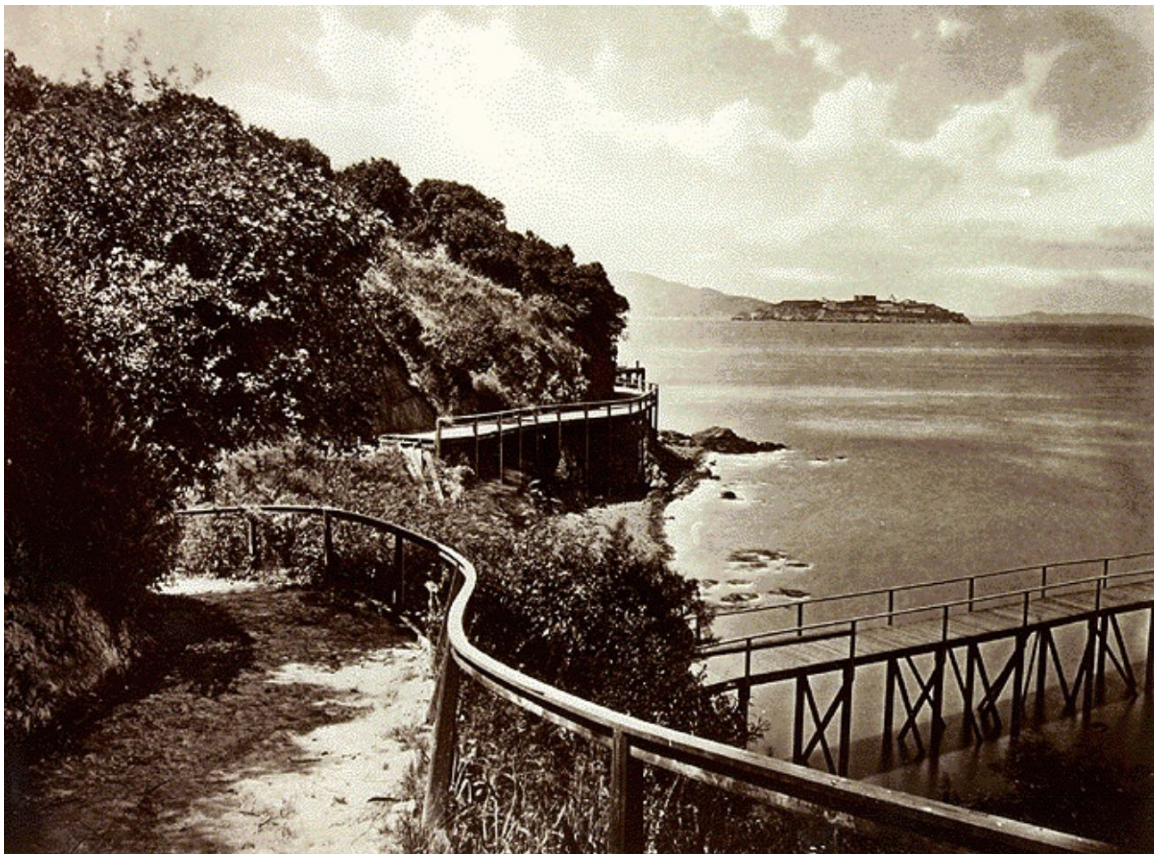
Figure 2-9. Remnant of Lobos Creek / Black Point Flume (c. 1900). Alcatraz Island in the background. (Photo credit: SFPUC)

Figure 2-9 shows a remnant of the Lobos Creek flume, circa 1900, by which time the flume had been taken out of service. The reason that the flume was taken out of service relates to the degraded water quality of the source water in the Government Reserve (Mountain Lake, Lobos Creek), and possibly, in part, by the competing local demand by the Army for water in the Presidio. Within the Presidio, the Army ultimately constructed their own 2 MG reservoir just to the north of Mountain Lake, with source water from local springs. The Army constructed their own water distribution pipes, cast iron pipe in the 1800s and through the middle 20th century, and asbestos cement pipe more recently. A water treatment plant was eventually built in the Presidio, able to treat up to 2 MG from Lobos Creek; this treatment plant was upgraded (including seismic renovations) in the mid 1980s. The water system in the Presidio was run more-or-less independent of the City of San Francisco water system from 1900 to 1994. After 1994, the National Park Service operates this water system (water treatment plant, pipes, the 2 MG reservoir and related facilities) in the Presidio. Today (2024), the water system in the Presidio continues to be largely separate and disconnected from the water system serving the rest of the City of San Francisco.

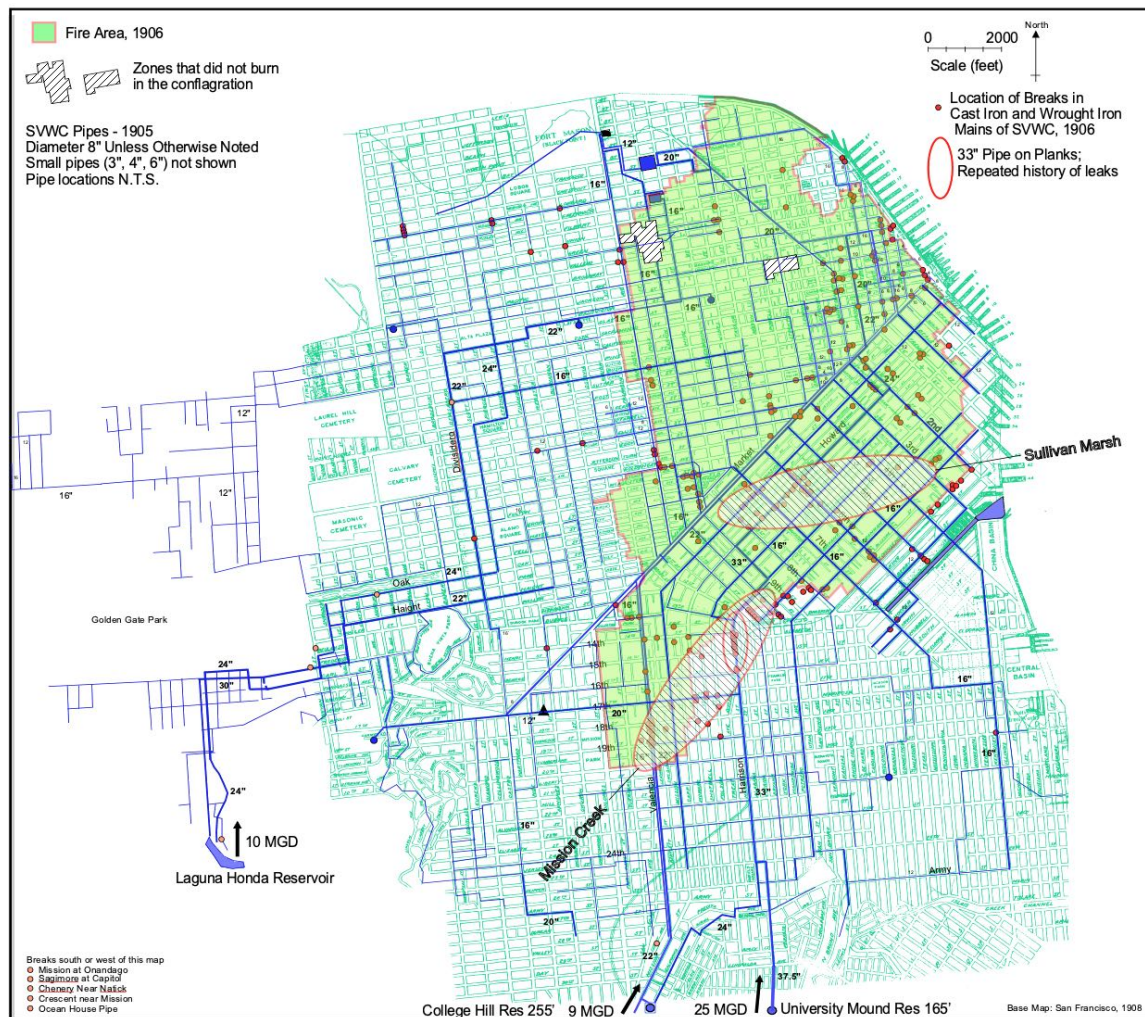
Figure 2-28. 1906 Water Pipe Breaks (Dots) in City Mains (Blue Lines) and Ultimate Fire Area (Green)

Figure 2-28 shows the water distribution system serving San Francisco, as it existed just prior to the 1906 earthquake. At the south side of the City were three terminal reservoirs: Laguna Honda, College Hill and University Mound. Water from reservoirs along the Peninsula and Alameda County was delivered to these three terminal reservoirs by the four transmission conduits. In 1906, Average Day Demand (ADD) was about 29 MGD. Prior to the 1906 earthquake, water supply capability was 10 MGD via Laguna Honda, 9 MGD via College Hill Reservoir, and 25 MGD via University Mound reservoir. The red dots show the location of where 299 distribution system water pipes broke in the 1906 earthquake. The major liquefaction areas in the 1906 earthquake were in the Sullivan Marsh and Mission Creek zones, schematically highlighted in Figure 2-27 by the two ovals; these same areas are shown in Figure 2-28 by the diagonal hatched areas.

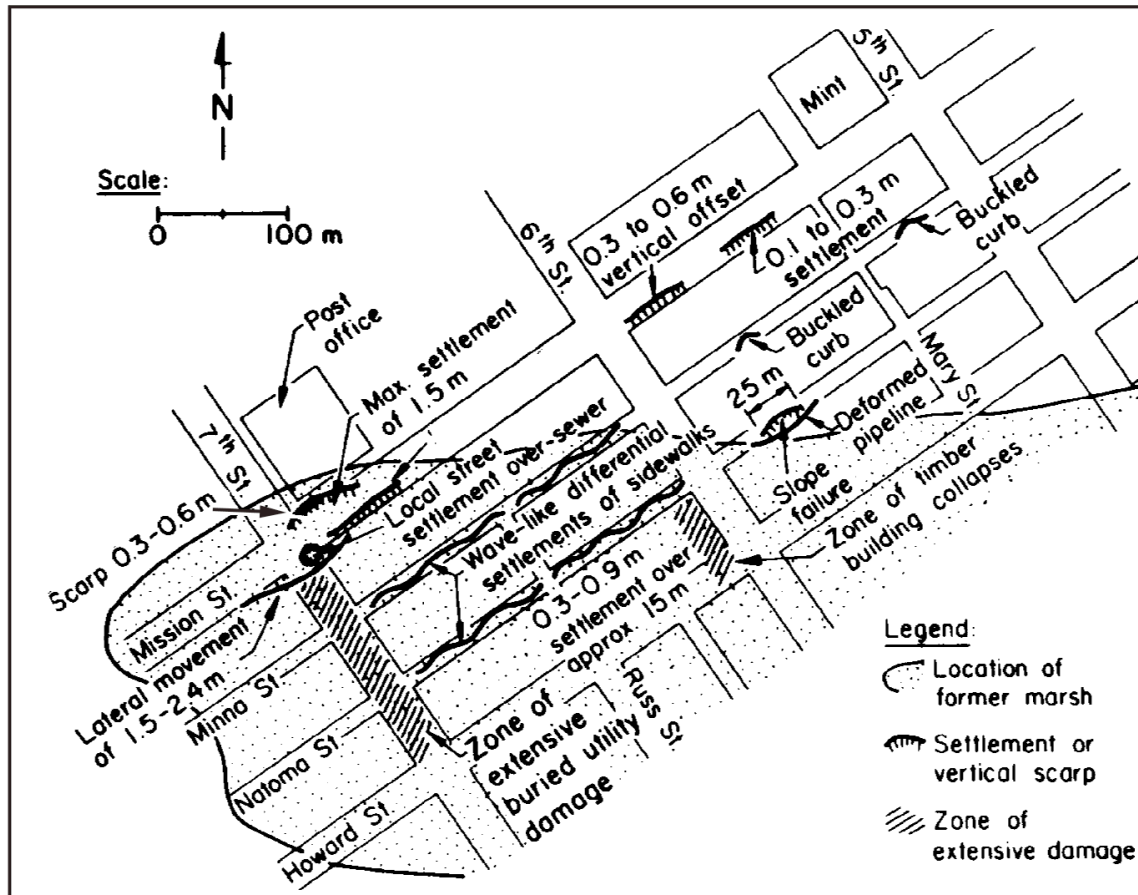
Figure 3-4a. Detailed map of 1906 Earthquake-Induced PGDs (Sullivan Marsh Area) (O'Rourke 1992)

Lateral spreads of up to 8 feet were recorded along the length of 7th Street, with ground moving from northwest to southeast. 1 to 2 foot settlements occurred sporadically over the entire lengths of Minna and Natoma streets. Probable lateral spreads on 6th Street between Natoma and Howard led to collapse of timber structures.

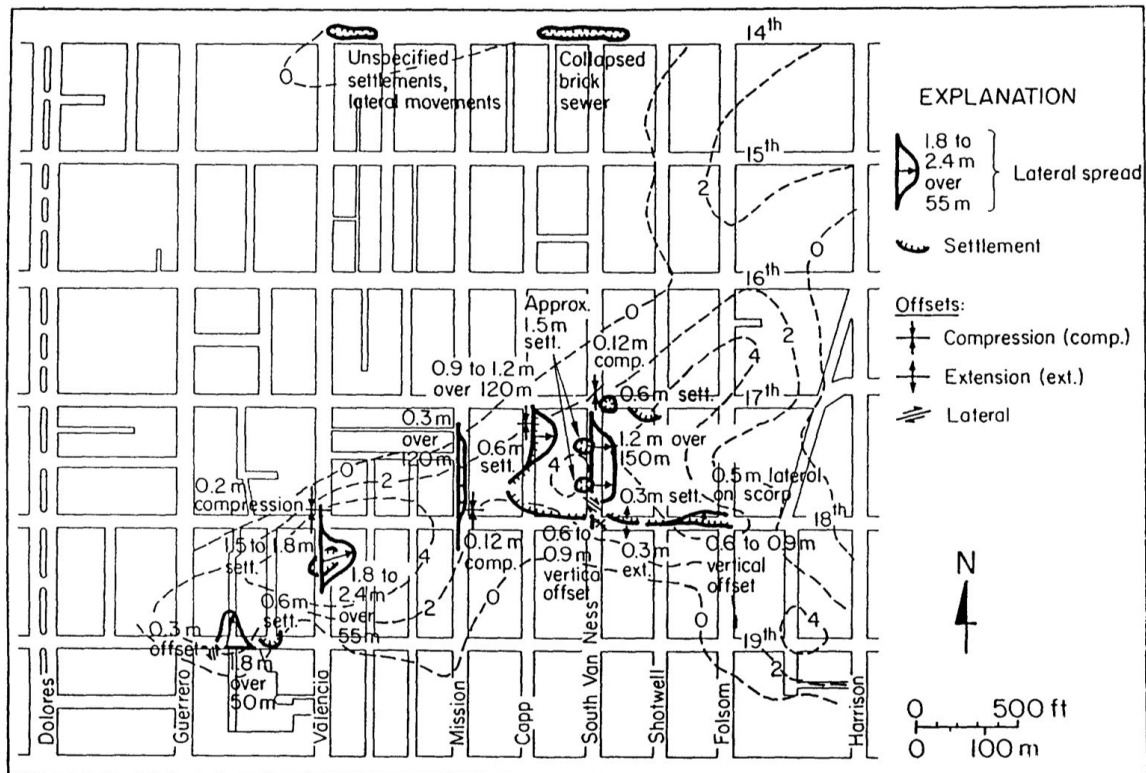
Figure 3-4b. Detailed map of 1906 Earthquake-Induced PGDs (Mission Creek Area). Dashed lines show depth of fill in 2 meter contours. (O'Rourke 1992)

Figure 3-4b shows that PGDs along Valencia Street were on the order of 1.5 to 1.8 meters (settlement) and 1.8 to 2.4 meters of lateral spread. In the 1906 earthquake, these PGDs led to major damage to water pipelines where they traversed the filled areas of the former Mission Creek and its lagoonal waters. See Section 7.7 for further details of the pipe damage along Valencia Street and the collapse of the Valencia Hotel.

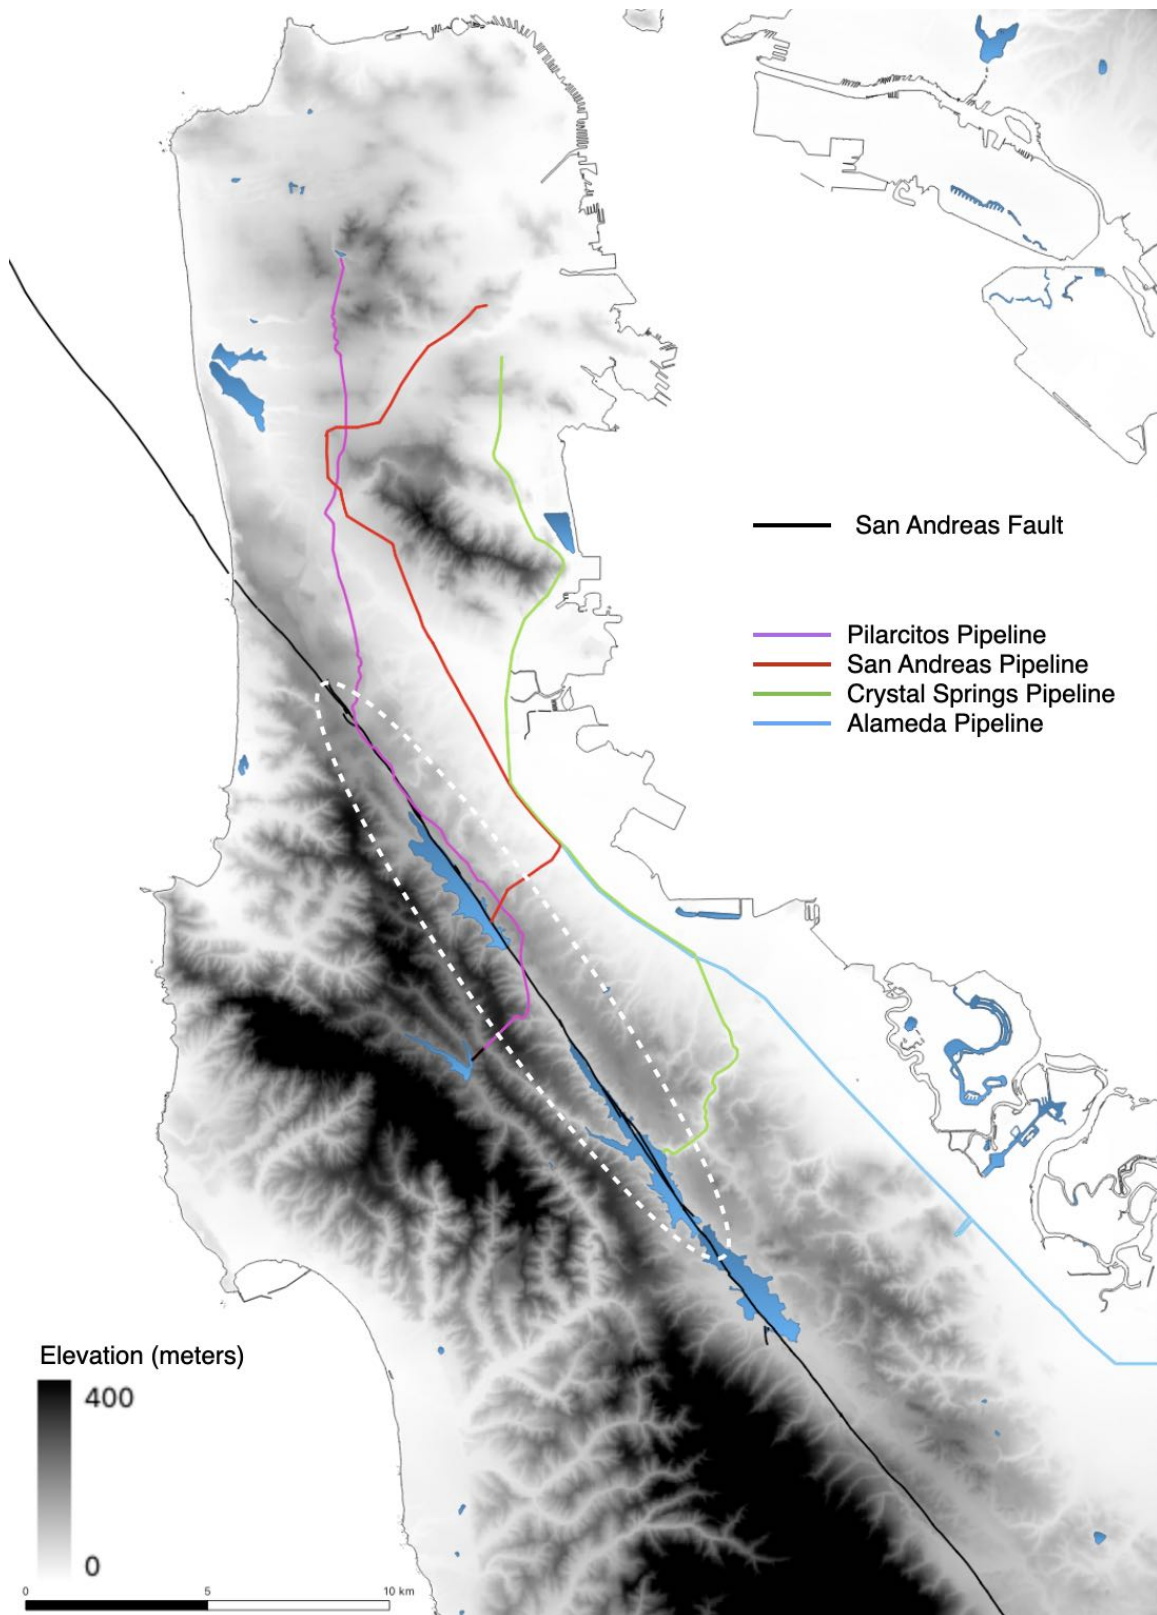
Figure 3-11 shows a topographic relief map of the San Francisco Peninsula. The four pipelines are the SVWC supply conduits as of 1906. The elevations are NAVD 1988. The map shows the present day (2024) coastline. The black line shows the location of observed surface fault offset in the 1906 earthquake. The white dashed line highlights the area of the fault that is examined in more detail in this report in Section 4.1.

Figure 3-11. San Andreas Fault Rupture and 1906 SVWC Transmission Pipes

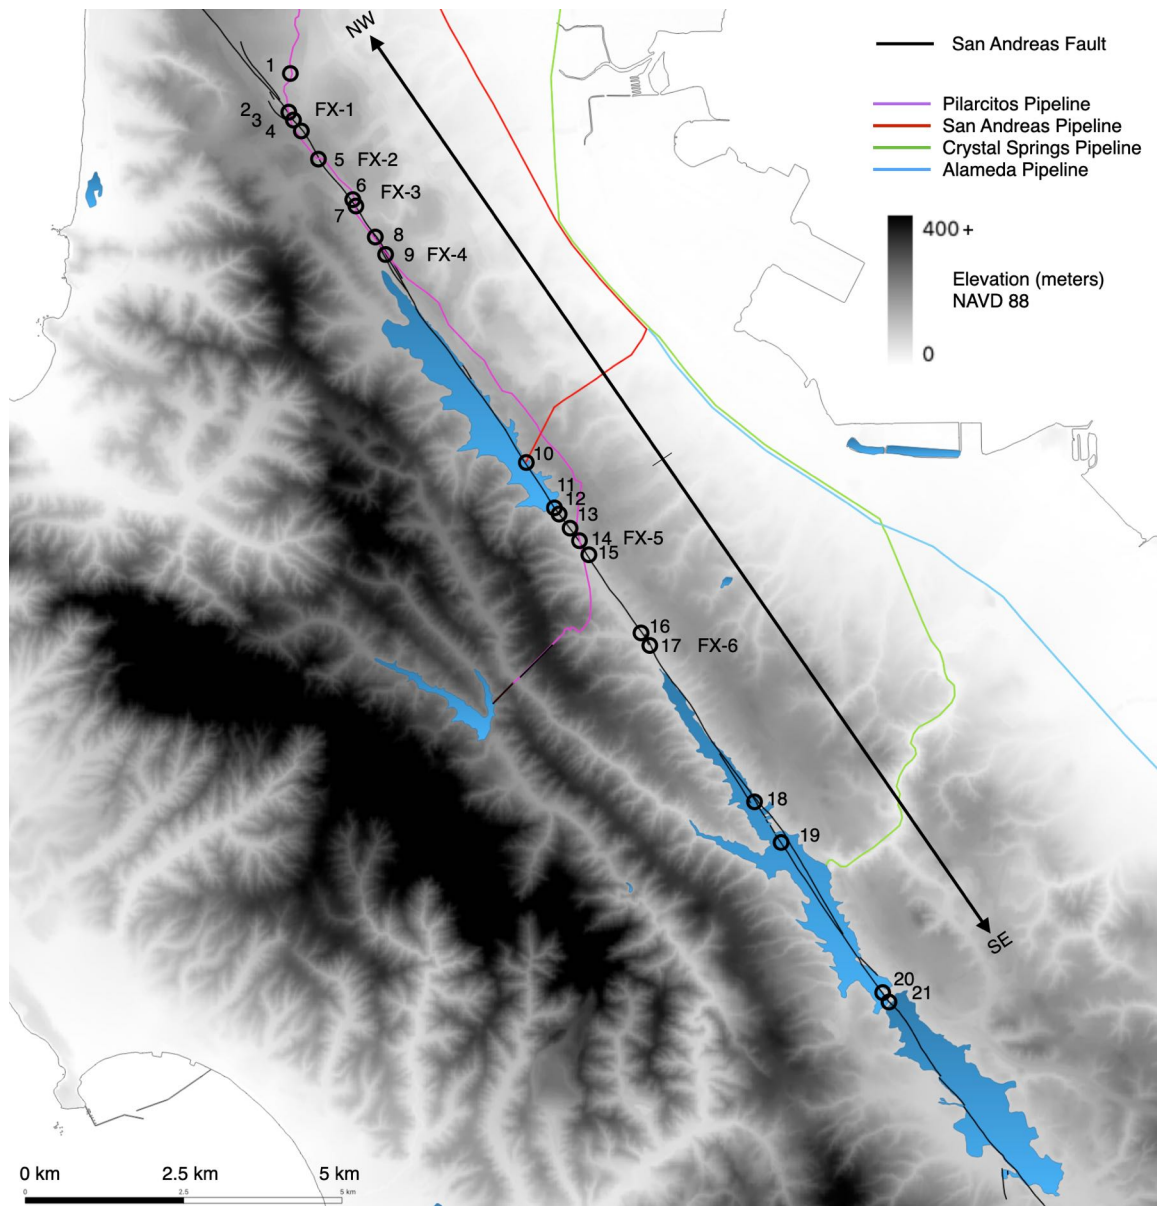
Figure 3-12. Location of Fault Offset / Other Pipe Damage Descriptions in the San Andreas Valley

The Pilarcitos 30-inch WI pipe (thin wall) pipe collapsed at two trestle locations with the pipe broken and laying at the bottom of the canyons and the two wooden trestles collapsed or with major damage (Locations 1 and 2 in Figure 3-12). The San Andreas 37-inch WI pipe broke atop one trestle, where an expansion joint pulled open, requiring repair to 2 pipe segments. The Crystal Springs 44-inch WI pipe broke at three trestles across San Bruno (Colma), Guadalupe and Visitacion Valley marshes: at these locations, the 44-inch WI pipe was thrown sideways up to 5 feet, and broken open at multiple expansion joint locations. The abandoned 37.5-inch Stone Dam (Locks Creek) pipe on an old trestle that traversed under the flooded Crystal Springs Reservoir (Site 18) failed.

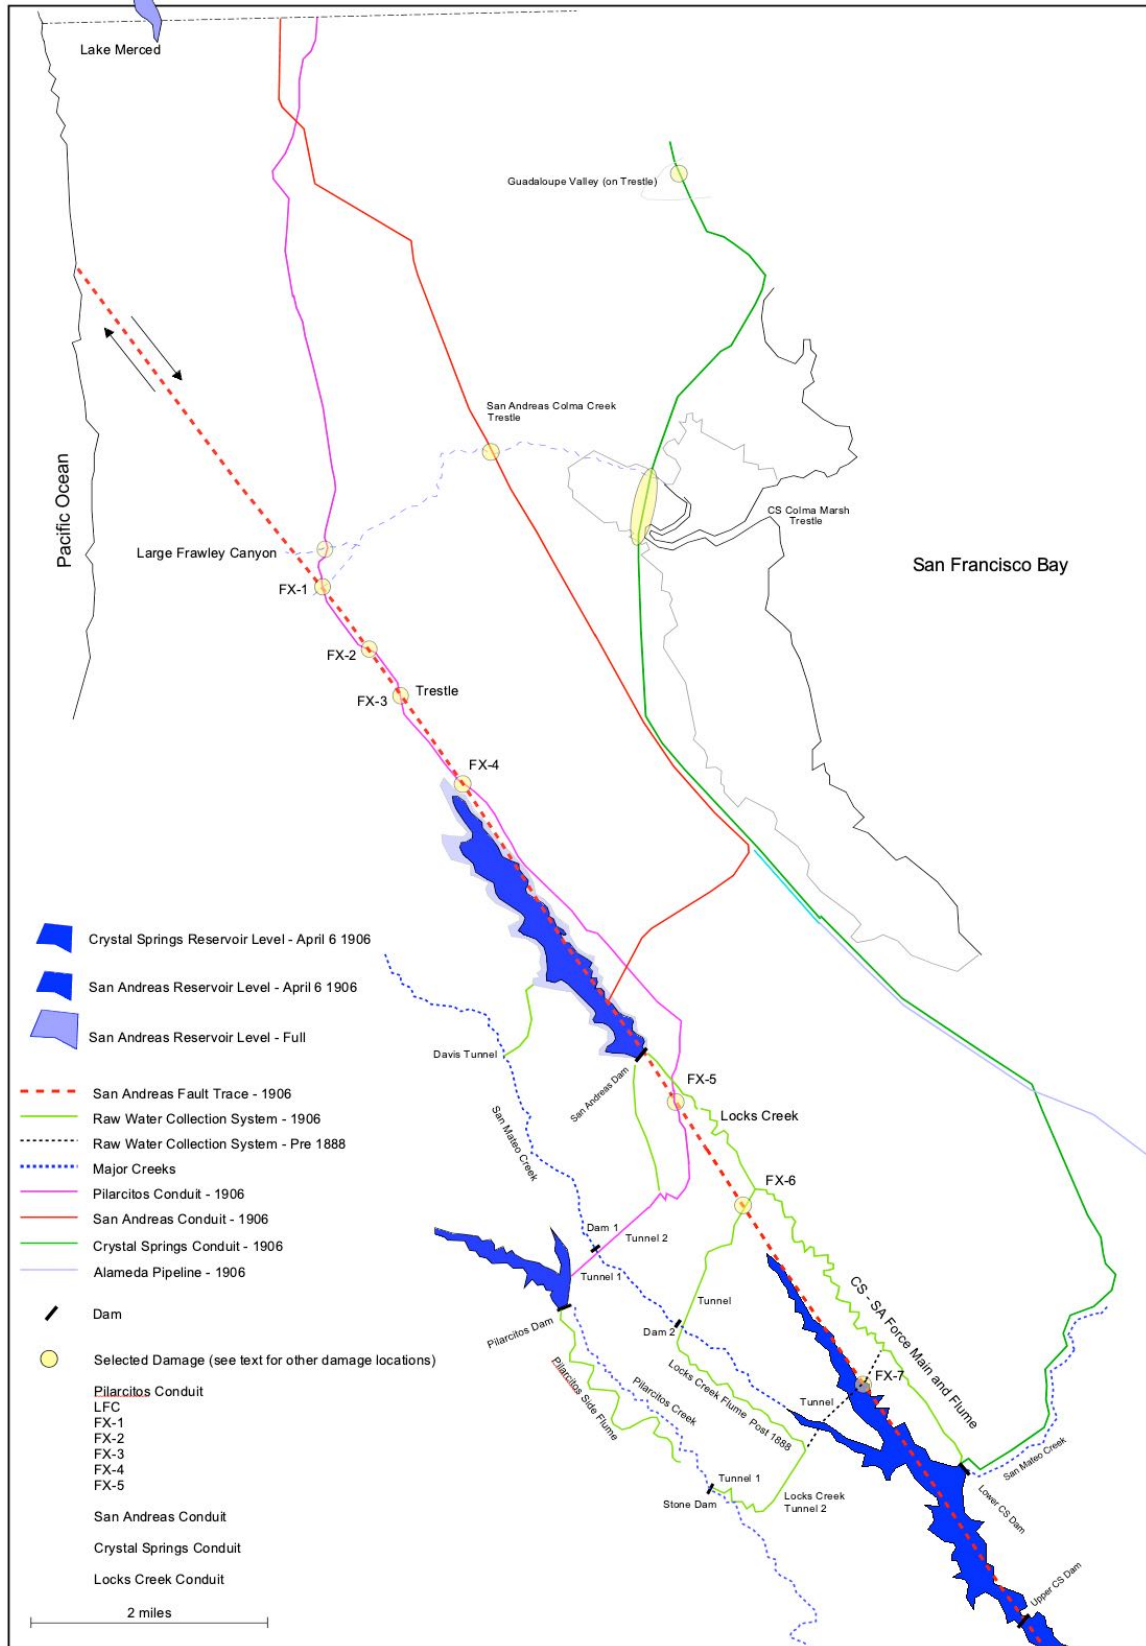
Figures 4-1 and 4-2 show maps of the damage to SVWC's transmission pipeline system in the 1906 earthquake. See Figures 3-12, 4-9 for more detail of locations of damage along the Pilarcitos pipeline.

Figure 4-2. Location of Selected Pipeline Damage in the 1906 Earthquake

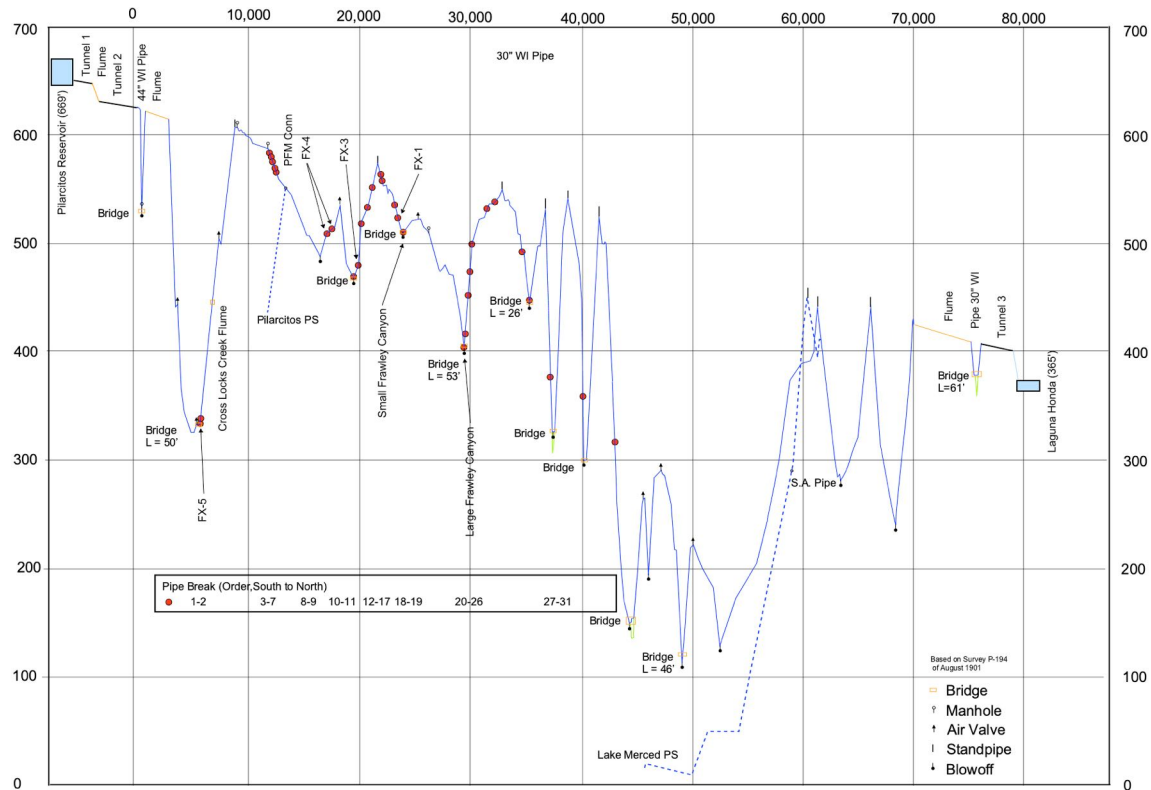
Figure 4-9 shows the approximate locations of the pipe breaks. There are 31 reported pipe break locations, as reported by Schussler (1906). Schussler also reported "*between these breaks, there are no doubt many more*". To aide in interpretation, each red dot is assigned a number (1 through 31). Some dots represent 1 break; some dots represent multiple breaks (the red dot numbering in Figure 4-9 differs from the site numbering in Figure 3-12). The locations of FX-1 through FX-4 and small and large Frawley Canyons are highlighted by arrows (actual geographic locations should not be scaled from this drawing).

Figure 4-9. Pilarcitos Conduit Profile and Earthquake Breaks (Location of Breaks (Red Dots) after Schussler 1906)

Today, we have no photographic evidence of the damage at most of the locations: dots 3-7, 12-17, 21-31. The rate of damage (breaks / km) tapers off as the pipe heads further away from the San Andreas fault (somewhat lower shaking) and at lower elevations (thicker wall and stronger girth joints).

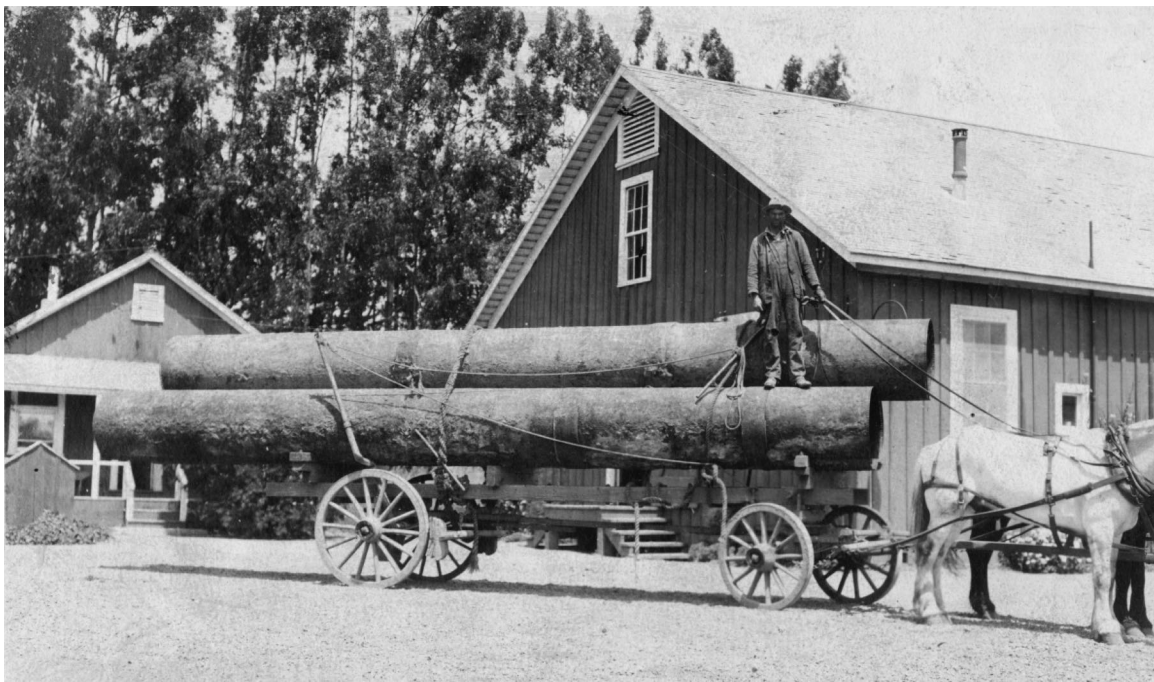
The following portions of the Pilarcitos pipe were removed after the 1906 earthquake through 1907 (stations approximate). The remainder of the pipe was removed by 1913, Figure 4-10.

Figure 4-10. Portion of Pilarcitos Pipeline taken up. (Photo: SVWC, May 1913)

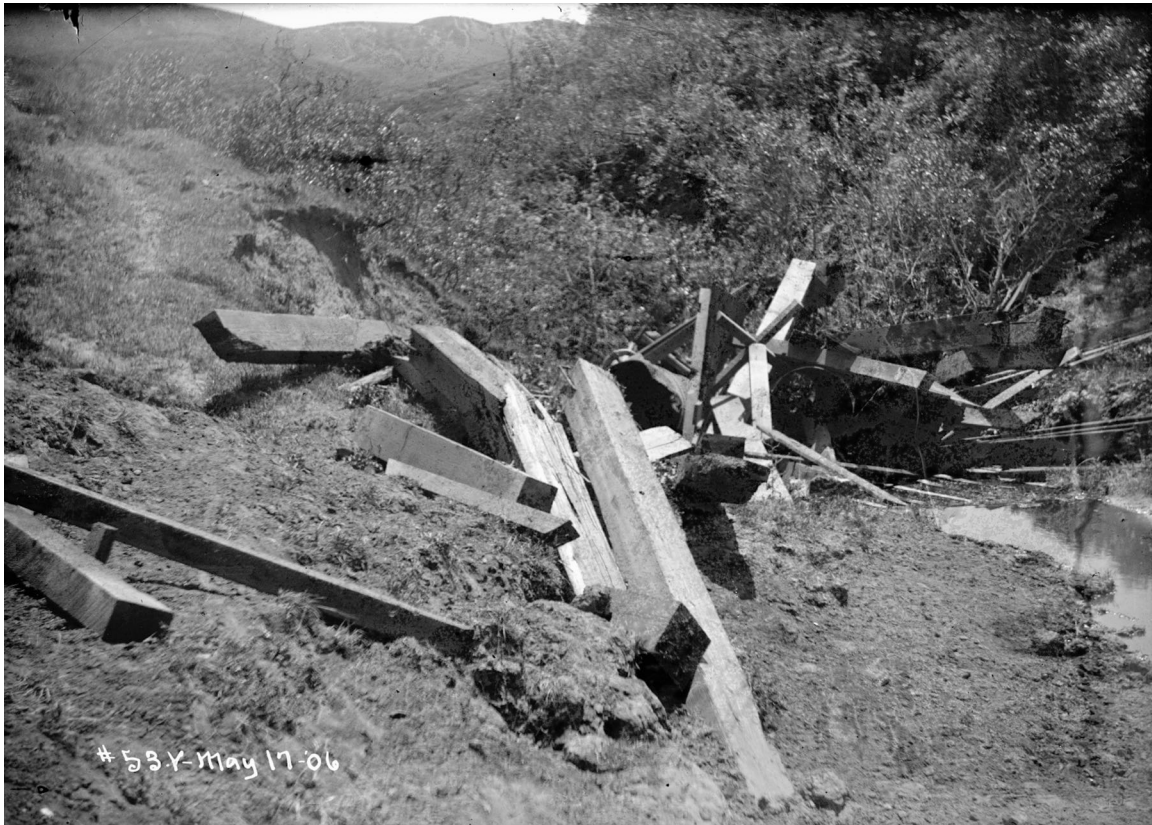
Figure 4.1.1-3 shows the debris from the failed trestle.

Figure 4.1.1-3. Large Frawley Canyon. View downstream, looking easterly Shows debris of the bridge that has been thrown 40' to 50' to the east. (Photo: Schussler 1906, HS10)

In the gully can be observed two sections of pipe. Several 12x12 pieces of lumber show steel "dogs": a $\frac{3}{4}$ " diameter steel bar, L-shaped, about 12" long and 3" wide; these steel bars were used to form connections between heavy lumber.

Unlike the 1907-era bridge in Figure 4-4, the ~1868 bridge would have had very little seismic lateral (transverse to the direction of the pipe) load-carrying capacity. This style of post-and-beam construction, with weak connections, is now understood to be seismically weak. The pipe would have been nearly free to slide sideways under inertial loads. High vertical motions would have placed some of the main 12x12 members into temporary tension, and with extremely small capacity of the joinery to take tension or bending loads, inertial overload was likely, leading to complete collapse of the bridge structure.

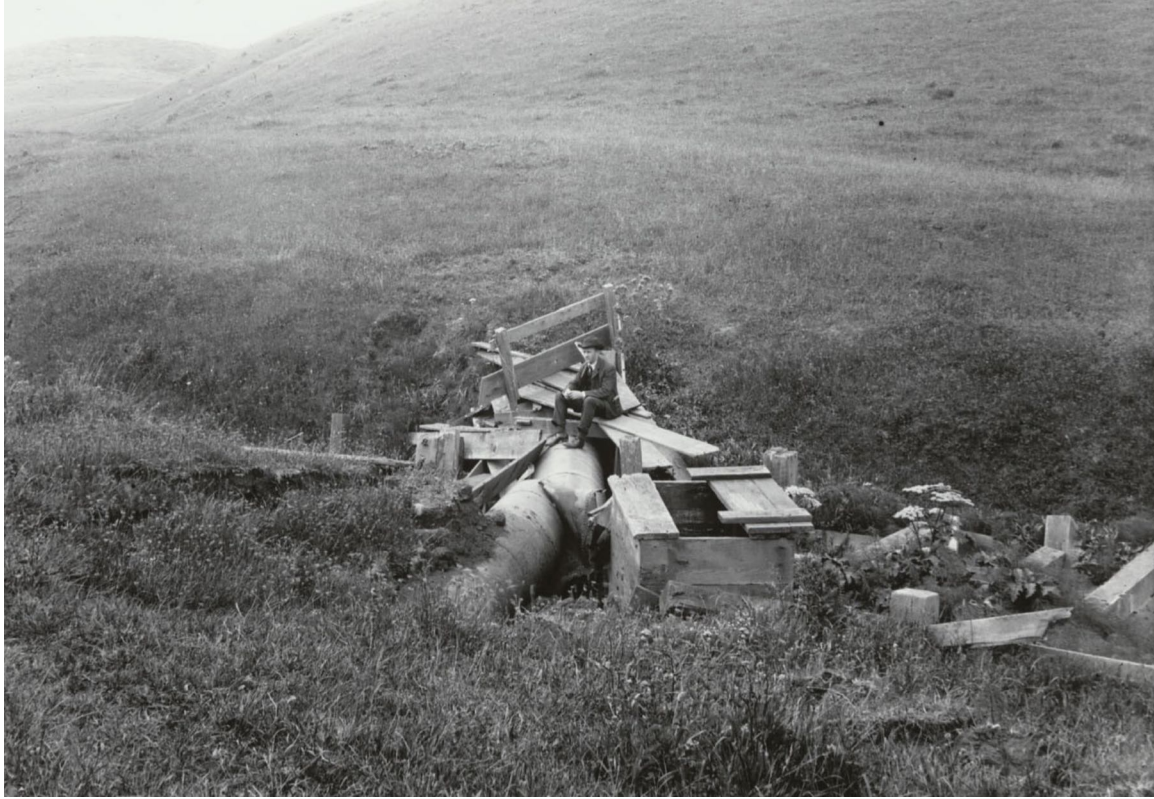
Figure 4.1.2-2 shows the same location, but with a wider view of the environs. In the central part of this photo, the active fault trace is marked by a north-trending, left stepping en echelon ground cracks. This suggests that the major telescoping / shearing offset of the pipe is located very close to, or right at the fault offset.

Figure 4.1.2-2. Failure of Pilarcitos 30 inch pipeline. Pipe telescoped and was thrown sideways off the wooden bridge crossing Small Frawley Canyon. View looking northeasterly. (Photo: Harry O. Wood, 1906)

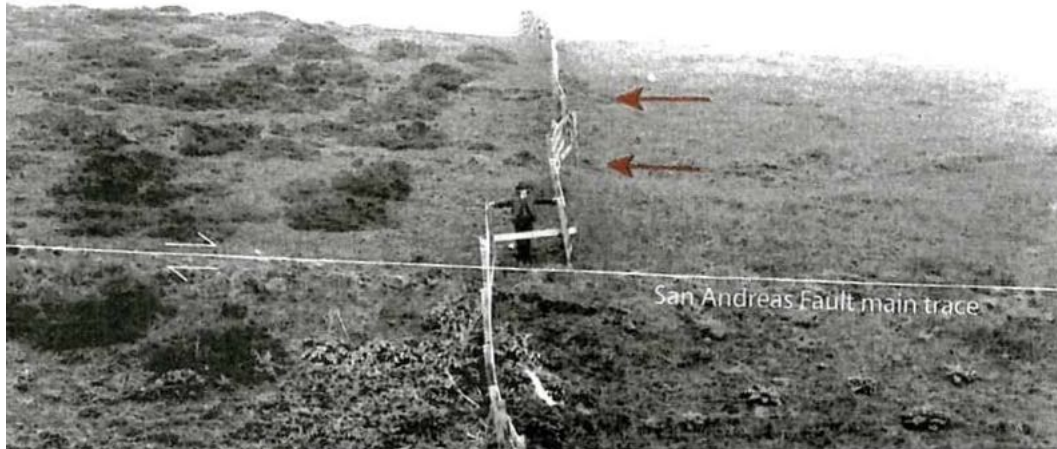
in relation to where the Pilarcitos pipeline is known to have failed in 1906. We suspect that the Pilarcitos pipeline lies buried within the linear swale that lies just west of the offset fence shown in Figure 4.1.4-2. The Pilarcitos pipeline did fail at over 20 locations where the pipe was parallel (but not crossing) the fault, likely reflecting ongoing corrosion, hydrodynamic water pressure pulses as well as ground strain related to high ground velocities.

Figure 4.1.4-1. Offset of Fence, looking east, (Photo: Bancroft Library, U. C. Berkeley)

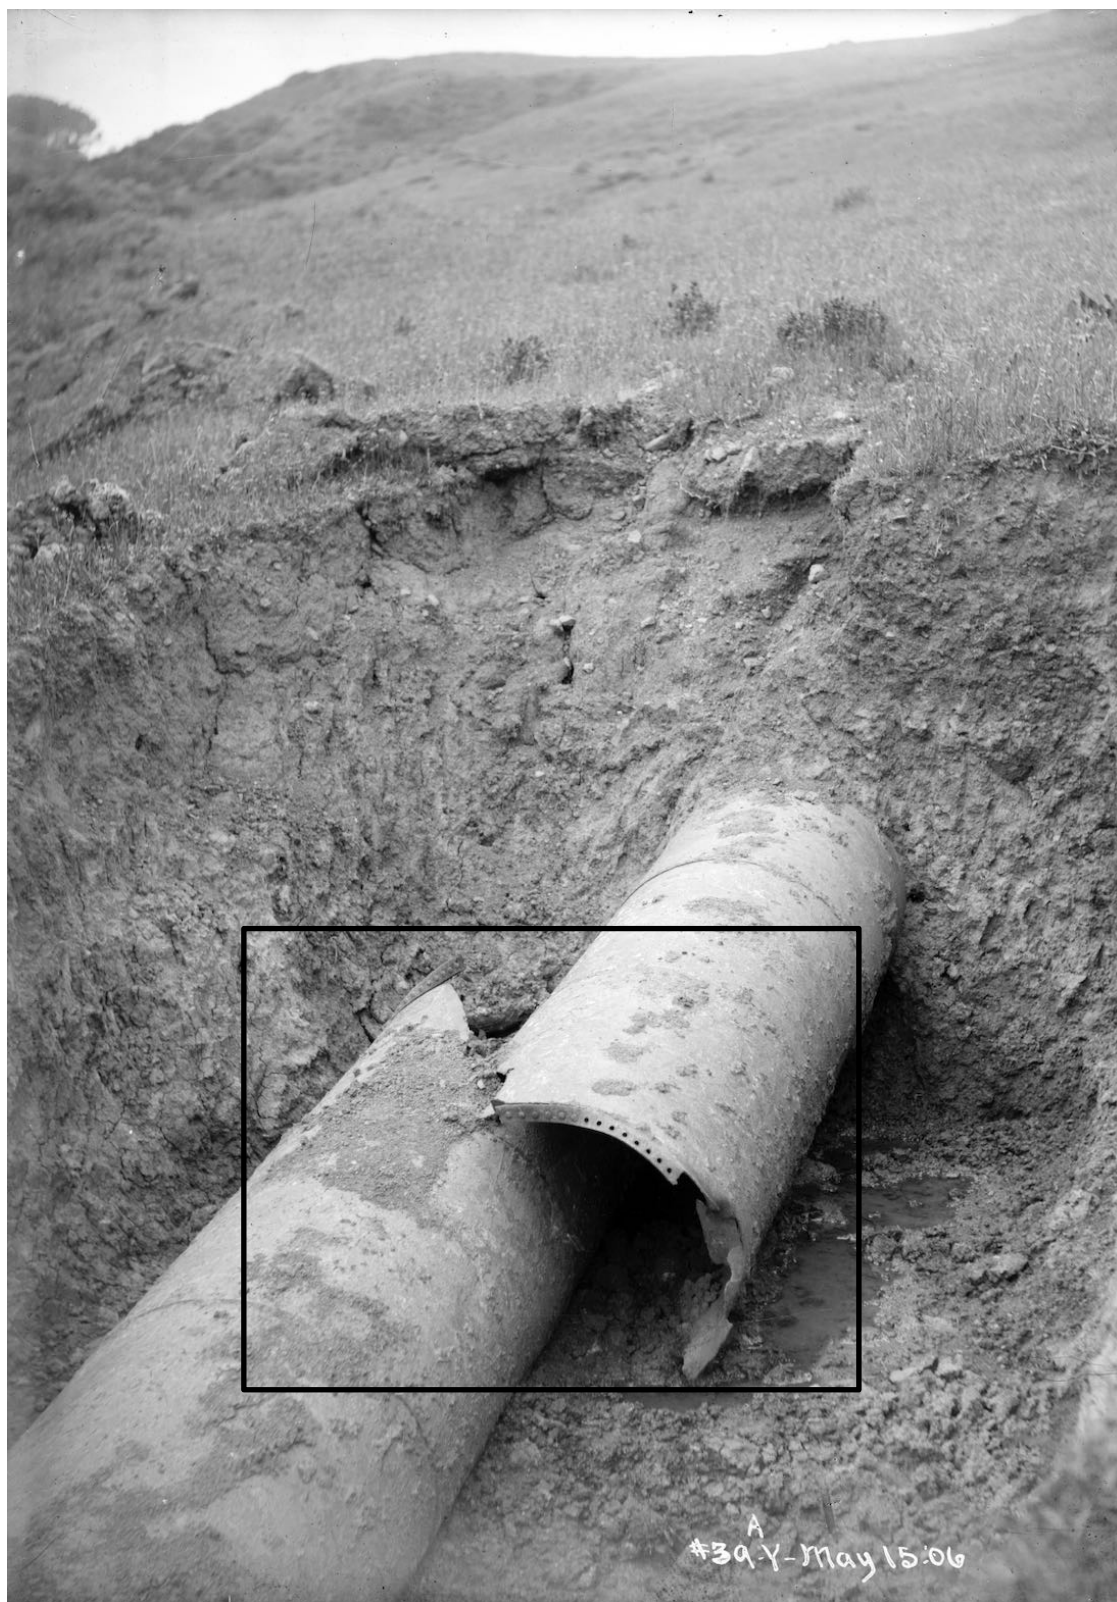
*Figure 4.1.6-2. Detail of north end of fault crossing 3. (Photo: Schussler HS6).
See Figure 4.1.6-3 for closeup of rivets.*

The girth riveted joint is clearly seen in Figure 4.1.6-2, 4.1.6-3. In the foreground of the closeup (Figure 4.1.6-3), 8 rivets are missing, 6 rivet heads remain. In the background is the continuation of the riveted joint. The neat fold in the steel adjacent to the rivets suggests that the inch (or so) at the end of the pipe has been specially prepared to accept rivets, in a manner that might (?) allow overlap of the pipe in the riveted girth connection zone. The visual evidence suggests that the riveted girth joint is much weaker than the main barrel of the pipe. The hole spacing suggest about 80 rivets around the girth joint; circumference about 95 inches. This suggest center-to-center rivet spacing about 1.19 inches, and rivet hole about 0.5 inches. This suggests a rivet cross sectional area of about 0.2 square inches. Allowing $F_u = 50$ ksi, and 80 rivets, the single shear ultimate strength of the joint is $80 \text{ rivets} * 0.2 \text{ sq in} * 50 \text{ ksi} * 1/1.73 = 462 \text{ kips}$. Allowing $D = 30"$ and $t = 0.1875"$, Area (pipe) = 17.78 sq inches. Allowing $F_u = 50$ ksi, the nominal tensile or compressive strength of the pipe = 889 kips. Nowhere along the length of pipe is there any evidence of pipe wrinkling, which should initiate at about compressive strain $0.175t/R$ (or so), considering the eccentricity of the lap girth joint (about compressive strain $0.6t/R$ if the adjacent pipes are perfectly concentric, which they are not).

The "fold" at the base of the girth rivet line (sharp fold seen in the figure above) gives a clue as to the failure mode. At this offset location, the rivets are being loaded in single shear by net compression in the pipe. The overall eccentricity of the ends of adjacent pipe segments introduces some bending into the pipe. For a rivet to reach yield in single shear, a bending moment of 0.36 kip-inch is applied to the base width ($2\pi R/80$) of the steel fold. Assuming $F_y = 30$ ksi, under pure local bending, the steel fold yields at about 0.06 kip-inches. In other words, the girth joint folds (as observed) at about $1/6^{\text{th}}$ the yield level of the rivet. At other locations, the rivet joint fails in tension, and we do not see the fold. Once folding is initiated, the rivet is loaded in high shear and bending, and many of the rivets break off.

Thus, it is clear that high compression in the pipe induces bending at the girth joint due to eccentricities, and this bending fails the girth joint fold well before the rivets break in direct shear and well before main pipe has initiated wrinkling. In other words, this is not a ductile seismic design.

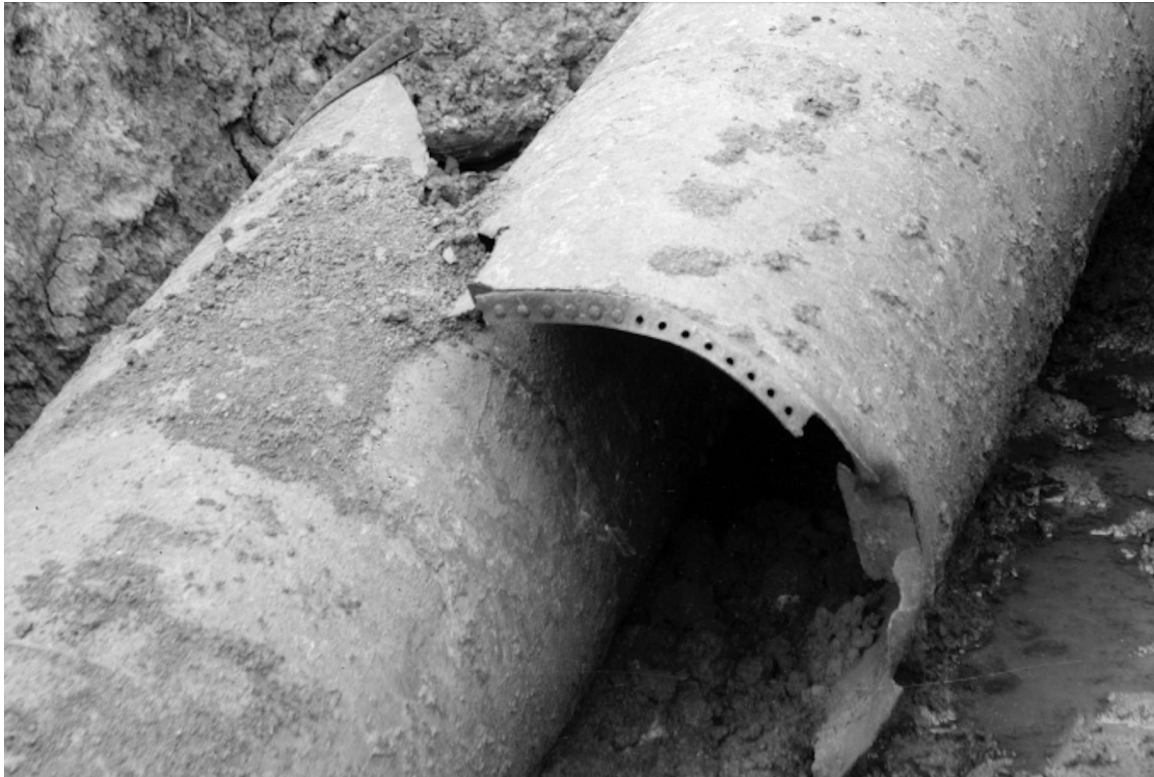
Figure 4.1.6-3. Closeup of Figure 4.1.6-2 showing rivets. (Photo Schussler HS6)

Assuming $t = 0.104"$, $R = 15"$, then idealized local wrinkling should occur at elastically computed compressive stress = $29,000 \text{ ksi} * .6 (.104)/15 = -120 \text{ ksi}$, and initiating near a girth joint at elastically computed compressive stress = $29,000 \text{ ksi} * 0.175 * 0.104 / 15 = -35 \text{ ksi}$. As the girth joint will rupture at about half the stress of the main pipe, or perhaps no more than about -15 ksi to -20 ksi in the main barrel of the pipe, one might expect the

compressive failure mode to sometimes be exhibited as local wrinkling. But, local wrinkling was not exhibited at this or any other site.

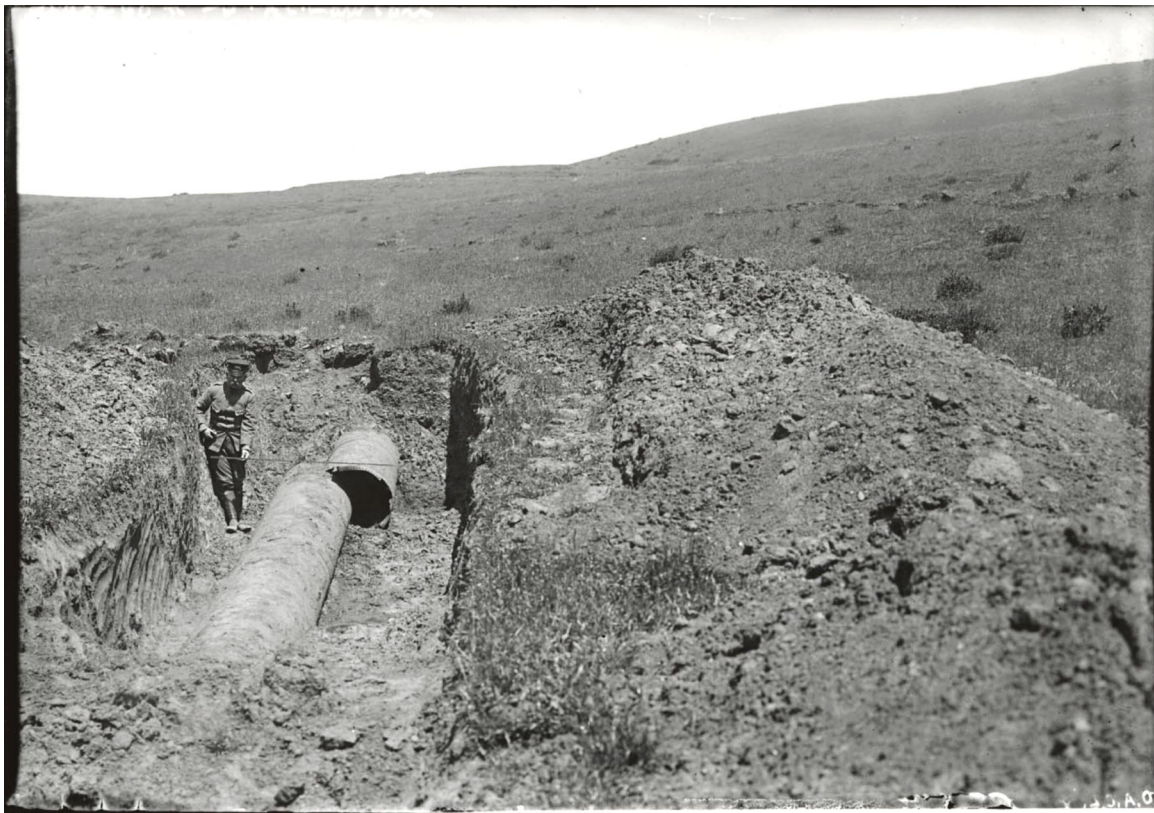
*Figure 4.1.6-4. Crossing FX-3. Failure of Pilarcitos 30 inch pipe.
(Photo: Lawson 1908)*

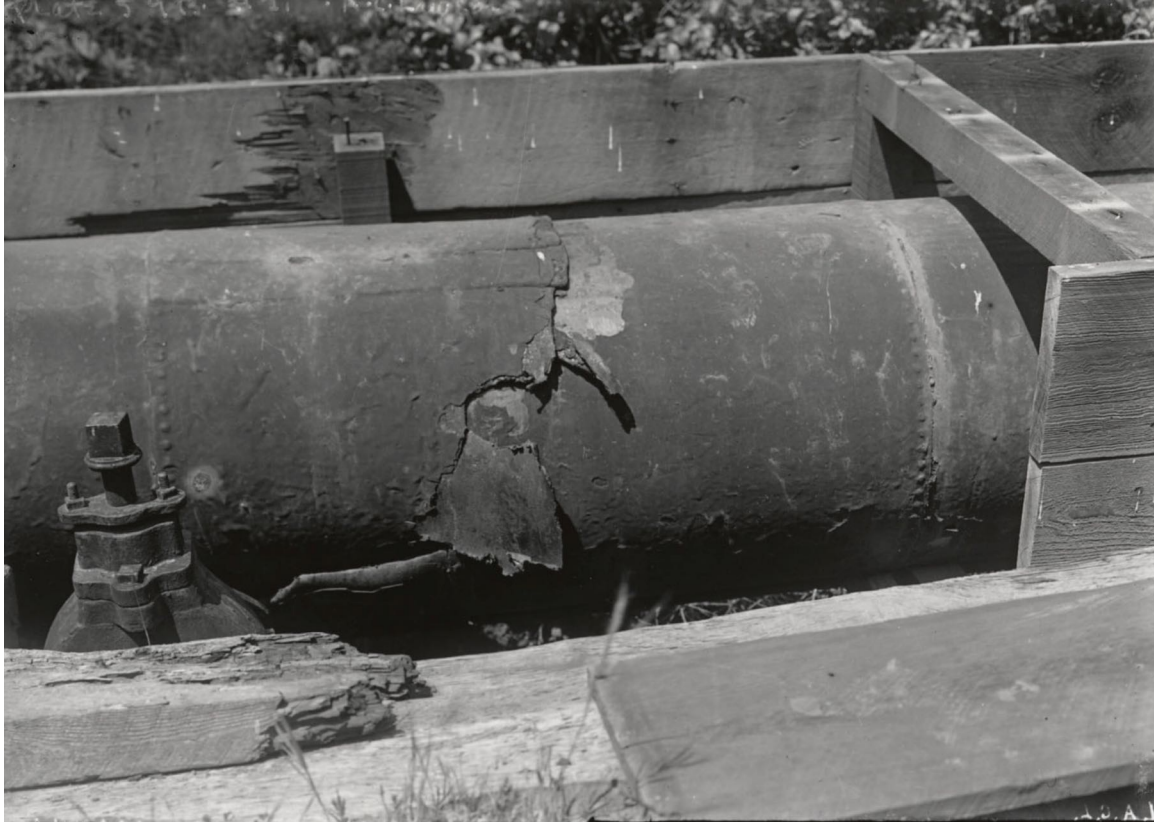
Figure 4.1.7-2 shows the same location as Figure 4.1.7-1, looking easterly. Just a few of the girth joint rivets for the outer pipe are seen at the top: the edge of the girth joint has folded in on itself as the pipe telescoped in compression. FX-3 is just to the north of this location, and the sense of slip placed the pipe into compression.

Figure 4.1.7-2. South of FX-3. Failure of Pilarcitos 30 inch pipeline. About 1 mile northwest of San Andreas Reservoir. Looking easterly. (Photo: Lawson 1908)
