History of the Water Works of San Francisco: Its Performance in the 1906 Earthquake and Aftermath

John M. Eidinger and N. Timothy Hall

Revision 2

August 2024

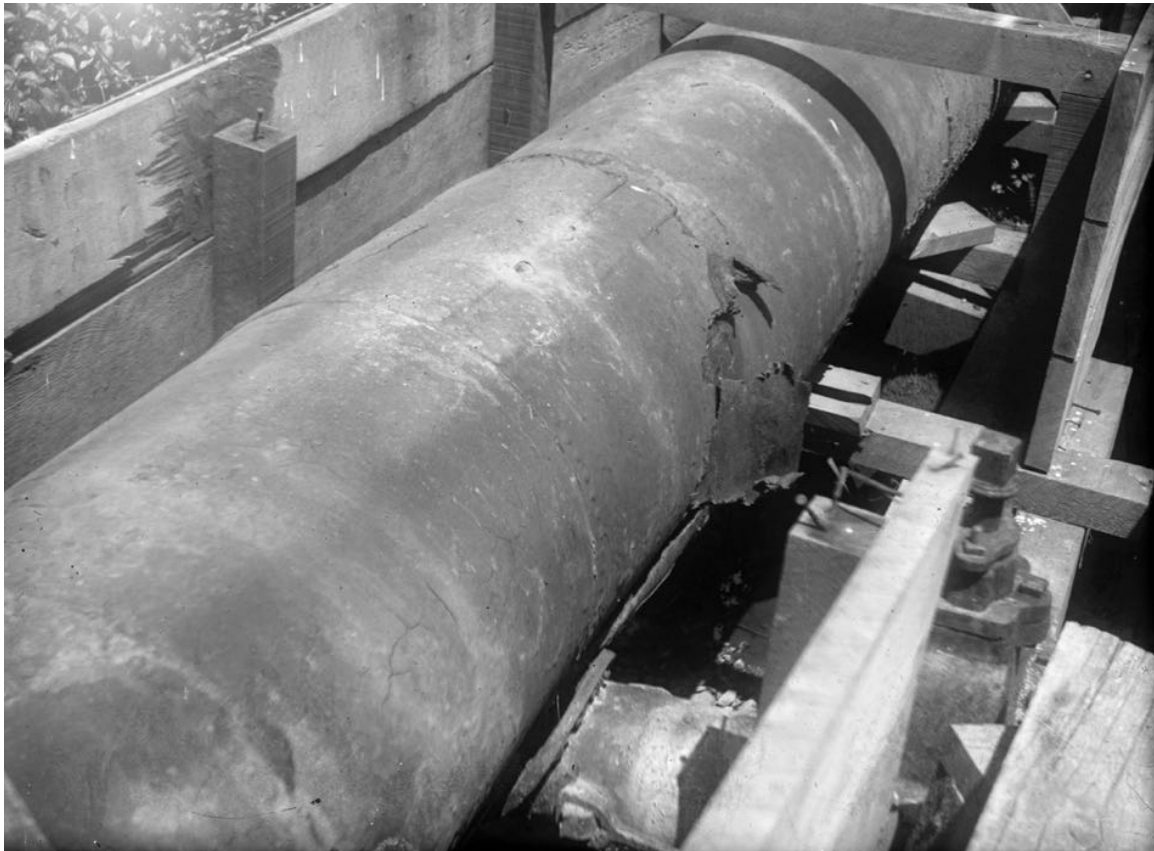
In Figure 4.1.7-3 shows another view of the telescoped section of this pipe.

*Figure 4.1.7-3. South of FX-3. Pipe has telescoped on the bridge. Looking southerly.
(Photo: SVWC 1906)*

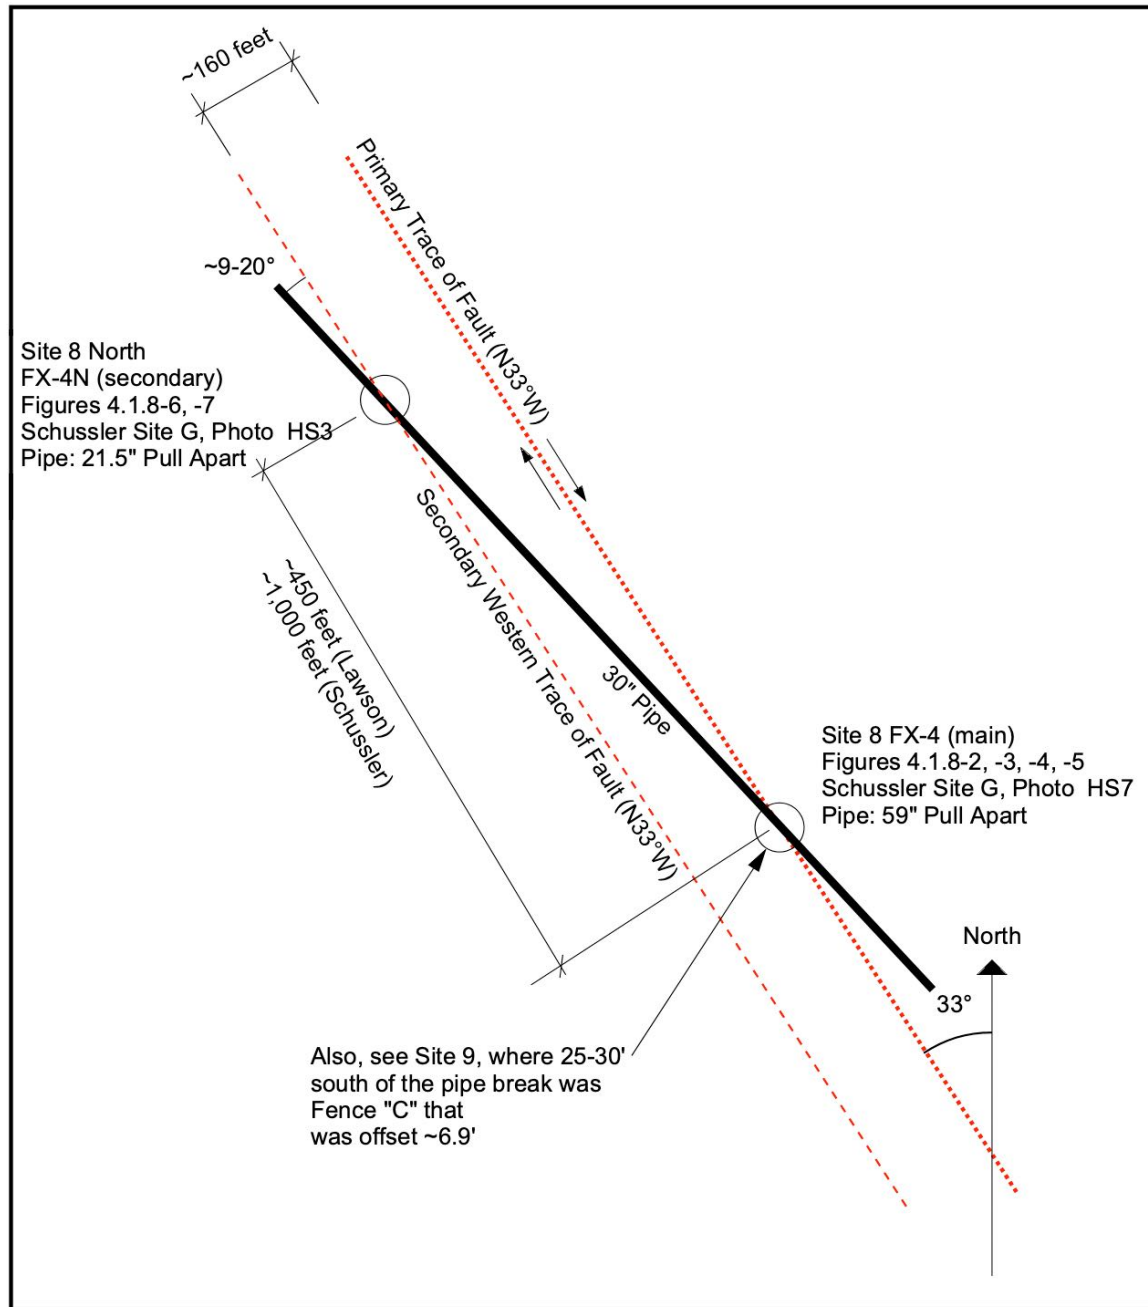
Figure 4.1.8-1 provides a sketch that shows our interpretation of what might have happened at Site 8.

Figure 4.1.8-1. FX-4, FX-4N. Orientation of the Pipe, Fault and Pipe failures at Site 8

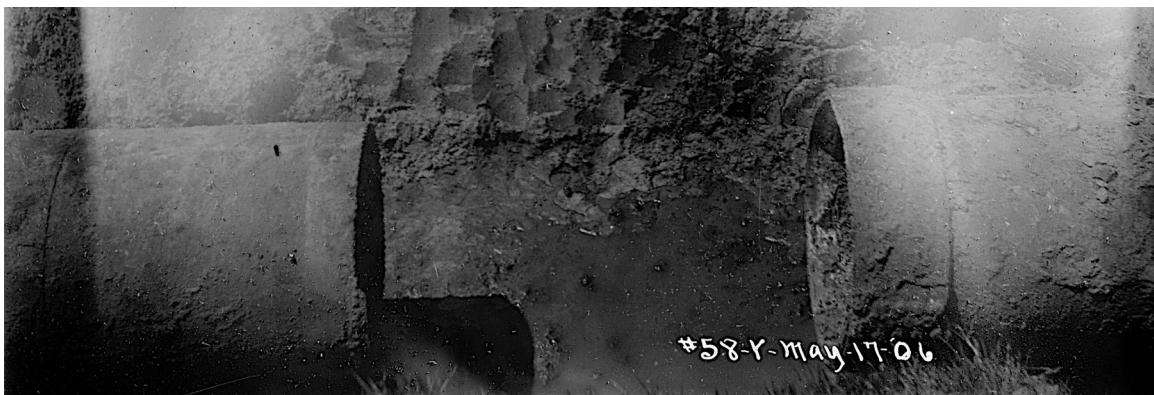
Figure 4.1.8-5 shows the torn joint at the primary offset location. The serrated edges of an edge-distance failure is seen on the left joint.

Figure 4.1.8-5. Crossing 4. Failure of Pilarcitos 30 inch pipeline at the main trace. Looking Westerly (Photo: SVWC 1906)

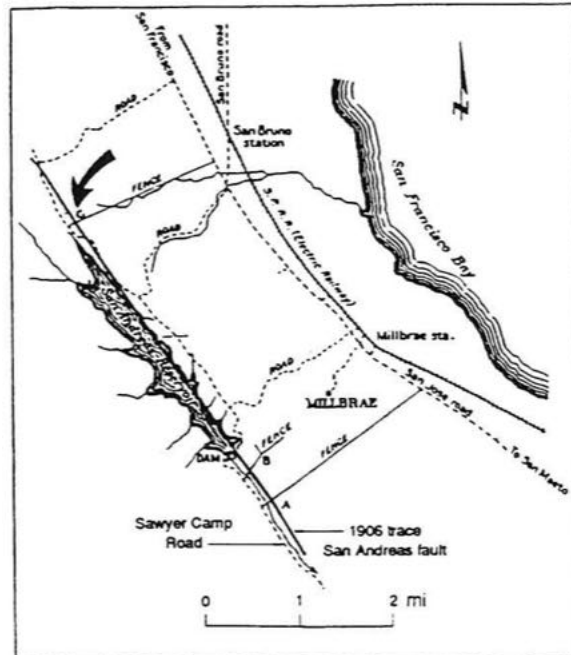
Figure 4.1.9-2. Arrow Marks Location of Fence "C" (after Lawson, 1908, Fig. 30)

Figures 4.1.9-2, -3 (Site 9) show the location of Fence "C". The configuration of Fence C following the 1906 earthquake shows a western trace, the primary trace, and an eastern zone of ground warping.

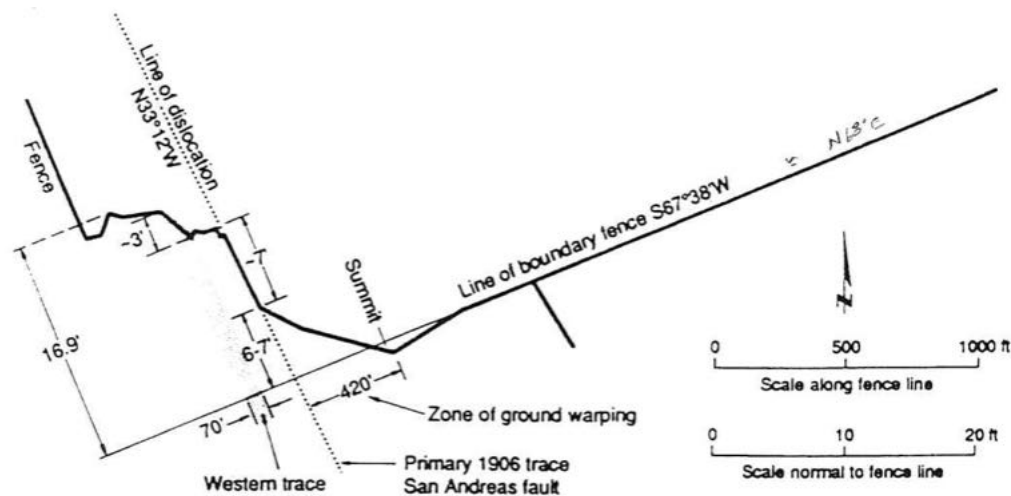
Figure 4.1.9-3. Details of Fence "C" (After Lawson, 1908, Fig. 31)

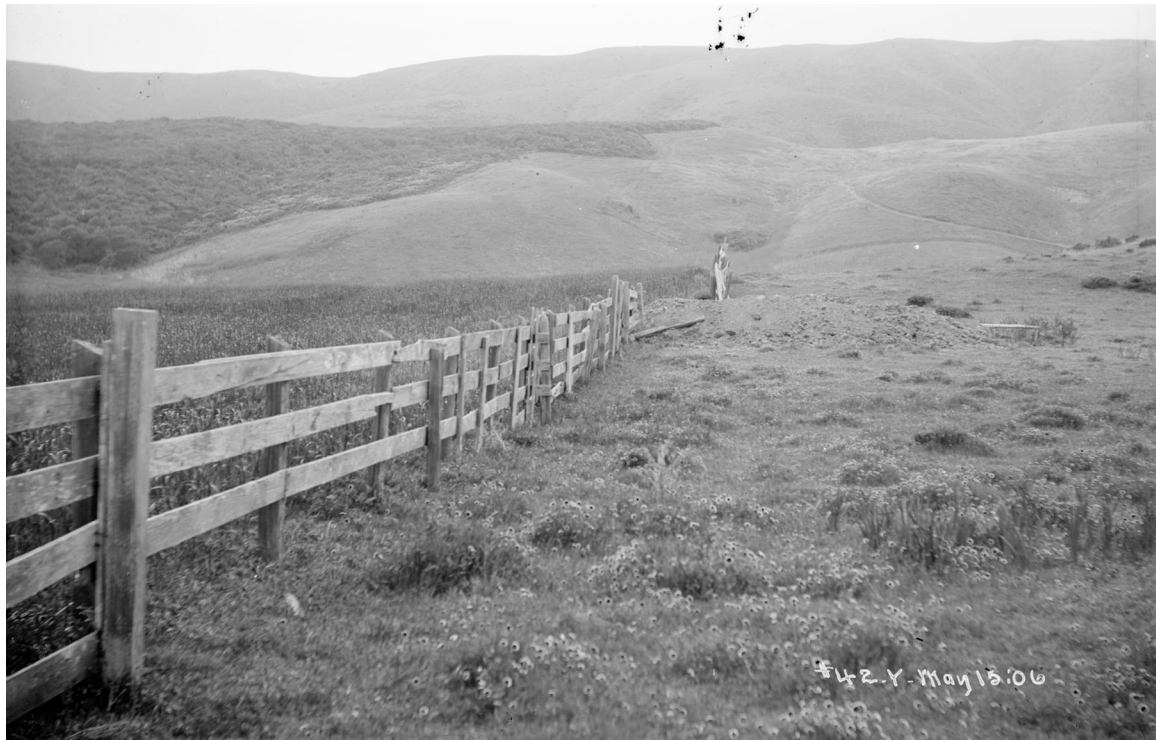
Figures 4.1.9-4 and 4.1.9-5 show Fence "C", looking towards the southwest (same photo, without and with author's notes). Figure 4.1.9-6 shows a close up of the fence offset, including 5 members of the investigation team seen in Figure 0-1. At the center of the photos can be seen the primary fault offset of 6.9 feet in the fence (corresponds to the ~7' offset in Figure 4.1.9-3). In the distance, marked "western trace, offset ~2.5' " (corresponds to the ~3' offset in Figure 4.1.9-3). At the right side of the photo is marked "valve box", which corresponds to the wooden box seen in Figures 4.1.8-2, -3, -4. Just to the left of "valve box" is marked "excavated dirt exposing Pilarcitos Pipe" (corresponds to the dirt piled up on the right side of Figures 4.1.8-2, -3, -4).

Figure 4.1.9-4. Fence C, View to Southwest (Photo: SVWC 1906)

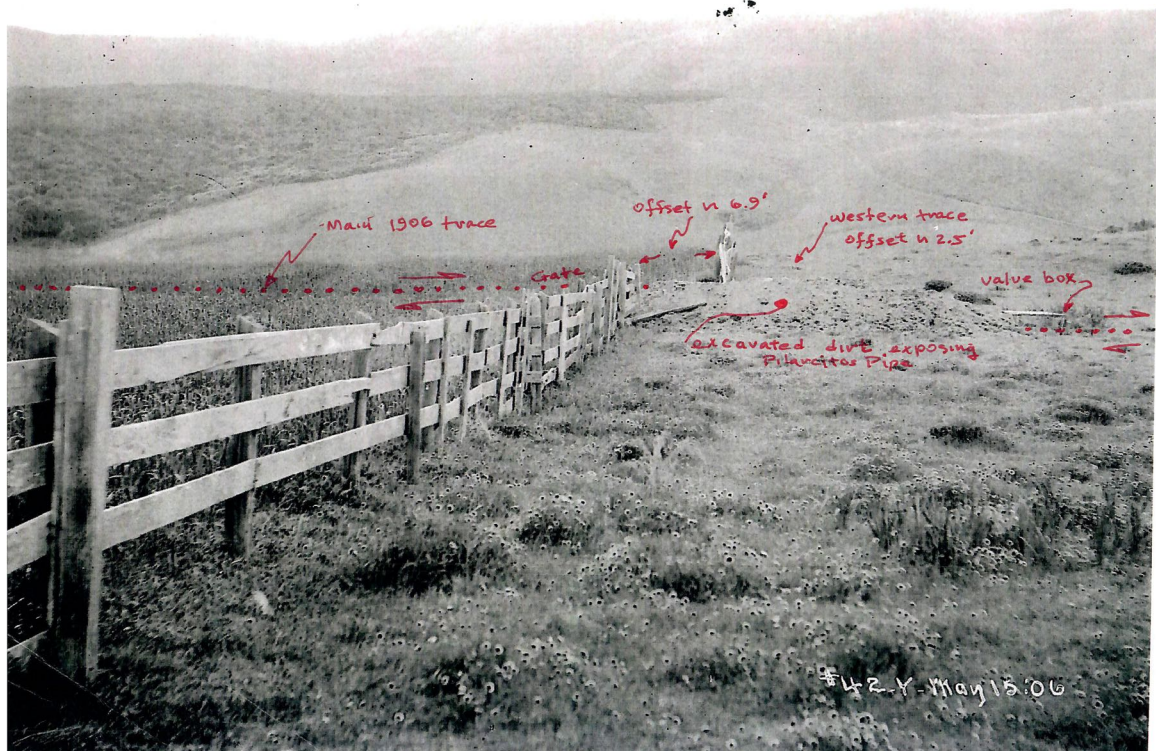
Figure 4.1.9-5. Fence C, View to Southwest (Photo: Schussler 1906) with Author's notes

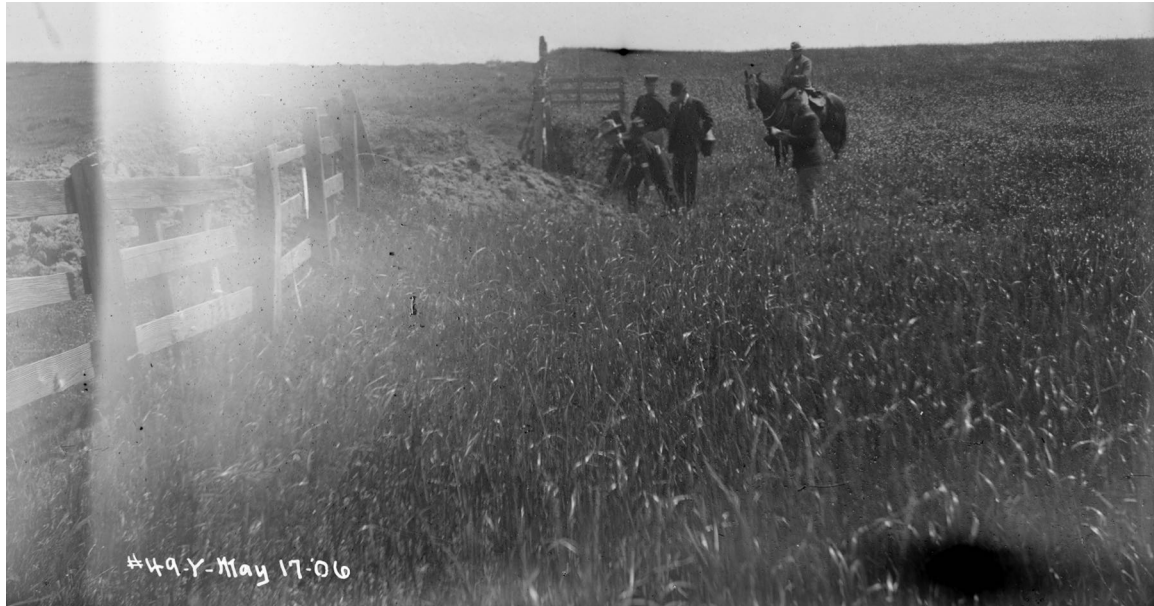
Figure 4.1.9-6 Fence C, View to Northeast (Photo: SVWC 1906)

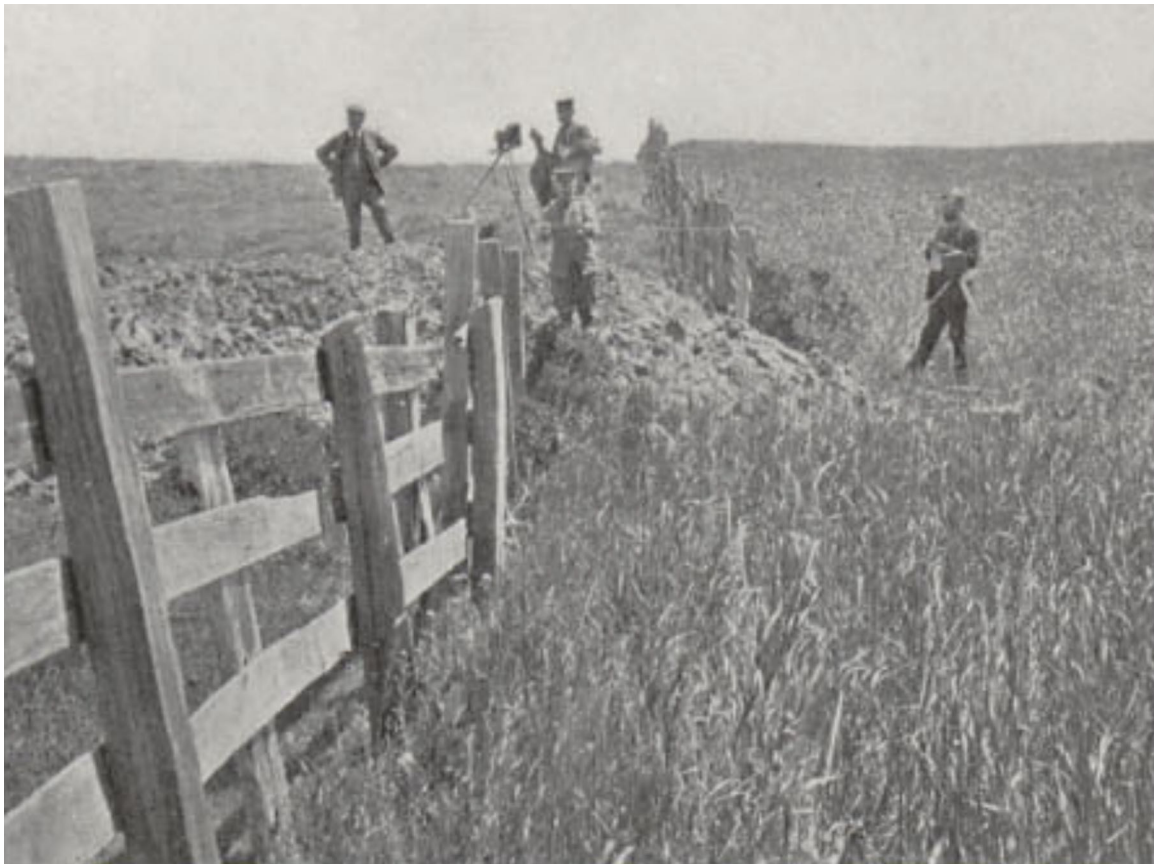
Figure 4.1.9-7 Fence C, View to Northeast (Photo: Lawson 1908 Plate 60C)

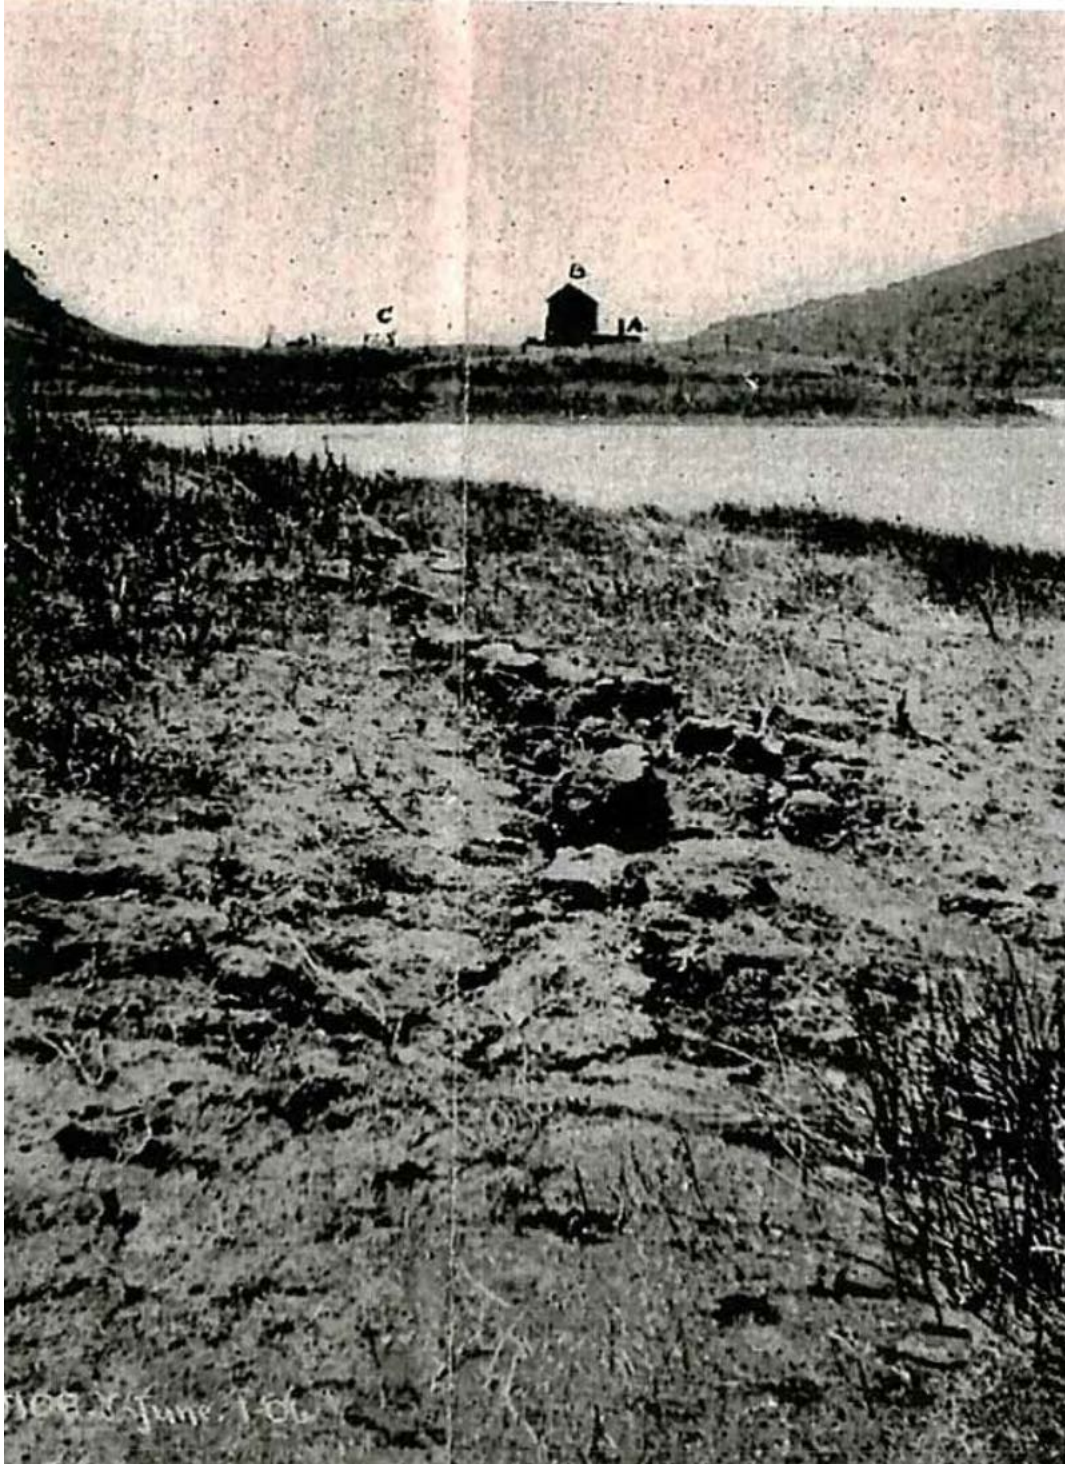
Figure 4.1.10-2 shows the ground surface rupture of the San Andras fault, as of June 1906. The photo direction is south-southwesterly, and the three structures A, B, C in Figure 4.1.10-1 can be seen in the background. The primary ground rupture extends along the uphill eastern side of structure A.

Figure 4.1.10-2. San Andreas Fault Rupture (Credit Schussler)

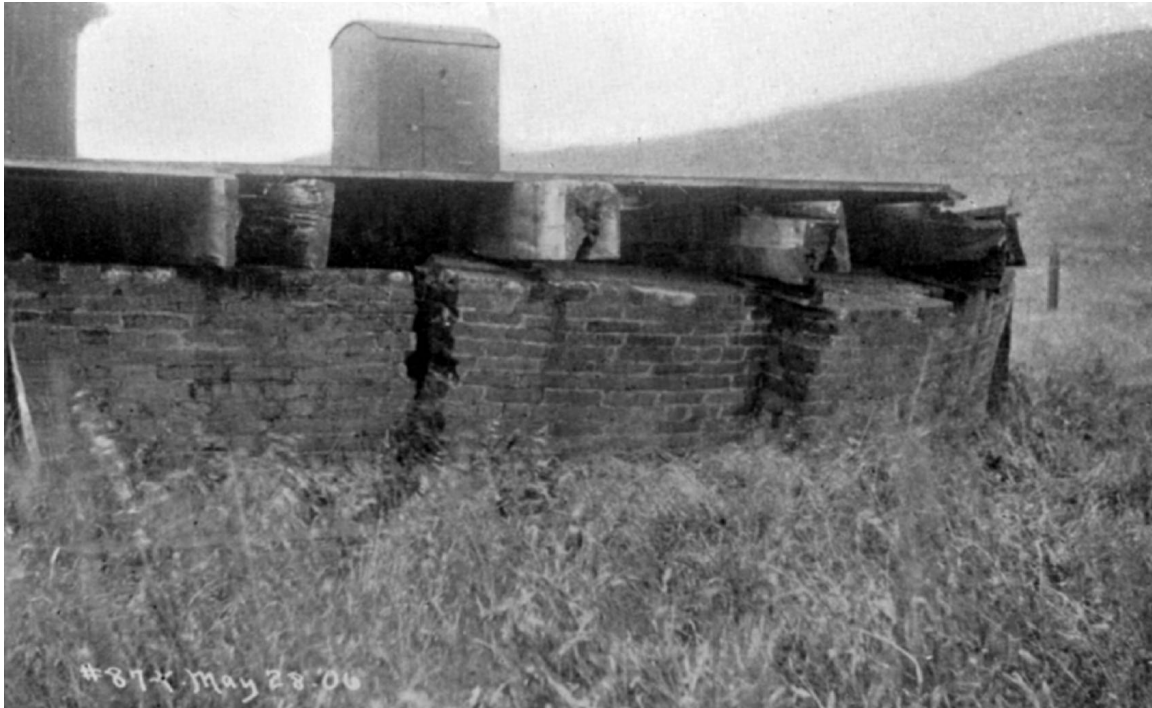
Immediately after the 1906 earthquake, water from the lake went undisturbed into the Bald Hill Outlet Tunnel, even though there was major damage to the brick forebay. Figure 4.1.10-6 shows the damage to the brick forebay at the ground level. The cracks in the brick walls correspond to the breaks in the brickwork seen in Figure 4.1.10-5.

Figure 4.1.10-6. Brick forebay damage (view looking northerly) (Photo: Schussler)

- Schussler (1906) noted that *"The brick tunnel, connecting the concrete gate-well and the main San Andreas Bald Hill tunnel, was somewhat damaged by the earthquake, but not so as to interfere with the flow of water through the same... the fissure will be easily closed by cement grouting"*.

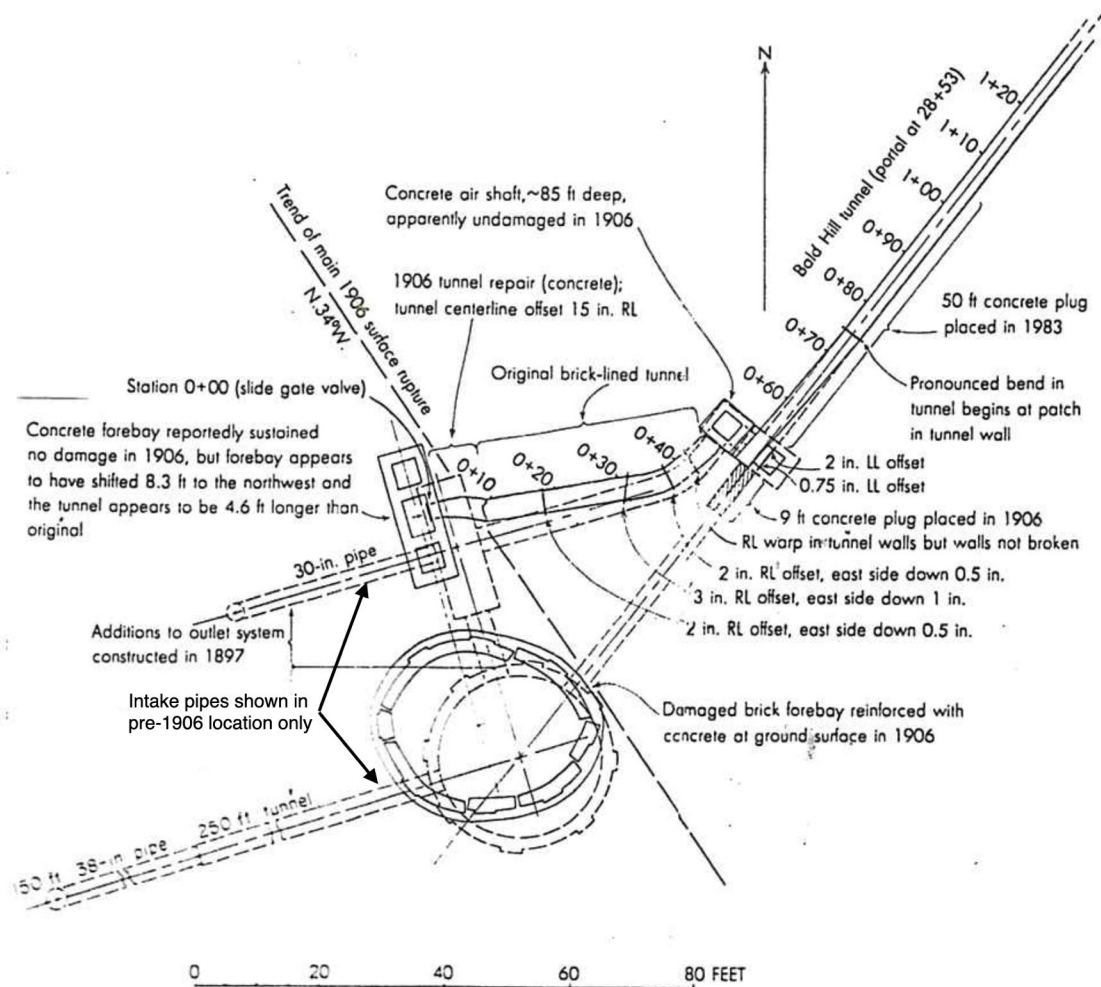
- Figure 4.1.10-7 documents the findings in 1983. At about station 0+75 along the Bald Hill Tunnel, there was a repair made; and a concrete ring was placed around the damaged brick shaft.

- About half way through the Bald Hill Tunnel, the tunnel was damaged and squeezed. Hall hypothesized that the tunnel traversed a zone of squeezing clayey soils within the Franciscan bedrock. At this location, there is no mapped surface trace of the Serra fault; but that fault is inclined, and thus this zone may (?) correspond to a shear zone associated with the Serra fault (this is speculative).

Figure 4.1.10-7. Survey of Outlet Works, 1983 (adapted from Pampeyan 1983)

Soon thereafter the second 1983 inspection, the SFPUC pumped concrete into the shaft and west end of the Bald Hill Tunnel. As of 2024, the tunnel is now plugged, and further investigation of the 1906 damage from the interior of the Bald Hill Tunnel is no longer feasible.

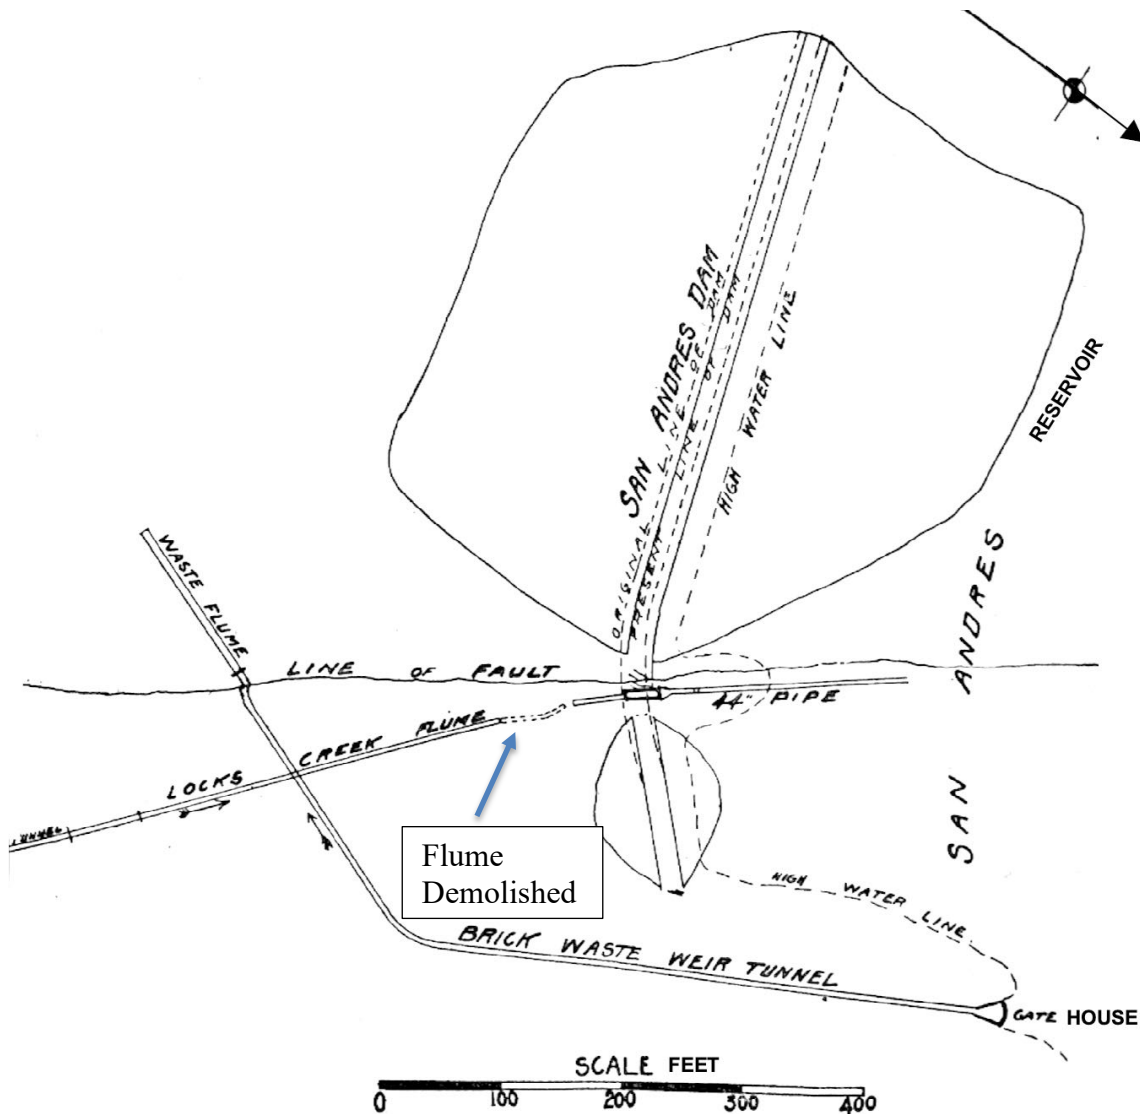
Figure 4.1.11-2. San Andreas Dam
(Sketch: Schussler 1906)

Figures 4.1.11-2 and 4.1.11-3 provide an overview of San Andreas Dam and shows where the line of the 1906 fault rupture crossed the crest *between* embankment structures 1 and 2. It also shows the relationship of the San Andreas fault to the brick waste water tunnel and the northern end of the Stone Dam/Locks Creek flume where it empties into the San Andreas Reservoir. Although the 44" wrought iron discharge pipe from the flume and a concrete culvert were very close to the fault, they were not damaged. However, an ~80-foot-long section of the flume that fed into this pipe and was located a bit further from the fault, collapsed just south of the crest of the dam. The dashed lines below the dam highlights where this section of the flume was probably demolished by a combination of strong ground shaking and potentially influenced by some fault slip as further described herein. The damage to the brick waste water tunnel at the fault crossing and its wooden outlet flume are also documented and assessed as described in Section 4.1.12.

What is startling in Figures 4.1.11-2 and -3 from an engineering perspective is that they show the dam crossed a major active fault whose presence here was apparently unknown at the time the dam was constructed in the 1860s. Then came the 1906 earthquake! Today we know that this fault is one of our planet's major tectonic plate boundaries, and therefore, lacking suitable seismic design provisions, is a less than safe place to store vital water supplies! Fortunately, surface fault slip at the dam crest was probably largely confined to a low ridge of ancient Franciscan Assemblage bedrock located between the two engineered embankments.

From a geological perspective, this dam was unique in that the builders incorporated a highly sheared, clay-rich “bedrock” ridge of Franciscan Assemblage mélange into the area between the two embankments of the dam (Figure 4.1.11-2). This not only reduced the amount of fill necessary to construct the embankment, it also contained the then unknown main active trace of the San Andreas fault, which provided a pathway that kept the 1906 fault slip from slicing through the man-made embankments. Despite being crossed by the active fault, San Andreas Dam survived both the 1906 right-lateral fault slip of 7 feet as measured by Schussler, and the accompanying severe ground shaking in 1906. The dam remains in service today (2024).

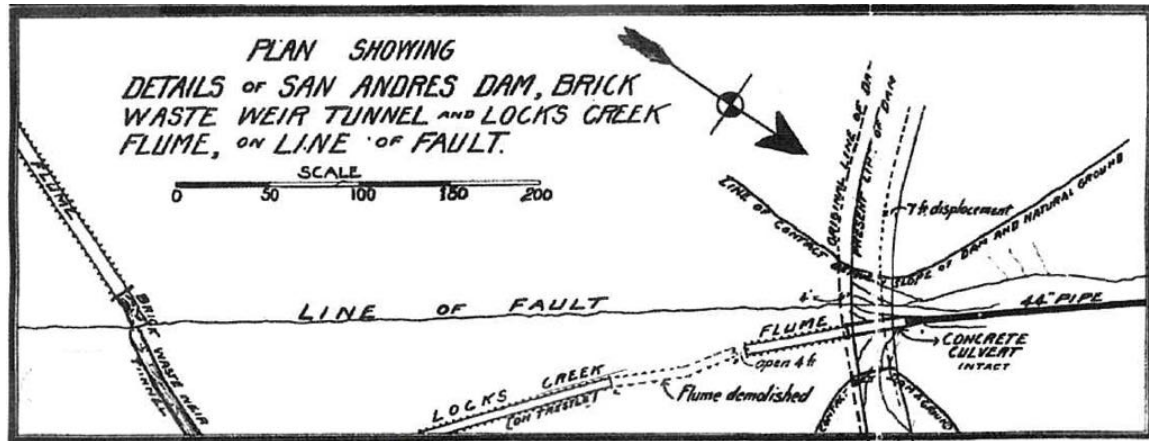
Figure 4.1.11-3. San Andreas Dam
(Sketch: Schussler 1906)

1906 Fault Slip: Schussler's sketch shown in Figure 4.1.11-3 depicts a ~50+-foot-wide zone delineated primarily by north-trending, left-stepping en echelon cracks that are characteristic of the right-lateral San Andreas fault's surface expression within the ridge of highly sheared, clay-rich Franciscan Assemblage mélange. Mélange (i.e., a mixture) is just another name for "mega" fault gouge that was formed in an ancient subduction zone where oceanic crust of the Farallon Plate slid beneath the North American Plate. Here Schussler also shows his measurement that the crest of San Andreas Dam had been displaced right-laterally 7 feet by the 1906 event. Why this magnitude of right slip is

Schussler's sketch (Figure 4.1.11-3) of the dam crest shows that the Stone Dam/Locks Creek flume lies just east of fault's eastern boundary (defined by points D-E-F on Figure 4.1.11-7) and is essentially congruent with the main trace of the fault in the middle of the fault zone as it reached the crest. This sketch also shows that there is one crack/fault trace that lies on the east side of the 44-inch pipe above the words "*concrete culvert*". 1906 fault slip on this trace might help explain the 4-foot-long A-B separation of the flume, but it is entirely uncertain how the imposed forces due to net stretching action on the intact wooden flume on the south side of the dam could be transmitted to point B

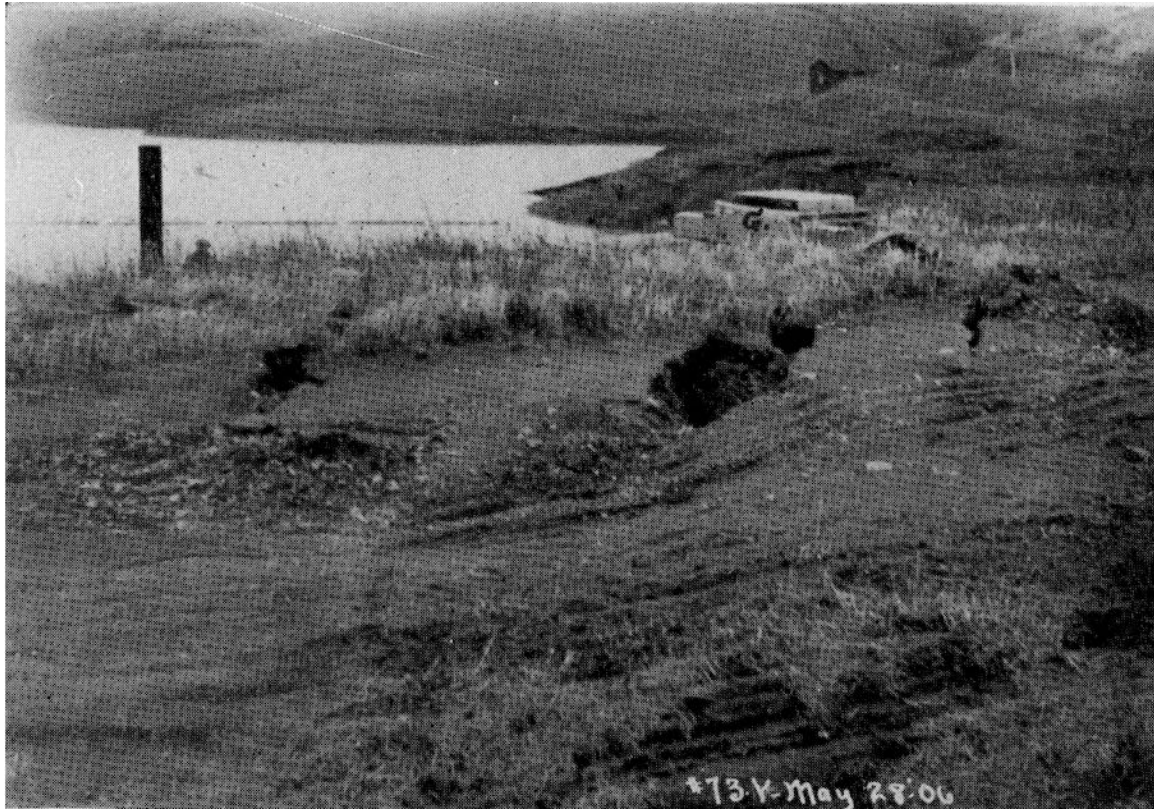
Figure 4.1.11-6 shows three northwest-trending extensional cracks developed in the upstream face of the dam near the left abutment of the larger embankment. These cracks might have been caused by slumping, settlement and/or ground warping of the Franciscan bedrock along the west side zone of active fault slip, but did not cause the dam to fail. As shown in Figure 4.1.11-7, the San Andreas fault slices across the center of this photo and passes the near side of structure "G".

Figure 4.1.11-6. View of San Andreas Dam looking northeasterly. Item "G" is a concrete vault atop the dam at the high point of the 44" discharge Locks Creek pipe. To the left (north) of the concrete vault is see the top part of a man, standing next to what appears to be a standpipe on the 44" pipe. (photo: Schussler, HS32)

The concrete structure labelled "G" in this figure is an undamaged concrete culvert on the Stone Dam/Locks Creek transmission system that connects the wooden flume coming from the south with the 44" iron pipe that discharges into the reservoir (Figure 4.1.11-3). This connection is within the central zone of faulting but was not reported to have been disrupted by fault slip. Although hard to see, the hillside beyond this culvert, but in front of the building, is scarred by what appear to be north-trending, left-stepping en echelon ground cracks and scarps commonly observed on the eastern side of main San Andreas fault trace in this area. We believe these are caused by ground warping along the active trace. The building beyond, which is partially visible in the upper right corner of this photo, is the gate house for the waste water weir system that is discussed next in Section 4.1.12.

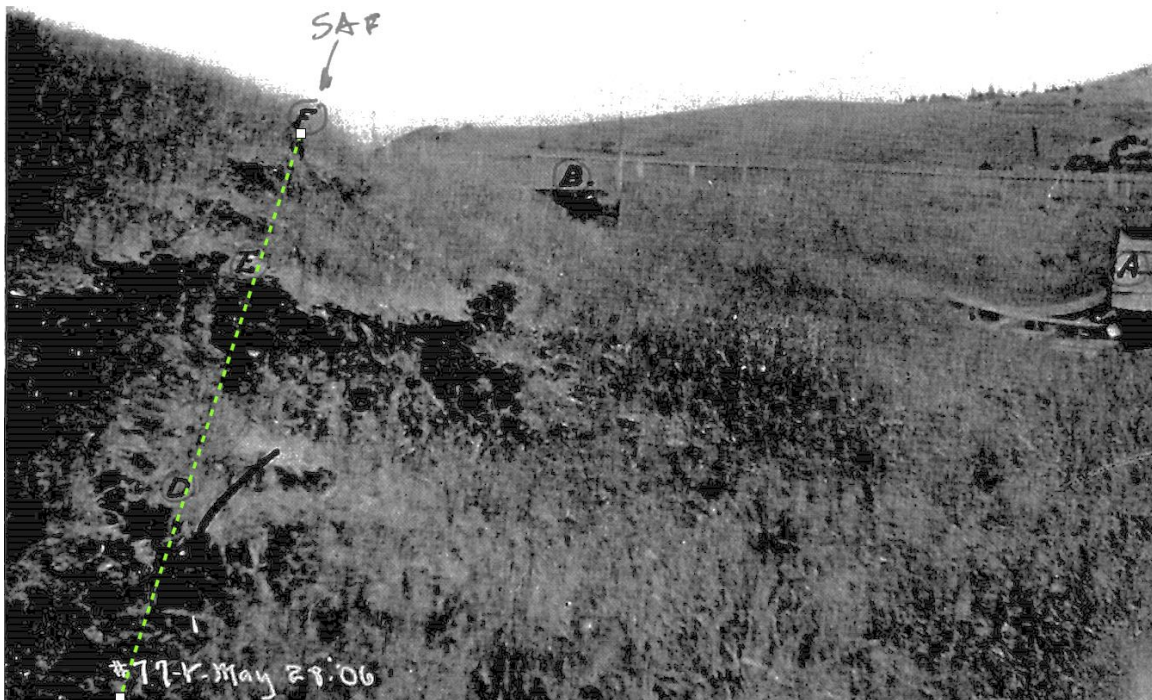
Points A and B in Figure 4.1.11-7 are located on the ends of an approximately 75-foot-long, 4- foot x 6-foot-wide wooden flume segment that was reported by Schussler to have collapsed and been pulled apart 4 feet. According to Schussler's caption, the flume was destroyed from A to B. "*Point B*" (which marks where the intact flume passes beneath the road atop the crest), "*moved farther away from "A" than before the earthquake.*" We cannot tell from his sketches if the A-B flume segment was elevated on a short trestle or placed on the ground. Clearly the topography of the dam site shows that the flume on the downstream face of the dam well below "A" was built on a much taller trestle that extended southeastward to near the white building identified in Figure 4.1.11-5. This trestle may have reached heights of 14 feet or more near the waste water tunnel / fault crossing (Site 12).

Figure 4.1.11-7. Fault Offset Near Flume, Looking northwesterly. Yellow dashed line D-E-F is the primary trace of the San Andreas fault (Photo: Schussler 1906 HS53)

We noted some discrepancies in Schussler's documentation of the performance of the Stone Dam / Locks Creek flume here where it approaches and crosses beneath the crest of the dam. Both of Schussler's sketches show the collapsed flume segment ending about 50 feet south of point B, located on the south edge of the dam crest, and not at B itself as described in Schussler's photo caption. Figure 4.1.11-7 was taken 41 days after the quake,

time enough after the quake to remove debris from a failure of the flume from the site. We have studied the available evidence from this reported collapse to constrain the cause of this flume failure to: either 4 feet of ground extension cause by fault slip, structural collapse of the flume in response to strong ground motions or a combination of both processes.

These observations do not give us a definitive answer as to the cause(s) if the flume failure between points A and B. These observations do not allow the hypothesis of fault slip as the cause of flume separation at point B to be summarily discarded.

Therefore, we the authors (Hall and Eidinger) are not entirely certain what caused the four feet of extension of the flume at its damaged northern end (point B) as reported by Schussler, but there is no doubt that the flume was not designed to accept extensional forces. Thus, its collapse here could have been due to high inertial loading of the wooden structure; high imposed water sloshing or impulsive loading of the carried water; by some type of fault offset loading at the flume / fault crossing; or perhaps by a combination of all three.

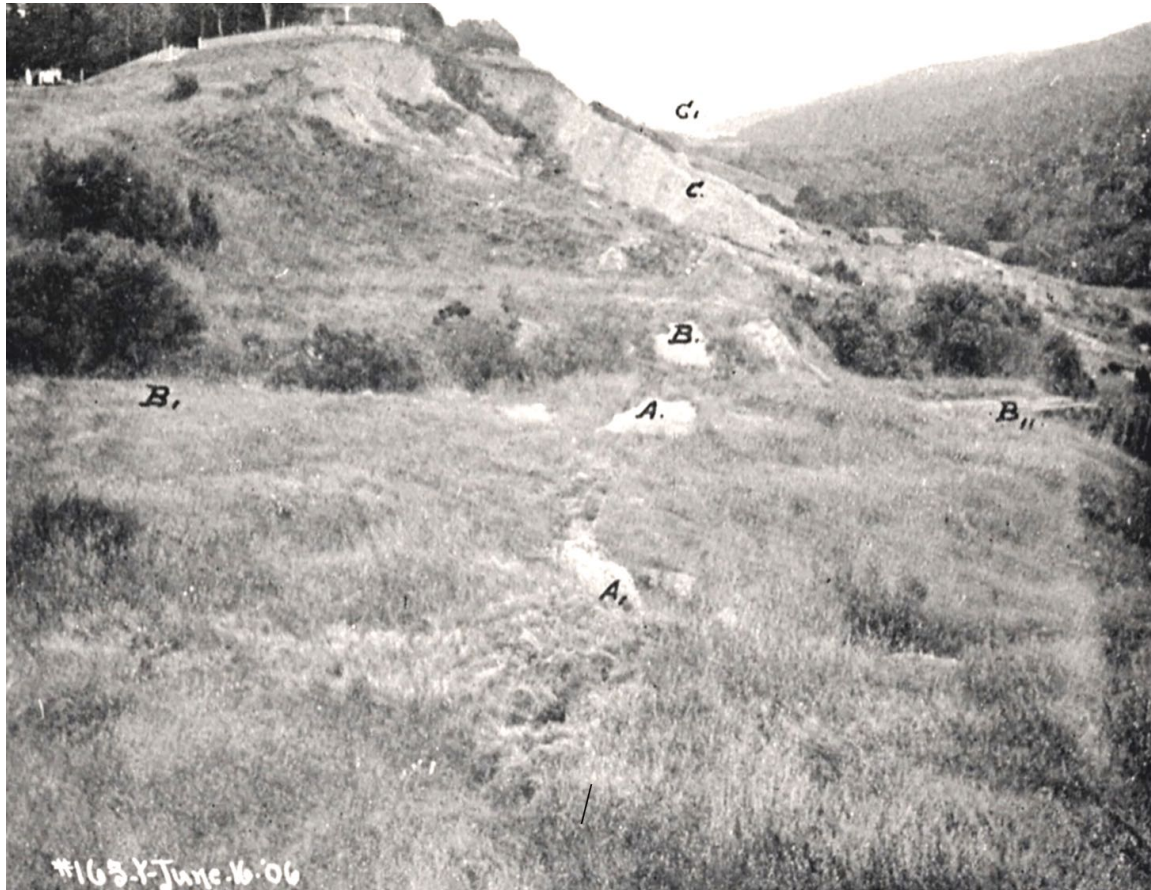
In Figure 4.1.12-1, the primary fault trace follows points A₁-A-B-C-C₁, and the brick wastewater tunnel and exit wood flume traverse the fault, roughly from points B_I (left side of photo) to B_{II} (right side of photo). The photo is taken from near the top the San Andreas dam, just west of the Locks Creek flume, and looking southeasterly. The transition from the brick tunnel to a downstream wooden flume was located a few feet (~15-20 feet) to the west of the fault crossing. The wooden flume is quite visible near point B_{II}. Point C₁ near the top of the photo marks where the San Andreas fault continues along the east side of the fault valley and passes into Lower Crystal Springs Reservoir.

Figure 4.1.12-1. San Andreas Fault Track through A₁ – A – B – C – C₁). Dotted line B_I – B_{II} is the alignment of the buried wastewater tunnel outlet. Looking Southeasterly (Credit: Schussler HS31)

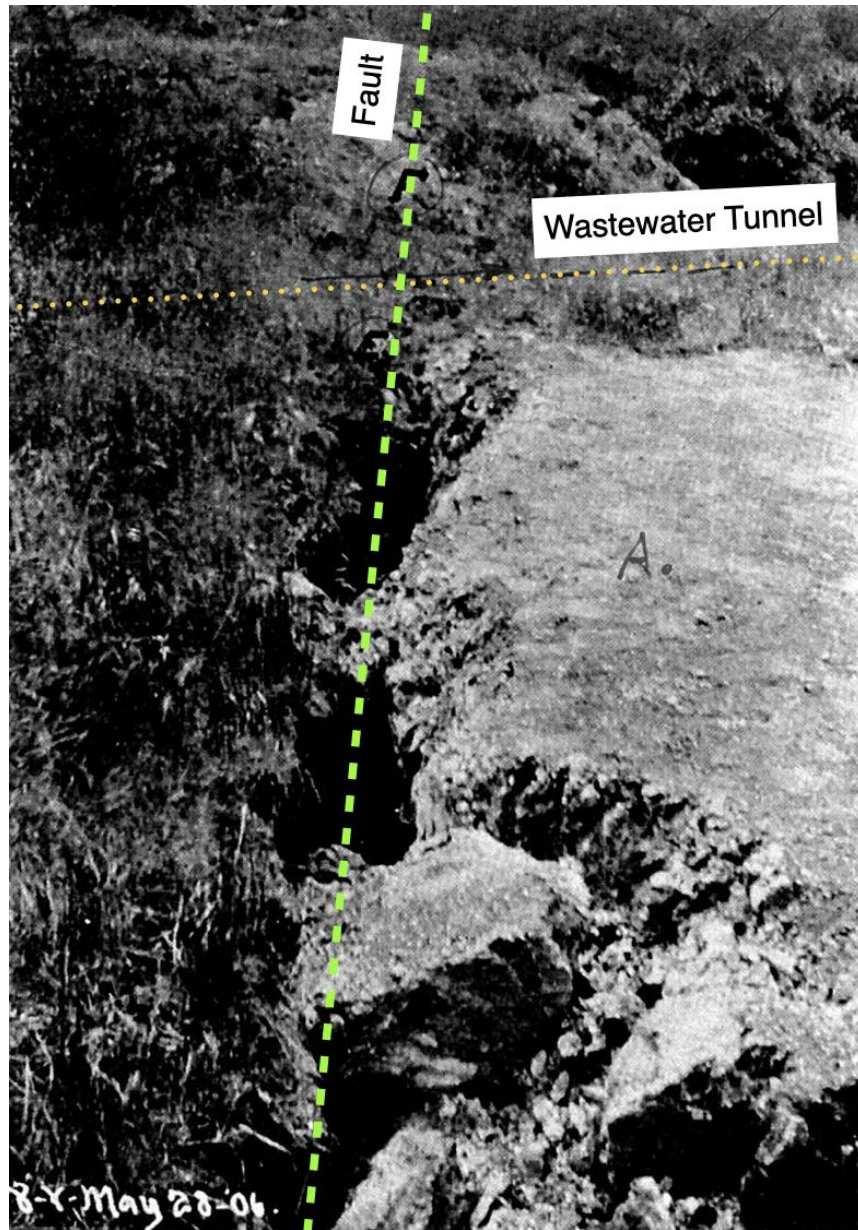
In Figure 4.1.12-2, the Brick Wastewater Tunnel and Exit Wood Flume traverse the fault (green dotted line). Point "A" in Figure 4.1.12-2 corresponds to point "A" in Figure 4.1.12-1. The fault rupture path is indicated by the yellow dashed line. The photo is taken from the downstream face of the dam, west of the Locks Creek flume, and looking southeasterly. This photo shows that the trace of the main fault here was marked by fault-parallel open cracks and not by the north trending, left-stepping en echelon cracks typically seen elsewhere along the fault in this area. It is possible that strong earthquake shaking might have caused the ground here to “feel” the fault and spread towards the free face of the nearby stream channel to the west

*Figure 4.1.12-2. Closeup of San Andreas Fault Trace Looking Southeasterly
(Credit: Schussler 1906 HS 29)*

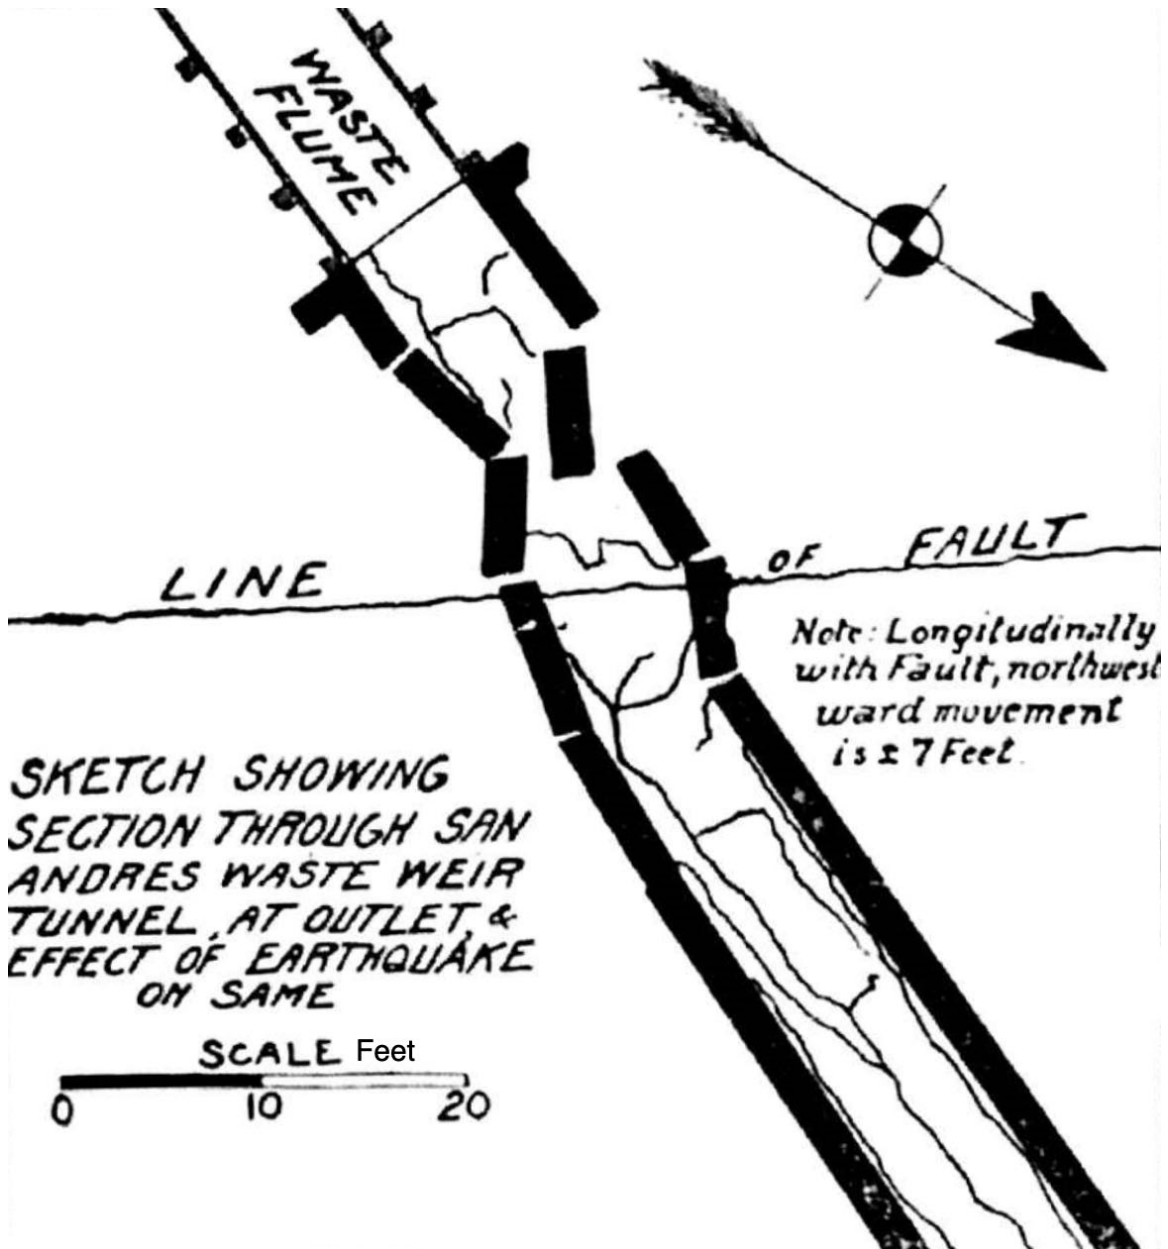
Figure 4.1.12-3. Line of Fault Through Wastewater Tunnel (Sketch: Schussler)

The tunnel crosses the fault at a $\sim 45^\circ$ angle to the strike of the fault, an orientation that placed the tunnel in compression. 15 to 20 feet to the south of the fault crossing, the brick

The main tunnel was several feet wide, and built with four layers of cement and brick both of good quality. When the fault slipped, cracking occurred equally across both brick and mortar, i.e., the bricks did not pull away from the mortar, see Figure 4.1.12-4. Lawson (1908, p. 100) reported that the tunnel was "*stove in and smashed in pieces for a distance of about 28 feet*" and was offset about 5 feet. Schussler also made a map of the tunnel cracks and estimated that right slip across the fault here was ~7 feet (see Figure 4.1.12-3). Schussler also photographed the brick tunnel and the wooded flume:
