History of the Water Works of San Francisco: Its Performance in the 1906 Earthquake and Aftermath

John M. Eidinger and N. Timothy Hall

Revision 2

August 2024

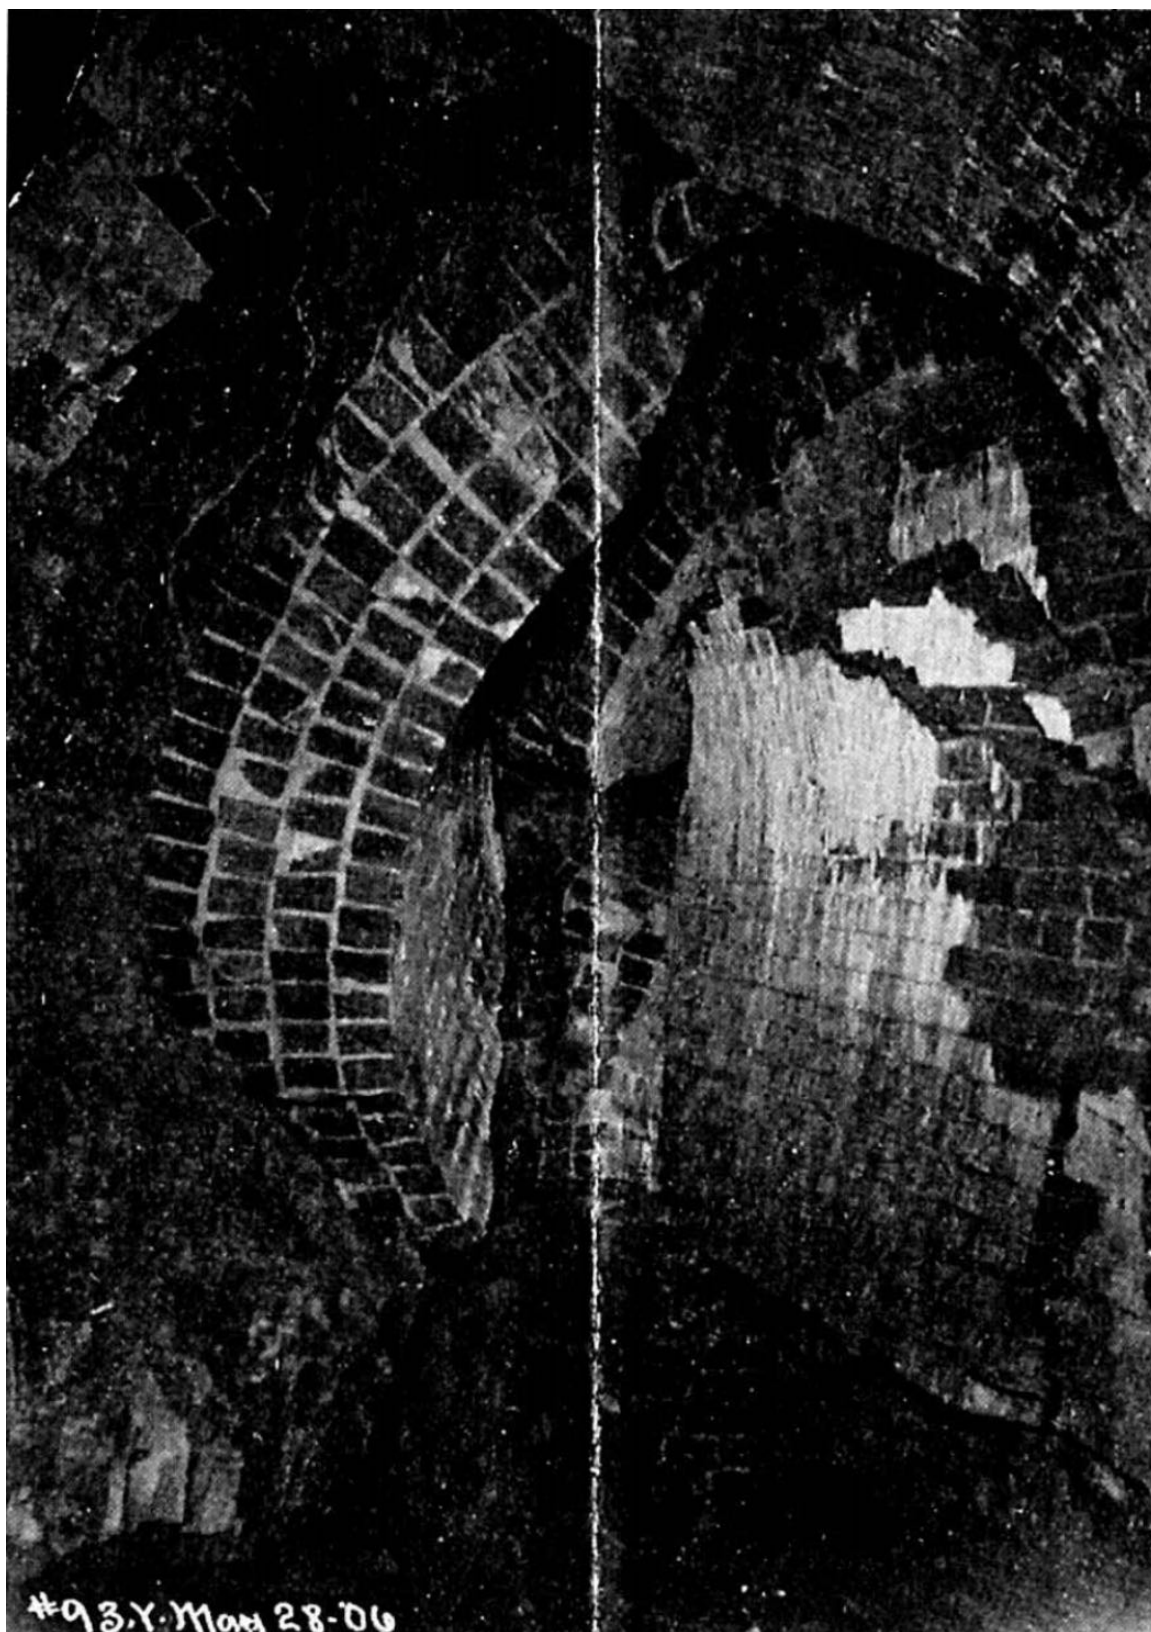
Figure 4.1.12-4. Wastewater Tunnel looking northerly (photo: Schussler HS33)

- Figure 4.1.12-4. Shows damaged wastewater brick tunnel.
- Figure 4.1.12-5. Shows damaged wastewater brick tunnel.
- Figure 4.1.12-6. Shows the interior of the damaged wastewater wood flume, looking southwesterly.

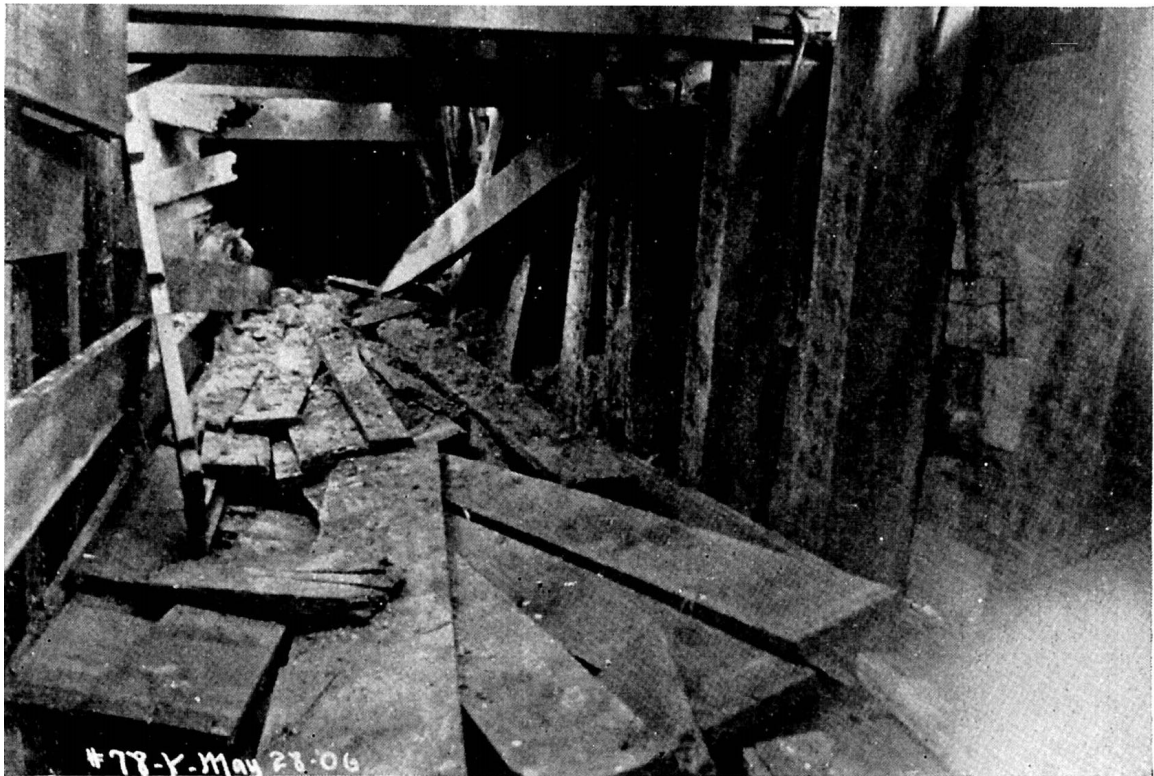
Figure 4.1.12-7. Interior of Wastewater Flume, Looking Northeasterly (photo: Schussler HS35)

- Figure 4.1.12-7. Shows the interior of the damaged exit wastewater wood flume, looking northeasterly. Note the separation of the horizontal wood 12x12s from the vertical 12x12s, which had been connected with ~0.5" diameter steel dowels ("dogs" using Schussler's description).

Figures 4.1.12-6, -7 show many ~1x8 (possibly ~2x10) lumber planks resting on the floor of the tunnel. The evidence suggests that these planks were lightly nailed to the interior of the 12x12s to form a fairly smooth interior surface for when the tunnel was flooded. More than 90 percent of these nailed connections failed, allowing this lumber to fall to the floor (a few connections staying intact, with a couple of planks now diagonally resting in the damaged flume).

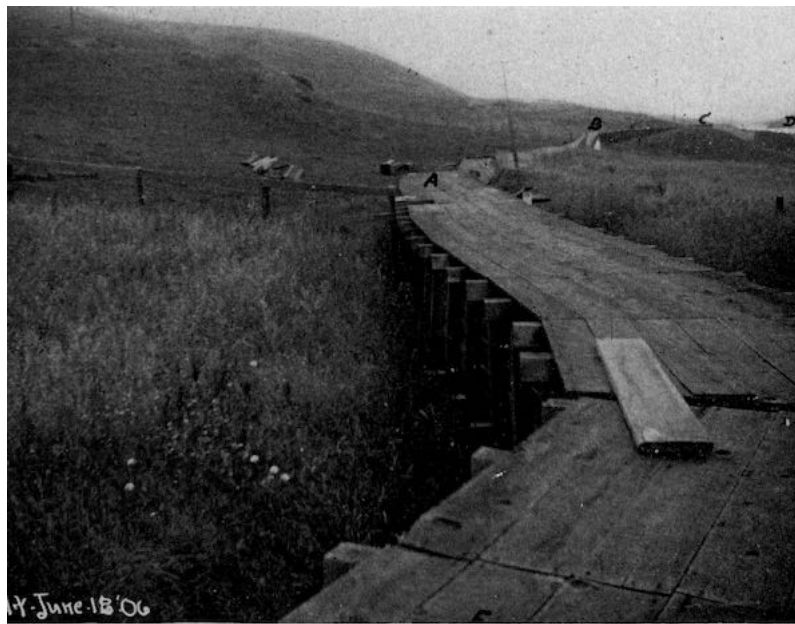
Figures 4.1.12-11, -12, -13 show about 250 feet of the Locks Creek flume that was wrecked, between points "A" and "B" in these photos. The location of the failure is about 600 feet east of the main San Andreas fault offset, and about 1,400 feet south of the San Andreas dam. The cross section of the flume at this location was 6 feet wide by 4 feet high. The elevated flume was sound between points B and C. In the distance in Figures 4.1.12-11 and -12 at point D is the northern end of Lower Crystal Springs Reservoir.

Figure 4.1.12-11. Failure of Stone Dam Flume, Looking Southerly (Photo: Schussler 1906 HS50)

Figures 4.1.12-12, -13 show that this section of the flume has collapsed towards the west. The main fault does not approach this segment of flume. One question arises: was there an eastern secondary trace of the San Andreas fault that might have displaced perhaps a few inches, that led to collapse shown in Figures 4.1.12-11, -12, -13? We suspect not.

- There are no clearly observed landslides in these locations (Figures 4.1.12-11, -12, -13, also Figures 4.6-3, -4).
- The flume failures did not extend indefinitely: the bulk of the length of the flumes remained standing. The style of construction was similar along the entire length, and the height of water would have been the similar along the length.

- Could high inertial loading have contributed to the observed failures?. The photos suggest that the 4x6 vertical bents rotated and that led to the collapses. This type of failure mode is consistent with a large sideways inertial loading (weight of water plus lumber, acting sideways). The toe nailing and small dado joints would have been sufficient to resist opposing hydrostatic water forces, but under seismic loading, all forces can be to one side, and these joints were not strong enough to resist the applied moments.

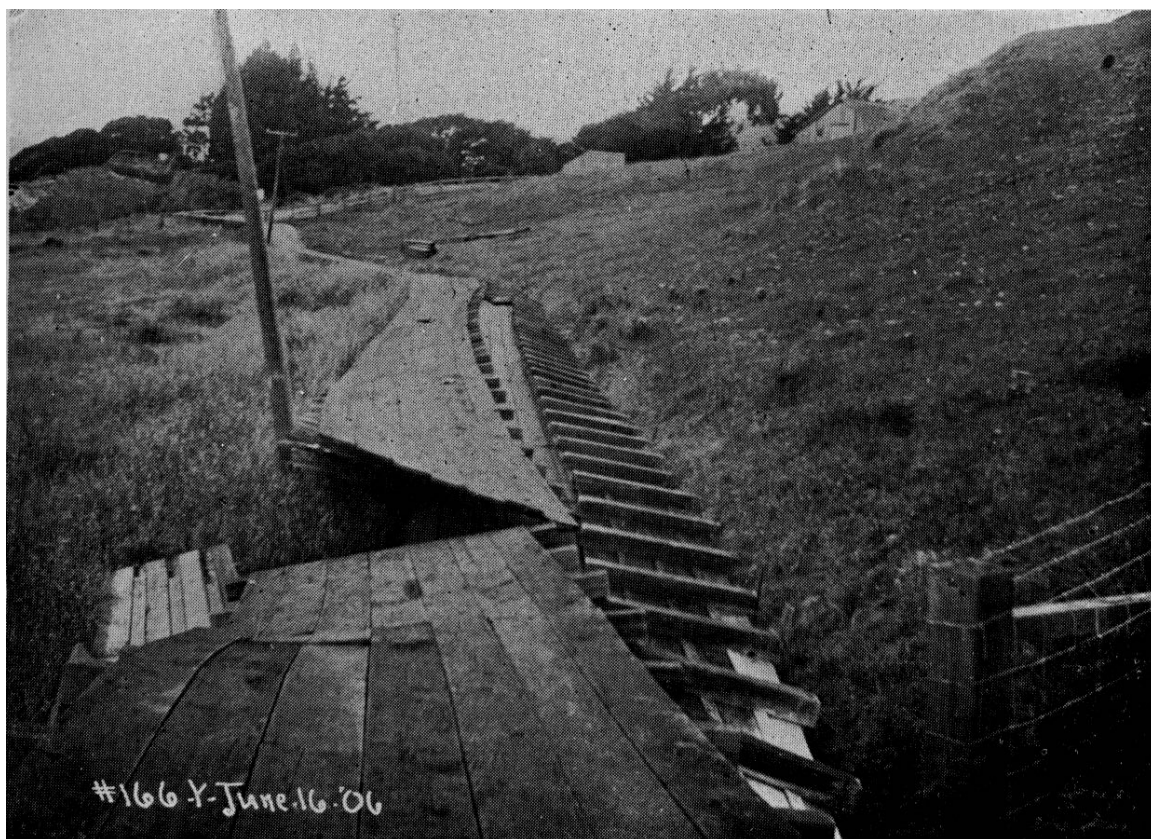
Figure 4.1.12-13. Failure of Stone Dam Flume, Looking Northerly (Photo: Schussler 1906 HS51)

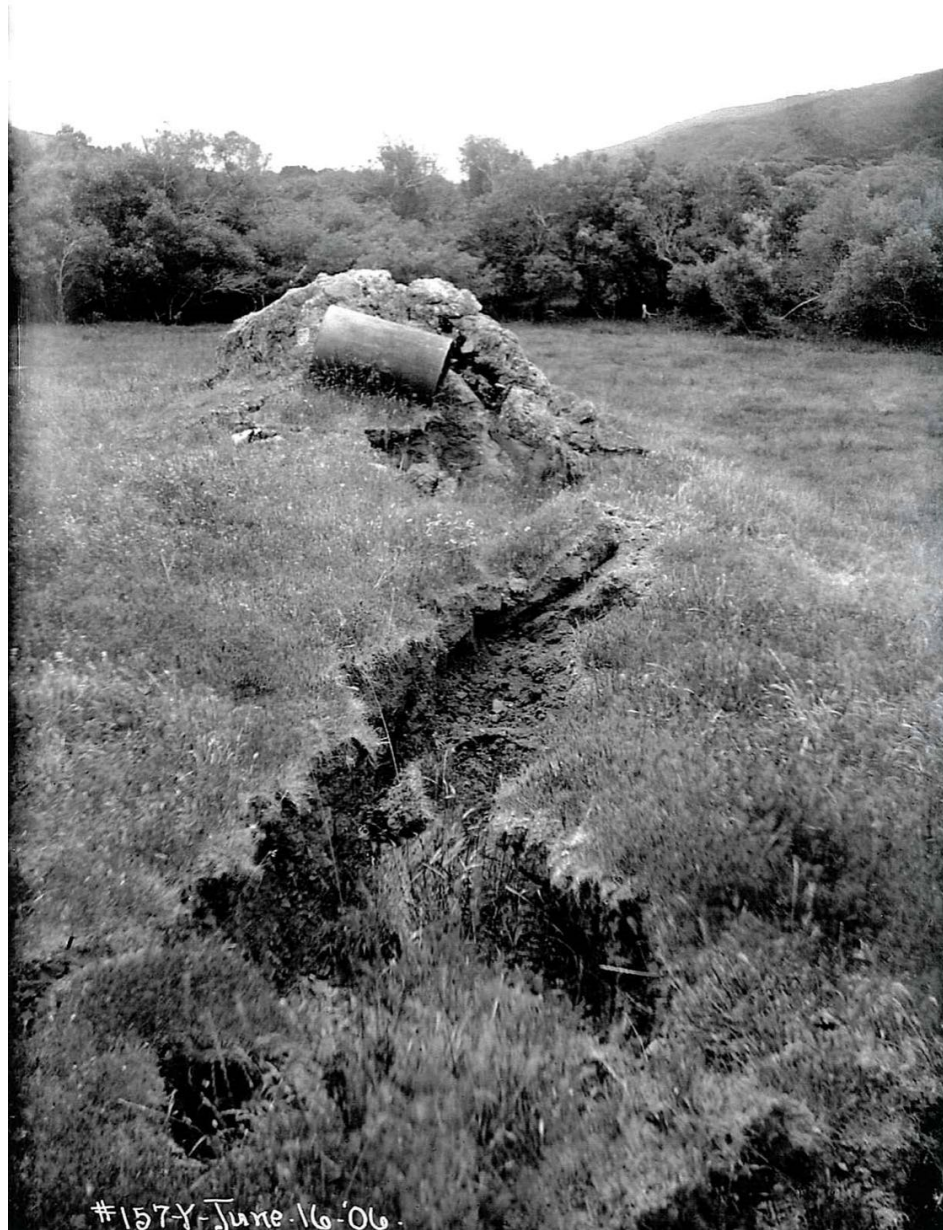
Perhaps ~1,600 feet southeast of Site 13 is a photo of the fault offset trace, Figure 4.1.13-2. This photo is believed to have been taken looking southeasterly. Schussler's 1906 report places this photo someplace between Sites 13 and 14. Based on a trench excavated at the base of this boulder, Hall suggests that this photo is in fact about 600 feet north of Site 14. At this boulder, Schussler describes the offset here as about 7 feet. In the middle of the photo is a short segment of riveted wrought iron pipe, resting on a tectonic "knocker" of Franciscan chert. It is uncertain if this is a 30" or 44" diameter WI pipe from the Pilarcitos pipe, or a 37.5" or 44" pipe from the Locks Creek pipe.

Figure 4.1.13-2. About ¼ miles southeast of Site 13, looking southeasterly (Credit: Schussler 1906). Believed to be within 600 feet± of Site 14, FX-5

The "tectonic knocker" seen Figure 4.1.13-2, is one of the common very hard rock type of marine origin found in Franciscan mélangé; it demonstrates clearly that the fault, seeking to navigate the path of least resistance through the earth to reach the surface, will

not necessarily be able to choose a straight path. Schussler's caption on this photo says the fault here slipped 7 feet, but does not tell us what sort of feature he found to measure this displacement. Another 0.1 mile southeast along the fault from this chert boulder is our well-located site 15, which where the San Andreas fault crossed Lawson's Fence "A". In any case, we believe that seven feet of right slip for Site 13 is likely a minimum value and indicates there might have been an unrecognized fault strand near the chert knocker or at least two or more feet of ground warping in this neighborhood that was not recognized or recorded.

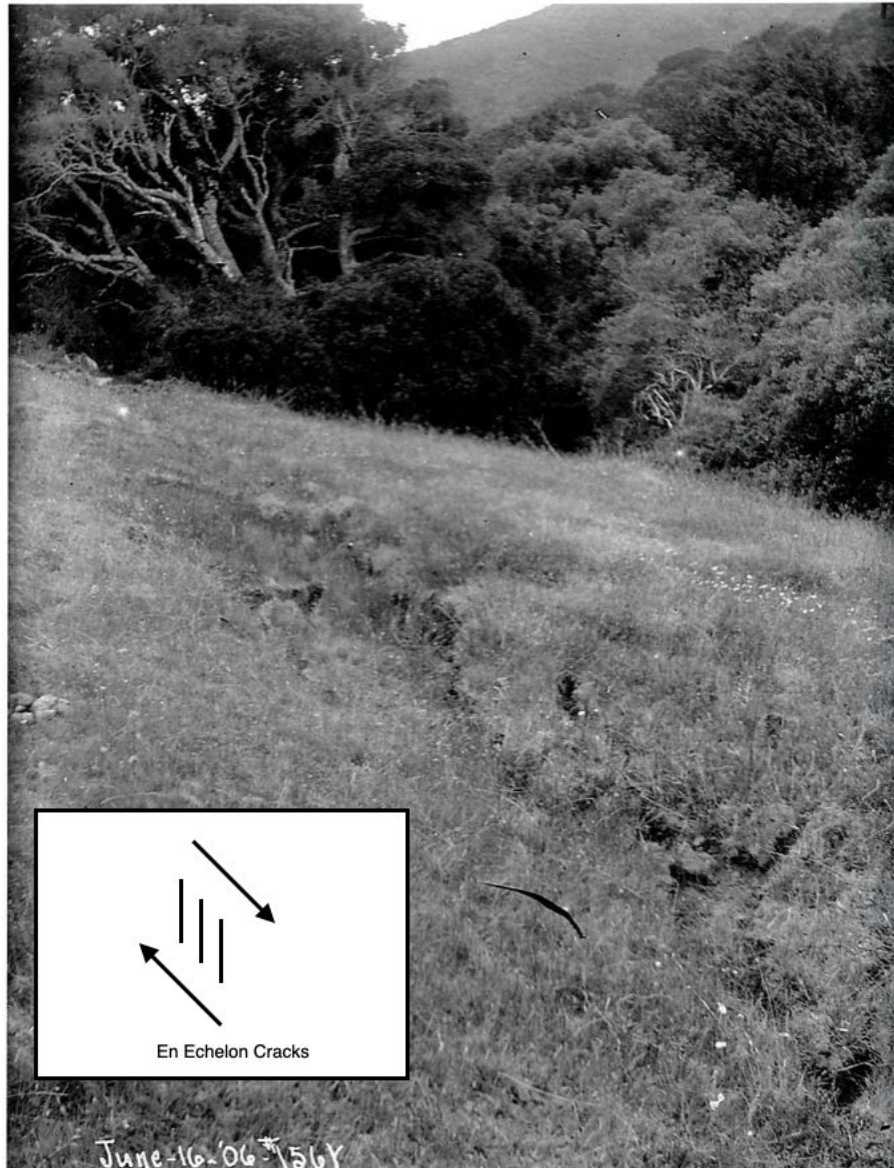
Figure 4.1.13-3 shows the fault surface rupture trace looking south, from the vantage point of the rock seen in Figure 4.1.13-2. The cracks in the ground suggest some en echelon cracking, which reflects an overall right lateral offset pattern, coupled with some extension.

Figure 4.1.13-3. Some distance Southeast of Site 13, Looking Southeasterly. Photo taken from atop the rock in Figure 4.1.13-2. (Credit: Schussler 1906)

From this data we conclude that a minimum of about 9 feet of discrete right slip probably occurred here and was likely augmented by at least 1+ feet of warping.

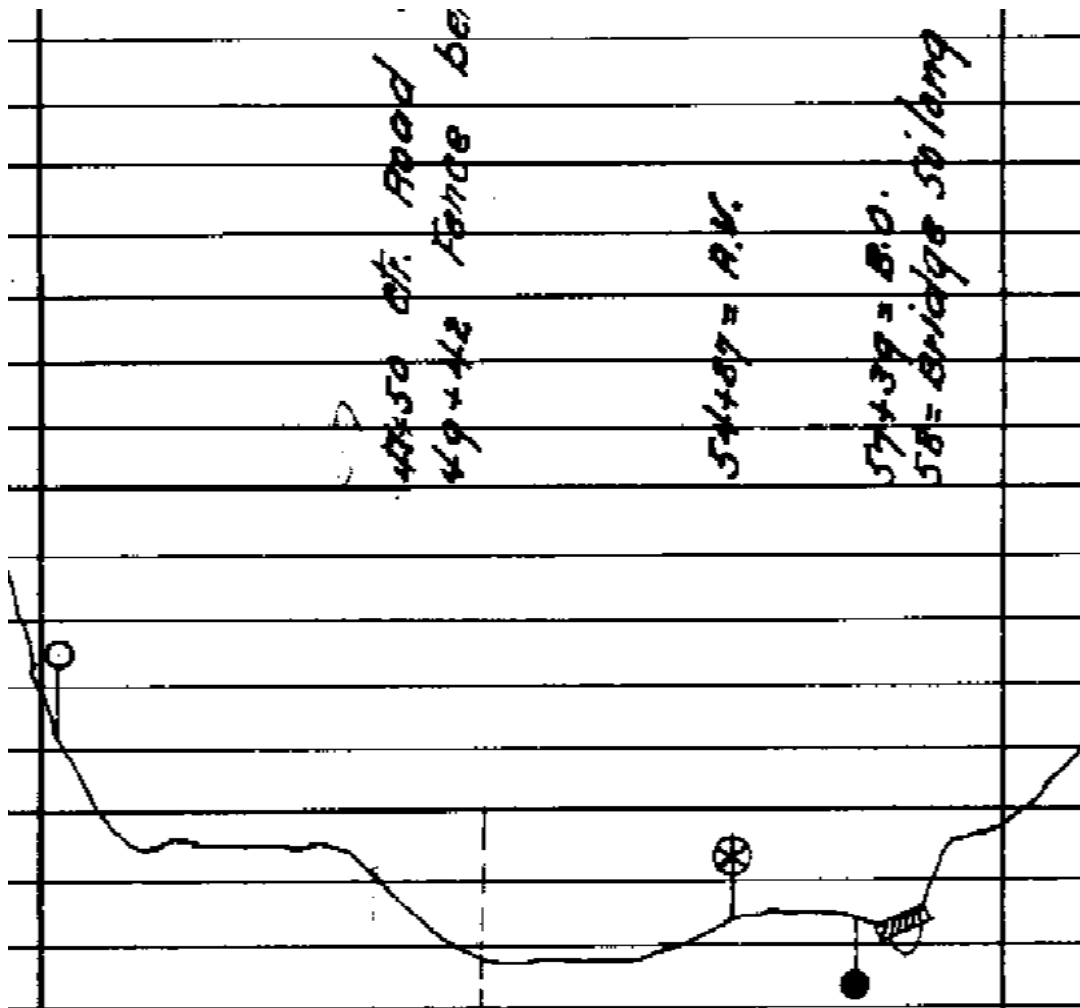
At FX-5, the pipe was on a 50-foot long wooden bridge, crossing San Andreas Creek. The pipe alignment azimuth was about N 25°E, making an angle of about 65° with the strike of the fault (90° = perpendicular to fault). Figure 4.1.14-2 shows the profile of the pipe near FX-5. The sense of the fault offset placed the pipe into net compression coupled with a lot of bending.

Figure 4.1.14-2. Pilarcitos Pipeline Profile at the San Andreas FX-5 Fault Crossing (left = west; right. = east). Source: SVWC drawings P189, P194).

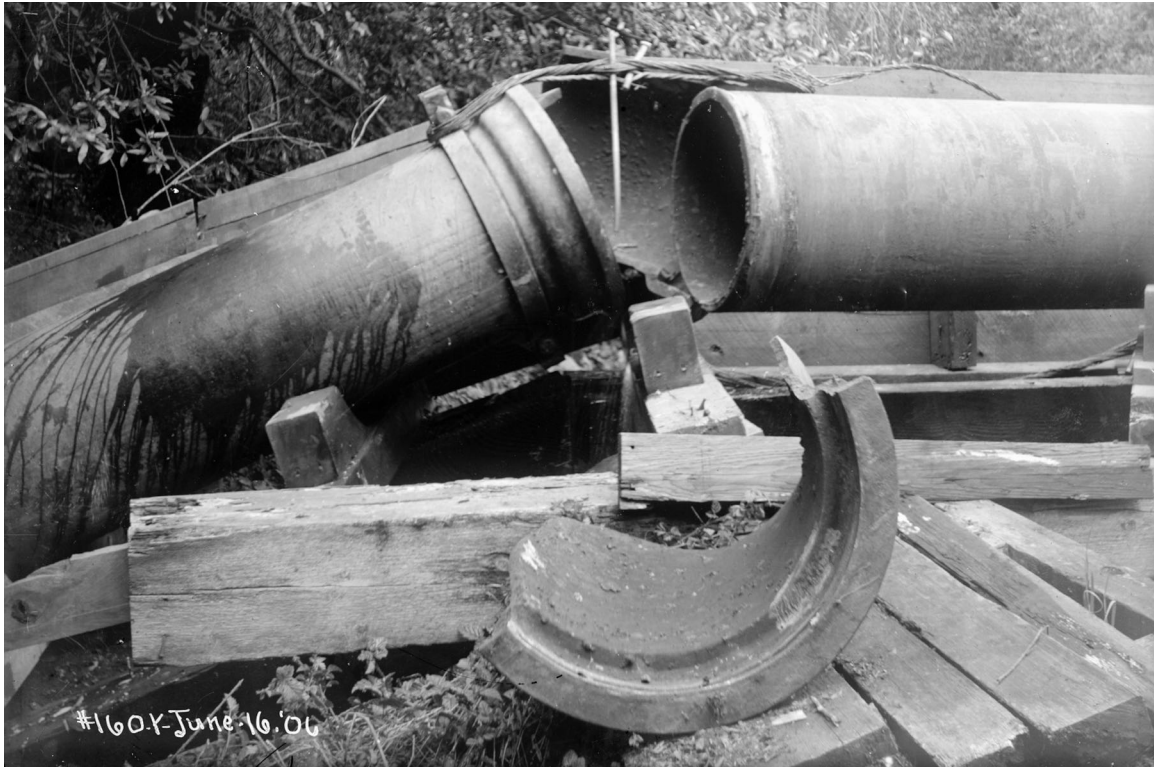
On the bridge, the pipe was a 24" cast iron pipe with bell and spigot joints, and 1" thick wall. Figures 4.1.14-3, -4 show the damage of the pipe at FX-5. Note the clamp on the left pipe segment (Figure 4.1.14-3) (foreground in Figure 4.1.14-4) and a cable; presumably these were restrained joints for the bridge crossing; but these restrained joints were insufficient to accommodate anything resembling ductile response of the complete cast iron pipe when subjected to the right lateral offset. The collapse of the bridge in Figure 4.1.14-4 indicates that the cast iron pipe segment in the foreground must be similarly disconnected to the continuing cast iron pipe behind the photographer's location. Further, we have assumed that these photos were taken looking northerly or easterly (Figures 4.1.14-3, -4 respectively); but given the shadows, a case could be made that the photos were taken looking in the opposite directions.

*Figure 4.1.14-3. Crossing 5. 24" Pilarcitos Cast Iron Pipe. Elbow crushed. View looking north.
(Photo: Schussler 1906 HS11)*

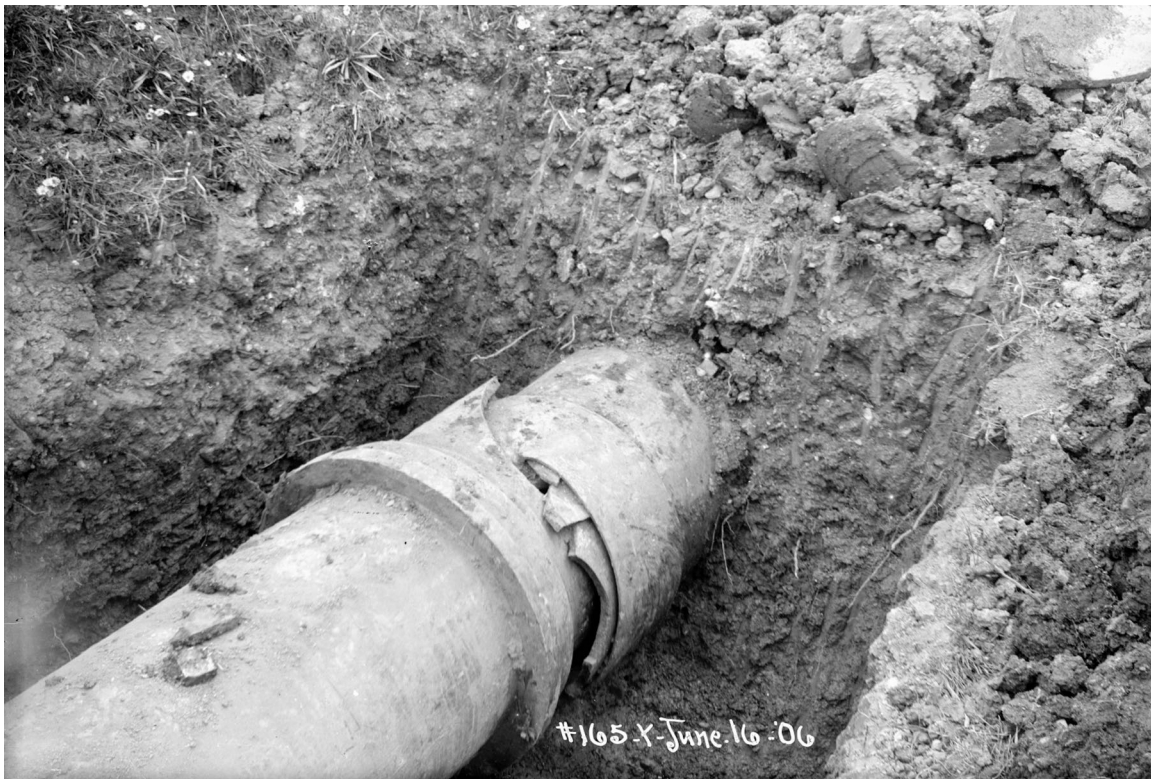
Just east of the fault, the pipe takes an upward bend, as the pipe rises to the 600-foot high hills to the east of the San Andreas reservoir. The pipe broke at an upward bend, see Figure 4.1.14-5. Here, the pipe is 24" cast iron. The pipe has cracked in the main body a few inches away from the bell. An elbow at the bend was crushed by the compression and thrown down, while the two remaining ends were brought about 22 inches nearer together. At the same time they were faulted past each other a distance of 20 inches (Lawson 1908).

*Figure 4.1.14-5. FX-5. 24" Pipe has telescoped $\pm 1'$. About 100' north of FX-5.
(Credit: Schussler 1906 HS13)*

Hall suggests that there might have been about 28" of right lateral slip at the location where the cast iron pipe telescoped (Figure 4.1.14-5). The question is open as to whether the damage at Figure 4.1.14-5 is due to some type of local fault offset, or from forces transmitted through the pipe at the main FX-5 crossing to this location. Eidinger thinks the damage shown in Figure 4.1.14-5 is due to the high compressive forces imposed on the pipe, coupled with some local bending, which then cracked the cast iron body; this factors in that the observed pipe offsets at the wood trestle are insufficient to take up the full 7 feet of offset; but Hall's explanation could also be correct.

In Table 3-2, the amount of fault offset for Site 14 is listed as 7.0 feet. This reflects the measurements / observations by Schussler (1906) and Reid (1910). If one attributes the damage in Figure 4.1.14-5 as due to a secondary trace of the fault that is not documented by Lawson (1908) or Reid (1910), then the total right lateral slip across the fault at FX-5 would be about 8.3 feet.

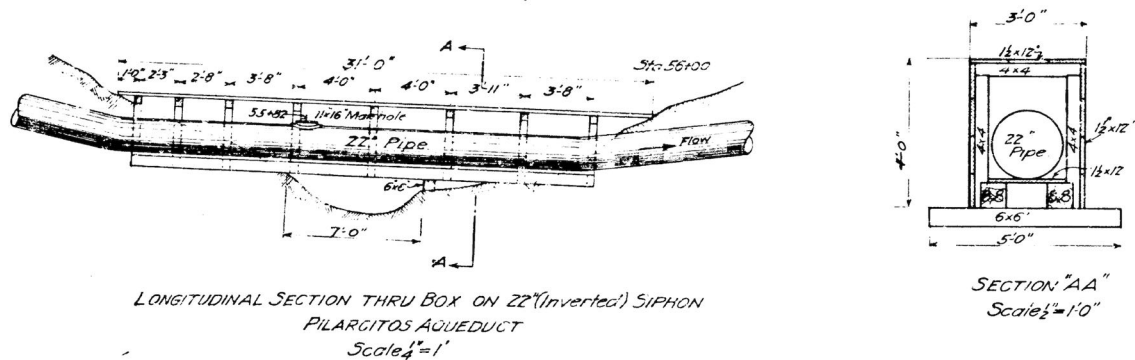
Figure 4.1.14-6. FX-5. 24" Pipe on Wood Bridge across creek (typical style of construction) (SVWC drawings)

Figure 4.1.14-6 shows the details of the wood bridge that supported the Pilarcitos pipe across San Andreas Creek. These details do not exactly match the observed damage in Figures 4.1.14-3, -4:

- The details are sufficient for an OD 22" pipe, with inside width of $36" - 4" - 4" - 1.5" - 1.5" = 25"$ (leaving 3" clear space); or possibly just enough for a 24" OD pipe (as long as the bell connections are not placed at the 4x4 posts); but not sufficient for a ID 24" pipe.
- Section AA shows the pipe supported by horizontal 1.5×12^{18} . The damage pictures post-earthquake show the pipe was supported on $\sim 6 \times 6$ saddles that have been shaped to match the OD of the lower $\sim 120^\circ$ of the pipe, and which in turn rest upon $\sim 4 \times 8$ that span to the longitudinal 8×8 .
- The width of the boxed section is 3 feet, just large enough to contain the pipe. But Figure 4.1.14-4 shows a large lateral offset of the pipe, on the order of ~ 3 feet. This strongly suggests that the primary offset went directly through the wooden bridge.

- The explanation for these differences could be:
- The wood bridge (and possibly pipe) had been replaced sometime between 1868 and 1906 (1868 is the implied date of Figure 4.1.14-6, corresponding to original construction of the Pilarcitos pipeline). The new larger pipe (24") was installed to get somewhat higher flow rate through the pipeline.

- We conclude that the most likely reason for the mismatch between the drawings and the observed wood trestle system is that the drawing is outdated (from 1868). With the fire that burned SVWC headquarters in downtown San Francisco, many pre-1906 drawings and documents were lost. Although copies were also held at the Millbrae offices, and that is where Figure 4.1.14-6 was located, it is possible that not every document was held at Millbrae.

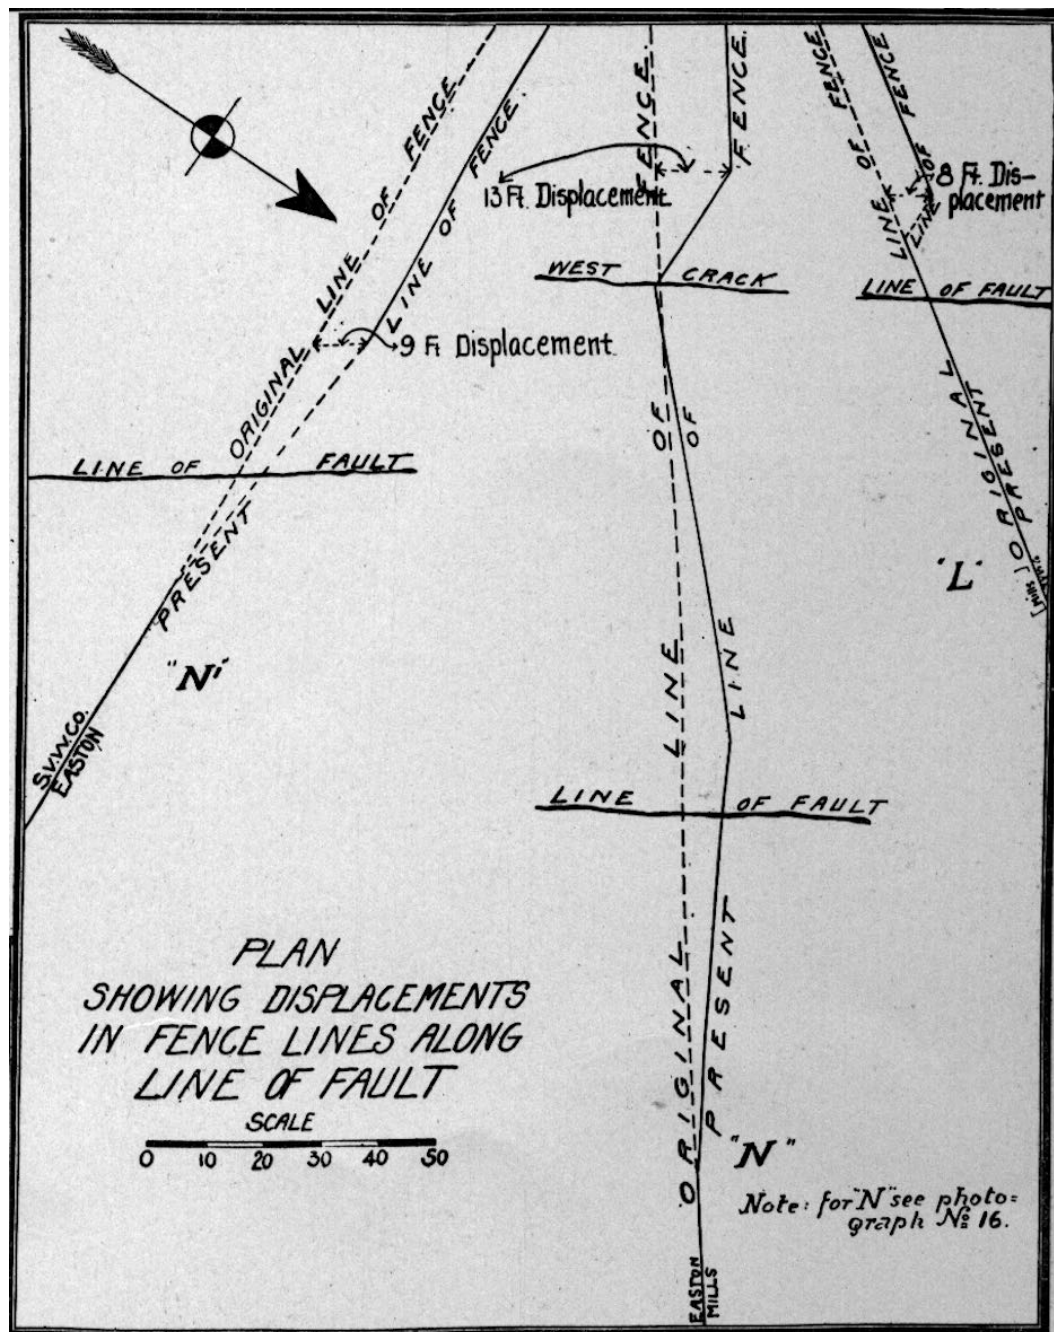
This property boundary wire fence trends N52°E and crosses the 1906 San Andreas faulting at almost a right angle making it a potentially high-quality strain gauge for measuring fault slip. Schussler's sketch map of this area (Figure 4.1.15-1) identified two parallel cracks about 90 feet apart with a combined right lateral slip of 13 feet as measured by the fence offset (center fence in map below). Using Schussler's terms, the "west crack line of fault" break manifested the larger amount of slip.

Figure 4.1.15-1. Map of Faults and Fences (Credit: Schussler 1906)

between DE and C-D₁ as an expression of the vanishing point perspective. In other words, the "triangular" shapes drawn by Schussler as "present line of" and "original line of" in Figure 4.1.15-1 at "line of fault" is incorrect; and the "line of fault" at the bottom of the sketch in Figure 4.1.15-1 is also incorrect and did not exist.

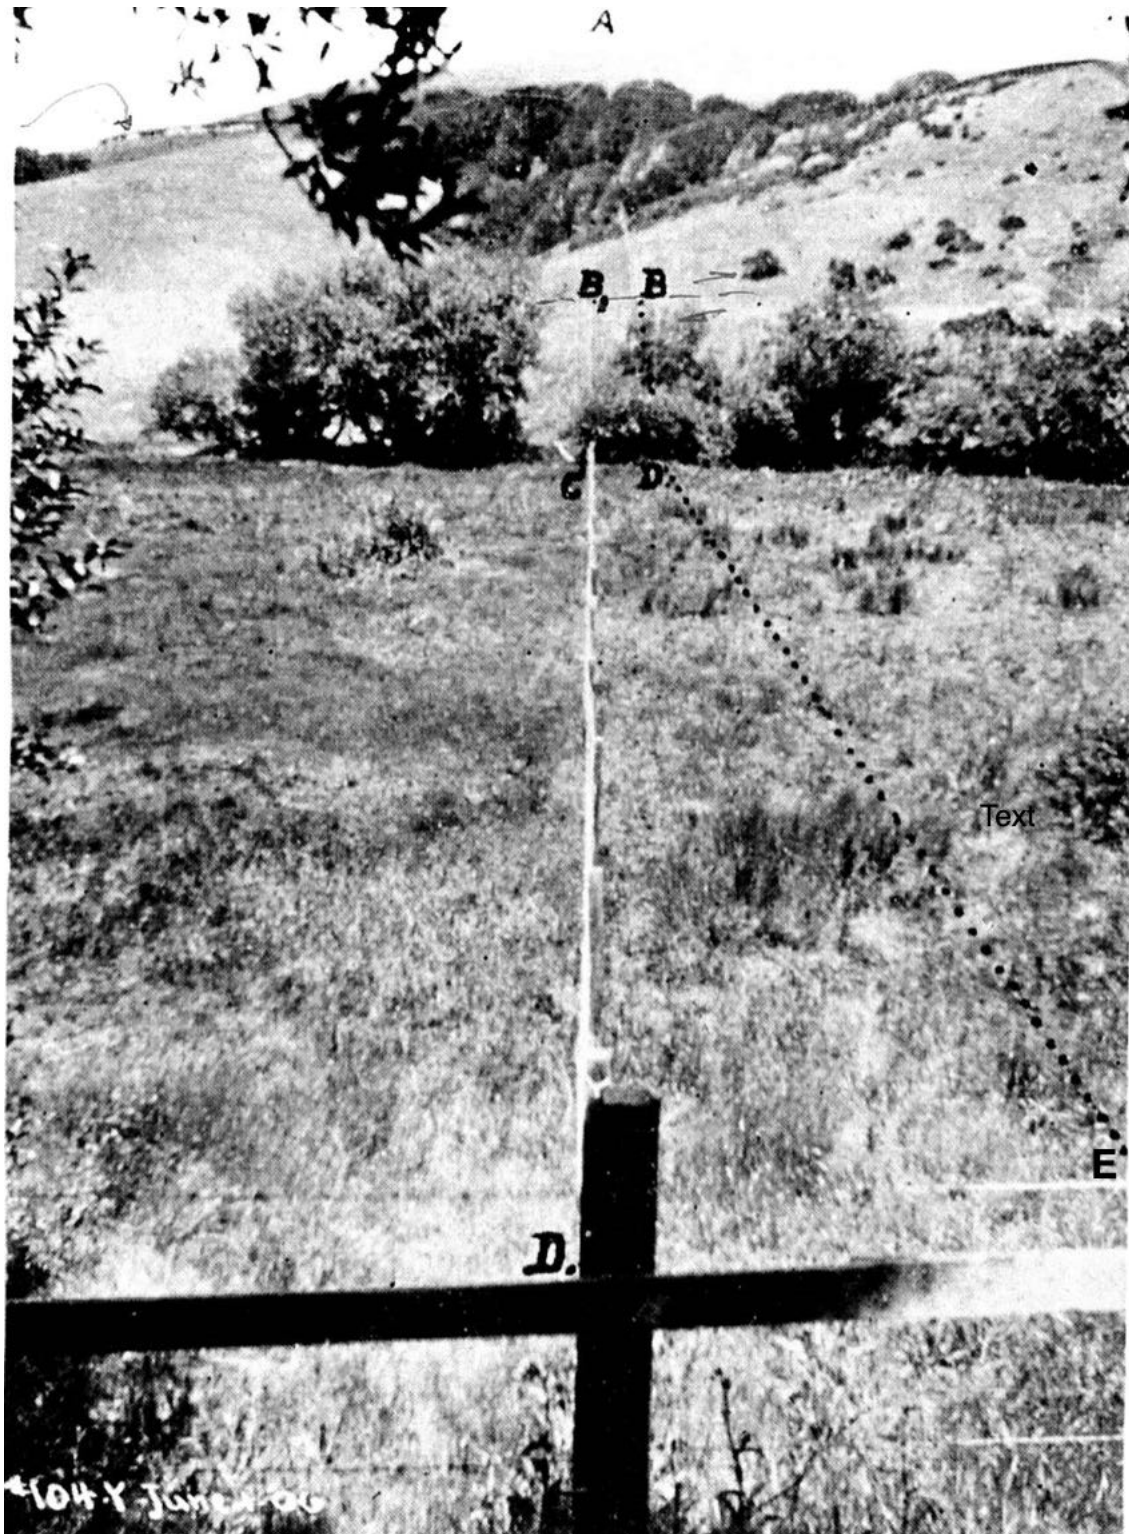
Figure 4.1.15-4. Offset of Fence N, looking northeasterly (Credit: Schussler, 1906)

4.1.15-4 is a photo by Schussler (1906). The post-earthquake location of the fence is A-B-B₁-C-D₁. Schussler hand-drew in the dotted line (Point D to E) as to original location of the fence. We interpret the seemingly "left lateral" offset suggested by the angle

Schussler noted that the primary offset is nearly normal to the fence line, just beyond B₁-B.

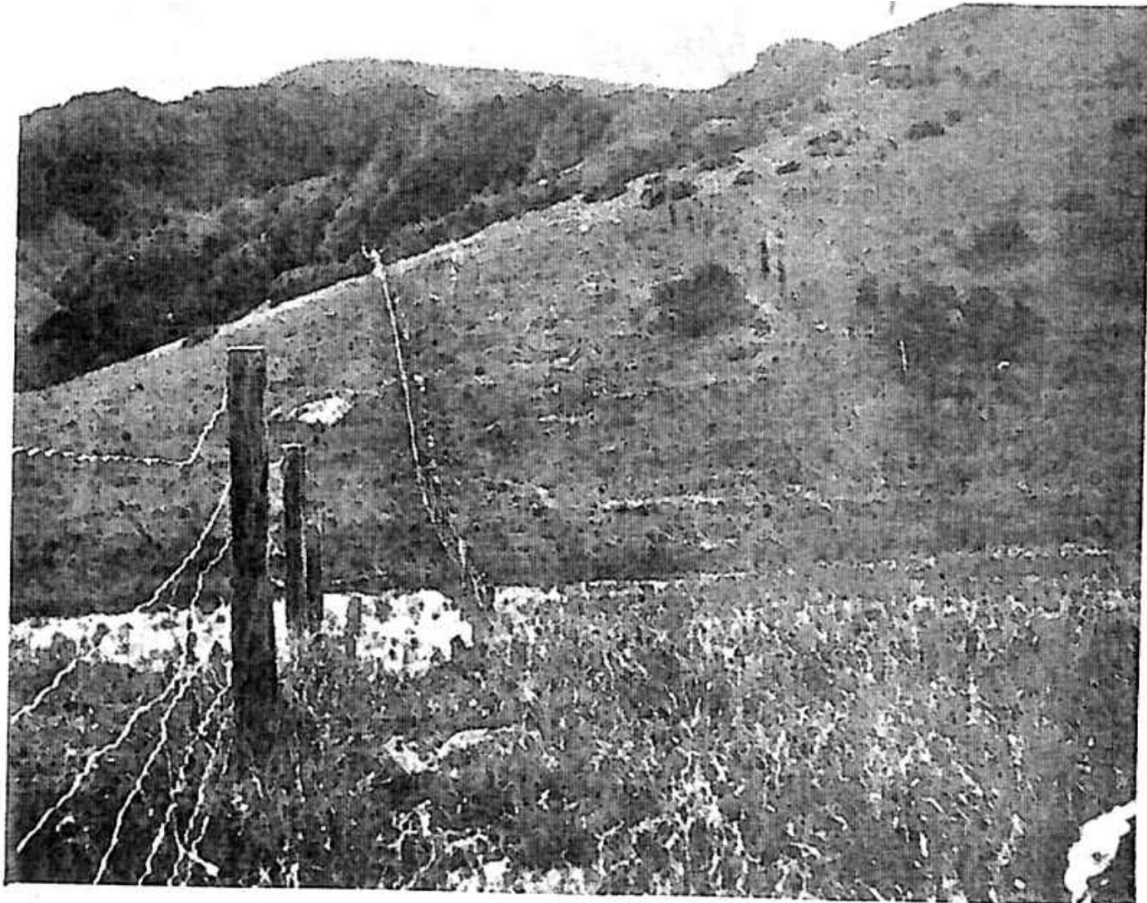
Hall notes: At the eastern pipe failure location (Figure 4.1.15-5), Schussler documented another break in this 24" cast iron pipe about 100 feet to the north of the FX-5. At this northerly break, the pipe was telescoped about 1 foot, which if the angle of the pipe/fault intersection has not changed (which is speculative), indicates right slip in the plane of the fault of ~28". If the observed two measurements of telescoping are added, the amount of right slip at this wide fault crossing due to shortening of the pipe is about 80" or 6.7 feet. This matches the magnitude of 6.75 feet of right slip along the fault plane here that was calculated by Reid (1910, V.II, p. 37).

If the observed lateral dislocation of 20 inches from Figure 4.1.15-5 is added to the total measured pipe shortening, the total fault slip at this crossing might have been as much as 8.3 feet. One of the objectives of this report is to make a *reasonably conservative* assessment of the Peninsula segment of the San Andreas fault's slip hazard. So we are more comfortable with the larger estimate and would not consider modern design using a knife edge right lateral offset value of 6.7 feet as sufficiently conservative or suitable for design. Rather, we prefer 8.3 feet (knife edge) or 6.7 feet (knife edge plus 1.6 feet (secondary)).

Figure 4.1.15-5. Offset of Fence N, looking northeasterly (Lawson, 1908)

4.1.15-5 is a photo by Branner, published as Plate 60D in Lawson (1908). We interpret this photo as looking to the northeast, with the low spot being where the fence crossed a sag pond at about elevation 320 feet. In this photo, the offset of the fence is about 6 feet according to the caption for the prior-mentioned Plate 60. Hall trenched this site in 1980 and interpreted that this fence offset location as the primary offset zone.

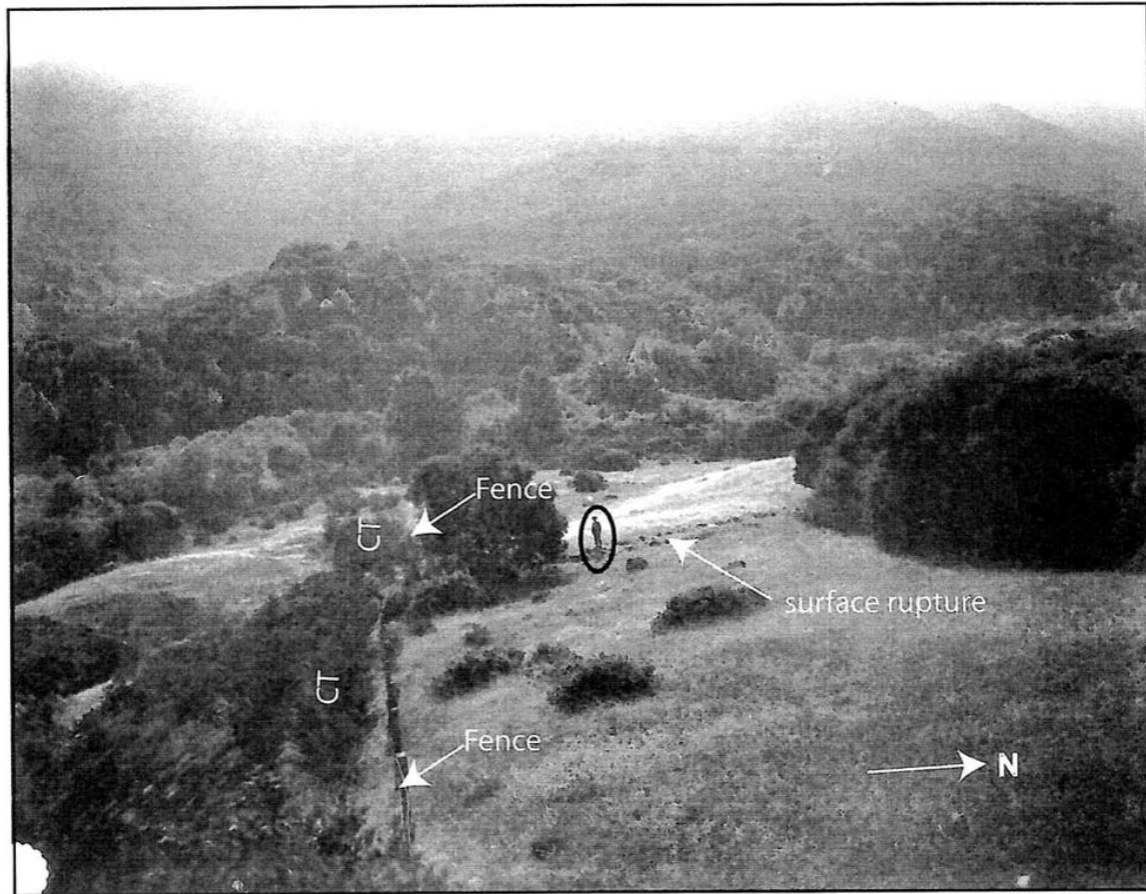
Fence line N¹ is denoted by the fence line sketched by Schussler in Figure 4.1.16-1. Figure 4.1.16-2 shows the same area mapped by Hall in 1984. Here, a property boundary is marked by a fence and a row of Cypress trees that were offset 9 feet right laterally. Figure 4.1.16-3 clearly shows the young trees, the bent fence and a geologist standing bravely on the 1906 mole track.

Figure 4.1.16-3. Photo showing surface rupture, fence and trees (Photo: Lawson 1908 Plate 61B)

Schussler (1906) and Lawson (1908) both sketched the site and both agreed on 9 feet or right lateral offset. Hall (1984, p. 286) also surveyed this site in 1980 and measured the same displacement even though the fence had obviously been repaired. Because the watershed lands are protected, the fence may yet exist today (2023). At the time of the 1980 survey, the tree trunks were several feet in diameter, making it difficult to measure their exact position when planted at least 80 years earlier. What the 1980 survey did show is that here the zone of maximum slip was at least 30 feet wide and showed evidence in the form of a hillside bench with a central trough and sag that indicated the ground surface along the fault here experienced some extension during fault slip. It is also interesting to speculate that the absence of two trees within the zone of concentrated slip probably had their roots sheared in 1906, which might have weakened them and led to their premature demise.

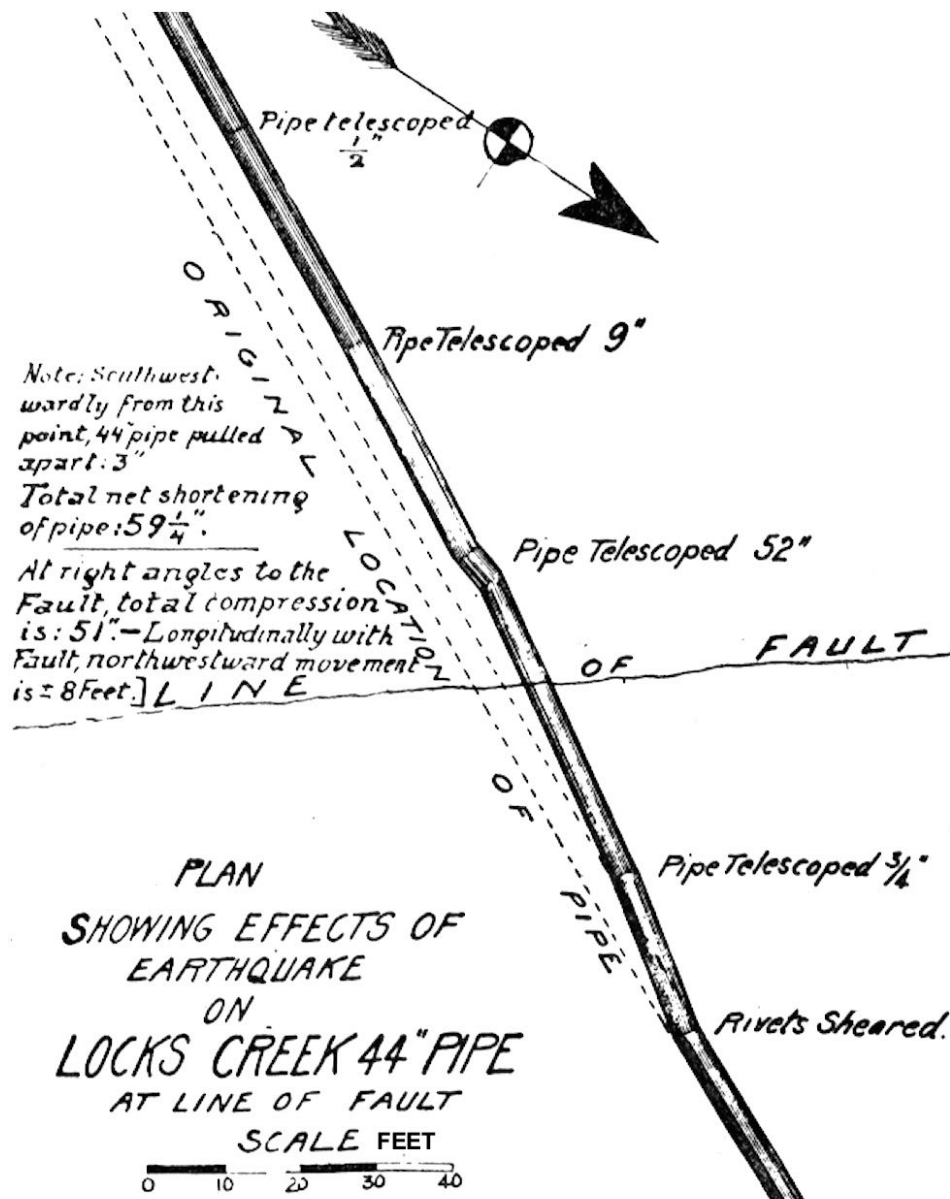
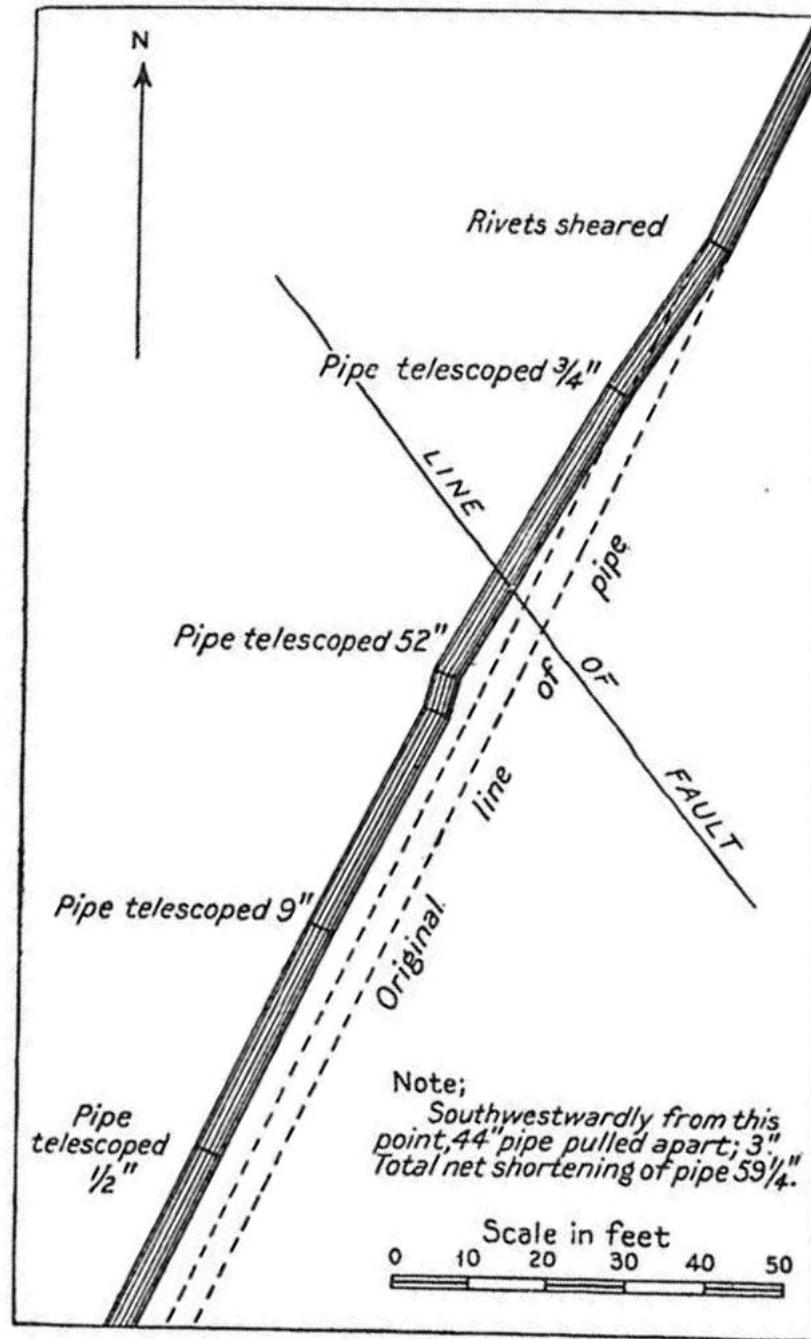
Figure 4.1.17-1 shows Schussler's sketch of the 44" riveted wrought iron pipe at Site 17. Figure 4.1.17-2 shows the re-drafted sketch by Lawson. Here, the pipe crosses the fault at an angle of about 70°, and right lateral offset would place the pipe into net compression, and well as much bending. On the east side of the fault, the pipe shows concentrated damage at two locations, about 30 feet and 50 feet away from the primary fault offset location. On the west side of the fault, the pipe shows concentrated damage at four locations, with compressive/bending failures at about 20 feet and 50 feet away from the primary fault offset location, and another tensile failure at about 400 feet distance from the fault or ±600 feet east of a county road.

The multiple damage locations either side of the fault is the natural condition of a beam (pipe) on nonlinear springs, when subjected to knife edge fault offset. The high bending moment ruptures the pipe in two locations either side of the fault, and this damage pattern was similarly duplicated by the Thames River 2.2 m diameter steel pipeline where it was exposed to similar right lateral fault offset in the 1999 Izmit earthquake (Eidinger, O'Rourke, Bachhuber, 1999b). The Thames River pipeline was butt-welded steel; so the failure mode was gross wrinkling of the pipe, rather than shearing the riveted joints as was the case for the 44" Locks Creek pipeline.

The distance (in feet) between the first two failure locations either side of the primary fault offset (about 50 feet in this case) is a function of the relative stiffness and strength of the pipe versus the stiffness of the backfill soils around the pipe: the stiffer / stronger the pipe and the softer the soil, the wider the distance between the two failure locations.

The four locations where the pipe was reported as "telescoped" are places where the net shortening of the pipe had to occur. If we allow that at a 55° angle and 8 feet of right lateral offset, then the net shortening should be about $96'' \sin 25^\circ = 41$ inches. Schussler computes 59.25 inches. We suspect the discrepancy is in the measurement of 52" at the telescoped failure just west of the fault; perhaps this was the maximum measured around the circumference, rather than the average. It is unclear as to the mechanism that led to the tensile failure and pull apart of $\sim 3''$ at a distance of about 400 feet to the west of the fault.

Figure 4.1.17-1. FX-6. Locks Creek 44" Wrought Iron Pipe (Schussler 1906)

Figure 4.1.17-2. FX-6. Locks Creek 44" Wrought Iron Pipe (Lawson 1908 Fig. 39)

The hand-drawn before-and-after pipe locations in Figures 4.1.17-1, -2 suggest the pipe was offset laterally by about 1.5 pipe diameters (66"), but Schussler documents 14" of transverse pipe offset. The difference in these two figures (66", 14") cannot be readily reconciled as a sudden "knife edge" offset of the pipe; but could reflect the transverse offset over several tens of feet.
