History of the Water Works of San Francisco: Its Performance in the 1906 Earthquake and Aftermath

John M. Eidinger and N. Timothy Hall

Revision 2

August 2024

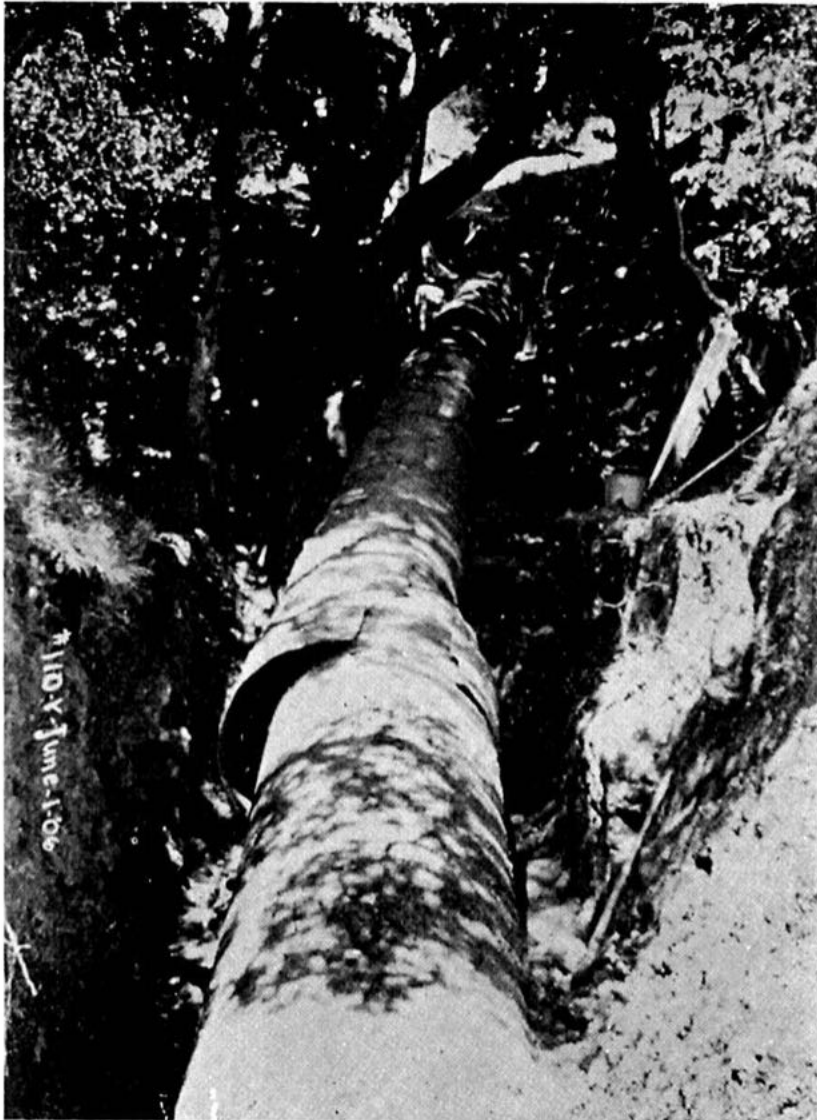
At this location, the 44" riveted wrought iron pipe was buried with 3-4 feet of cover and had wall $t = 0.125$ inches. This pipe runs up the hill from the San Andreas Creek valley in a direction of about $N 28^{\circ}E$. The fault offset bisected this pipe at the base of the hill, with the fault azimuth being $N 37^{\circ}W$. Thus, the intersection angle between the fault and the pipe is about 65° . At the intersection of the fault, the rivets were torn out all the way around at a girth joint and two pipe segments were telescoped into one another a distance of 52 inches. One observer suggested there was no lateral displacement, the whole

movement being taken up by telescoping of the pipe, but there was bending of the pipes at the point of the break.

Figure 4.1.17-3. FX-6. Locks Creek 37.5" Wrought Iron Pipe is offset to the north about 14" and telescoped about 51". Looking easterly. Location is about 50 feet east of the County road between the San Andreas and Crystal Springs reservoirs. (Photo: Schussler 1906 HS14)

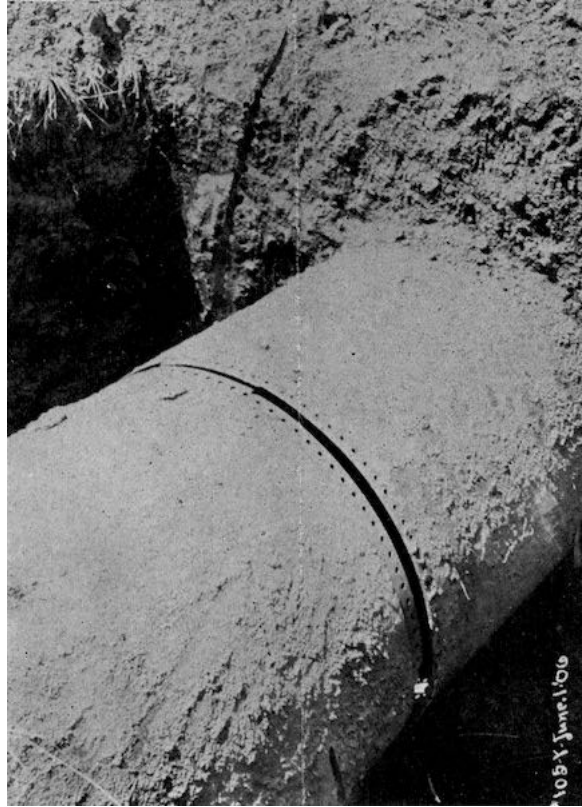
This pipe was also broken about 400 feet on the southwest side of the, see Figure 4.1.17-4. This break occurred at the junction of 2 sections, the rivets having been sheared off and part of the rim torn away at the rivet holes. The ends were pulled apart 3.375 inches

(Lawson 1908). This suggests the pipe here was in nearly pure tension. At the primary offset location, the pipe is under enormous stress, a combination of huge bending and some compression. The question arises as to how the pipe also failed some 400 feet away on the southwest side of the fault, and in what apparently is tension. If one assumes no applied PGDs between the primary trace and this location, then what produced the high tension?

- Possibility 3. Clearly, there was strong ground shaking in the area. Elsewhere in this report, we describe the strength of the riveted joint being only half the strength of the main barrel of the pipe. Almost certainly, this is a low pressure pipe ($D/t = 44 / 0.125 = 344, \gg 200$), as the required head would have been on the order of 100 to 150 feet only, between the two open channel flume sections at about elevation 500 feet (either side of the valley, and the fault location being about 325 feet, or 175 feet head or hydrostatic pressure of about 75 psi (pipe hoop stress = $175 / 2.31 * 22 / 0.125 = 13,300$ psi). Assuming the pipe wall thickness was set to have F.S. = 2 under maximum static head, wall t is thin (and the rivet joints corresponding designed). Then, the longitudinal stress due to shaking might have been ~+5 ksi, and a water hammer stress about +5 ksi, and the stress due to internal pressure might have been +6 ksi (or so). Combining these three effects, the longitudinal stress (~16 ksi) might have been sufficient to break a particularly weak riveted girth joint.

In zones with soils with highly susceptible to liquefaction, design the pipe for a few inches of PGD. Lacking detailed site specific study, it will be rare to be able to define the exact PGD profile. A lateral spread of >3 inches to the northeast may have occurred at this location, leading to the tensile failure observed in Figure 4.1.17-4, and the additional 9" telescoping location noted in Figures 4.1.17-1, -2.

*Figure 4.1.17-4. Locks Creek 44" Wrought Iron Pipe is pulled apart about 3.375" inches.
(Photo: Schussler 1906 HS15)*

- In zones with high ground shaking ($PGV > 30$ cm/sec), for pipes that are important and should not break in the earthquake, for low pressure pipes (maximum hydrostatic internal pressures under 100 psi) girth joints should be

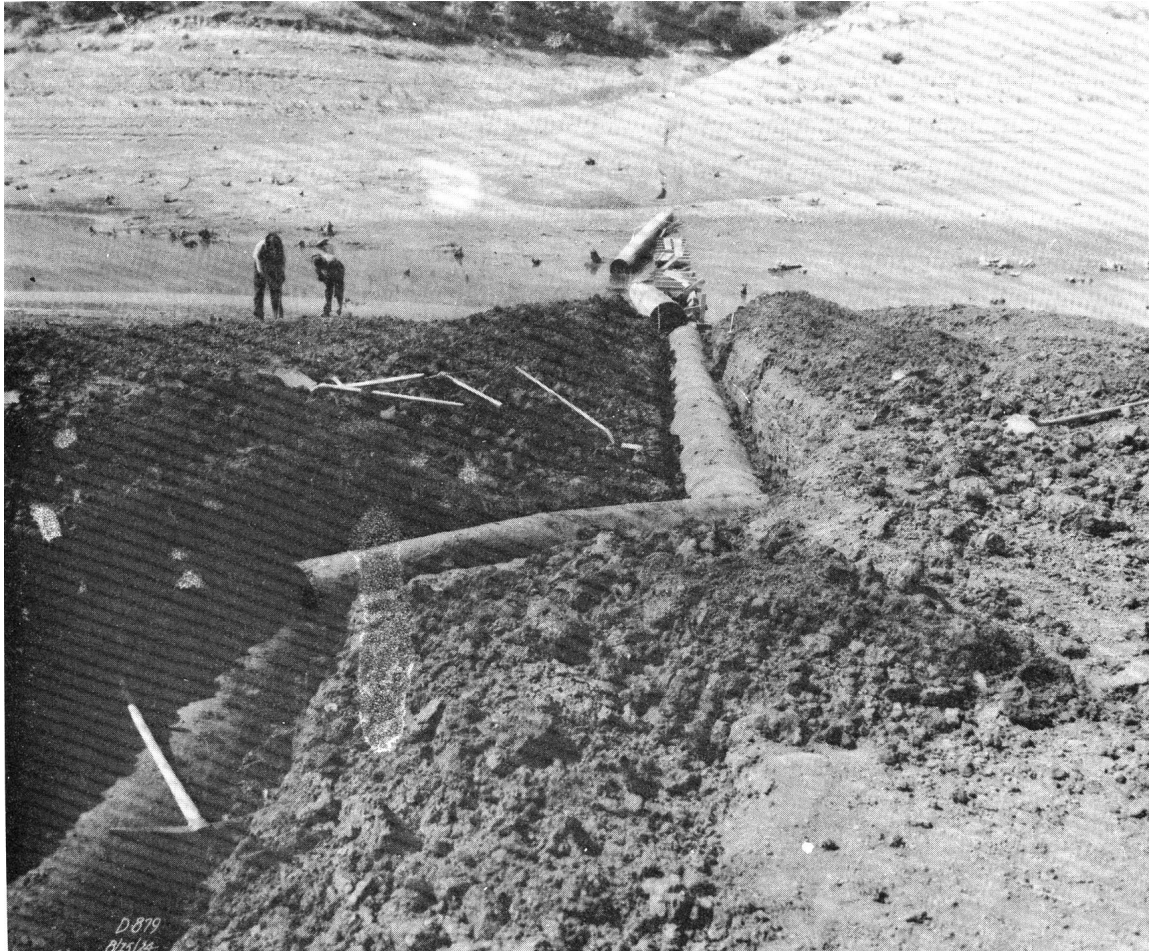
Figure 4.1.18-2. 37.5" Abandoned Pipe, 8-25-1924, D-879 (Credit: SVWC 1924). Looking West

In 1924, the lake level was lowered, and the 37.5" pipe was taken up. At the San Andreas fault crossing, it crossed at about 78° to the fault (90° being perpendicular), and the pipe was exposed to nearly pure bending offset, coupled with a small compressive component. Figure 4.1.18-2 shows the pipe being removed. This photo is taken looking westerly, and the lowered Crystal Springs Reservoir is seen in the background. The ~9-foot right lateral offset of the pipe at the primary offset zone is seen in the foreground.

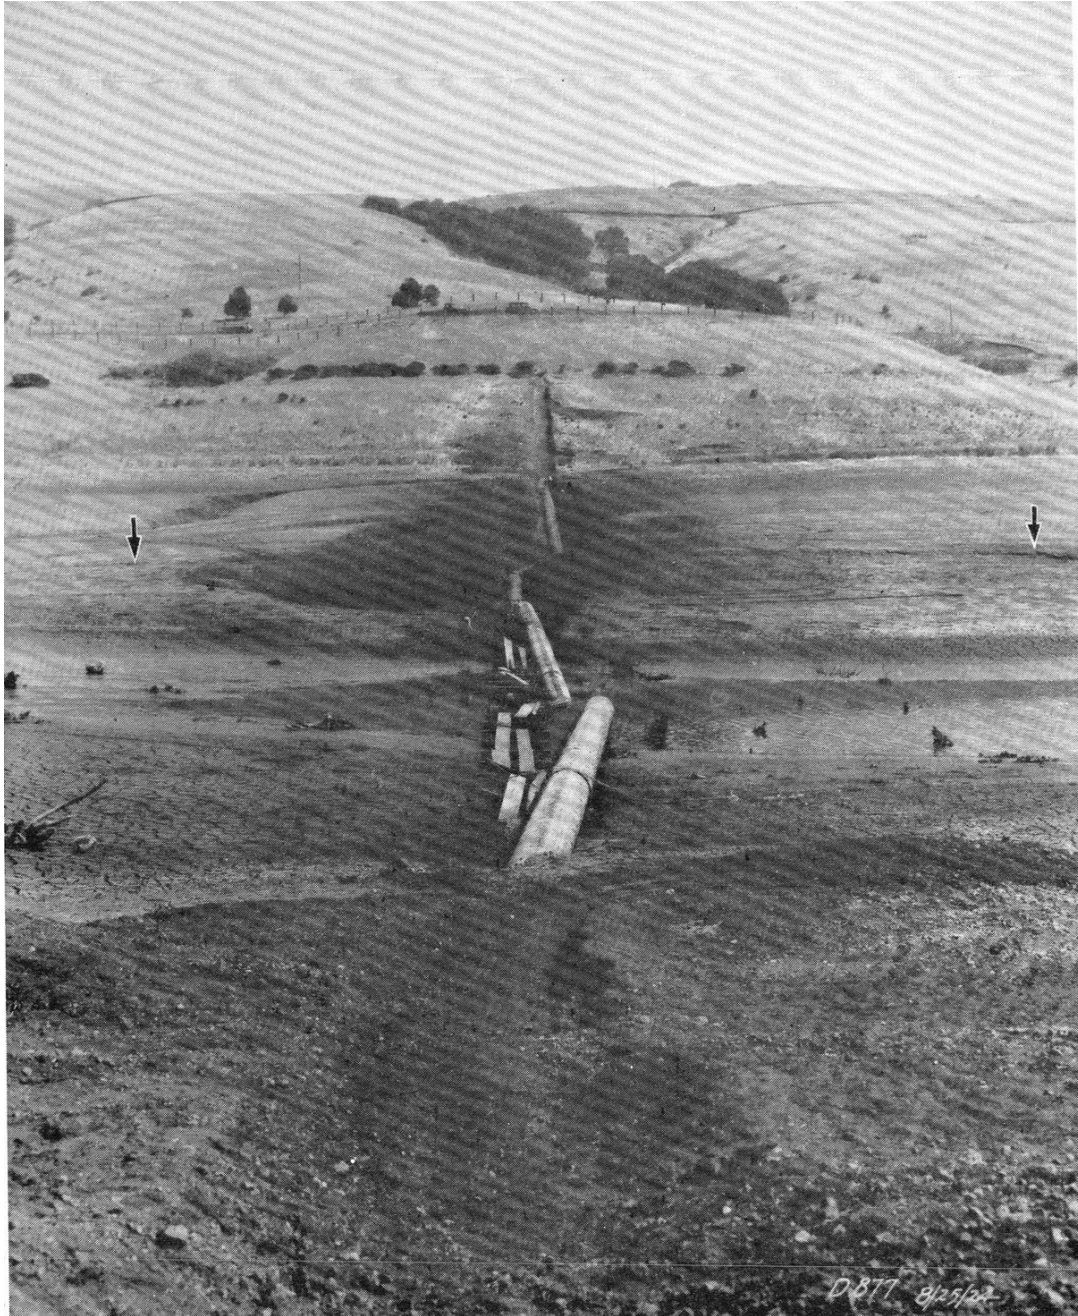
Figure 4.1.18-3. 37.5" Abandoned Pipe, 8-25-1924, D-877 (Credit: SVWC 1924). Looking East

Figure 4.1.18-3 shows the 37.5" pipe being removed. This photo is taken looking easterly, and the lowered Crystal Springs reservoir is seen in the foreground. The mole track of the fault is denoted by the two arrows.

In the foreground of Figure 4.1.18-3, the pipe is seen fallen off a wood trestle, where it was originally built to go over San Andreas Creek. Whether that damage was due to fluid-structure loading in the 1906 earthquake, or reflects part of the disassembly process, is uncertain.

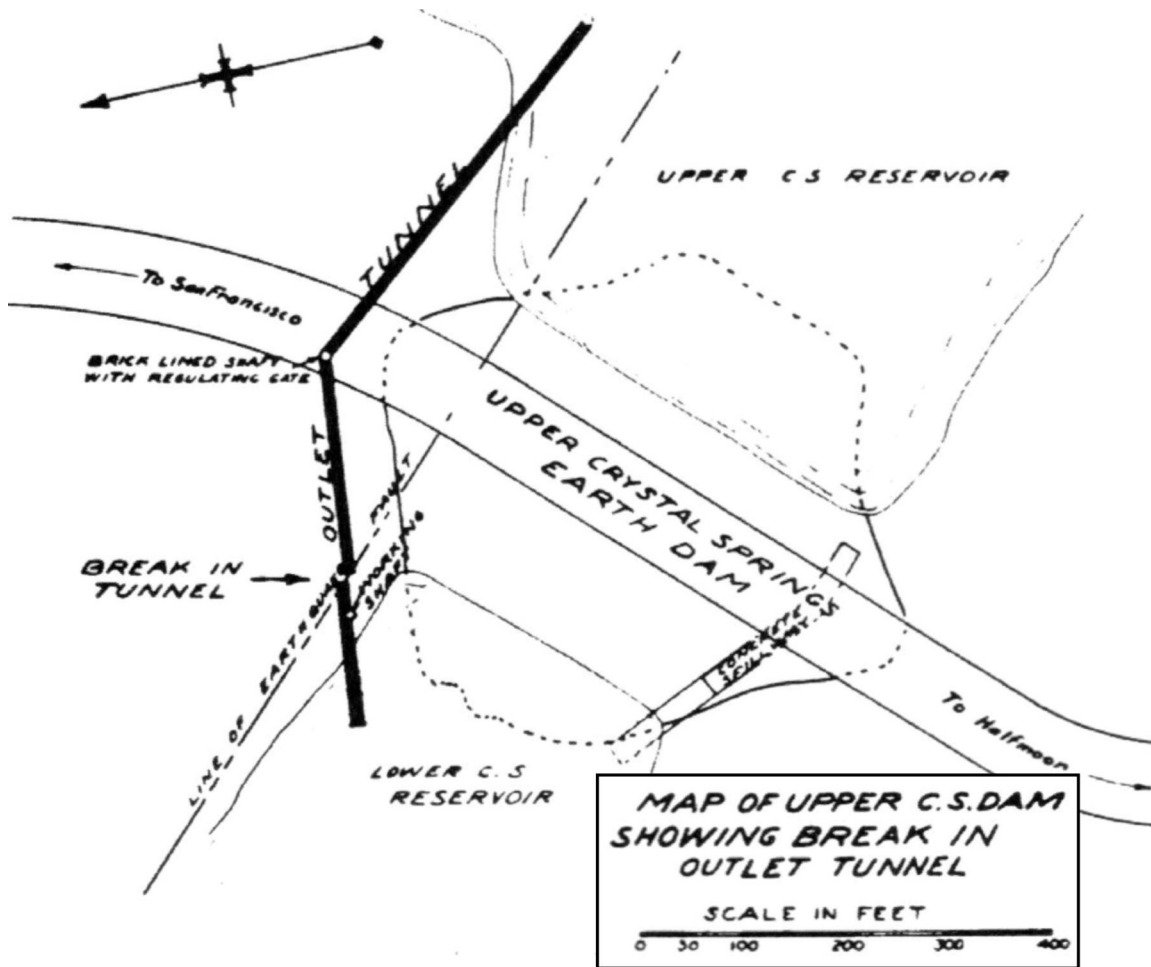
Figure 4.1.20-1. Outlet Tunnel Connecting Upper (southerly) and Lower (northerly) Crystal Spring Reservoirs (Credit: Schussler 1909)

Figure 4.1.20-1 shows the location of fault offset damage to the outlet tunnel between the Upper and Lower Crystal Springs reservoirs. (See Section 4.1.21 for more detail of the fault offset through the dam).

During the 1906 earthquake, the primary trace of the San Andras fault bisected the outlet tunnel. As the tunnel was no longer in regular usage, it was not until 1924 that it was repaired.

Pampeyan (1983) noted the offset was 5.5 feet in the outlet tunnel; given the azimuths, this translates to about 8.8 feet of right lateral offset of the fault at this location.

Pampeyan reports that the zone of major damage to the tunnel was about 20 feet long, and that the tunnel west of the fault break apparently dropped about 12 inches.

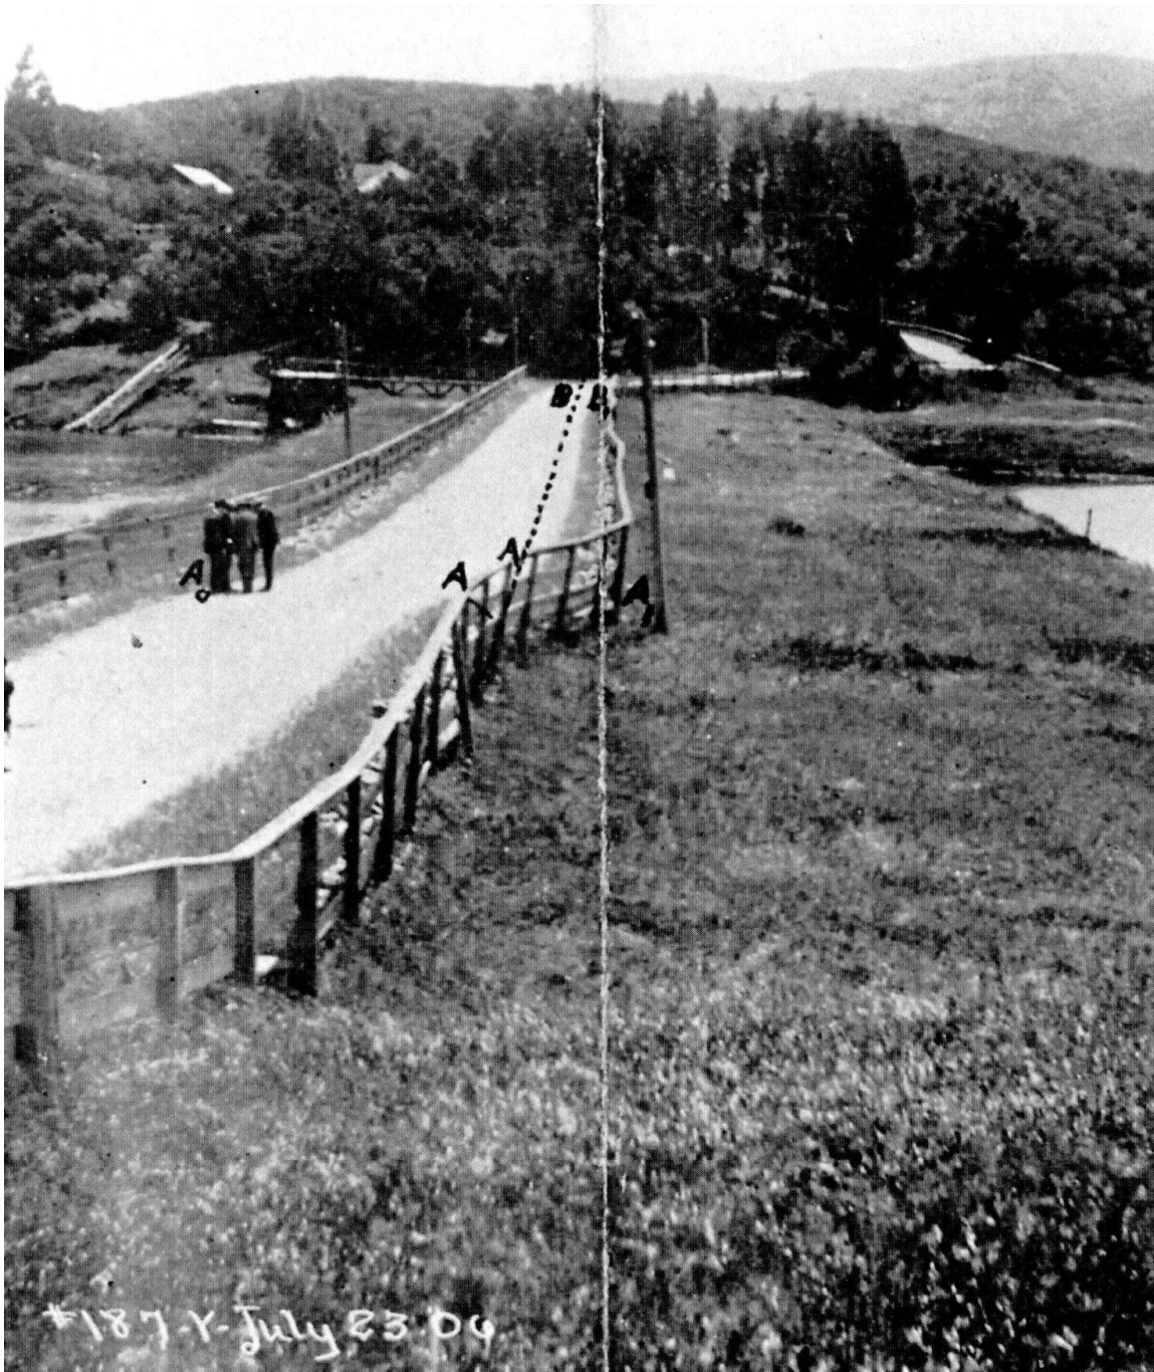
Figure 4.1.21-1. Upper Crystal Springs Dam, looking westerly (Credit: Schussler 1906)

Figure 4.1.21-1 shows a side view looking to the west of the Upper Crystal Springs Dam. The photo was taken on July 23, 1906. Figure 4.1.21.-2 shows a plan view sketch of the San Andreas fault going through the dam. The San Andreas fault rupture traverses the dam at azimuth N35°W, while alignment of the dam is about N22°E. Schussler states (1906) that there was about 8 to 9 feet of right lateral movement through the dam. Figure 4.1.21-1 shows the bulk of that offset concentrated at locations A₀ to A. The offset in the

road and fence is clearly seen. The westerly 90% of the dam has no observable offset. The line A-B indicates the pre-earthquake location of the northerly fence. The line A₁ – B₁ shows the post-earthquake location of the fence. The telephone wires that crossed the dam on wood poles are sagged considerably, that shortening due to the faulting that moved the poles closer together.

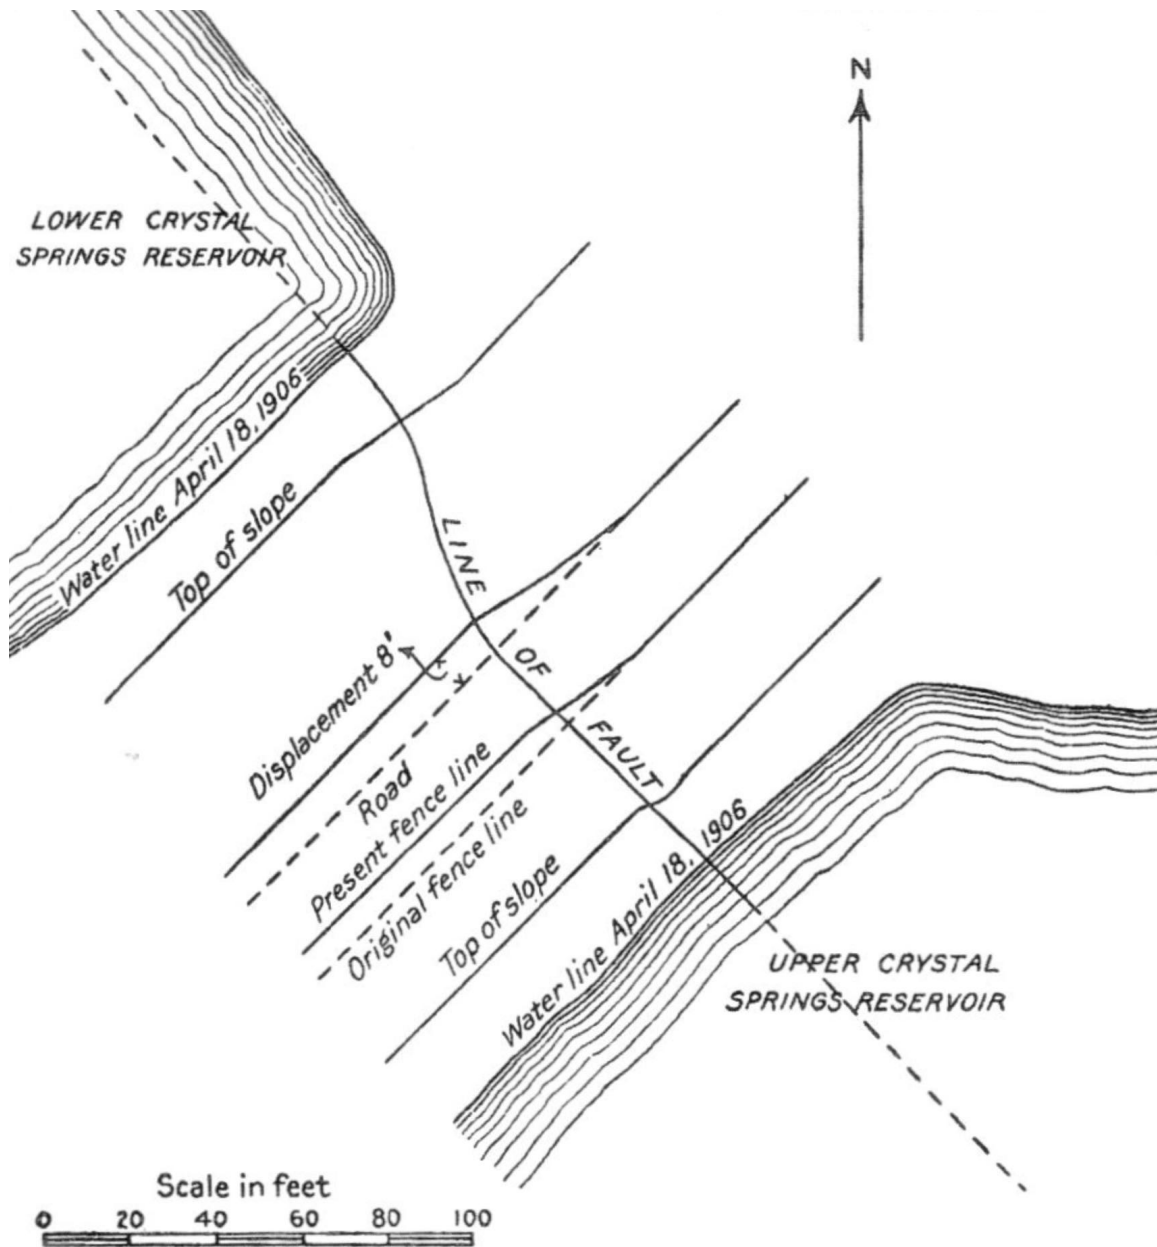
Figure 4.1.21-2. Upper Crystal Springs Dam, looking westerly (Credit: Lawson 1908 Fig. 40)

Trending more easterly than the fault, the dam experienced compression during the slip event, causing the fence boards to bend and shorten and the telephone wires to sag. However locally, the right step or bend in the fault is a local releasing environment that probably contributed to the complexity of cracking in the eastern abutment area.

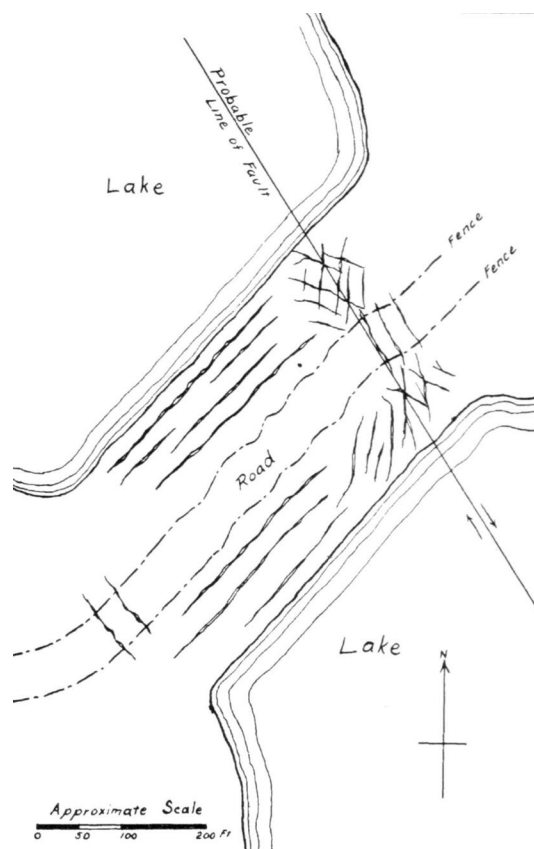
Figure 4.1.21-3. Upper Crystal Springs Dam, (Credit: Taber 1906)

Stephen Taber of Stanford University made his own measurements of the dam and published his findings in 1906, Figure 4.1.21-3. In this figure, Taber documents both the fault rupture location as well as the pattern of cracks that developed in the road surface and embankments. Cracks parallel to the long axis of the dam up to 6-inches wide developed in the embankments on both sides of the road; these cracks could be attributed to lurching and/or settlements of the embankment; but a pre- and post-earthquake survey of the elevation of the dam crest is not available, so the settlement of the dam is speculative. Taber also shows two sets of transverse cracks at both abutments. As the Lower reservoir (north of the dam) had the same water level at the Upper reservoir (south of the dam), the damage to the dam did not present any immediate life safety issue. Taber also reported that the road, where it crossed the fault at the northeast abutment area, was offset by about 6 feet of right slip. This translates to about 7 feet (after correcting for azimuth); this contrasts with Schussler's report of 8 to 9 feet; the discrepancy of Schussler's and Taber's offset amounts may reflect that Schussler measured the offset based on offset of the fences. Taber also reports: *"the fences on both side of the road were broken in a number of places, and the unbroken boards were bent and arched so as to give a serpentine appearance to the fences. The wires of a telephone pole line crossing the dam sag in great loops"*. This is not at all surprising; given that the mapping (Pampeyan 1983) suggests about a 77° orientation of the fault strike versus the road alignment, which would impart some compression into the road assuming a perfect right lateral offset pattern. From a pipeline designer's point of view, should a new water (or other type) of pipe be installed across this dam (now called Highway 92), it should be evaluated for a primary offset of 7 feet over a width of perhaps a few feet (but knife edge offset is preferred for design), plus another 1 or 2 feet of distributed right lateral offset over a width of perhaps 25 feet either side of the primary offset, plus a shortening along the alignment of the pipe of 1 foot.

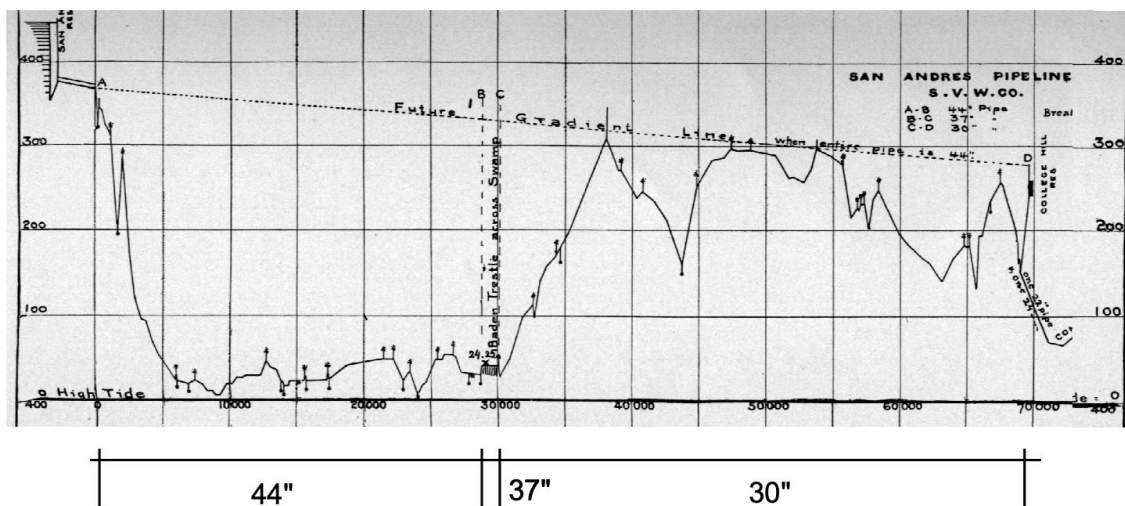
Figure 4.2-1. San Andreas Conduit Profile and Pipe Diameters (SCWV drawing)

Figure 4.2-1 shows the profile of the San Andreas pipeline at the time of the 1906 earthquake. The numbers "24, 25" at the left side of the "Baden Trestle" over Colma Creek was the location of the broken pipe. This is near the south end of the Holy Cross Cemetery.

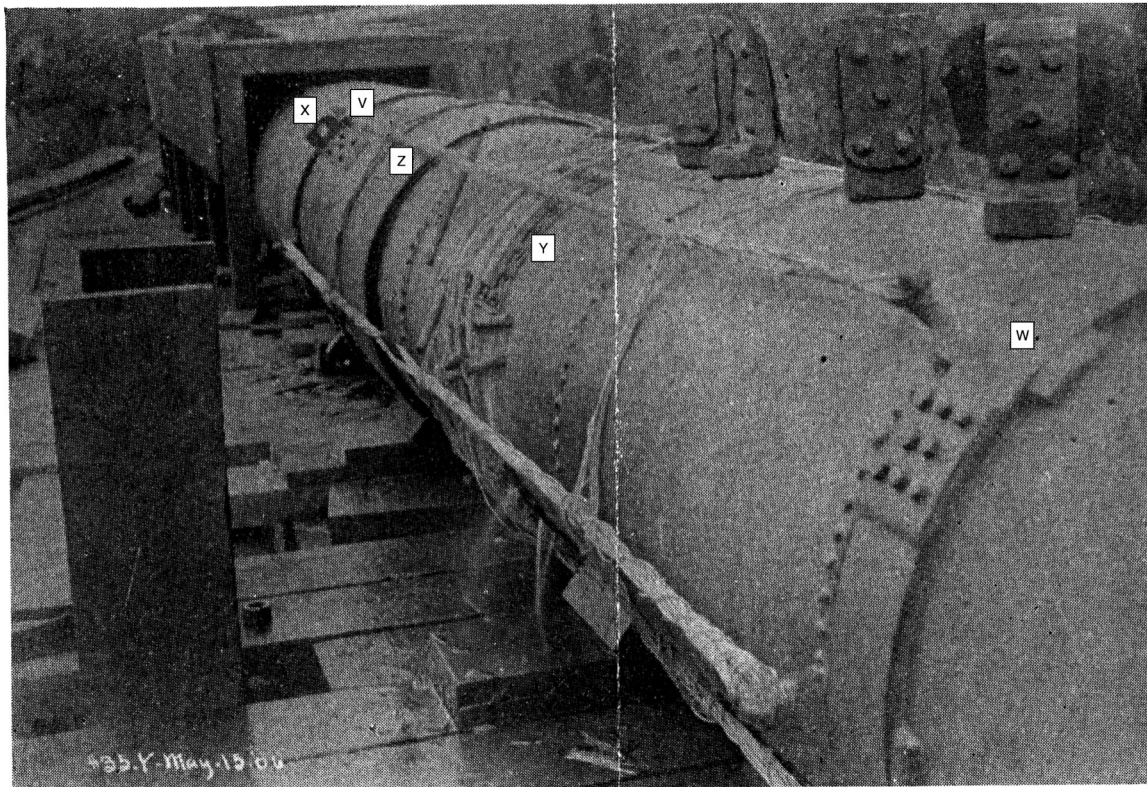
Figure 4.2-4. San Andreas Pipe Repair at Colma Creek Crossing (Credit Schussler 1906 HS24)

At the Baden crossing, the damage consisted of 4 iron lugs that had been torn off by the earthquake, for example see the lug at point "X" in Figure 4.2-4. When the lugs were torn off, they left behind 4 ragged holes in the pipe, each about 8"x 10". The holes were closed by installing patch plates at "Y"; the plates were from an old pipe, put on with tap bolts and rubber gaskets. The assembly was then strapped with wires; thereafter the slip joint at "Z" was straddled by 6 wire ropes between bands "V" to "W".

From Schussler's description of the damage and repair at Baden, it can be interpreted that the 37" pipe originally had a slip joint at "Z" that was reinforced longitudinally by tie

rods that were attached to the pipe "ears". During the earthquake, the pipe either moved to open at the slip joint (due to long reach of continuous pipe with a single slip joint due to travelling wave phenomena), or bent sideways due to inertial loading of the pipe on the trestle. The travelling wave phenomena is the preferred explanation as to why the joint tried to open during the shaking. As the joint opened, the tie rods underwent tension to try to limit the opening; clearly, the "ears" were put into high tension, and the rivets that held the ears and underlying plate to the main pipe were grossly overloaded and sheared off at the 4 locations.

Figure 4.2-4 shows the repair of the 37" San Andreas pipeline atop a wood trestle at Colma Creek, near Baden. At this location, the pipe had a slip joint of the type seen on the Crystal Springs pipeline in the foreground in Figure 4.3-1. The slip joint was formed by inserting two ends of pipe into a larger-diameter steel ring, filled with lead. In this manner, the pipe could contract or expand perhaps a couple of inches or so. These slip joints were used by Schussler adjacent to valves (for purpose of assisting replacement / maintenance of the valve), or along long reaches of above ground pipe (for thermal expansion growth / contraction purposes). Exterior wire ropes were attached to the pipe either side of the slip joint to provide some axial restraint.

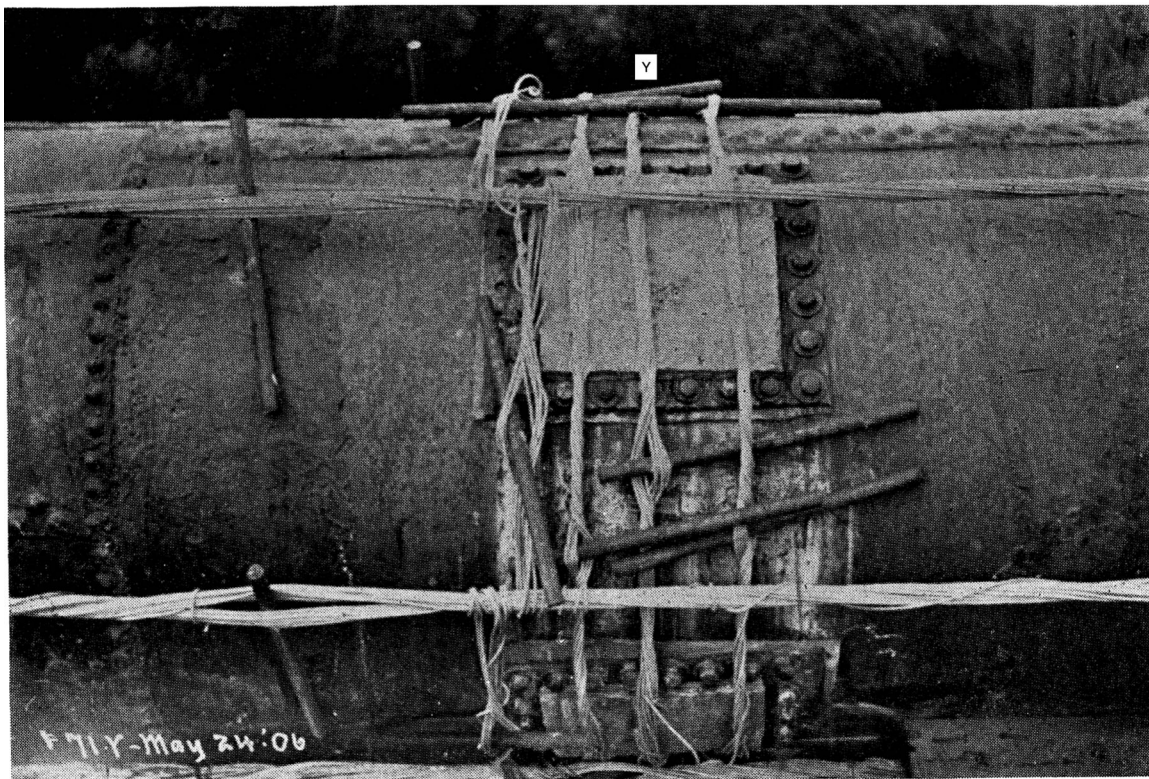
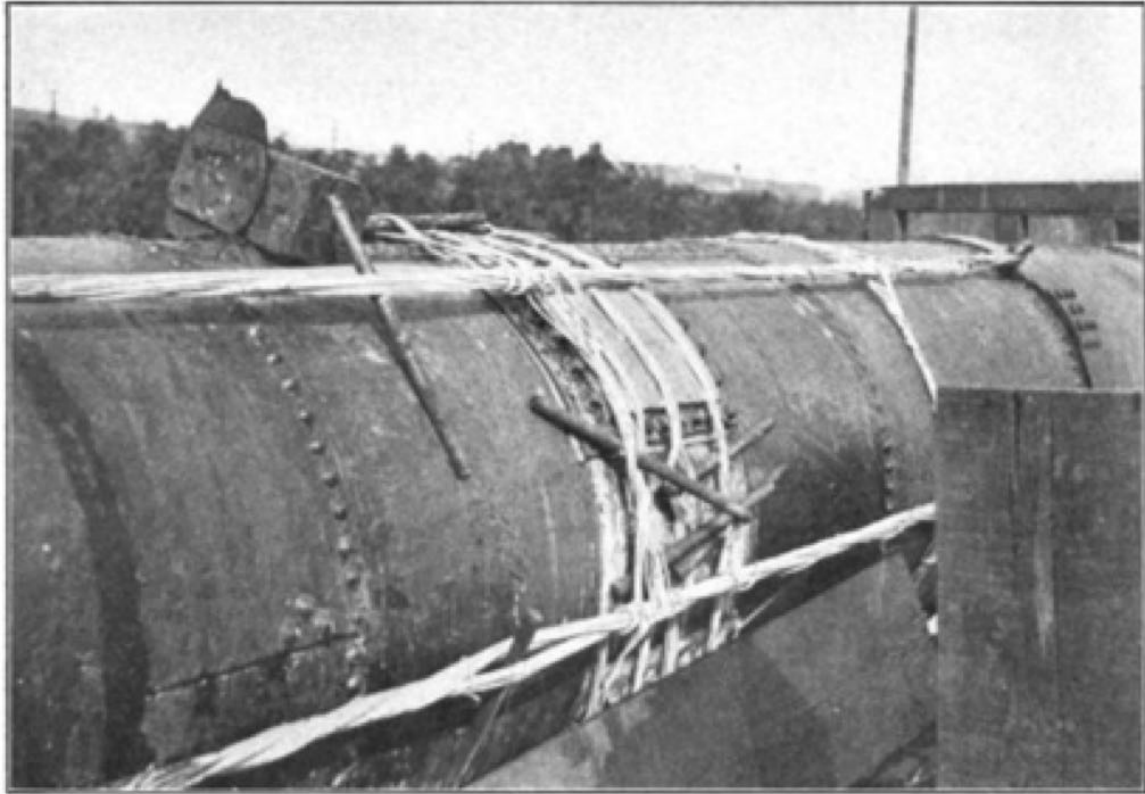
Figures 4.2-5 and 4.2-6 show the repaired 37" wrought iron San Andreas pipeline at point "Y".

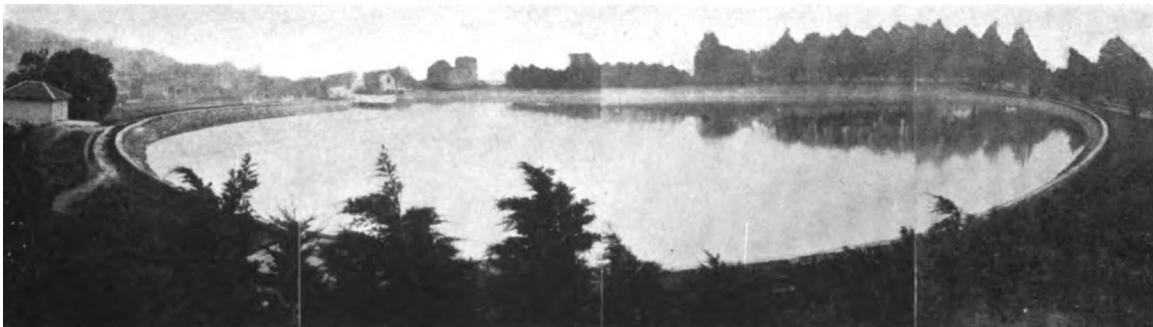
Figure 4.2-7. College Hill Reservoir, Terminus of San Andreas Pipeline (Credit: Schussler 1919)

Figure 4.2-7 shows College Hill Reservoir, the terminus of the San Andreas pipeline. In the 1906 earthquake, water sloshed out of the reservoir, but no major damage occurred.

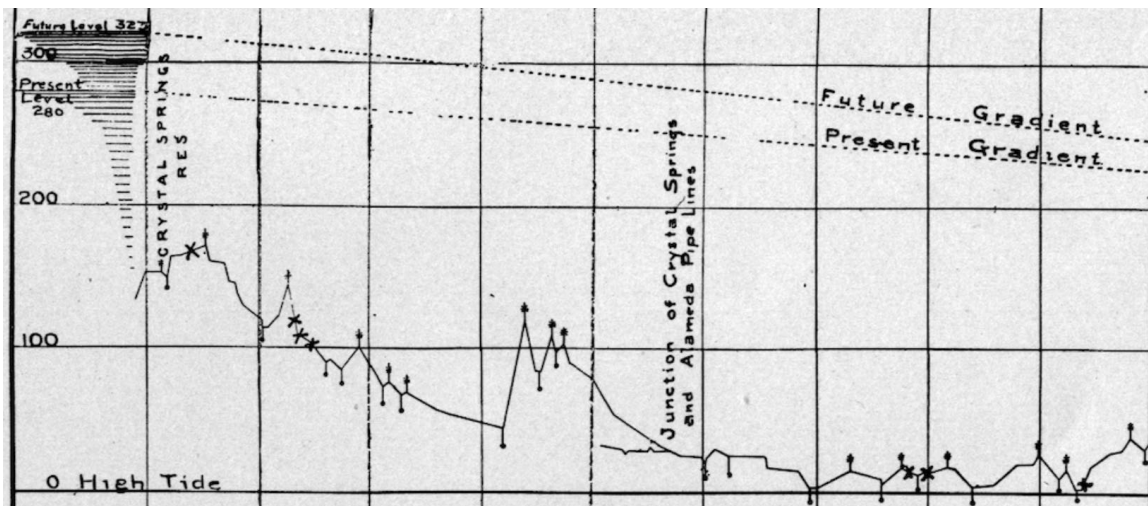
Figure 4.3-4. Location of Upper Crystal Springs 44" Pipeline Damage ("X"s) (Schussler 1906)

Figure 4.3-4 shows locations of 7 spots ("X"s) of damage on the 44" pipeline between the Crystal Springs Dam outlet and south of the Millbrae pump station.

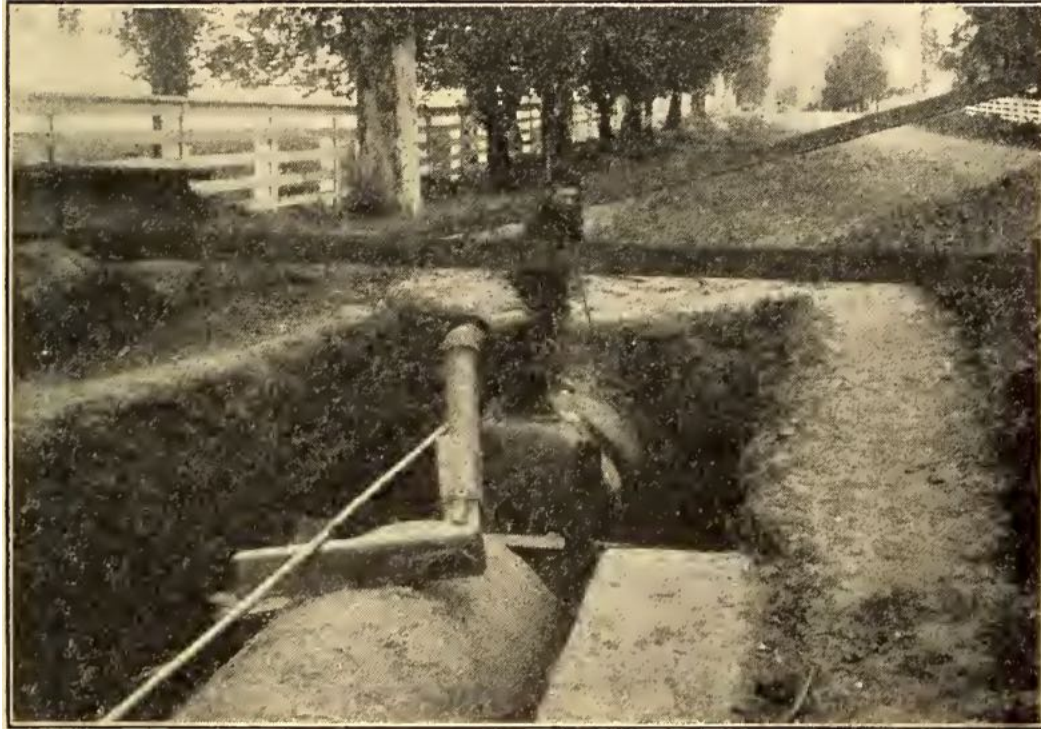
Figure 4.3-5. Crystal Springs Pipeline between San Mateo and Millbrae (Photo: Derleth, 1907)

Figure 4.3-5 shows an exposed segment between San Mateo and Millbrae, soon after the earthquake. Here, the buried pipe has been exposed and isolated to stop the flow northwards towards San Francisco, and thus maintain pressure and supply for the City of San Mateo.

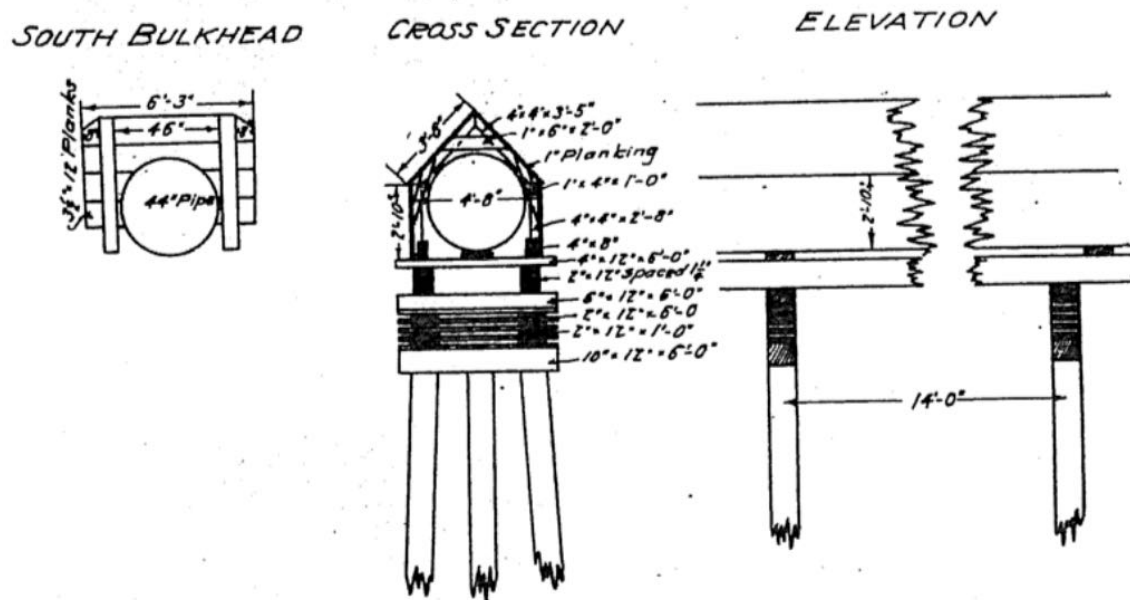
Figure 4.3-7. Crystal Springs Trestle 12 (3,039 feet long) (SVWC Drawing)

Trestle 12 is 3,038.9 feet long, see Figure 4.3-7. It consists of wood pile supports spaced at 14 feet.

- Buried section, parallel to and just north of San Mateo Creek, to the east of the Lower Crystal Springs Dam. Damaged at 7 locations.
- Trestle 12, across San Bruno Marsh (Colma Creek). Worst damage, over a length of about 1,600 feet (variously reported as 1,300 feet). Here, the pipe rested on a

wooden floor, supported by pile bents. The pile penetration was commonly 40 feet. After the earthquake, the pipe was replaced atop a re-built trestle, taking 28 days. The trestle had to be rebuilt, as many of the timbers had rotted. Few (if any) of the piles had to be rebuilt. Humphrey (in Lawson 1908) reported that the where the Crystal Springs 44" pipeline failed atop a trestle crossing Colma Creek, the pipe had telescoped 42 inches, shearing off a 8" gate valve. Along the long trestle through the San Bruno marsh, the 44" pipe was thrown off the trestle by 4 to 5 feet, either in a easterly or westerly direction.

The drawings below show some of the repairs along Trestle 12. The station numbers are to the closest ± 500 feet or so, following the station numbering in Table 4.3-1, based on Schussler (1906).

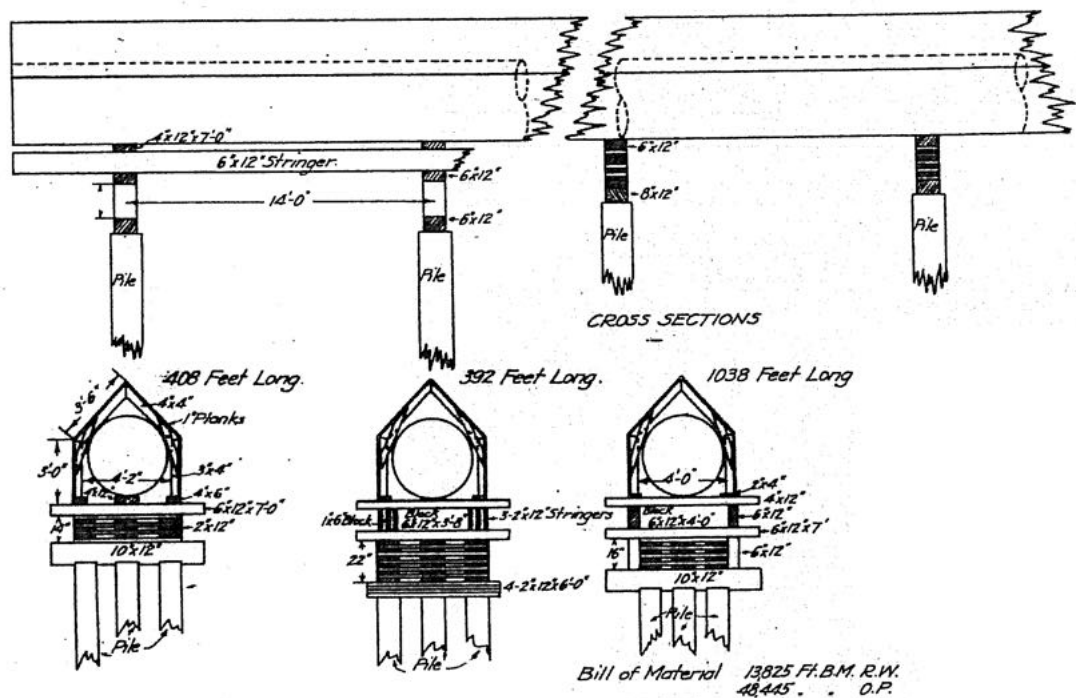
Figures 4.3-8 and 4.3-9 show the details of the wood trestle that supported the pipe through Guadalupe and Visitacion Valleys, respectively. The pipe failed at multiple locations atop both these trestles. The trestle details are very similar to those at Trestle 12, where the pipe also failed at multiple locations. There are 140 support bents (Guadalupe), or 54 support bents (Visitacion Valley) at 14-foot spacing. The available historical evidence suggests that the pipe had restrained slip joints at about 500-foot spacing, or likely at about 4 locations along these two trestles. Under high lateral inertial loading, the pipes would impart high lateral loads on the longitudinal stringers, which would have a tendency to roll over.

The historical records suggests that the pile system was not damaged in the earthquake. Trestles 11, 12, 17, 18 all traverse mapped liquefaction zones. We interpret that liquefaction, per se, did not directly lead to the pipe failures at these locations.

Figure 4.3-8. Crystal Springs Trestle 17 (1,961 feet long) Guadalupe Valley (SVWC drawing)

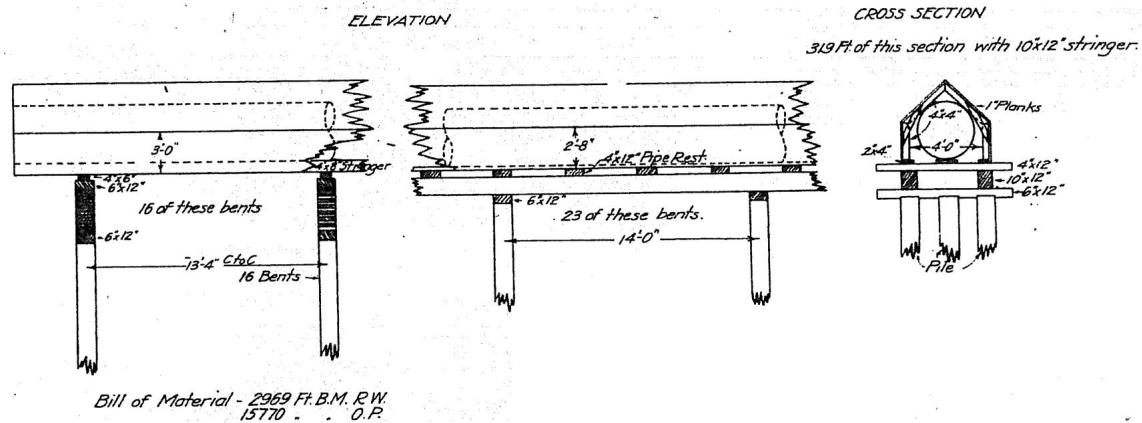
Figure 4.3-9. Crystal Springs Trestle 18 (766 feet long) Visitacion Valley (SVWC drawing)

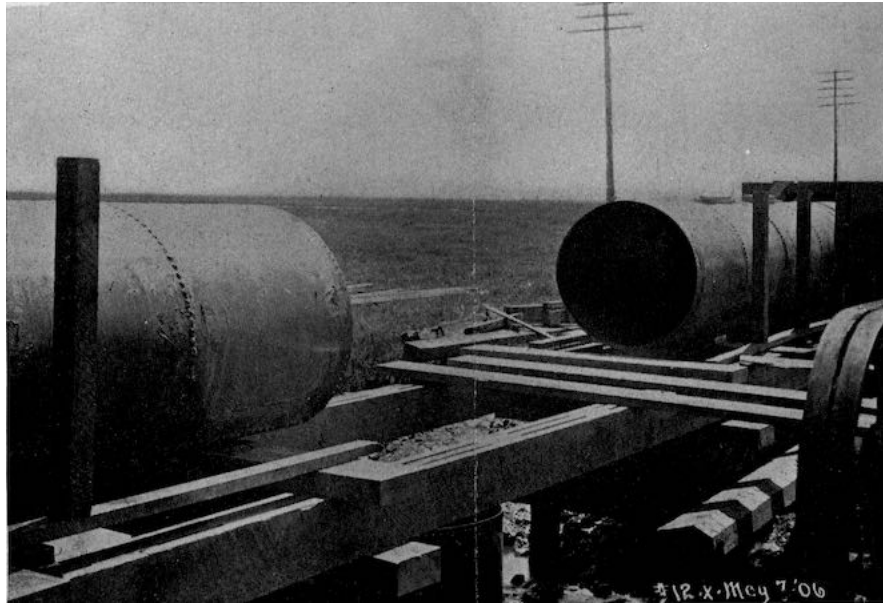
Figure 4.3-11 shows the 44" Crystal Springs pipe atop the trestle at San Bruno Marsh. The blocking and stringers are made of 2-inch thick wood planks. The riveted girth joint indicates 80 rivets for about the circumference. The handrail in the foreground is for a steel bridge. This photo was taken May 7, 1906, 20 days after the earthquake: the repair of the pipe is then about two-thirds complete.

Figure 4.3-11. Crystal Springs 44" at San Bruno Marsh, showing repair process. Photo viewing southeasterly. (Photo: Schussler HS21)

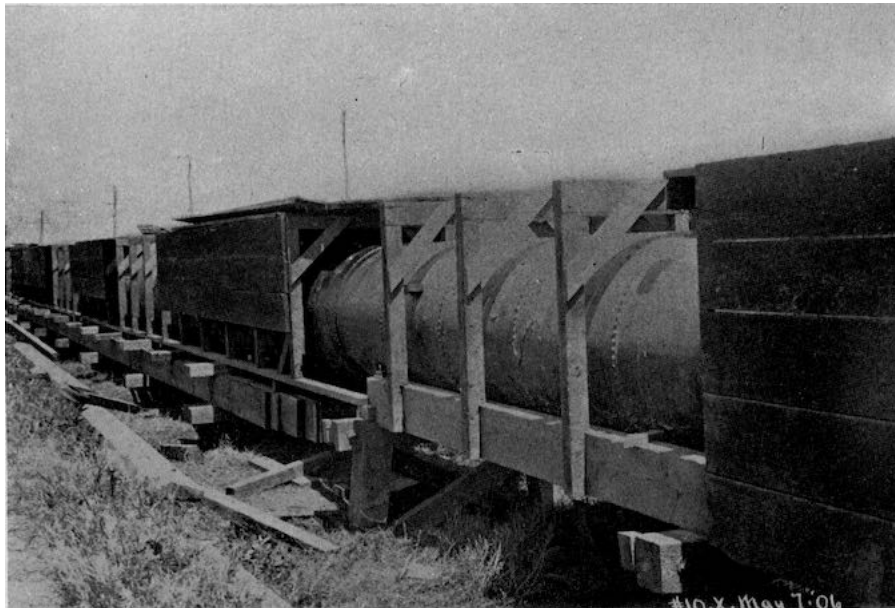
Figure 4.3-12 shows the 44" Crystal Springs pipe atop a trestle at San Bruno Marsh. The pipe enters from the right from "firm" marsh on original bents and stringers, to "soft" marsh on left. The photo is dated May 7, 1906, showing the reconstructed blocking on pile caps and plank stringers.

The purpose of the wood box around the pipe (sides and top) was an attempt to limit the salty air environment from attacking the exterior of the pipe. The riveted girth joints are spaced at about 3.5 feet.

Figure 4.3-12. Crystal Springs 44" at San Bruno Marsh (Trestle 12) (Photo: Schussler 1906 HS22)

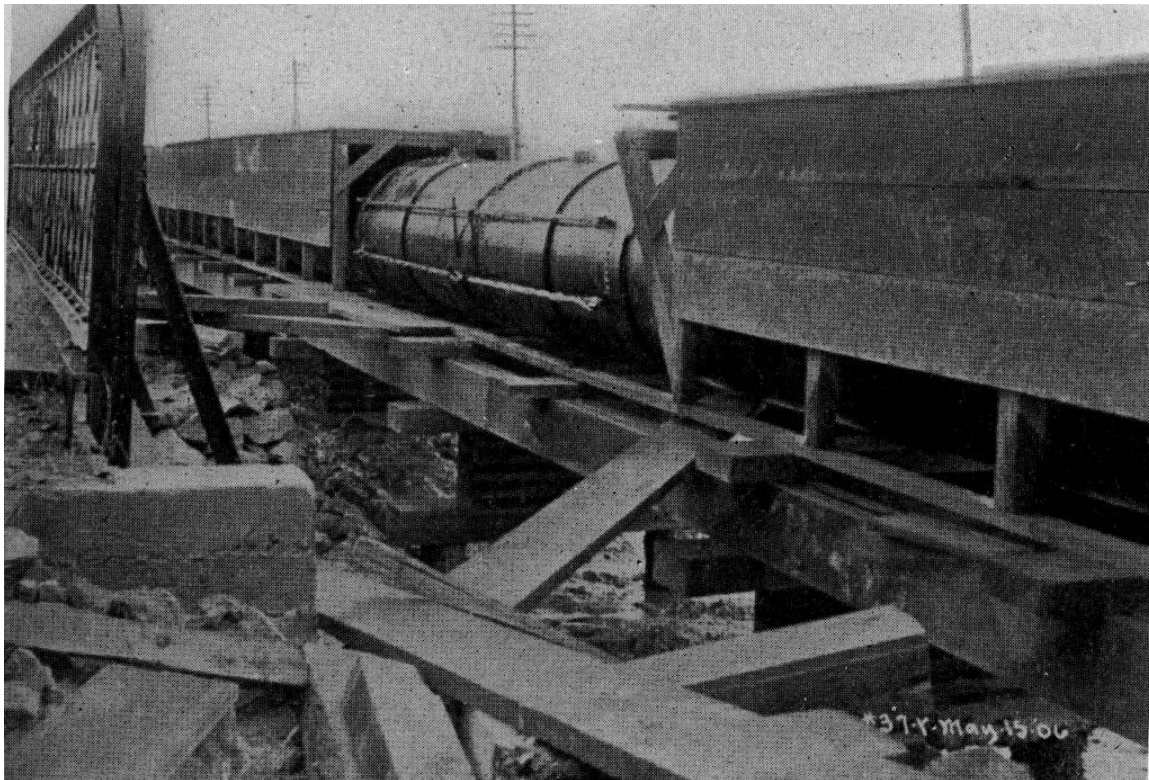
Figure 4.3-13 shows a flexible joint installed along the pipe, with the photo taken a few days later, at the same location as Figure 4.3-10. This joint is similar to that used for the 37" San Andreas pipe across Colma Creek. The ropes used to restrain the expansion joint are made of four 1"Ø galvanized wires. The slip joint is packed with lead.

Figure 4.3-13. Crystal Springs 44" at San Bruno Marsh, showing original pile foundation and caps. The plank stringers and blocking are made of 2x12 redwood, spiked cross and lengthwise and 6x12 pine caps. (Trestle 12) (Photo: Schussler 1906 HS23)

The need for slip joints for the above ground pipe is predicated that the pipe must be allowed to expand / contract a considerable amount over a 3,000 foot run, when the pipe is empty. For example, the change in the strain in the pipe for a temperature change from 40°F to 80°F over 3,000 feet is $0.0000065 * 40^{\circ}\text{F} = 0.000260$. Without any expansion joints, this would put the pipe into 7.5 ksi compression on a hot day. With expansion joints, the pipe can be kept unstressed, but the joints would need to be able to open / close about 9.4 inches over this 3,000-foot long stretch. Assuming Schussler allowed for each joint to take ± 1 inch of movement for a 40 degree temperature swing, there might be as many as 9 or 10 joints over the length of the trestle. The net result is that the pipe would have 9 or 10 slip joints along its 3,000 foot length.
