History of the Water Works of San Francisco: Its Performance in the 1906 Earthquake and Aftermath

John M. Eidinger and N. Timothy Hall

Revision 2

August 2024

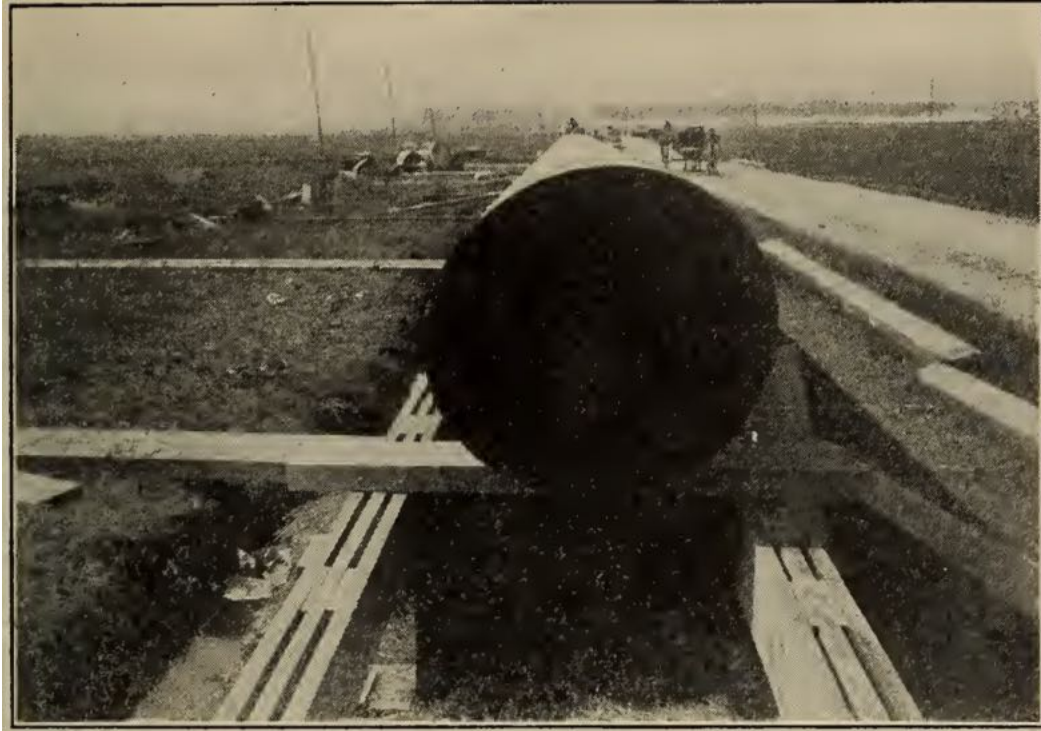
Figure 4.3-14 shows the damaged Crystal Springs pipeline during the restoration process (about May 2, 1906) where it has already been placed back atop the trestle in the San Bruno Marsh area. The open pipe is awaiting connection, likely with a slip joint. The wood “box housing” has not yet been installed.

Figure 4.3-14. Crystal Springs 44" at San Bruno Marsh, during the repair process (Photo: Derleth 1907)

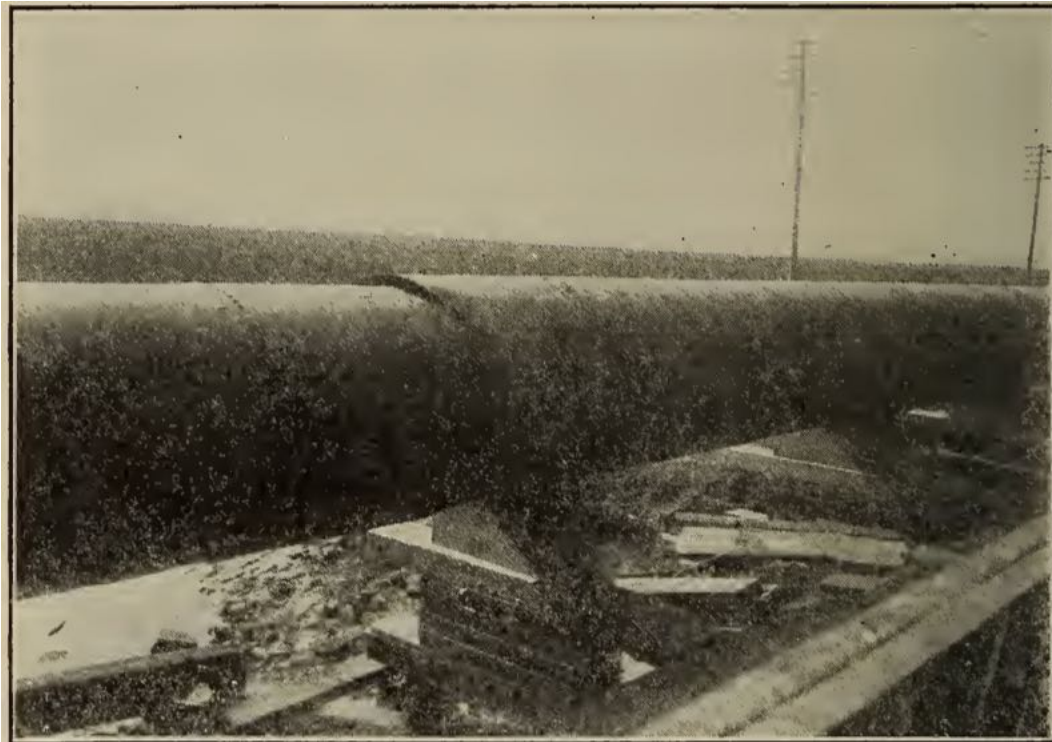
Figure 4.3-15 shows the Crystal Springs Pipeline repair process as of May 2, 1906. Here, the riveted pipe segments that had fallen off the damaged trestle, have been restored atop temporary stacked wood supports akin to the detail in Figure 4.3-7; and two segments of the pipe have been positioned awaiting connecting the girth joints by rivets. Redwood planks were sometimes used for the temporary sills and stringers in part because larger timber was not quickly available.

Figure 4.3-15. Crystal Springs 44" at San Bruno Marsh, during the repair process (Photo: May 2, 1907 Derleth)

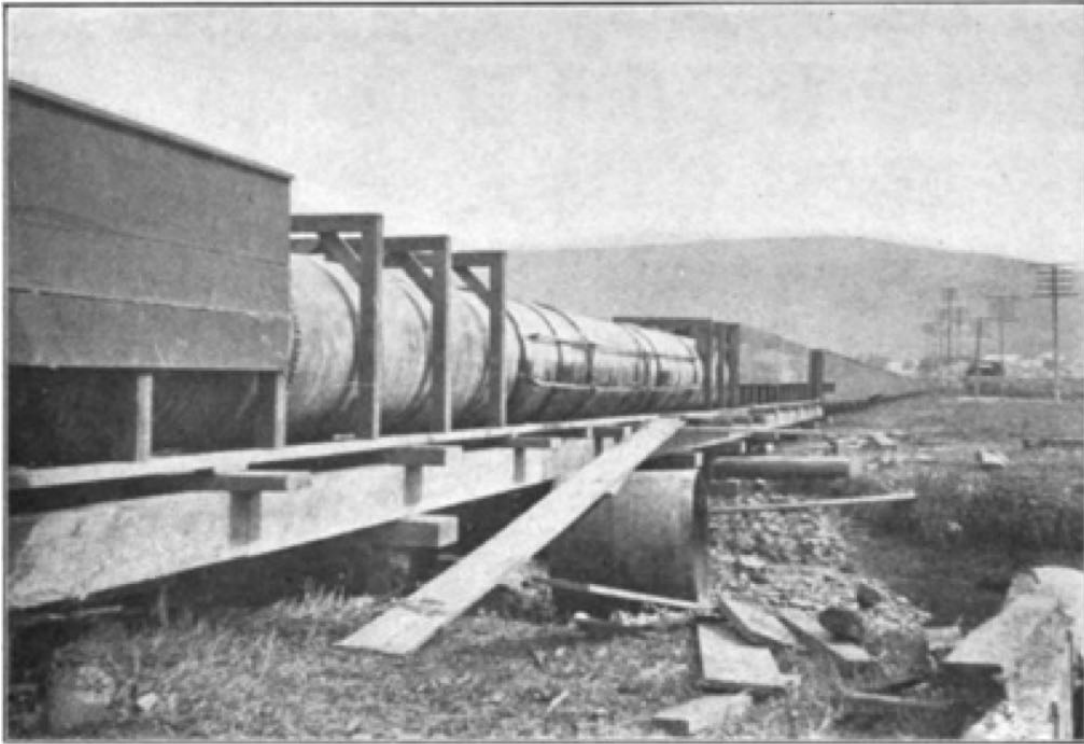
Figures 4.3-10 to 4.3-16 show the pipe in various stages of repair atop the Trestle 12 at San Bruno Marsh (now called Colma Creek liquefaction zone).

Figure 4.3-16. Crystal Springs 44" at San Bruno Marsh, during the repair process (Photo: ASCE 1907)

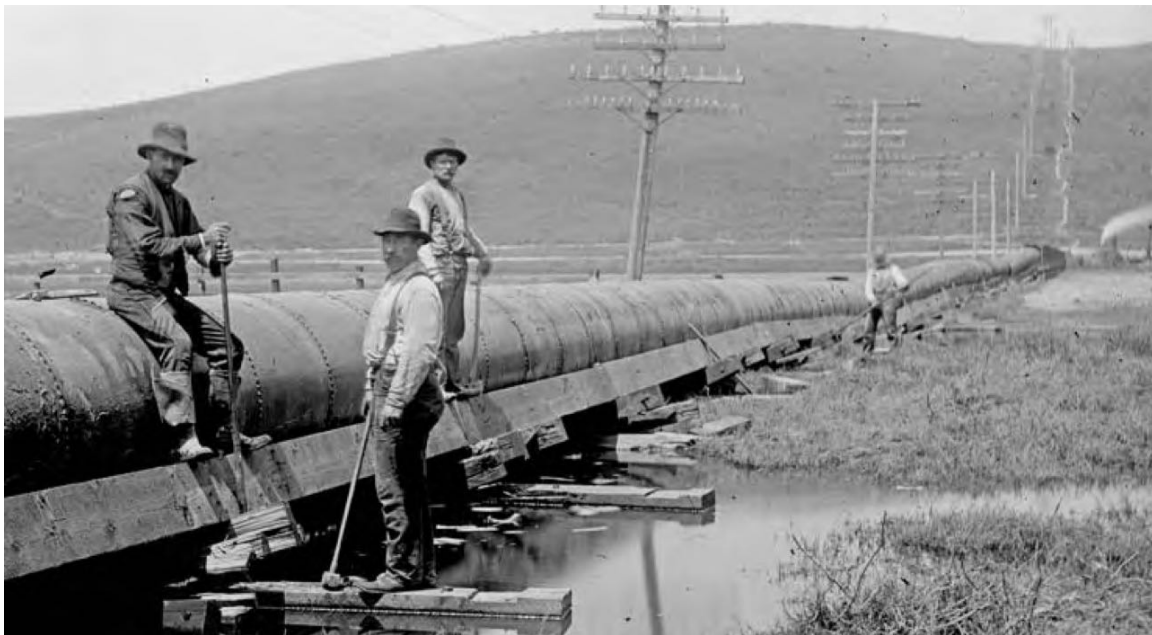
Figure 4.3-17 shows the 44" pipeline after the 1906 earthquake. The photo is taken looking north, with San Bruno Mountain in the background.

Figure 4.3-17. Crystal Springs Pipeline after the 1906 Earthquake, through San Bruno Marsh (Photo: SFPUC)

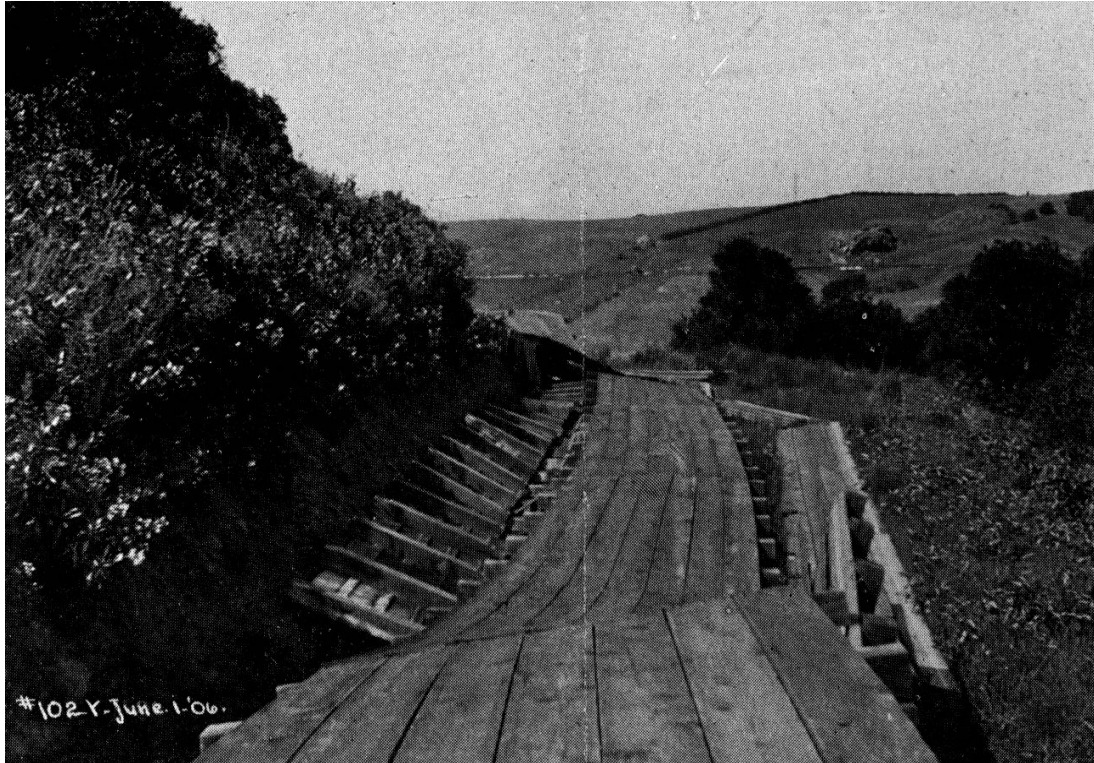
Figures 4.6-3, -4 show another wooden flume that collapsed due to inertial forces. Schussler notes that this flume (about 6' wide and 4' high) is on the opposite side of the San Andreas Valley from the fault rupture. In the distance the linear feature is believed to

be the Crystal Springs to San Andreas flume (Number 7 in Figure 4.6-1). Figure 4.6-4 is just a little to the north of Figure 4.6-3.

We interpret the correct location as being along the flume section denoted "6" in Figure 4.6-1. The manner of failure appears similar to that in Figure 4.1.12-12, with the flume collapsing sideways to the east, probably due to inertial forces. This appears to be an inertial failure; although it is possible it was initiated or aggravated by a landslide under this section.

Figure 4.6-3. Failure of Pilarcitos Waste Water (Side) Flume to San Andreas Reservoir, Looking Northerly (Photo: Schussler 1906 HS47)

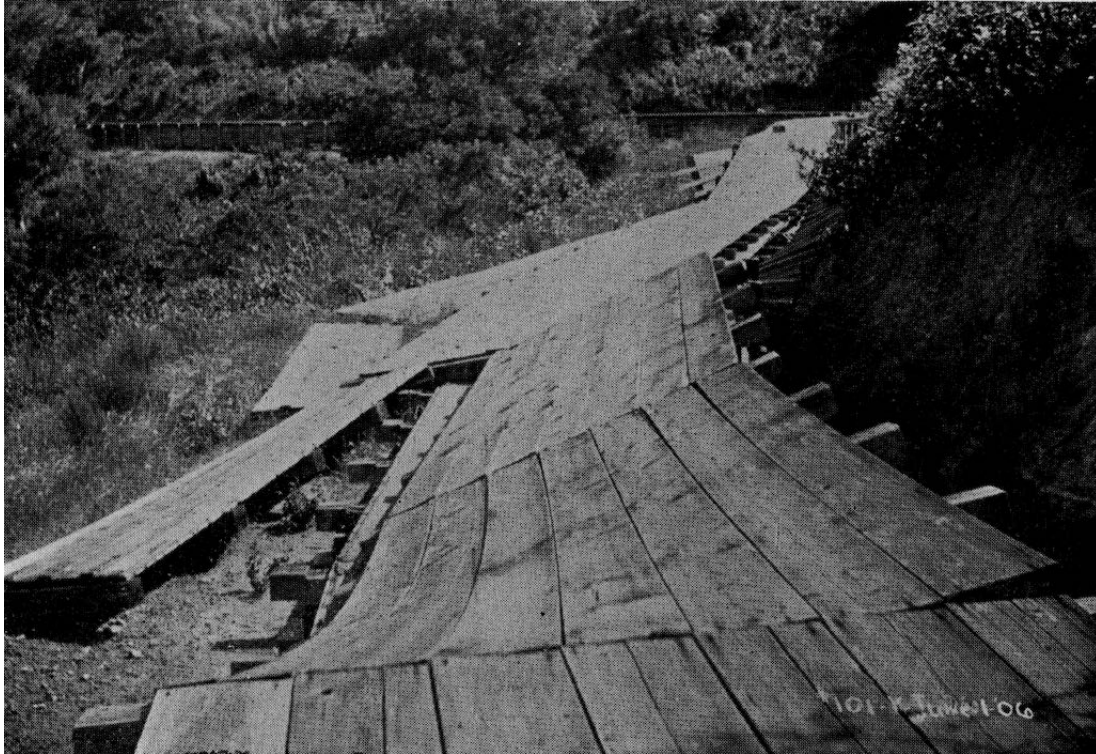
Figure 4.6-4. Failure of Pilarcitos Waste Water (Side) Flume to San Andreas Reservoir, Looking Southerly (Photo: Schussler 1906 HS48)

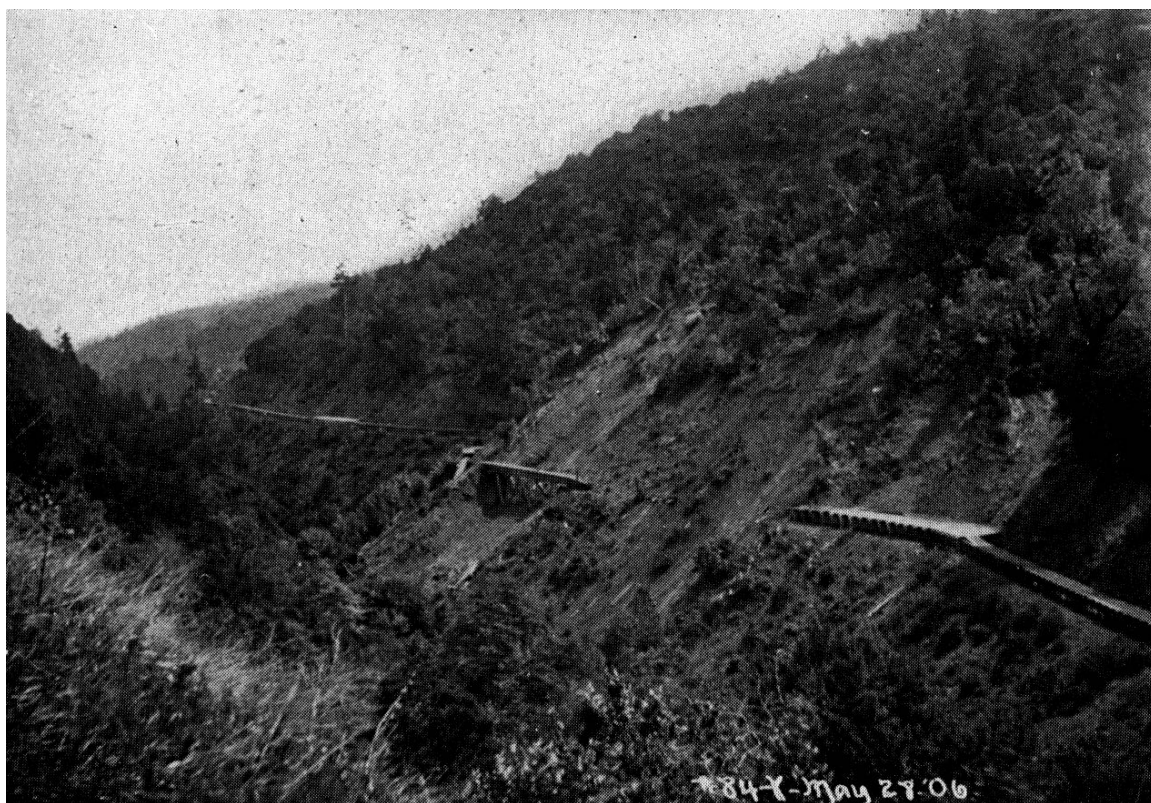
Figure 4.6-5 shows the collapse of a flume section that Schussler described as being in Upper San Mateo Creek canyon. Based on the V-shaped valley we believe this to have occurred along flume section Number 5 in Figure 4.6-1. This section of flume was destroyed by a landslide with head scarp above the flume.

Figure 4.6-5. Collapse of Pilarcitos Side Flume between (here 5' x 3') in Upper San Mateo Canyon. Photo dated May 27, 1906. (Photo: Schussler HS46).

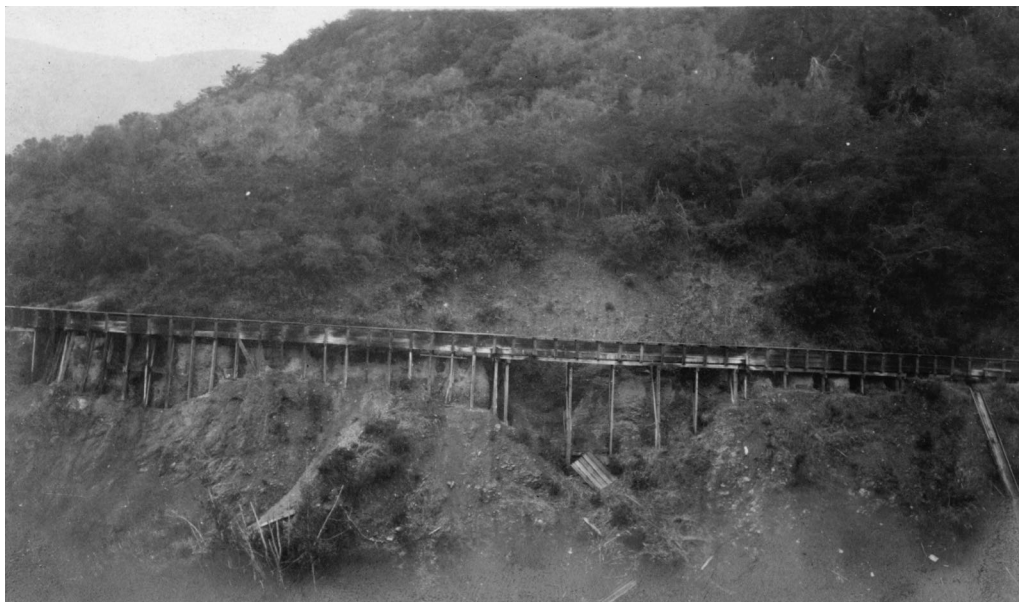
Figure 4.6-7. Repair of Flume. (Photo: SVWC).

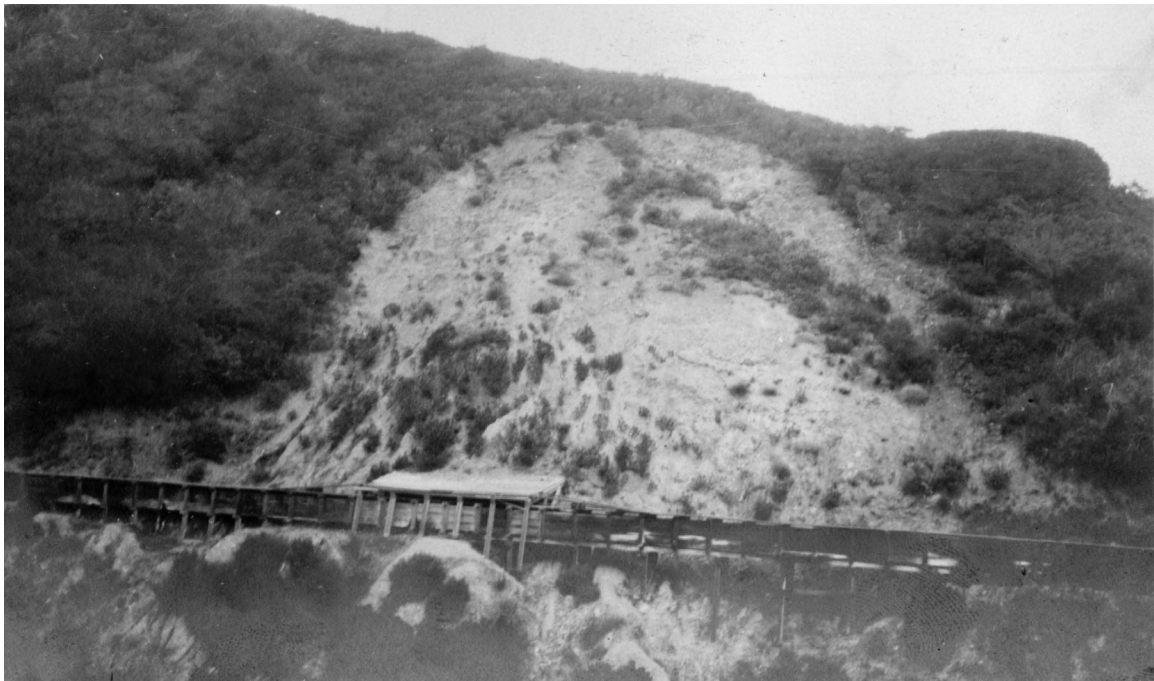
Figure 4.6-8 shows another section of flume. It is believed that this section of flume was above the Pilarcitos Creek Canyon, possibly No. 8 in Figure 4.6-1.

Figure 4.6-8. Portion of Flume. (Photo: SVWC). Note the wooden "slide shed" through a portion of the slide zone.

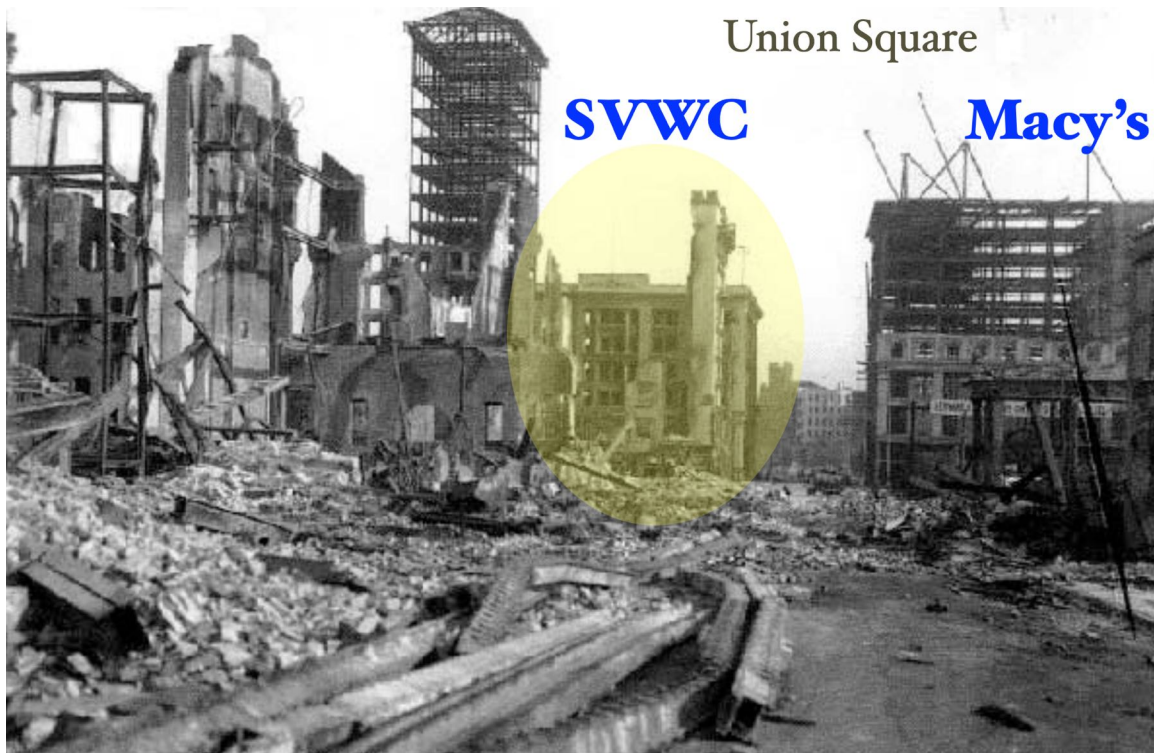
At the time of the 1906 earthquake, the Spring Valley Water Company's headquarters building near Union Square. It was a 6 story building. The offices were open on April 18, 1906, the day of the earthquake. But the spread of the fire on April 19 into the Union Square area effectively destroyed the building and much of its contents, see Figure 4.7-1. Essentially all records at this office building were lost to the fire. Fortunately, a backup set of many documents were held at the company's facilities in Millbrae.

Figure 4.7-1. SVWC Office Building, Looking South, After 1906 Fire

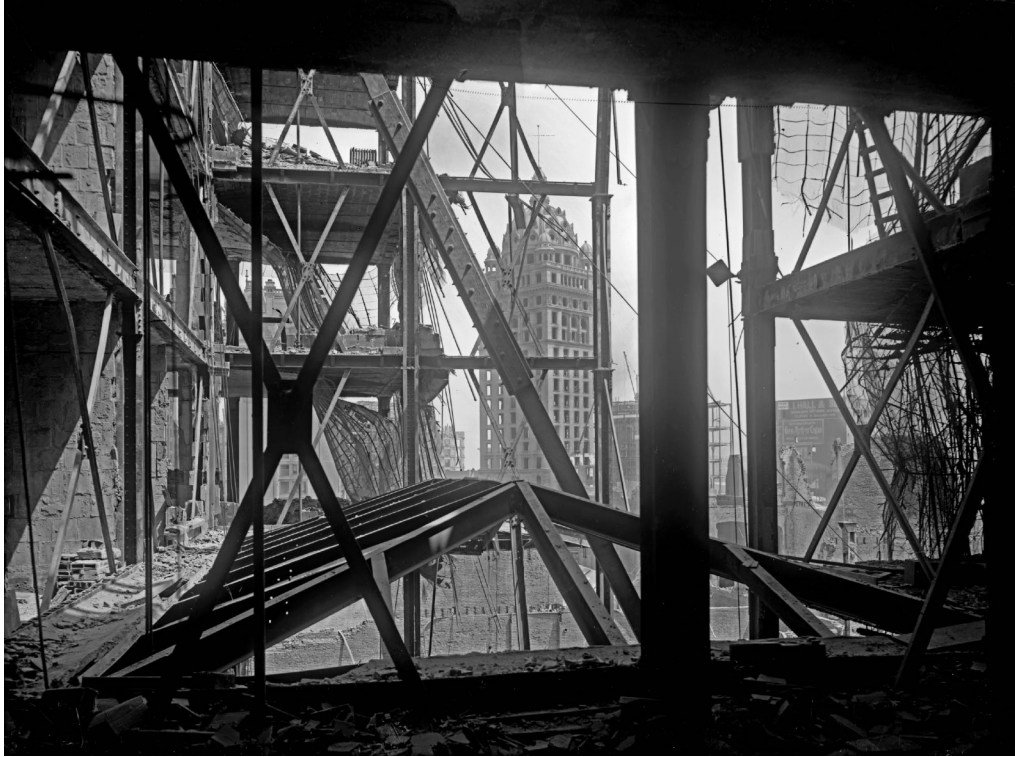
The building had a steel skeleton (Figure 4.7-2). Partitions, column protection and floor arches were made of hollow clay tile. Many floor arches failed. Many clay tile walls failed. The 2-inch thick tile on columns generally failed (see Figure 4.7-3). The columns in the southeast corner of the building buckled, and the upper floors collapsed.

Figure 4.7-2. Interior of SVWC Office Building after 1906 earthquake. Call building in the background. (photo: Courtesy Mike Housh, SF Historian)

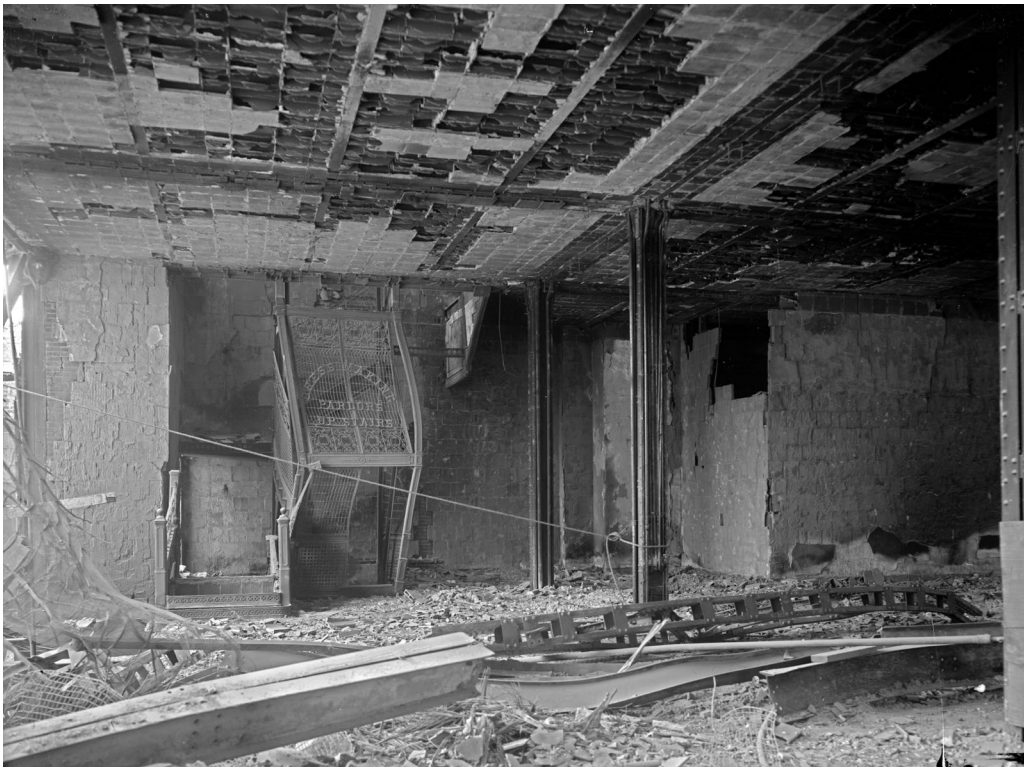
Figure 4.7-3. Interior of SVWC Office Building after 1906 earthquake (photo: Courtesy Mike Housh, SF Historian)

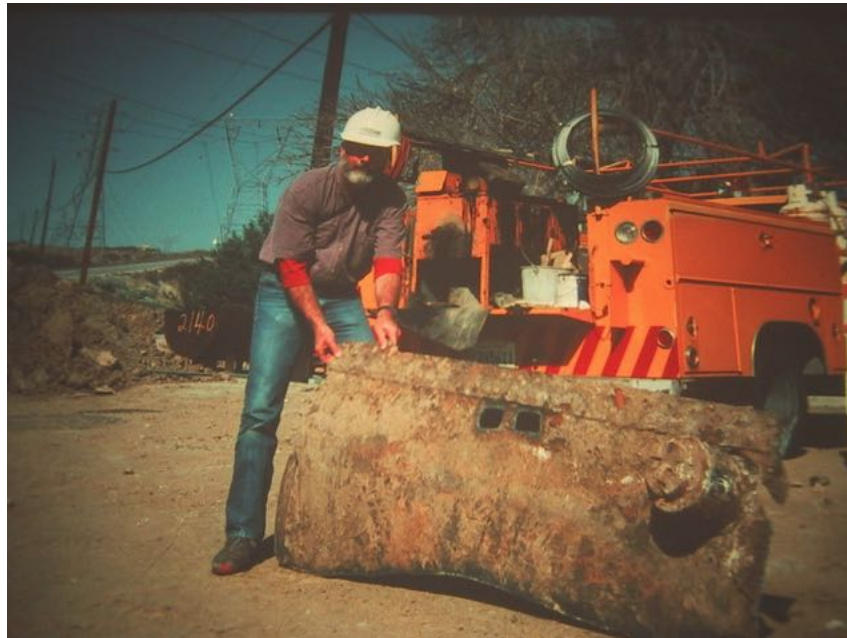
LADWP. The Los Angeles Aqueduct Number 1 (233 miles long) was built between 1908 and 1913; Number 2 was built in 1970 (177 miles long). Both Aqueducts were damaged in the 1994 Northridge earthquake (Eidinger and Avila, 1999a). The type of damage included failed riveted pipe, as well as failed canal segments, failed concrete pipe segments, failed single lap welded steel segments. Figures 6-1 and 6-2 shows the Author, Tim Hall, holding a damaged large diameter LADWP riveted steel pipe; this segment of pipe was in the San Fernando Valley, and was exposed to very strong shaking in the 1994 Northridge earthquake.

Figure 6-1. Tim Hall with Segment of Damaged LADWP Riveted Pipe, 1994

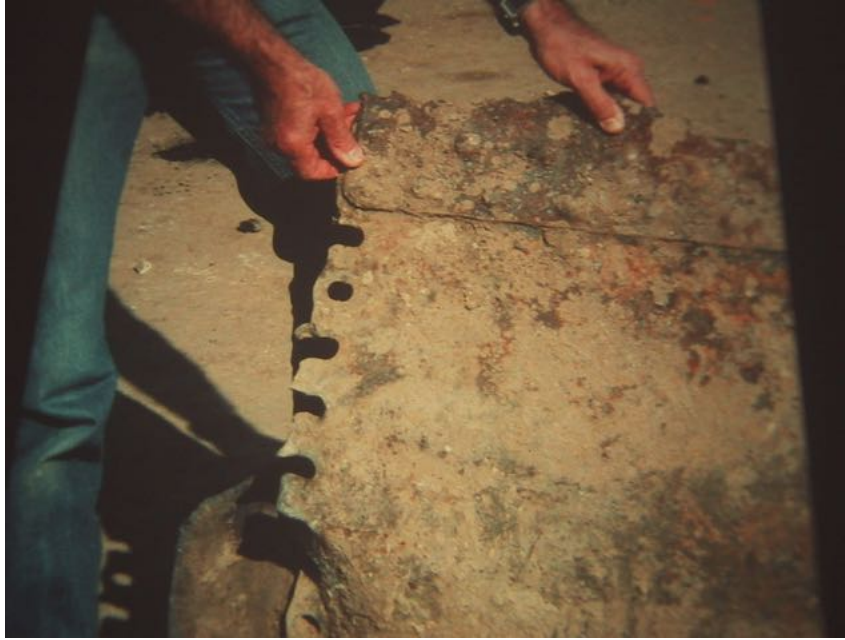
Figure 6-2. Close Up View of Damaged LADWP Riveted Pipe, 1994

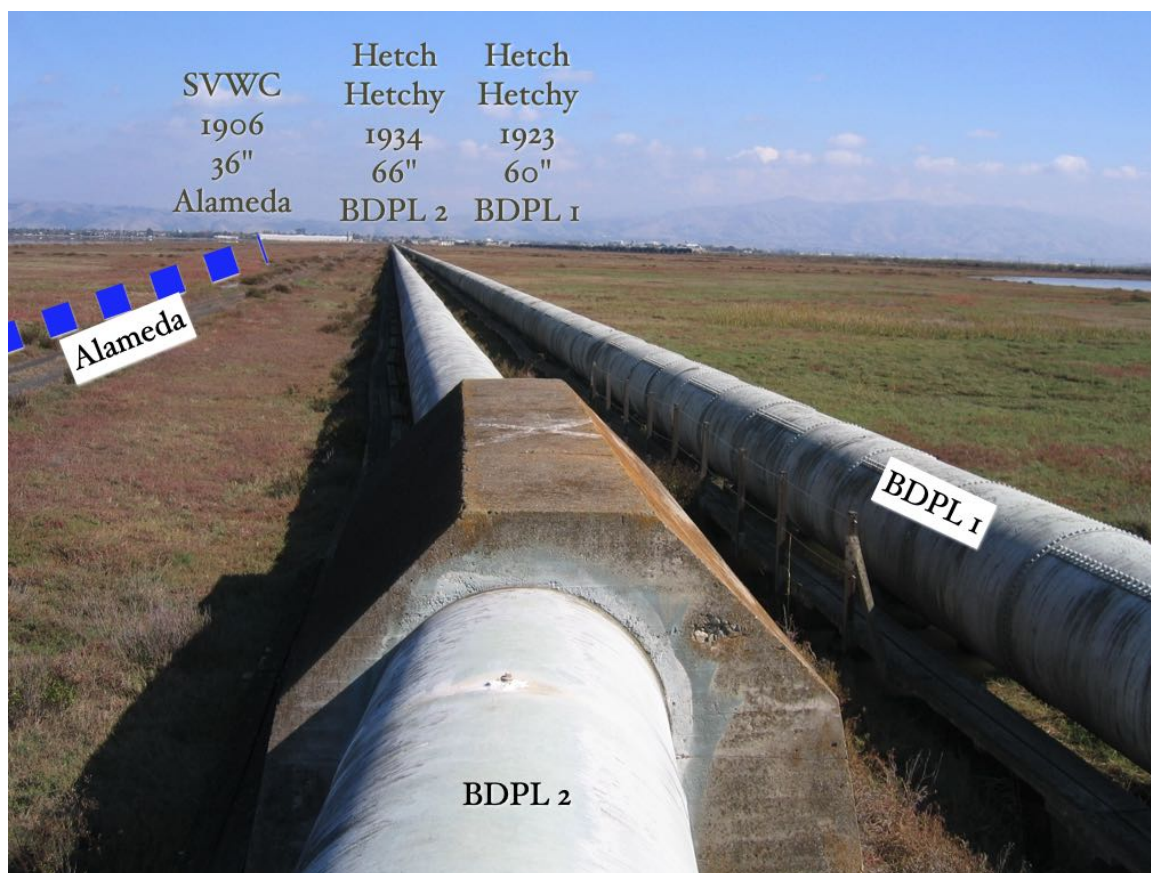
Figure 6-3 (2008) shows a photo of the Bay Division Pipelines 1 and 2 where they cross the San Francisco Bay near Dumbarton Strait. The first pipe, called BDPL 1, is a riveted steel pipe (single line of girth rivets). This same style of construction was used where BDPL 1 crossed the active Hayward fault. The SFPUC removed the riveted section of the BDPL 1 pipe and the single lap-welded BDPL 2 pipe at the Hayward fault crossing in 2003, replacing both of them with heavy-wall butt welded steel pipes. The SFPUC bypassed this section of the BDPL 1 and 2 pipelines with a new tunnel (called BDPL 5) in 2015. Chapter 9 of this report describes design of the Hetch Hetchy system in some detail.

Figure 6-3. SFPUC's Hetch Hetchy Aqueduct BDPL 1 and 2 Pipelines (2008)

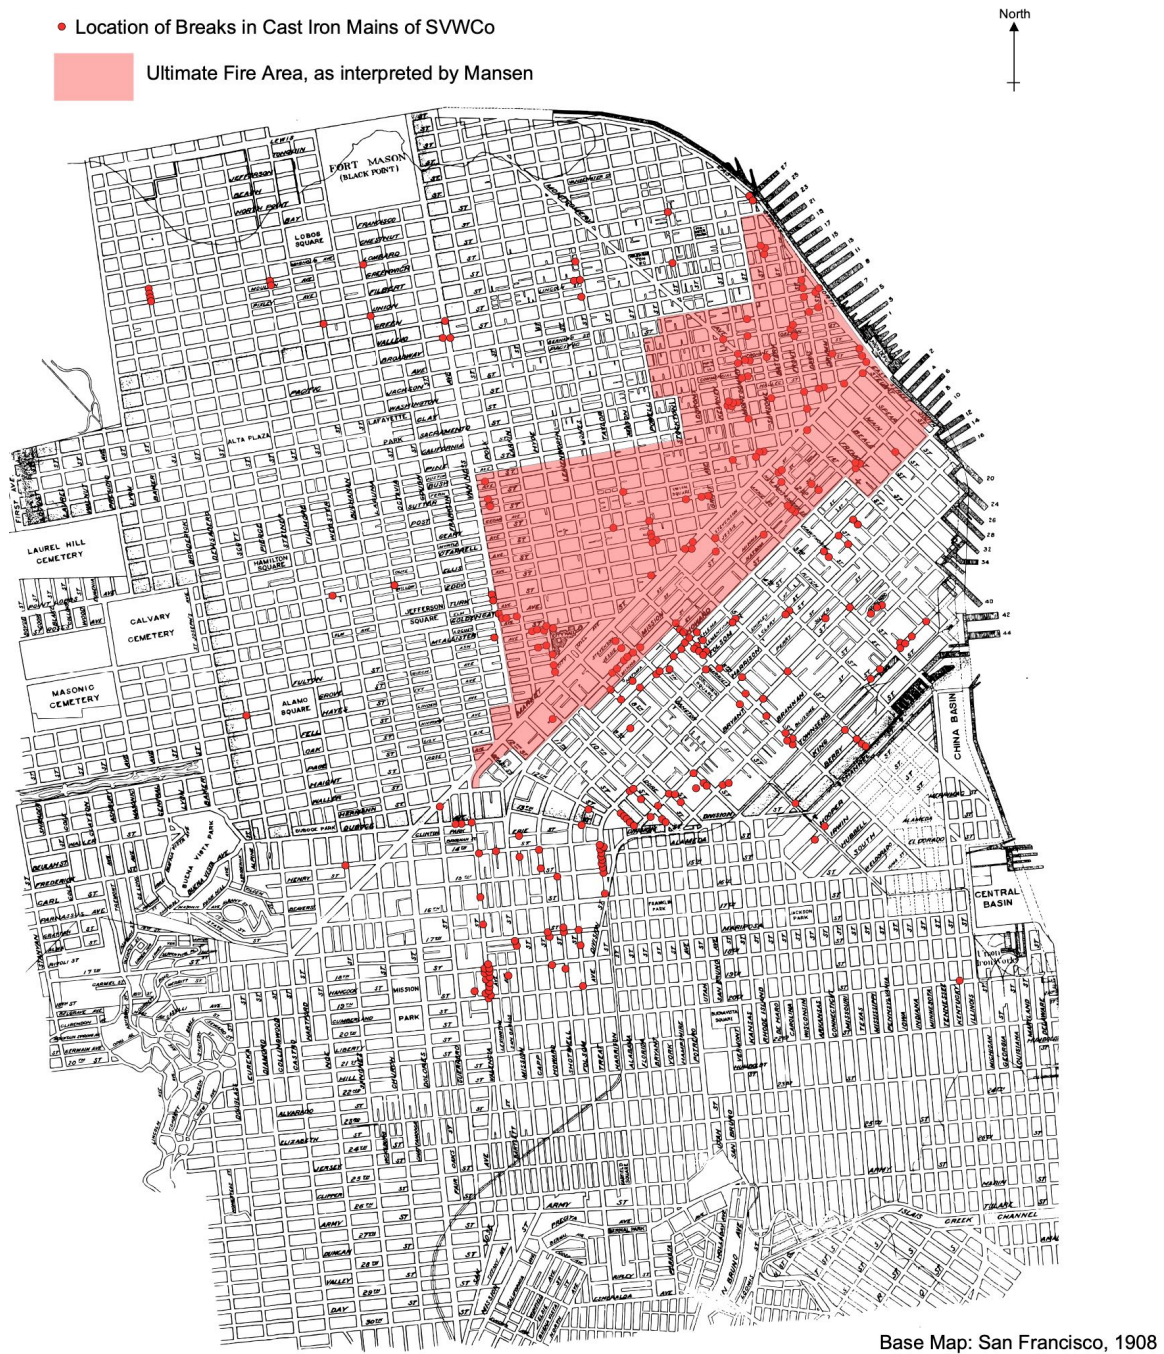
Figure 7-2. San Francisco 1906 Fire – final extents in shaded area as interpreted by M. Manson, H. D. Connick and T.W. Ransom during the years 1907-1908; breaks to cast iron mains in the water distribution system shown as red dots, as interpreted by H. Schussler, 1906; base map by Manson et al, 1908.

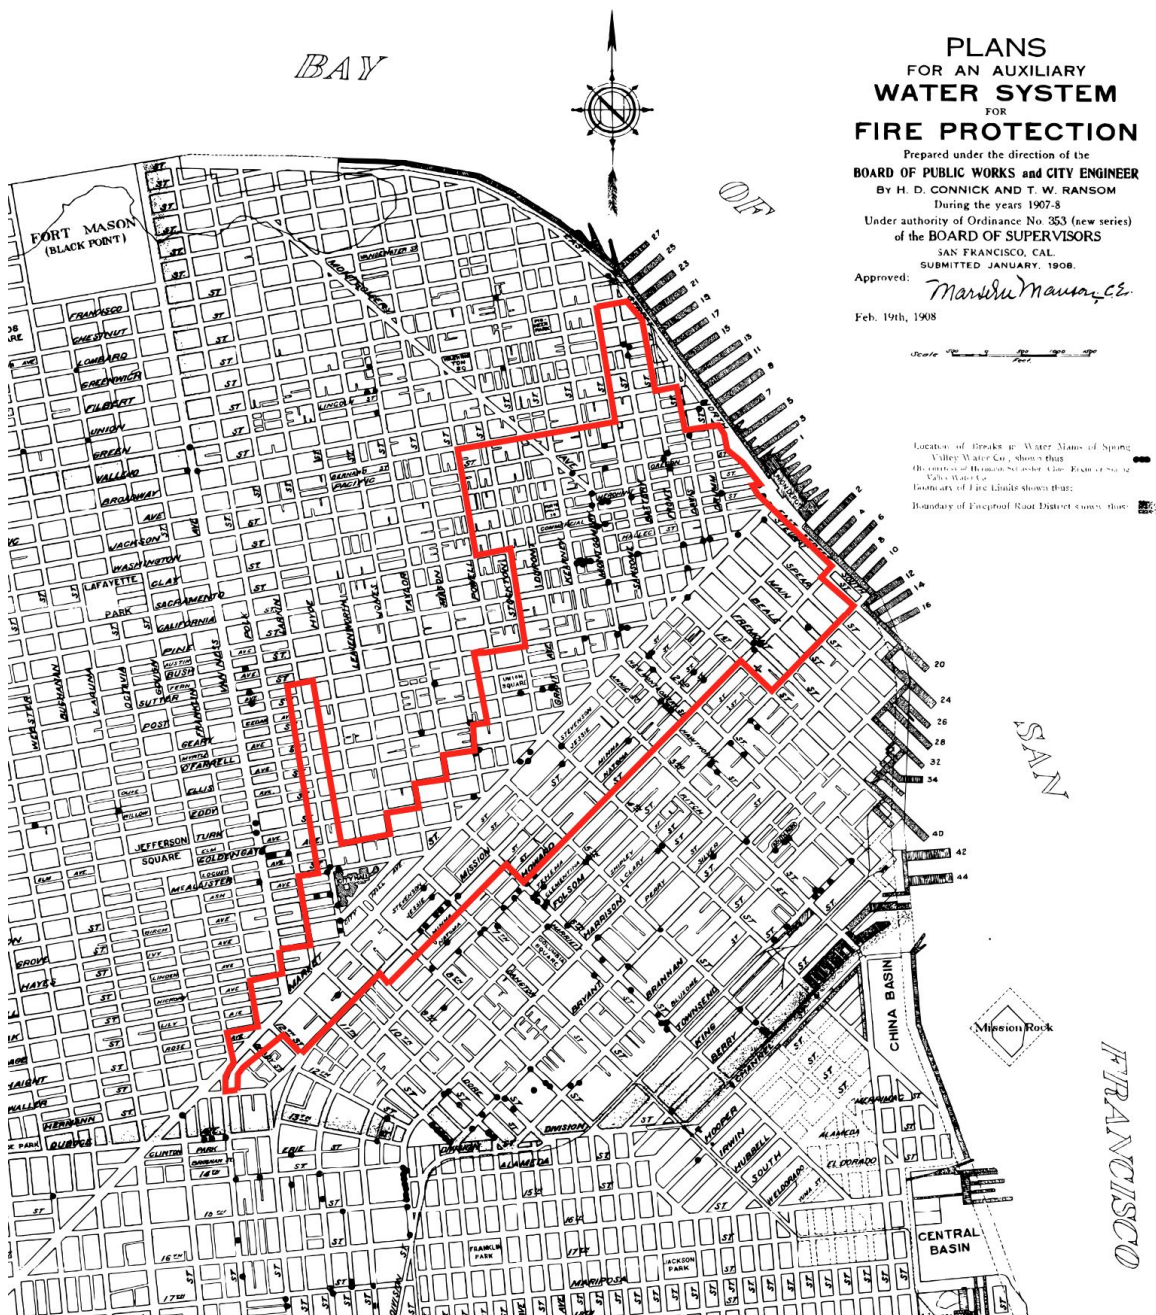
Figure 7-3. San Francisco 1906 Fire – heavy red line shows final limits as mapped by Sanborn (1911). Breaks to cast iron mains in the water distribution system shown as black dots, as interpreted by H. Schussler, 1906; base map by Manson et al, 1908.

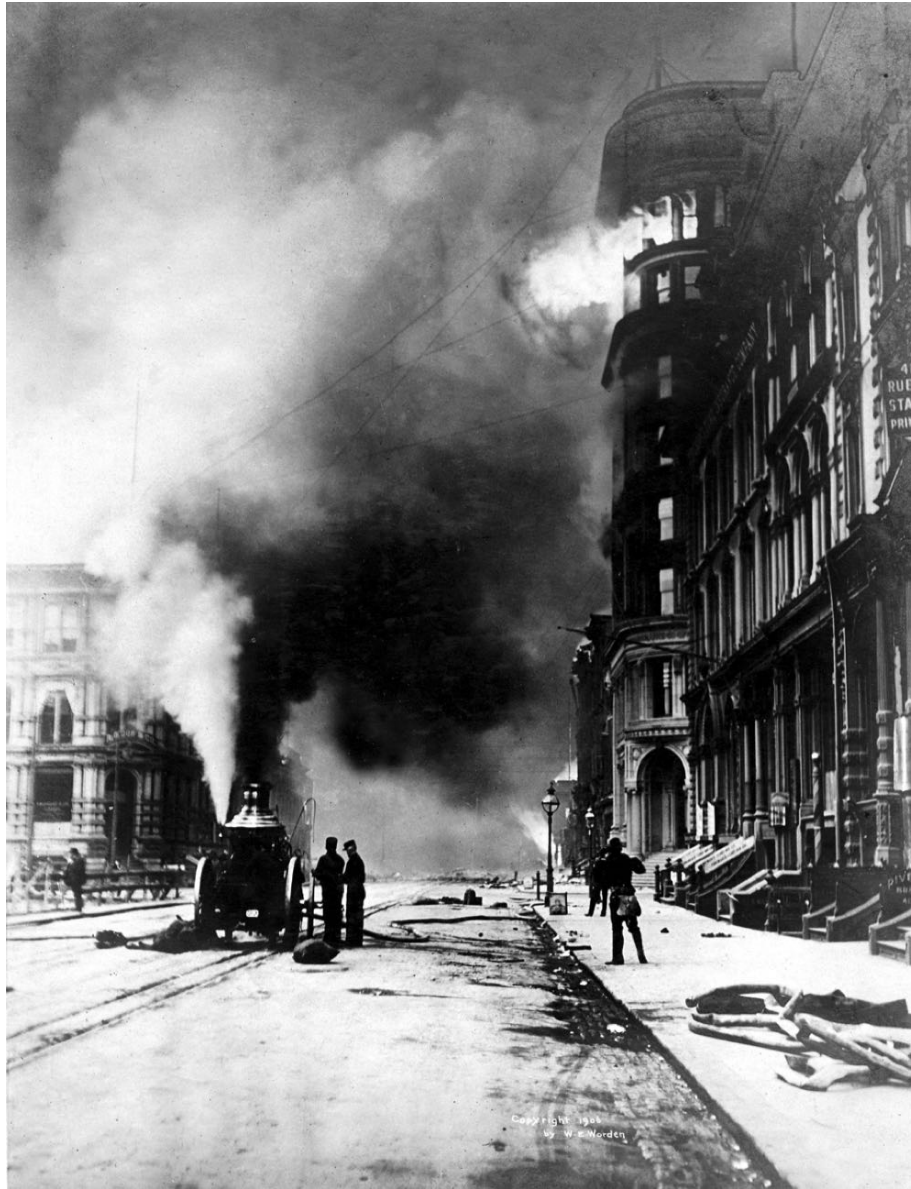
Figure 7-26. A fire department steam engine is in the center. Fires are actively burning in the 8 story building to the right, and in the background. At this time, there is no water via the piped water system here, so it is surmised that this engine is pumping out water from a local cistern, but to little effect. It is possible this photo was taken the morning of April 19.

Figure 7-26. April 18 pm. California Street, between Sansome and Market. (Photo: W. E. Warden, 1906)

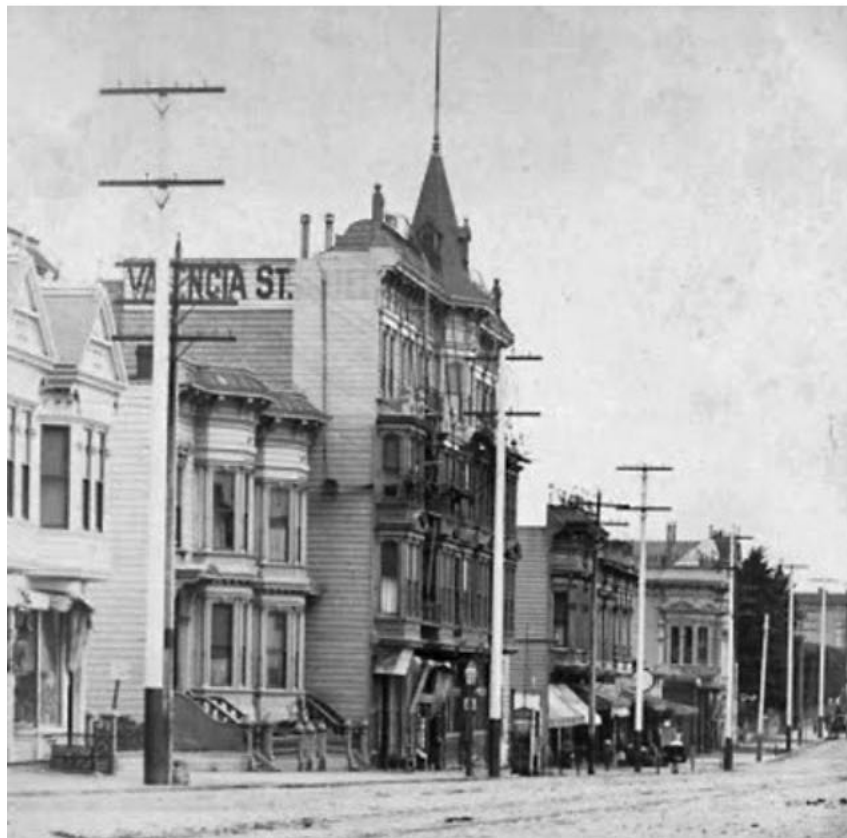
Figure 7-40 shows the Valencia Street Hotel, circa 1898. This photo is taken looking northwesterly, between 18th and 19th streets.

Figure 7-40. c. 1898. Valencia Street Hotel (Photo possibly by Marcel Tanron, Online Archive of California, The 1906 San Francisco Earthquake and Fire Digital Collection, U. C. Berkeley, Bancroft Library)

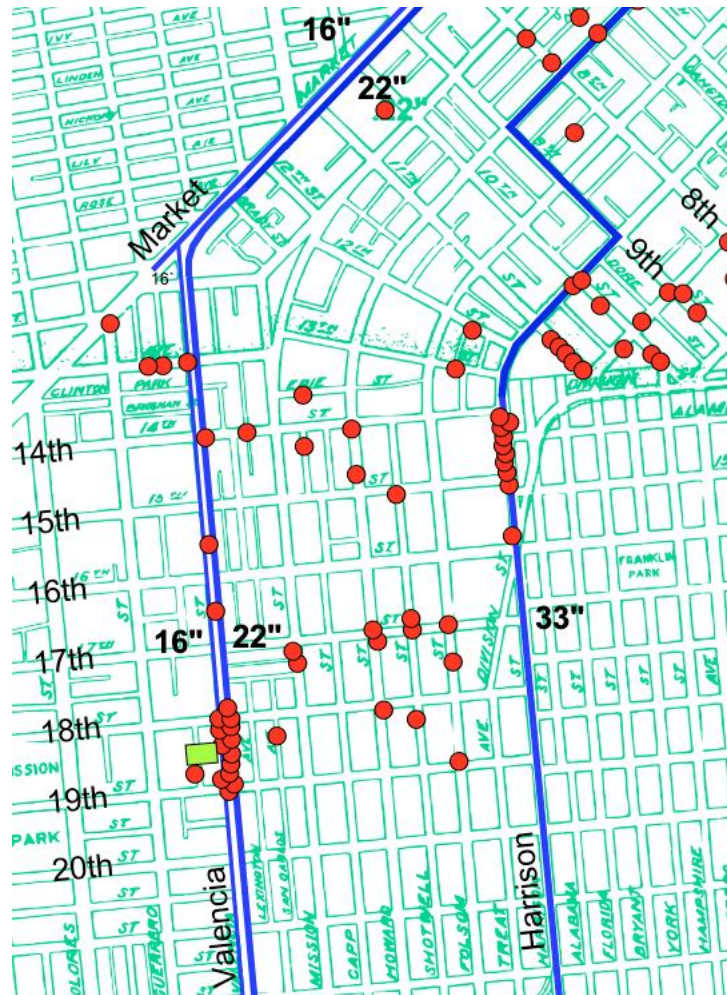
Figure 7-41 shows the main water pipe lines in the vicinity of the Valencia Street Hotel. The green box outline shows approximate location of the hotel. The red dots show locations of water main pipe damage (all diameters). Smaller diameter pipe (3" to 12") are not shown. Compare this with Figure 2-28, showing all water pipes 8" and larger. The normal direction of water flow in the 16" and 22" pipes along Valencia Street and the 33" pipe along Harrison Street would be northbound, coming from the College Hill and University Mound reservoirs, respectively. See Figures 3-3 and 3-5 for maps of the original shorelines and drainages in this area. The location and density of pipe breaks (red dots) closely follows the location of Laguna Dolores / Mission Creek.

Figure 7-41. Water Mains (16" - 33") in Vicinity of Valencia Street Hotel (green rectangle)

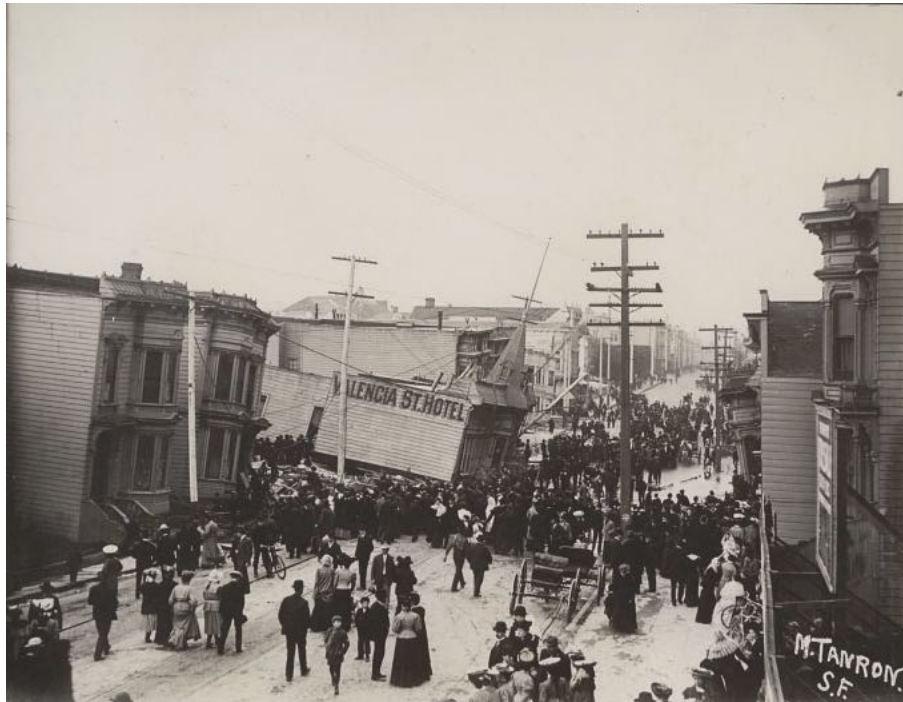
Figure 7-42 shows the collapse of the Valencia Street Hotel. This photo was taken the morning of April 18. The large crowd is possibly more than 200 people. The front of the building has sunk and collapsed some 30 feet or so, with just the fourth floor remaining above ground and displaced sideways into Valencia Street. People are attempting to rescue occupants via a 4th floor window. This building, along with most of the other smaller buildings on the block, were constructed atop a filled-in area of the former Dolores Laguna, a tidal area connected to the Bay via Mission Creek. The area liquefied during the earthquake.

Note that the lightweight telegraph poles remain standing; some are tilted, possibly reflecting the temporary loss of bearing resistance during the time the soil was liquefied; or possibly aggravated by wire pull down forces from the nearby collapsed or partially collapsed buildings.

Figure 7-42. April 18 am. Collapse of Valencia Street Hotel (Photo credit Marcel Tanron, Camera Craft, Vol, 27 1921, Online Archive of California, The 1906 San Francisco Earthquake and Fire Digital Collection, U. C. Berkeley, Bancroft Library)

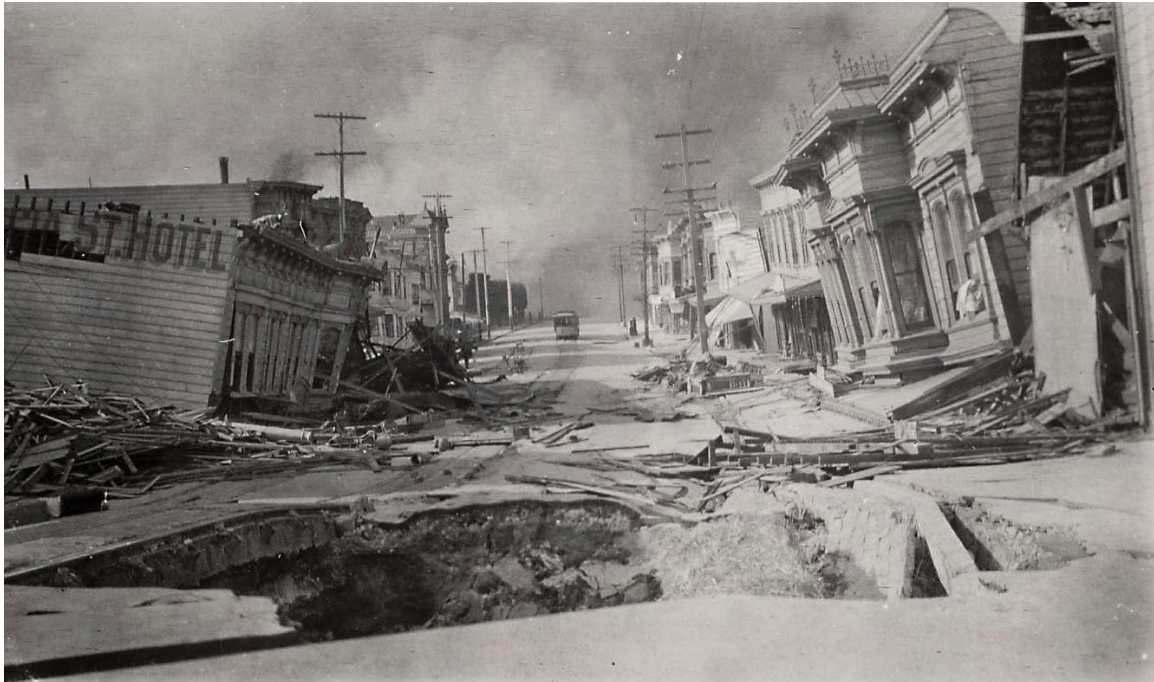
Figure 7-44 shows a wider view of Valencia Street, showing the damage to wood buildings on the east side of the street. This photo is believed to have been taken the morning of April 19, and the fire, then about 16th street, is in the background. The streetcar was stopped at the south side of 18th street. At this time, the street has been evacuated.

Figure 7-44. April 19. Looking North. The fire that was burning near Market Street on April 18 has advanced and is making its way southwards along Valencia Street. Liquefaction had wrecked other wood buildings on the east side of Valencia Street. (Photo credit: Online Archive of California, The 1906 San Francisco Earthquake and Fire Digital Collection, U. C. Berkeley, Bancroft Library)

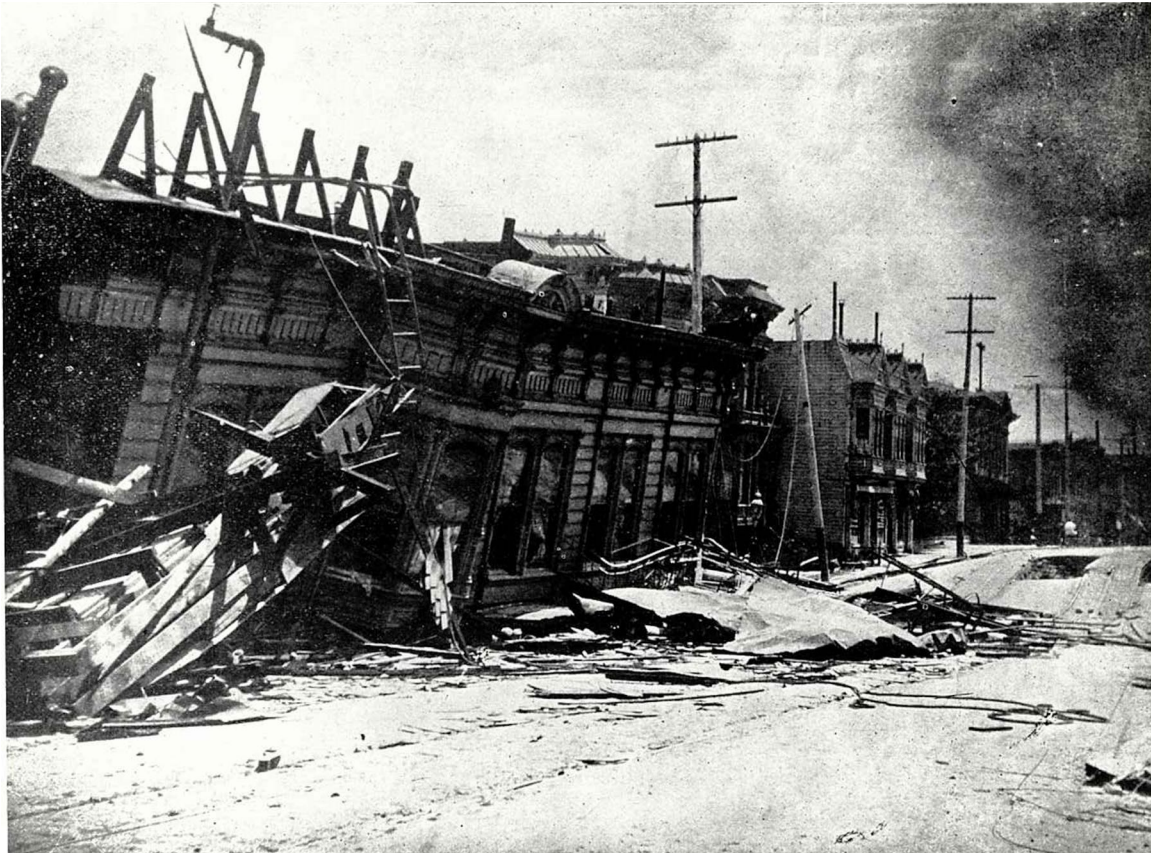
Figure 7-46 shows a close up of the damaged Valencia Street Hotel. The photo is believed to have been taken in the afternoon of April 19. The dark smoke of the fire indicated active burning around 17th Street. The twin trolley car tracks are sunken suggesting a continuing settlement in the liquefied zone over a 24± hour period.

The fire will soon reach the area and all the buildings will be consumed by the fire.

Figure 7-46. April 19. Valencia Hotel Collapse (left foreground); fire approaching from the north. (Photo: provided courtesy USGS). The fire will eventually consume all the buildings seen in this photo. (Photo credit: courtesy of USGS)
