History of the Water Works of San Francisco: Its Performance in the 1906 Earthquake and Aftermath

John M. Eidinger and N. Timothy Hall

Revision 2

August 2024

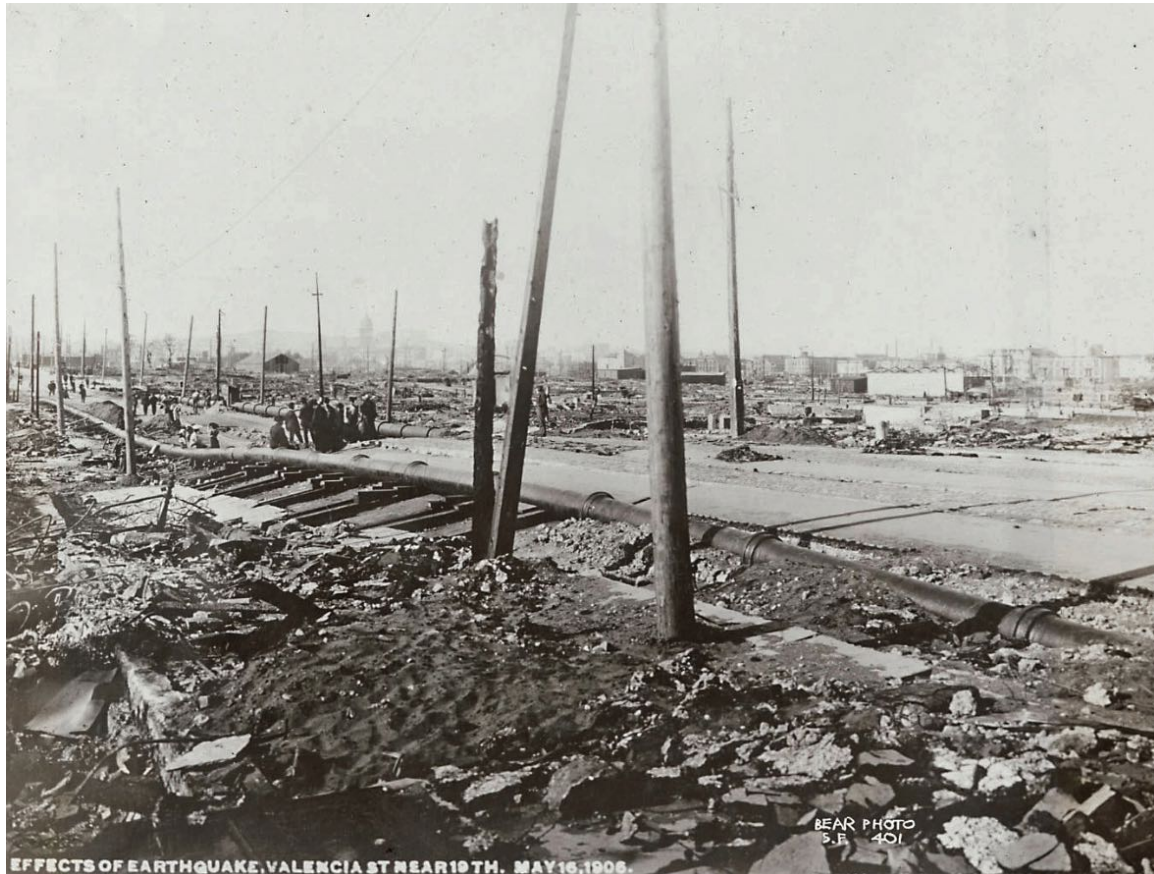
Figure 7-47. May 16, 1906. View of Valencia Street between 18th and 19th street, looking northeast. In the foreground is an above-ground 16" pipe laid by SVWC as a temporary bypass. In the background is the above-ground 22" pipe laid by SVWC as a temporary bypass on the east side of the street. City Hall dome is dimly seen in the distance just above the group of people in the center of the photo. The cross-arms on the power / telegraph poles have been lost to the fire, but most poles remain standing. (Photo credit: Bear Photo S.F. 401; Online Archive of California, The 1906 San Francisco Earthquake and Fire Digital Collection, U. C. Berkeley, Bancroft Library)

Figure 7-47 shows the area as of May 16, 1906 (28 days after the earthquake). SVWC was able to restore water to College Hill Reservoir from San Andreas Reservoir about 62 hours after the earthquake (April 20). The maps in Figures 2-28, 7-5, 7-41 show that restoring flow to the downtown area (Market Street) would need repair of the 16" and 22" pipes on Valencia Street (at least one of them). The great amount of settlement precluded simple patches on the buried pipe; SVWC elected to construct two new (temporary) above ground pipes instead. The historic photos suggest the temporary 16" pipe (west side of street) was installed first.

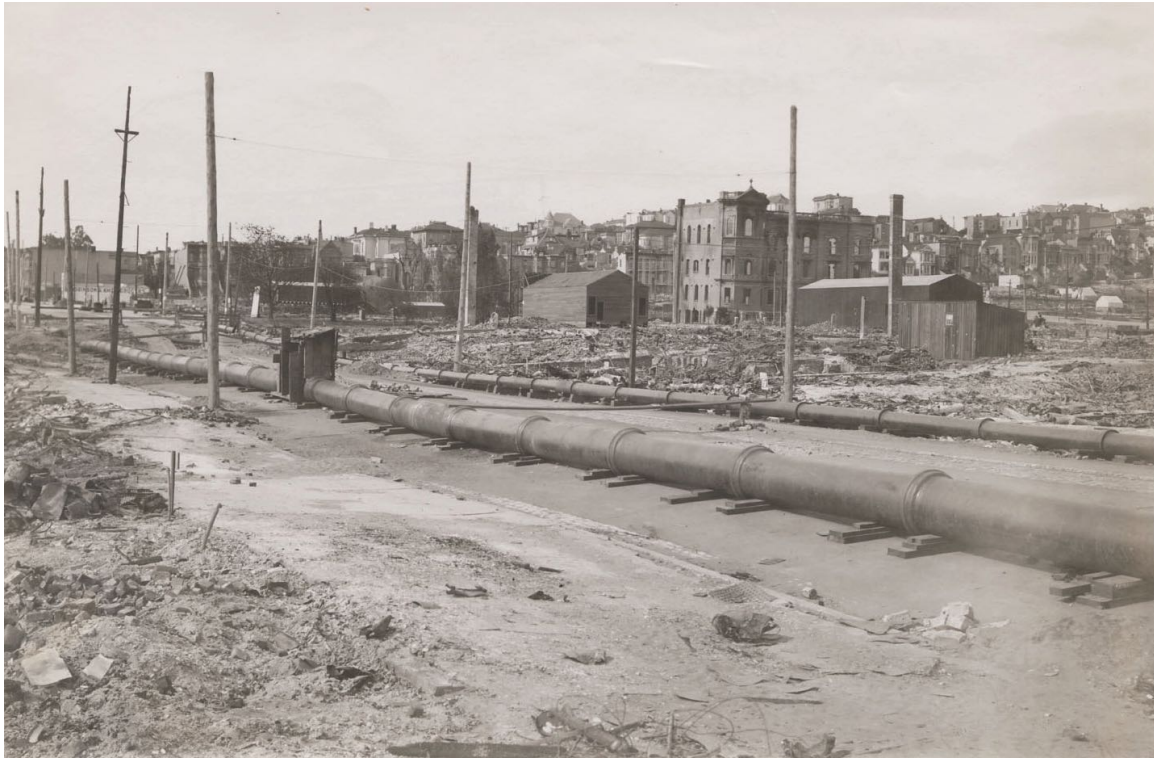
Figure 7-49. c. May 16 1906. View of Valencia Street between 18th and 19th street, looking southwesterly. The two temporary pipes are cast iron with belled joints; no restraints are seen placed across the segmented joints. Each segment is typically supported by two sets of wooden planks. (Photo credit: Online Archive of California, The 1906 San Francisco Earthquake and Fire Digital Collection, U. C. Berkeley, Bancroft Library)

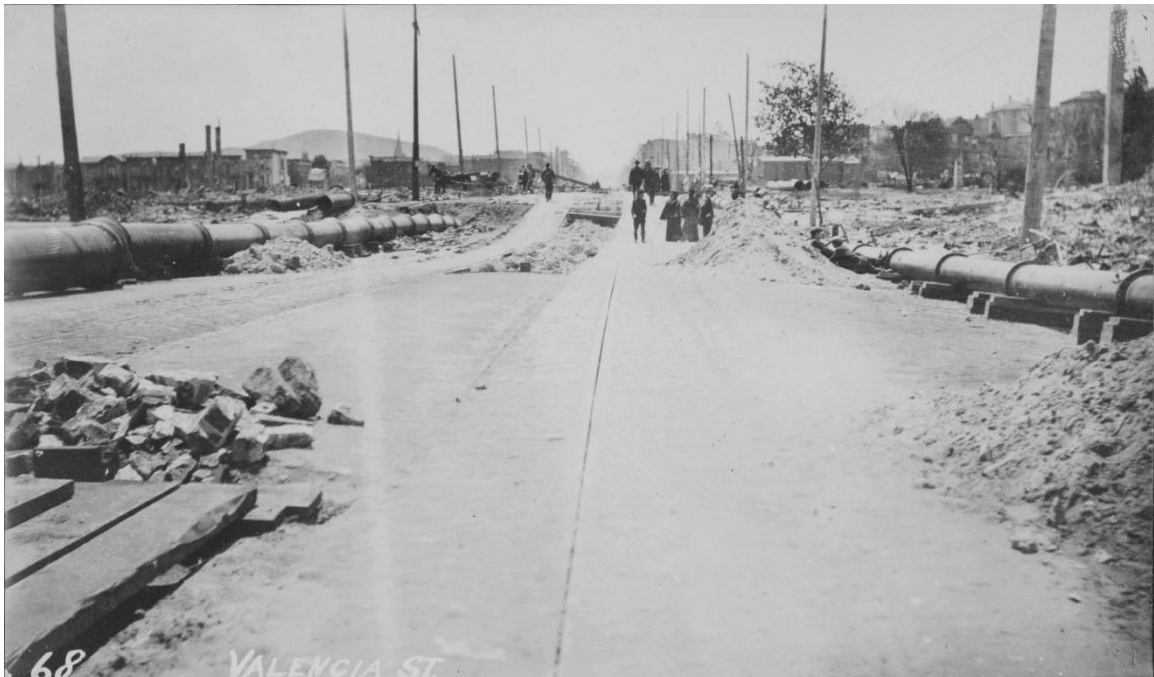
Figure 7-50 shows another view of the temporary pipes. The smaller 16" pipe is on the west (right) side of the street, and the larger 22" pipe is on the east (left) side of the street.

Figure 7-50. c. May 16, 1906. View of Valencia Street between 18th and 19th street, looking south.
(Photo credit: Online Archive of California, The 1906 San Francisco Earthquake and Fire Digital Collection, U. C. Berkeley, Bancroft Library)

The historic photographic record is not clear as to which pipe SVWC laid first: the smaller (16") or the larger (22"). Practically, this would depend on which diameter pipe SVWC had most available in its yard, and which was easiest / quickest to install. To make the connections to the College Hill Reservoir, the old damaged pipes buried in the street would have had to have been excavated and exposed, and then suitable joinery made; this appears to have been done as straight connections to the undamaged buried pipes either side of the liquefaction zone.

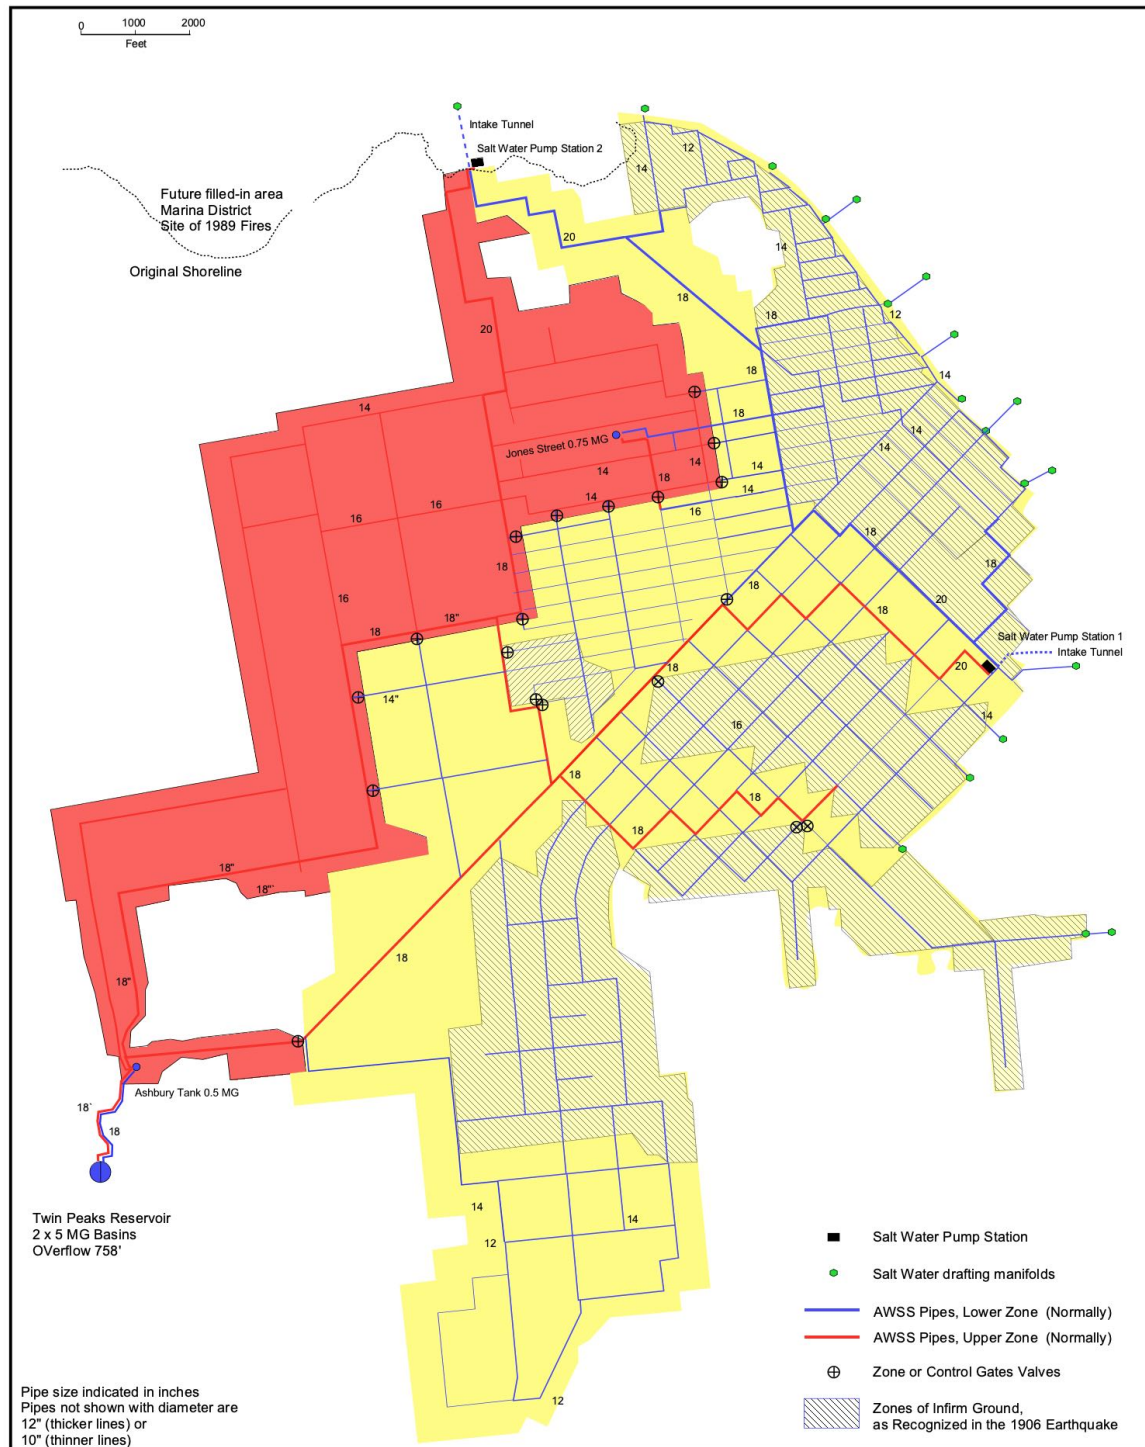
The map in Figure 8-2 highlights that the larger diameter pipes (generally 18-inch) that provide the backbone to move water from the Salt Water pump stations (or the reservoirs) to the grid, were purposely installed outside the infirm ground areas. While this was sound design, the fundamental error in the AWSS design still remains: the cast iron pipes in the infirm ground area are going to break in earthquakes that trigger PGDs; and the time needed to manually identify, send crews, and turn valves will always be more than 1 hour (and could easily be several hours). Any initial fire ignitions, if not controlled within 10 minutes or so, can readily spread to adjacent buildings, especially if it is windy.

Figure 8-2. The AWSS Pipe System, 1908. Zones of Infirm Ground Highlighted by hatched areas. Red and yellow-colored areas are the pressure zones, same as in Figure 8-1

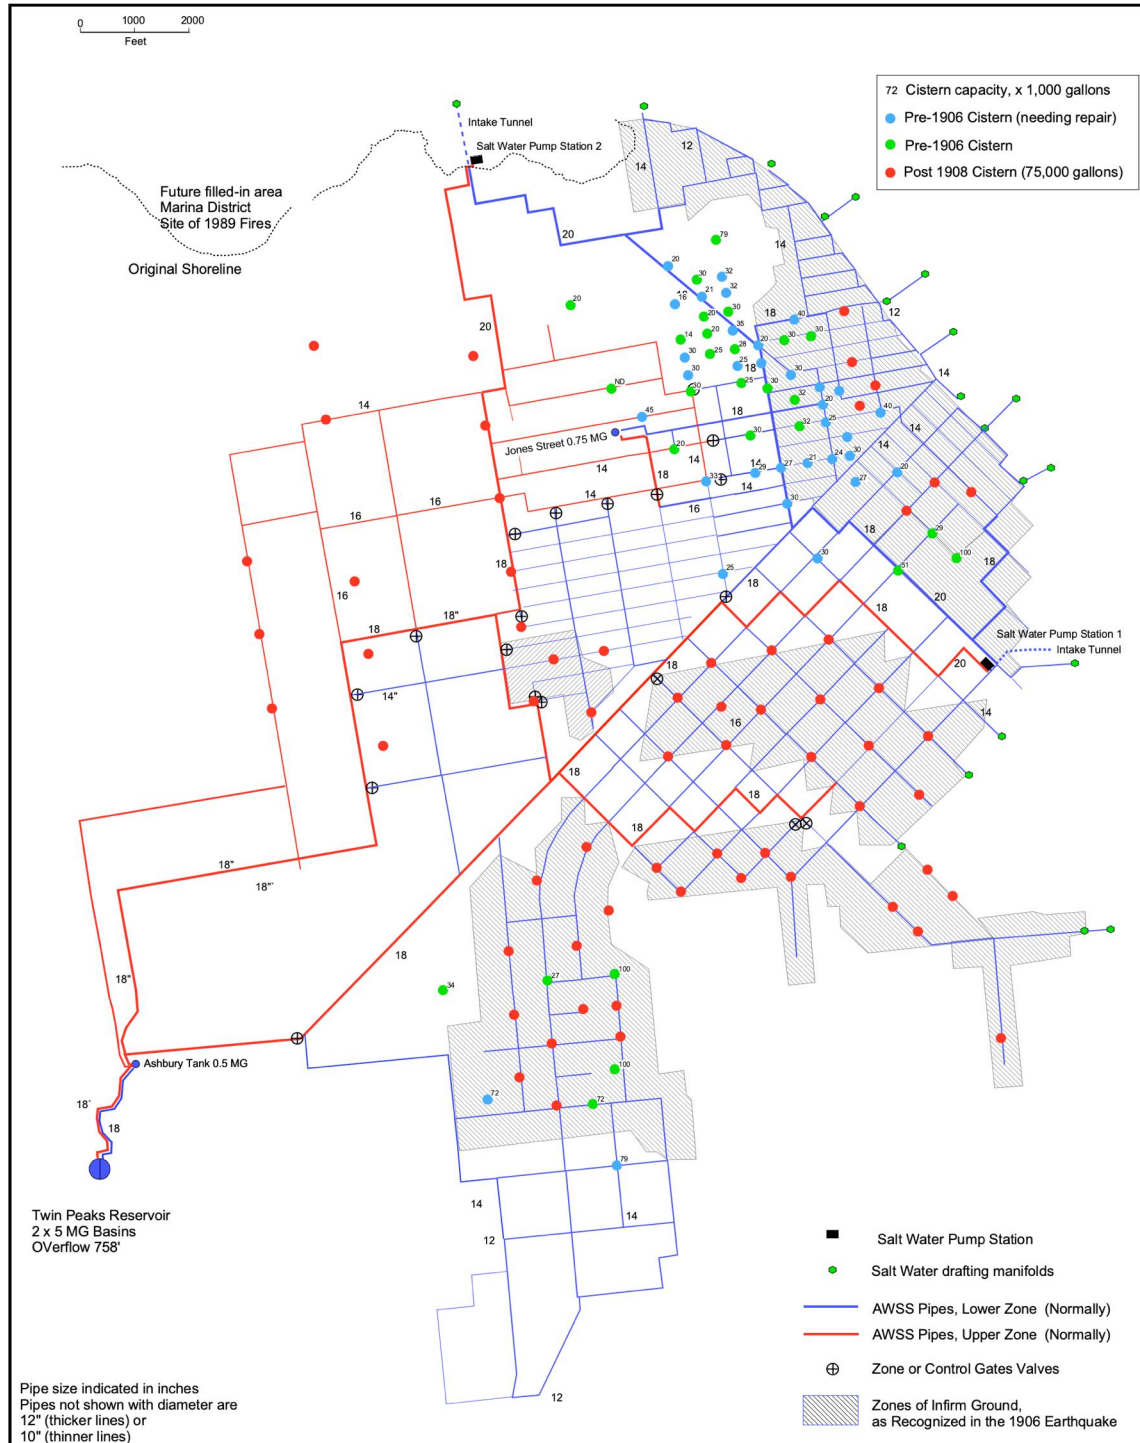
Figure 8-3 shows the planned AWSS system, this time highlighting the location of cisterns. The green and blue cisterns were in place (and filled) at the time of the 1906 earthquake. The red cisterns were those proposed to be built as part of the 1908 bond issue.

Figure 8-3. The AWSS Cistern and Pipe System, 1908, With Zones of Infirm Ground Highlighted

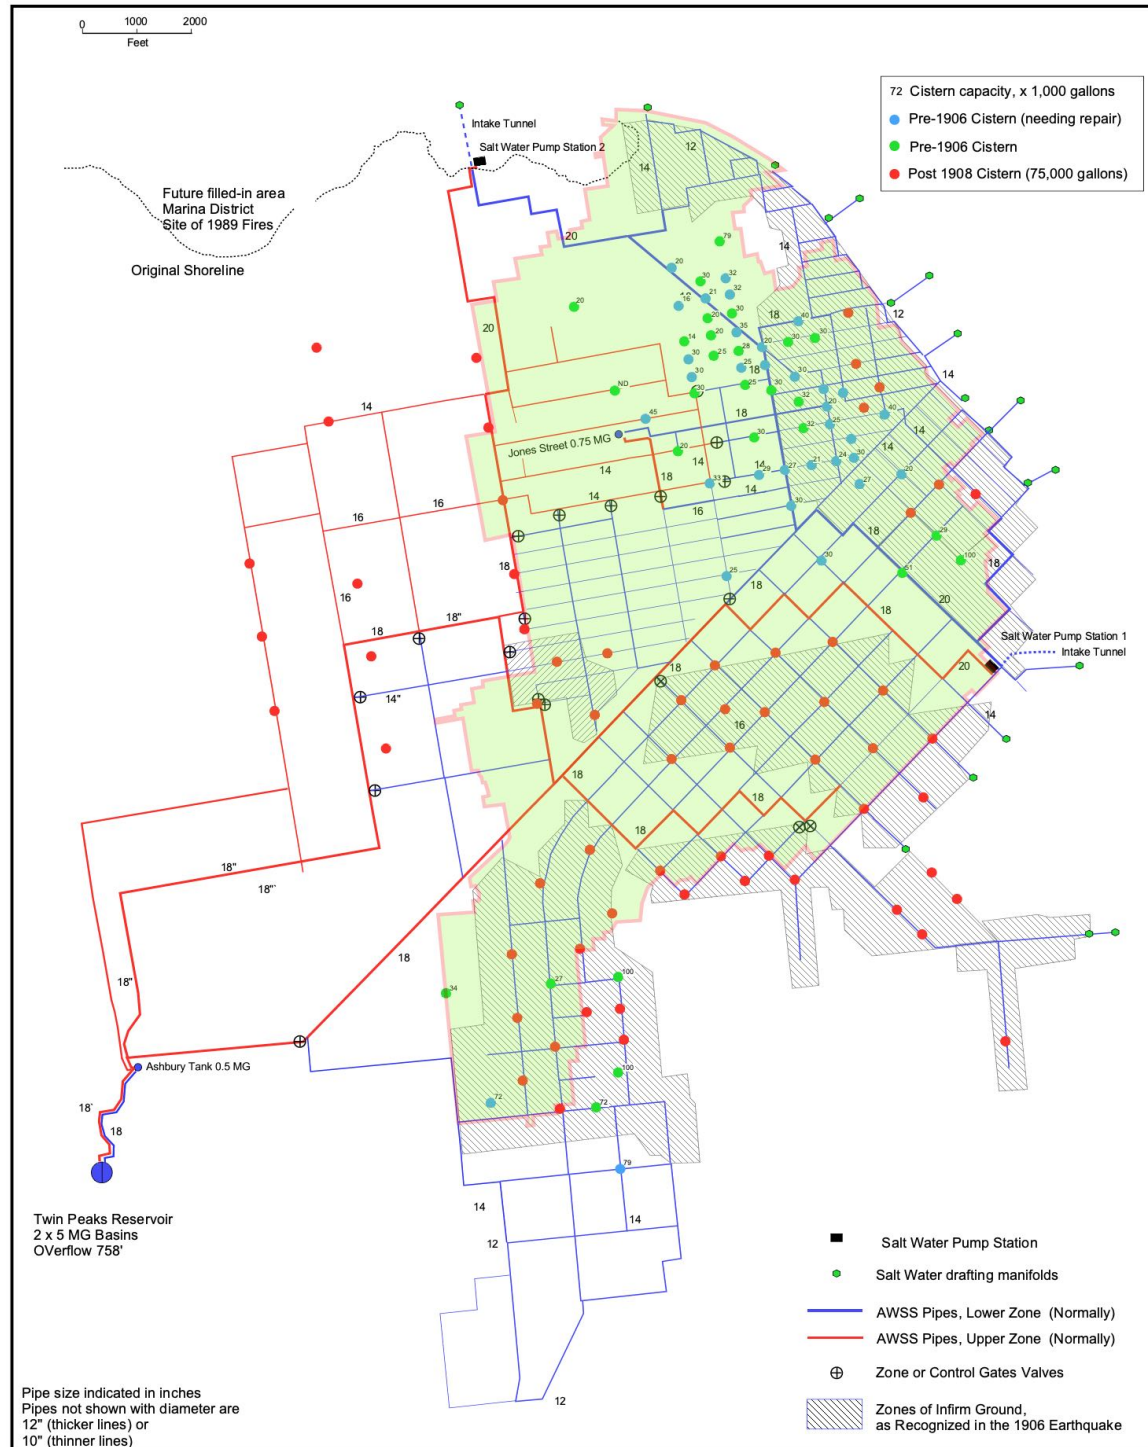
Figure 8-4 overlays the ultimate fire burn area with the location of the then-existing (and planned future) cisterns. It is evident that the vast majority of the 1906-existing cisterns were located within the ultimate fire boundary. The 11 cisterns in the area burned in Day 1 (mostly in the South of Market and the Mission Creek areas) were largely ineffective in controlling the initial ignition fires, nor the initial spread, even during Day 1, when winds were light. Not shown in Figures 8-3 and 8-4 are an additional 35 cisterns to be built as part of the 1908 bond issue, with locations to be picked by the fire department.

Figure 8-4. The AWSS Cistern and Pipe System, 1908, With Zones of Infirm Ground (cross hatch) and the Ultimate Burned Area (shaded) from the 1906 Earthquake Highlighted

The location of many of the new planned cisterns (red dots in Figures 8-3 and 8-4) are within the infirm ground areas. This poses the question: if there are to be PGDs in these areas, would the buried cisterns, constructed of brick or perhaps reinforced concrete, remain serviceable, when exposed to PGDs? To some extent, "yes", if the PGDs are from

settlement only and are located above the level of the cistern's foundation. But, to some extent "no", if the PGDs are below the bottom of the cistern, or if the site is exposed to differential lateral spreads. In any case, having some water in a cistern is arguably better than having no water than all.

Figure 8-4 also shows that the 1908 design largely omits placing cisterns in areas to be served by water pipes (either AWSS or SVWC) in areas of firm ground; as well as along and within a few hundred feet of the waterfront, where fire-flow water coverage could be provided by fire boats.

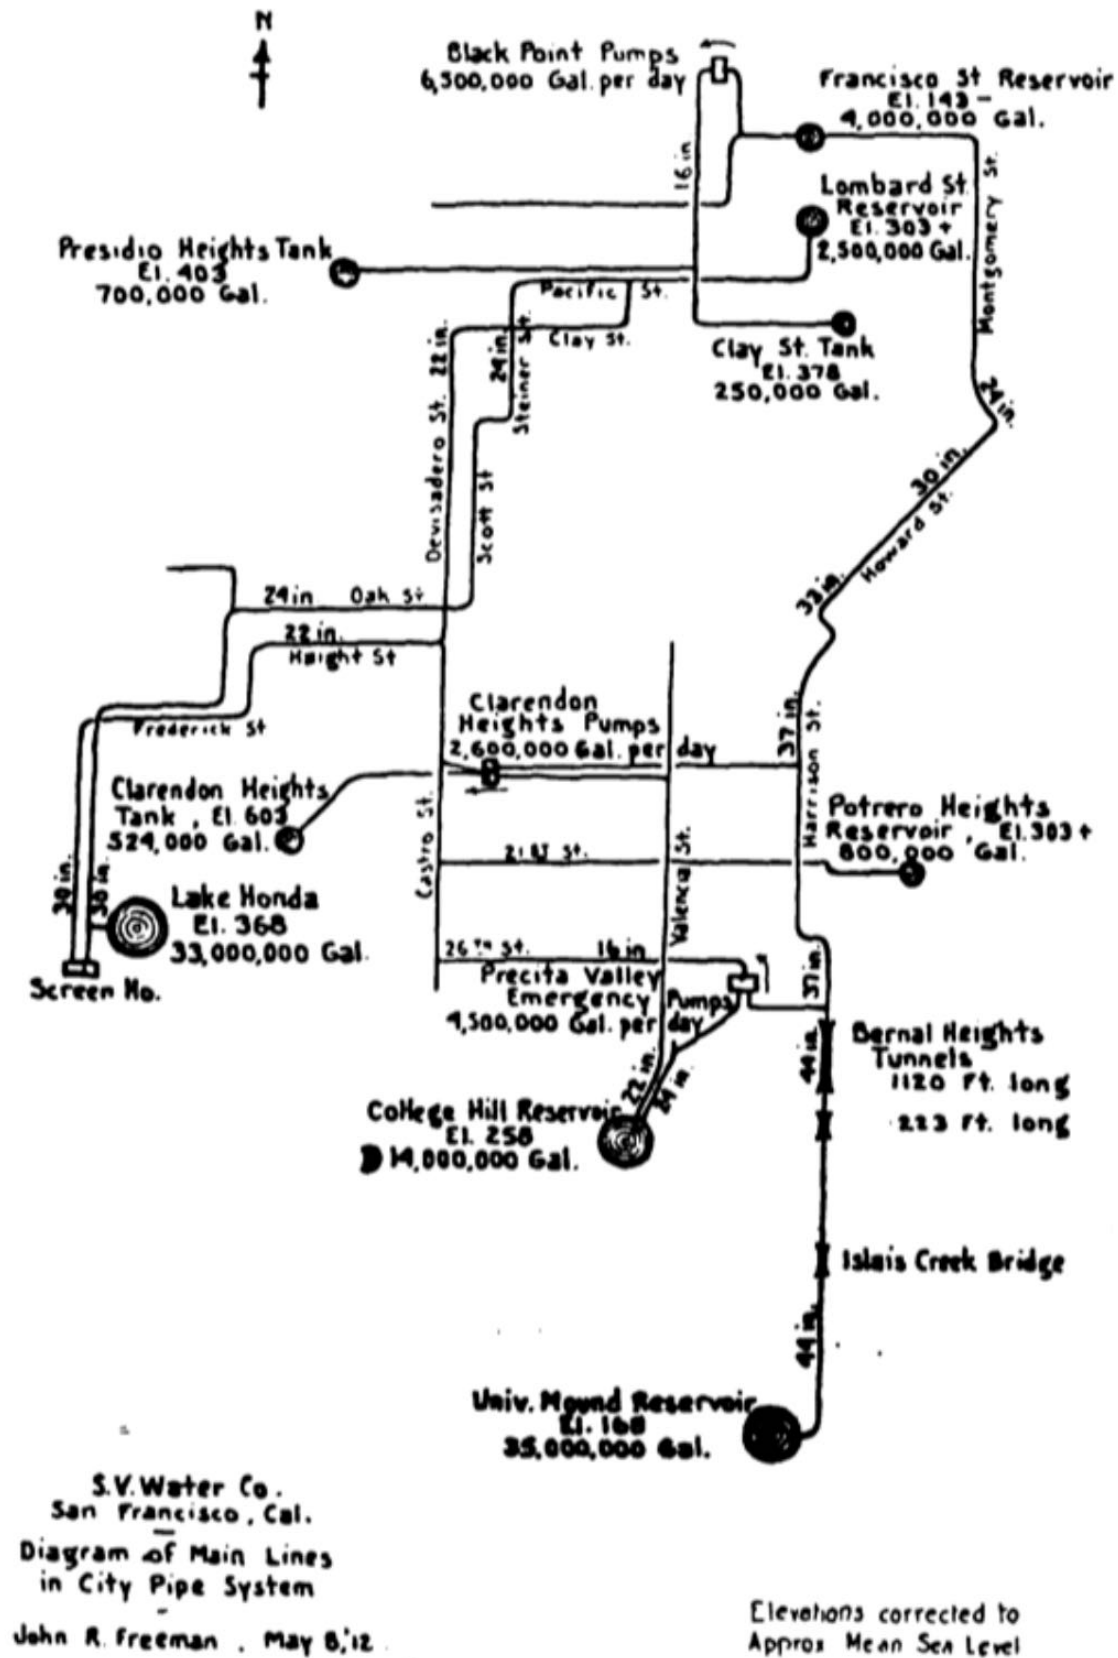
The City trunk line system sketch prepared by Freeman in 1912. Figure 9-12 highlights the main changes since 1906.

- The Precita Valley pumps were installed (relocated from the abandoned Pilarcitos pump station) to move water from the Crystal Springs zone up to the Lake Honda Zone; this was needed to reinforce the reliability of supply to the upper zone, given that its original supply pipeline (Pilarcitos) was no longer available.

- The 37-inch pipe down Harrison Street (through Mission Creek Marsh) and the 22-inch line down Valencia Street (through Mission Creek) are still shown. This suggests that the rebuild of the water system post-1906 was done as rapidly as possible, to get the city back in business. Conceivably, the Precita Valley pumps could bypass these liquefaction zones; but this is limited in flow, requires pumping, and a fair amount of manual turning of zone gates to achieve. Perhaps SVWC just abandoned fire flows as a core mission, as the City was building its parallel AWSS. Whichever the case, both the SVWC system (later to be bought and operated by SFWD) and the AWSS system (operated by SFFD) remained seismically vulnerable in 1912, and remains vulnerable in 2024.

Figure 9-12. City Trunk Line System, After the 1906 Earthquake, Freeman (1912)

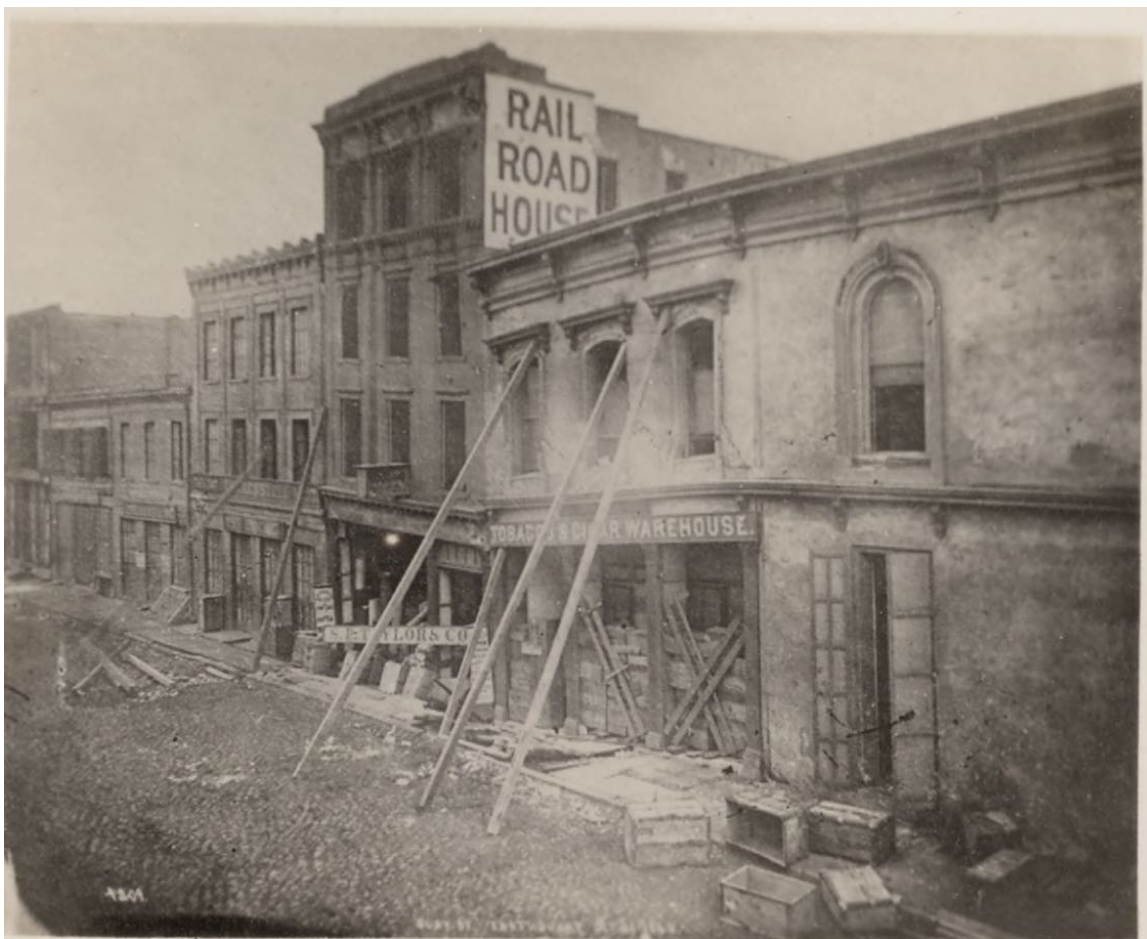
Figure A-1. Clay Street East of Sansome (Photo: Thomas Woodward, 1868)

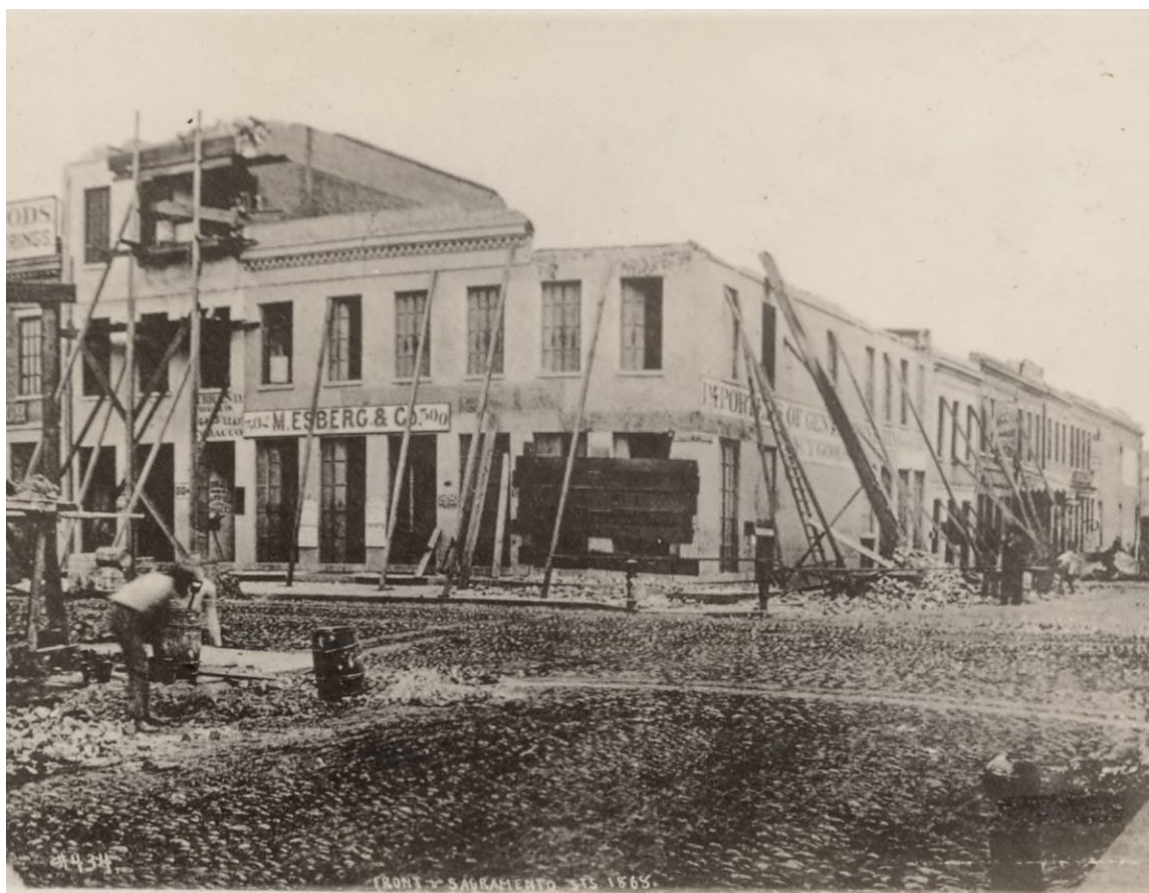
Figure A-2. Front and Sacramento (Photo: Thomas Woodward, 1868)

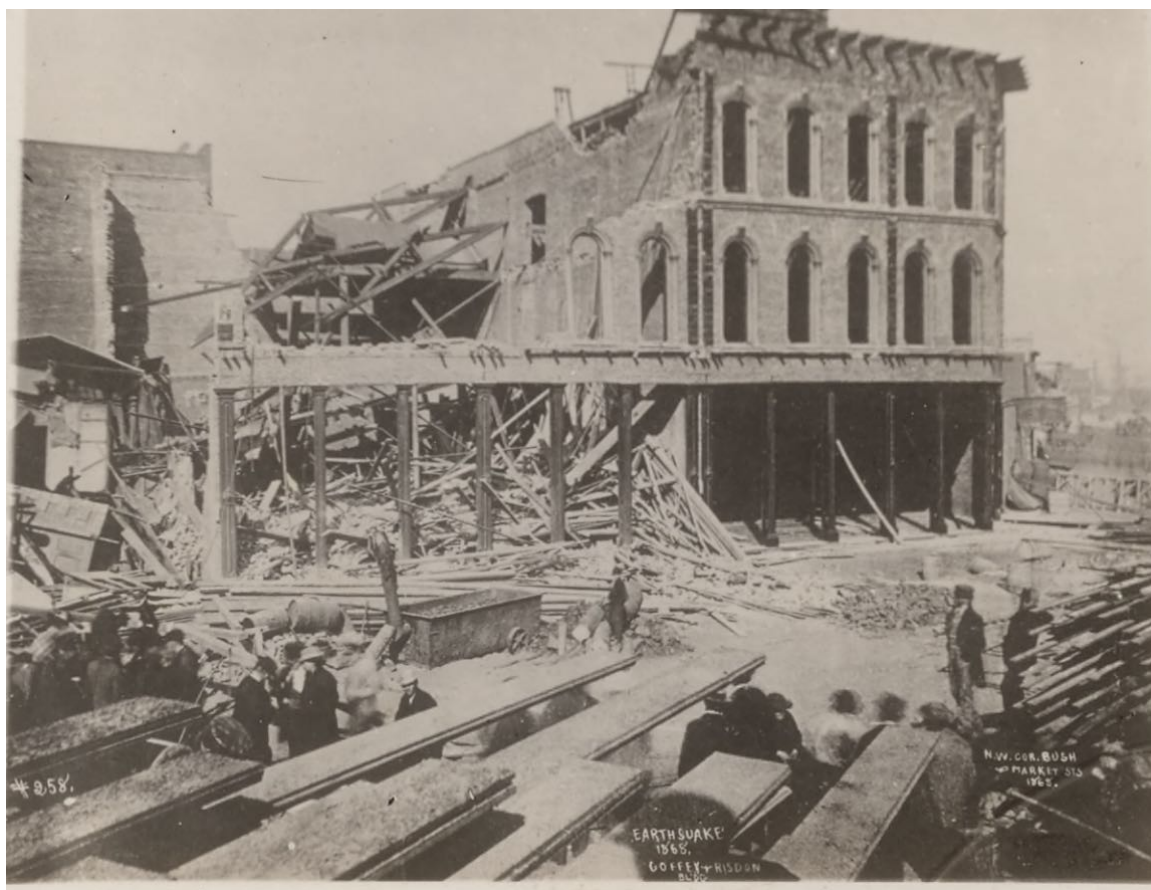
Figure A-3. Northwest Bush and Market Streets (Photo: Thomas Woodward, 1868)

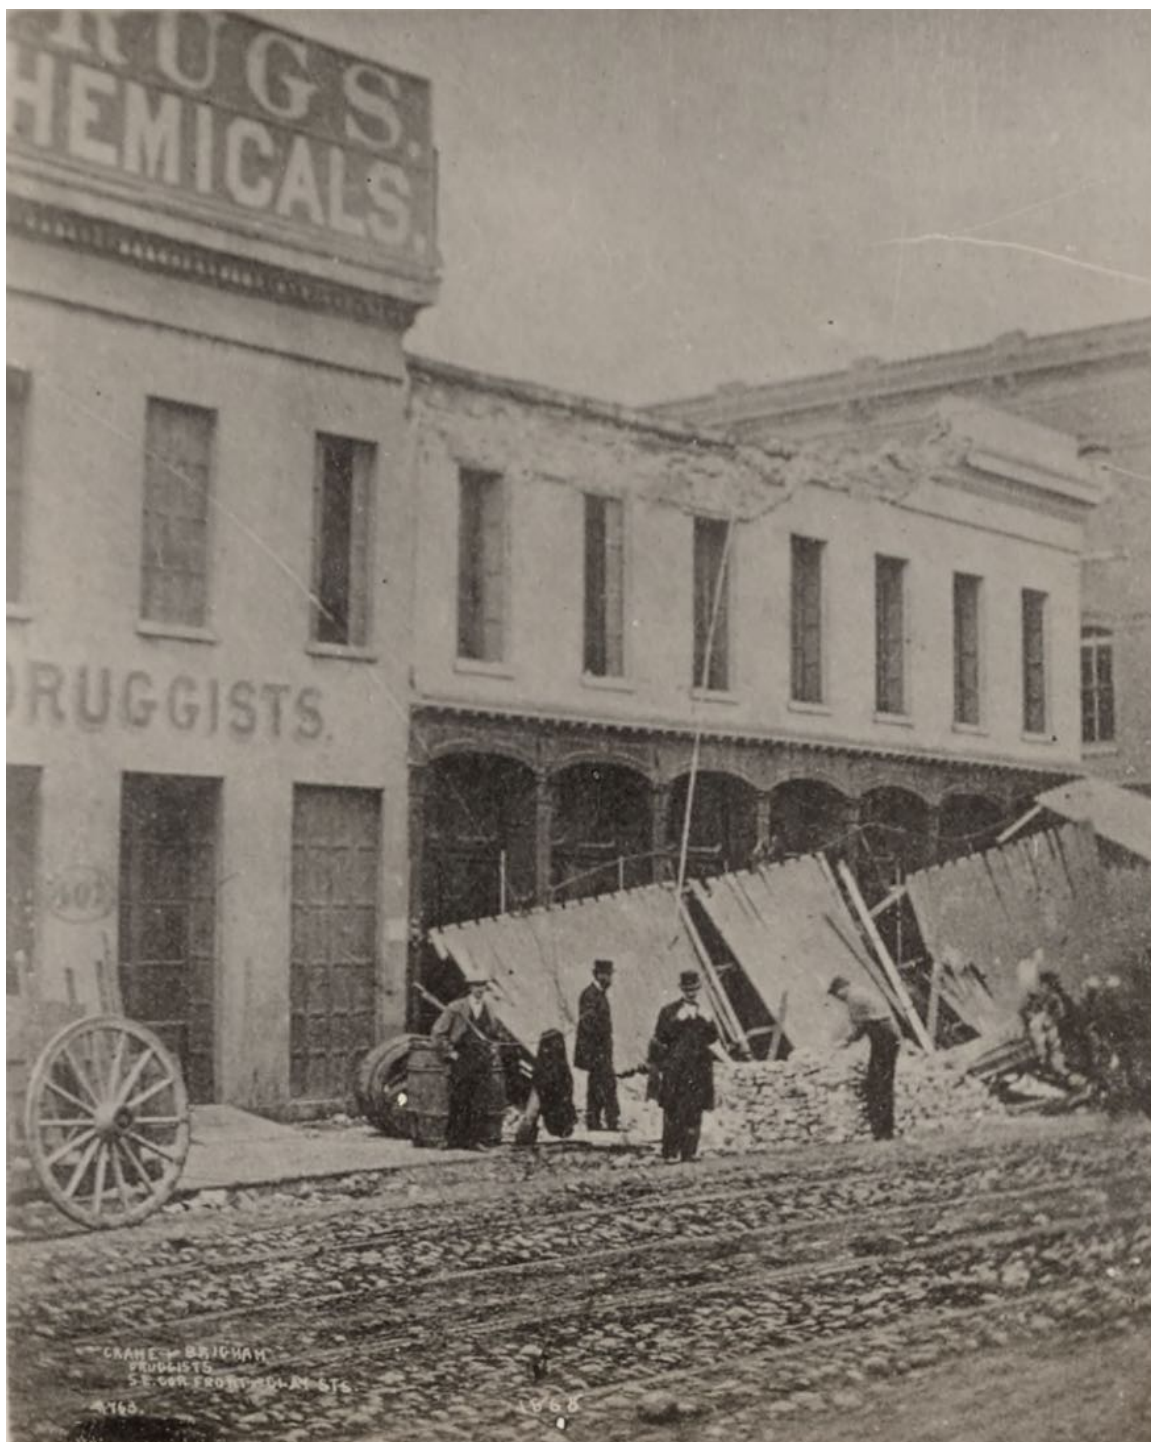
Figure A-4. Southeast Front and Clay (Photo: Thomas Woodward, 1868)
