The 1906 Earthquake Impacts on the San Francisco and Santa Clara Water Systems - What We Learned, and What We are Doing About It

John Eidinger¹, M.EERI, Lota de Castro², Dennis Ma³

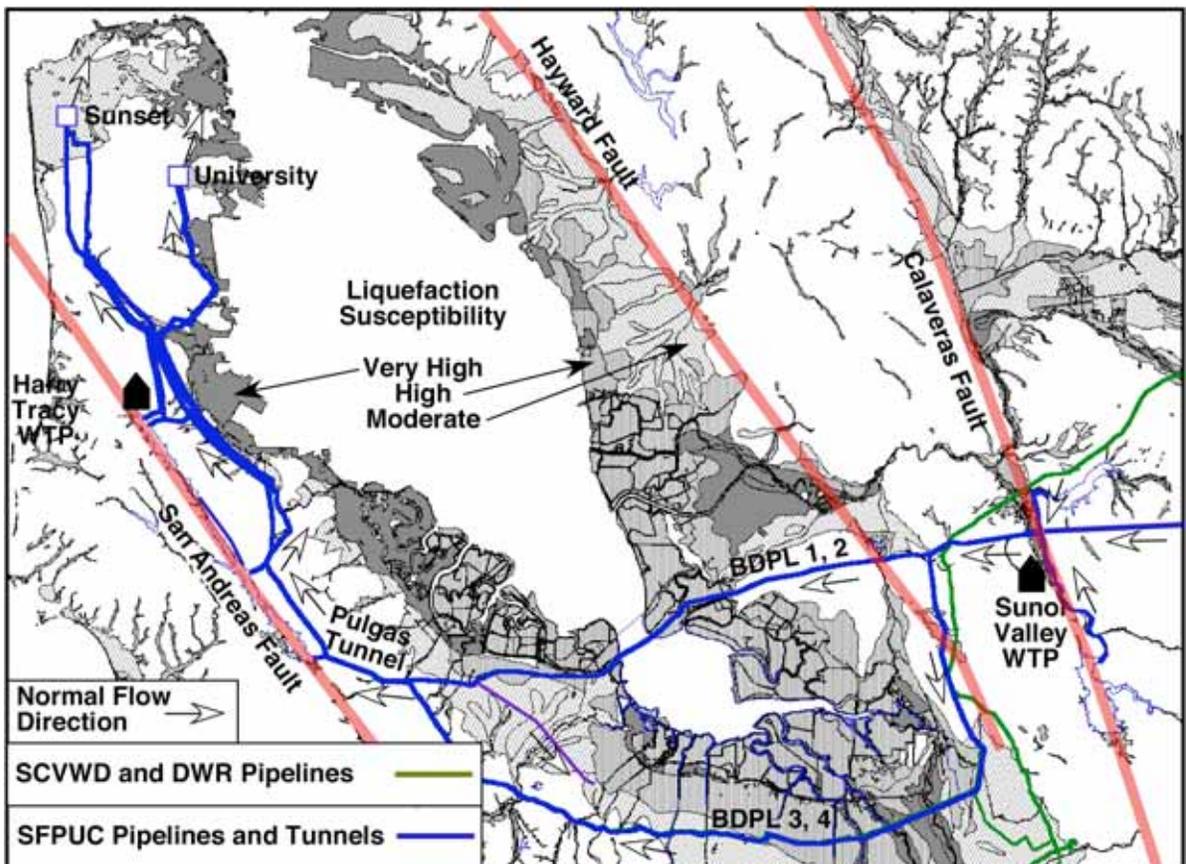
Figure 1. SFPUC Transmission System (2005) and Geologic Hazards (Knudson et al 2000)

Figure 1 shows a map of the current water transmission system in the local San Francisco Bay Area. In Sunol Valley, water from Yosemite is blended with water from the Sunol Valley Water Treatment Plant (WTP), and then heads westward. All of the SFPUC's seven major pipelines in Sunol Valley cross the Calaveras fault; some with multiple crossings. Then, the water is split into four pipelines, called the Bay Division Pipelines (BDPL) 1, 2, 3 and 4. BDPL 1 and 2 pipelines head westward, where they cross the Hayward fault, and then the Dumbarton Strait. BDPL 3 and 4 pipelines head southwards, around the San Francisco Bay, crossing through the cities of Fremont, Milpitas, San Jose, Santa Clara, Sunnyvale, Mountain View, Palo alto and Redwood City, where they joint up

Figure 1 shows the major pipelines and tunnels in the SFPUC regional transmission system. Figure 1 also shows areas as having "very high", "high" or "moderate" risk of liquefaction as mapped by Knudson (2000). A zone mapped as having a very high susceptibility of liquefaction means that about 25% to 100% of the area will liquefy, given a nearby major earthquake that produces PGA at that area of 0.2g or more. Similarly, a zone mapped as having a high or moderate susceptibility of liquefaction means that about 5% to 25% (high) or 1% to 5% (moderate) of the areas will liquefy, respectively, under similar earthquake conditions.

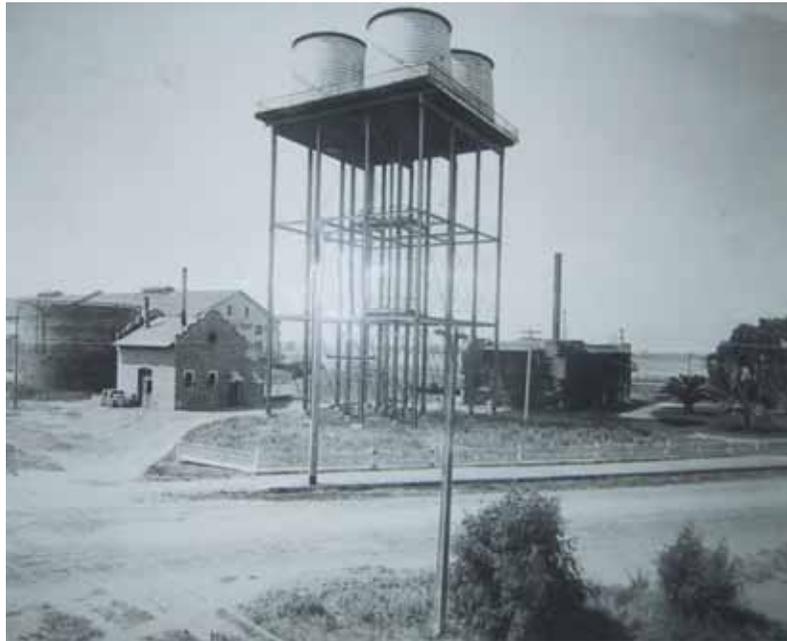
Figure 8. Santa Clara Waterworks and Gas Plant (c. 1905)

The 1906 earthquake exposed the then considerably smaller City of Santa Clara water system to moderate to strong ground shaking. Recorded damage to the Santa Clara water system included the collapse of its water tanks. Figure 8 shows the four elevated wood tanks then in use in the City (pre-earthquake). Figure 9 show the same tank structure, collapsed by ground shaking in the 1906 earthquake.
