# PERFORMANCE OF BURIED HIGH VOLTAGE POWER CABLES DUE TO LIQUEFACTION

John M. EIDINGER<sup>1</sup>

**ABSTRACT:** Buried high voltage power cables failed in many locations in the February 22, 2011 M 6.3 Christchurch earthquake, due to liquefaction. The empirical evidence of these failures is presented. The original design of the cables is considered, and what made the cables so vulnerable. Nonlinear analyses of buried cables are presented to see how they "theoretically" should perform due to liquefaction. Full scale tests are conducted for unreinforced and reinforced buried cable duct banks to examine their relative capability to absorb the effects of liquefaction. Recommendations are made for the design of new buried cables in liquefaction zones.

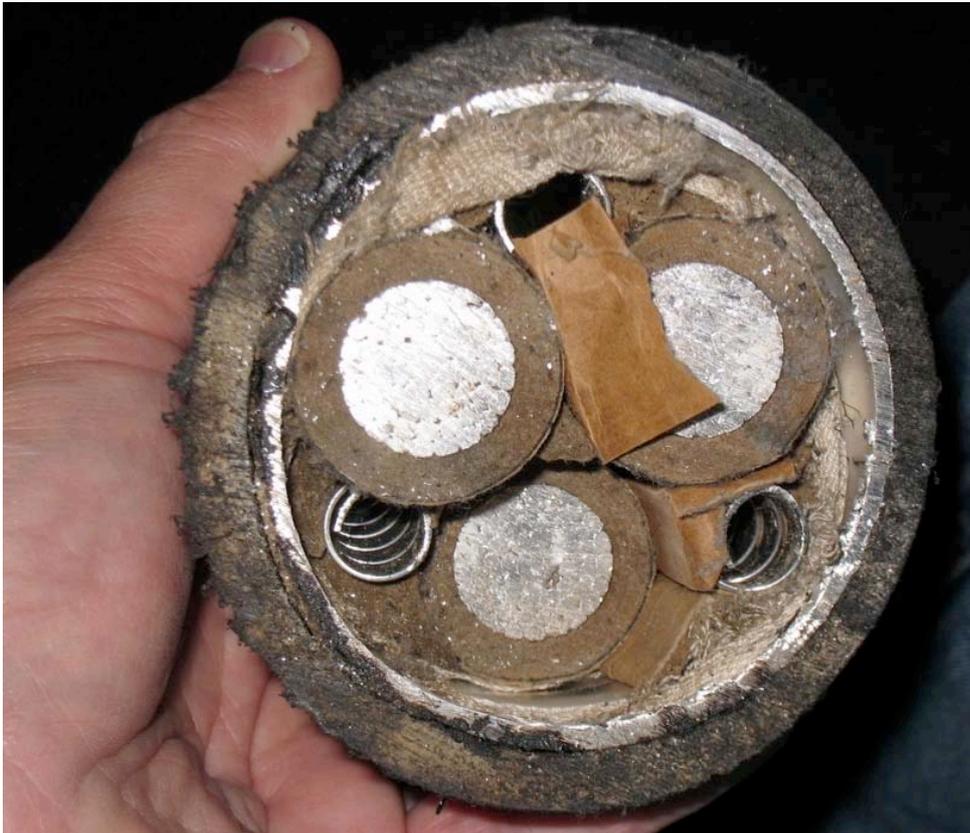
Figure 6. Oil-Type Cable Cross Section

Figure 3 shows failure Location 1. Figure 4 shows the cross section of the trench design used at Location 1, same as used at Locations 2 and 3. In the field, we observed the actual "230 mm cement-bound sand" and "80 mm red concrete cap" to have the consistency of a moderate strength concrete. Native soil in the top 3 meters, surrounding the cables, are typically moderate strength clays / silts, able to withstand a vertical-cut trench wall. Figure 5 Shows the buckled cables, as crews dig them up after the earthquake. Figure 6 shows the cable cross section, comprised of three aluminum phases (300 mm<sup>2</sup>), paper wrapped, with three oil-ducts; all housed within a corrugated aluminum pipe and then with protective plastic outer sheath.

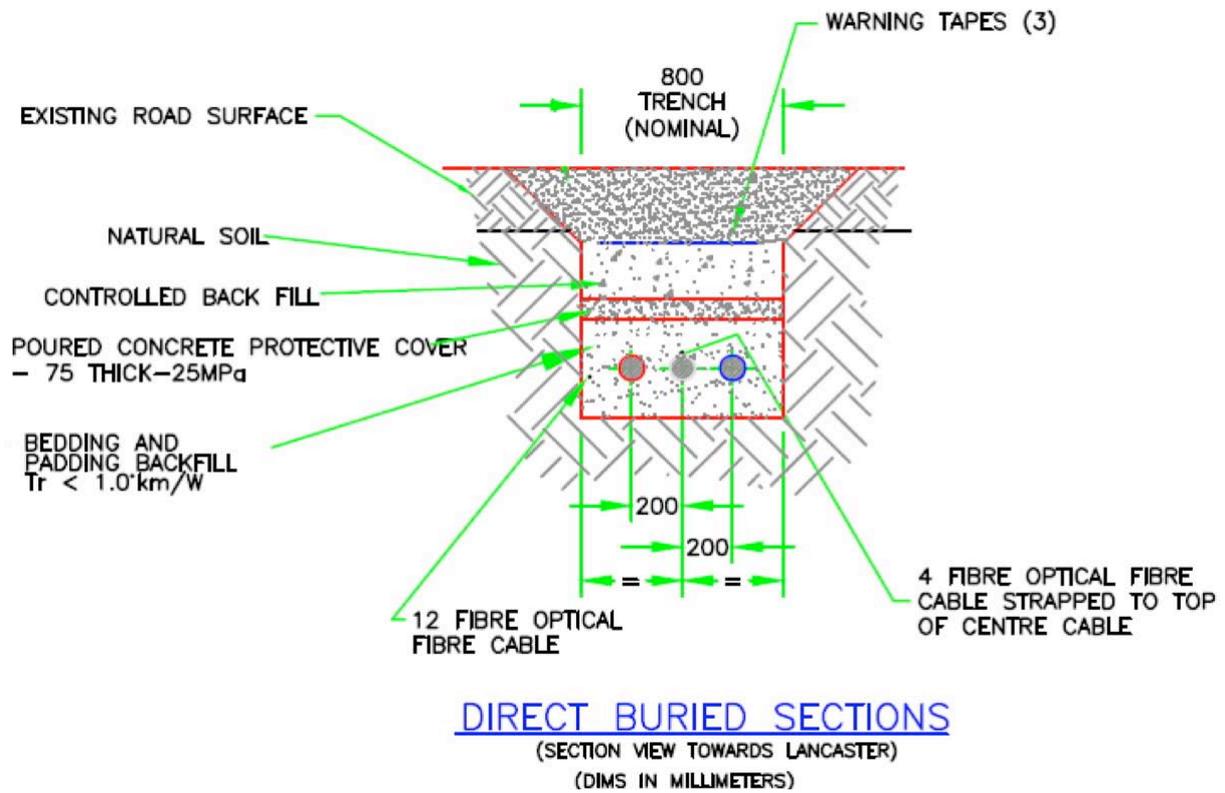
Figure 8. Trench Design 66 kV XLPE-type Cable

The cables used at Locations 4, 5 and 6 are XLPE-type. Cores are 1600 mm<sup>2</sup> copper. Figures 8 and 9 show the typical trench installation and cross section of the cable.
