Maule, Chile M_w 8.8 Earthquake of February 27, 2010

By: John Eidinger, G&E Engineering Systems Inc. Copyright 2010.

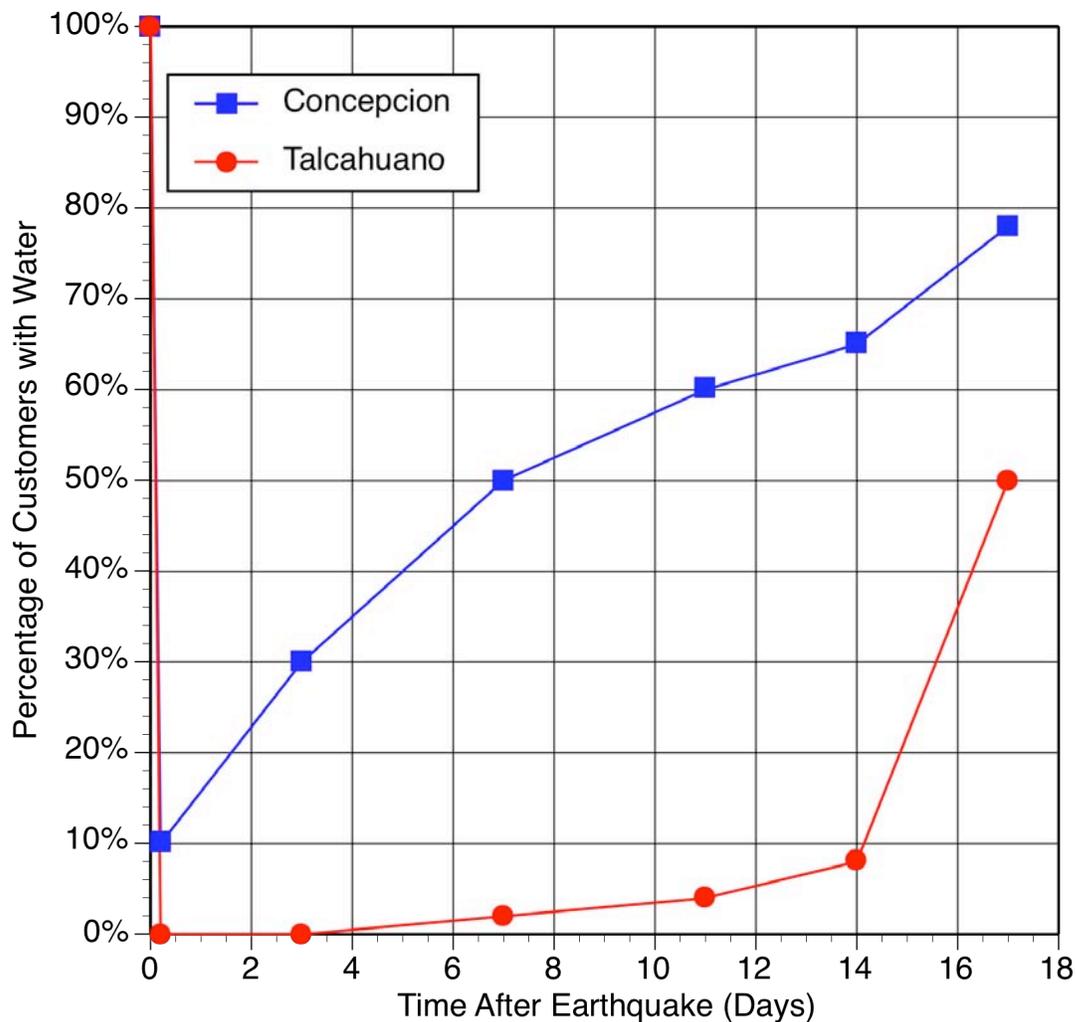
Figure 5. Water Restoration

By far the largest amount of damage to the various Essbio water systems was concentrated in Concepcion and the adjacent community of Talcahuano. Figure 5 shows a plot of the restoration of potable water service for these cities. This plot was developed in conjunction with Essbio, and reflects a preliminary assessment. Water restoration in the Concepcion region was to over 99% of customers able to take water by the first week of April, 2010.

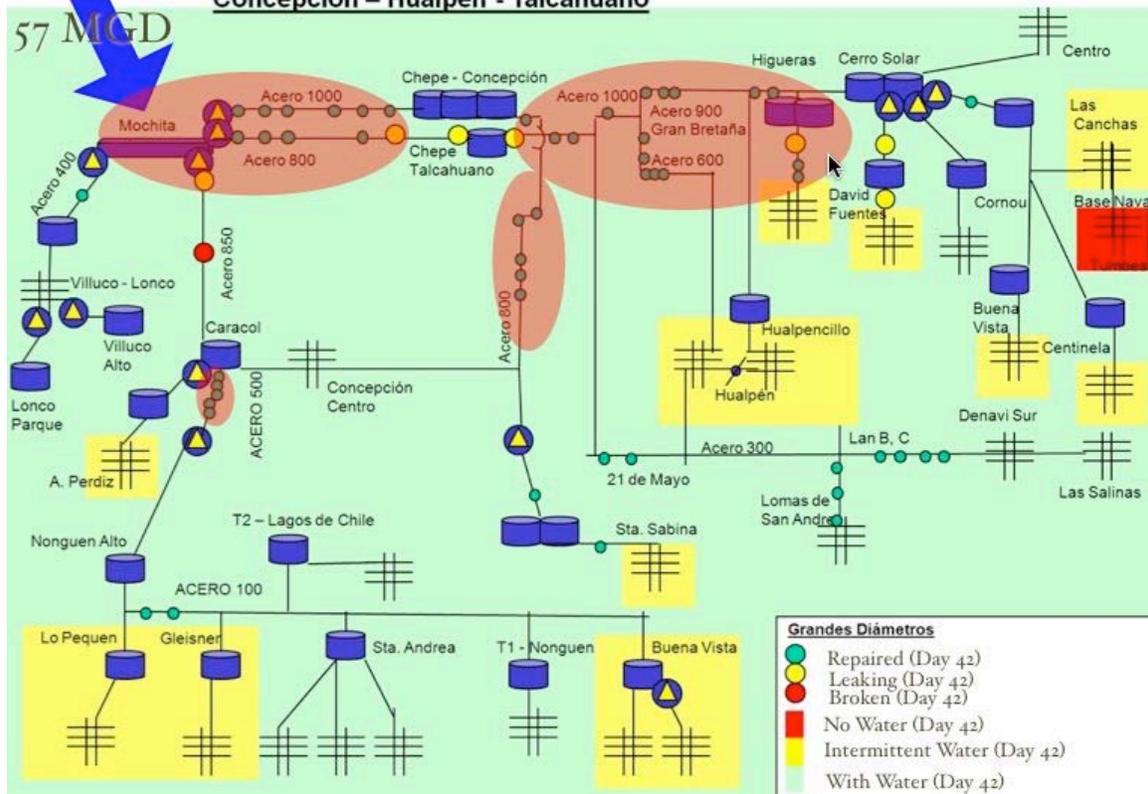
Figure 6. Schematic Diagram for Concepcion and Talcahuano Water Systems

The Concepcion water system includes one water treatment plant (Mochita WTP, estimated PGA = 0.30g to 0.40g), a large pressure zone serving the downtown and nearby low-elevation areas of Concepcion, and a variety of small pressure zones serving hilly terrain. Figures 6 and 7 show the major facilities and pipelines in the water system. In both Figures 6 and 7, red zones indicate areas that experienced liquefaction with corresponding damage to large diameter (16" to 40" diameter) pipes. The small circles in Figure 6 show the schematic locations of individual breaks of larger diameter welded steel water pipes. The solid red zone in Figure 6 schematically shows the continuing water outage at the Naval base just north of Talcahuano. (Note: in Figure 6, "Acero" means welded steel pipe, and diameters are listed in millimeters).

By examining Figures 6 and 7, one sees that every major transmission pipeline from the Machito WTP to the downtown area (heading easterly or northerly) suffered damage immediately after the earthquake. A smaller residential area east of the WTP was able to get water as soon as the emergency generator at the WTP was activated, about 45 minutes after the earthquake.

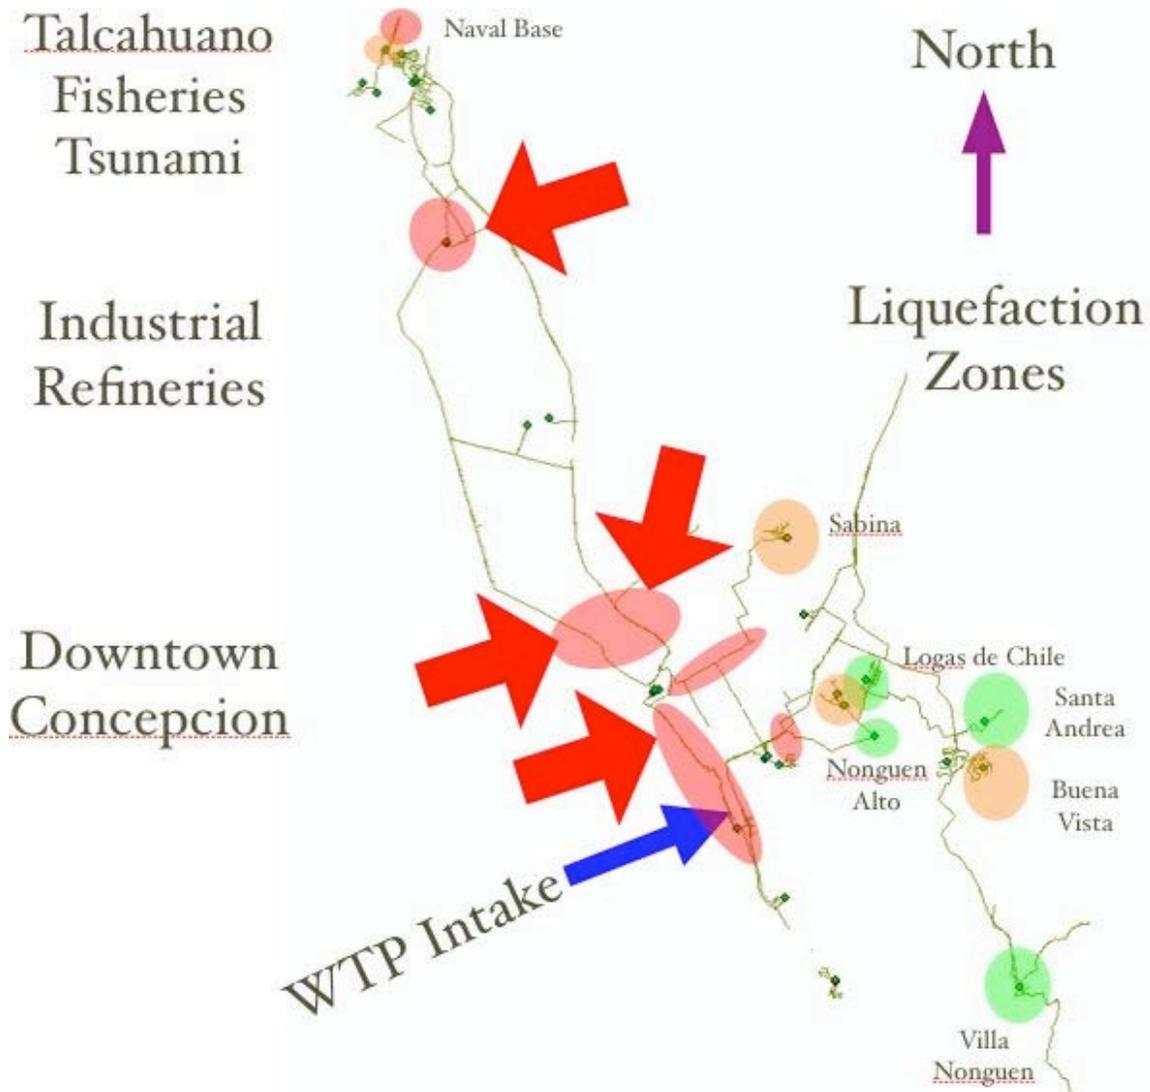
Figure 7. Map of Major Pipes and Liquefaction Zones, Concepcion and Talcahuano

Preliminary evaluations show that the bulk of pipe damage was due to permanent ground deformations (PGDs) induced by liquefaction. Recently installed fusion-butt welded

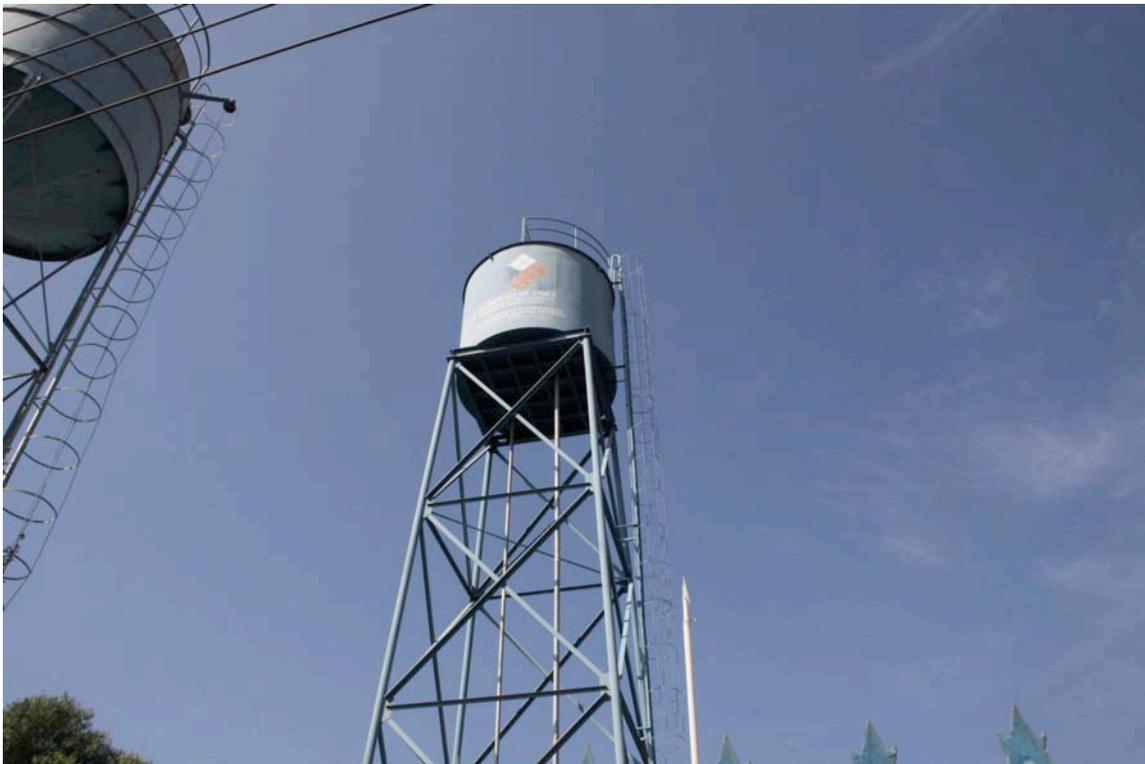
Figure 11. Typical Elevated Small Steel Tank (Constructed 2006)

Figure 11 shows a common elevated steel tank (undamaged). It is estimated that there are more than 1,000 nearly identical tanks situation throughout rural Chile. Figure 12 shows the steel tank resting (it is welded, but the welds cannot be seen in the photo) on a steel beam; and one of the four tubular column-upper frame connections; it is suspected that this bolted beam-to-column connection was the weakest link that led to the many collapses. Figure 13 shows one of the 73 collapsed tanks. It was reported that in a few cases the collapsed tank damaged nearby structures with casualties due to the impacts. We obtained conflicting data as to the total number of such tanks that collapsed; we verified 73, but one official indicated the total was over 400. In any case, we estimate that most (more than 75%) of these types of elevated steel tanks collapsed, if they experienced ground motions of PGA much over 0.25g.

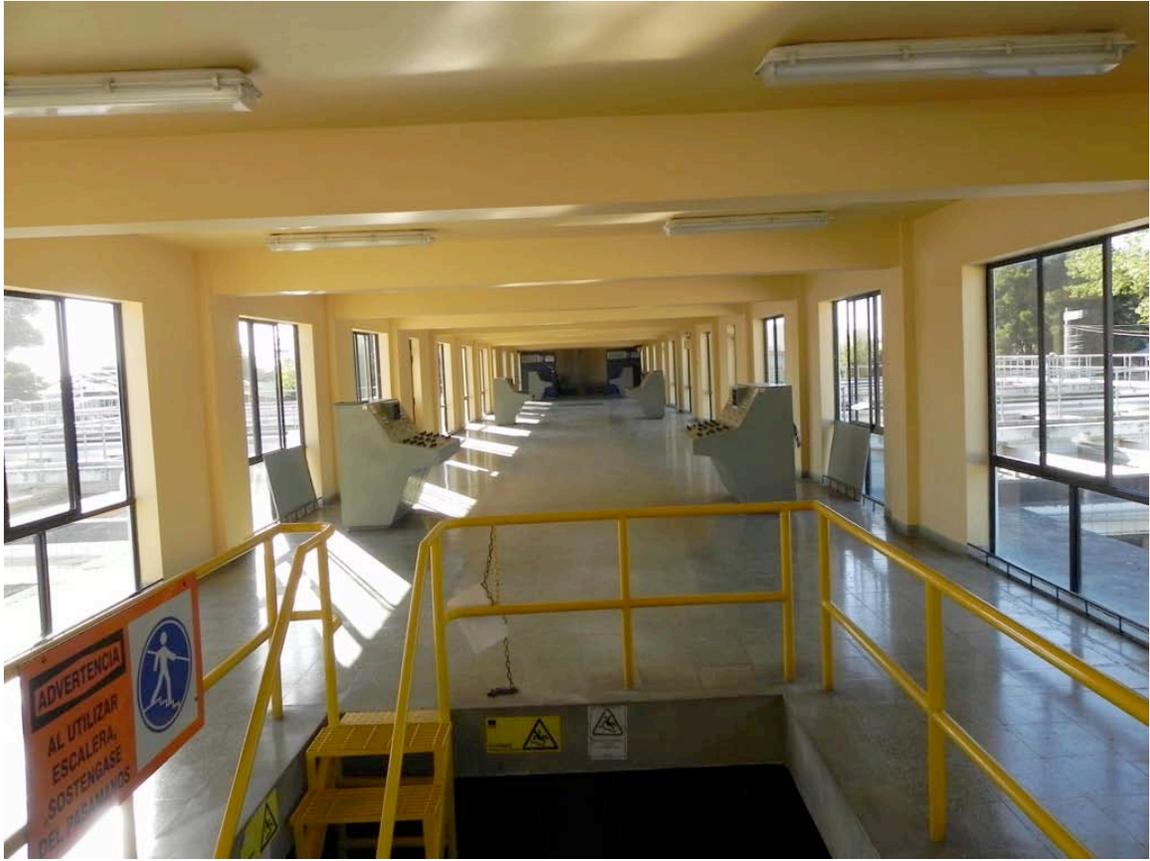
Figure 22. Filter Building Operating Floor

The filter building showed no evidence of structural or nonstructural damage. Figure 22 shows the operating deck floor; none of the control panels had sliding or damage to components within. The building style is reinforced concrete roof supported on columns and beams. We did not observe cracking in the structure. The filters boxes, immediately outside the windows in Figure 22, were not known to have any leakage post-earthquake; nor was there damage to the launders.

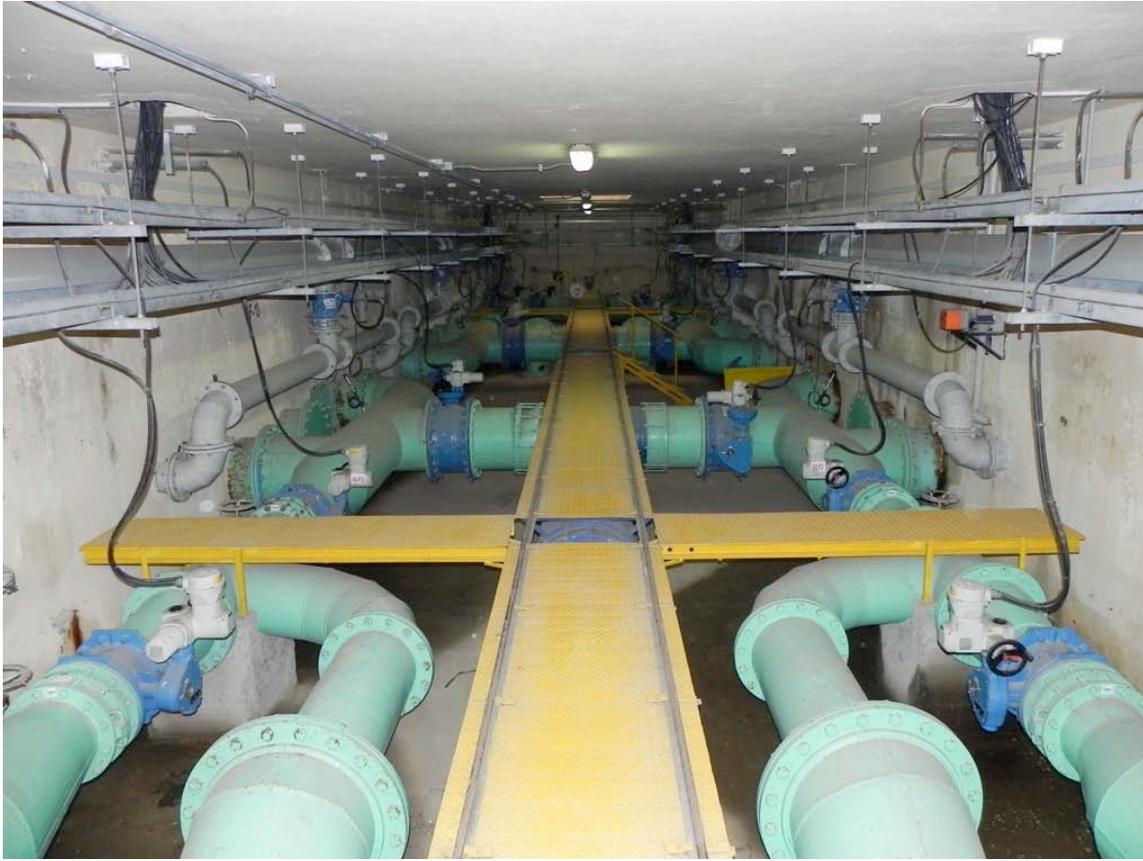
Figure 23. Filter Building Pipe Gallery

Figure 23 shows the pipe galley directly beneath the operating floor seen in Figure 22. There were no leaks of any of the large diameter pipes or damage to any valve or control. Along both sides of the filter gallery are two-level rod-hung cable trays. These cable trays have no lateral supports as would be required by the non-structural provisions of the ASCE 7, IBC, NBCC, SMACNA, NSF13 codes and guidelines; this strongly suggests that these and similar code provisions that proscriptively require lateral bracing of cable trays, conduits, pipes at ~10 foot spans, needs to be re-written. Note in Figure 23 that by providing some flexibility in the cables from the trays, the trays can swing laterally during the earthquake without imposing any distress on the rod hangers or the electrical cables.

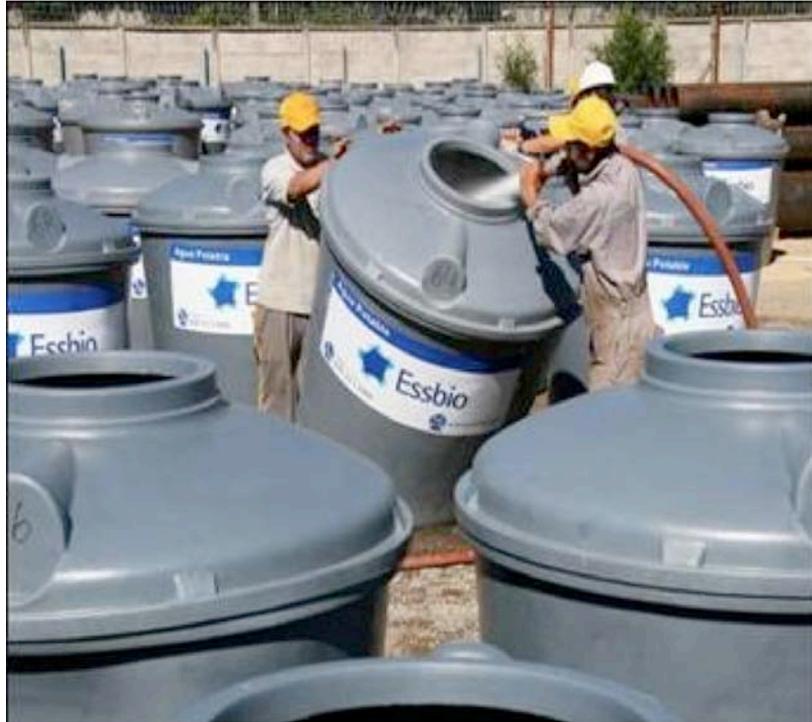
Figure 26. Plastic Tanks Used for Water Distribution

Figure 26 shows some of the nearly 900 plastic tanks used to distribute potable water in and near Concepcion after the earthquake. The tanks would be filled at the Mochita WTP and then truck-driven and dropped off at a suitable distribution point.
