Technical Council on Lifeline Earthquake Engineering (TCLEE)
Report of the
4 September 2010 M_w 7.1 Canterbury (Darfield), New Zealand Earthquake
By: John Eidinger, Alex Tang, Thomas O'Rourke

Summary

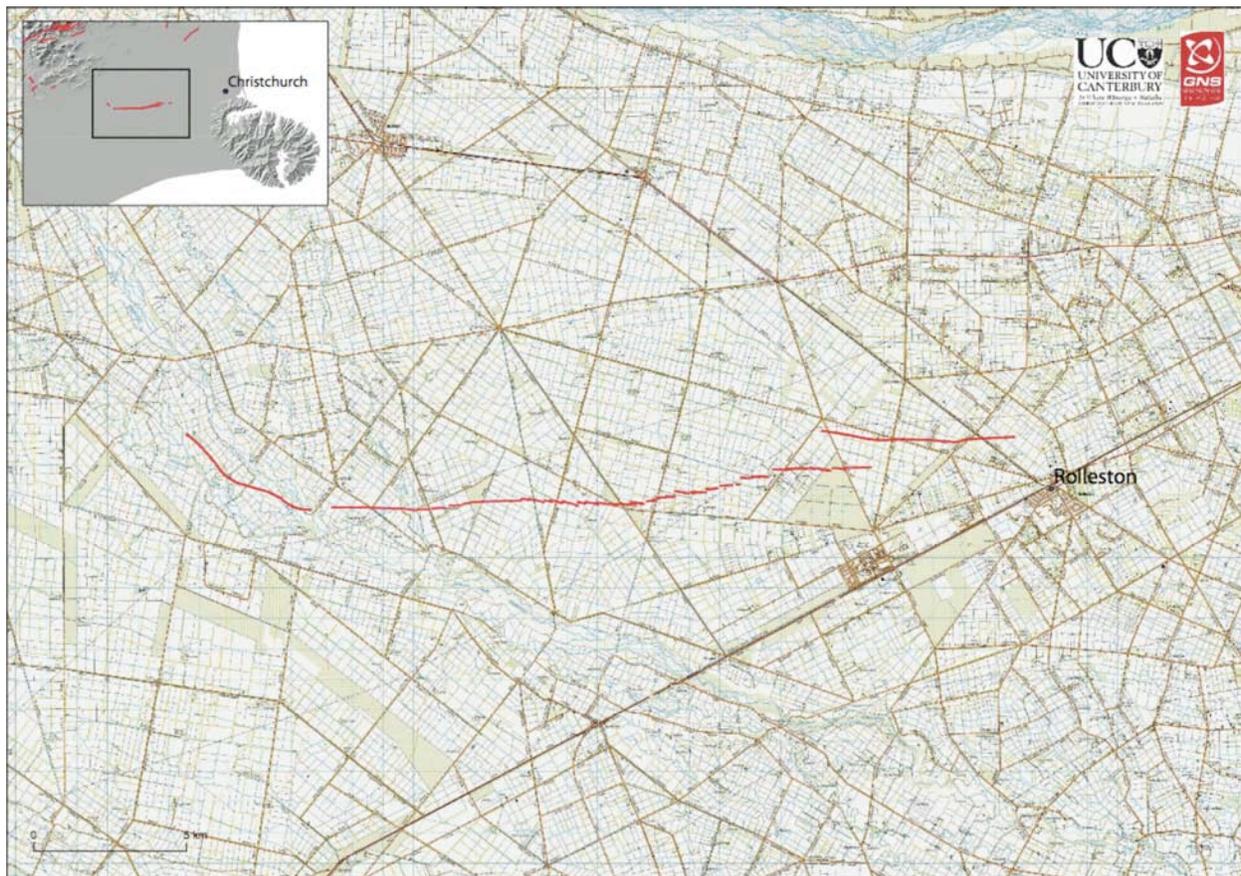
Figure 6. Fault Rupture Map

The earthquake occurred on a previously unknown fault, since named the Greendale fault. The surface rupture of the main shock occurred in an almost east-west direction, extending for about 29 km, see Figure 6. Surface offsets were largely right lateral in nature, ranging up to about 4 meters of right lateral offset near the center of the rupture zone, reducing to about 1 meter of right lateral offset near the tail edges at either end of the rupture zone. The dip of the broken fault over the top 10 km of the crust was nearly vertical. Common width of offset zone was about 10 meters, characterized by a series of en echelon cracks in the ground. In some places, there was

coincident uplift on the south side of the fault of about 1 meter, in other places some uplift was observed on the north side, and in many places there was no coincident uplift. Average right lateral offset over the entire fault length was about 2.3 meters.

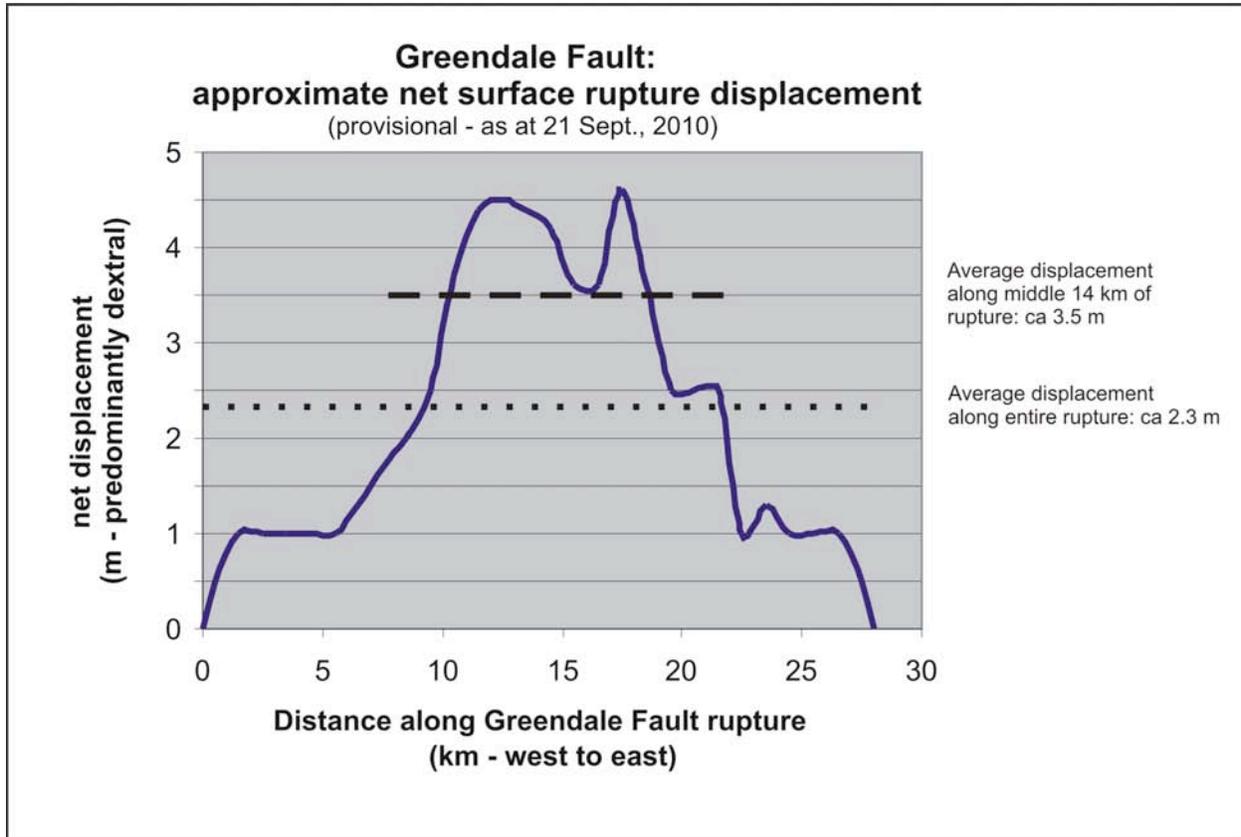
Figure 7. Measured Fault Offset

These offset amounts are the cumulative amounts as of about September 21, 2010 (Figure 7). Almost without doubt the original offset was lower than these values, and there was ongoing aftershock creep that was leading to increasing amounts of total offset; as evidenced by the need to reset train track rails over the fault, multiple times, in the weeks after the earthquake.

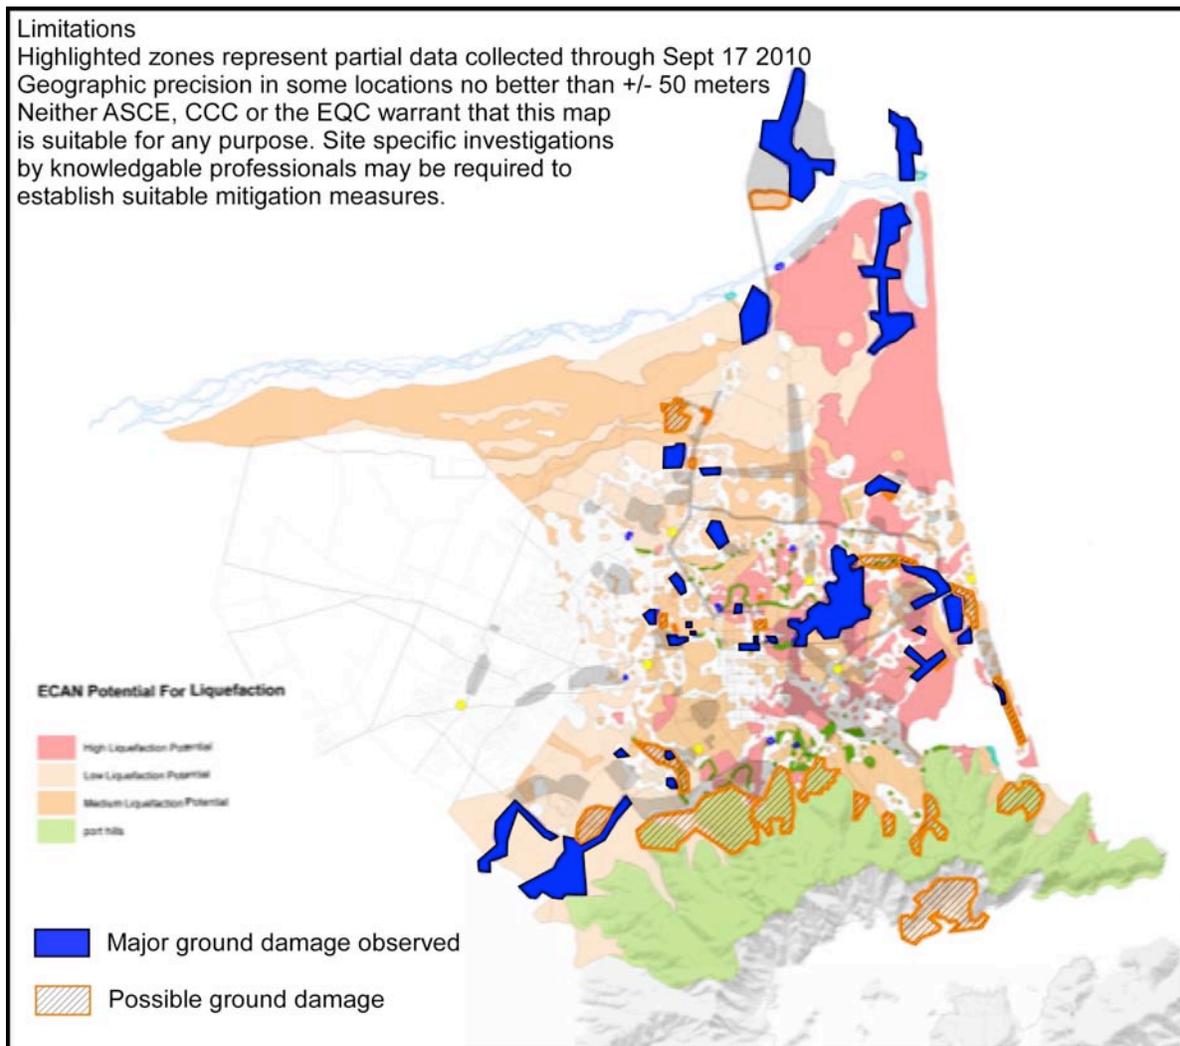
Figure 11. Map Showing Observed Major (Blue) or Possible (Diagonal) Ground Deformation

Of particular interest in Figures 3, 10 and 11 are that only a portion (about 5% to 10%) of the Christchurch and Springston Formations (Figure 3) or the "red" zones (Figure 10) actually did liquefy to the extent to produce observable major ground deformations. This may be in part due to the relatively short duration of strong ground shaking in this earthquake (perhaps 8 seconds or so) coupled with site specific geologic and ground water conditions. Other indications suggest that the zones that did have major ground deformations represent soils which have the highest liquefaction susceptibility; the remaining areas still remain a liquefaction threat in future larger or longer duration earthquakes (Misko Cubrinovski, personal communication, 2010). Maps prepared by the water and wastewater utilities showing actual locations of damaged buried pipes will likely be substantially more accurate indicators of permanent ground displacements, as the broken pipes act like "gages" to show locations of high ground strains.

It is evident from Figure 11 that the earthquake triggered widespread liquefaction in Christchurch and surrounding communities (blue zones). Sand boils were a common site. Many of these areas had been developed as single family residential communities, with the most common type of building being wood frame single-story atop concrete slab-on-grade. An estimated 2,900 structures in these blue zones were exposed to some type of settlements, and a portion of these were also exposed to lateral spreads. Estimated permanent ground settlements ranged from about 5 cm (2 inches) (perhaps a third of affected structures) to 10 cm (4 inches) (perhaps another third of affected structures). The remaining third of affected structures were exposed to a combination of settlements and lateral spreads; the spreads ranged from a few inches to as much as 1 meter (3 feet) or so.

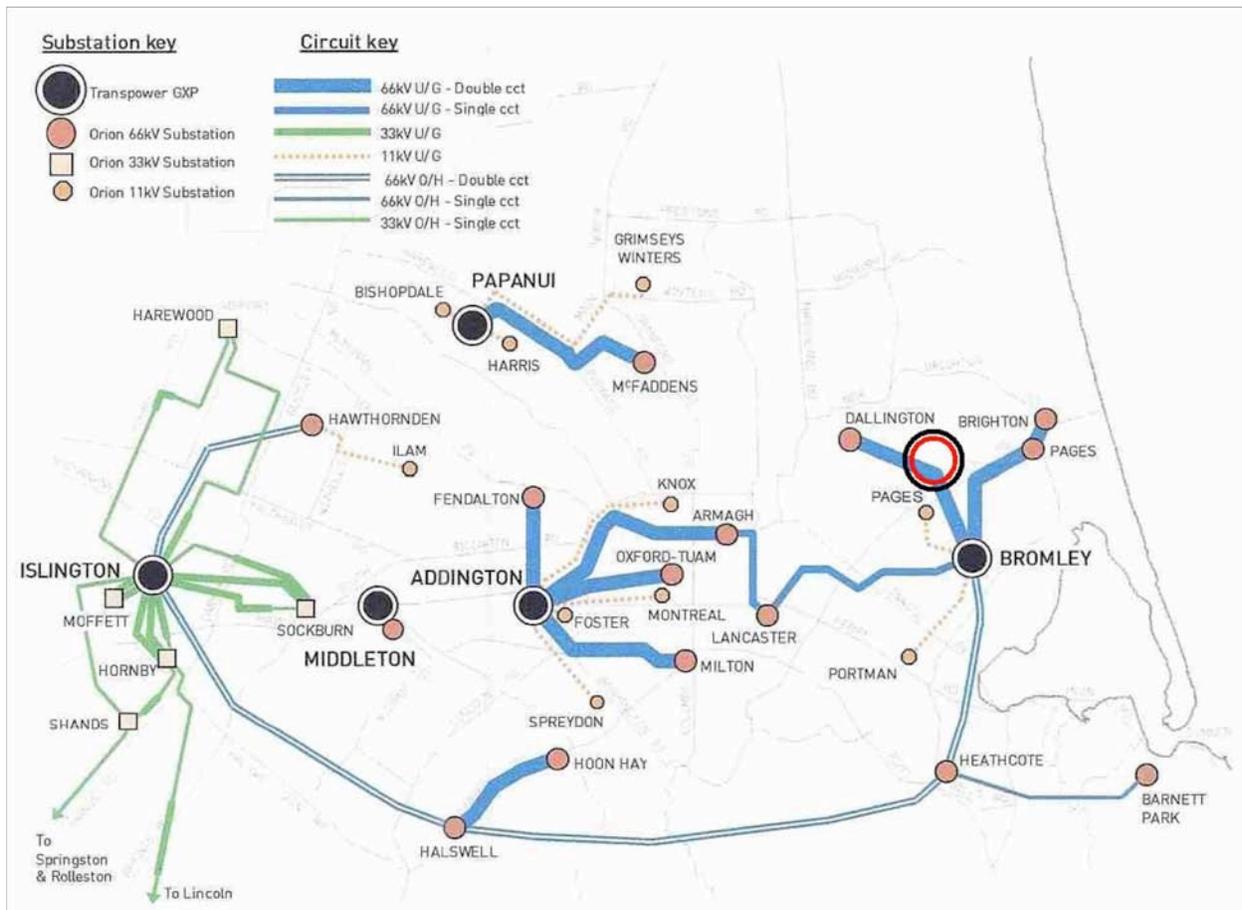
Figure 19. Orion System

Figure 19 shows the main transmission lines of the Orion system. The circled location on the Bromley-Dallington double circuit 66 kV line was damaged due to settlement and lateral spread.

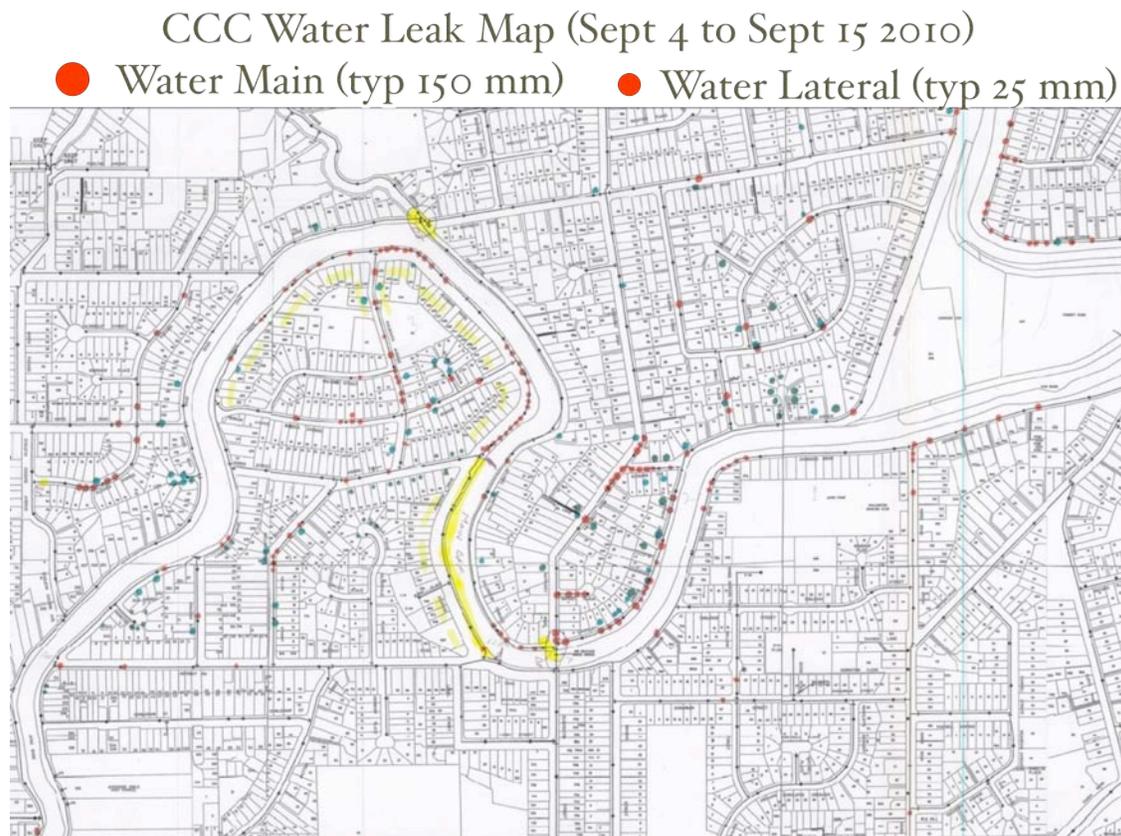
Figure 25. Map of Water Pipe Repairs, Christchurch City Council, as of September 15, 2010 (partial)

Through mid-October, 2010, the CCC had spent about \$12 million on repairs to water and wastewater pipes. A much higher cost will be required to completely restore CCC's water and wastewater systems entirely. CCC staff estimate that as much as 25 km of potable water will have to be eventually replaced entirely; the location of these replacements coincides with the zones that underwent substantial liquefaction-caused settlement or lateral spread.

Through October 14, 2011 (6 weeks post-earthquake), there have been (so far) about 280 repairs made to CCC water pipes and their service connections; most of these repairs were in the liquefaction zones. Most of the water pipes were repaired within 6 days post-earthquake. There were no reports of disease due to water quality impacts, and post-earthquake water sampling tests showed no contamination in the water system in Christchurch.

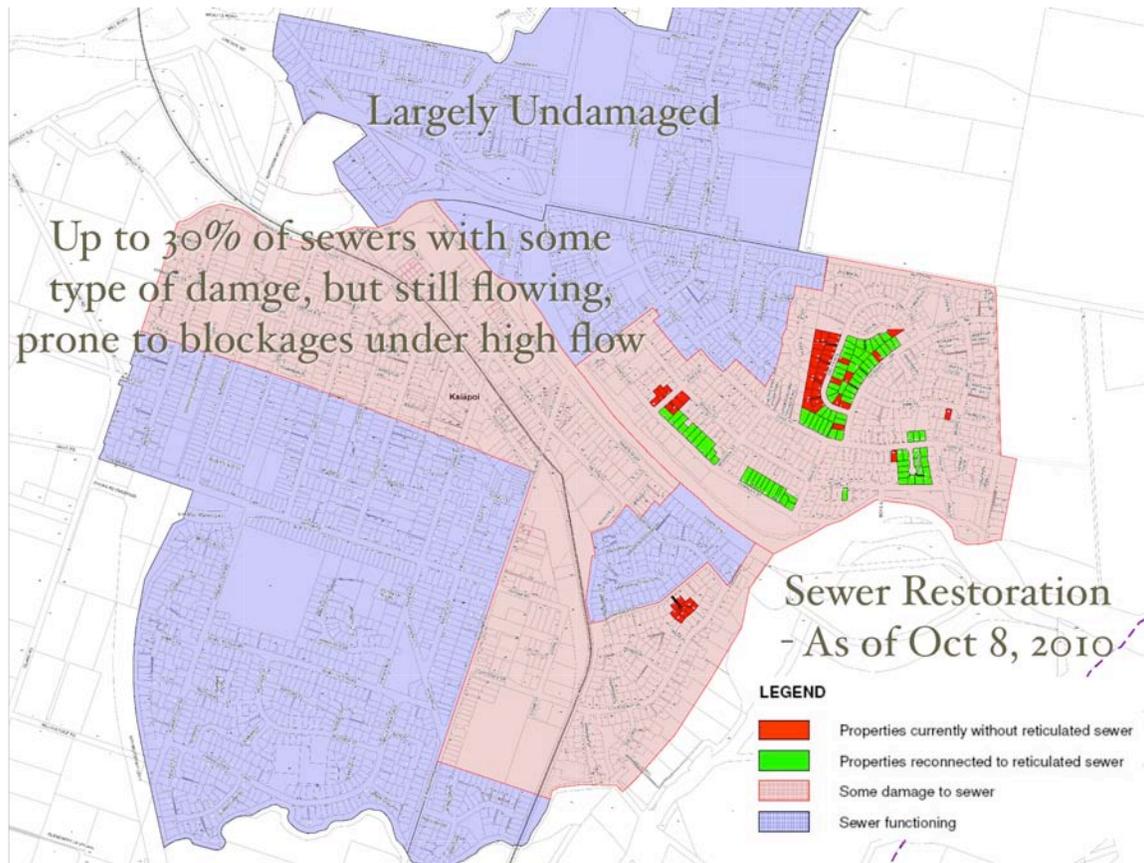
Damage to sanitary sewers (Figures 29, 30) in many places led to direct discharge of untreated sewage into local rivers, leading to contamination warnings. Damage to the sewers has also resulted in substantial inflows of silts, leading to clogging of sewers, as well as infiltration of water. Figure 31 shows a map for Kaiapoi highlighting where the wastewater collection had failed and portable toilets were still in use 6 weeks after the earthquake; more than 200 structures were also so-affected in Christchurch.

Figure 30. CCTV picture of Broken Sewer, MDC
