Seismic Fragility of Natural Gas Transmission Pipelines and Wells

G&E Engineering Systems Inc.

November 14 2021 | Revision 4

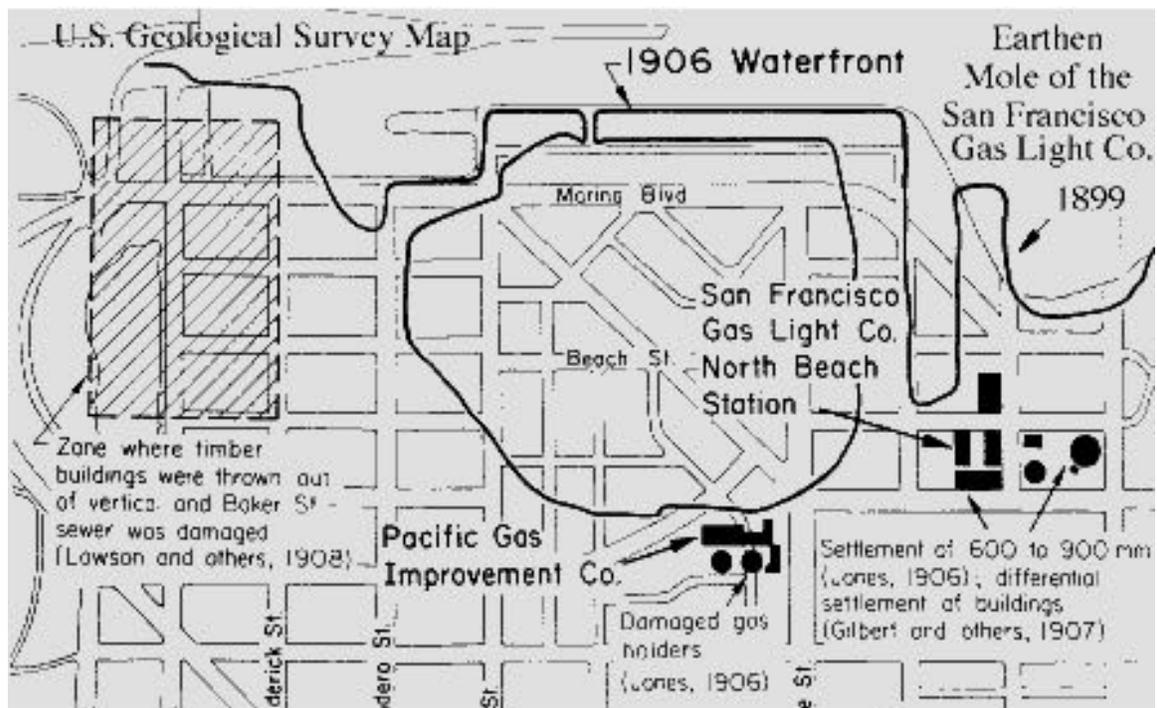
Figure 6.1-3. Locations of PGIC and SFG&E Gas Plants, San Francisco 1906

The earthquake damaged the North Beach Station (Figures 6.1-2, 6.1-3), where liquefaction resulted in settlements locally on the order of 2 to 3 feet. A gas holder station and storehouse at Fifth and Tehama Streets were destroyed by the fire (this gas holder was located within Sullivan Marsh, and probably also subject to liquefaction). The gas plants at Potrero and Martin were subject only to ground shaking, and had little damage.

At Pacific Gas Improvement Co. (Figure 6.1-3), sometime before 7:00 am, the gas had been shut off at the inlet and outlet of the holders. Holder No. 3, with a capacity of 700,000 cubic feet, had slight damage; Holders 1 and 2, each with 325,000 cubic feet capacity, were so badly damaged that the gas escaped.

At the North Beach Station (Figure 6.1-3), the gas was shut off at the inlet of the meter, and the valves were closed at the inlet of the 2,000,000 cubic foot storage holder. The 24-inch outlet pipe connections of this holder were broken off between the holder and the outlet valves, so the holder could not be isolated and the gas leaked out. The valves on the damaged 24-inch pipe were closed, and this prevented gas coming from Potrero to leak out from this location. This report suggests that the 36-inch cast iron pipe that ran between the Potrero and North Beach stations was, in itself, largely undamaged by the earthquake at this point in time (it was later damaged by explosions). As a 36-inch cast iron pipe of the style of construction likely circa 1905 or so cannot take much PGD, this suggests that this 36-inch pipe alignment traversed stable soils.

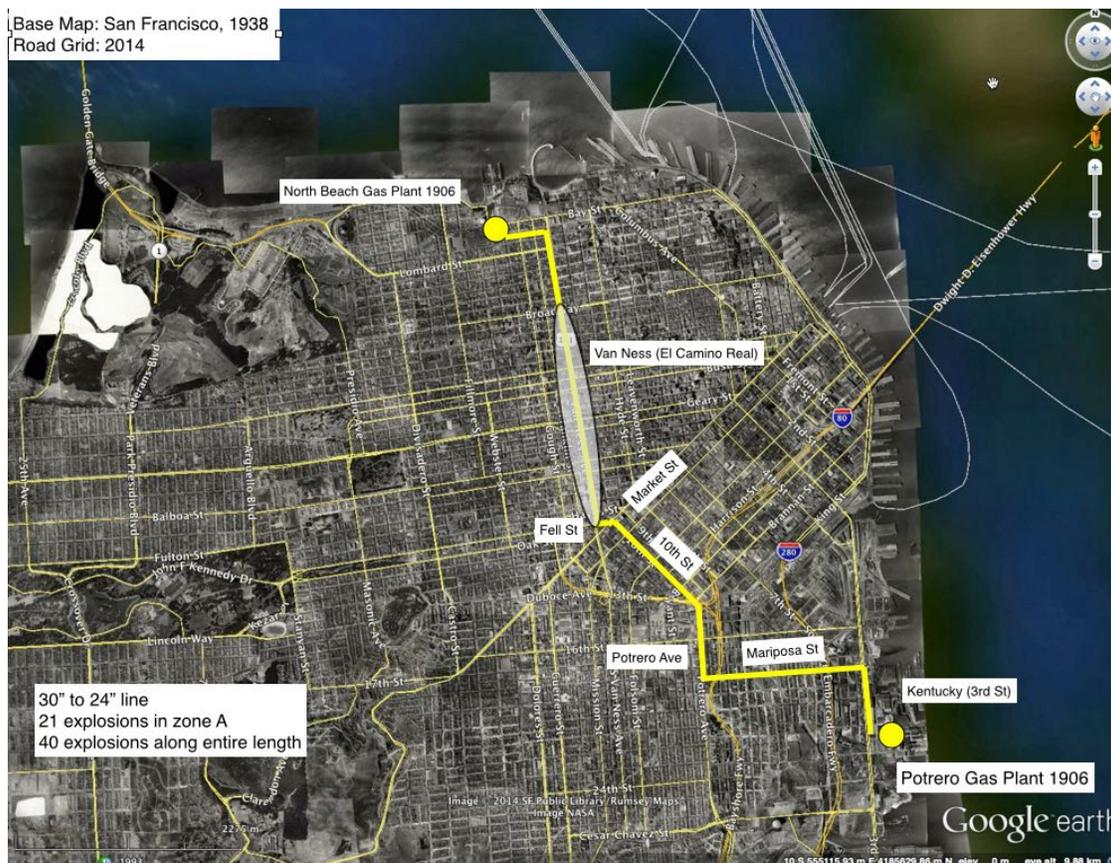
Figure 6.1-4. Map Showing Gas 30"-24" Main, Potrero to North Beach, 1906

Between April 18 and 20, there were successive explosions in the underground gas pipes linking the Potrero and North Beach gas plants. On the 30-inch gas main (Figure 6.1-4), running from Potrero works on Kentucky row (now Third Street), Mariposa, Potrero Avenue, Tenth, Market, Fell to Van Ness Avenue, along Van Ness to Broadway, there were 21 explosions in Zone A (highlighted by the elongated oval). In nearly every case the explosion took place at a line drip or cross, where the main was weakest, and the earth around the main was thrown up, leaving openings of various sizes up to 12 foot wide and 30 feet long. Along the 24-inch main linking the two stations, there were as many as 40 breaks due to explosions. Fortunately, these explosions caused no damage to life or property (according to a PG&E worker; but other accounts suggest many injuries in the South of Market area).

One possible reason for the gas explosions was that there remained many gas stoves in the city being used in the days after the earthquake, relying on the residual gas in the gas pipes. With damage to the gas pipes, air entered into the pipes, and the use of the gas stoves allowed ignitions / burning fuel to back up into the mains; the traveling wave of the burning fuel backup until it found a weak spot in the gas main.

In reviewing the gas pipe alignment in Figure 6.1-4 its alignment is shown along 10th Street through the South of Market area. There were also several water pipe breaks along 10th Street. Over the past decade, the author as well as various PG&E engineers have tried to locate a 1905-era map of PG&E's historic gas mains, to verify / validate the location of the historic 36-inch (variously 24-inch to 30-inch) gas pipe between Potrero and North Beach and other infrastructure; nobody yet has been able to find such a map. Considering these two inconsistent findings (36-inch gas main with no damage; much damage to adjacent water pipes), the assumed location of the gas main pipe in Figure 6.1-4 might not be correct.

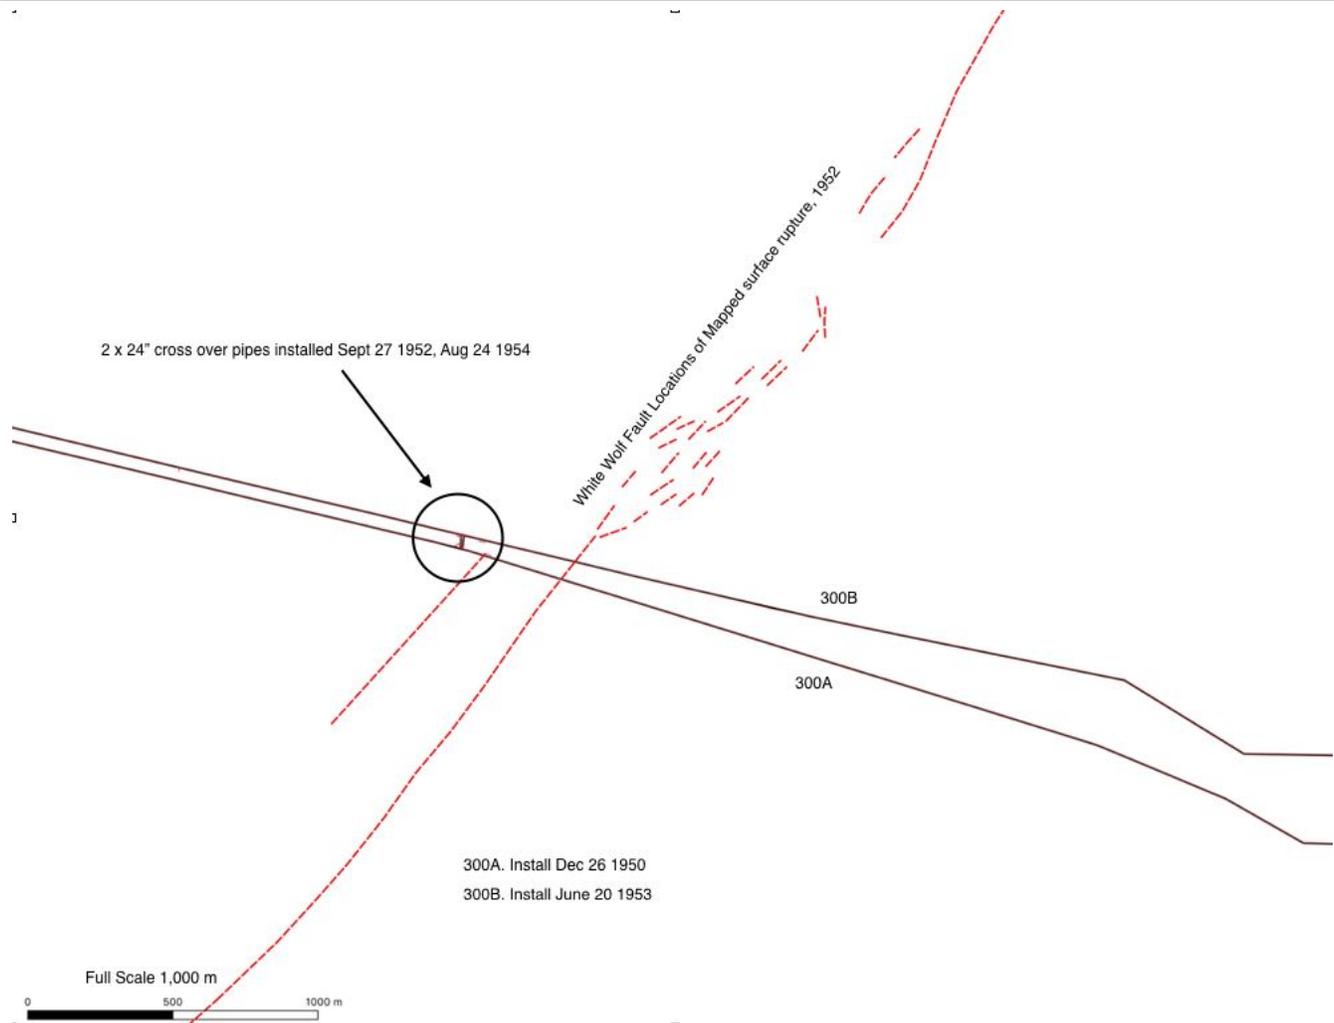
Figure 6.2-1. Gas Transmission Pipes (black lines) at the White Wolf Fault (red lines).

Figure 6.2-1 shows a closeup of the White Wolf fault crossing location. This shows the current (2020) pipe alignments and names, and the mapped traces of the surface rupture of the White Wolf fault (red dashed lines). The main trace (northeastward strike) crosses the Line 300A 34-inch transmission line as shown in the main map.

- Line 300 crossed the main trace of the fault (Figure 6.2-1). The earthquake effects were noticeable for 43 miles along the Line 300 alignment.
- Personnel were dispatched along Line 300 to establish radio communications between the Hinkley and Kettleman compressor stations. Pipeline employees patrolled Line 300 on foot and by vehicle.
- Patrolmen found telephone wires wrapped around each other where cross arm constructed had been used. These were repaired by 12:35 pm July 21.
- The Patrolmen noted that there were many landslides / ground cracks near or crossing Line 300. No leakage or pipe damage to Line 300 was encountered.

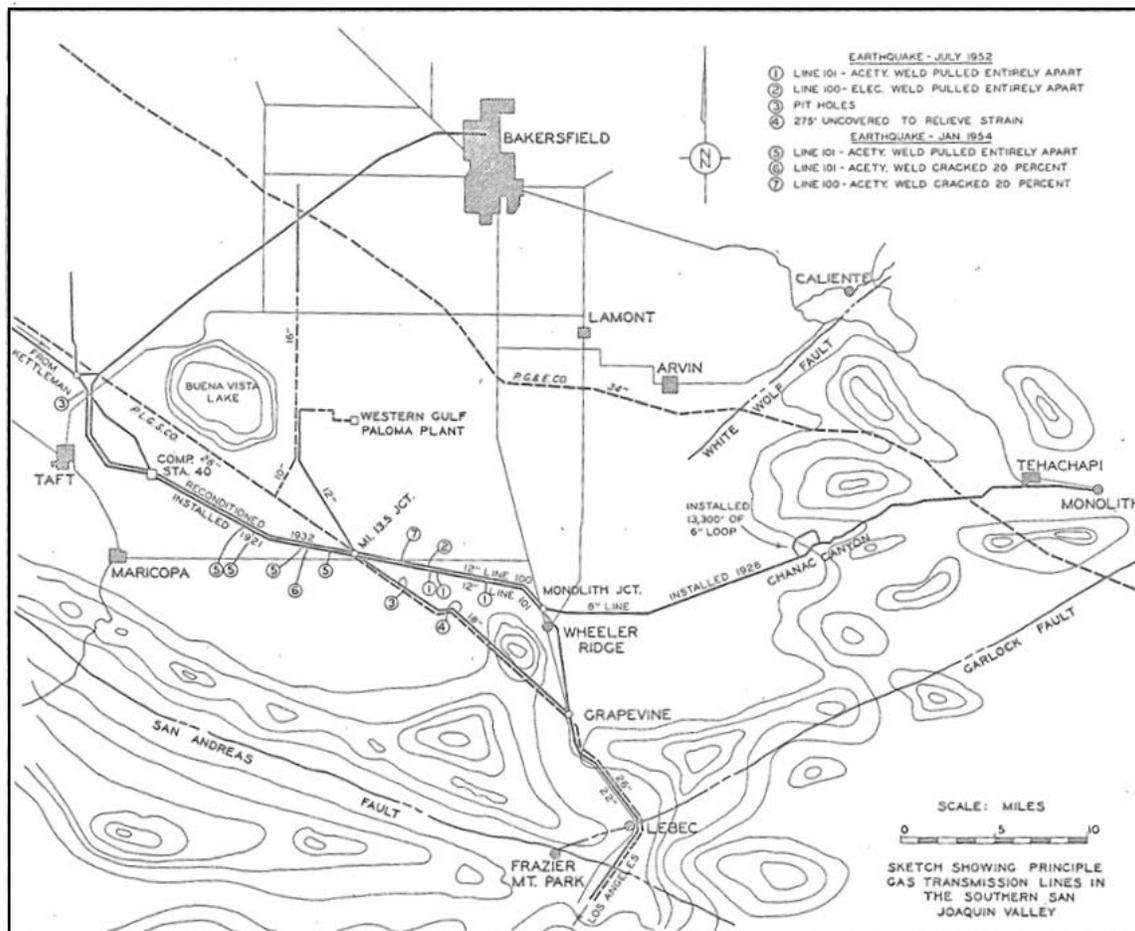
Figure 6.2-2. Gas Transmission Pipes, SoCalGas, 1952 White Wolf Earthquake (after Newby, 1954)

Mr. A. B. Newby described the damage to the SoCalGas pipeline system in the 1952 earthquake and nearby smaller 1954 earthquake in his report (1952). Figure 6.2-2 shows a map of the various SoCalGas facilities affected in the 1952 M 7.3 earthquake and the smaller January 12, 1954 M 5.9 earthquake in this area.

Reports suggested that everything was intact except between Mile 13.5 Junction and Monolith Junction (see Figure 6.2-2 for locations). In this reach:

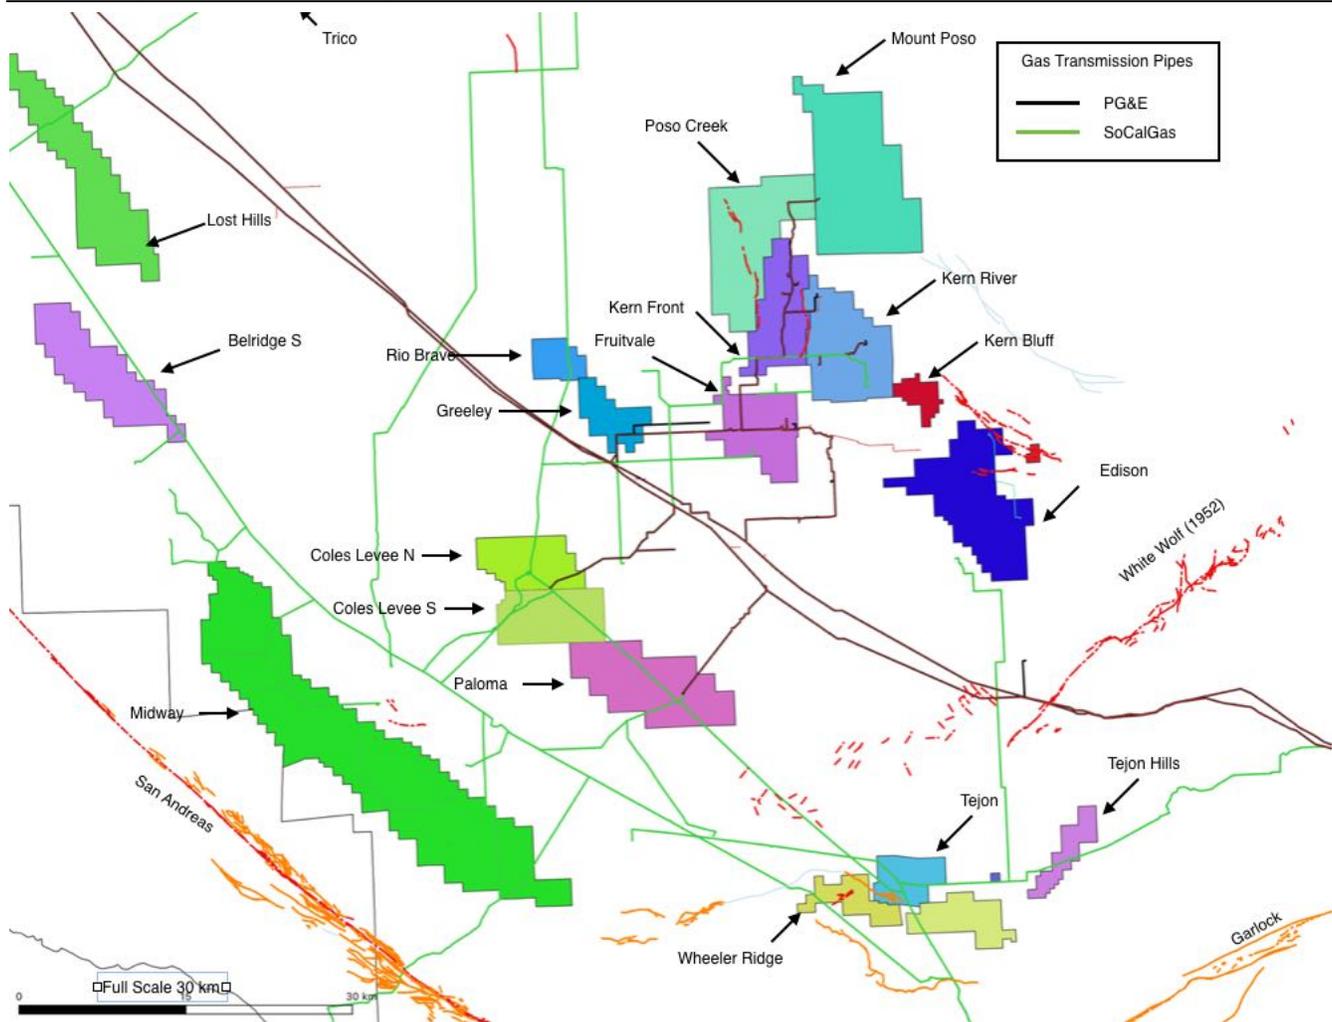
Figure 6.2-3. Well Fields, Near White Wolf Fault

Figure 6.2-3 shows the administrative boundaries of the gas well fields near the white Wolf fault rupture (red lines). The nearby Garlock and San Andreas faults (orange, red lines) are also shown. In the following paragraphs, the damage at gas wells is noted; the PGA levels are very approximate, factoring in attenuation functions; with the exception of one strong motion instrument in the town of Taft (PGA = 0.22g), there were no strong motion recordings in this earthquake.

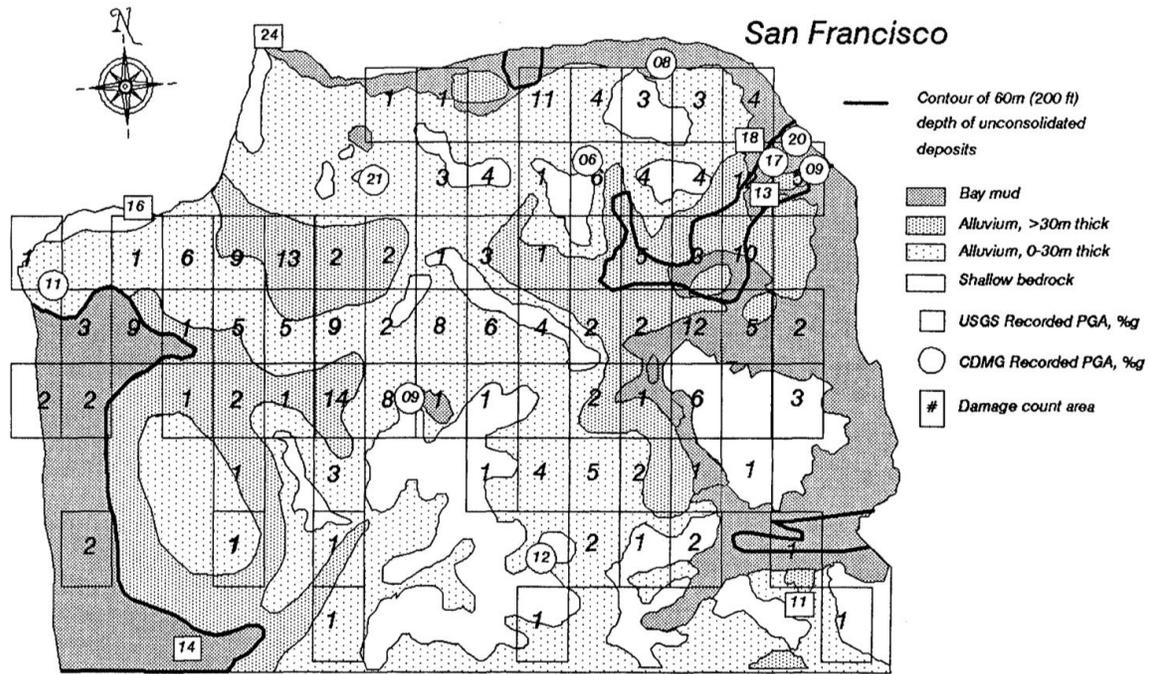
Figure 6.10-3. Location of Leak Repairs in Northern San Francisco

After the earthquake, USGS published a report on the performance of the built environment (Honegger 1991). Figure 6.10-3 shows a map of 302 leaks in San Francisco. The boxes represent plats, and are about 1,700 feet long (north-south) and 1,100 feet wide (east-west).

- The leak data reported in Figure 6.10-3 was based on paper maps for the period October 17 – 31 1989, and reflect only leaks with noticeable odor. The 302 leaks in San Francisco reported in Figure 6.10-3 included:

- 31 repairs to mains (3 steel, 27 cast iron, 1 plastic)
 - 271 repairs to service laterals (241 steel, 10 plastic, 20 copper)

Notes for Figure 6.10-3: Horizontal PGA is shown in circles as percent g; the number of repairs in each plat box is shown in bold numbers; surface geology per CDMG. Map is after (Honegger 1991).

About 90% of the leaks in Figure 6.10-3 were on service laterals and about 10% on distribution mains.

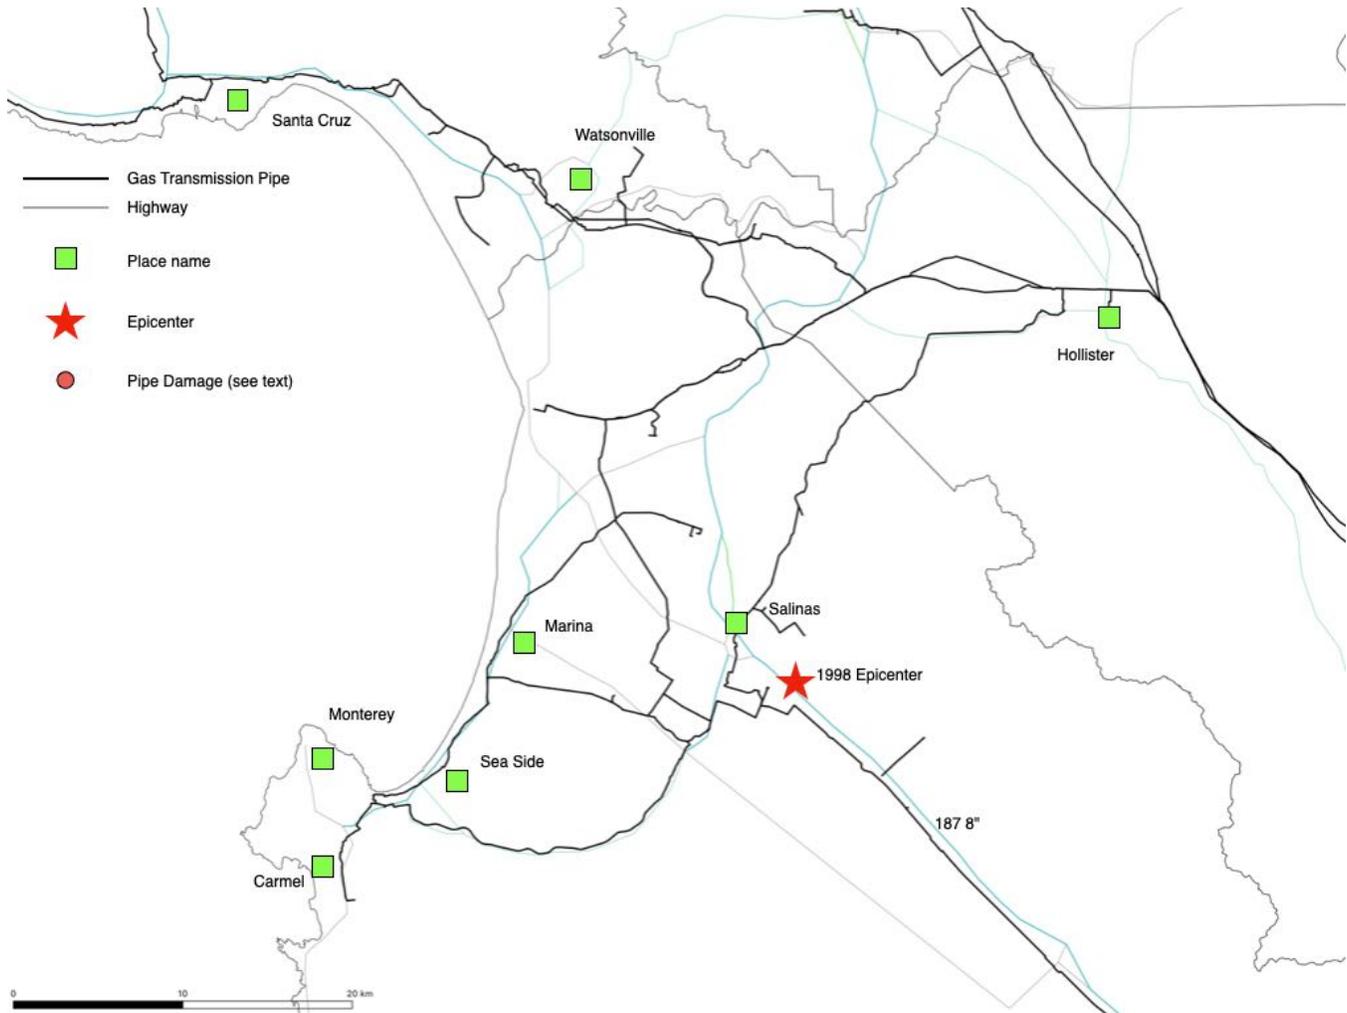
Figure 6.12-1. Gas Transmission and Distribution System Near Salinas

There was 1 reported leak in the gas transmission system in the vicinity of Salinas. This occurred more than 3 weeks after the earthquake, near the red dot shown in Figure 6.12-1. The leak was on Line 187 (8-inch steel pipe), and the cause was described as TPD (Third Party Damage).

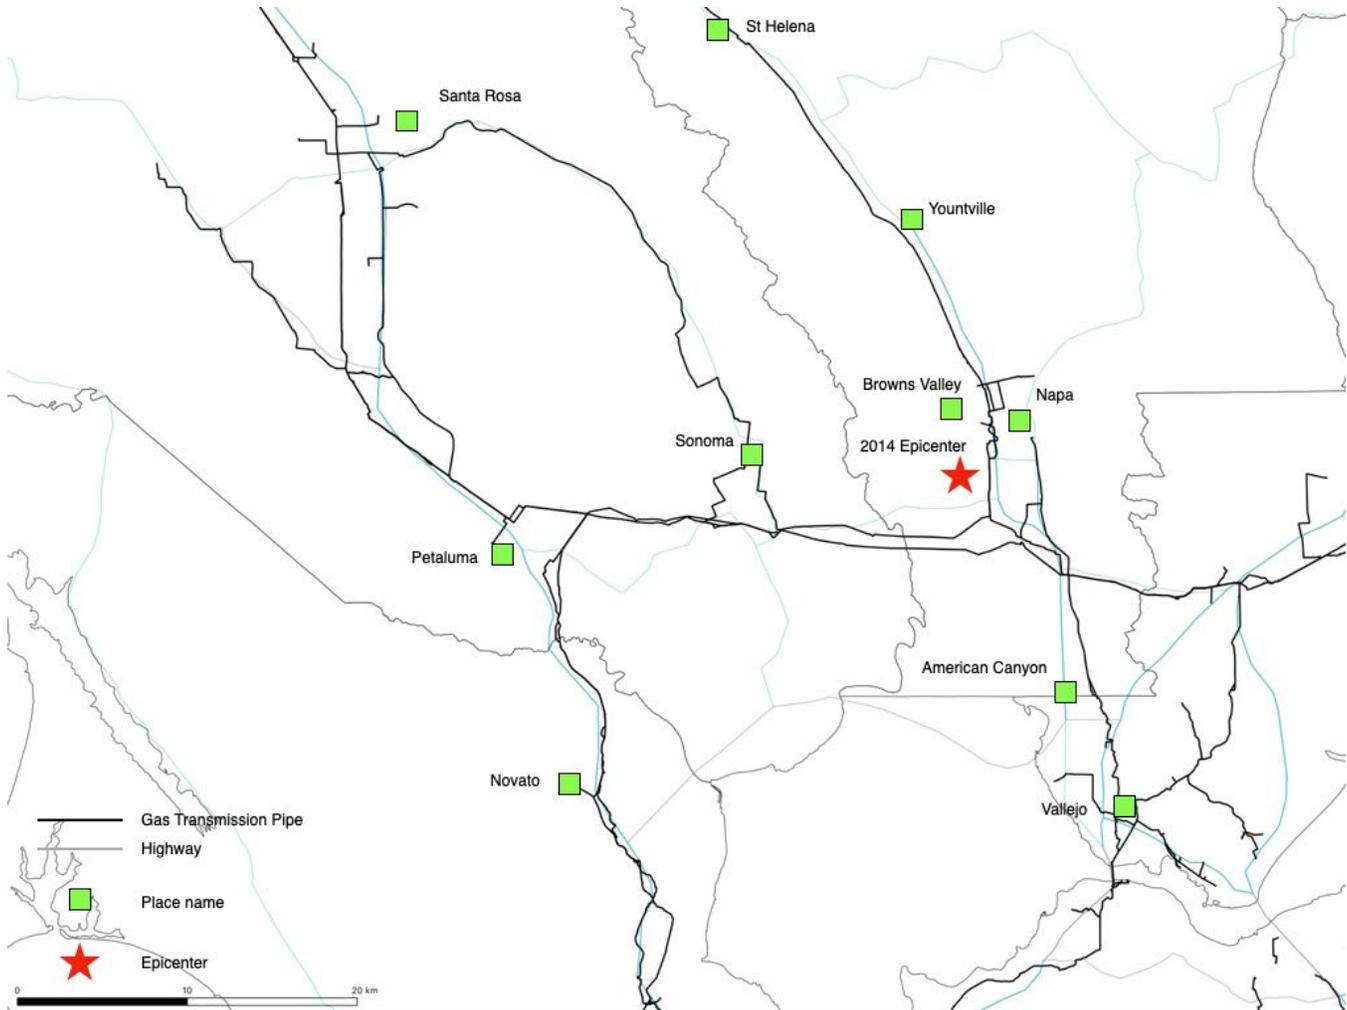
Figure 6.17-1. Gas System near Napa

There were no leaks in the gas transmission system shown in Figure 6.17-1.

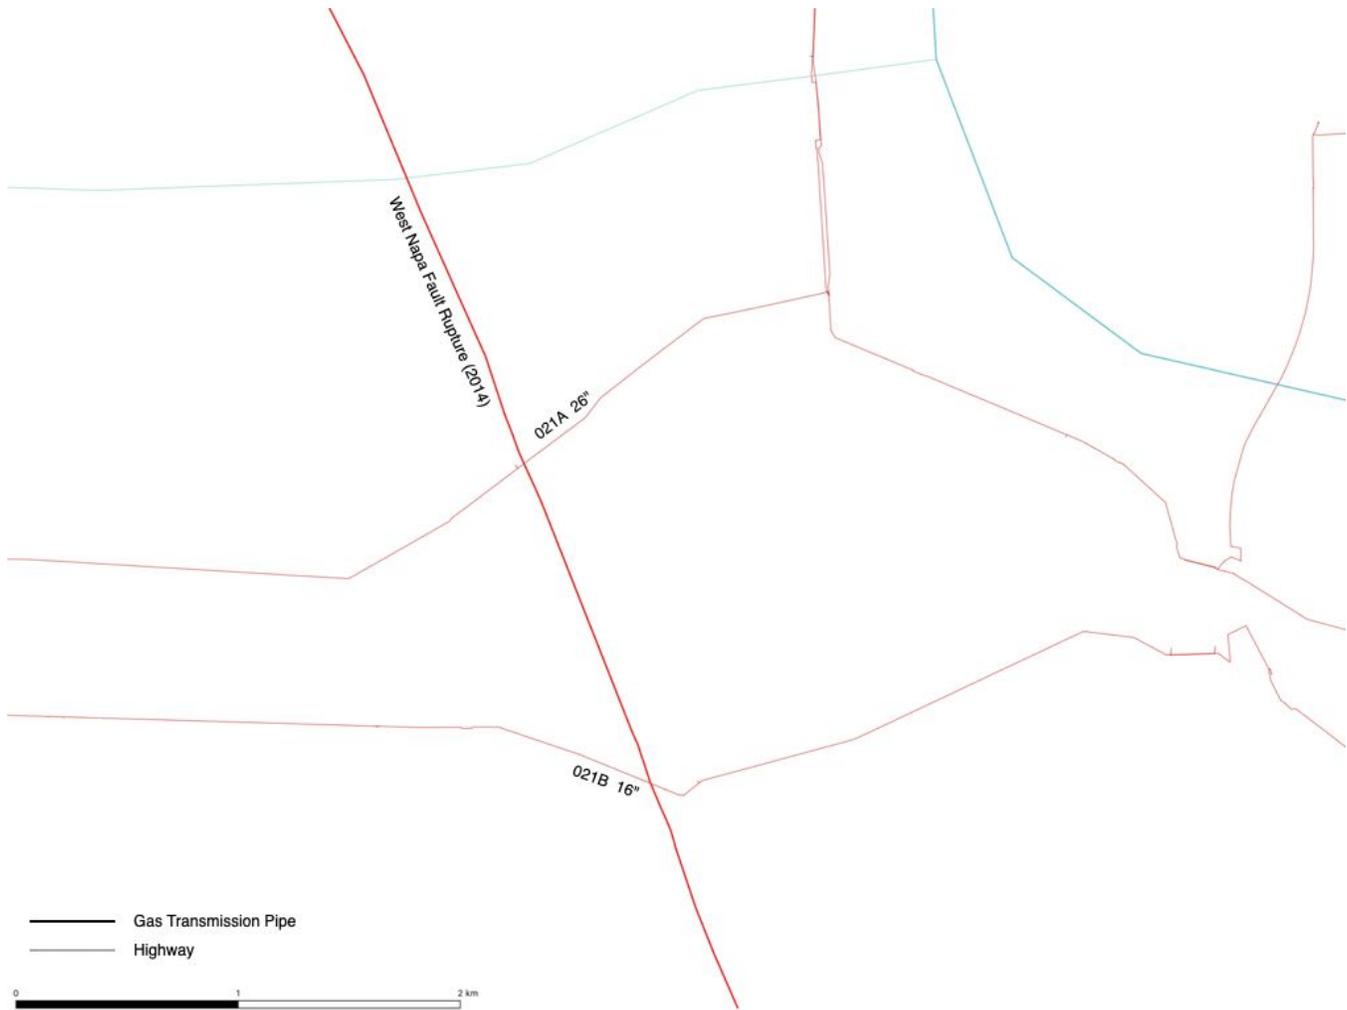
Figure 6.17-2. Napa Earthquake, Pipes at Crossing Zones – South Napa

In Figure 6.17-2, two transmission pipes (Lines 021A and 021B) crossed the West Napa fault that had surface rupture in the 2014 earthquake. In this map, the surface fault trace (red line) was observed to initially (within one day) to have about 2 to 3 inches of right lateral offset, and post-event after slip (within a week) about doubled the amount of offset. Neither of these transmission pipes leaked gas after the earthquake. As a precautionary measure, within a few weeks after the earthquake, PG&E replaced both of these steel transmission pipes with new unstressed steel pipes.

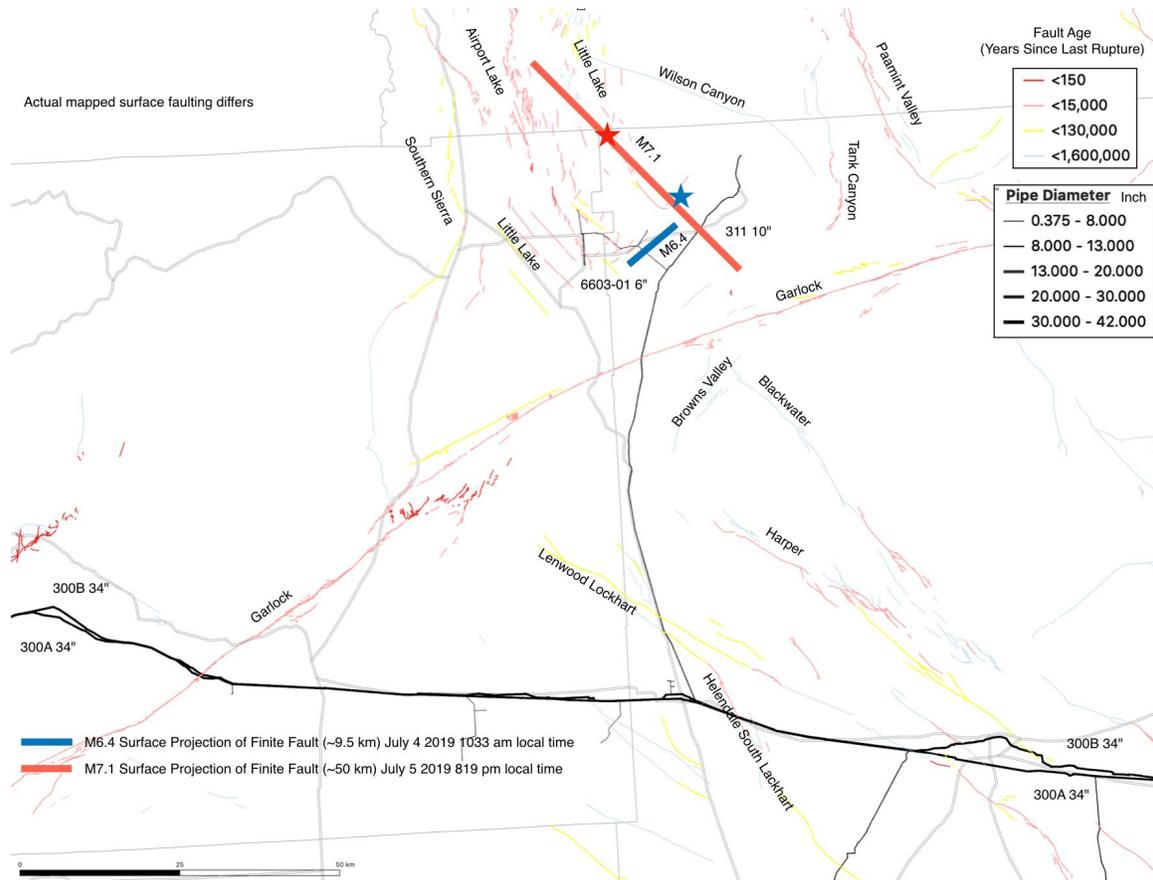
Figure 6.18-1. Ridgecrest Earthquakes – Gas Transmission Pipes

Figure 6.18-1 shows a map with PG&E's gas transmission pipes in the vicinity of the Ridgecrest earthquakes. In Figure 6.18-1, the surface faulting of interest for the July 4 M 6.4 event is highlighted as a blue line, striking NE to SW; and the surface faulting for the July 5 M 7.1 event is highlighted as a red line, striking NW to SE. Other mapped faults in the area are highlighted as thin red or orange (Holocene active) or green (last 130,000 years) or blue (last 1,600,000 years) lines. Gas transmission pipes are shows as heavy black lines (Lines 300A, 300B, both 34-inch), or thin black lines (10-inch, 6-inch).

Gas leak surveys were performed along gas transmission pipelines. Pressure and leak testing confirmed that the M 6.4 rupture did not result in a leak along the 6-inch gas transmission pipeline at the surface faulting location. Pressure and leak testing after the M 7.1 event confirmed there was still no leaks at the 6-inch pipe crossing of the M 6.4 fault, and similarly no leaks of the 10-inch pipe at the M 7.1 fault offset location.

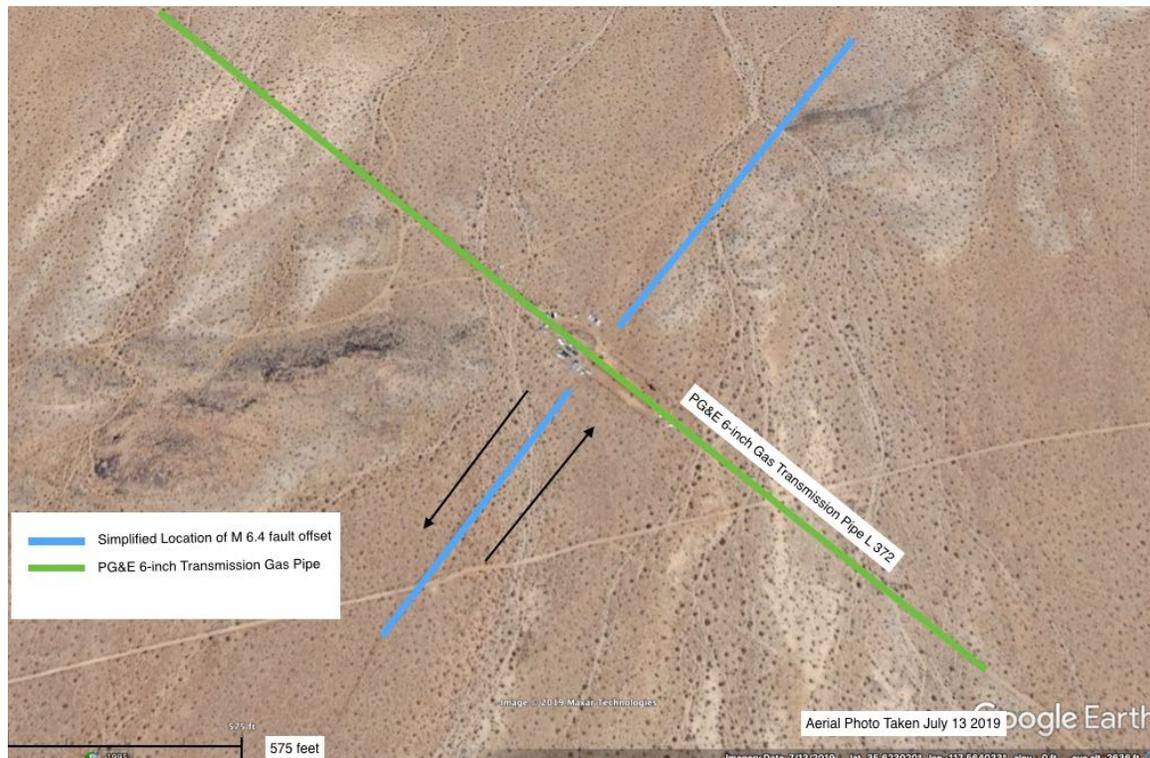
Figure 6.18-3. M 6.4 Offset Location Showing Line 372

Within a week after the earthquakes, PG&E crews dug trenches along the two transmission pipes at the crossing zones, with the intention to observe the condition of the pipes, as well as to replace the stressed pipes with new unstressed pipes. Figure 6.18-4 shows Line 311. Figure 6.18-5 shows Line 372. At the stage of excavation shown in these figures, the pipes are still mostly buried. Lines 311 (10.75" OD) and 372 (6.625" OD) were both replaced where each crossed the faults.

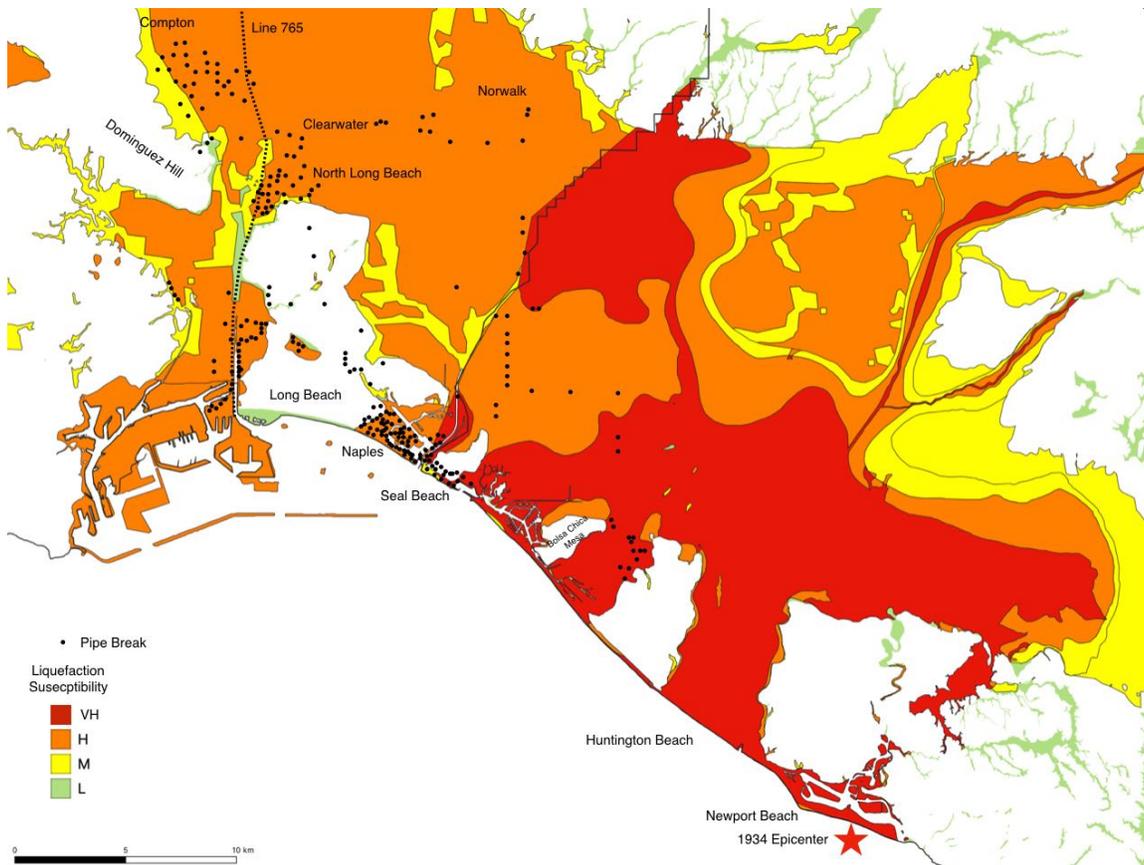
Figure 6.20-2. 1933 Long Beach Earthquake (Pipe Breaks After Hoff 1934)

been "leaks", and collectively, all of them would have been "repairs") from the 1933 earthquake are based on Hoff (1934). The liquefaction map is based on regional-scale liquefaction susceptibility mapping by Bedrossian (2011, Los Angeles County) and unpublished work for Orange County. SoCalGas transmission Line 765 is shown schematically as a dashed line, following the west bank of the Los Angeles River to Long Beach. The differentiation between very high, high and moderate liquefaction susceptibility reflects modern (post 2000) interpretation of the underlying ground water depth (0 to 10 feet, 10 to 30 feet, over 30 feet, respectively), as well as the surficial geologic units. The areas mapped in white are mesas or hilly terrain, both of which are generally considered non-liquefiable except locally along minor drainages or zones with perched water.

The urbanized areas in 1933 include where the broken pipelines are mapped, as well as the zone mapped in white as "Long Beach". The majority of the pipeline damage occurred along the floodplain of the Los Angeles River from Compton, North Long Beach and San Pedro; as well as in the mouth of the original San Gabriel River near Seal Beach and Naples. The lack of pipe damage along the Santa Ana River reflects the lack of urbanized development in that area at that time; and / or lack of historic documentation. At the time of the earthquake, the most common types of materials used for buried pipe were cast iron (prevalent for water systems, also used in gas distribution systems), or threaded steel pipe (sometimes used in water systems, prevalent in gas distribution systems), or welded steel pipe (used for high pressure (≥ 150 psi) gas transmission systems).

Line 765, shown in Figure 6.20-2 as a heavy dashed line, was built in 1931. It was 26-inch diameter, $t = 0.25$ inch, using Grade A and B steel, with MAOP of 150 psi. This pipe was built using electric arc welds, with girth joints formed by having both ends of the spool piece belled, which were positioned using an underlying steel ring. In this fashion, there is eccentricity at each belled joint. Although this pipe traversed liquefiable zones, there are no records of damage or repair to this line from the 1933 earthquake, even though there were a variety of repairs needed for nearby water pipes made from cast iron.

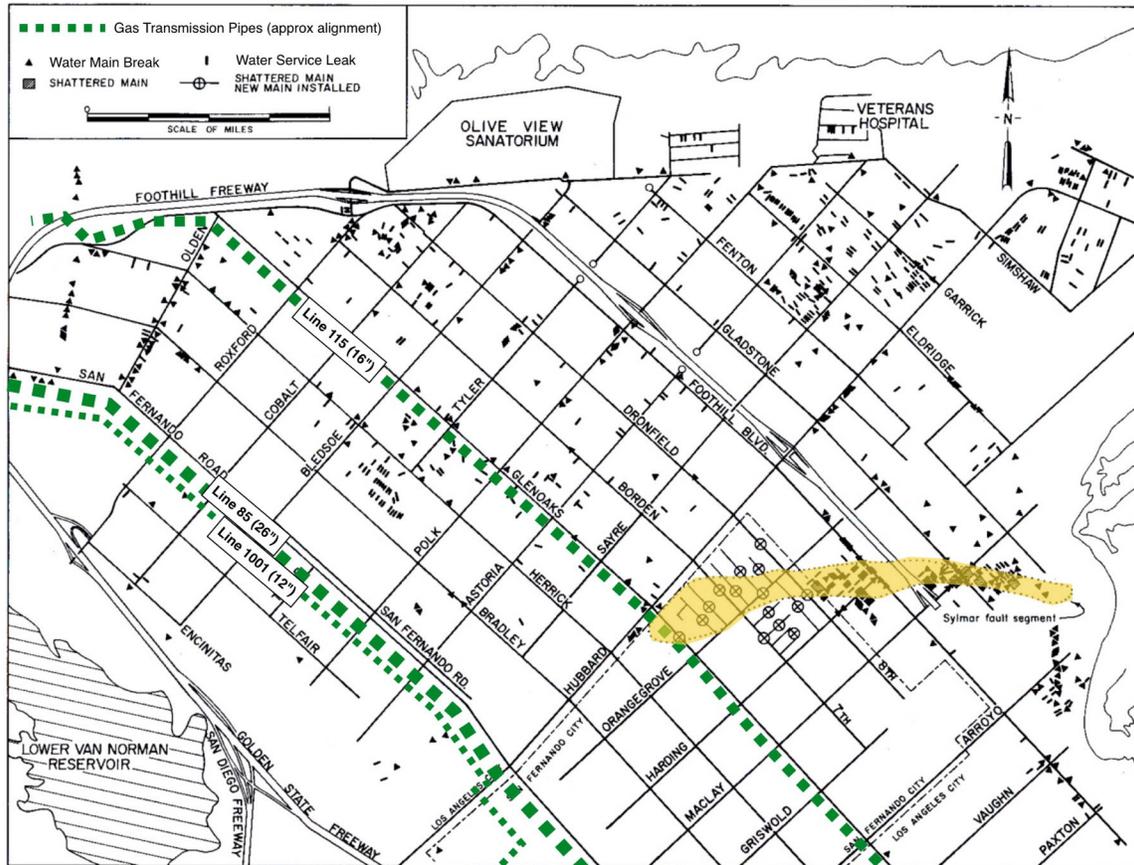
Figure 6.21-1. Map of 1971 San Fernando Earthquake. Damage to water pipes of the LADWP and City of San Fernando water systems indicated. Location of Gas Transmission Pipes indicated.

- There was substantial damage to Lines 1001 and 115 that (then) traversed through the City of San Fernando. These pipes are shown in Figure 6.21-1 as dashed green lines, along with the location and style of damage to nearby water pipes.

- Line 115 was a 16-inch diameter steel pipeline of unknown grade, constructed in 1926 using oxy-acetylene welds. In the ~6 mile reach of the pipe between Clampett Junction and San Fernando, there were 52 breaks. Shell buckling of the pipeline occurred where the pipe crossed the Sylmar segment of the rupture zone (13 damage points in the colored zone in Figure 6.21-1 / hatched zone in Figure 6.21-2).

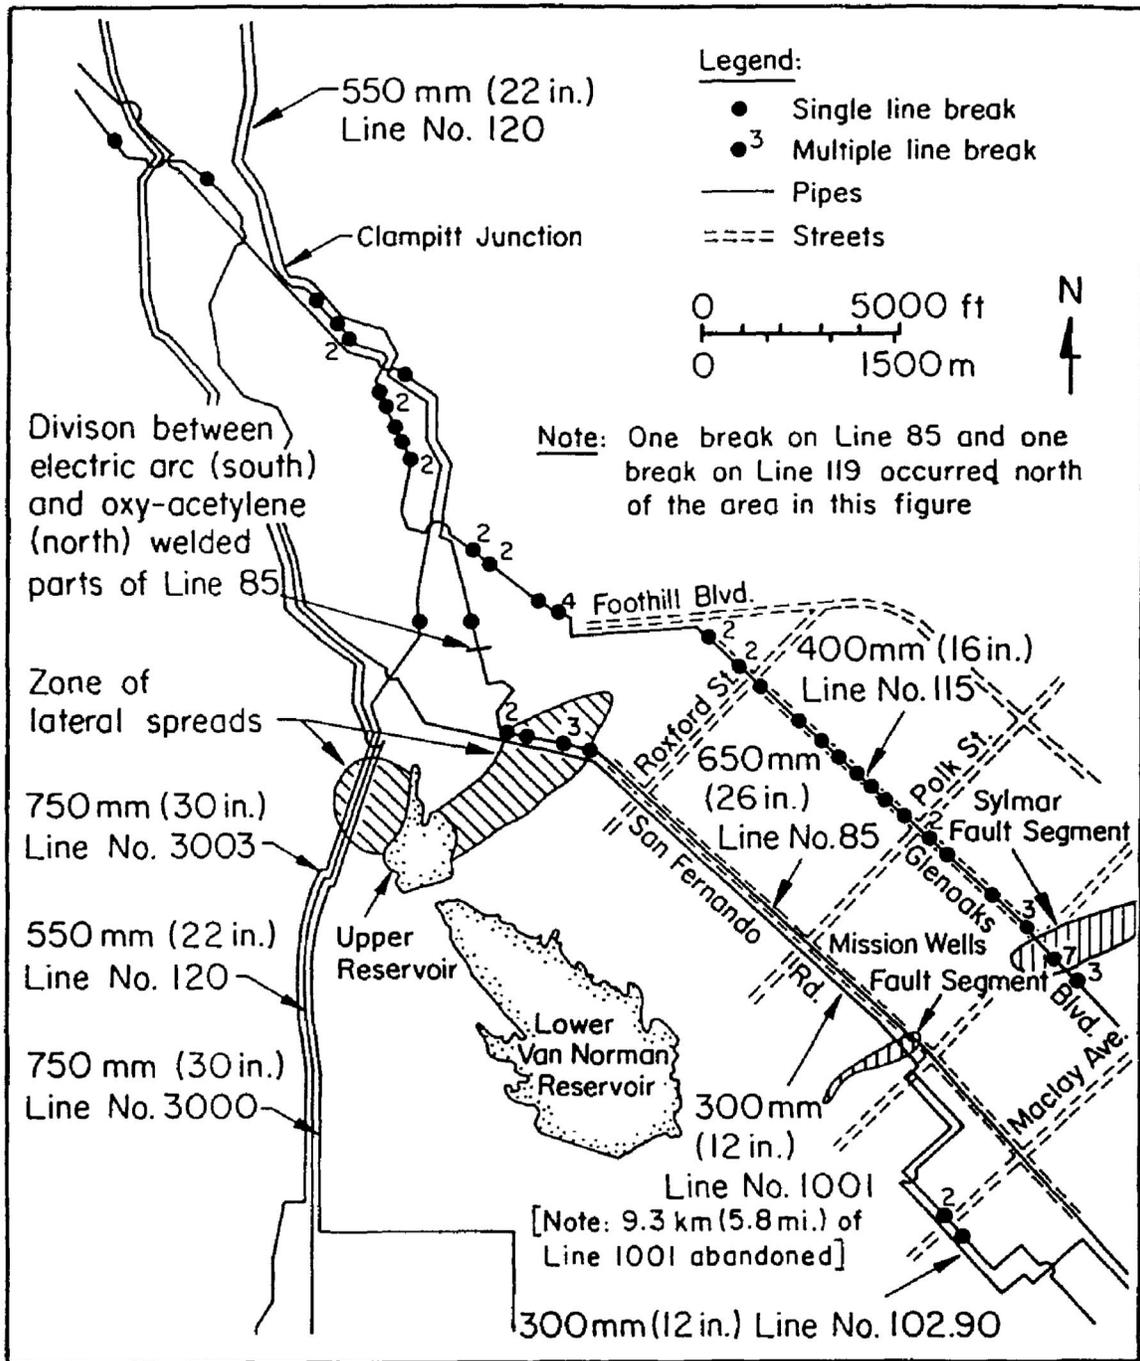
Figure 6.21-2. Location of Gas Pipeline Damage, Lateral Spreads and Fault Segments (after SoCalGas 1973, and O'Rourke 1974)

- Line 85 was a 26-inch diameter pipe, with Grade A steel and $t = 0.25$ -inch, operated at MAOP 250 psi. In Figure 6.21-2, a mark shows where the welding style switched between oxy-acetylene (northern part) and electric arc (southern part). In 1932, about 30% of the oxy-acetylene welds in the northern section were reconditioned with electric arc welded reinforcements. South of the point, the line was constructed with unshielded electric arc welded belled pipe in a manner similar to that of Line 765 which was affected in the 1933 Long Beach earthquake. The electric arc welded portion of Line 85 was damaged at 7 locations within the zone of lateral spread along the east side of Upper Van Norman Reservoir.

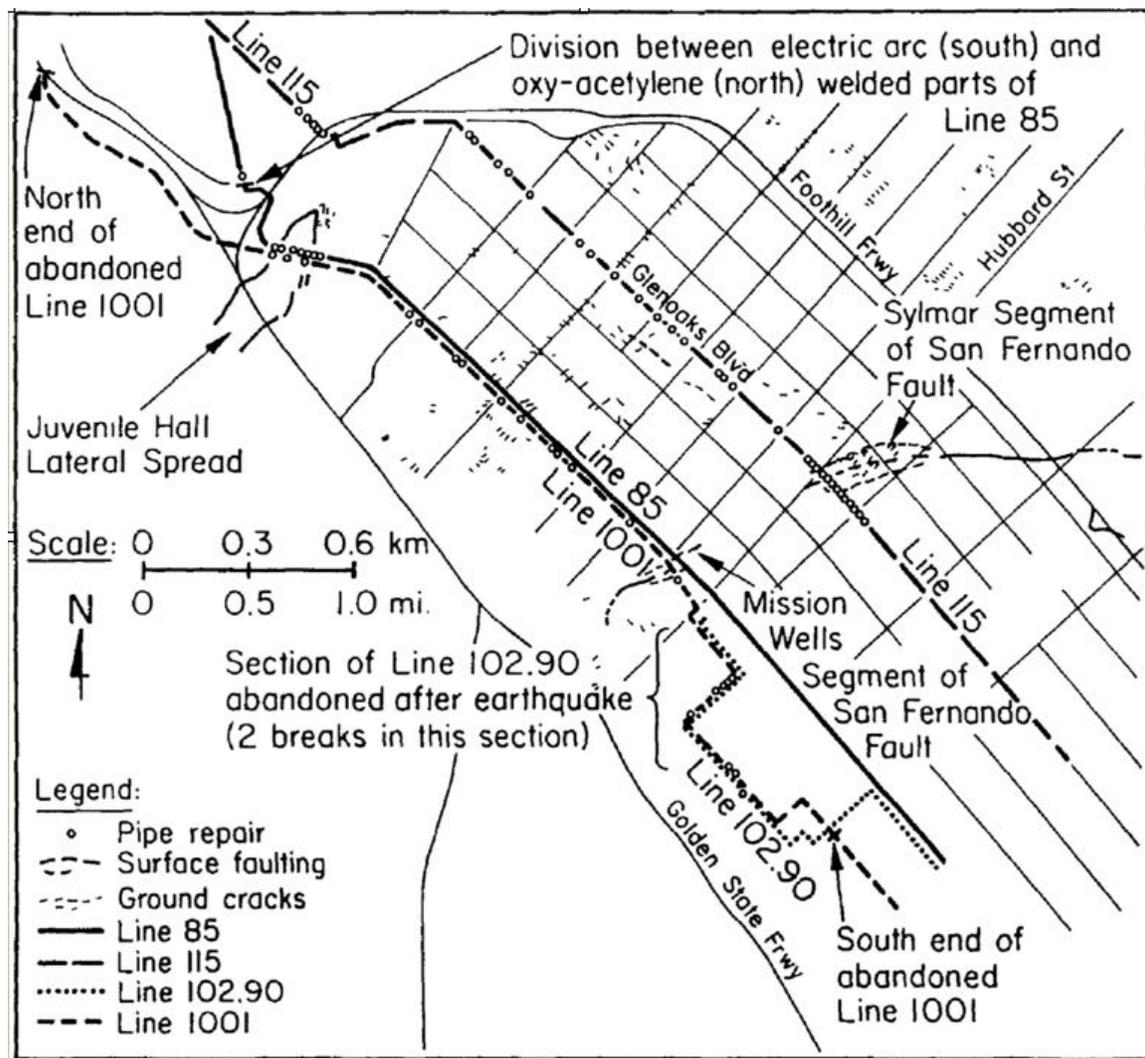
Figure 6.21-3. San Fernando, Location of Gas Pipeline Damage, Lateral Spreads and Fault Segments (after SoCalGas, 1973, O'Rourke 1974)

Figure 6.21-3 highlights the gas transmission system damage in the City of San Fernando. The damage locations are based on repair records prepared by SoCalGas personnel. The common damage was rupture of leakage at oxy-acetylene welds. Also shown in the map are the mapped locations of ground failures and surface cracks in the area.

- Line 115. About 3 compression and 10 tensile failures near the Sylmar Segment of ground rupture.
- Line 1001. 1 break where it crossed the Mission Wells Segment of ground rupture, and 3 breaks in the vicinity of the Juvenile Hall lateral spread on San Fernando Road.
- Line 85. 7 breaks in the vicinity of the Juvenile Hall lateral spread on San Fernando Road.

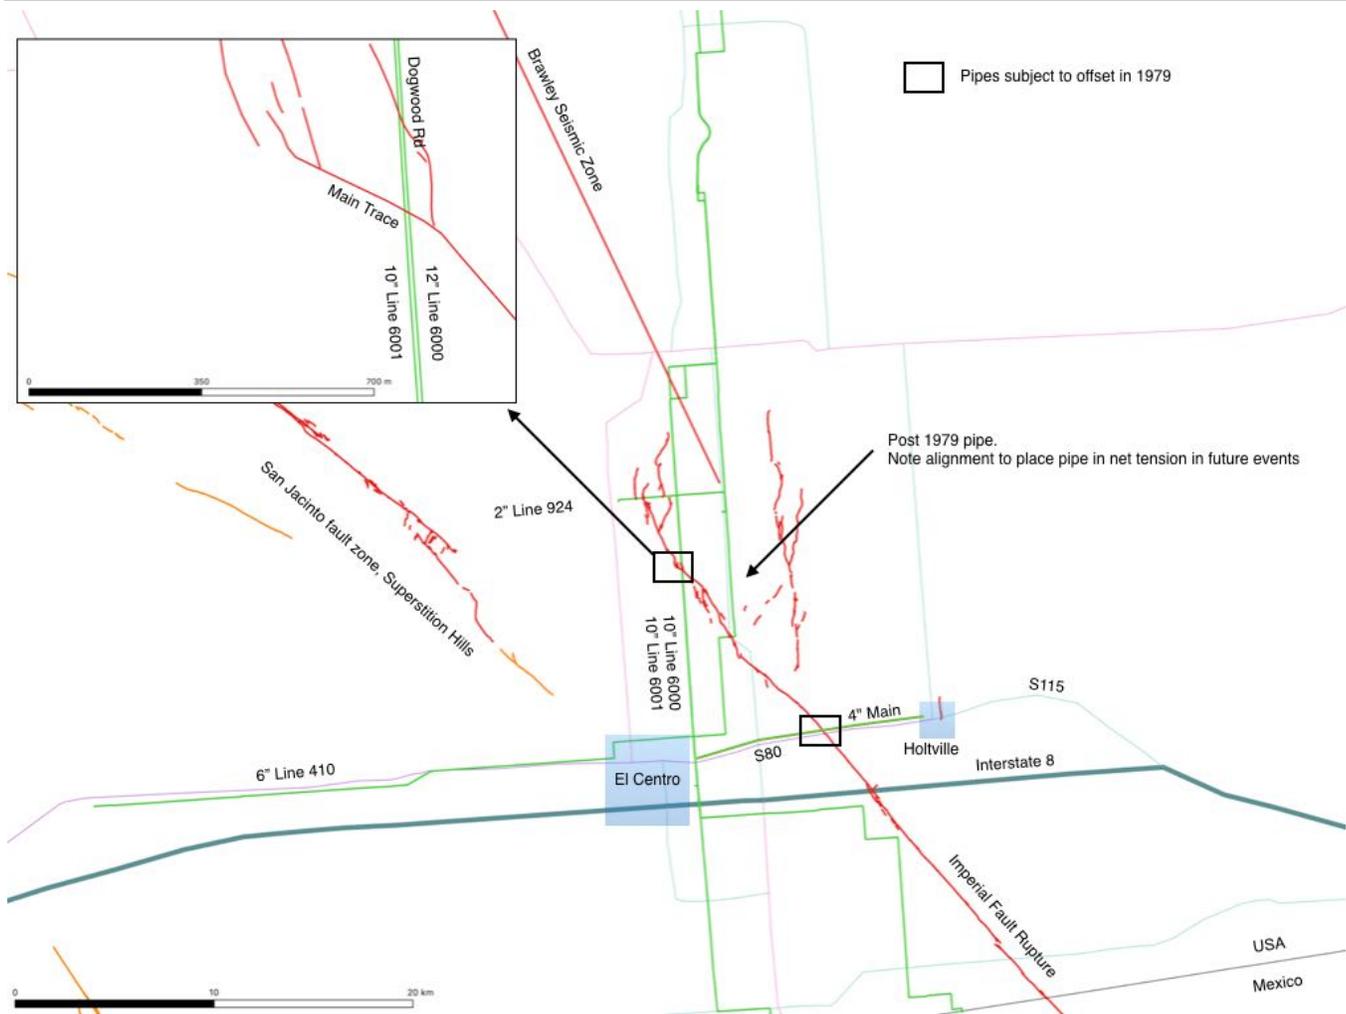
Figure 6.23-1. SoCalGas Transmission Pipes and 1979 Imperial Valley Fault Rupture

Ground rupture crossed three of SoCalGas's steel pipelines. This included two supply lines running north-to-south along Dogwood Road and a 4-inch distribution line running east just north of Highway 80, towards Holtville. This earthquake did not damage (resulting in leak) any of these three gas pipelines.

Figure 6-23-1 shows the region, highlighting (in heavy black boxes) the two parallel steel high pressure gas pipelines along Dogwood Road that deliver gas from the north to the community of El Centro in the south and the 4-inch pipe delivering gas to the community of Holtville to the east. Light blue lines indicate major roads in the area. Dark red lines shows historic fault ruptures in the area along the Imperial Valley and San Jacinto faults; orange lines show mapped active faults in the area; the Brawley fault zone is shown schematically; gas transmission lines are shown in green; urbanized areas shown as shaded blue boxes.
