Seismic Fragility of Natural Gas Transmission Pipelines and Wells

G&E Engineering Systems Inc.

November 14 2021 | Revision 4

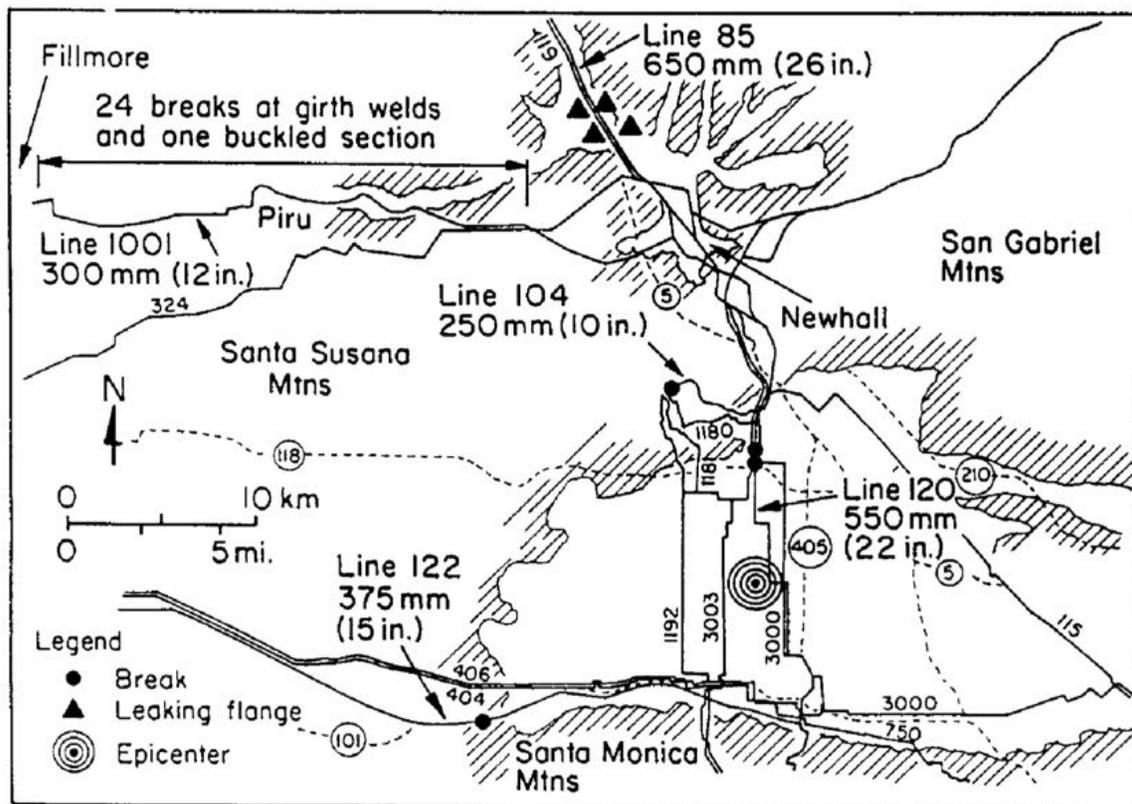
Figure 6.28-1. Gas Transmission Pipelines and Area of Strong Ground Shaking, 1994 Northridge (after O'Rourke 1996)

- Line 85 is a 26-inch pipe with $t = 0.25$ inch, Grade A steel, operated at 317 psi. There were gas leaks noted at above ground flanges at sections of above ground pipe, at the locations shown in Figure 6.28-1. This area was exposed to very strong shaking ($PGA > 0.5g$). Damage was mainly in the form of flange separation and leaking gaskets; one of the flanges was fractured. A oxy-acetylene weld failed about 24 miles northwest of Newhall (off map). There was another weld failure near Taft, about 75 miles north of the epicenter; this portion was built in 1931 with electric arc welds, pressure 360 psi.

- Line 122 (Figure 6.28-1). There was a failed oxy-acetylene weld. Pressure 150 psi. Pipe built 1927, $t = 0.25$ inch, unknown grade of steel.
- Line 104. Break at the Aliso Canyon gas storage field. This pipe is 10-inch diameter, MAOP 228 psi, constructed 1941 with electric arc welds, $t = 0.203$ inches, unknown grade.

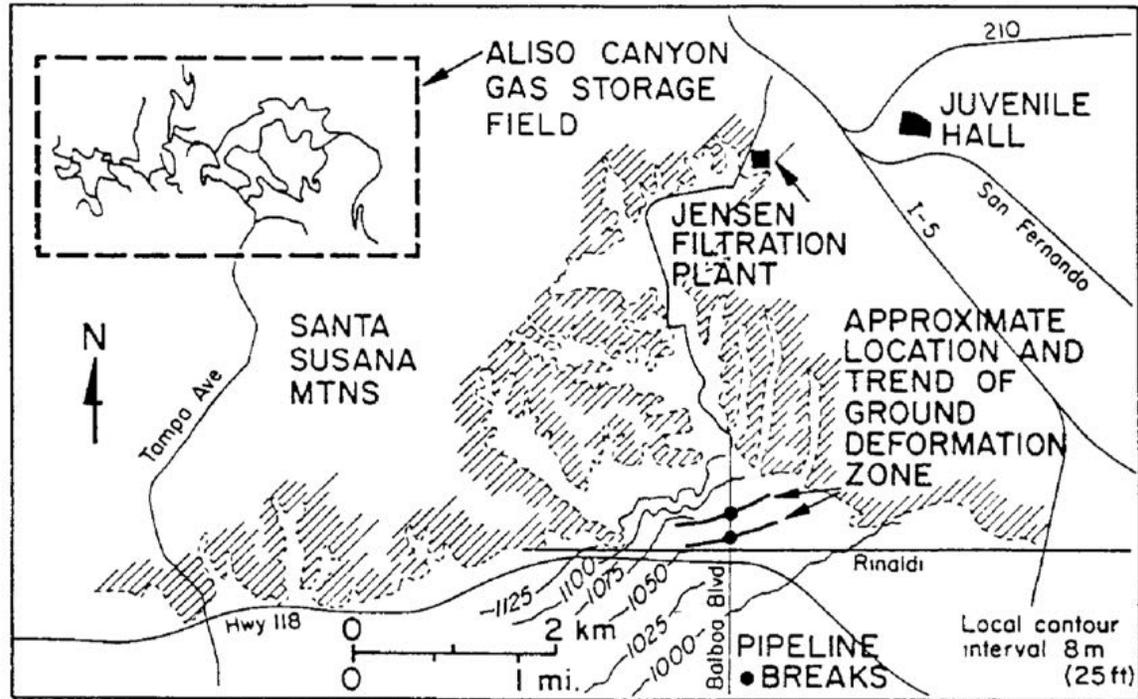
Figure 6.28-2. Gas System in Northern San Fernando Valley, Balboa Boulevard (after O'Rourke)

Figure 6.28-1 shows the gas transmission pipes in the area of strong shaking. Figure 6.28-2 shows the area in the north part of San Fernando Valley where ground failures occurred along Line 120.

There were 35 non-corrosion related repairs in the gas transmission system, of which 27 were at cracked or ruptured oxy-acetylene girth welds in pre-1932 pipelines. The failure of the Line 120 on Balboa Blvd resulted in a large fire, is possibly the most "famous" of these pipe failures, and aspects of that fire are described in "Fire Following Earthquake" (Scawthorn, Eidinger, Schiff, 2004).

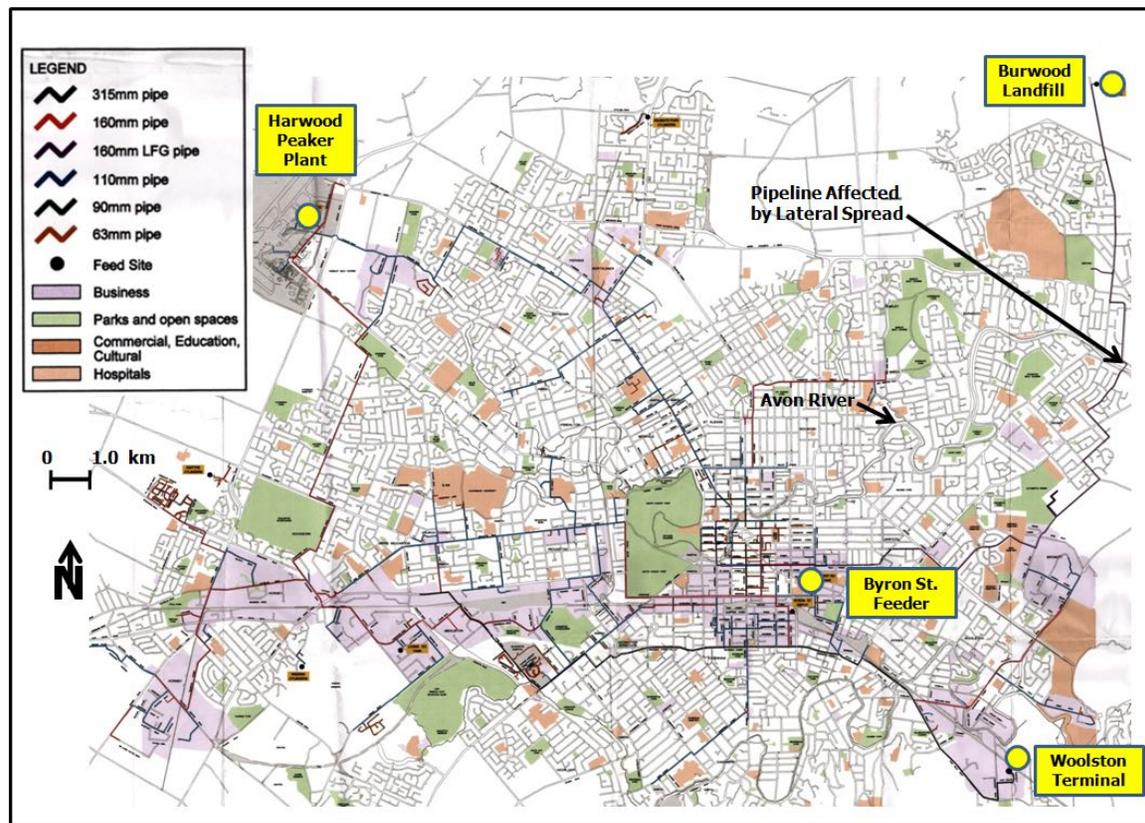
Figure 6.32-2. Gas Pipeline Network in Christchurch, Selected Features

Figure 6.32-2 highlights the 160-mm pipeline conveying gas from the Burwood Landfill. A portion of this pipeline parallel to the Avon River moved in an area where there was displacement and contact by a nearby water well head. The deformed portion of the pipeline was circumvented by replacing approximately 100 meters of pipe between two elbows that had not moved.

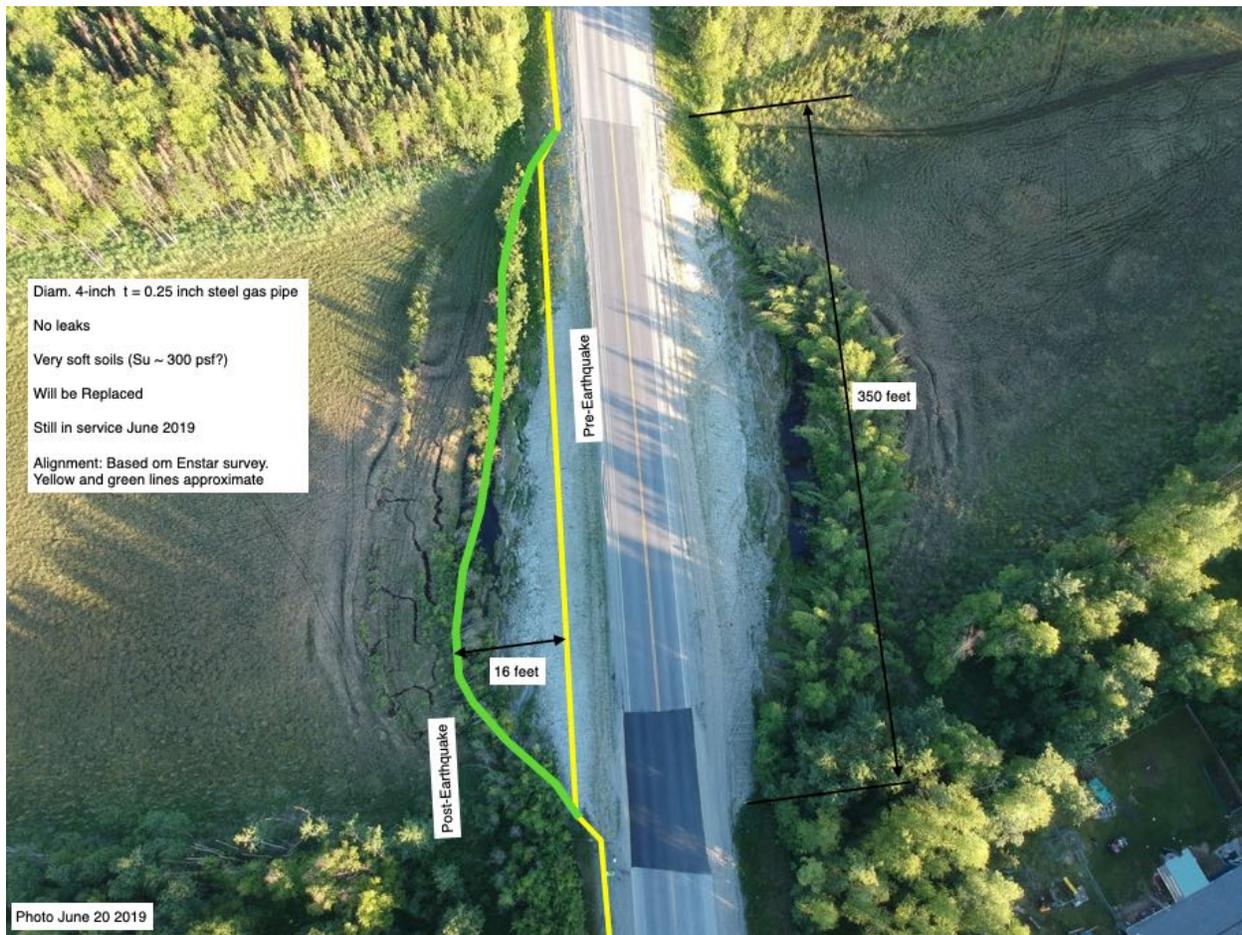
Figure 6.36-3. Gas Pipe Location (June 20 2019)

A few road embankments slumped downwards and sideways, with movements of 10 feet or more. These road embankment failures were amongst the most spectacular soil failures in this earthquake, Figure 6.36-2. A 4-inch diameter steel natural gas pipeline (yellow line shows pre-earthquake location) was embedded in one of these embankments in Wasilla. The pipe underwent lateral displacements up to 16 feet (green line shows post-earthquake location), Figure 6.36-3. The pipe remained in service with no leaks; this reflects the rather gradual curvature of the soil movements over a span of about 350 feet; the high quality of construction of the pipe; and the very soft / weak nature of the soils along this pipe alignment.

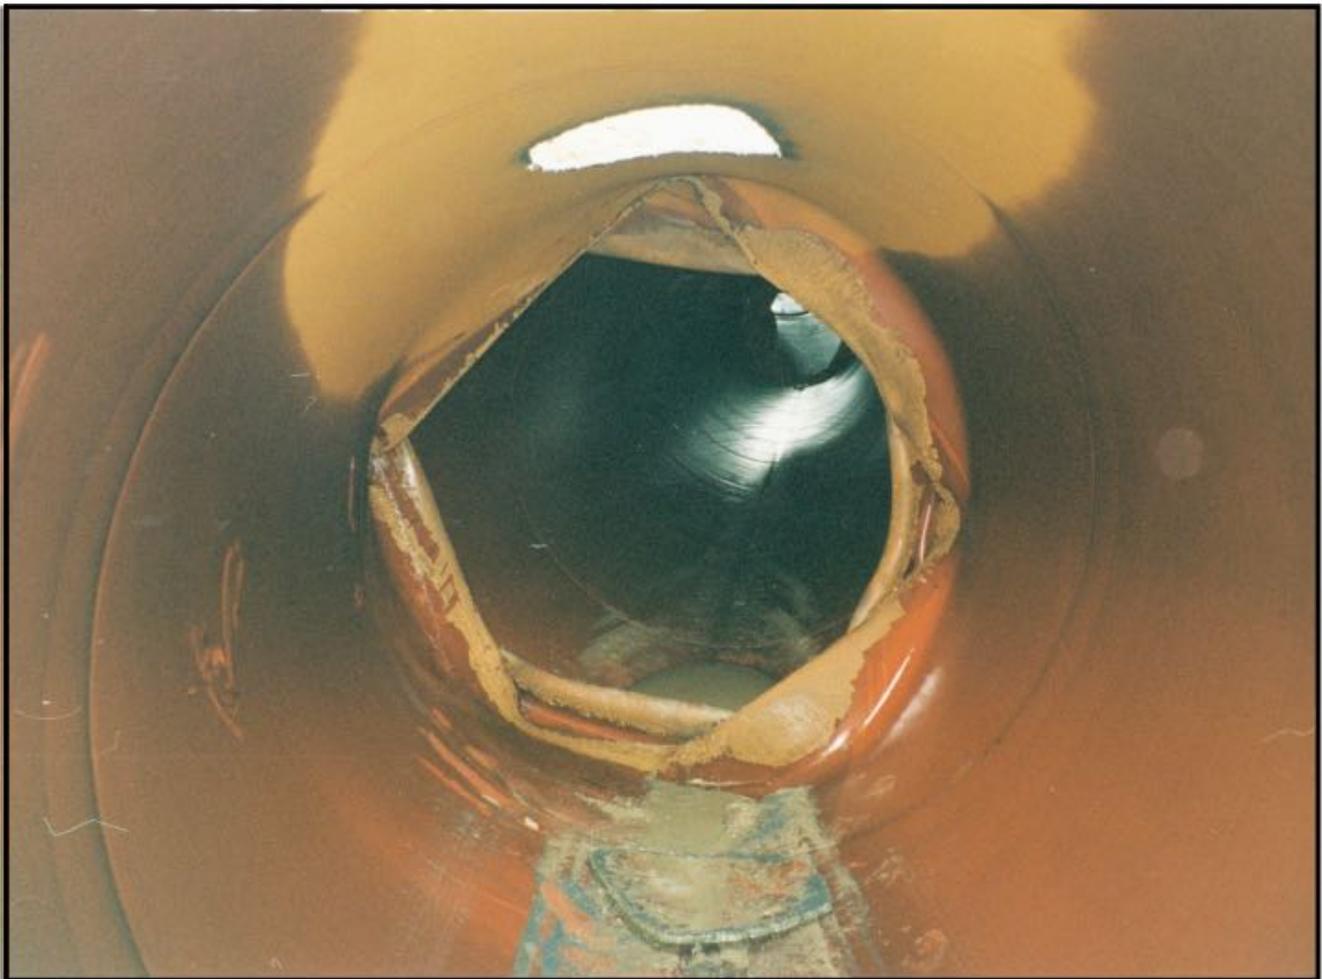
Figure 7-2. Wrinkled Pipe 1+337 Looking South

Picture taken at approximately Station 1+400, looking south.

Discoloration shown near the top of the pipe near the manhole is presumed due to the heat caused by torching open the inspection manhole.

The wrinkled pipelines at stations 1+320 and 1+337 have wrinkles on the order of 10s of centimeters (see Figures 7-2 to 7-5). A finger-width tear and leak occurred at station 1+337. A slight leak was reported to have occurred at station 1+349.

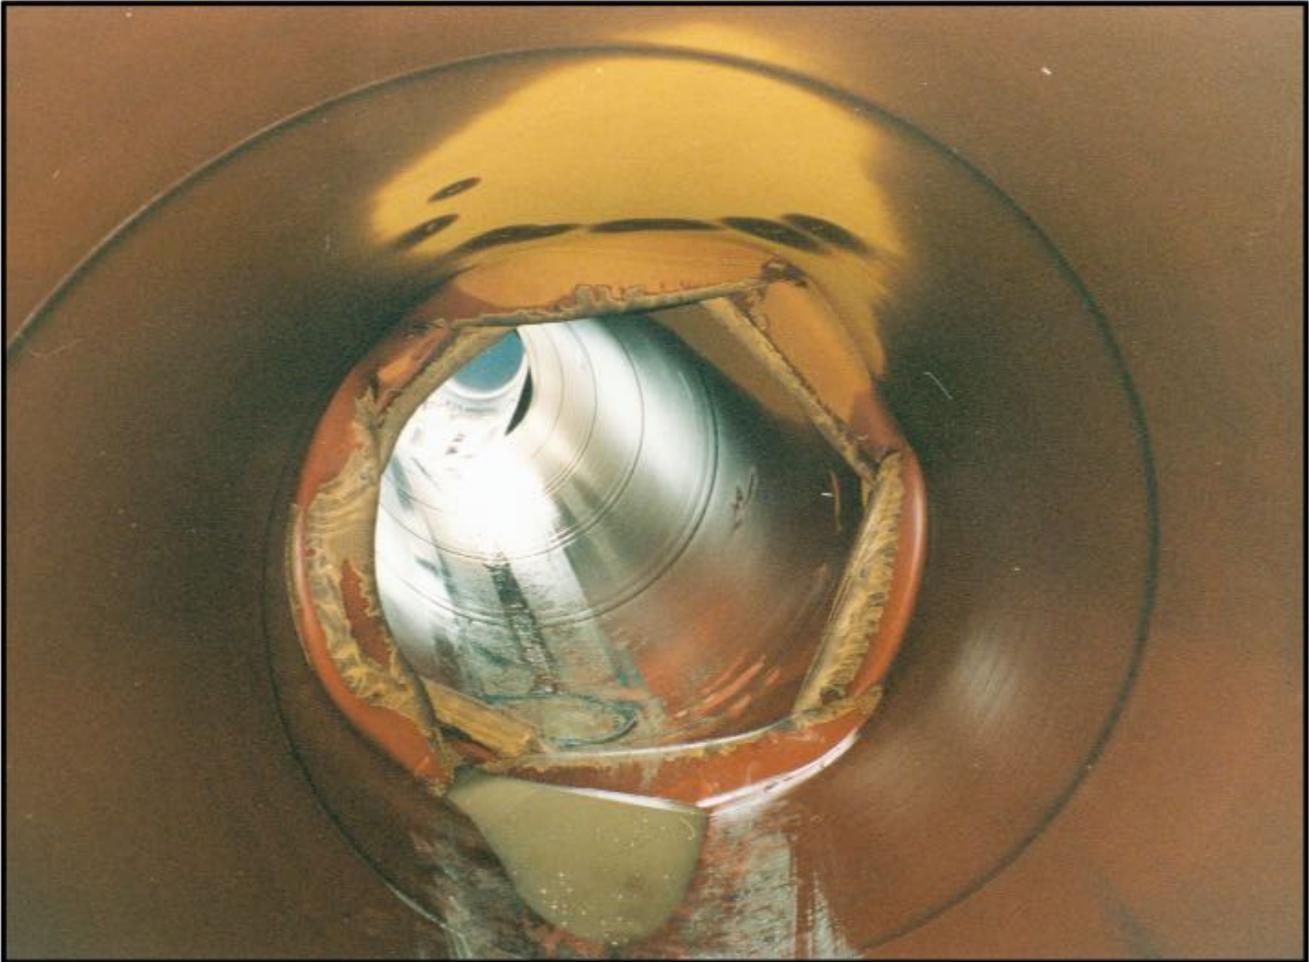
Figure 7-3. Wrinkled Pipe 1+337 Looking North

Picture taken at approximately Station 1+340, looking north.

Discoloration shown near the top of the pipe near the manhole is presumed due to the heat
caused by torching open the inspection manhole.

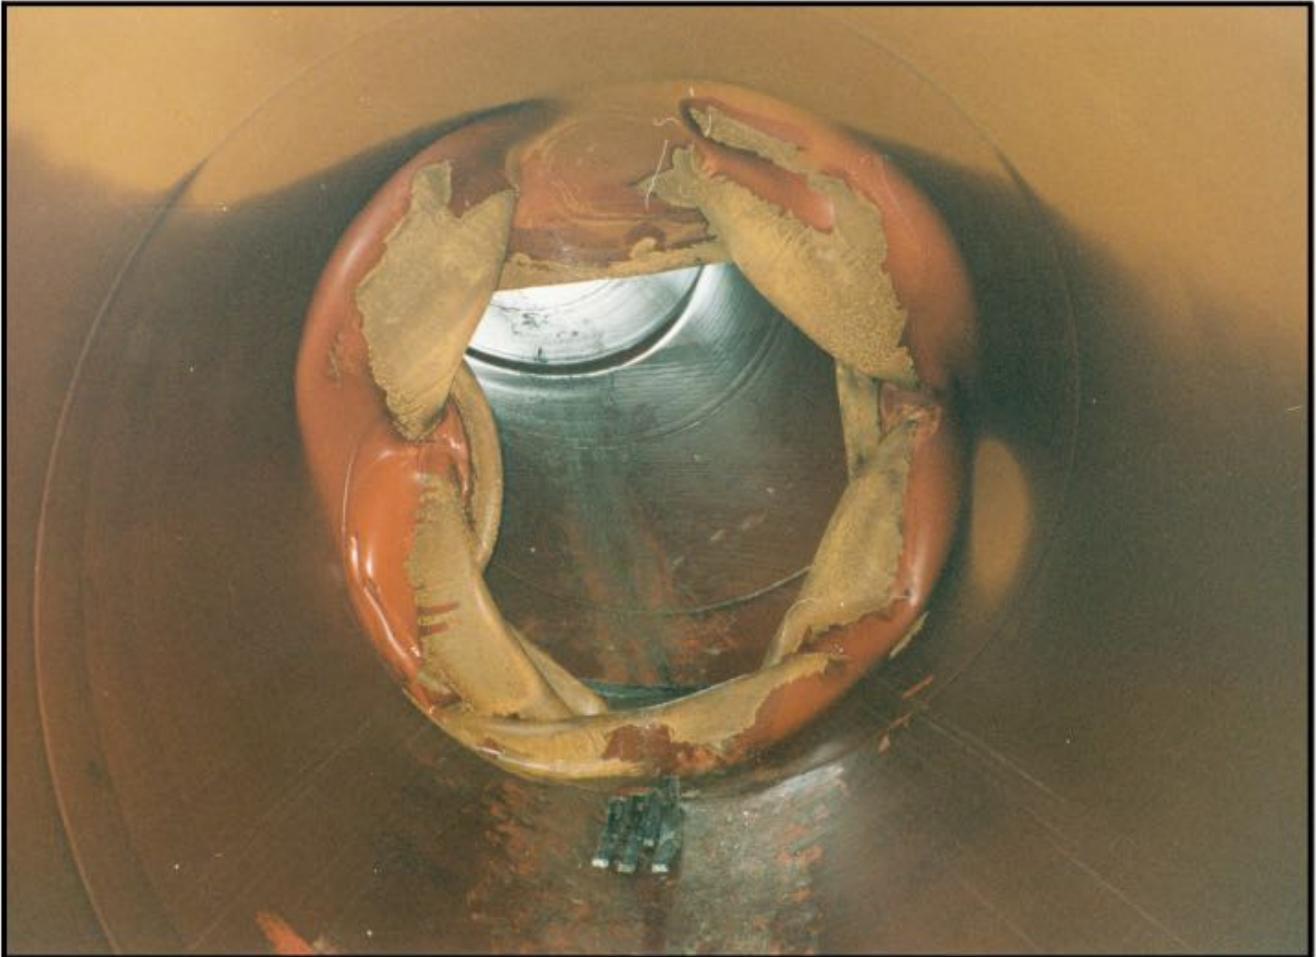
Figure 7-4. Wrinkled Pipe 1+320 Looking North

Picture taken at approximately Station 1+317, looking north.

Discoloration shown near the top of the pipe near the manhole is presumed due to the heat caused by torching open the inspection manhole.

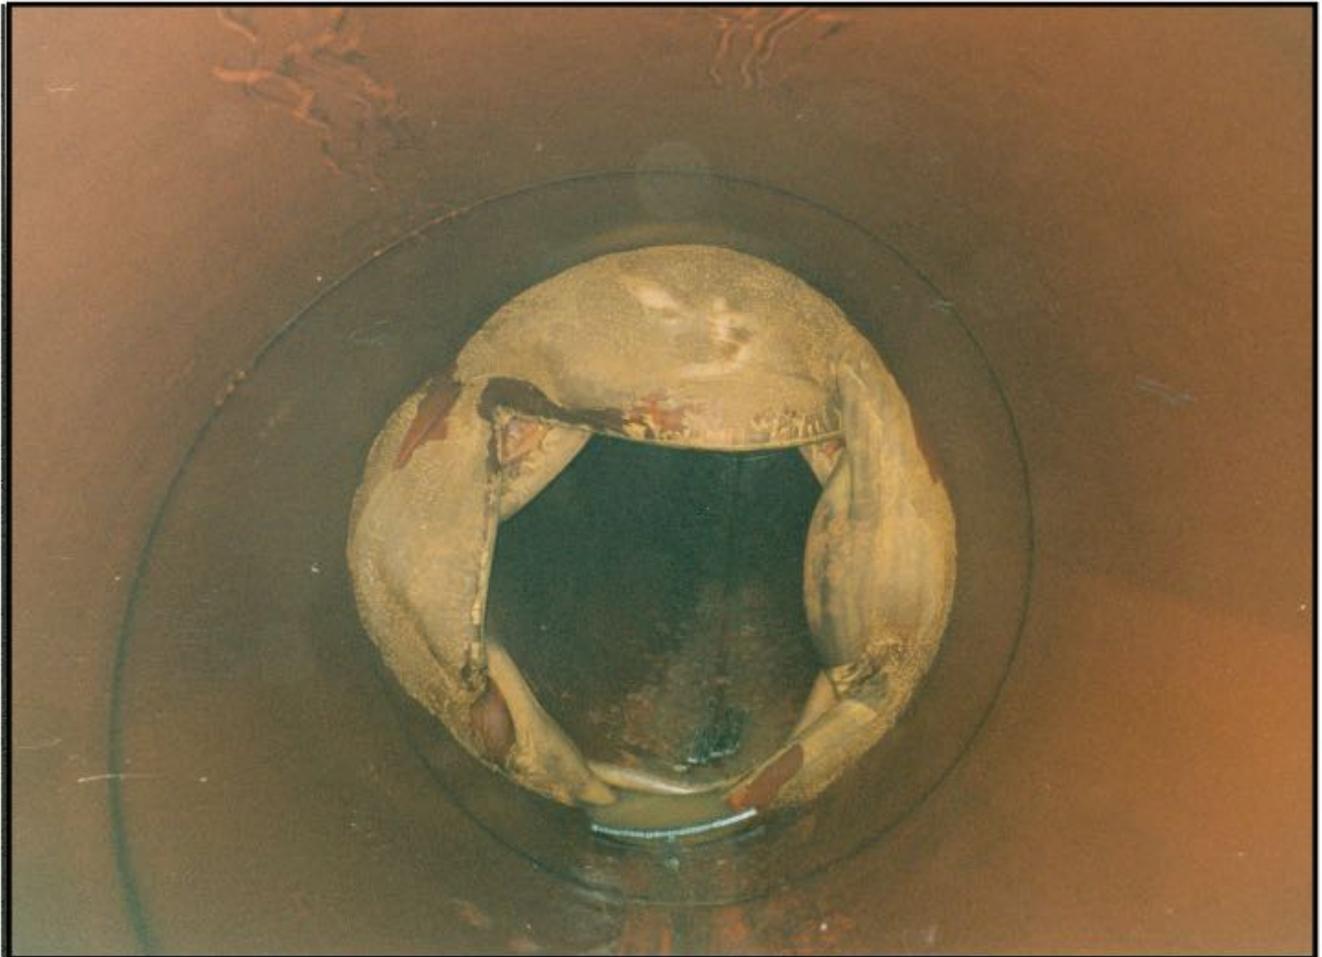
Figure 7-5. Wrinkled Pipe 1+320 Looking South

Picture taken at approximately Station 1+323, looking south.
The wrinkle is at station 1+320.
The wrinkle is as much as 200 mm deep (or more) from the original diameter of the pipe.
The internal epoxy lining has been stripped away from the pipe at the wrinkle location.
There is a significant change in direction of the pipe at the wrinkled location.

The average compression strain including the wrinkles would be about -9.7% ($= 1.70 / 17.6$). The allowable compressive strain is $0.88 t / R = 0.88 * 18 \text{ mm} / 1100 \text{ mm} = -1.44\%$. Clearly, with a tendency to shorten of -9.7%, the pipe was bound to wrinkle; and it did. The extreme folding of the wrinkles (Figures 7-2 through 7-5) reflect that once the wrinkle initiated, further shortening of the pipe was accommodated by distortions of the two wrinkles.

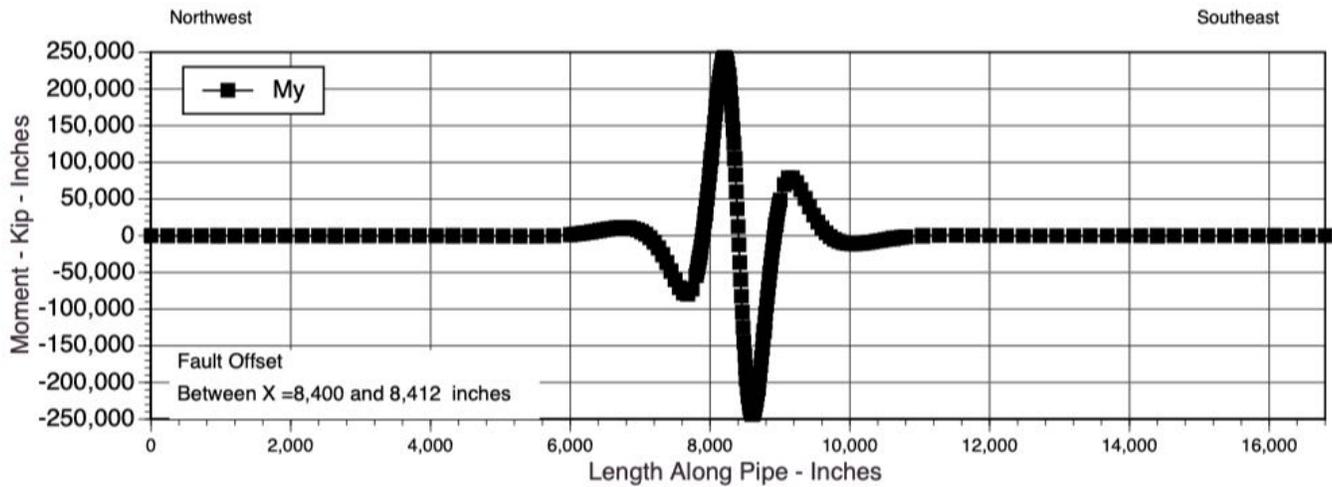
Figure 7-11. Pipe Bending Moments

Figure 7-11 shows the computed bending moment about the vertical axis within the pipeline. This is the bending moment caused by transverse movement of the soil.

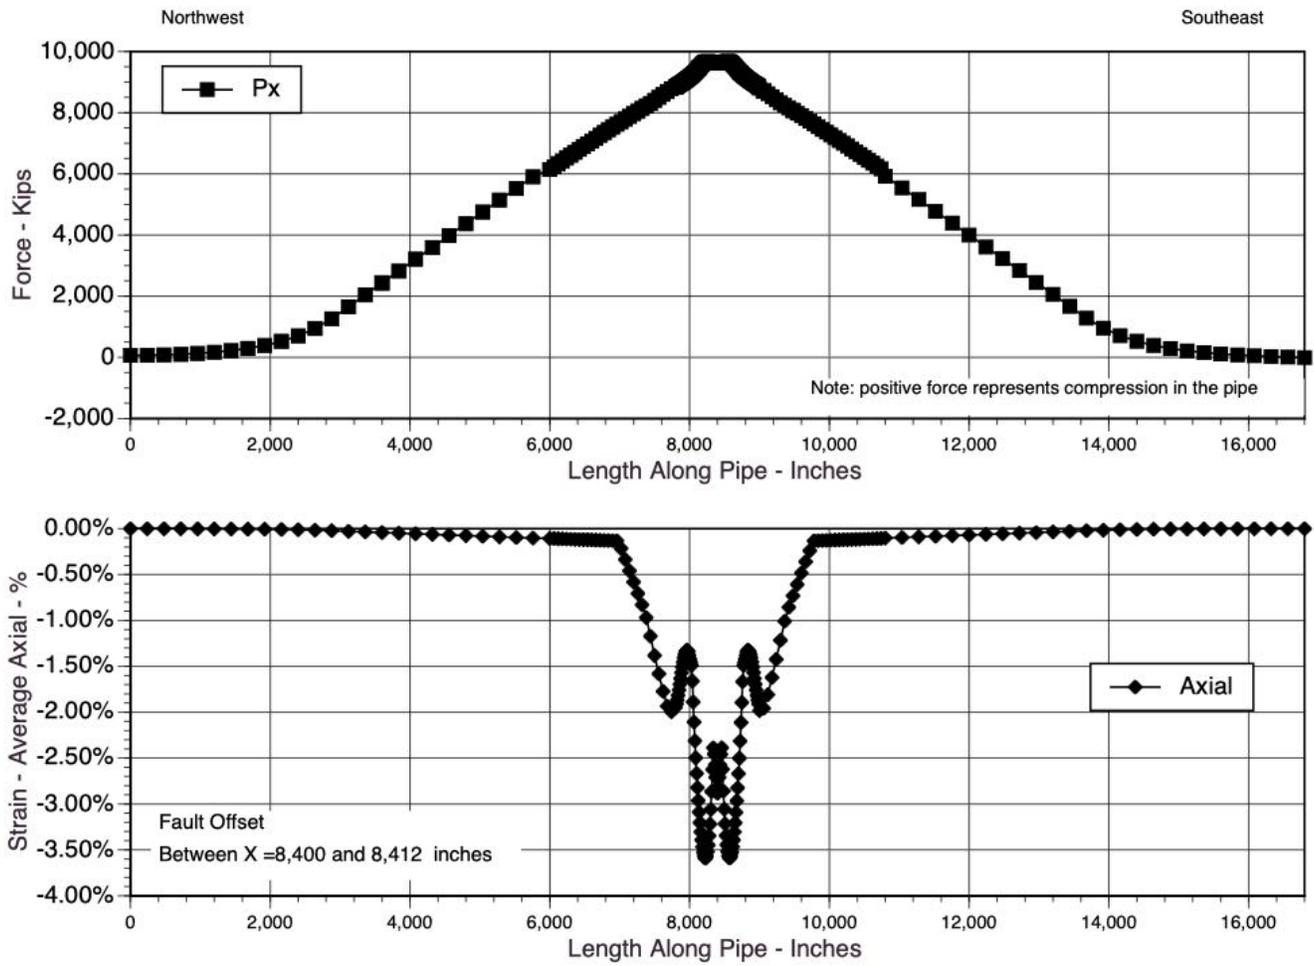
Figure 7-12. Pipe Axial Forces and Strains

Figure 7-12. The top portion shows the computed axial force within the pipeline. The bottom portion shows the computed average axial strain within the pipeline. The highest force is 9,671 kips (positive meaning compression). The highest average axial strain is -3.6% (negative meaning compression). As the model does not have post-wrinkling pipe elements, these forces and strains should be interpreted as average values through the entire pipe, excluding the additional local softening caused by the excessive wrinkles. A more detailed analysis with a shell-type model would show a different force and strain pattern. These type of refinements are not necessary, as the computed strains are clearly high enough to initiate wrinkling, as the allowable compressive strain is -1.44% , much lower than the computed compressive strain. The rapid variations in computed peak axial strain nearest the fault reflects the simultaneous application of high bending forces in the pipe, with a von Mises yield surface assumption with strain hardening, coupled with the assumptions of large geometry deflections of the pipeline near the fault. In other words, if the fault offset design displacement called for 3 meters of offset, this design would *fail* the code guidelines; and in practice, it did fail.

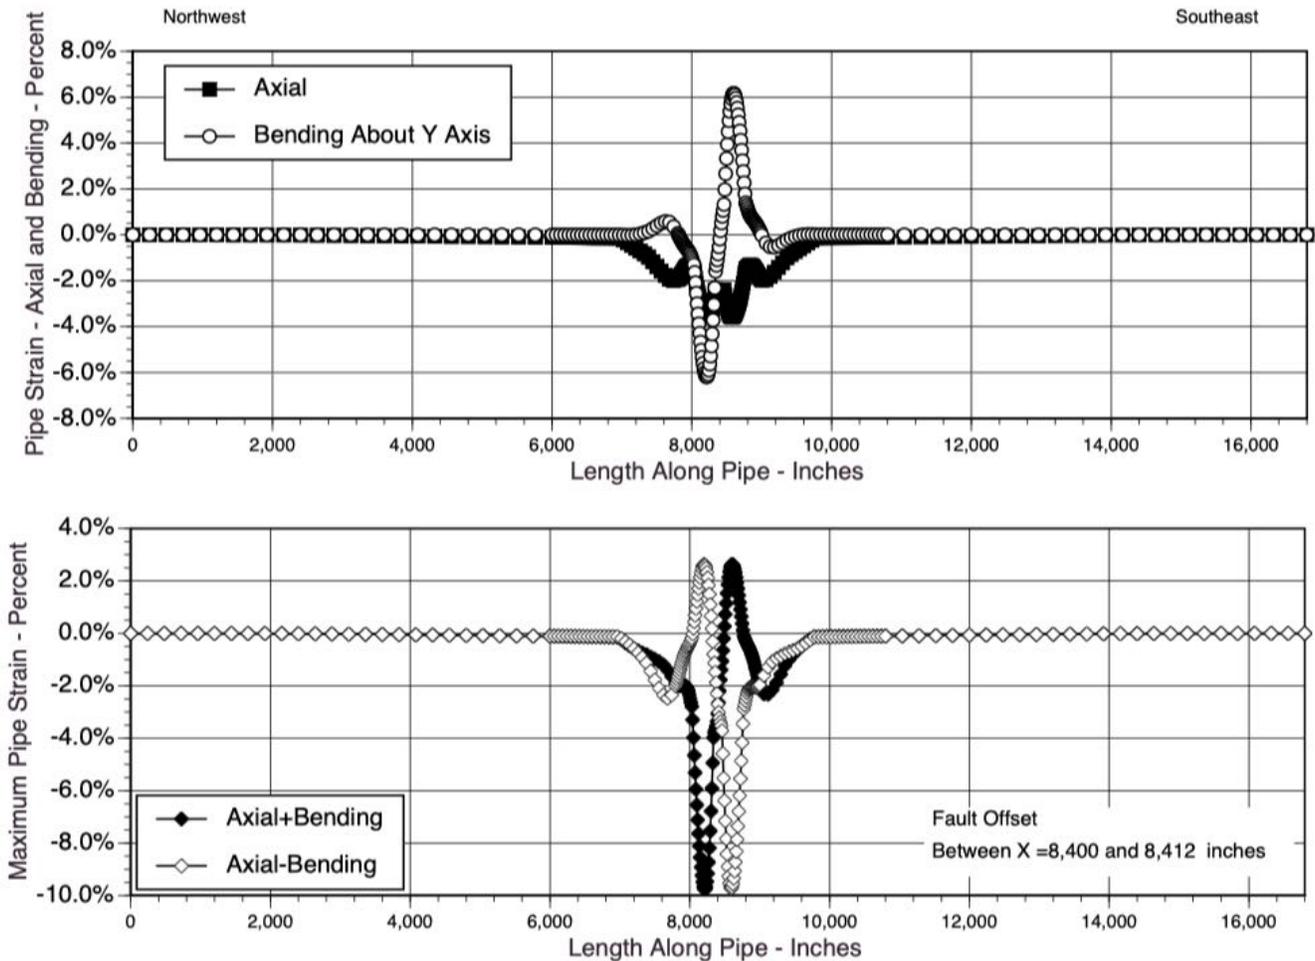
Figure 7-13. Pipe Combined Axial and Bending Strains

While the results from Figure 7-12 already show the pipe should fail, these results do not tell the entire story. The transverse offset of the fault induced high bending moments in the pipe, and it is the combination of both bending (Figure 7-11) and axial (Figure 7-12) that is of interest. Figure 7-13 shows these results.

The top portion of Figure 7-13 shows the computed strain in the pipe separately for axial forces (same as Figure 7-12) and bending moments. The bending strain shown is based on the assumption of no wrinkling in the pipeline, and plane sections remaining plane, even in the post-yield condition; these assumptions are not valid at locations where the pipe undergoes severe wrinkling; but by that time, the pipe has "failed". The bottom portion of Figure 7-13 combines the average axial and peak bending components of strain, to produce a net maxima / minima strain diagram along the pipeline. If the pipe does not wrinkle, the highest strains in the pipeline would be about +2.6% (tension) and -9.8% (compression). The comparison of the axial and bending strains clearly shows that the bending strain is numerically larger (-6.2% bending vs. -3.6% axial), suggesting that the onset of wrinkling is caused primarily by the high bending moments. This suggests that computational models which ignore the effect of pipe bending near the fault cannot accurately predict the onset of pipe wrinkling. Once wrinkles occur, the imposition of additional fault offset will tend to distort the pipe mostly at the wrinkled locations, due to the "softening" of the pipe at those locations, with little increase in deformations in the

pipeline at non-wrinkled locations. As wrinkling proceeds at wrinkled locations, the local bending in the pipe, coupled with hoop stress, will ultimately result in localized pipe strains in excess of the rupture capacity of ductile steel, somewhere in the 20% to 30% (local) range. Figures 7-2 through 7-5 show both sides of the two main wrinkled locations in the pipeline; the distortions in these wrinkles would suggest that localized strains likely exceeded 20% in many locations; it is surprising that only one tear (rupture of the pressure boundary) of the steel actually occurred.

- The nominal allowable compressive strain is -1.44%. At this level of strain, some bulging of the pipe would occur.
- If the acceptance criteria allows the pipe to initiate wrinkle, but not to allow the wrinkle to excessively deform (-1.44%), then this design for this fault offset "fails". Perhaps a better design would have been to use a pipe alignment that would allow net tension across the fault (not net compression), and then select D/t on the order of 50. This would result in much higher capacity against wrinkling. Possibly, the trench backfill could have been engineered with pea gravel or similar granular or soft backfill material, which would reduce the curvature of the pipe, and hence reduce the bending moments. From a cost perspective, having $D/t = 50$ means having a wall thickness of 44 mm, which is much thicker (and costlier) than is needed to carry the internal pressure. However, examining Figure 7-13, the length of pipe subject to high bending / strains is about 200 feet; so the extra heavy wall pipe need only be specified for that length, and thinner wall pipes can be selected beyond those zones, careful to assure that the thinner wall pipes can still take the high axial anchor forces which extend for a much wide zone (see Figure 7-12 top). Practically speaking, a better designed pipe might have $D/t = 50$ for 200 feet, $D/t = 90$ for 800

feet, and $D/t = 122$ (maximum to accommodate the internal pressure) beyond; if the local site conditions permit, a pea-gravel trench through the primary fault offset zone can be a good design feature. The incremental cost for such a design can be modest in context of the complete pipeline cost, as the length of pipe so requiring the special fault offset features is relatively short.

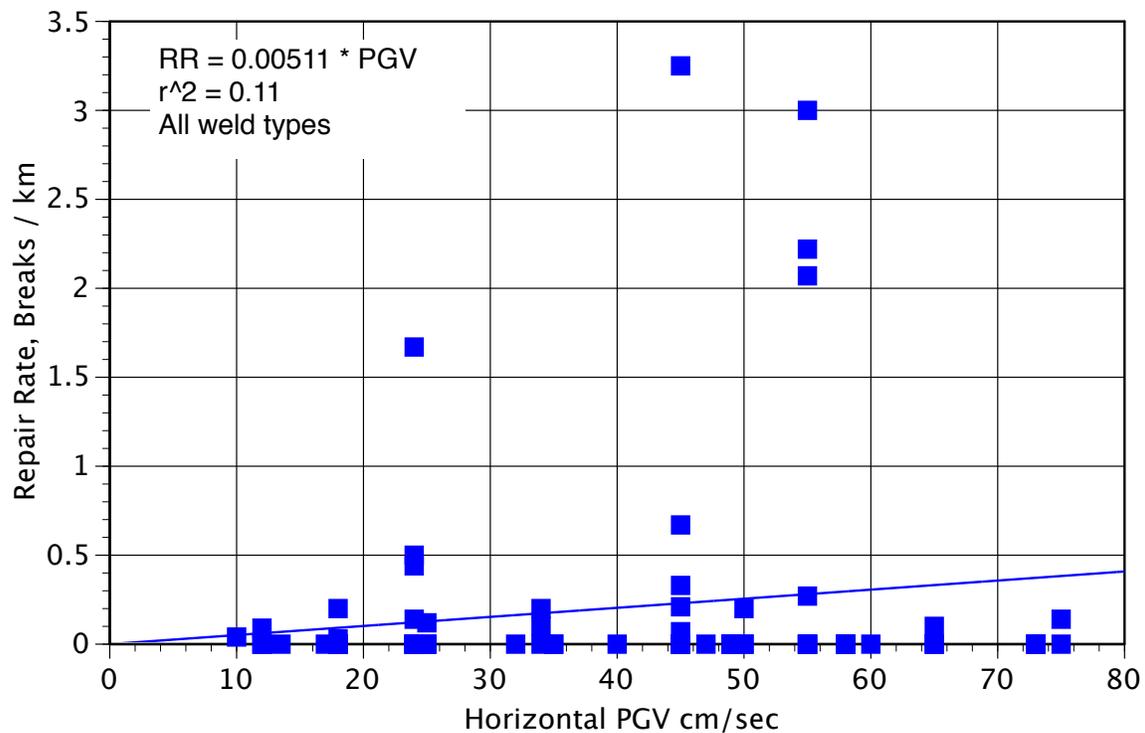
Figure 8-1. Repair Rate, Ground Shaking, Steel All Weld Types, All Ages, SoCalGas

Figures 8-1, 8-2 and 8-3 shows the SoCalGas gas transmission pipe repair rates due to ground shaking, (excludes pipes exposed to fault offset or liquefaction or landslide). All these pipes were steel. Most repairs were to the main barrel of the pipe (mostly at girth welds, a few cases of pipe wrinkling or leaking flanges). This historical data set does not include damage to appurtenances; this is not to say that this type of damage did not occur.

- Figure 8-1. Includes pipes from 1921 to 1994 vintage. All data are for steel pipe, using both oxy-acetylene welds (generally pre-1928) or arc welded (generally post-1931). Pipe diameter (nominal) 6 to 30 inches.
- Figure 8-2. Includes only arc welded pipes from 1926 to 1994 vintage. All data are for steel pipe. Pipe diameter (nominal) 10 to 30 inches. Total repairs 2.
- Figure 8-3. Includes only oxy-acetylene welded pipes from 1921 to 1927 vintage. All data are for steel pipe. Pipe diameter (nominal) 6 to 26 inches. Total repairs 81.

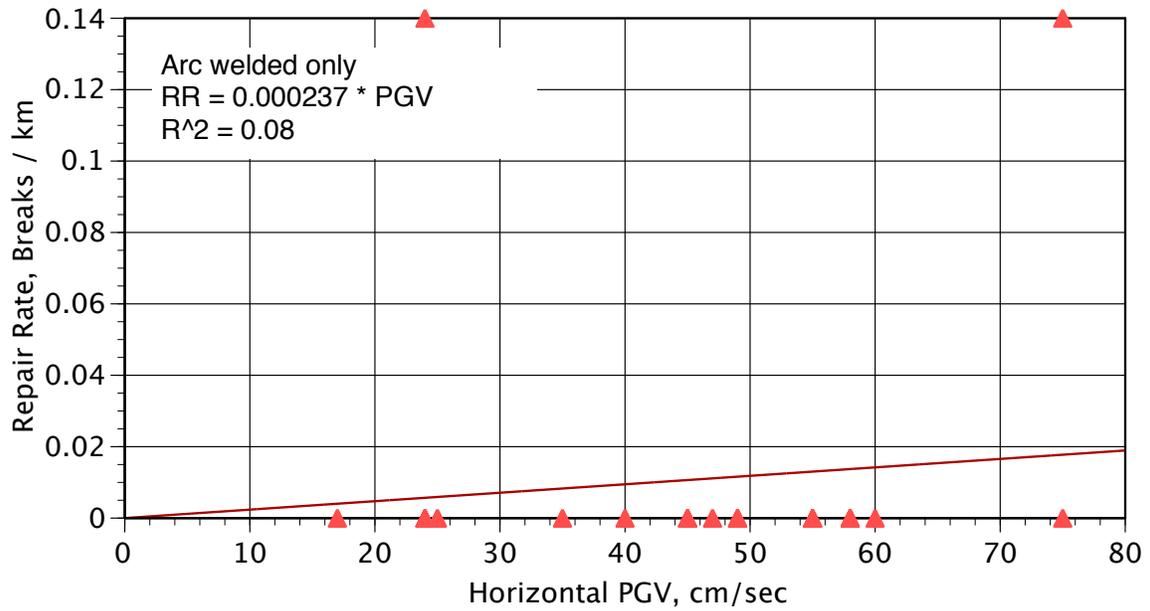
Figure 8-2. Repair Rate, Ground Shaking. Steel Arc Welded Steel Pipes Only – SoCalGas Transmission Pipes

There is nearly a 38-fold difference in the capability of steel pipes between Figures 8-2 (generally post 1930) and 8-3 (generally pre-1929). Some researchers initially attributed this to the differences between older-style oxy-acetylene girth welds versus more modern electric-arc welds. But other researchers doubt this to be the case, as well made welds, using either technique, are equally as strong; although the heat affected zone for oxy-acetylene-made welds tends to be larger than for arc-welds, suggesting perhaps lower ductility. However, for ground shaking effects, say at $PGV = 20$ inch/sec, vertically-propagating shear waves from the earthquake, assuming a propagation speed of 12,000 feet/sec, and no slippage between the pipe and ground, should only result in about 2 ksi tensile or compressive longitudinal stress in the barrel of the pipe. $\pm 2 \text{ ksi} = 29,000 \text{ ksi} * [20 \text{ inch/sec} / (2 * 12,000 \text{ feet} / \text{sec} * 12 \text{ inch} / \text{feet})]$. Even if one adopts 2 times stronger ground velocities (40 inch/sec), and double the ground strains to reflect local topography conditions, one only obtains ± 8 ksi longitudinal stress in the main barrel of a straight pipe. So, one would rarely expect yielding of full penetration welds; and yet the empirical evidence shows many failures. Why?

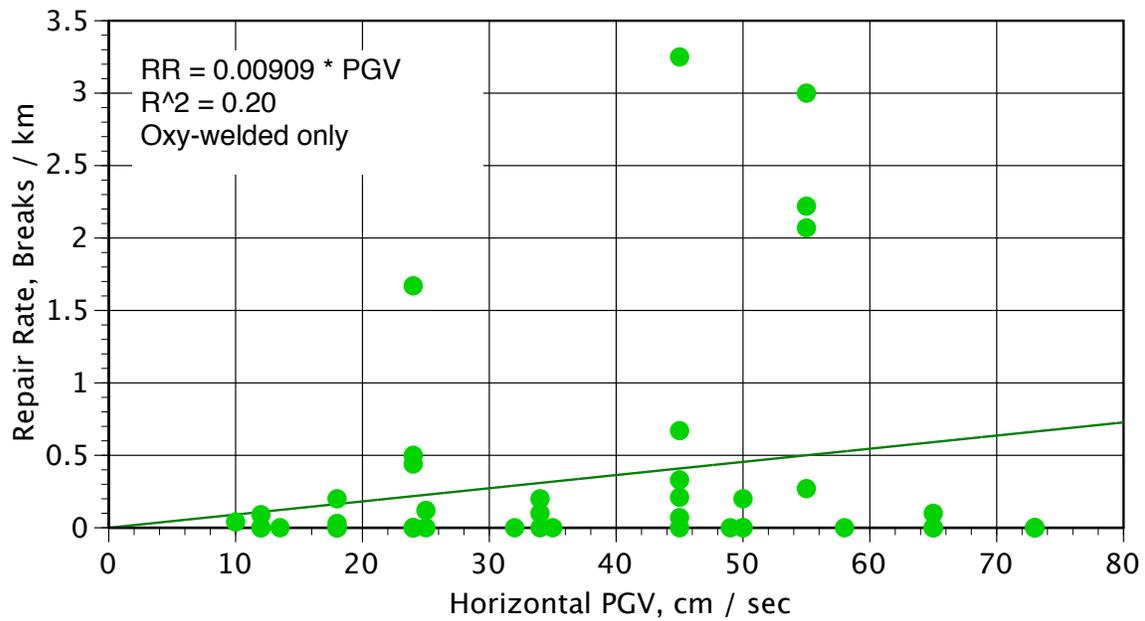
Figure 8-3. Repair Rate, Ground Shaking, Steel Oxy-Acetylene Welded Pipes Only SoCalGas Transmission Pipes

- Considering all the above explanations, one gets a plausible overall rational explanation for the much higher failure rate for SoCalGas's pre-1930 pipe: the welds were poor quality (primary reason), and the ground motions / ground strains were locally much higher than would be predicted using median-based PGV (secondary reason). This implies that any welded steel gas pipe (whether using older oxy-acetylene welds or modern electric arc welds) will fail prematurely in earthquakes if the girth welds are defective (in particular, not full penetration; or with significant internal flaws) in such a manner that the pipe cannot sustain mild yielding in tension under large ground motions, becoming especially important when PGVs are over 50 cm/sec.

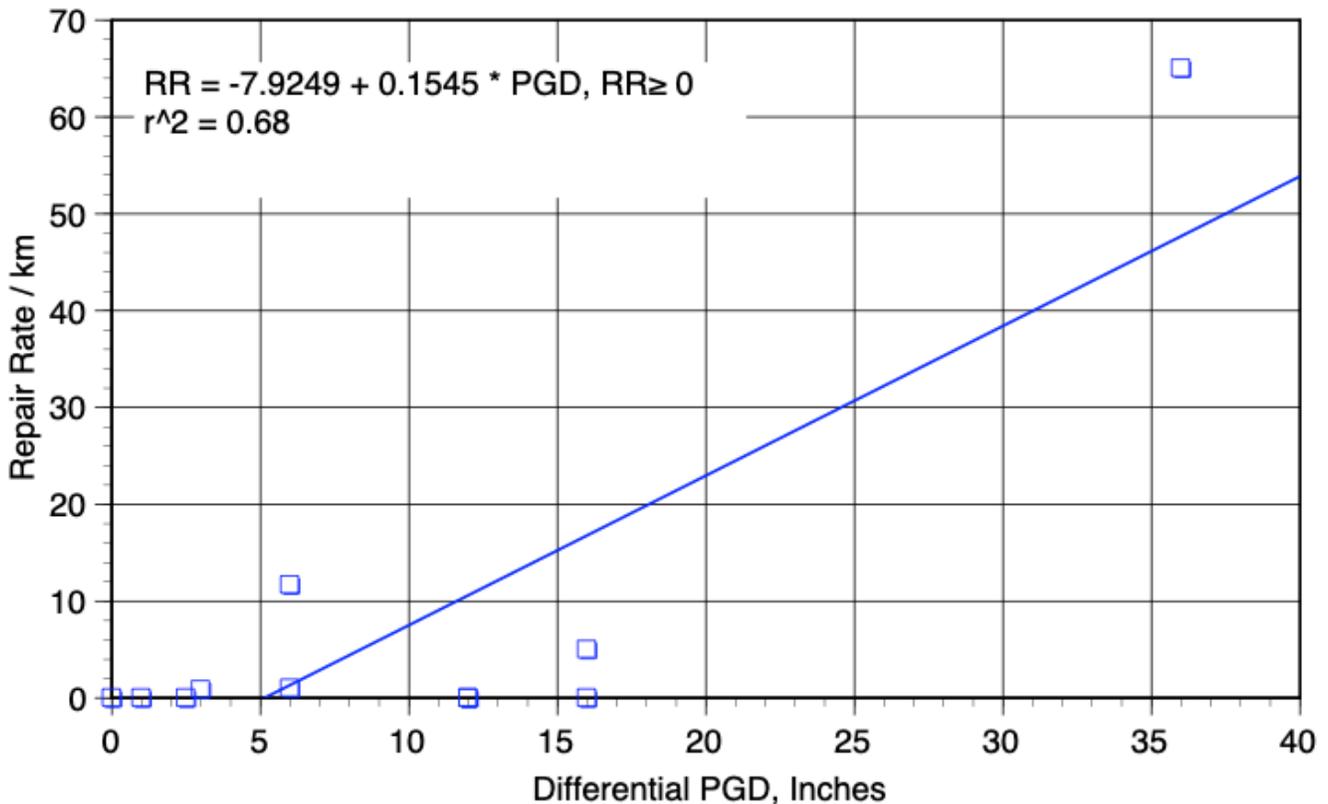
Figure 8-4. Repair Rate, Permanent Ground Deformations, SoCalGas Steel Pipe

Figure 8-4 shows the repair rates for steel gas transmission pipes, due to differential PGDs. By "differential", it is meant that if the pipe was exposed to a near constant settlement of 2 inches, it would have essentially zero imposed stresses; it is differential PGDs that imposes stress in a pipe.

For PGDs under about 2 to 3 inches, the historical rate of SoCalGas' welded steel pipe failures is essentially nil. Above 3 inches, the historical repair rate becomes significant.

Some of the pipe damage included in Figure 8-4 occurred due to liquefaction effects; primarily in the 1971 San Fernando earthquake, where large lateral spreads transverse to the pipe led to many pipe failures in and adjacent to the PGD zone. In the 1933 Long Beach earthquake, current understanding suggests that Line 765 was exposed to between 1 and 3 inches of settlement PGDs; the available records do not indicate the pipe was exposed to lateral spreads; and the pipe had no repairs. This is interpreted to mean that the settlement PGDs were not especially sharp (not generally knife-edge); and thus might not have loaded the pipe excessively.

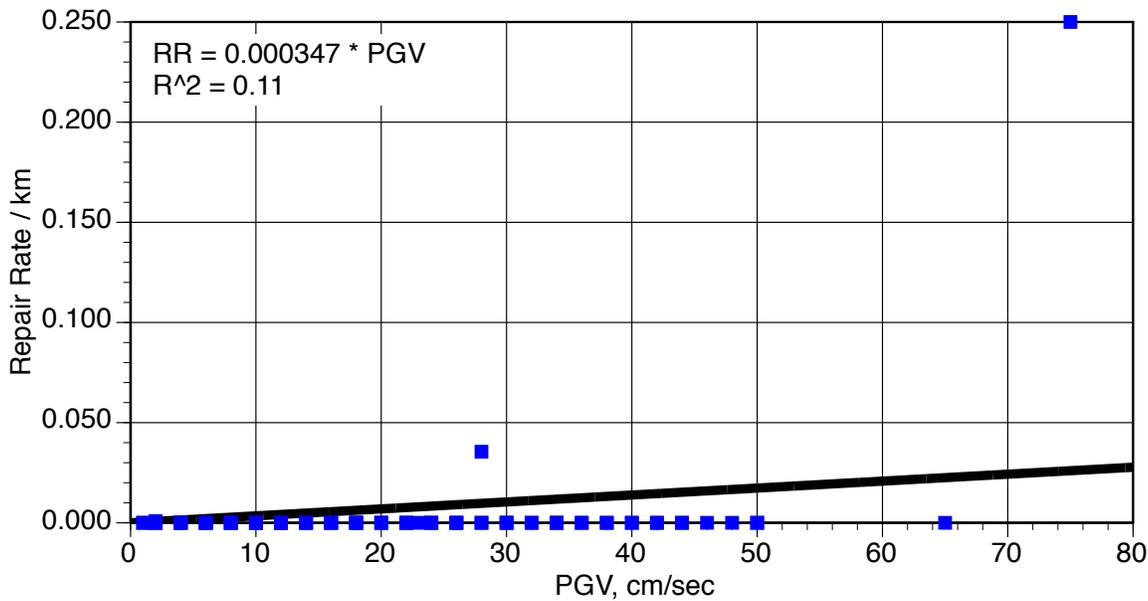
Figure 8-5. Repair Rate, Ground Shaking, PG&E Steel Transmission Pipes

Figure 8-5 shows the empirical dataset with repair rates for PG&E's gas transmission pipes due to ground shaking (2019 Ridgecrest, 2014 Napa, 2010 Eureka, 2007 Alum Rock, 1952 Kern County). The horizontal axis PGV represents the highest horizontal PGV of two orthogonal directions. The black line shows the least square regression through the dataset. The repair rate for PG&E transmission pipes is $0.000347 * PGV$, including both modern (vast majority) and older (≤ 1930 , minority) gas pipes. The corresponding historical repair rate for arc-welded SoCalGas pipes is $0.000237 * PGV$ (Figure 8-2).

Unlike the SoCalGas pipes, the empirical data for PG&E's pipes shows no obvious tendency for higher repair rates for pre-1930 pipes.

All of the repairs in Figure 8-5 were to appurtenances, corrosion or to equipment; none were described as girth weld tension failures or pipe wrinkling. All these repairs are assigned DS2.
